Investigation of Concrete Sidewalk Scaling by Petrographic Examinations Of A Concrete Core

Traditions of America
1076 Constitution Drive
Lititz, Pennsylvania 17543

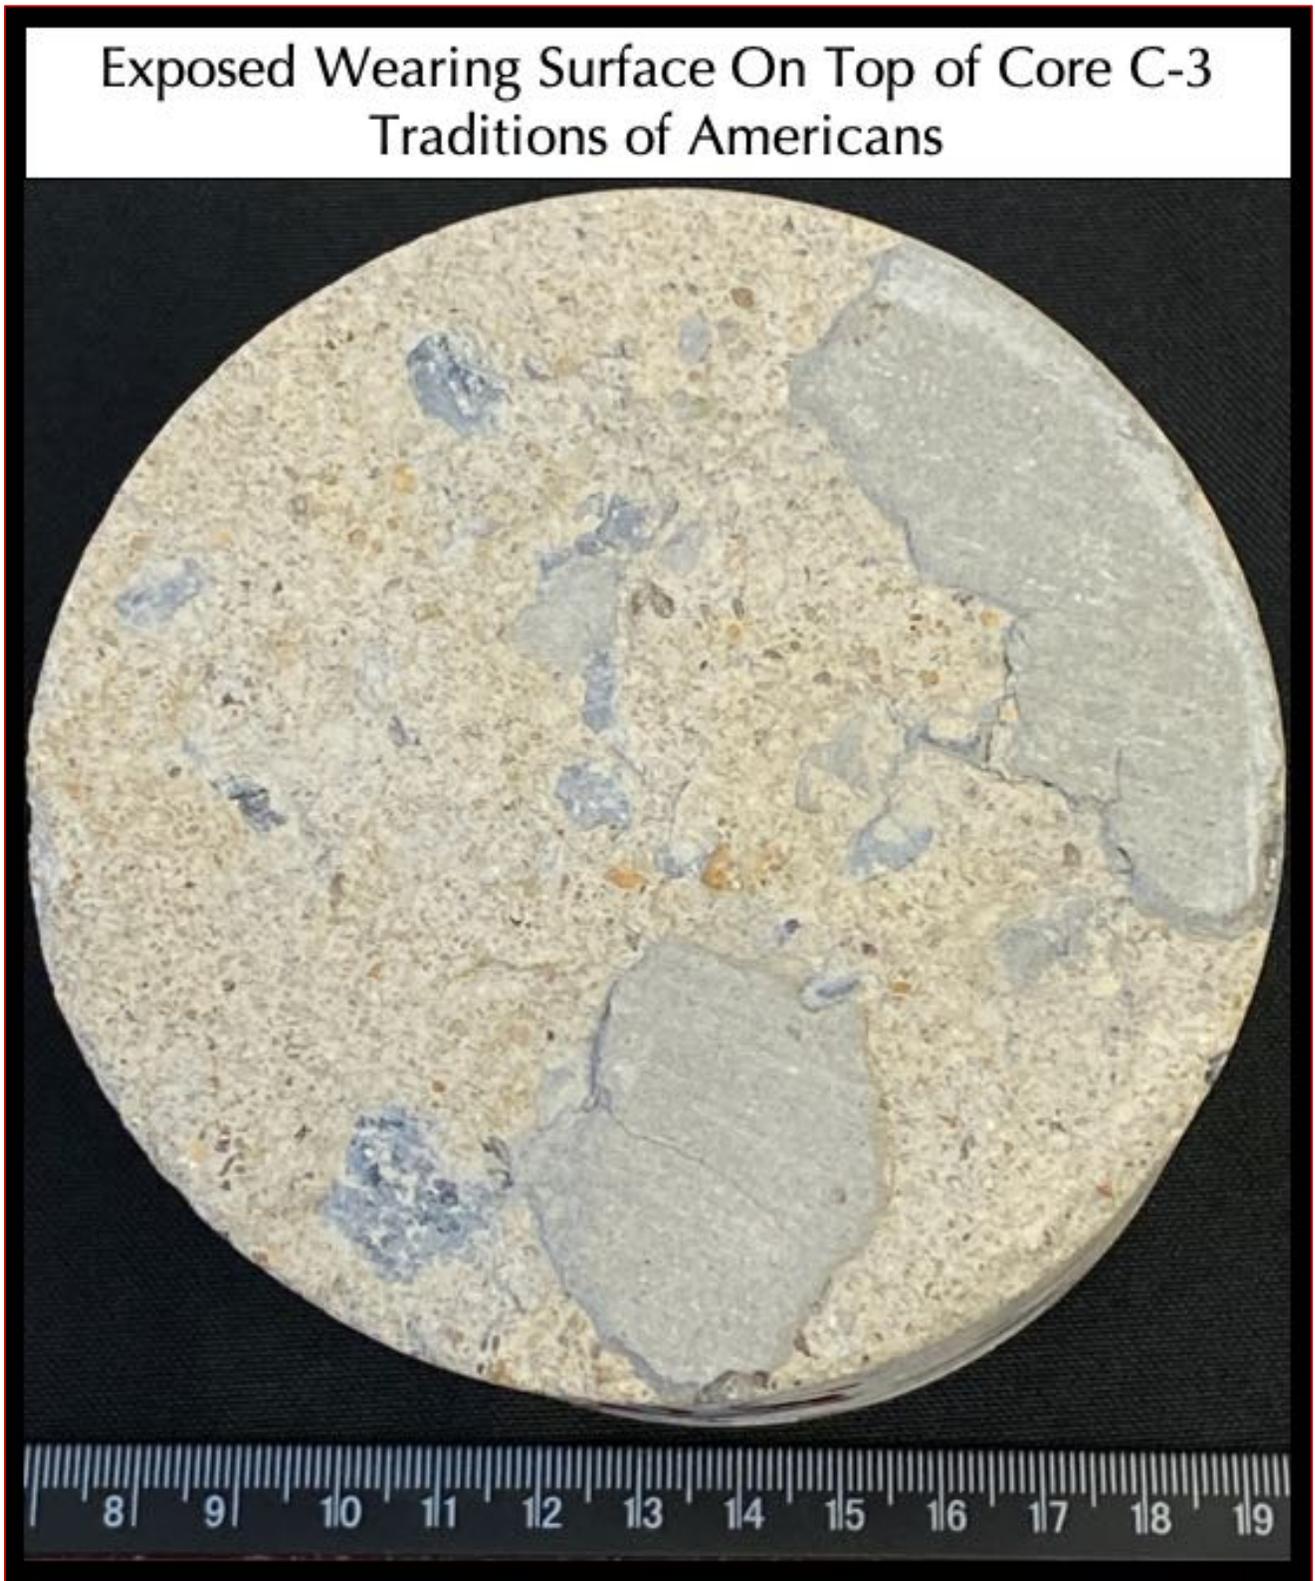
The top exposed/wearing surface shows severe scaling as loss of the original finished surface and exposures of underlying coarse aggregate particles and mortar fraction of concrete and remains of dark gray thin (thickness 5 mm) repair patch at two locations. The bottom end is freshly fractured indicating partial-depth recovery of core.

Figure 1: The top exposed surface of core showing severe scaling as loss of the original finished surface and exposure of underlying coarse aggregate and mortar fraction of concrete, and two remains of dark gray thin repair patches.

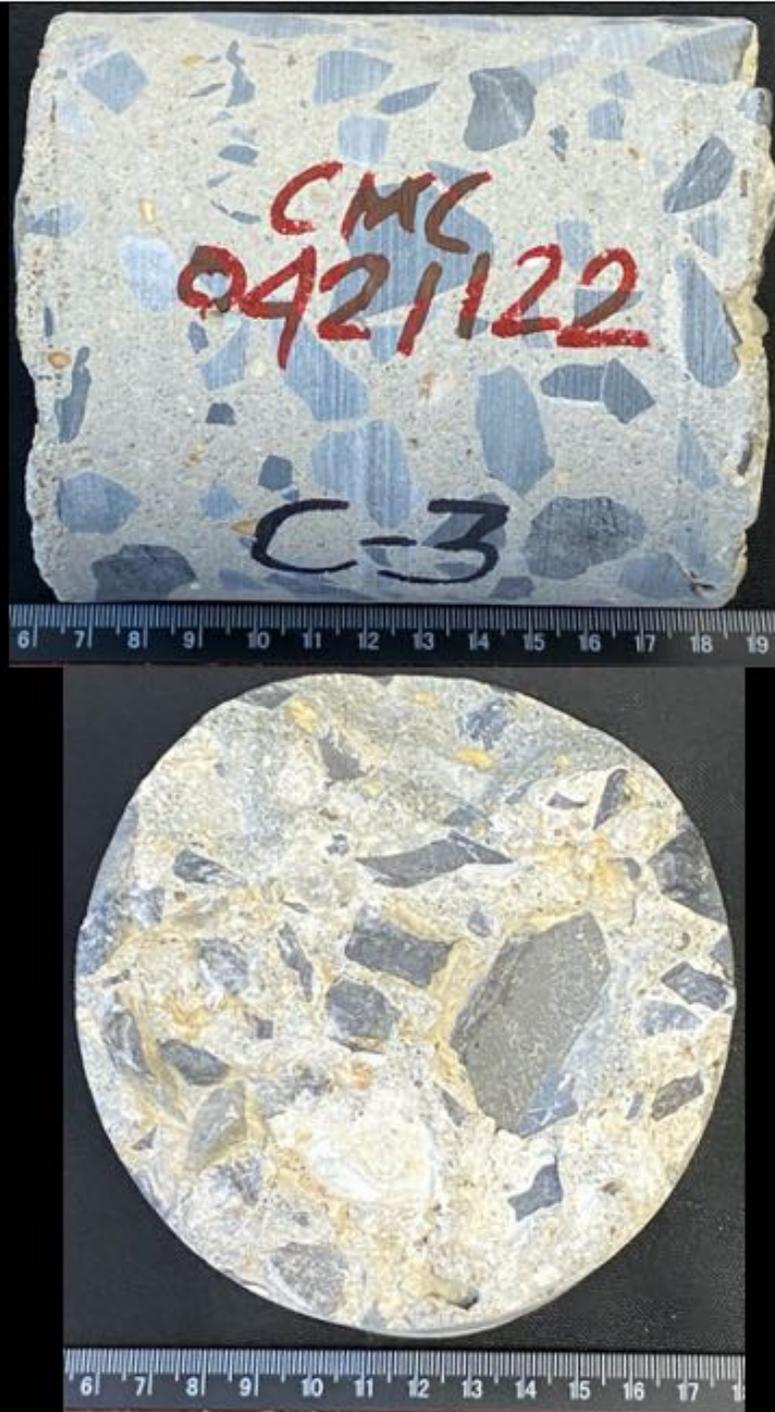
Side View (Top Photo) and Fresh Fractured Bottom End (Bottom Photo) Of Core C-3

Figure 2: The side cylindrical surface (top) and bottom fresh fractured end (bottom) of the core, as received indicating partial-depth recovery of core from the slab.

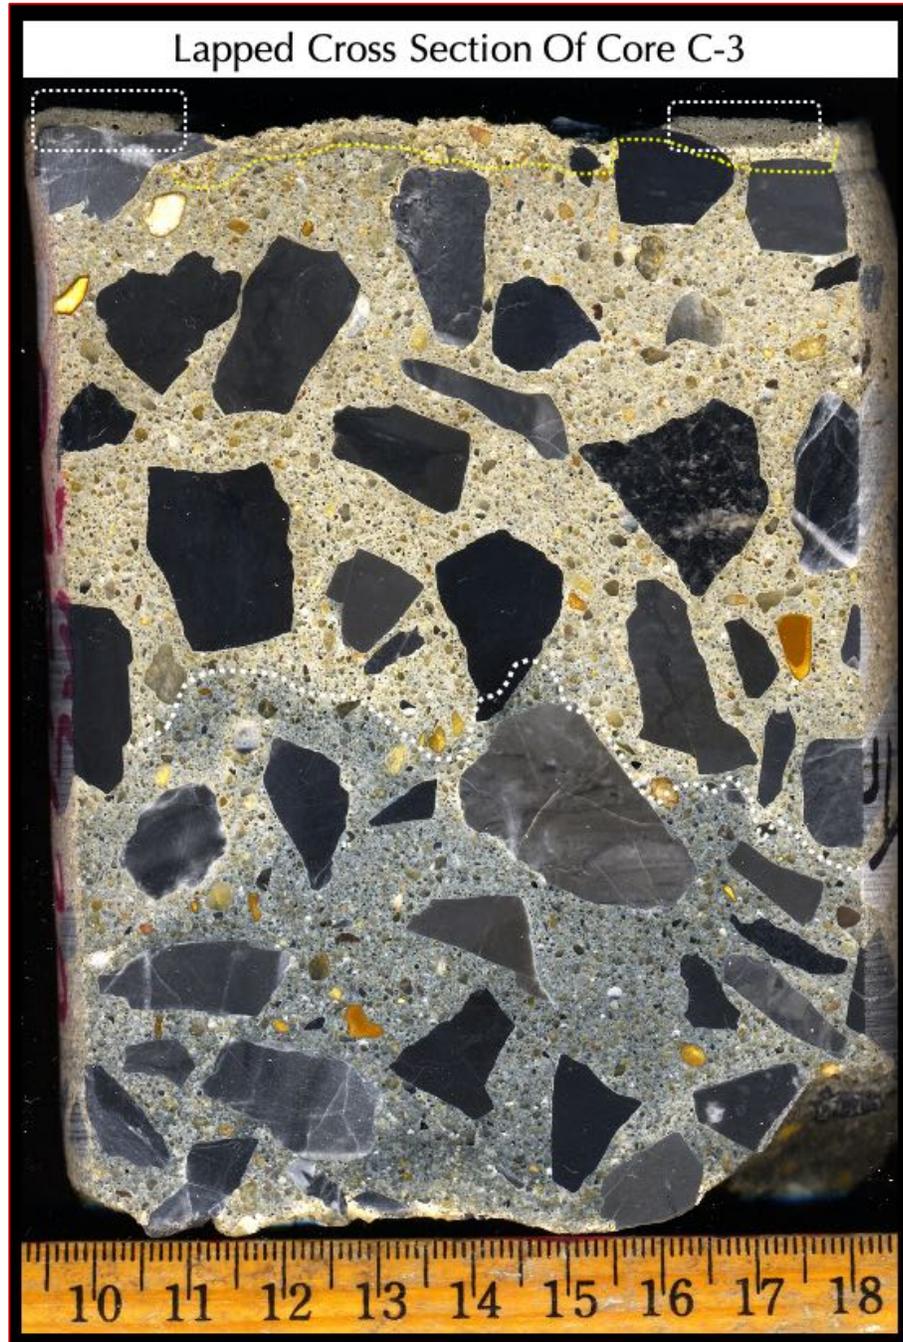
Figure 4: Lapped cross section of Core C-3 showing: (a) the scaled exposed surface end at the top; (a) a thin lighter gray colored paste at the top 3 to 5 mm compared to the relatively darker gray paste beneath and in the interior; (b) crushed stone coarse aggregate where particles are well-distributed but poorly graded due to the deficiency of some finer and intermediate-sized particles; (c) a darker gray tone of paste at the bottom half due to the presence of sulfide phases in the fly ash used as a supplementary cementitious material; and (d) two dark gray 4 to 5 mm thick remains of repair patch at two ends at the top (boxed) that are adhered to the concrete.

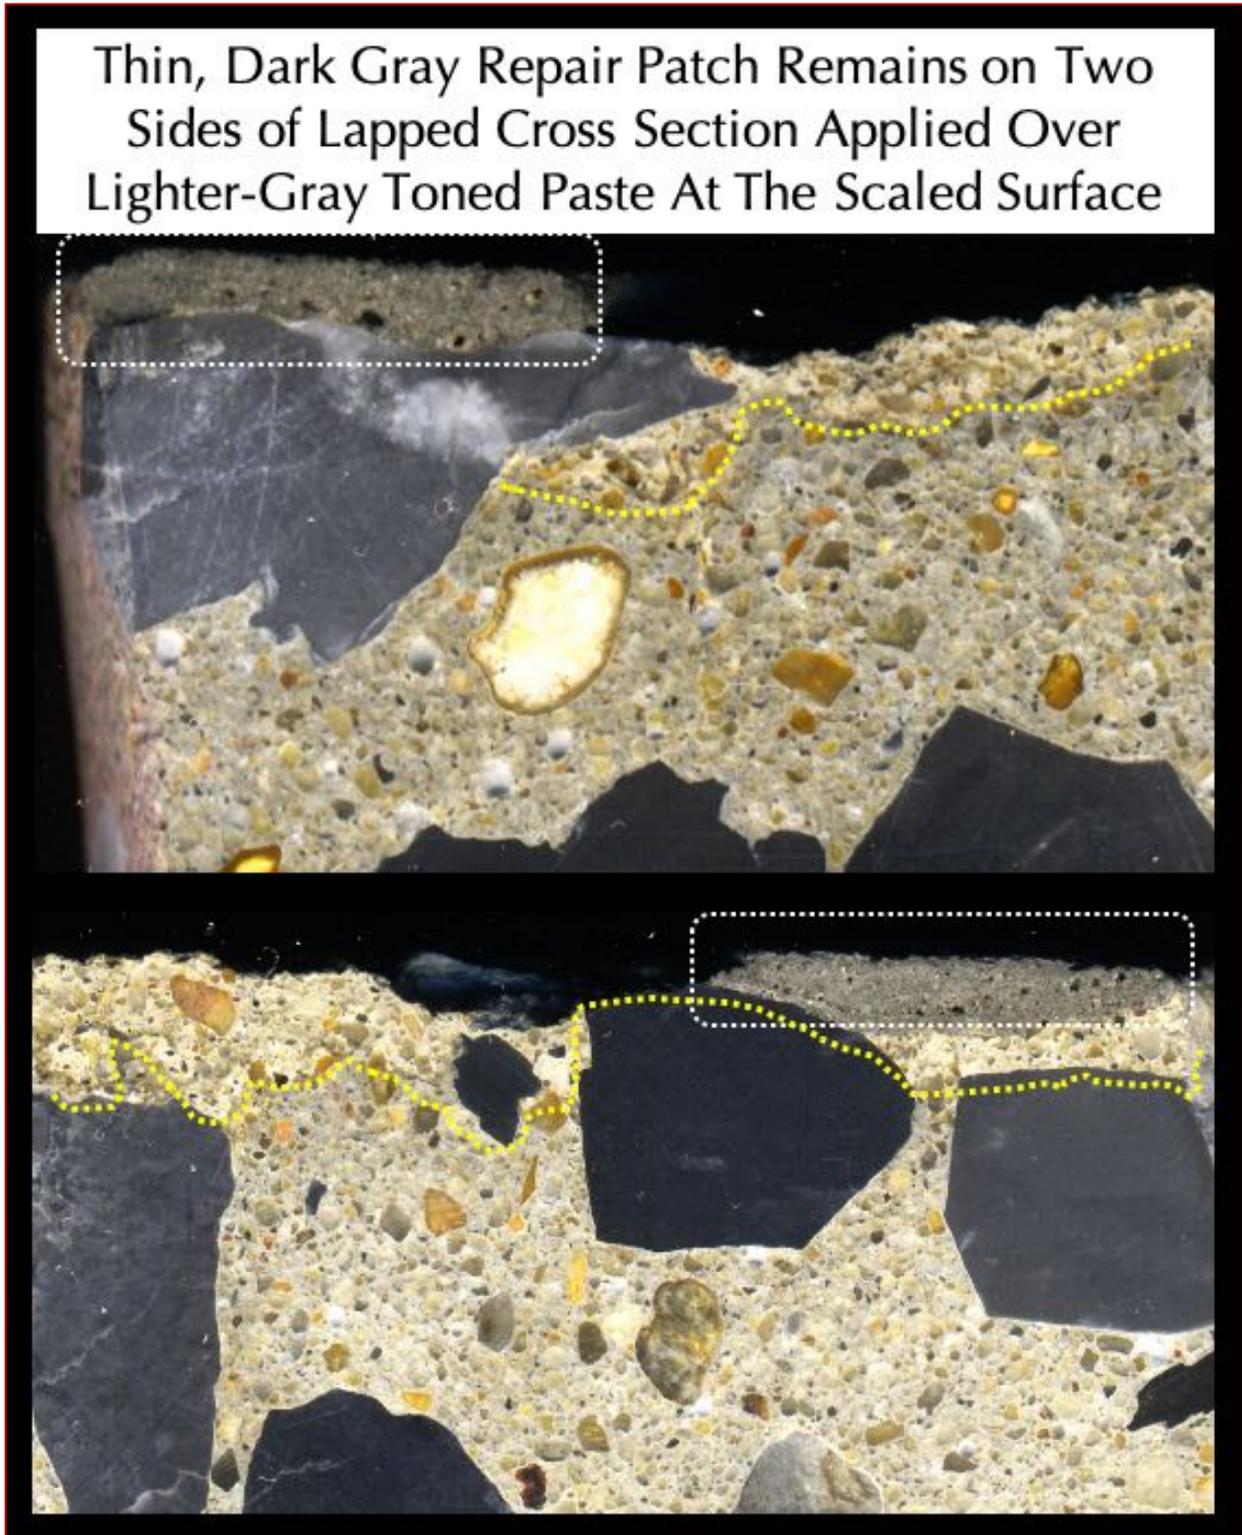
Figure 5: Lapped cross section of Core C-3 showing: (a) the scaled exposed surface end at the top; (a) a thin lighter gray colored paste at the top 3 to 5 mm compared to the relatively darker gray paste beneath and in the interior; (b) crushed stone coarse aggregate where particles are well-distributed but poorly graded due to the deficiency of some finer and intermediate-sized particles; (c) a darker gray tone of paste at the bottom half due to the presence of sulfide phases in the fly ash used as a supplementary cementitious material; and (d) two dark gray 4 to 5 mm thick remains of repair patch at two ends at the top surface (boxed) that are adhered to the concrete.

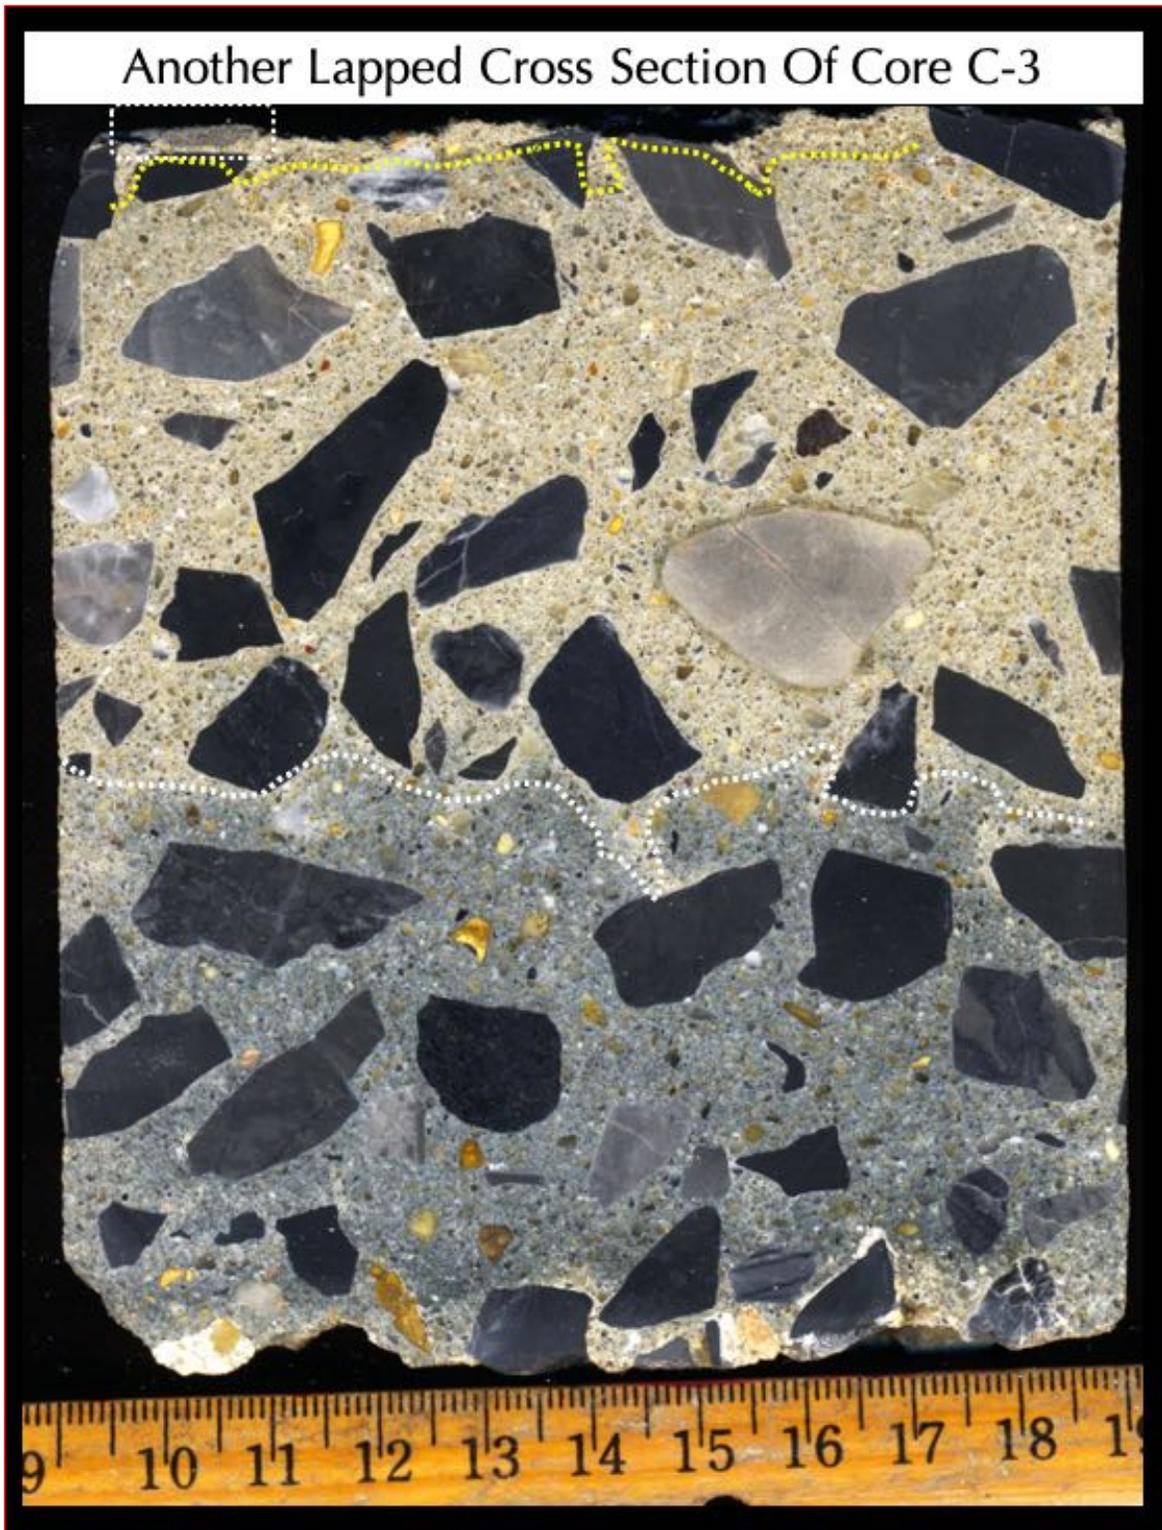
Figure 6: A second lapped cross section of Core C-3 sectioned parallel to the first one showing: (a) the scaled exposed surface end at the top; (a) a thin lighter gray colored paste at the top 3 to 5 mm compared to the relatively darker gray paste beneath and in the interior; (b) crushed stone coarse aggregate where particles are well-distributed but poorly graded due to the deficiency of some finer and intermediate-sized particles; (c) a darker gray tone of paste at the bottom half due to the presence of sulfide phases in the fly ash used as a supplementary cementitious material; and (d) a dark gray 4 to 5 mm thick remain of repair patch at the top left end (boxed) that is adhered to the concrete.

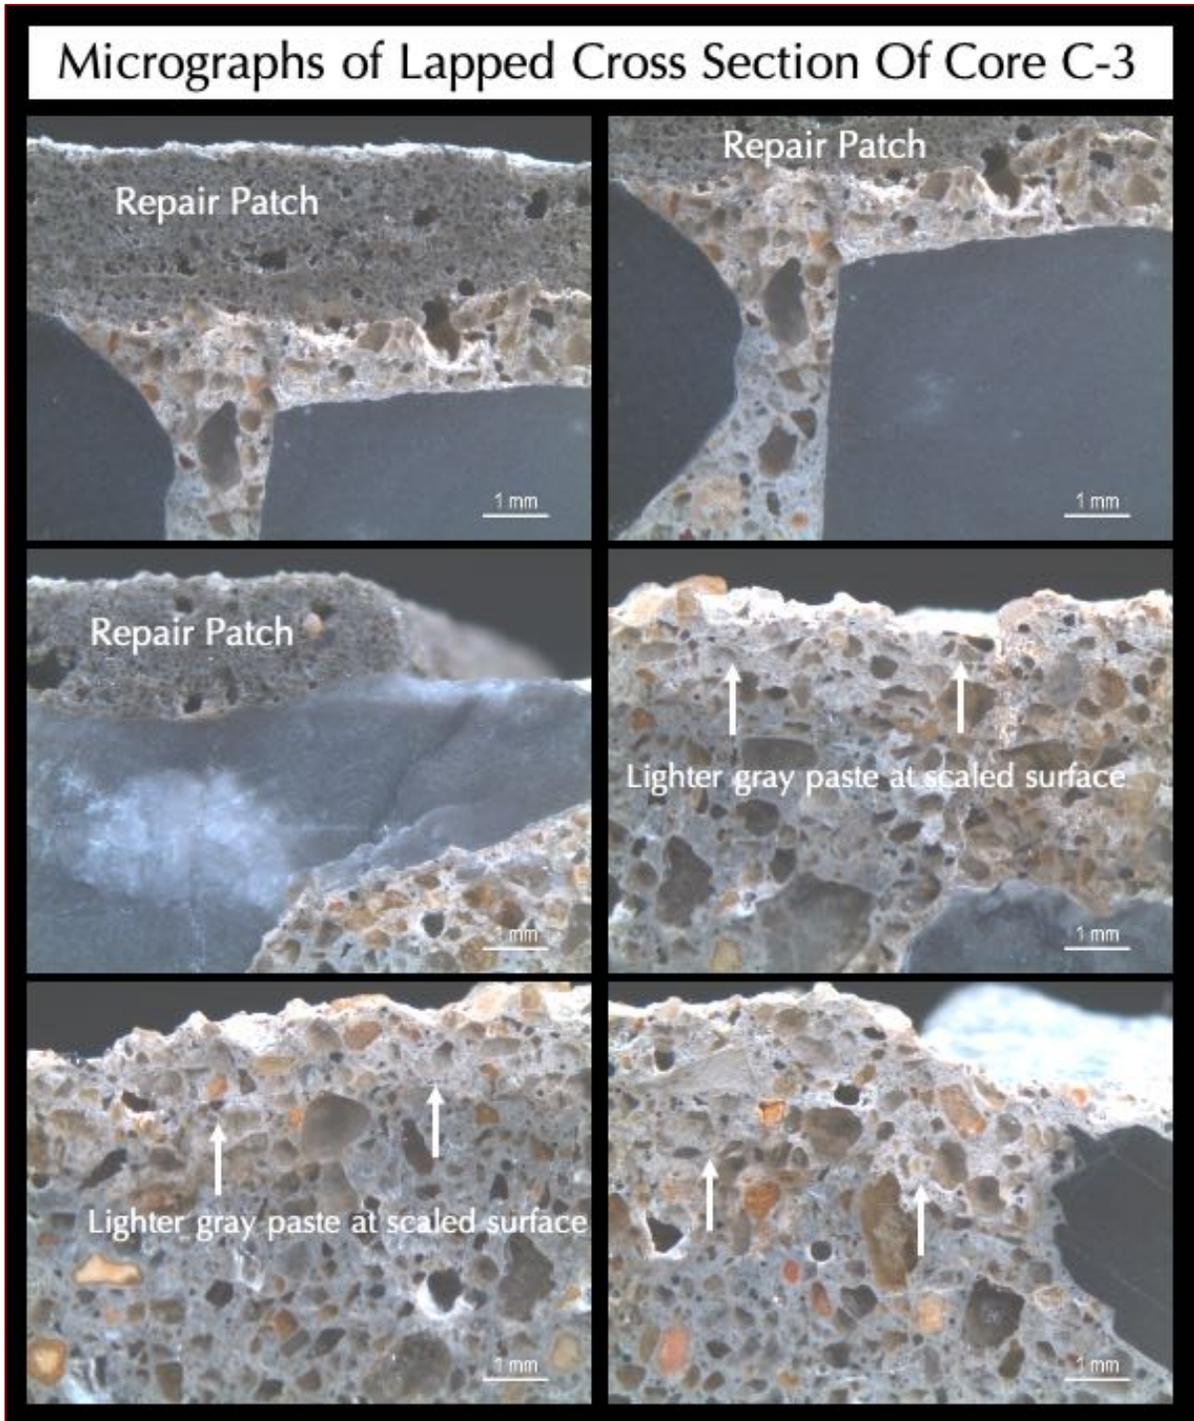
Figure 7: Micrographs of lapped cross section of the core showing: (a) the dark grey repair patch adhered to the scaled concrete surface; (b) lighter tone of paste at the top 3 mm of scaled surface due to higher water-cementitious materials ratio of paste at the scaled surface region (marked with vertical arrows) compared to the interior; and (c) lack of air entrainment in the concrete, or, in the repair patch except a few coarse spherical, near-spherical and irregularly-shaped entrapped air voids.

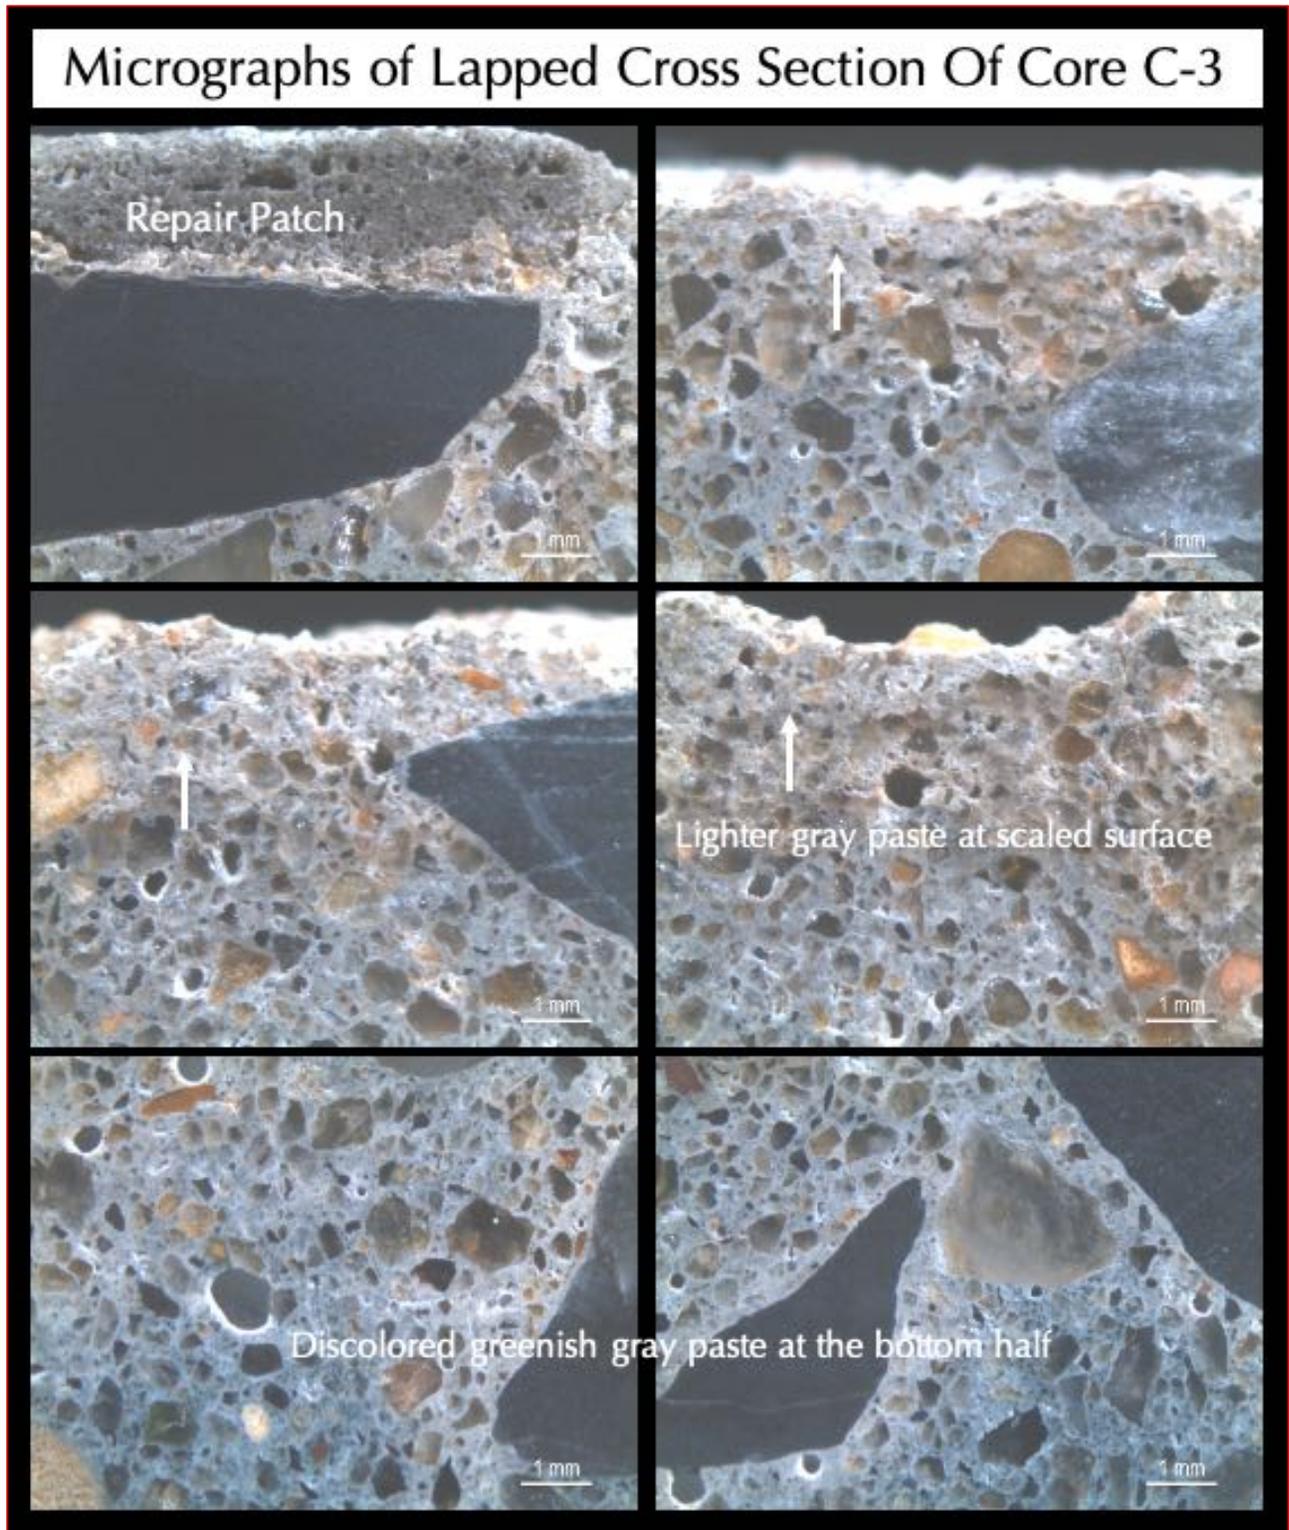
Figure 8: Micrographs of lapped cross section of the core showing: (a) the dark grey repair patch adhered to the scaled concrete surface; (b) lighter tone of paste at the top 3 mm of scaled surface due to higher water-cementitious materials ratio of paste at the scaled surface region (marked with vertical arrows) compared to the interior; and (c) lack of air entrainment in the concrete, or, in the repair patch except a few coarse spherical, near-spherical and irregularly-shaped entrapped air voids.

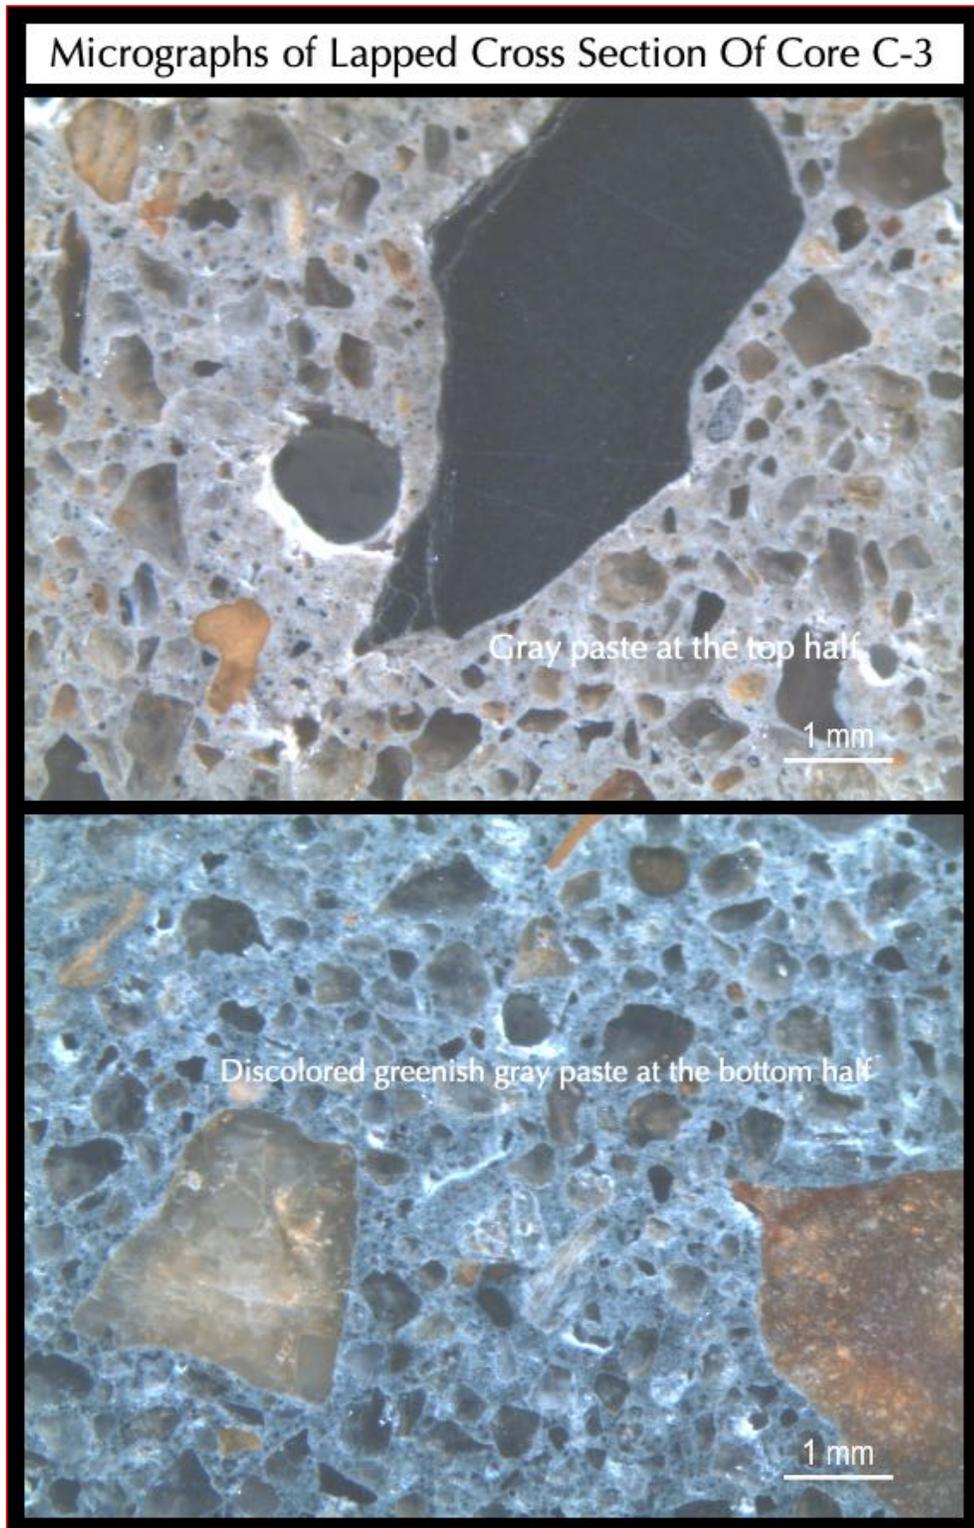
Figure 9: Micrographs of lapped cross section of the core showing the contrasting color tones of paste at the top half of core (top) versus the bottom half (bottom) due to the presence of sulfide phases in the fly ash used as a supplementary cementitious material which has imparted the greenish tone, whereas oxidation of binary Portland cement and fly ash paste has changed the original green discoloration to medium gray at the top half (except the very top 5 mm where paste is even lighter gray).

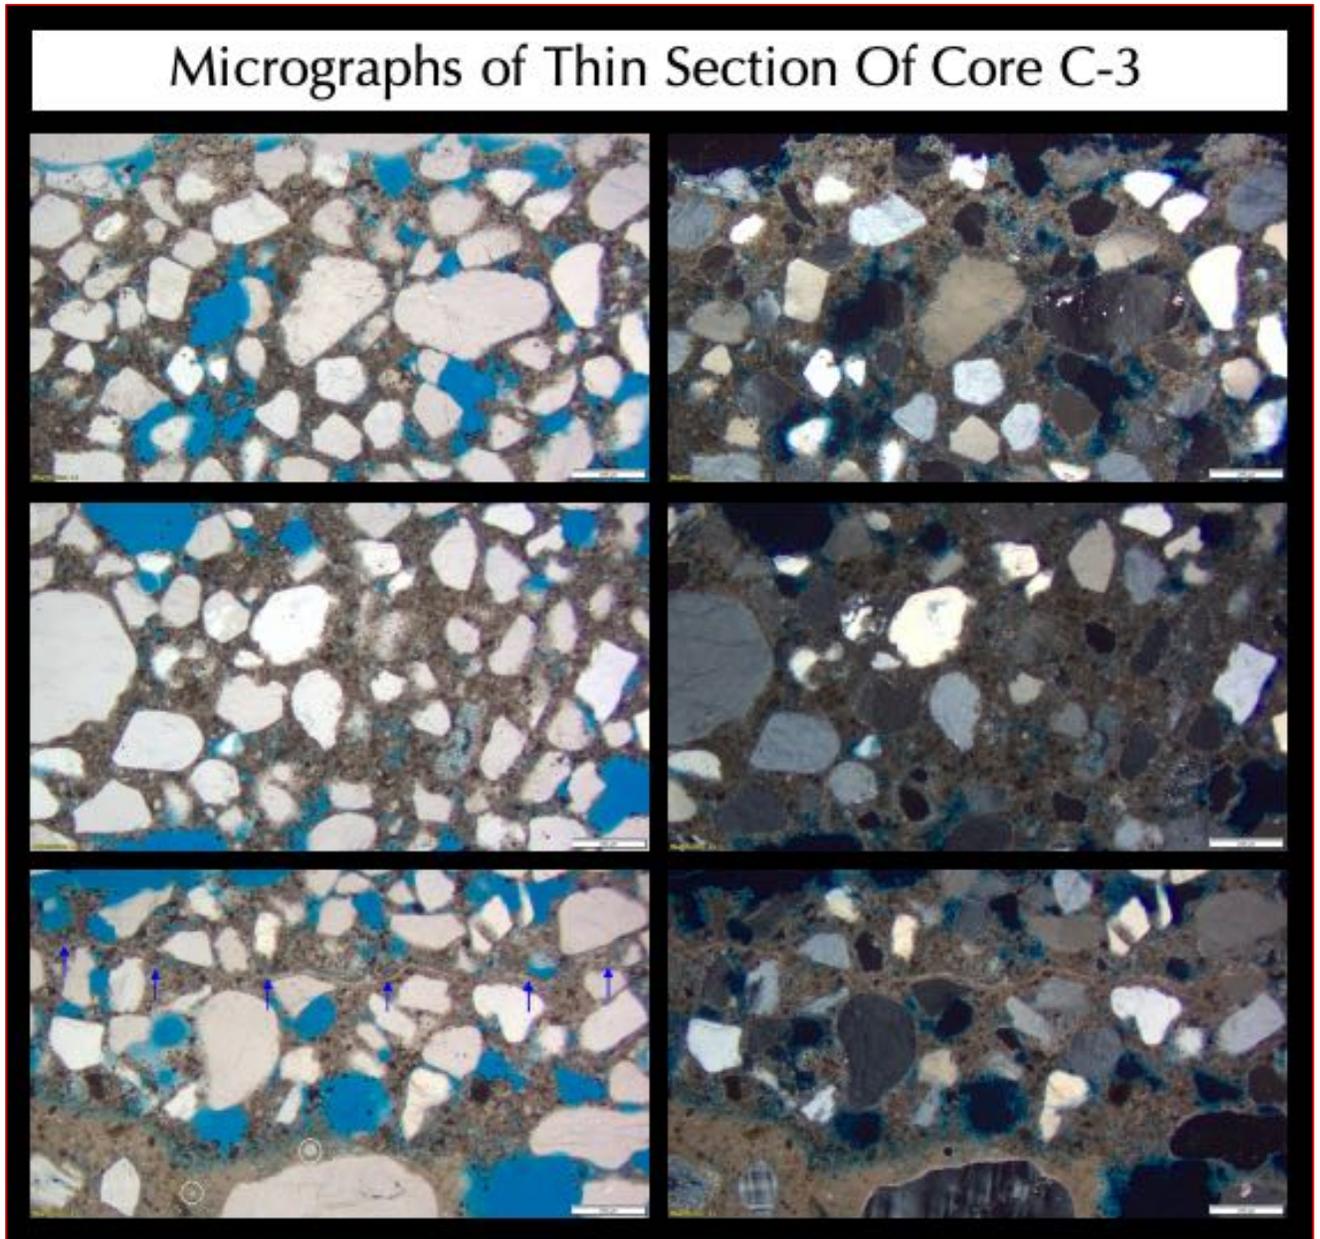
Figure 12: Micrographs of blue dye-mixed epoxy-impregnated thin section of core showing the dark gray repair patch consisting of fine quartz sand less than 1 mm in size, and dense, low water-cement ratio (estimated to be <math><0.40</math>) Portland cement paste; and carbonation of pate in the repair grout from interaction with atmospheric carbon dioxide.

Remains of two dark gray 4 to 5 mm thick repair patch are found loosely adhered to the scaled surface at the two ends of exposed surface of core. The patch contains fine silica sand (less than 1 mm in size), and dense Portland cement paste having a water-cement ratio estimated to be less than 0.40.

Loss of the repair patch from most of the exposed surface of core except only two isolated remains of such patch indicate inadequate bond of the patch to the underlying concrete, which could be due to ineffective surface preparation of concrete before installation of the patch, or thin application of patch or other reasons not evident in the present study.

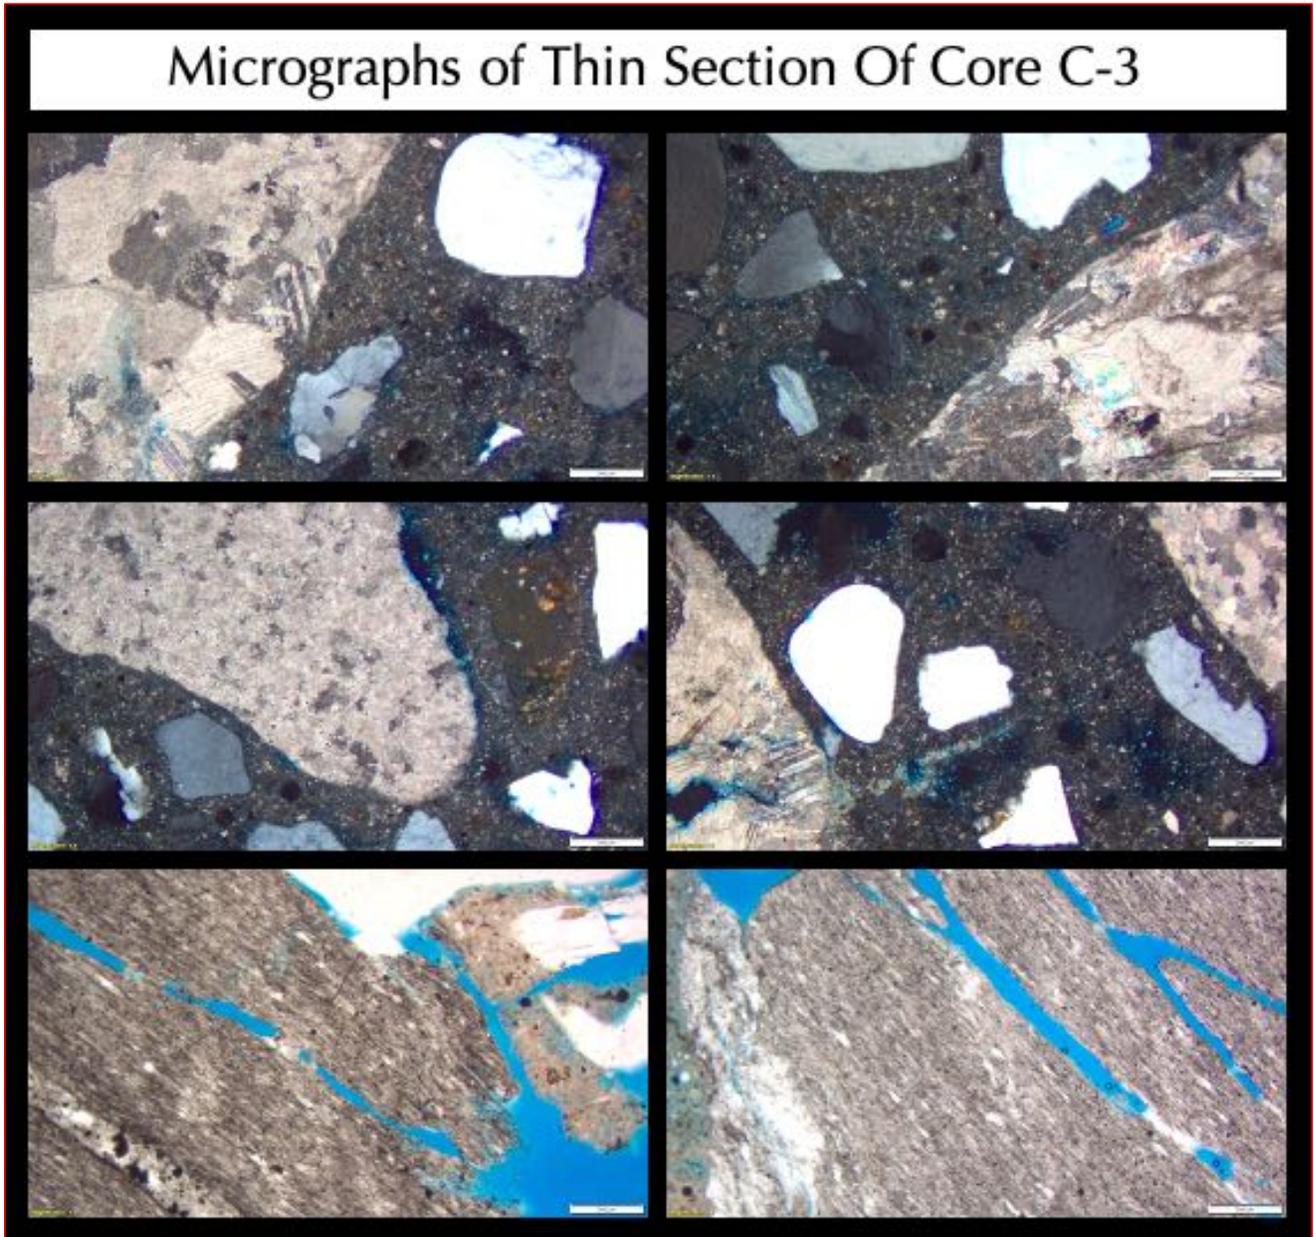
Figure 16: Micrographs of thin section showing crushed limestone coarse aggregate and silica sand fine aggregate in top and middle rows. However, the bottom row shows a near-surface dark gray shale particle in coarse aggregate, which has developed cracking within the particle and in neighboring paste. Such shale particles are potentially deleterious to concrete when exposed to near-surface region where the particles can absorb moisture and expand to cause pop-outs, which can also develop from subsequent freezing at saturated conditions.

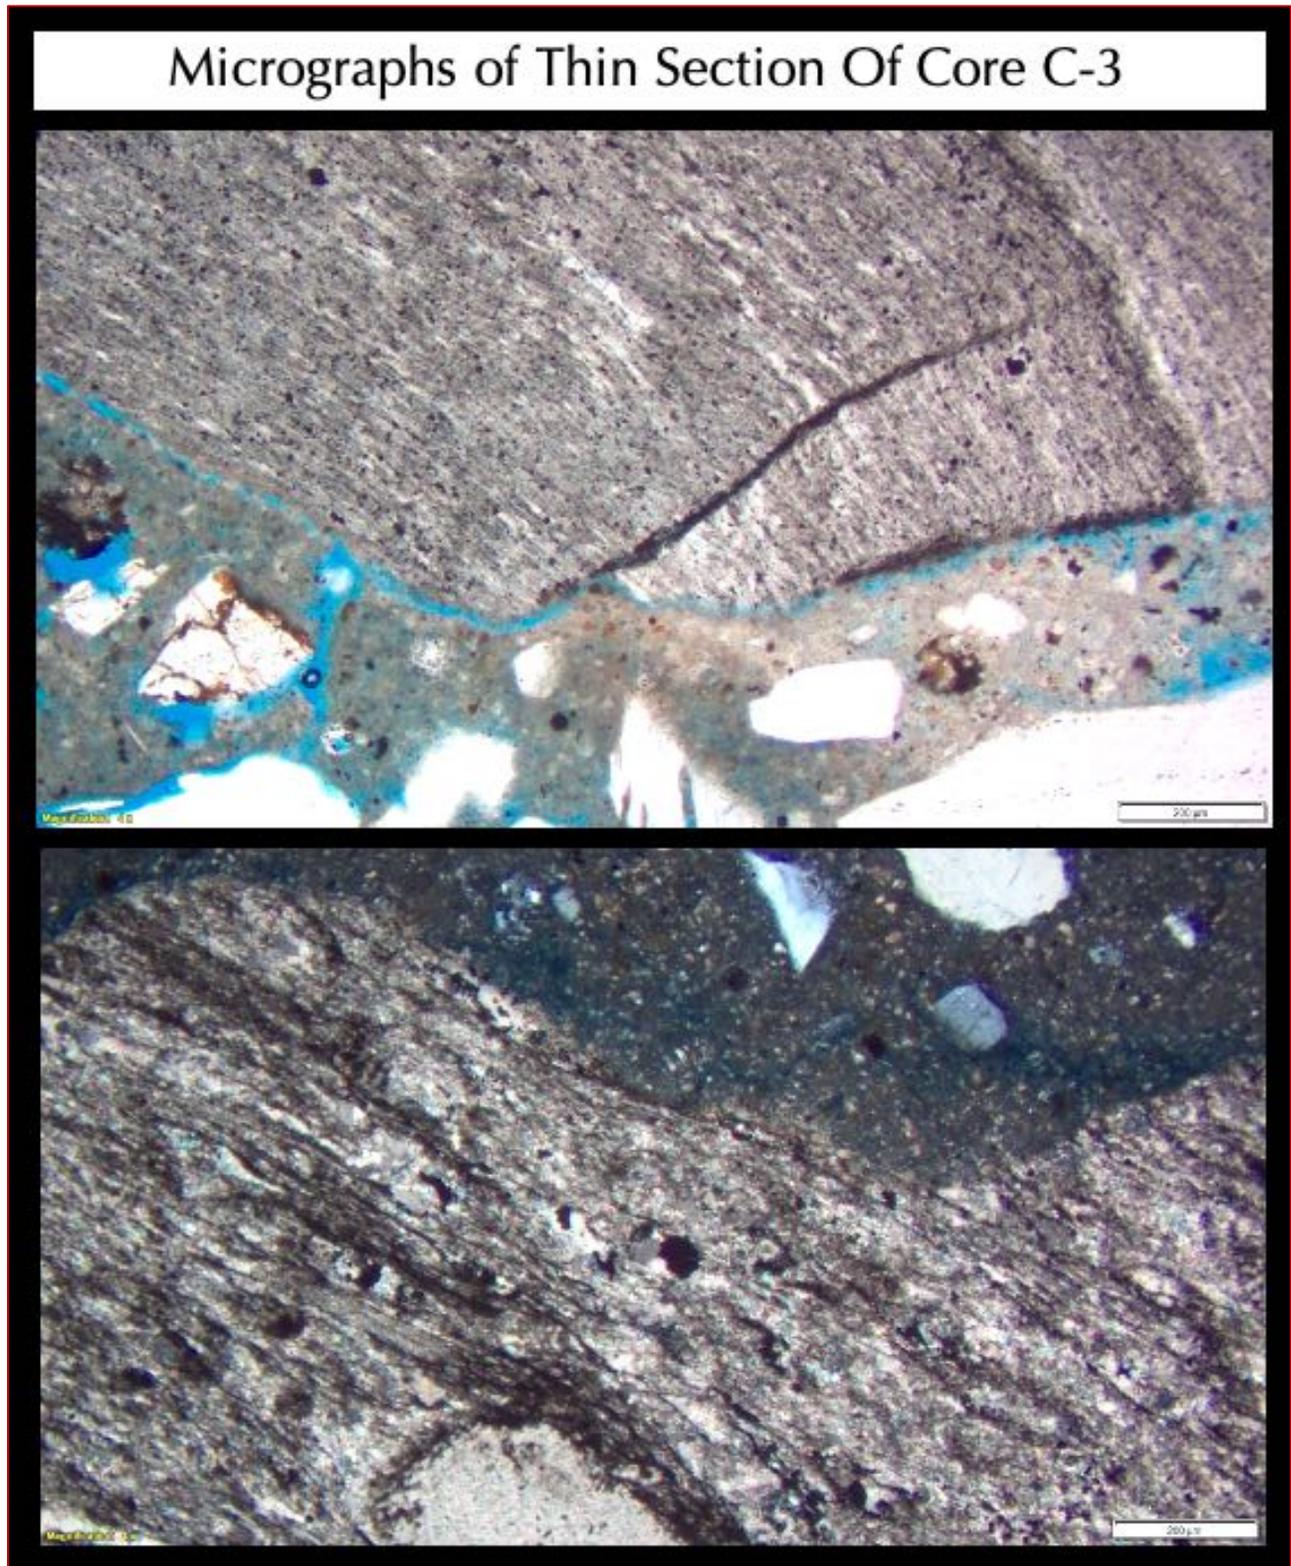
Figure 17: Micrographs of thin section showing a near-surface dark gray shale particle in coarse aggregate, which has developed cracking within the particle and in neighboring paste. Such shale particles are potentially deleterious to concrete when exposed to near-surface region where the particles can absorb moisture and expand to cause pop-outs, which can also develop from subsequent freezing at saturated conditions.

There are, however, a few dark gray crushed shale particles found near surface region of concrete which has developed potential unsoundness as cracking within the unsound shale particles as well as in the neighboring paste which are judged to be due to expansions associated with absorption of moisture from the surface along with potential additional expansions from freezing at moisture-saturated conditions.

- (b) Potentially deleterious effects of some crushed shale particles in coarse aggregate, which can cause pop outs from moisture absorption and subsequent freezing;
