Laboratory Studies of a Mortar Coating Sample From a Prestressed Concrete Cylinder Pipe

Englewood 24-inch Transmission Main
Dean Street, Englewood, New Jersey

EXECUTIVE SUMMARY

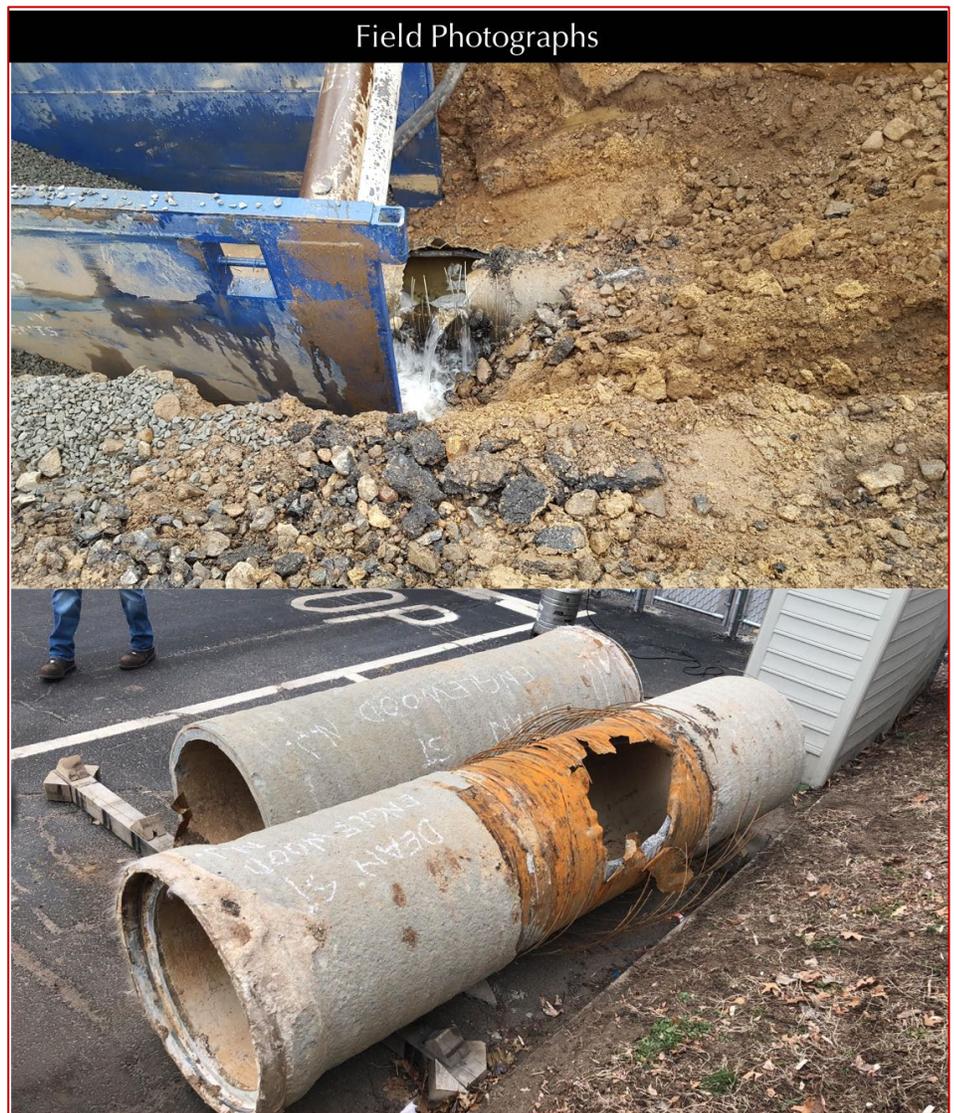
The prestressed concrete cylinder pipe sample was taken from buried pipeline reportedly laid in October 1974. Prestressed concrete cylinder pipe failed on 12/14/18 while in service. No indication pipe was going to fail until it did, which was catastrophic to the pipe. Pipe was buried approximately 5 feet underground. After the failure, the pipe was stored outside in a utility yard for one month before samples were collected. Figure 1 shows portion of the failed pipe, particularly brown corrosion products at the failed portion.

Figure 1: Shown are the failed pipe in the field (top), and the removed failed portion of pipe (bottom). Notice severe brown corrosion products at the failed portion of the pipe.

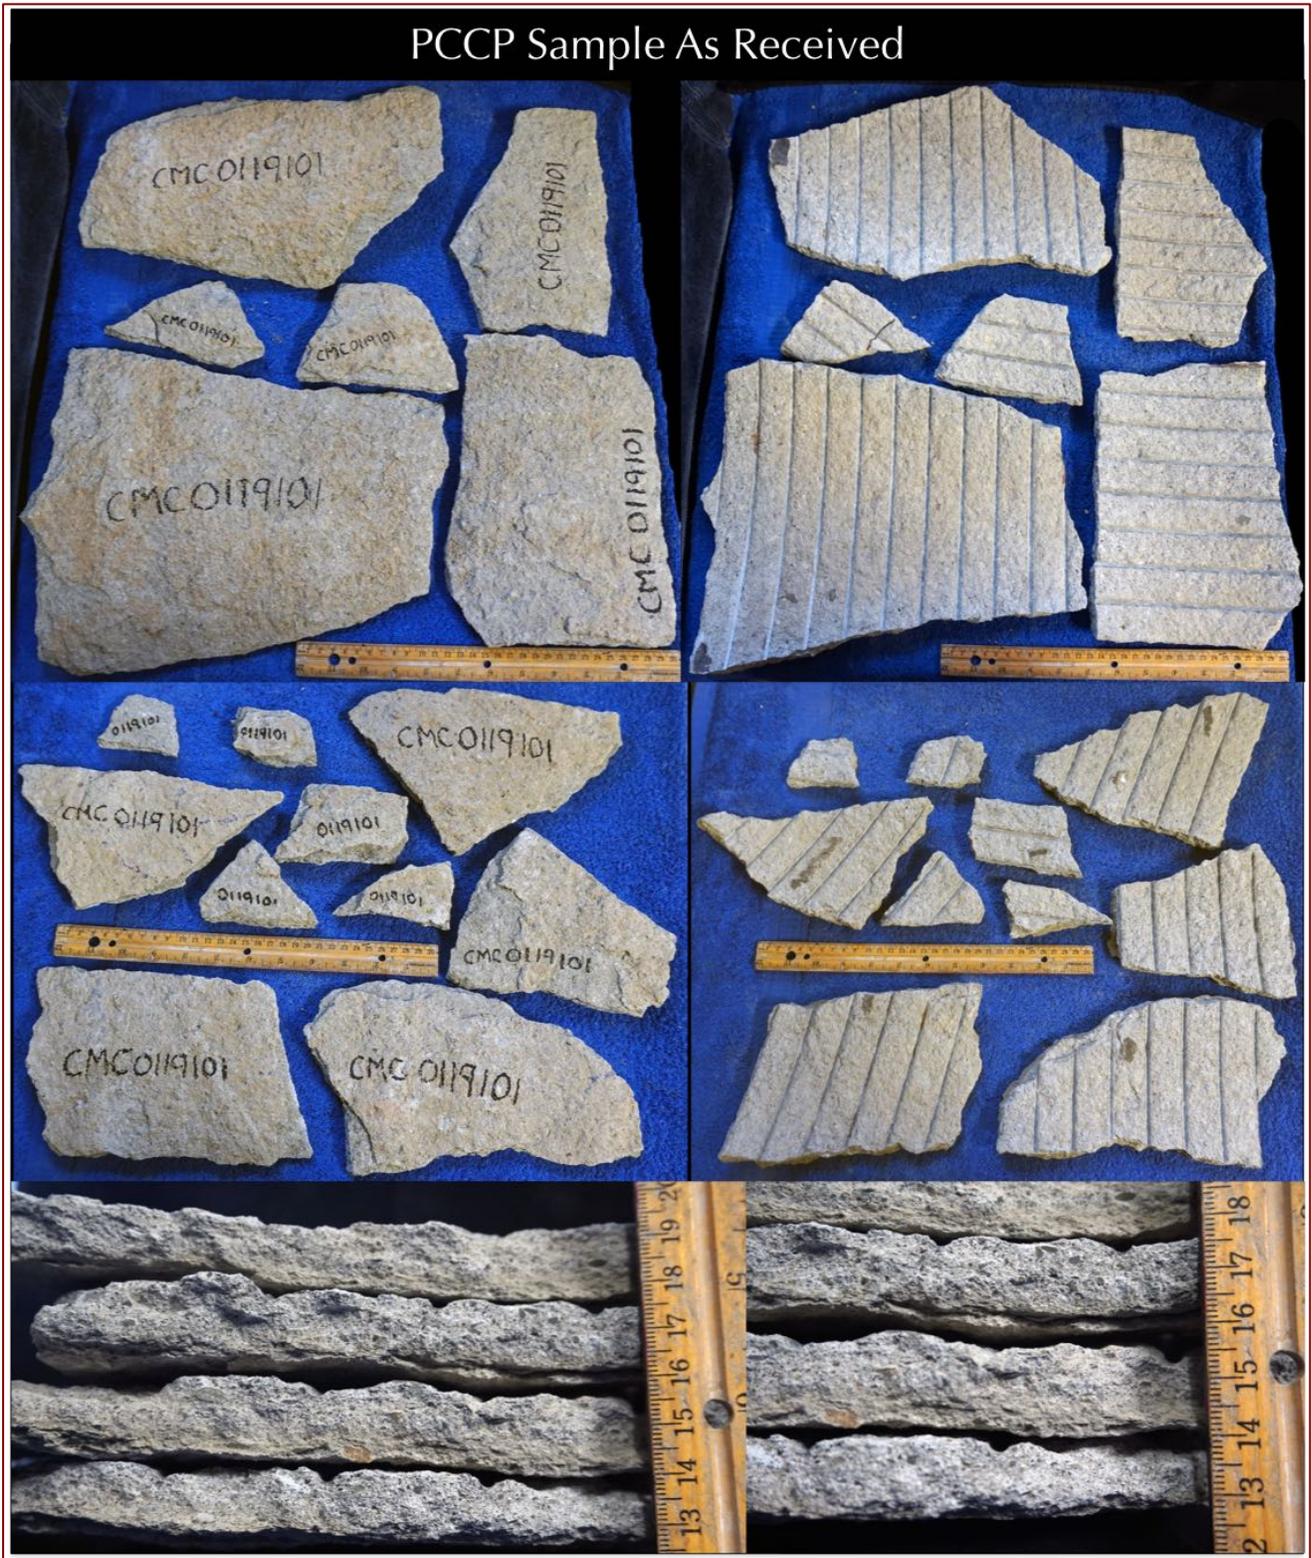
Figure 4 shows condition of the mortar coating sample, as received in multiple pieces. The largest piece measures $13\frac{1}{2}$ in. \times 11 in. \times $\frac{9}{16}$ in. (350 mm \times 280 mm \times 14 mm). Nominal thickness of individual pieces varies from 10 to 20 mm.

The inside of the wire cast surfaces are concave, fresh fractured, having partial impressions of prestressing wires as parallel wire cast surfaces showing trace remains of reddish-brown corrosion products (Figures 4 and 6).

Figure 4: The mortar coating sample, as received in multiple pieces, showing: (i) the severely weathered exposed surfaces in the top and middle left photos, (ii) the fresh fractured interior surfaces having impressions of the prestressing wires in the top and middle right photos, and (iii) side views of the coating in the bottom photos.

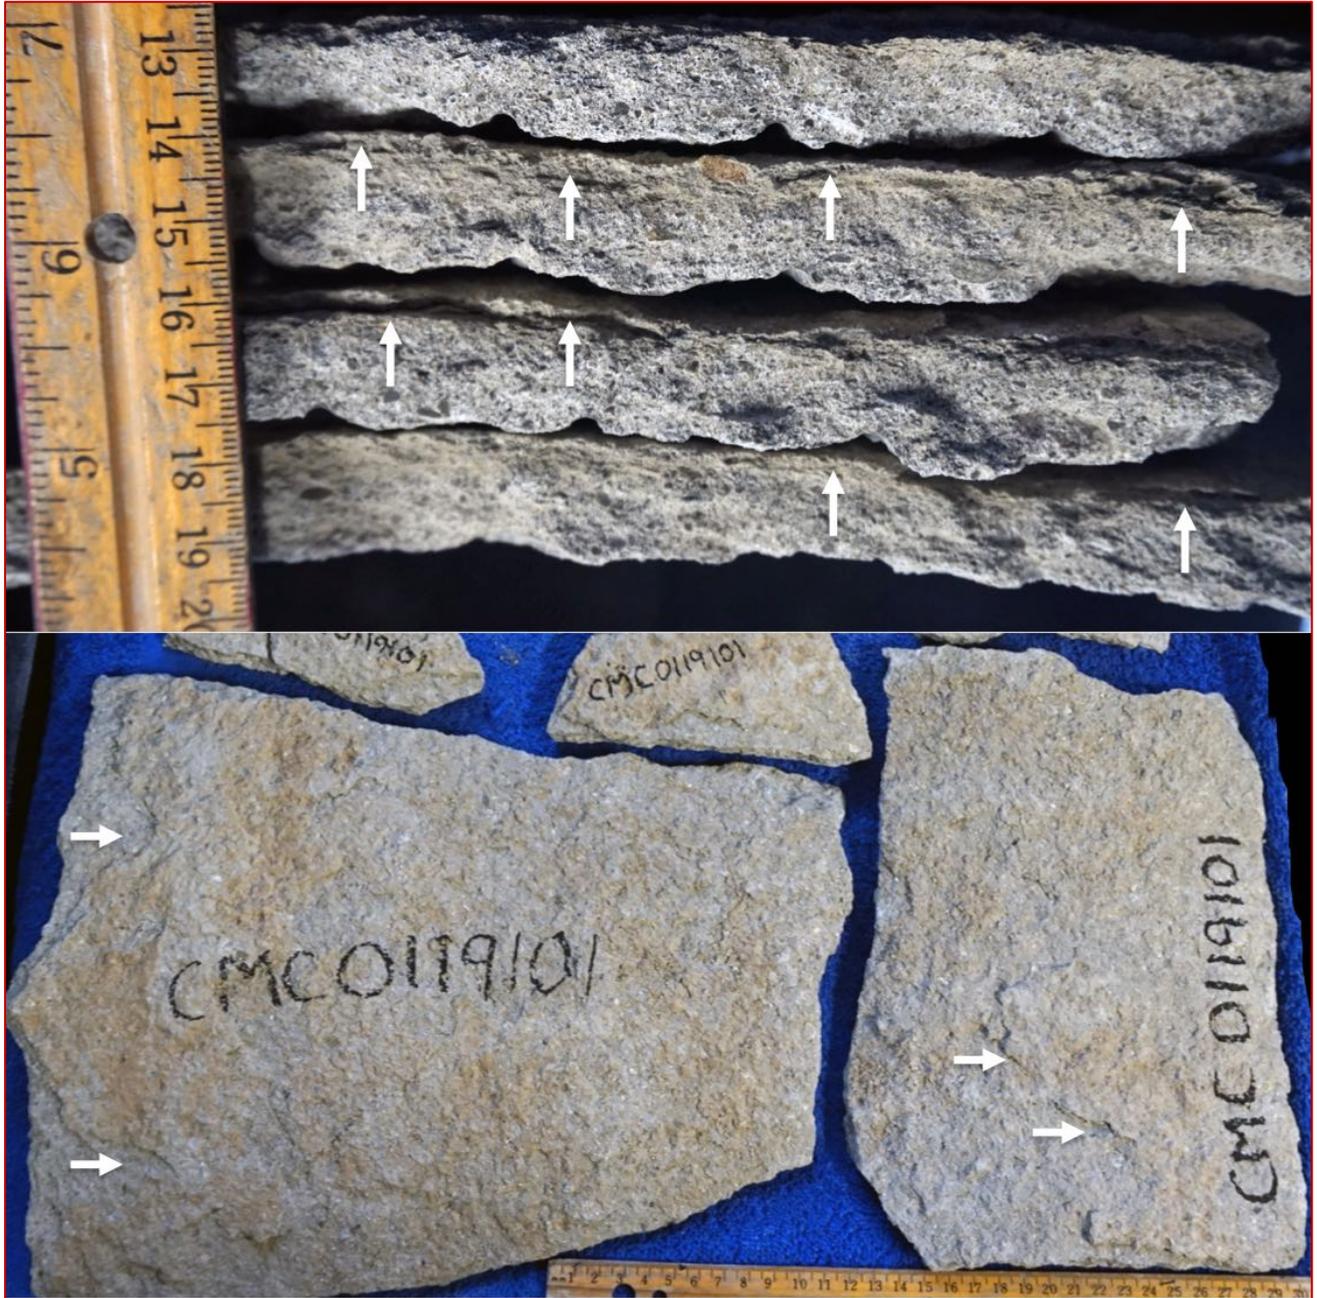
The mortar coating shows rough, convex, severely weathered, carbonated, and altered exposed outside surface that contains numerous fine parallel cracks to depths of 2 to 5 mm from the exposed scaled/exfoliated surface indicating continuing scaling or exfoliation of pipe from the exposed surface downwards with progressive deterioration that has eventually led to the reported failure.

These exposed surface-parallel microcracks are best seen on the as received and lapped cross sections of pipe pieces in Figures 5 and 8, respectively. These parallel microcracks have reduced the overall thickness of the pipe to the point of failure.

Figure 5: Rough, convex, severely weathered, carbonated, and altered exposed outside surface that contains numerous fine parallel cracks to depths of 2 to 5 mm from the exposed scaled/exfoliated surface indicating continuing scaling or exfoliation of pipe from the exposed surface downwards with progressive deterioration that has eventually led to the reported failure. Arrows show incipient scales that have reduced the overall thickness of the pipe.

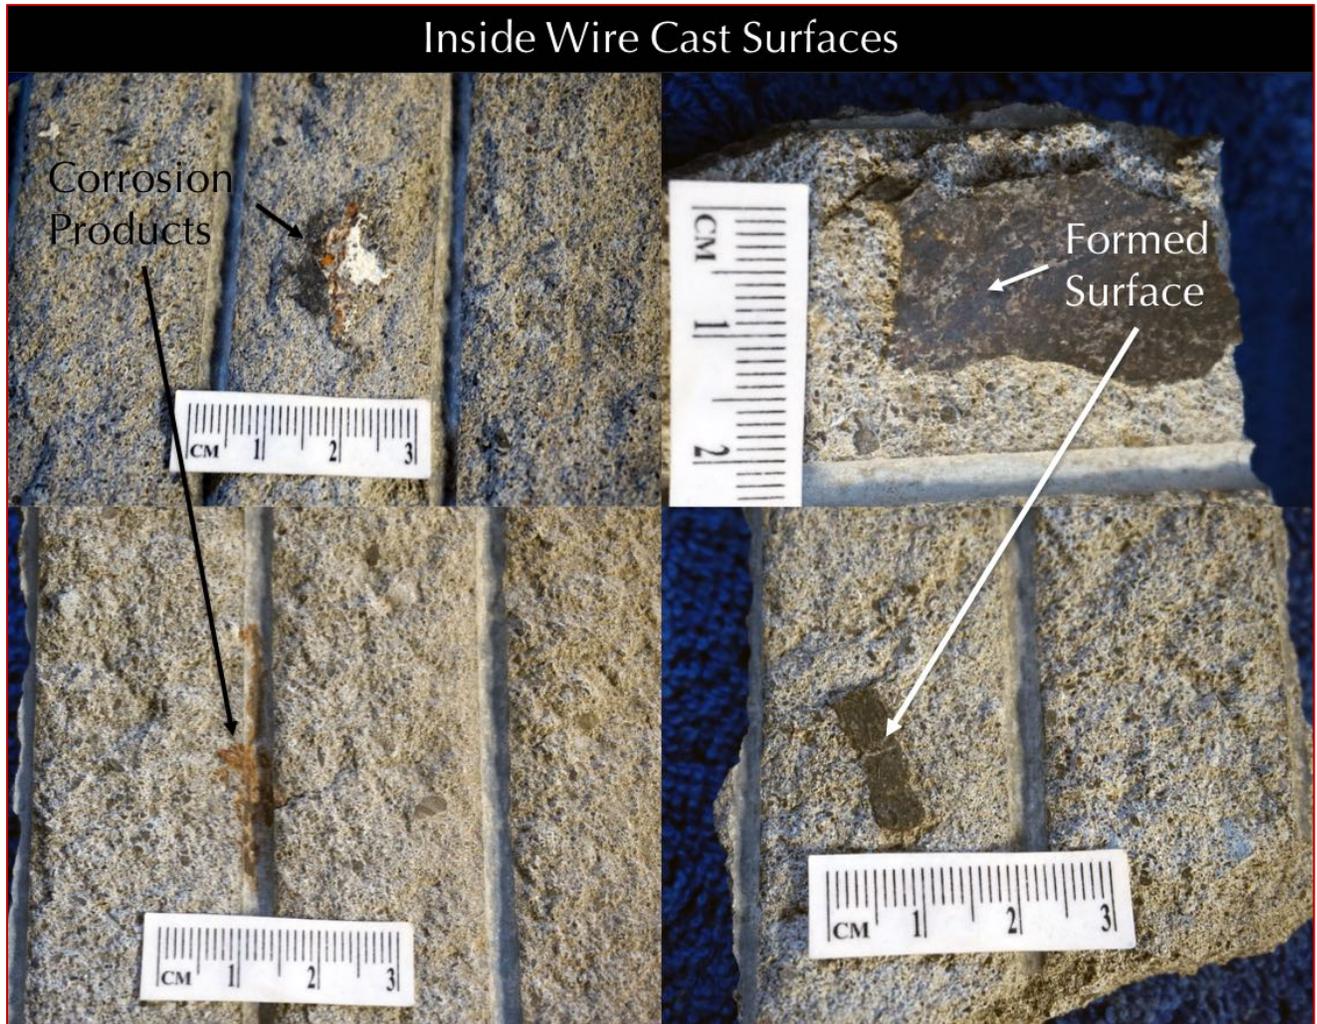
The inside wire cast surfaces (Figures 4 and 6) show impressions of $\frac{1}{8}$ in. diameter prestressing wires at $1\frac{1}{4}$ -in. center-to-center distances (Figures 4 and 6), and have $\frac{1}{16}$ in. thick neat pastes at the wire cast surfaces.

Figure 6: Fresh fractured interior and parallel wire cast surface of pipe showing corrosion products of prestressing wires. The inside wire cast surfaces showing impressions of $\frac{1}{8}$ in. diameter prestressing wires at $1\frac{1}{4}$ -in. center-to-center distances, and have $\frac{1}{16}$ in. thick neat pastes at the wire cast surfaces. The wire cast surfaces are smooth, shiny, medium gray, and have lower water-cement ratios (w/c is estimated to be less than 0.40 to 0.45 in the $\frac{1}{16}$ in. of the neat pastes of wire cast surfaces).

Wire cast surfaces show occasional reddish-brown corrosion products of prestressing wires, which from severe carbonation of paste at the top 2 to 6 mm as seen in thin section photomicrographs along with high chloride content determined later are judged to be carbonation-induced loss of alkalinity of the coating and subsequent carbonation of prestressing wires as well as chloride-induced corrosion of prestressing wires.

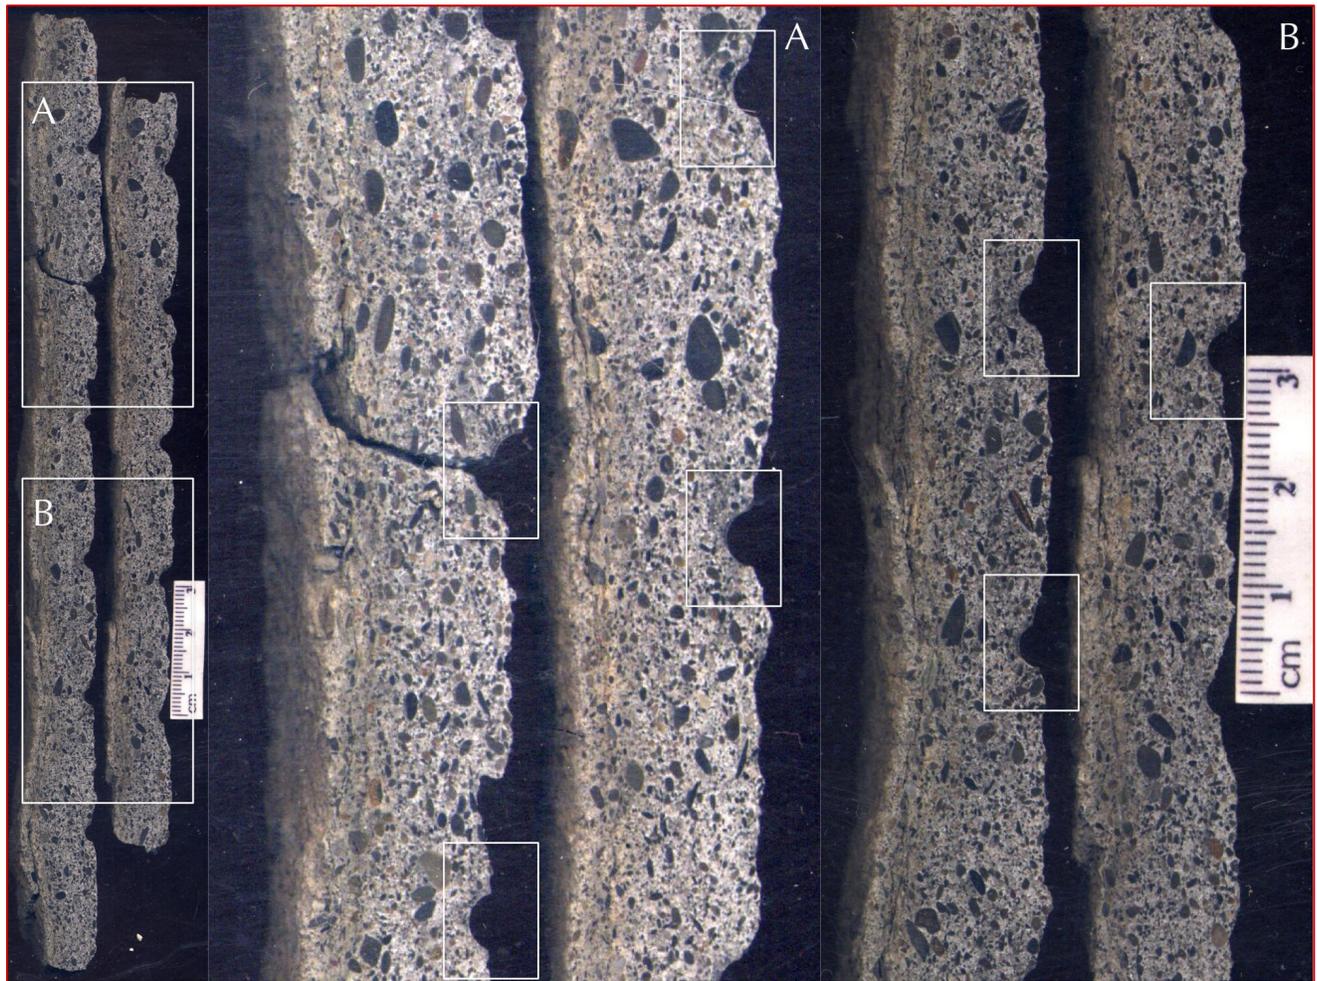
Figure 7 shows lapped cross sections of mortar coating where the leftmost figure shows two long coating and middle and right photos show enlarged portions of the lapped cross section from the left photo.

All photos show natural siliceous-argillaceous-calcareous sand aggregates, well-graded, well-distributed, Portland cement paste, altered cracked nature of the exposed surface region and sound nature of interior fresh fractured surface region, wire cast surfaces (boxed in middle and right photos).

Figure 7: Lapped cross sections of pipe showing natural siliceous-argillaceous-calcareous sand aggregates, well-graded, well-distributed, Portland cement paste, altered cracked nature of the exposed surface region and sound nature of interior fresh fractured surface region, wire cast surfaces.

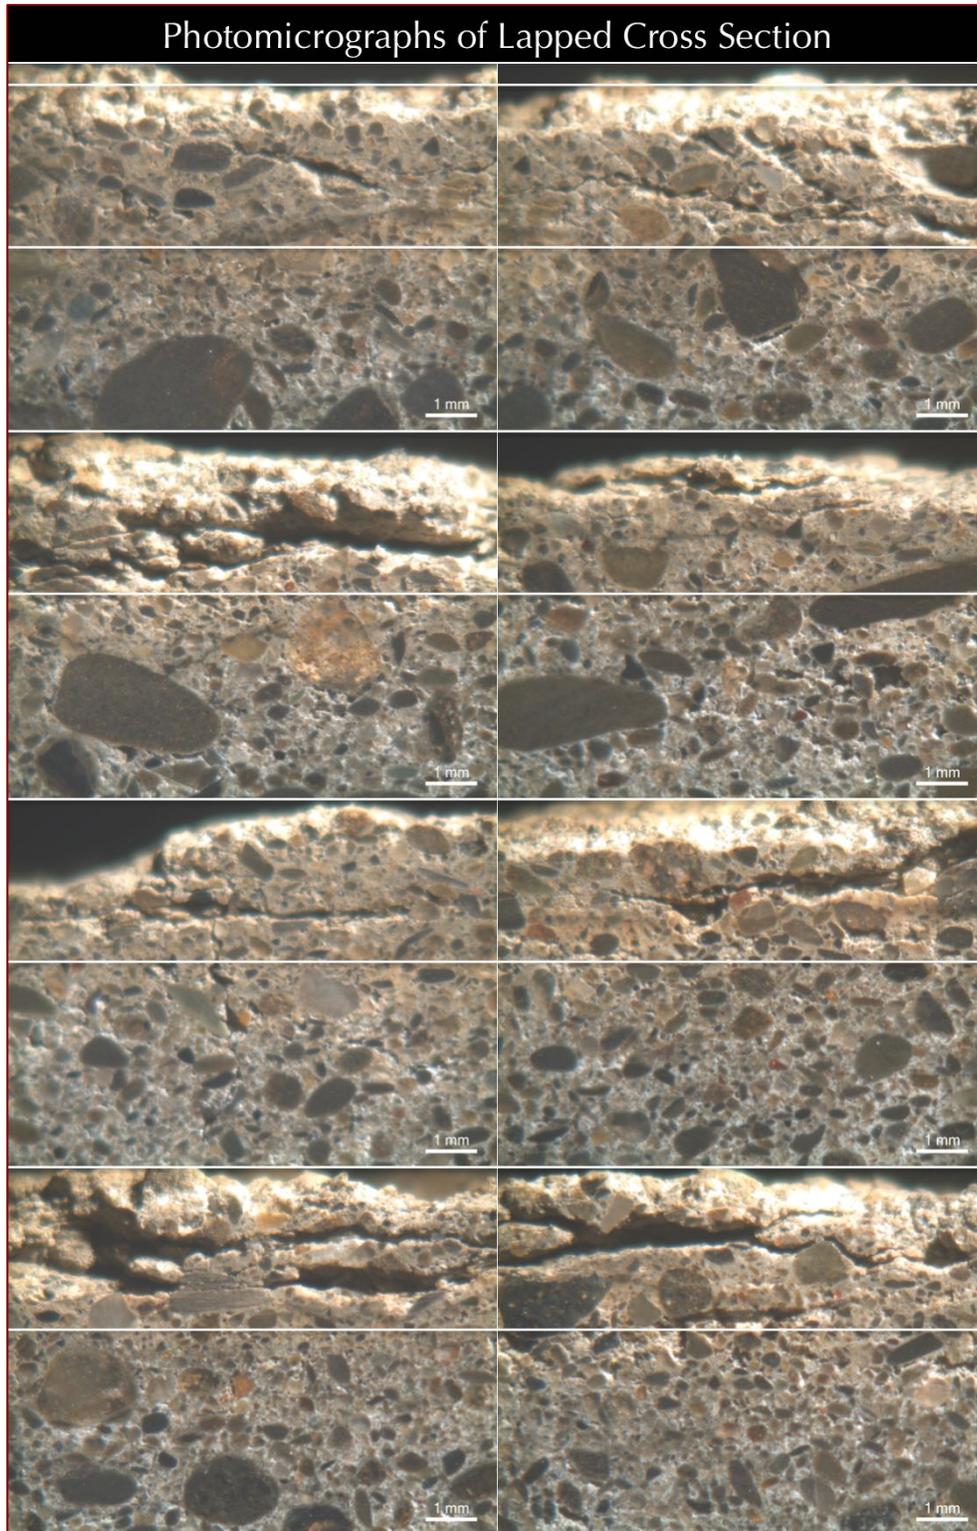
Figure 8: Photomicrographs of lapped cross section of mortar coating showing the deteriorated soft, fragile, leached light-toned and cracked paste at the exposed surface region having parallel cracks (boxed) at the top 2 to 5 mm depth from the exposed surface and relatively sound coating beneath the deteriorated portion in the boxed areas.

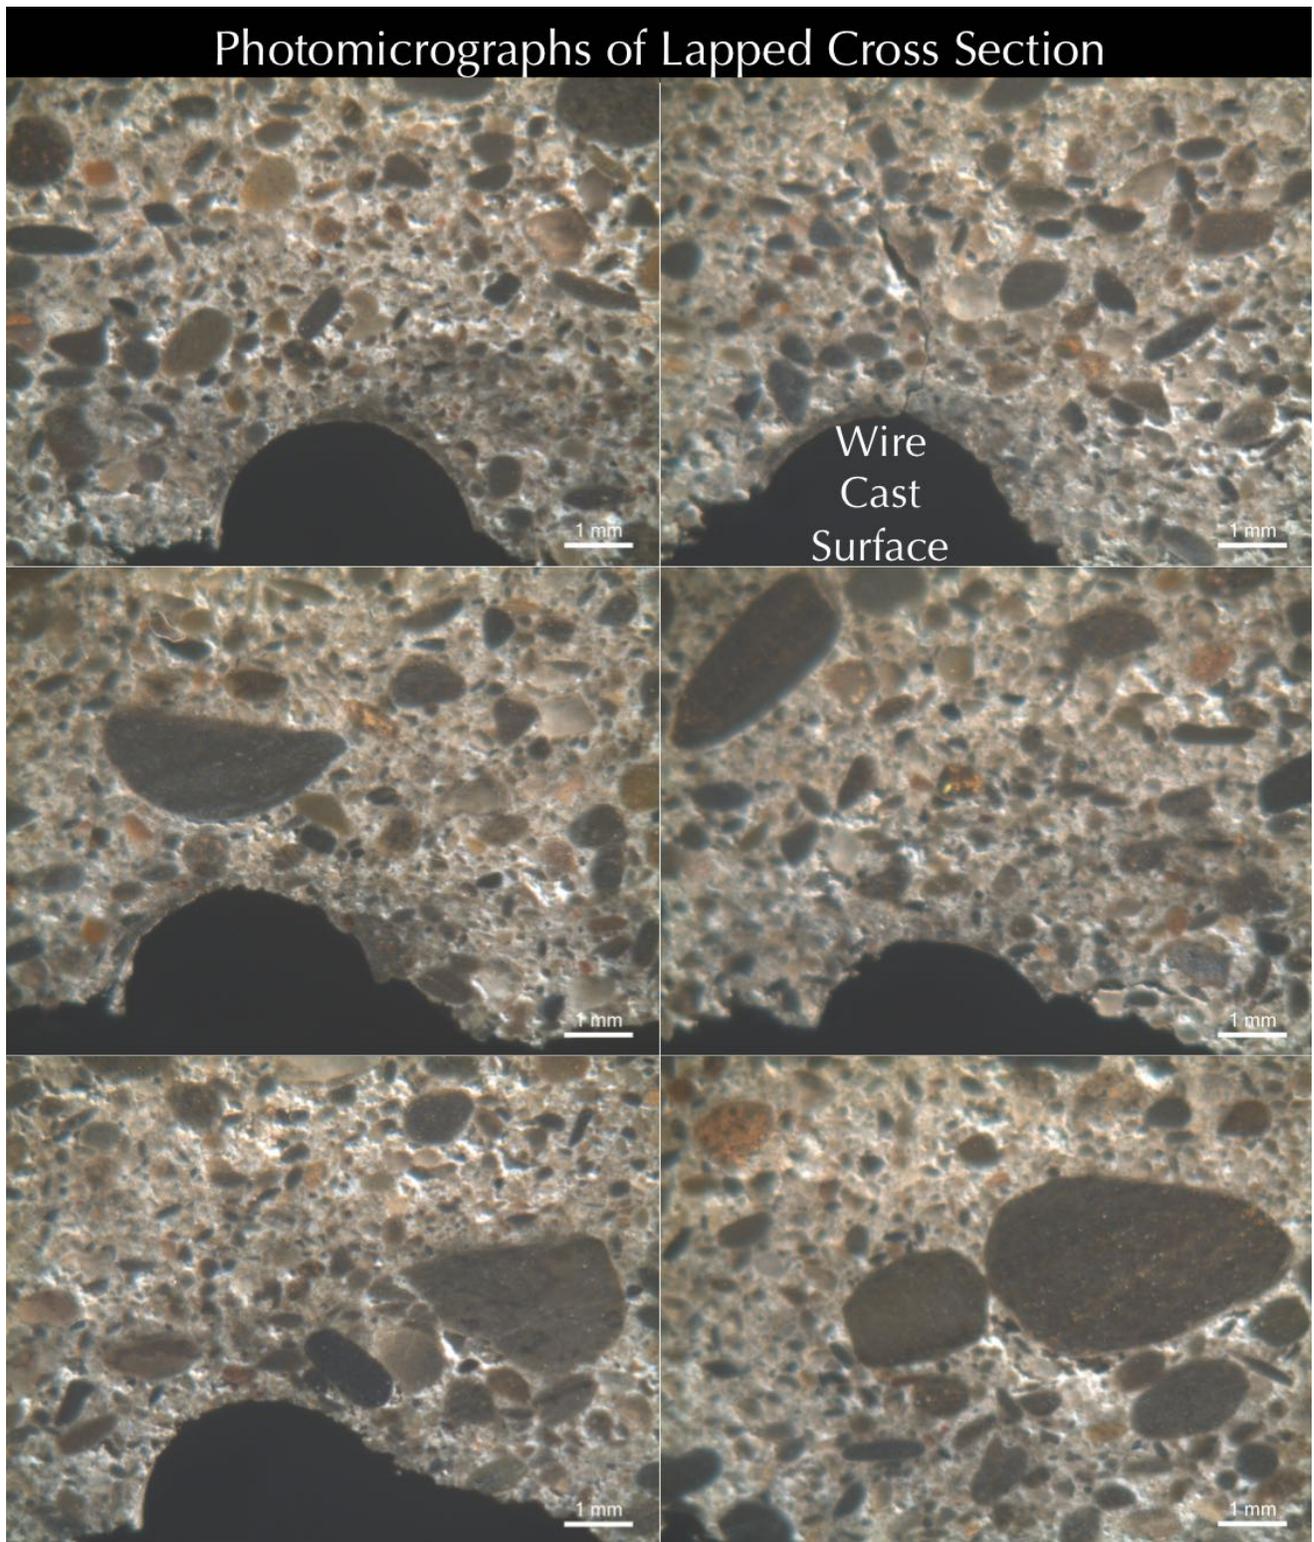
As opposed to the top half of the pipe thickness, the bottom half i.e. from the interior body down to the wire cast surface region is relative sound and free of any cracking (Figures 7 and 9). There are, however, many fine to coarse voids and interstitial spaces between aggregate particles that are best seen in microstructures in Figures 9, 13, and 14.

Figure 9: Photomicrographs of lapped cross section of mortar coating from the mid-depth to bottom fresh fractured and wire cast surface region showing relatively sound condition of coating that is free of any cracking as seen at the exposed surface region. Notice neat paste darker gray in color than the body in the wire cast surface region.

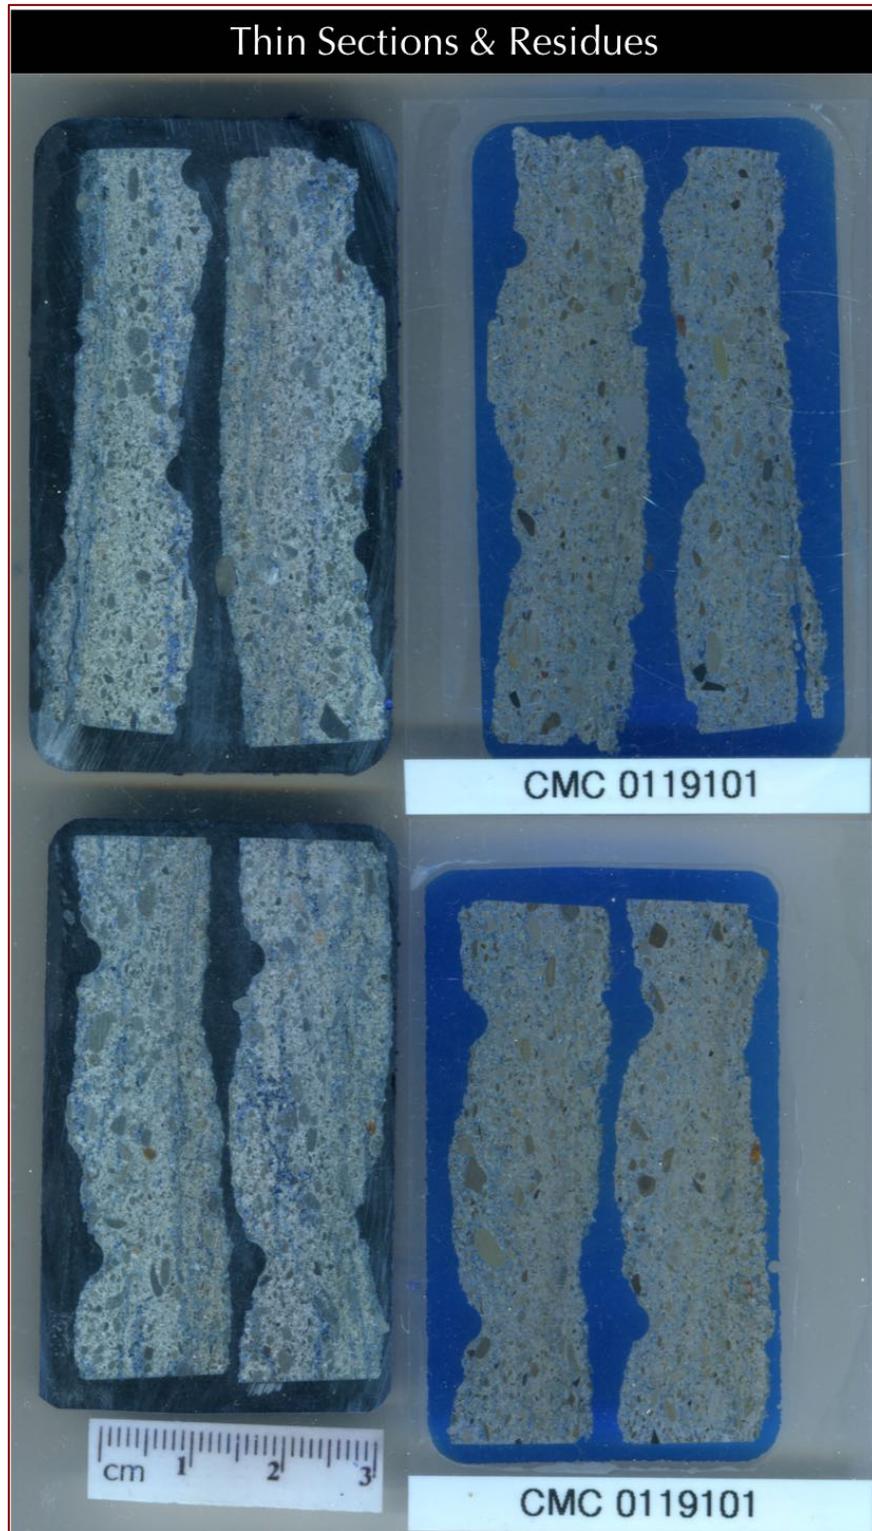
Figure 10: Blue dye-mixed epoxy-impregnated thin sections of mortar coating and corresponding residues from thin section preparation. Thin sections show deep absorption of blue epoxy due to high inherent porosities from interstitial voids and paste.

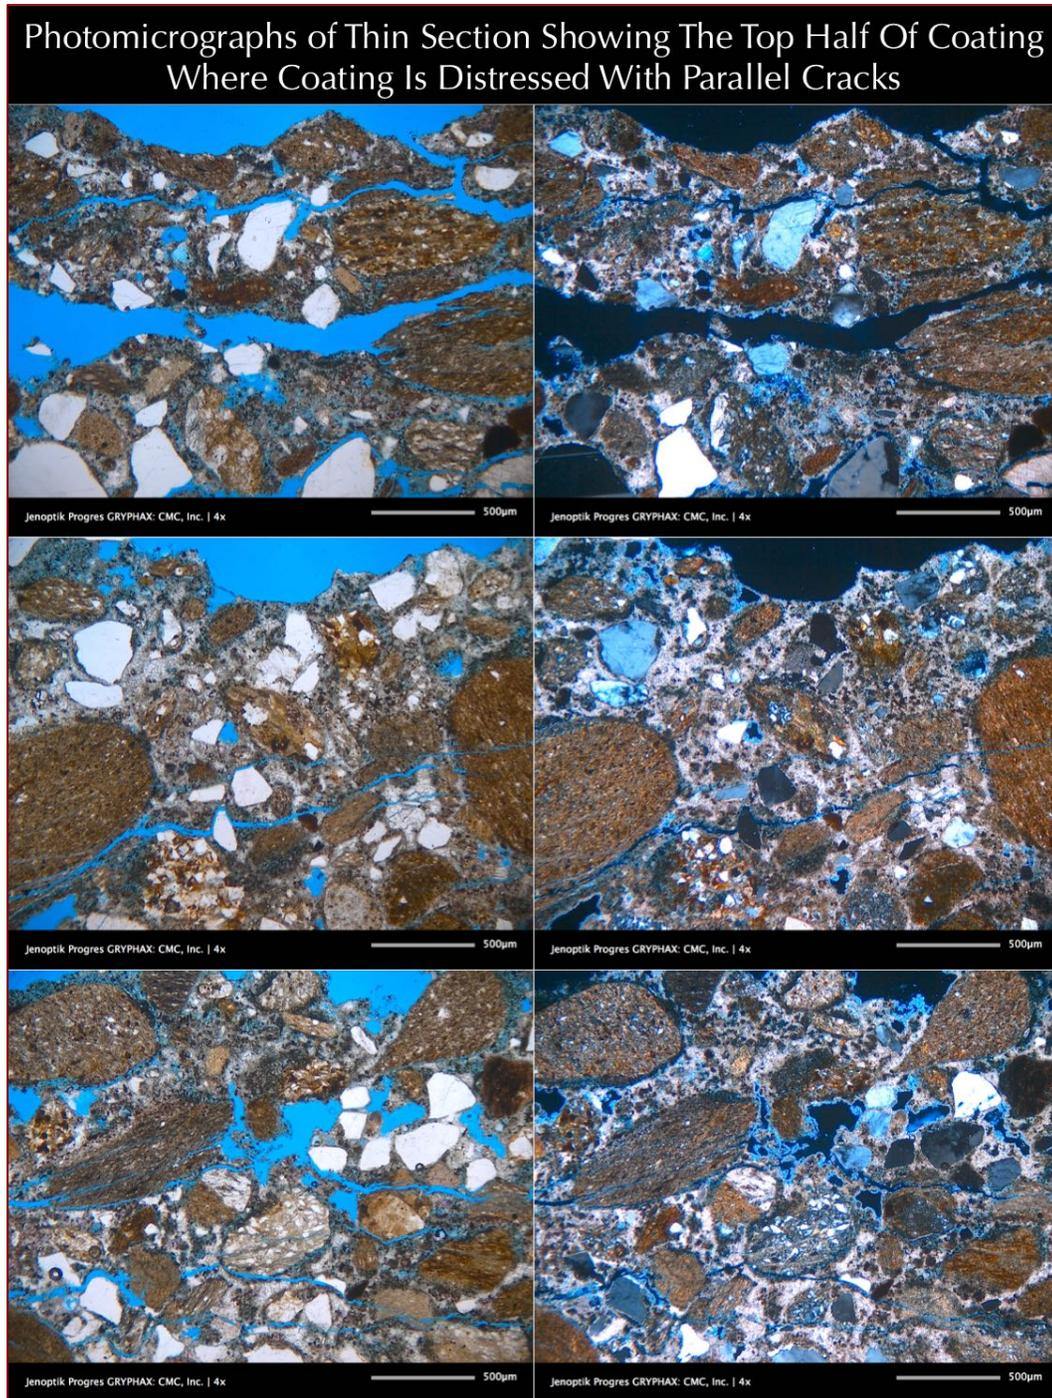
Figure 11: Photomicrographs of blue dye-mixed epoxy-impregnated thin section of mortar coating showing: (a) severe cracking and deterioration of exposed surface region where parallel cracks are highlighted by blue epoxy; (b) natural argillaceous-siliceous-calcareous sand consisting of major amounts of rounded and subrounded shale and other argillaceous rocks, and subordinate amounts of rounded and subrounded quartz, quartzite, and minor amounts of carbonates (limestone); (c) overall porous and carbonated nature of paste from the altered exposed surface region at the top 2 to 5 mm where interstitial void spaces are filled with secondary calcium carbonate deposits.

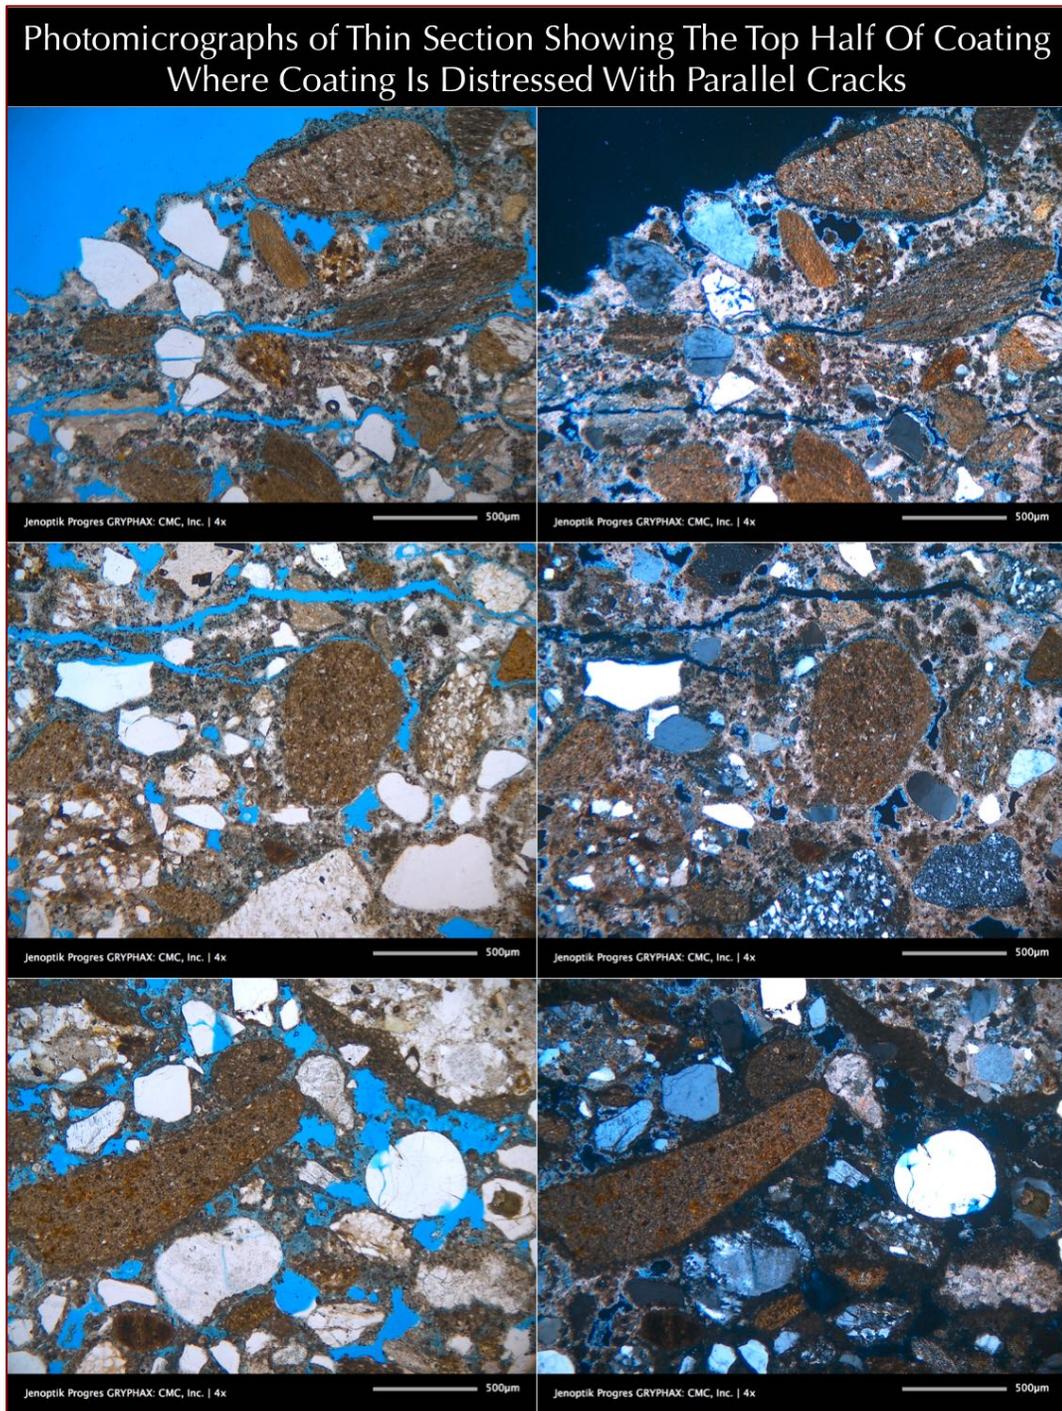
Figure 12: Photomicrographs of blue dye-mixed epoxy-impregnated thin section of mortar coating showing: (a) severe cracking and deterioration of exposed surface region where parallel cracks are highlighted by blue epoxy; (b) natural argillaceous-siliceous-calcareous sand consisting of major amounts of rounded and subrounded shale and other argillaceous rocks, and subordinate amounts of rounded and subrounded quartz, quartzite, and minor amounts of carbonates (limestone); (c) overall porous and carbonated nature of paste from the altered exposed surface region at the top 2 to 5 mm where interstitial void spaces are filled with secondary calcium carbonate deposits. The bottom row shows interior coating beneath the cracked and carbonated surface region, where paste is not carbonated but porous due to the presence of many void spaces highlighted by blue epoxy.

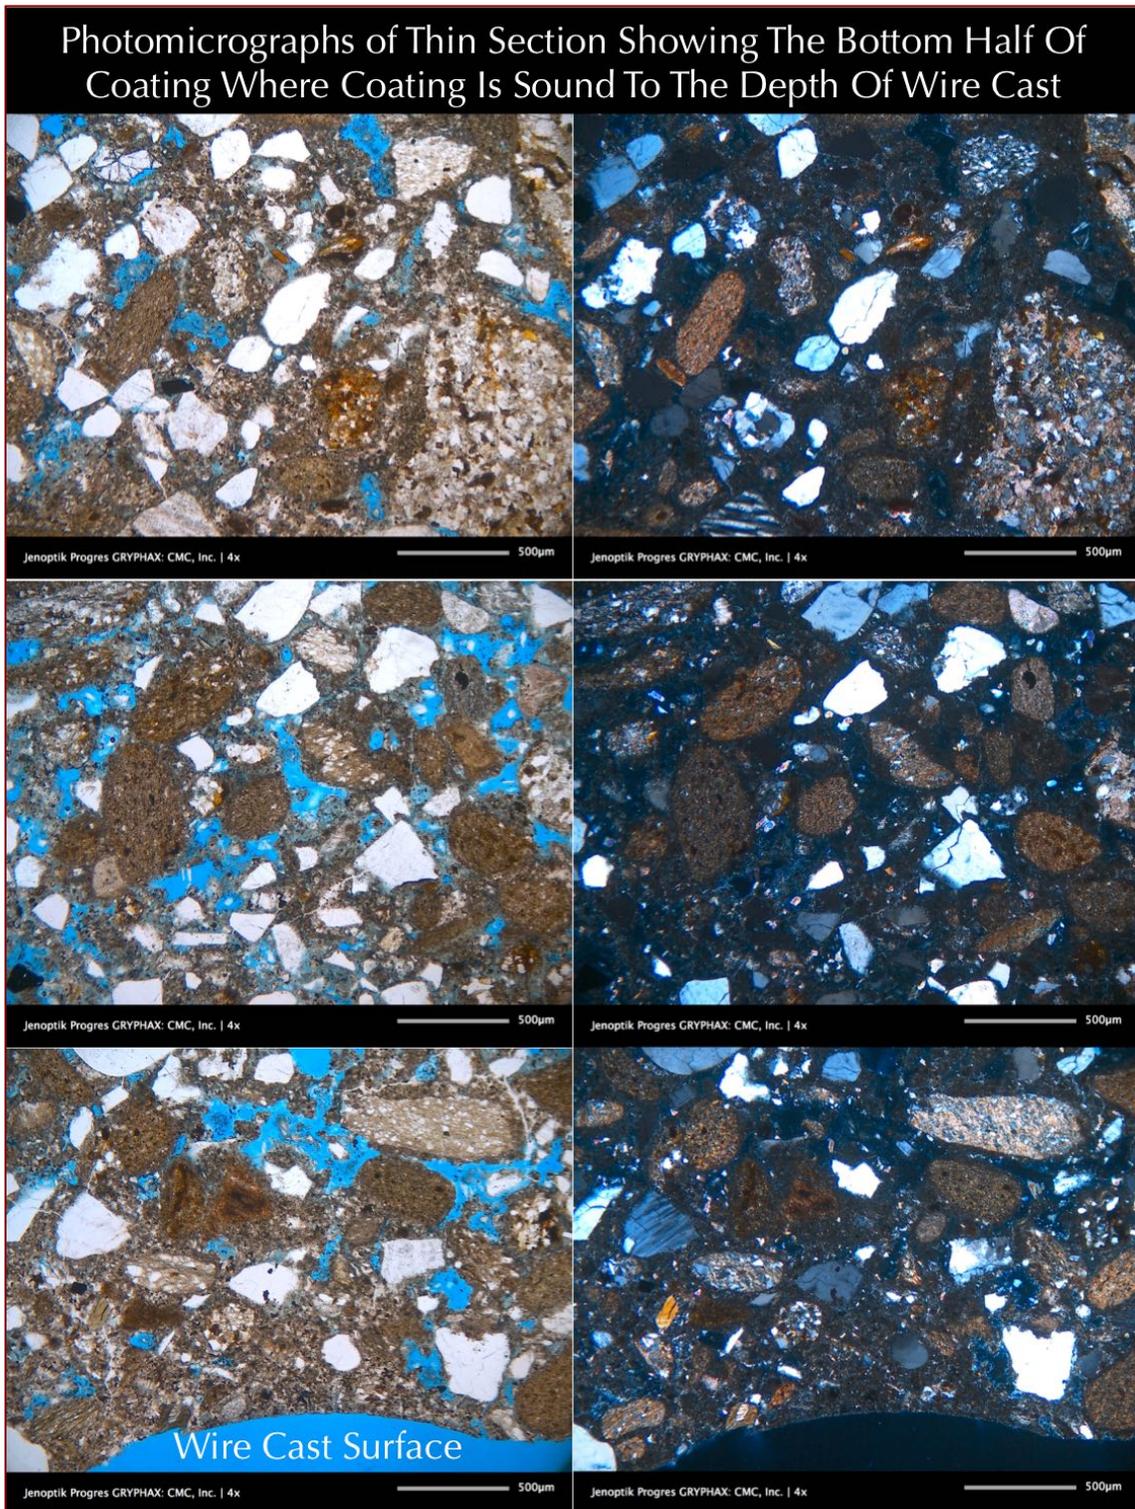
Figure 13: Photomicrographs of blue dye-mixed epoxy-impregnated thin section of mortar coating from the interior down to the fresh fractured and wire cast surface region showing many pore and void spaces between sand particles highlighted by blue epoxy, natural sand having major amount of shale and other argillaceous rocks, dense neat paste at the wire cast surface region (bottom row) and lack of carbonation of paste in the bottom half of the coating that is so prominent at the top 5 mm of the exposed surface region seen in Figures 11 and 12.

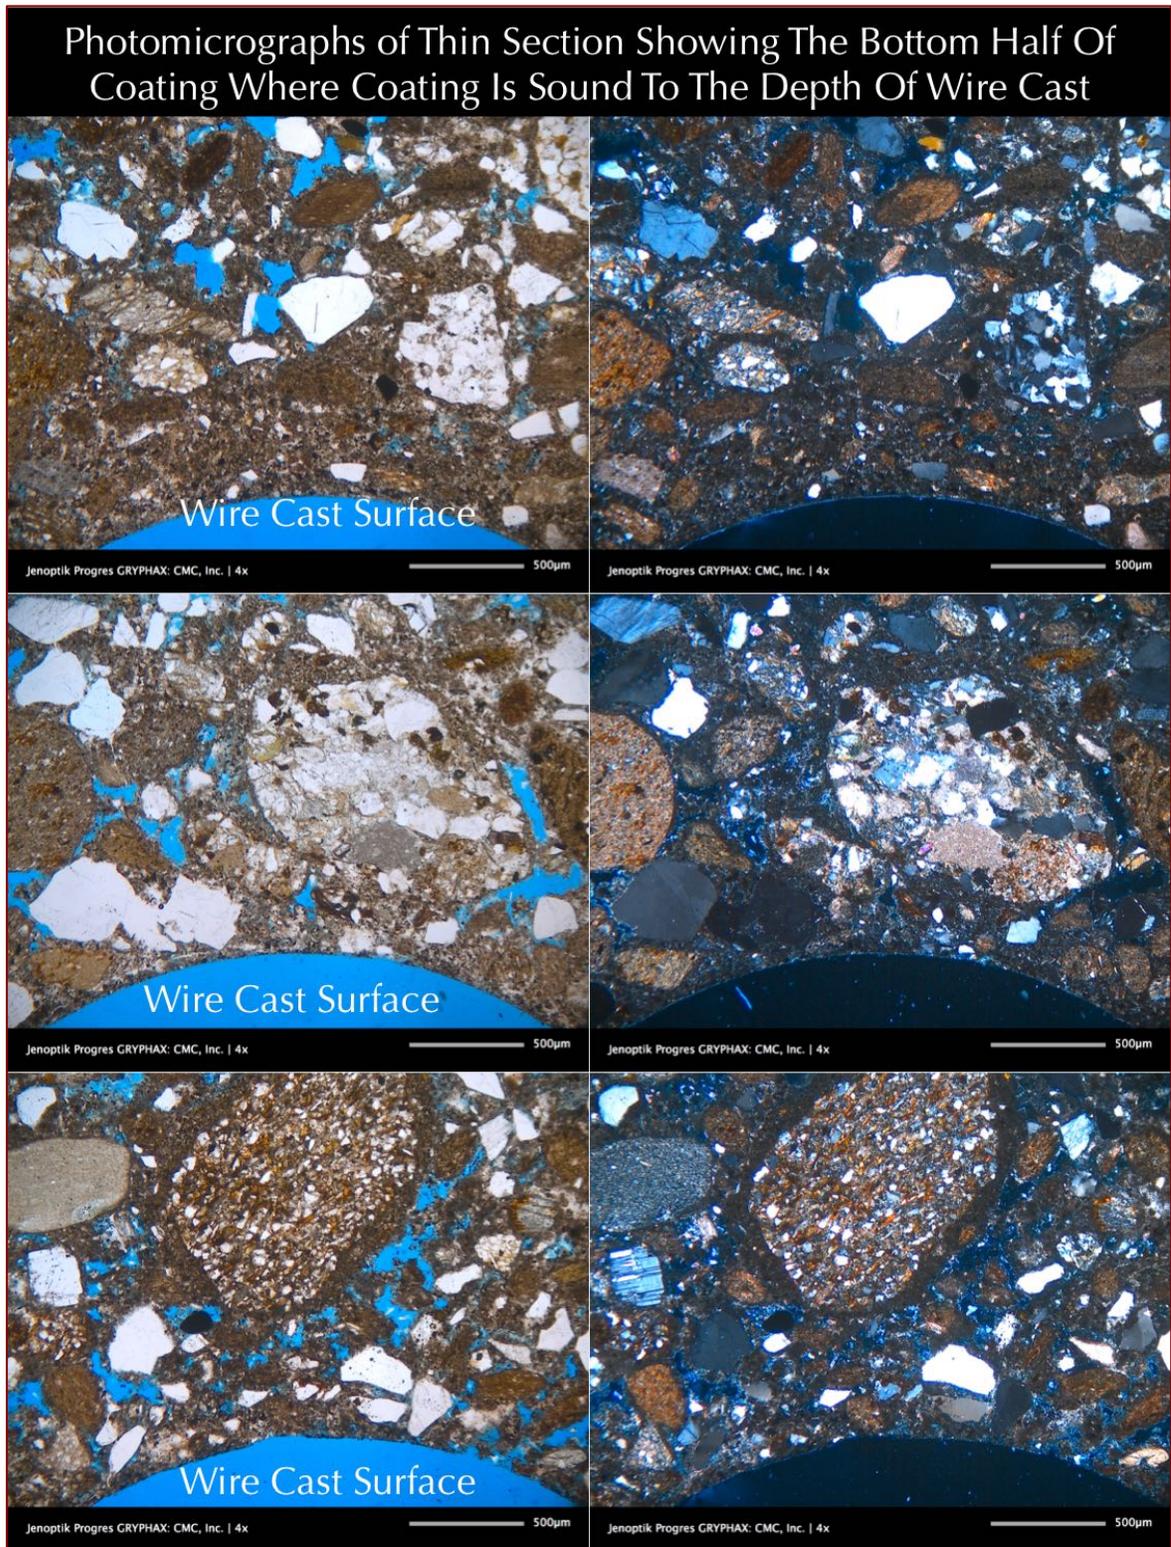
Figure 14: Photomicrographs of blue dye-mixed epoxy-impregnated thin section of mortar coating from the interior down to the fresh fractured and wire cast surface region showing many pore and void spaces between sand particles highlighted by blue epoxy, natural sand having major amount of shale and other argillaceous rocks, dense neat paste at the wire cast surface region (bottom row) and lack of carbonation of paste in the bottom half of the coating that is so prominent at the top 5 mm of the exposed surface region seen in Figures 11 and 12.

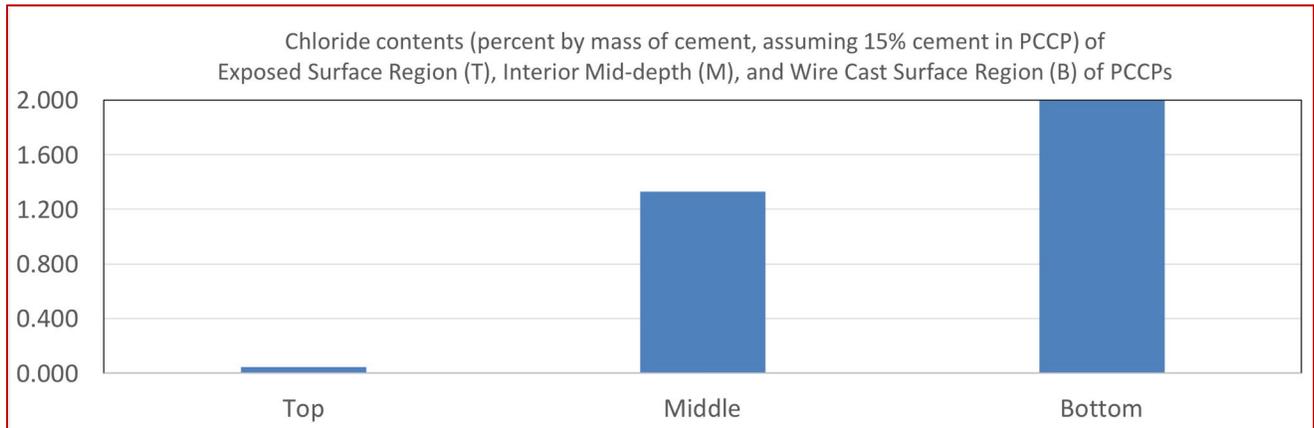
Results show negligible chloride content at the top exposed surface region due to leaching of chloride but high chloride content in the mid-depth and wire cast surface region indicating penetration of chloride from the environment, which has caused corrosion of prestressing wires and resultant corrosion products seen in the failed portion of pipe in field photos.

Figure 15: Acid-soluble chloride contents of coatings in relation to threshold chloride level of 0.2 percent needed to initiate chloride-induced corrosion of prestressing wires in the presence of oxygen and moisture. Top exposed surface region showed negligible chloride due to leaching whereas mid-depth and wire cast surface region showed high chloride contents indicating potential chloride-induced corrosion of prestressing wires.

The minimum threshold chloride content to initiate corrosion of prestressing wires in the presence of oxygen and moisture is somewhere in the range of 0.15 to 0.20 percent chloride i.e. by mass of cement. Chloride contents at the mid-depth and wire cast surface region are significantly higher than this threshold limit of corrosion. Therefore, chloride content is determined to be higher than the minimum chloride needed to trigger the corrosion of wires in the presence of both oxygen and moisture.
