Acid Attack on PCCP Mortar Coating

Dipayan Jana, P.G.¹
Richard A. Lewis, P. E.²

During the failure investigation of a 2.59 meter (102 inch) diameter prestressed concrete cylinder pipe (PCCP) sewer force main, petrographic examination of mortar coating samples revealed that the protective qualities of the coating had been environmentally degraded by exposure to acidic soils. While the mechanisms of carbonation of PCCP from atmospheric carbon dioxide in the form of carbonic acid attack are well documented, relatively little information is available on the effects of acidic soils on PCCP mortar coating. Petrographic examinations of mortar coatings exposed to acidic soil is presented along with discussion of the mechanisms involved in the coating deterioration.

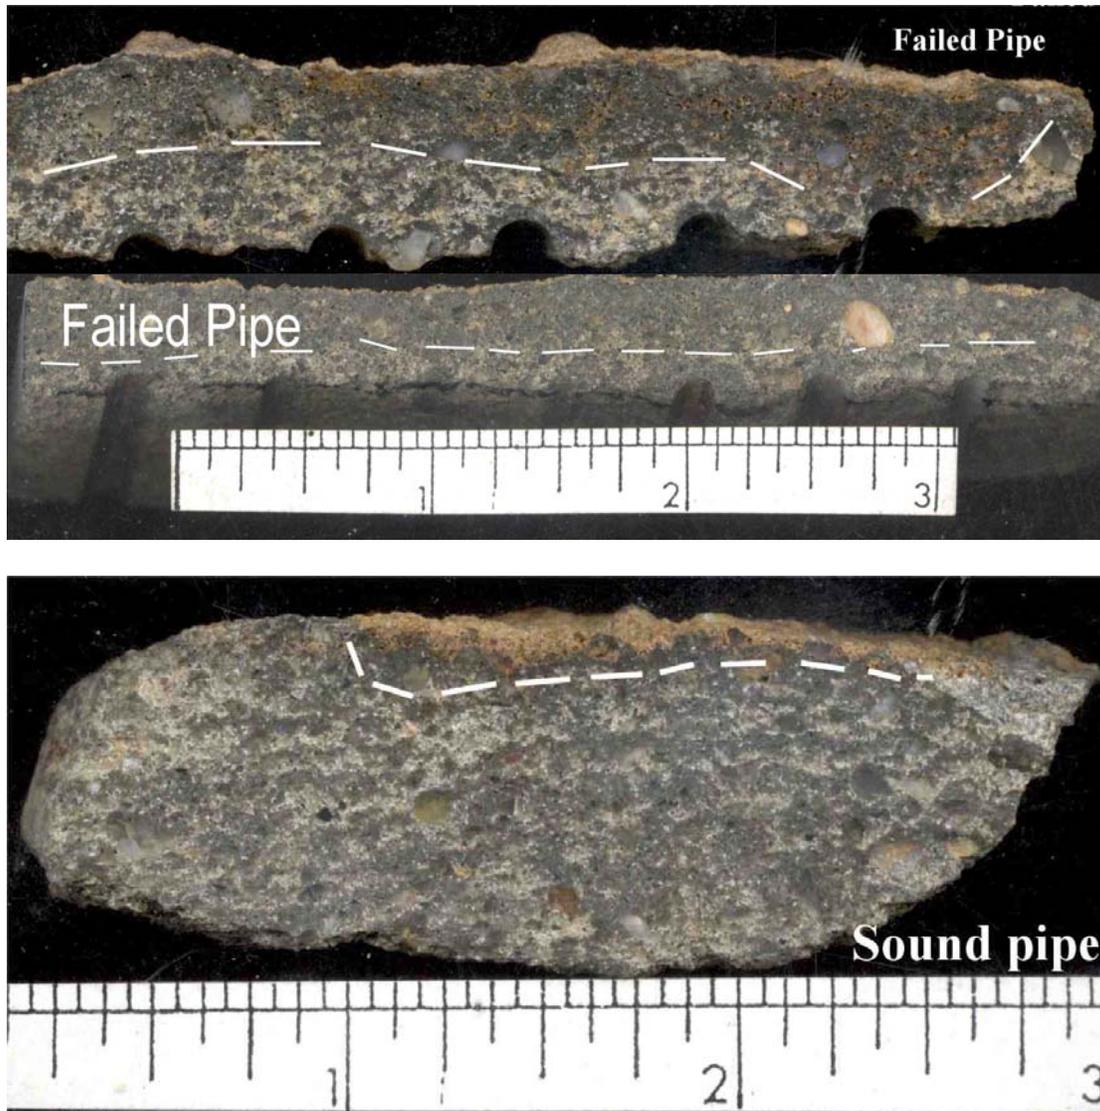
Pastes – Pastes contain alternate light and dark bands – the banded nature is the result of the method of application of the coating and is most prominent in the sound pipe (Figure 1). Pastes are relatively hard and dense in the dark portions and soft and porous in the light areas. Freshly fractured surfaces have semi-conchoidal textures and subvitreous lusters. Residual and relict cement particles are estimated to constitute 16 to 18 percent of the paste volume in the dark colored paste and 10 to 12 percent in the light colored paste. The calcium hydroxide component of cement hydration occurs as small platy and patchy units in the dark and light pastes and is estimated to constitute 8 to 10 percent of the paste volume. Hydration of the cement is normal.

Cross-sections and Surfaces – The exposed surfaces of the coatings are weathered (Figure 2), moderately soft, light to deep reddish brown, carbonated and leached. Loss of coating is severe in the failed pipe, but negligible in the sound pipe. Coating from the failed pipe has a thickness ranging from 8 mm ($\frac{5}{16}$ in.) to a maximum of 19 mm ($\frac{3}{4}$ in.); whereas the sample from the sound pipe has a coating thickness of 25 mm (1 in.) (Figure 1). The inside surfaces are freshly fractured surfaces at the haunch levels of the wires (Figure 2).

Figure 1. Cross-sections of samples of the failed and sound pipes showing: (a) alternate dark and light colored pastes, (b) reddish brown exposed surfaces, (c) wire-cast surfaces, (d) relatively darker coloration of paste at the top half of the failed pipe sections (above the dashed lines) due to interaction with acidic solutions, (e) distribution and overall good grading of the aggregates, and (f) difference in thicknesses of the failed and sound pipe sections. Scale varies as the photographs have been resized.

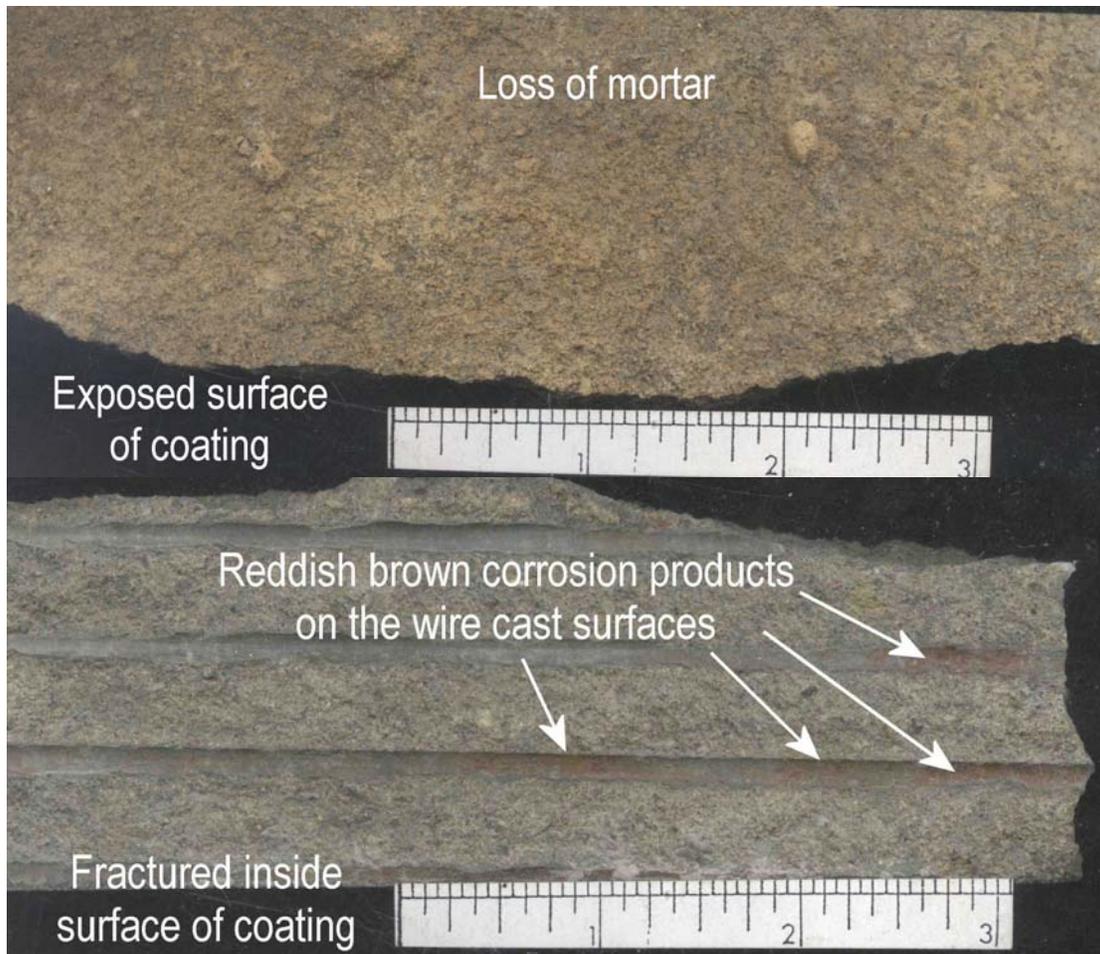
Evidences of Acid Attack – Paste of the failed pipe shows two distinct evidences of acid attack – one is the significant loss of the thickness of the coating (Figure 2), and the other is the compositional profile of successive layers of outer zones of corrosion, carbonation, leaching and the innermost zone of less altered to sound interior paste (Figure 3). The zone of corrosion is characterized by preferential loss of paste relative to aggregates and as a result proud exposure of the aggregate particles at the surface (Figure 1). The zone of carbonation is characterized by occurrences of very fine grains of calcium carbonate (Figure 3). Immediately

Figure 2. Shown are the exposed surface (top photo) and inside surface (bottom photo) of a mortar sample from a failed pipe. The exposed surface is weathered, reddish brown and has lost a significant amount of mortar due to corrosion in the presence of acidic soil. The fractured inside surface shows parallel arrangements of wire cast surfaces, neat paste on wire cast surfaces and reddish brown corrosion products on the wire-cast surfaces.

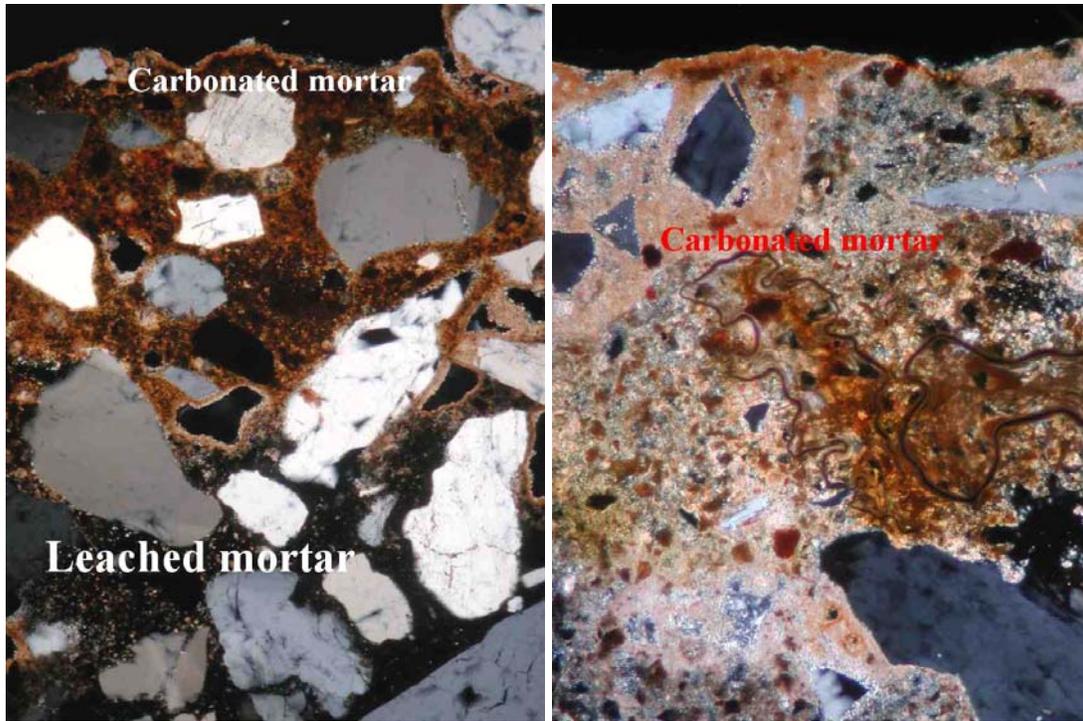
Carbonation – The near-surface regions of the samples of both good and failed pipes are carbonated (Figure 3). Carbonation has extended to depths of 3 mm ($\frac{1}{8}$ in.) to 6 mm ($\frac{1}{4}$ in.). In both the sound and failed pipes, however, sporadic carbonation has extended throughout the mortar and particularly concentrated in pastes around the irregularly shaped voids (Figure 4). The neat paste in the wire cast surface is not carbonated (Figure 4), except for a few occurrences of secondary calcium carbonate deposits described below, which may have formed after the removal of samples or in the field.

underneath the carbonation is a zone of leaching where the paste is devoid of calcium hydroxide that has been leached out by the action of acidic solutions. Due to leaching, the paste is very dark in petrographic microscope and porous (Figure 3). Below the leached zone is the less altered to relatively sound paste where irregularly shaped voids have thin rims of carbonation. Beside these two features, another consequence of acid attack is reddish brown staining at the exposed surface due to the dissolution of ferruginous components from aggregates and paste.

Figure 3. Thin-section photomicrographs showing evidences of acid attack in the microstructure of the mortar coating sample from the failed pipe. The photomicrographs were taken from near the surface region which shows carbonation of coating, reddish brown staining in the carbonated zone (right photo) and a zone of leached paste below the carbonated paste (left photo). Widths of photos = 2.5 mm.

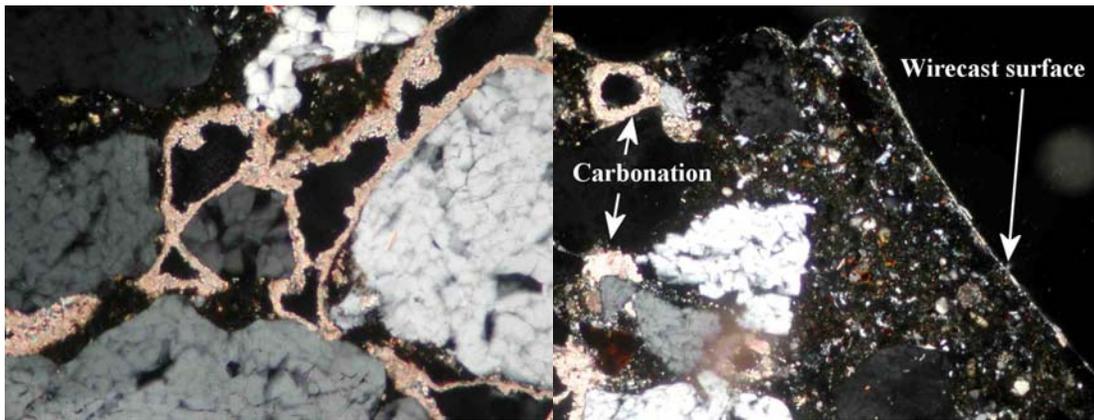
Air – Air occurs as irregularly shaped voids having nominal sizes up to 3 mm ($\frac{1}{8}$ in.) that are characteristic of entrapped voids (Figures 3 and 4). Entrapped voids are mostly present in the porous areas in light gray bands as gaps between the aggregate particles. The coatings are non-air-entrained and have air contents estimated to be $1\frac{1}{2}$ to $2\frac{1}{2}$ percent. The light gray bands have the higher air contents than the alternating dark bands. The neat pastes in the wire cast surfaces do not have air voids.

Figure 4. Thin-section photomicrographs of samples of good pipe showing carbonation of paste around the irregularly shaped voids (left photo) but dense, sound, non-carbonated paste at the wire cast surface (right photo). Paste carbonation around irregularly shaped voids is also common in the failed pipe. Widths of fields = 2.5 mm. Widths of photos = 0.15 mm.

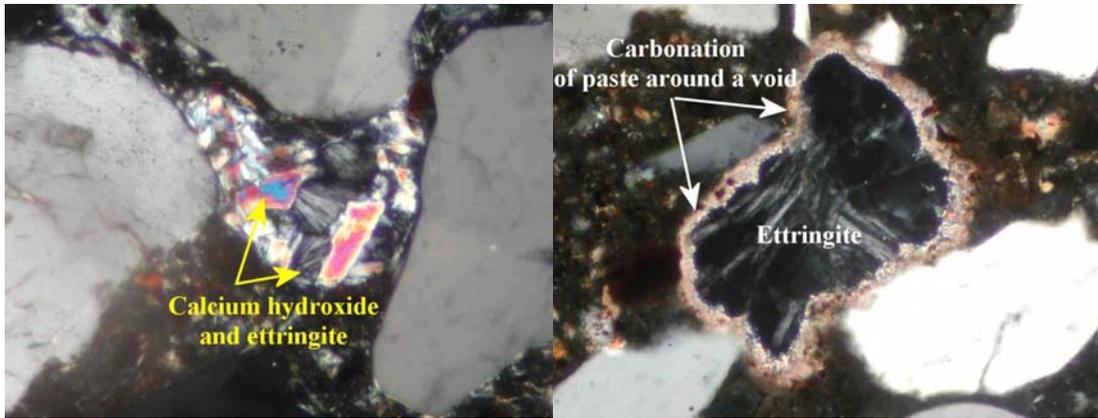
Secondary Deposits – In voids throughout the samples from the 'good' pipe are fine, radiating, acicular crystals of secondary ettringite ($3\text{CaO}\cdot\text{Al}_2\text{O}_3\cdot 3\text{CaSO}_4\cdot 32\text{H}_2\text{O}$), and lath shaped crystals of secondary calcium hydroxide [$\text{Ca}(\text{OH})_2$] (Figure 5). These secondary deposits are indicative of exposure of the coatings to moisture for prolonged periods. Secondary calcium hydroxide deposits in the voids are more abundant in samples from the good pipe but are rare in the samples from the failed pipe.

Figure 5. Thin-section photomicrographs showing secondary deposits in the voids and in pore spaces in the paste of mortar coatings – left photo shows large crystals of calcium hydroxide and ettringite and right photo shows ettringite in a void, which has a thin carbonation rim. These features are present in the unaltered portion (body) of both failed and relatively sound pipe. Widths of photos = 0.15 mm.

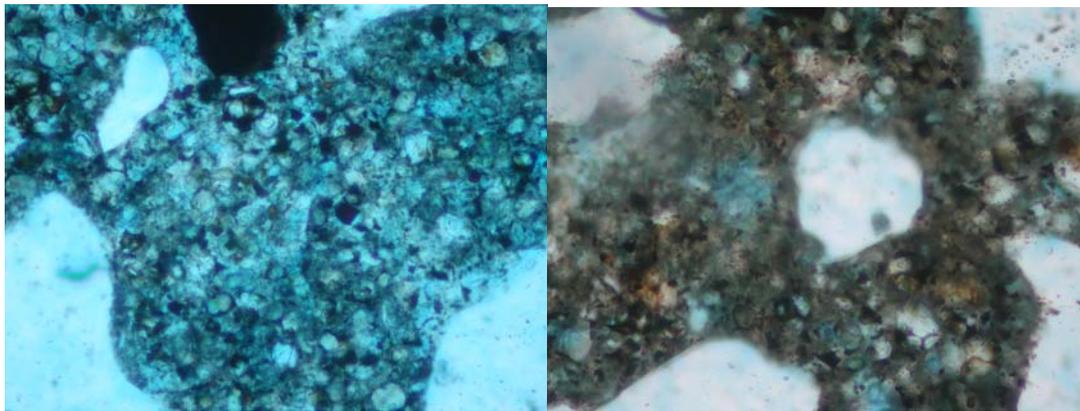
Figure 6. Thin-section photomicrographs showing residual Portland cement particles in the paste in light and dark bands in the relatively unaltered portion (body) of the sound pipe. The left photo is for lighter paste, which is more porous than the denser and darker paste in the right photo. Widths of photos = 0.15 mm.

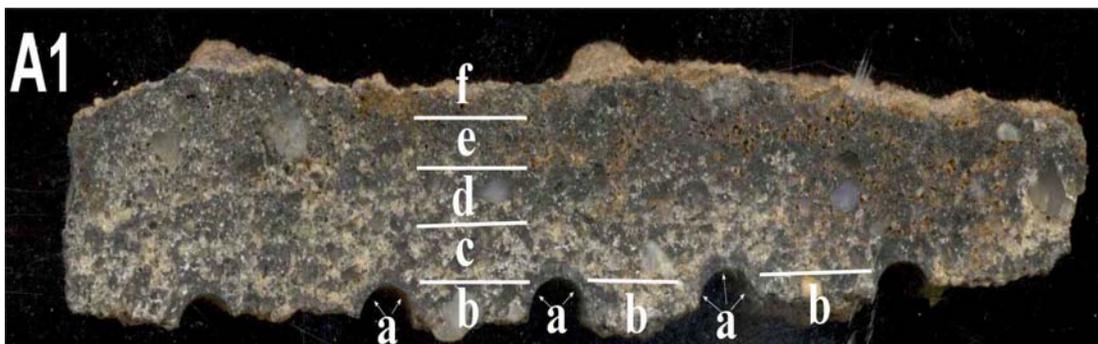
Figure 7. Locations of samples in a cross-section for determining the chloride profile.

Chloride Analysis – Chloride profile analyses were done using specimens obtained by dry drilling methods. The locations of the samples for chloride profiles are shown in Figure 7. The chloride contents are more or less consistent in two pieces of the good pipe but are variable in two pieces of the failed pipe.

The chloride contents of the neat pastes at the wire cast surfaces of samples from the failed pipe are 0.024 and 0.076 percent by mass of the pastes. The chloride contents in the body of the mortars are from 0.005 - 0.030 percent at the bottom to 0.002 - 0.029 percent at the exposed surface of the coatings. The chloride profiles are indicative of chloride in the mortar-making materials plus an uptake from the environment. Assuming a portland cement content of 20 percent, the chloride values at various depths exceed the maximum 0.06 percent chloride content threshold considered by ACI Committee 222 for minimizing the risk of chloride-induced corrosion of reinforcing steel in non-carbonated, prestressed concrete when oxygen and moisture are present.
