**ACID ATTACK IN A CONCRETE SEWER PIPE
- A PETROGRAPHIC & CHEMICAL INVESTIGATION**

Dipayan Jana¹ and Richard A. Lewis²

ABSTRACT

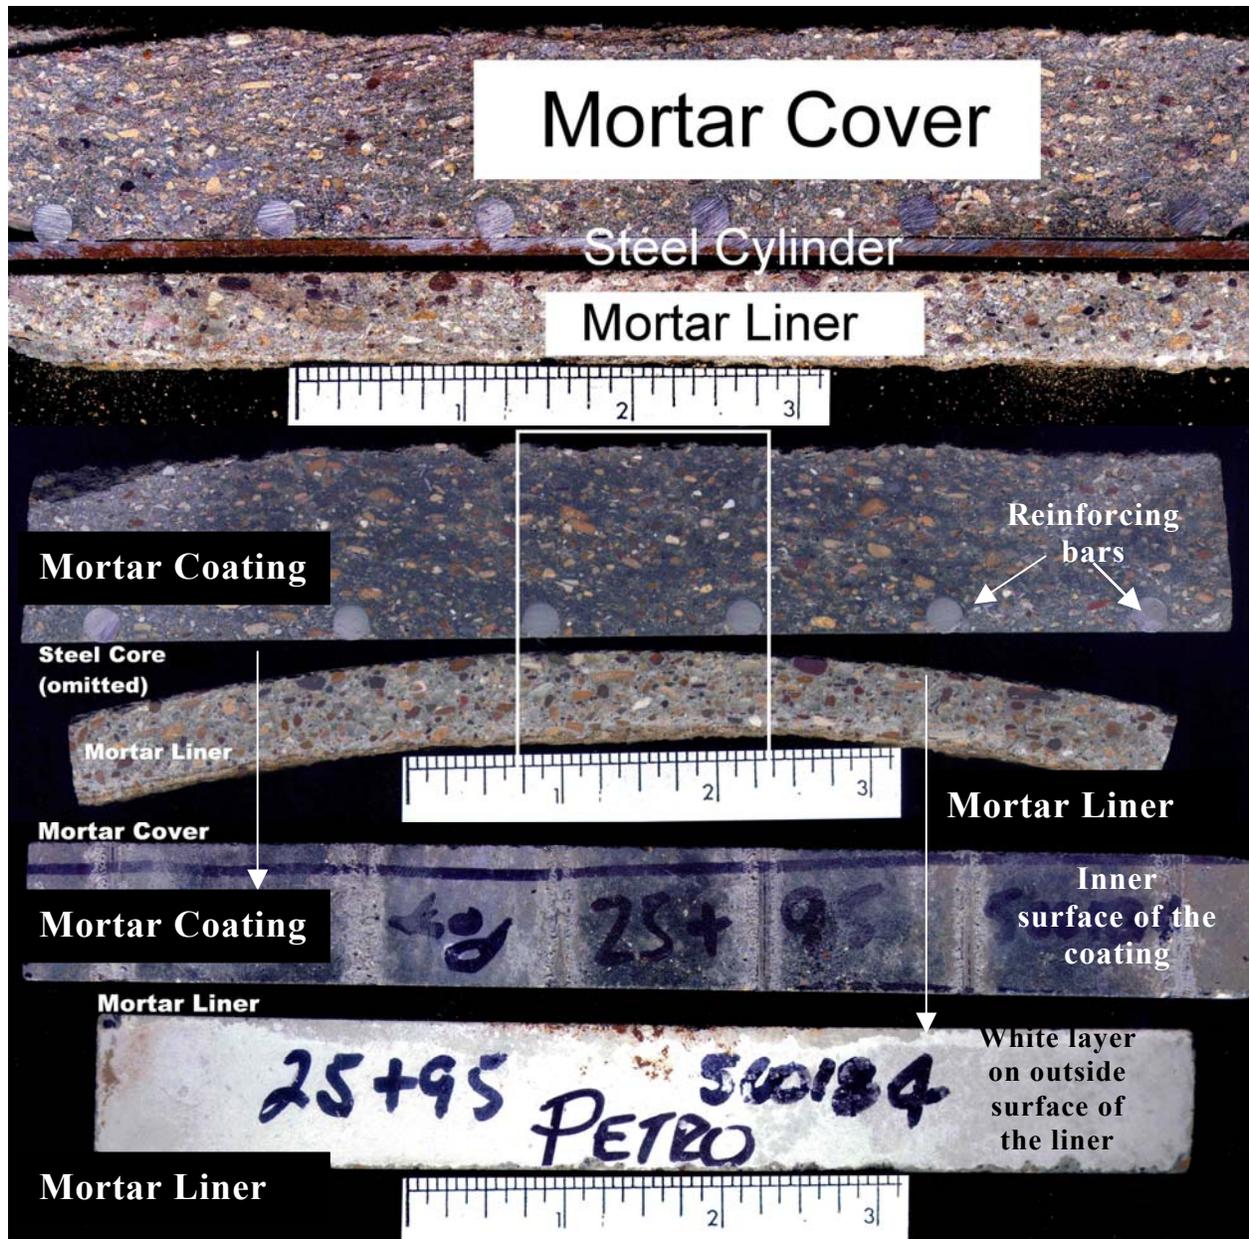
lected from a station (25+95) for laboratory analyses (Figures 2, 5, and 6). The mortar coating was unaffected by the exterior soil but the inner surface of the liner was severely corroded with a 25 percent loss of the total thickness and severe leaching of paste. The mortar coating, steel cylinder, and mortar liner, though mated to each other, were received in de-bonded conditions.

The mortar coating is $1\frac{1}{4}$ in. in maximum thickness (Figure 2). The outer surface, in contact with soil, is rough, grayish brown, weathered, and covered with loose soil and sand particles. The inner surface, in contact with the steel cylinder, is smooth, formed, dark gray, and contains parallel, embedded, reinforcing bars having nominal diameters of $\frac{7}{32}$ in. and regular center-to-center spacing of $1\frac{5}{8}$ in. to $1\frac{1}{4}$ in. The reinforcing bars were not corroded. The reinforcing bar-cast surfaces contain neat paste having a thickness of $\frac{1}{64}$ in.

Figure 2: Saw-cut (top) and lapped (middle) cross-sections of pipe sample showing the coating, steel cylinder, and the liner. The bottom photo shows plan views of the inner surface of the coating and the outer surface of the liner (notice the white coat on the outer surface of liner).

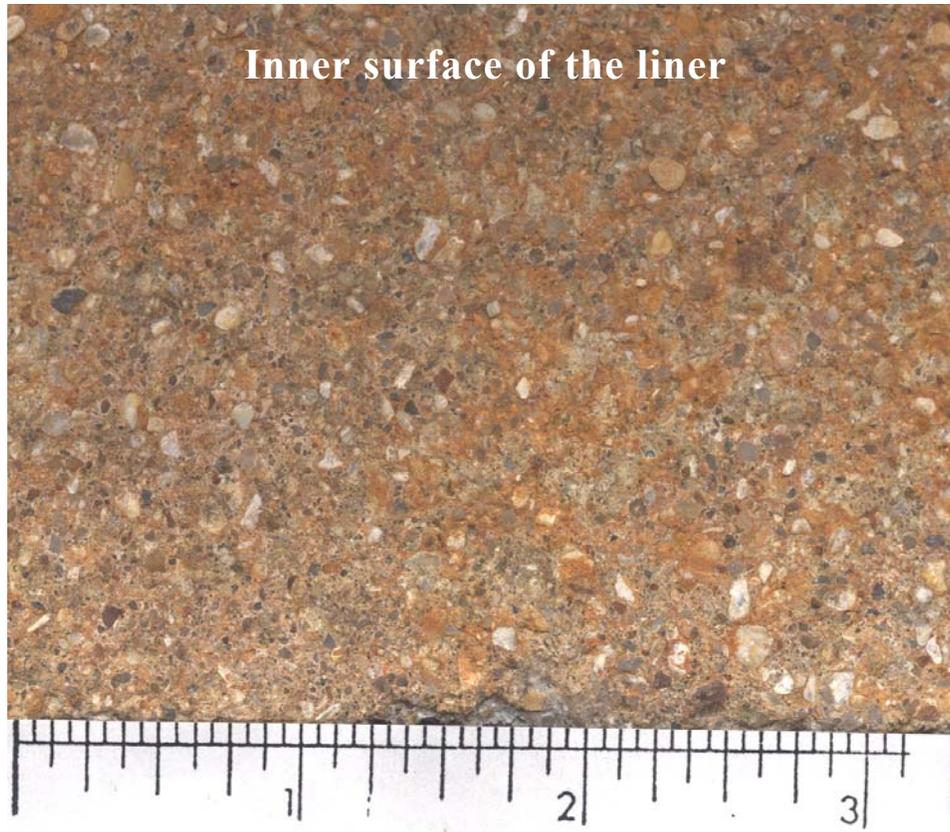
- (1) Corrosion of the liner – The nominal thickness of the liner is ⁹/₁₆ in., which is 75 percent of the reported 'original' nominal thickness of ³/₄ in. Thus, there is a 25 percent loss of the thickness of the mortar liner.

sand) are more sound and durable during leaching and stood prominently against the leached paste, whereas carbonate aggregate particles are less durable and showed evidence of acid erosion. The yellowish brown stain of the inner surface (Figure 3) is from the leached ferruginous components of the aggregates.

Figure 3: Shown is the corroded inner wall of the mortar liner where the aggregate particles are exposed and the paste has leached.

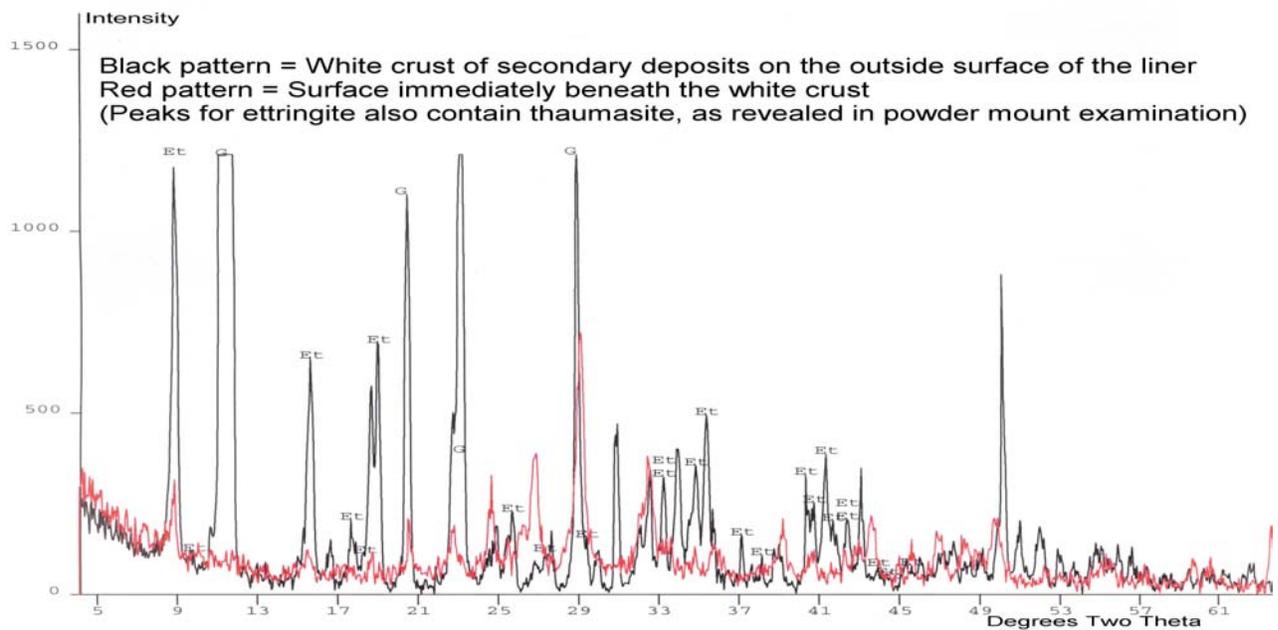
(3) Gypsum and Ettringite/Thaumasite Formation – As mentioned before, XRD analyses of the white layer on the outside surface of the liner detected gypsum, ettringite, and thaumasite (Figure 4). Also detected are some very fine, secondary calcite, and dolomite crystals. Such crusts of gypsum, ettringite and thaumasite indicate migration of sulfate and carbonate ions through the liner into the steel-liner interface. Figure 9 shows oil immersion mount of inter-grown mixture of ettringite and thaumasite in the white layer, and thin section photomicrograph of secondary ettringite precipitation along an aggregate-paste interface. Figure 10 shows SEM-EDS spectra of gypsum and ettringite from the white layer. Unlike other mechanisms of concrete deterioration, such as delayed ettringite formation, these ettringite occurrences indicate a slow leaching and decay of the liner without any noticeable expansion. There is no evidence of microcracking or so-called “gaps” around the aggregates to indicate any bulk expansion of paste. Ettringite found, therefore, are the benign precipitates of the sulfuric acid attack that has caused more of the loss of mass than its apparent expansion (if any).

Figure 4: X-ray diffraction pattern of the white layer on the outside surface of the mortar liner showing the major peaks for gypsum and ettringite. The red pattern is for the liner surface immediately beneath the white layer.

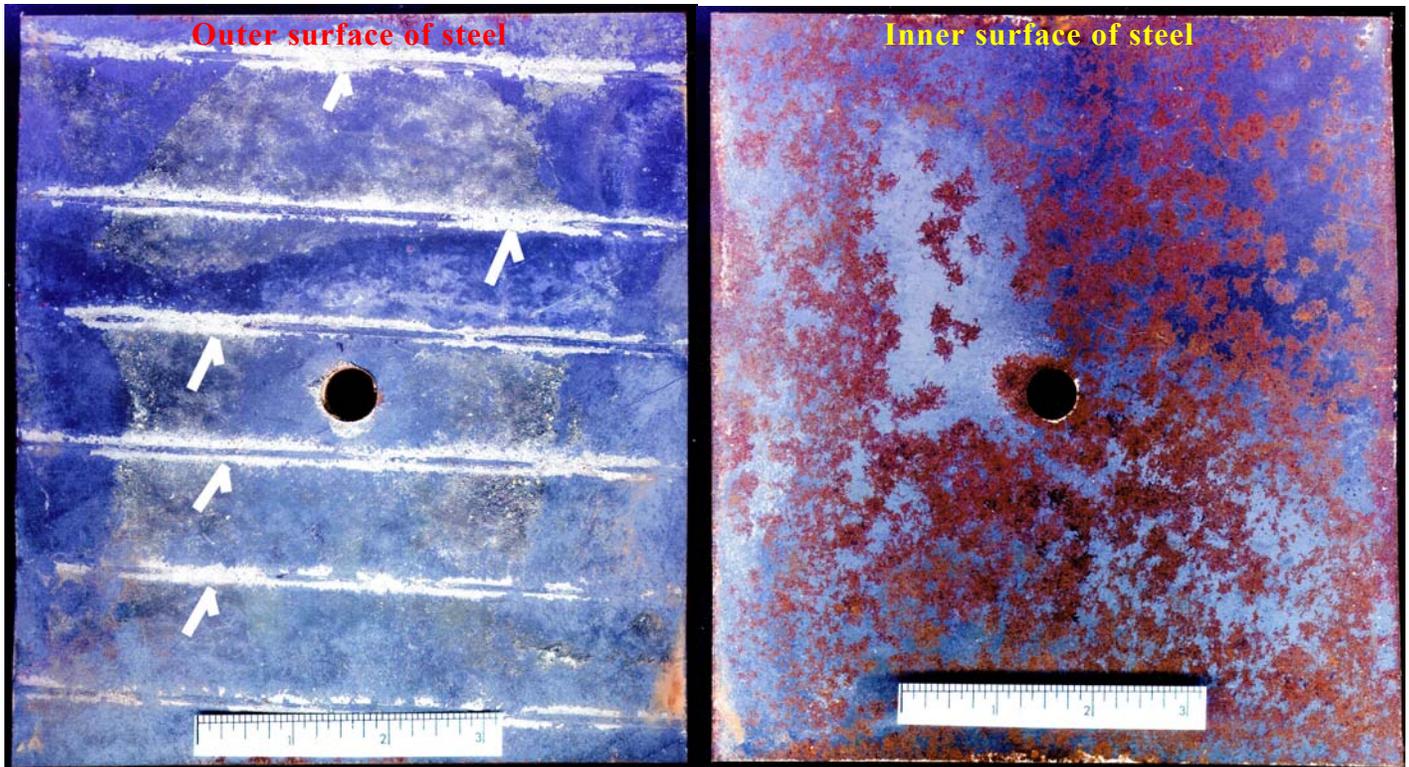
The arched section of the steel cylinder between the liner and the coating has a thickness of $\frac{3}{16}$ in. and a lateral dimension of 8 in. \times 7 $\frac{1}{4}$ in. Its convex outer surface, in contact with the mortar coating, was not corroded - it contains impressions of the reinforced reinforcing bars and associated mortars (Figure 6). The inner surface in contact with the liner, however, has pitting corrosion at several small patches (Figure 6). The absence of corrosion in the outer surface but distinct pitting corrosion in the inside surface of the steel is indicative of: (a) a better quality of the mortar coating than the mortar liner in resisting the corrosive agents; and/or (b) migration of the agents of corrosion (chloride, carbonates, moisture, and oxygen) predominantly from the inner environment of the pipe through the mortar liner. The liner was more porous than the coating, which allowed ready movement of chemicals through the liner to the steel. Moreover, the erosion of the liner has reduced its thickness and helped ready access of corrosive agents to the steel.

Figure 5: Shown are the outside (left photo) and inside (right photo) surfaces of the steel cylinder that were in contact with the bottom surface of the mortar coating and the top, white surface of the mortar liner, respectively. The reddish-brown, pitted corrosion of the inner surface of steel is typical of chloride-induced corrosion of steel. The parallel impressions on the outside surface of the steel (arrows) is from the reinforcing bars and mortars associated with the reinforcement.

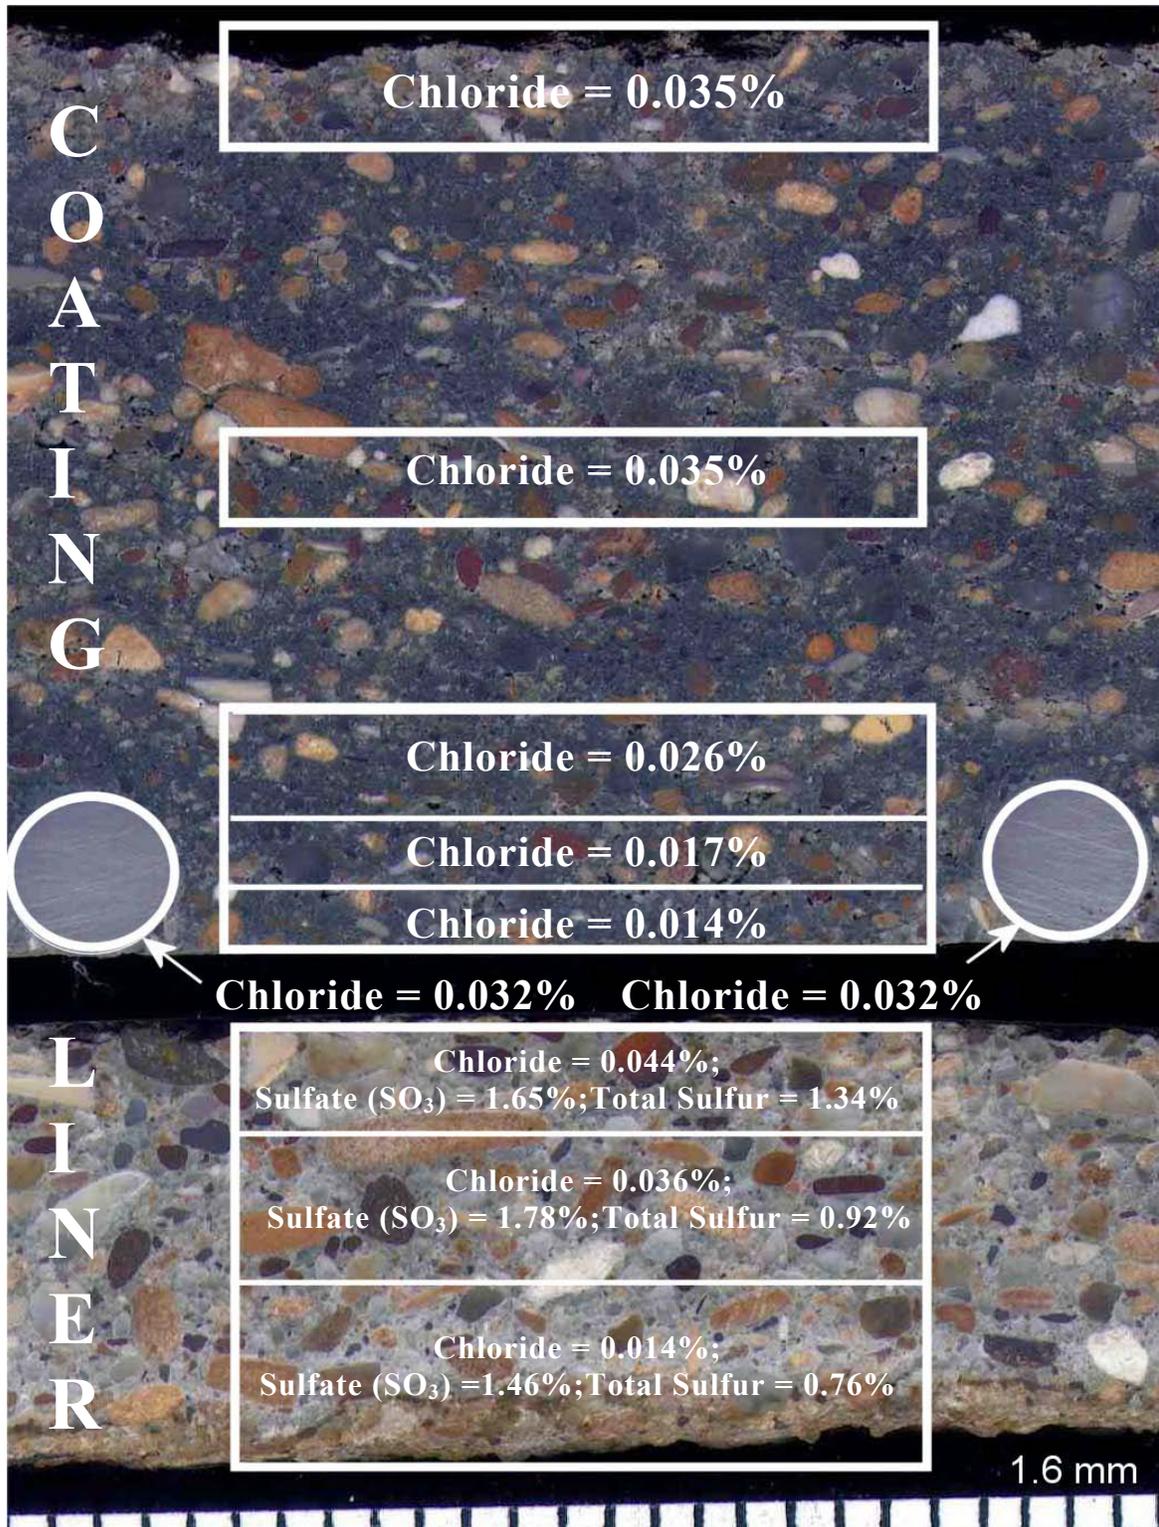
Chloride Profile – Despite the absence of corrosion of the reinforcing bars, the mortar coating was analyzed for chloride contents at various depths to determine the chloride levels and any possibility for future corrosion. Figure 9 shows the sample locations and chloride contents at each depth. Samples adjacent to reinforcing bars were taken by dry drilling of neat paste in the bar-cast surfaces. The chloride contents increase from 0.014 percent at the bottom to 0.035 percent at the top. The profile is indicative of the introduction of chloride from the mortar-making ingredients and a portion contributed from the environment (i.e., from soil and groundwater above the pipe) that has penetrated into the coating. In the neat-paste in bar-cast surface, the chloride content is 0.032 percent, which is comparable to the value in the top. Such a high chloride is due to the absence of aggregates in the neat paste. All chloride contents are reported as percent by mass of the mortar. Despite the somewhat high chloride, the absence of corrosion of reinforcing

Chloride Profile – Similar to the coating, the liner was analyzed for chloride contents at various depths. Samples were obtained from the top, middle, and bottom portions of the liner (Figure 9); the top portion includes the white coat on the exposed surface and the bottom portion includes the brown, leached paste at the inside surface. The chloride contents are 0.044 percent at the top, 0.036 percent in the middle and 0.014 percent at the bottom. The profile is indicative of an upward migration of chloride-containing solutions through the liner (as well as some leaching of chloride at the inside wall).

Sulfate Profile – The mortar liner was also analyzed for sulfate (SO_3) and total sulfur. The top (excluding the outside white coat), middle, and bottom (including the inside surface) of the liner were separately analyzed. The respective sulfate contents are 1.65 percent at the top, 1.78 percent in the middle, and 1.46 percent at the bottom (Figure 9). The total sulfur contents are 1.34 percent at the top, 0.92 percent in the middle, and 0.76 percent at the bottom. The lowest sulfate and sulfur concentrations at the bottom are consistent with leaching of the paste by sulfuric acid. The sulfate and total sulfur contents are both indicative of sulfuric acid (sulfate) attack in the liner.

Figure 6: Shown are the chloride, sulfate and total sulfur profiles in the mortar coating and liner.

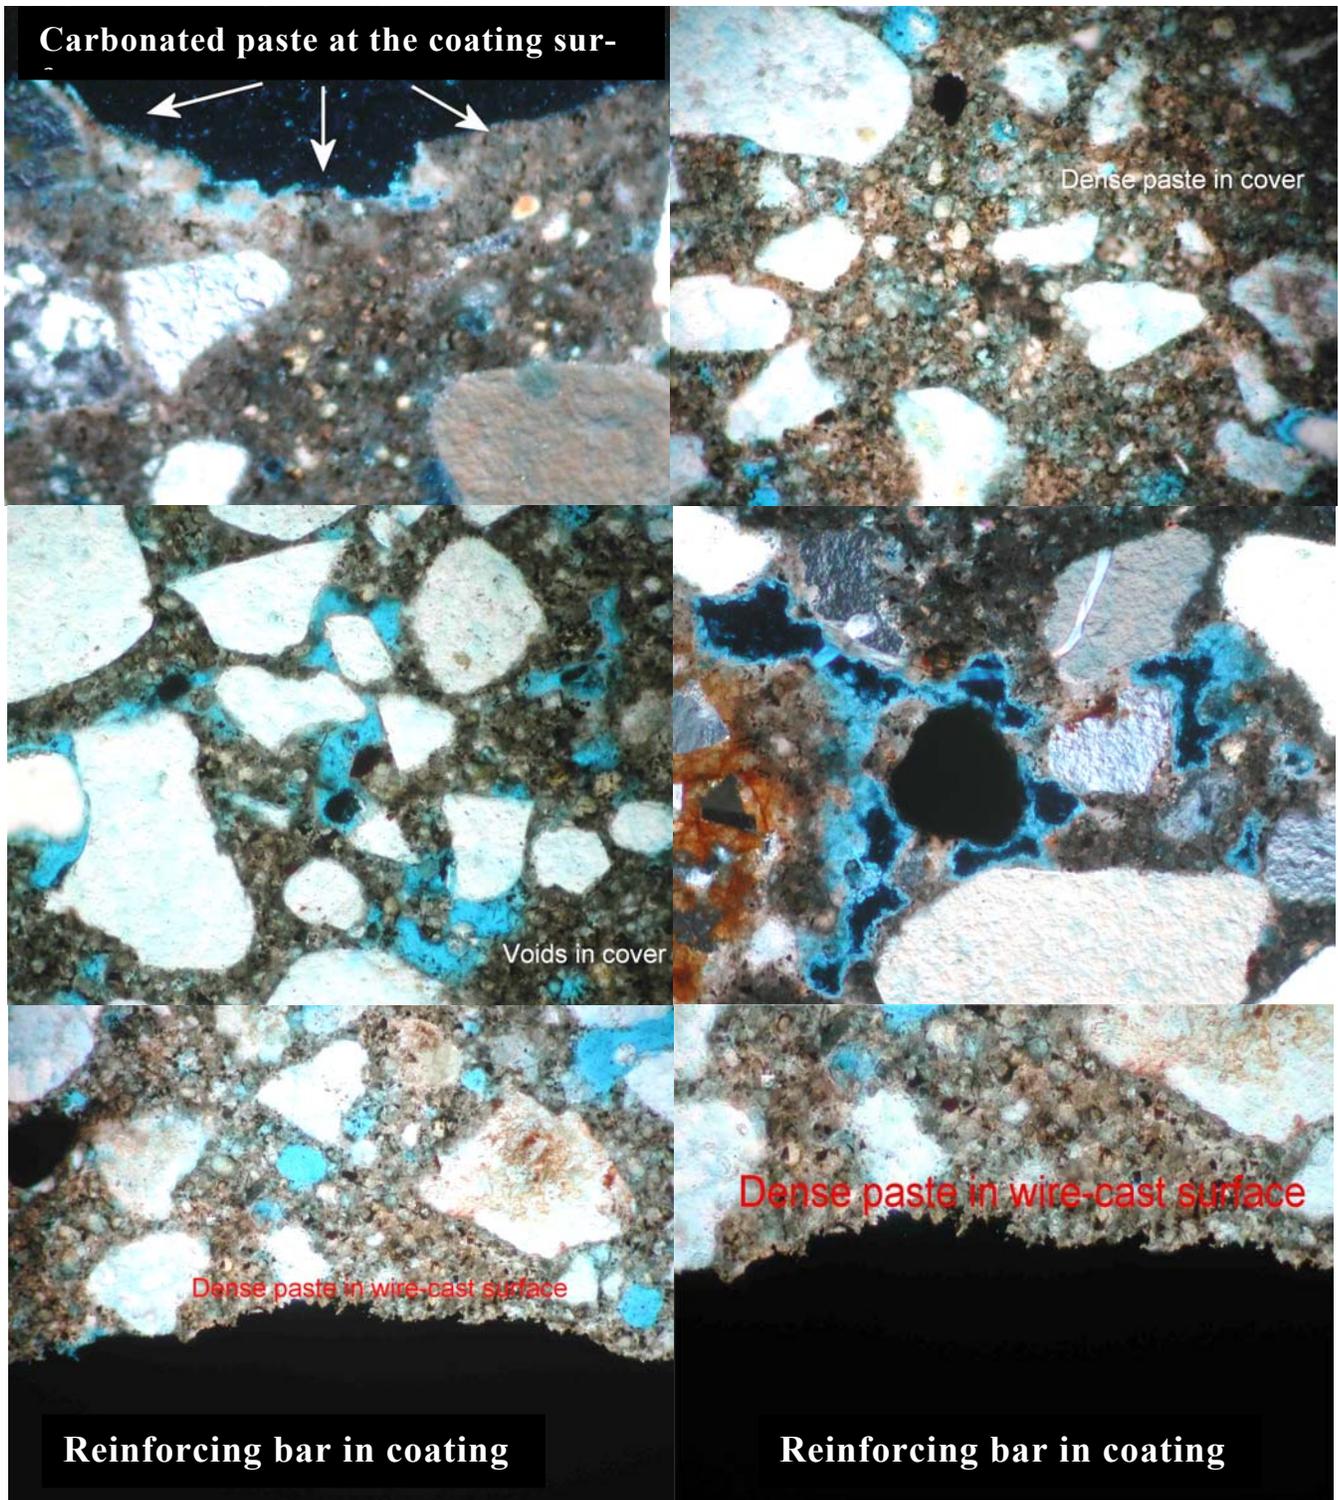
Figure 7 shows the microstructural profile of mortar coating in thin-section photomicrographs taken by using a petrographic microscope. Overall, the mortar coating is sound and does not show any evidence of deterioration or chemical attack from the environment.

Figure 7: Thin-section photomicrographs of cross-section of the mortar coating showing: (a) carbonated paste at the top, exposed surface of the coating (top, left); (b) dense, low *w/c* paste in the interior of the coating (top, right); (c) entrapped air voids in the coating (middle, left); (d) carbonate of paste lining the entrapped voids in the coating (middle, right); (e) dense paste in the reinforcing bar-cast surface around a steel reinforcing bar at the base of the coating (bottom photos). The widths of the photomicrographs are from 1.5 to 2.5 mm.

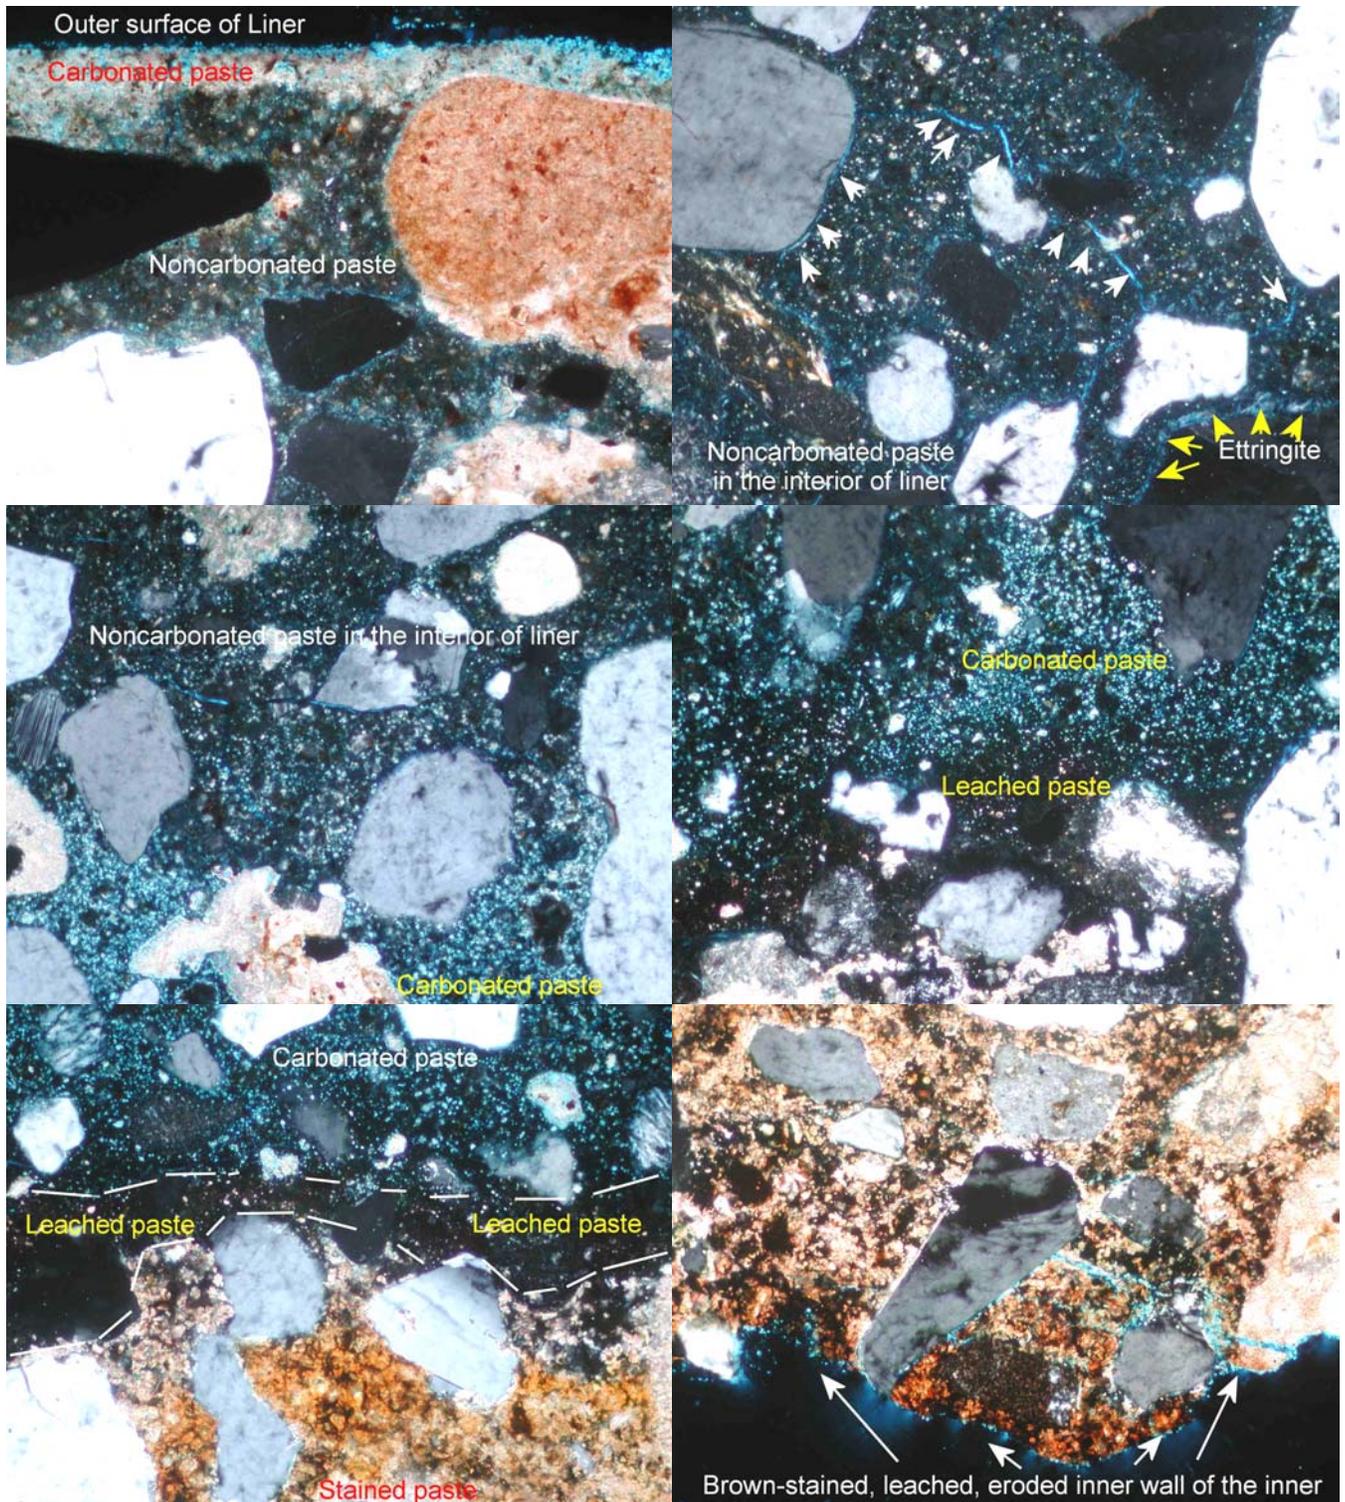
Figure 8 shows the microstructural profile of mortar liner in thin-section photomicrographs taken by using a petrographic microscope.

(4) Compositional Zonation of Paste – The mortar liner shows a distinct compositional zonation from the outer (i.e., in contact with the steel cylinder) – to the inner surface as follows (see Figure 8):

- (1) A thin ($>1/132$ -in.) white layer of secondary gypsum, ettringite, and thaumasite
- (2) A thin (10-20 microns) layer of mortar having soft and carbonated paste,
- (3) Noncarbonated mortar in the interior of the liner (nominally $7/16$ -in. thick)
- (4) A thin layer of porous mortar (nominally 15 microns thick),
- (5) A thin layer of mortar with leached and carbonated paste (nominally 25 microns thick),
- (6) Inner surface of mortar liner having brown stained, iron oxide rich leached and carbonated paste (nominally $1/8$ -in. thick). Erosion of paste has exposed the aggregate particles

Figure 8: Thin-section photomicrographs of cross-section of the mortar liner showing successive compositional zonation from the outer to the inner surface as follows: (a) carbonated paste at the top surface in contact with the steel (top, left); (b) non-carbonated interior below the top (top, right); (c) interface between the noncarbonated interior and carbonate zone near the base (middle, left); (d) interface between the carbonated and leached zones of paste near the base (middle, right); (e) interfaces between the carbonated, leached, and brown-stained corroded zone at the base (bottom, left); and (f) the brown-stained corroded zone at the inner surface of the liner (bottom, right). The widths of the photos are from 1.5 to 2.5 mm.

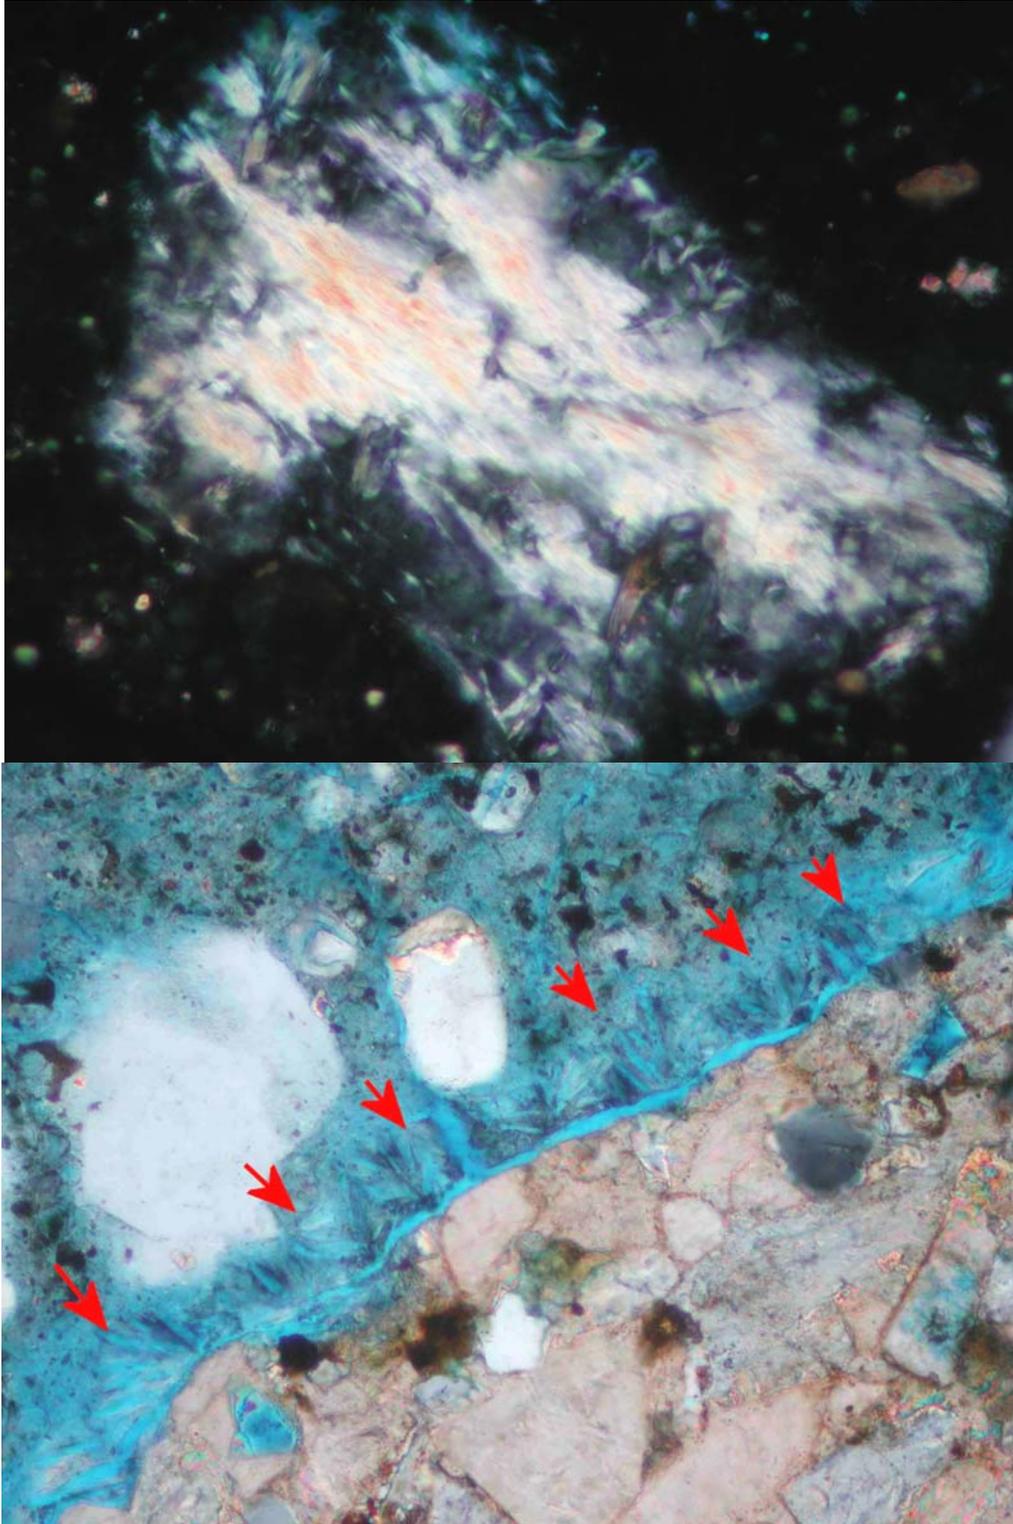
Secondary Deposits – Secondary deposits are present all throughout the mortar liner – (a) as a thin, white layer of secondary ettringite, thaumasite, and gypsum on the outer surface of the liner, (b) acicular and fibrous ettringite in voids within the paste and along aggregate-paste interfaces (Figure 9), (c) matted thaumasite in voids near and at the out-

Sulfate Layer – Of special importance is the distinct white layer of secondary ettringite, thaumasite, and gypsum at the top surface of the liner that formed immediately beneath the steel cylinder. Such massive occurrence of sulfates as a distinct layer is the direct indication of sulfuric acid (sulfate) attack and the presence of abundant sulfate solution in the liner. Figure 4 shows x-ray diffraction analysis of this layer scraped from the surface – the abundance of gypsum and ettringite has decreased significantly at the mortar liner surface immediately beneath the white layer. Oil immersion mounts of white layer show intermixed fibers of secondary ettringite and thaumasite (the latter occur due to the presence of sulfate, carbonate, and cold temperature inside the pipe).

Figure 9: Evidences of sulfate attack from sulfuric acid in the mortar liner. The top photo is of an oil immersion mount of the white layer on the outer surface of the liner showing an intimate intergrowth of ettringite and thaumasite fibers. The bottom photo shows precipitation of secondary ettringite along an aggregate-paste interface (red arrows). Notice the more porous nature of the interface than the bulk paste away from the interface. The widths of the photos are 1.5 mm.

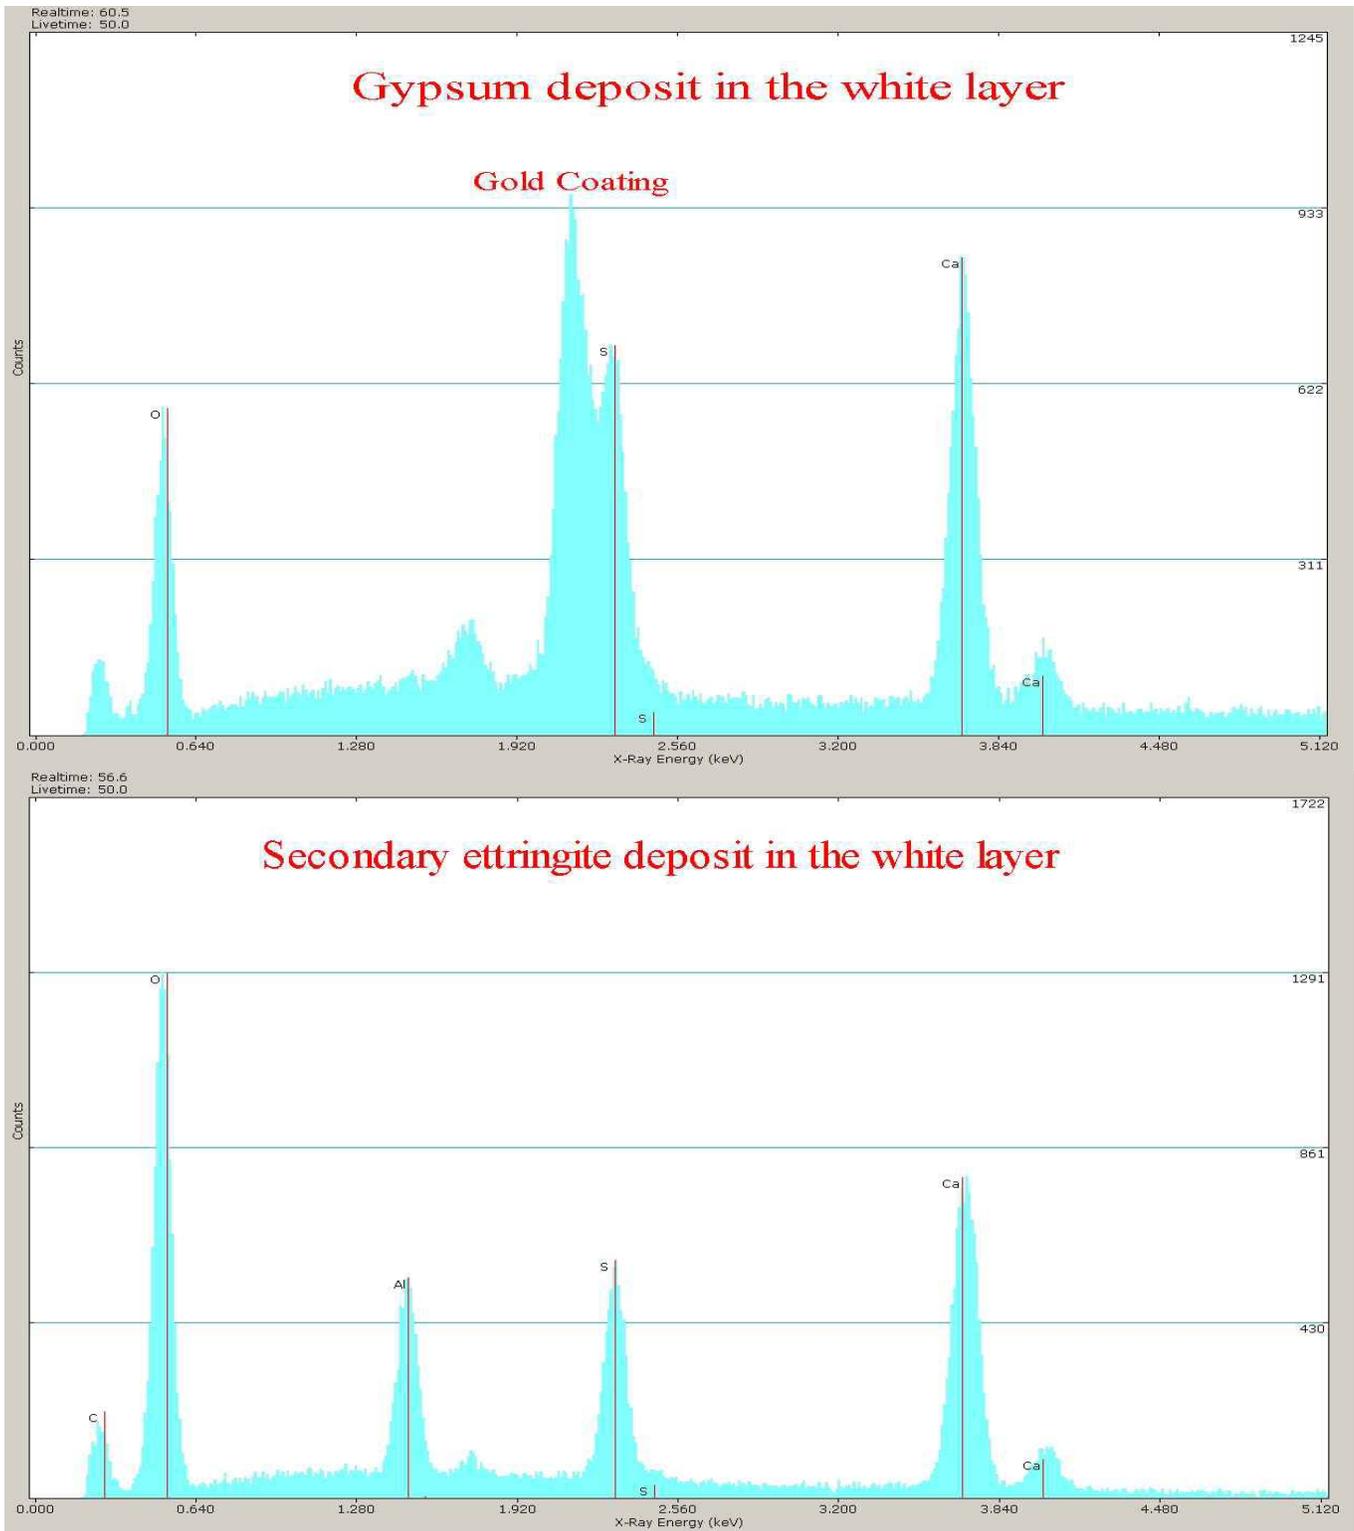
Figure 10: SEM-EDS elemental spectrum of the white layer in the mortar liner showing the gypsum and ettringite deposits. The ettringite spectrum was obtained without using a coating on the sample.
