CONSTRUCTION MATERIALS CONSULTANTS, INC.

Laboratory Investigation of Epoxy Terrazzo Failure From Concrete Slab-on-Grade

Knott Hall
Loyola Blakefield
Towson, Maryland

April 03, 2019
CMC 0219107

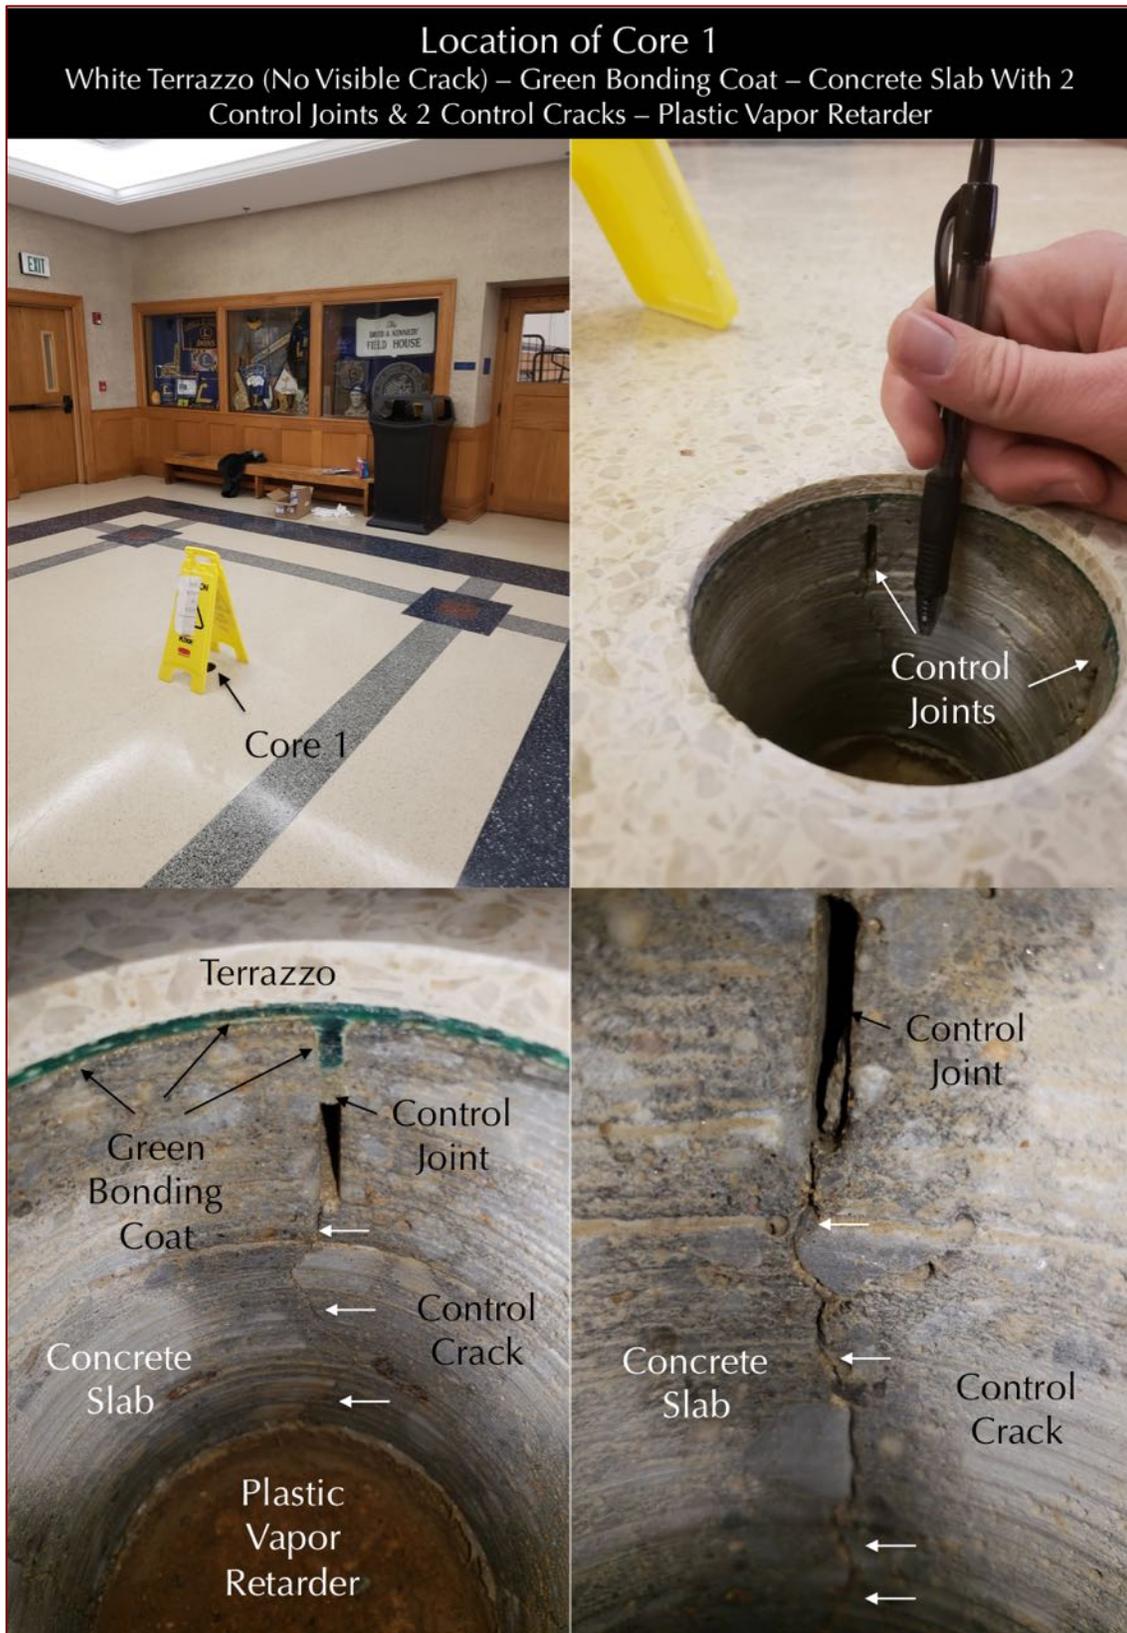
Figure 3: Location of Core 1 from a white terrazzo floor (top left), interior slab after removing the core (top right) showing two control joints with associated cracks (bottom photos), and a green bond coat beneath the terrazzo, and a subbase on which a plastic vapor retarder was placed (not shown in bottom left) before placement of the slab.

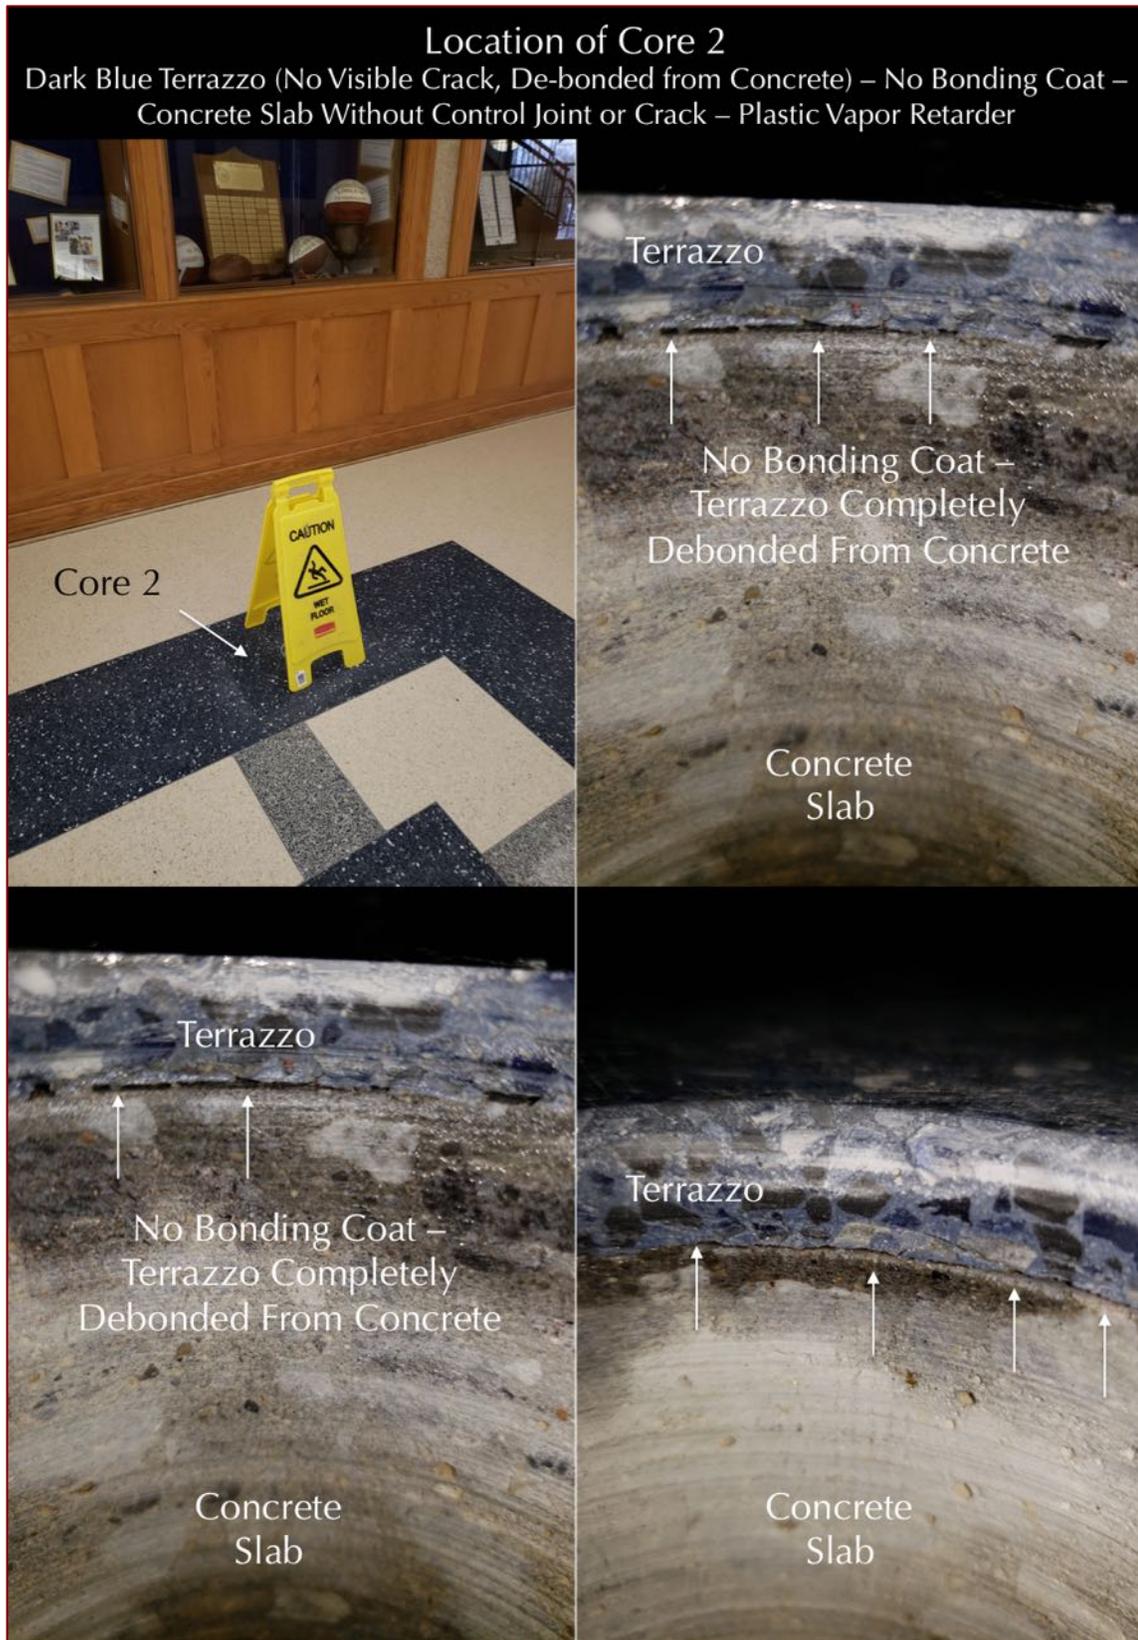
Figure 4: Location of Core 2 from a dark blue band of terrazzo floor (top left), interior slab after removing the core (top right) showing complete debonding of terrazzo from concrete with no intermediate bond coat (top right and bottom photos).

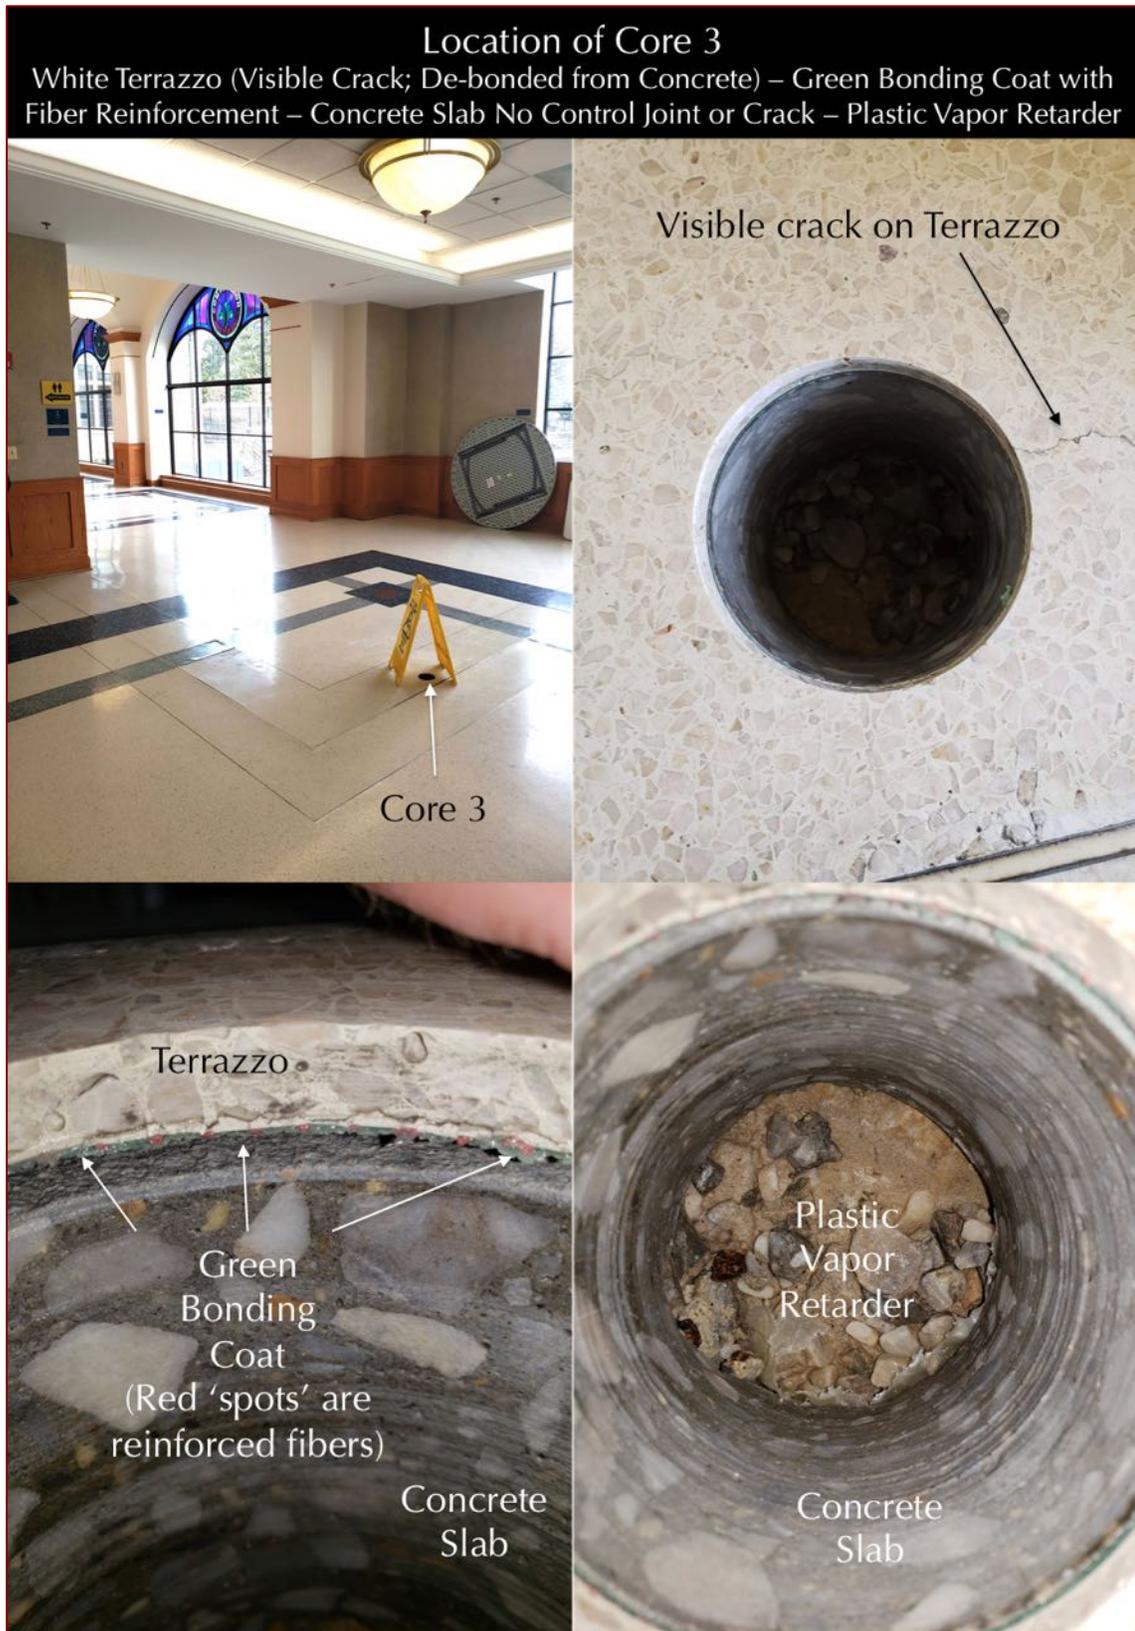
Figure 5: Location of Core 3 from a white terrazzo floor (top left), interior slab after removing the core (top right) showing terrazzo and concrete (bottom photos), and a green bond coat beneath the terrazzo (bottom left), and a subbase on which a plastic vapor retarder was placed (not shown in bottom right) before placement of the slab.

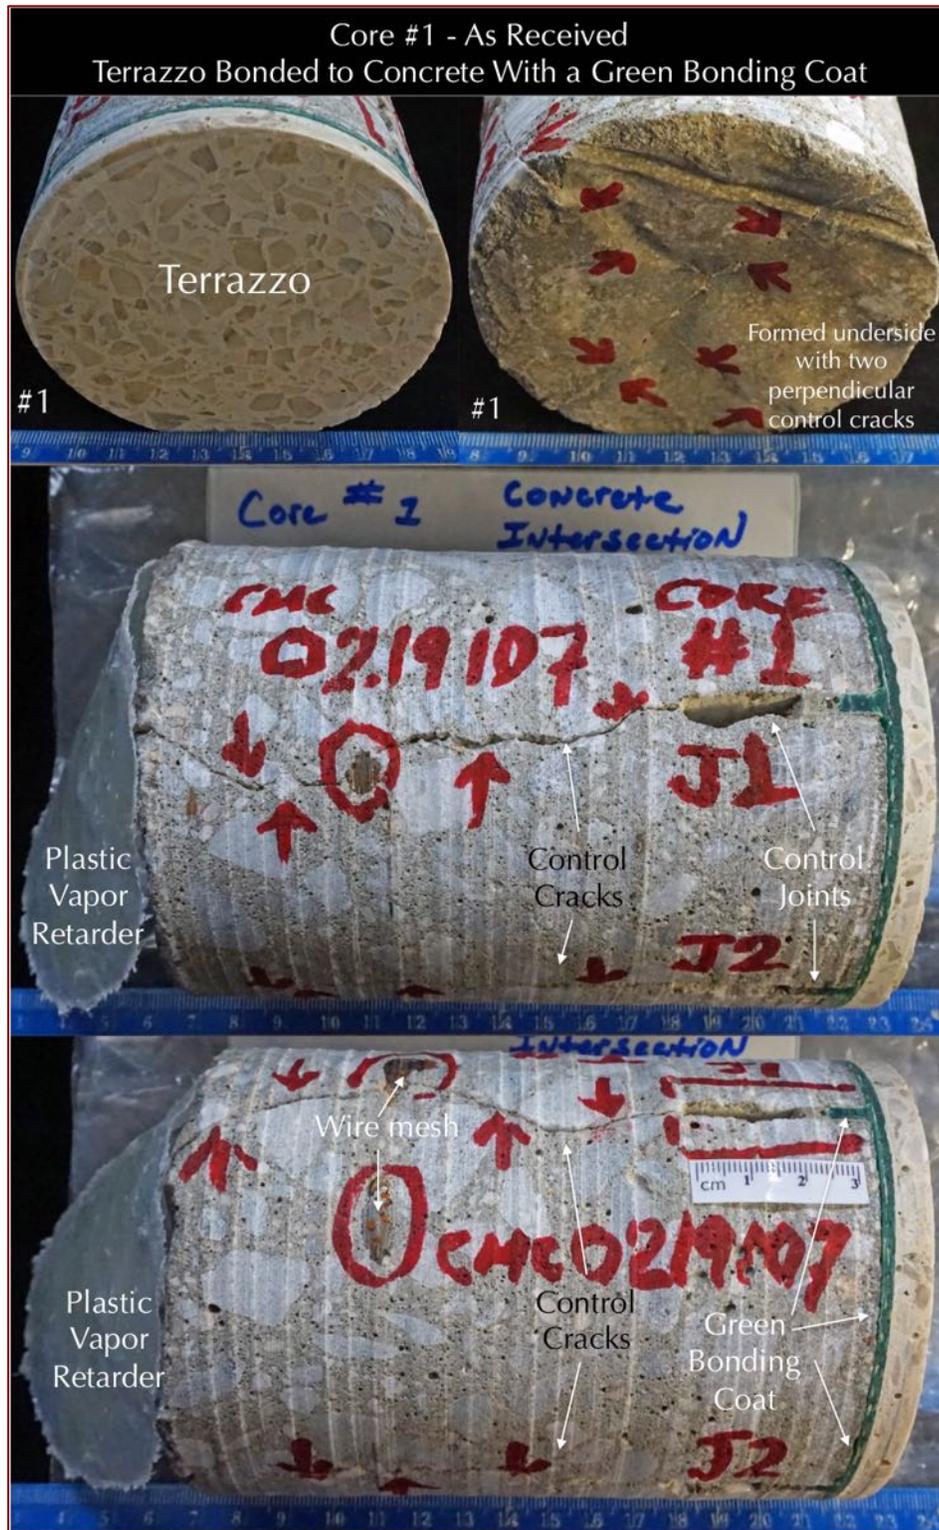
Figure 7: Core 1 as received showing: (a) white terrazzo flooring without any visible crack (top left); (b) smooth, wavy formed bottom end of concrete with impression of placement of slab on a plastic vapor retarder, and two visible perpendicular cracks from two control joints in the core (top right); (c) terrazzo, a green bond coat, and concrete with a control joint and associated crack and a plastic sheet at the base (middle row); and (d) another side view of terrazzo-green bond coat-concrete composite where two control joints and cracks beneath joints are seen (bottom).

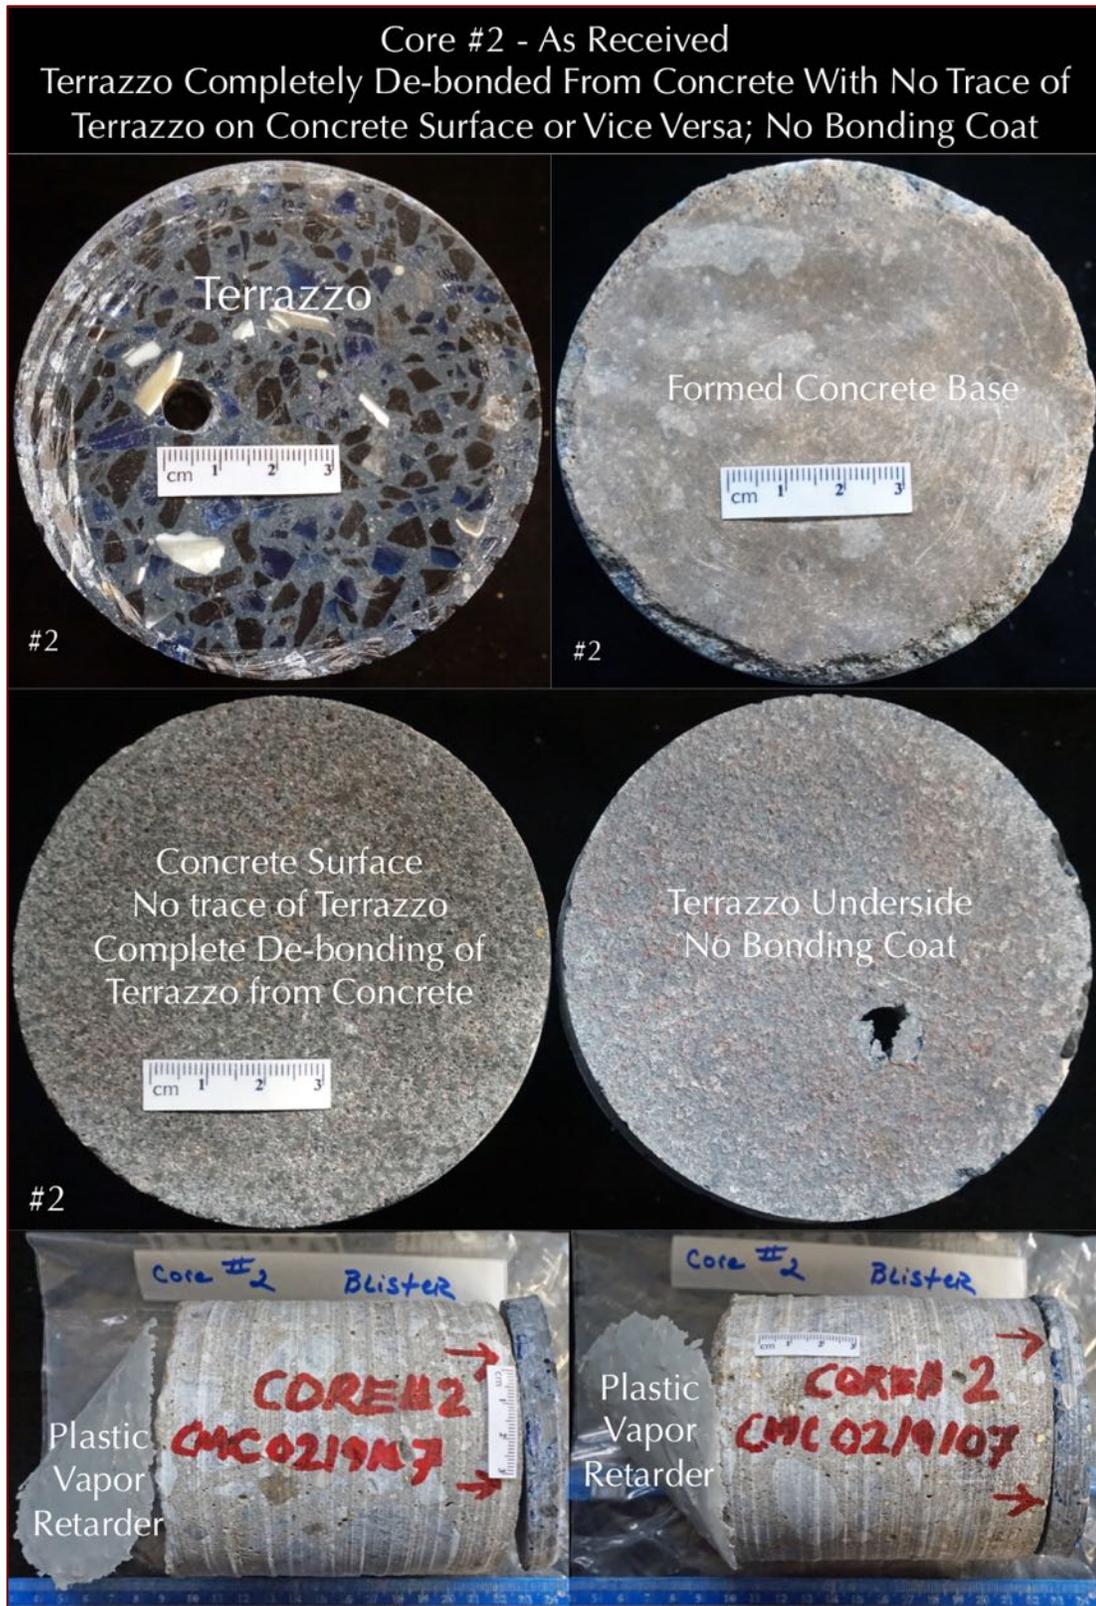
Figure 8: Core 2 as received showing: (a) blue terrazzo flooring without any visible crack but a drill hole (top left); (b) smooth, wavy formed bottom end of concrete with impression of placement of slab on a plastic vapor retarder (top right); (c) top concrete surface (middle left) and underside of terrazzo (middle right) showing clean separation of two, and (d) side views of terrazzo, complete de-bonding from concrete, and plastic sheet at the base of concrete.

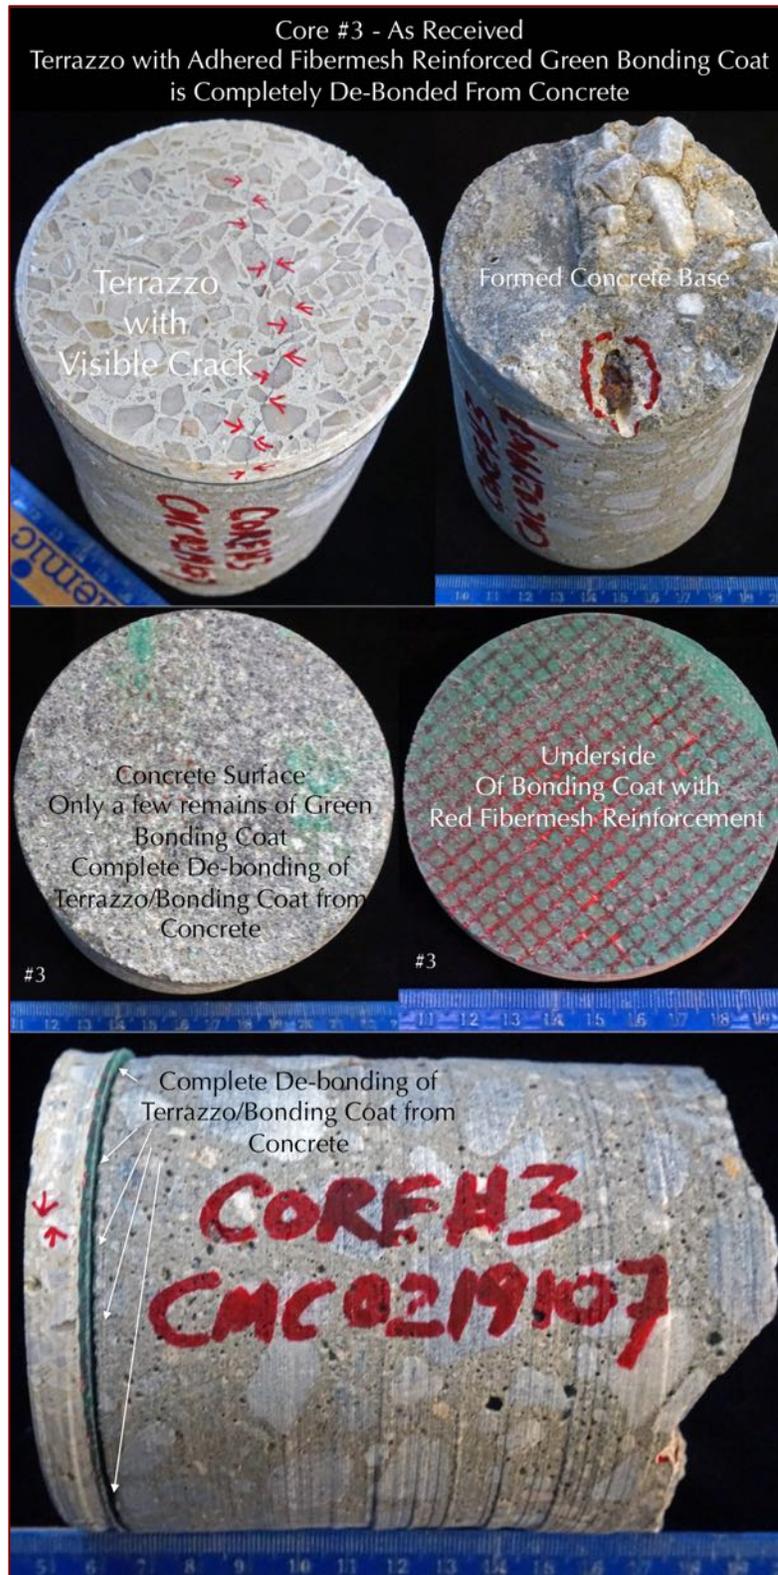
Figure 9: Core 3 as received showing: (a) terrazzo flooring with a visible crack (top left); (b) smooth, wavy formed bottom end of concrete with impression of placement of slab on a plastic vapor retarder (top right); (c) top concrete surface (middle left) and underside of terrazzo showing a green bond coat with red fibermesh reinforcement (middle right) showing clean separation of concrete from terrazzo-green coat composite (middle row); and (d) a side view of terrazzo-green bond coat – complete separation plane and concrete composite (bottom row).

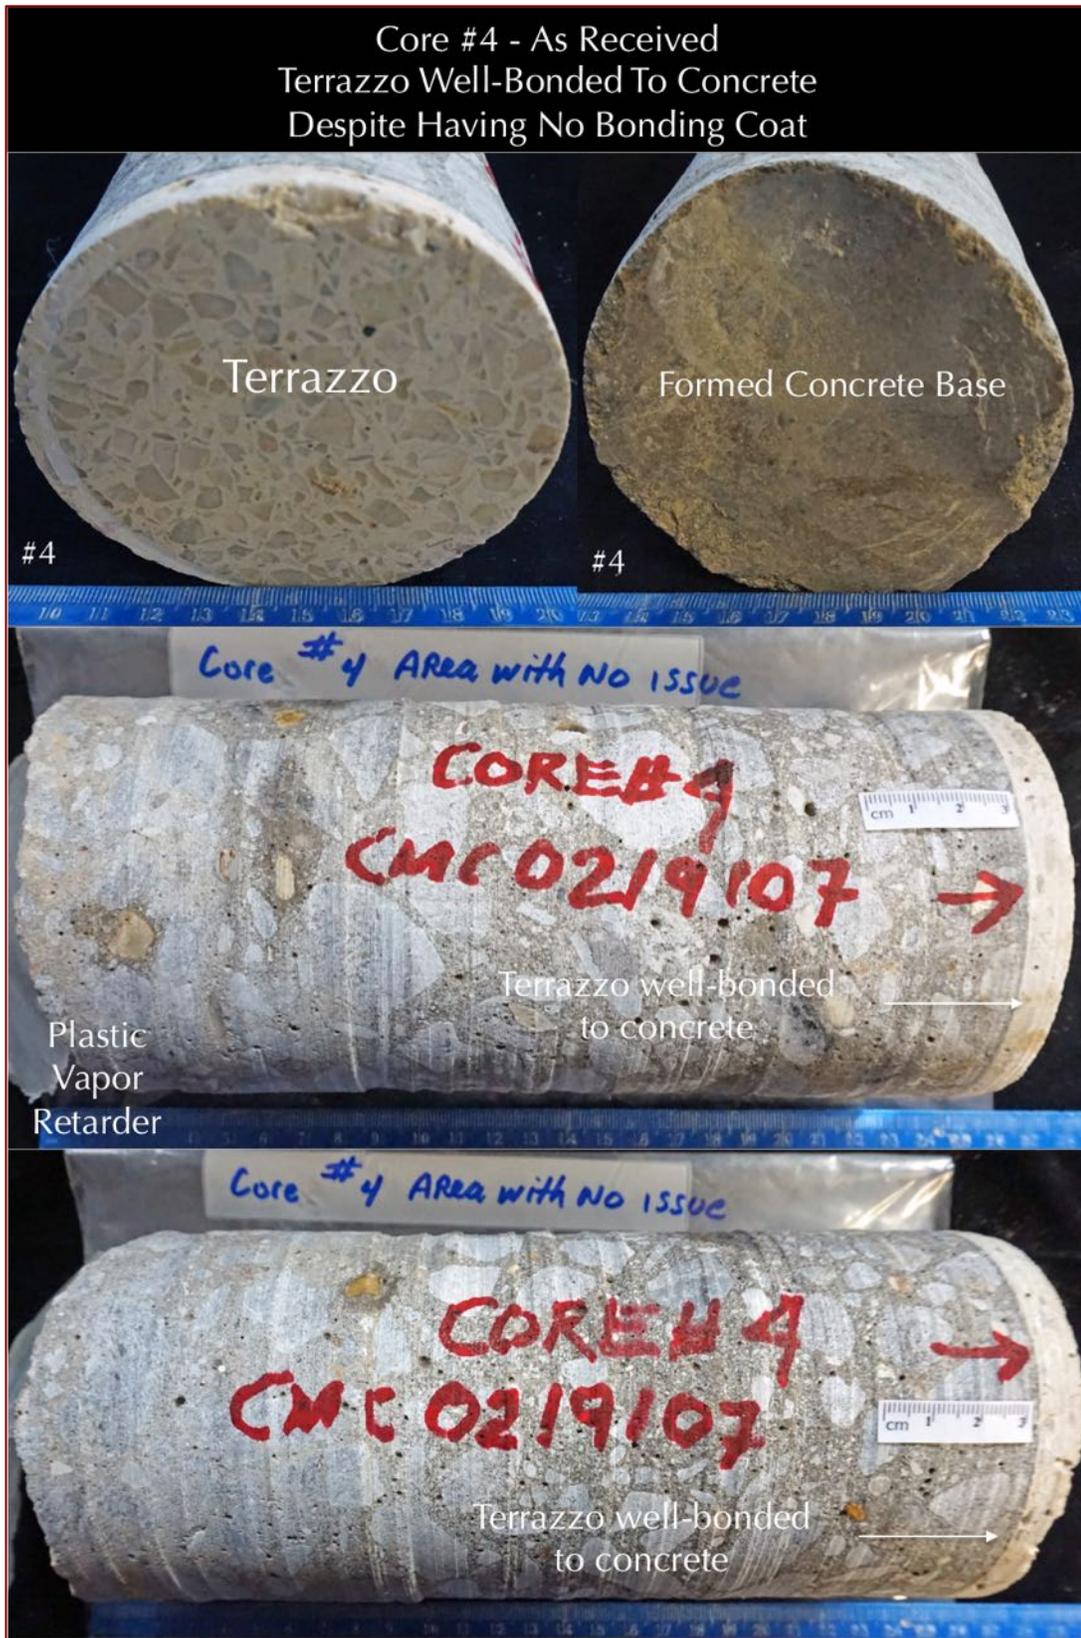
Figure 10: Core 4 as received showing: (a) terrazzo flooring without any visible crack (top left); (b) smooth, wavy formed bottom end of concrete with impression of placement of slab on a plastic vapor retarder (top right); and (c) two side views of terrazzo and concrete substrate with good bond between the top (middle and bottom rows).

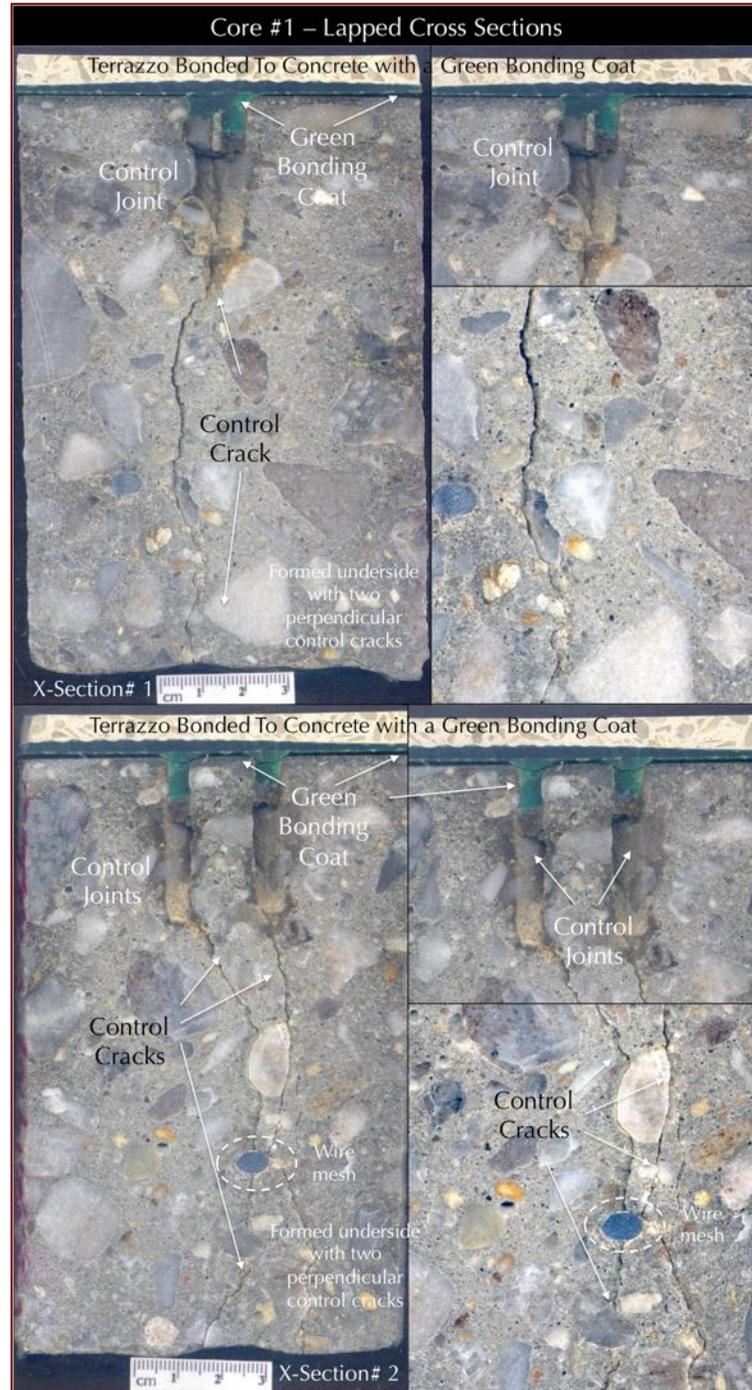
Figure 11: Lapped cross section of Core 1 showing: (a) white terrazzo flooring without any visible crack and smooth, wavy formed bottom end of concrete with impression of placement of slab on a plastic vapor retarder; (c) terrazzo, a green bond coat, and concrete with control joints and associated cracks; (d) good grading and well-distribution of crushed stone coarse aggregate in concrete, (e) dense terrazzo having crushed aggregate chips and white binder, (f) well-bonding of terrazzo to concrete by the green bond coat that has penetrated into control joints.

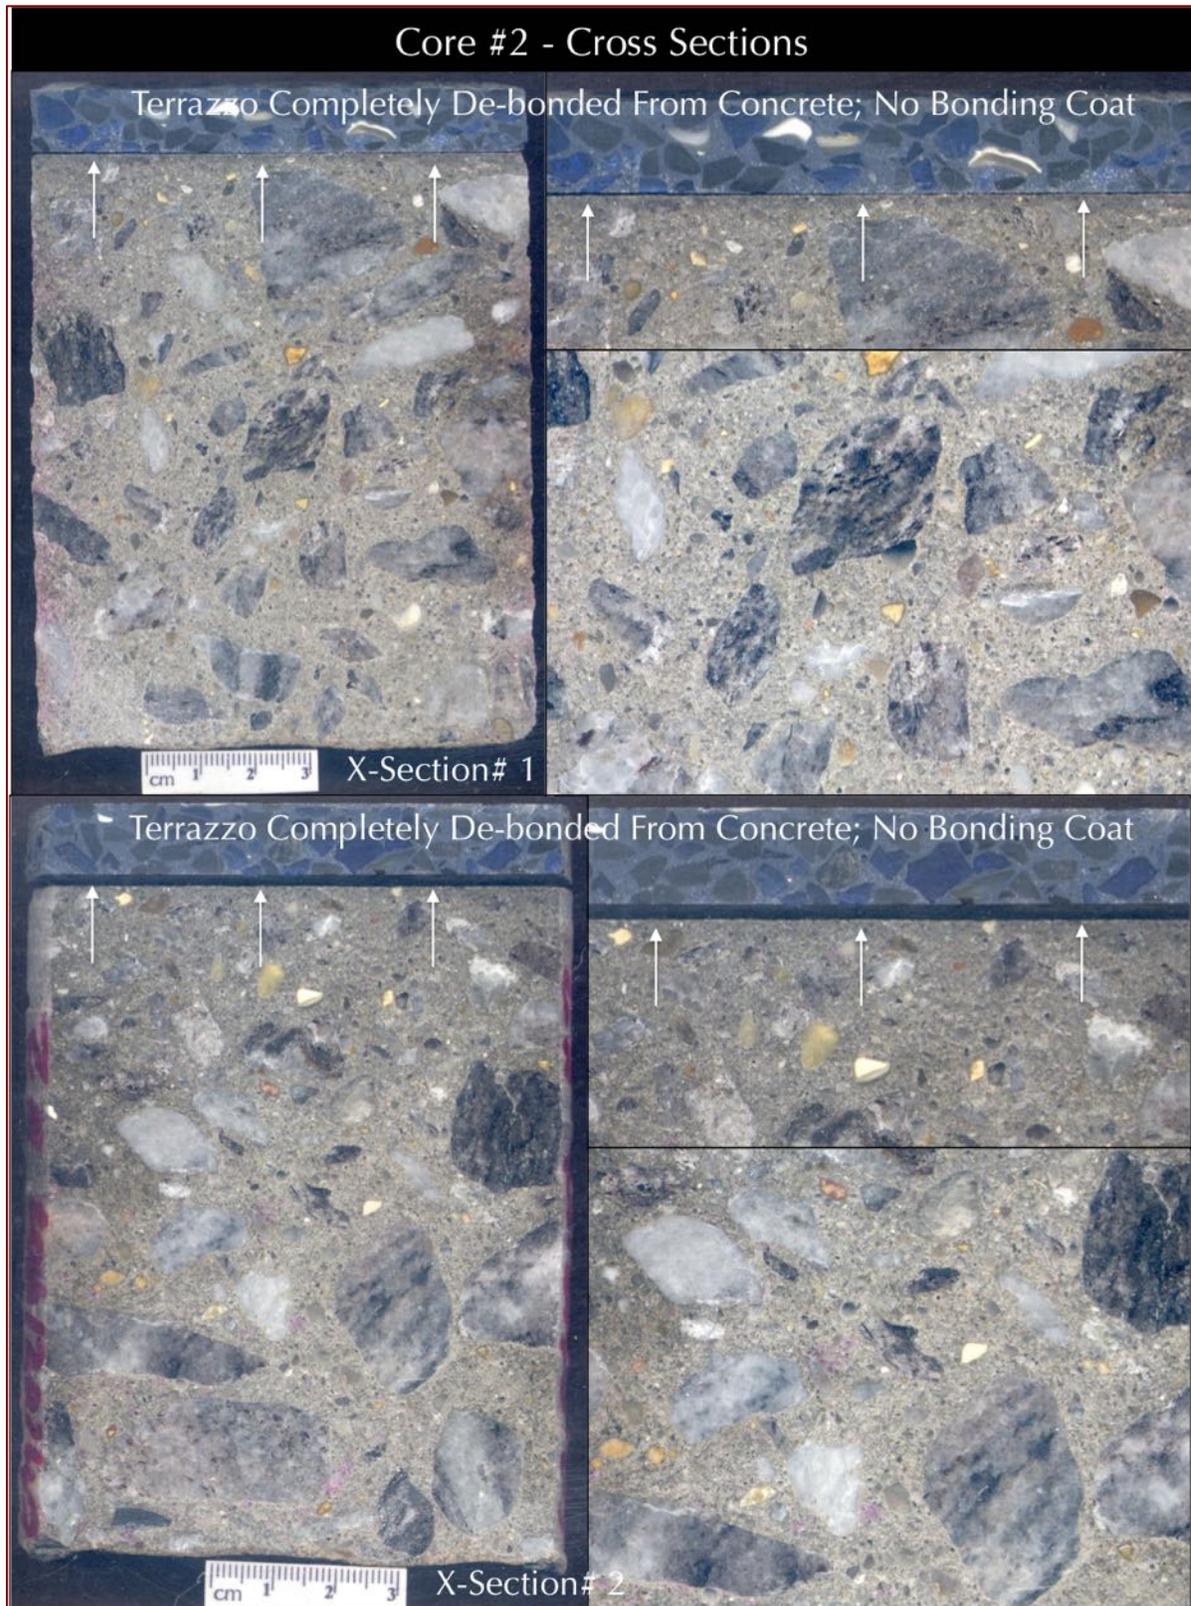
Figure 12: Lapped cross section of Core 2 showing: (a) blue terrazzo flooring without any visible crack and smooth, wavy formed bottom end of concrete with impression of placement of slab on a plastic vapor retarder; (c) complete separation of terrazzo from concrete; (d) good grading and well-distribution of crushed stone coarse aggregate in concrete, and (e) dense terrazzo having crushed aggregate chips and dark blue polymer binder.

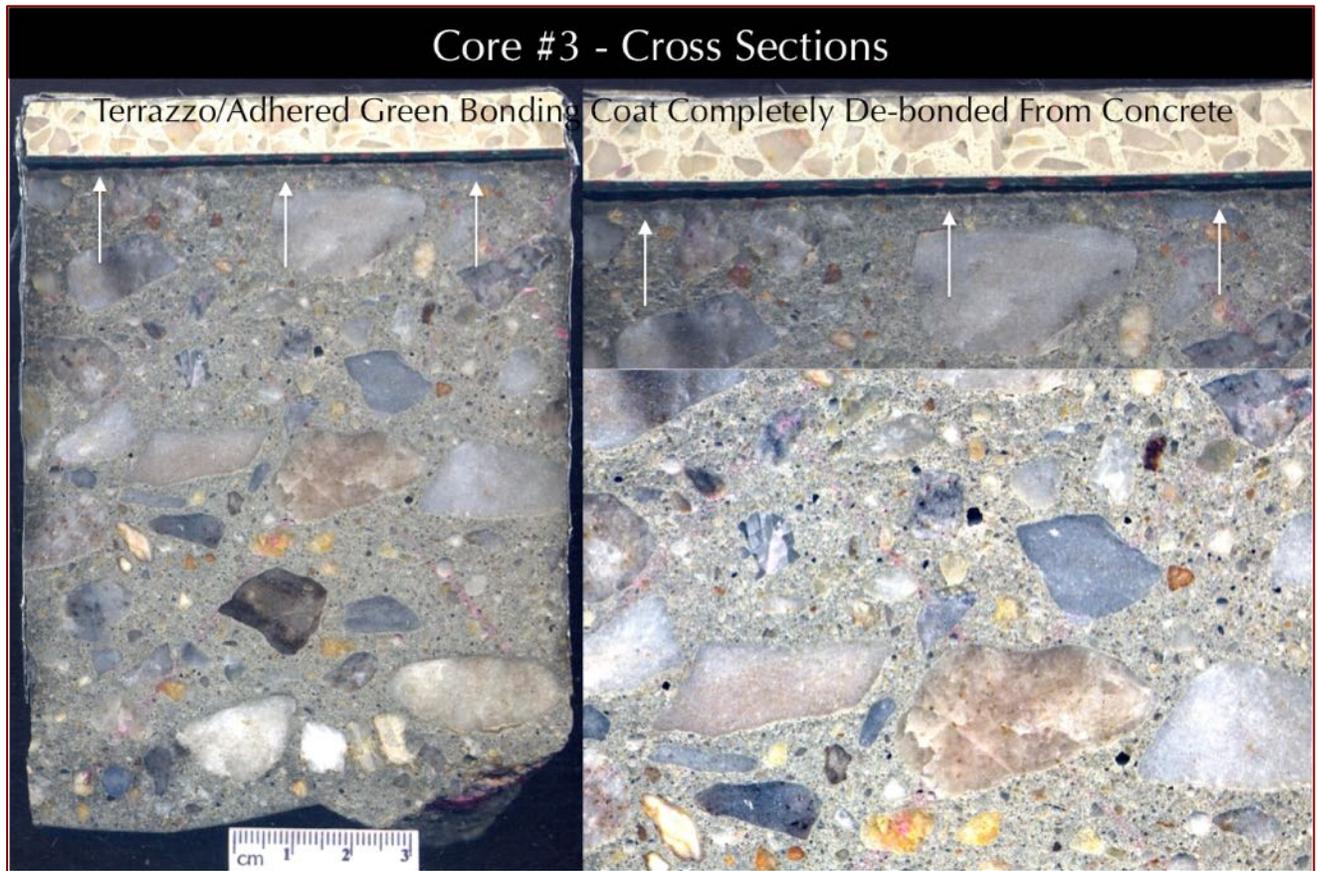
Figure 13: Lapped cross section of Core 3 showing: (a) white terrazzo flooring and smooth, wavy formed bottom end of concrete with impression of placement of slab on a plastic vapor retarder; (c) terrazzo, and a green bond coat, which are mutually bonded but together de-bonded from concrete; (d) good grading and well-distribution of crushed stone coarse aggregate in concrete, and (e) dense terrazzo having crushed aggregate chips and white binder.

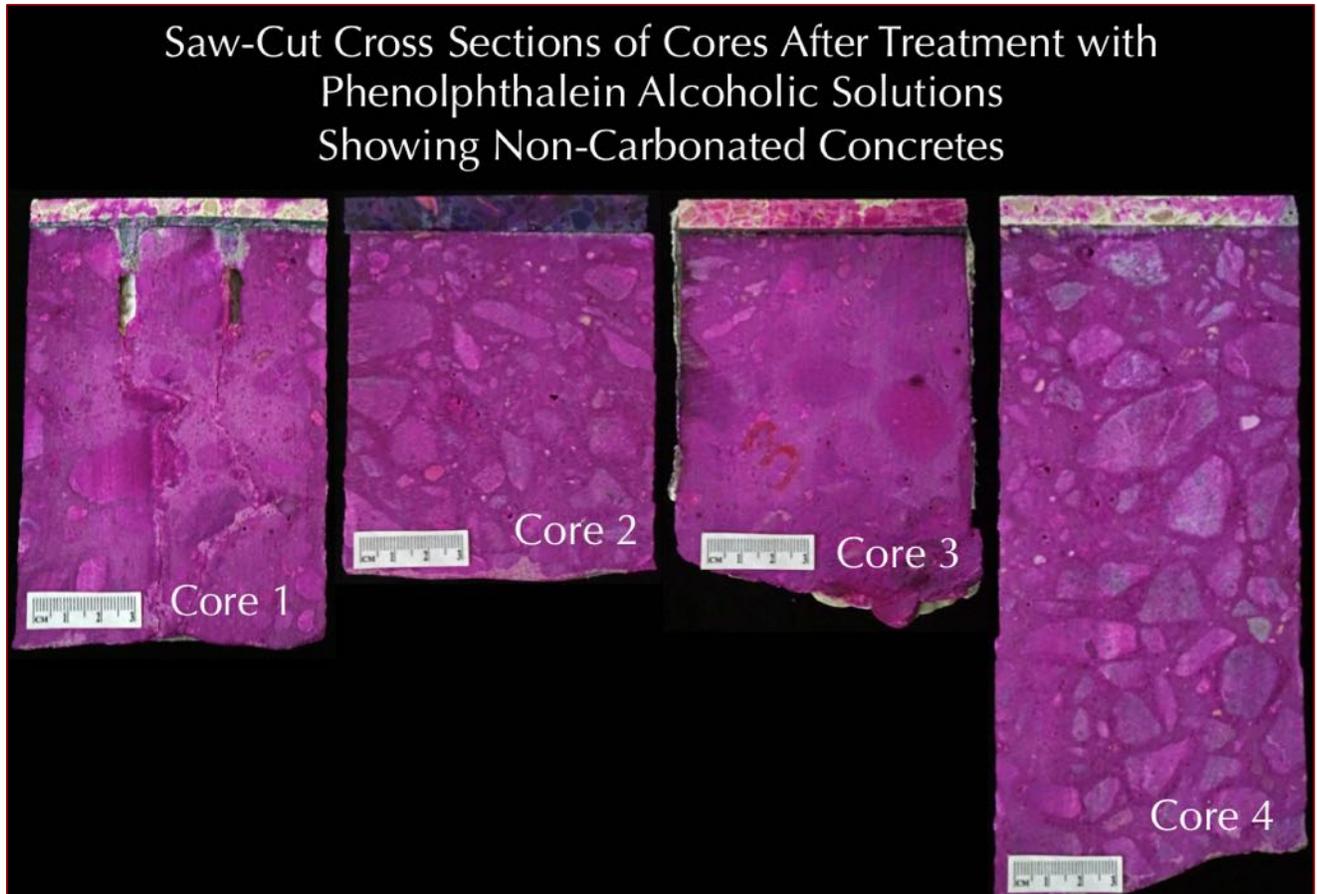
Figure 15: Saw-cut cross sections of four cores after treatment with phenolphthalein alcoholic solutions showing lack of carbonation of concrete where concrete turned dark pink after treatment, and carbonated aggregate chips in terrazzo which remain clear after treatment except for some contaminated stain from underlying concrete.

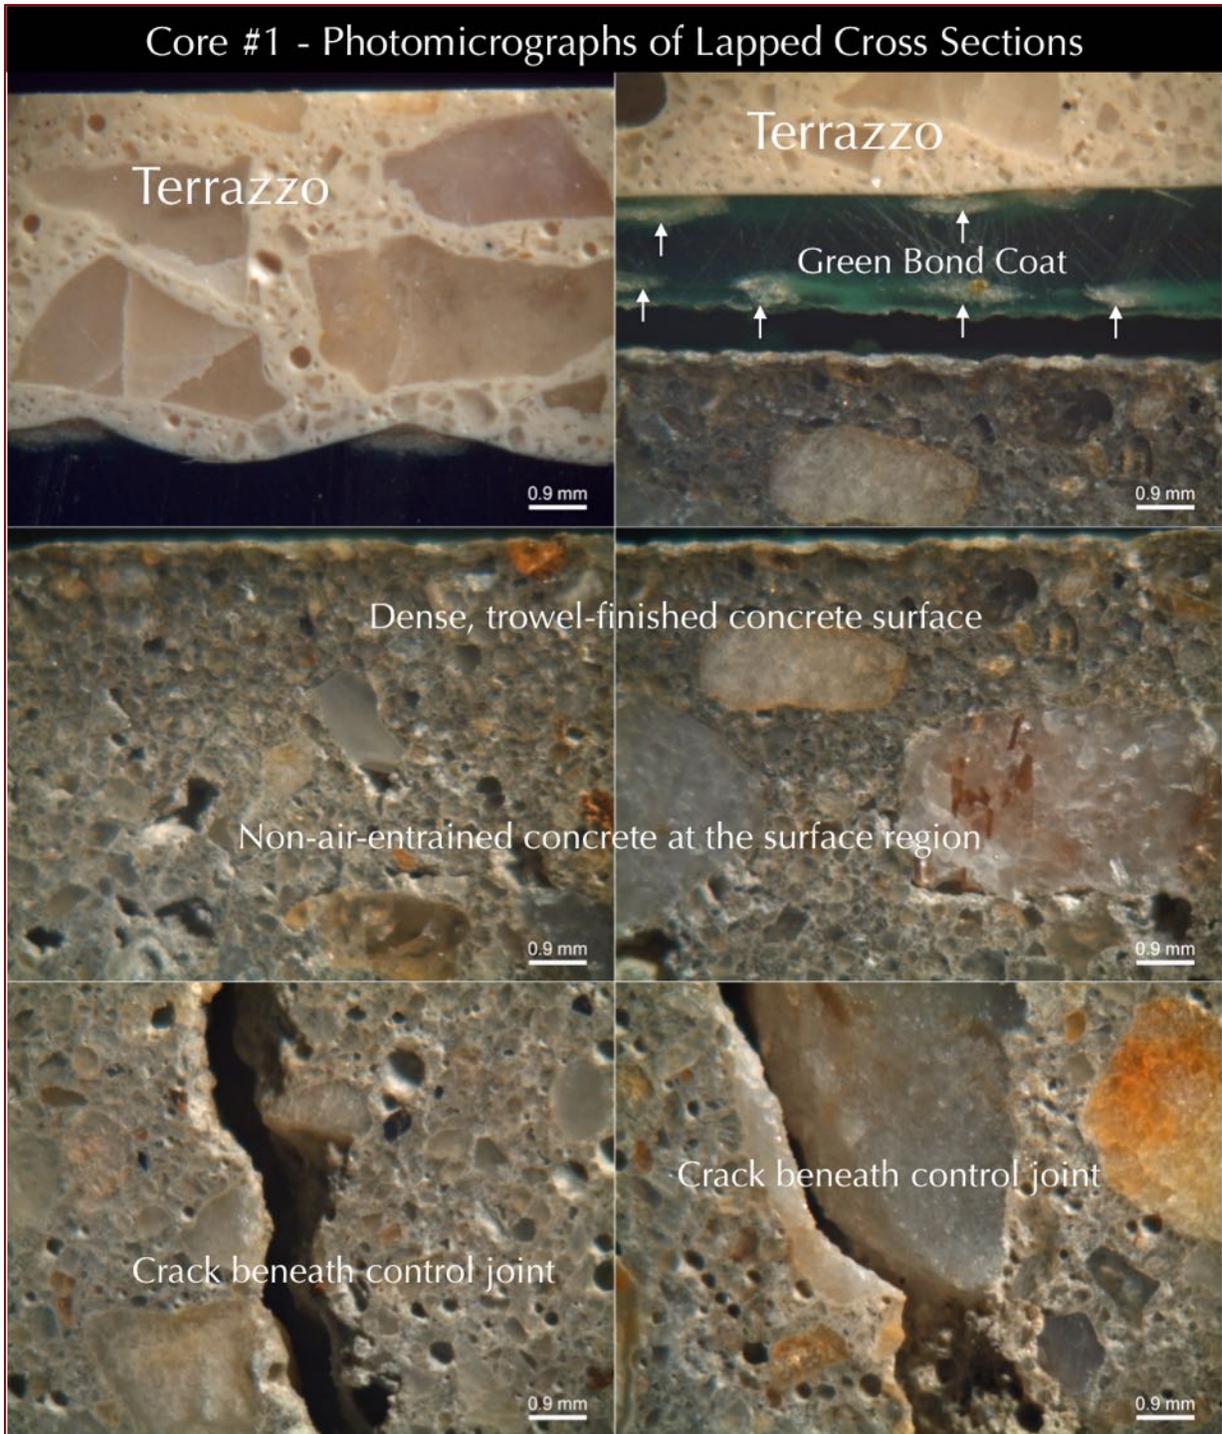
Figure 16: Photomicrographs of lapped cross section of Core 1 showing: (a) terrazzo flooring 7 mm in thickness, having crushed limestone/marble chips (3 mm nominal size) in white polymer binder, and dense, non-air-entrained nature of terrazzo; (b) green bond coat adhered to the base of terrazzo (nominal 2.5 to 3 mm thick) but completely de-bonded from concrete (the coat has fiber reinforcement at its top and bottom ends as shown by arrows at the cross sections); (c) dense, dark gray, air-free trowel-finished surface region of concrete floor with no trace of bonding coat on it; (d) non-air-entrained nature of concrete; and (e) extension of crack in concrete from control joints.

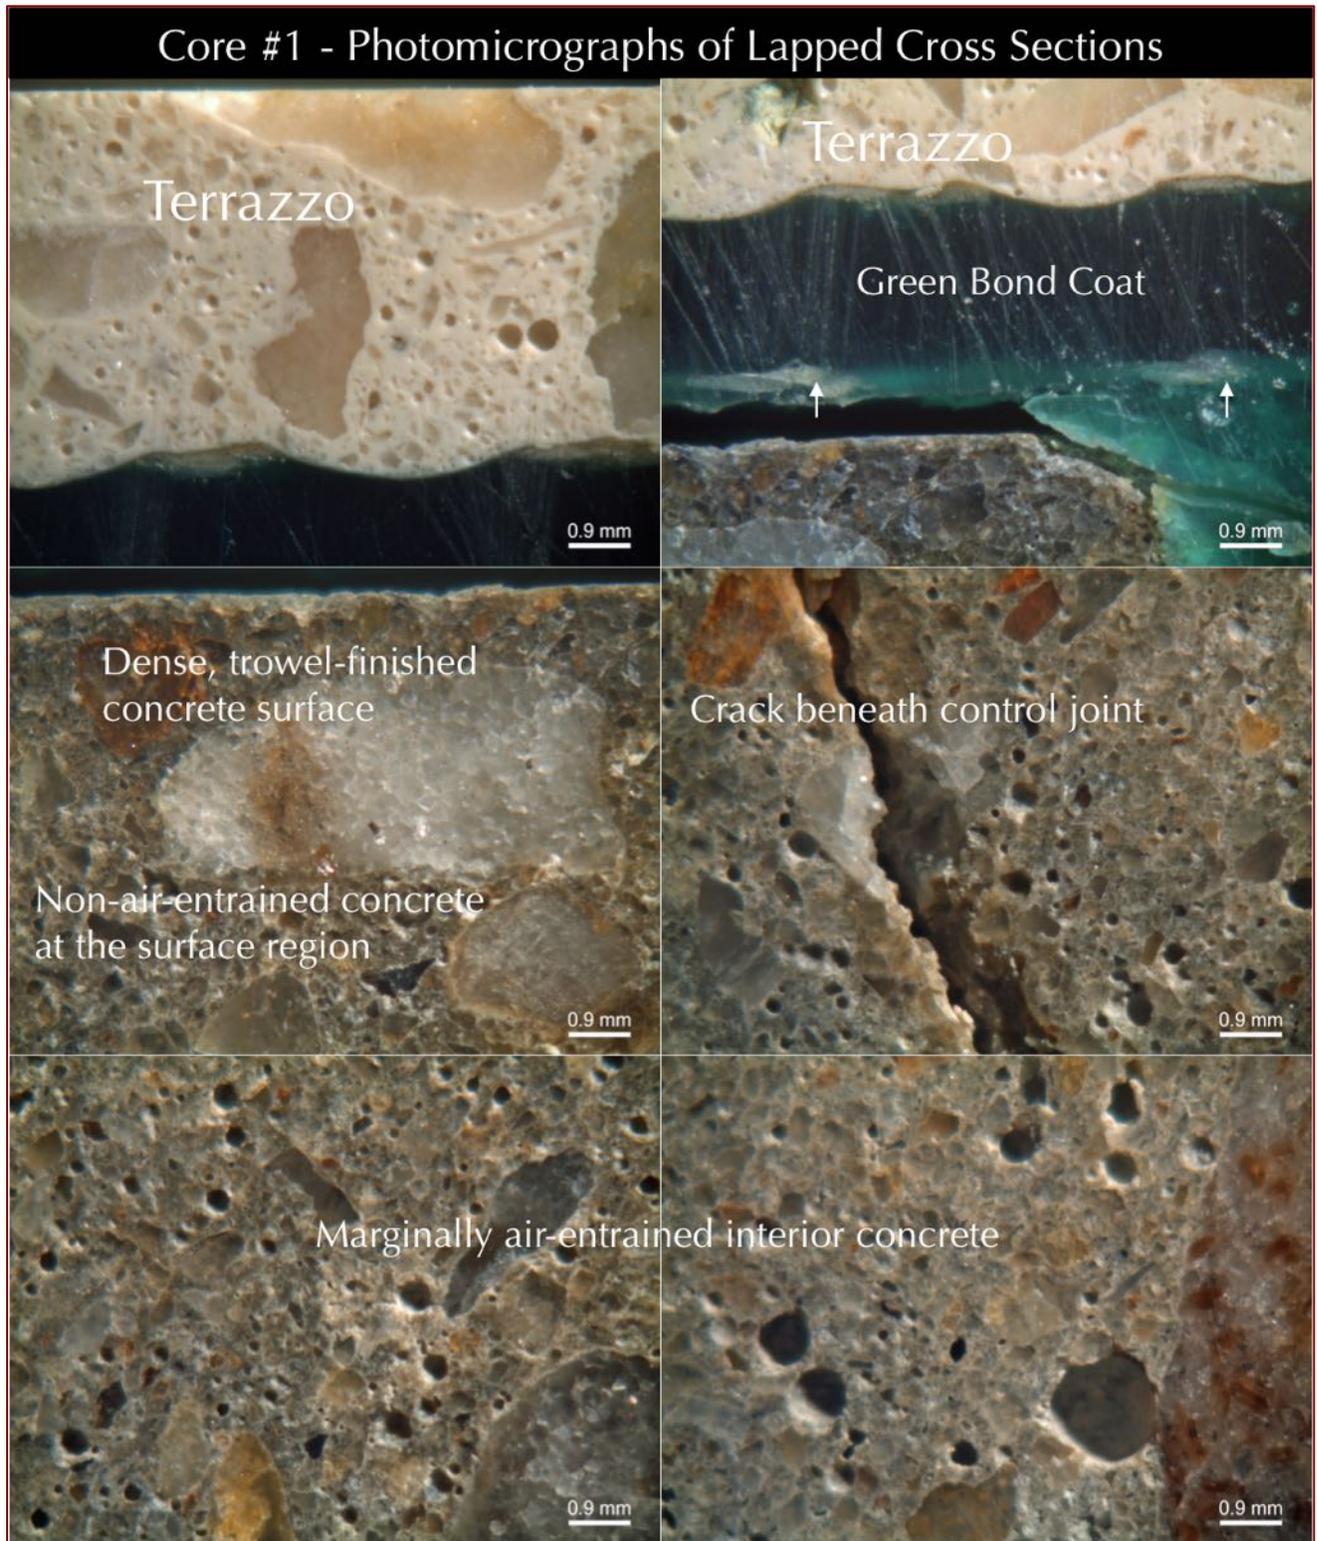
Figure 17: Photomicrographs of lapped cross section of Core 1 showing: (a) terrazzo flooring 7 mm in thickness, having crushed limestone/marble chips (3 mm nominal size) in white polymer binder, and dense, non-air-entrained nature of terrazzo; (b) green bond coat adhered to the base of terrazzo (nominal 2.5 to 3 mm thick) but completely de-bonded from concrete (fiber reinforcement at the base of this coat is marked by arrows); (c) dense, dark gray, air-free trowel-finished surface region of concrete floor with no trace of bonding coat on it; (d) non-air-entrained to marginally air entrained nature of concrete; and (e) extension of crack in concrete from control joints.
