CONSTRUCTION MATERIALS CONSULTANTS, INC.

Laboratory Investigation of Epoxy Terrazzo Failure From Concrete Slab-on-Grade

Knott Hall
Loyola Blakefield
Towson, Maryland

April 03, 2019
CMC 0219107

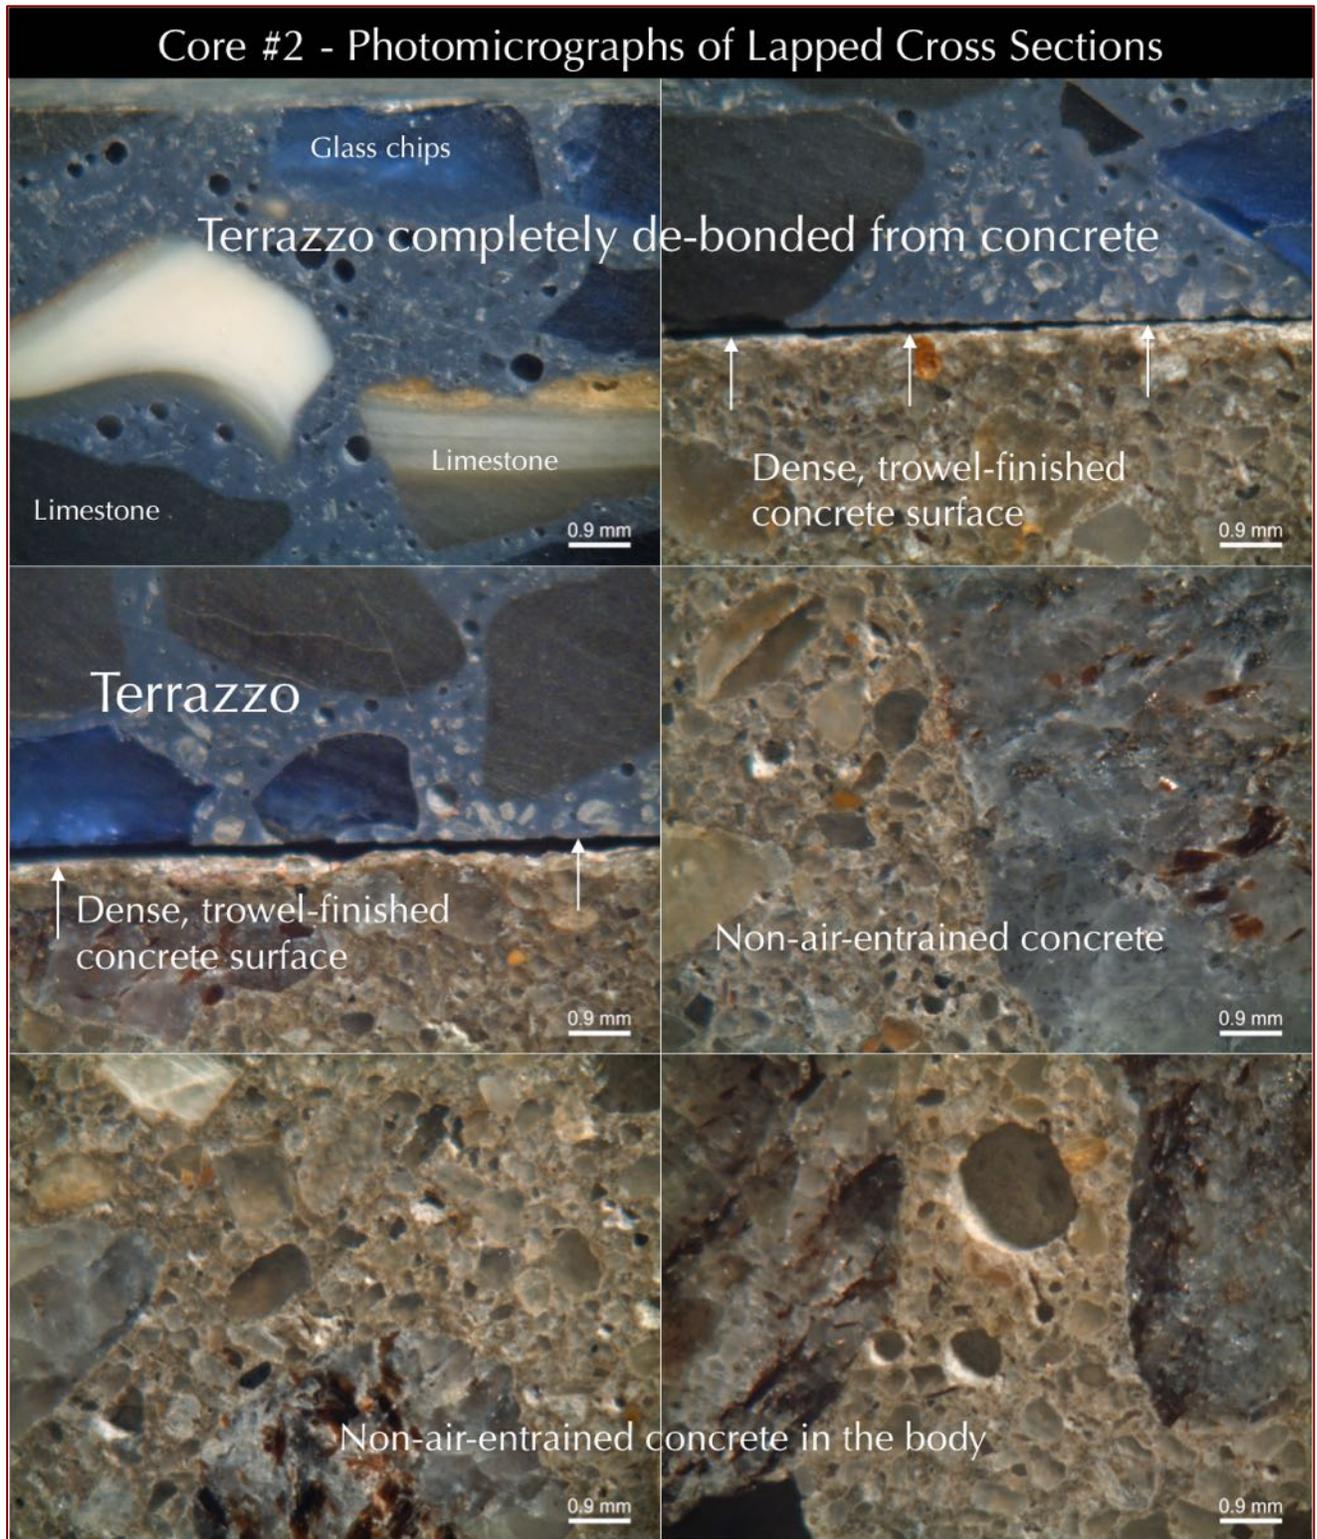
Figure 18: Photomicrographs of lapped cross section of Core 2 showing: (a) terrazzo flooring 12 mm in thickness, having crushed limestone/marble/glass chips (5 mm nominal size) in dark blue pigmented polymer binder, and dense, non-air-entrained nature of terrazzo; (b) lack of any bond coat beneath terrazzo, and complete de-bonding of terrazzo from concrete; (c) dense, dark gray, air-free trowel-finished surface region of concrete floor with no trace of terrazzo on it; and (d) non-air-entrained nature of concrete.

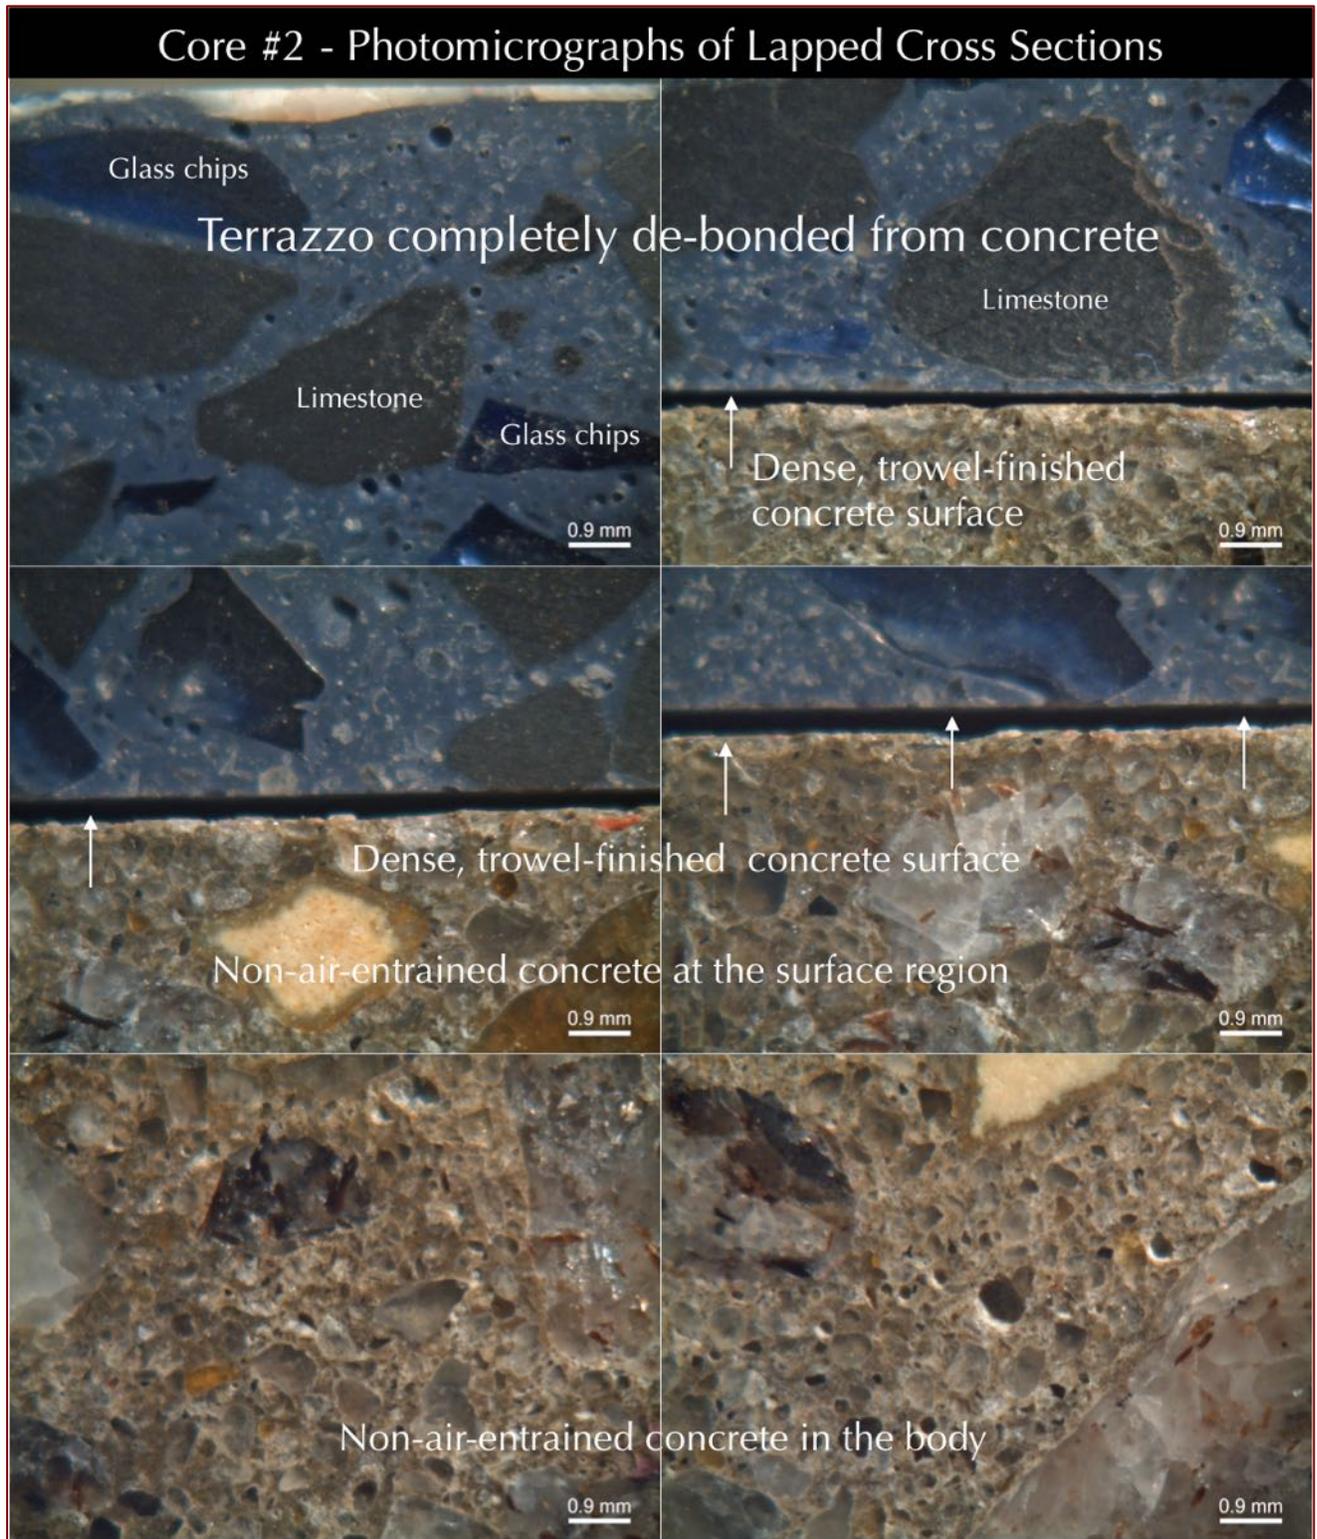
Figure 19: Photomicrographs of lapped cross section of Core 2 showing: (a) terrazzo flooring 12 mm in thickness, having crushed limestone/marble/glass chips (5 mm nominal size) in dark blue pigmented polymer binder, and dense, non-air-entrained nature of terrazzo; (b) lack of any bond coat beneath terrazzo, and complete de-bonding of terrazzo from concrete; (c) dense, dark gray, air-free trowel-finished surface region of concrete floor with no trace of terrazzo on it; and (d) non-air-entrained nature of concrete.

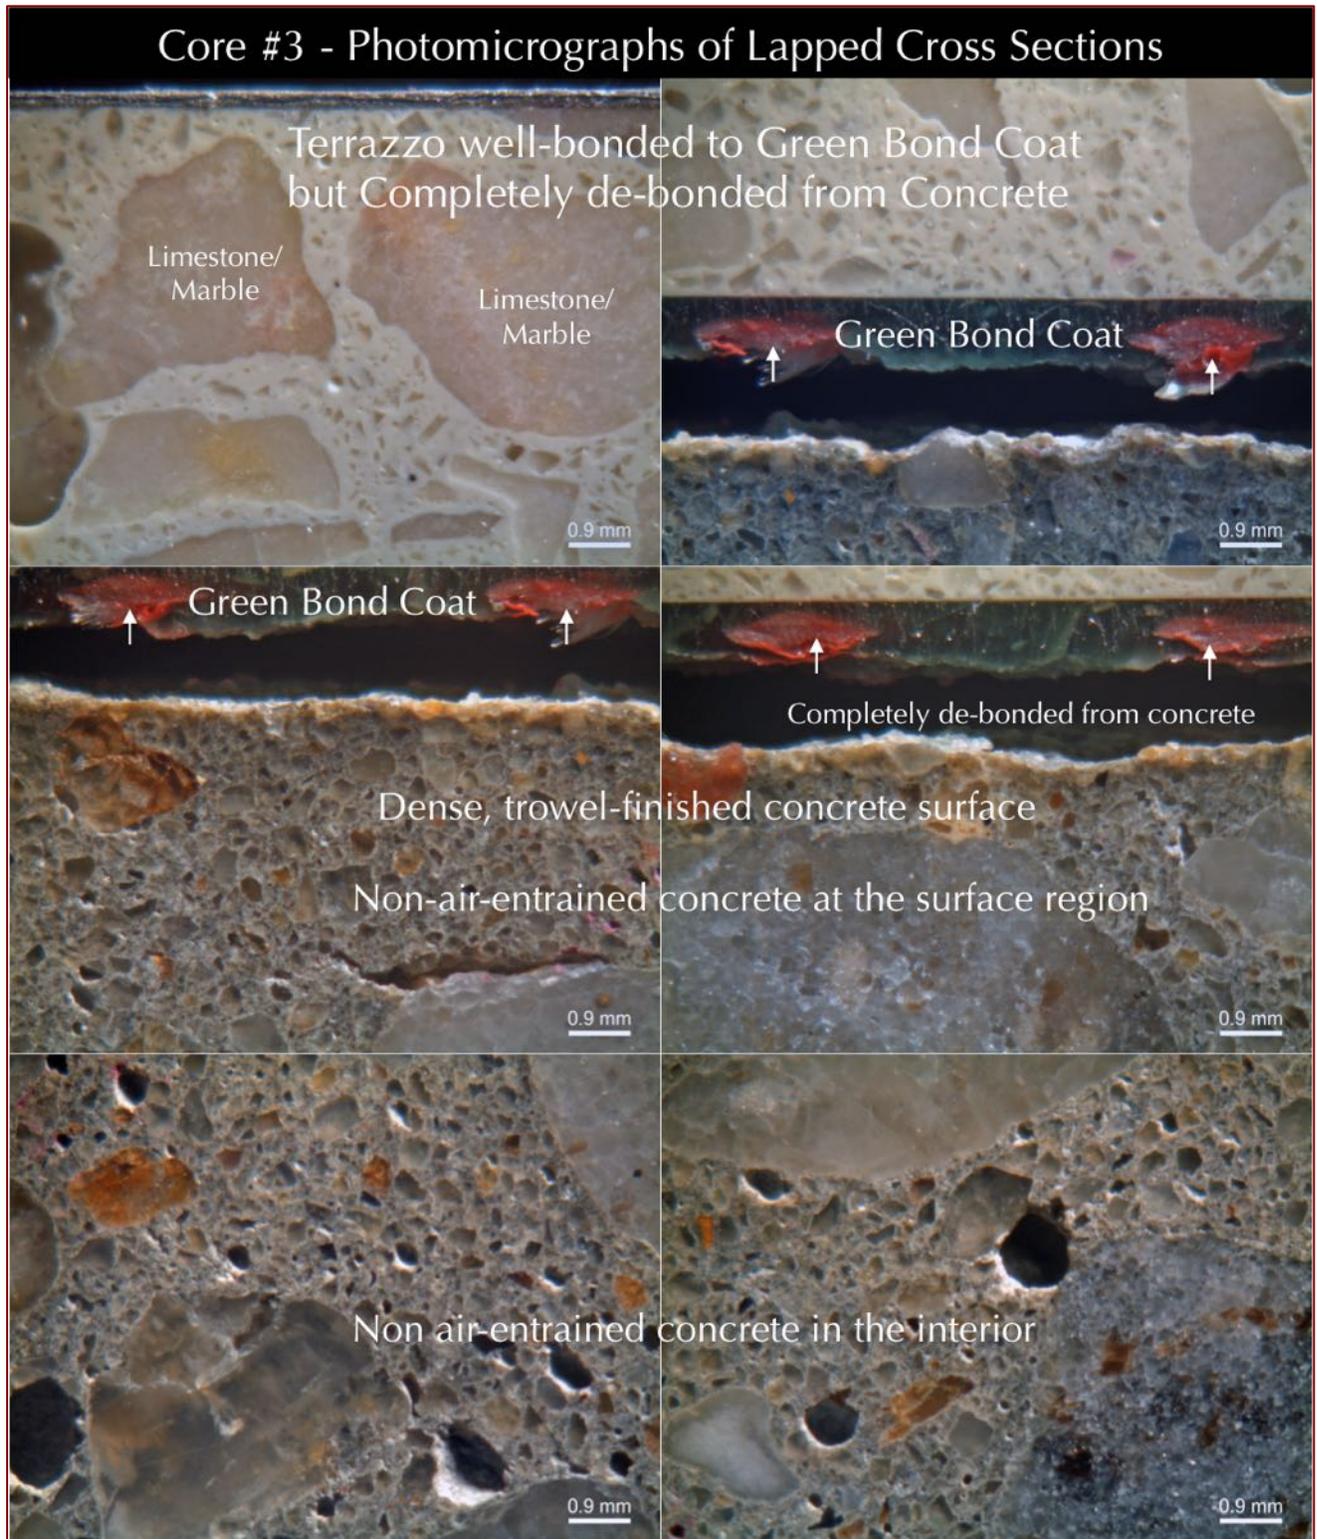
Figure 20: Photomicrographs of lapped cross section of Core 3 showing: (a) terrazzo flooring 10 mm in thickness, having crushed limestone/marble chips (3 mm nominal size) in white polymer binder, and dense, non-air-entrained nature of terrazzo; (b) green bond coat with red fibermesh reinforcement adhered to the base of terrazzo (nominal 2.5 to 3 mm thick) but completely de-bonded from concrete; (c) dense, dark gray, air-free trowel-finished surface region of concrete floor with no trace of bonding coat on it; and (d) non-air-entrained nature of concrete.

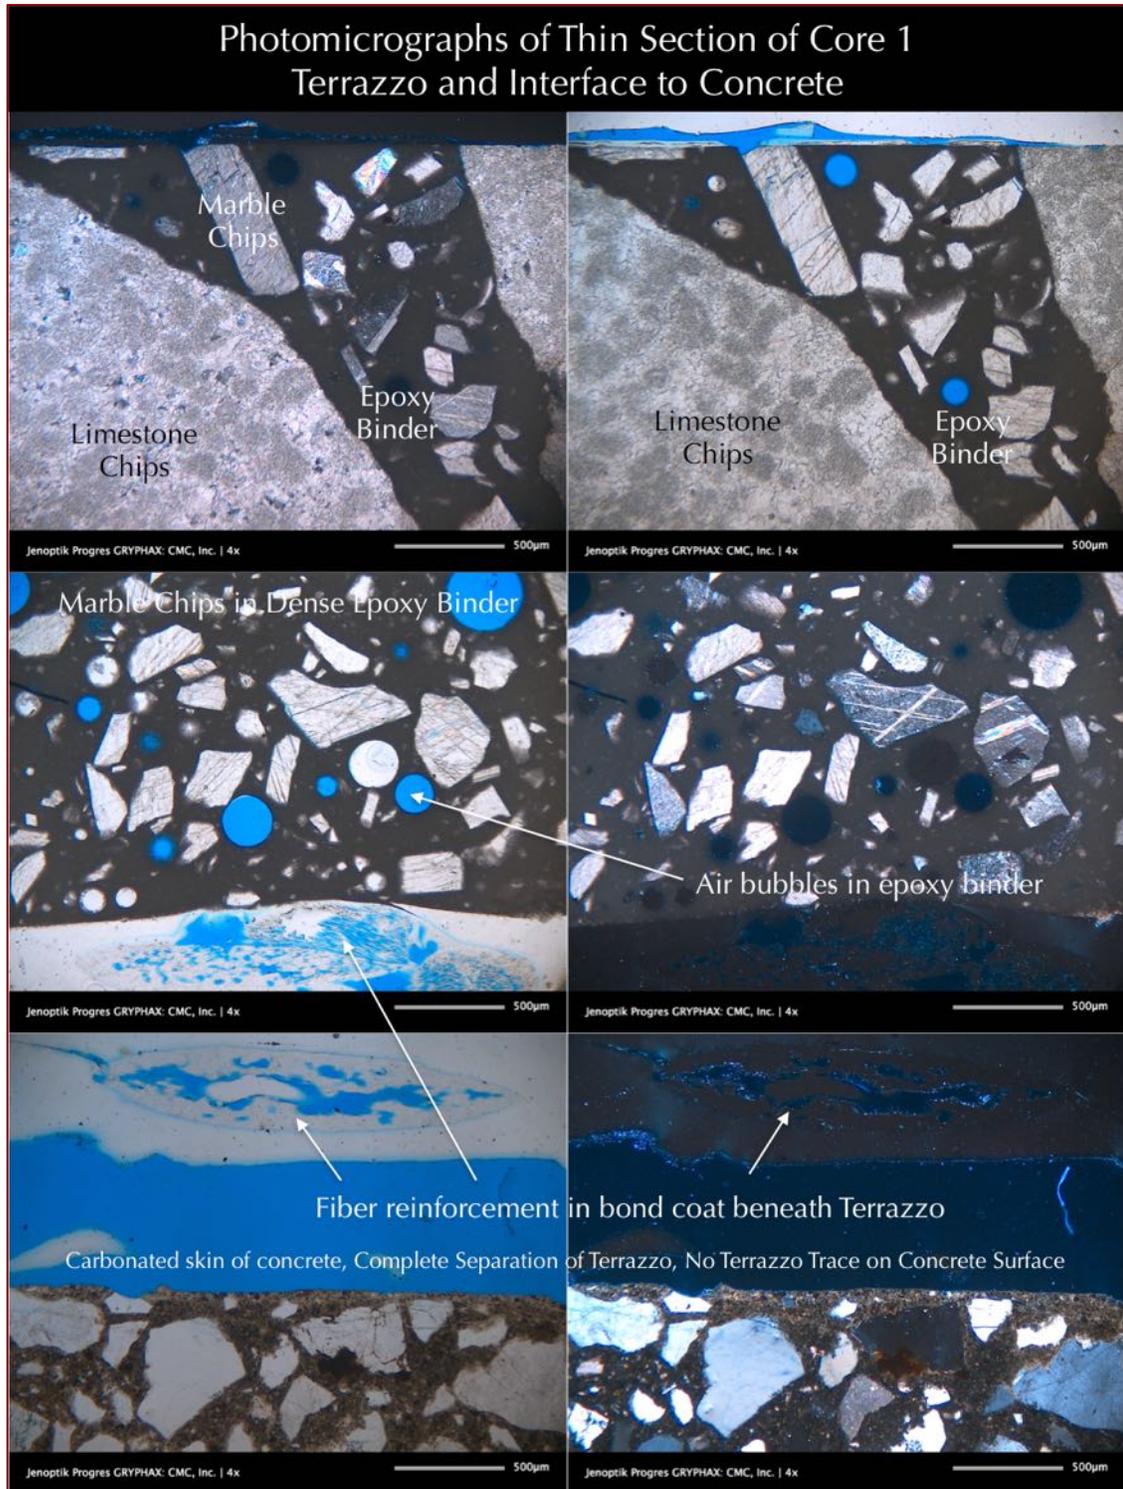
Figure 24: Photomicrographs of thin section of Core 1 showing: (a) crushed limestone and marble chips in dense polymer binder with occasional spherical entrapped voids in terrazzo; (b) fibermesh reinforcement of a bond coat at the base of terrazzo; (c) complete debonding of terrazzo and adhered bond coat from underlying concrete; (d) dense trowel-finished concrete surface with a carbonated skin at the top on which terrazzo was placed, indicating inadequate removal of concrete surface prior to terrazzo installation.

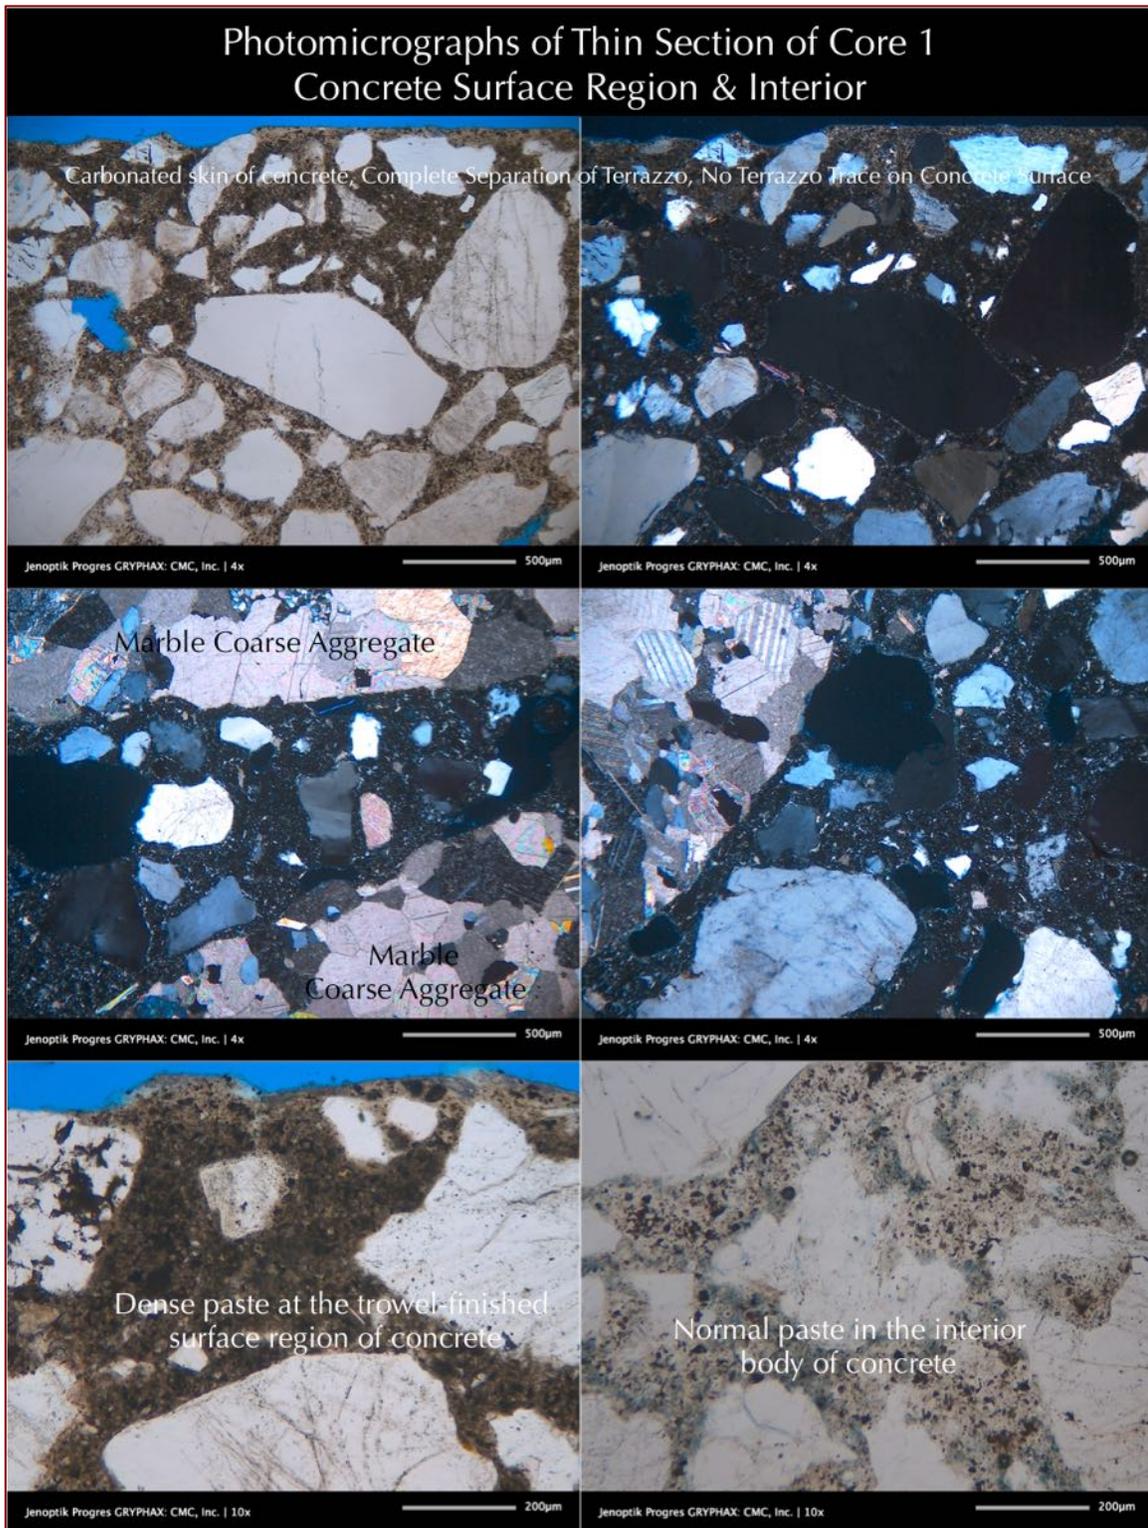
Figure 25: Photomicrographs of thin section of Core 1 showing: (a) dense trowel-finished concrete surface with a carbonated skin at the top on which terrazzo was placed, indicating inadequate removal of concrete surface prior to terrazzo installation; (b) crushed marble coarse aggregate and natural siliceous (quartz-quartzite) sand fine aggregate in concrete (middle row); (c) contrasting dense paste at the surface region versus normal paste in the body of concrete indicating incomplete removal of the dense paste at the surface that has prevented development of a good bond to the flooring components (as well as removal of any moisture build up from concrete).

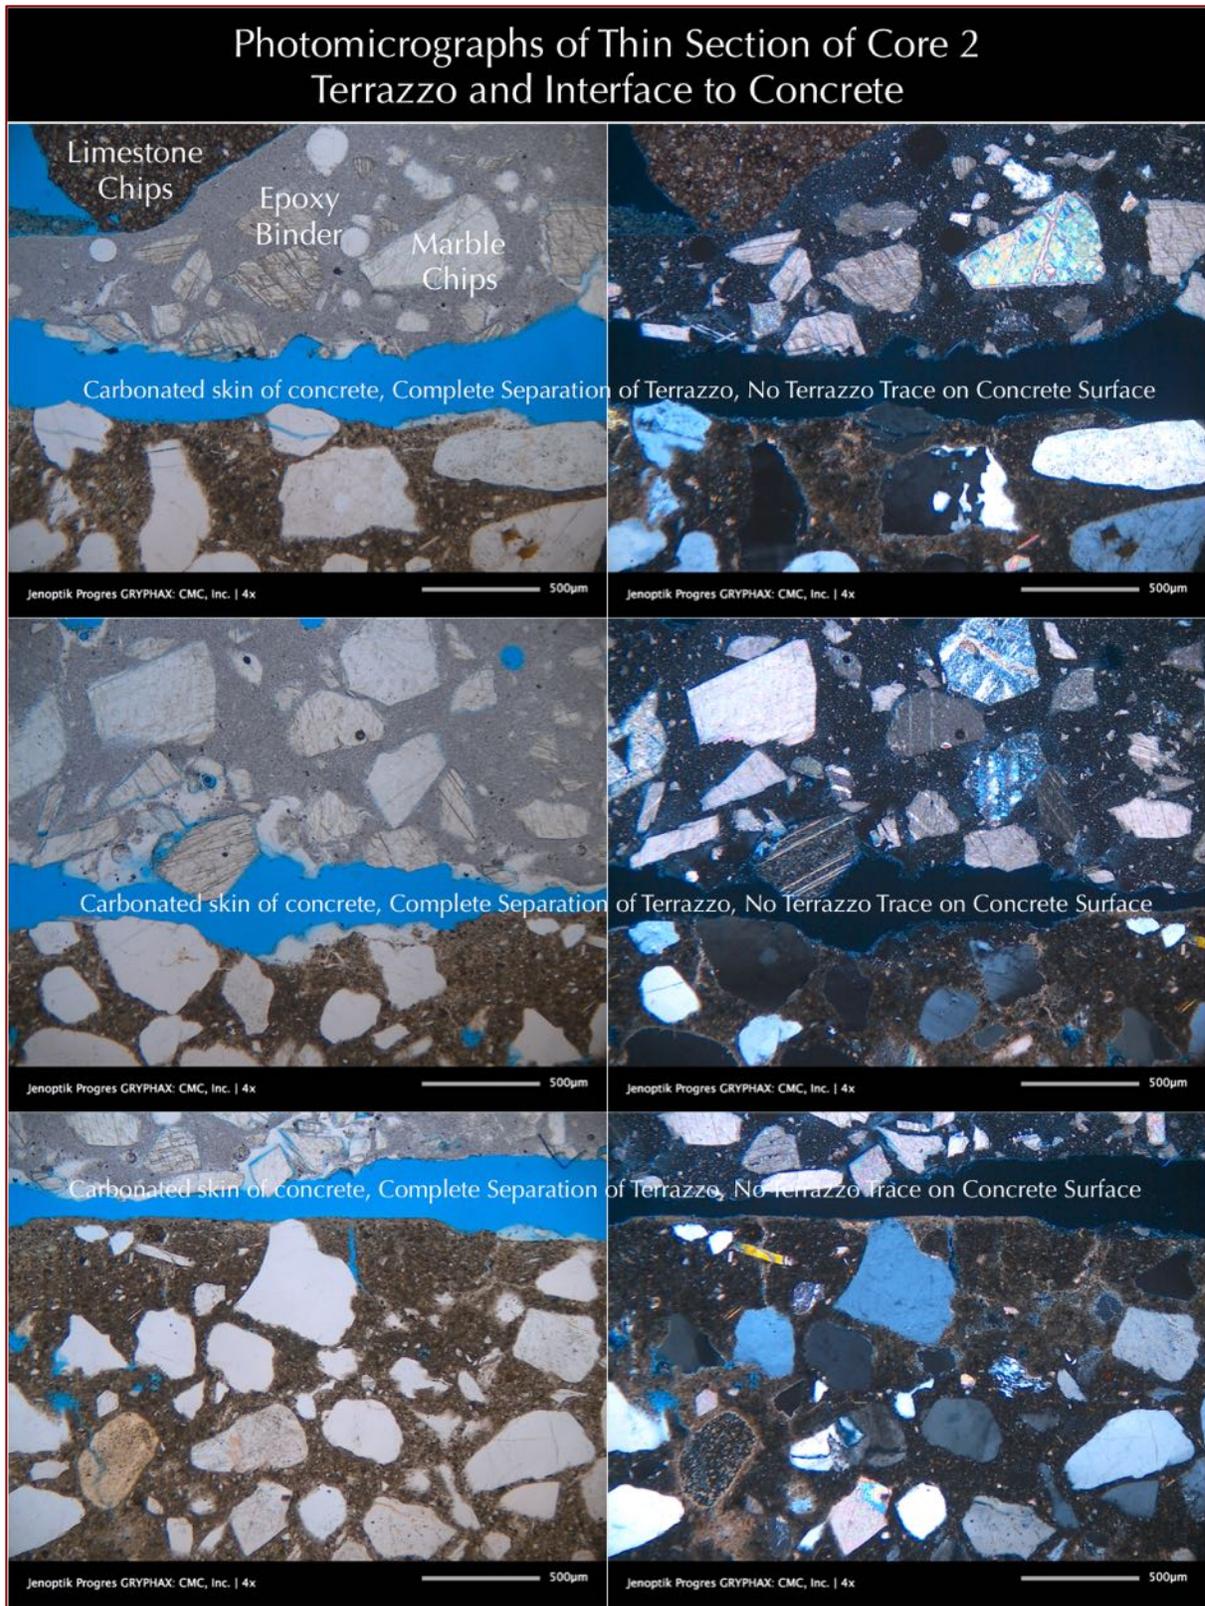
Figure 27: Photomicrographs of thin section of Core 2 showing: (a) crushed limestone, marble, and isotropic glass chips in dense polymer binder; (b) complete debonding of terrazzo from underlying concrete; (c) dense trowel-finished concrete surface with a carbonated skin (having occasional vertical shrinkage microcracks) at the top on which terrazzo was placed, indicating inadequate removal of concrete surface prior to terrazzo installation.

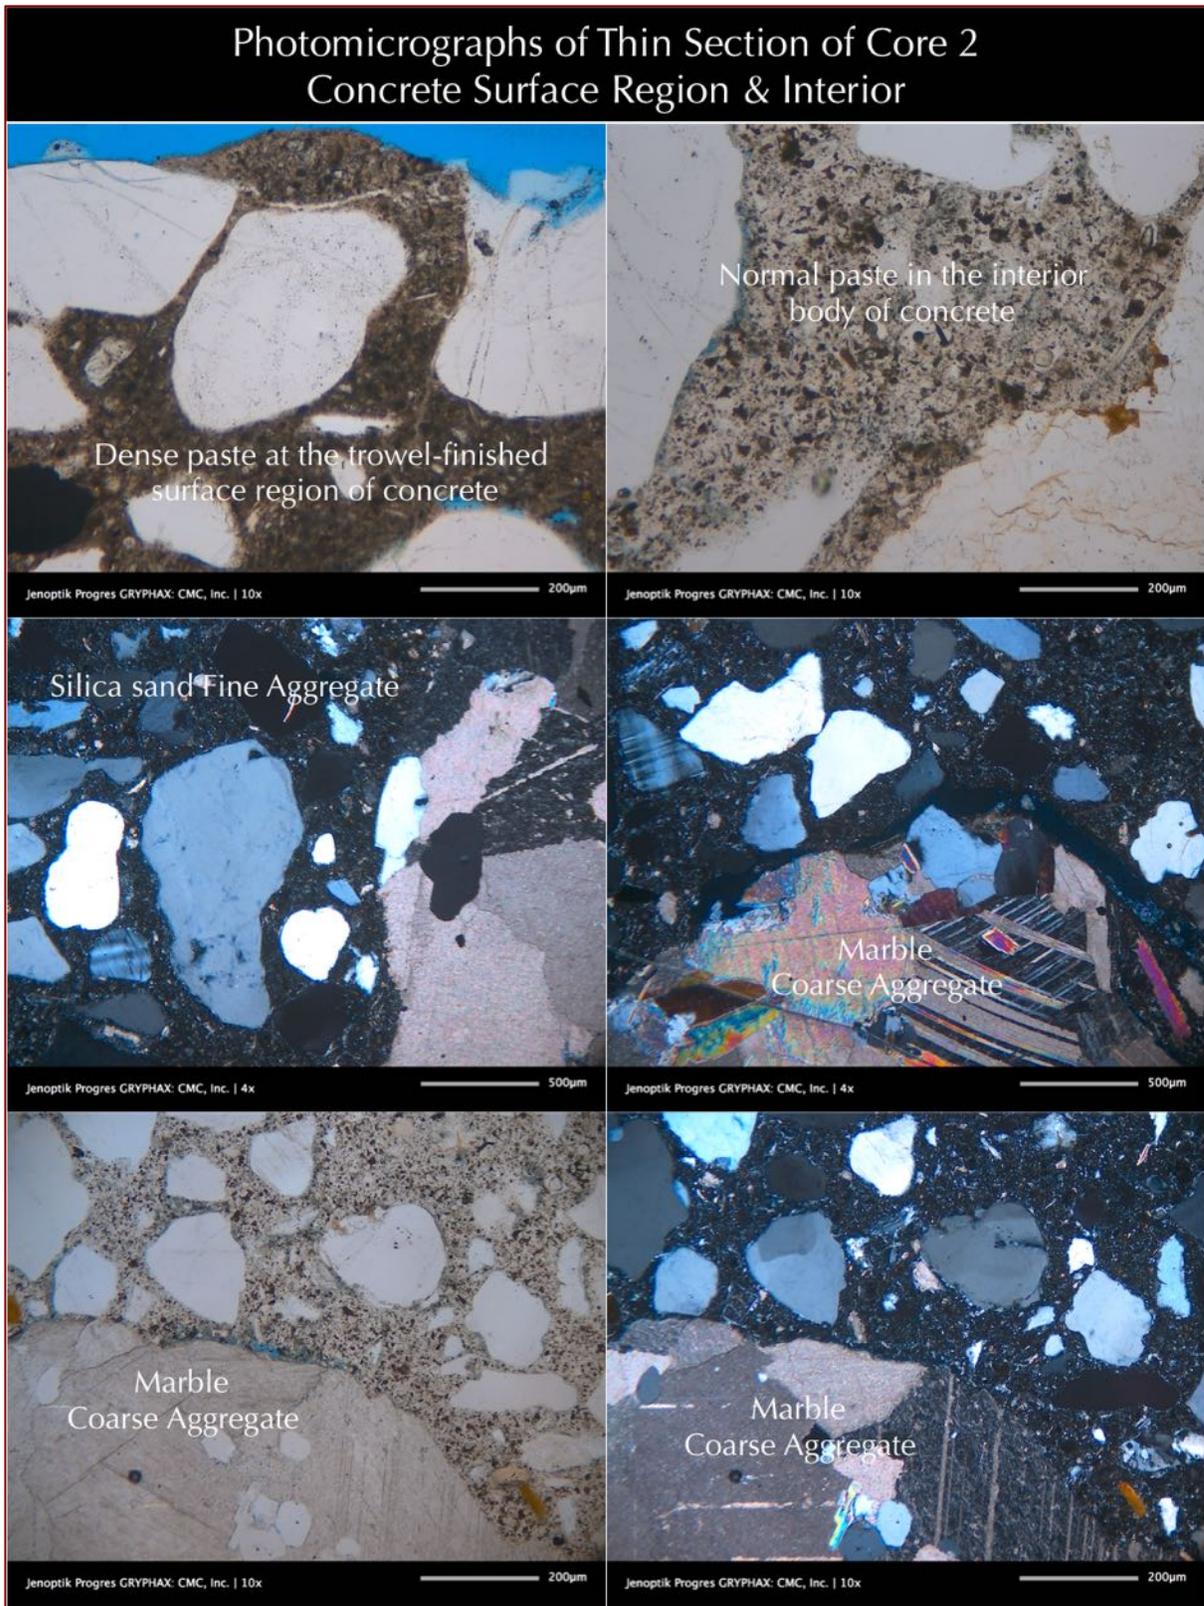
Figure 28: Photomicrographs of thin section of Core 2 showing: (a) dense trowel-finished concrete surface with a carbonated skin at the top on which terrazzo was placed, indicating inadequate removal of concrete surface prior to terrazzo installation; (b) crushed marble coarse aggregate and natural siliceous (quartz-quartzite) sand fine aggregate in concrete (middle row); (c) crushed marble and normal Portland cement paste in the body of concrete.

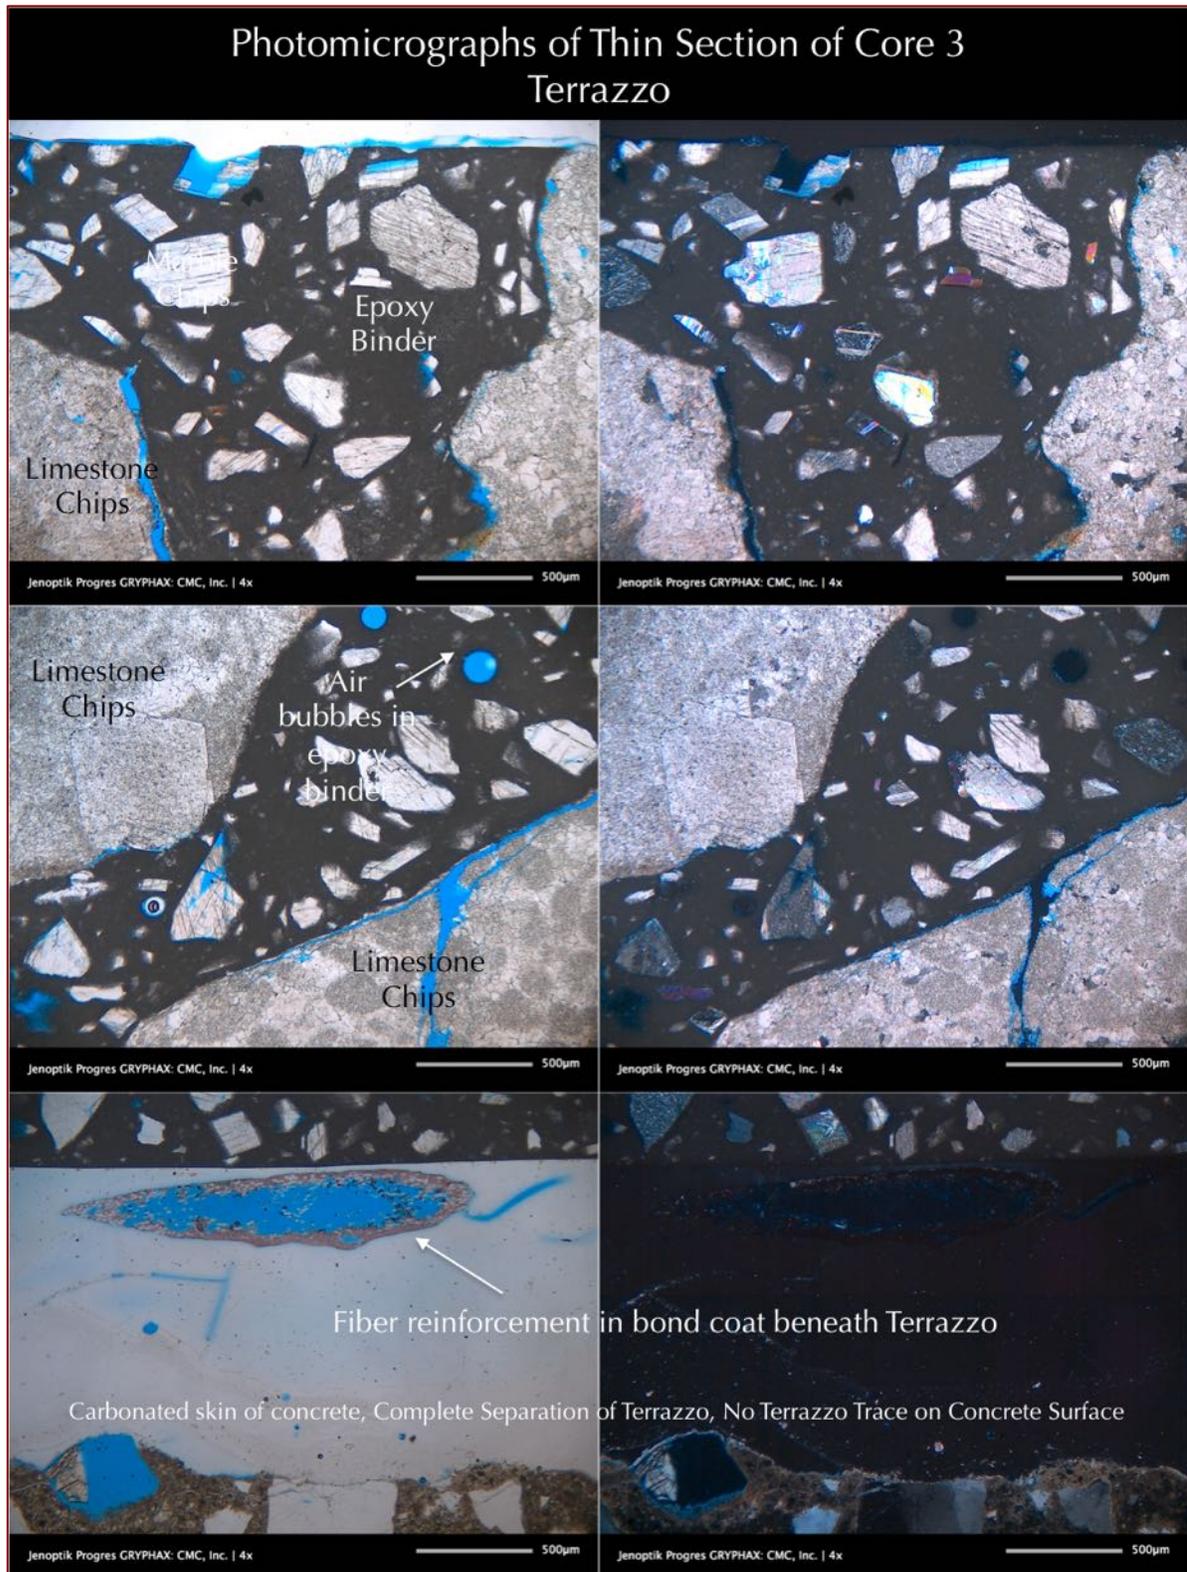
Figure 29: Photomicrographs of thin section of Core 3 showing: (a) crushed limestone and marble chips in dense polymer binder with occasional spherical entrapped voids in terrazzo; (b) fibermesh reinforcement of a bond coat at the base of terrazzo; (c) complete debonding of terrazzo and adhered bond coat from underlying concrete; (d) dense trowel-finished concrete surface with a carbonated skin at the top on which terrazzo was placed, indicating inadequate removal of concrete surface prior to terrazzo installation.

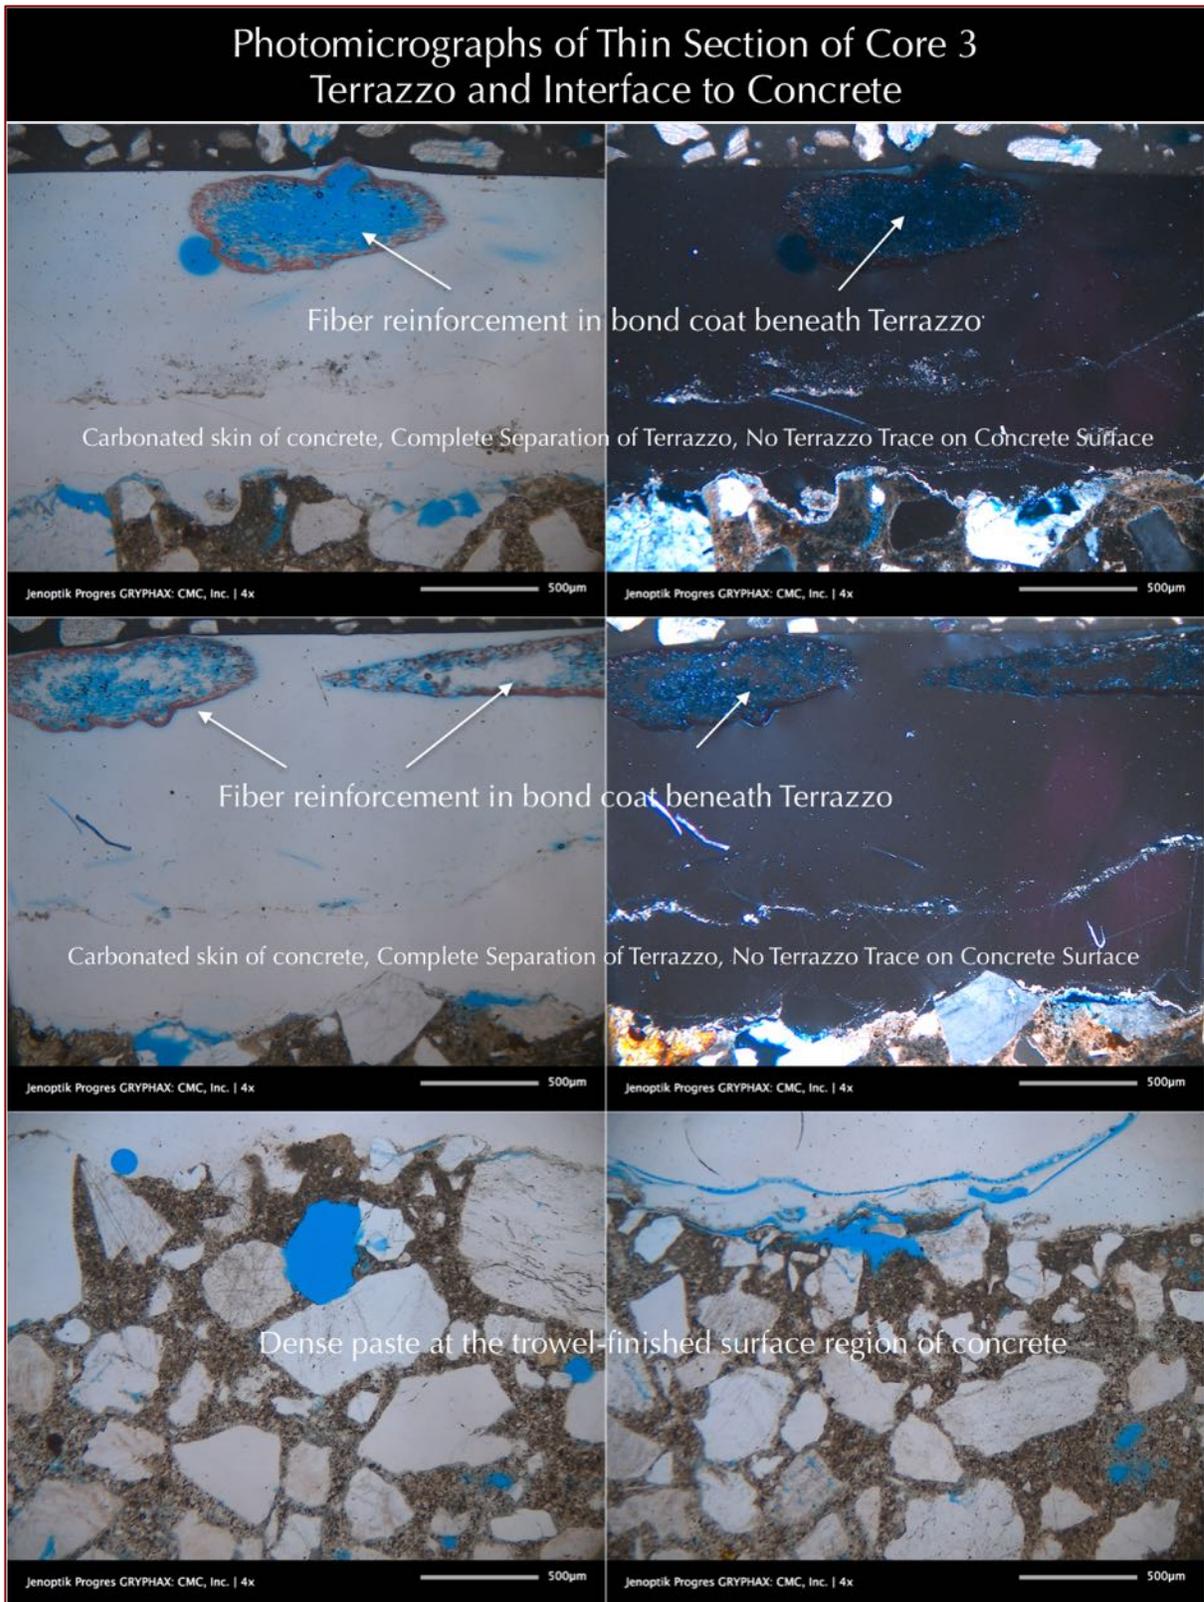
Figure 30: Photomicrographs of thin section of Core 3 showing: (a) fibermesh reinforcement of a bond coat at the base of terrazzo; (b) complete debonding of terrazzo and adhered bond coat from underlying concrete; (c) dense trowel-finished concrete surface with a carbonated skin at the top on which terrazzo was placed, indicating inadequate removal of concrete surface prior to terrazzo installation.

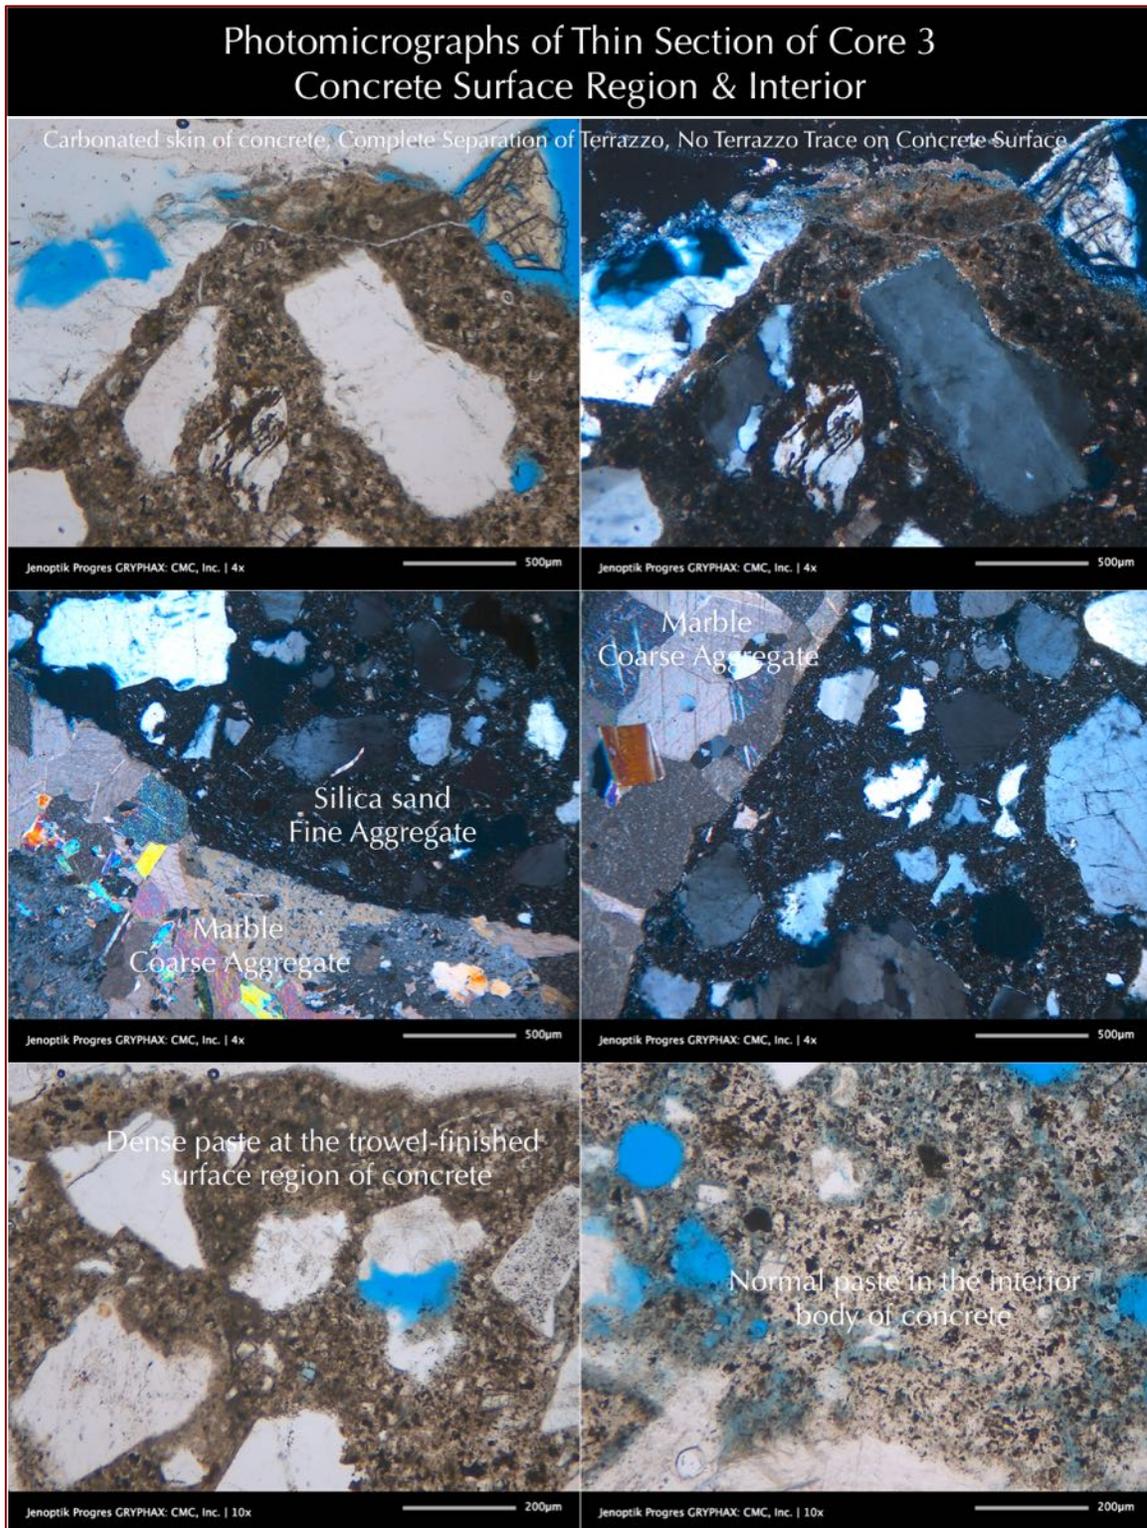
Figure 31: Photomicrographs of thin section of Core 3 showing: (a) dense trowel-finished concrete surface with a carbonated skin at the top on which terrazzo was placed, indicating inadequate removal of concrete surface prior to terrazzo installation; (b) crushed marble coarse aggregate and natural siliceous (quartz-quartzite) sand fine aggregate in concrete (middle row); (c) contrasting dense paste at the surface region versus normal paste in the body of concrete indicating incomplete removal of the dense paste at the surface that has prevented development of a good bond to the flooring components (as well as removal of any moisture build up from concrete).

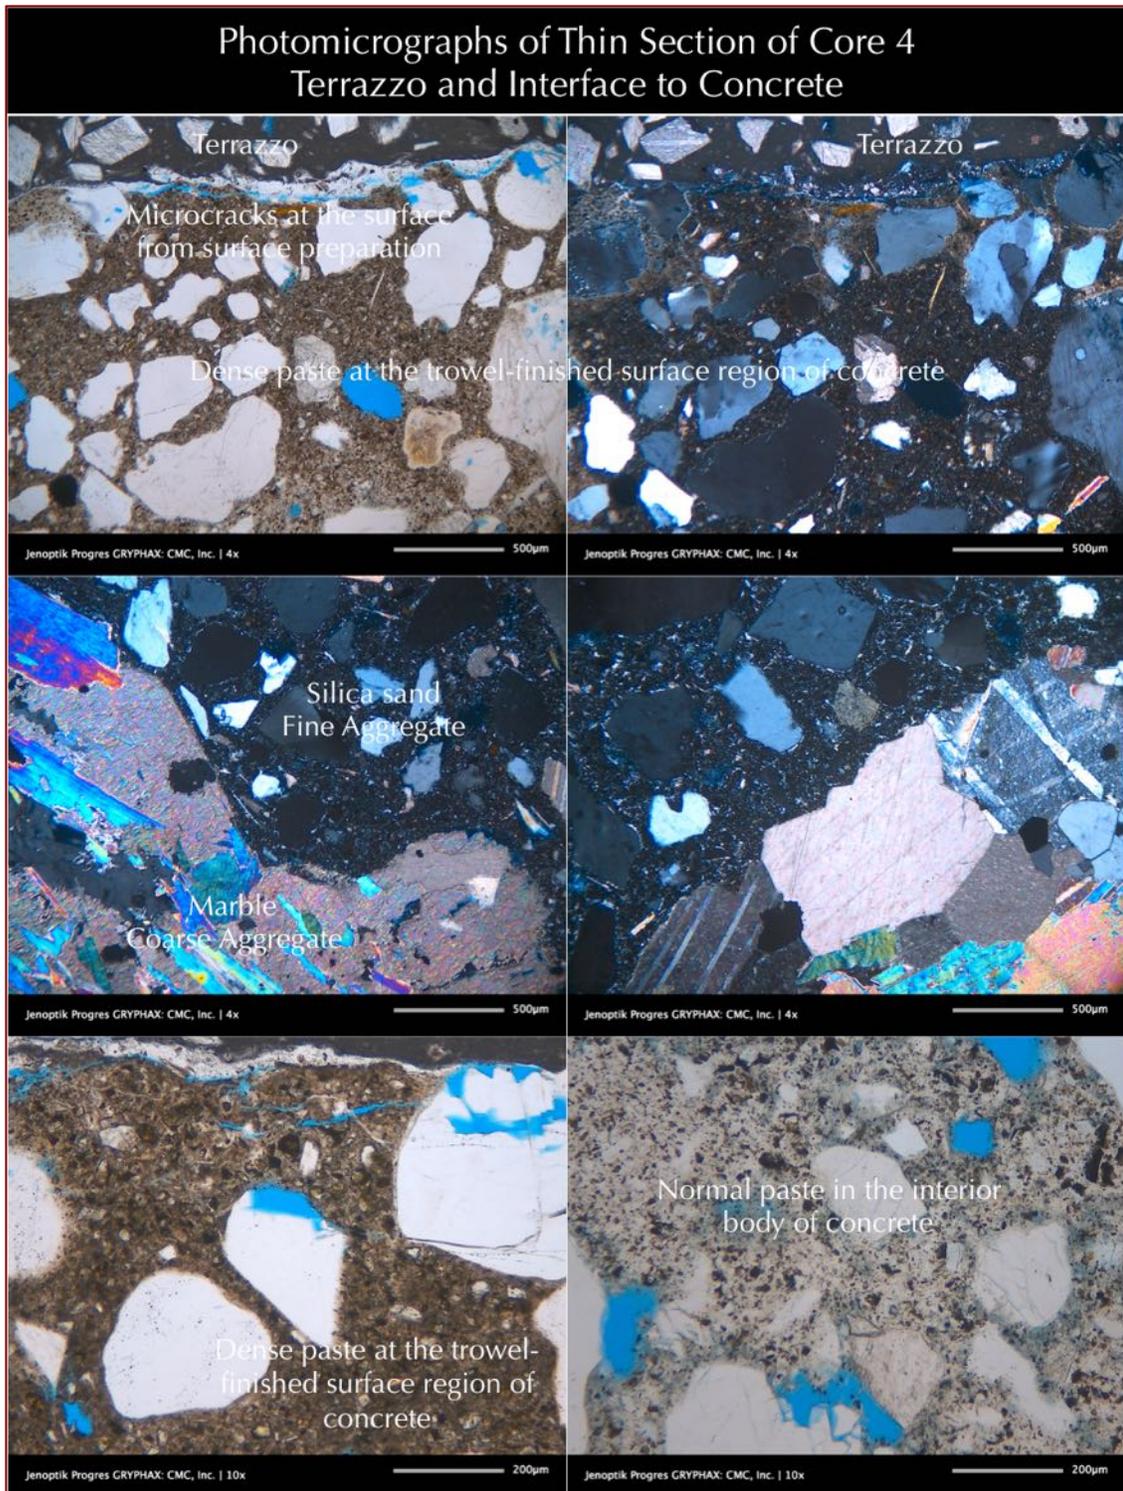
Figure 33: Photomicrographs of thin section of Core 4 showing: (a) dense trowel-finished concrete surface with a carbonated and microcracked skin at the top and a thin film of a possible primer at the top on which terrazzo was placed, indicating inadequate removal of concrete surface prior to primer and terrazzo installation; (b) crushed marble coarse aggregate and natural siliceous (quartz-quartzite) sand fine aggregate in concrete (middle row); (c) contrasting dense paste at the surface region versus normal paste in the body of concrete indicating incomplete removal of the dense paste at the surface that has prevented development of a good bond to the flooring components (as well as removal of any moisture build up from concrete).
