CONSTRUCTION MATERIALS CONSULTANTS, INC.

Laboratory Investigation of Epoxy Terrazzo Failure From Concrete Slab-on-Grade

Knott Hall
Loyola Blakefield
Towson, Maryland

April 03, 2019
CMC 0219107

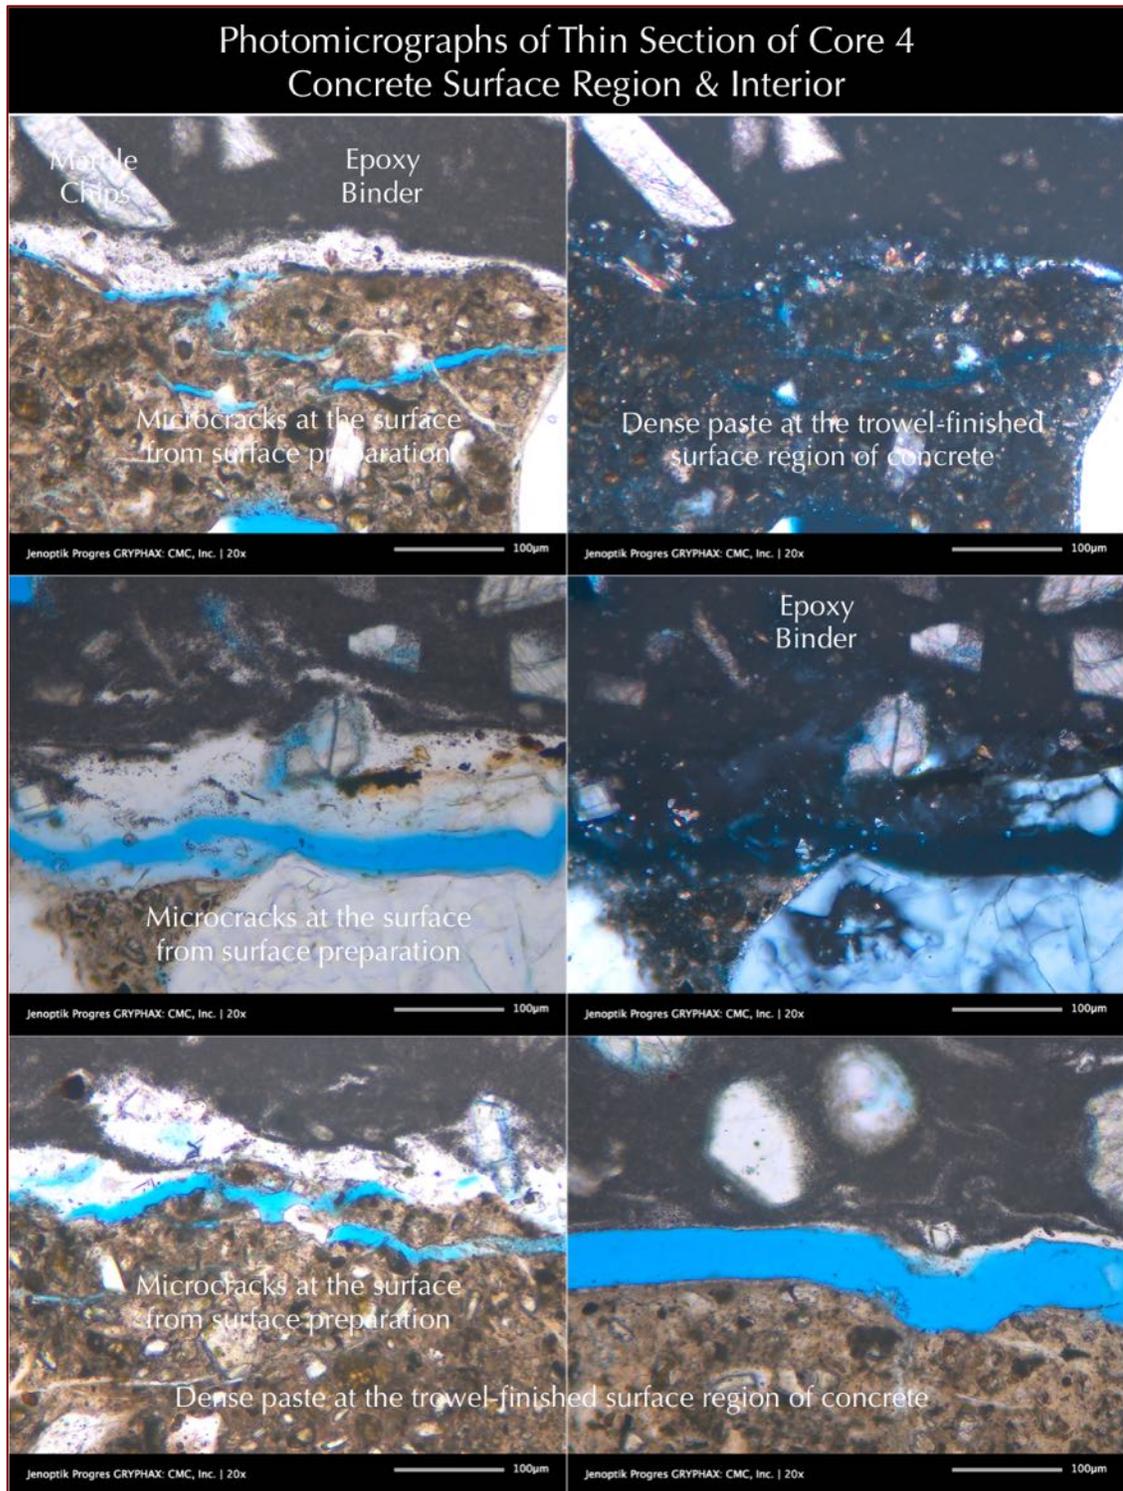
Figure 34: Photomicrographs of thin section of Core 4 showing: (a) dense trowel-finished concrete surface with a carbonated and microcracked skin at the top and a thin film of a possible primer at the top on which terrazzo was placed, indicating inadequate removal of concrete surface prior to primer and terrazzo installation; (b) crushed marble coarse aggregate and natural siliceous (quartz-quartzite) sand fine aggregate in concrete (middle row); (c) contrasting dense paste at the surface region versus normal paste in the body of concrete indicating incomplete removal of the dense paste at the surface that has prevented development of a good bond to the flooring components (as well as removal of any moisture build up from concrete).

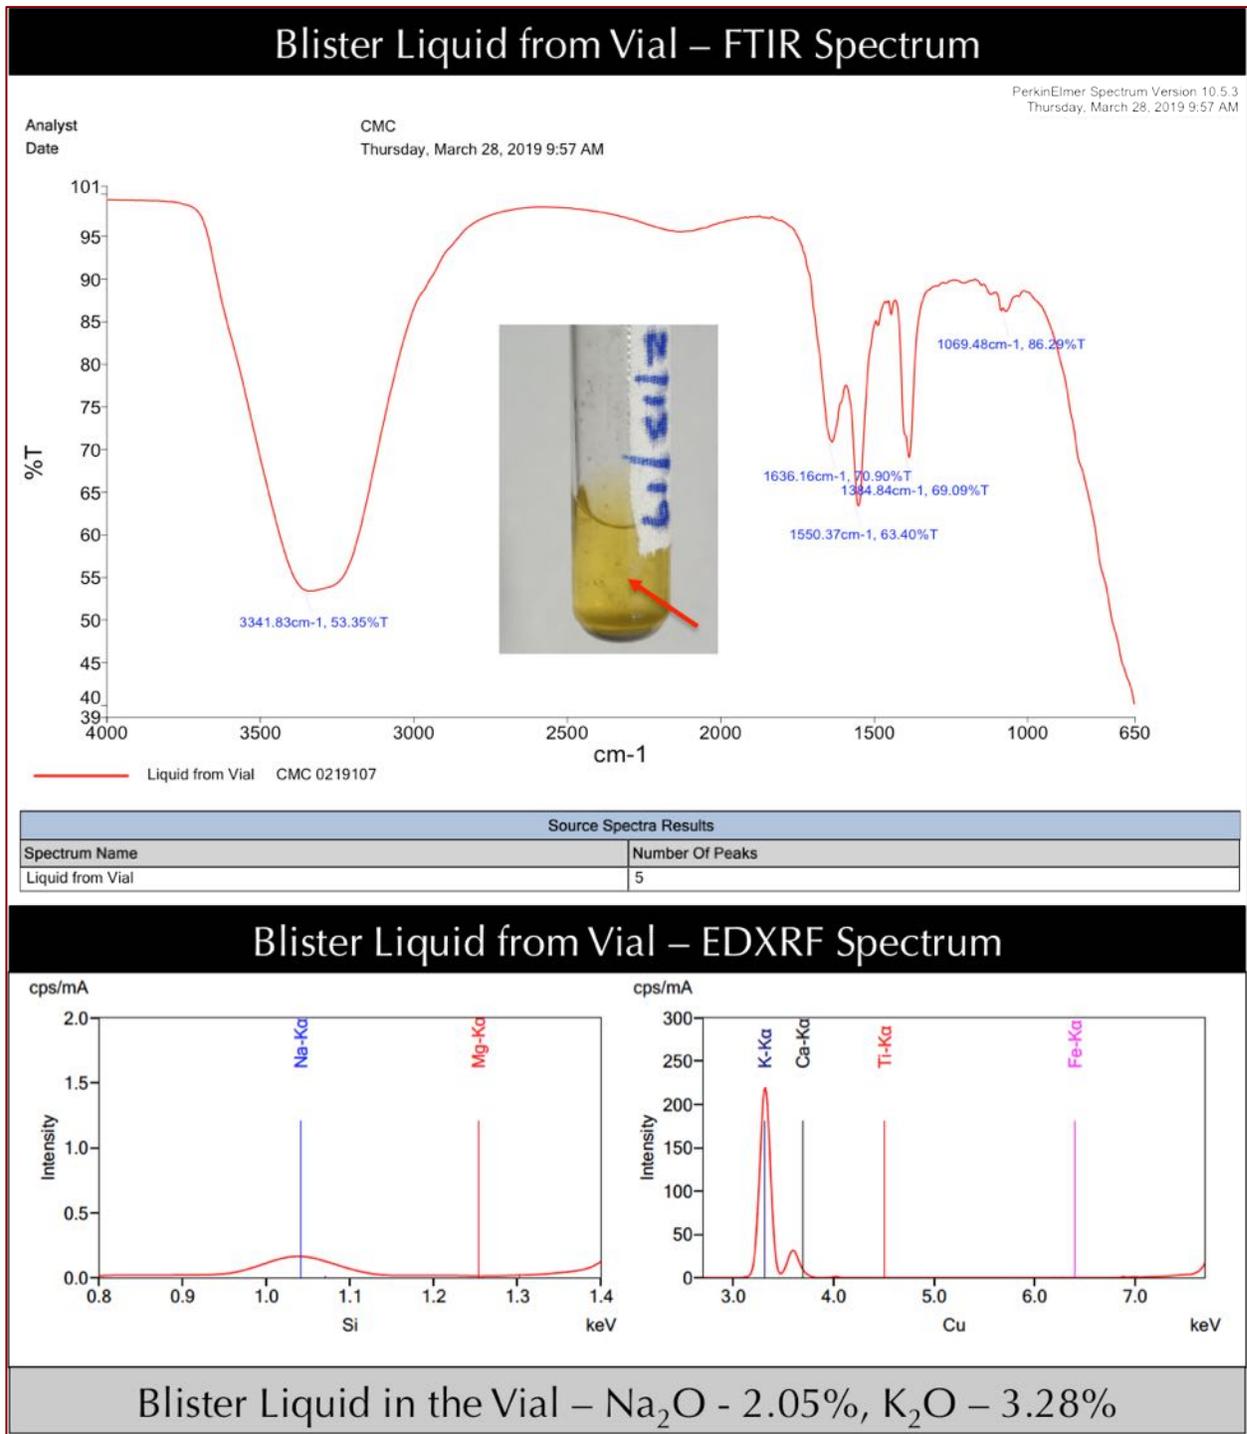
Blister Liquid - High alkalis (2.05% Na₂O and 3.28% K₂O), alkalinity (pH 11.2), and organic components found in the liquid reportedly collected from a blister can come from multiple sources, e.g., from interior concrete slab by moisture upwelling from concrete's batch water, as well as from exterior sources, e.g., ambient humidity, floor cleaning solutions, curing water, dewpoint, precipitation, etc. Without knowing the source of the liquid, or for that matter examining a so-called 'blister' itself, analysis of liquid in a vial cannot provide clues to the moisture-induced flooring failure. If it is from an external source then it has no direct role on terrazzo failure except perhaps destabilization of bonding agent by its high alkalinity. However, if it is indeed from an internal source, e.g., from concrete's batch water that has risen by moisture upwelling under a relative humidity gradient then moisture build up beneath an impermeable terrazzo floor can create enough pressure to cause blistering or debonding. Liquid in vial received was reported by maintenance personnel to be collected by first dry drilling through the terrazzo then applying pressure on the terrazzo to release the liquid from underneath the terrazzo to collect in the vial, which indicates the presence of moisture and moisture buildup beneath the terrazzo. Four cores examined, however, showed no evidence of 'blistering' as dome-shaped upwelling of terrazzo or possible extrusion by buildup of moisture and/or other ingredients (e.g., alkali-silica gel) that are commonly suspected from blister formation. Terrazzo in all four cores is epoxy-based, very dense, hard and showed complete smooth clear, flat separation from the underlying lightly ground concrete surface with a mated flat underside. Such clear separation of flooring from concrete has occurred irrespective of presence or absence of an intermediate bond coat (latter, when present, showed good adhesion to terrazzo but not to concrete). Cores 1 and 3 show the presence of a thin (2.5 to 3 mm thickness) green polymer bond coat well-adhered to the underside of terrazzo but completely debonded from concrete. Liquid in a vial reportedly received from a blister having water beneath the terrazzo, however, keep the possibility of moisture-related blistering open, which was not possible to investigate from the cores alone.

Figure 43: Fourier transform infrared spectroscopy of the yellowish liquid reportedly retrieved from underneath a blister and received in a glass vial shown in the top inset. FTIR spectrum indicates the presence of an organic (possibly of a primer) component in the liquid. Also shown below is elemental spectrum from X-ray fluorescence spectroscopy of the same liquid showing 2.05% sodium and 3.28% potassium oxides in the liquid. Both studies were done after filtering the liquid through two 0.22-micron filter papers to collect the filtrate. The pH of liquid is tested to be 11.2.

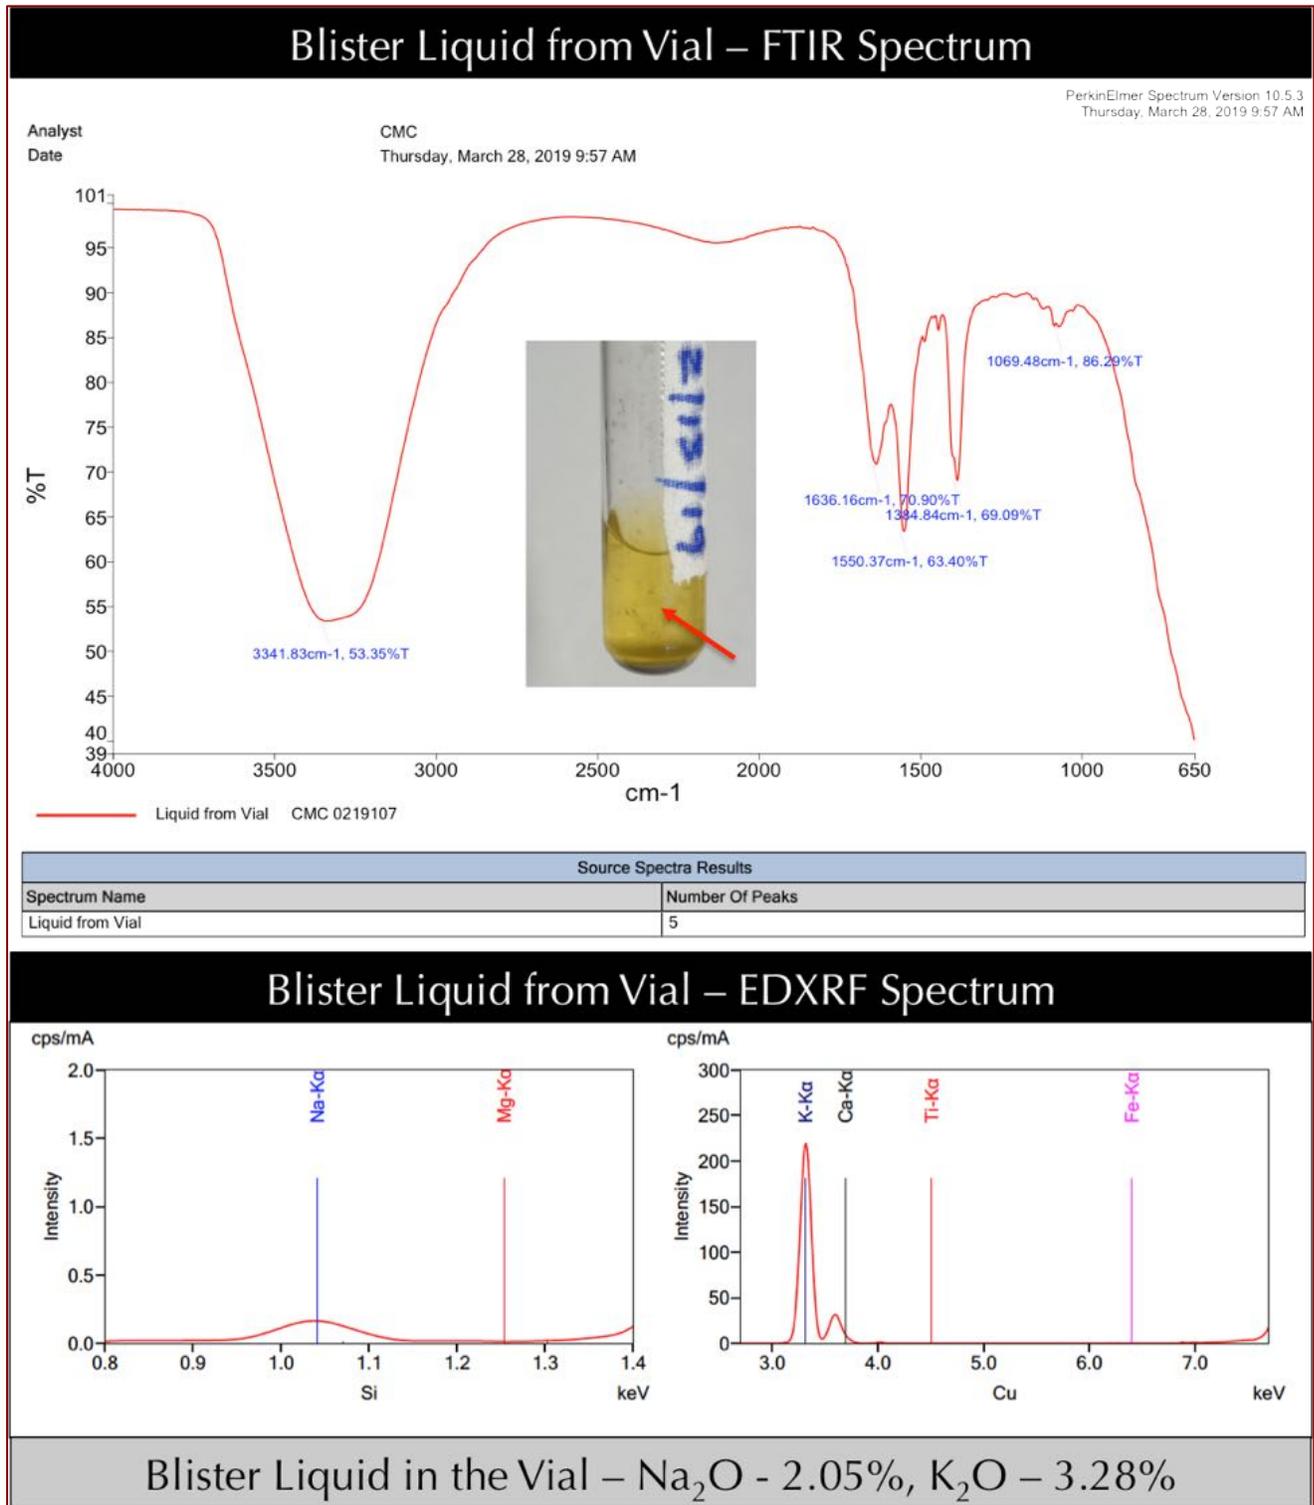
Figure 50: FTIR spectra (top) and X-ray fluorescence elemental spectra (bottom) of yellow liquid in the vial reportedly collected from underneath a blister. FTIR spectra indicates the presence of organic components in the liquid, possibly from a primer component applied to the surface, whereas XRF spectra clearly showed noticeable peaks for sodium and potassium, having 2.05% Na₂O and 3.28% K₂O in the liquid.
