CORROSION OF ALUMINUM METAL IN CONCRETE – A CASE STUDY

Abstract

Background

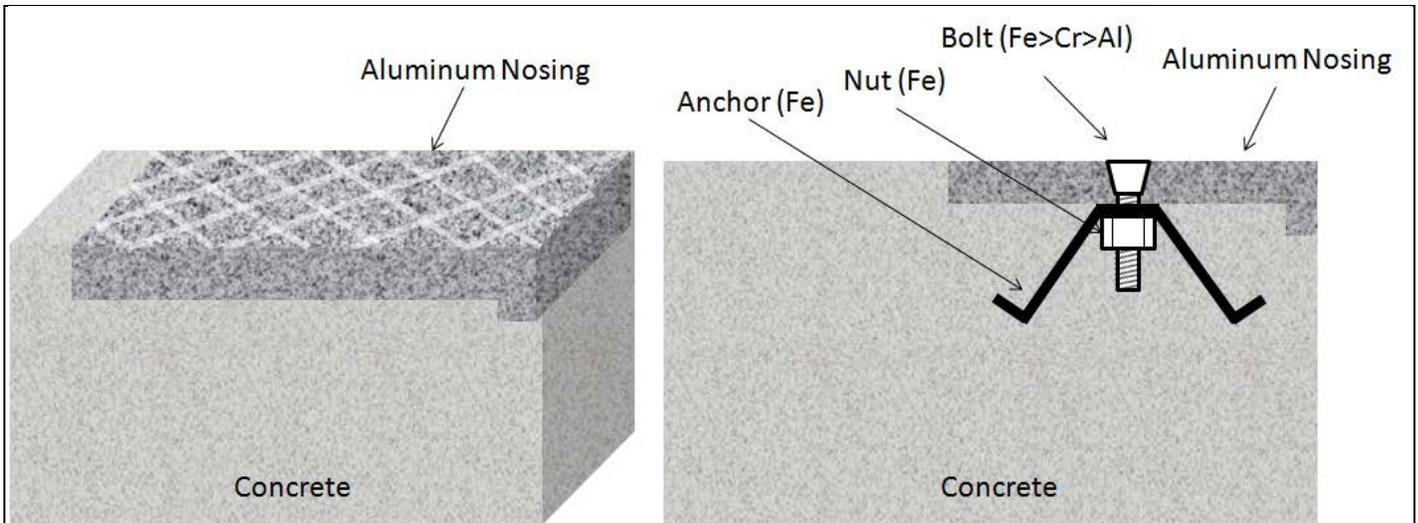
Figure 1: Schematic diagram of aluminum nosing and its attachment to concrete stair by steel wing anchor, bolt, and nut. The table shows SEM-EDS analyses of compositions of metals.

As can be seen from the elemental analyses: (a) the aluminum nosing contains a major amount (i.e. >75%) of aluminum, and subordinate amount (15 to 20%) of silicon from the embedded silicon carbide granules; (b) the steel wing anchor contains a major amount (i.e. >85%) of iron and subordinate amounts (i.e. 4-10%) of aluminum and silicon; (c) the bolt used to attach the nosing to the anchor contains a major amount (i.e. 45 to 50%) of iron and subordinate amounts (i.e. 10 to 25%) of aluminum and chrome; and, (d) the nut completely embedded in concrete contains a major amount (i.e. >85%) of iron and minor amounts (i.e. 3 to 9%) of aluminum and silicon.

The anchoring process itself, therefore, created an excellent aluminum-iron alloy-steel coupling in an outdoor environment of moisture and salts in the concrete stairs, which has set the stage to initiate a galvanic action of dissimilar metals in the presence of chloride-based deicers reportedly applied to the stairs.

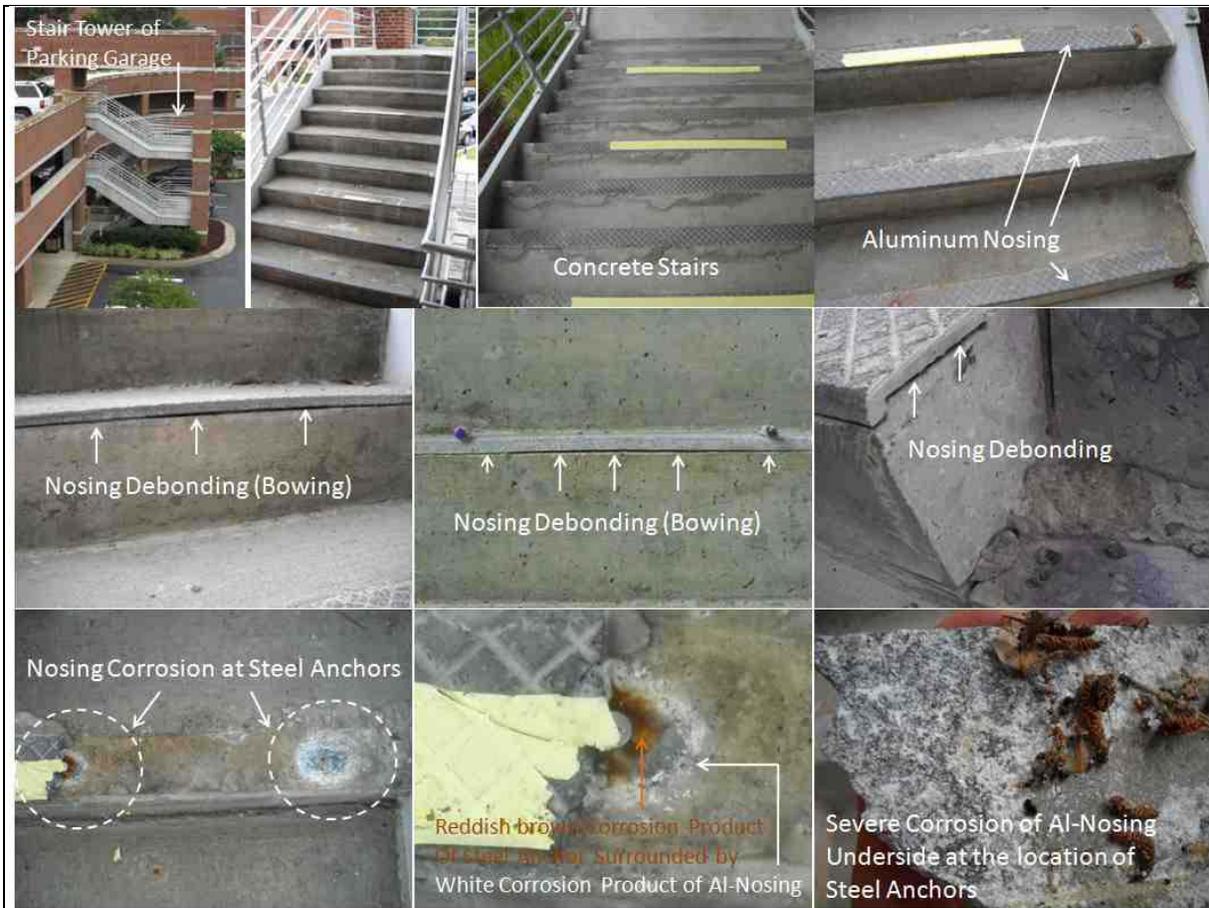
- (a) Severe corrosion of metal in terms of loss of the cross sectional thickness (e.g., from 7.9 mm maximum to 6.1 mm at the location of steel anchor in one nosing sample), and
- (b) Ring-textured corrosion products (see Figure 2) concentric around the corroded steel nuts, consisting of reddish brown iron oxide corrosion products of steel nut/bolt/anchor at the center, dark greenish gray mass of highly corroded, fragile, sheet-like metal consisting of alternating bands of white corrosion products and gray metal hydrates, and an outer ring of soft, powdery, white corrosion products from the nosing.

Concrete at the locations of steel anchors show cracking and spalling. Cracks sometimes are filled with white corrosion products from the nosing and/or reddish brown corrosion products from the steel anchor/nut/bolt. Portions of the nosing underside in between the steel anchors are present mostly in sound condition with no noticeable corrosion compared to the areas adjacent to the anchor locations.

Figure 2: Field photographs of corrosion and debonding of aluminum nosing and associated concrete distress.

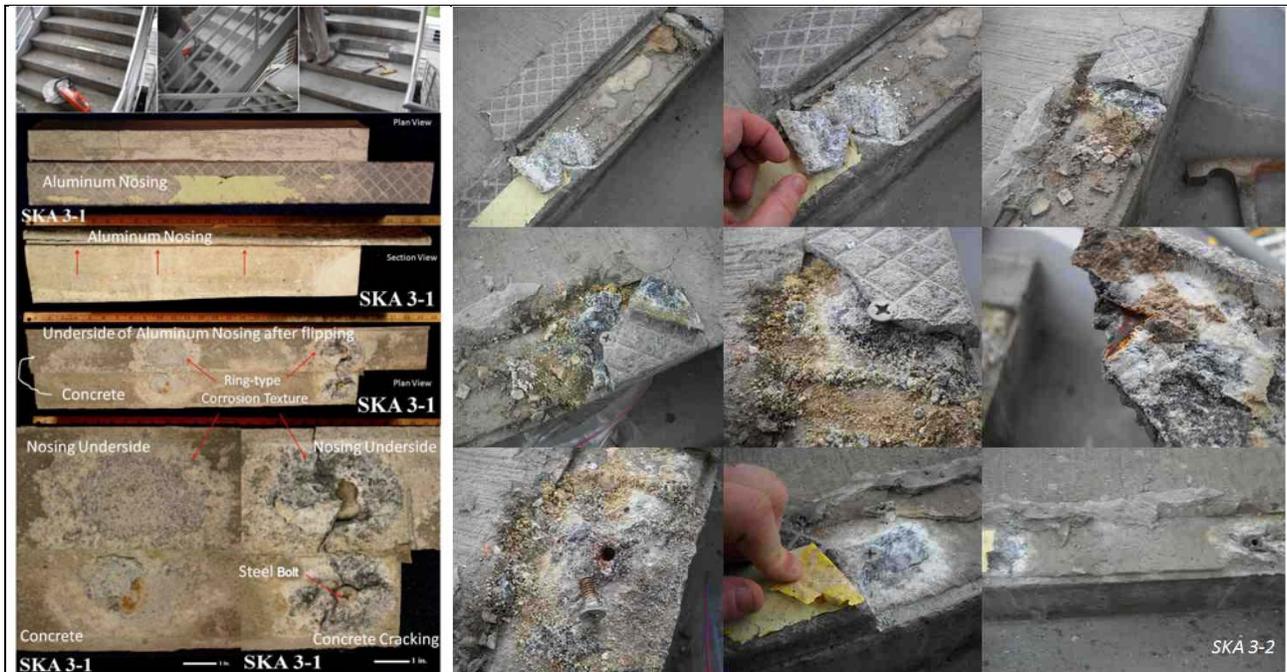
Figure 3 shows the two samples received for detailed laboratory studies. The first sample, SKA 3-1, was taken by dry saw-cutting a 24 in. long \times 5 $\frac{1}{4}$ in. wide \times 5 in. thick section of a stair containing a 30 in. long \times 3 in. wide \times $\frac{1}{4}$ in. thick aluminum nosing (shown in the top left field photo), where the aluminum nosing shows separation (bowling) from concrete, and severe corrosion at its underside, at the two locations of steel anchor. As shown in the bottom left column photo, the underside of the nosing shows severe and preferential corrosion of metal at the locations of steel anchor, white corrosion products forming around the hole in the metal for steel bolt, and cracking of concrete at the corroded locations.

The second sample, SKA 3-2, consists of a portion of a corroded, debonded aluminum nosing (shown in the top right composite field photo), and several plastic bags of loose powdery to fragmented pieces of corrosion products of nosing collected from around the steel anchors. Of particular importance in this sample are: (a) the white corrosion products from metal nosing, (b) loose pieces of sheet-like masses of severely corroded metal consisting of alternating bands of white corrosion products and dark corroded metal, and (c) the underside of the corroded aluminum piece.

Figure 3: Two samples, SKA 3-1 and 3-2 from two different locations of stairs that show aluminum nosing corrosion and associated concrete cracking and spalling.

The right composite photos in Figure 3 show field locations of debonding and associated corrosion products of nosing for Sample SKA 3-2. The middle photo in the bottom row of this right composite set shows a typical ring-structure of corrosion consisting of dark gray colored somewhat hard corrosion products formed around a steel nut, which is surrounded by a layer of soft, powdery white corrosion products. The underside of nosing at this location shows severe corrosion and remains of the white deposits. Notice the nosing was fractured at this location due to significant thickness reduction of metal by corrosion. Small pieces of these corrosion products in the field were carefully collected in plastic bags for detailed laboratory examinations.

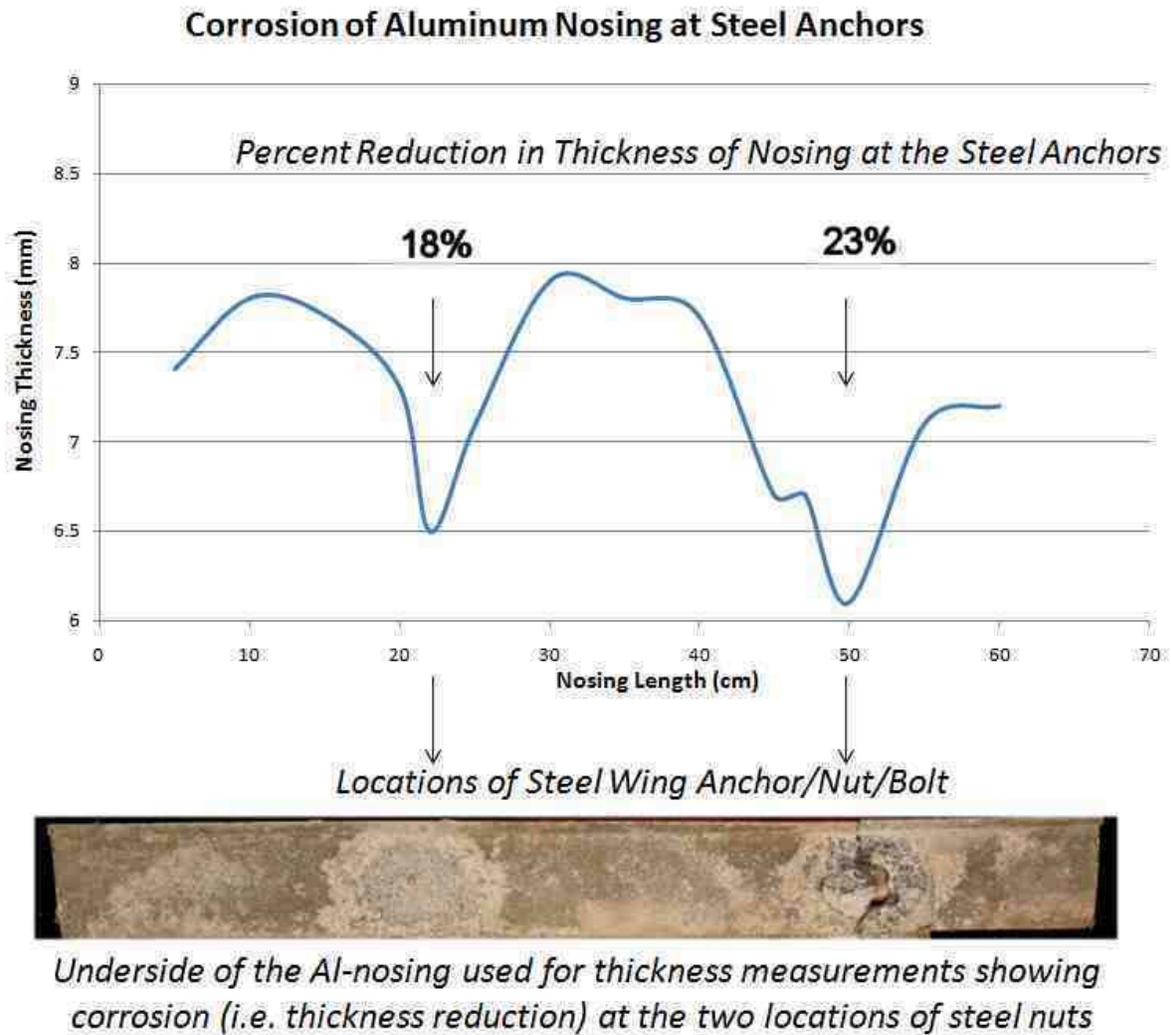
A measurement of nominal maximum thickness of the debonded aluminum nosing in SKA 3-1 by a digital micrometer shows severe preferential corrosion of nosing at the locations of steel anchors, which is measured to be ~18 to ~23 percent loss of thickness by corrosion of the metal, as shown in the graph in Figure 4. Such a thickness reduction by corrosion has caused loss of strength of the metal, and cracking and debonding of the nosing at many stairs.

Figure 4: Reduction in cross sectional thickness of aluminum nosing at the locations of steel anchors.

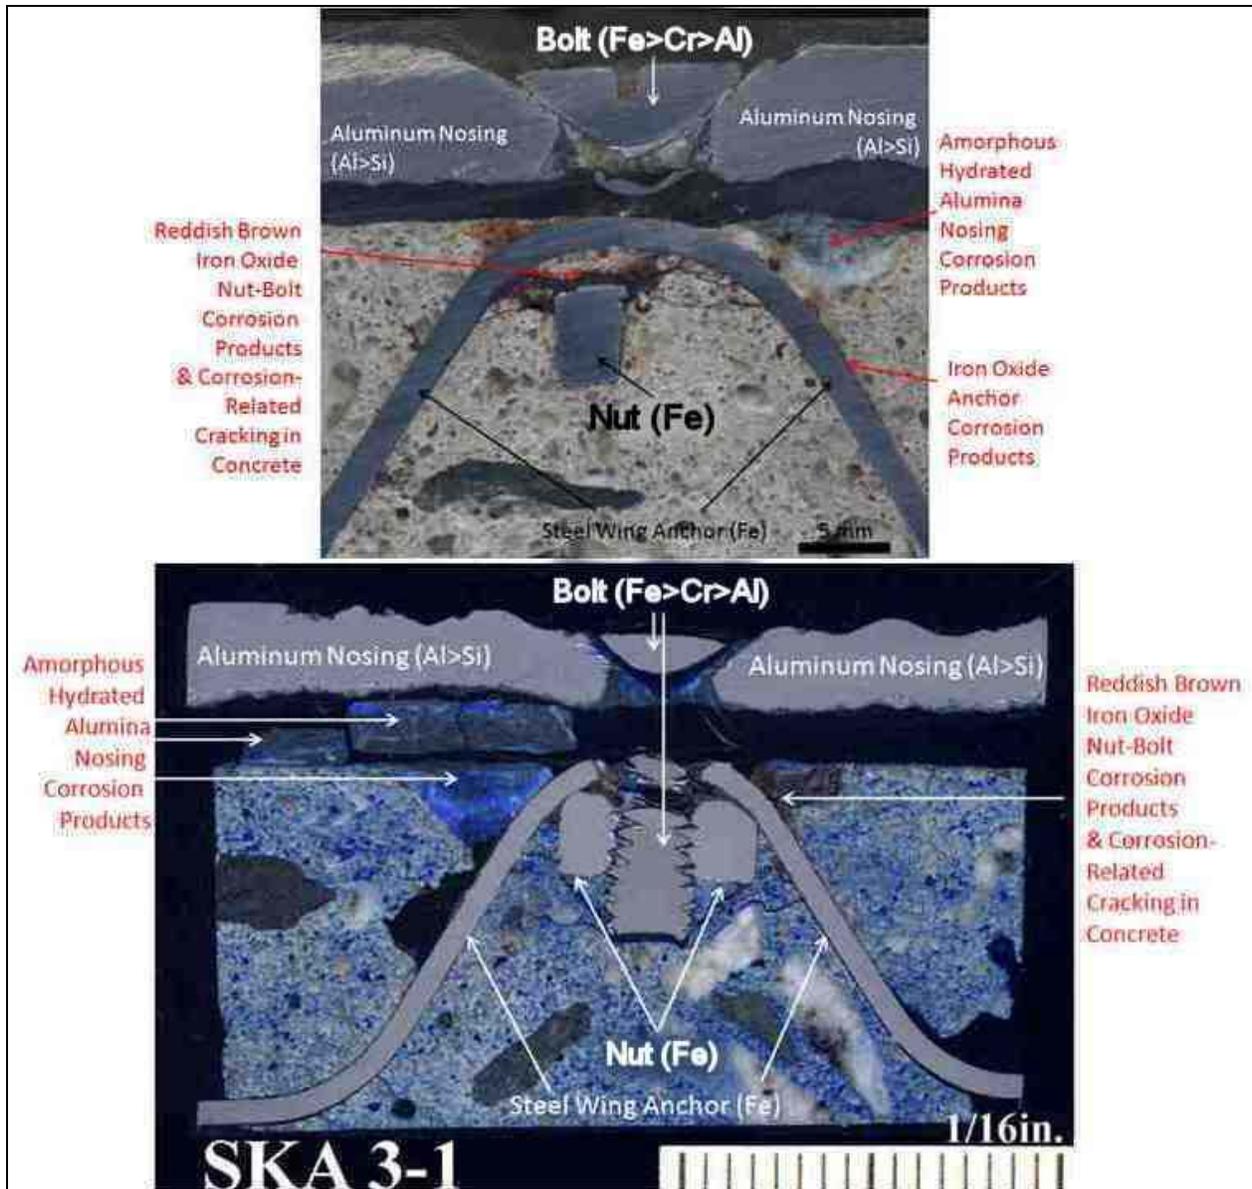
Figure 5 shows a clear epoxy-impregnated lapped cross section (top photo, carefully sectioned through a steel bolt and nut), and a blue dye-mixed epoxy-impregnated polished cross section (bottom photo) of small portions saw-cut from around a corroded nosing/anchor area in the sample. Important features in these figures include:

- (a) Complete separation of nosing from concrete,
- (b) Reddish brown iron oxide corrosion products and associated concrete cracking around the corroded steel component,
- (c) Layered-type or banded corrosion products of aluminum nosing (described in detail, later determined to be amorphous hydrated aluminum) situated around the steel anchor as well as at the interface between the nosing and concrete, and
- (d) Aluminum-iron alloy-steel coupling of nosing and anchor/bolt/nut where compositions of metals are given before.

Figure 5: Lapped (top) and blue dye-mixed epoxy impregnated polished cross section (bottom) of SKA 3-1 through aluminum nosing, steel anchor, nut, and bolt showing corrosion of nosing and anchor materials.

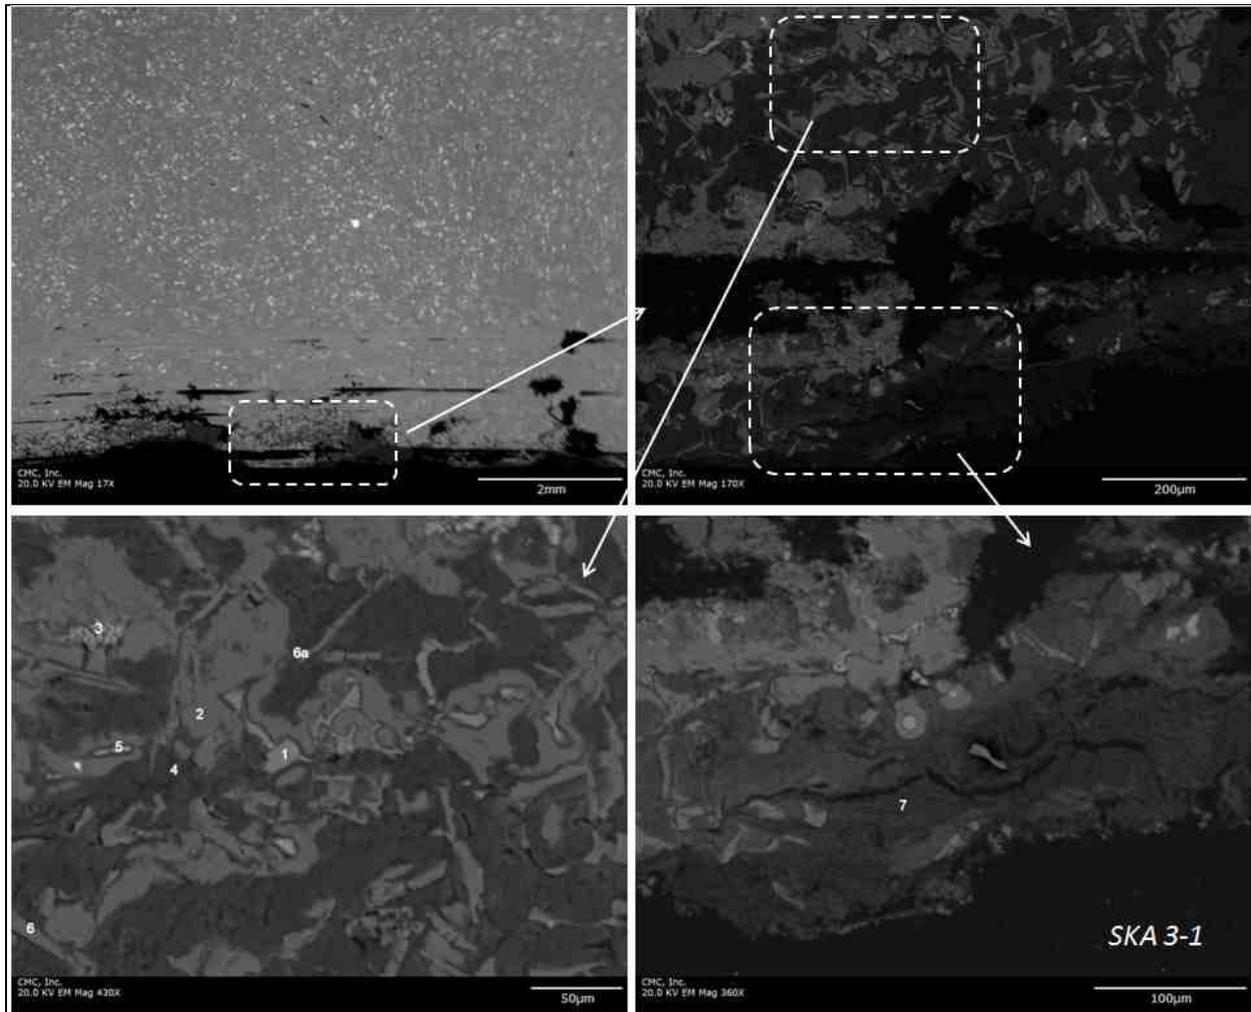
Figure 6 shows backscatter electron (BSE) images of cross section of aluminum nosing in Sample SKA 3-1, where the top left photo shows the bottom half of the metal including the “corrosion zone” at the very base (e.g., boxed) that was in contact with portland cement concrete stairs.

Figure 6: Backscatter electron images of cross section of an aluminum nosing, showing corrosion microstructure along its base near the nosing-concrete interface.

The very bottom 1 mm thick zone of the aluminum nosing is the “corrosion zone” (the top right photo in Figure 6, which is an enlarged view of the boxed area in the top left photo), where the overall somewhat “monotonous” microstructure of silicon-rich spots in aluminum matrix changes into a complex microstructure consisting of at least 6 to 7 different phases with compositions different from the overall metal in the body, above the corrosion zone. The bottom two photos in the figure are enlarged views of two areas of this corrosion zone, where

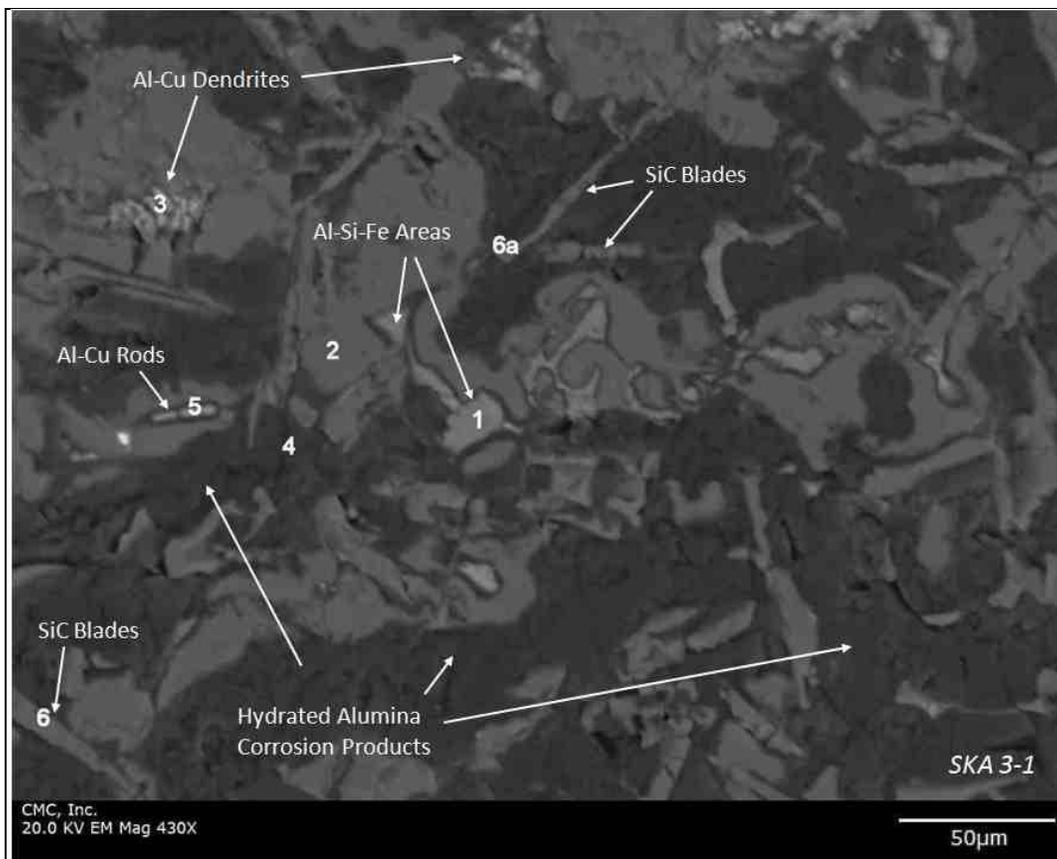
six to seven different spots with phases of different compositions are detected. The following Figure 7 is an enlarged view of the bottom left photo, where six different phases are detected. The major phase (the darkest phase in BSE image) is aluminum hydroxide (Al and O as major peaks in SEM-EDS spectra, e.g., Spot Nos. 4 and 7) with various incorporations of Ca, Mg, Cl, S, Cu, Si, etc. The brightest areas (e.g., Spot# 1) are of Al-Si-Fe composition (e.g., >70% Al, 10-15% Si, 10% Fe), where incorporation of iron (possibly from the steel nut/bolt/anchor) has caused increased brightness in BSE-image. The blade-shaped phases (e.g., Spot Nos. 6 and 6a) are rich in silicon, from the original silicon carbide grains, with 85 to 90% Si and 5 to 10% Al. The bright dendritic-textured and stout rod-shaped phases incorporated copper (e.g., > 60% Al, > 25% Cu). The overall gray areas in the matrix (e.g., Spot# 2) are very rich in aluminum (e.g., >90% Al, 2.5% Si, 1% Cu). Therefore, the “corrosion zone” shows: (a) an overall shapeless hydrated aluminum matrix (the darkest areas) with (b) major amounts of irregularly-shaped aluminum-rich areas (gray areas), (c) minor amounts of blade-shaped silicon-rich phases from embedded silicon carbide grains and bright Al-Si-Fe areas, and (d) trace amounts of dendritic or stout rod-shaped Al-Cu alloy phases.

Figure 7: Different phases from corrosion of aluminum nosing.

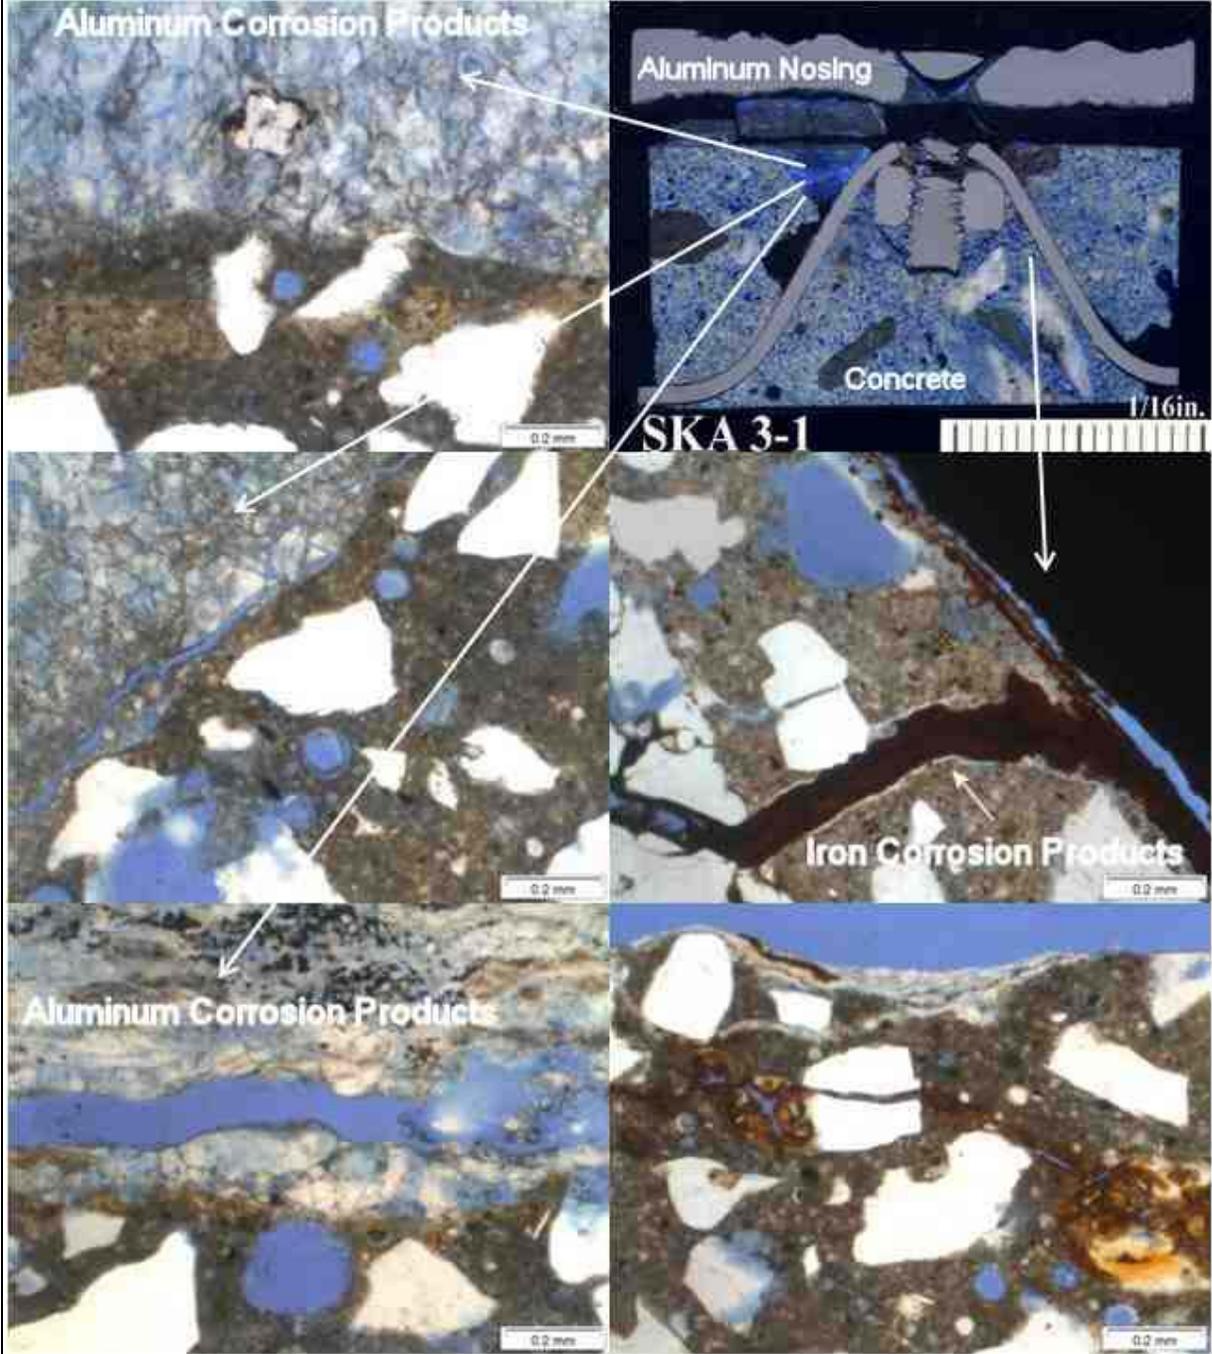
Petrographic examinations of blue dye-mixed epoxy-impregnated thin section of SKA 3-1 (from the top right polished block in Figure 8) detected two different types of corrosion products (from two different metals) in the concrete and at concrete-nosing interface.

The first one is reddish brown iron-oxide based corrosion products (the top, middle, and bottom right column photos in Figure 8) from corrosion of steel anchor and nut embedded in concrete, in the presence of chloride, oxygen, and moisture in concrete – the common chloride-induced corrosion of steel in concrete, which has caused some local macro and micro-cracking in concrete adjacent to the anchor and nut, and migration of corrosion products along the cracks. Apart from some local cracking in concrete from expansions associated with formation of steel anchor/nut corrosion products in concrete, such a steel corrosion process itself is judged not to have caused the reported separation of nosing plates from the concrete stairs.

The second one is white deposits of aluminum nosing corrosion products, which occur as soft, powdery to flake-like deposits, often present as outer rings around reddish brown corrosion products of steel nuts, (e.g., see Figure 2), at and around the locations of corroded steel, where corrosion (thickness reduction) of aluminum nosing is maximum. The bottom surface of nosing at the location of steel anchor shows severe corrosion, and, formation of flaky or sheet-like masses of soft, friable corroded metal hydrates with alternating bands of white deposits and dark hydrated aluminum layers (Figures 8 and 9).

The white deposits (appear blue in Figure 8 due impregnation with a blue dye-mixed epoxy) are optically isotropic, indicating the gelatinous or amorphous to crypto or microcrystalline nature (see the left column photos in Figure 8). The microstructure of these white deposits of aluminum corrosion products are fascinating, showing a distinct banded texture of alternating layers of small, stout, prismatic dark gray, brown-to-black crystals aligned in a dense, dark, hard layer (which are determined to be silicon-rich phases from the embedded hard silicon carbide grains in the soft aluminum matrix) and alternating colorless or light-colored isotropic layers of gelatinous hydrated aluminum mass.

Figure 8: Photomicrographs of thin section of SKA 3-1, sectioned through iron-based anchor, nut, bolt, and aluminum nosing showing two types of corrosion products – a reddish brown product associated with corroded steel anchor, and a white (appears blue in the photo from blue epoxy) banded-type product from corroded aluminum nosing.

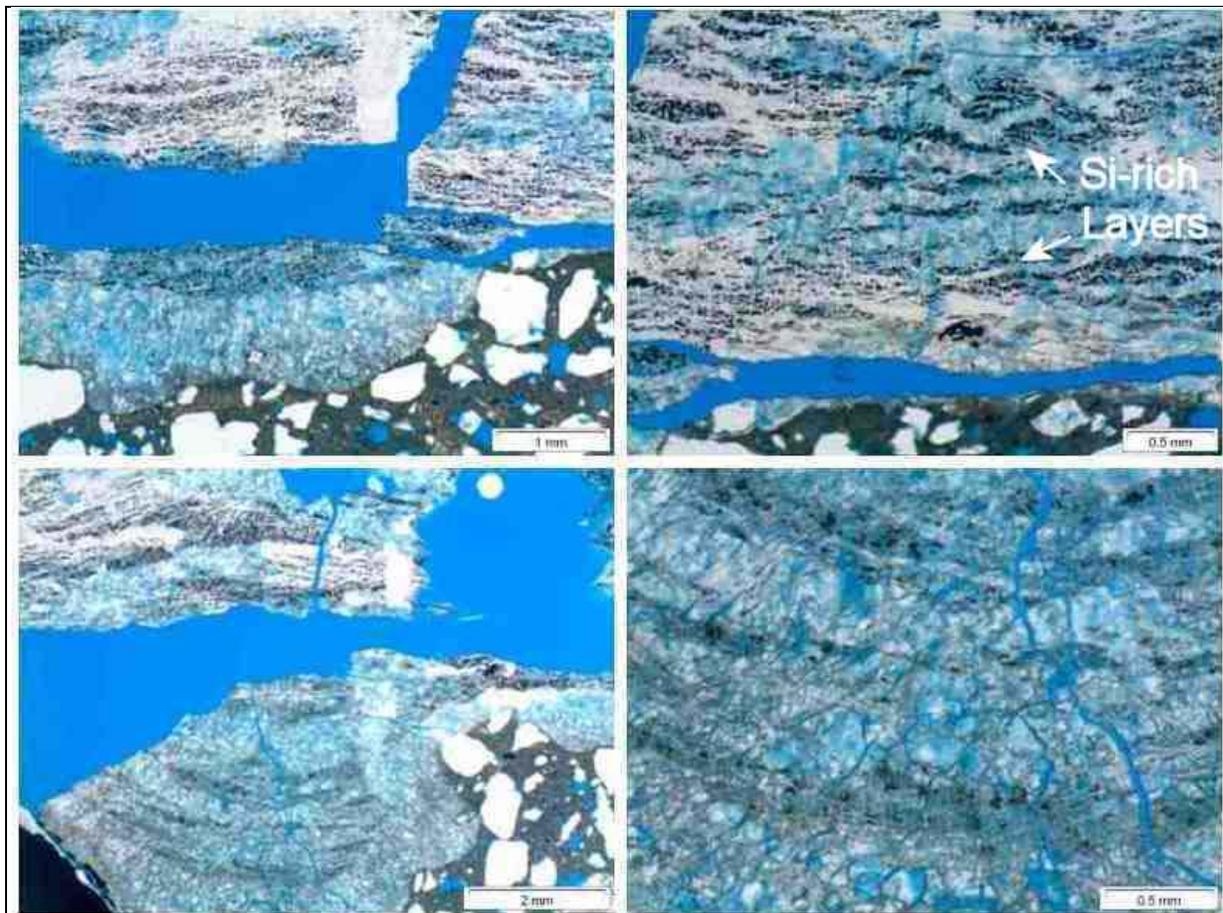
Figure 9 shows transmitted-light photomicrographs of blue dye-mixed epoxy-impregnated thin section of SKA 3-1 (of the block shown in the bottom photo of Figure 5 and top right photo in Figure 8). The photos were taken from the aluminum nosing corrosion products situated in the debonded interface between the nosing and concrete surface. Due to the soft, friable nature of the white deposits that formed from nosing corrosion, an epoxy-impregnation step was essential to improve the integrity prior to thin sectioning. The photos were taken by using a stereomicroscope where white light was transmitted from the base through the thin section.

The characteristic texture of nosing corrosion products, as mentioned before, is its banded nature with alternating dark and light-colored bands (ranging in thickness from 0.05 to 0.5 mm), where the dark bands are enriched in fine, stout prismatic or irregularly-shaped, isotropic masses of silicon-rich phases (less than 10 to 50 microns in length) from the embedded silicon carbide grains in the metal, and the light bands are enriched in hydrated aluminum corrosion products. The microstructure is indicative of preferential corrosion of the overall aluminum matrix leaving silicon-rich residues as bands alternating with hydrated alumina products.

Figure 9: Photomicrographs of thin section of corroded nosing pieces showing characteristic banded nature of corrosion products consisting of alternating dark and light bands.

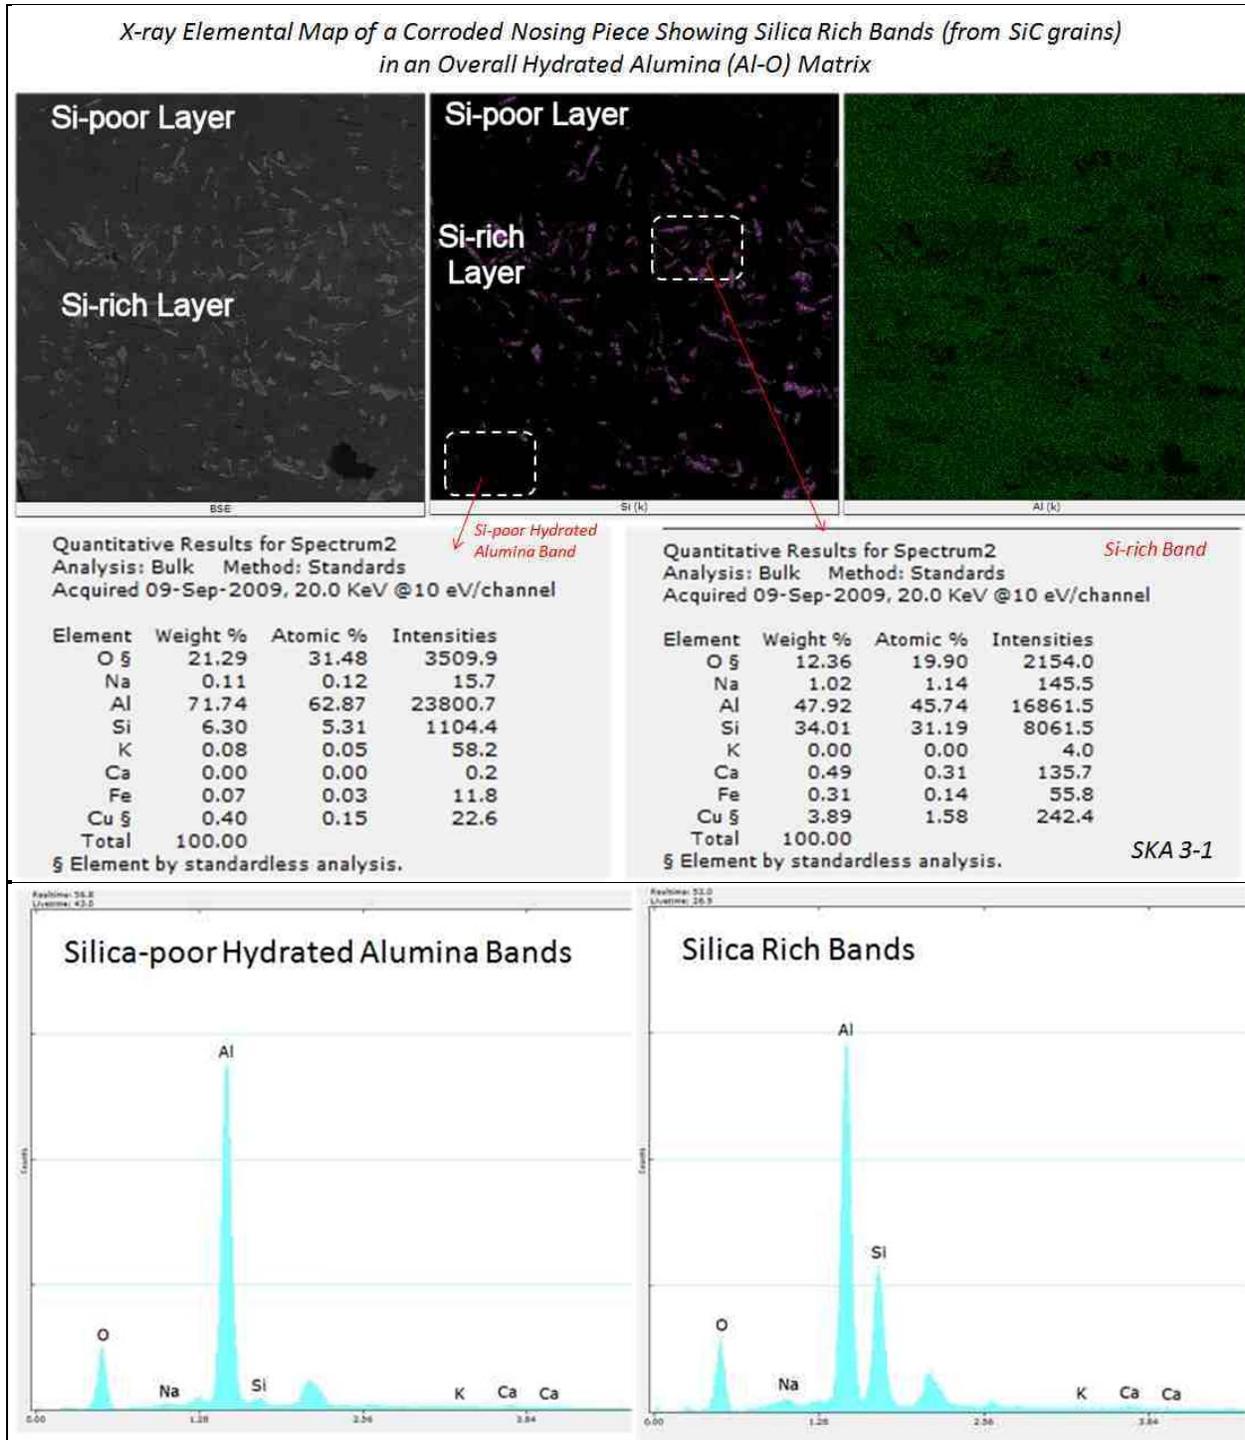
Figure 10 shows backscatter electron image and corresponding x-ray elemental maps for silicon and aluminum, where alternate bands of silicon-rich areas (consisting of fine, prismatic or irregular shaped silicon-rich phases) and silicon-poor aluminum rich areas are distinct.

Figure 10: X-ray elemental maps and elemental analyses of areas from silicon-rich and silicon-poor aluminum rich bands.

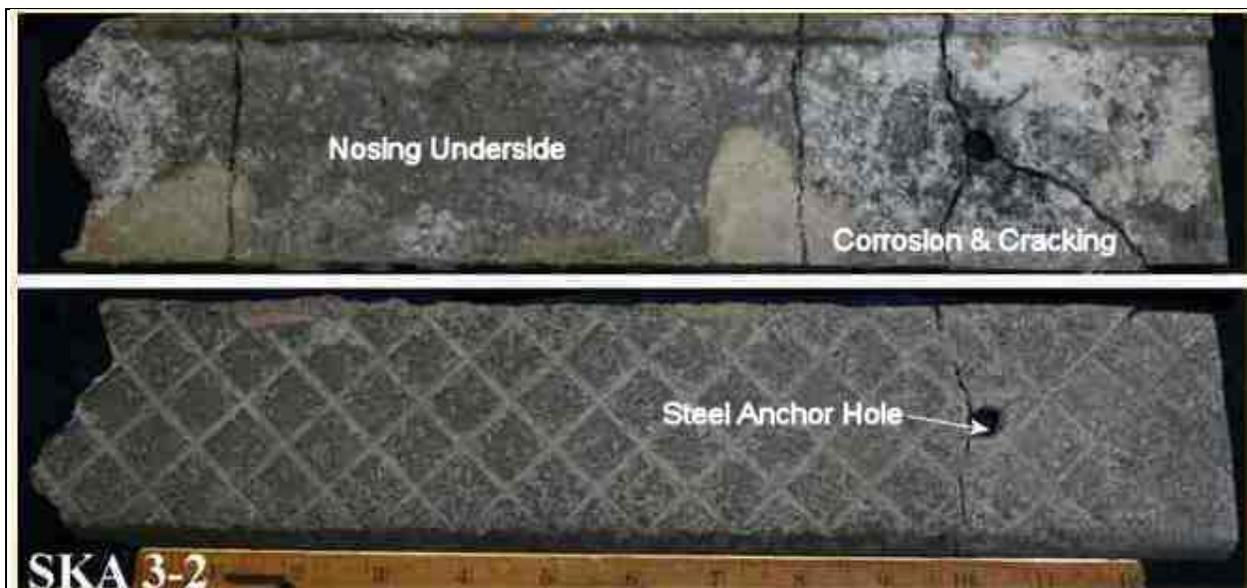
Figure 11 shows a debonded nosing piece from Sample SKA 3-2 (the top photo shows the underside of the nosing and the bottom photo shows corresponding exposed walking surface of the nosing). Two features are apparent from this figure – (a) preferential location of corrosion of nosing underside at the steel anchors locations, where white corrosion products were formed around the hole in nosing in the right side of photos, where steel components have anchored the nosing to the stair; and (b) radial cracking of the nosing plate itself from reduction in cross sectional thickness of nosing by galvanic corrosion of nosing at the steel interface, in the presence of chloride from the application of deicing salts on concrete stairs.

Figure 11: Preferential corrosion of nosing underside at the location of a steel anchor bolt, and cracking by reduction in thickness from corrosion.

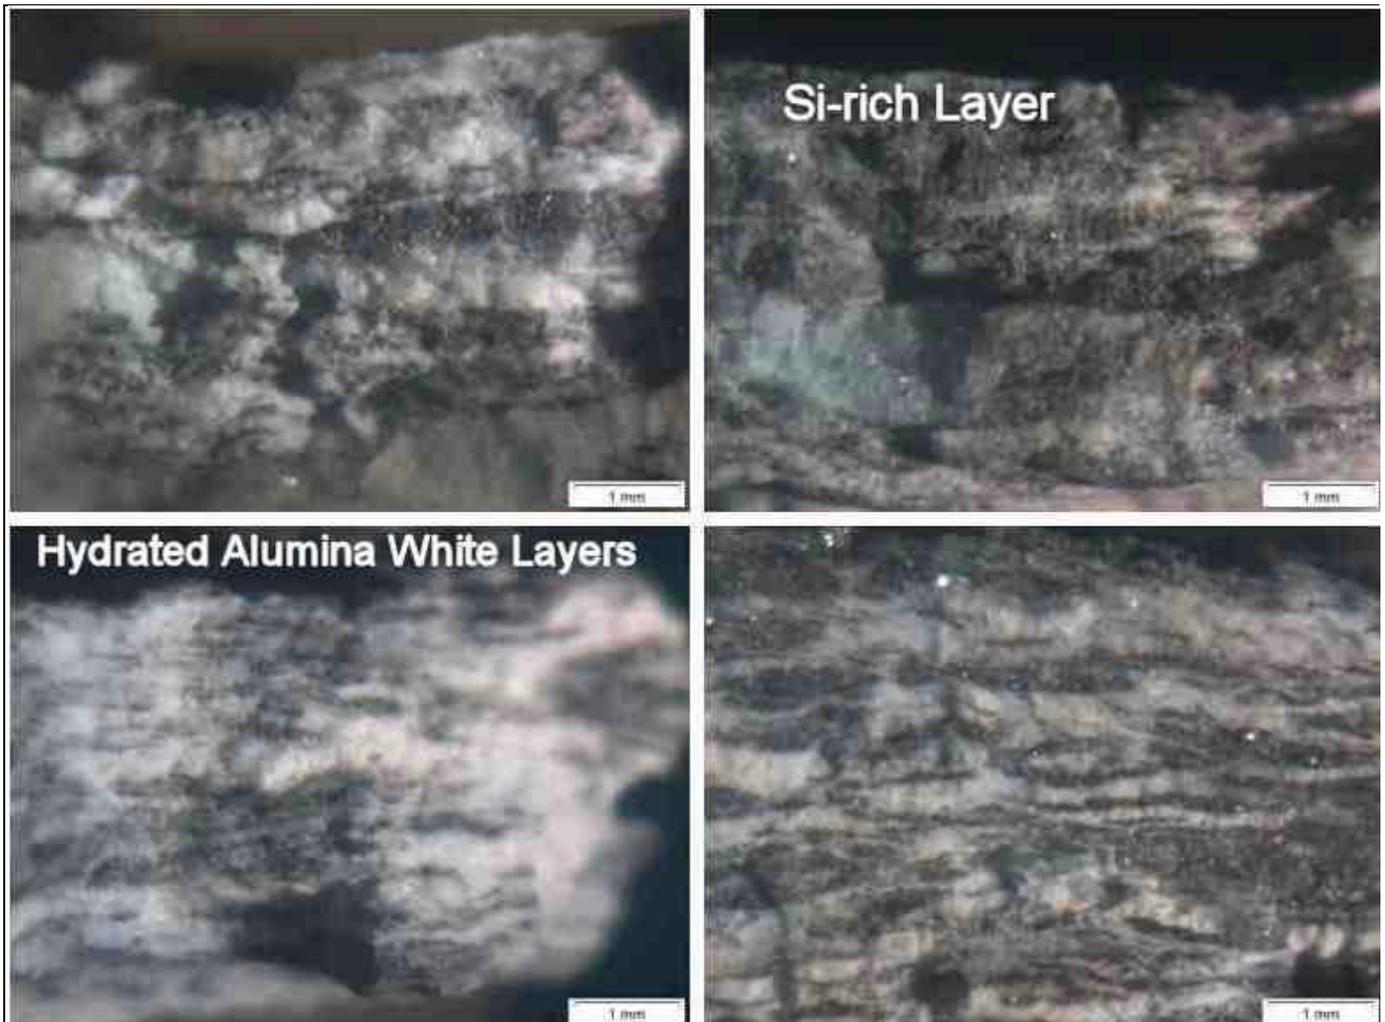
Cross sections of those corroded metal pieces show unique banded microstructure (Figure 12) of alternating layers of white deposits and dark corroded metal. The light (white) and dark (gray) alternating bands are very distinct and similar to gneissose structure seen in gneiss. The

Figure 12: Banded nature of individual pieces of nosing corrosion products showing alternating bands of white deposits and dark hydrated aluminum layers on the fresh fractured cross sections.

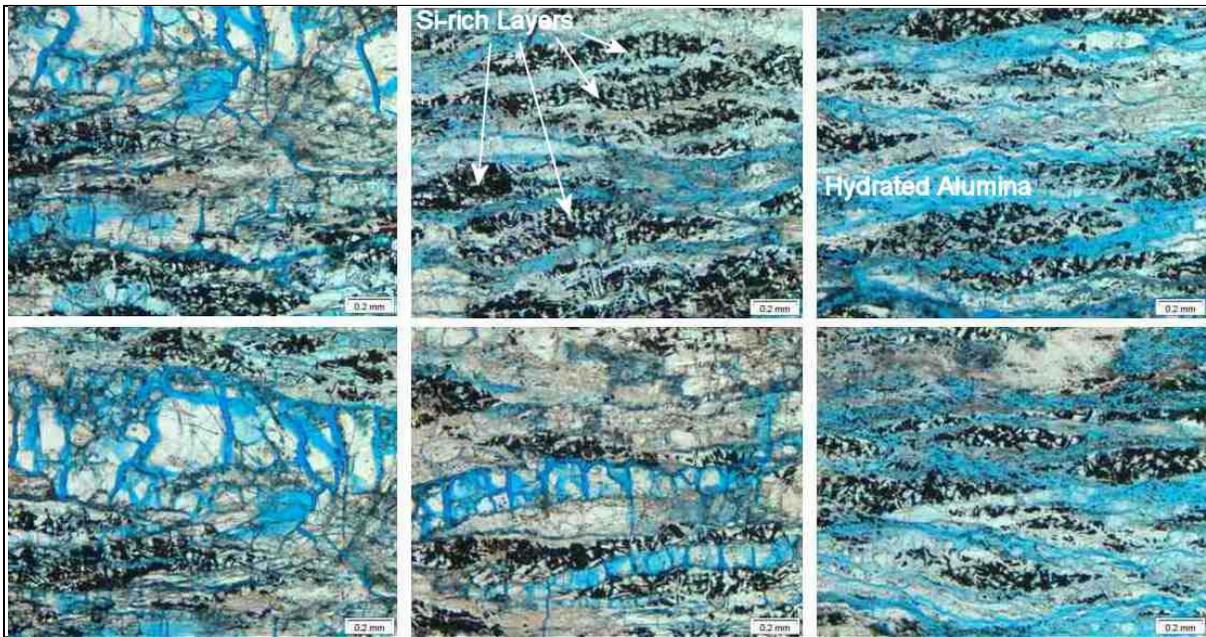
Figure 13: Transmitted light photomicrographs of banded microstructure of nosing corrosion products showing alternating bands of silicon and aluminum-rich phases.

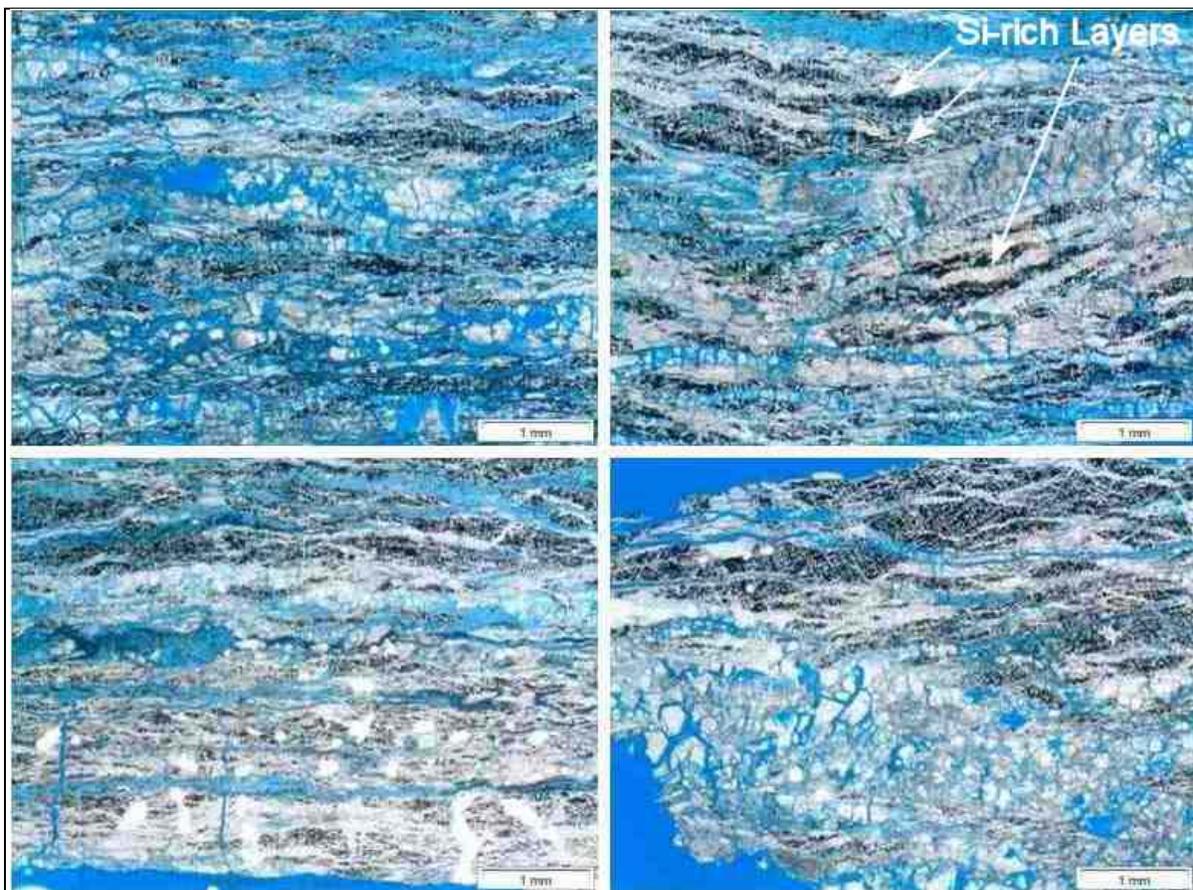
Figure 14: Transmitted light photomicrographs of banded microstructure of nosing corrosion products showing alternating bands of silicon and aluminum-rich phases.

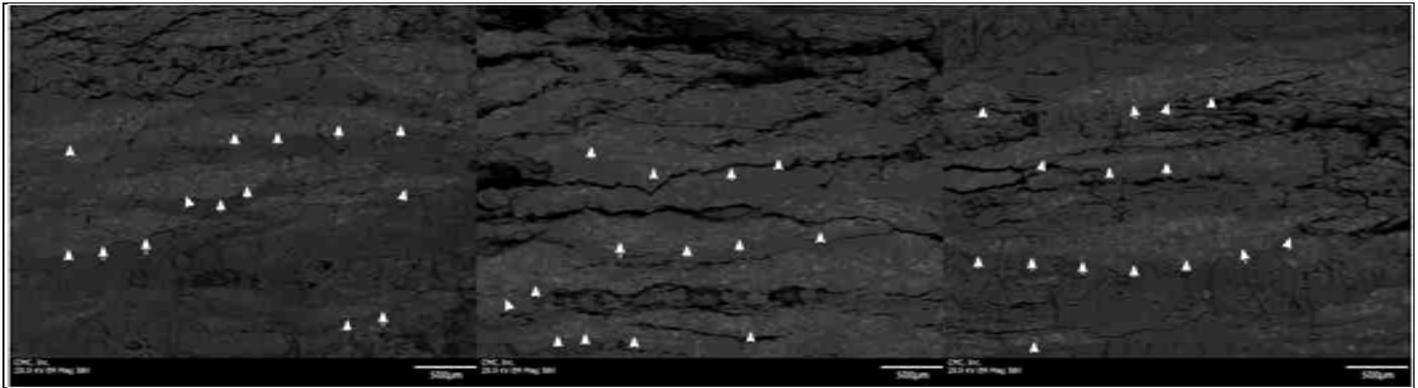
In a petrographic microscope (in cross polarized-light mode), the white deposits show a completely optically isotropic nature, which is indicative of its gelatinous (amorphous) nature. The deposits resemble typical alkali-silica reaction gel in a concrete in terms of isotropic masses of deposits with numerous shrinkage microcracks transecting the masses. The following backscatter electron image of epoxy-impregnated polished cross section of a corroded nosing piece (received as a small friable piece) confirms its sheet-like layered structure with numerous parallel microcracks, and alternating bands of silicon-rich (marked with arrows) and silicon-poor hydrated aluminum layers.

Figure 15: Backscatter electron images of aluminum nosing corrosion products in SKA 3-2 showing its flake or sheet-like nature with parallel microcracks and alternating bands of silicon-rich (arrows) and silicon-poor layers.

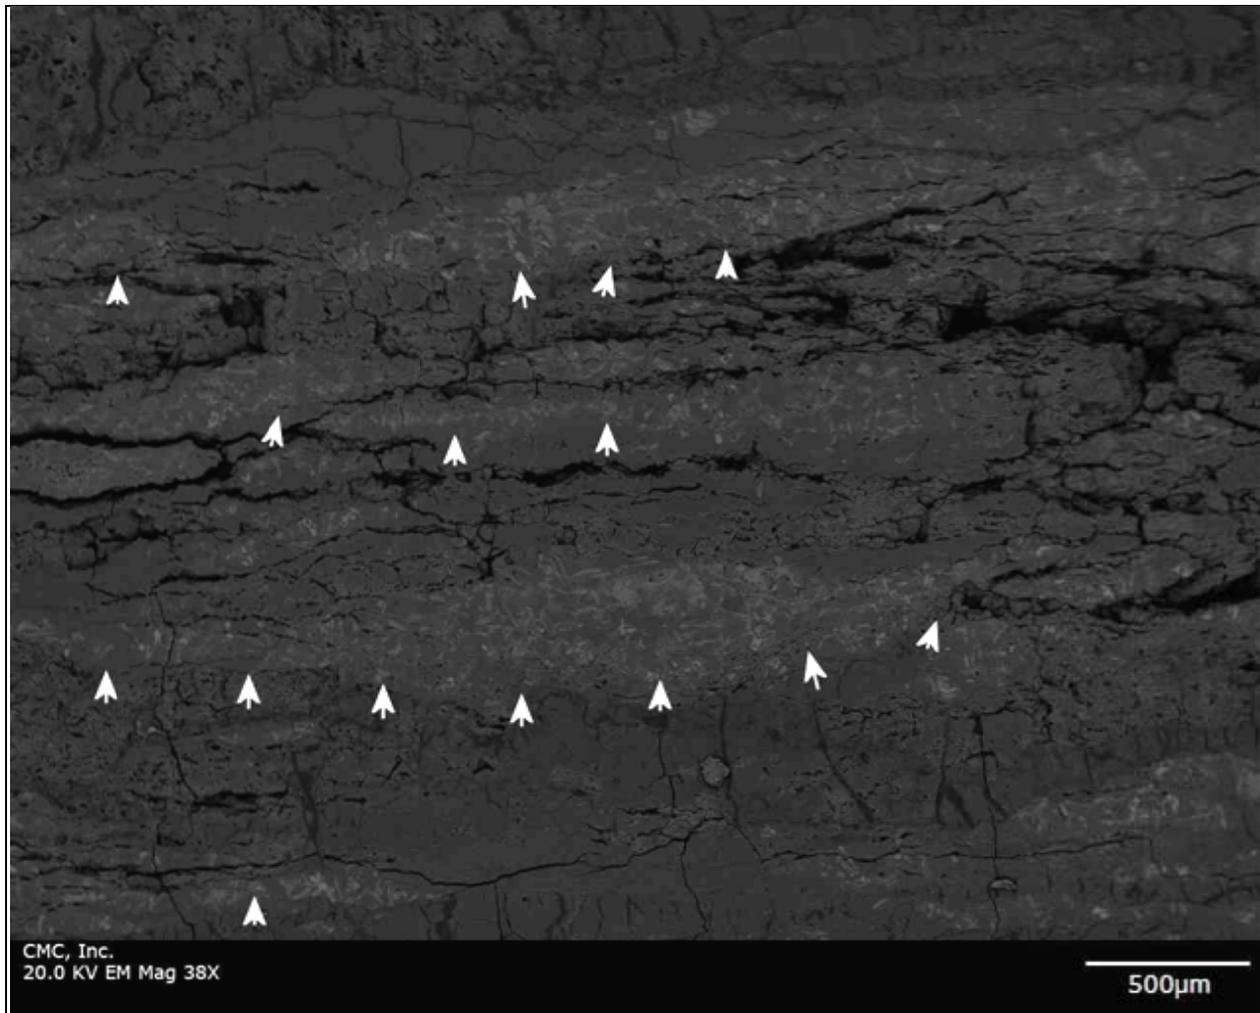
An enlarged view of one of the photos in Figure 15 is shown in Figure 16 where numerous parallel and perpendicular microcracks and alternating bands of silicon-rich layers (arrows) and silicon-poor layers are distinct. White layers in Figure 12 correspond to the hydrated aluminum/silicon-poor layers in the backscatter and elemental maps in Figures 16 and 17, and alternating dark bands in Figure 12 layers correspond to the silicon-rich layers in Figures 16 and 17. Figures 15 and 16 are not of the corroded bottom layer of the nosing but from a separate small sheet-like friable piece of the corrosion products that was received in a plastic bag.

Figure 16: An enlarged view of the right BSE image in Figure 15 showing parallel microcracks and alternating bands of silicon-rich (arrows) and silicon-poor layers in a sheet-like corrosion product of aluminum nosing.
