CORROSION OF ALUMINUM METAL IN CONCRETE – A CASE STUDY

Abstract

Background

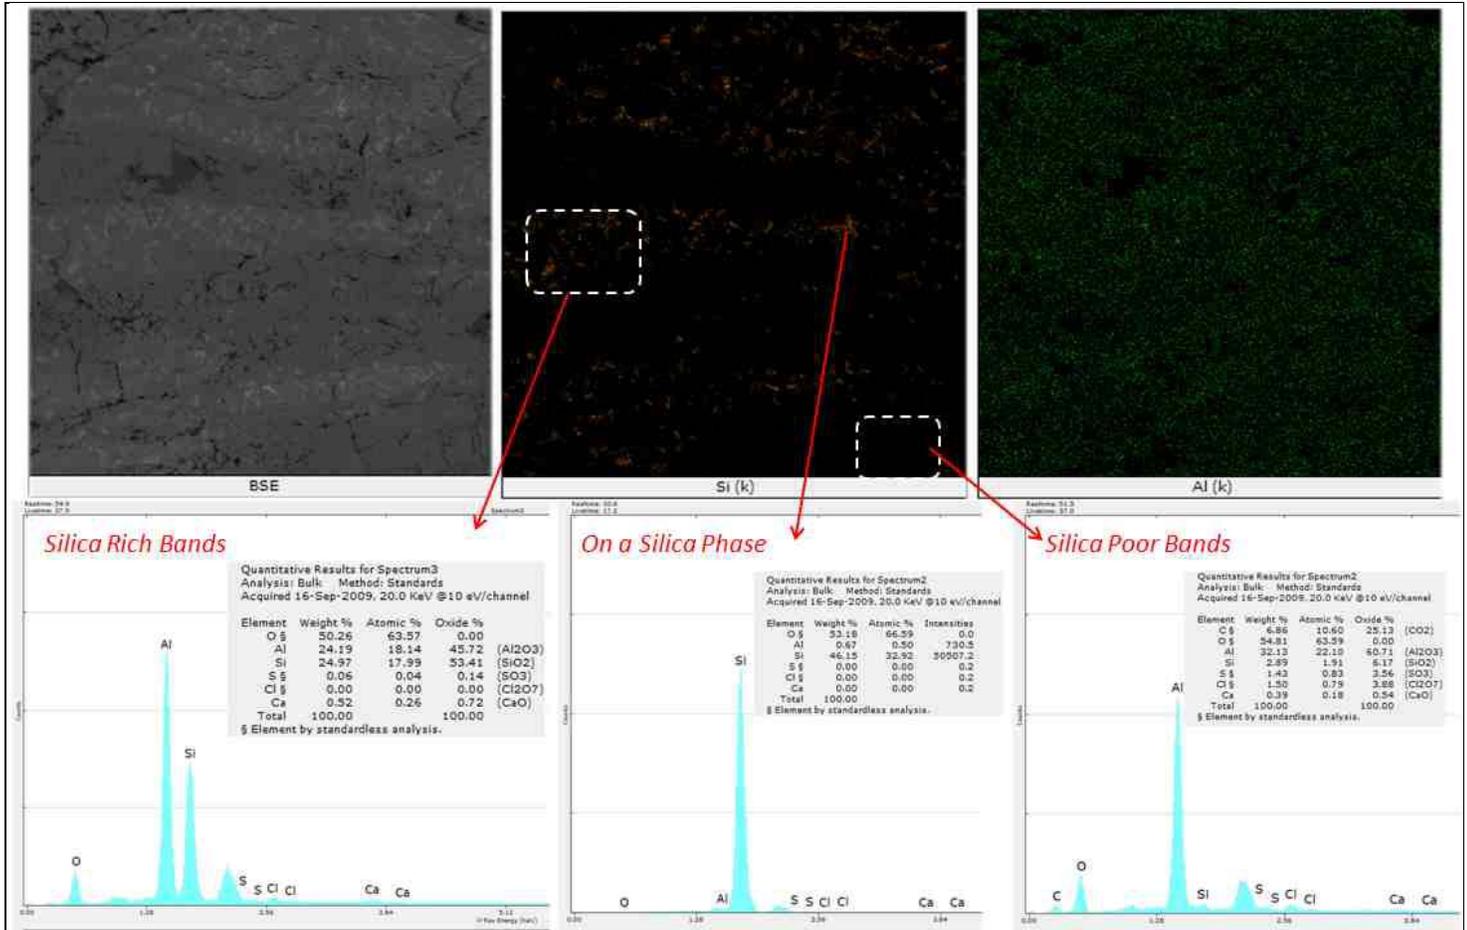
Figure 17 shows detailed compositional analyses and x-ray elemental mapping of silicon-rich layers and silicon-poor hydrated aluminum layers in the corrosion product of nosing in SKA 3-2, where the left photo shows the BSE image, and middle and right photos show corresponding elemental mapping of distribution of silicon and aluminum, respectively:

Figure 17: BSE image and corresponding silicon and aluminum distribution maps showing the banded nature of silicon-rich and silicon-poor layers.

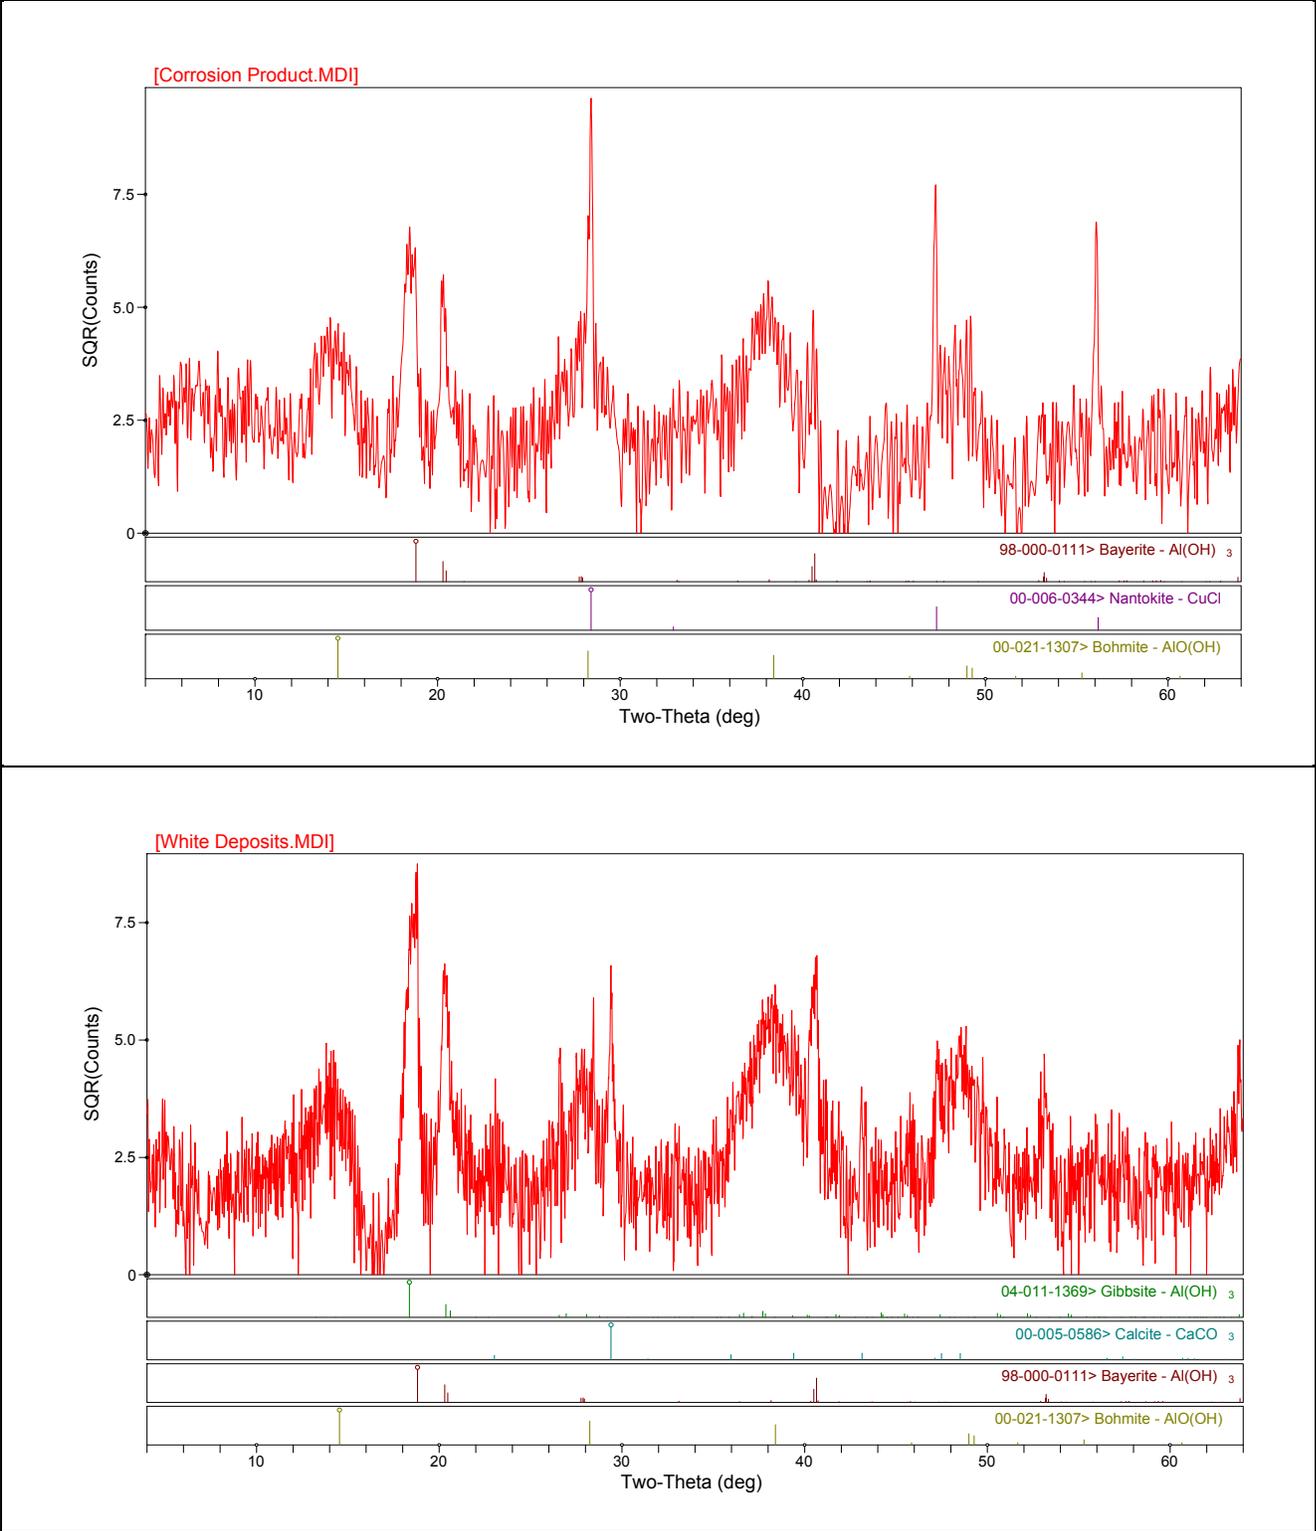
Despite the overall optically amorphous nature of white corrosion products of aluminum nosing, x-ray diffraction studies of the corrosion products detected a few low-intensity peaks of crystalline phases of aluminum hydroxide [Bayerite and Gibbsite $\text{Al}(\text{OH})_3$, and Boehmite $\text{AlO}(\text{OH})$], along with minor to trace amounts of calcite [CaCO_3] and Nantokite [CuCl] (Figure 18). Detection of bayerite in concrete from aluminum corrosion is not uncommon [4], where bayerite forms as metastable phase between amorphous hydrated aluminum and monoclinic gibbsite. Occurrences of aluminum hydroxide phases, i.e. bayerite, gibbsite, and boehmite were previously described in other studies [4], where aluminum hydroxide initially form as bayerite, which is metastable and is reportedly an intermediate stage between amorphous hydrated aluminum and monoclinic gibbsite. Both bayerite and gibbsite form of aluminum hydroxide are found (where gibbsite is previously reported in Ref. 4 to form at advanced stage at the expense of bayerite), as well as a metastable phase boehmite, which, reportedly, forms at an initial stage from soluble hydroxyl aluminate ions [$\text{Al}(\text{OH})_4^-$] prior to the formation of bayerite and gibbsite [4]. Detection of a minor Nantokite (CuCl) phase in the pattern is not surprising from the detection of Al-Cu alloy phases in the corroded base of nosing (Figure 7) and the presence of chloride in the concrete.

Figure 18: X-ray diffraction patterns of white corrosion products collected from two samples showing the presence of aluminum hydroxide (bayerite, gibbsite, and boehmite) crystals in an overall gelatinous mass.

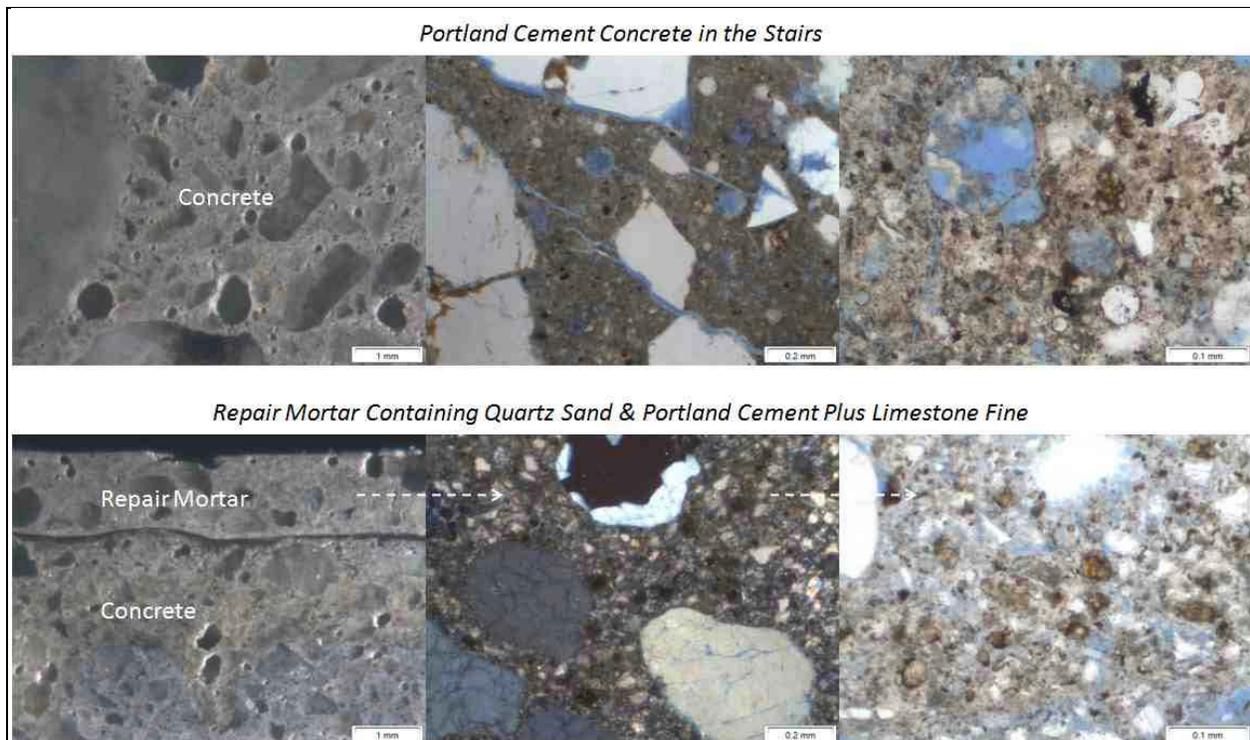
Repair materials (Figure 19, bottom row) used as patches in an attempt to hold debonded nosings to the concrete in previous repair attempts are determined to be dense, hardened neat paste or mortar of portland cement plus limestone fine based cementitious materials, with or without fine quartz sand (1 mm nominal size), which are judged ineffective in preventing nosing corrosion and de-bonding that have occurred from inside, i.e. from underlying steel anchor/nut/bolt in the presence of chlorides and moisture in the concrete.

Neither the repair materials or the portland cement concrete substrate is judged to have any direct influence on the deterioration of the nosings from concrete materials-related distress because similar concrete was used at all stair locations and only a portion of the stair nosings were in an advanced state of distress. These areas reportedly coincided with areas that receive more foot traffic and therefore could be exposed to more transient salts.

Figure 19: Photomicrographs of lapped cross section (left), and thin section (middle and right) of concrete (top photos) and repair mortar (bottom photos) showing air-entrained concrete containing sand and crushed stone aggregates, and portland cement and fly ash particles in paste, and fine quartz sand, portland cement, and limestone fine particles in a dense repair mortar coat applied on concrete.

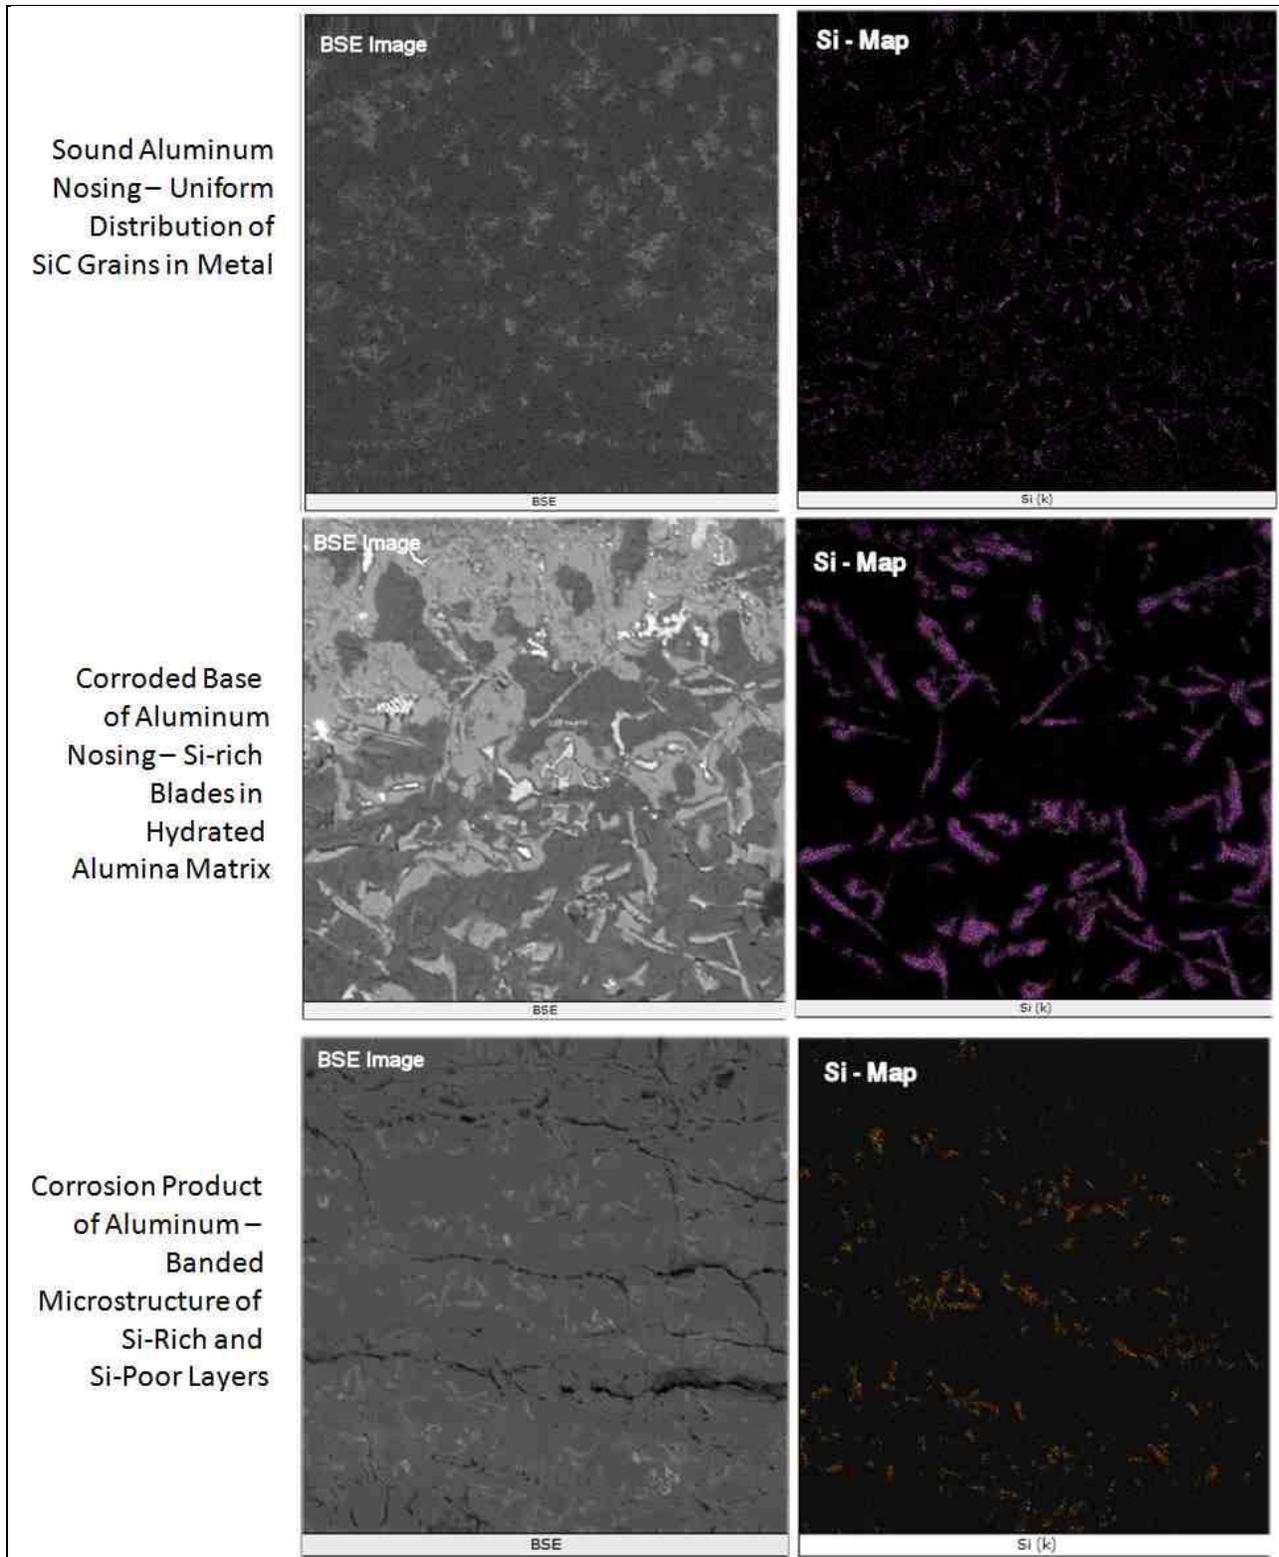
from the sound metal to sheet-like corroded metal corrosion product can be shown by the BSE image and corresponding Al-Si distribution maps in Figure 20, and in the schematic diagram in Figure 21 illustrating possible process of formation of sheet-like corrosion products through metal dissolution in solution (the *through solution* process of aluminum corrosion).

Figure 20: Progressive change in microstructure of aluminum-silicon distribution from uniform distribution of Al and Si in the sound metal nosing (top) to blade-shaped silicon-rich phases at its corroded base (middle) to sheet-like corrosion product showing banded microstructure with layered arrangement of silicon-rich (dashed lines) and silicon-poor phases (bottom).
