CONSTRUCTION MATERIALS CONSULTANTS, INC.

Laboratory Investigation Of A Precast Roof Assessment
At The Biofilter Structure
In Arauco Wood Manufacturing Plant
In Moncure, North Carolina

Biofilter Roof Assessment At Arauco Wood Manufacturing Plant
Moncure, North Carolina

April 28, 2021
CMC 0321111

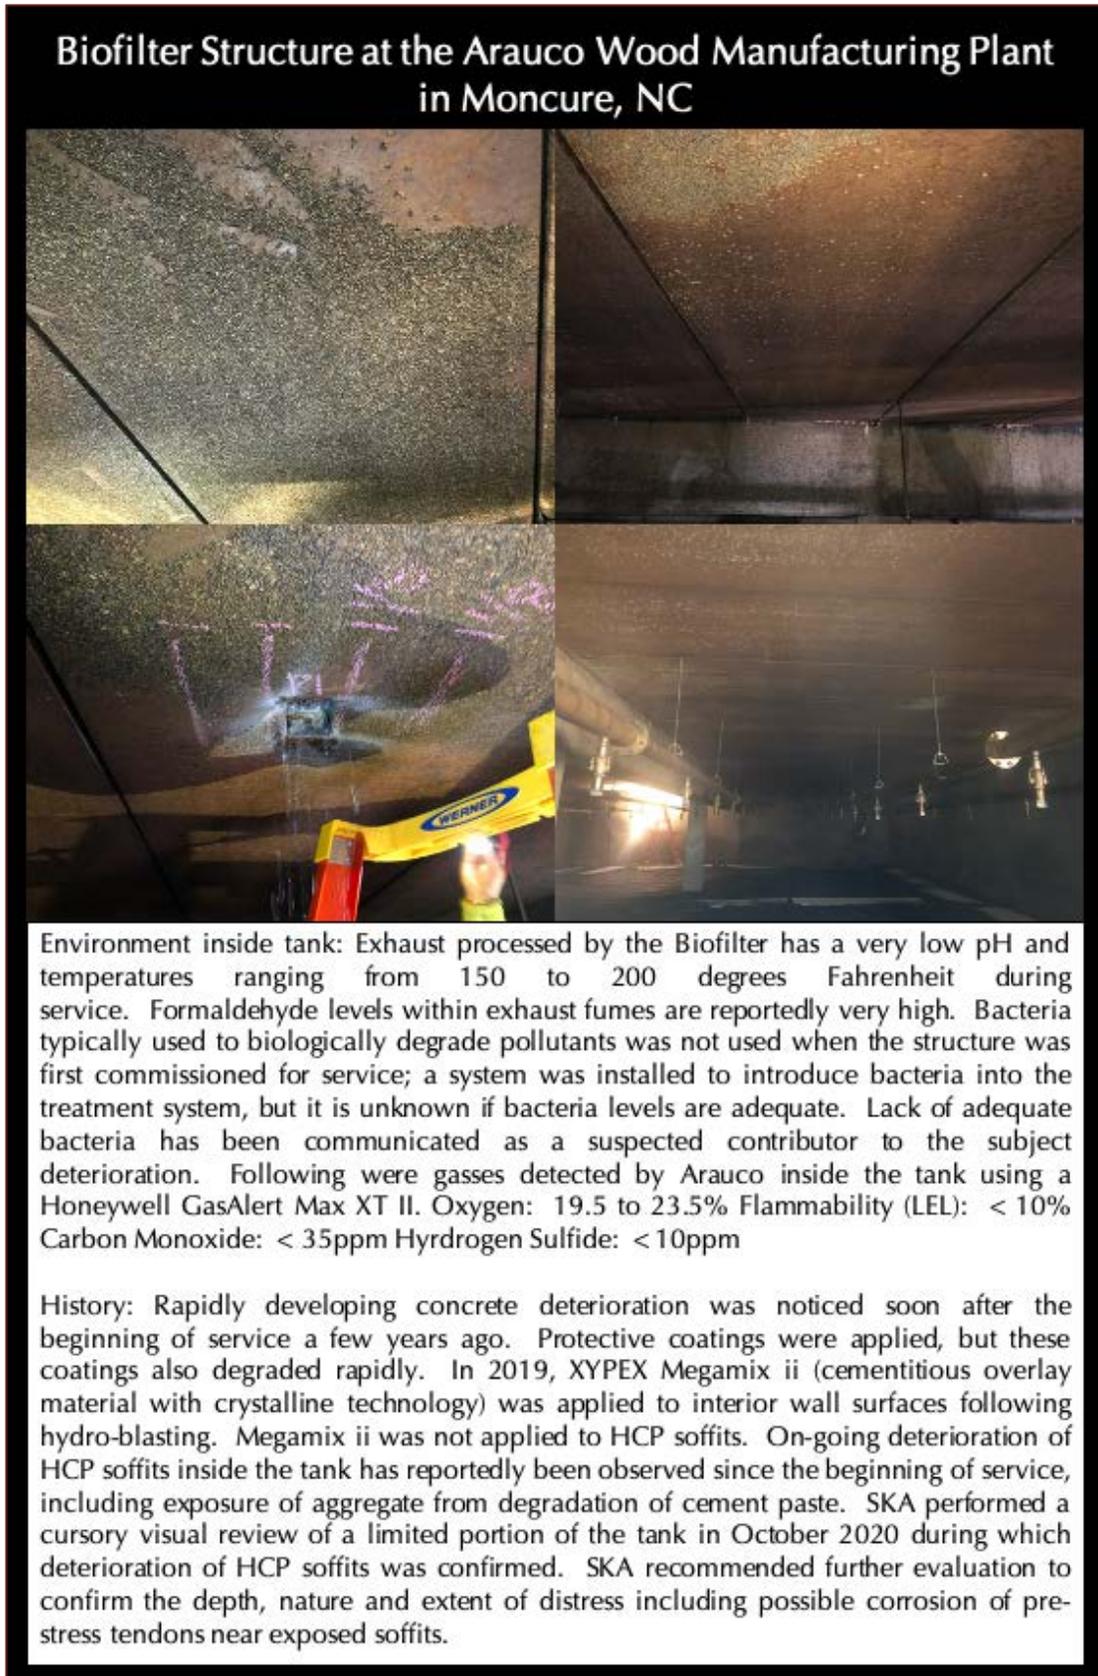
Figure 2: Field photos of the condition of inside of tank showing concrete deterioration of interior wall surfaces, despite reported application of protective coatings.

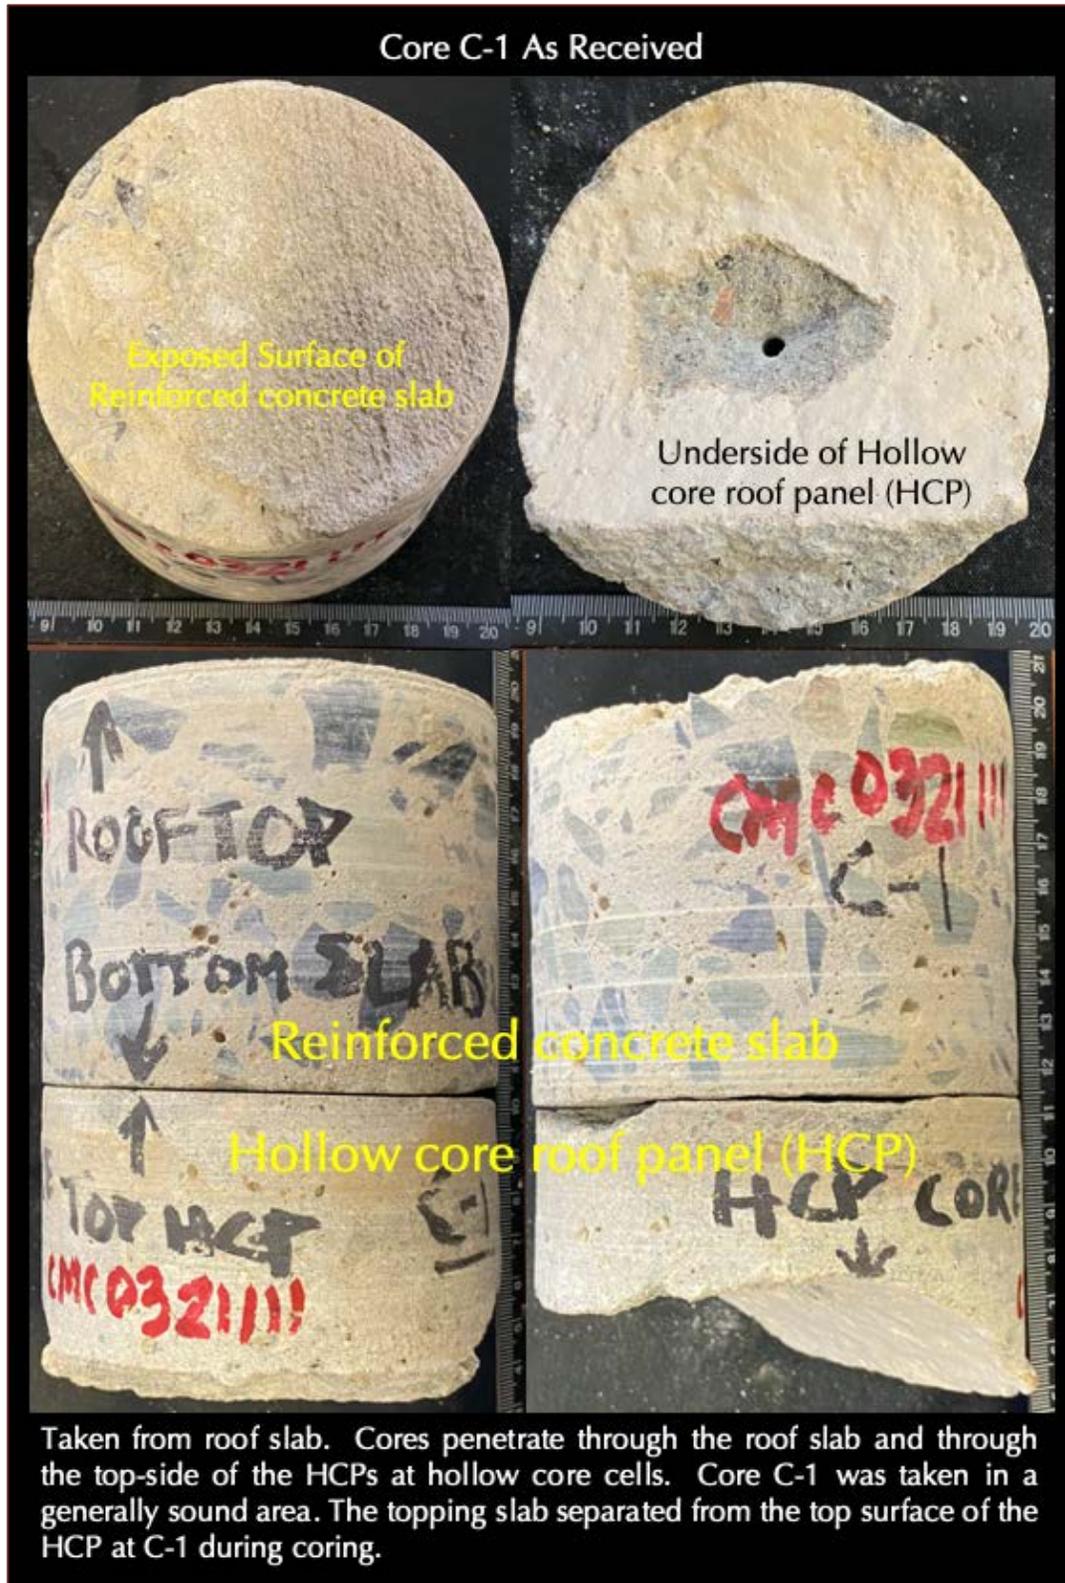
Figure 6: Core C-1 as received showing top exposed sound, fine broom-finished surface of reinforced concrete slab (RCS) at the top left with some edge scaling of concrete, concave underside of hollow core panel (HCP) at the bottom half of core in top right photo, and de-bonded interface of two components, the RCS at the top and HCP at the bottom, with typical concave surface of interior of HCP. Core was reportedly taken from a sound area.

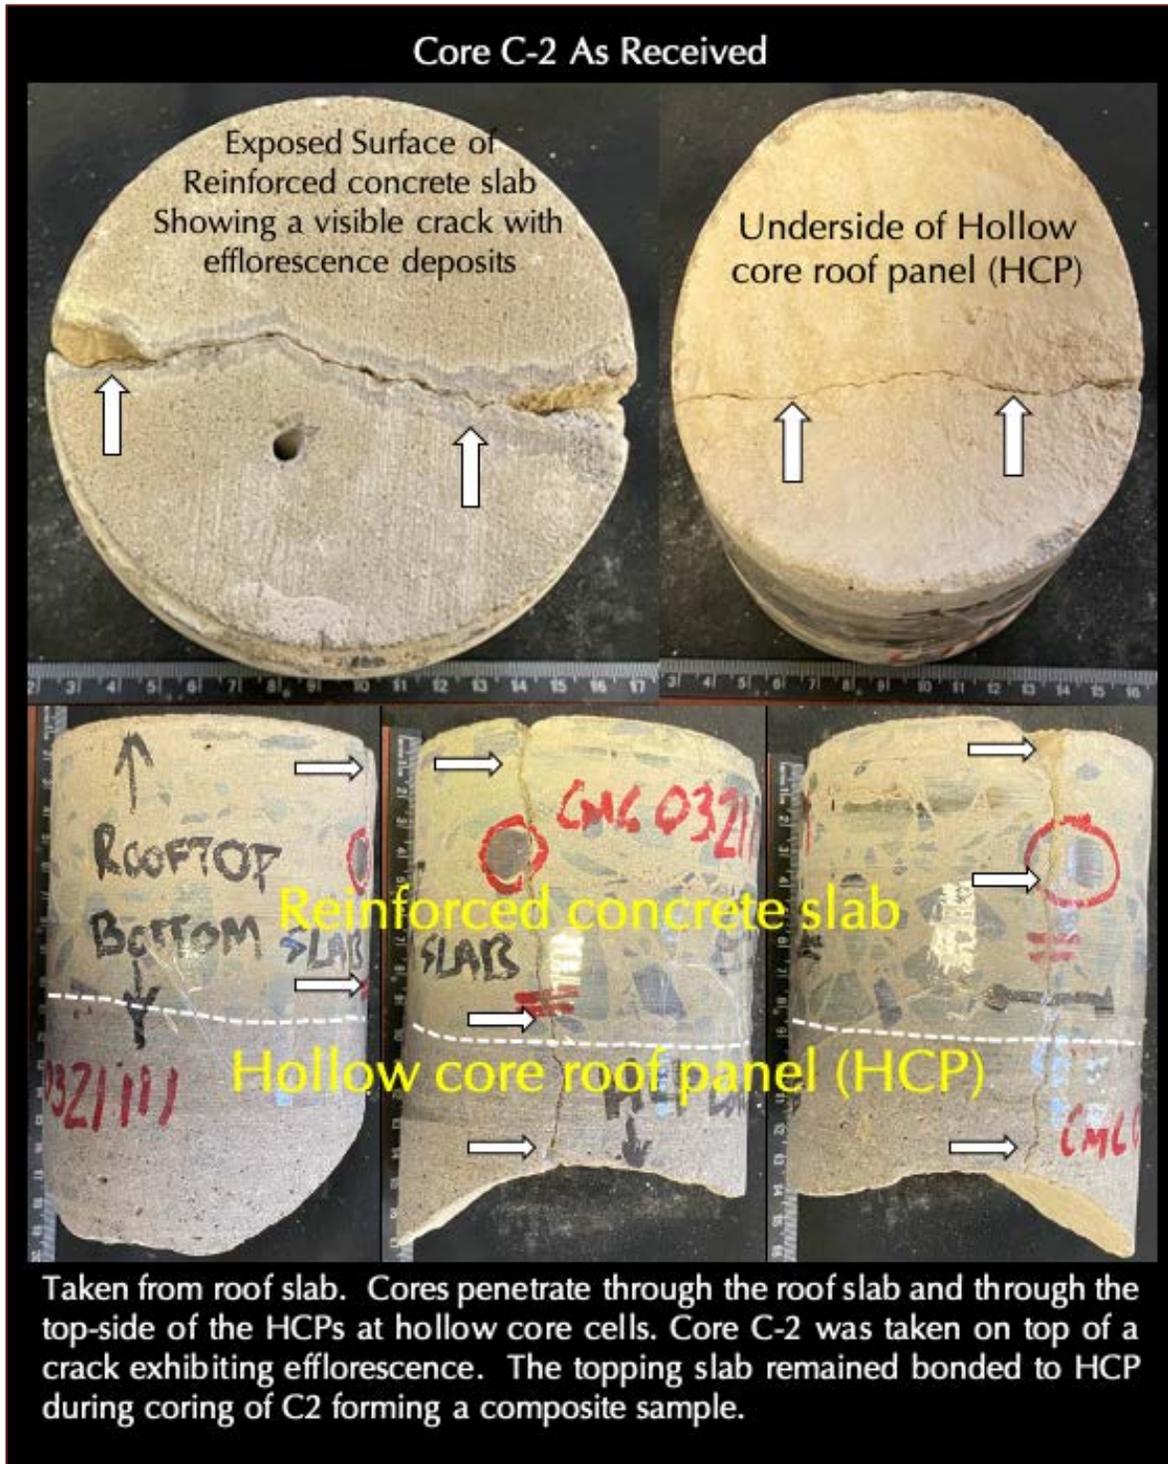
Major vertical crack extended through the entire thickness of RCS and HCP is seen in Core C-2 where the RCS component is well-bonded to HCP. By contrast, no cracking is found in RCS or HCP components in Core C-1 where the two components are completely de-bonded. Petrographic examinations of RCS or HCP found no evidence for any physical or chemical deterioration of concretes in these components to cause cracking. The vertical through-depth crack in Core C-2 is judged to be due to reasons not related to any deterioration in RCS and/or in HCP component. Perhaps, reasons such as the lack of control joints or expansion joints in the RCS have caused unaccommodative drying shrinkage cracking in RCS, which has extended not only through the RCS, but also through the HCP component, especially where the two components are well-bonded as in the case of Core C-2.

Figure 7: Core C-2 as received showing top exposed cracked, fine broom-finished surface of reinforced concrete slab (RCS) at the top left with a long continuous surface crack and discoloration of surface along the crack, concave underside of hollow core panel (HCP) at the bottom half of core in top right photo, and bonded interface of two components, the RCS at the top and HCP at the bottom with typical concave surface of interior of HCP where the surface crack has vertically transected through both components throughout the depth of the core. Core was reportedly taken from the top of a surface crack exhibiting efflorescence.

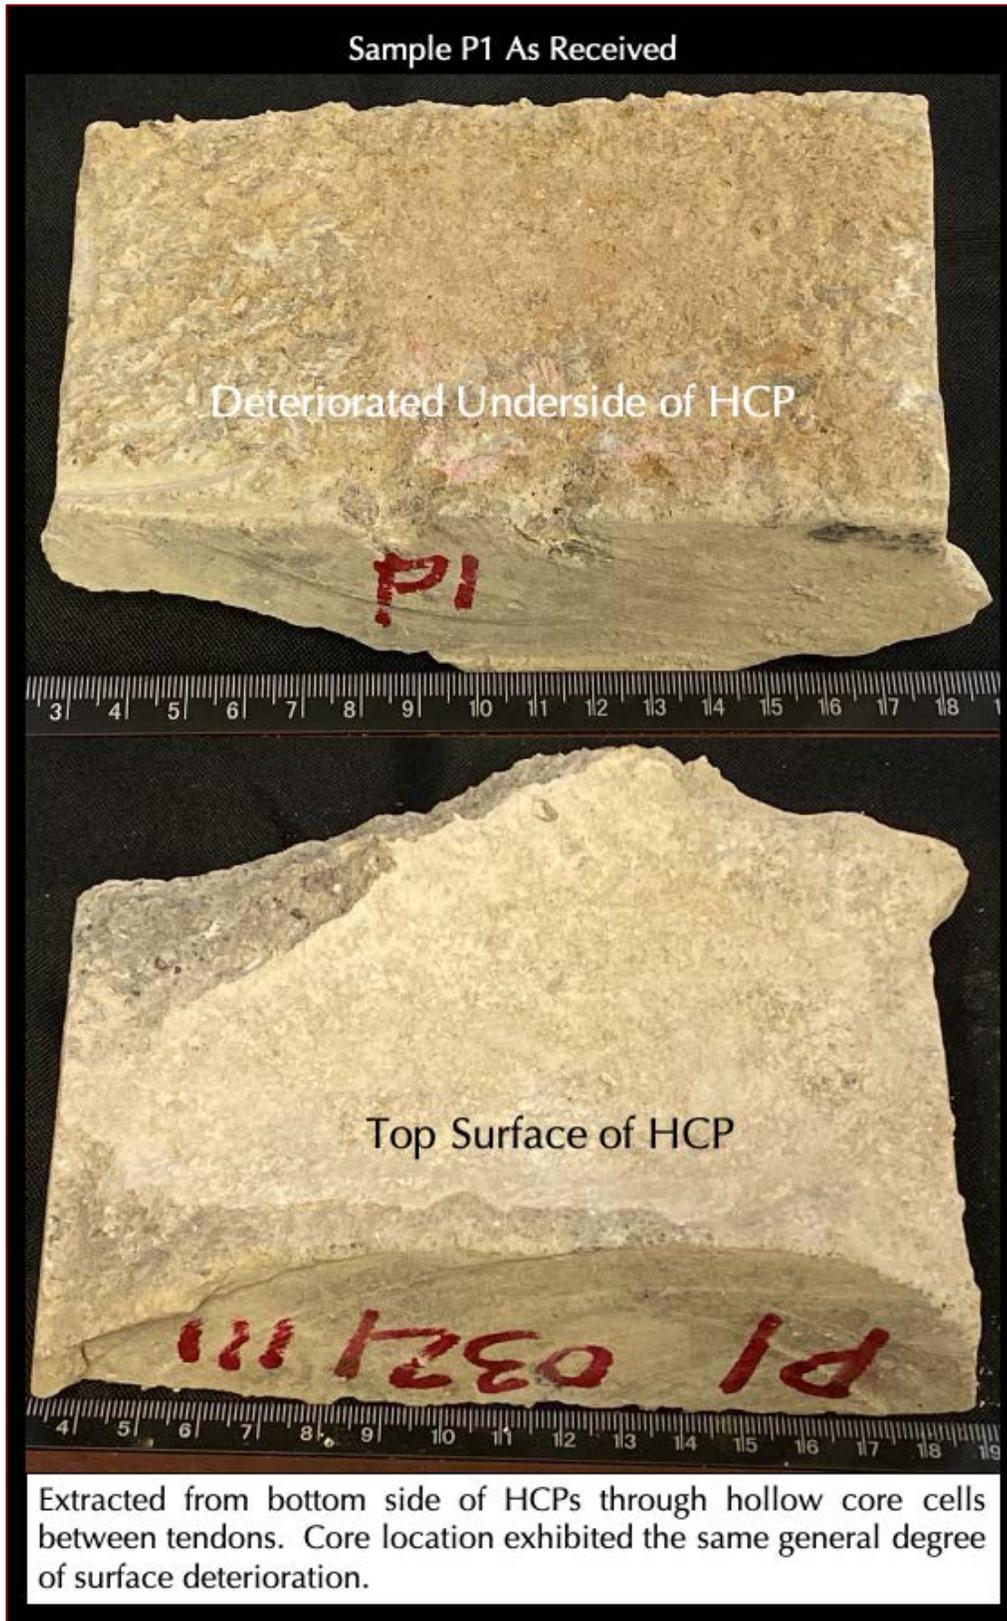
The undersides of HCP in P-1, P-2, and P-3 showed weathered brown altered, carbonated and leached paste exposing the aggregate particles relative to paste due to interactions with exhaust materials, which has affected the 5 to 10 mm zone of the underside. Coarsely crystalline secondary calcite precipitates are found at the underside surfaces of HCP, which are precipitated on leached and carbonated and porous pastes extended to depths of 2 to 3 mm beyond which paste is denser, but still shows carbonation for a few millimeters before sound non-carbonated interior paste. Beyond the altered zone, the majority of the interior portions of HCP are present in dense, well-consolidated, and sound conditions without any physical or chemical deterioration.

Figure 8: Portion of hollow core panel (HCP) received in Sample P-1 showing the overall brown, weathered, rough deteriorated underside of the HCP in the top photo and concave top surface of HCP in the bottom photo.

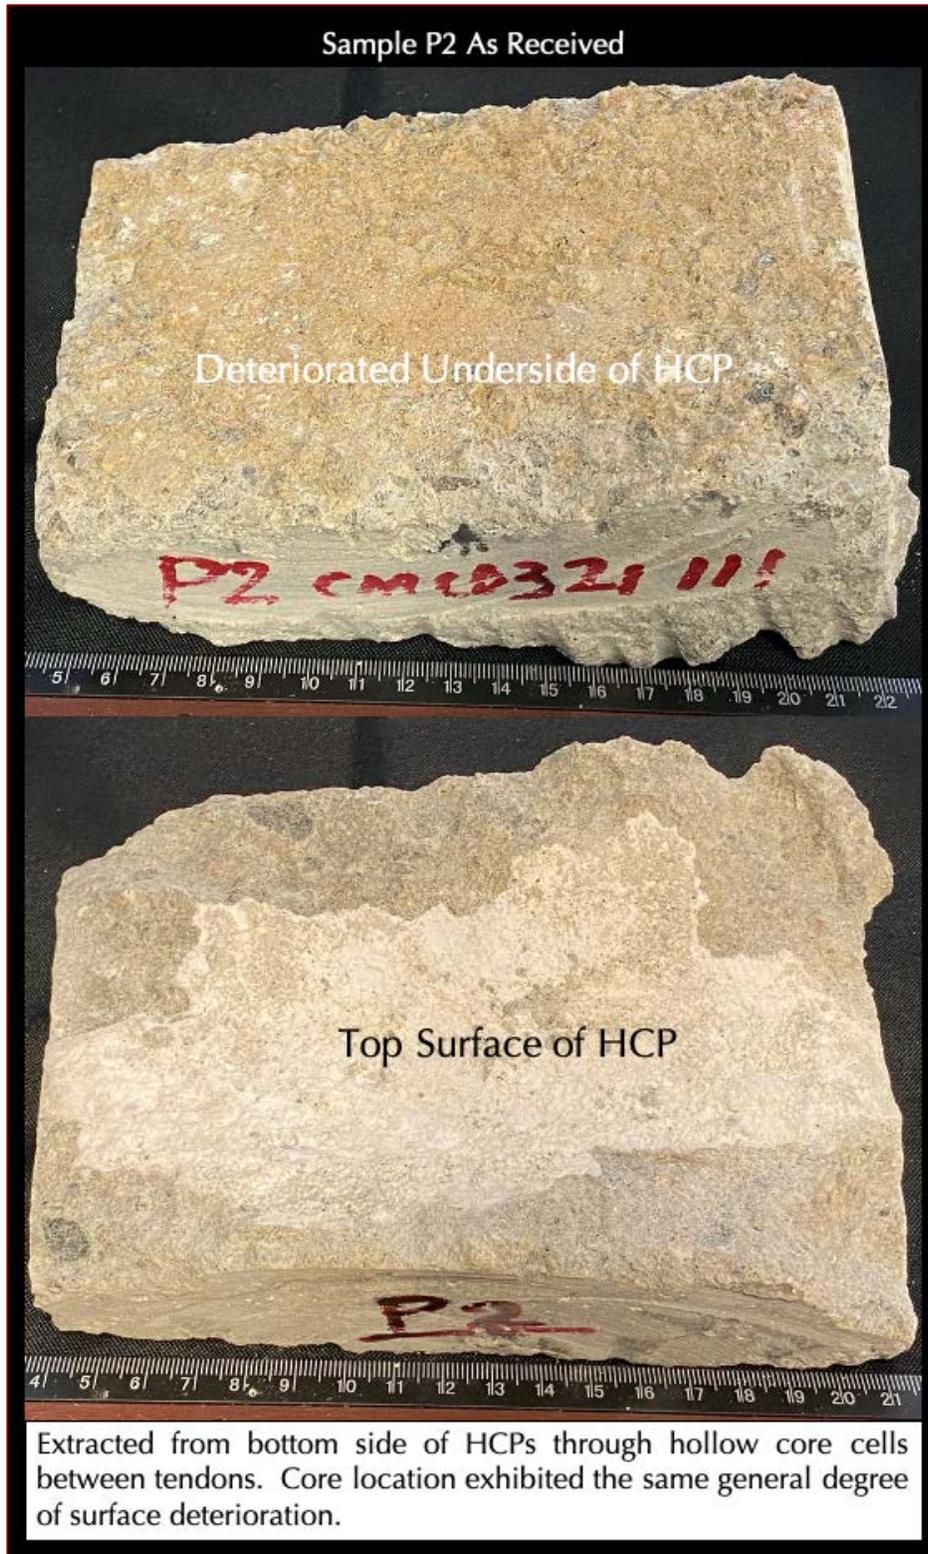
Figure 9: Portion of hollow core panel (HCP) received in Sample P-2 showing the overall brown, weathered, rough deteriorated underside of the HCP in the top photo and concave top surface of HCP in the bottom photo. All three samples of HCP in P-1, P-2, and P-3 show brown discoloration and rough altered weathered underside with exposures of aggregate particles against altered paste, which is a common microstructural feature that forms due to higher dissolution of interstitial paste compared to aggregates, typically found in concretes exposed to acidic solutions as in sewer environments.

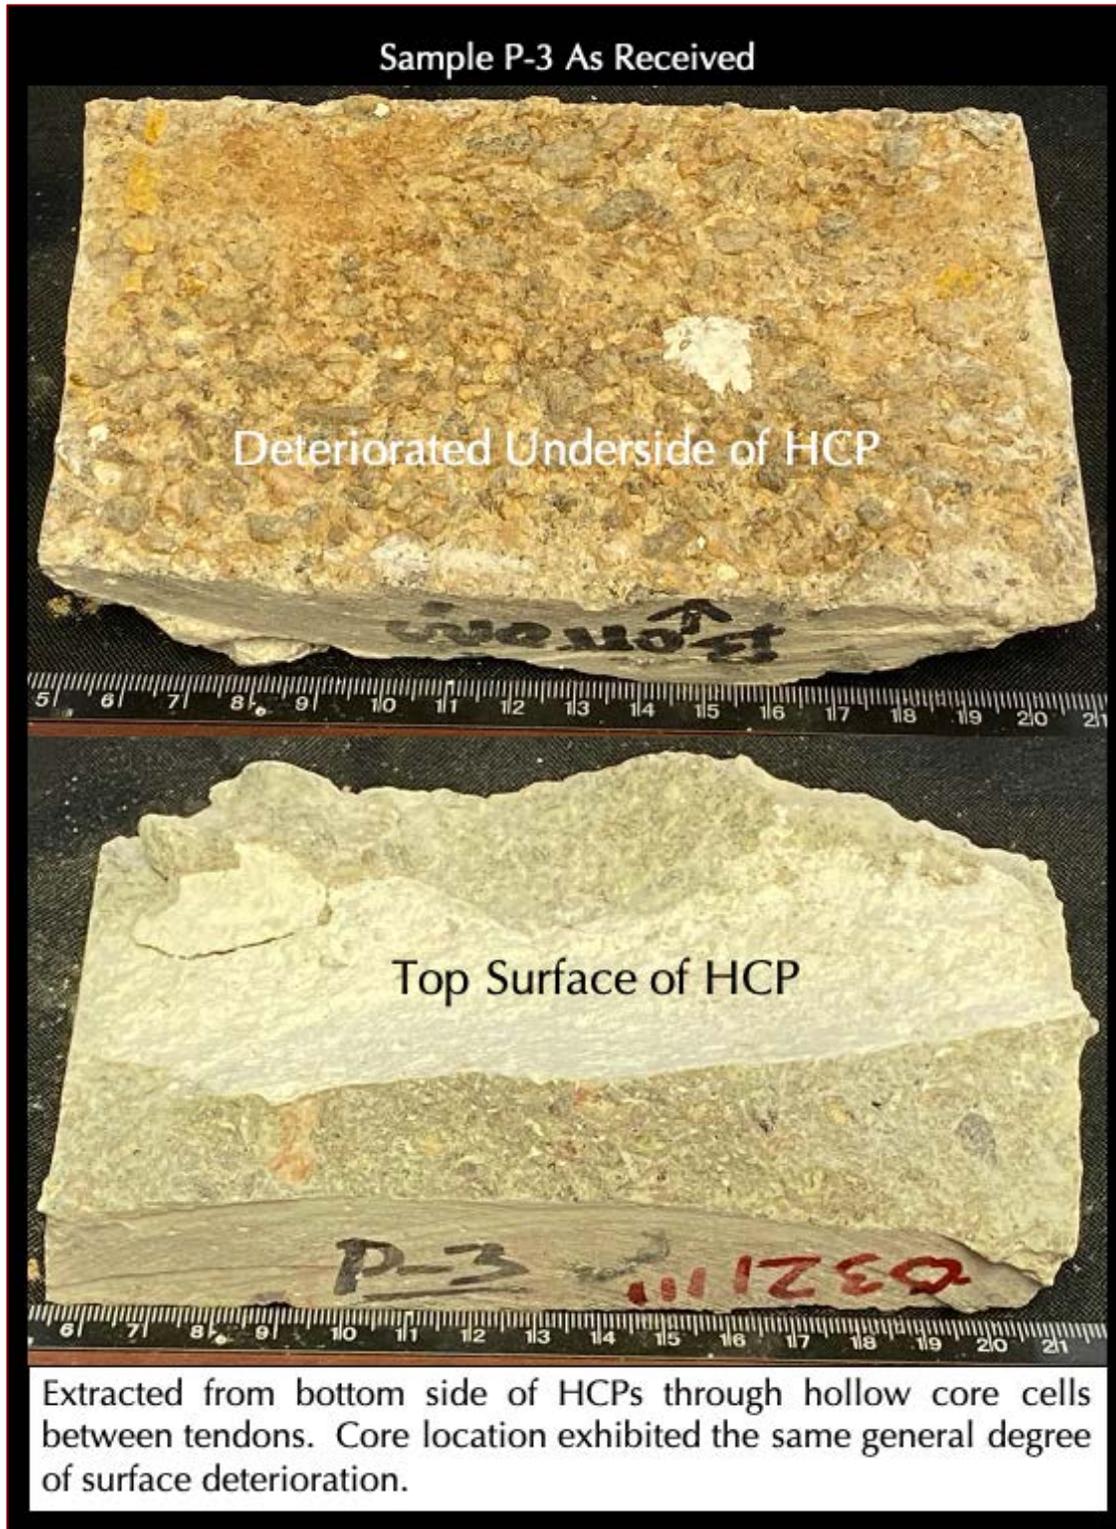
Figure 10: Portion of hollow core panel (HCP) received in Sample P-3 showing the overall brown, weathered, rough deteriorated underside of the HCP in the top photo and concave top surface of HCP in the bottom photo. All three samples of HCP in P-1, P-2, and P-3 show brown discoloration and rough altered weathered underside with exposures of aggregate particles against altered paste, which is a common microstructural feature forms due to higher dissolution of interstitial paste compared to aggregates, typically found in concretes exposed to acidic solutions as in sewer environments.

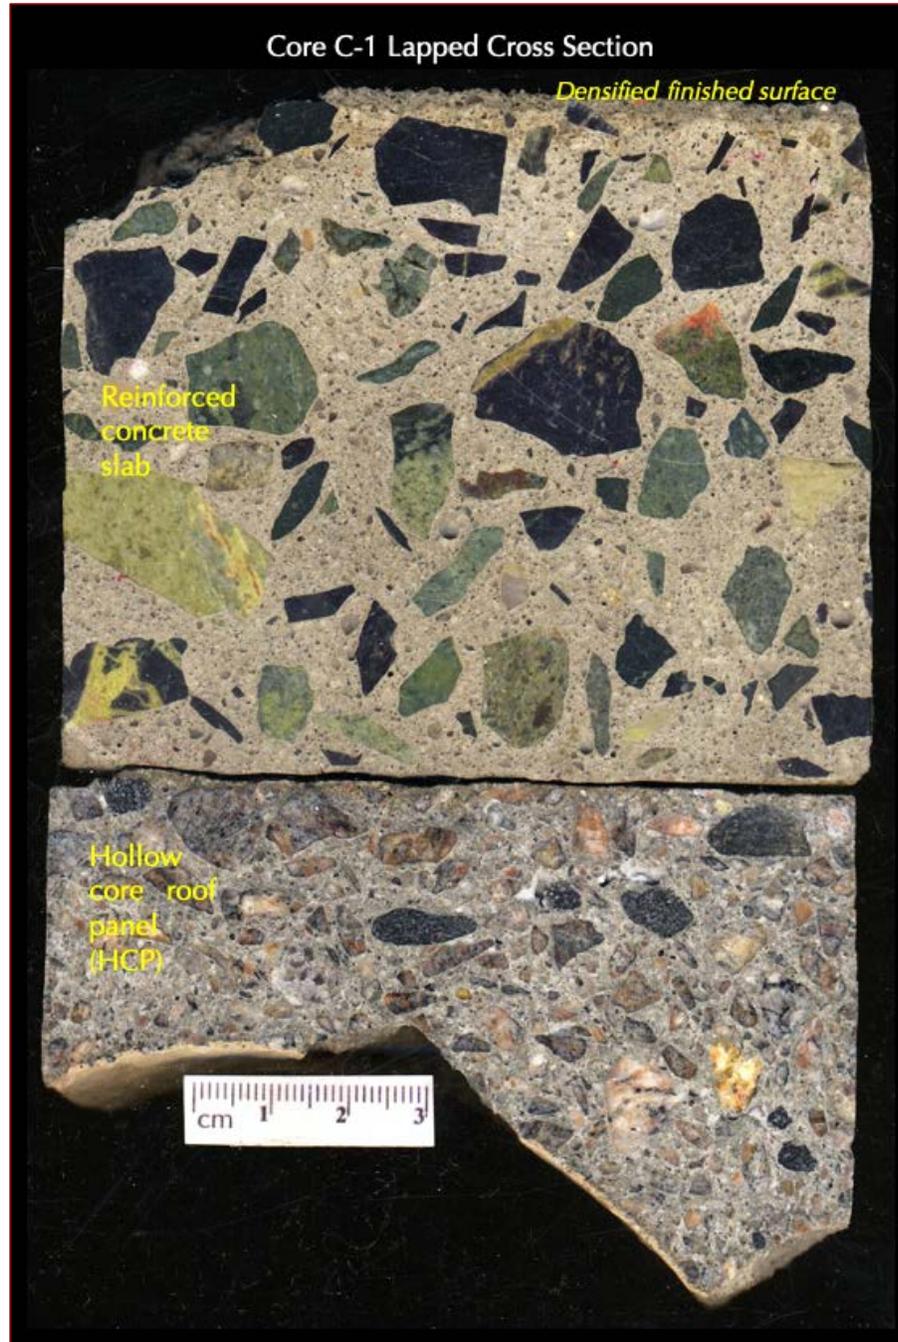
Figure 11: Lapped cross section of Core C-1 showing: (a) the reinforced concrete slab (RCS) at the top, completely de-bonded from the hollow core roof panel (HCP) at the bottom; (b) crushed volcanic stone coarse aggregate of 1 in. (25 mm) nominal size in RCS as opposed to crushed granite coarse aggregate of 1/2 in. (12.5 mm) nominal size in HCP; (c) medium beige color tone of paste in RCS as opposed to darker gray paste in HCP; (d) densified finished surface of RCS at the top 1/8 in.; (e) relatively better grading of crushed granite coarse aggregate in HCP as opposed to crushed volcanic rock coarse aggregate in RCS; (f) overall dense and well-consolidated natures of RCS and HCP concretes; and (g) relatively clear separation of RCS from HCP with no trace of one adhered to the other.

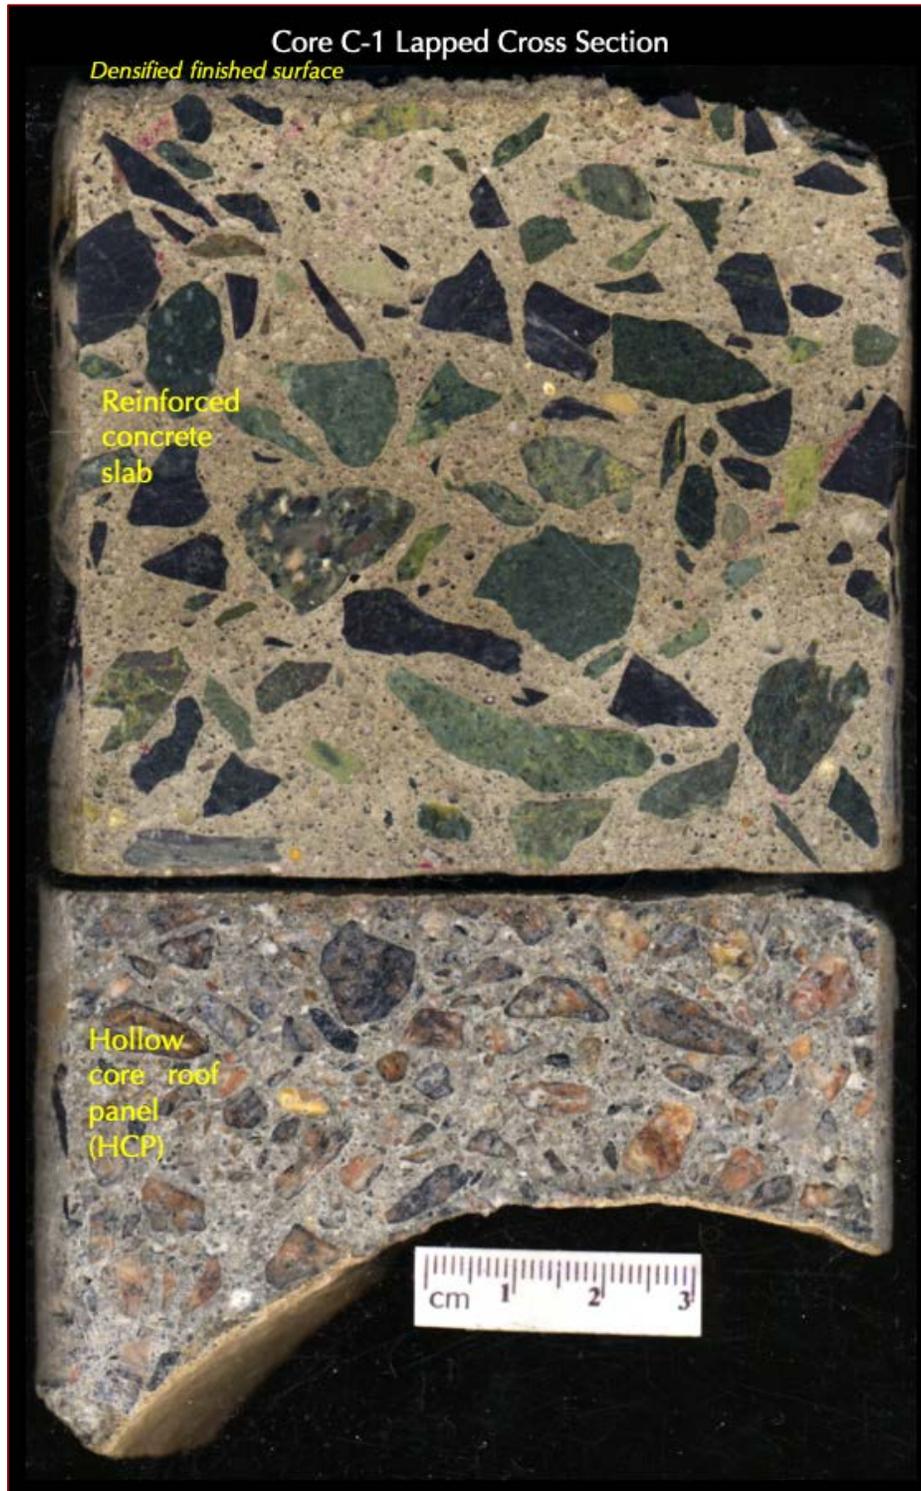
Figure 12: A second lapped cross section of Core C-1 showing: (a) the reinforced concrete slab (RCS) at the top, completely de-bonded from the hollow core roof panel (HCP) at the bottom; (b) crushed volcanic stone coarse aggregate of 1 in. (25 mm) nominal size in RCS as opposed to crushed granite coarse aggregate of 1/2 in. (12.5 mm) nominal size in HCP; (c) medium beige color tone of paste in RCS as opposed to darker gray paste in HCP; (d) densified finished surface of RCS at the top 1/8 in.; (e) relatively better grading of crushed granite coarse aggregate in HCP as opposed to crushed volcanic rock coarse aggregate in RCS; (f) overall dense and well-consolidated natures of RCS and HCP concretes; and (g) relatively clear separation of RCS from HCP with no trace of one adhered to the other.

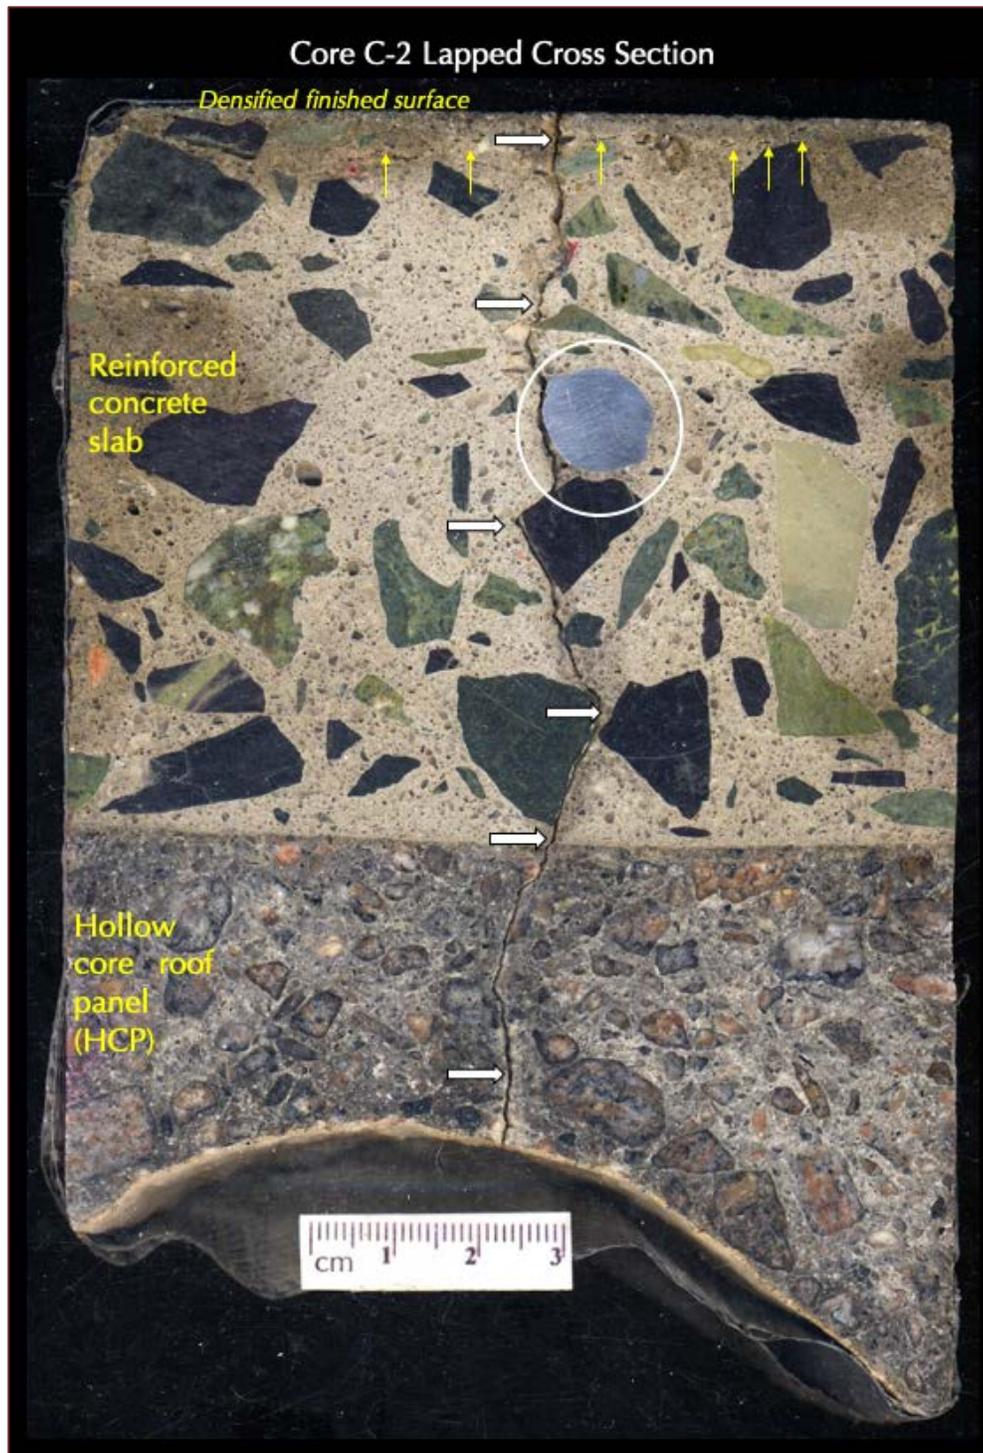
Figure 14: Lapped cross section of Core C-2 showing: (a) the reinforced concrete slab (RCS) at the top, well-bonded to the hollow core roof panel (HCP) at the bottom; (b) crushed volcanic stone coarse aggregate of 1 in. (25 mm) nominal size in RCS as opposed to crushed granite coarse aggregate of 1/2 in. (12.5 mm) nominal size in HCP; (c) medium beige color tone of paste in RCS as opposed to darker gray paste in HCP; (d) densified finished surface of RCS at the top 1/8 in., which has developed short, elongated gaps or separations as incipient delaminations (marked with fine vertical arrows) from the main body; (e) relatively better grading of crushed granite coarse aggregate in HCP as opposed to crushed volcanic rock coarse aggregate in RCS; (f) overall dense and well-consolidated natures of RCS and HCP concretes; and (g) a long continuous vertical crack transected through both RCS and HCP components and circumscribed the reinforcing steel at the mid-depth location of RCS.

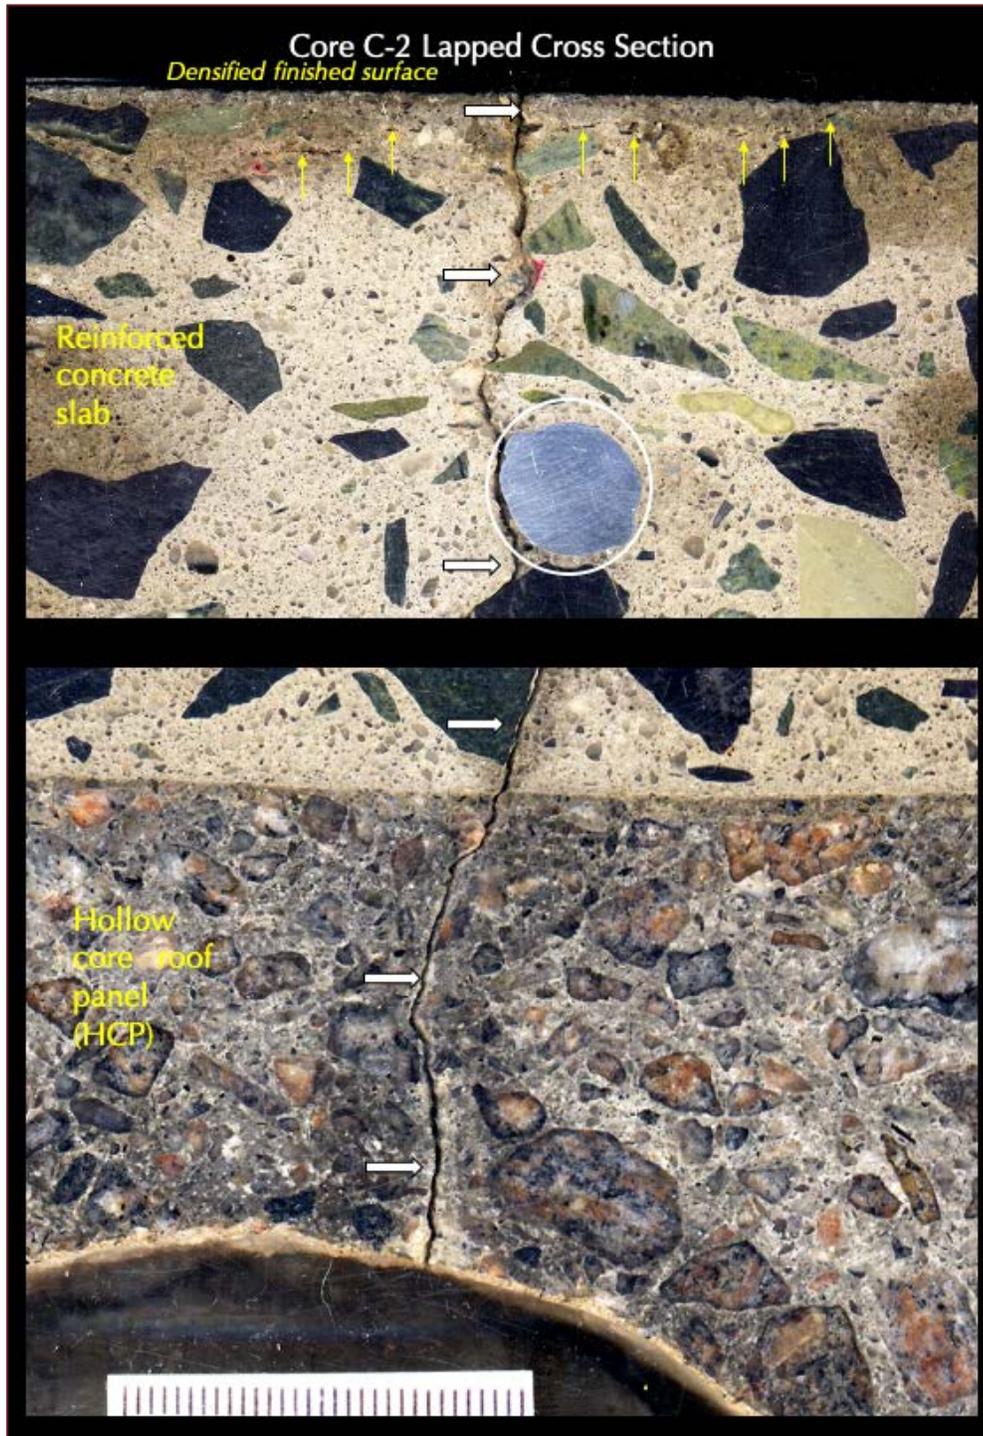
Figure 15: Lapped cross section of Core C-2 showing: (a) the reinforced concrete slab (RCS) at the top, well-bonded to the hollow core roof panel (HCP) at the bottom; (b) crushed volcanic stone coarse aggregate of 1 in. (25 mm) nominal size in RCS, as opposed to crushed granite coarse aggregate of $\frac{1}{2}$ in. (12.5 mm) nominal size in HCP; (c) medium beige color tone of paste in RCS as opposed to darker gray paste in HCP; (d) densified finished surface of RCS at the top $\frac{1}{8}$ in., which has developed short, elongated gaps or separations as incipient delaminations (marked with fine vertical arrows) from the main body; (e) relatively better grading of crushed granite coarse aggregate in HCP as opposed to crushed volcanic rock coarse aggregate in RCS; (f) overall dense and well-consolidated natures of RCS and HCP concretes; and (g) a long continuous vertical crack transected through both RCS and HCP components and circumscribed the reinforcing steel at the mid-depth location of RCS.

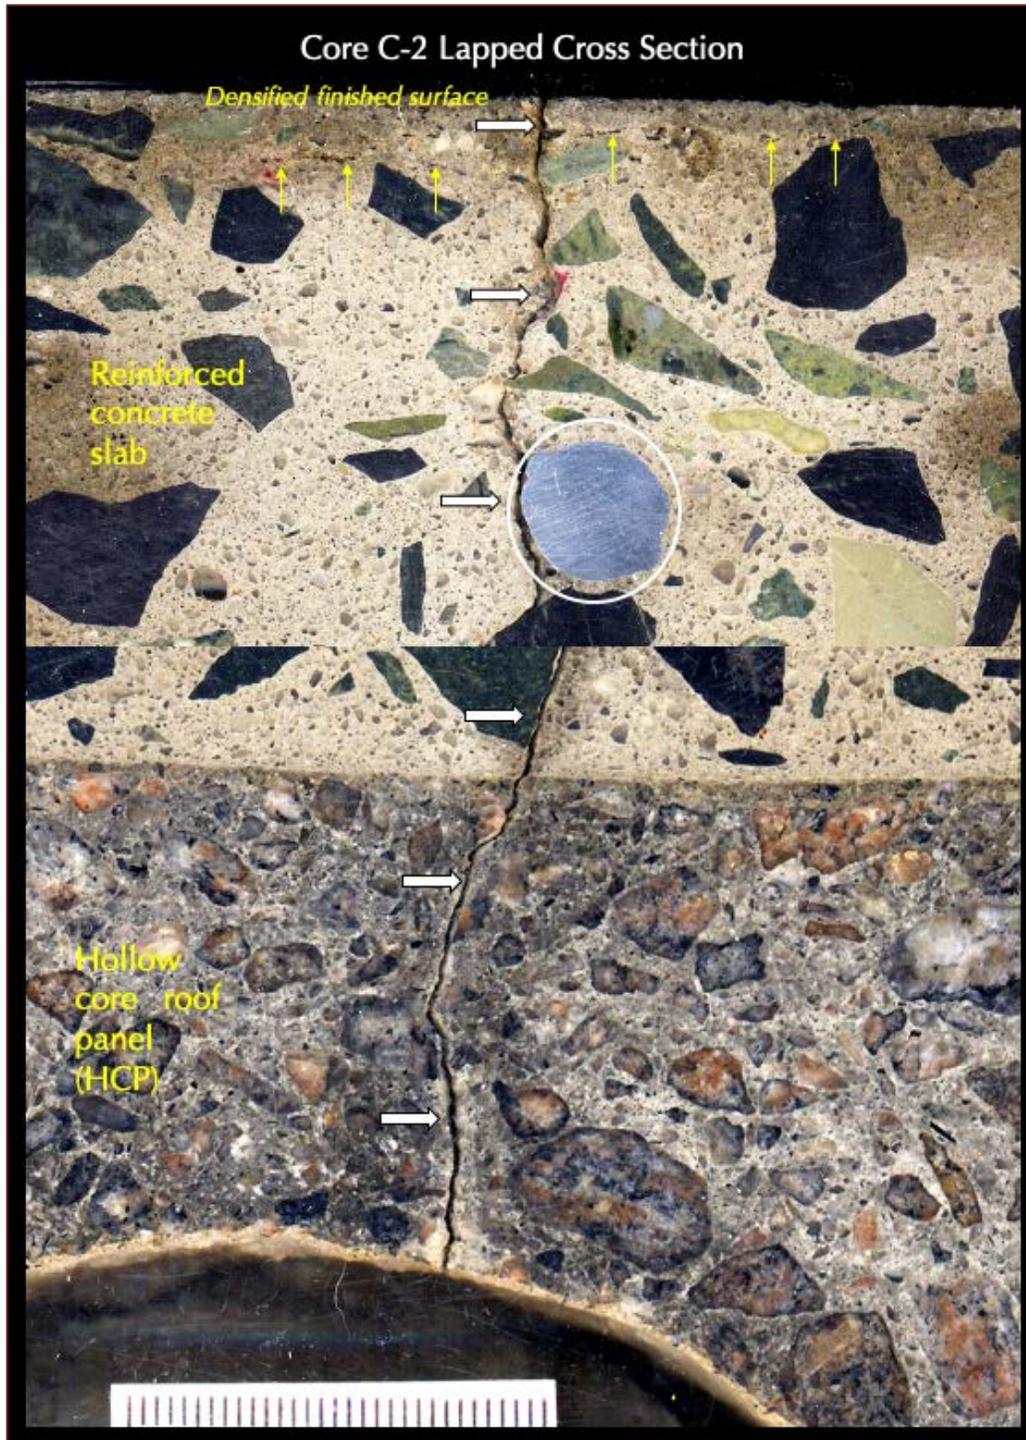
Figure 16: Lapped cross section of Core C-2 showing: (a) the reinforced concrete slab (RCS) at the top, well-bonded to the hollow core roof panel (HCP) at the bottom; (b) crushed volcanic stone coarse aggregate of 1 in. (25 mm) nominal size in RCS as opposed to crushed granite coarse aggregate of $\frac{1}{2}$ in. (12.5 mm) nominal size in HCP; (c) medium beige color tone of paste in RCS as opposed to darker gray paste in HCP; (d) densified finished surface of RCS at the top $\frac{1}{8}$ in., which developed short, elongated gaps or separations as incipient delaminations (marked with fine vertical arrows) from the main body; (e) relatively better grading of crushed granite coarse aggregate in HCP as opposed to crushed volcanic rock coarse aggregate in RCS; (f) overall dense and well-consolidated natures of RCS and HCP concretes; and (g) a long continuous vertical crack transected through both RCS and HCP components and circumscribed the reinforcing steel at the mid-depth location of RCS.

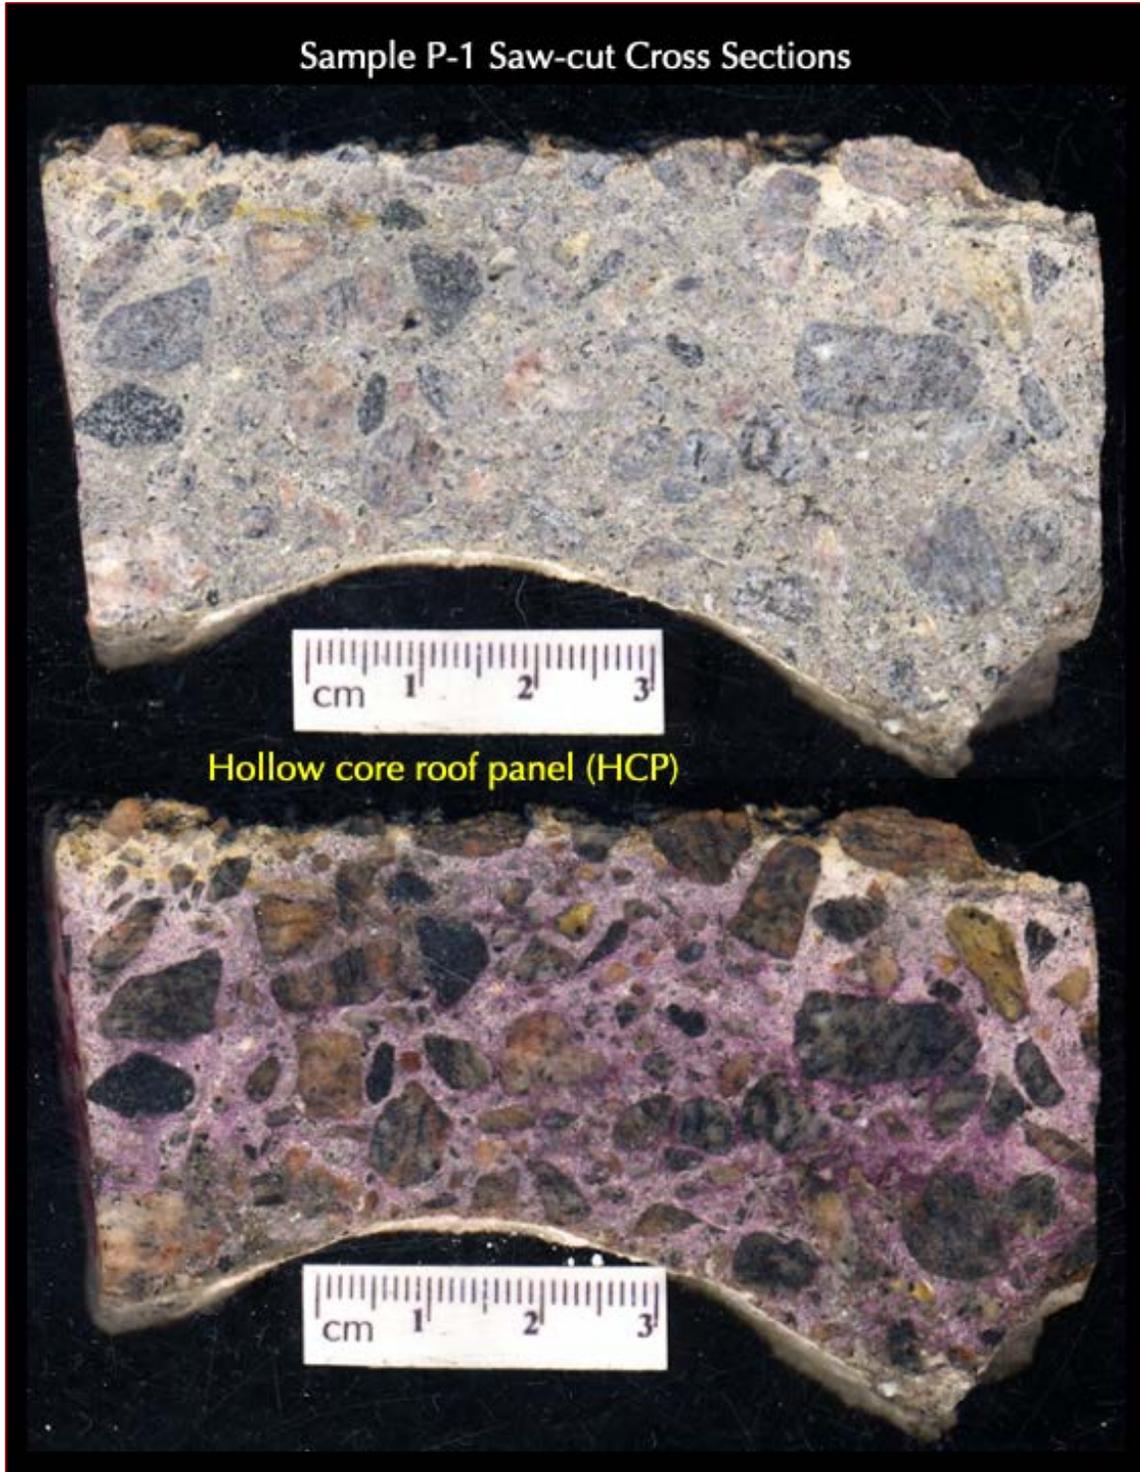
Figure 20: Saw-cut cross section of hollow core panel (HCP) in P-1 before (top) and after (bottom) treatment with phenolphthalein alcoholic solutions to highlight the carbonated paste at the top 5 to 10 mm of the altered weathered brown surface where aggregate particles are exposed relative to paste, and overall non-carbonated interior body due to pinkish discoloration of paste after the treatment.
