CONSTRUCTION MATERIALS CONSULTANTS, INC.

Laboratory Investigation Of A Precast Roof Assessment
At The Biofilter Structure
In Arauco Wood Manufacturing Plant
In Moncure, North Carolina

Biofilter Roof Assessment At Arauco Wood Manufacturing Plant
Moncure, North Carolina

April 28, 2021
CMC 0321111

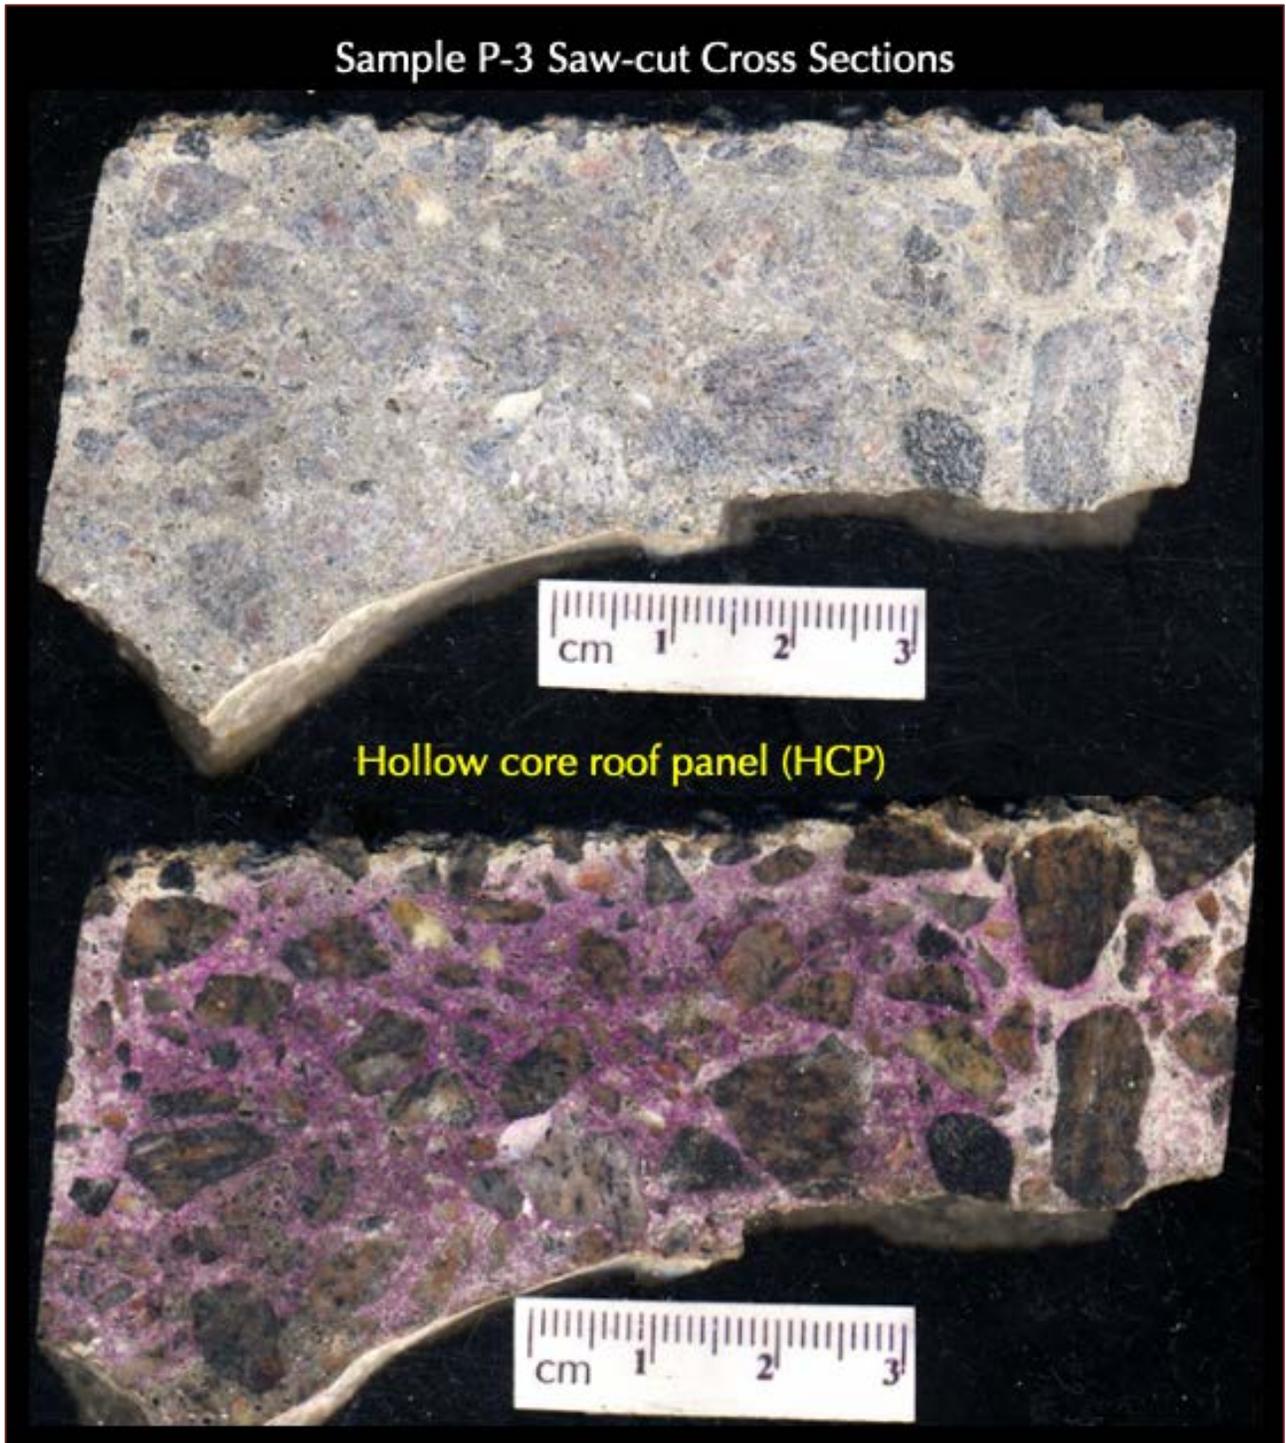
Figure 21: Saw-cut cross section of hollow core panel (HCP) in P-3 before (top) and after (bottom) treatment with phenolphthalein alcoholic solutions to highlight the carbonated paste at the top 5 to 10 mm of the altered weathered brown surface where aggregate particles are exposed to paste, and overall non-carbonated interior body due to pinkish discoloration of paste after the treatment.

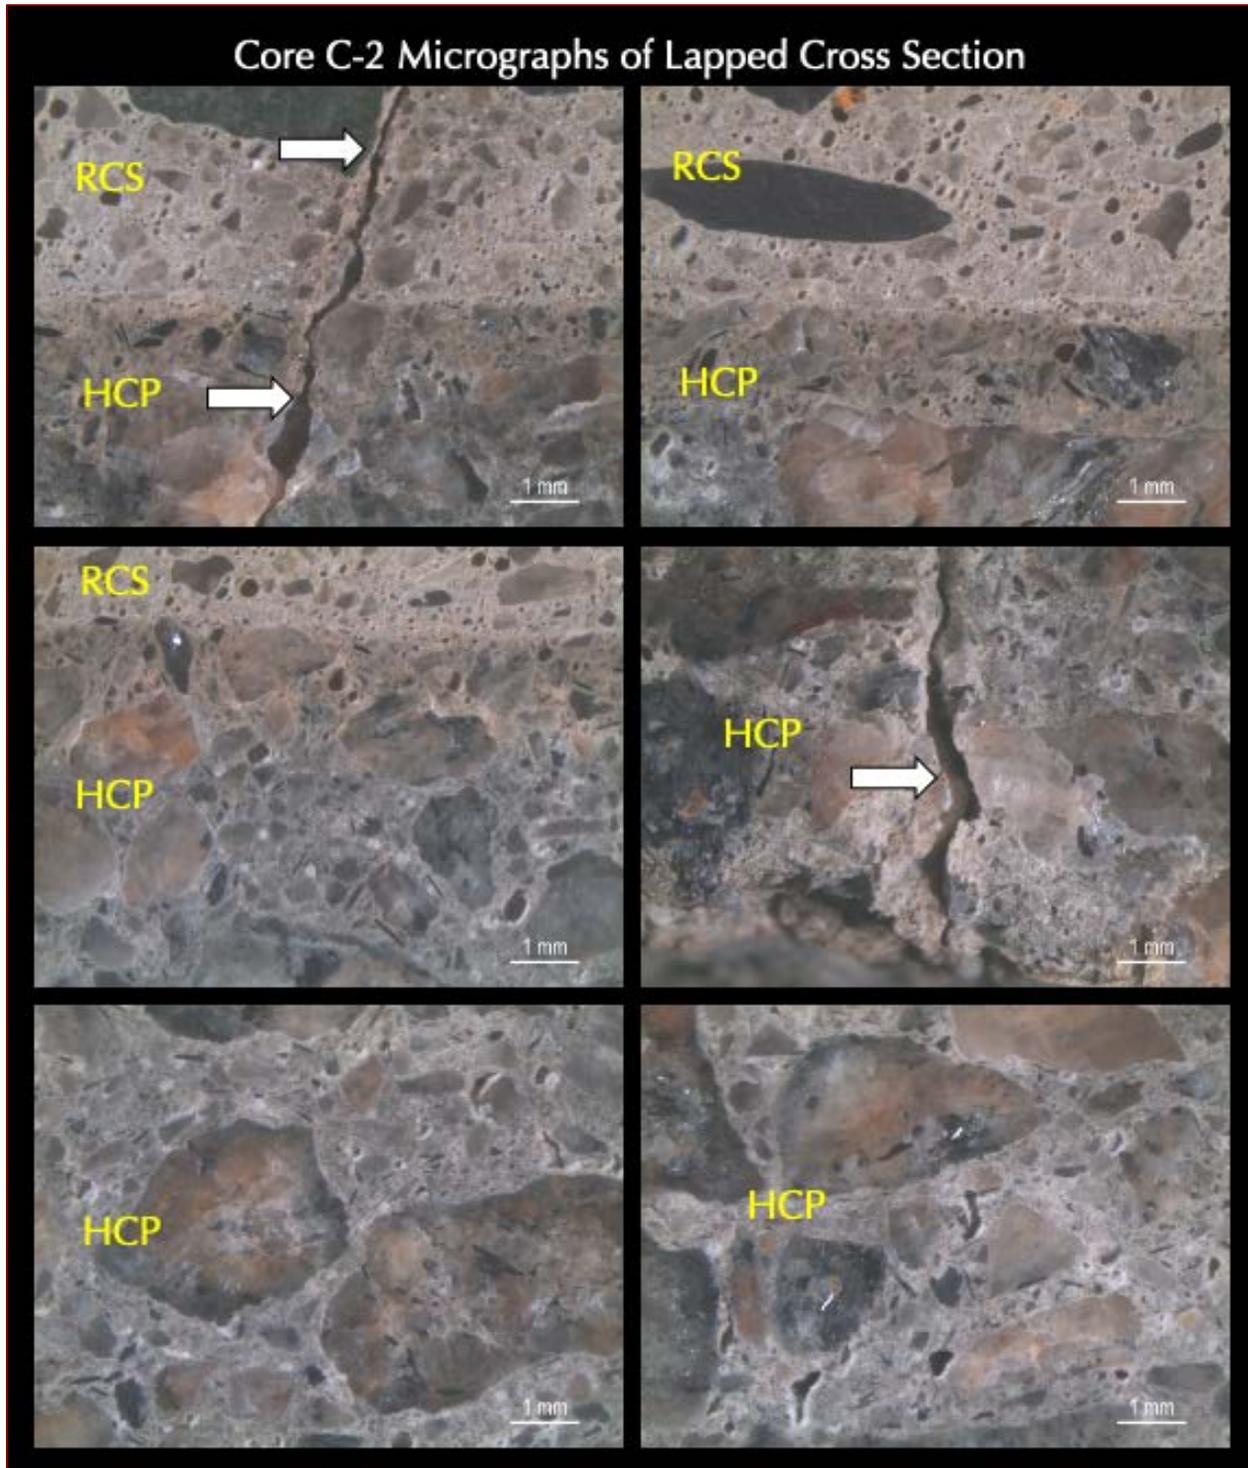
Figure 22: Micrographs of lapped cross section of Core C-2 showing: (a) the excessively air-entrained reinforced concrete slab (RCS) as opposed to non-air-entrained hollow core panel (HCP) with a good bond between the two components; and (b) a vertical crack trasected through both RCS and HCP components.

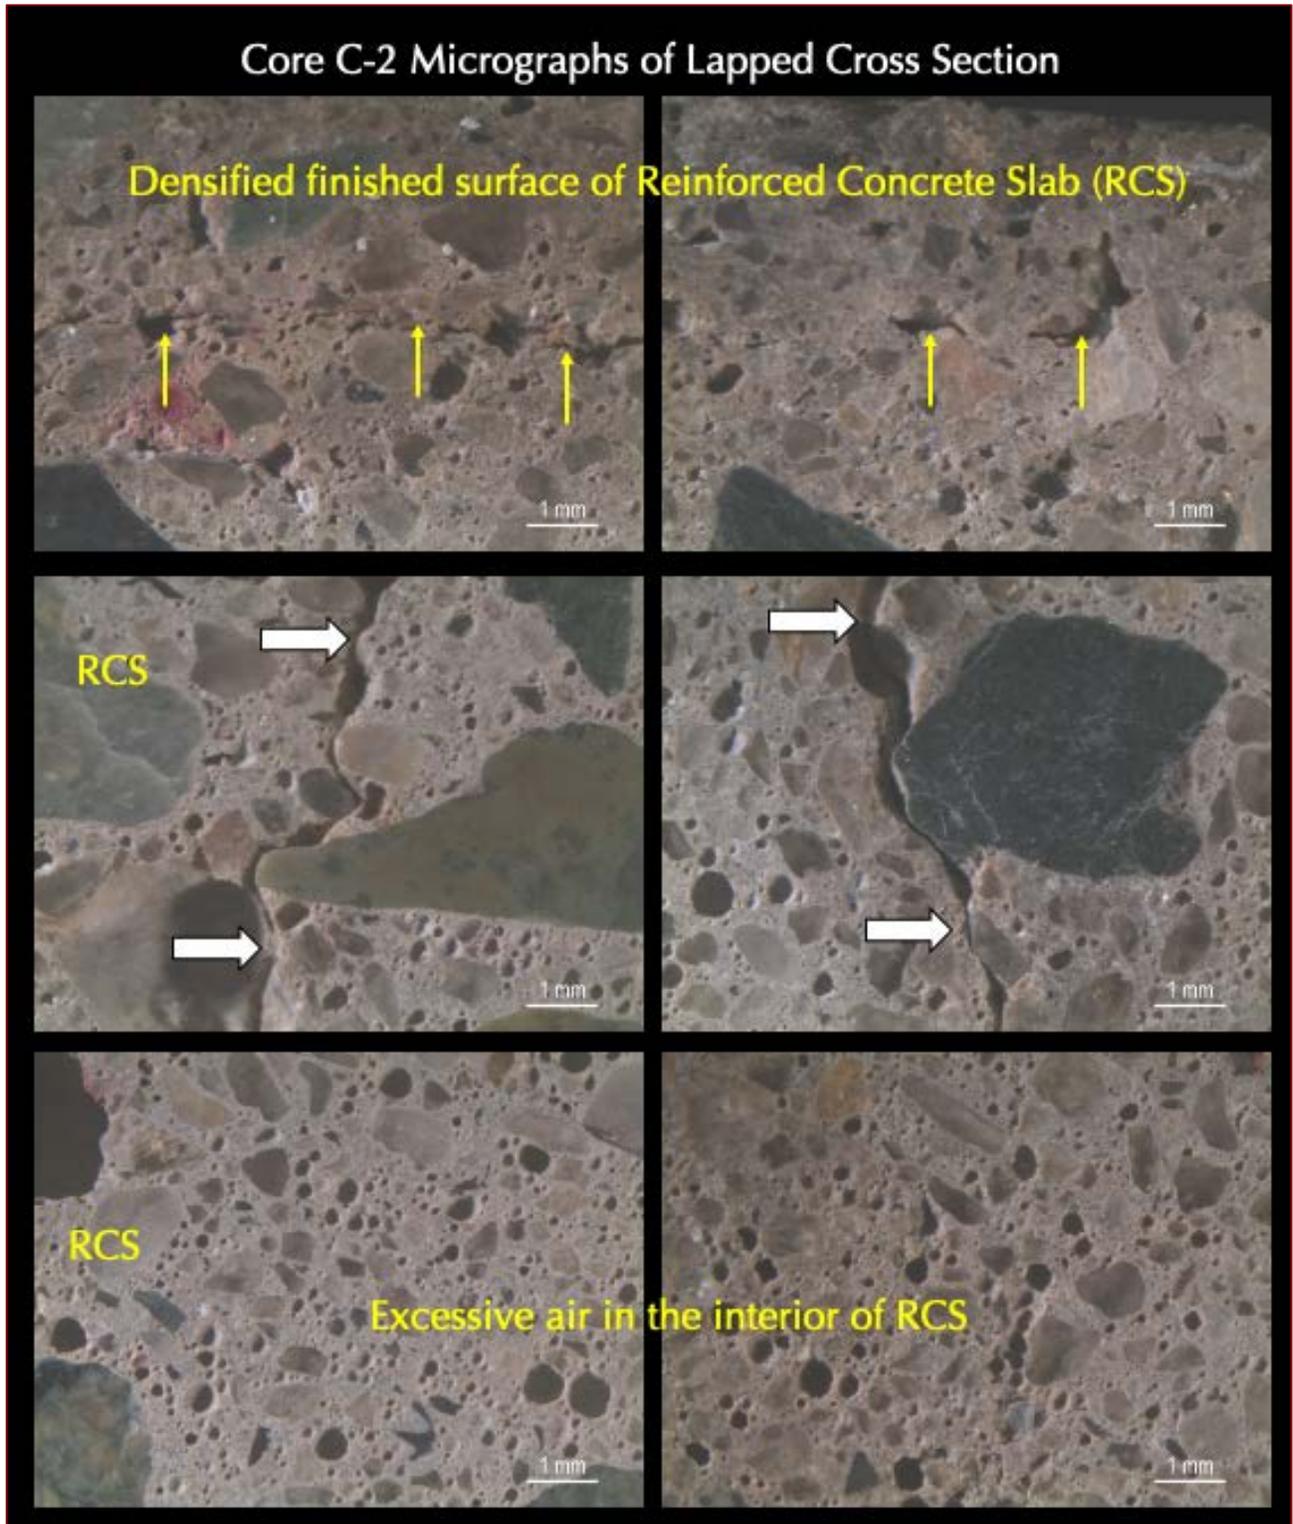
Figure 23: Micrographs of lapped cross section of Core C-2 showing: (a) the excessively air-entrained reinforced concrete slab (RCS), and, (b) lack of air voids at the top $\frac{1}{8}$ in. due to finishing-induced densification of an excessively air-entrained concrete, which has developed short, discontinuous, elongated gaps or separations as incipient delaminations, which are marked as yellow arrows in the top two photos. Notice the main vertical crack transected through the RCS.

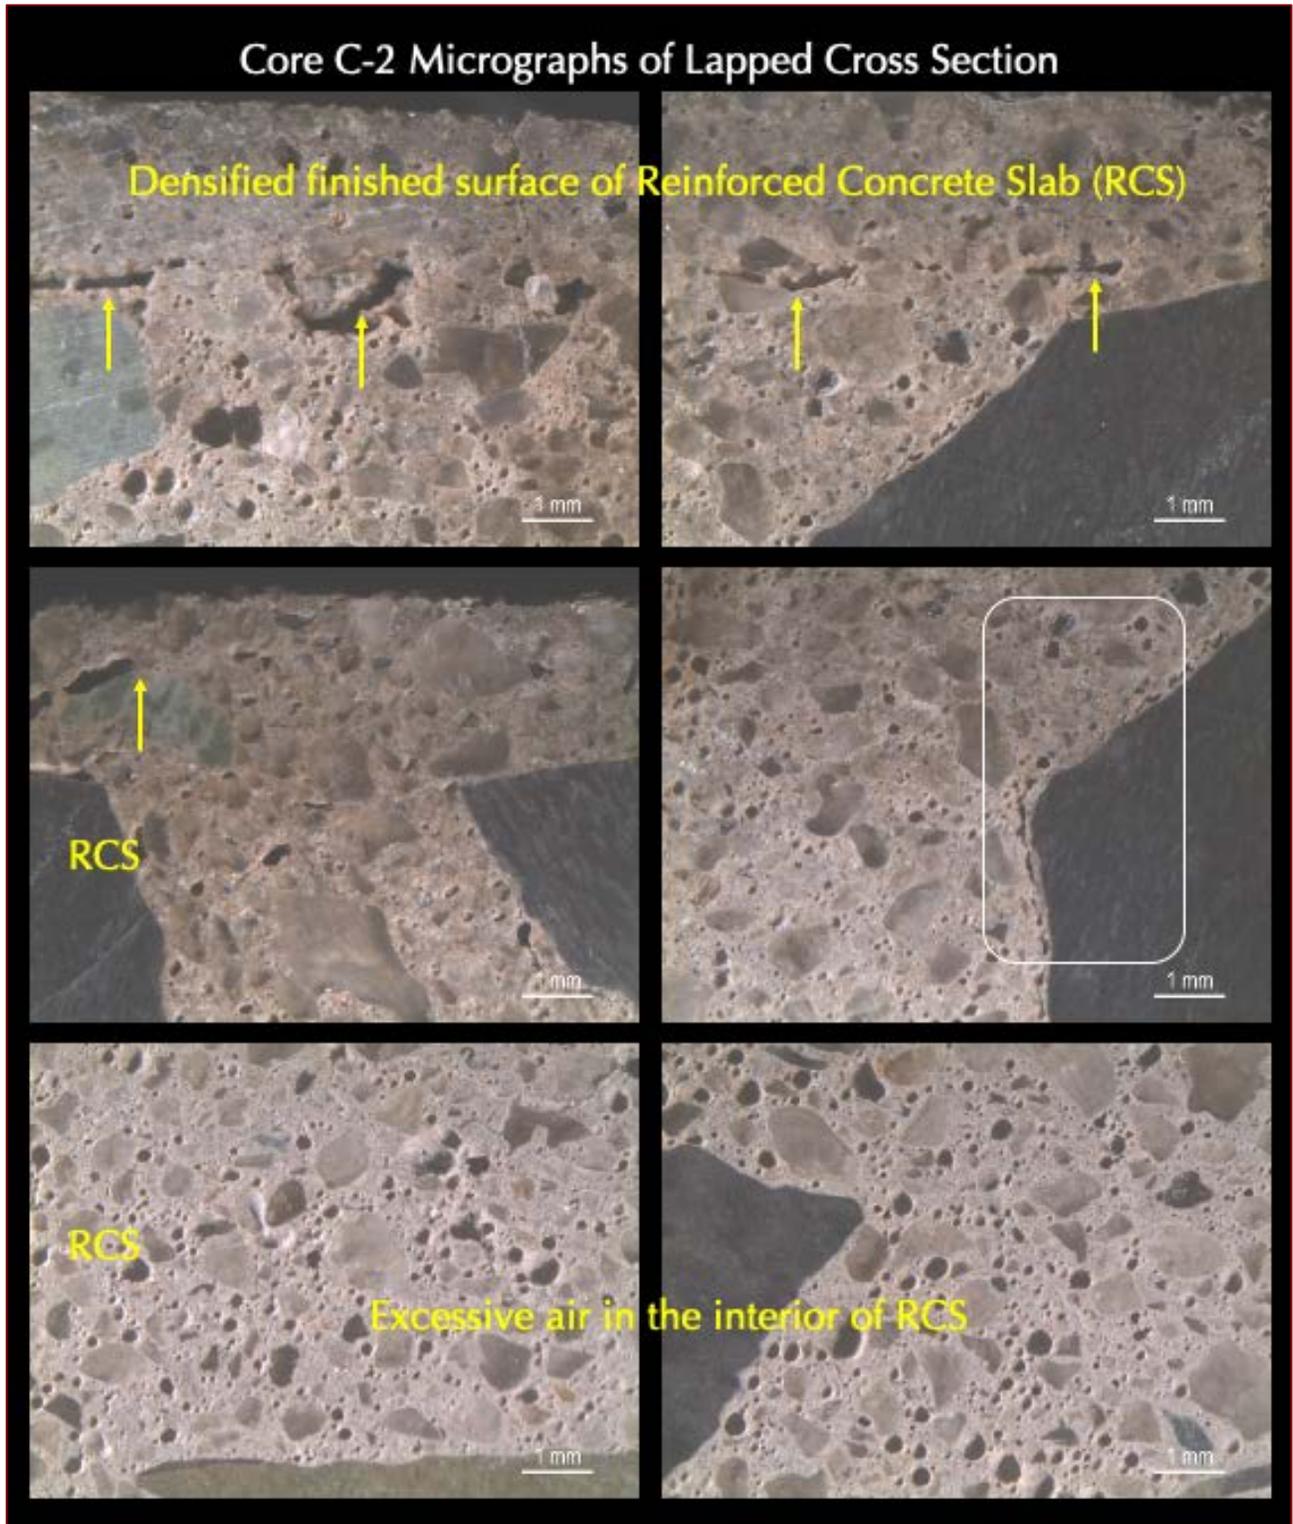
Figure 24: Micrographs of lapped cross section of Core C-2 showing: (a) the excessively air-entrained reinforced concrete slab (RCS), and, (b) lack of air voids at the top $\frac{1}{8}$ in. due to finishing-induced densification of an excessively air-entrained concrete, which has developed short, discontinuous, elongated gaps or separations as incipient delaminations, which are marked as yellow arrows in the top two and middle left photos. Notice clustering of air voids at aggregate-paste interfaces (boxed in middle right photo) due to excessive air entrainment in the RCS.

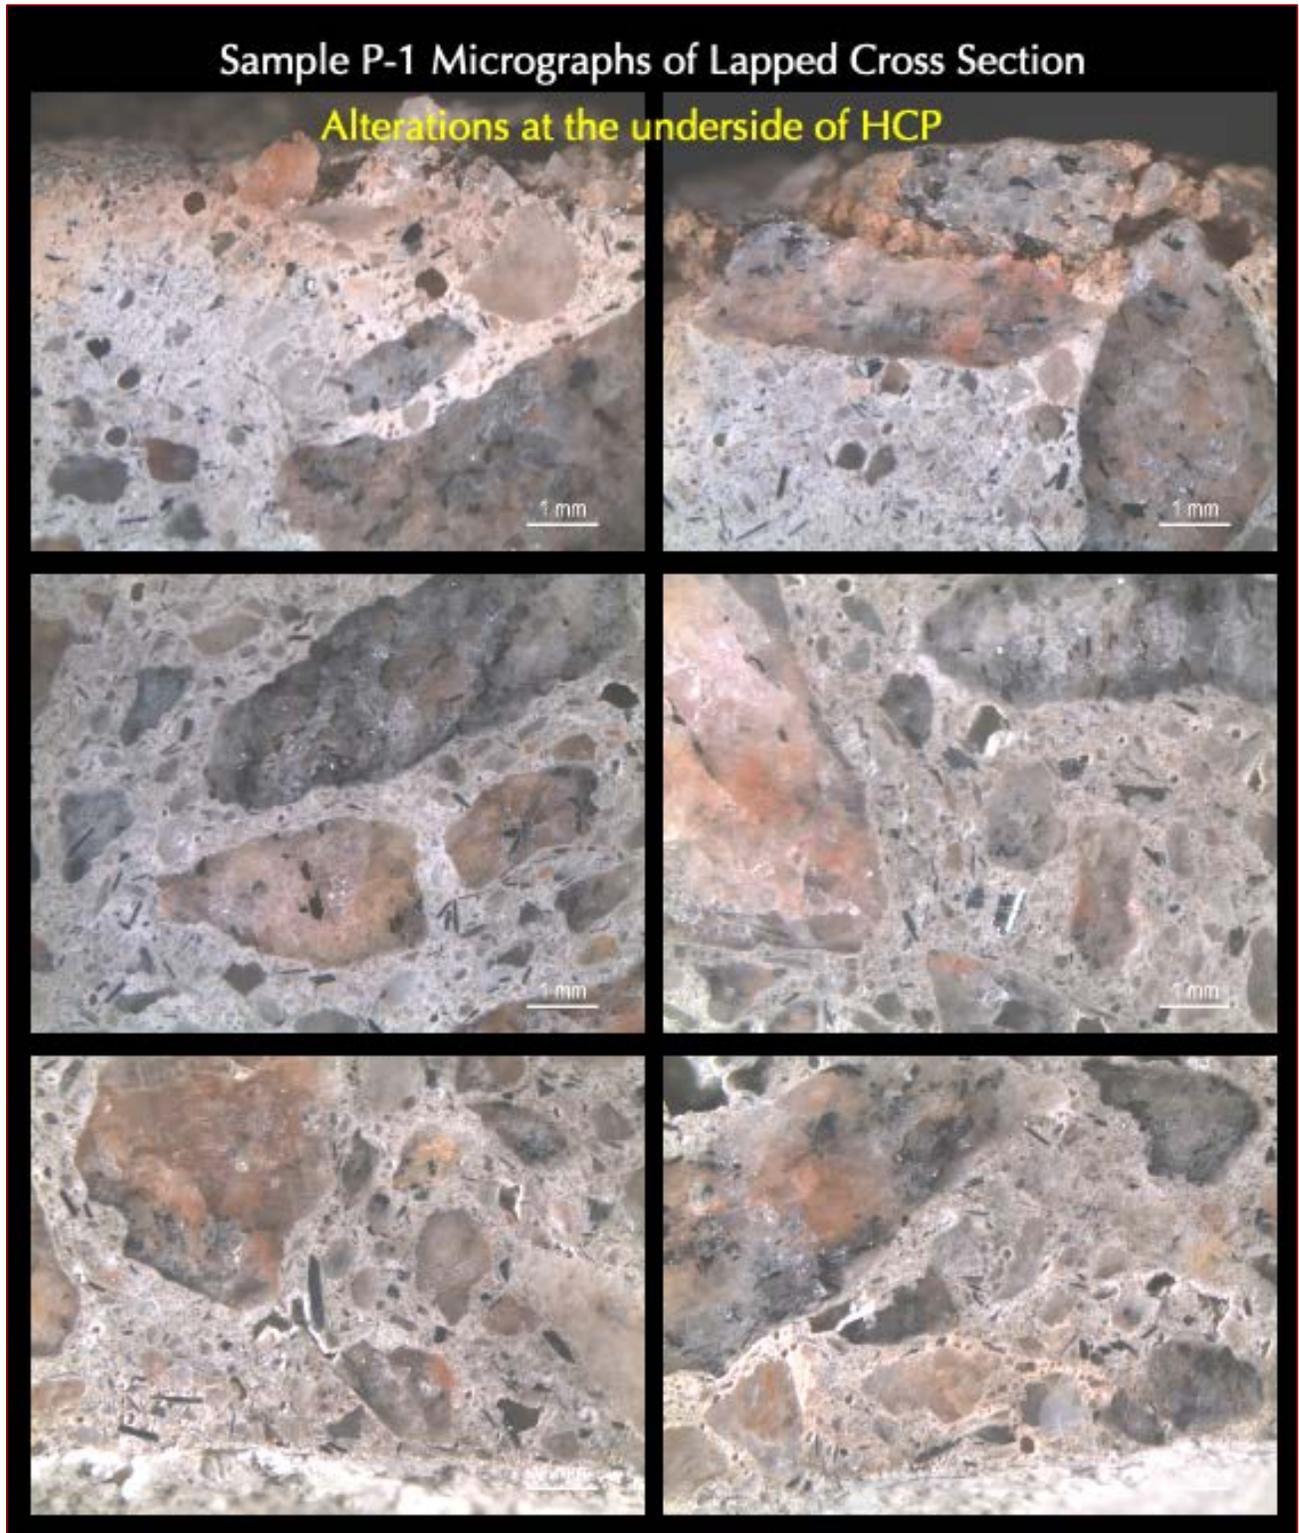
Figure 25: Micrographs of lapped cross section of hollow core panel (HCP) in P-1 showing: (a) altered, discolored light beige carbonated paste at the top 5 to 10 mm of weathered brown surface of HCP in the top two photos where aggregate particles are exposed relative to paste, and (b) interior non-air-entrained concrete in the middle and bottom row photos.

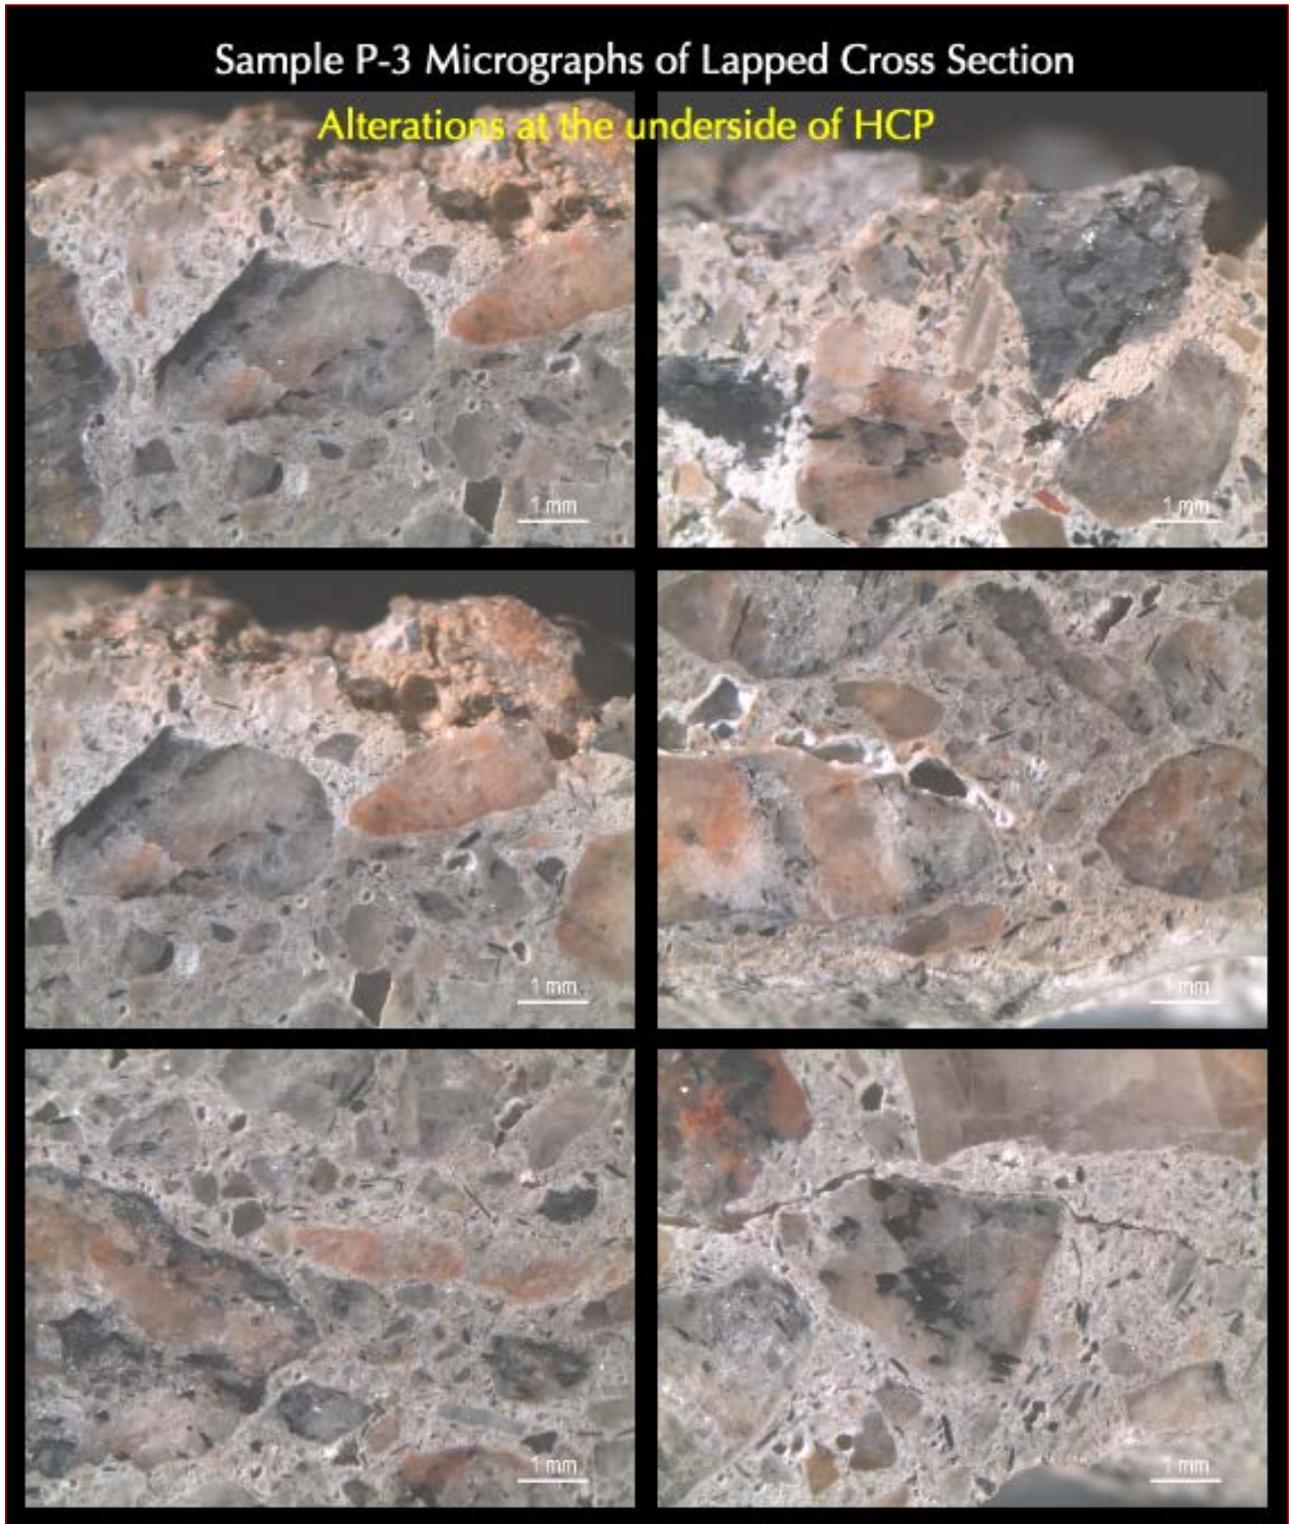
Figure 26: Micrographs of lapped cross section of hollow core panel (HCP) in P-3 showing: (a) altered, discolored light beige carbonated paste at the top 5 to 10 mm of weathered brown surface of HCP in the top two photos, where aggregate particles are exposed relative to paste, and (b) interior non-air-entrained concrete in the middle and bottom row photos. Notice fine horizontal cracks beneath the altered zone in the bottom right photo. Notice white secondary ettringite deposits lining the walls of entrapped air voids in the top and middle right photos.

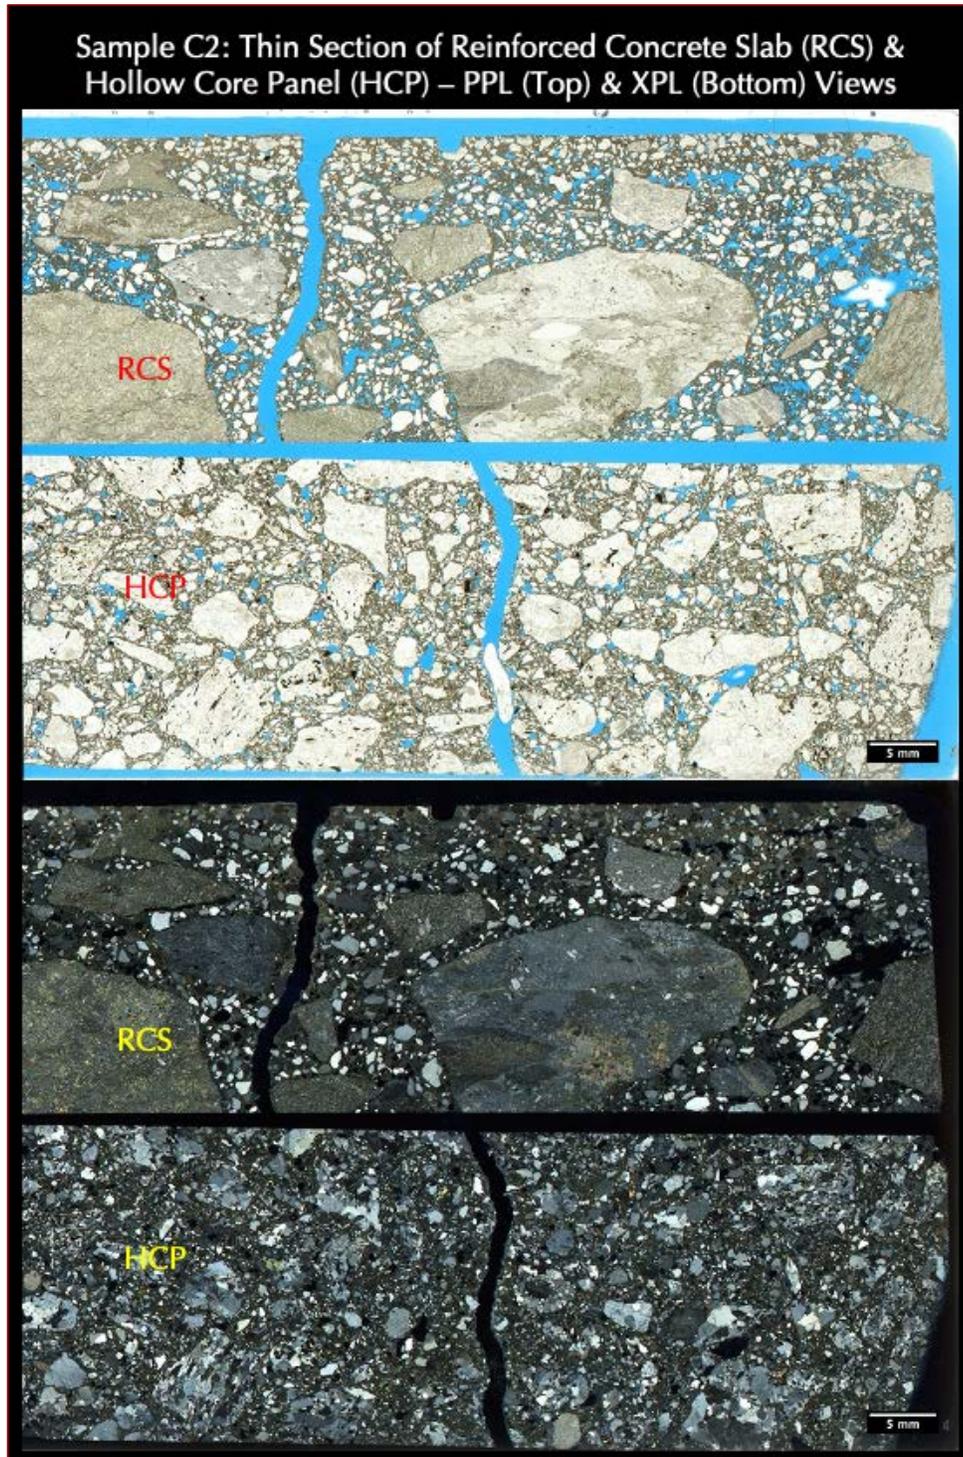
Figure 27: Blue dye-mixed epoxy-impregnated thin section of Core C-2 in plane polarized light (PPL) at the top and corresponding crossed-polarized light (XPL) mode at the bottom showing: (a) the crushed volcanic stone coarse aggregate particles in RCS as opposed to finer sized crushed granite coarse aggregate in HCP; (b) crushed silica sand fine aggregate in both RCS and HCP; (c) excessively air-entrained RCS as opposed to non-air-entrained HCP where air voids are highlighted in blue epoxy in PPL, and (c) overall dense, non-carbonated interiors of both RCS and HCP which are evident in both PPL and XPL images.

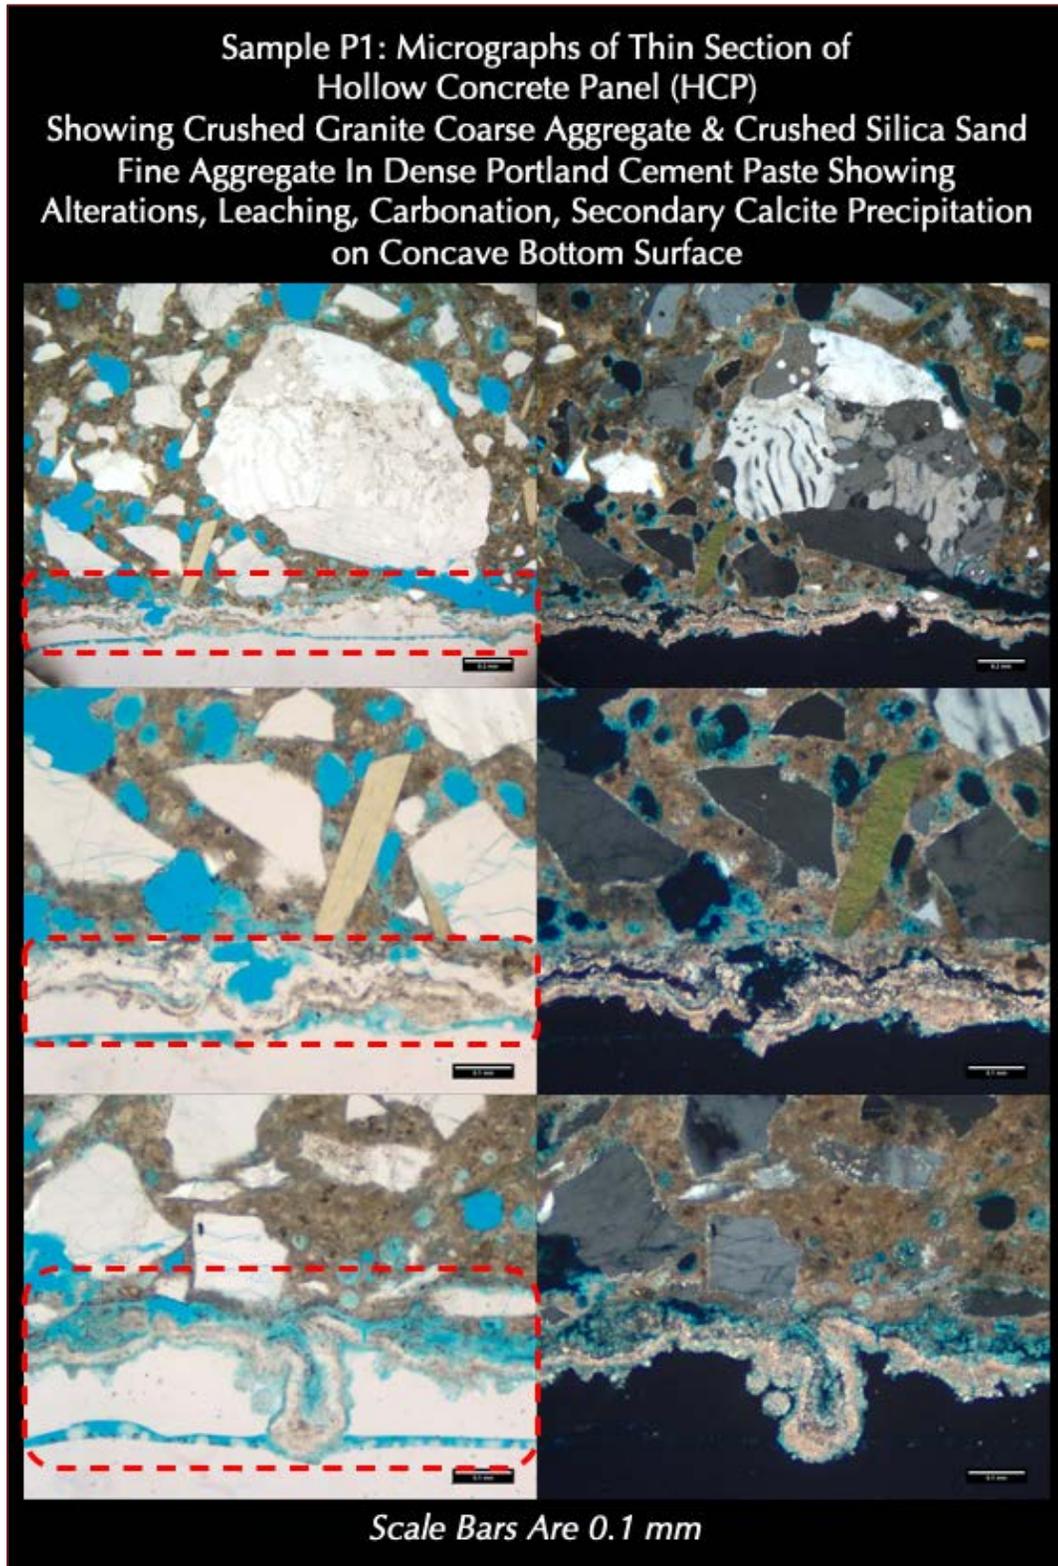
Figure 42: Micrographs of thin section of hollow core panel (HCP) in P-1 showing the altered zone at the weathered brown underside surface end consisting of coarsely crystalline secondary calcite precipitates at the very end (which is boxed at left column photos) above a leached paste zone, which, in turn, is followed by a carbonated paste in the interior of HCP. All these alterations are confined to within 3 to 5 mm of the weathered altered underside surface.

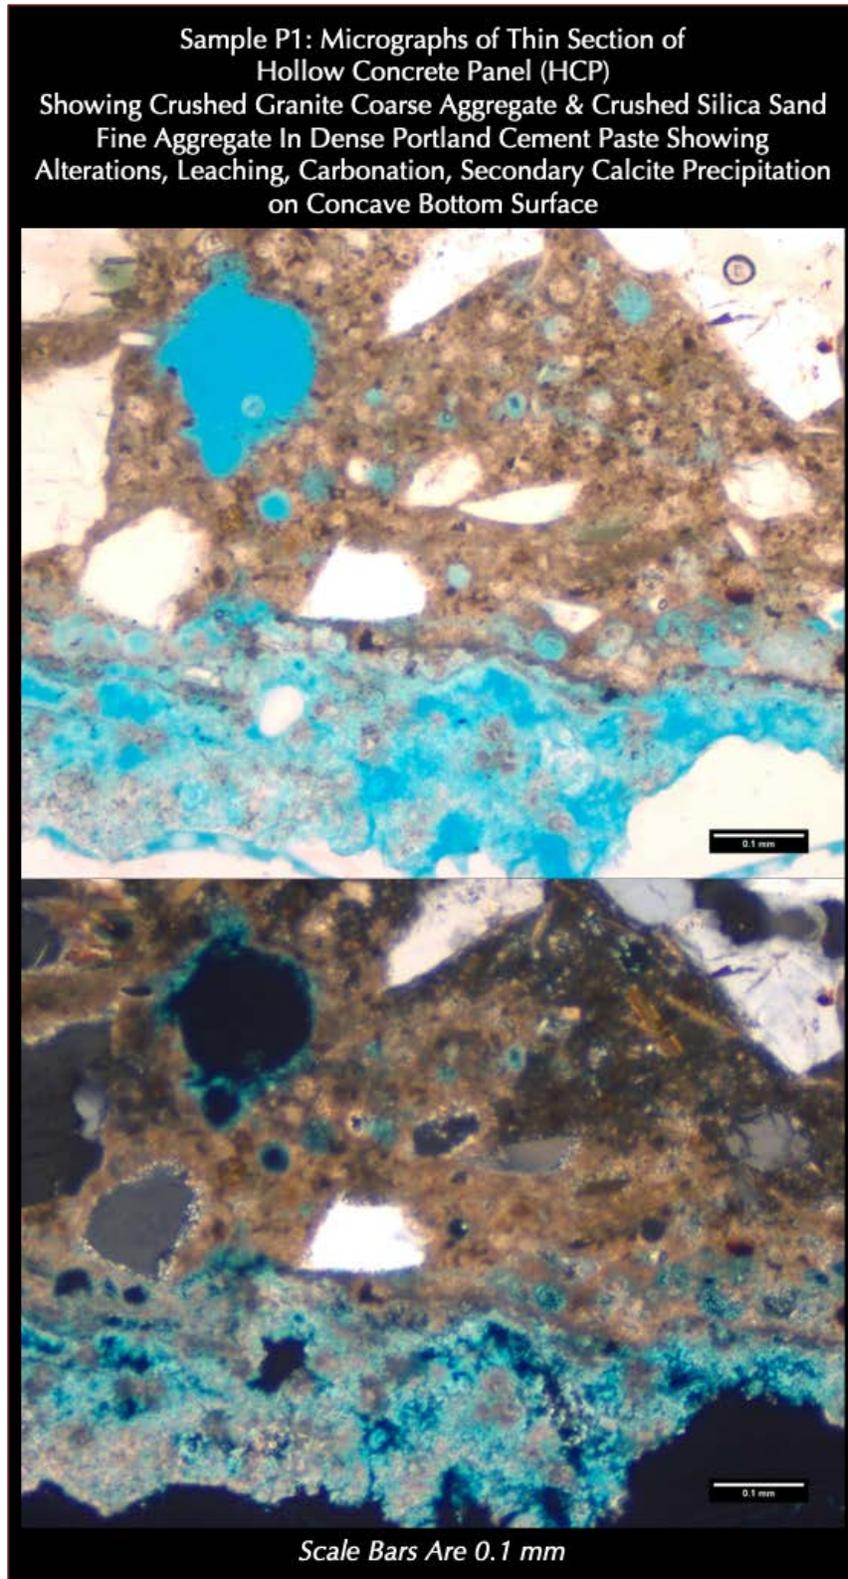
Figure 43: Micrographs of thin section of hollow core panel (HCP) in P-1 showing the altered zone at the weathered brown underside surface end consisting of coarsely crystalline secondary calcite precipitates at the very end above a leached paste zone, which, in turn, is followed by a carbonated paste in the interior of HCP. All these alterations are confined to within 3 to 5 mm of the weathered altered underside surface.

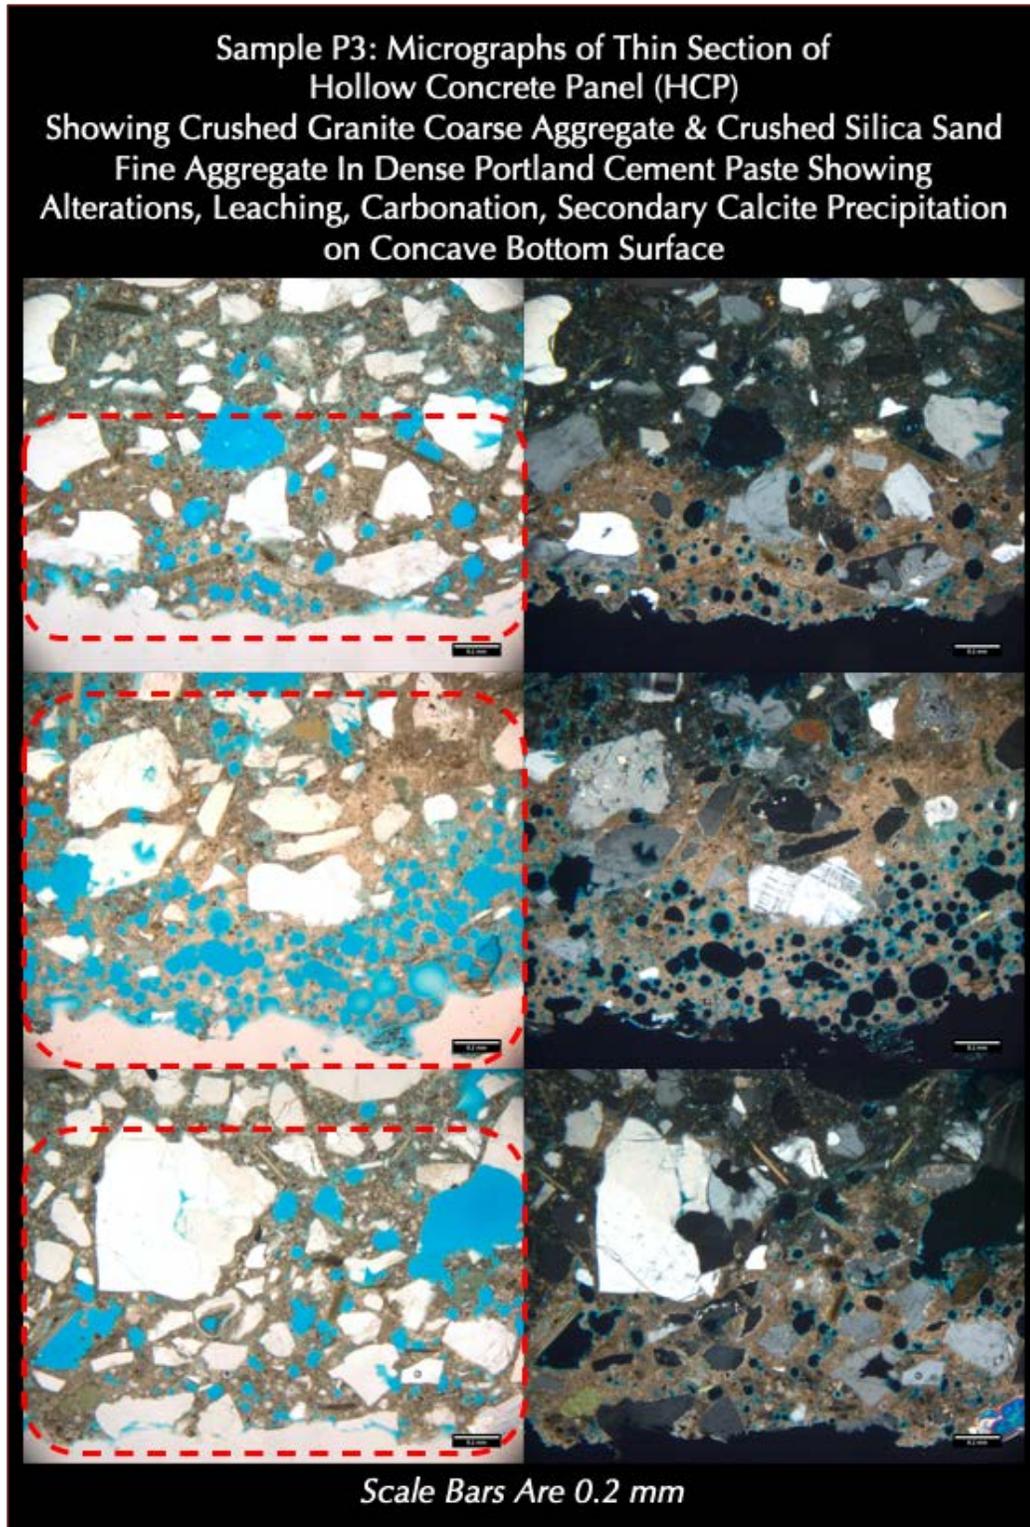
Figure 46: Micrographs of thin section of hollow core panel (HCP) in P-3 showing the altered zone at the weathered brown underside surface end consisting of coarsely crystalline secondary calcite precipitates at the very end (which is boxed at left column photos) above a leached paste zone, which, in turn, is followed by a carbonated paste in the interior of HCP. All these alterations are confined to within 3 to 5 mm of the weathered altered underside surface. Notice some frothy-textured excessively air-entrained paste at the very bottom of altered underside best seen in the middle row images due to interaction with the moist exhaust materials inside the HCP.
