SWIMMING POOL PLASTER DETERIORATION – OVERVIEW & CASE STUDIES

Dipayan Jana

Applied Petrographic Services, Inc., and Construction Materials Consultants, Inc. Greensburg, PA, USA

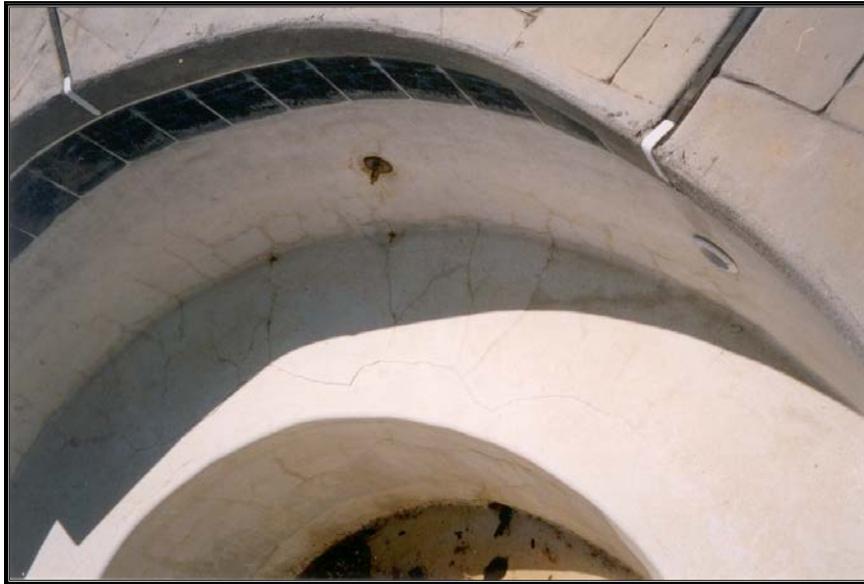
Figure 1 – A pool plaster showing random cracks on the steps.

The steps and floor of a swimming pool show extensive closed, polygonal-shaped cracks, many of which are up to 2 mm in surface width, and reported to be “early cracks,” i.e., formed prior to the immersion of plaster underwater.

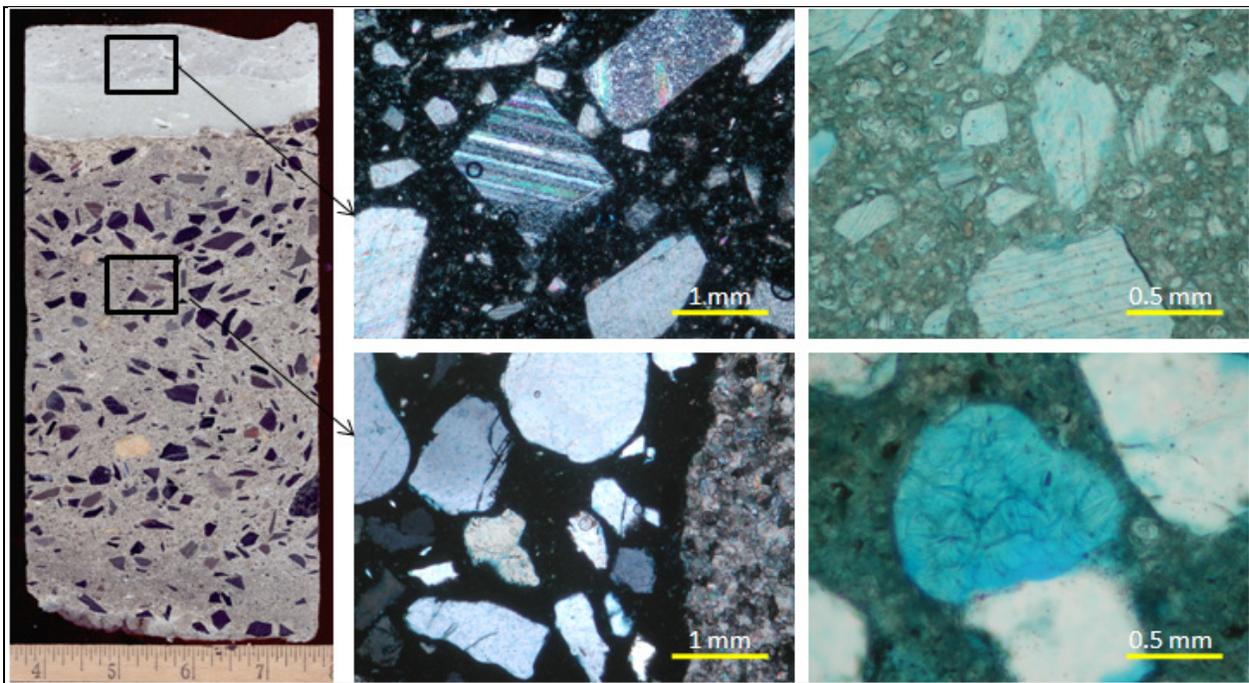
Figure 2 – Left - Lapped cross section of a core from the pool shown in Figure 1. The section shows a thick plaster (comprising two ¹/₂ to ³/₄ in. thick applications), which is intimately bonded to the concrete substrate. Middle = Thin section photomicrographs of plaster (top) and concrete substrate (bottom) showing marble aggregates in plaster and dolomite-quartz aggregates in concrete, and portland cement pastes. Right = Thin section photomicrographs of plaster showing marble aggregates in plaster (top), and an air void in concrete, which is filled with secondary ettringite deposits (bottom).

Based on the reported early occurrence of cracking, the observed absence of any deleterious reaction in the plaster or substrate, the intimate bond of plaster to substrate, and, most importantly, thicker-than-usual application of plaster (in two ¹/₂ to ³/₄ in. coats), and excessive calcium chloride set-accelerating admixture addition (which is known to increase plaster shrinkage), the cracking was judged to have formed due to excessive early shrinkage of a thick plaster prior to immersion in water (steps commonly having thicker plaster than floor and filled at the end usually show more cracking).

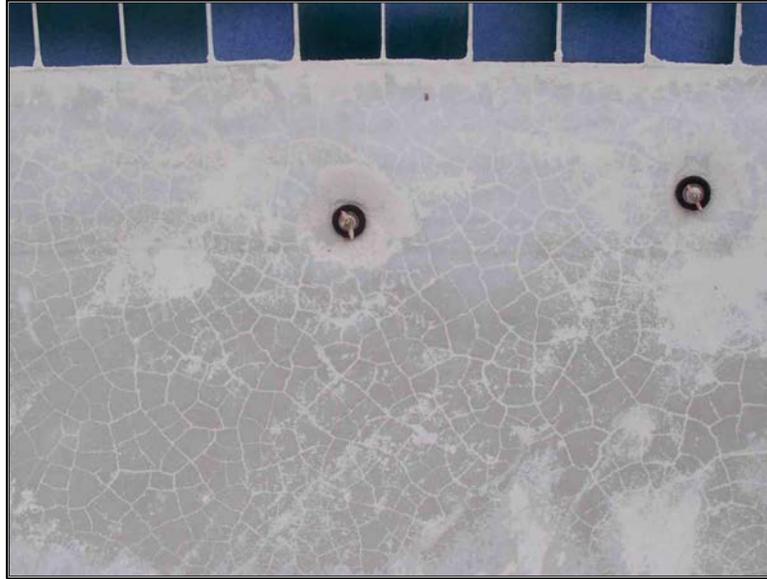
Figure 3 – A pool plaster surface showing closed polygonal-shaped check cracks.

The above photo shows a pool plaster having numerous fine, closed polygonal-shaped cracks. The plaster was approximately $\frac{1}{2}$ in. in thickness and was applied on a concrete substrate. No evidence of any deleterious reaction was found in the plaster, or in the substrate. The plaster contained an excessive dosage of calcium chloride admixture, which is known to cause excessive shrinkage, and, as a result, development of these fine check cracks prior to the immersion of the plaster underwater. The cracks inside the body of the plaster have been partially sealed by cement hydration processes underwater, but were still open enough to be seen on the surface after being in service.

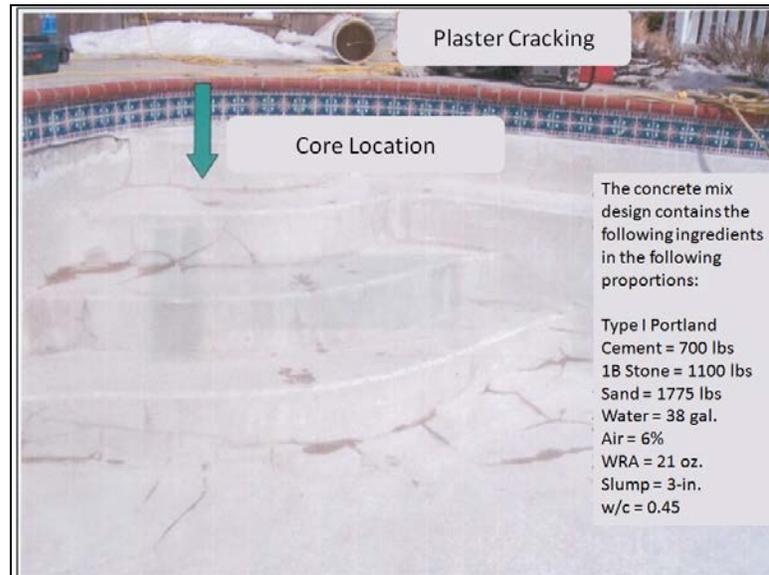
Figure 4 – Steps of a swimming pool showing cracks in plaster, mainly along the bases of the steps. Notice the radial pattern of cracks from the steps. Also shown is the location of the core presented for laboratory study (Case Study 3).

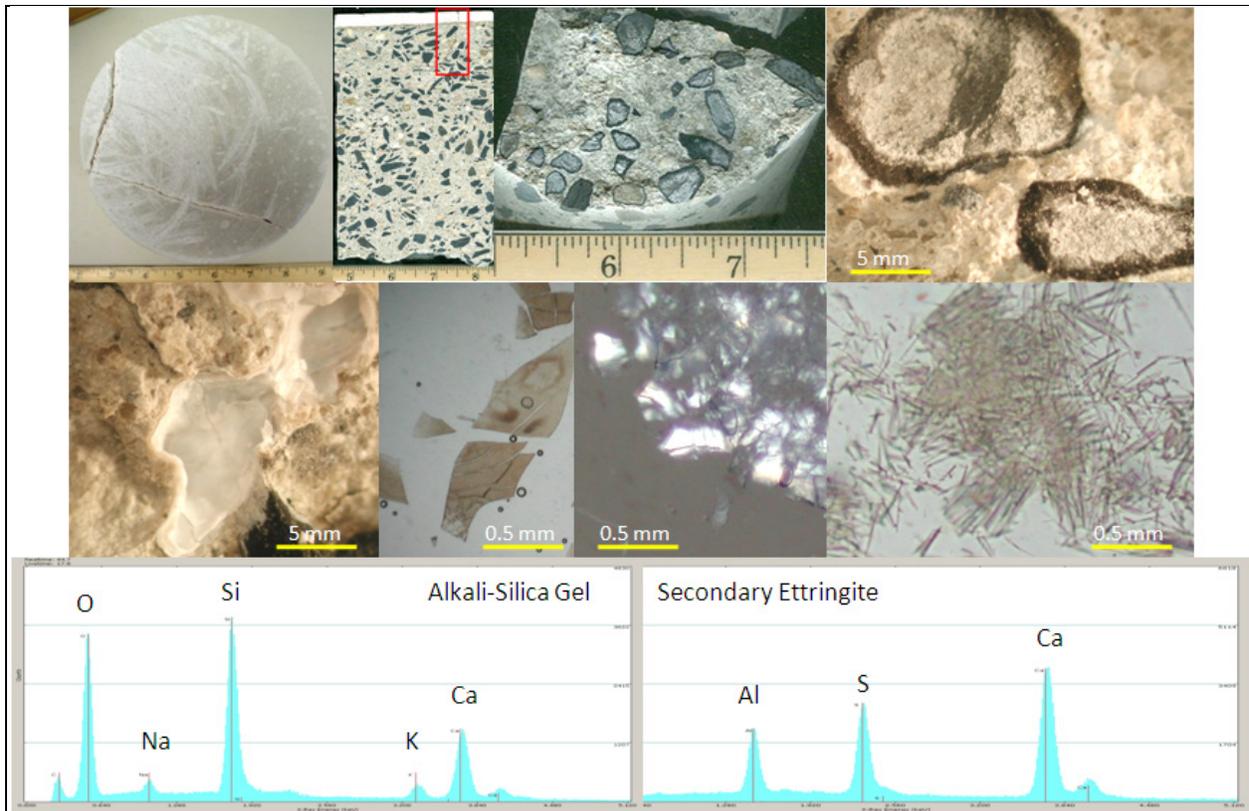
Concrete alkali-silica reaction (ASR) is evidenced by (see Figure 5):

- (a) Dark reaction rims around many reactive coarse aggregate particles; and, soft, white alkali-silica gel deposits on the fractured surfaces within the dark rims of such aggregates;
- (b) Microcracking extending from reactive coarse aggregate into paste; and,
- (c) Various forms of alkali-silica reaction gels in microcracks, entrapped voids, paste, and rims of reactive aggregates that are white porcelain-type, clear glassy and shiny type, light cream colored porcelain-type, layered birefringent-type, and massive isotropic type.

All forms of gel contained sodium, potassium, calcium, and silica (see Figure 5), where calcium in gel came from paste by cation-exchange with alkali; white gel deposits on the fresh fractured surfaces of dark-rimmed coarse aggregate particles, however, do not show calcium enrichment due to the absence of such cation exchange. Associated with ASR gel in many places are secondary ettringite deposits indicating prolonged presence of moisture in the concrete, a condition necessary for sustaining ASR.

Figure 5 – Top Row from Left = Top surface of a core showing plaster cracks; lapped cross section of the core showing the plaster intimately bonded to the concrete substrate, within the boxed area is a vertical crack that has extended through the entire plaster and a portion of the concrete substrate; fresh fractured surface of core showing white deposits of alkali-silica gel on the fractured aggregate surfaces in concrete that are surrounded by dark reaction rims; photomicrograph of fractured aggregate surfaces showing dark reaction rims and white powdery alkali-silica gel deposits on aggregate surface within the rims. Middle Row = Air voids in concrete lined with white alkali-silica gel; oil immersion mounts of white deposits in voids showing layered and birefringent gel deposits; the right photo shows immersion mount of acicular secondary ettringite deposits that are associated with ASR gel in many voids. Bottom Row = X-ray microanalyses of gel and secondary ettringite deposits in voids.

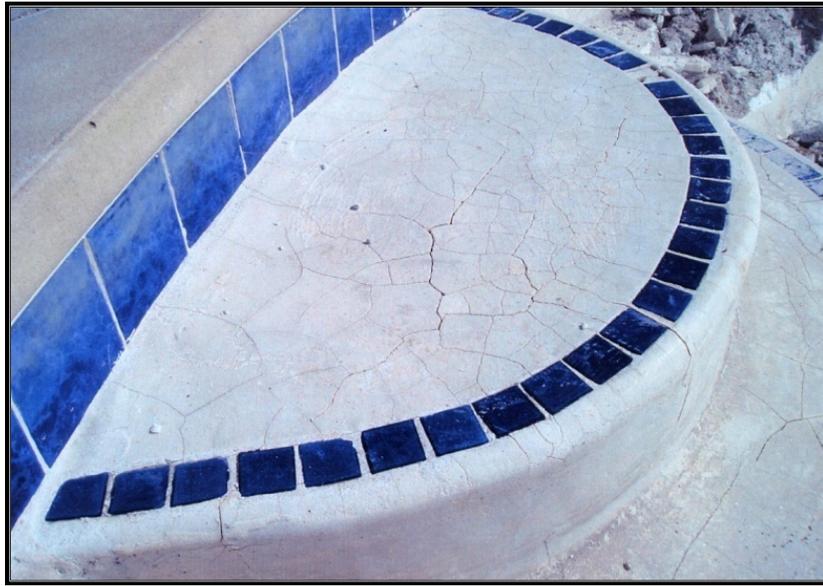
The steps, wall, and floor of a pool plaster showed extensive closed polygonal-shaped cracking, as well as some long cracks. A core from over a plaster crack was received. The plaster was made using white portland cement and marble chip aggregate. The nominal thickness of plaster, as measured in the core, is 10 to 15 mm. The plaster is intimately bonded to a concrete substrate.

Figure 6 – Photo showing severe polygonal-shaped cracking in a pool plaster.

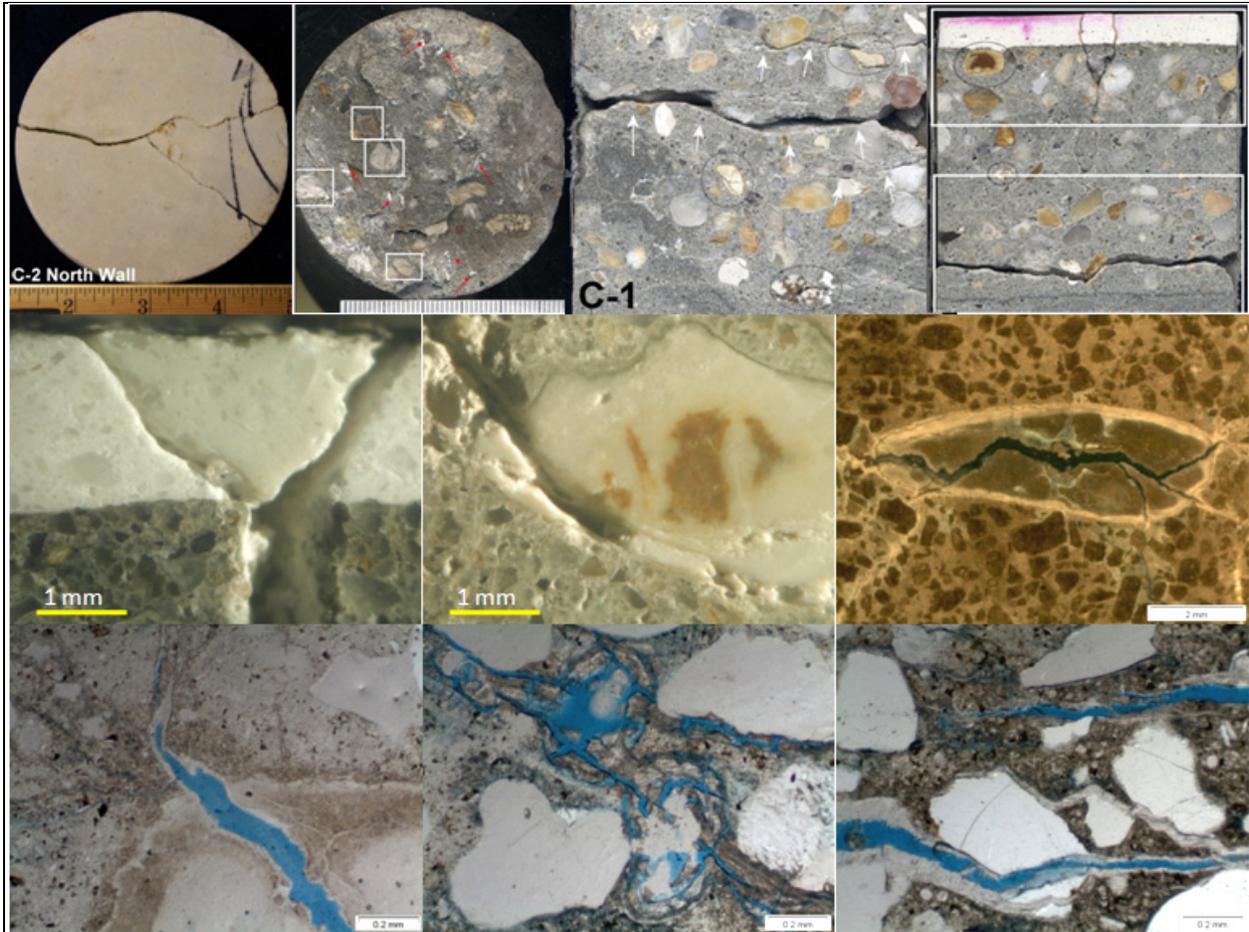
Concrete and associated plaster cracking are determined to be due to alkali-silica reaction (ASR) in concrete, which is diagnosed by (see Figure 7):

- (a) Extensive microcracking in reactive chert and strained quartzite gravels in coarse aggregate that radiate out to the paste;
- (b) Light to dark brown reaction rims along the periphery of many of these particles; and,
- (c) Extensive development and migration of alkali-silica reaction gels forming within cracks, voids, paste, and margins of reactive particles.

Reactive particles, along with the use of a high-alkali cement and the moist environment in the concrete have triggered the deleterious reaction.

Figure 7 – Top Row from Left = Top surface of a core showing cracks; fractured surface of concrete substrate showing alkali-silica reactive chert and quartzite aggregates (boxed) and alkali-silica gel deposits in voids (arrows); lapped section of concrete substrate showing parallel cracks formed due to cyclic freezing and thawing of concrete at critically saturated conditions. Middle Row from Left = Photomicrographs of lapped cross section of the core showing cracks in plaster that have originated from the concrete substrate; cracking of an alkali-silica reactive chert aggregate in concrete; right photo shows thin section of concrete where an elliptical reactive chert aggregate shows severe cracking due to alkali-silica reaction. Bottom = Photomicrographs of thin section of core showing microcracking due to alkali-silica reaction, many originated from the reactive particle and extended to the paste; also notice alkali-silica gel deposits lining the walls of the microcracks.

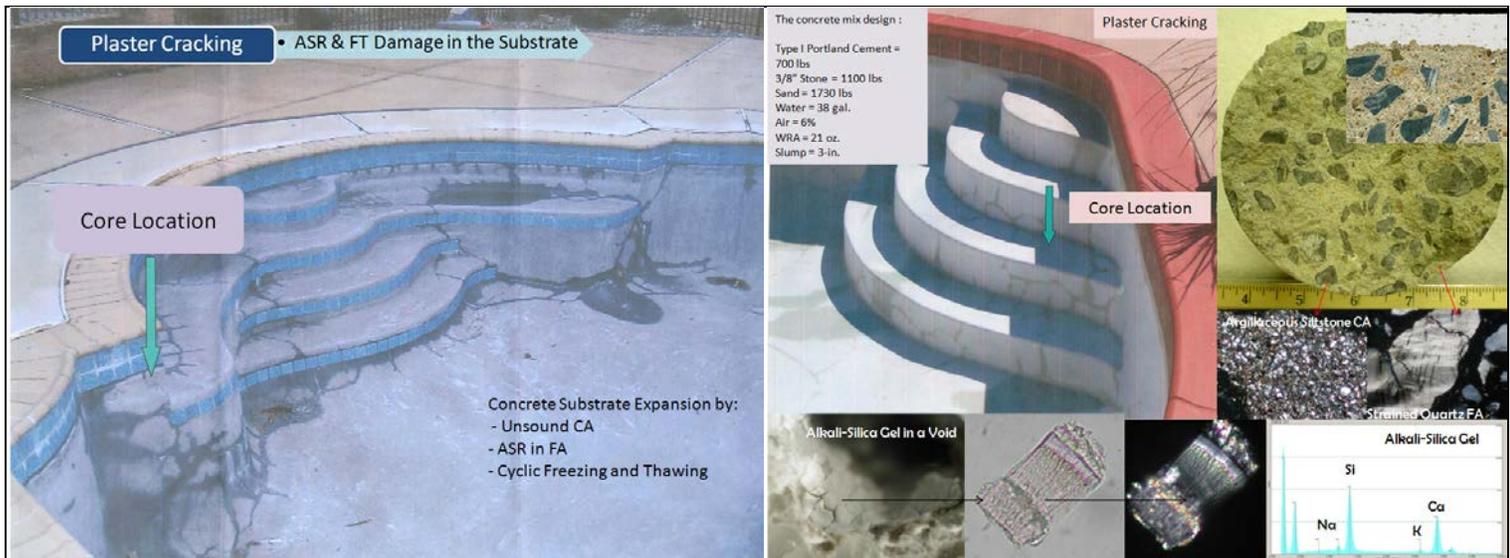
The following photos of plaster cracking, from two very similar case studies, show three superimposed deteriorations, all occurring in the concrete substrates that have caused cracking in polymer-modified white cement and quartz sand plasters: (a) physical unsoundness of crushed argillaceous limestone coarse aggregate particles in concrete causing expansion and fracturing, (b) alkali-silica reaction of severely strained quartz and quartzite particles in fine aggregate of substrate that have caused microcracking, reaction rims and alkali-silica gel formation in cracks and voids, and (c) cyclic freezing and thawing of concrete that was designed to be air-entrained but contained no air entraining agent. Crack patterns from these mechanisms were different but all continued to the plaster to show visible cracking. Clearly, durability of the substrate plays an important role in controlling plaster cracking. In both cases, plasters were sound and made using sound aggregates.

Figure 8 – Two separate pools showing cracking of pool plaster due to expansion of the underlying concrete substrate, which occurred due to unsoundness of argillaceous siltstone coarse aggregate and alkali-silica reaction of severely strained quartz-quartzite particles in fine aggregate in the concrete substrate. The right photo shows white ASR gel deposits on fresh fractured surfaces of reactive aggregates and dark reaction rims; unsound siltstone and reactive quartz particles in aggregate, white gel deposits lining the walls of voids, oil immersion mounts of gel showing its layered type birefringent nature, and EDS composition of gel having Na, K, Ca, and Si.

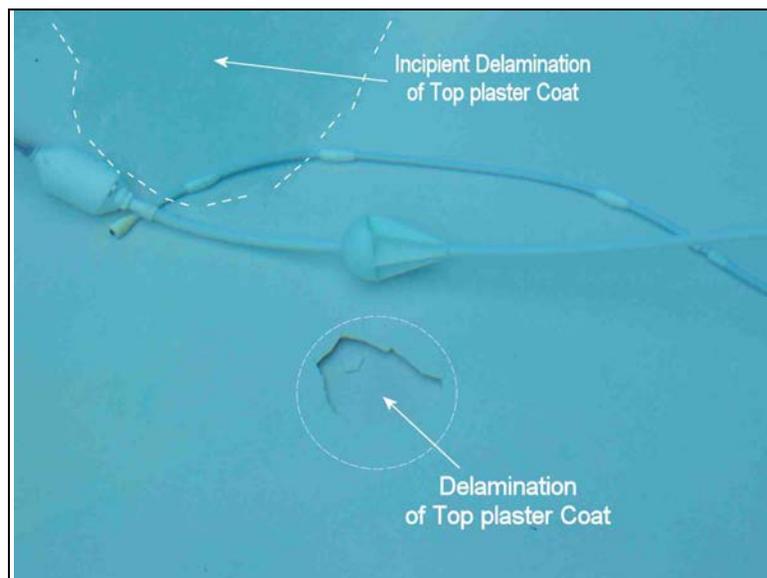
Figure 9 – Incipient and Complete Delamination of Pool Plaster.

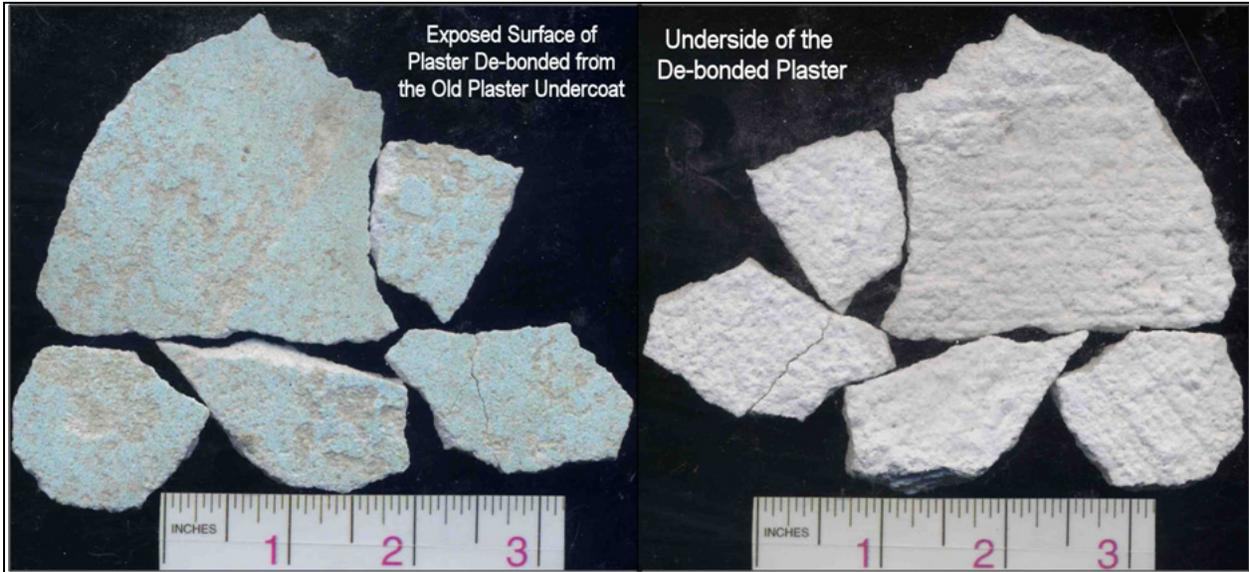
The delaminated new plaster was too thin, only $\frac{1}{8}$ in. in nominal thickness, which showed evidence of rapid drying and restricted hydration of portland cement particles. The plaster was made using marble chips and white portland cement. Acid-soluble chloride analysis showed 0.126 percent chloride, by mass of plaster, which is indicative of less than one percent calcium chloride addition by mass of cement, well within the normal range, or of no addition, where chloride came from interactions with pool water. Thin section photomicrographs of plaster show surface-parallel microcracking from shrinkage and abundant residual portland cement particles and high capillary porosity in the paste in the body of the thin plaster (Figure 11), indicating premature drying prior to the immersion of plaster underwater. Debonding was judged to be due to premature stiffening and rapid drying of a thin plaster coat, which was probably overly wet and exposed to a dry or windy weather condition.

Figure 10 – Loose samples of a de-bonded plaster that was delaminated from an old plaster coat, after a replastering project. Notice the light green copper stain on the exposed surfaces of plaster pieces.

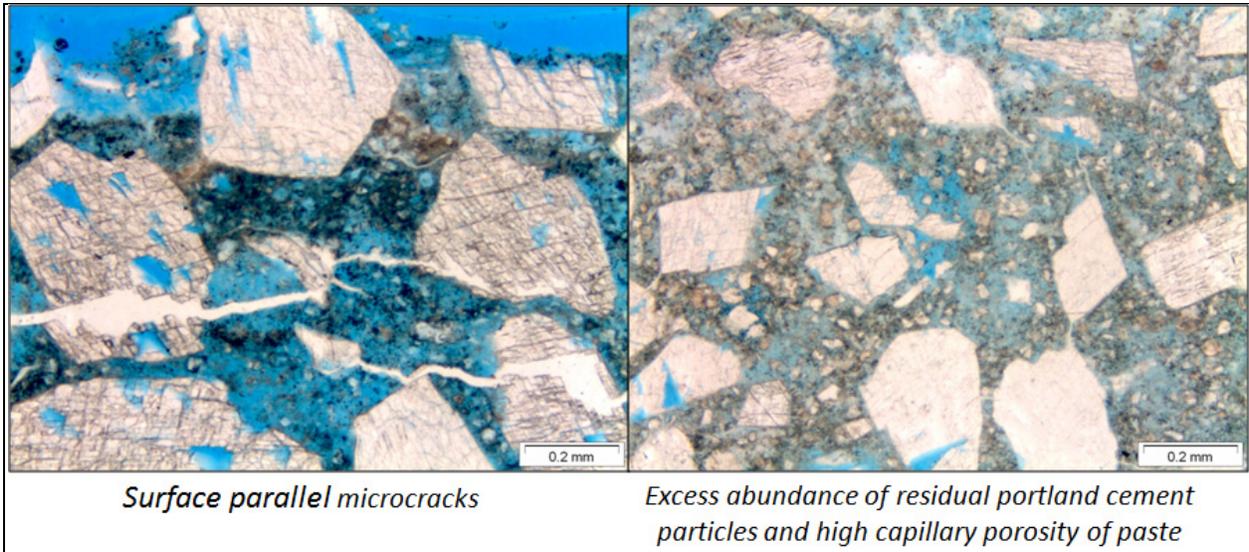
Figure 11 – Thin section photomicrographs showing microstructure of loose, debonded plaster samples. The left photo shows surface-parallel microcracks and porous paste in plaster. The right photo shows excess abundances of residual portland cement particles and capillary pores in the paste. Both features indicate premature stiffening and rapid curing of plaster.

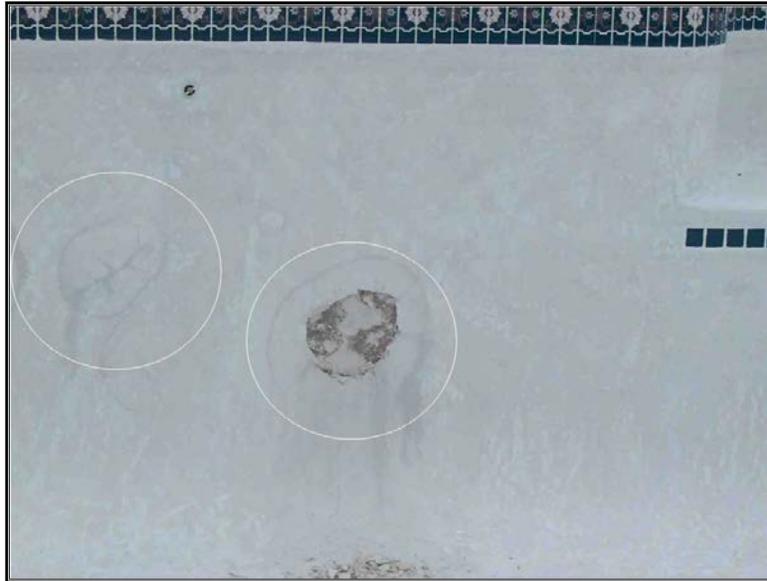
Figure 12 – Blistering on Plaster Surface.

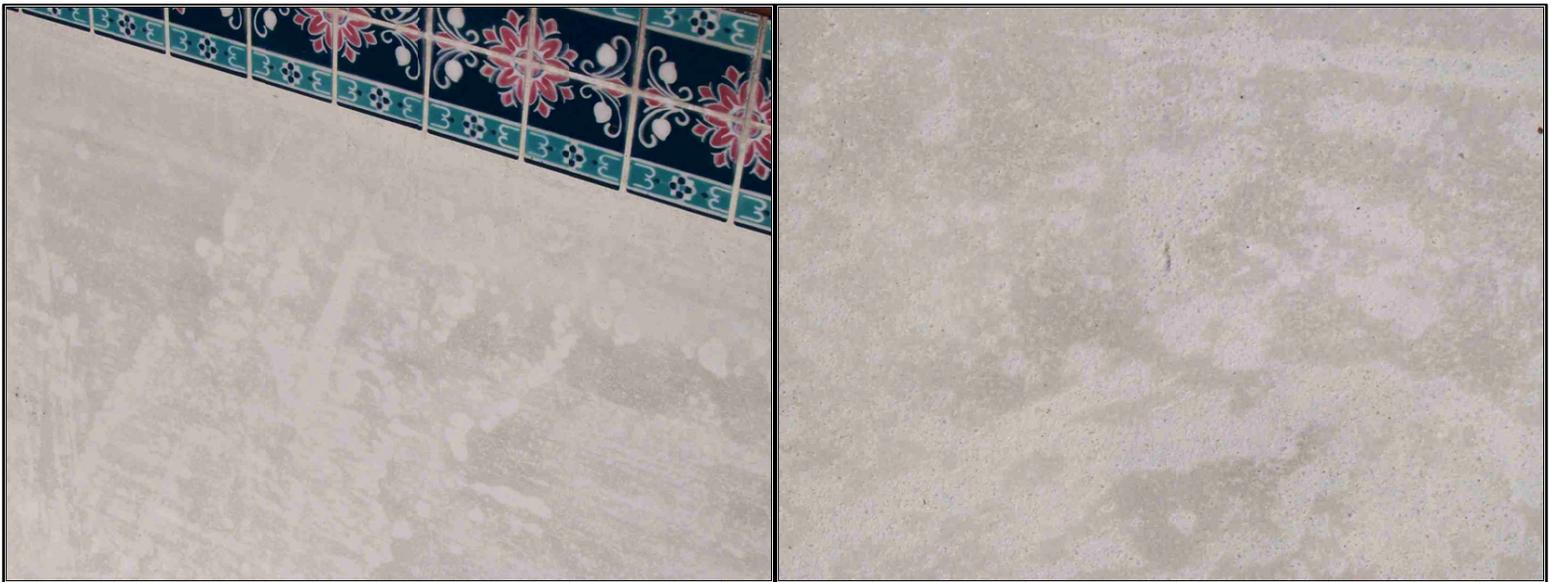
Due to the alkaline nature of the plaster, aggressive pool water causes etching of plaster paste and carbonate aggregates. The depth and severity of etching depends on the aggressiveness of the water, the duration that the water remained aggressive, and the quality of the plaster. The following case study shows an example, where plaster surface developed broad areas of etching (see Figure 13).

Figure 13 – Photographs of a swimming pool showing etching of plaster surface.

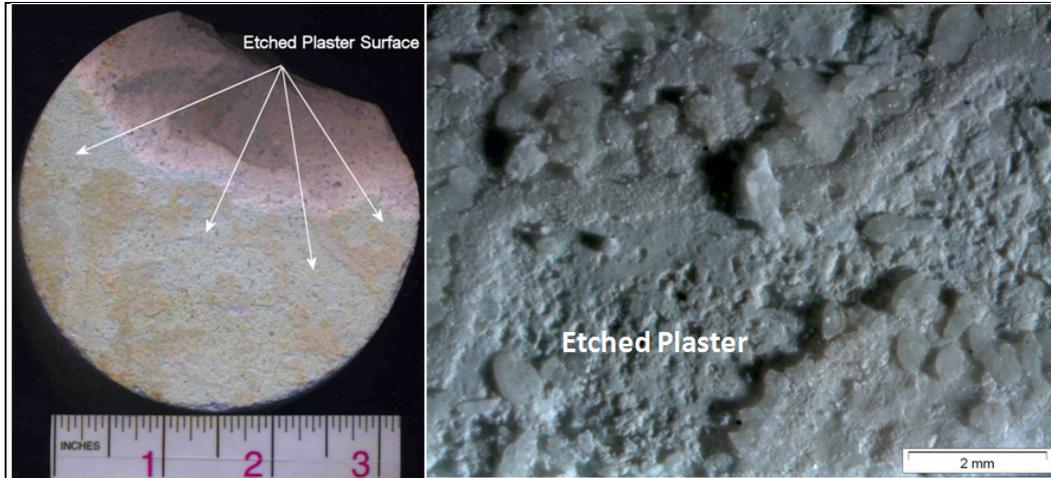
Thin section photomicrographs of the plaster show clear evidence of loss of the paste and carbonate aggregates at the plaster surface, to a depth of 0.2 to 0.5 mm (Figure 15), and an overall porous nature of the plaster paste at the surface and down to a uniform depth of 3 to 4 mm. The total plaster thickness is 10 to 12 mm, where a denser region is present beneath the top porous region. The porous nature at the surface is clearly distinct in blue dye-mixed epoxy-impregnated thin section by a greater degree of blue dye absorption at the top 3 to 4 mm than the interior denser plaster body. Such a porous surface may indicate application of a finish coat having a higher water-cementitious materials ratio than the body, or, finishing in the presence of excess water at the surface, either of which has decreased the resistance of plaster to surface etching by the aggressive water.

Figure 14 – Photograph of the top etched plaster surface in the core (left photo) taken from the pool shown in Figure 13, which, at a higher magnification (right photo) shows the loss of paste from around the aggregate particles, and loss of marble aggregate particles at the surface as well. The brown patchy areas are rich in aggregates and lighter gray areas are etched paste.

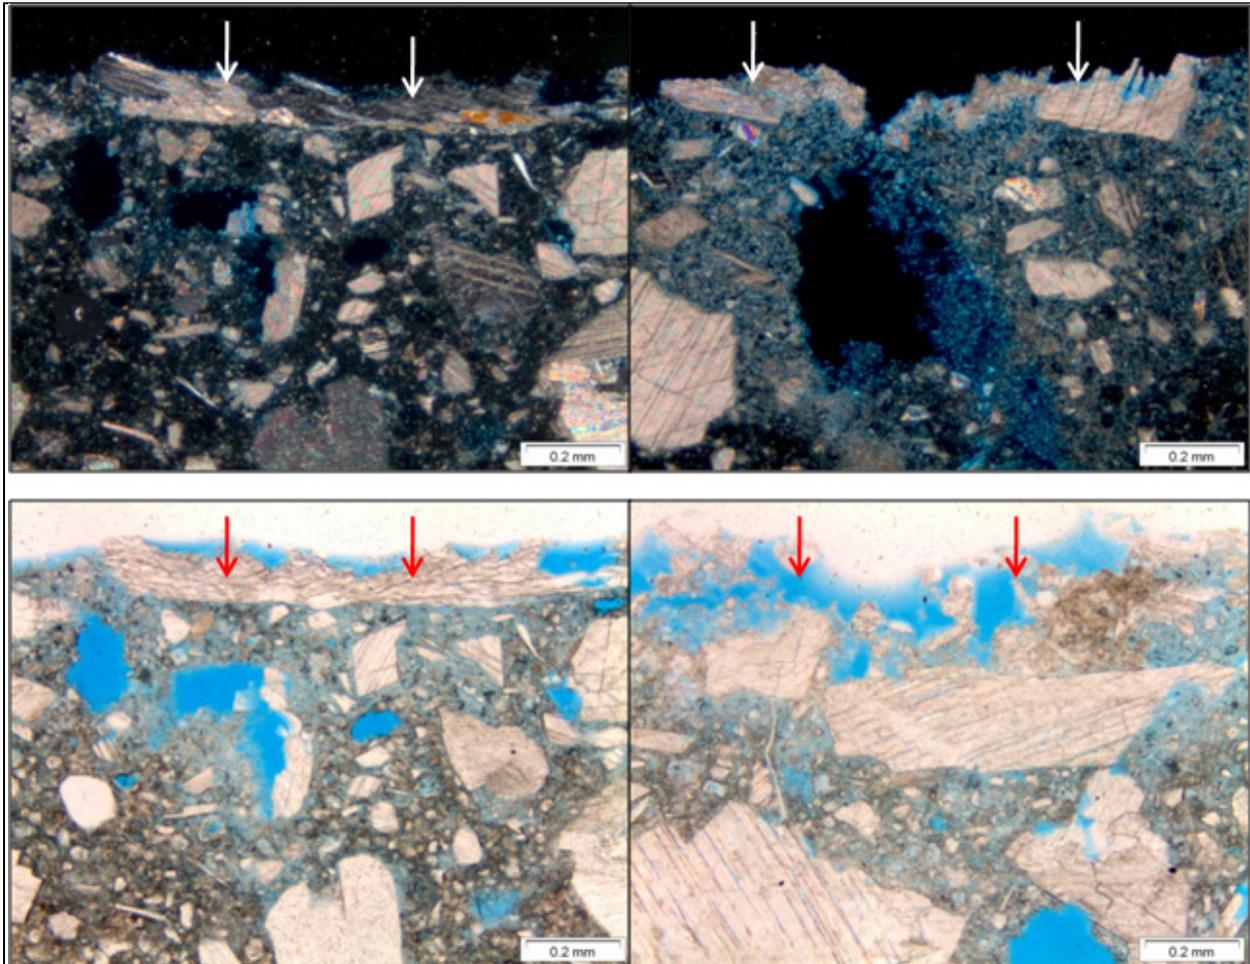
Figure 15 – Photomicrographs of blue dye-mixed epoxy-impregnated thin section of plaster showing etching of marble aggregates and paste on the plaster surface, loss of paste, and highly porous zone of paste at the top 0.2 to 0.5 mm. The porous nature of the paste at the surface region, beneath the etched plaster surface can be readily highlighted by the blue dye-mixed epoxy used for impregnating the sample prior to thin sectioning.

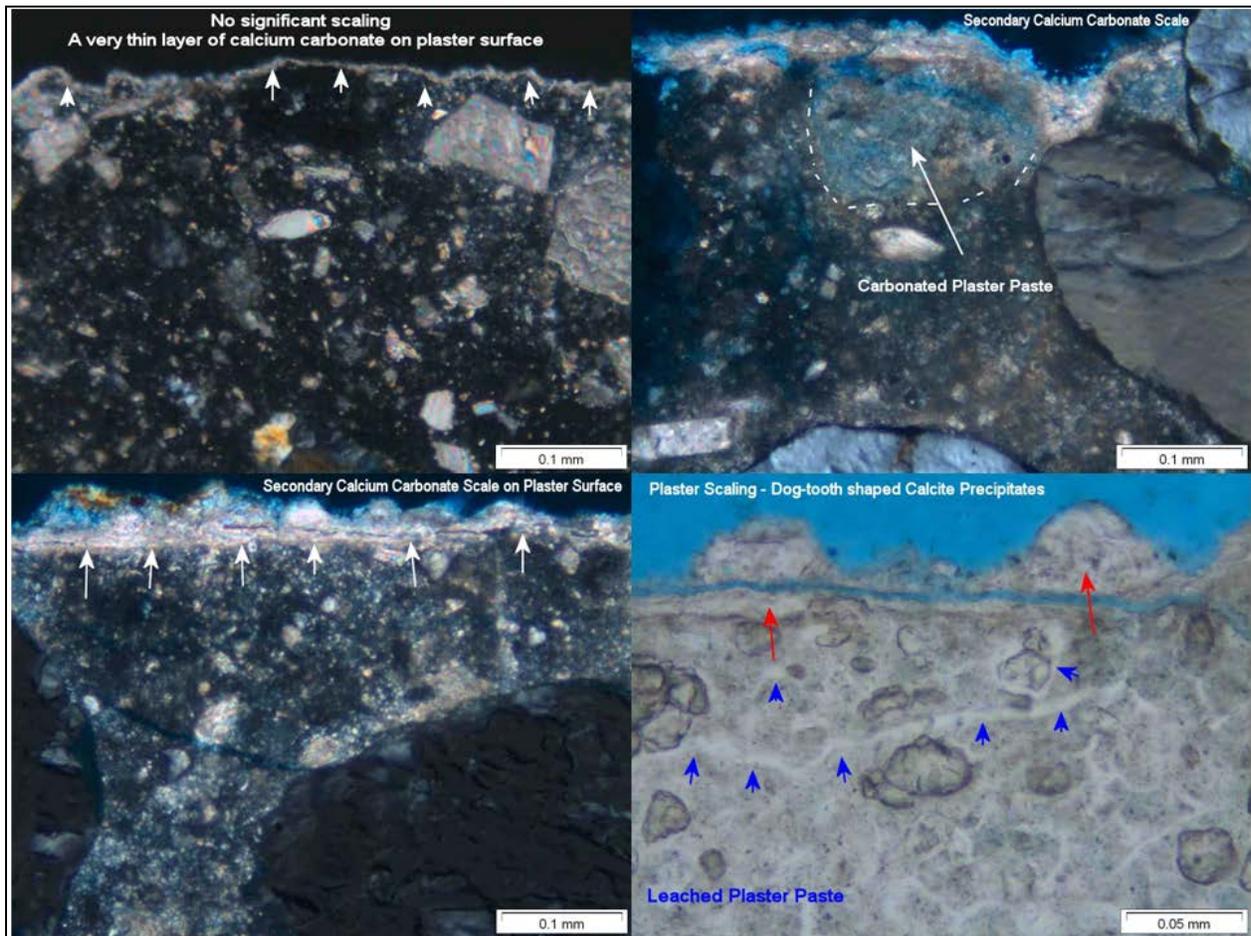
As the opposite extreme of etching, the following case study shows surface scaling, as secondary calcium carbonate precipitates on the plaster surface, due to the exposure of plaster to a pool water having a high pH, high alkalinity, high calcium hardness, and the presence of excess dissolved solids. The plaster surface showed dog-tooth shaped secondary calcite precipitates, 50 to 70 micron in thickness, some overlain by a relatively leached and porous paste.

Figure 16 – Photomicrographs of thin sections of plasters showing no scaling in the top left photo versus scaling and dog-tooth shaped secondary calcite precipitates on the plaster surface in the other photos. The bottom right photo shows leaching of paste beneath the calcite scales indicating effects of a fluctuating pool water chemistry from a low pH (caused leaching) to a high pH environment (caused scaling).

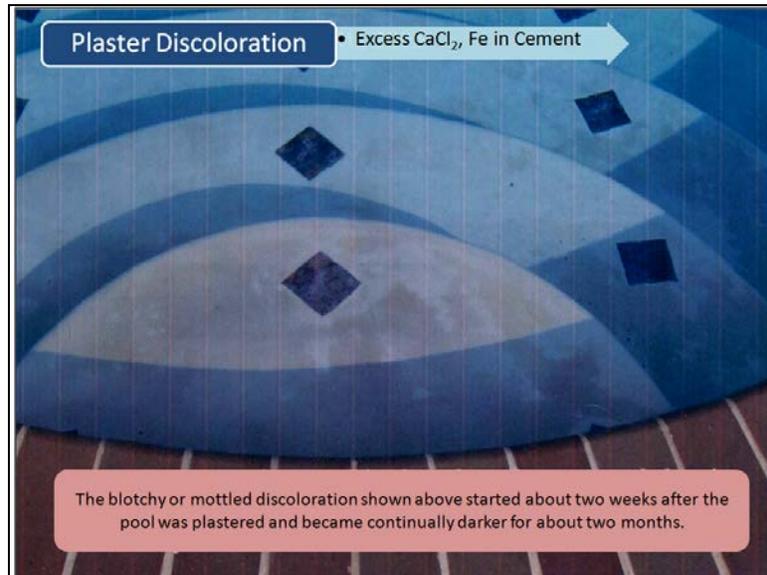
Figure 17 – Photograph of a swimming pool showing blotchy or mottled grey-hued discoloration of pool plaster over a broad area.

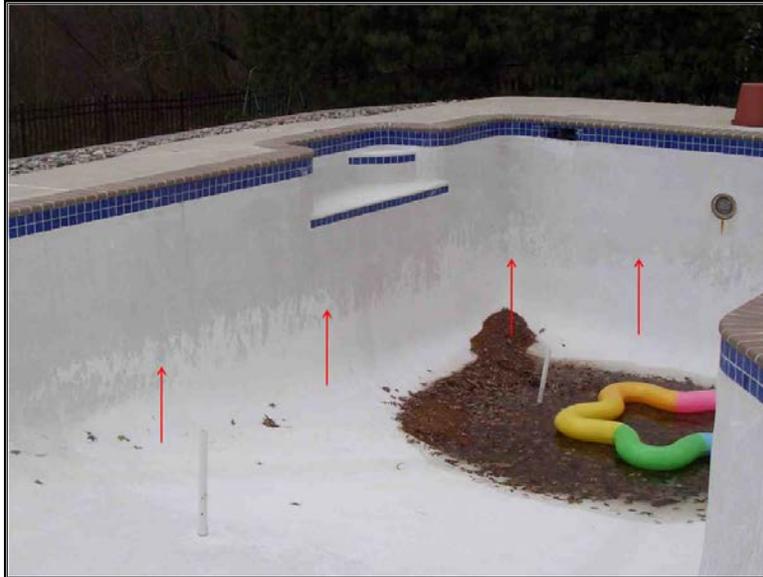
The following type of plaster discoloration (see Figure 18), from a uniform grey-hued top portion to a cloudy white bottom is very common in many pools, which is due to prolonged settling of pool water at a low level after a partial drainage (which was during the entire winter season in this case), where portions remained underwater appeared lighter in color than the aerated portion of the pool. The aerated portion, being drier than the underwater portion appeared as a darker shade.

Figure 18 – Darker versus lighter gray discoloration of aerated and underwater portions of a pool.

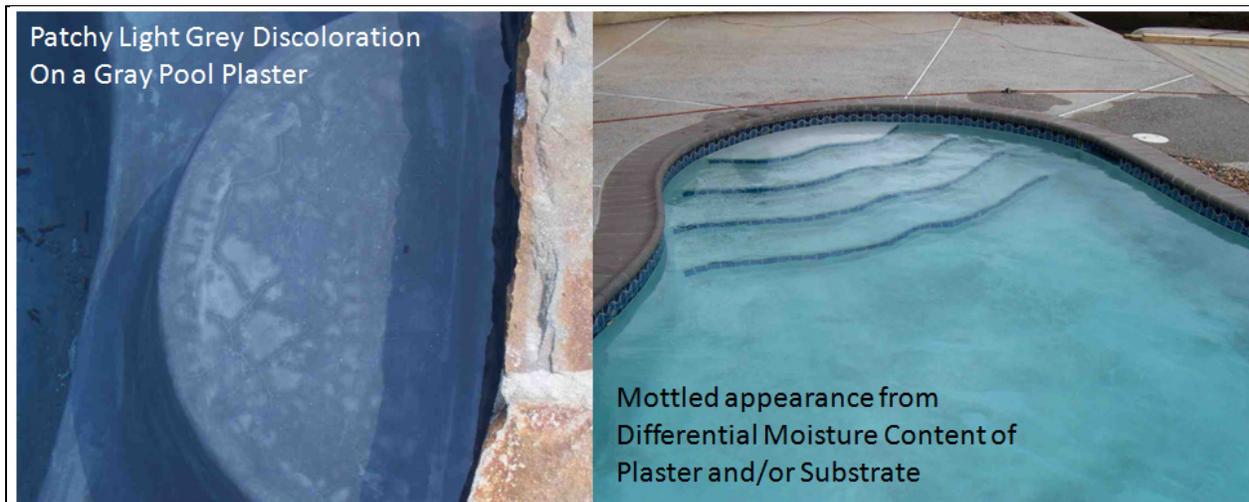
Figure 19 – Mottled Discoloration of Pool Plasters.

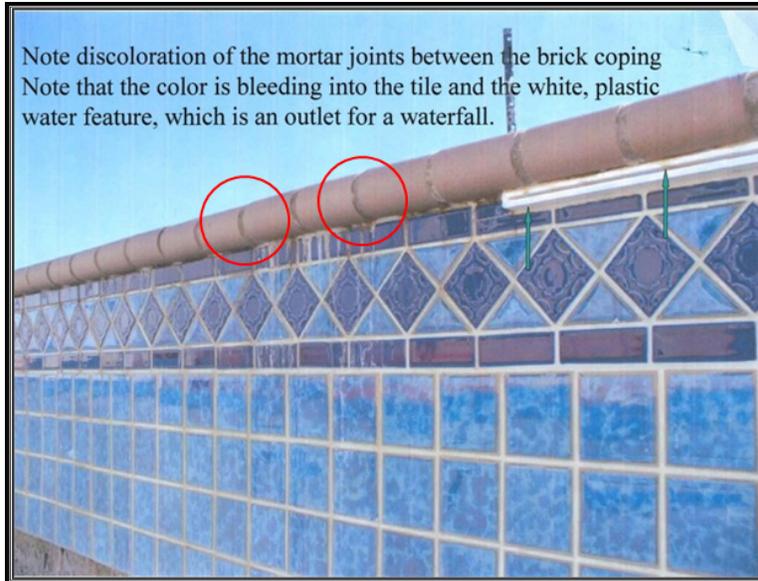
The brick-masonry coping of a swimming pool showed dark gray to brown discoloration of jointing mortars, causing drip stains on plaster surface from the mortar joints. Brick units were brown, solid, clay-fired masonry, containing dark brown glassy aluminosilicate matrix, fine (< 1 mm size), angular quartz and feldspar grains, and dark brown to black grog of ferruginous materials. Jointing mortars are non-air-entrained and made using portland cement, sand, and a polymer binder. Elemental analyses of jointing mortars from stained areas show a marked enrichment of manganese in the stained mortars, having maximum concentration at darkest stained areas adjacent to bricks, an element, also detected in the adjacent bricks. Migration of manganese from bricks to the adjacent jointing mortar by splashing of the pool water has caused the stain. Manganese is common in many clay fired bricks that can cause similar staining in masonry coping or pool plaster.

Figure 20 – Dark brown stain on mortar joints (circled) from migration of manganese in bricks.

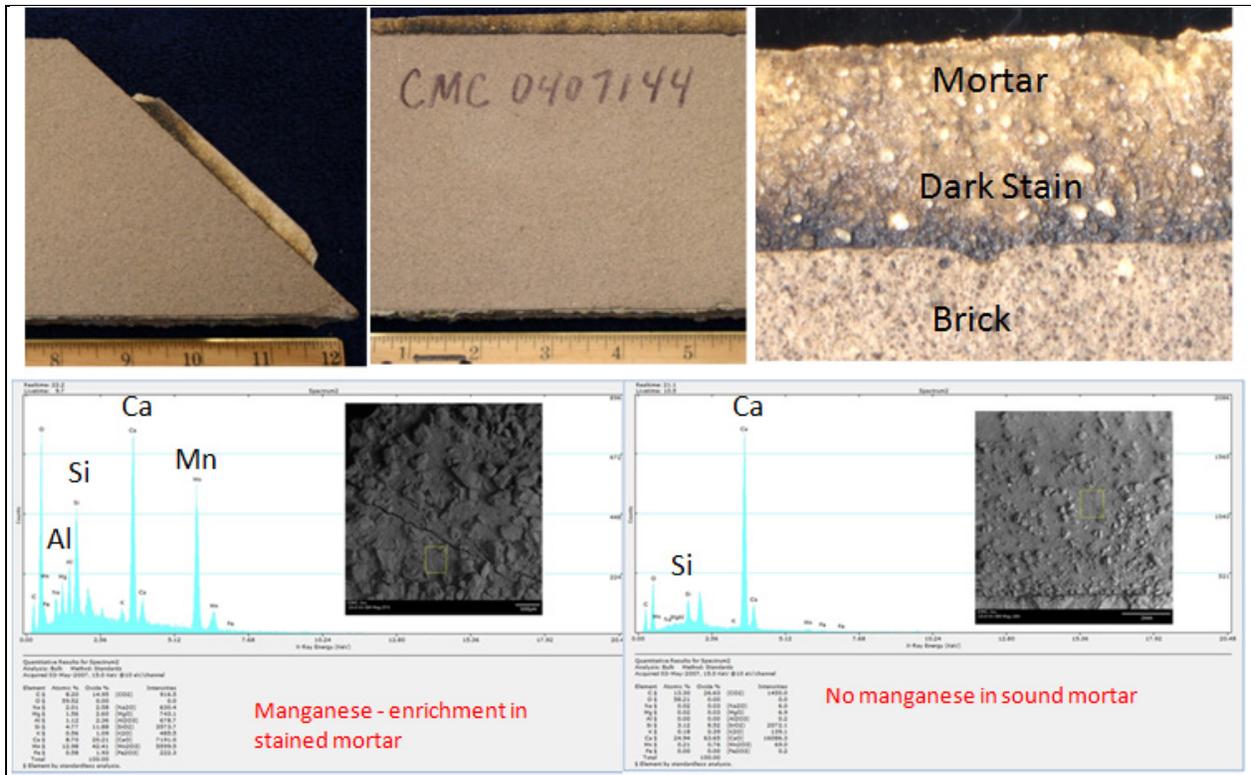
Figure 21 – The top row photos show the dark stain on jointing mortars, which have prompted the investigation. The bottom rows show manganese (Mn) enrichment in the stained mortar and its absence in the sound mortar, where Mn was derived from the adjacent bricks.

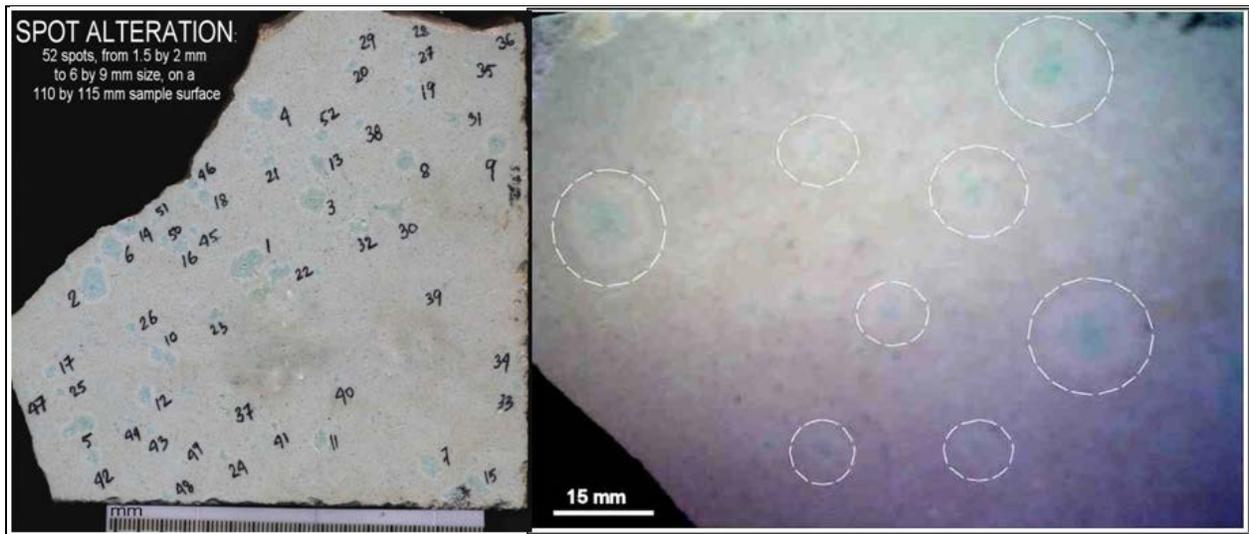
Figure 23 – Photographs of a plaster sample showing spot alteration. The left photo shows 52 spots of different sizes (from 1.5 × 2 mm to 6 × 9 mm) over an area of 110 × 115 mm. The right photo is an enlarged view showing spots having green stained cores and white rims.

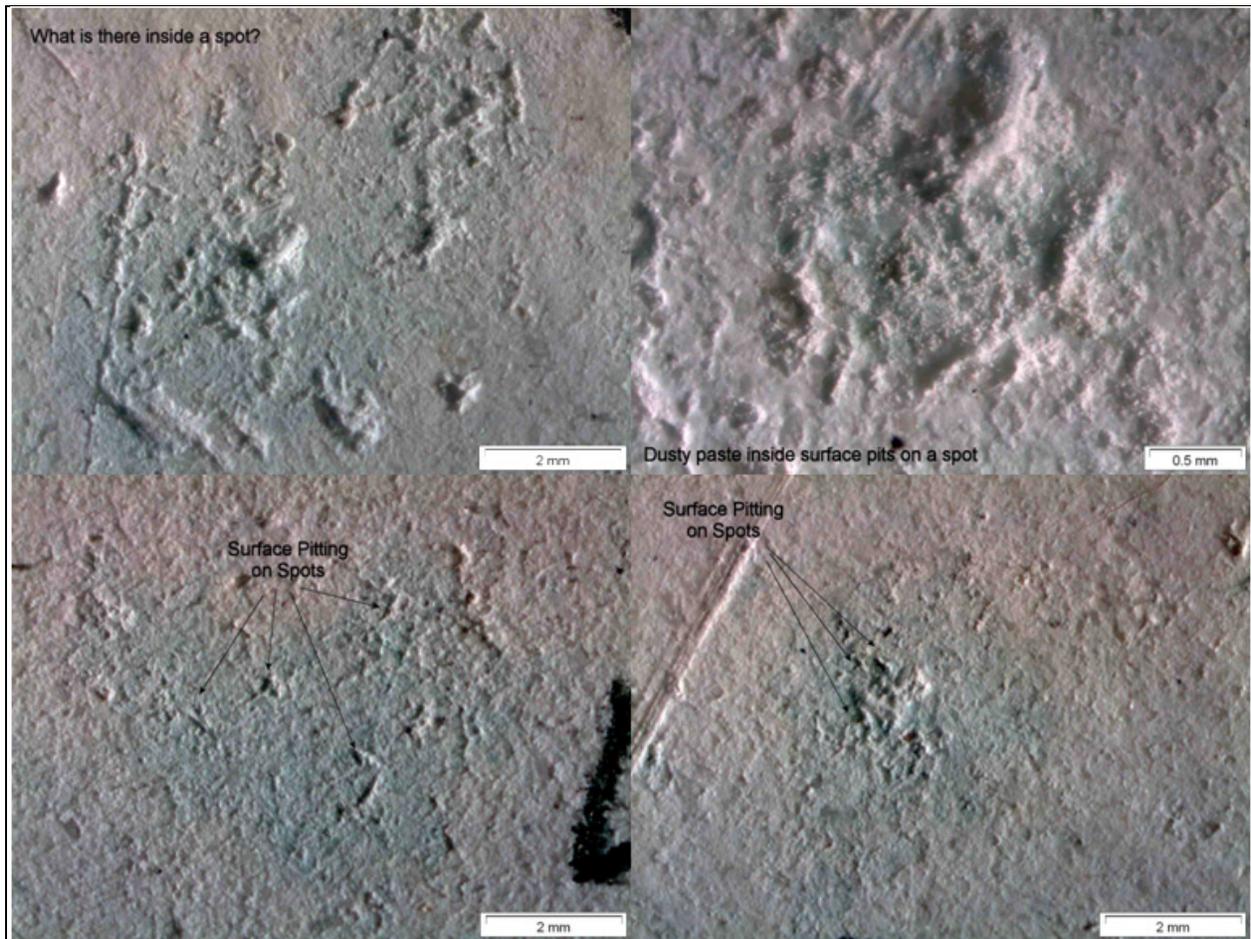
Scanning electron microscopical examinations show evidence of leaching of calcium hydroxide from plaster beneath the spots, and precipitation of secondary calcium carbonate deposits on the surfaces of some samples by the fluctuating water chemistries. Scales, when found, however, occurred not only over the spots but in other areas as well, as thin (less than 50 micron in thickness) carbonate layers.

Figure 24 – Photomicrographs of plaster surface on and around the spots (taken by using a stereo microscope at a magnification of 10X) showing small surface pitting and leaching of paste on the spots, dusty appearance of paste around the aggregate particles on the spots, and greenish stains due to preferential enrichment of copper at the spots. Note the surface pitting at the spots are characteristic, occurred in almost all the spots and are not so evident in areas away from the spots.

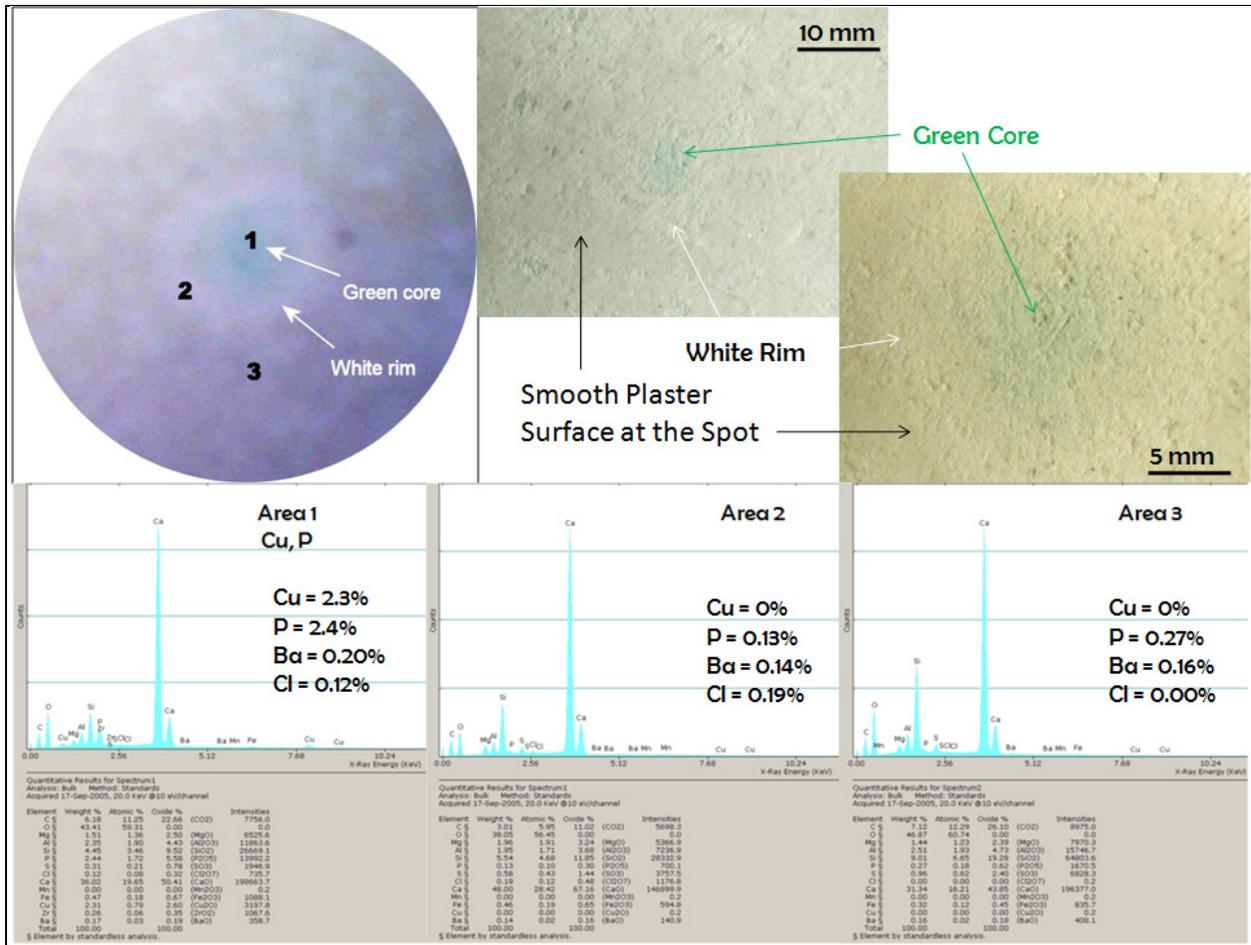
Figure 25 – The top left photo shows scanned image of a spot, where the green core, surrounded by a white rim are noticed. The two photomicrographs on the right show the spot at higher magnifications, where the green stain at the core is distinct. The lower three spectra are x-ray elemental analyses of the green core (marked as '1'), white rim (marked as '2'), and area away from the spot (marked as '3'), showing enrichment of copper, chlorine, and phosphorus at the spot. Copper stain at the spot is from copper algacides used in this pool, where the porous paste beneath the spot absorbed copper from the pool water.
