SWIMMING POOL PLASTER DETERIORATION – OVERVIEW & CASE STUDIES

Dipayan Jana

Applied Petrographic Services, Inc., and Construction Materials Consultants, Inc. Greensburg, PA, USA

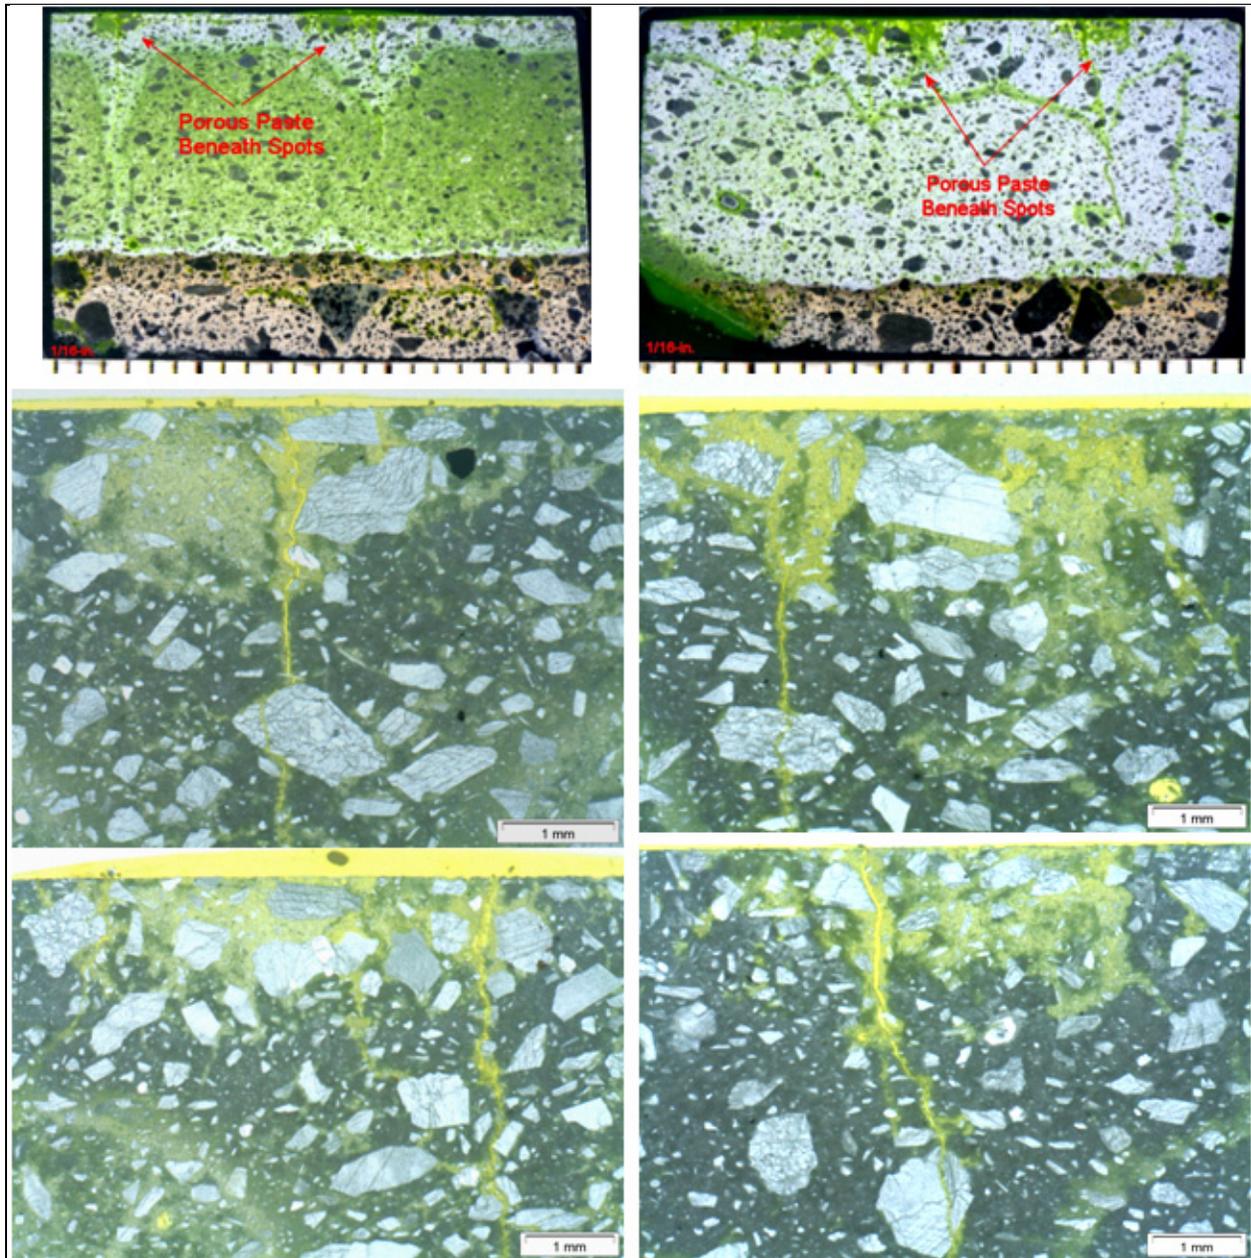
Figure 26 – Photomicrographs of polished fluorescent dye-mixed epoxy-impregnated thick sections (~100 microns thick) of plaster and concrete in the core, cross-sectioned through the spots, showing: (a) carbonation of plaster at the surface region, down to a depth of $\frac{1}{8}$ to $\frac{3}{16}$ in., where the carbonated paste at the surface being denser than the paste in the body showed a lower absorption of dyed epoxy than that in the body, a greater depth of carbonation along the vertical shrinkage microcracks than the areas in between the microcracks (creating V-shaped carbonation fronts along the paths of the microcracks), and (b) small zones of leached and porous paste at the surface, immediately beneath the spots, within the carbonated paste, which are highlighted by the fluorescent dye-mixed epoxy (marked with arrows).

The middle and bottom row photos are reflected-light photomicrographs of sections (by using an Olympus SZX12 stereo zoom microscope), where porous areas of paste around the microcracks and situated beneath the spots are readily highlighted by the yellow fluorescent dye-mixed epoxy.

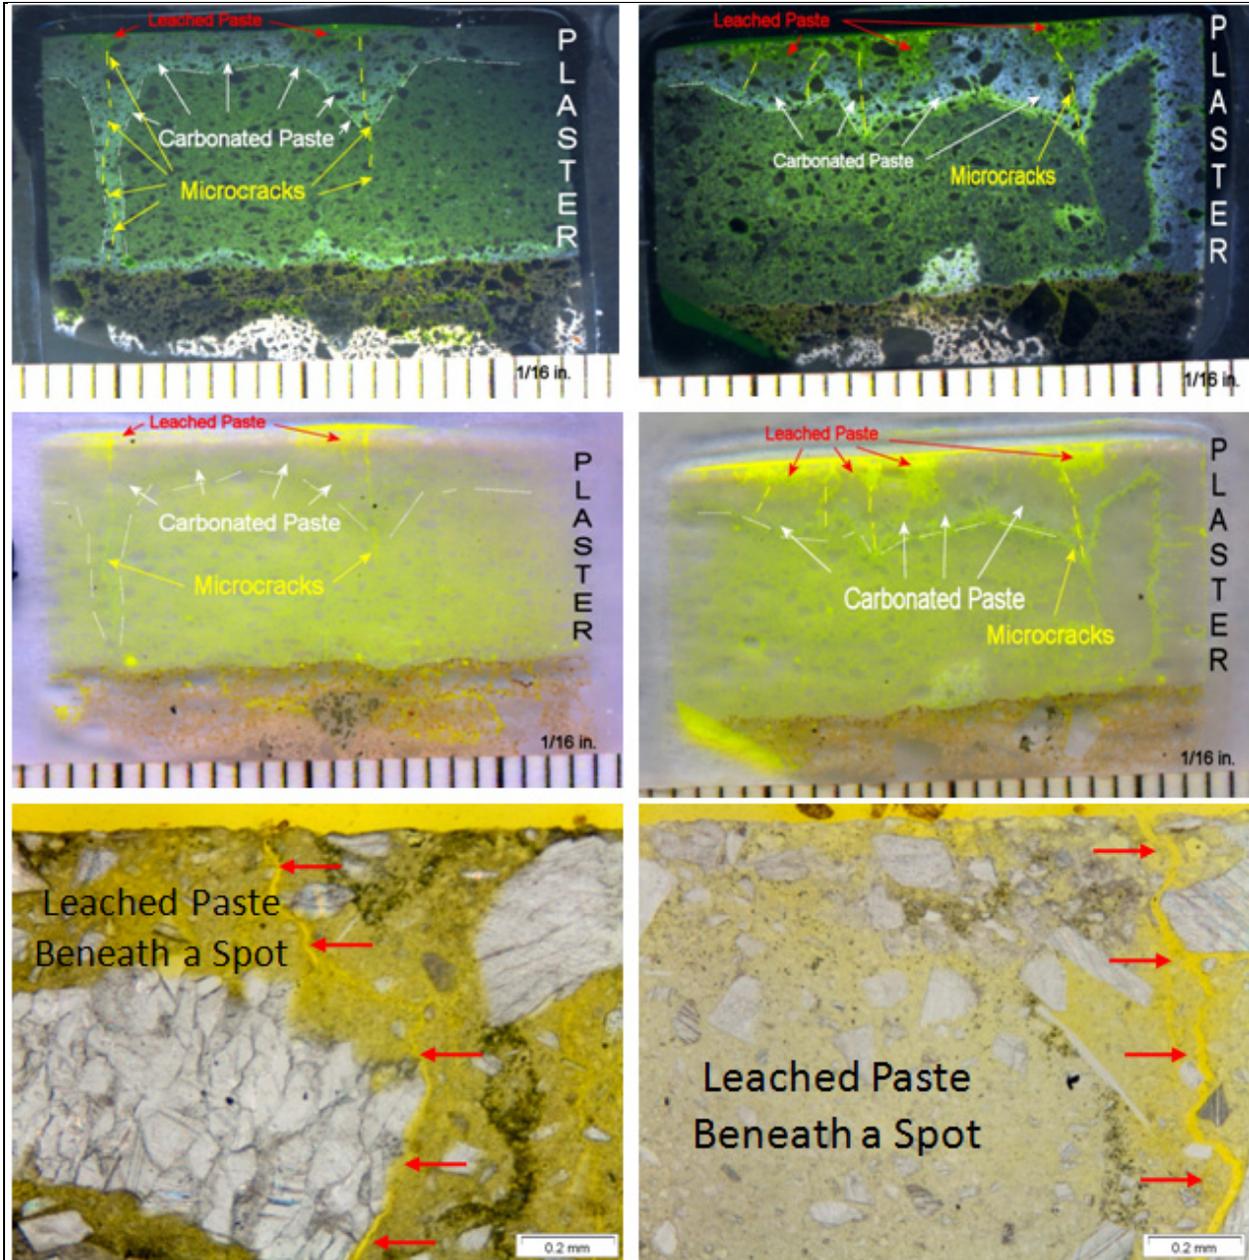
Figure 27 – Photomicrographs of fluorescent dye-mixed epoxy-impregnated thin sections (~ 30 microns thick) of plaster and concrete in the core, cross-sectioned through the spots (of the same samples shown in Figure 25 but after further grinding the sample thickness from ~ 100 to ~ 30 microns), showing: (a) carbonation of plaster at the surface region, down to a depth of $\frac{1}{8}$ to $\frac{3}{16}$ in., greater depth of carbonation along shrinkage microcracks (creating V-shaped carbonation front along the paths of the microcracks, and (b) small zones of leached paste immediately beneath the surface spots, where carbonated paste has been leached out relative to aggregates.

The top and middle row photos are of the same thin sections, scanned on a flatbed scanner, by using a black and a white background, respectively. The lower row photos were taken by using a Nikon Labophot 2 POL petrographic microscope in plane polarized-light mode.

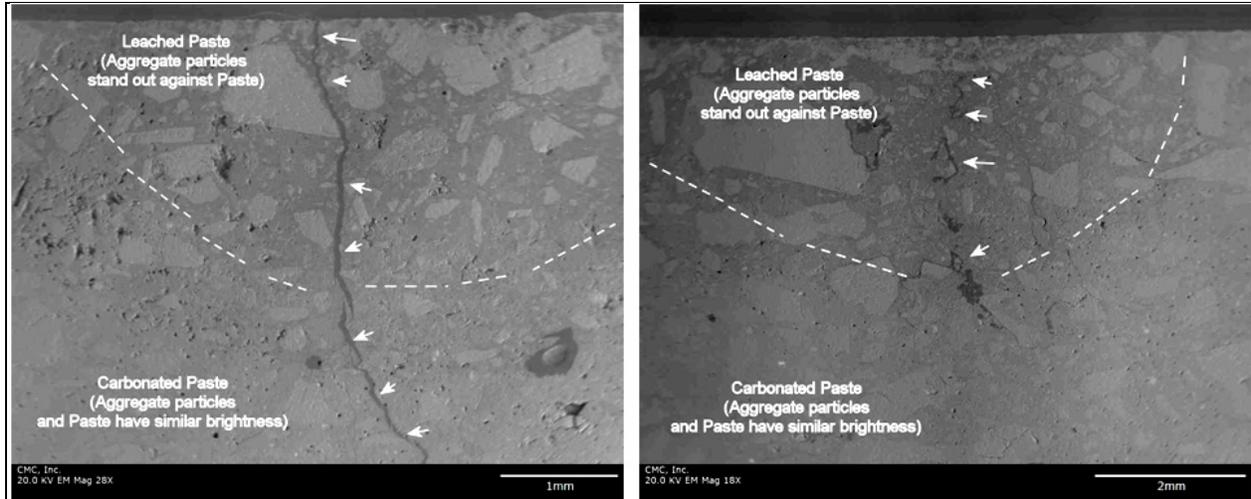
Figure 28 – Backscatter electron images of polished cross section of plaster (taken by using a CamScan Series II SEM) showing preferential leaching of paste relative to aggregates (areas within the dashed lines) beneath the surface spots causing proud exposure of aggregate against the paste, and, more or less non-differentiated aggregate and paste (carbonated) in areas away from the leached zones. Arrows mark shrinkage microcracks.

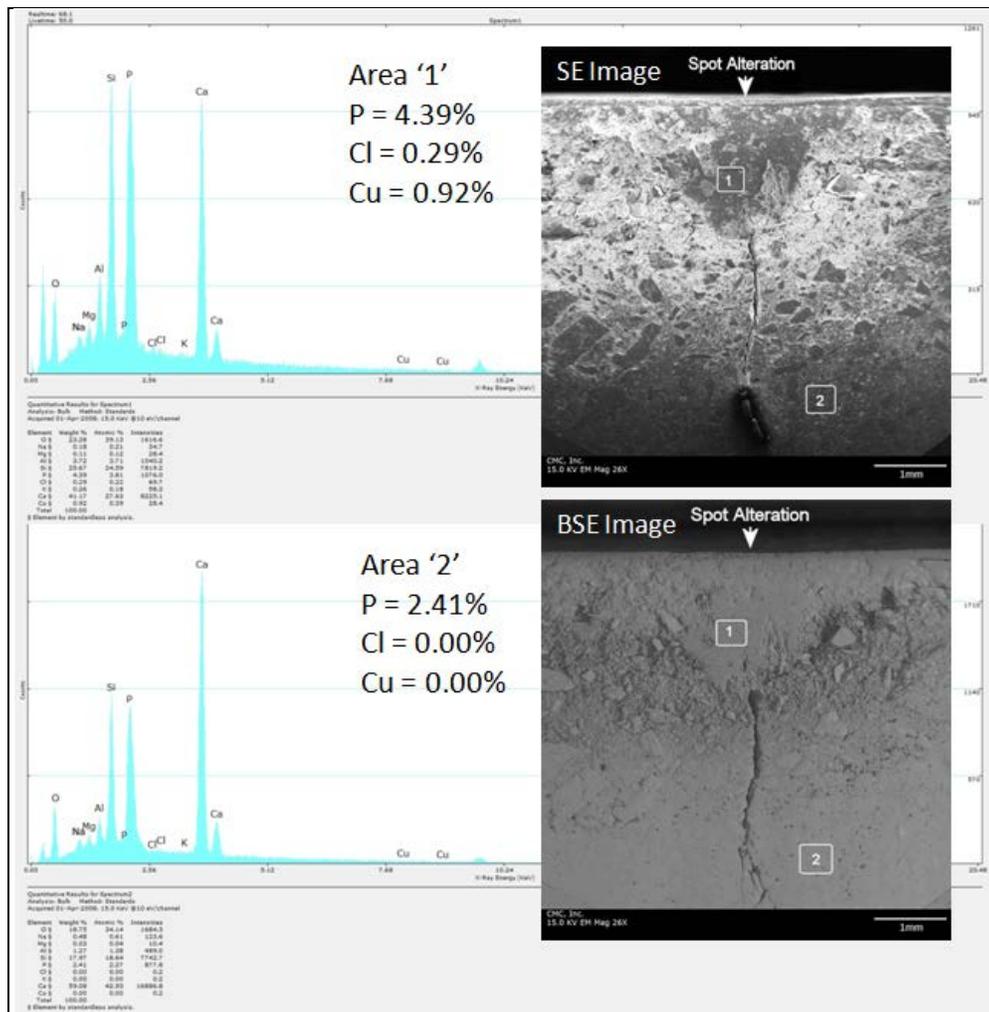
Figure 29 – X-ray elemental analyses of polished cross section of plaster showing P, Cu, and Cl enrichment in an area beneath the surface spot (marked as '1') and their depletion in an area away from the spot (marked as '2').
