## Laboratory Investigation Of Coating Failure From Stucco Façades Of An 18<sup>th</sup> Century Courthouse In Charleston, South Carolina

Charleston County Courthouse Exterior Façade  
Charleston, South Carolina

September 29, 2020  
CMC 0820145

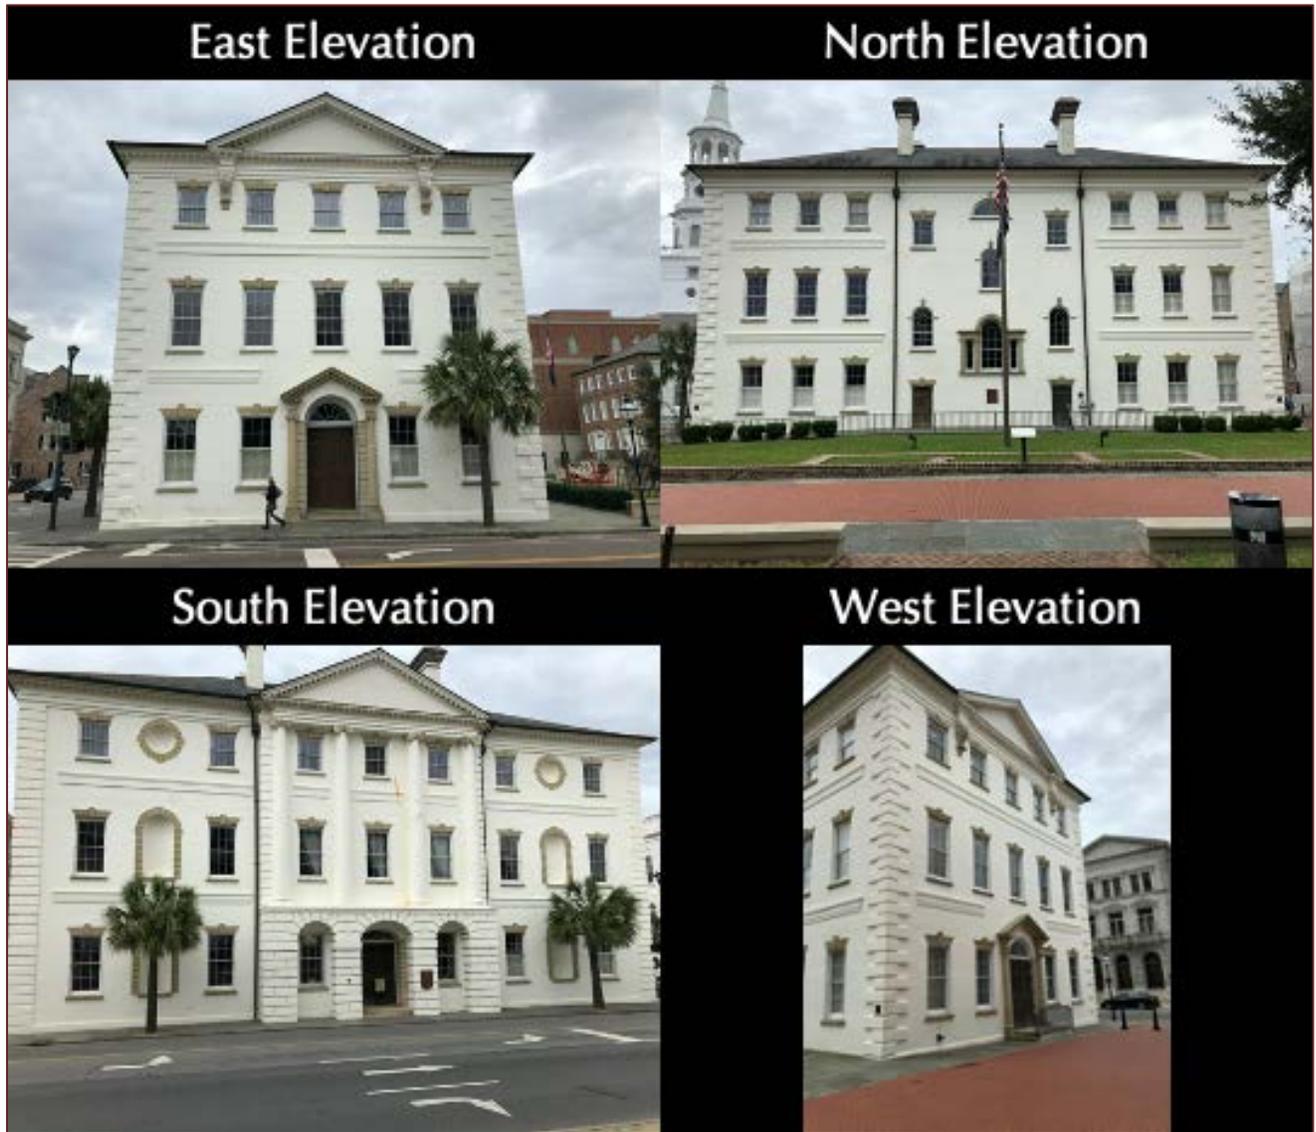
Figure 1: Field photos of north, south, east, and west elevations of Charleston County courthouse in Charleston, South Carolina. Samples for the present study were collected from the north, south, and east elevations. An additional sample from the west elevation was provided to study the paint coat. The next two photos show the sample locations as well as areas that show peeling of paint from stucco façade.

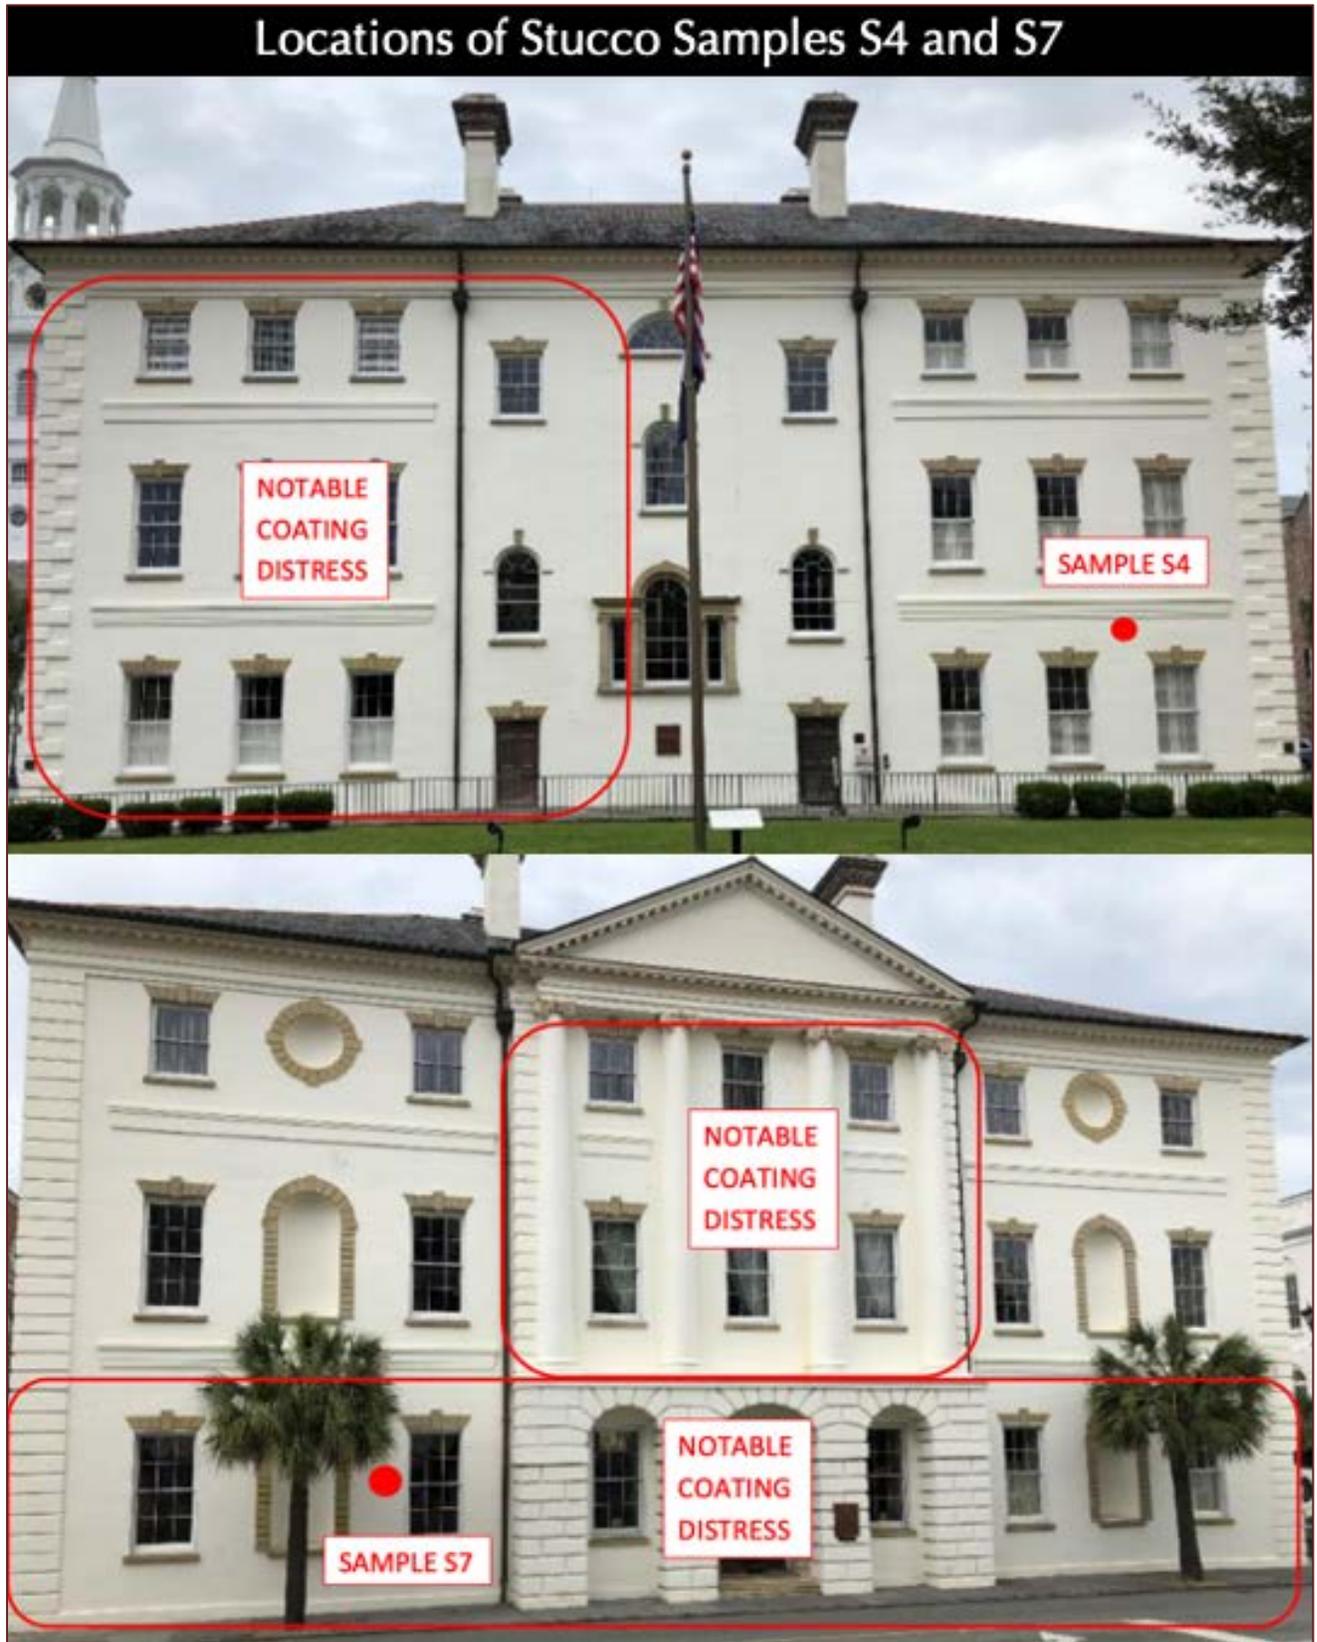
Figure 2: North (top) and south (bottom) elevations of courthouse showing areas of notable coating failures (boxes) and locations of Samples S4 at north elevation and S7 at south elevation.

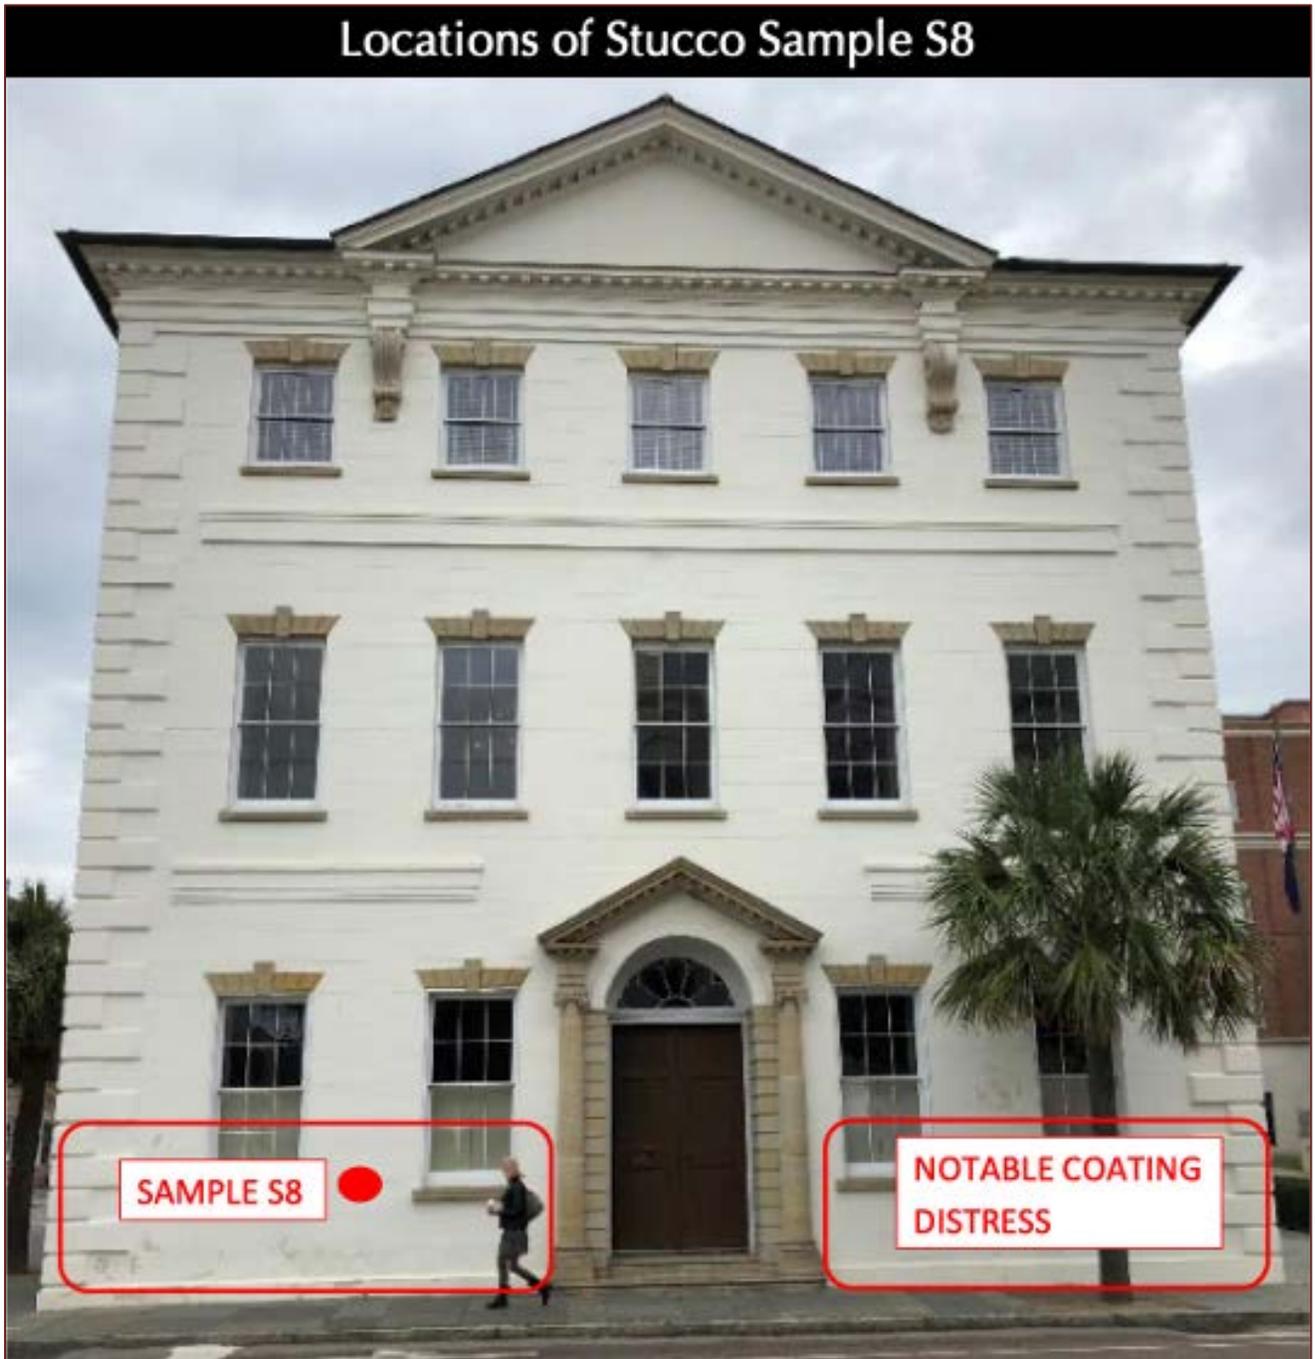
Figure 3: East elevation of courthouse showing area of notable coating failures (box) and location of Sample S8.

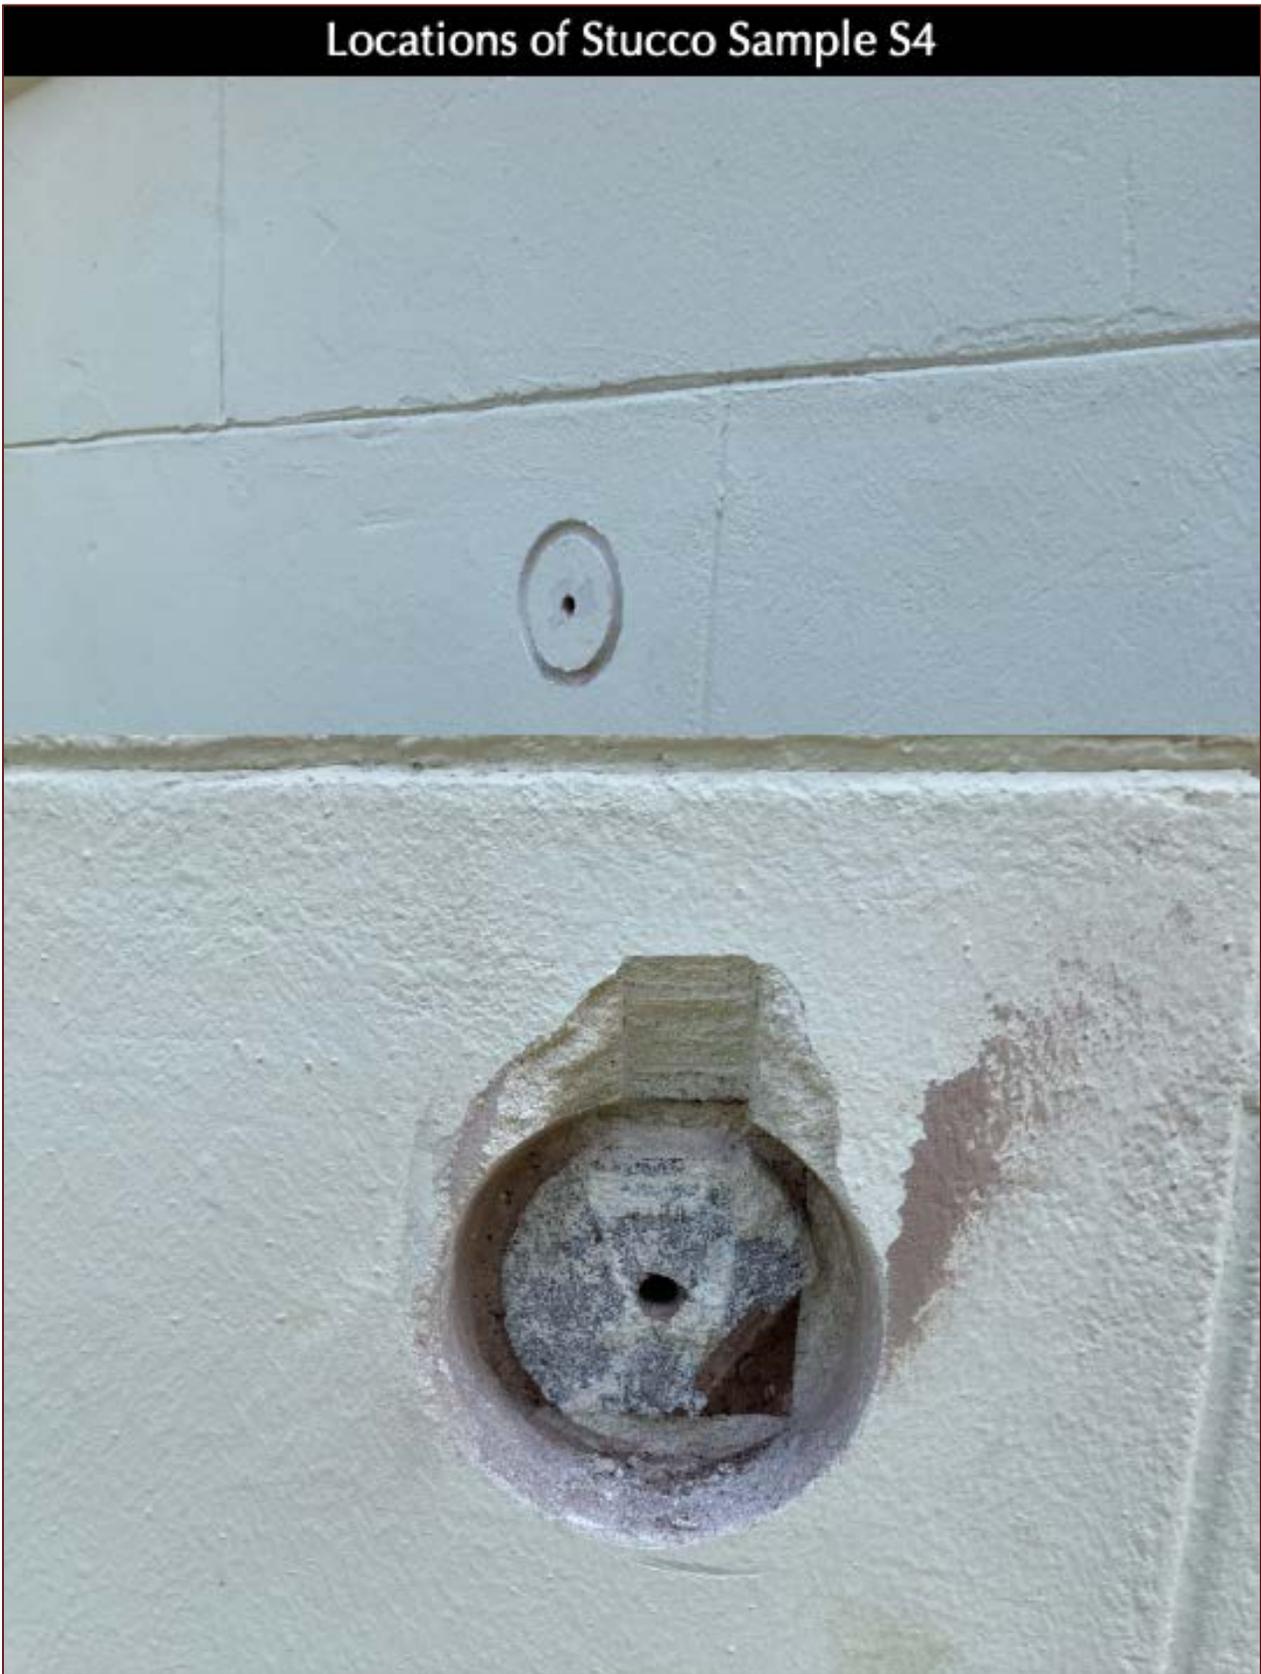
Figure 4: Close-up of location of Sample S4 at north elevation. Notice a thin paint coat on stucco where the paint is reportedly adhered well to the stucco base.

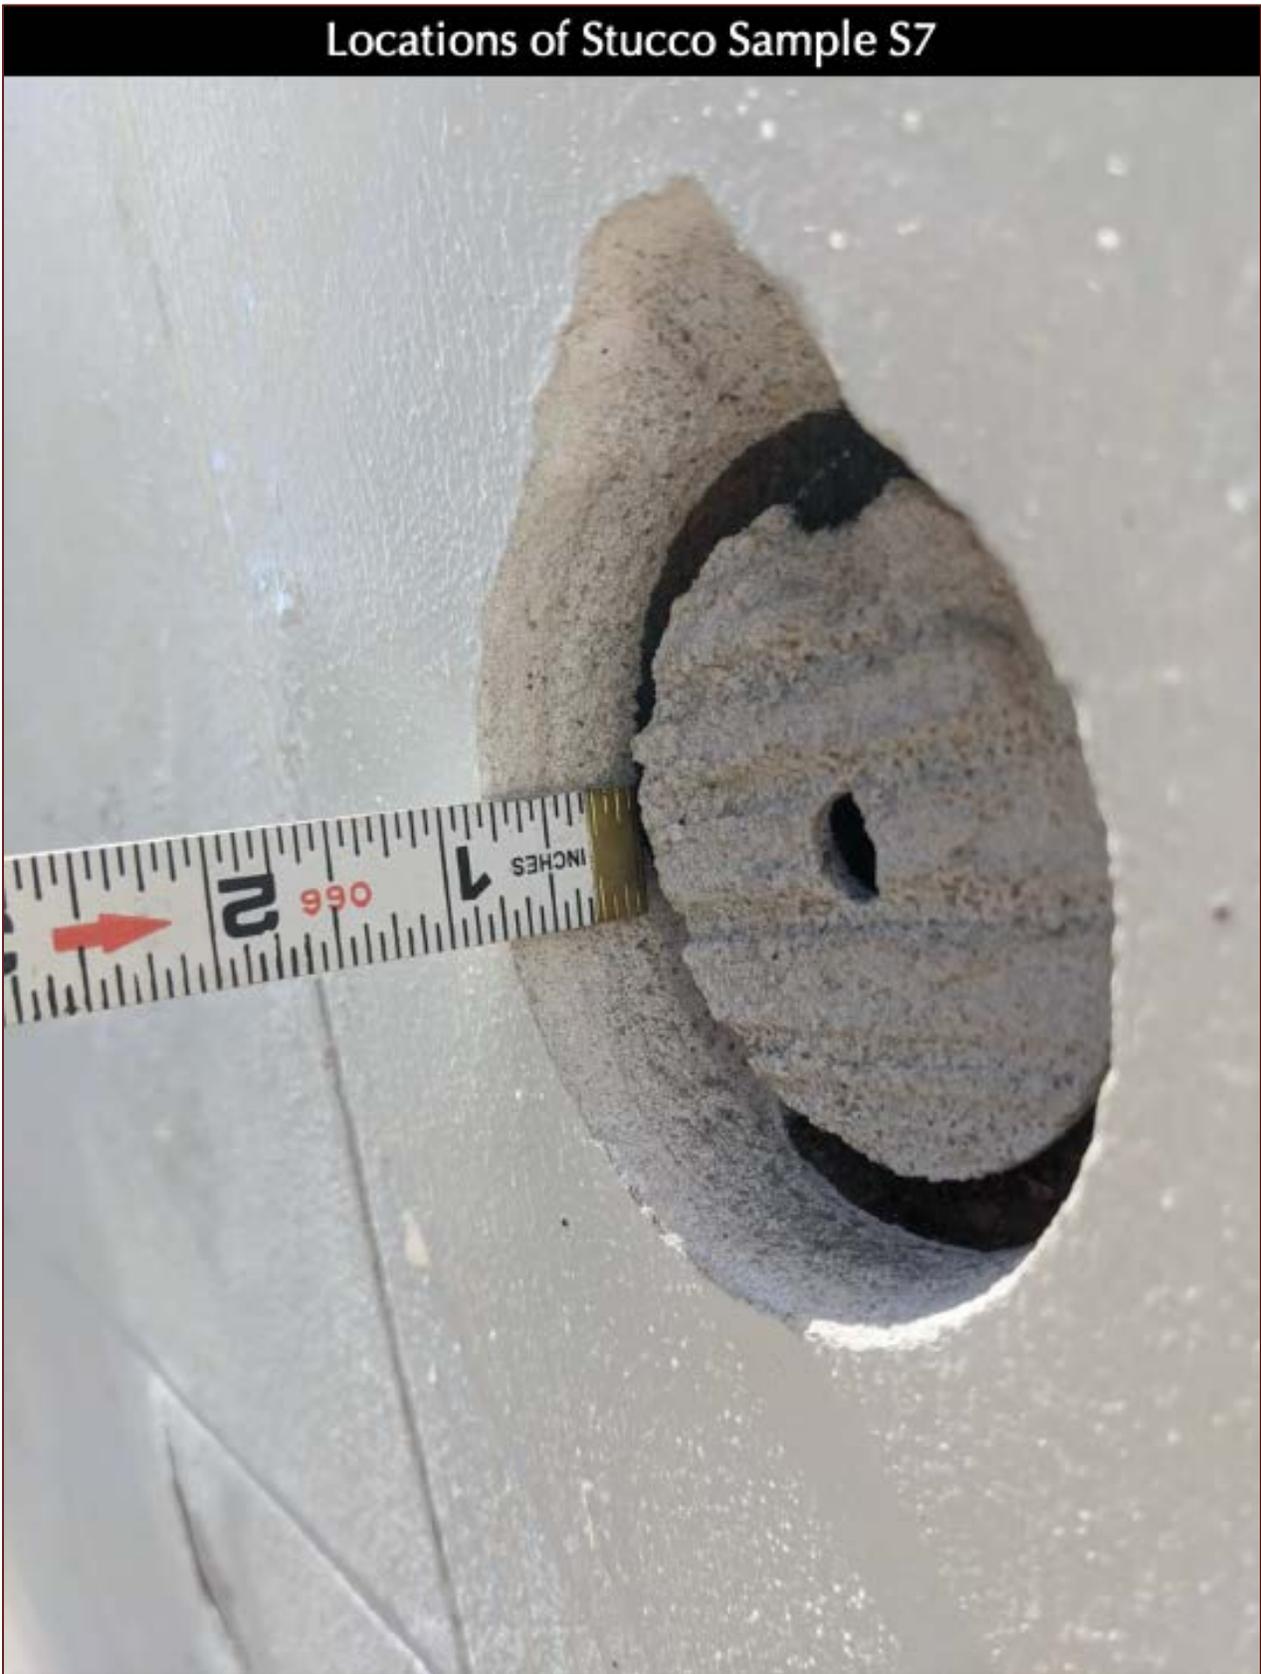
Figure 5: Close-up of location of Sample S7 at south elevation. Notice no apparent peeling or delamination of paint at the drilled core location. Two coats of stucco are seen at the drilled wall.

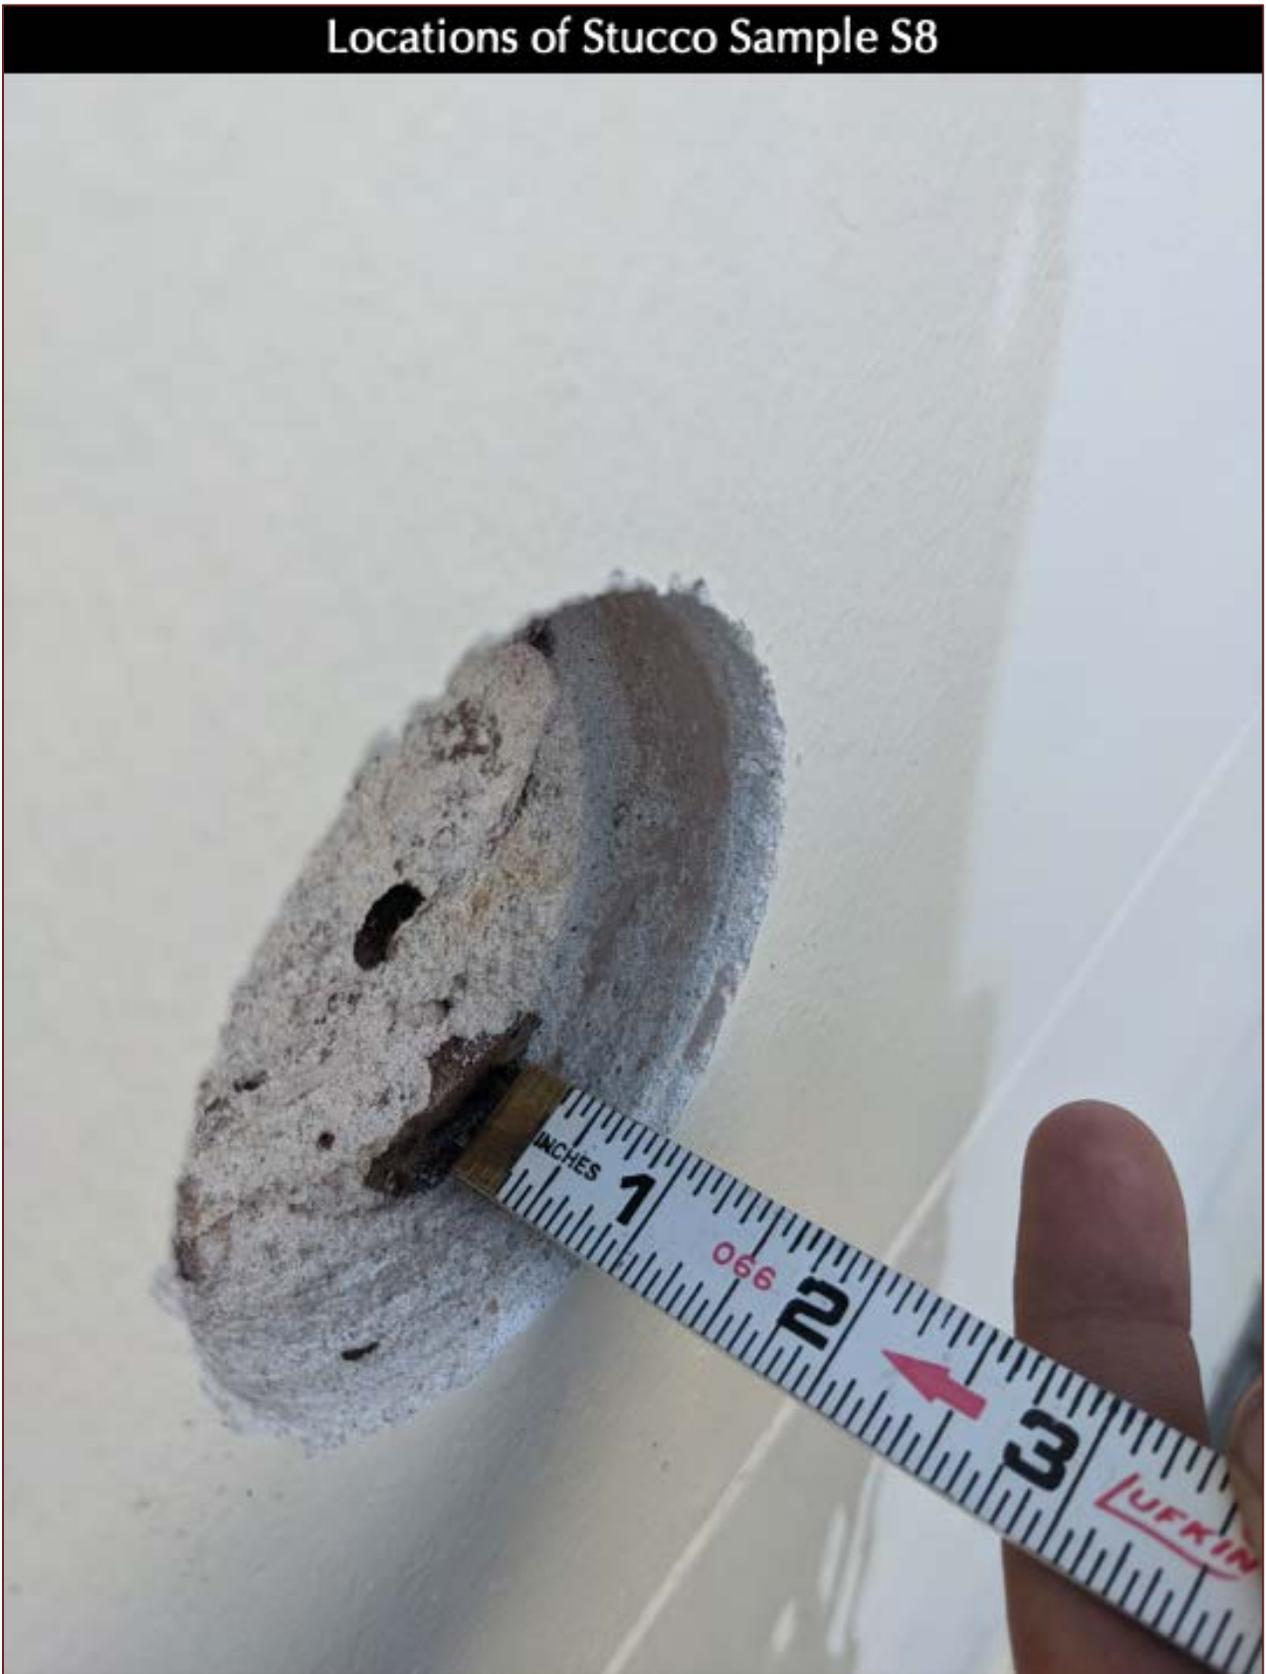
Figure 6: Close-up of location of Sample S8 at east elevation. Notice no apparent peeling or delamination of paint at the drilled core location.

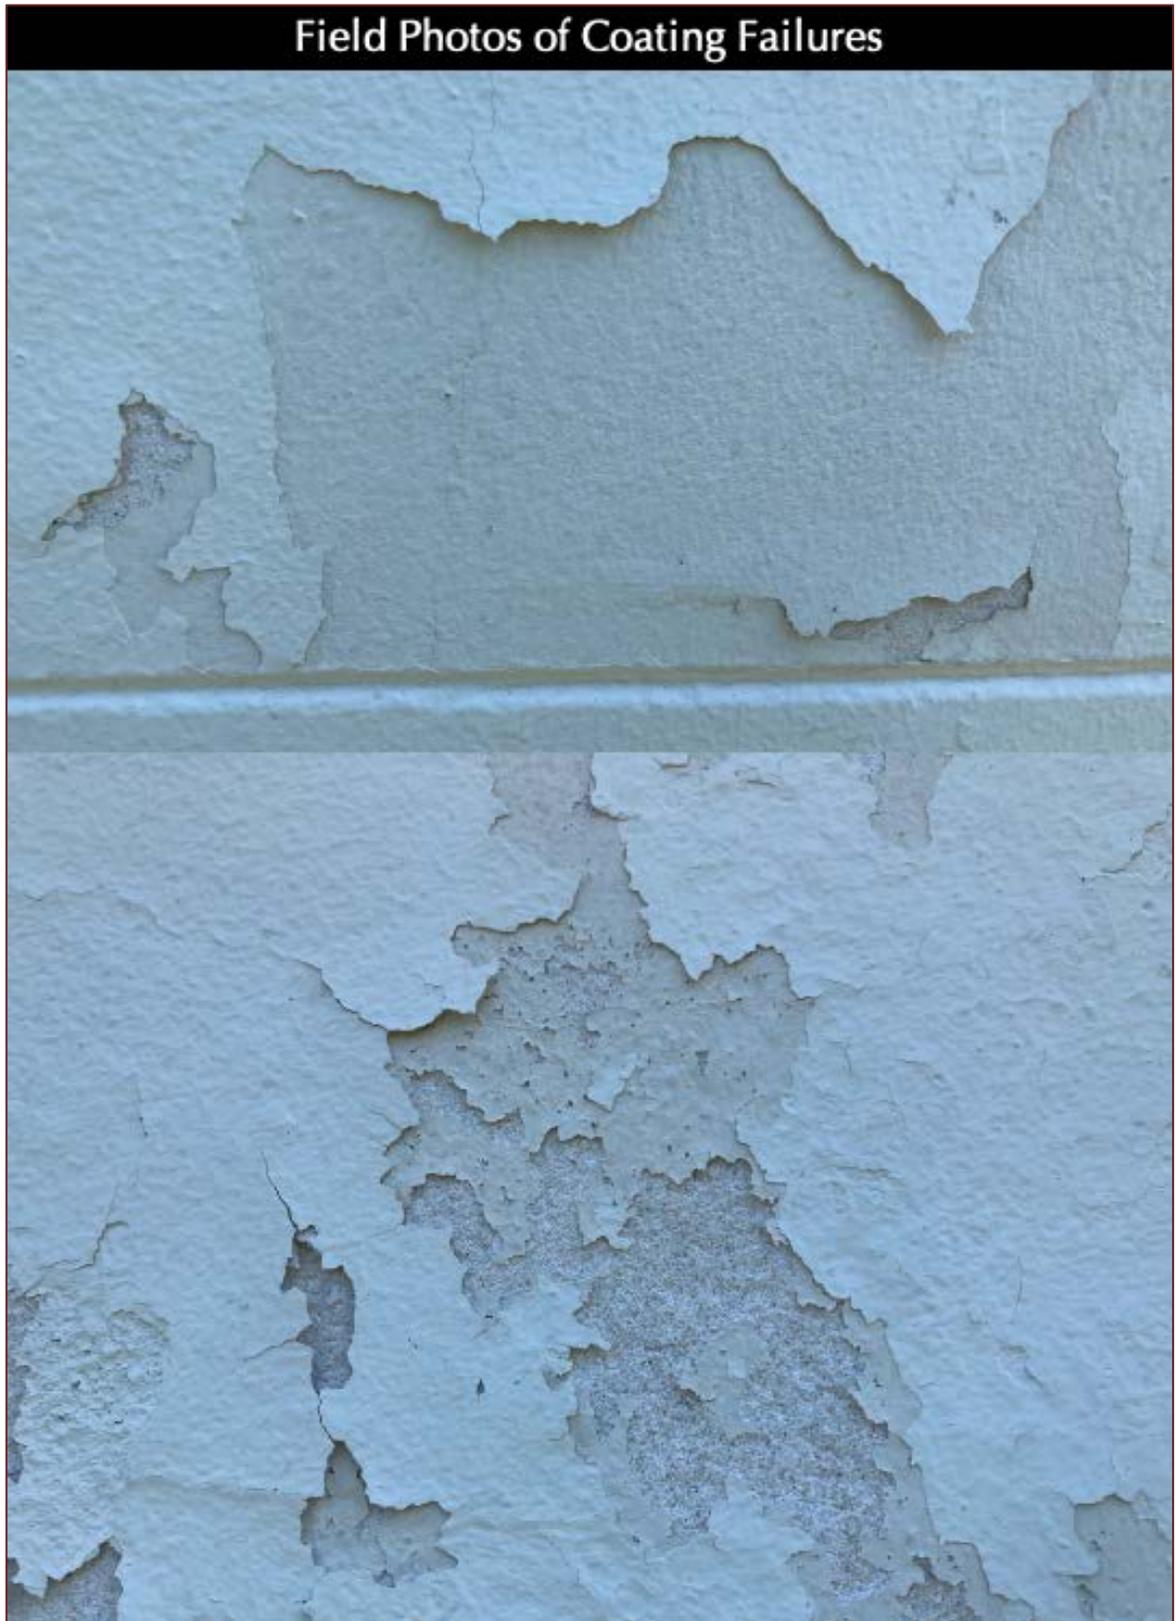
Figure 7: Coating failures as peeling of paint at various locations of stucco façade. Both photos show peeling of at least two applications of paint – peeling of a lighter color top paint coat from the underlying darker toned paint, which, in turn is de-bonded from the underlying soft stucco base.

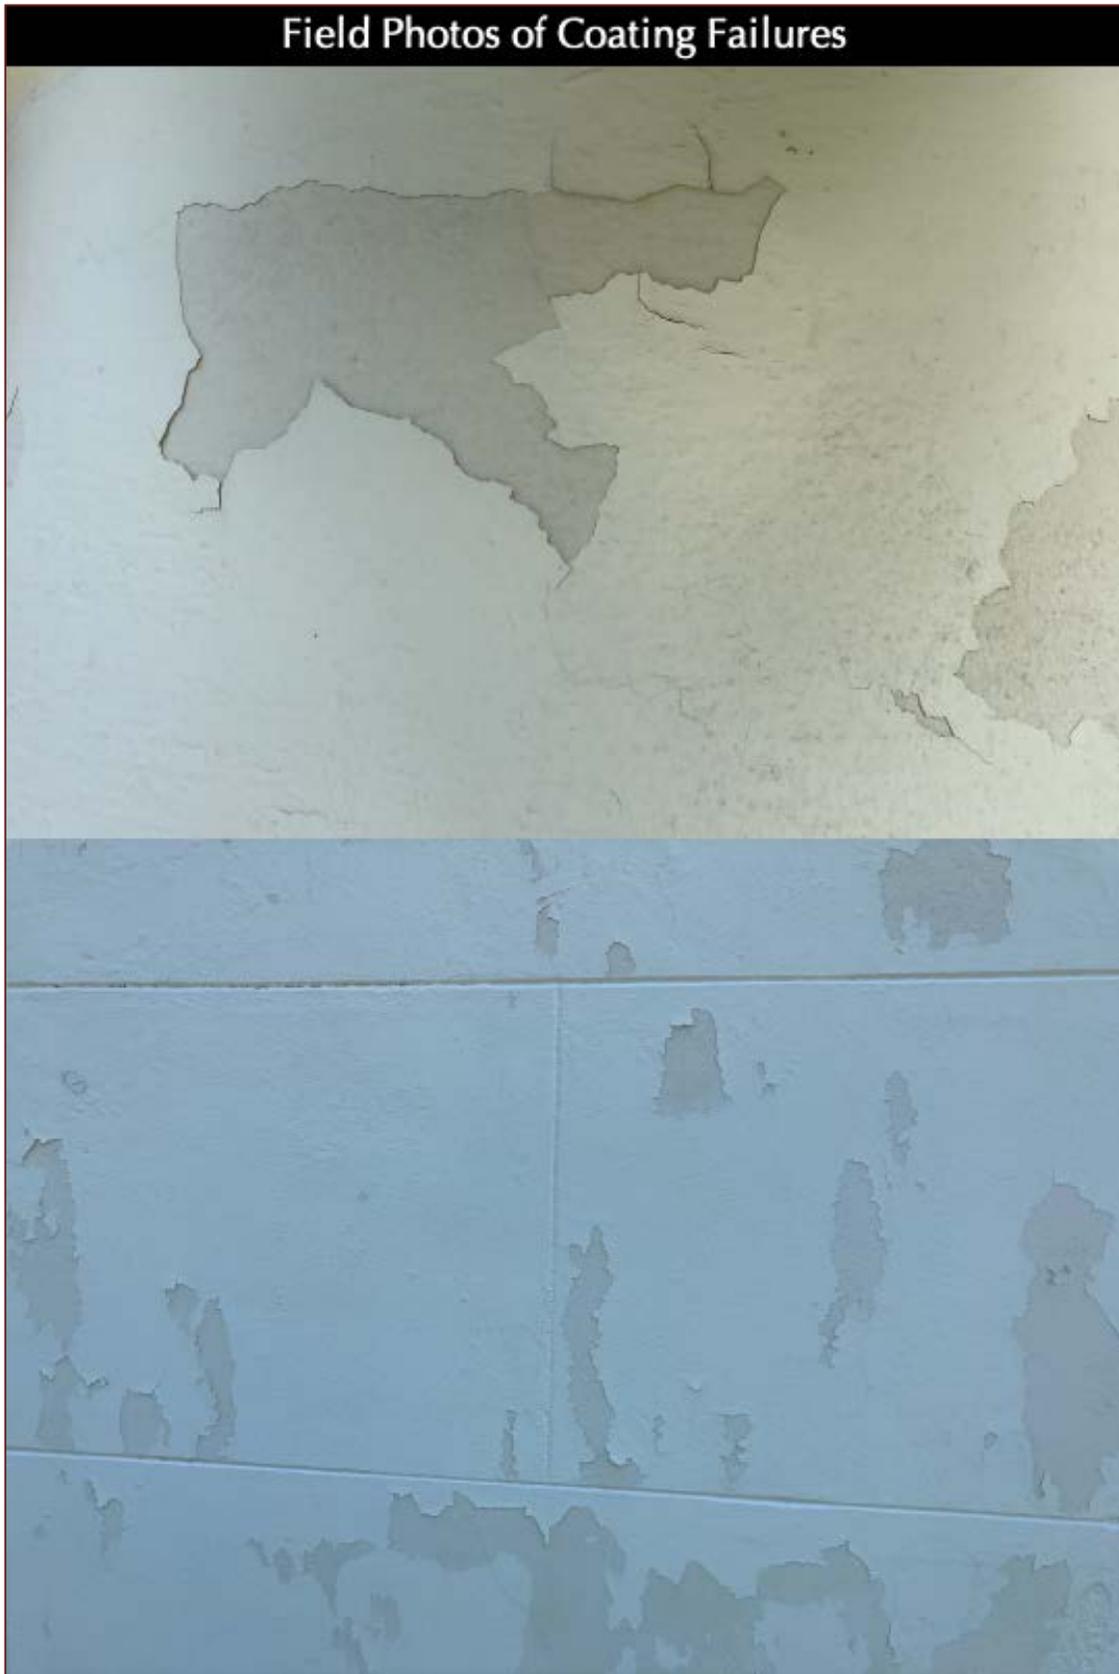
Figure 8: Coating failures as peeling of paint at various locations of stucco façade.

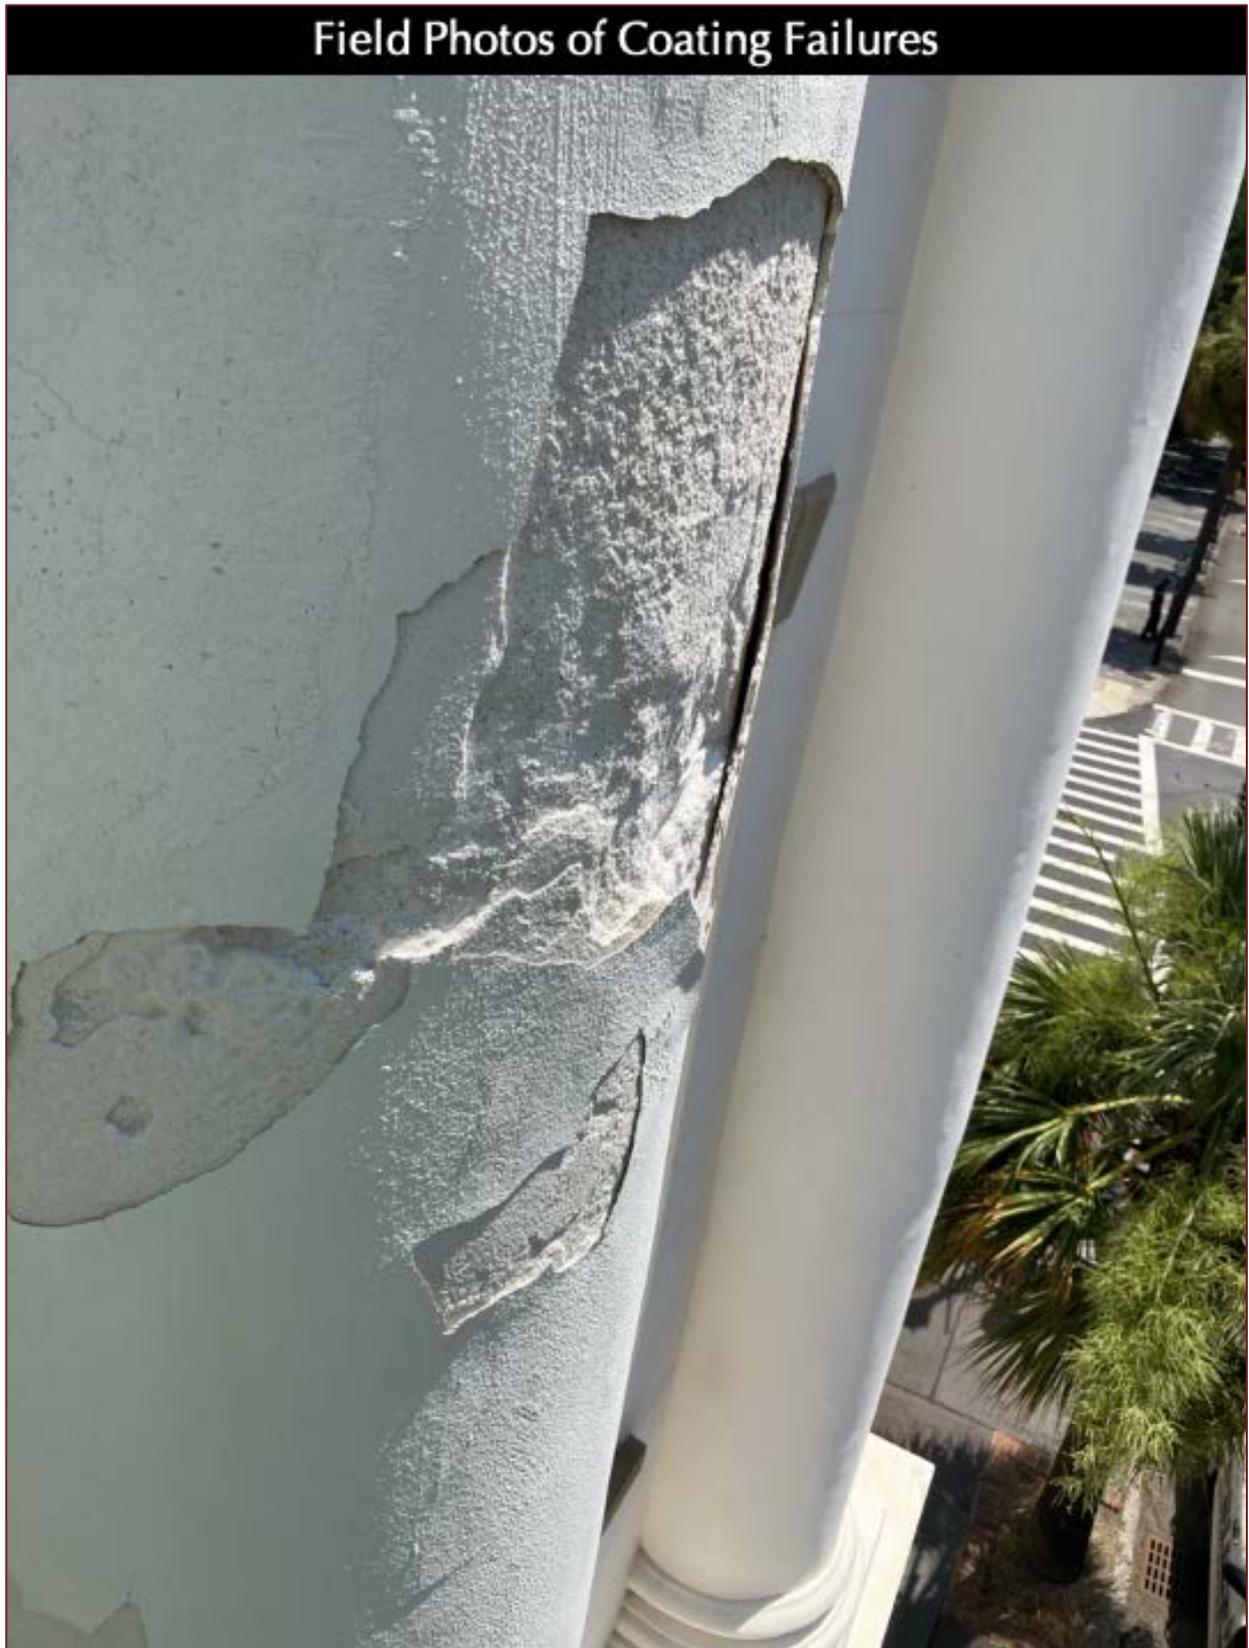
Figure 9: Coating failures as peeling of paint at columns. Notice relatively thicker paint coat that has been delaminated from the stucco base at this column location compared to the thin paint peeling seen in Figure 7 and 8.

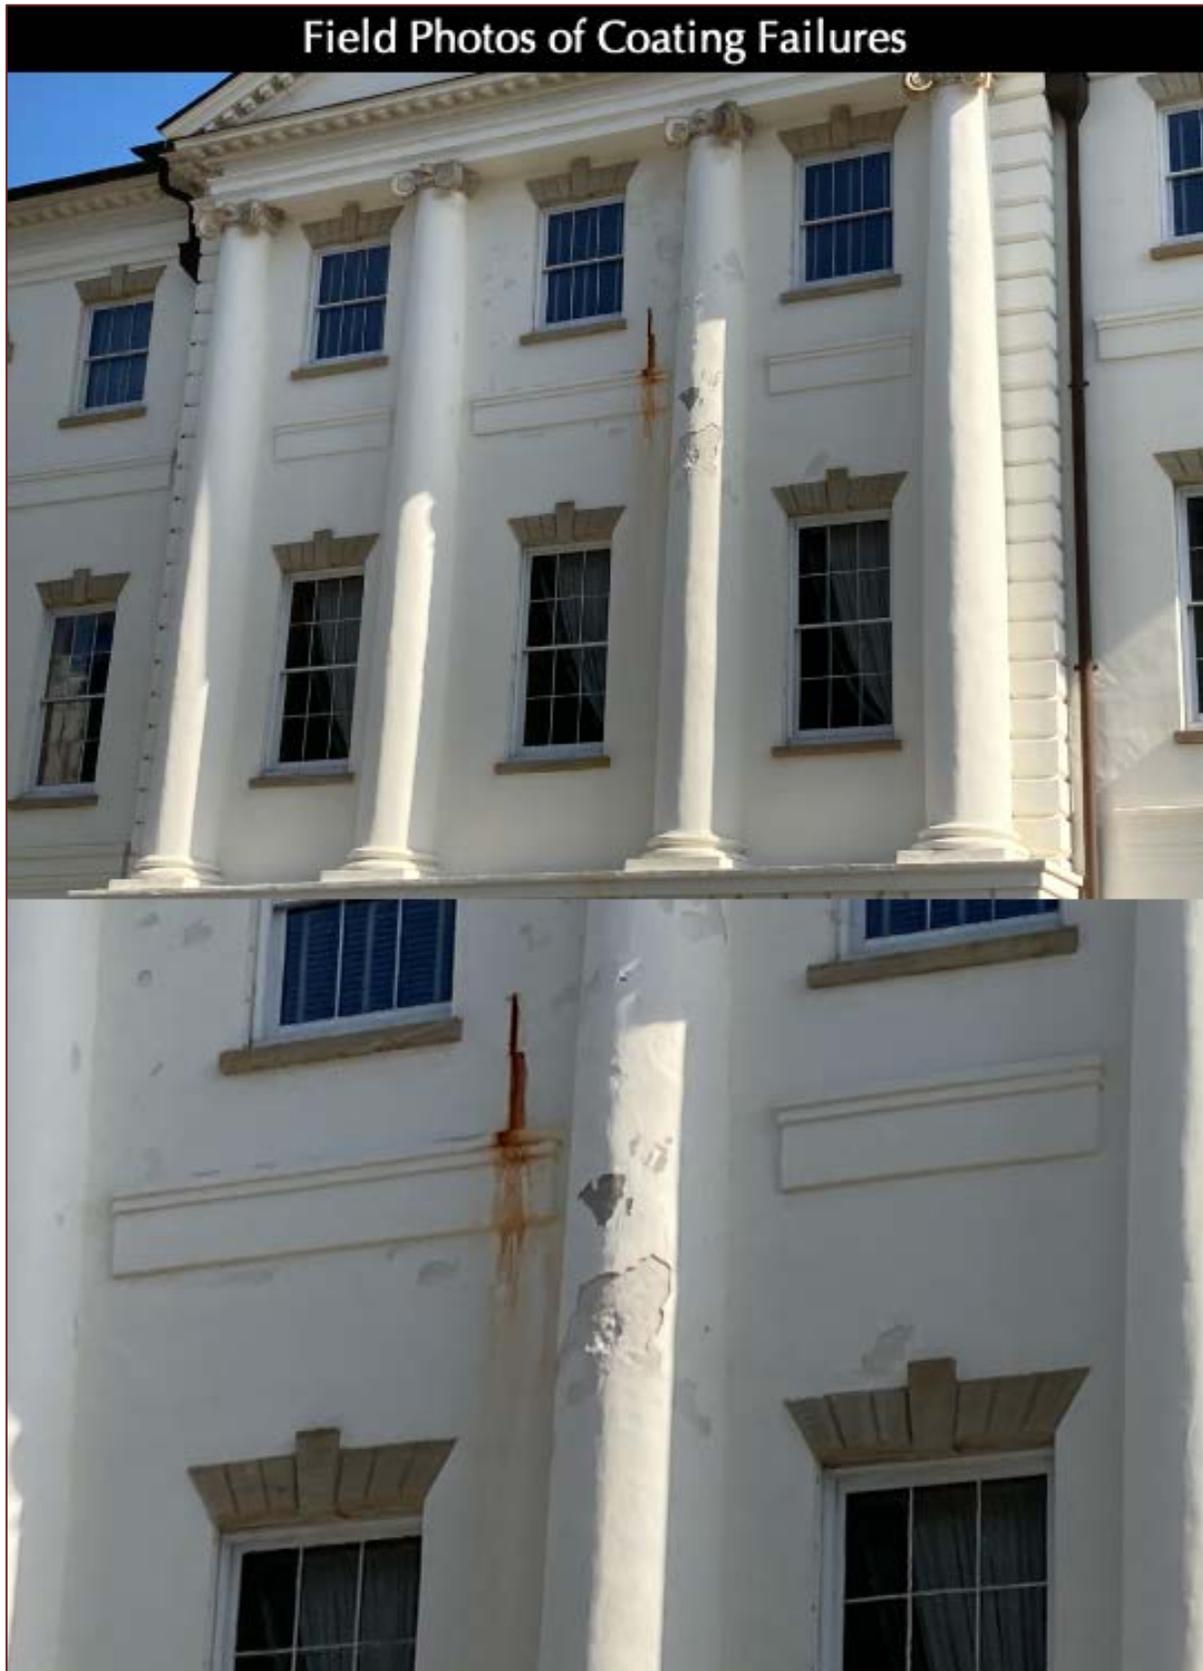
Figure 10: Reddish-brown stain and coating failures as peeling of paint at columns. Figure 9 showed a close-up of this column where paint has been delaminated.

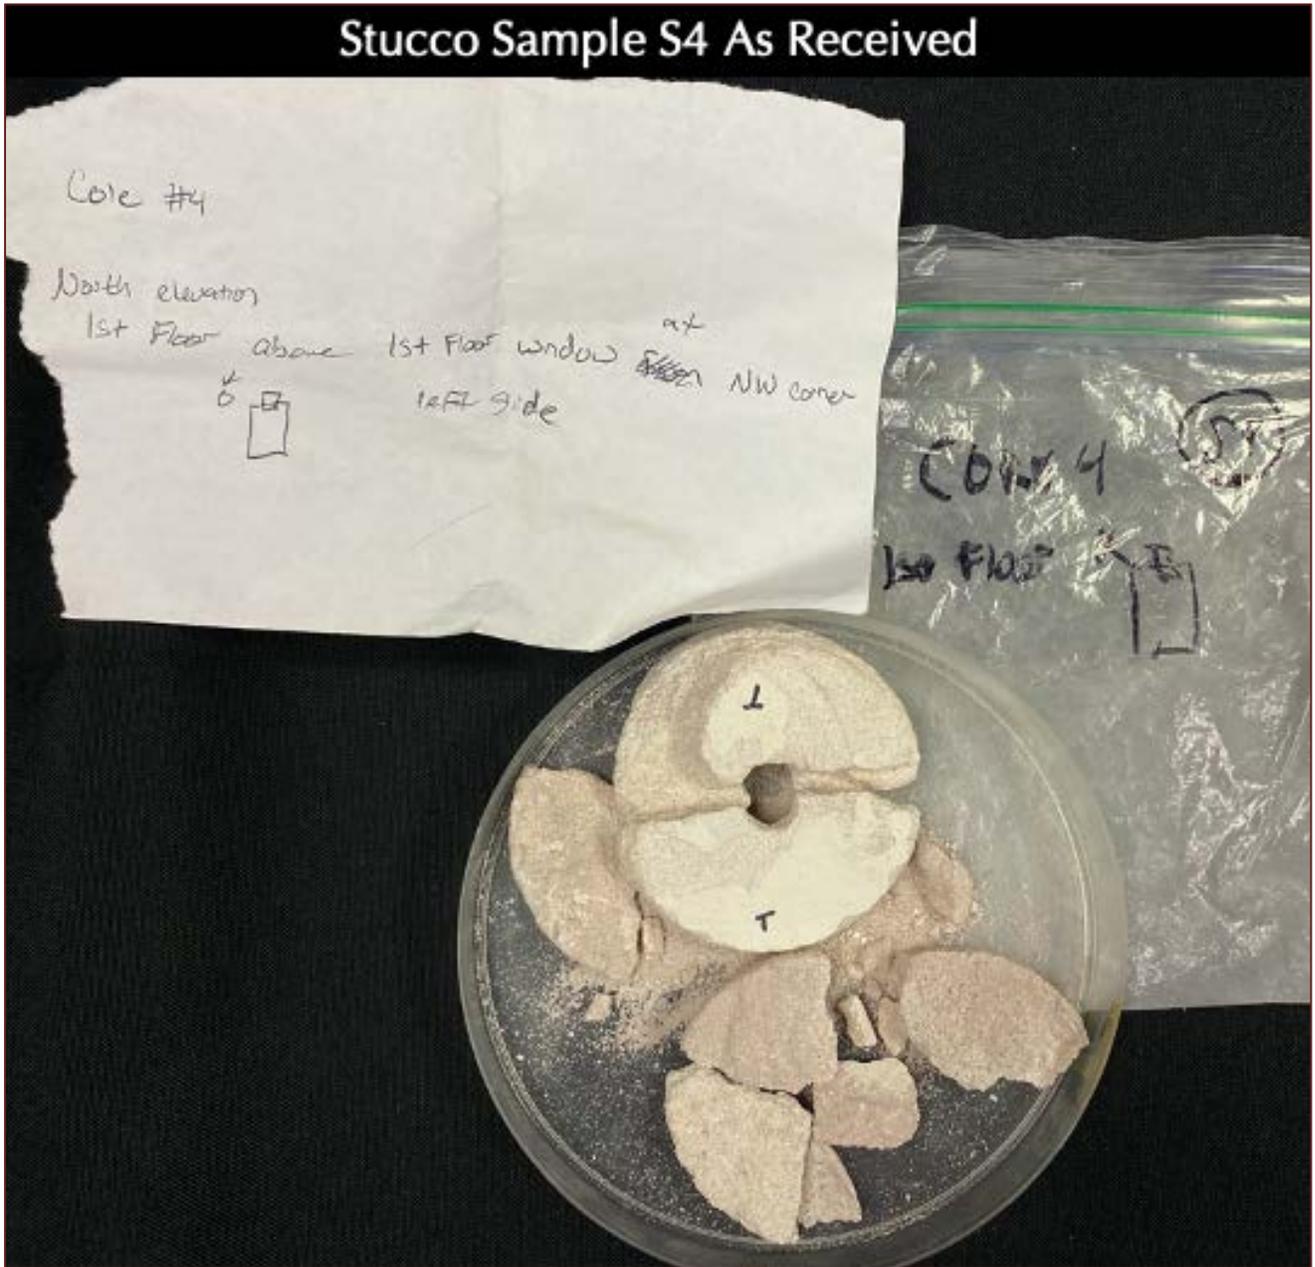
Sample S4 was received in multiple fragmented pieces even though the sample was reportedly collected from a location away from the location of coating failure in the north elevation (see Figures 2 and 4). By contrast, Samples S7 and S8 from south and east elevations, respectively were received in relatively intact conditions without any fragmentations.

Figure 18: A close-up of stucco from north elevation of courthouse marked as S4 that shows light-colored paint coat remains on some fragmented pieces of stucco. Notice the overall soft, dusty appearance of stucco pieces.
