## Laboratory Investigation Of Coating Failure From Stucco Façades Of An 18<sup>th</sup> Century Courthouse In Charleston, South Carolina

Charleston County Courthouse Exterior Façade  
Charleston, South Carolina

September 29, 2020  
CMC 0820145

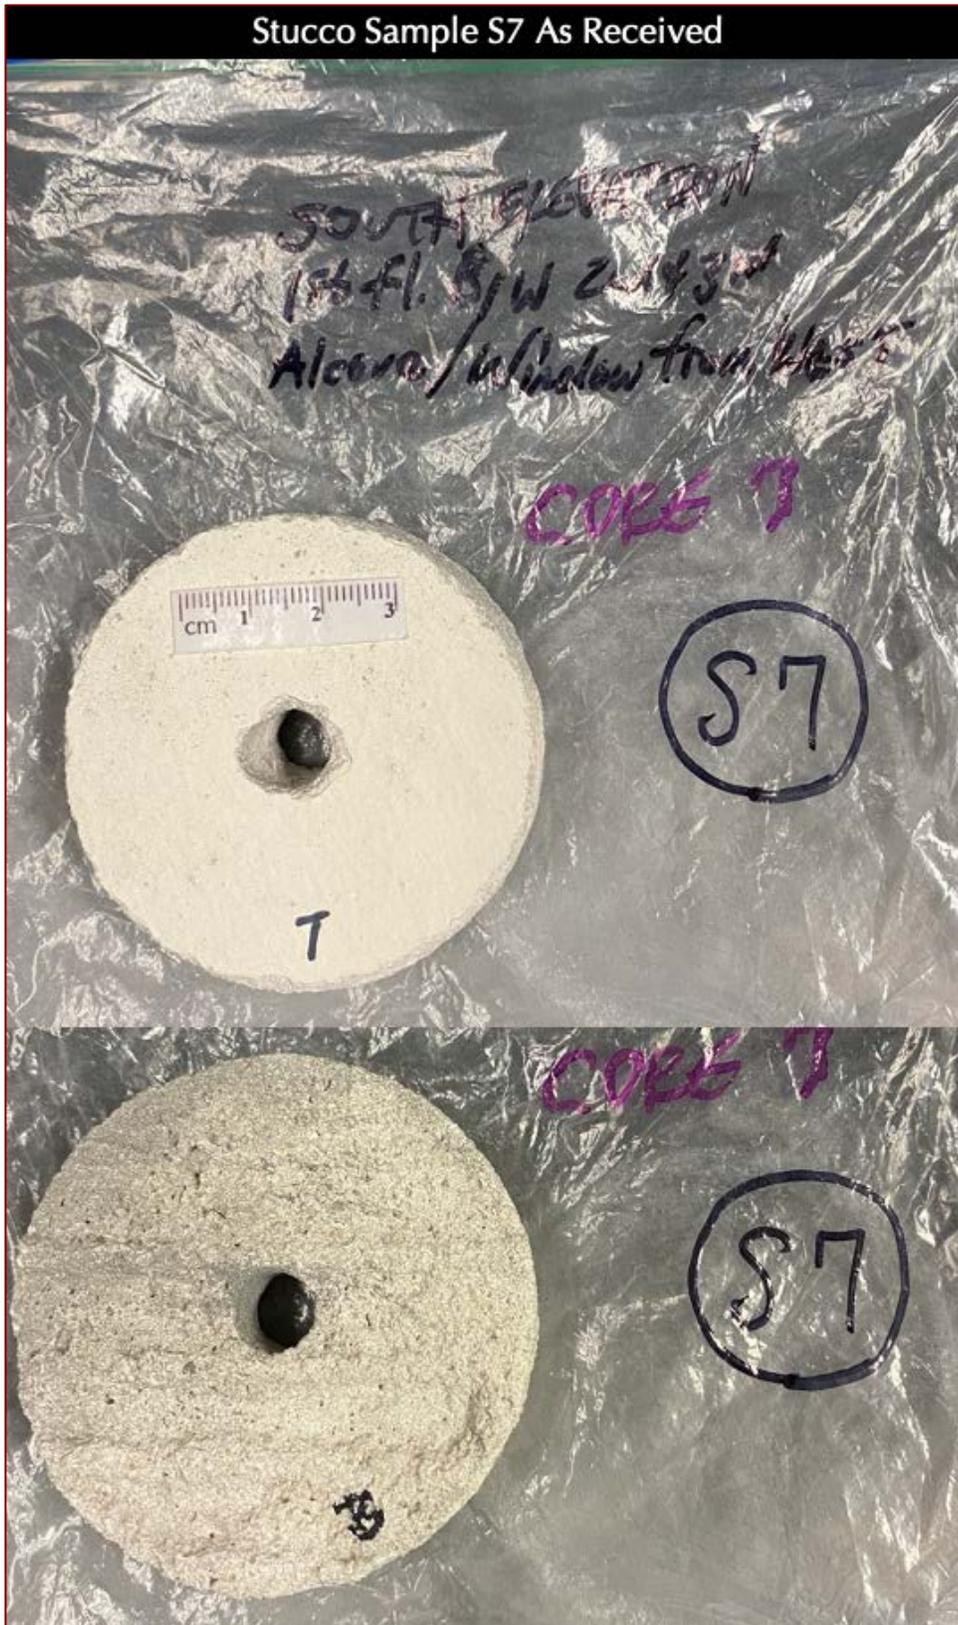
Figure 19: A close-up of stucco from south elevation of courthouse marked as S7 that shows light-colored paint coat remains on the stucco. Notice the overall soft, dusty appearance of stucco, but, overall intact condition of drilled core without any fragmentation as seen in S4.

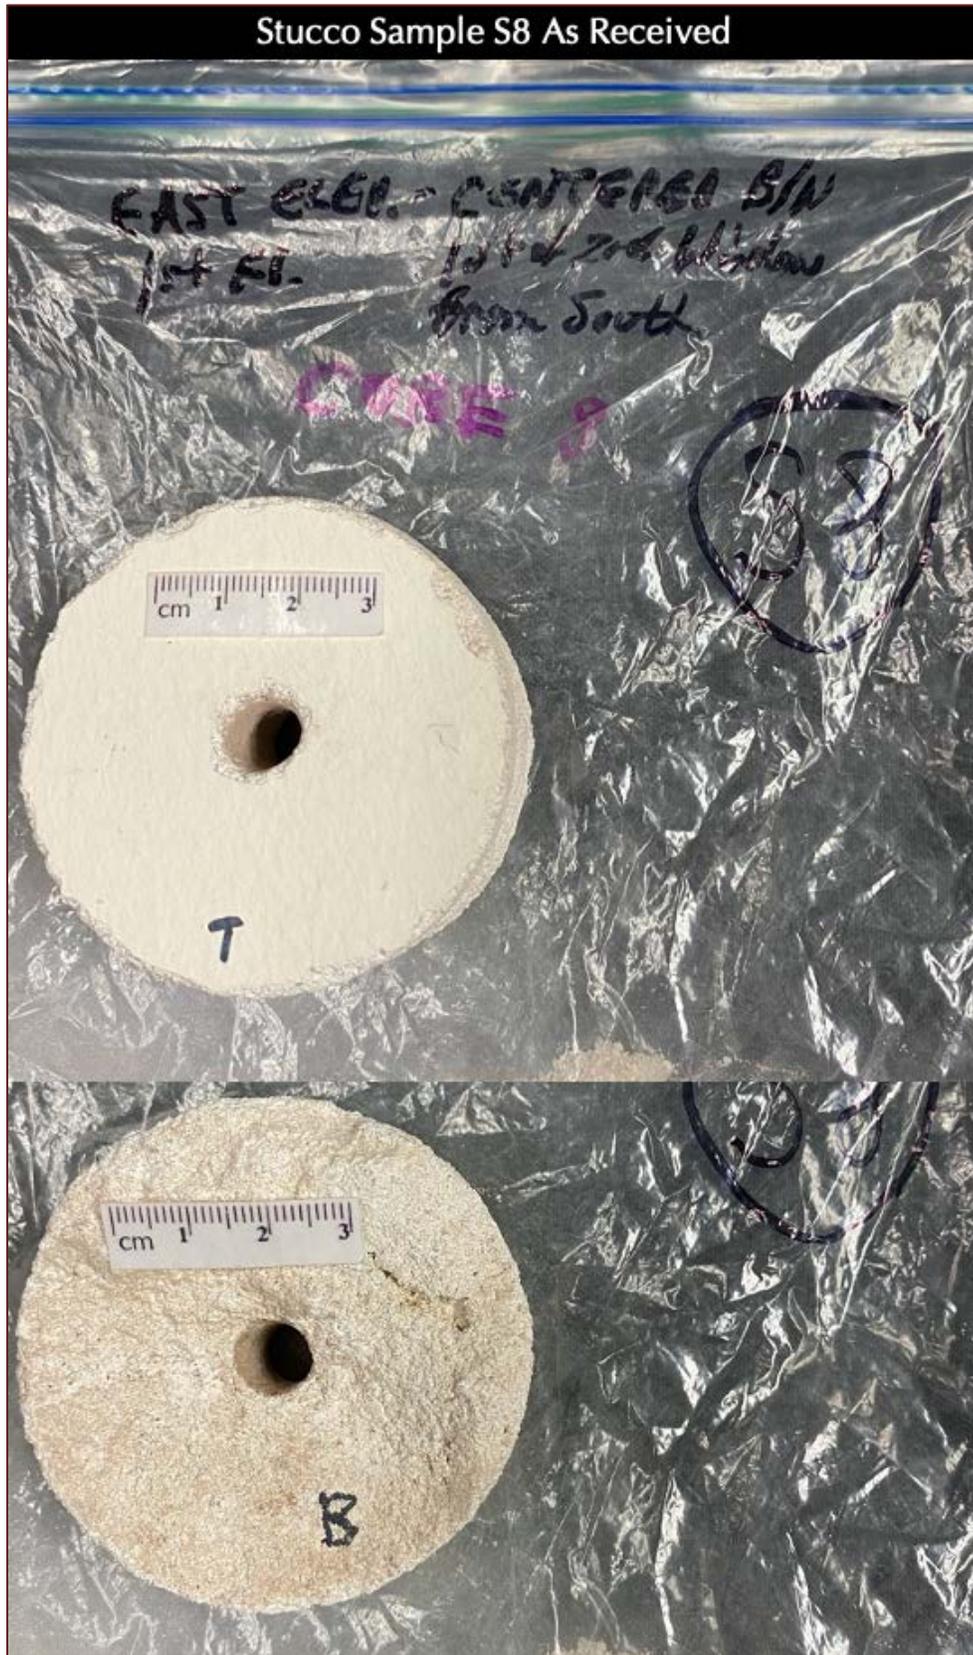
Figure 20: A close-up of stucco from east elevation of courthouse marked as S8 that shows light-colored paint coat remains on the stucco. Notice the overall soft, dusty appearance of stucco, but, overall intact condition of drilled core without any fragmentation as seen in S4.

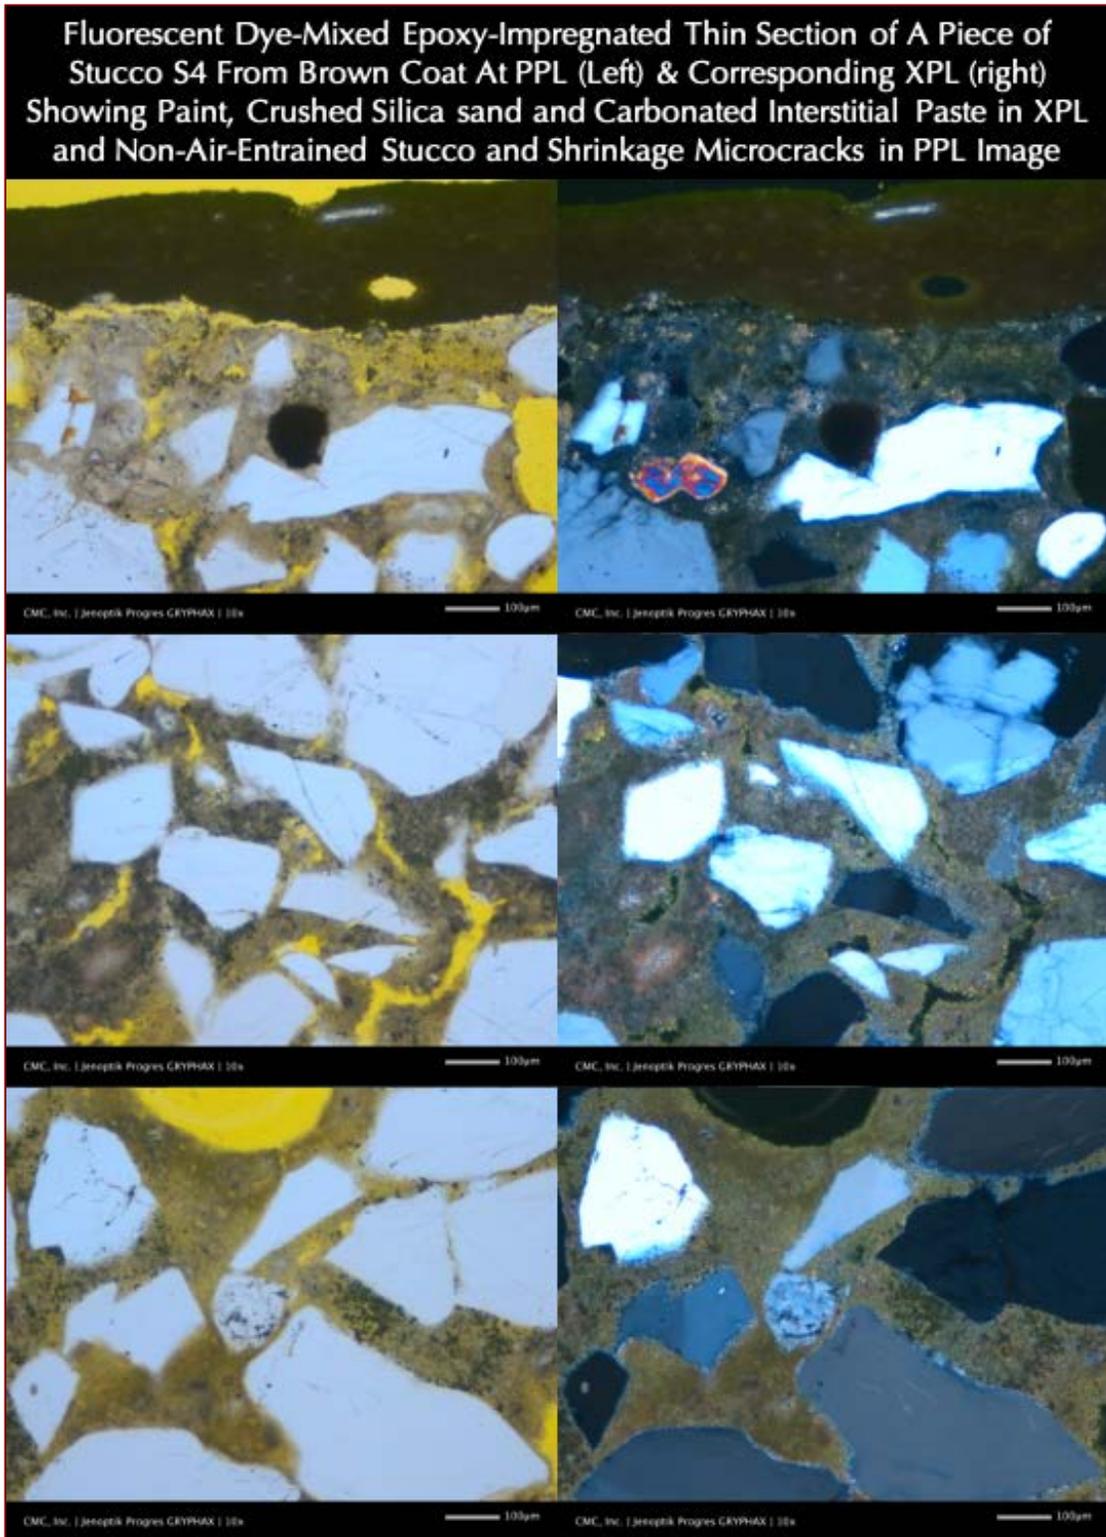
Figure 54: Micrographs of thin section of stucco S4 from north elevation in PPL (left) and corresponding XPL images, showing: (a) finer crushed silica sand particles in brown coat in top and middle rows and coarser crushed sand in the scratch coat in the bottom row; (b) fine-grained, porous, carbonated lime paste of brown and scratch coats having fine, hair-line, discontinuous elongated shrinkage microcracks in lime paste; and (c) dominance of quartz sand in the sand in both brown and scratch coats. Notice the absence of any Portland cement particles in the paste.

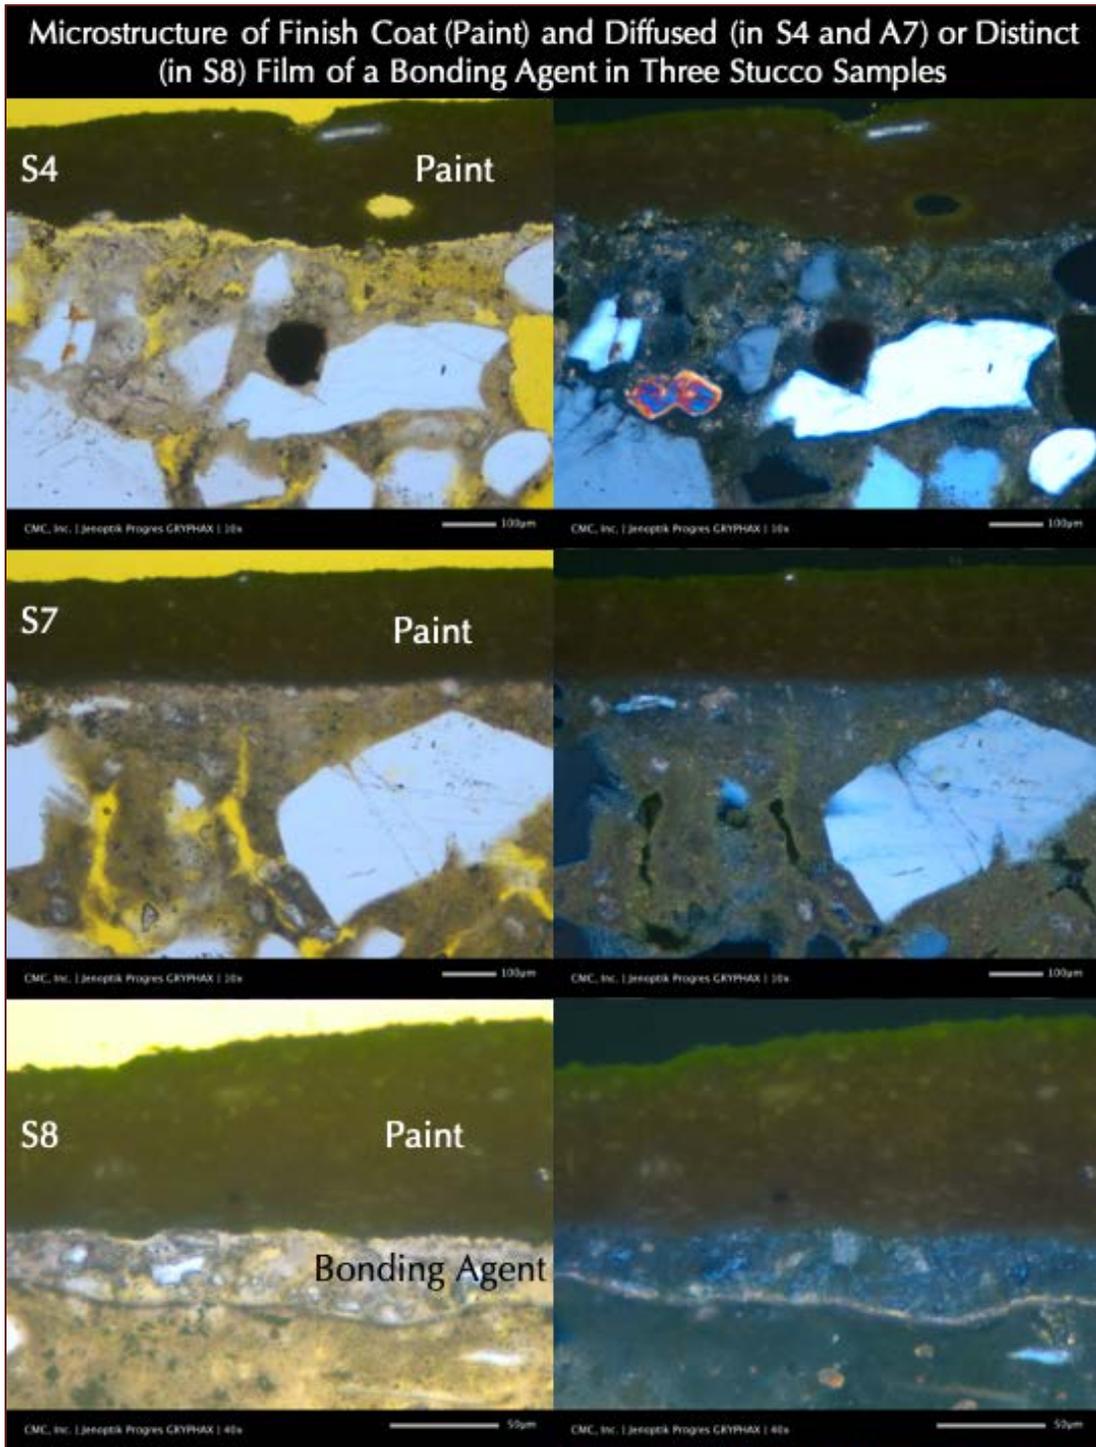
Figure 61: Micrographs of fluorescent dye-mixed epoxy-impregnated thin sections of all three stucco samples showing the details of the paint (finish) coat, which are 0.1 to 0.25 mm in thickness and show no distinct bonding agent in S4 and S7 even though it's presence is detected as diffused one in next two figures, but a distinct bonding agent in S8. The paint is dark brown and dense in PPL which has fine talc filler and titanium oxide pigment that are identified from SEM-EDS and FTIR studies. The bonding agent has fine residual alite and belite particles in a porous carbonated polymer medium which appears dark gray in XPL image.

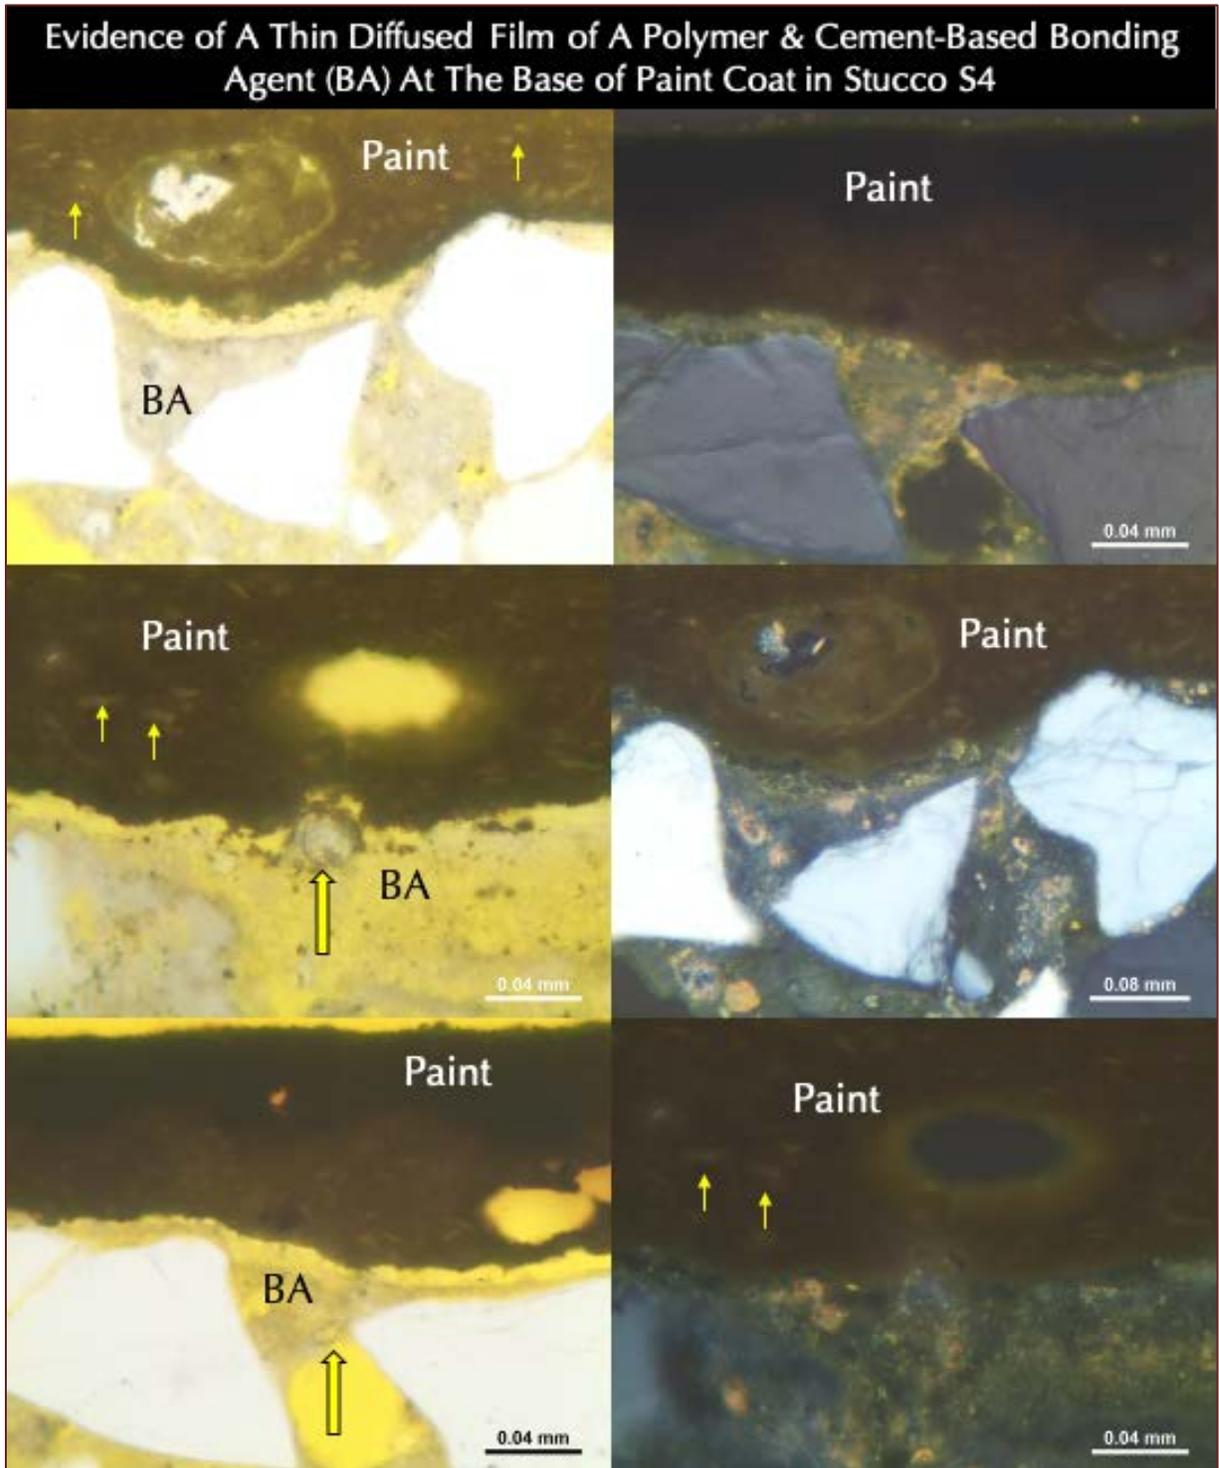
Figure 62: Micrographs of fluorescent dye-mixed epoxy-impregnated thin section of stucco S4 from north elevation showing details of paint coat, which has very fine talc filler (some are shown by fine vertical arrows) and titanium oxide pigment both of which are better detected from SEM-EDS and FTIR studies, an alkyd-based binder detected from FTIR studies, a thin porous diffused bonding agent beneath the paint containing fine residual cement particles (some are marked with thick vertical arrows) in a polymer binder which shows dark gray semi-isotropic appearance in XPL image with some fine carbonate fillers, somehow diffused into the stucco mass.
