INVESTIGATION OF SUSPENDED WALKWAY DISTRESS BY LABORATORY STUDIES OF FOUR CONCRETE CORES AND A POST-POCKET GROUT SAMPLE

EXECUTIVE SUMMARY

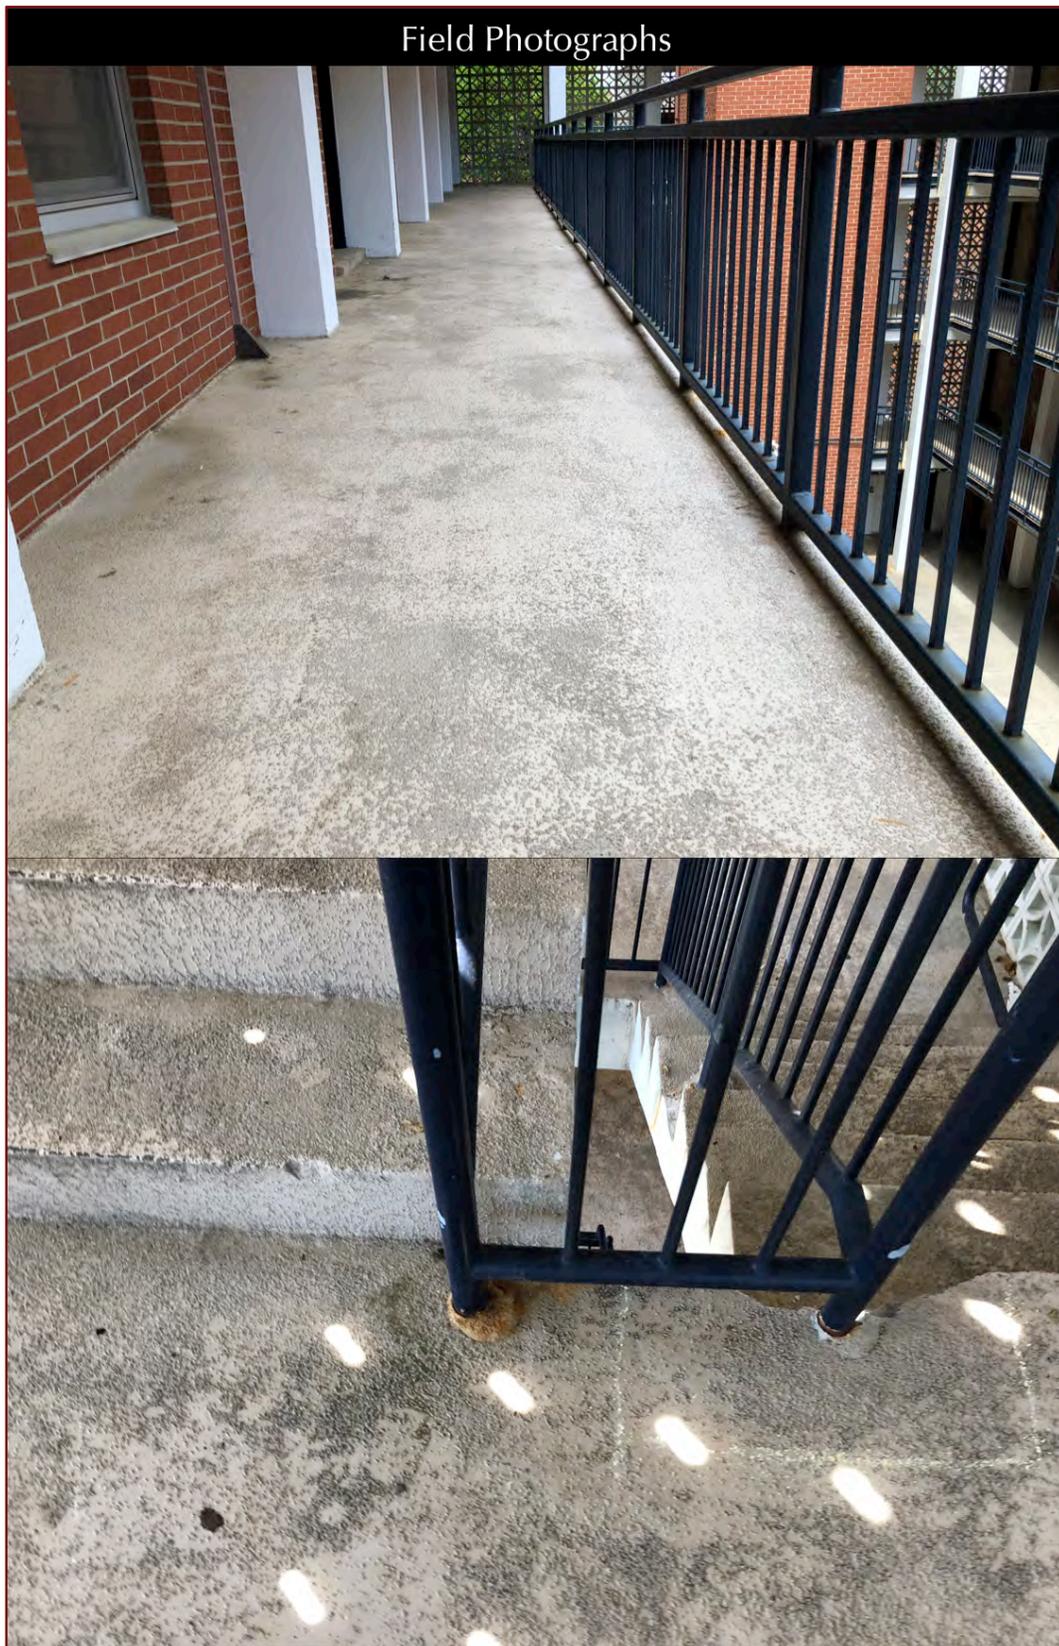
Figure 2: Field photographs showing the condition of the walkway surface (top), and the conditions of the concrete stairs and rail-post grout (bottom).

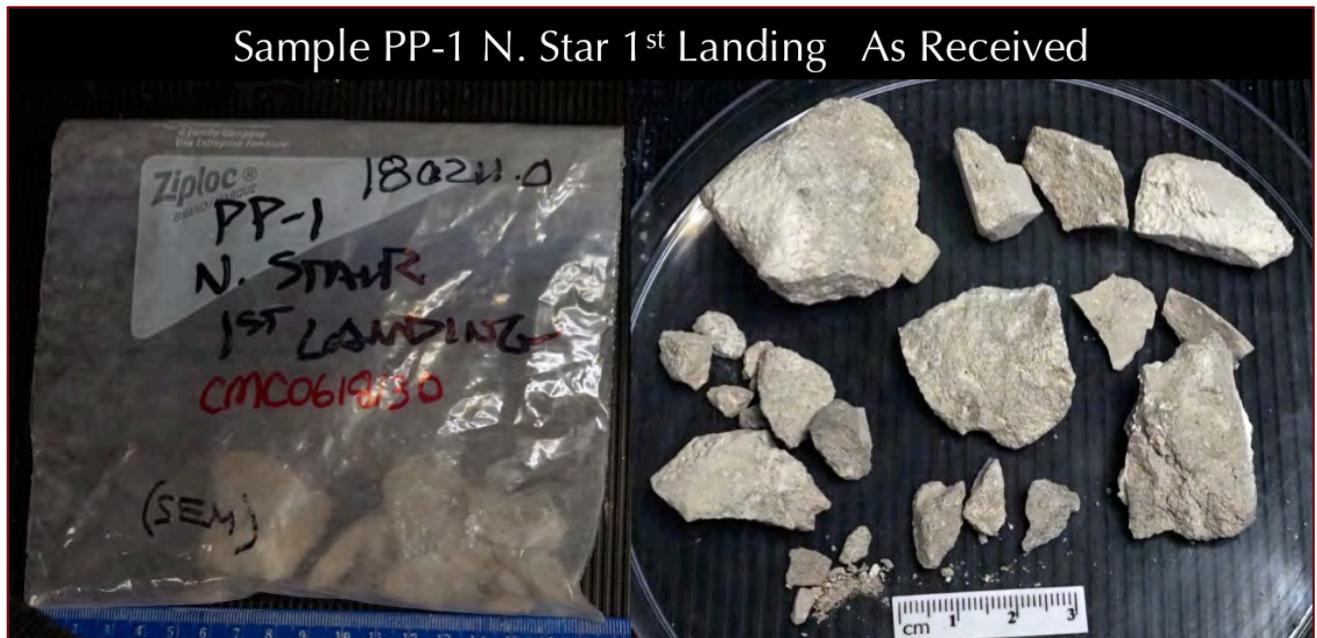
The examined fragmented but dense, hard, intact pieces of distressed anchoring grout (PP-1) showed a blended Portland cement and calcium aluminate/sulfoaluminate-based formulation, and its application in a moist outdoor environment, where the grout was exposed to moisture during service to facilitate post-hardening sulfate-aluminate reactions in the presence of moisture during service. As a result, the grout has undergone expansion not only during hardening to provide the anchoring but also after hardening, from exposure to water with further disintegration during service from continued sulfate-aluminate reactions in the hydration products of cementitious binders. Mineralogy and microstructure of the grout shows quartz sand in a Portland cement and calcium aluminate/sulfoaluminate-based binder formulation. No free gypsum was detected in optical, SEM-EDS, XRD, or thermal studies but compositions of paste in SEM-EDS studies indicated blended Portland and calcium sulfoaluminate-based formulation as opposed to gypsum-based formulation of grout. Bulk sulfate (as SO_3) content in the distressed grout is 4.3 percent, which is less than that of a gypsum-based grout but higher than that of a Portland cement-based grout, indicating presence of a sulfate component in the binder, which is not gypsum but a calcium sulfoaluminate cement. Reported swelling is judged to be due to a combination of continued sulfate-aluminate reactions in the presence of moisture during service along with possible freezing-related expansion at saturated conditions, both of which are related to easy accessibility of moisture to the grout during service. Unfortunately, the best method to mitigate the existing swelling problem is to remove the distressed grout and reinstall the anchoring grout with a more durable and acceptable material with a proven service-record in the moist outdoor environment, and installed by strictly following the manufacturer's application guidelines. Access of moisture to the grout during service must also be restricted.

Figure 3: Shown are the rail-post grout sample PP-1 as received in a plastic Ziploc bag (left), and the individual pieces after removal from the bag (right). Notice the overall hard intact nature of individual pieces, despite the fragmented nature of overall grout.

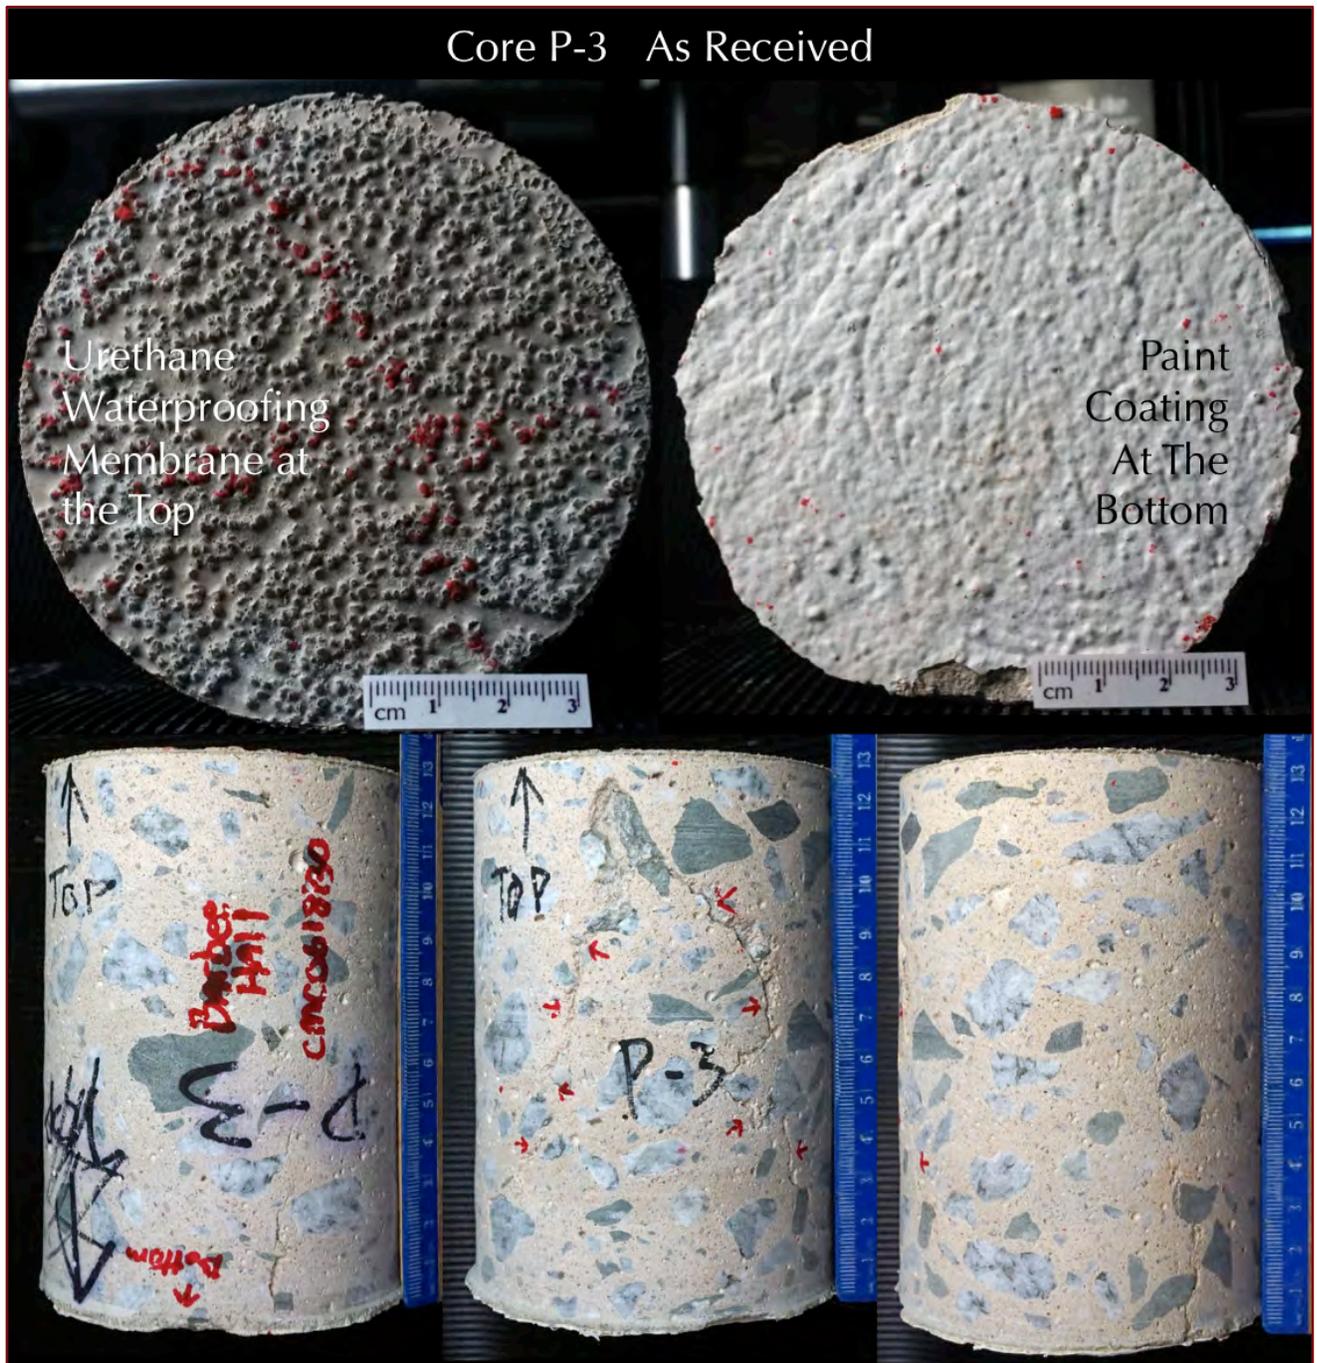
Core P-3 contains a major horse-shoe-shaped crack on the cylindrical side surface extending from a depth of 1 in. to 4 in. from the top surface (Figure 6). There is no evidence of any other distress of concrete found in the other three cores received.

Figure 6: Shown are: (a) the top surface with tan urethane-type waterproofing membrane (top left); (b) the bottom surface with white paint coating (top right); and (c) cylindrical side views of Core P-3 (bottom photos), as received. Red arrows in the bottom middle photo indicate the horse-shoe-shaped crack, which extends from 1 in. to 4 in. from the top surface.

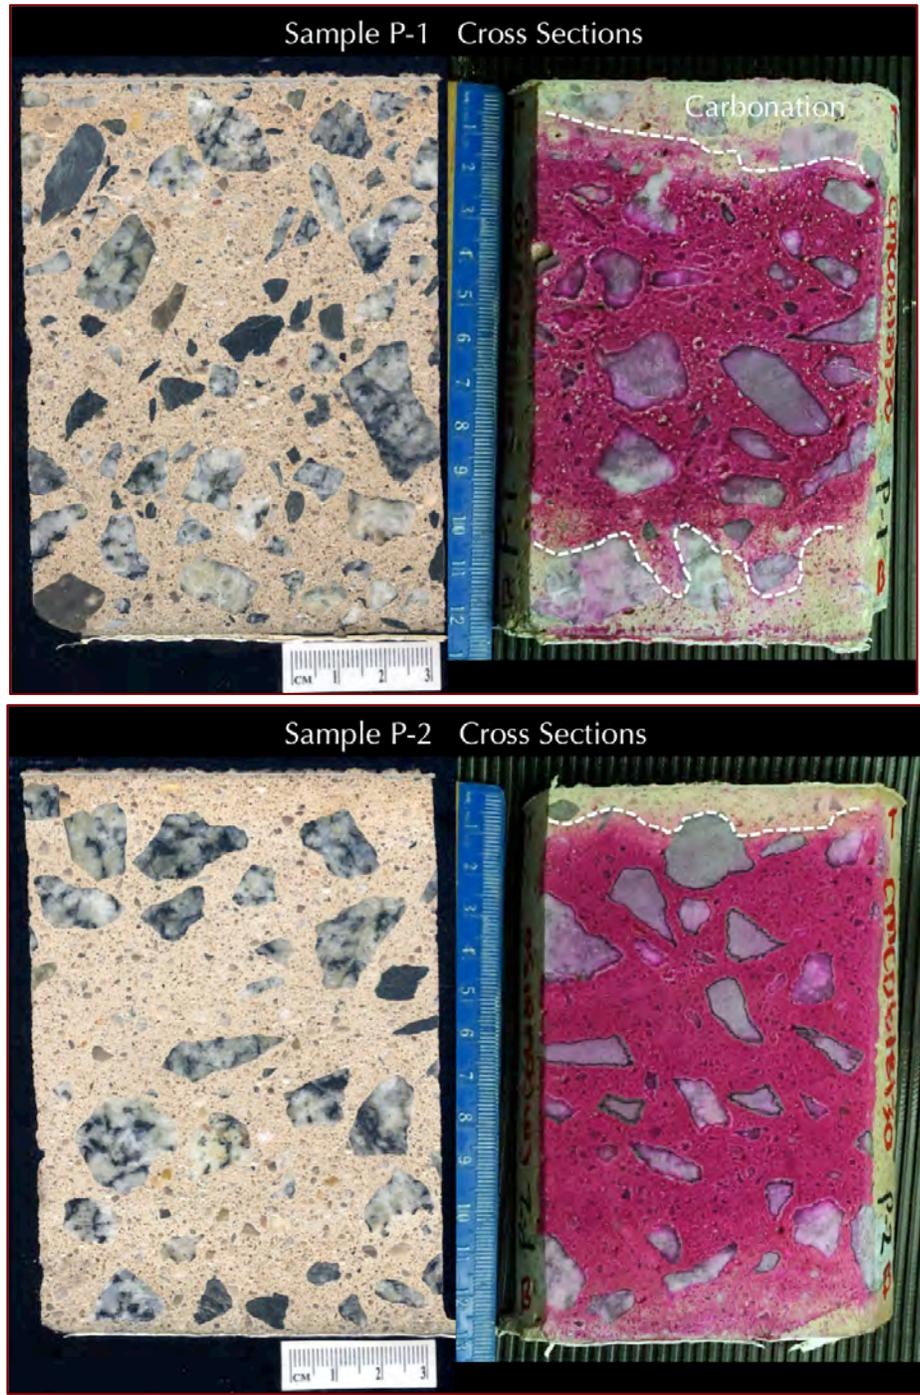
Carbonation of concrete has occurred from both top and bottom ends and measured to be from as low as 2 mm in Core P-4 to as high as 30 mm in Core P-3 (15 to 20 mm in Cores P-1 and P-2) from their top ends and from 25 mm (in Cores P-2 and P-4) to 35 mm in Core P-1 and as deep as 45 mm in Core P-3 from their bottom ends. Besides carbonations to as deep as 15 to 30 mm from the exposed end of the cores (which are higher than that normally anticipated for a well-consolidated concrete impermeable to atmospheric carbon dioxide) there is no evidence of any chemical or physical deterioration of concrete detected in the concrete in all cores.

Figure 14: Lapped cross section (left) and saw-cut cross section treated with phenolphthalein alcoholic solution (right) of Core P-1 (top) and P-2 (bottom) showing: (a) size, shape, angularity, gradation, and distribution of crushed stone coarse aggregate, (b) overall dense and well-consolidated nature of concrete; (c) carbonation of concrete from both ends as indicated by the cream-colored carbonated surface regions as opposed to pink discolored interior non-carbonated concrete.

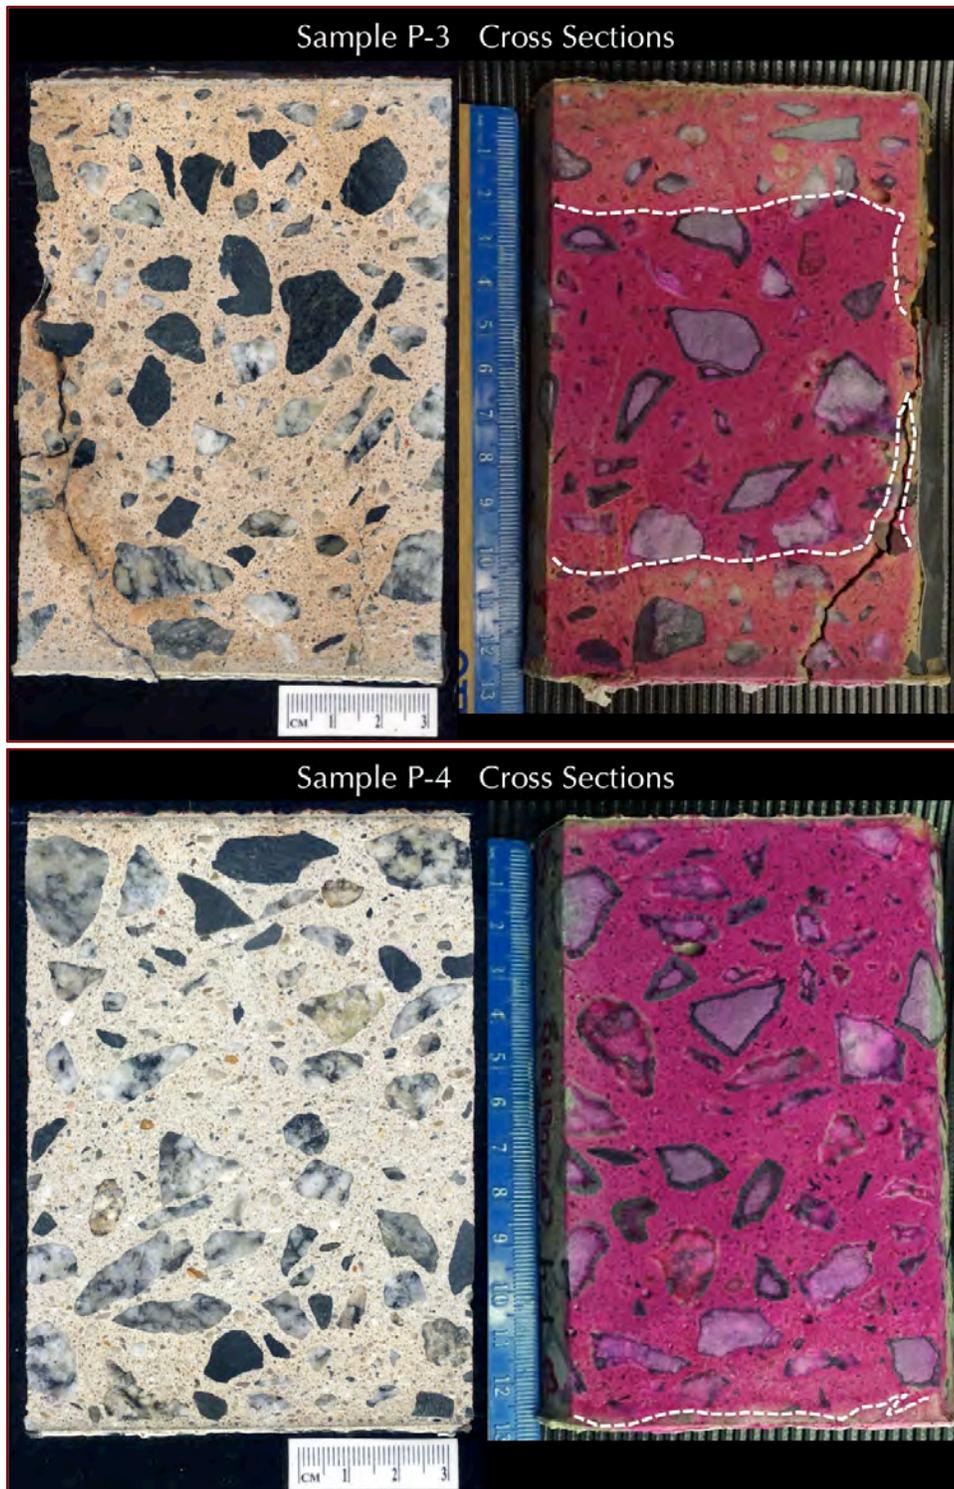
Figure 15: Lapped cross section (left) and saw-cut cross section treated with phenolphthalein alcoholic solution (right) of Core P-3 (top) and P-4 (bottom) showing: (a) size, shape, angularity, gradation, and distribution of crushed stone coarse aggregate, (b) overall dense and well-consolidated nature of concrete; (c) carbonation of concrete from both ends as indicated by the cream-colored carbonated surface regions as opposed to pink discolored interior non-carbonated concrete.

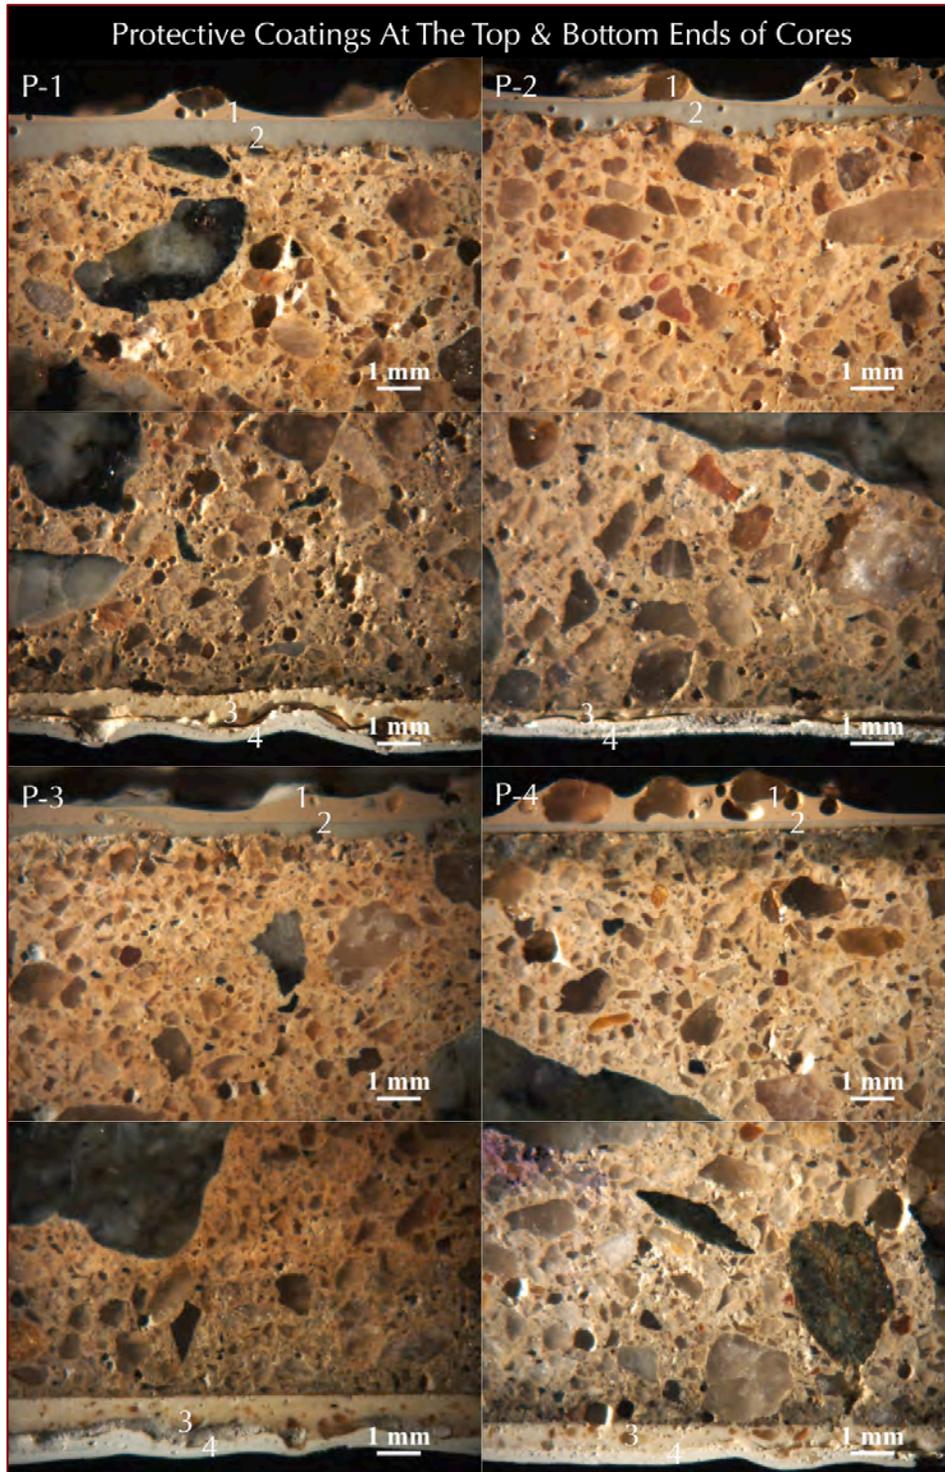
Figure 20: Photomicrographs of lapped cross sections of cores showing the presence of two layers of protective coatings at both ends in all four cores that appeared to be visually similar for each coat in all four cores (i.e. #1 is similar in all cores, and so on and so forth). Notice the coats directly adhered to concrete at both ends (i.e. #2 and 3) are well-bonded to the concrete but some de-bonding has occurred especially at the bottom coats between #3 and 4.

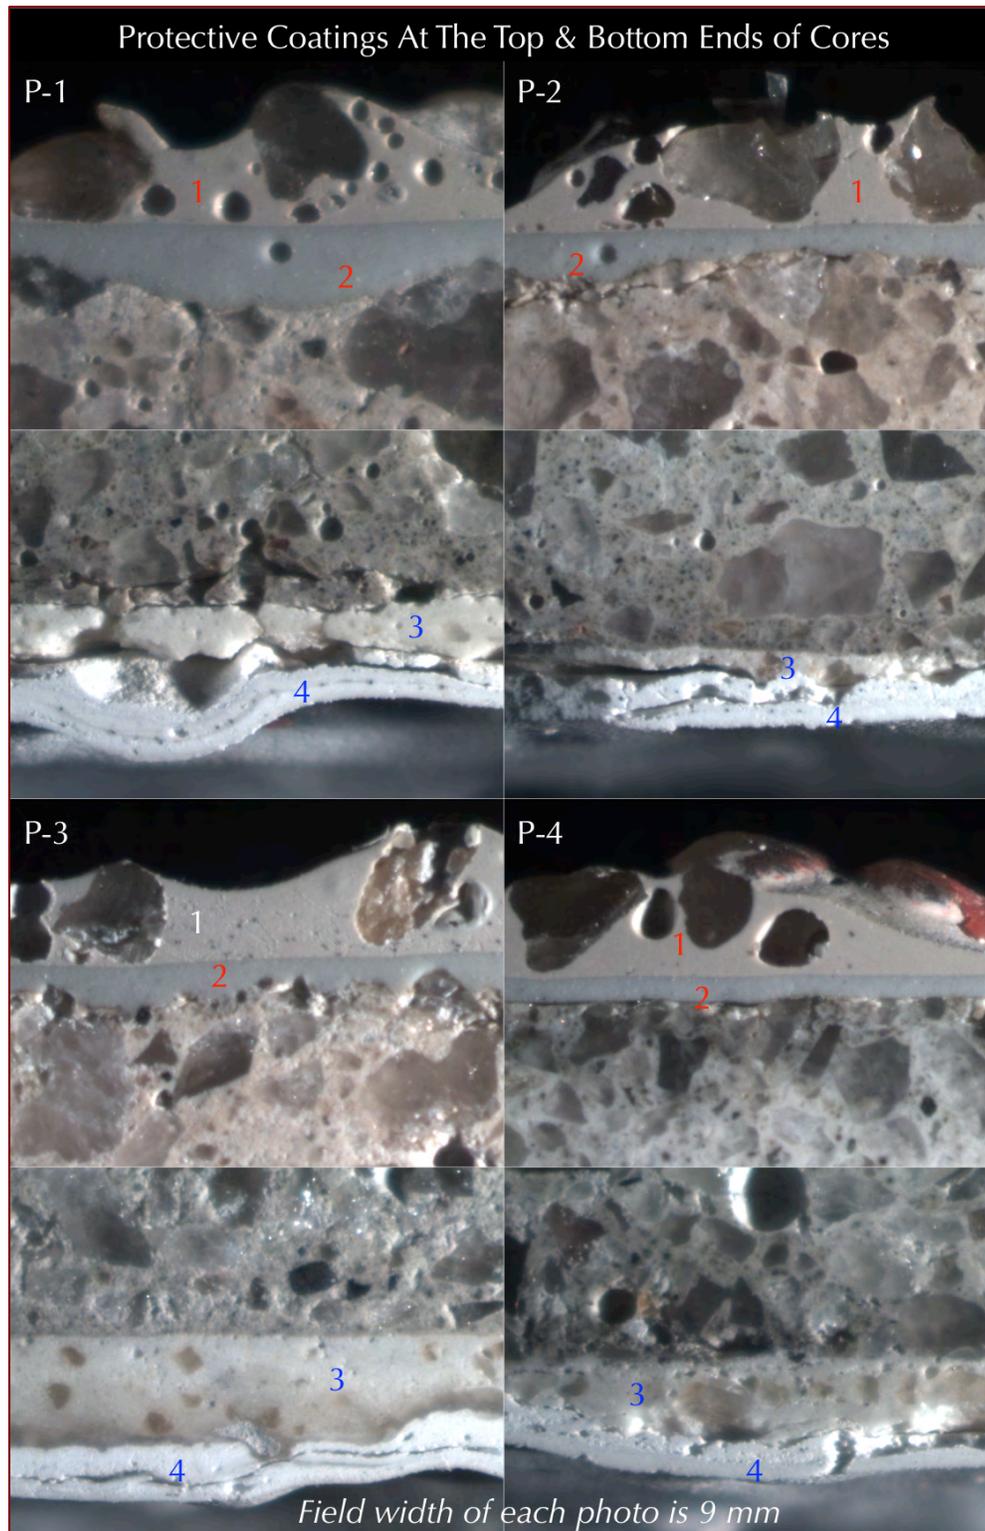
Figure 21: Photomicrographs of lapped cross sections of cores showing the presence of two layers of protective coatings at both ends in all four cores that appeared to be visually similar for each coat in all four cores (i.e. #1 is similar in all cores, and so on and so forth). Notice the coats directly adhered to concrete at both ends (i.e. #1 and 3) are well-bonded to the concrete but some de-bonding has occurred especially at the bottom coats between #3 and 4. Notice the presence of quartz filler in Coat #1 and finer more angular filler in Coat #3 but absence of such visible fillers in Coat #2 and 4. Notice multiple layers of de-bonding in Coat #4.

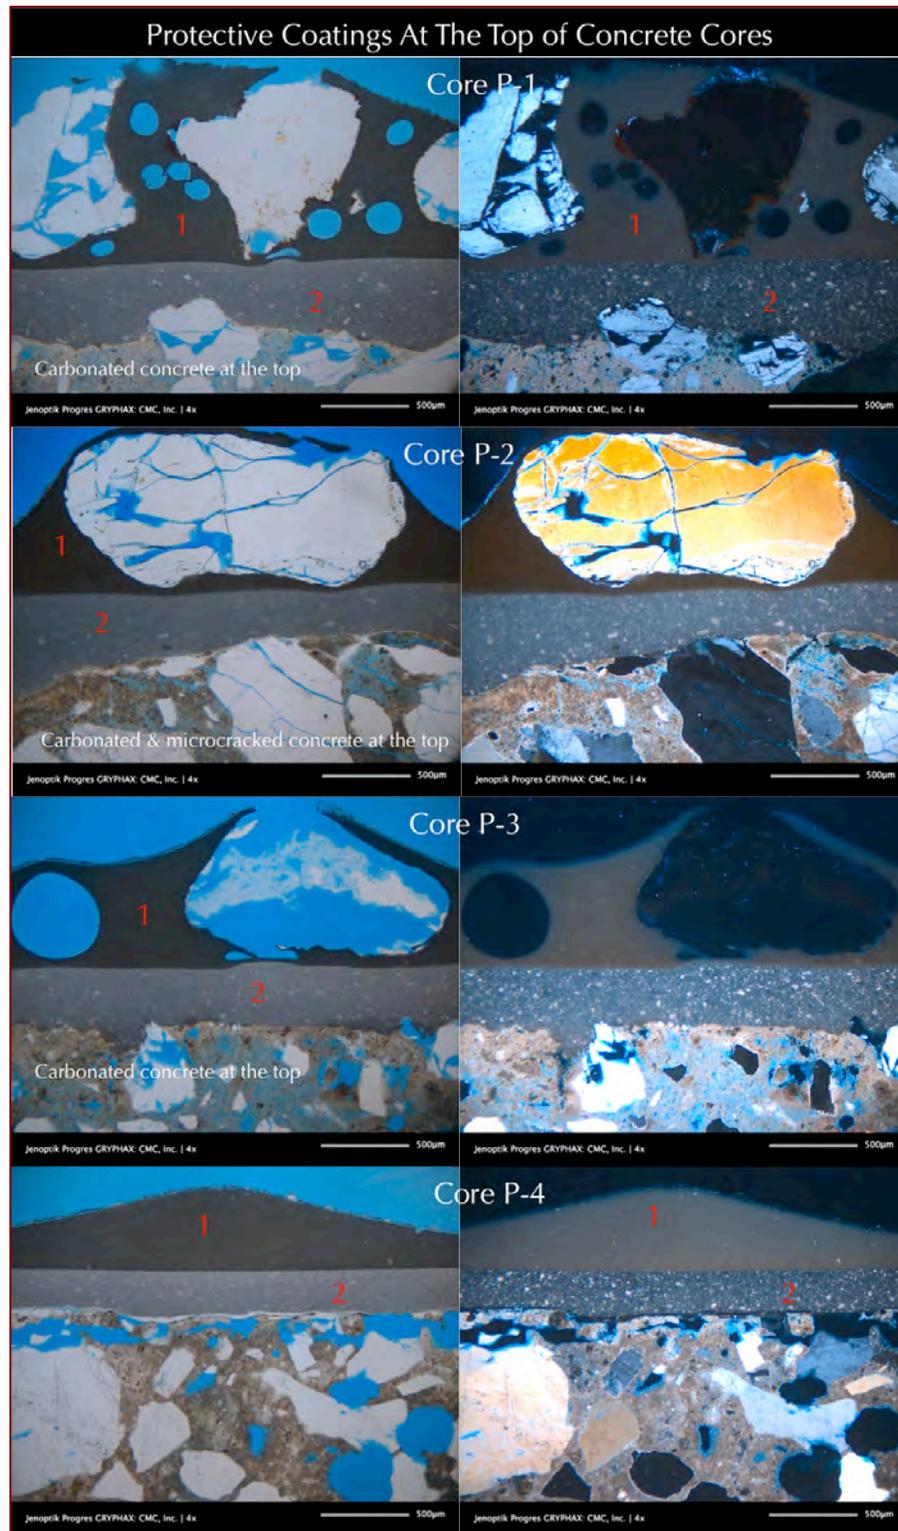
Figure 30: Photomicrographs of thin sections from top ends of all four cores showing the two protective coatings #1 and 2 – their compositional similarity for each coat in all four cores where Coat #1 contains rounded quartz fillers in a polymer medium in all four cores, whereas Coat #2 contains fine silt-sized particles in a polymer medium. Both coats are well-bonded to each other and also to the underlying concrete for the most part. Concrete beneath the coats are carbonated in all four cores indicating prolonged periods of exposures to atmospheric carbon dioxide prior to the installation of protective coats.

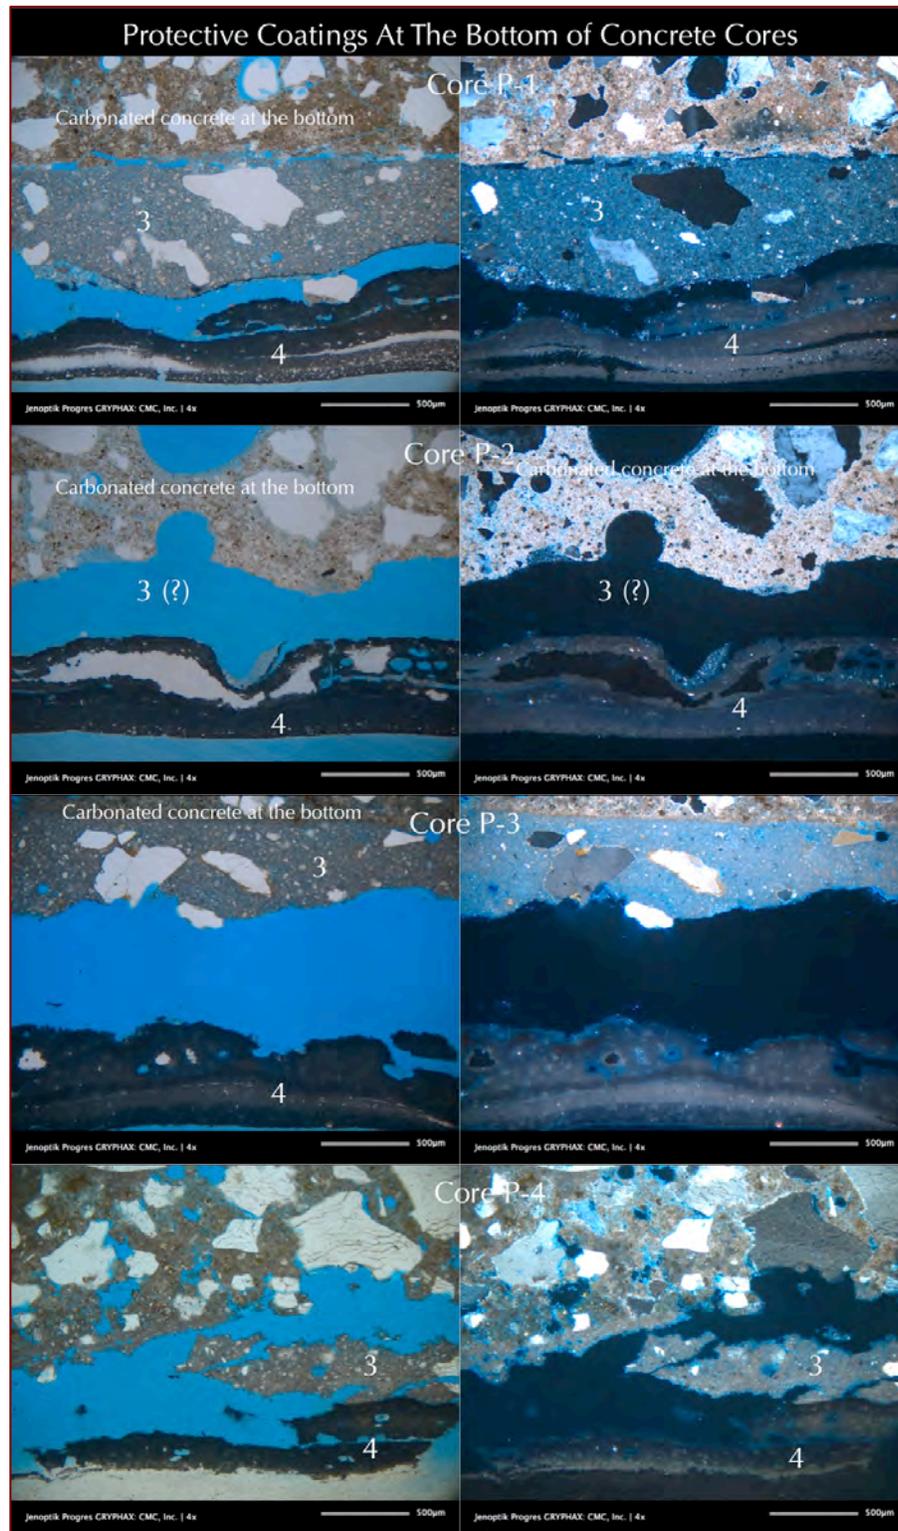
Figure 31: Photomicrographs of thin sections from bottom ends of all four cores showing the two protective coatings #3 and 4 – their compositional similarity for each coat in all four cores where Coat #3 contains fine angular quartz and fine silt-sized silicate fillers in a polymer medium in all four cores, whereas Coat #4 contains no such filler and appears dark opaque in all cores. Both coats are poorly bonded to each other. Concrete adjacent to the coats are carbonated in all four cores indicating prolonged periods of exposures to atmospheric carbon dioxide prior to the installation of protective coats.

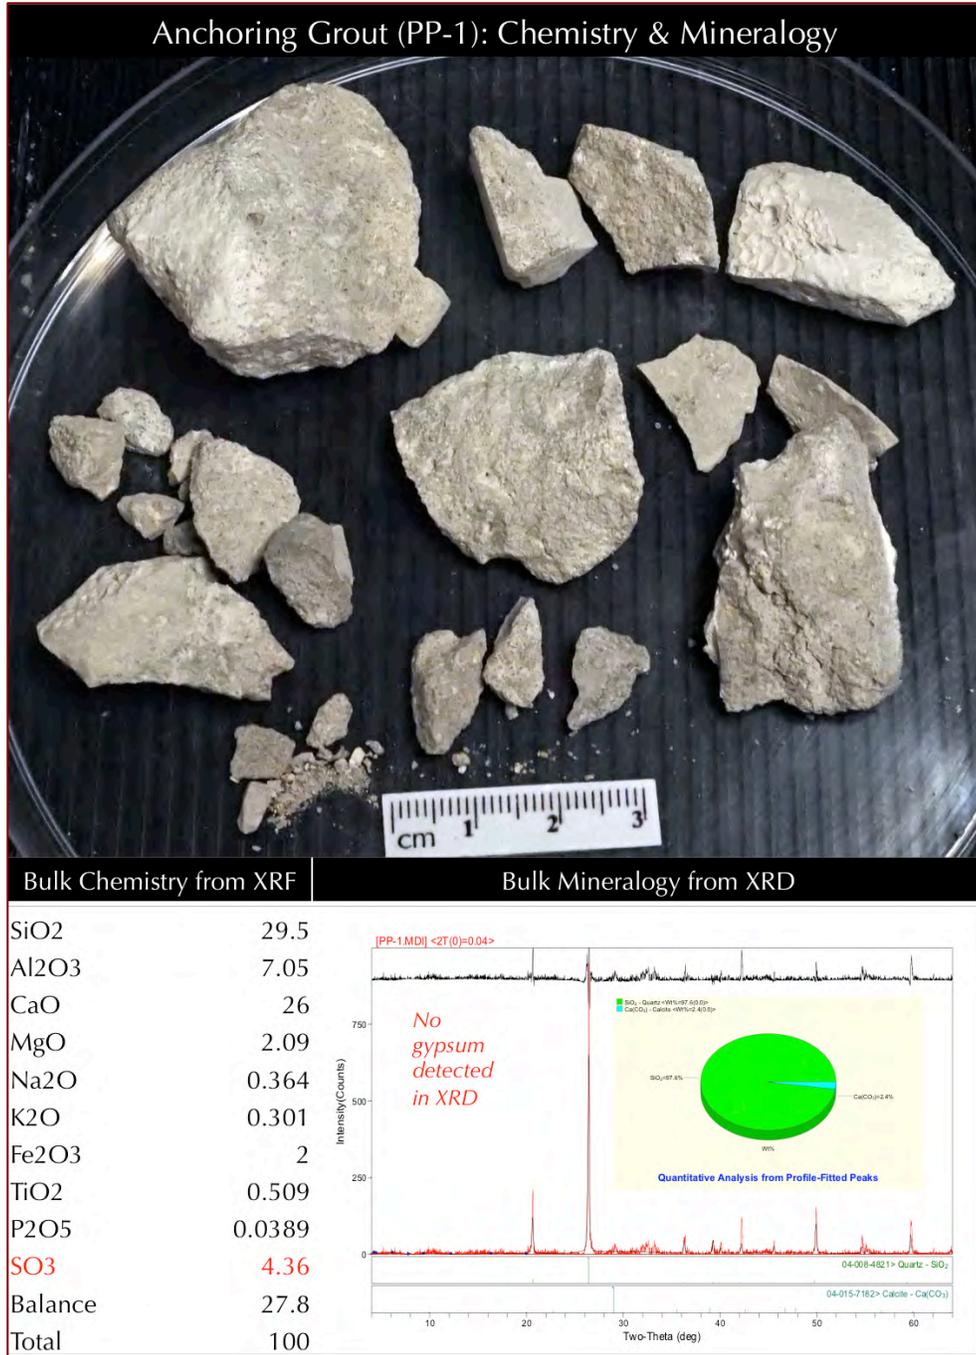
Figure 41: XRD and XRF of bulk grout to determine bulk mineralogy and chemical (oxide) composition, respectively. Sulfate content in grout indicates incorporation of a sulfate component in the binder, which, however, has not formed gypsum from hydration and hardening processes, as XRD did not find any gypsum peak. Bulk sulfate (as SO₃) content in the distressed grout is 4.3 percent, which is less than that of a gypsum-based grout but higher than that of a Portland cement-based grout, indicating presence of a sulfate component in the binder, which is not gypsum but a calcium sulfoaluminate cement.

The present examined grout belongs to the third category of blended Portland cement and calcium aluminate/sulfoaluminate cement-based cementitious grout, which is determined to contain no gypsum as a major binder component as found in the second category, but Portland cement as the major hydraulic cement along with possible presence of a calcium aluminate and/or sulfoaluminate-based binder. Bulk sulfate (as SO_3) content in the distressed grout is 4.3 percent, which is less than that of a gypsum-based grout but higher than that of a Portland cement-based grout, indicating presence of a sulfate component in the binder, which is not gypsum but a calcium sulfoaluminate cement.

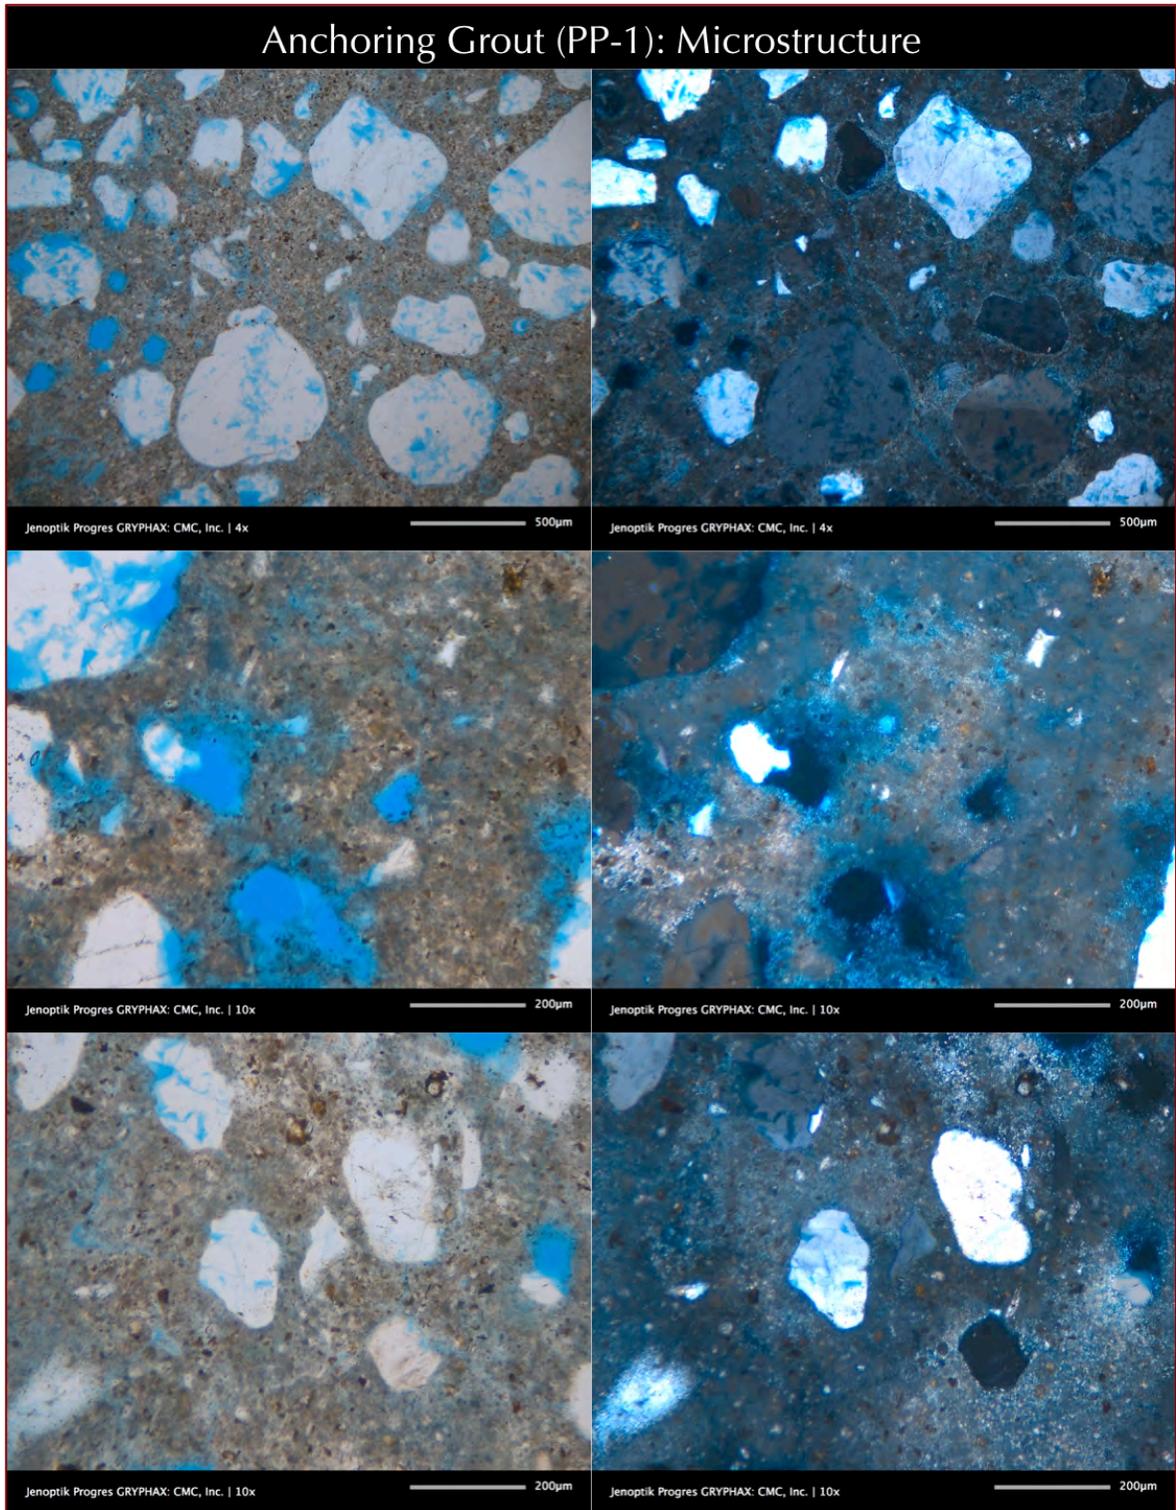
Figure 42: Photomicrographs of thin section of grout showing typical Portland cement paste composition of grout having many residual cement particles, but an overall variable density of paste from denser or porous areas as indicated by variable absorption of blue epoxy by the paste. Also present are fine silica (quartz) sand. Notice overall dense nature of grout and the absence of any visible or invisible cracking.
