Cracking Of A Swimming Pool Plaster – A Laboratory Investigation

Motamed Pool
3347 Green Acres Drive
Bethlehem, PA 18015

January 20, 2021
CMC 0121100

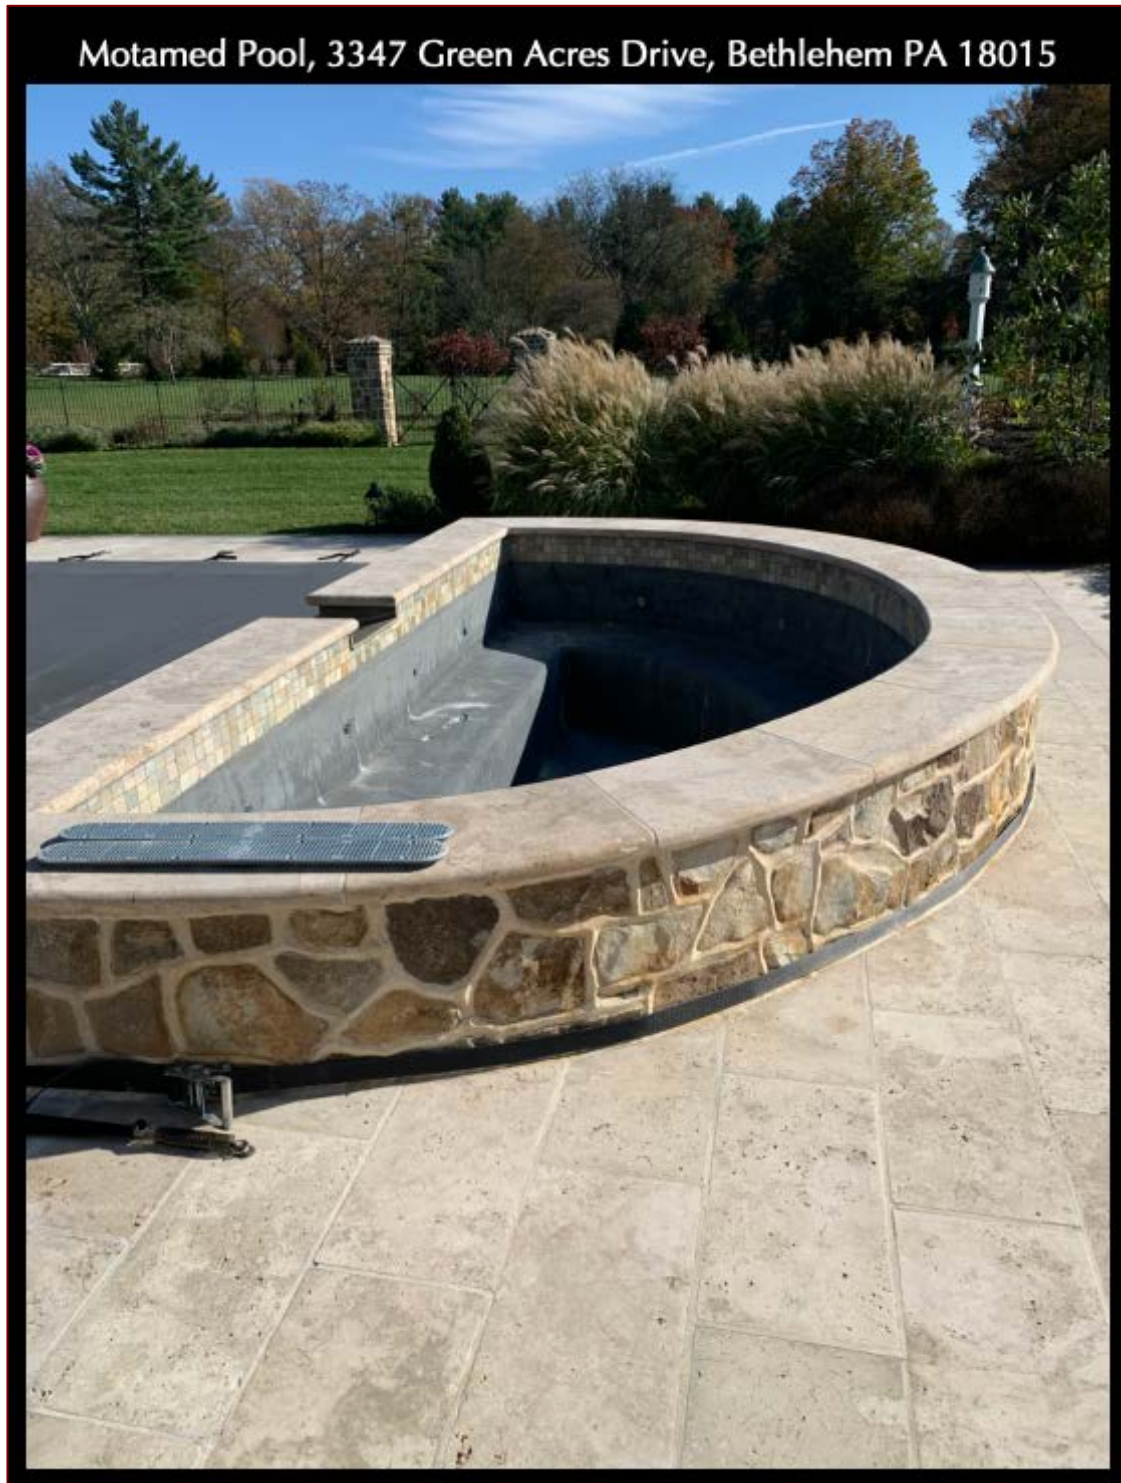
- a. Figure 1 shows the overall condition of the spa area of the pool consisting of dark gray pool plaster inside the masonry wall of the spa. Limestone tiles are seen on top of the masonry wall.

Figure 1: Field photo of the spa area of swimming pool showing limestone tiles on pool deck and masonry wall around the spa. The present investigation addresses extensive cracking in the dark gray pool plaster within the spa area.

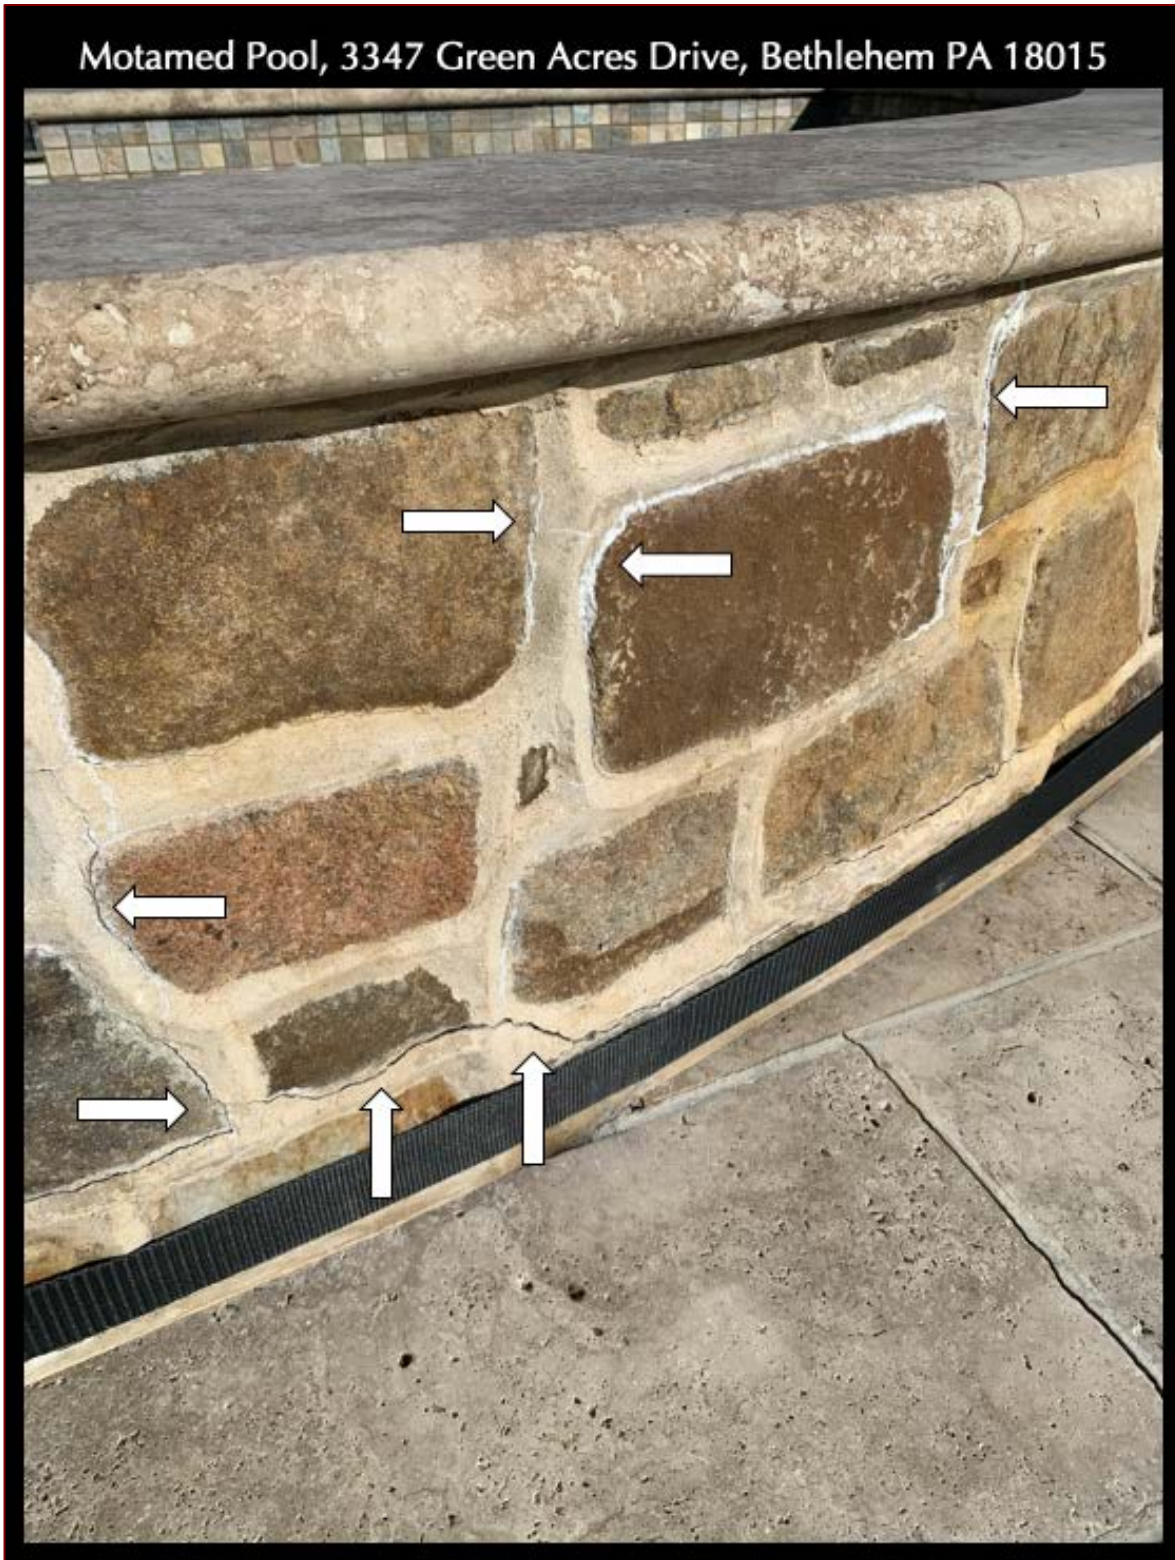
- b. Figure 2 shows a close view of the masonry wall where cracking and white efflorescence deposits along the cracks are seen. Cracks mostly followed the paths between the masonry units and jointing mortars.

Figure 2: A close view of some cracking and white efflorescence deposits on the outer masonry wall of the spa that are marked with arrows. These cracks may represent an extension of the cracks seen in the inside dark gray plaster in the spa and may as well have formed due to the same mechanism that has caused cracking in the plaster.

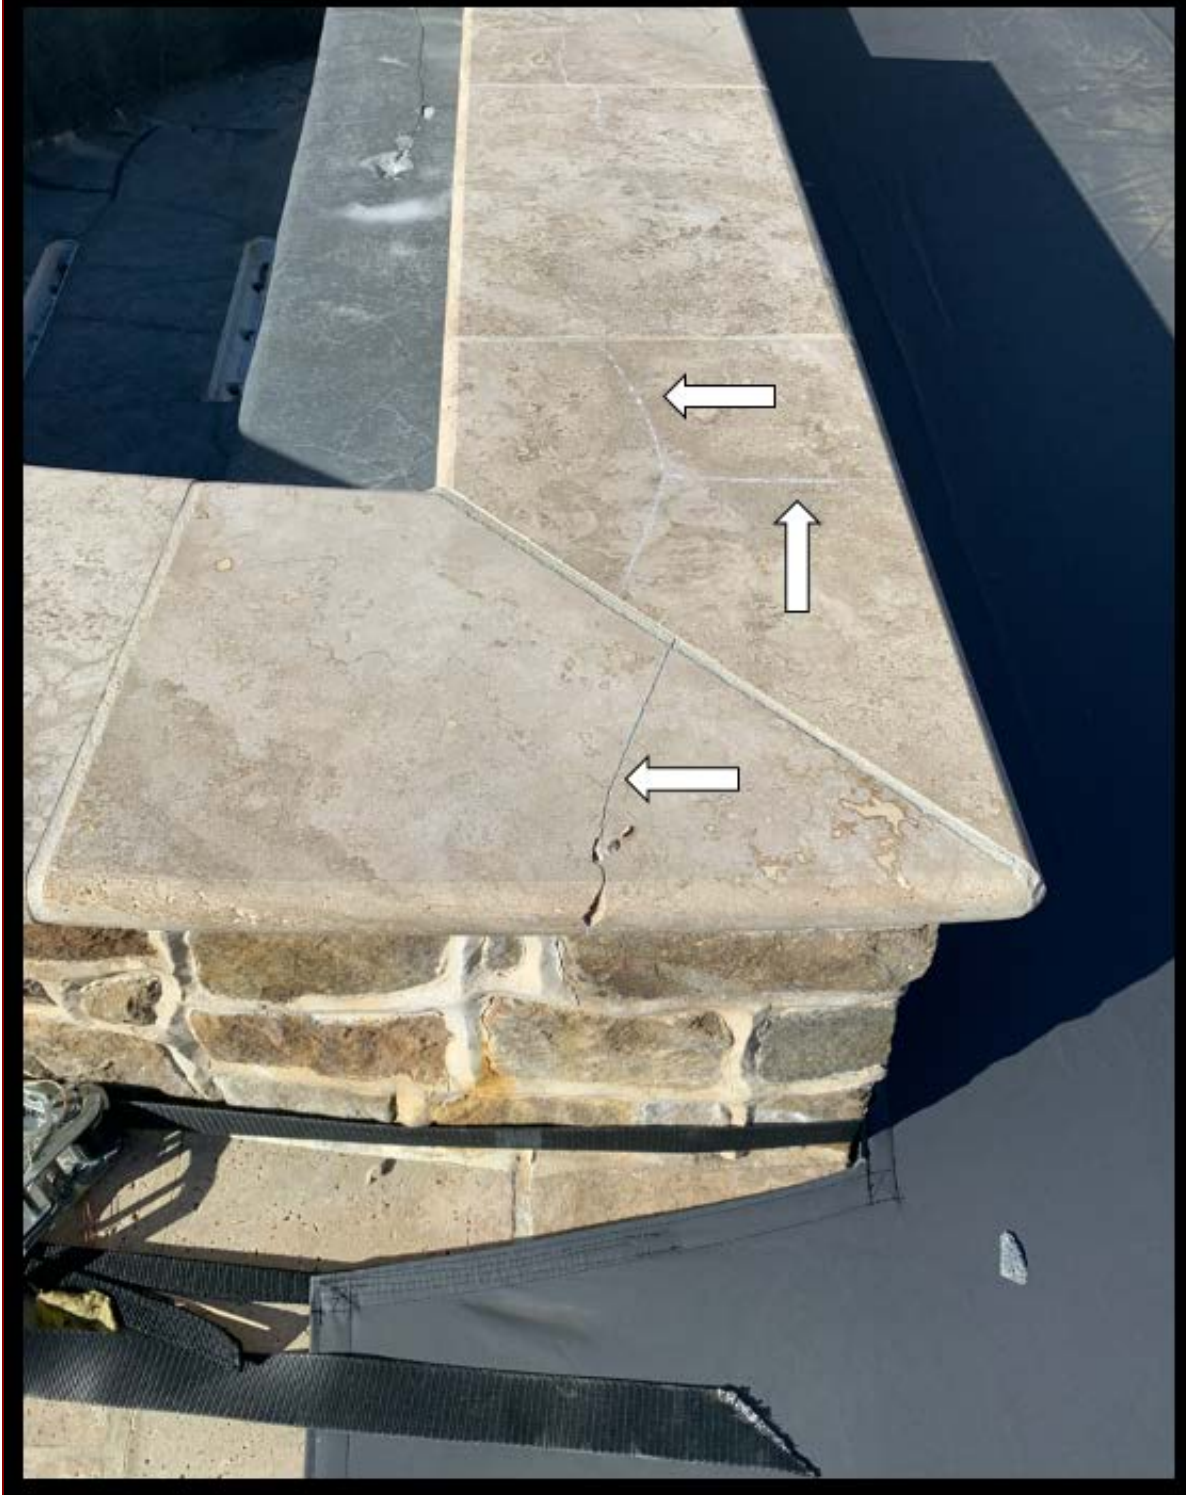
- c. Figure 3 shows visible cracks on the limestone tiles at the top of the masonry wall in the spa. These cracks are either random isolated or intersecting.

Figure 3: Enlarged view of some fine, visible cracks on the limestone tiles around the spa.

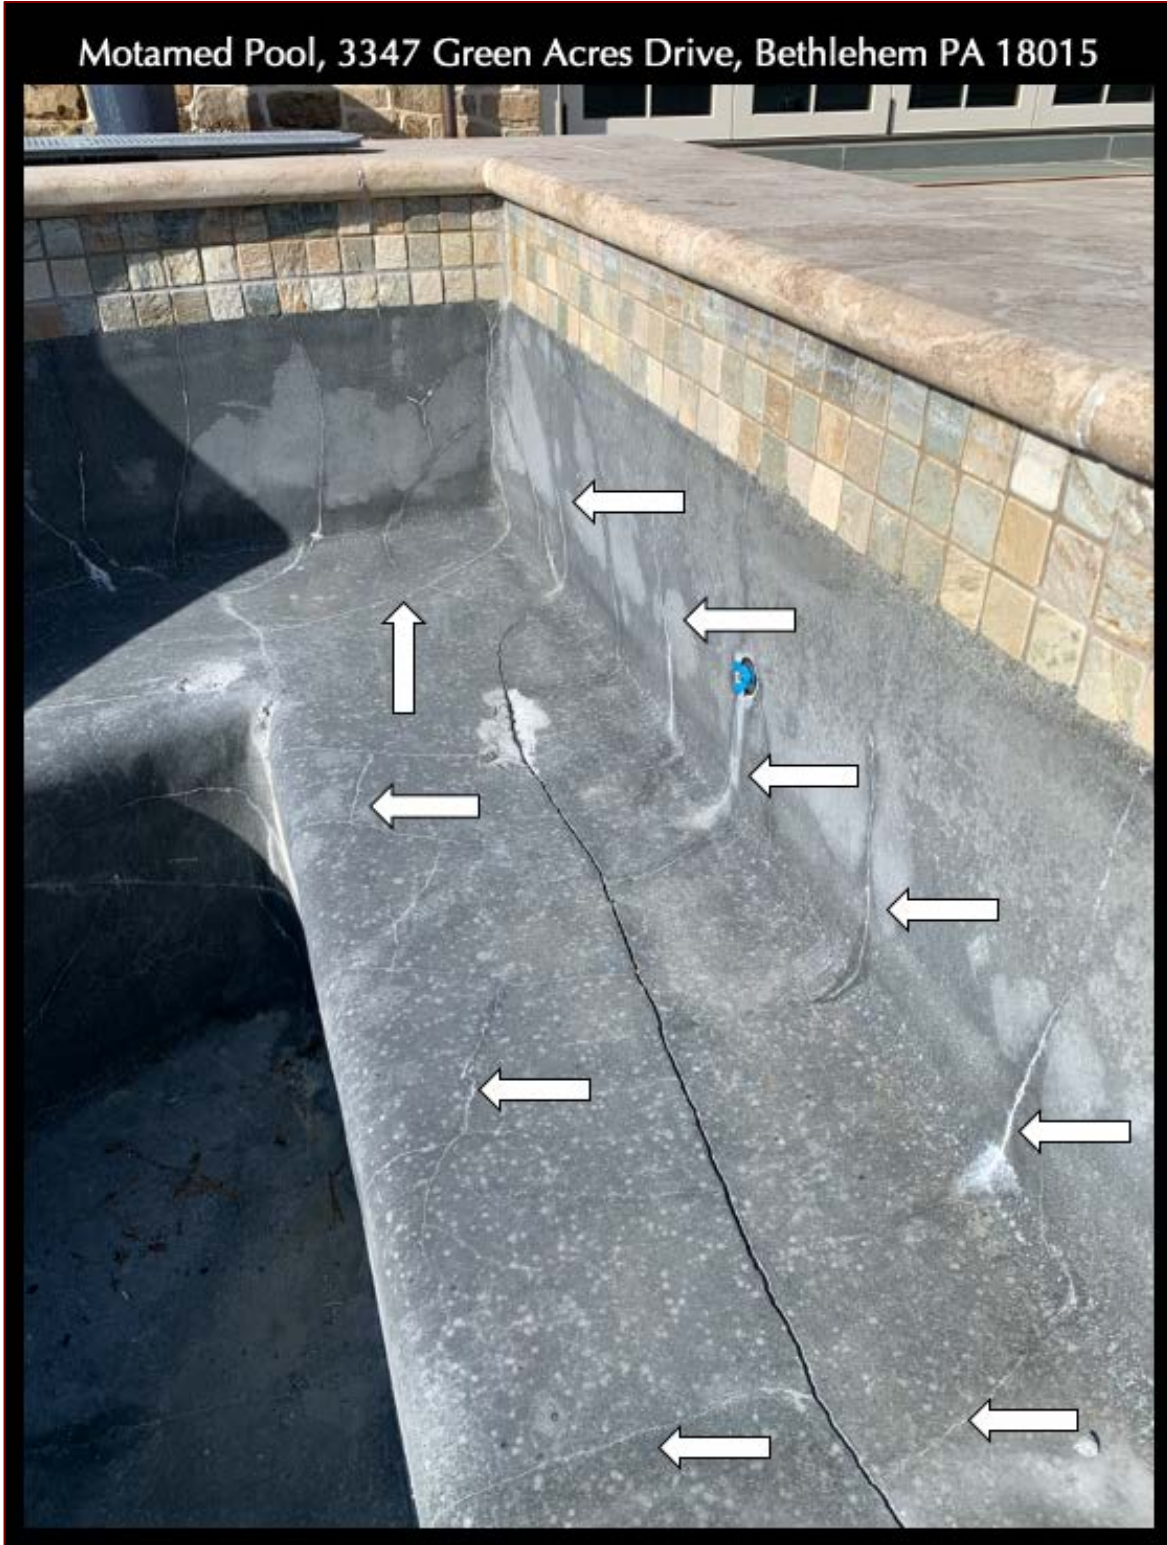
- d. Figure 4 shows close-up of cracking in the pool plaster, which is the purpose of this investigation. Cracks are mostly oriented vertical, parallel to each other, although some are diagonal or horizontal at the bench and more concentrated at the corners.

Figure 4: Extensive cracking in the dark gray pool plaster within the spa area, where many cracks show a more or less parallel pattern along with some diagonal cracks. These cracks are the reason for the present investigation.

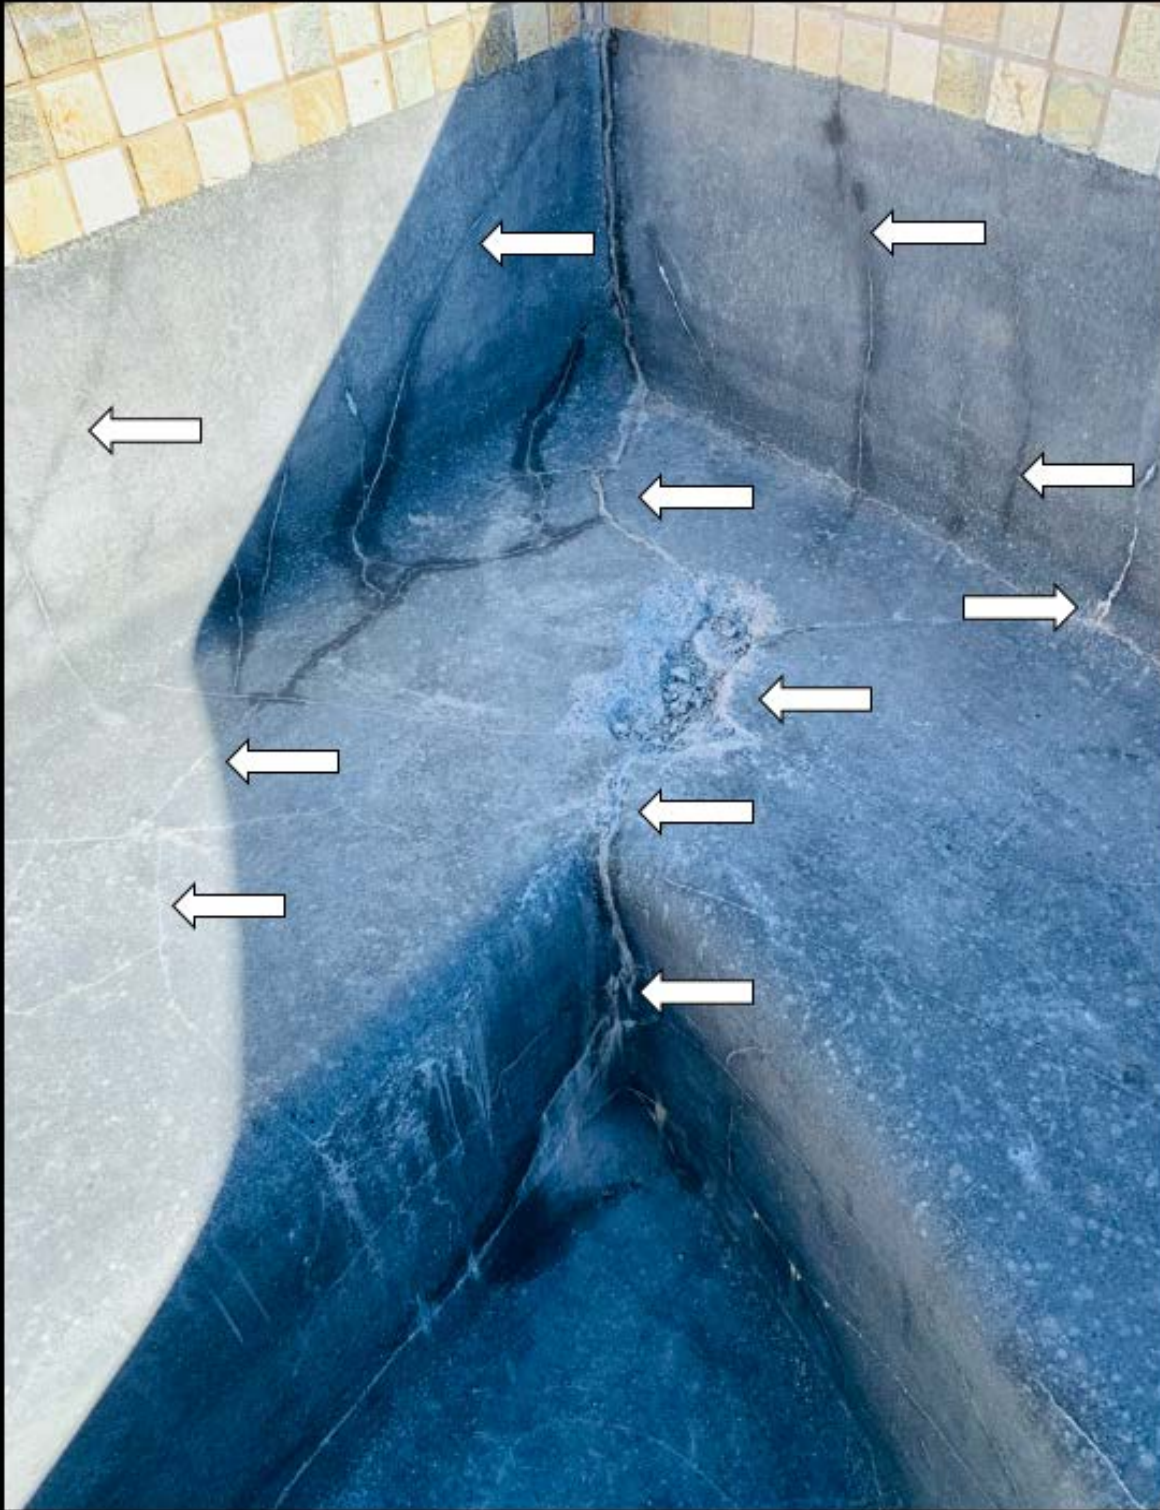
- e. Figure 5 shows a close-up of extensive cracking at the corners of the spa where not only visible cracking but spalling of pool plaster has occurred.

Figure 5: Enlarged view of extensive cracking in pool plaster. These cracks are the reason for the present investigation.

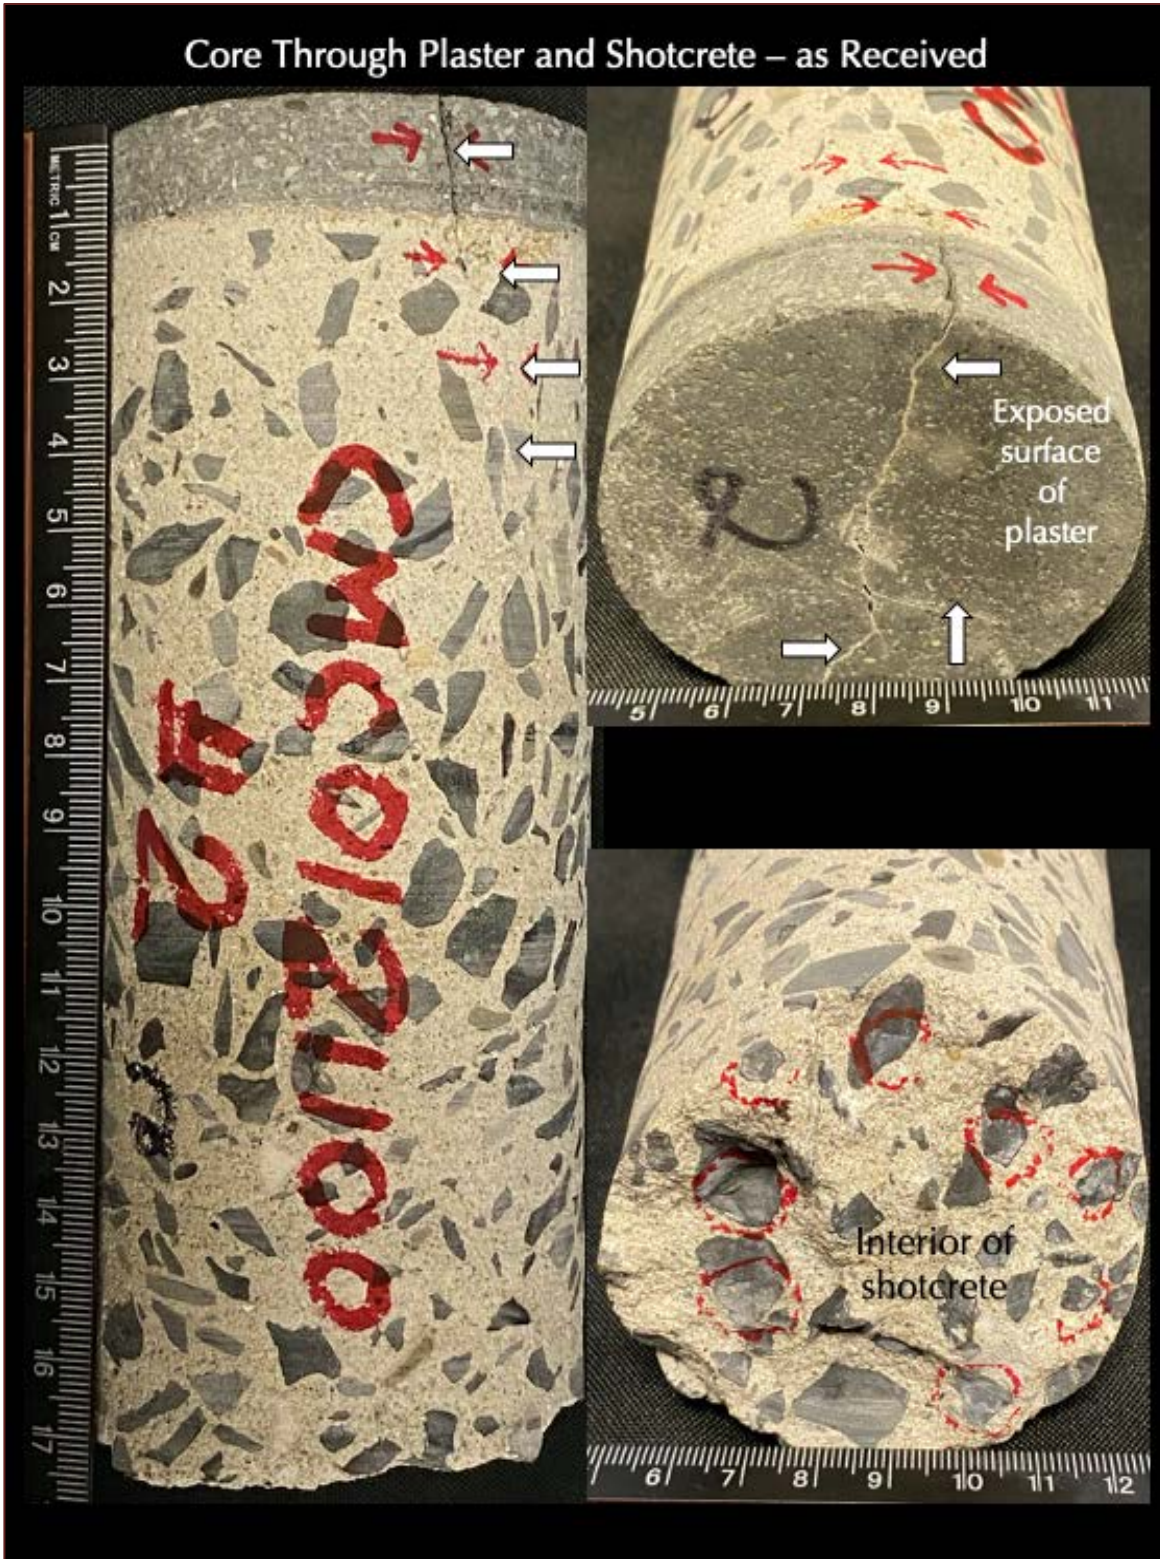
Figure 7: Core 2 as received showing:

A major visible crack is extended to a depth of 2 inches (50 mm) through the entire thickness of plaster to the shotcrete; the crack is wider at the exposed plaster surface and tapered down into shotcrete. Additionally, the fresh fractured surfaces of crushed shale coarse aggregate particles in shotcrete show internal cracking and white secondary deposits that are indicative of a potentially deleterious reaction (e.g., alkali-aggregate reaction) in shotcrete, which may have caused both internal cracking in many crushed shale particles from expansions as well as overall expansion of shotcrete to cause tensile cracking in shotcrete and plaster.

(a) A $\frac{5}{8}$ -in. (15-mm) thick dark gray pool plaster well-bonded to underlying shotcrete;

(b) A vertical crack through plaster extended to a depth of 2 in. (50 mm) into shotcrete which is wider at the exposed end and tapered down;

(c) Internal cracking in many crushed stone particles in shotcrete;

(d) White secondary deposits within fresh fractured surfaces of crushed stone in shotcrete some of which are circled in red in the bottom right photo; and,

(e) Overall dense and well-consolidated natures of plaster and shotcrete despite the visible cracking.

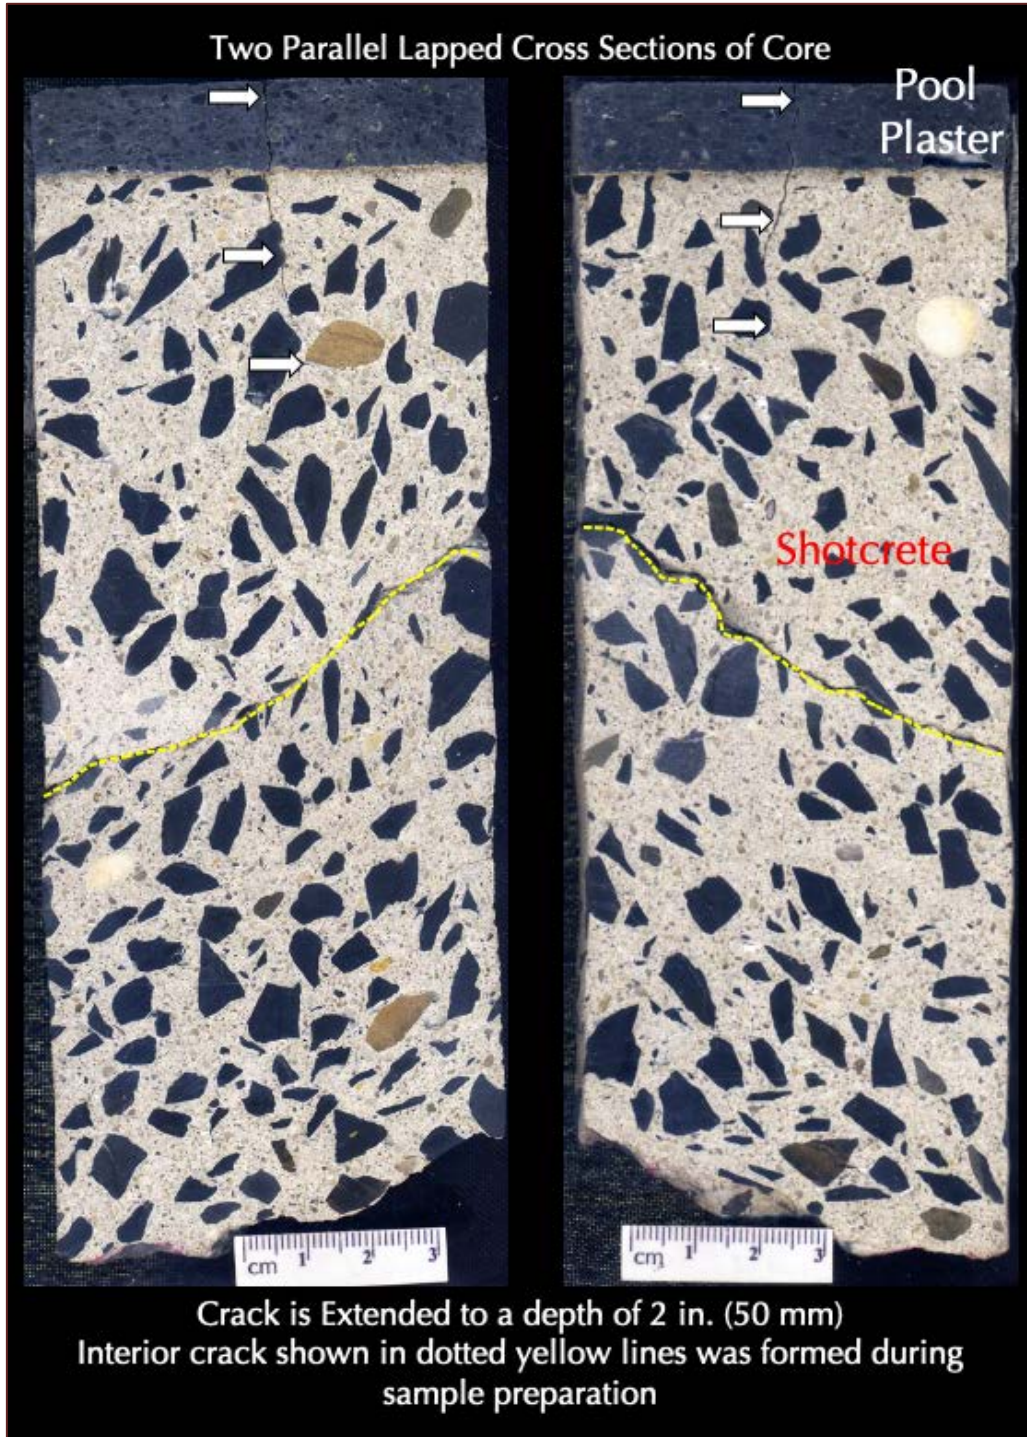
Figure 8: Lapped cross sections of Core No. 2 sectioned parallel to each other showing:

(a) A $\frac{5}{8}$ -in. (15-mm) thick dark gray pool plaster well-bonded to underlying shotcrete;

(b) A vertical crack (thick white arrows) through the plaster extended to a depth of 2 in. (50 mm) into shotcrete which is wider at the exposed end and tapered down;

(c) Internal cracking in many crushed stone particles in shotcrete; and,

(d) Overall dense and well-consolidated natures of plaster and shotcrete despite the visible cracking.

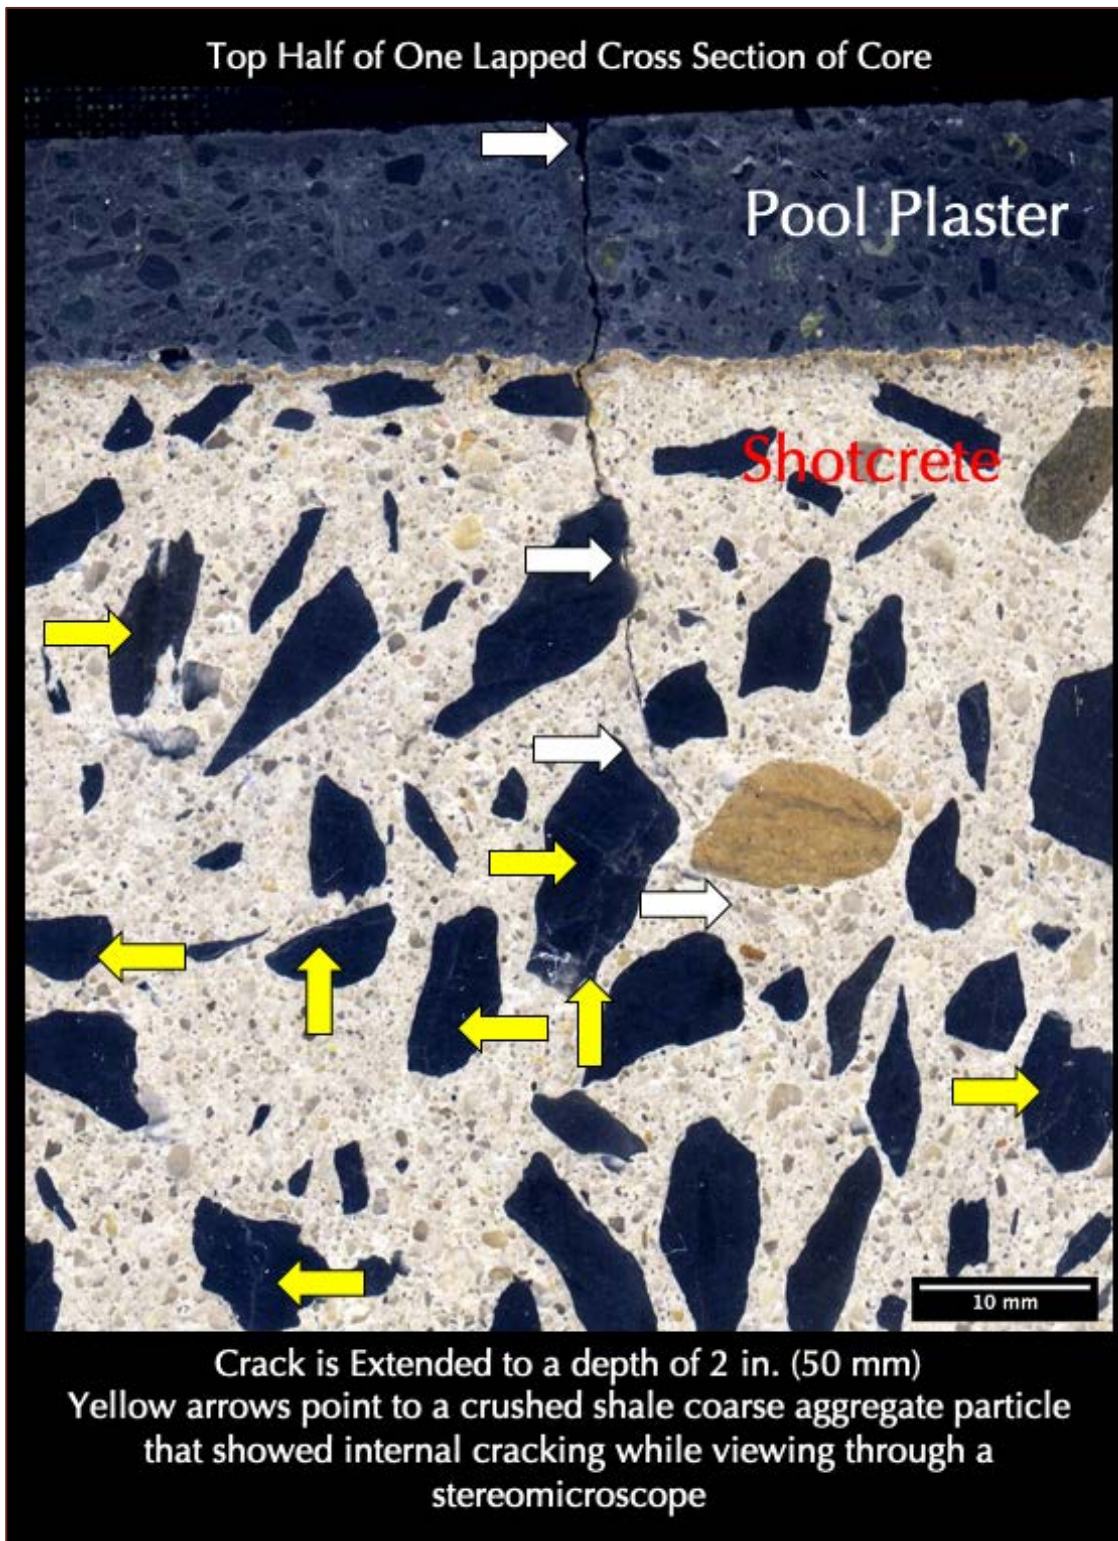
Figure 9: Lapped cross section of Core No. 2 showing:

(a) A $\frac{5}{8}$ -in. (15-mm) thick dark gray pool plaster well-bonded to underlying shotcrete;

(b) A vertical crack (thick white arrows) through the plaster extended to a depth of 2 in. (50 mm) into shotcrete which is wider at the exposed end and tapered down;

(c) Internal cracking (thick yellow arrows) in many crushed stone particles in shotcrete; and,

(d) Overall dense and well-consolidated natures of plaster and shotcrete despite the visible cracking.

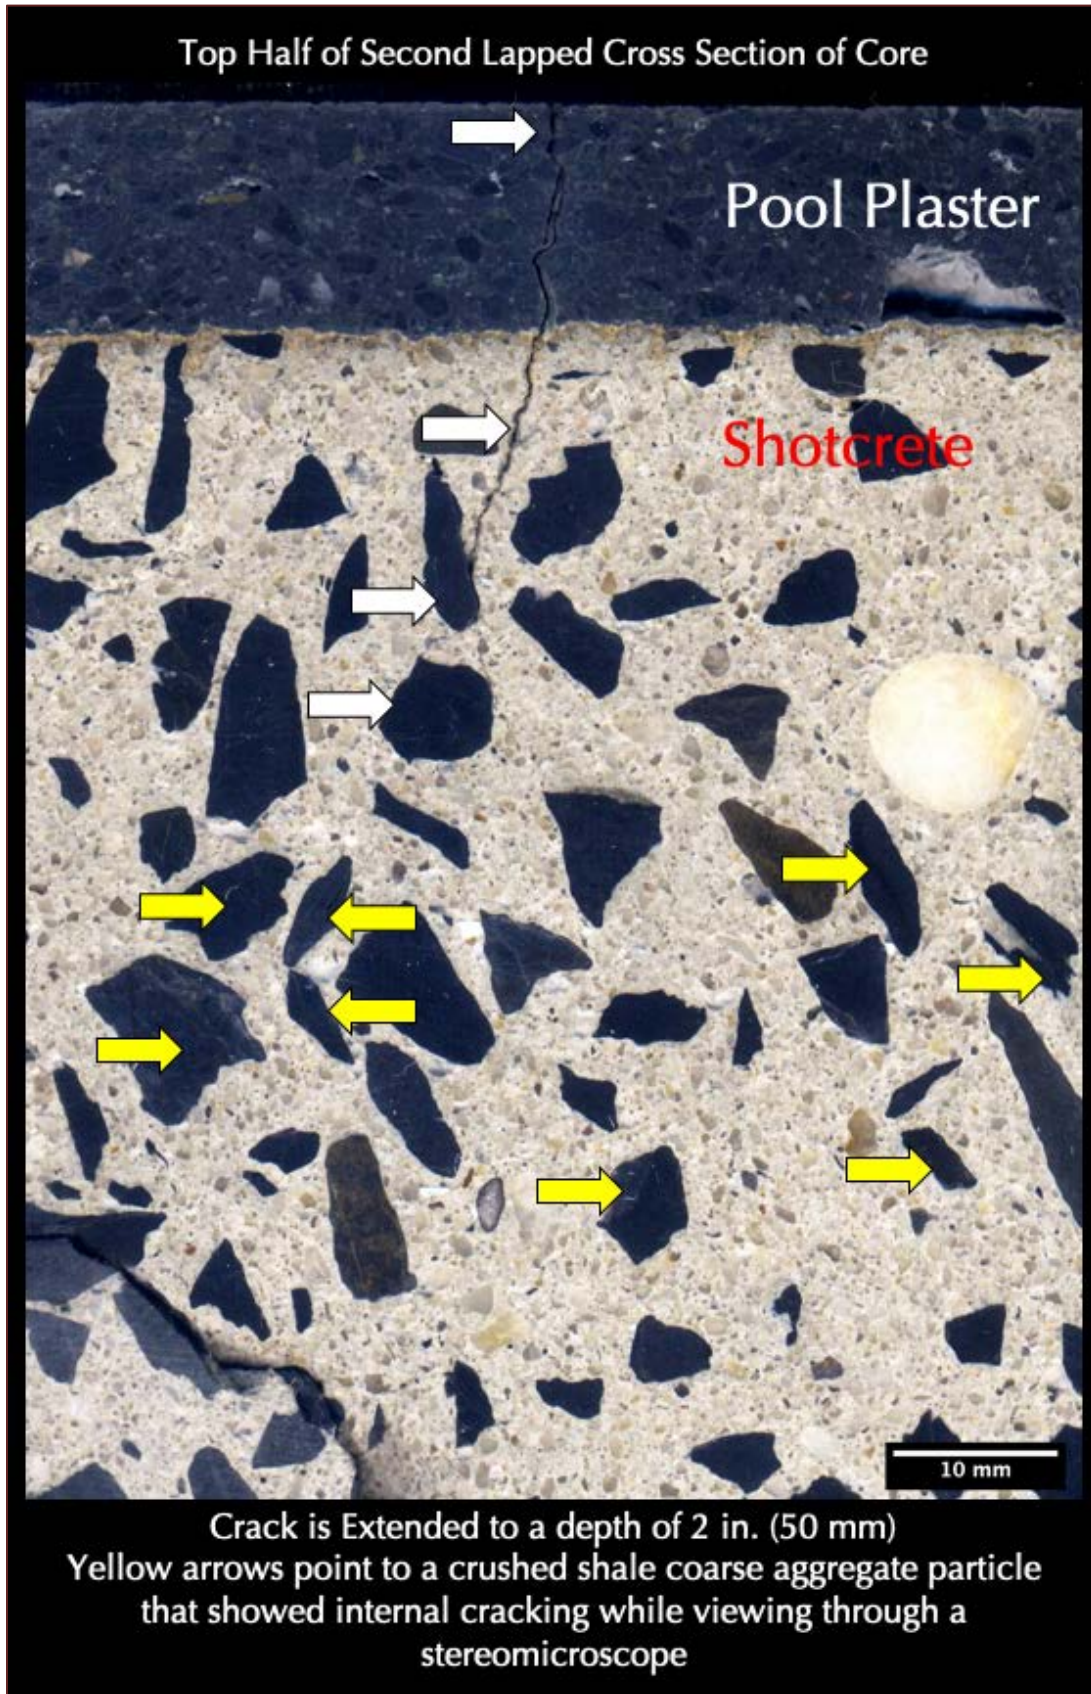
Figure 10: Lapped cross section of Core No. 2 showing:

(a) A 5/8-in. (15-mm) thick dark gray pool plaster well-bonded to underlying shotcrete;

(b) A vertical crack (thick white arrows) through the plaster extended to a depth of 2 in. (50 mm) into shotcrete which is wider at the exposed end and tapered down;

(c) Internal cracking (thick yellow arrows) in many crushed stone particles in shotcrete; and,

(d) Overall dense and well-consolidated natures of plaster and shotcrete despite the visible cracking.

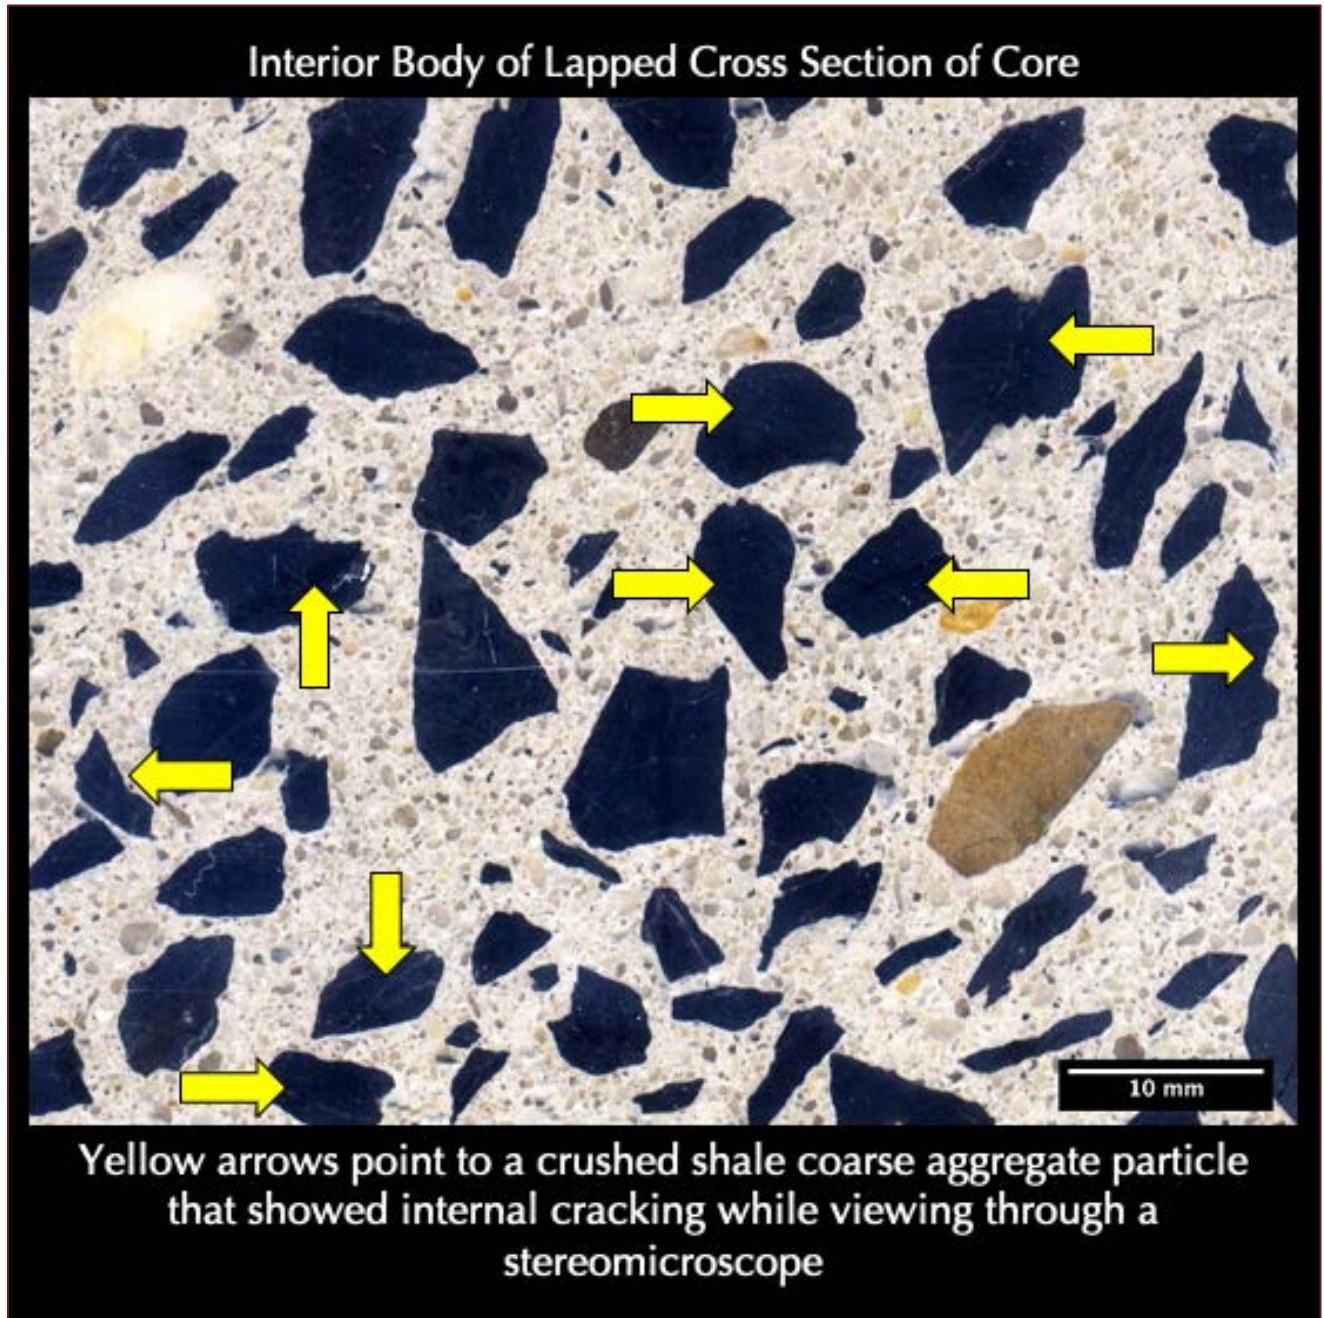
Figure 11: Lapped cross section of Core No. 2 showing the shotcrete portion particularly the well-graded and well-distributed nature of crushed stone aggregate, and internal cracking (thick yellow arrows) in many crushed stone particles in shotcrete.

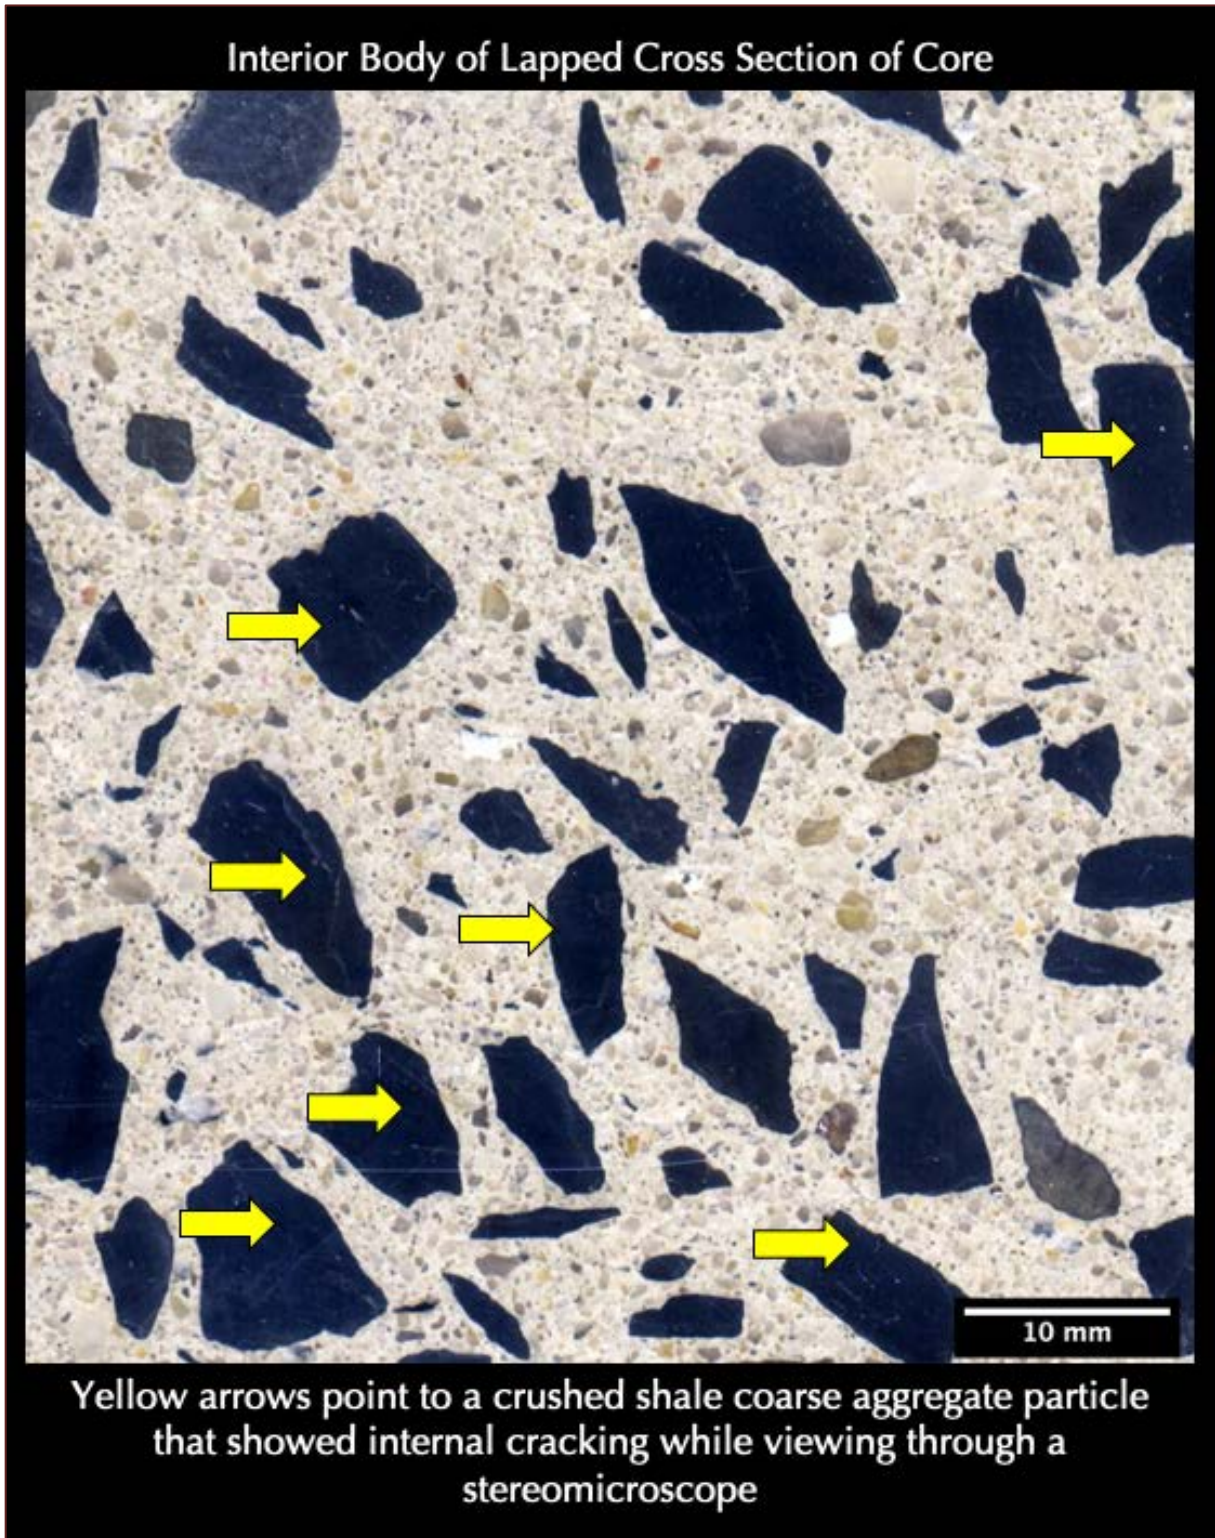
Figure 12: Lapped cross section of Core No. 2 showing the shotcrete portion particularly the well-graded and well-distributed nature of crushed stone aggregate, and internal cracking (thick yellow arrows) in many crushed stone particles in shotcrete.

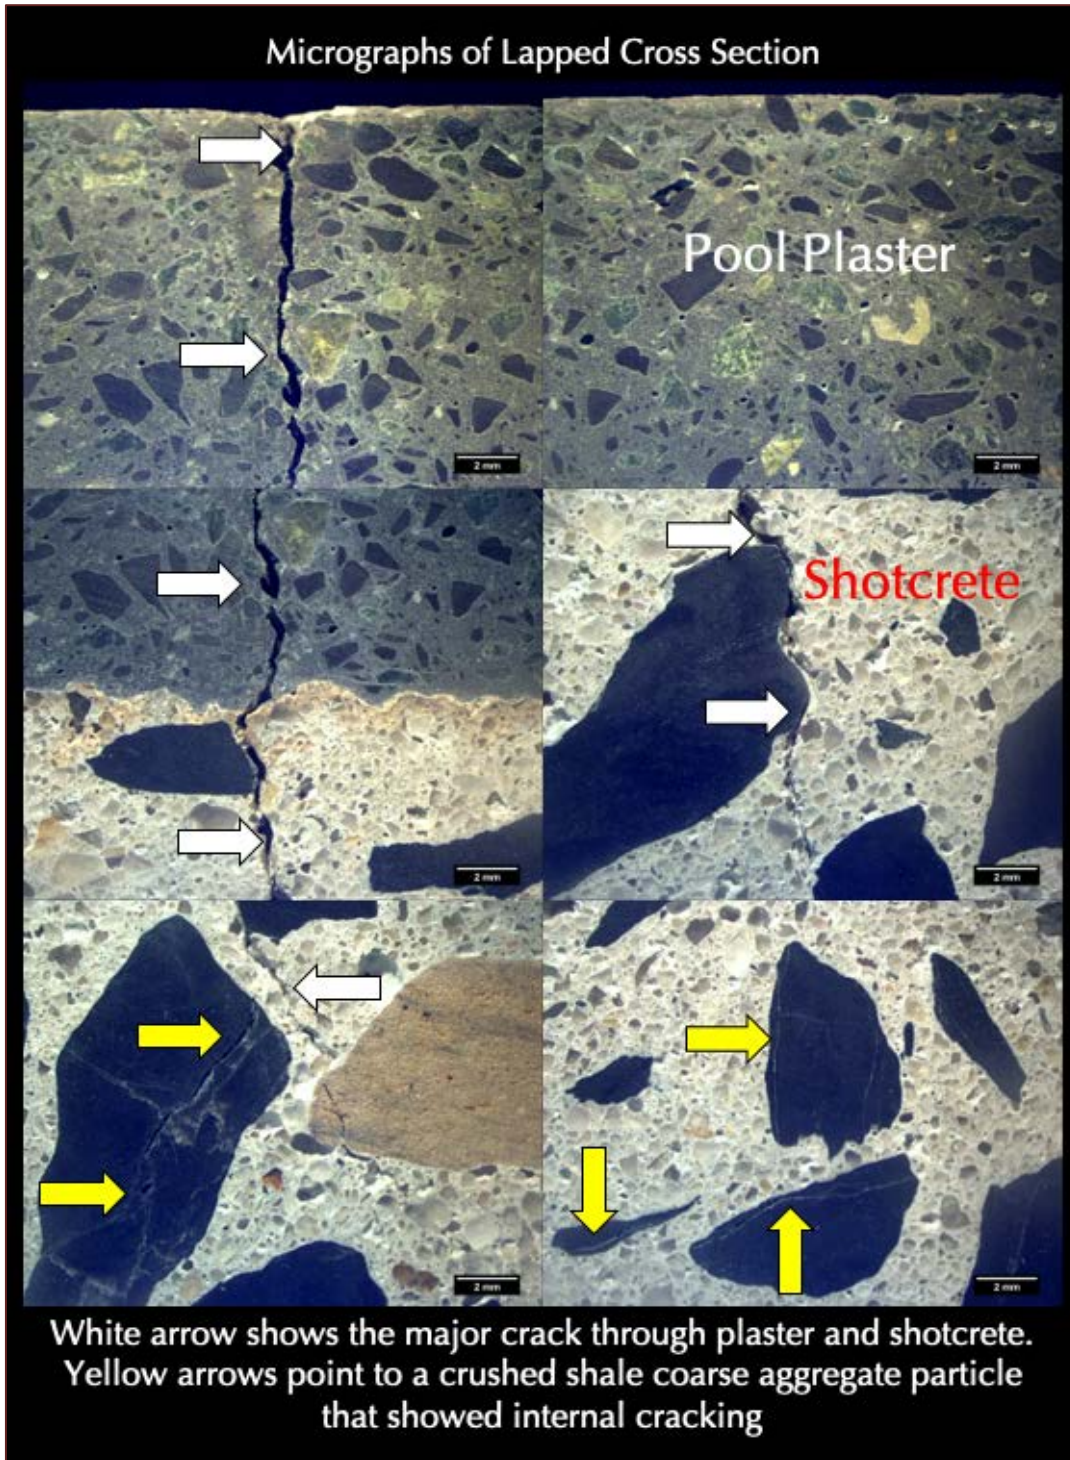
Figure 13: Micrographs of lapped cross section of core showing:

(a) $\frac{5}{8}$ -in. (15-mm) thick dark gray pool plaster well-bonded to underlying shotcrete;

(b) Beige discoloration of shotcrete at the interface to plaster due to a period of atmospheric carbonation of shotcrete prior to the installation of plaster;

(c) A vertical crack (thick white arrows) through the plaster extended to a depth of 2 in. (50 mm) into shotcrete which is wider at the exposed end and tapered down;

(d) Internal cracking (thick yellow arrows) in many crushed stone particles in shotcrete; and,

(e) Lack of air entrainment in the plaster, whereas air-entrained nature of shotcrete.
