Cracking Of A Swimming Pool Plaster – A Laboratory Investigation

Motamed Pool
3347 Green Acres Drive
Bethlehem, PA 18015

January 20, 2021
CMC 0121100

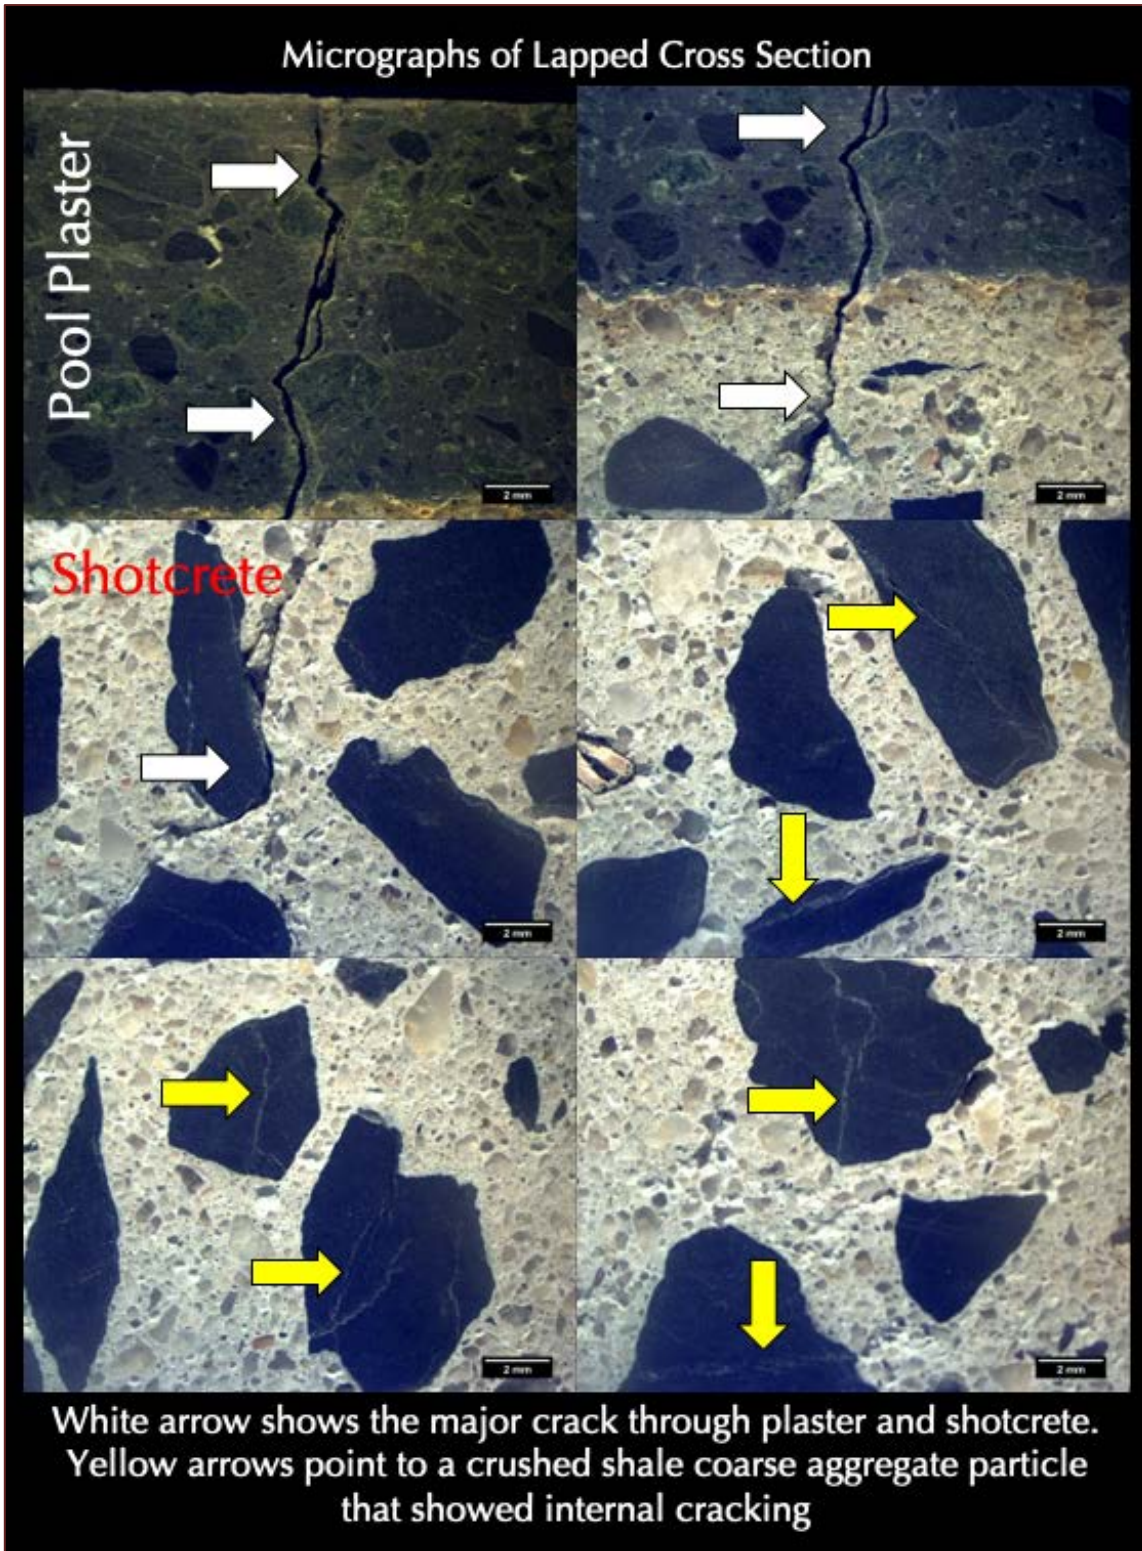
Figure 14: Micrographs of lapped cross section of core showing:

(a) $\frac{5}{8}$ -in. (15-mm) thick dark gray pool plaster well-bonded to underlying shotcrete;

(b) Beige discoloration of shotcrete at the interface to plaster due to a period of atmospheric carbonation of shotcrete prior to the installation of plaster;

(c) A vertical crack (thick white arrows) through the plaster extended to a depth of 2 in. (50 mm) into shotcrete which is wider at the exposed end and tapered down;

(d) Internal cracking (thick yellow arrows) in many crushed stone particles in shotcrete; and,

(e) Lack of air entrainment in the plaster, whereas air-entrained nature of shotcrete.

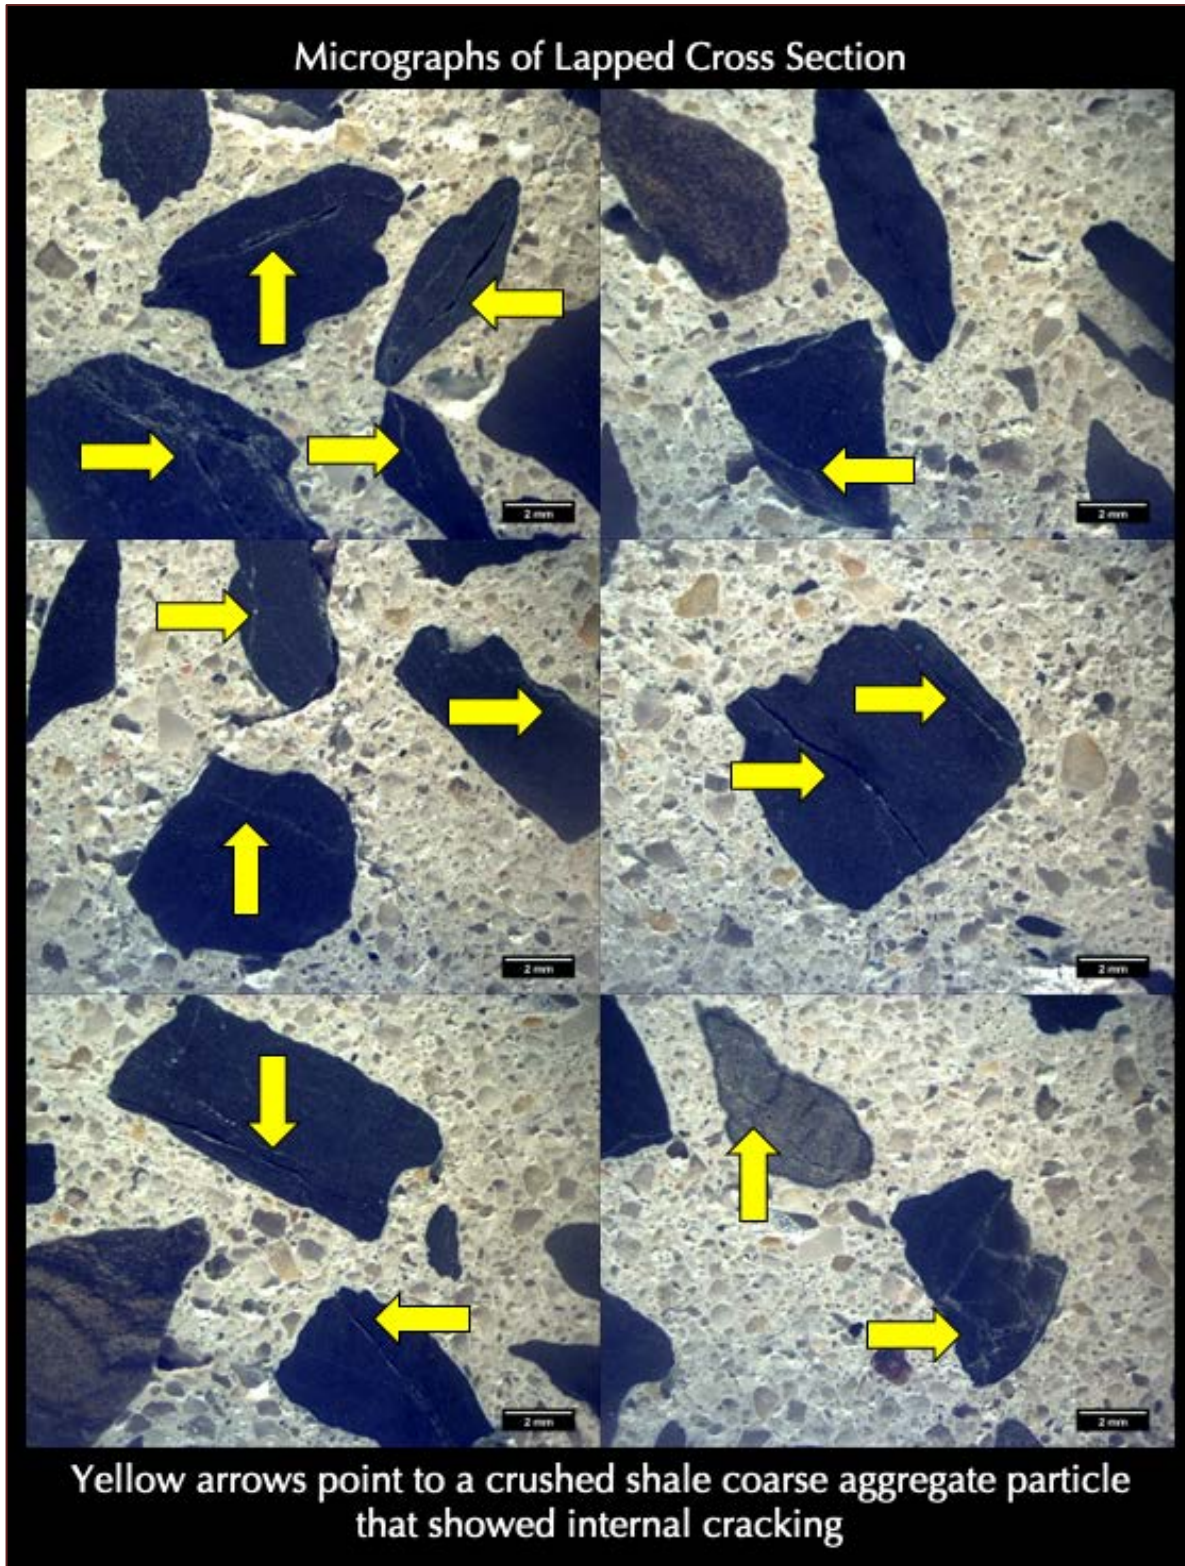
Figure 15: Micrographs of lapped cross section of core showing the shotcrete portion particularly:

(a) The well-graded and well-distributed nature of crushed stone aggregate;

(b) internal cracking (thick yellow arrows) in many crushed stone particles in shotcrete.

(c) The air-entrained nature of the shotcrete is revealed through numerous very fine, discrete spherical and near-spherical voids of sizes 1 mm or less.

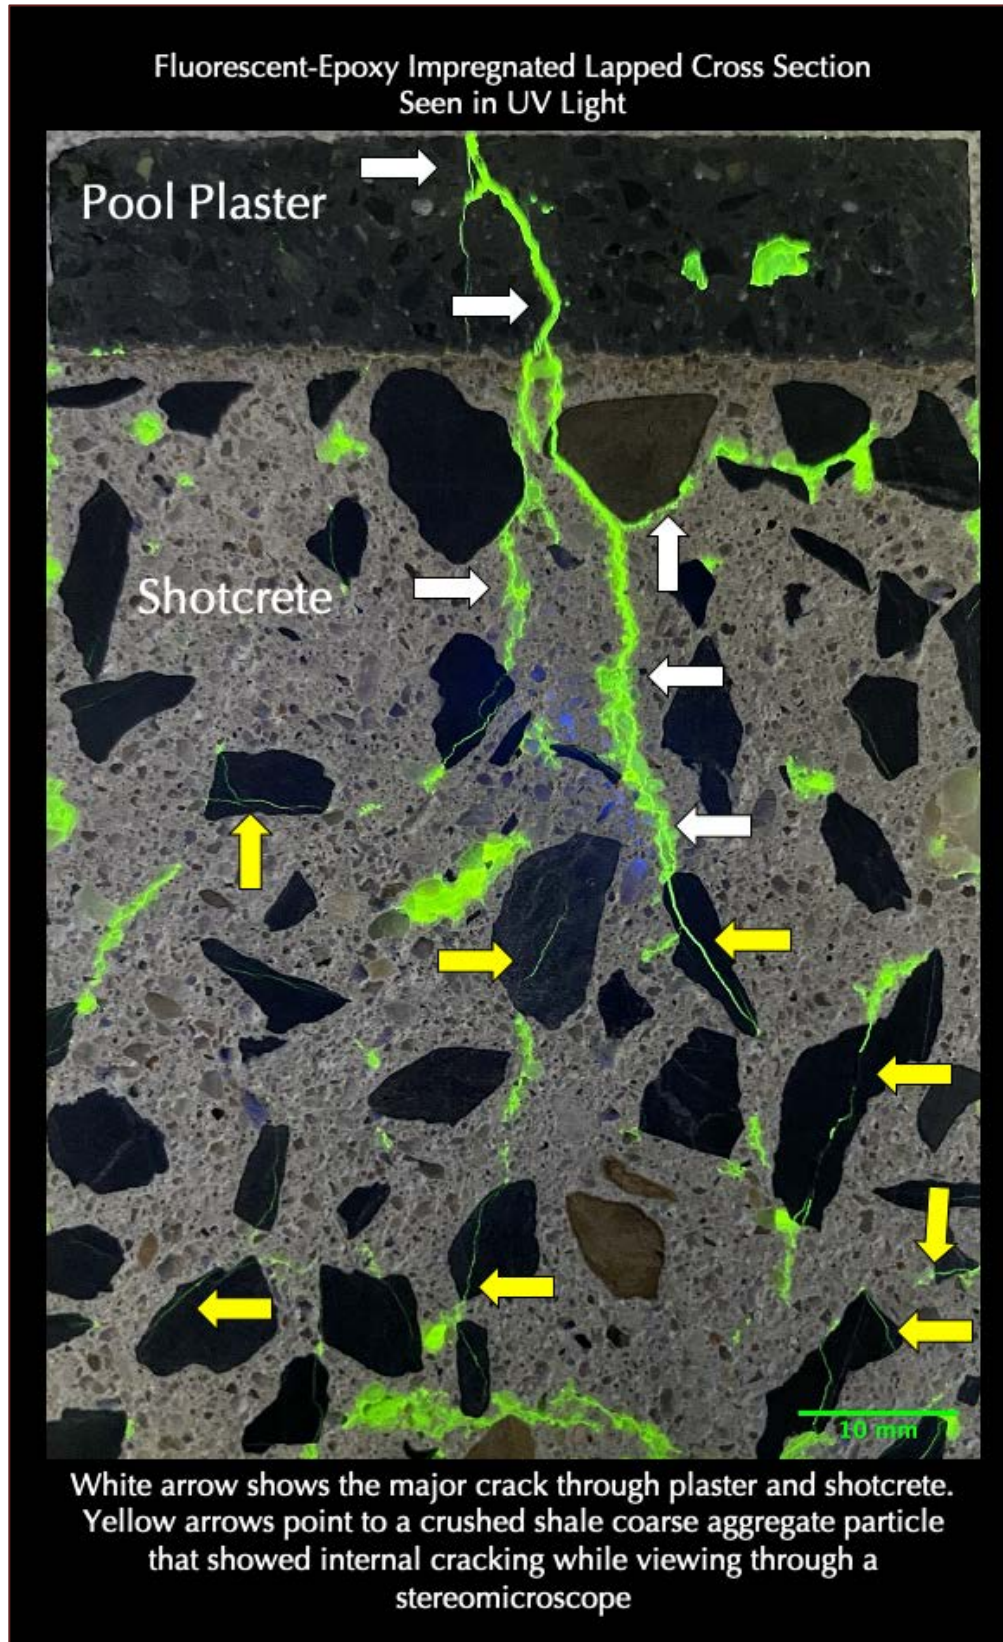
Figure 16: Fluorescent dye-mixed epoxy-impregnated lapped cross section highlighting the cracks while viewing in an UV light. Along with the major vertical cracks many fine hairline microcracks in crushed shale aggregate particles in shotcrete are highlighted.

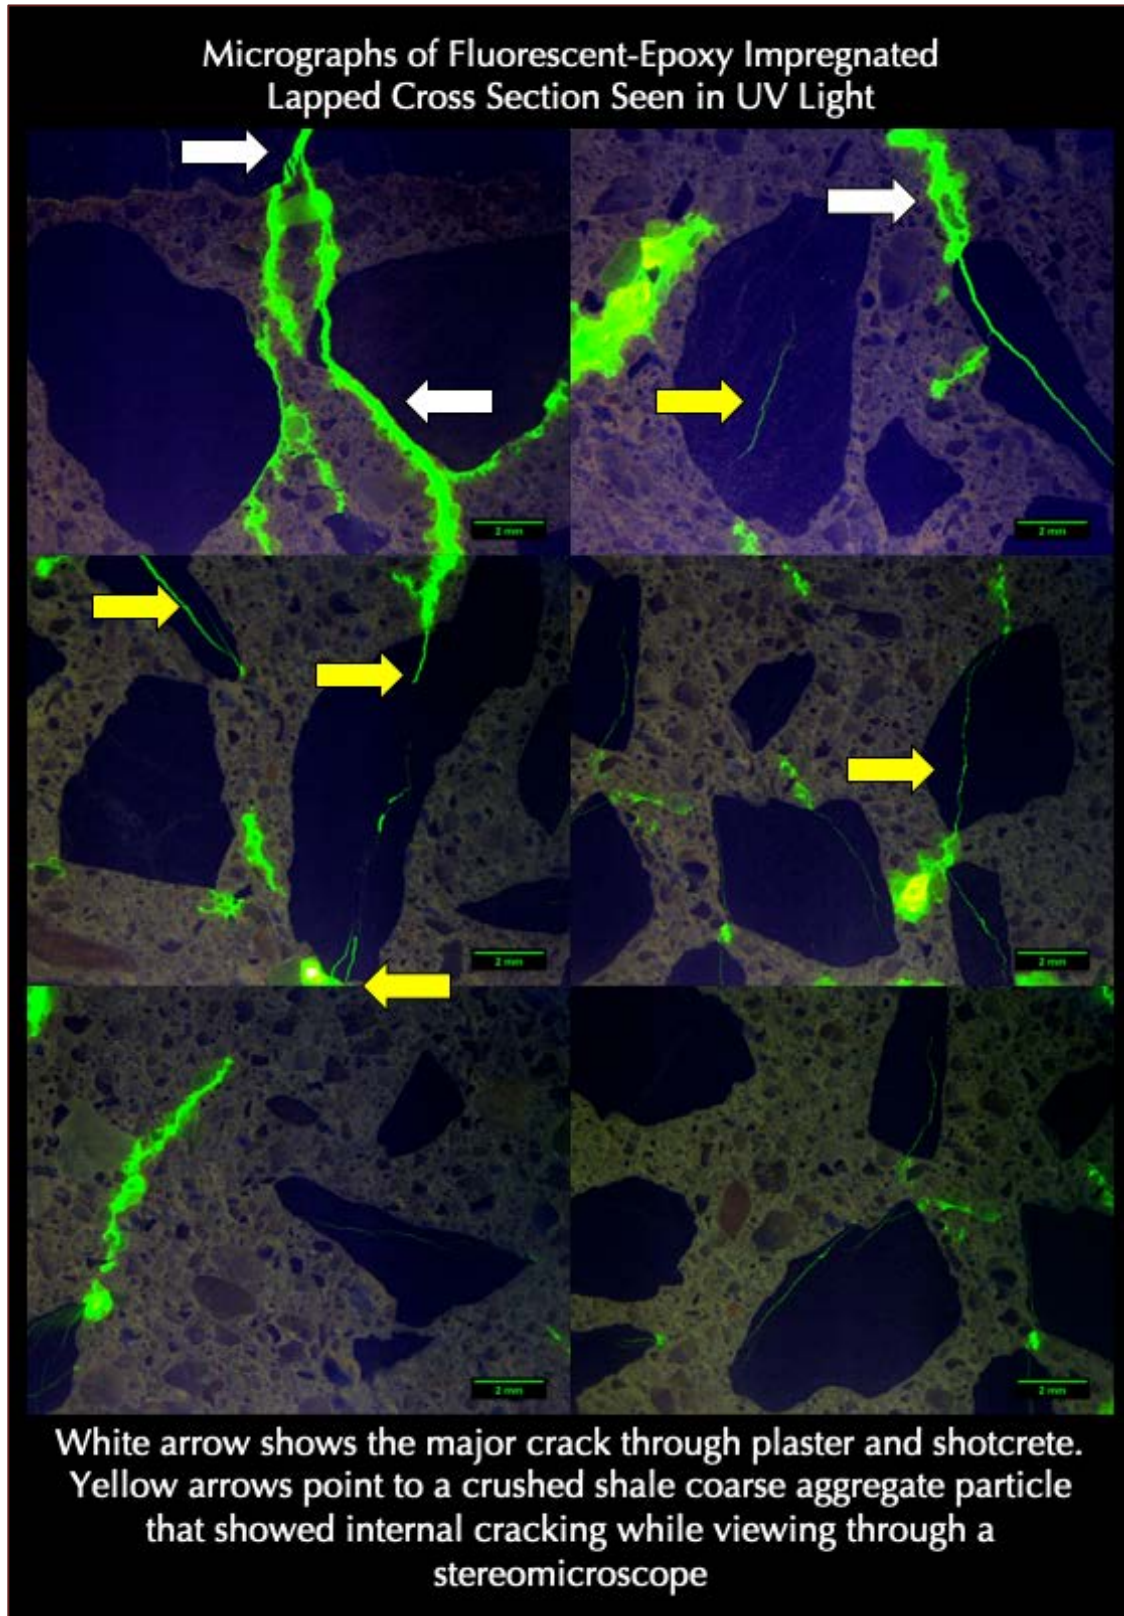
Figure 17: Micrographs of fluorescent dye-mixed epoxy-impregnated lapped cross section highlighting cracks while viewing in an UV light where along with the major vertical cracks many fine hairline microcracks in crushed shale aggregate particles in shotcrete are highlighted.

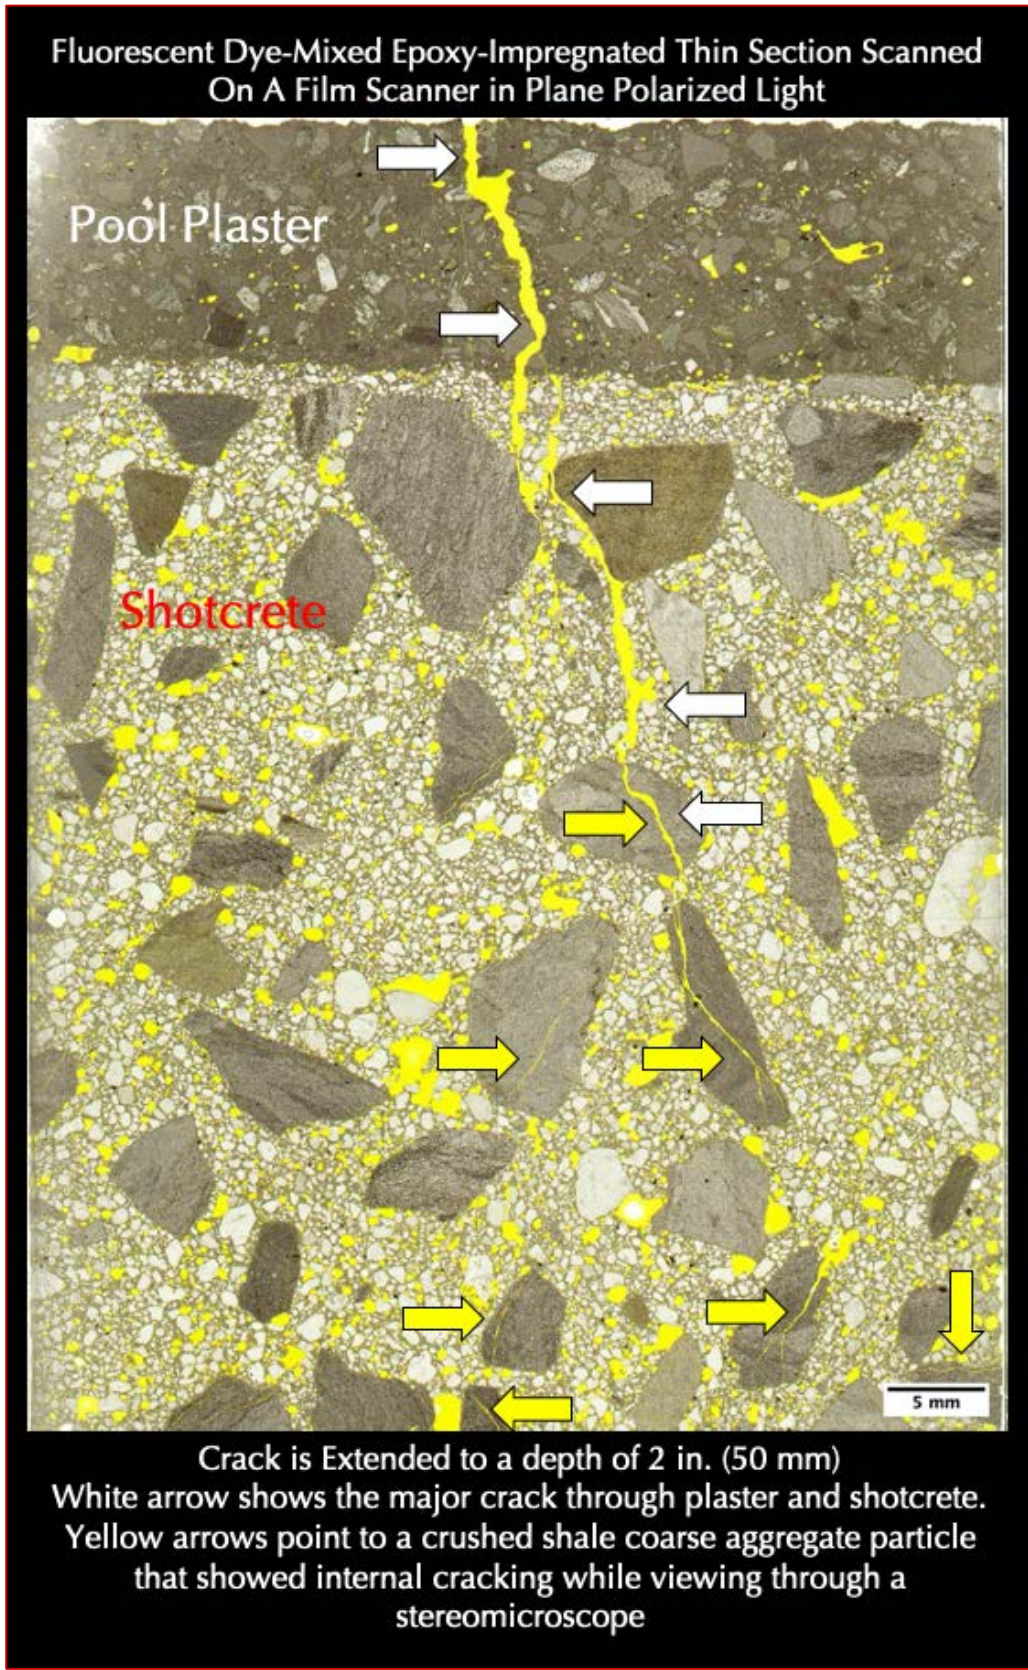
Figure 18: Fluorescent dye-mixed epoxy-impregnated thin section of core where the major and micro cracks, air voids, and porous areas of paste are highlighted by fluorescent epoxy. The image was taken in plane-polarized light mode (PPL) in a film scanner to highlight air voids in the shotcrete as opposed to lack of voids in plaster, crushed shale coarse aggregate particles, and air-entrained mortar fraction of fine silica sand and paste in shotcrete.

- (a) $\frac{5}{8}$ -in. (15-mm) thick dark gray pool plaster well-bonded to underlying shotcrete;
- (b) A vertical crack (thick white arrows) through the plaster extended to a depth of 2 in. (50 mm) into shotcrete which is wider at the exposed end and tapered down;
- (d) Internal cracking (thick yellow arrows) in many crushed stone particles in shotcrete;
- (e) Lack of air entrainment in the plaster, whereas air-entrained nature of shotcrete; and,
- (f) Compared to the porous nature of shotcrete a noticeably denser nature of the plaster.

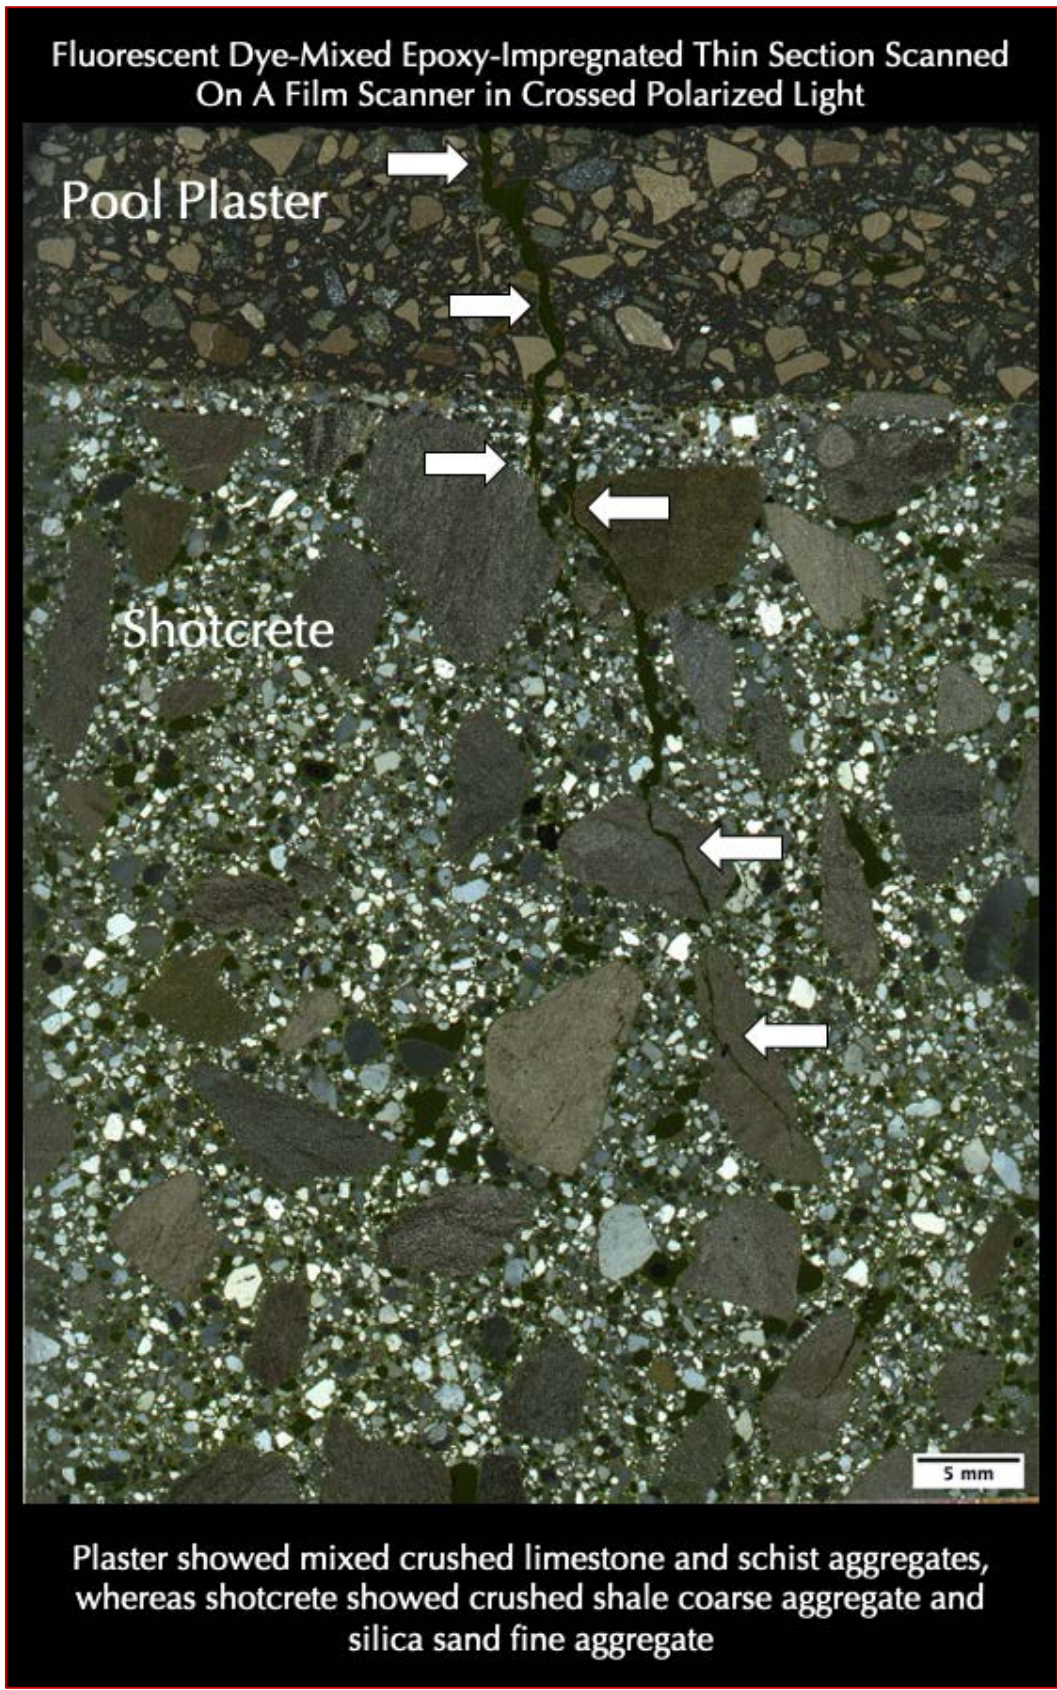
Figure 19: Fluorescent dye-mixed epoxy-impregnated thin section of core shown in crossed polarized light (XPL) mode to highlight:

(a) Mixed crushed limestone and schist particles in plaster;

(b) Crushed shale coarse aggregate particles in shotcrete which are mostly dark in XPL image;

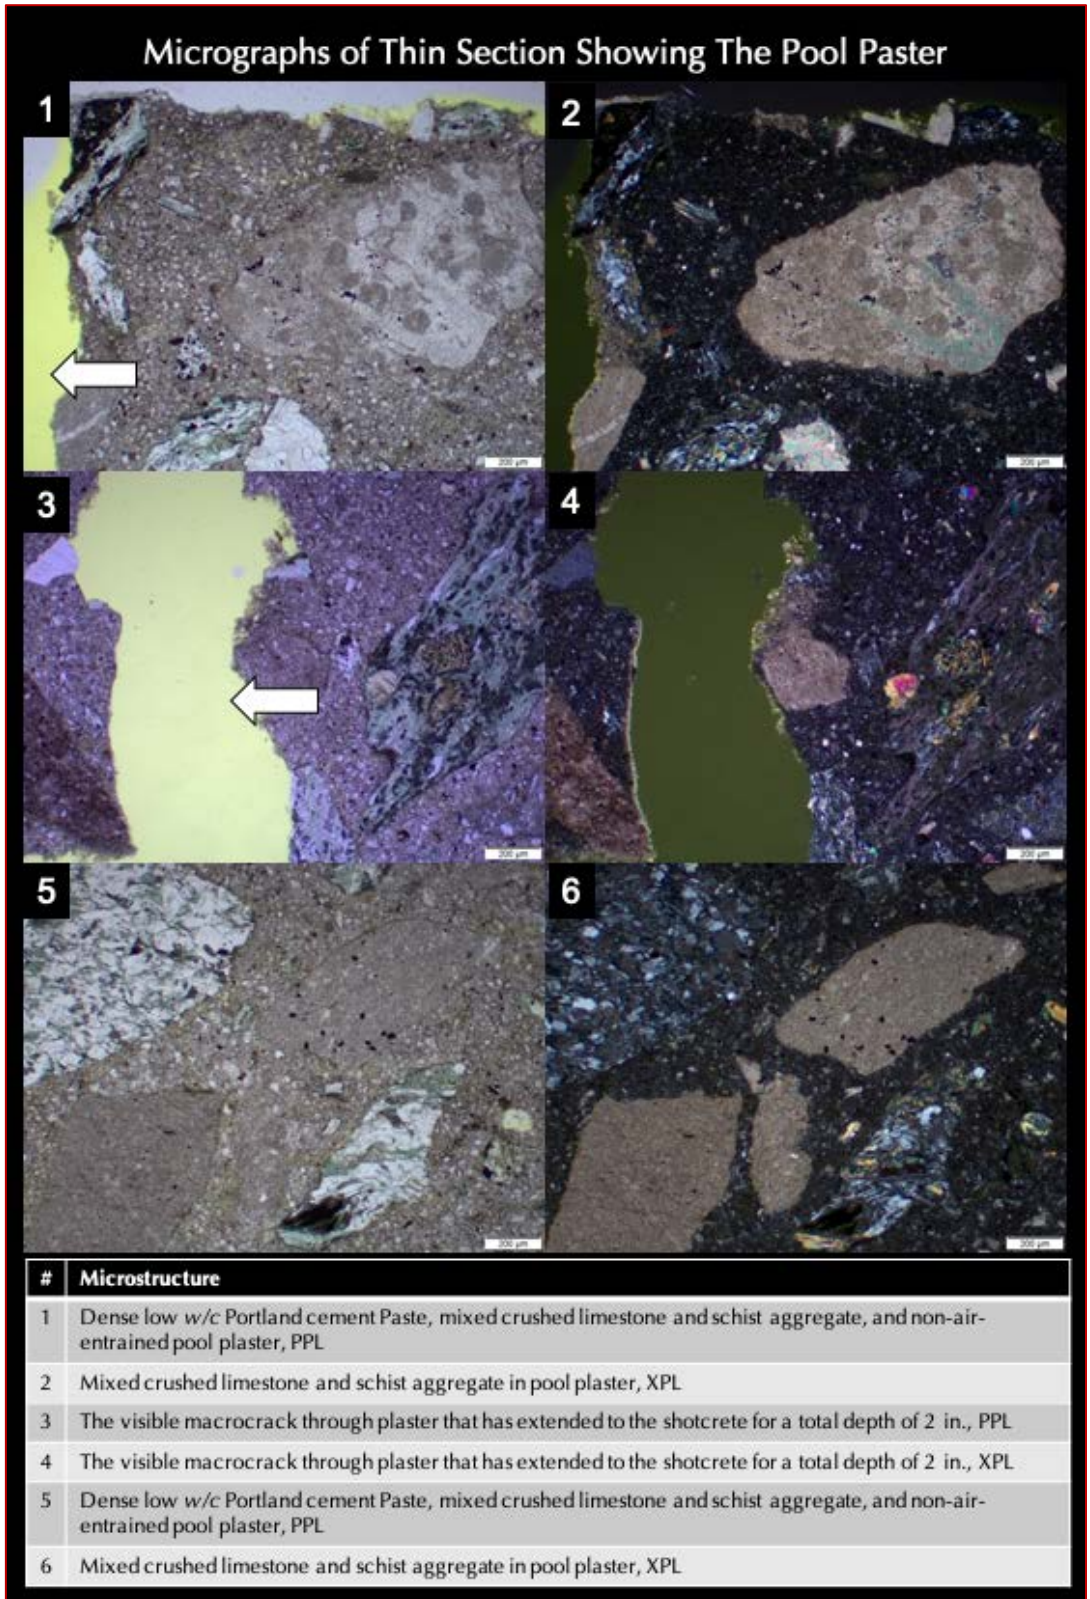
Figure 20: Micrographs of thin section showing compositions and microstructures of plaster portion.

Plaster showed mixed crushed limestone and amphibole-pyroxene mafic schist rocks in the aggregate; a dense Portland cement paste; and lack of air entrainment. The major vertical crack is shown with white arrows.

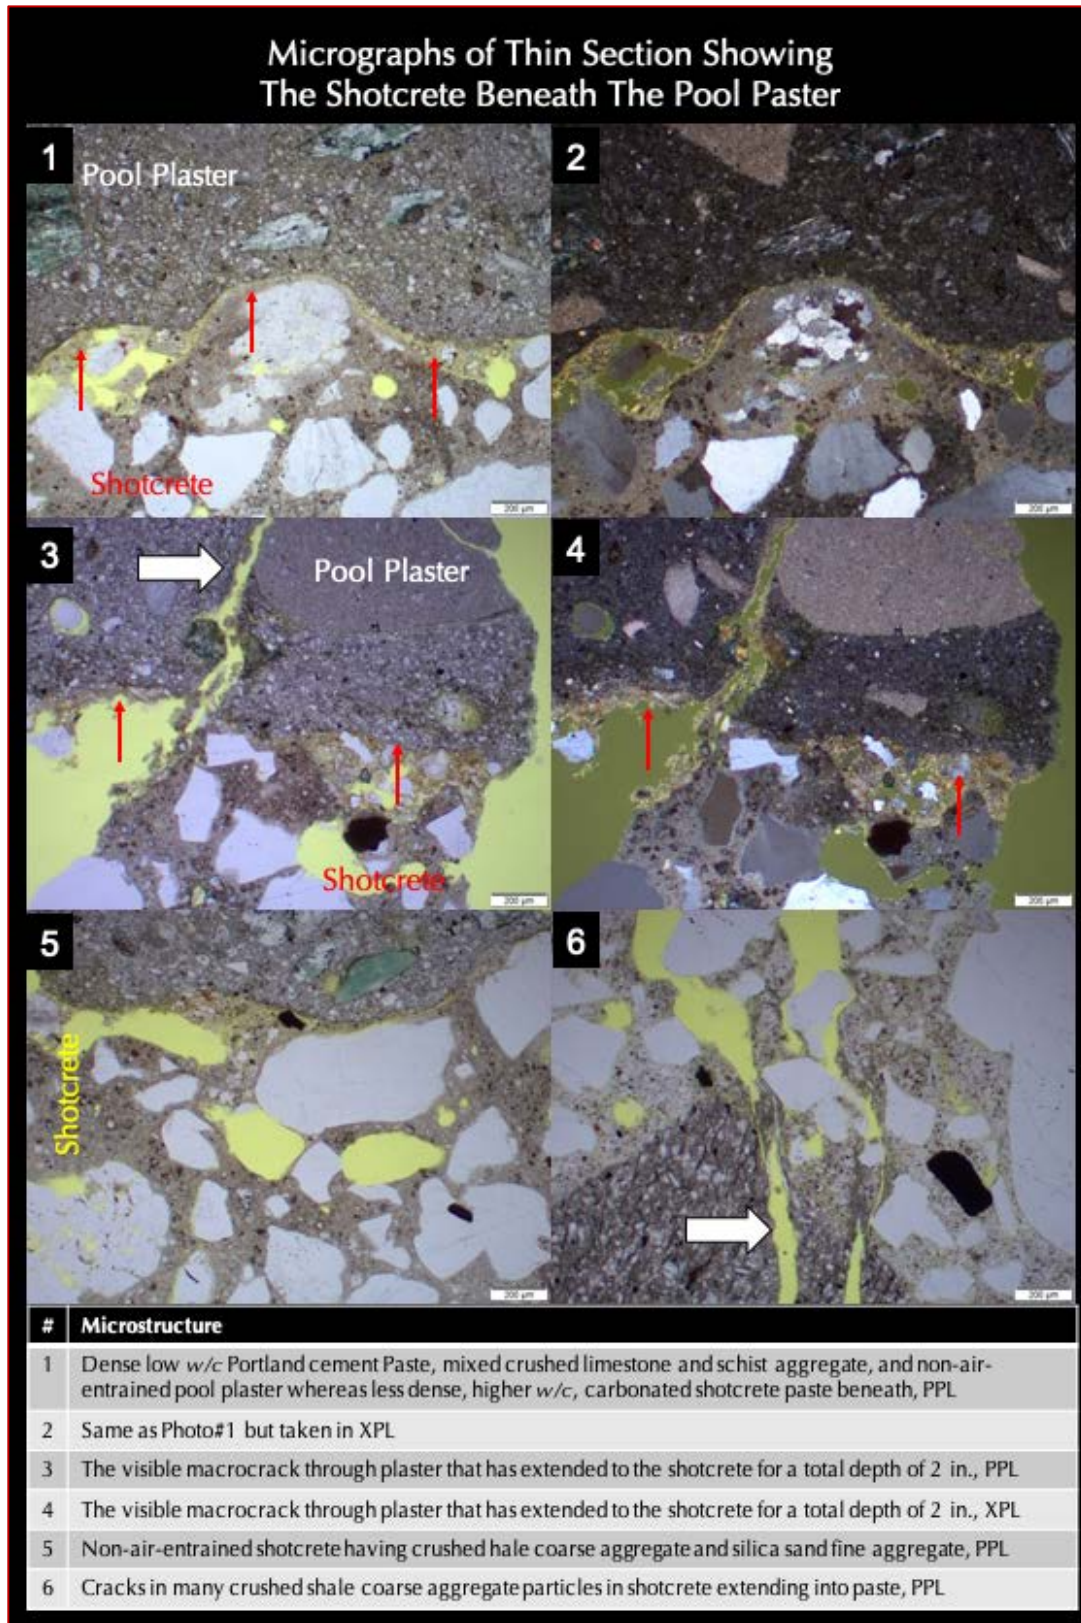
Figure 21: Micrographs of thin section showing the interface between the plaster and shotcrete, the carbonated nature of shotcrete at the interface (marked by thin red arrows) due to a prior exposure to atmospheric carbon dioxide before installation of plaster, the noticeably denser nature of low water-cement ratio paste in the plaster as opposed to relatively porous, higher water-cement ratio paste in the shotcrete, and the major vertical crack highlighted by fluorescent epoxy that has transected the plaster and entered (actually originated from) shotcrete.

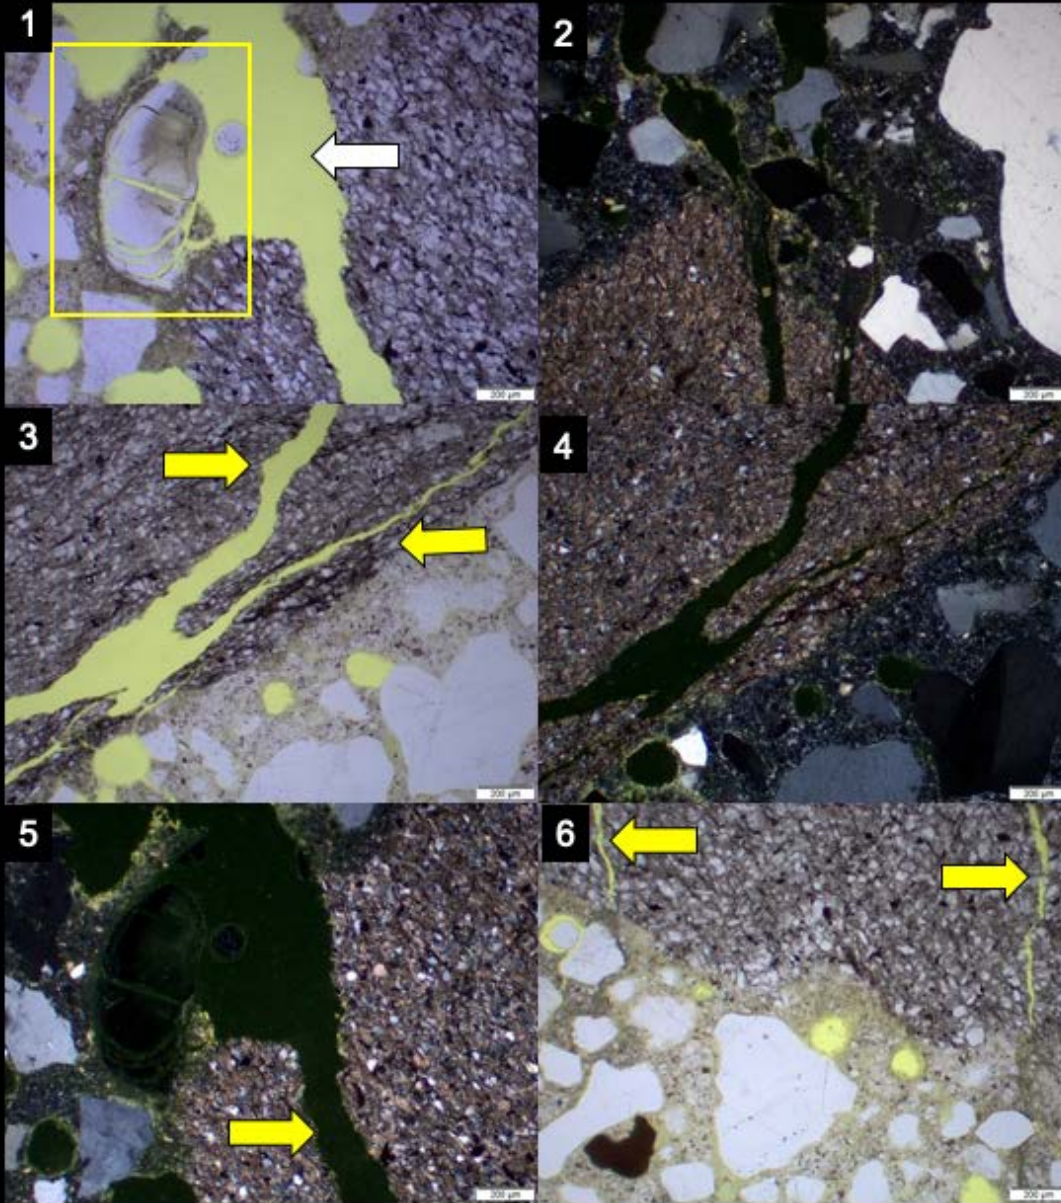
Figure 22: Micrographs of thin section of the shotcrete portion showing potentially deleterious alkali-silica gel in an air void adjacent to a potentially reactive crushed shale coarse aggregate particle in shotcrete where the reactive silica component has participated in alkali-silica reaction and formed the gel in the presence of moisture.

The macro and microcracks are shown in white and yellow arrows, respectively.

| # | Microstructure |
|---|--|
| 2 | Cracks in many crushed shale coarse aggregate particles in shotcrete extending into paste, XPL |
| 3 | Cracks in many crushed shale coarse aggregate particles in shotcrete extending into paste, PPL |
| 4 | Cracks in many crushed shale coarse aggregate particles in shotcrete extending into paste, XPL |
| 5 | Cracks in many crushed shale coarse aggregate particles in shotcrete extending into paste, XPL |
| 6 | Cracks in many crushed shale coarse aggregate particles in shotcrete extending into paste, PPL |

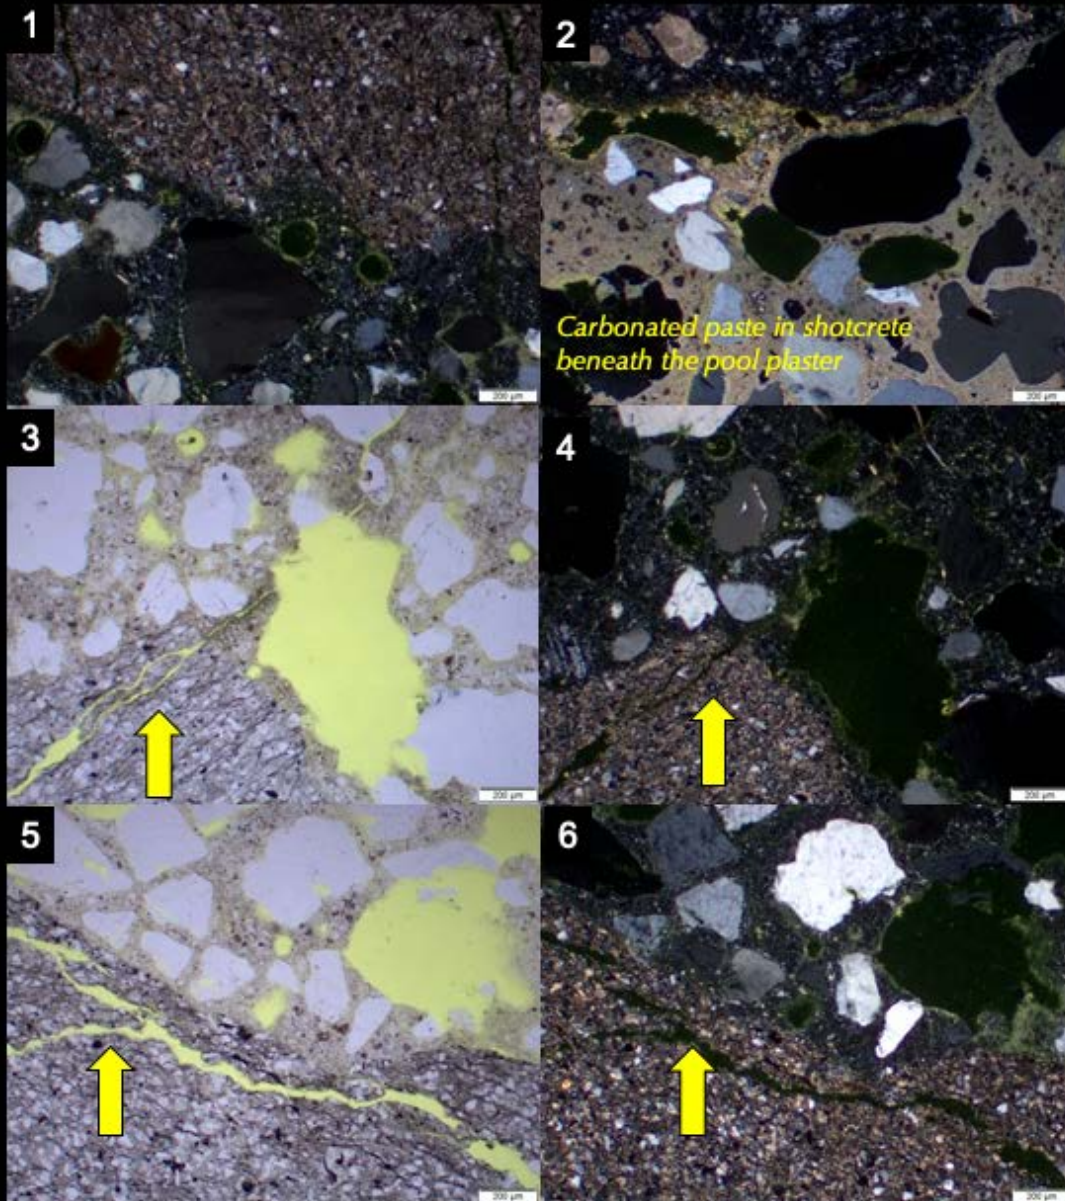
Figure 23: Micrographs of thin section showing the shotcrete portion to depict shale coarse aggregate and siliceous sand fine aggregate of shotcrete in Photo 1, carbonated paste at the exposed surface region in Photo 2, and fine hairline microcracks in unsound crushed shale coarse aggregate particles marked by yellow arrows.

| # | Microstructure |
|---|--|
| 5 | Cracks in many crushed shale coarse aggregate particles in shotcrete extending into paste, PPL |
| 6 | Cracks in many crushed shale coarse aggregate particles in shotcrete extending into paste, XPL |

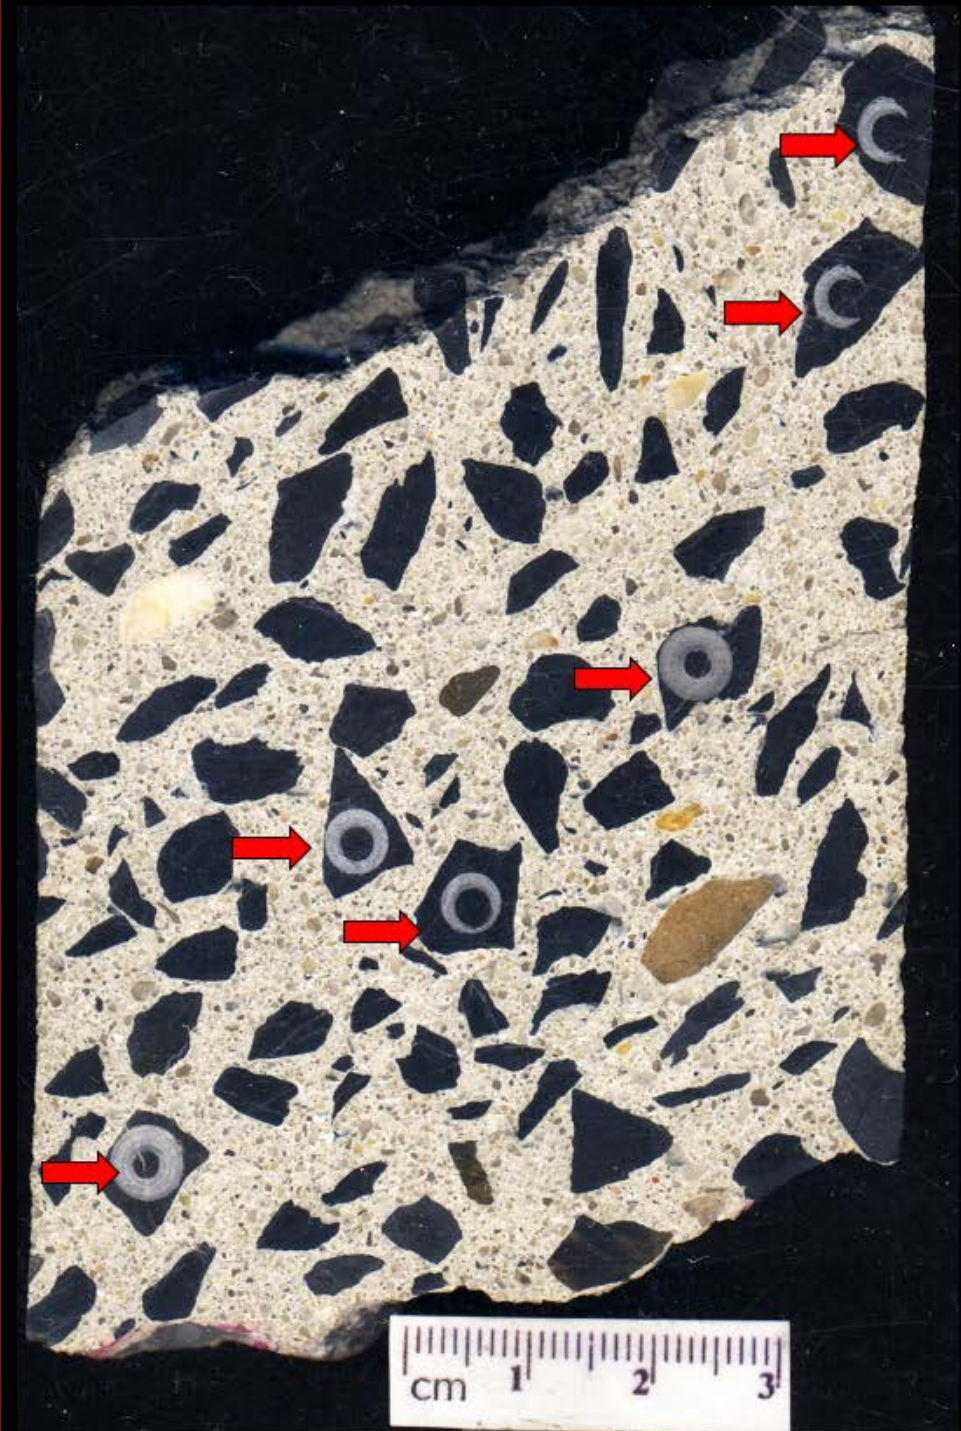
Figure 24: Lapped cross section of a portion of shotcrete where multiple potentially unsound crushed shale coarse aggregate particles were drilled with a benchtop drill to collect dusts of those particles to be used for X-ray diffraction analysis. The purpose is to determine the mineralogical composition of shale particles.

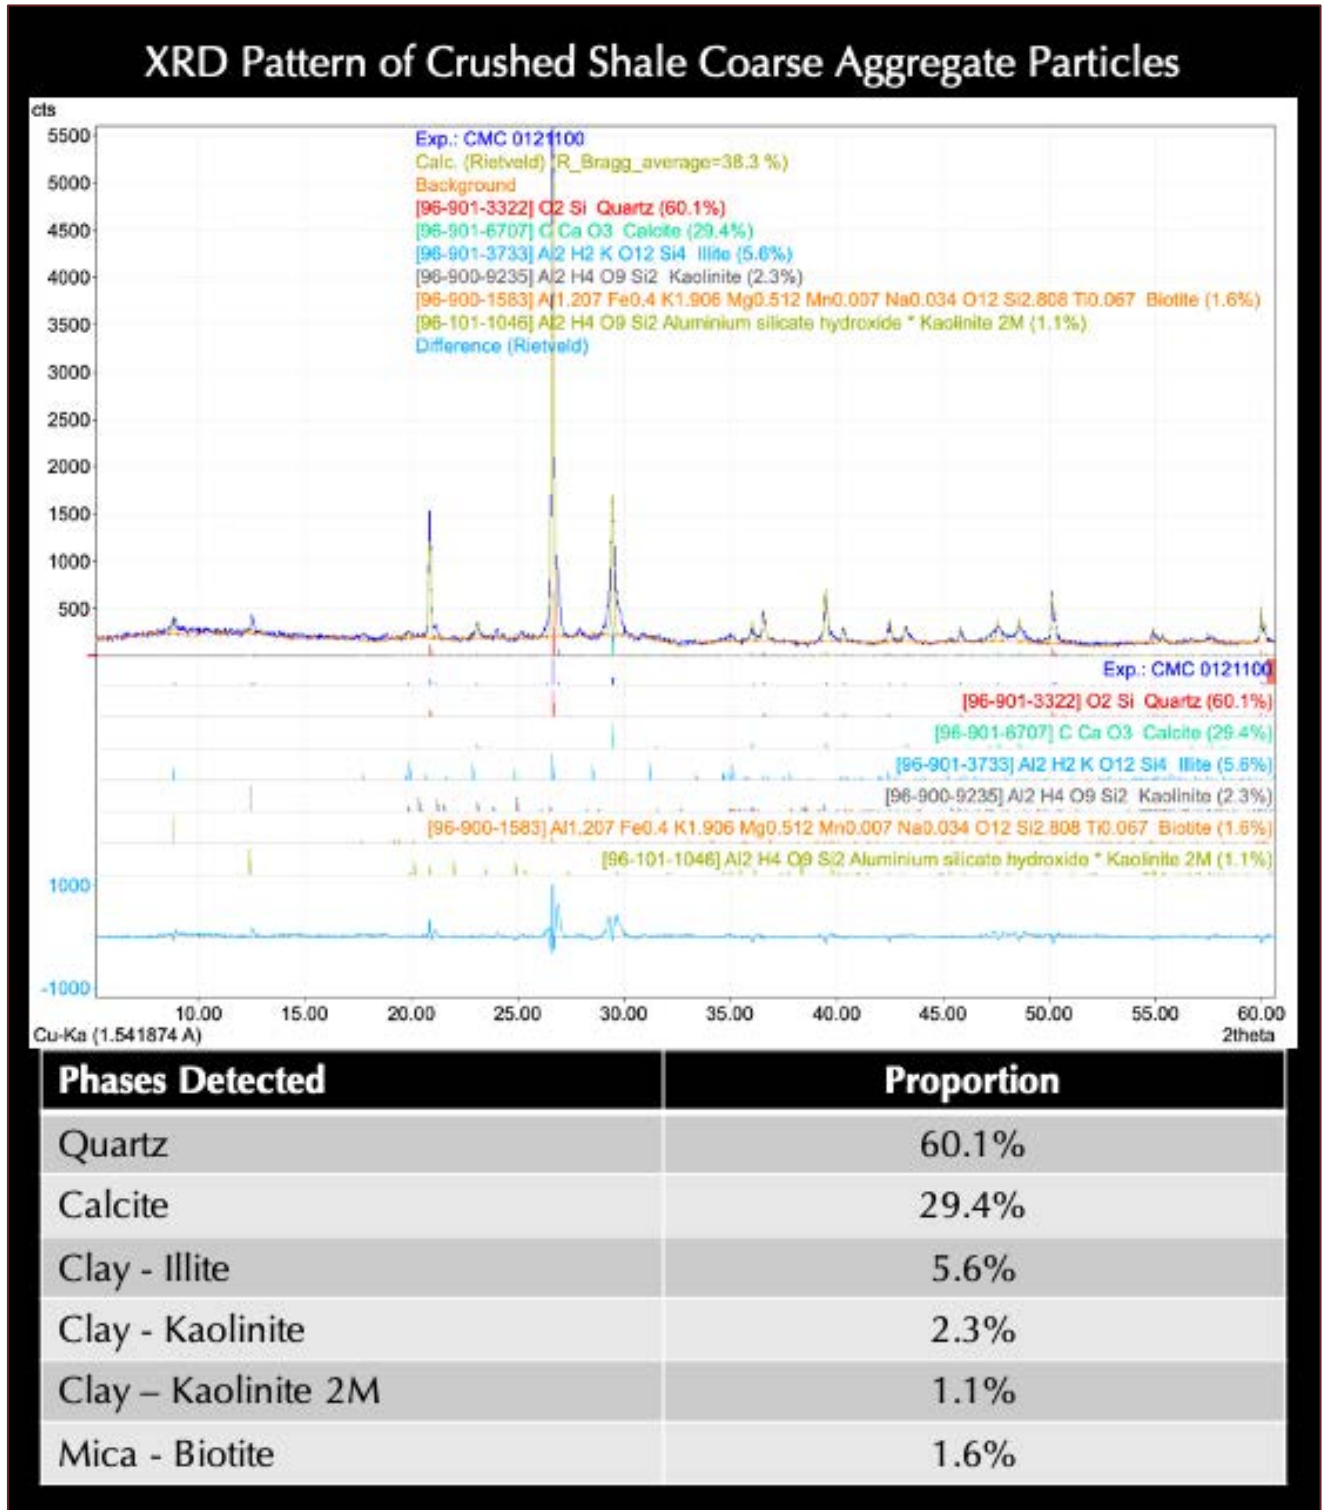
Figure 25: X-ray diffraction pattern of dusts collected from six randomly selected crushed shale coarse aggregate particles in shotcrete which are marked with arrows in the previous Figure.
