Laboratory Investigation of An Outdoor Suspended Concrete Slab Of An Underground Vault Adjacent To A Swimming Pool

Algonquin Pool
1614 Cypress Street
Louisville, KY 40210

July 8, 2020
CMC 0620128

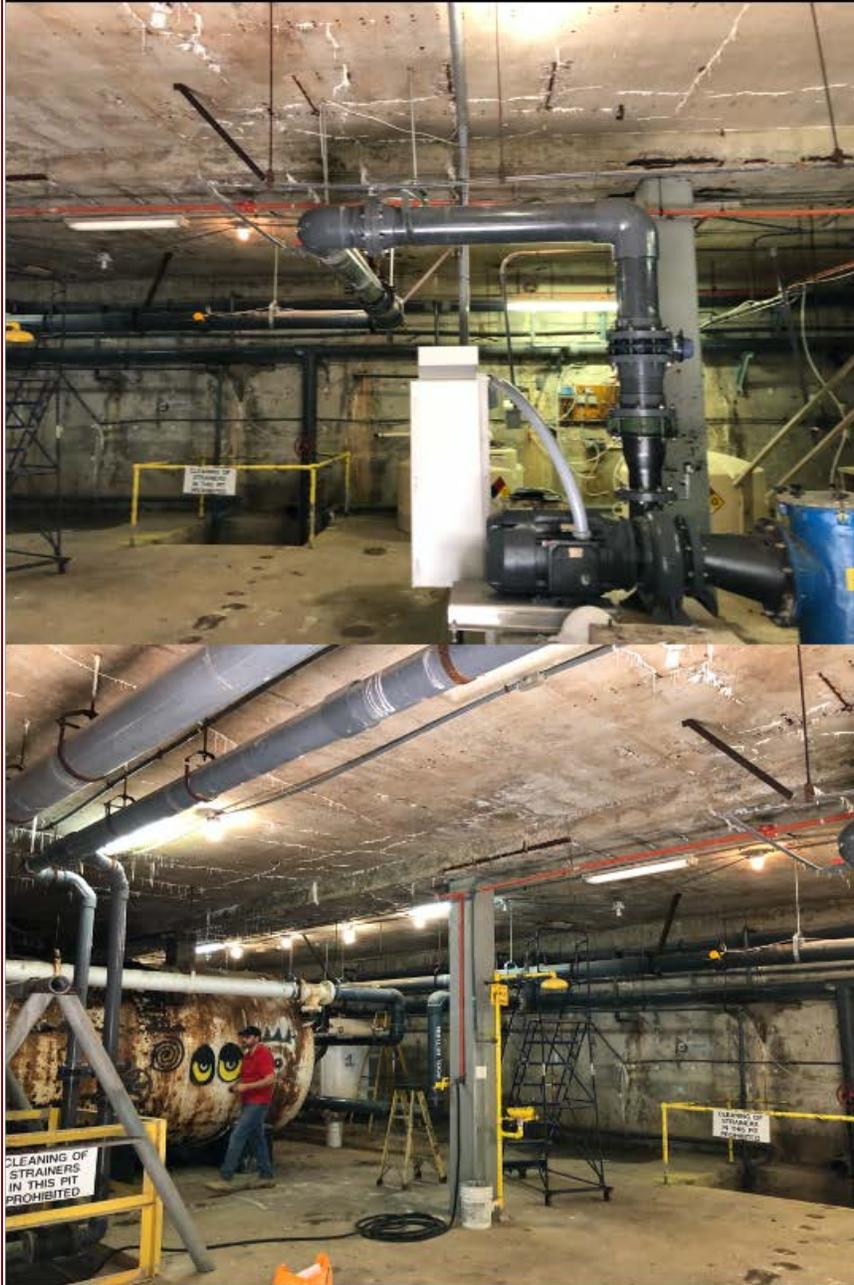
Occurrences of stalactite-type deposits from the underside of the top suspended slab are a testament that moisture migration has occurred through pre-existing cracks in the suspended slab during the course of its service.

Figure 2: Underground vault adjacent to the pool that houses various equipment and accessories for the pool. Notice the underside of top suspended slab of the vault that has many stalactite deposits hanging from the visible cracks due to migration of moisture through pre-existing cracks in the pool slab deck leaching soluble components of the concrete and eventually precipitating as stalactite deposits from the roof.

- Below grade concrete structure holds pumps, filters, and chlorine tank for the pool
- The height of the vault from floor slab to suspended slab is 12 ft.
- Three core samples were provided where the suspended concrete top slab of the vault has experienced deterioration at the underside of top slab

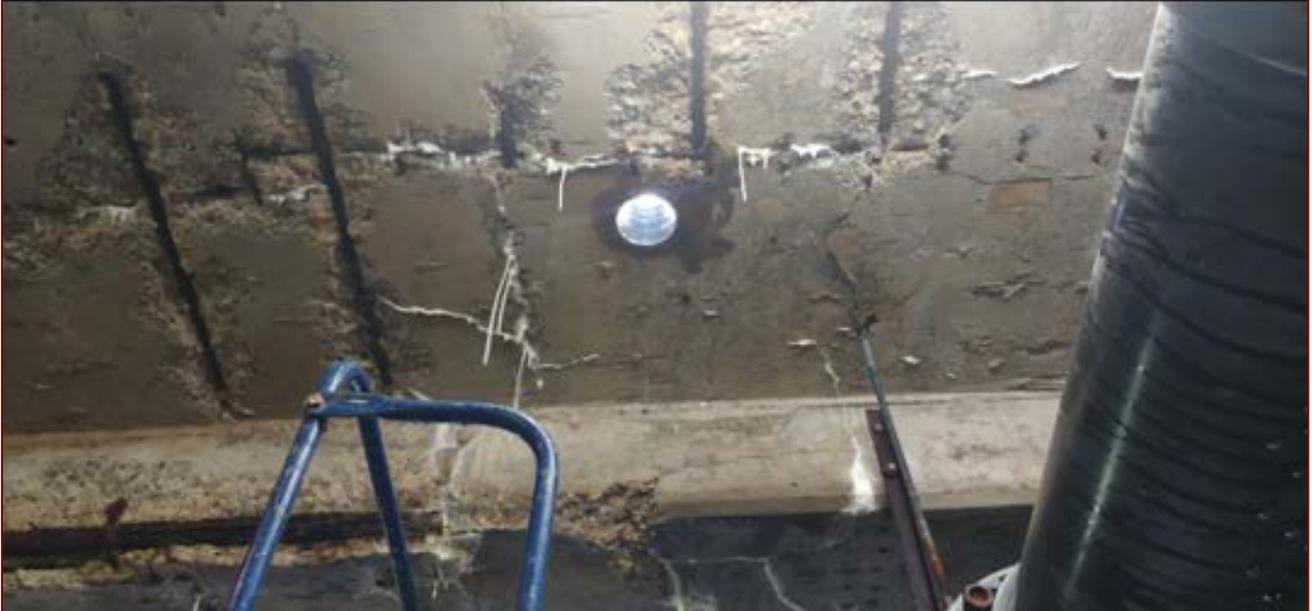
Field photos of the underside of top suspended slab of the vault shows stalactite deposits from the cracks indicating extensive moisture migration through the top slab during the course of its service. Spalling of concrete at the underside of top suspended slab and exposure of corroded reinforcing steel at the spalled location indicates chloride and/or carbonation-induced corrosion of steel or corrosion from moisture infiltration through the slab during service.

Stalactites of secondary calcium carbonate deposits from the cracks at the underside of suspended slab of vault

Figure 3: Close-up of the underside of the top suspended slab of underground vault that shows white stalactite deposits from pre-existing cracks in the top photo, and spalling of concrete due to corrosion of reinforcing steel exposing the corroded steel in the bottom photo.

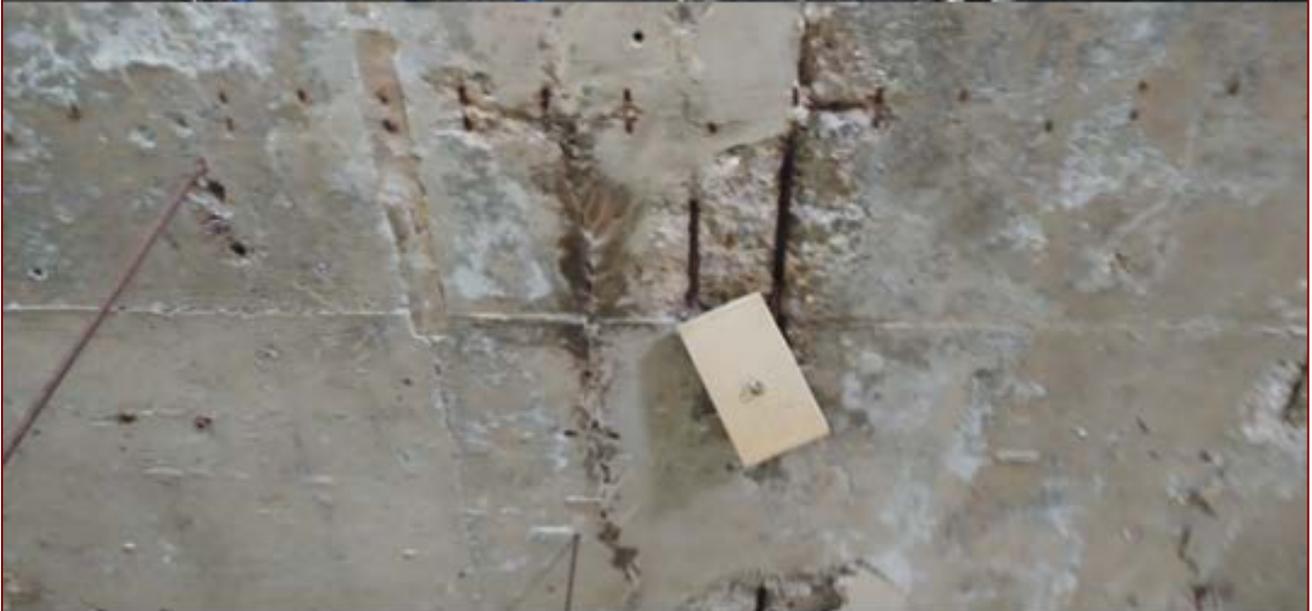
Spalling of the underside of concrete in the suspended top slab of vault and exposed corroded steel reinforcement found in the field photos of underside of the top slab are distresses judged to be due to carbonation-induced corrosion of steel reinforcement situated near the formed bottom end of the top slab. This is evidenced from beige discoloration of concrete found at the bottom end of Core 1, in the fragmented bottom chunk in Core 2, and at the bottom end of Core 3 – all three cores showed such beige discoloration of paste due to carbonation of the underside surface of top slab from carbon dioxide in the ambient air of the vault. Corrosion of steel and associated reddish-brown corrosion products are observed in all three cores situated within this carbonated zone at the underside of top slab. Besides, water-soluble chloride analyses of concrete showed negligible chloride at the bottom end of Core 3 (except at the bottom of Core 1 which showed detectable chloride probably introduced from the pool water during service, probably prior to the installation of topping). The observed corrosion of steel at the underside and associated spalling probably occurred due to de-passivation of the protective oxide films around steel by reduction in inherent alkalinity of concrete by atmospheric carbonation. Moisture infiltration through preexisting cracks have also contributed to steel corrosion.

Corrosion of steel and associated spalling of concrete exposing the corroded steel at the underside of suspended slab of vault

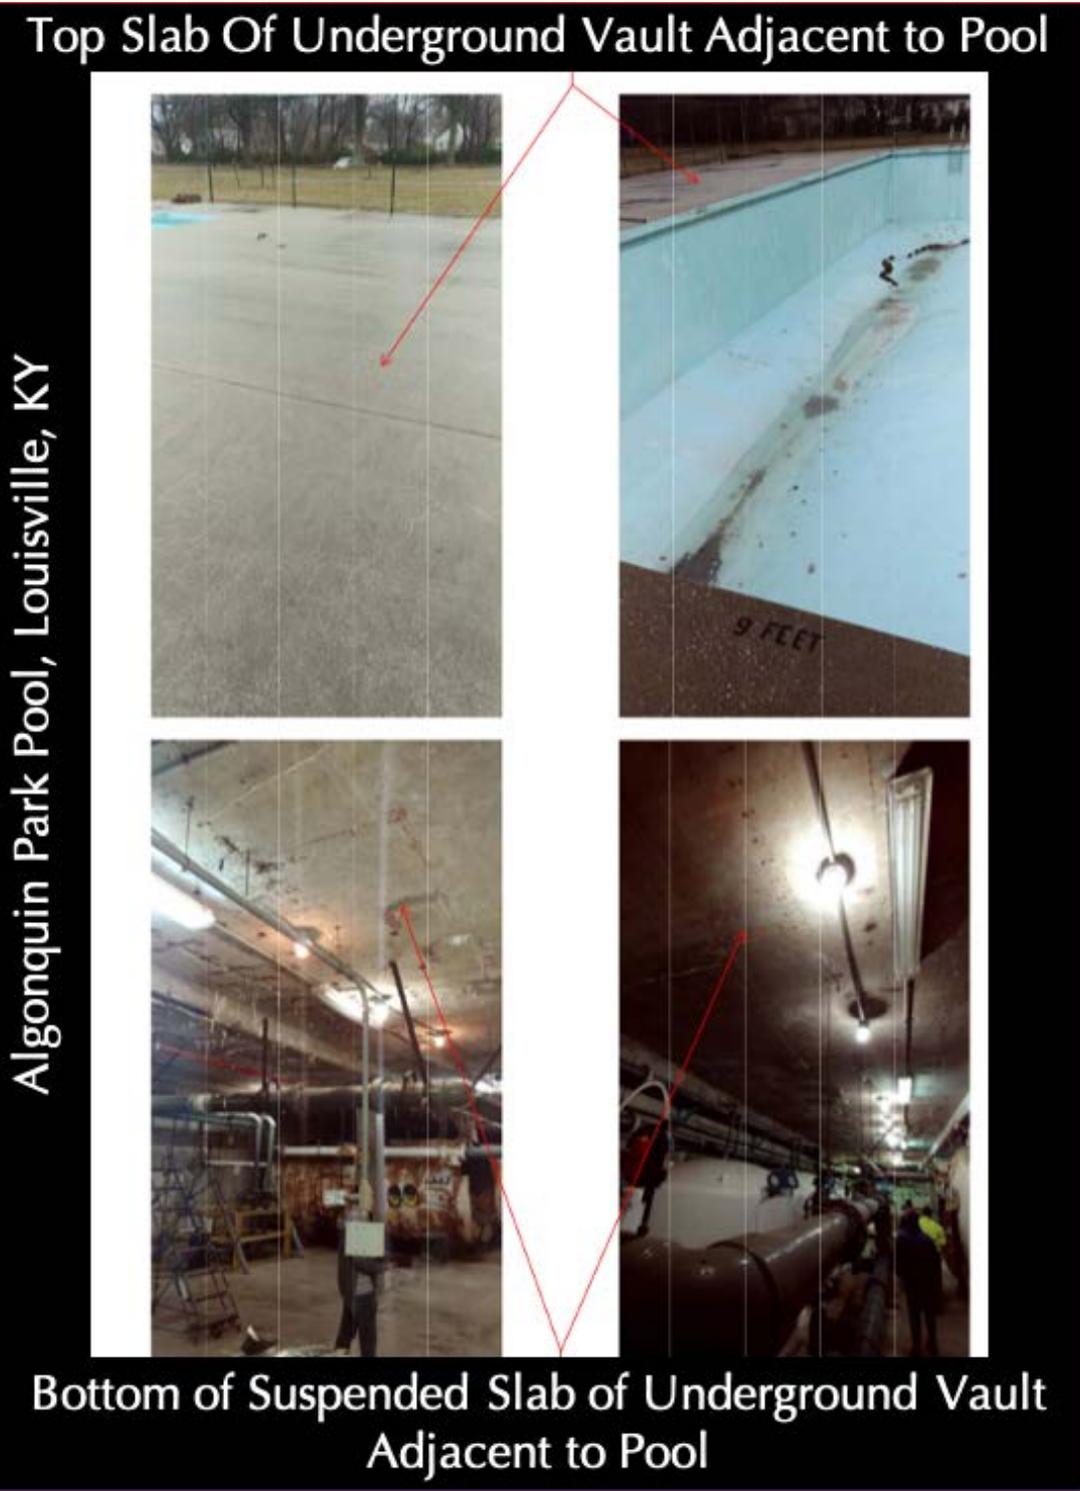
Figure 4: The top left photo shows the exposed outdoor suspended pool deck slab that has a 2-in. thick topping placed in 1991 above an 8-in. thick structural concrete slab placed in 1955. The top right photo shows the pool adjacent to the suspended deck slab above an underground vault system. Bottom two photos show the underground vault that houses various equipment and accessories for the pool.

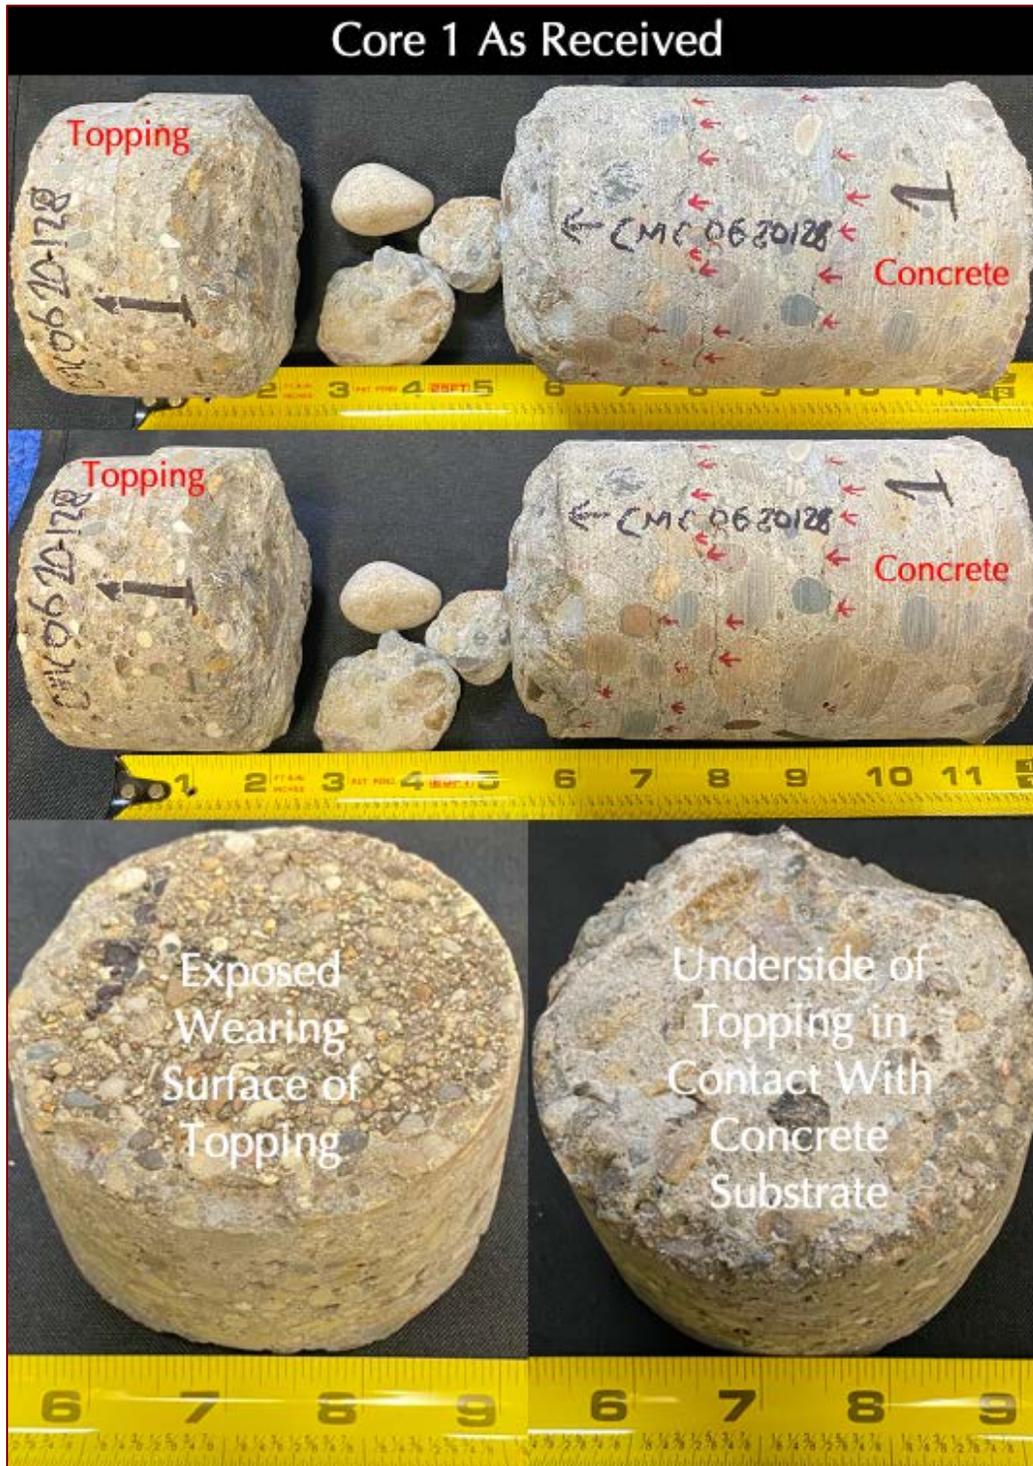
Figure 8: Core 1 as received showing:

- (a) A 2-in. thick topping entirely detached from concrete substrate;
- (b) Dense, sound, and well-consolidated nature of topping,
- (c) A few rubbles of concrete between topping and fractured top surface of concrete;
- (d) Extensive through-depth cracking in the concrete substrate that are oriented parallel to the top surface;
- (e) Overall intact condition of concrete despite extensive cracking; and,
- (f) Exposed weathered surface of topping and relatively flat underside of topping showing a more or less clean separation from the concrete substrate with no sign of a good bond between the two components.

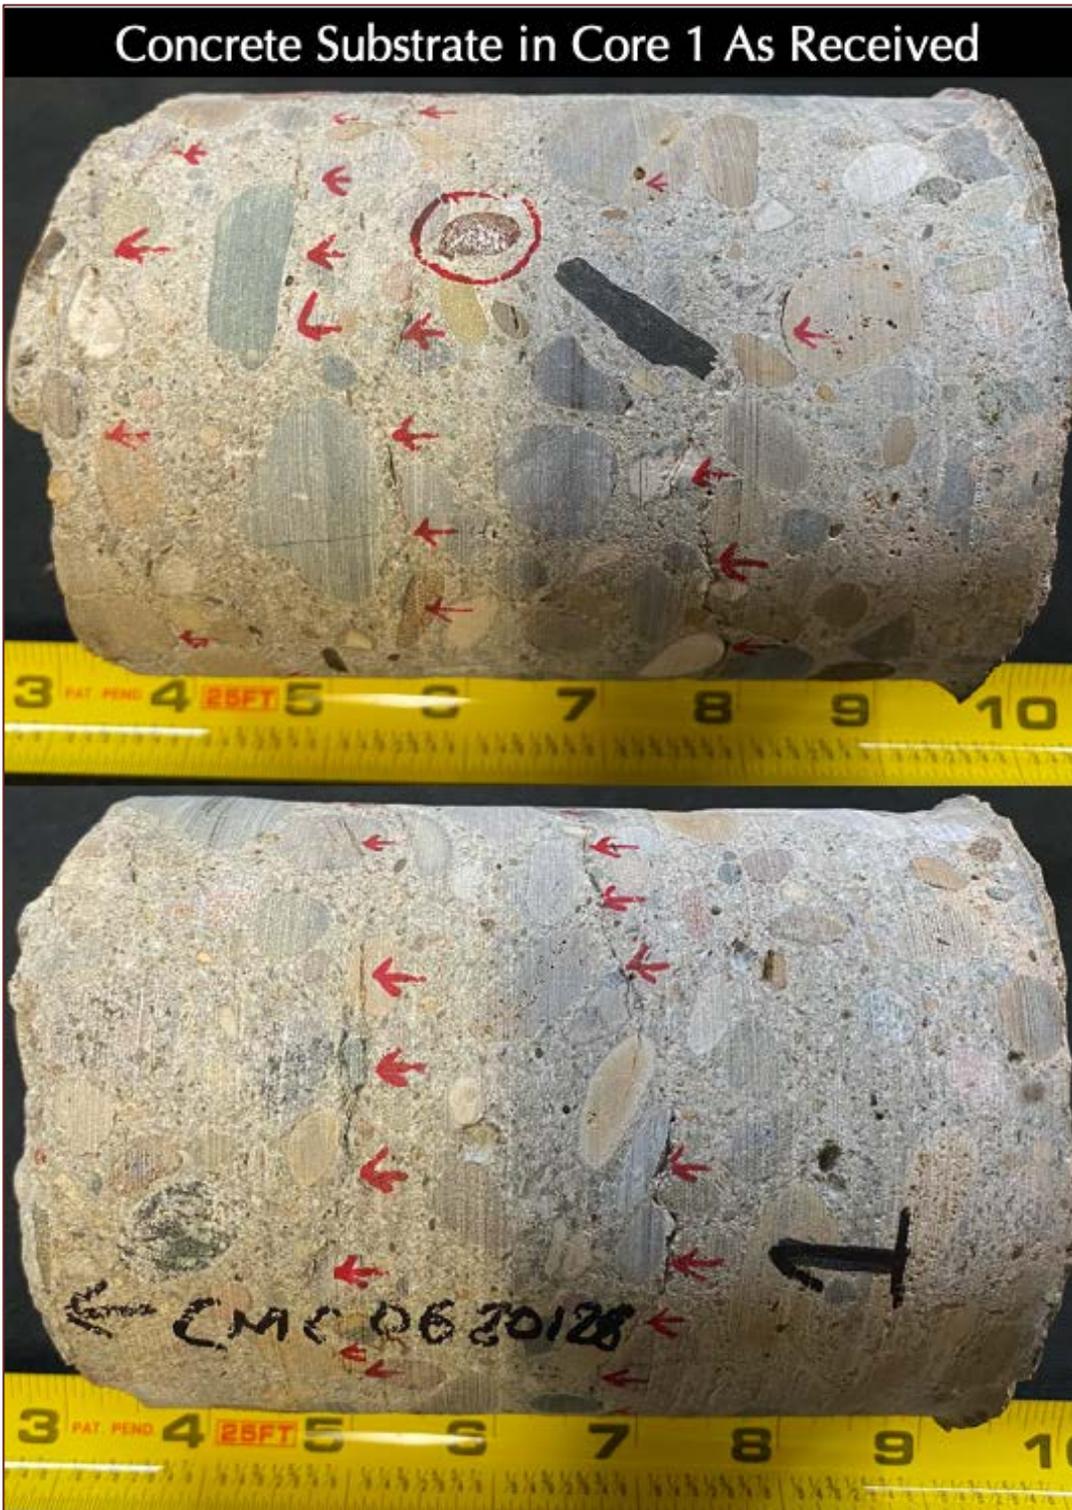
Concrete Substrate in Core 1 As Received

(a) Extensive through-depth cracking in the concrete substrate that are oriented parallel to the top surface; and,

(b) Overall intact condition of concrete despite extensive cracking.

Through-depth cracks are marked that have transected and circumscribed the aggregate particles.

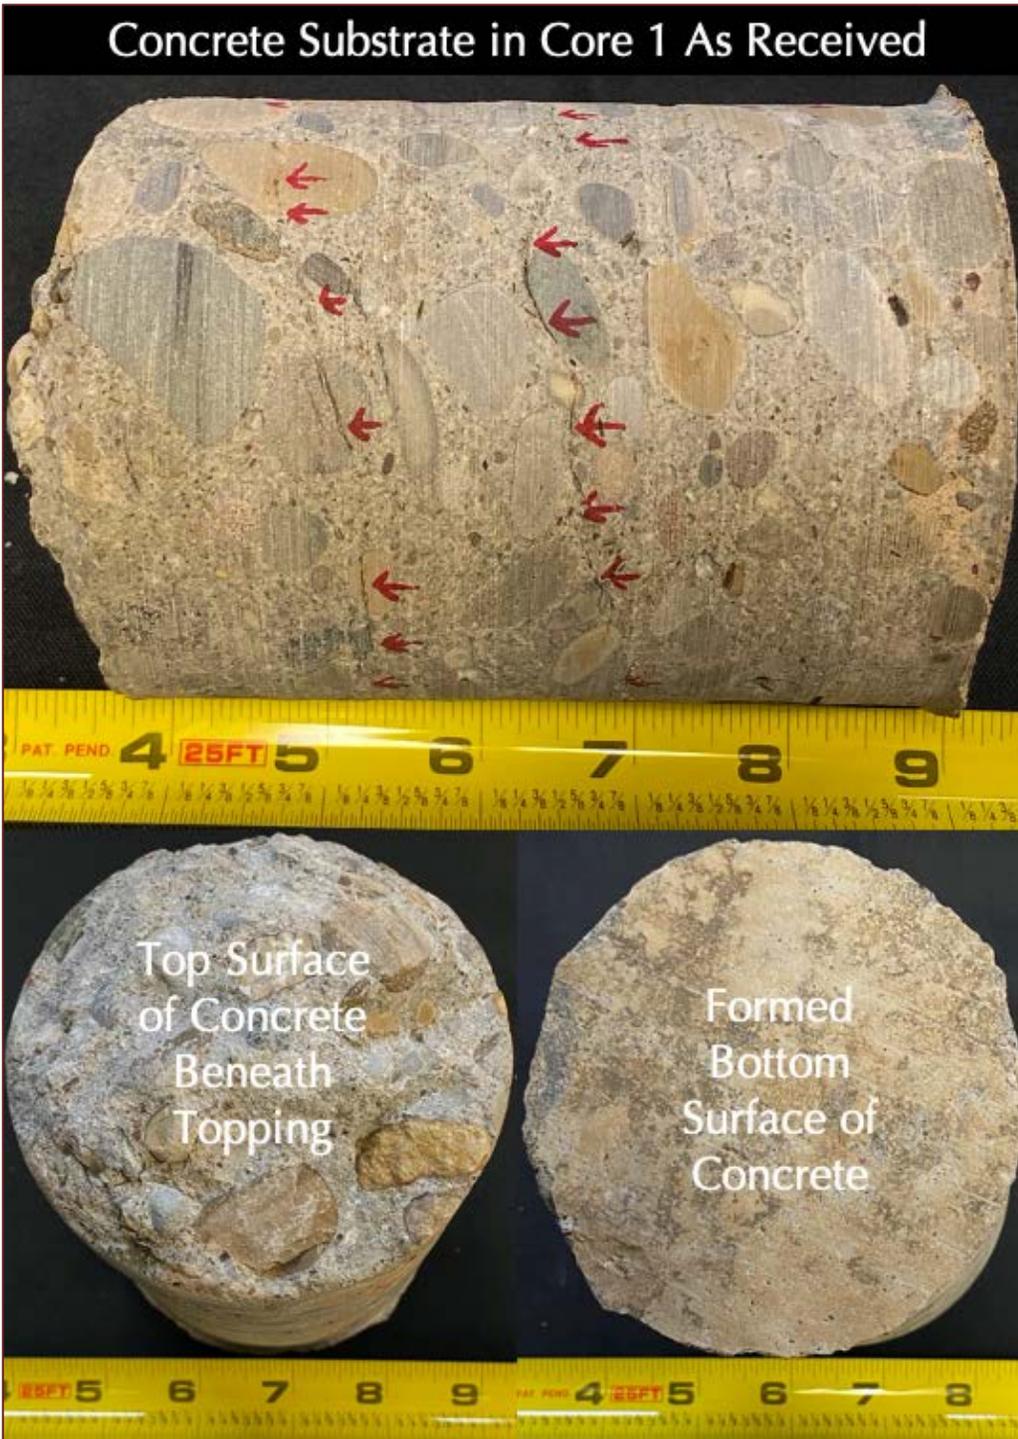
Figure 10: Continuation of overall condition of concrete substrate as seen in Core 1.

Through-depth cracks are marked that have transected and circumscribed the aggregate particles.

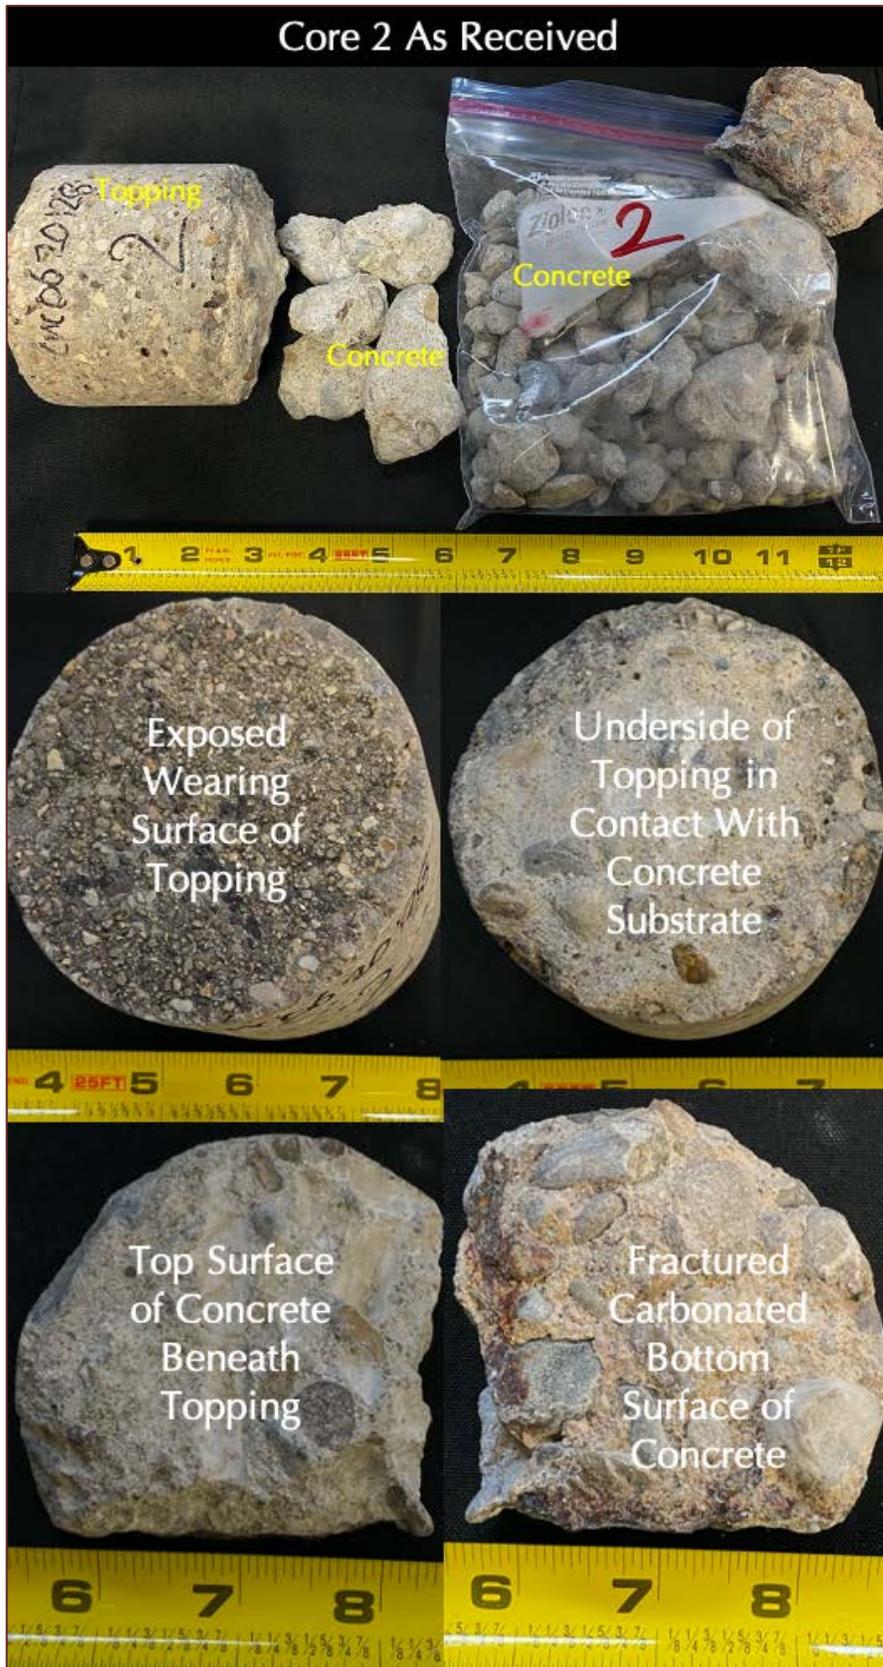
Figure 11: Core 2 as received showing:

(c) Extensive cracking and fragmentation of the concrete substrate to turn into a bag full of rubbles;

(e) Fractured top and bottom ends of concrete substrate where the bottom end in the bottom right photo shows beige discoloration of paste due to atmospheric carbonation of the underside of the suspended slab above the underground vault. Also present are reddish-brown corrosion products on this concrete chunk that represent carbonation-induced corrosion of steel situated within this carbonated zone near the underside surface of the suspended slab that has received carbon dioxide from the vault's air.

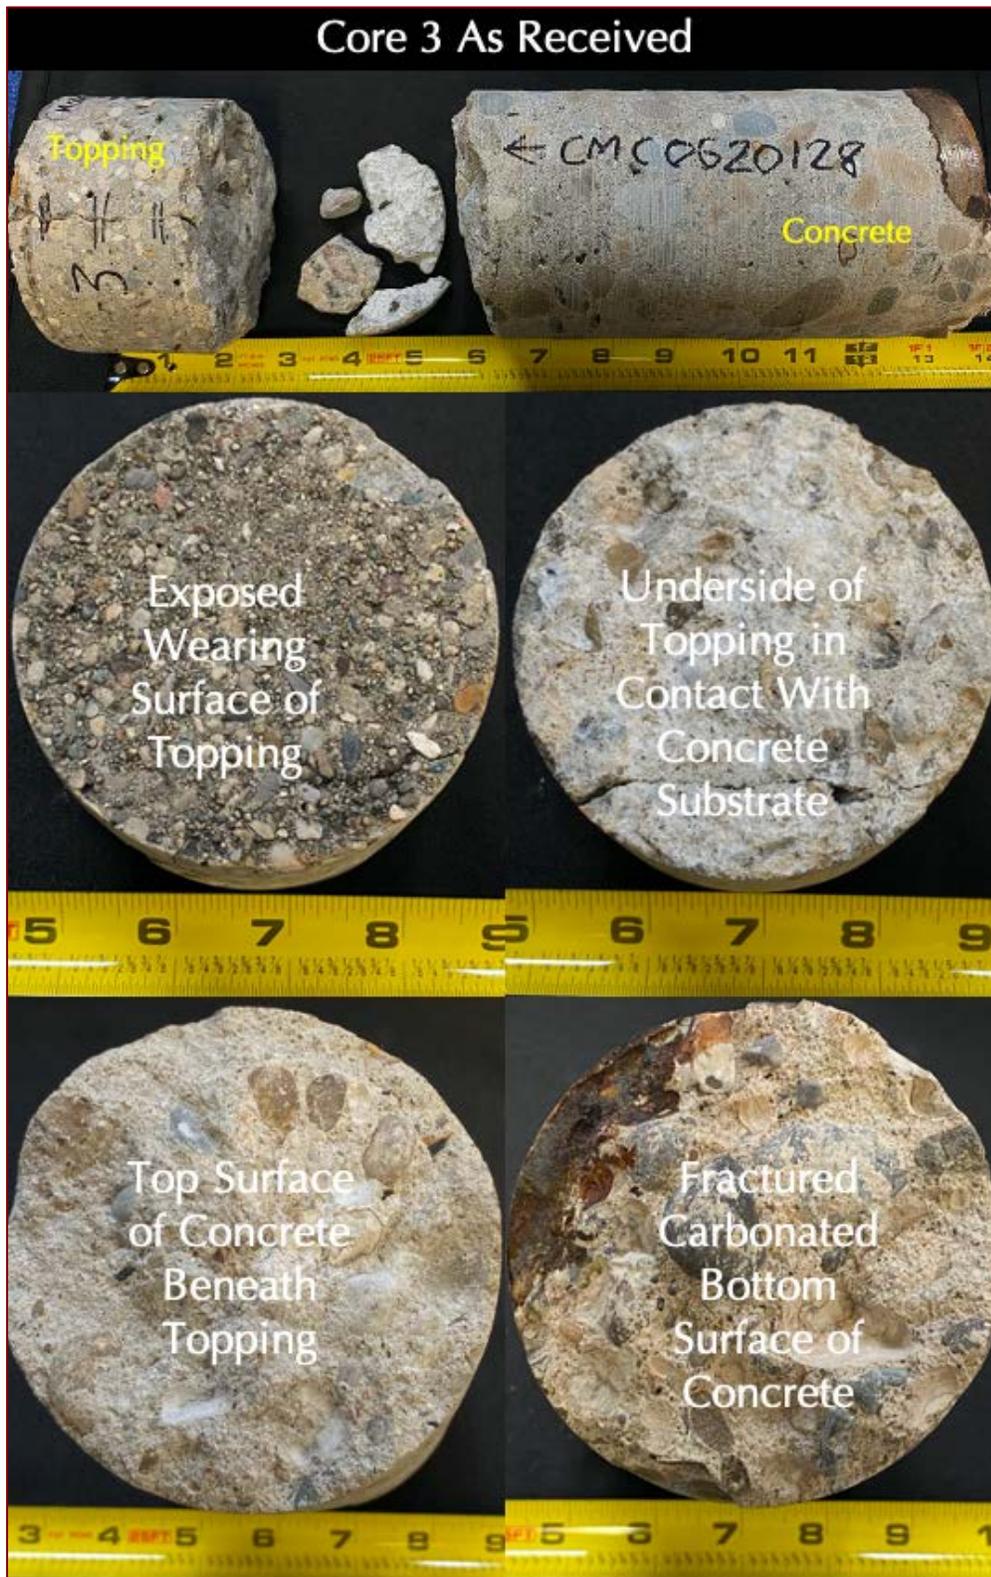
Figure 12: Core 3 as received showing:

(c) A few rubbles of concrete between topping and fractured top surface of concrete;

(d) Lack of extensive through-depth cracking in the concrete substrate that are oriented parallel to the top surface in Core 1; however, this core also contains similar through-depth cracks but at micro scale that were revealed during subsequent treatment of core with fluorescent dye;

(e) Overall intact condition of concrete despite through-depth cracking;

(g) Fractured top and bottom ends of concrete substrate where the bottom end in the bottom right photo shows beige discoloration of paste due to atmospheric

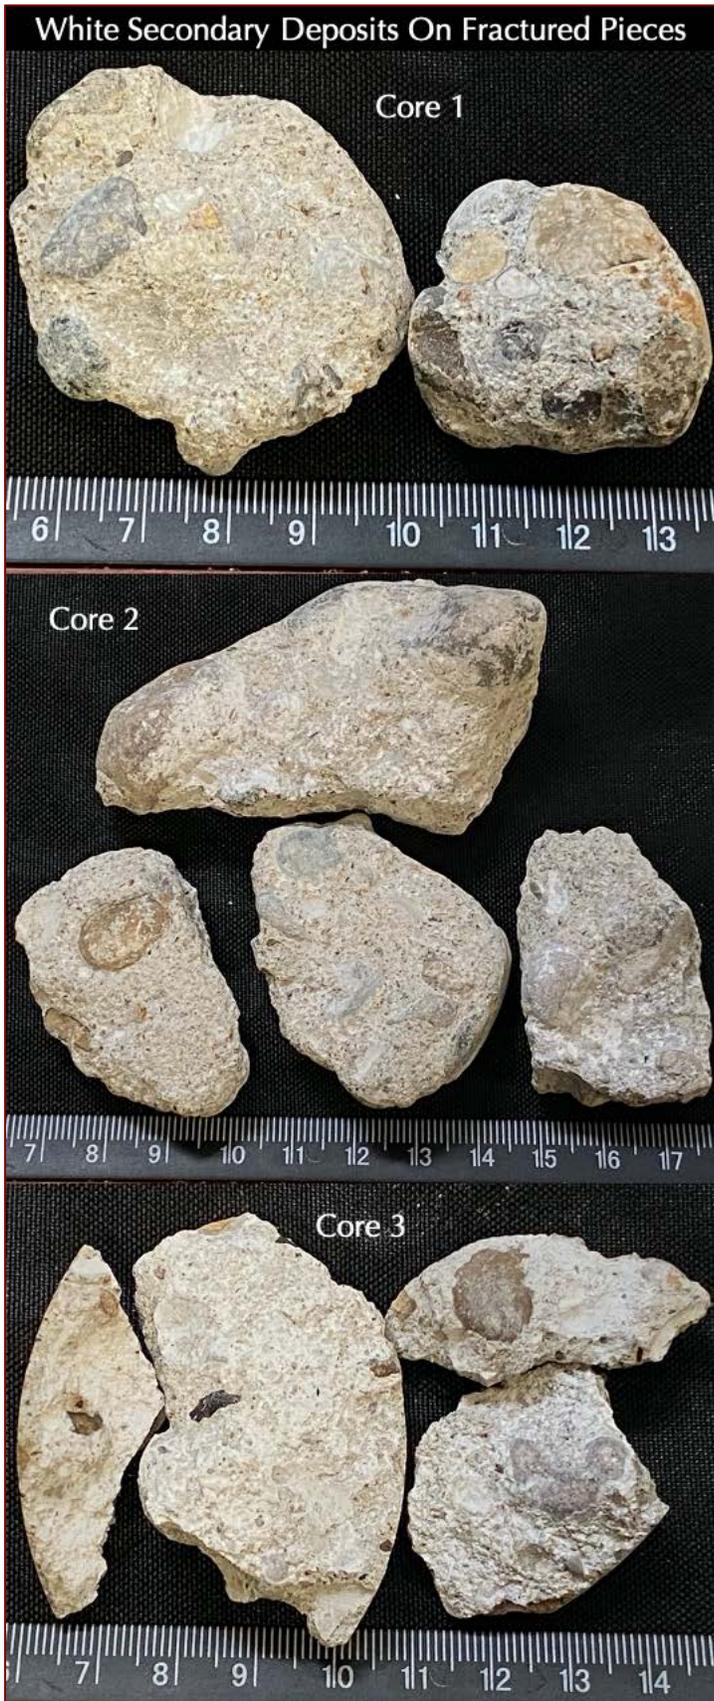
Figure 13: Shown are a few concrete rubbles collected from three cores that show white coating of secondary deposits on the surfaces. These coatings are mostly composed of carbonated products of leached materials from concrete that are removed by migration of moisture through the concrete.

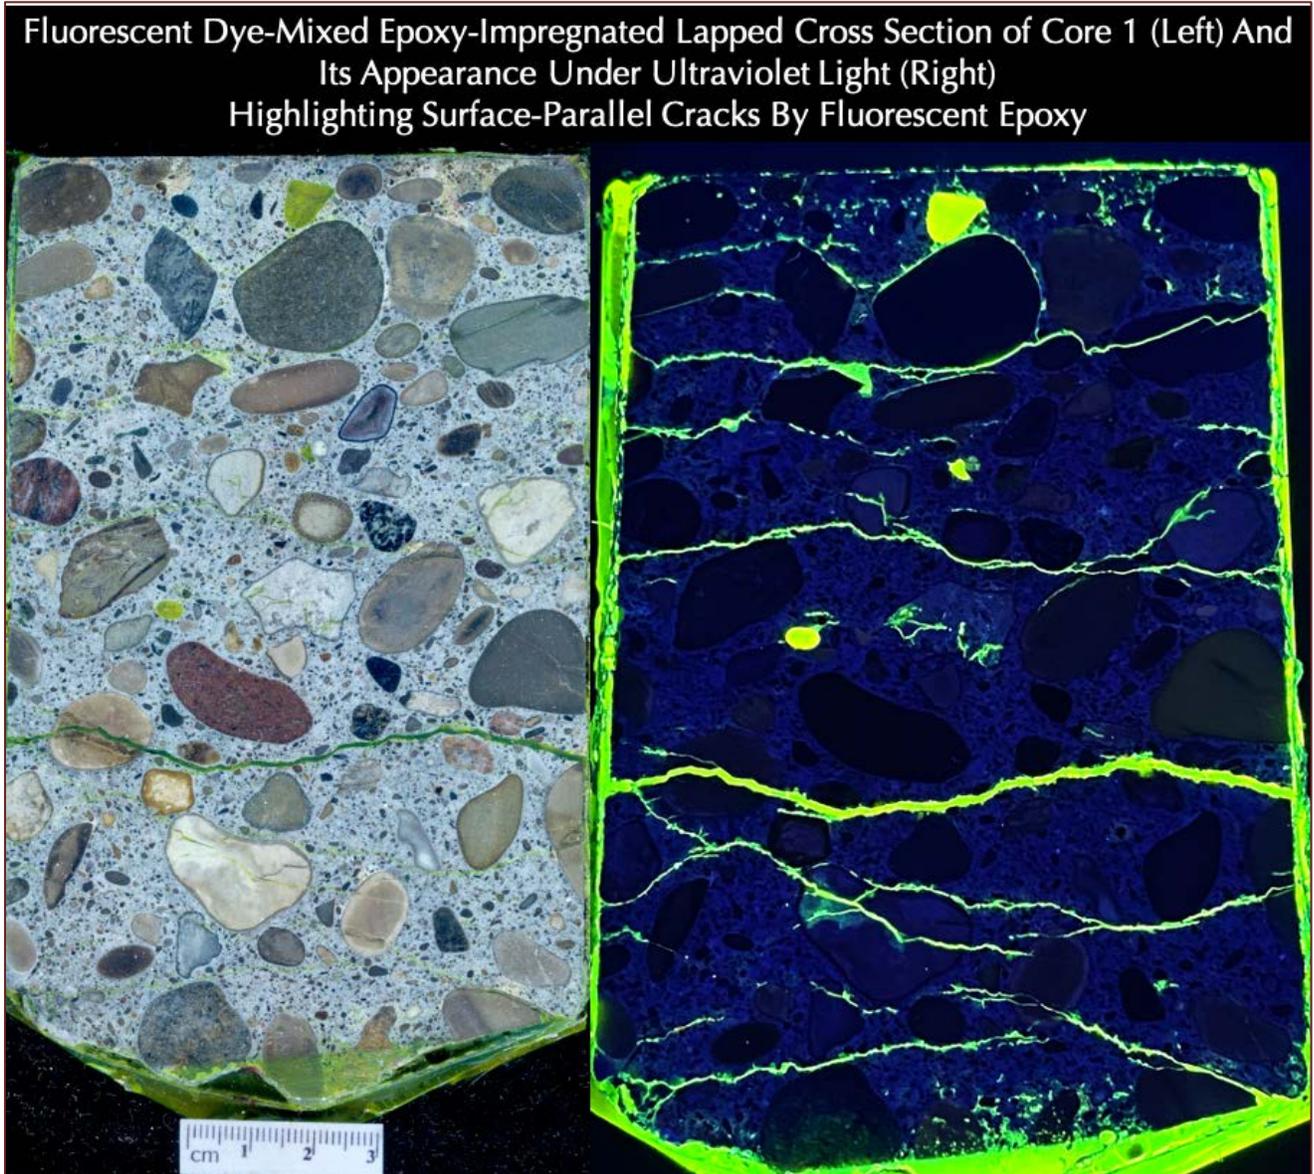
Figure 14: Lapped cross section of Core 1 shown after impregnating with a low-viscosity fluorescent dye-mixed epoxy under vacuum. Left photo shows the scanned image of the lapped cross section where a few visible cracks are seen but the right photo shows the same lapped cross section in a dark room after exposing it to an ultraviolet light where extensive through-depth cracks are revealed by the fluorescent epoxy.

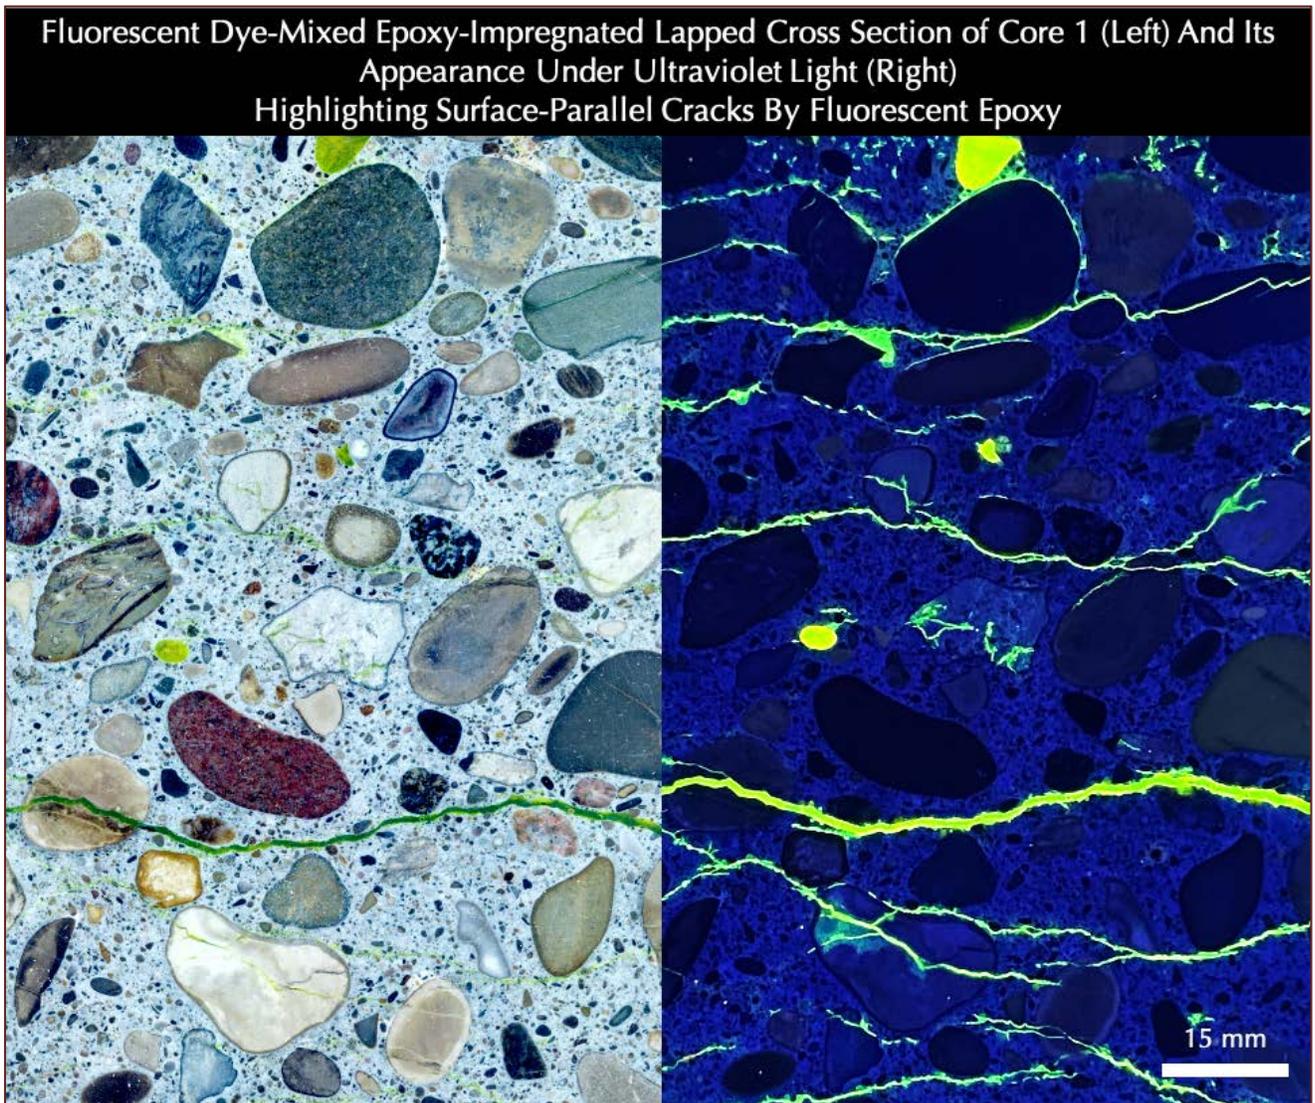
Figure 15: Lapped cross section of Core 1 shown after impregnating with a low-viscosity fluorescent dye-mixed epoxy under vacuum. Left photo shows the scanned image of the lapped cross section where a few visible cracks are seen but the right photo shows the same lapped cross section in a dark room after exposing it to an ultraviolet light where extensive through-depth cracks were revealed by the fluorescent epoxy.

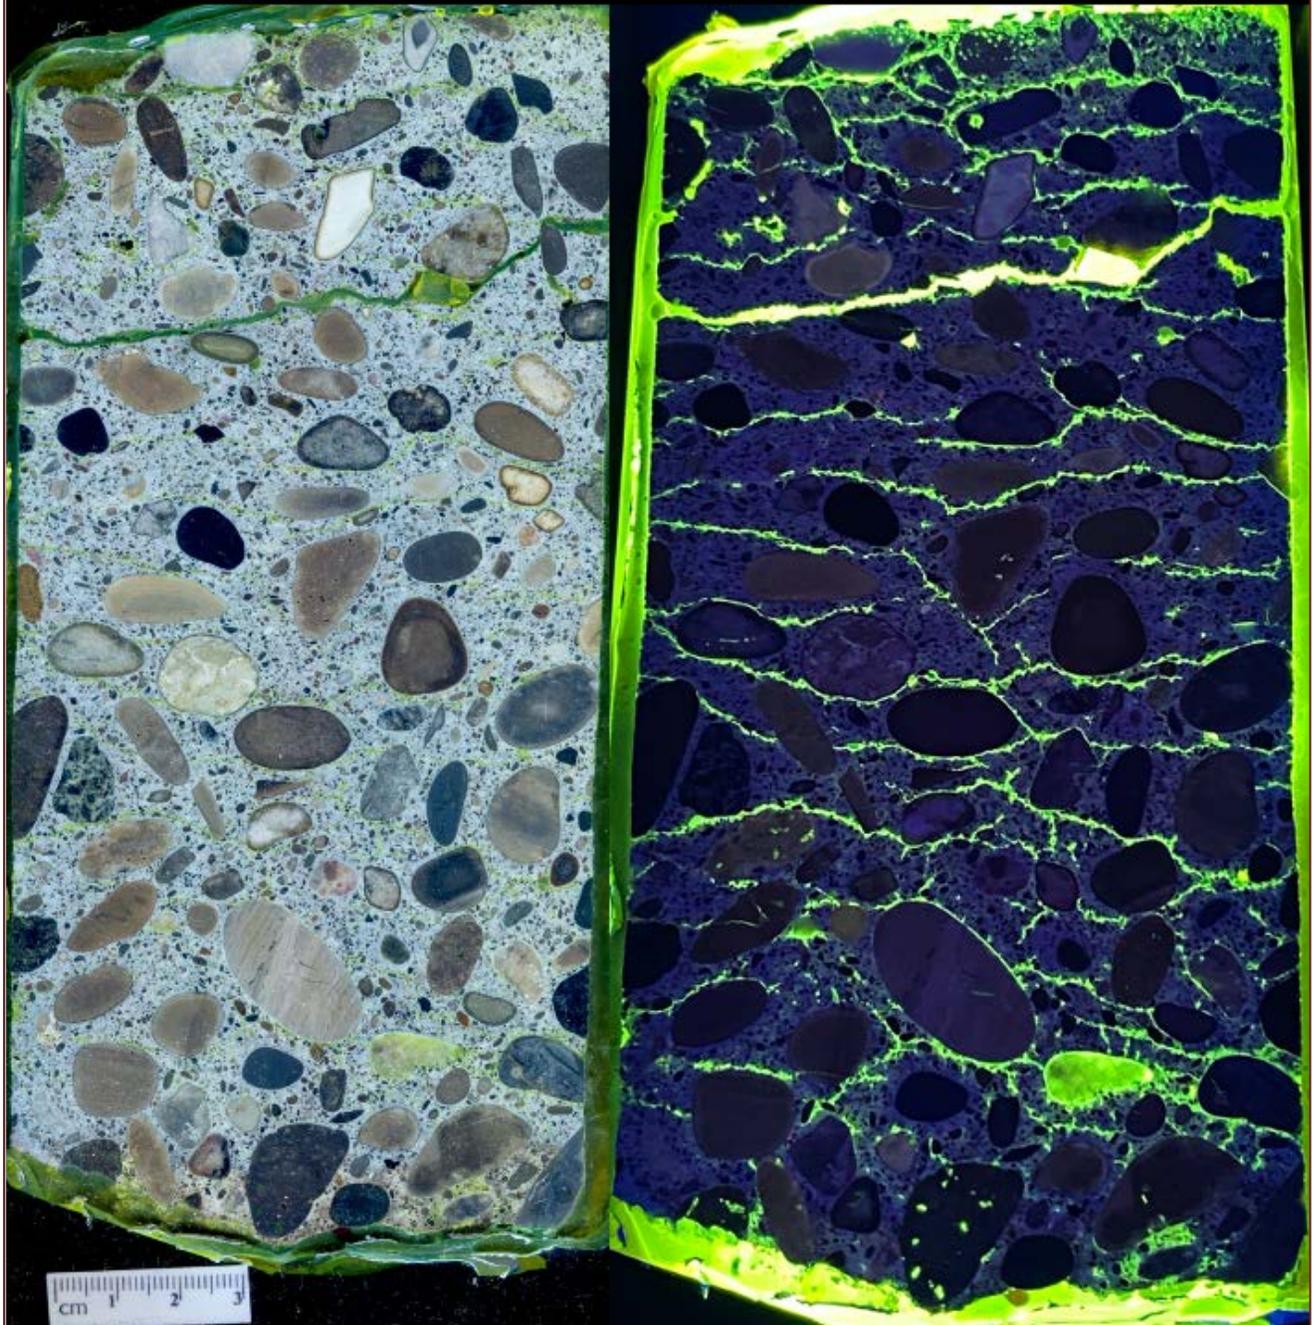
Fluorescent Dye-Mixed Epoxy-Impregnated Lapped Cross Section of Core 3 (Left) And Its Appearance Under Ultraviolet Light (Right) Highlighting Surface-Parallel Cracks By Fluorescent Epoxy

Figure 16: Lapped cross section of Core 3 shown after impregnating with a low-viscosity fluorescent dye-mixed epoxy under vacuum. Left photo shows the scanned image of the lapped cross section where a few visible cracks are seen, but the right photo shows the same lapped cross section in a dark room after exposing it to an ultraviolet light where extensive through-depth cracks were revealed by the fluorescent epoxy.

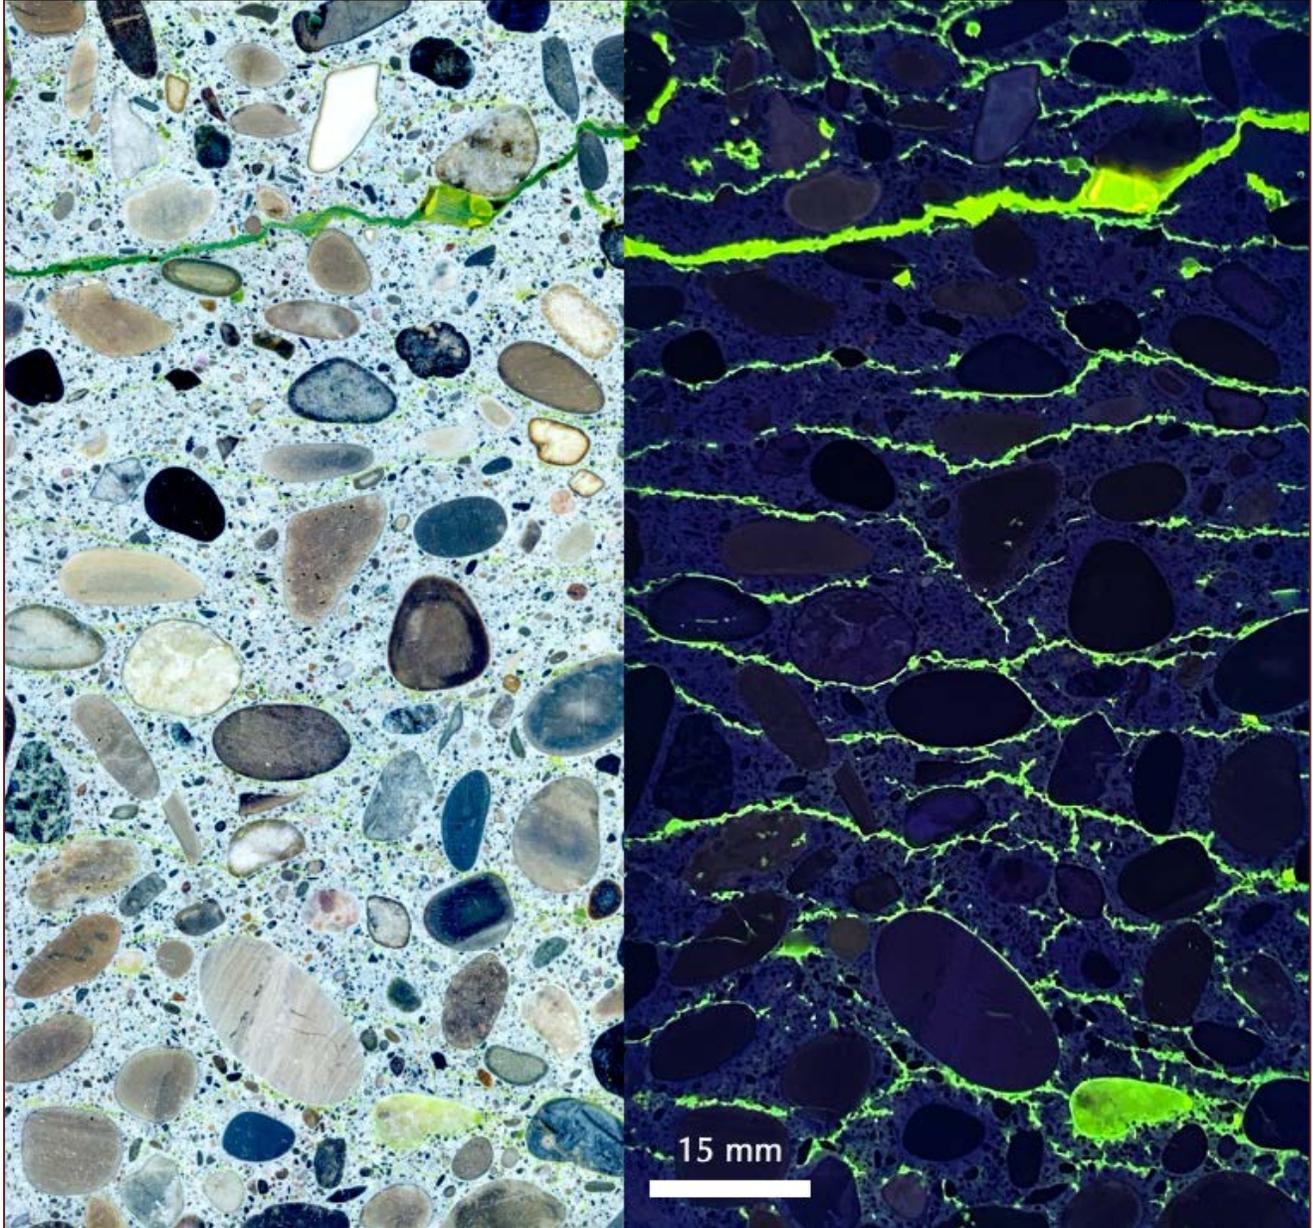
Figure 17: Lapped cross section of Core 3 shown after impregnating with a low-viscosity fluorescent dye-mixed epoxy under vacuum. Left photo shows the scanned image of the lapped cross section where a few visible cracks are seen but the right photo shows the same lapped cross section in a dark room after exposing it to an ultraviolet light where extensive through-depth cracks were revealed by the fluorescent epoxy.
