Laboratory Investigation of An Outdoor Suspended Concrete Slab Of An Underground Vault Adjacent To A Swimming Pool

Algonquin Pool
1614 Cypress Street
Louisville, KY 40210

July 8, 2020
CMC 0620128

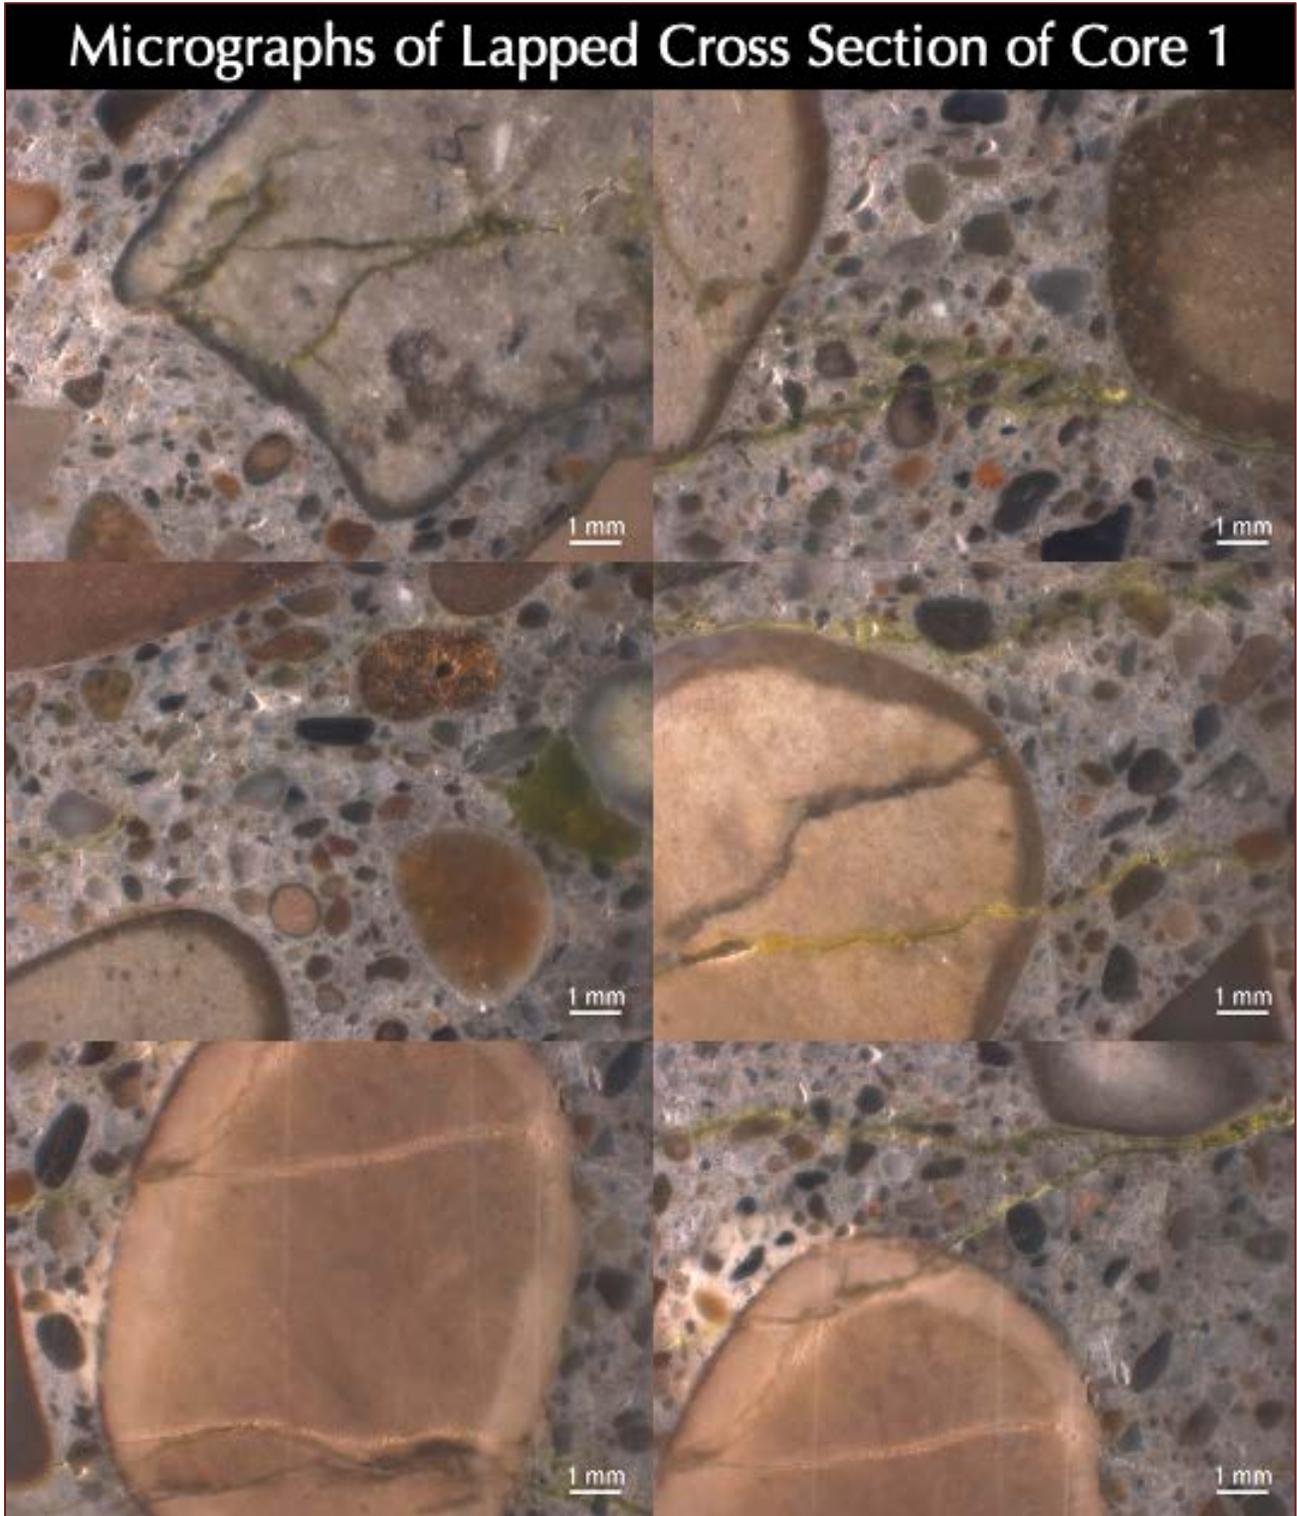
Figure 18: Micrographs of lapped cross section of Core 1 showing: (a) extensive cracking in the concrete where cracks have transected and/or circumscribed the aggregate particles; (b) rounded gravel coarse aggregate particles many showing weathering and/or reaction rims; (c) natural sand fine aggregate; and (d) non-air-entrained nature of concrete. Scale bars are 1 mm.

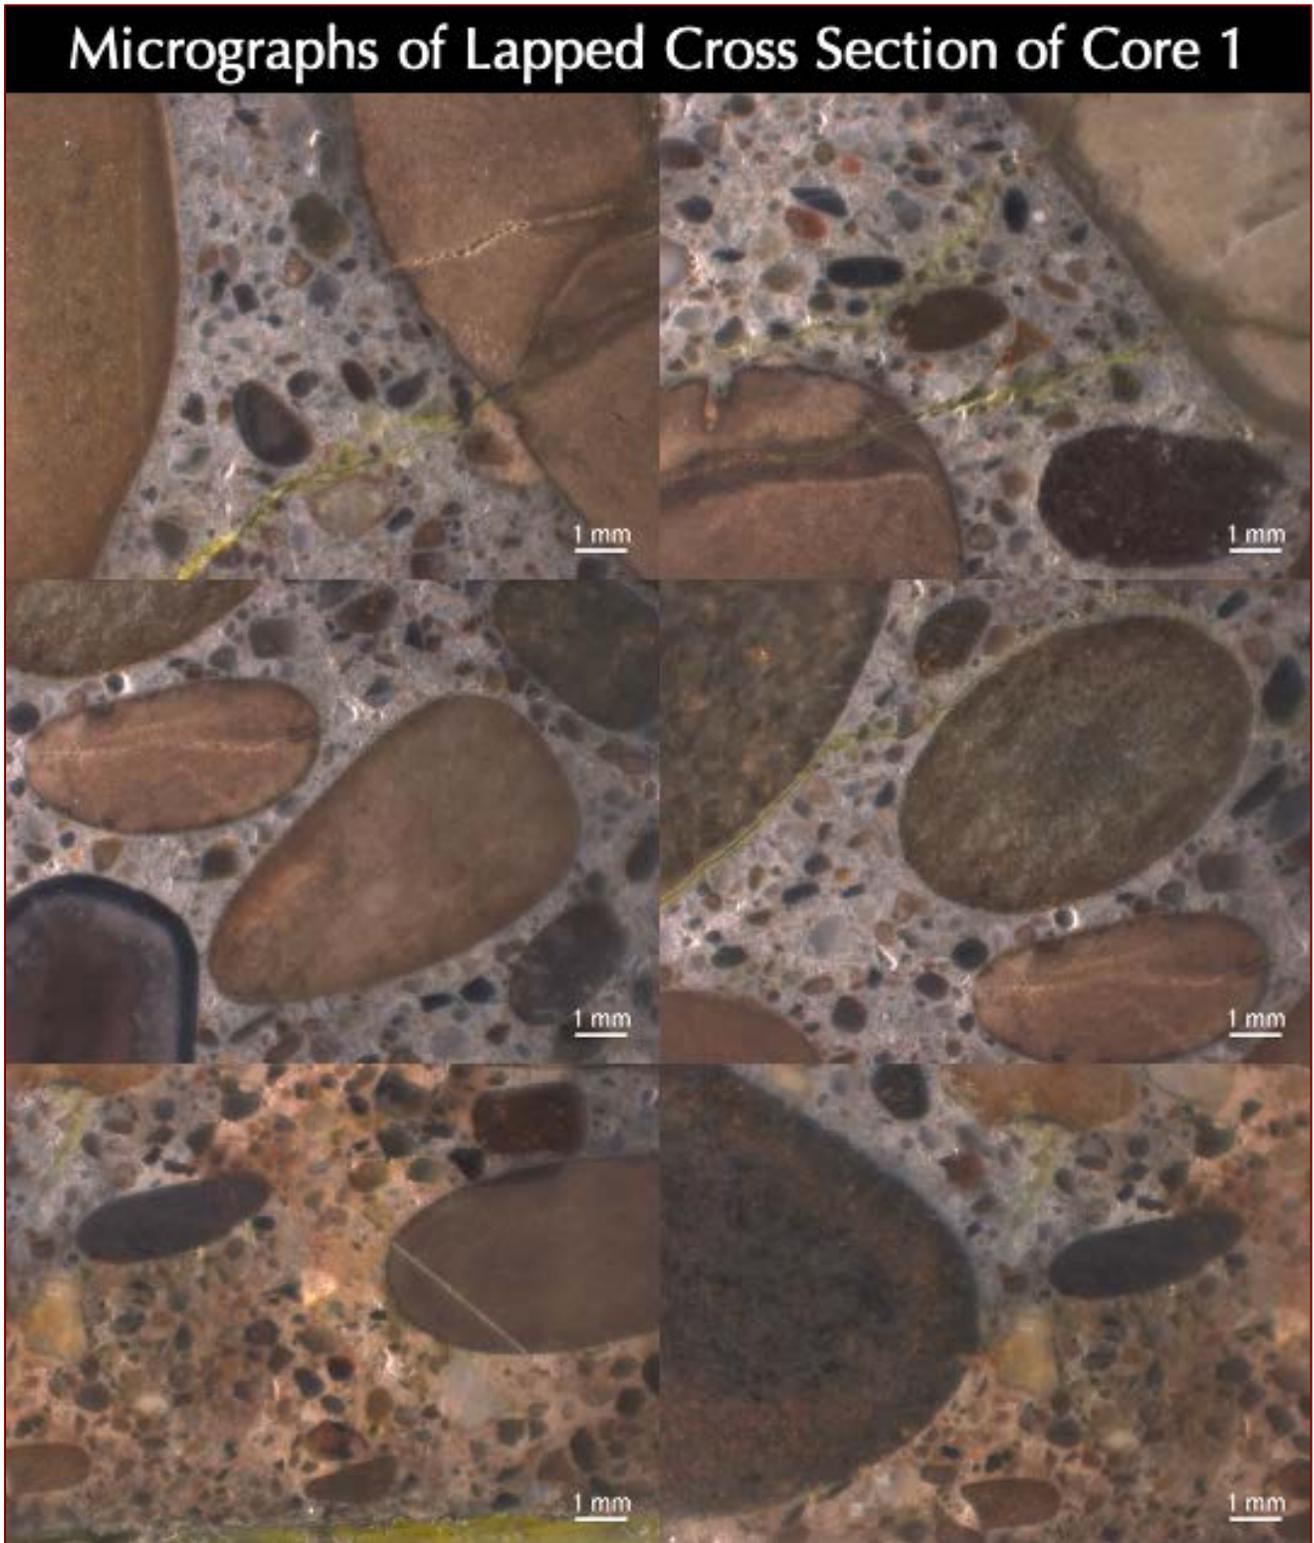
Figure 19: Micrographs of lapped cross section of Core 1 showing: (a) extensive cracking in the concrete where cracks have transected and/or circumscribed the aggregate particles; (b) rounded gravel coarse aggregate particles many showing weathering and/or reaction rims; (c) natural sand fine aggregate; (d) non-air-entrained nature of concrete; and (e) beige discoloration of concrete at the bottom end of core (seen in the bottom row photos) due to atmospheric carbonation from the air inside the vault that has interacted with the underside of the top suspended slab. Scale bars are 1 mm.

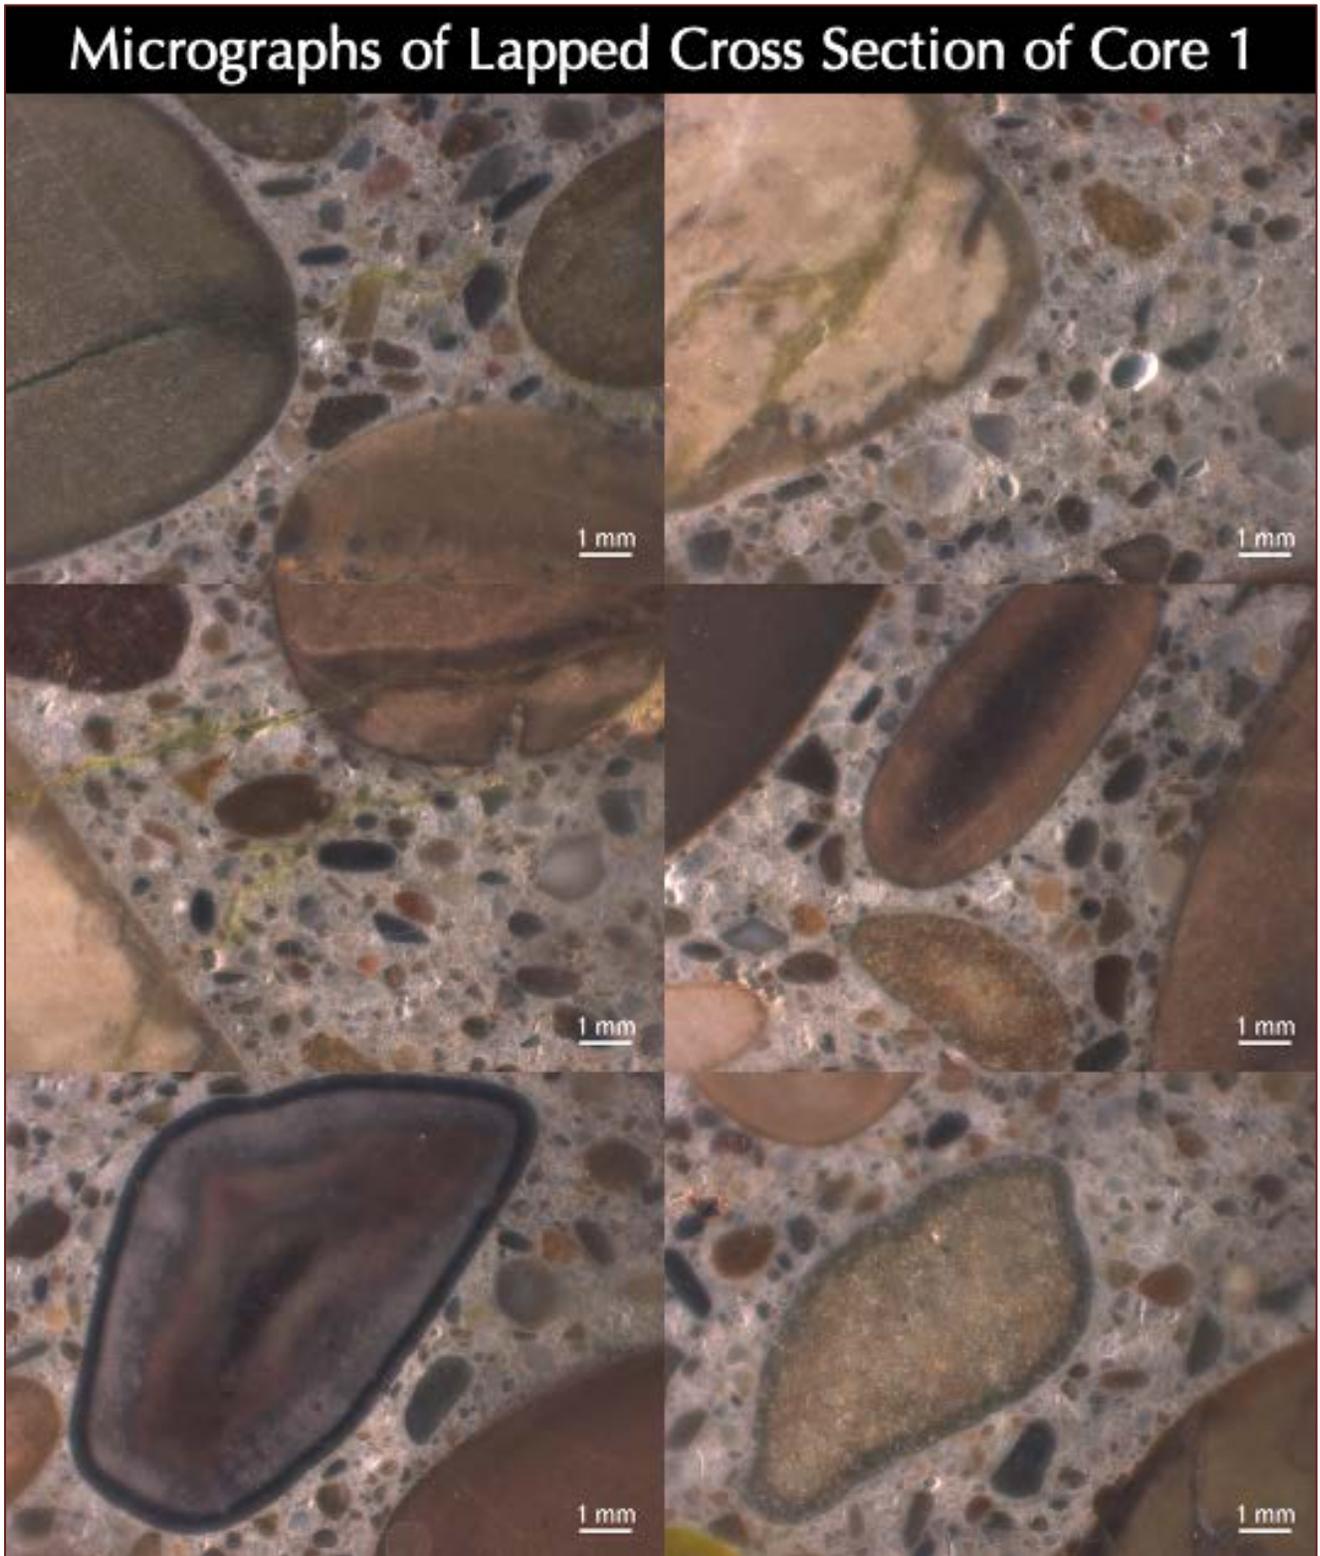
Figure 20: Micrographs of lapped cross section of Core 1 showing: (a) extensive cracking in the concrete where cracks have transected and/or circumscribed the aggregate particles; (b) rounded gravel coarse aggregate particles many showing weathering and/or reaction rims; (c) natural sand fine aggregate; and (d) non-air-entrained nature of concrete. Scale bars are 1 mm.

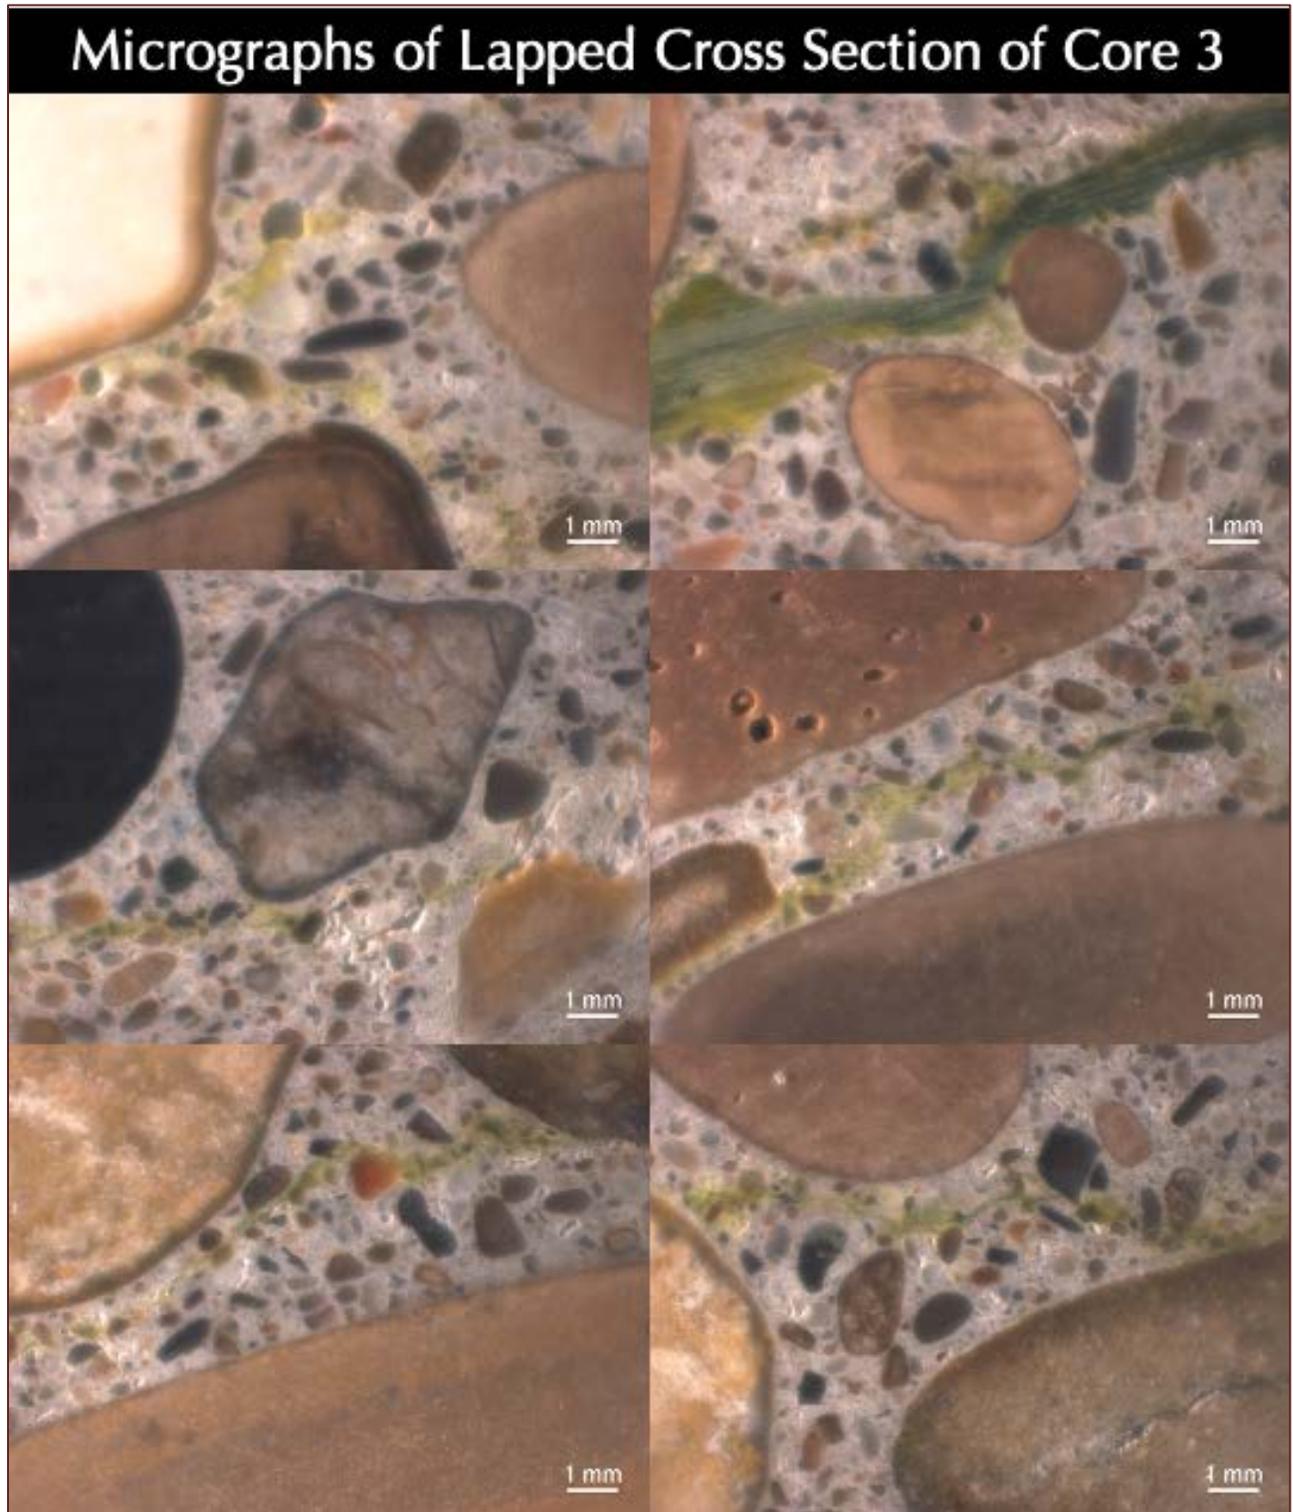
Figure 21: Micrographs of lapped cross section of Core 3 showing: (a) extensive cracking in the concrete where cracks have transected and/or circumscribed the aggregate particles; (b) rounded gravel coarse aggregate particles many showing weathering and/or reaction rims; (c) natural sand fine aggregate; and (d) non-air-entrained nature of concrete. Scale bars are 1 mm.

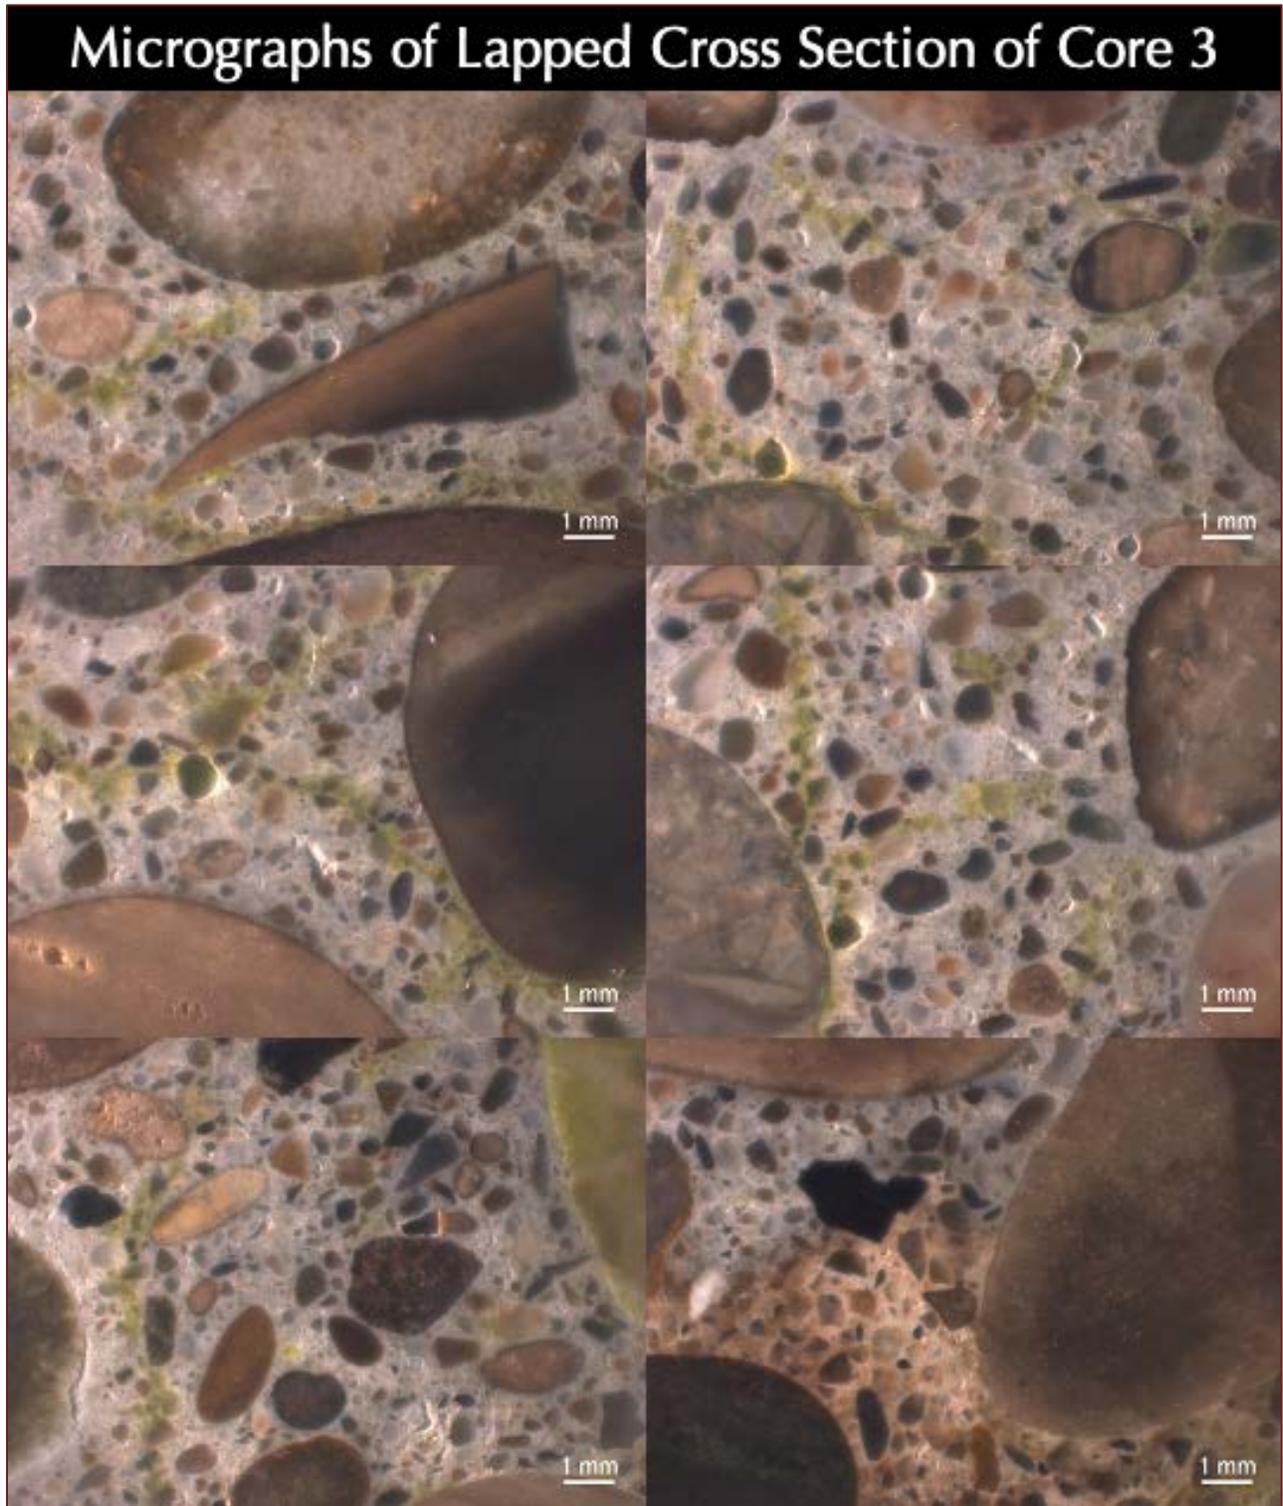
Figure 22: Micrographs of lapped cross section of Core 3 showing: (a) extensive cracking in the concrete where cracks have transected and/or circumscribed the aggregate particles; (b) rounded gravel coarse aggregate particles many showing weathering and/or reaction rims; (c) natural sand fine aggregate; (d) non-air-entrained nature of concrete; and (e) beige discoloration of concrete at the bottom end of core (seen in the bottom right photo) due to atmospheric carbonation from the air inside the vault that has interacted with the underside of the top suspended slab. Scale bars are 1 mm.

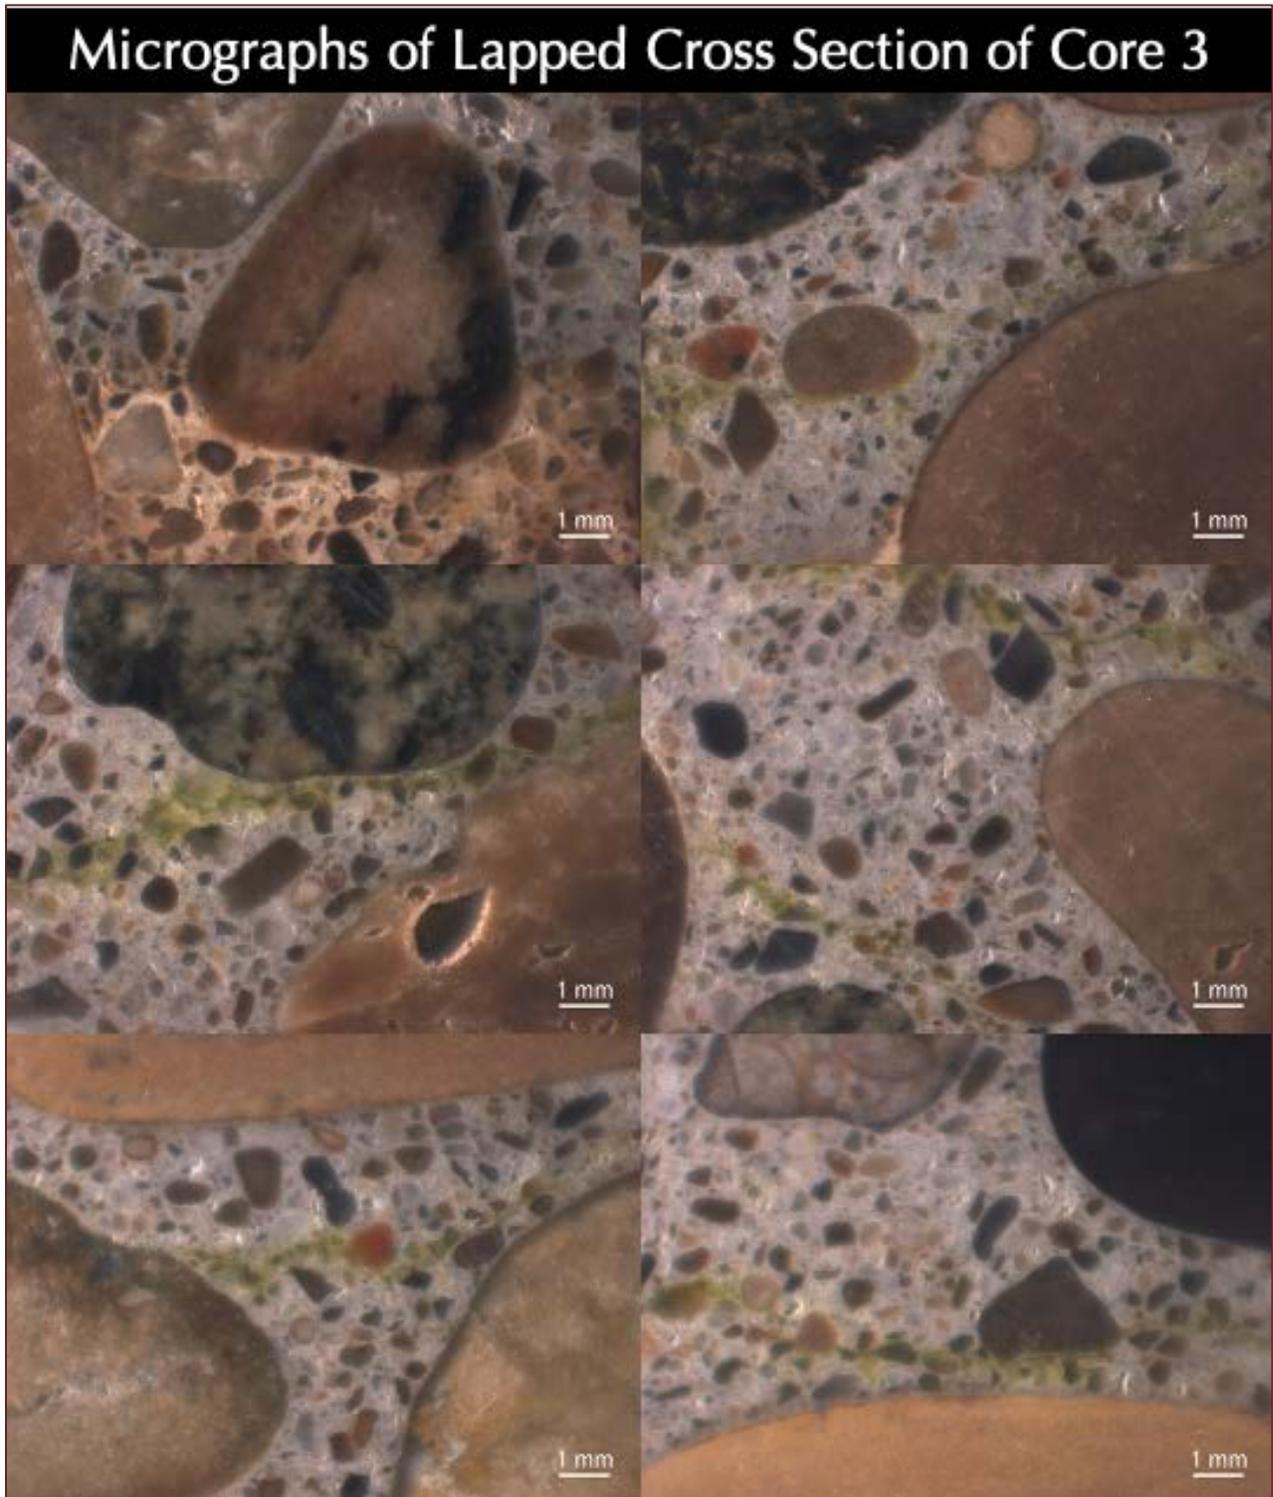
Figure 23: Micrographs of lapped cross section of Core 3 showing: (a) extensive cracking in the concrete where cracks have transected and/or circumscribed the aggregate particles; (b) rounded gravel coarse aggregate particles many showing weathering and/or reaction rims; (c) natural sand fine aggregate; (d) non-air-entrained nature of concrete; and (e) beige discoloration of concrete at the bottom end of core (seen in the top left photo) due to atmospheric carbonation from the air inside the vault that has interacted with the underside of the top suspended slab. Scale bars are 1 mm.

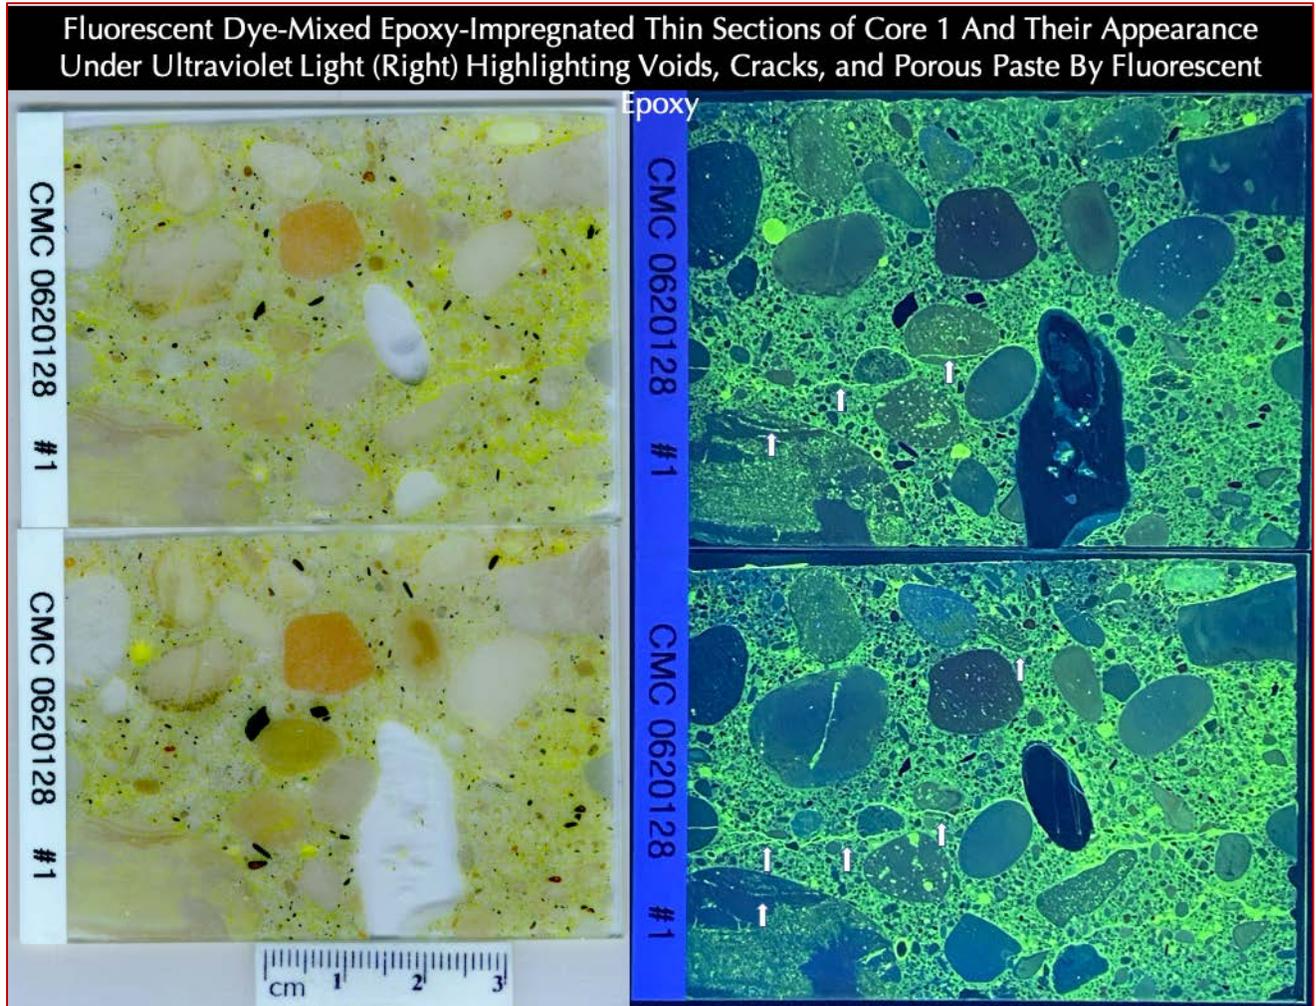
Figure 24: Fluorescent dye-mixed epoxy-impregnated thin sections of concrete in Core 1 where cracks, voids, and porous areas of paste are highlighted by fluorescent epoxy. Thin section shows: (a) rounded gravel coarse aggregate particles; (b) fine sand; and (c) extensive cracks through the depth of section where cracks have transected many aggregate particles. Thin section is approximately 30 microns (0.03 mm) in thickness and transparent to polarized-light.

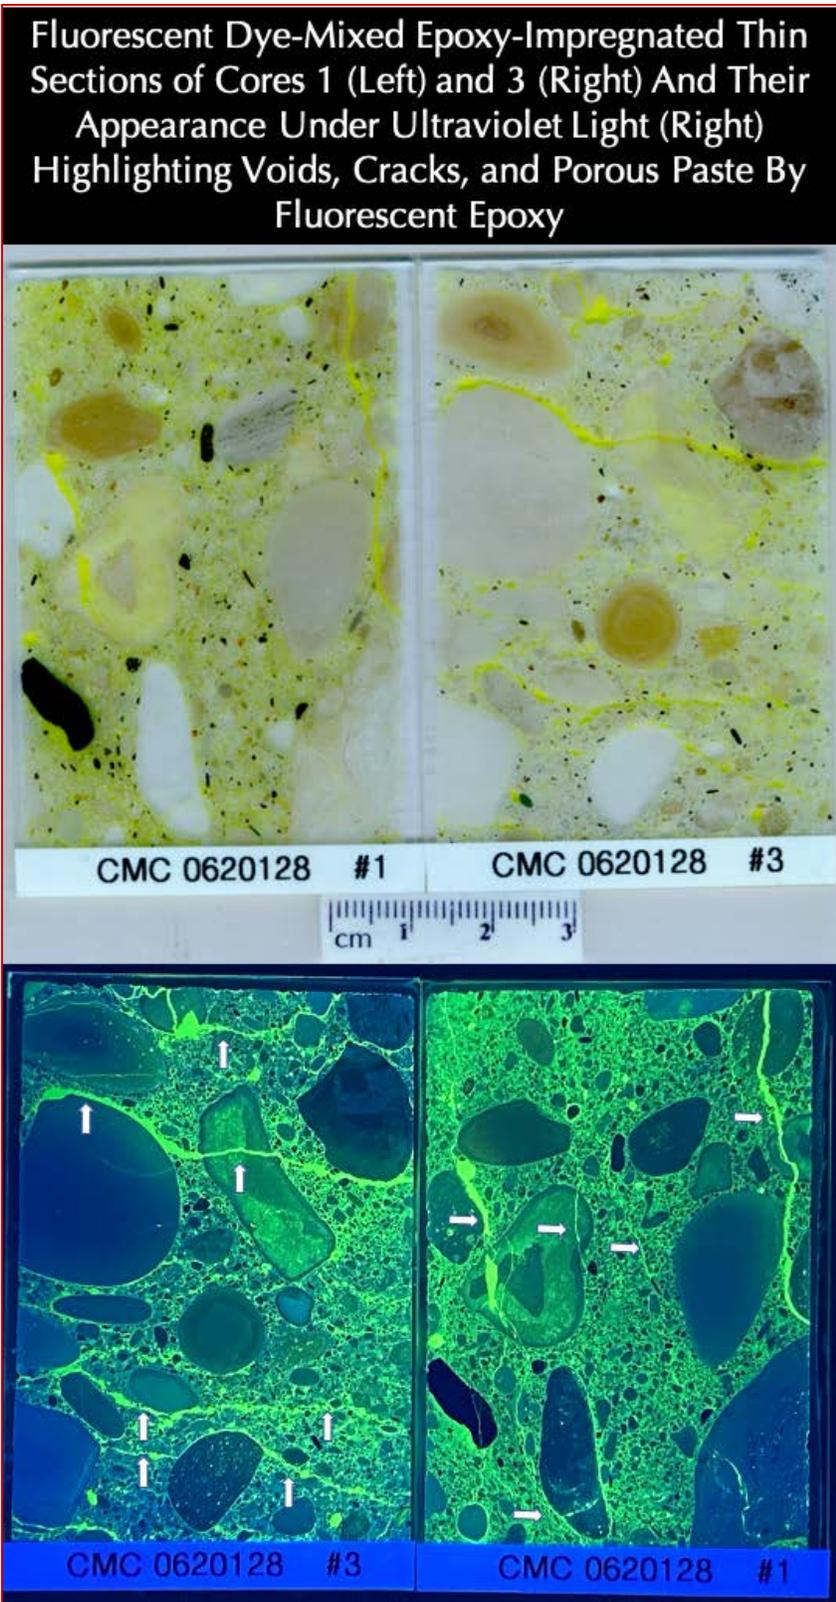
Figure 25: Fluorescent dye-mixed epoxy-impregnated thin sections of concrete in Cores 1 and 3 where cracks, voids, and porous areas of paste are highlighted by fluorescent epoxy. Thin section shows: (a) rounded gravel coarse aggregate particles; (b) fine sand; and (c) extensive cracks through the depth of section where cracks have transected many aggregate particles. Thin section is approximately 30 microns (0.03 mm) in thickness and transparent to polarized-light.

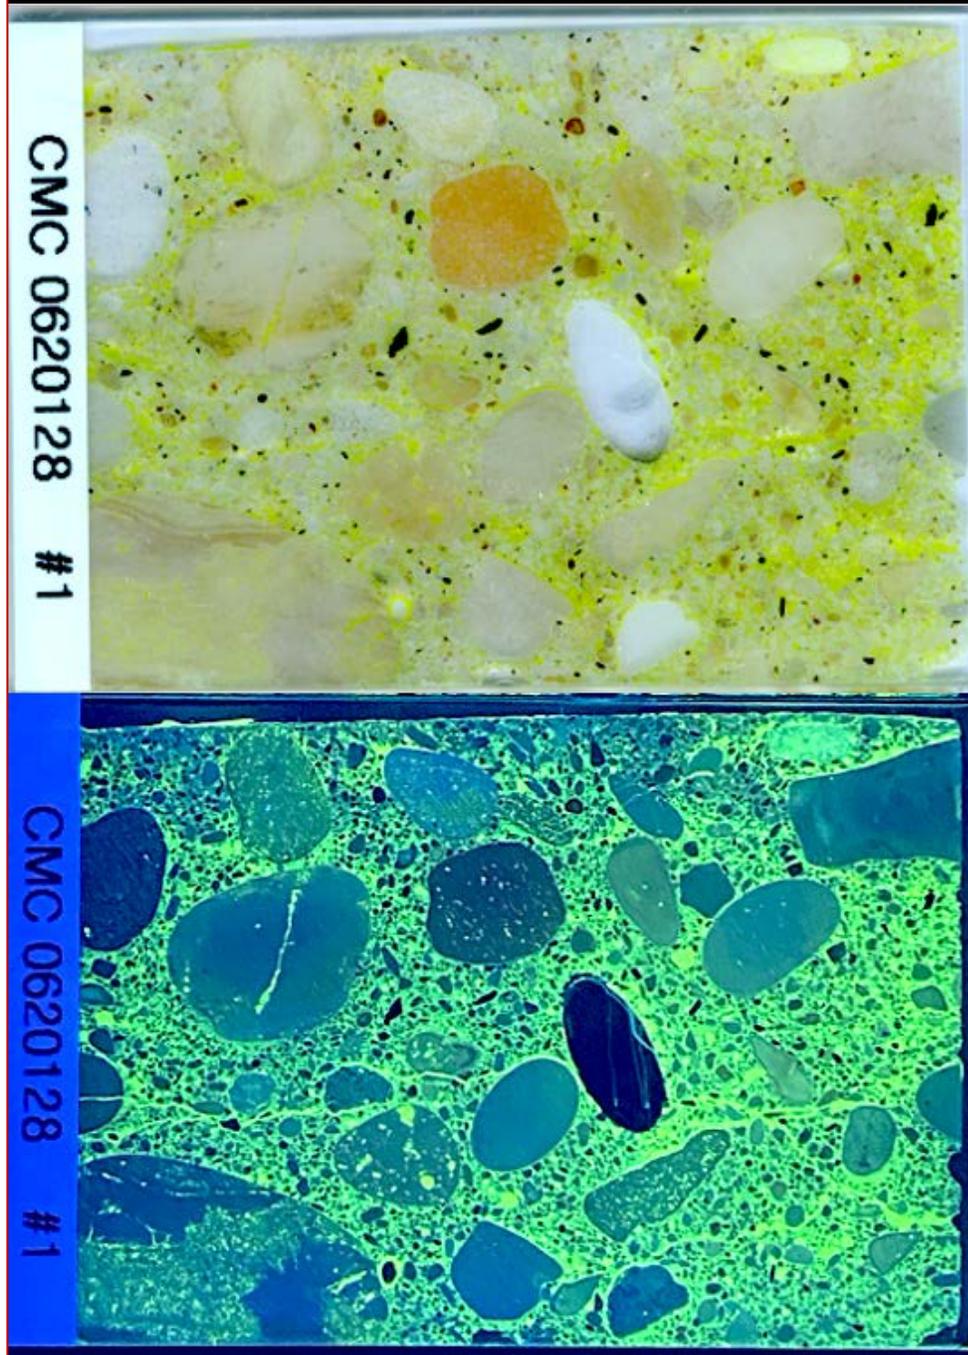
Figure 26: Fluorescent dye-mixed epoxy-impregnated thin section of concrete in Core 1 where cracks, voids, and porous areas of paste are highlighted by fluorescent epoxy. This section shows: (a) rounded gravel coarse aggregate particles; (b) fine sand; and (c) extensive cracks through the depth of section where cracks have transected many aggregate particles. Thin section is approximately 30 microns (0.03 mm) in thickness and transparent to polarized-light.

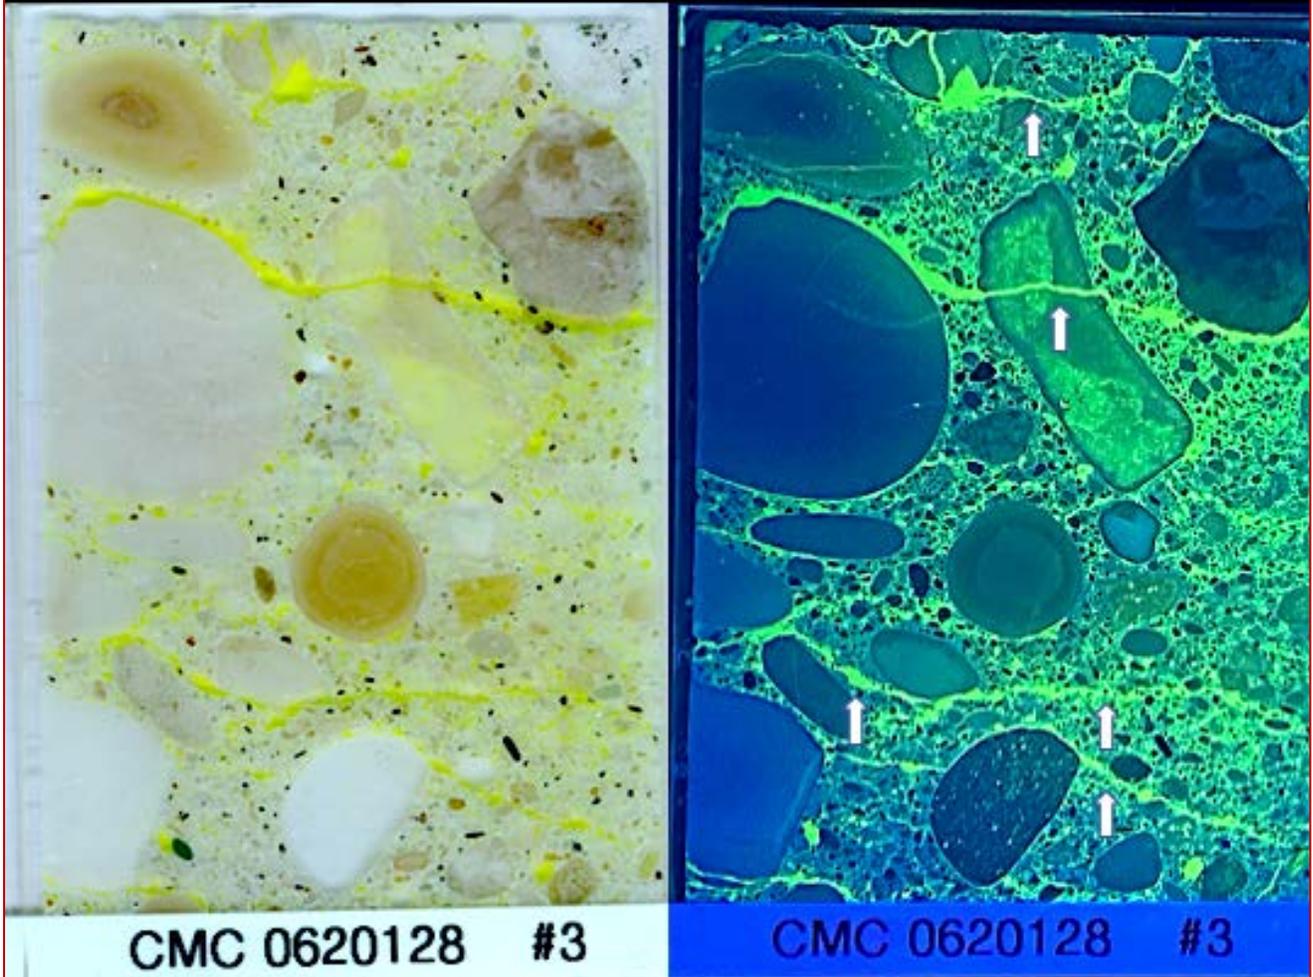
Figure 27: Fluorescent dye-mixed epoxy-impregnated thin section of concrete in Core 3 where cracks, voids, and porous areas of paste are highlighted by fluorescent epoxy. Thin section shows: (a) rounded gravel coarse aggregate particles; (b) fine sand; and (c) extensive cracks through the depth of section where cracks have transected many aggregate particles. Thin section is approximately 30 microns (0.03 mm) in thickness and transparent to polarized-light.

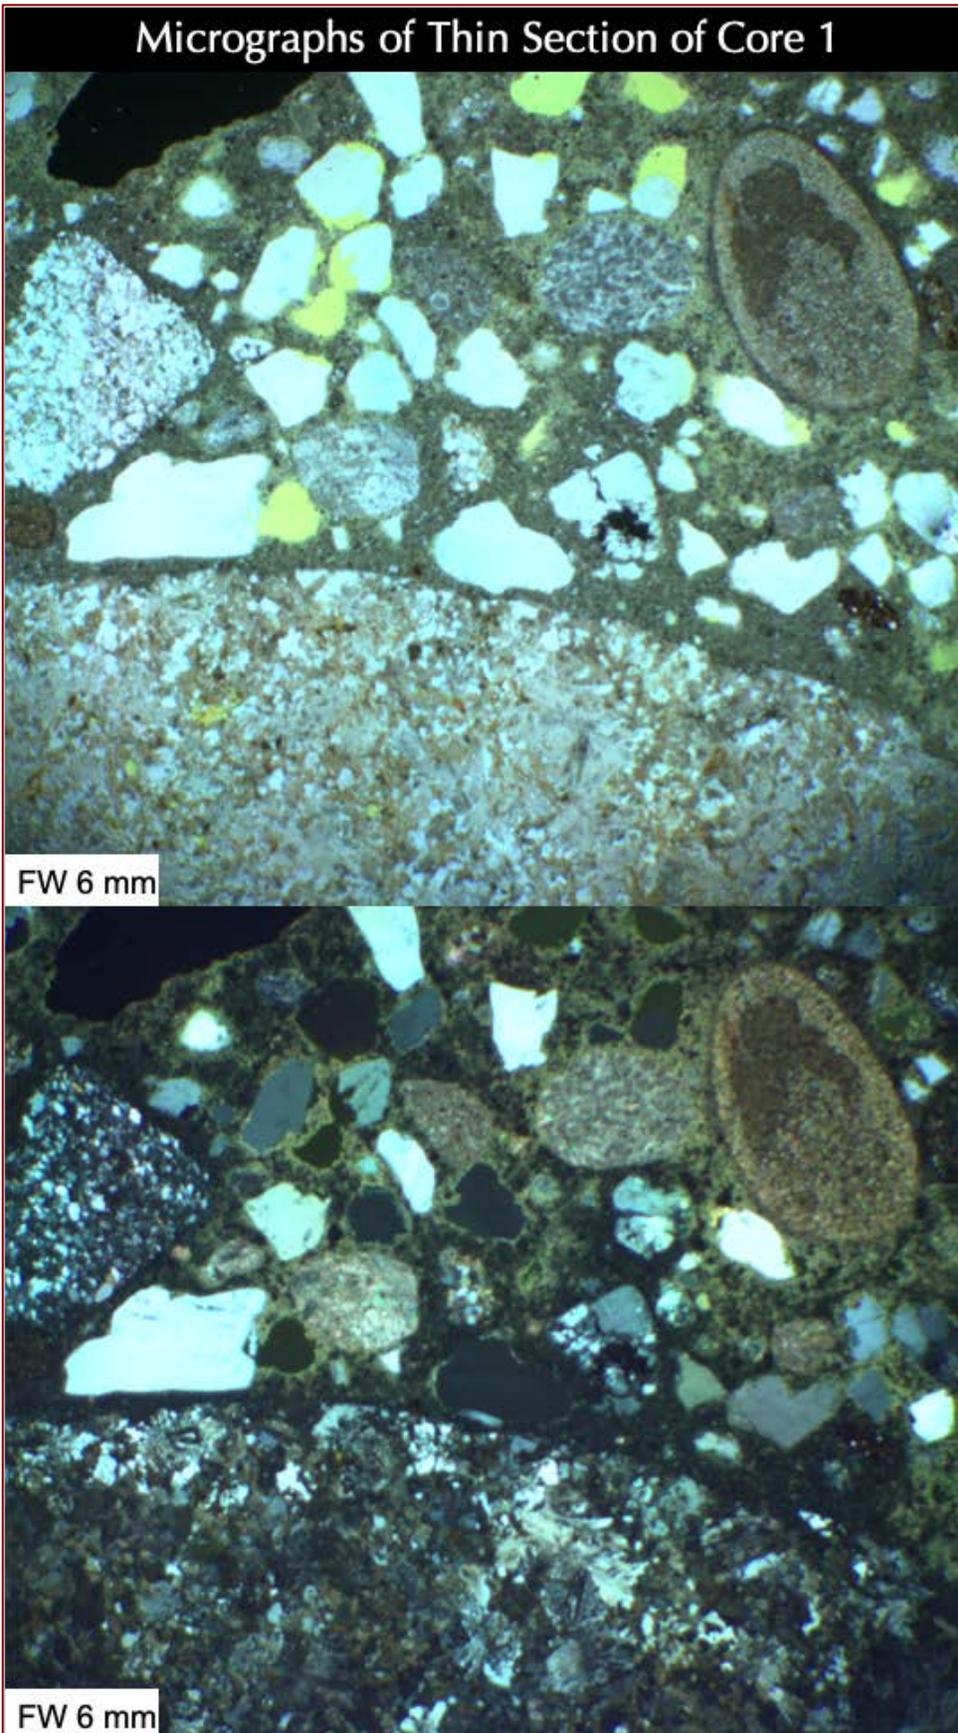
Figure 35: Micrographs of thin section of Core 1 taken in plane (top) and crossed-polarized (bottom) light modes with an Olympus SZX12 stereozoom fluorescent-light microscope with attachments for polarized light showing the non-air-entrained nature of the concrete.

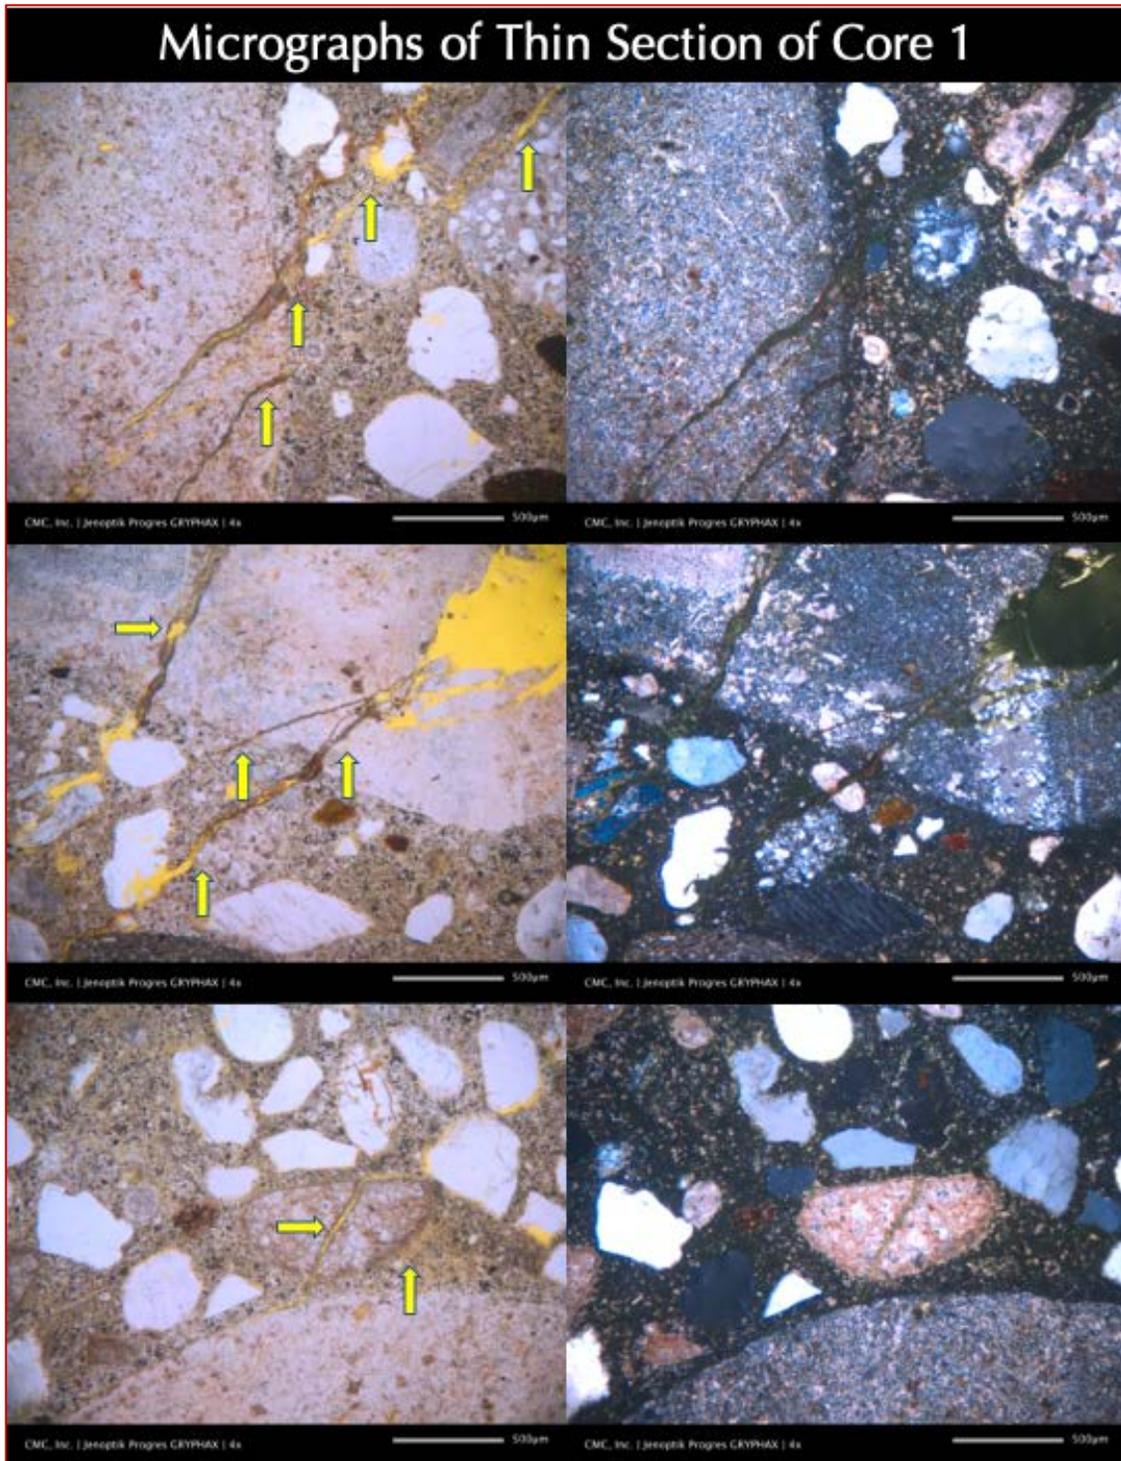
Figure 38: Micrographs of thin section of Core 1 taken with a Nikon Eclipse E600 POL Petrographic microscope with an attached Jenoptik Progres Gryphax camera showing many microcracks extending from cherty limestone and dolomitic chert gravel coarse aggregate particles to the paste where many such cracks from reactive aggregates to paste contain alkali-silica reaction gel formed due to reactions between such potentially reactive fine-grained cryptocrystalline to microcrystalline silica or chert component in limestone or dolomite and high alkali from cement in the presence of moisture. These microcrystalline silica or chert inclusions in limestone and dolomite are found in many gravel coarse aggregate particles across all three cores that are found to be reactive to cement alkalis in the presence of moisture.
