Laboratory Investigation of An Outdoor Suspended Concrete Slab Of An Underground Vault Adjacent To A Swimming Pool

Algonquin Pool
1614 Cypress Street
Louisville, KY 40210

July 8, 2020
CMC 0620128

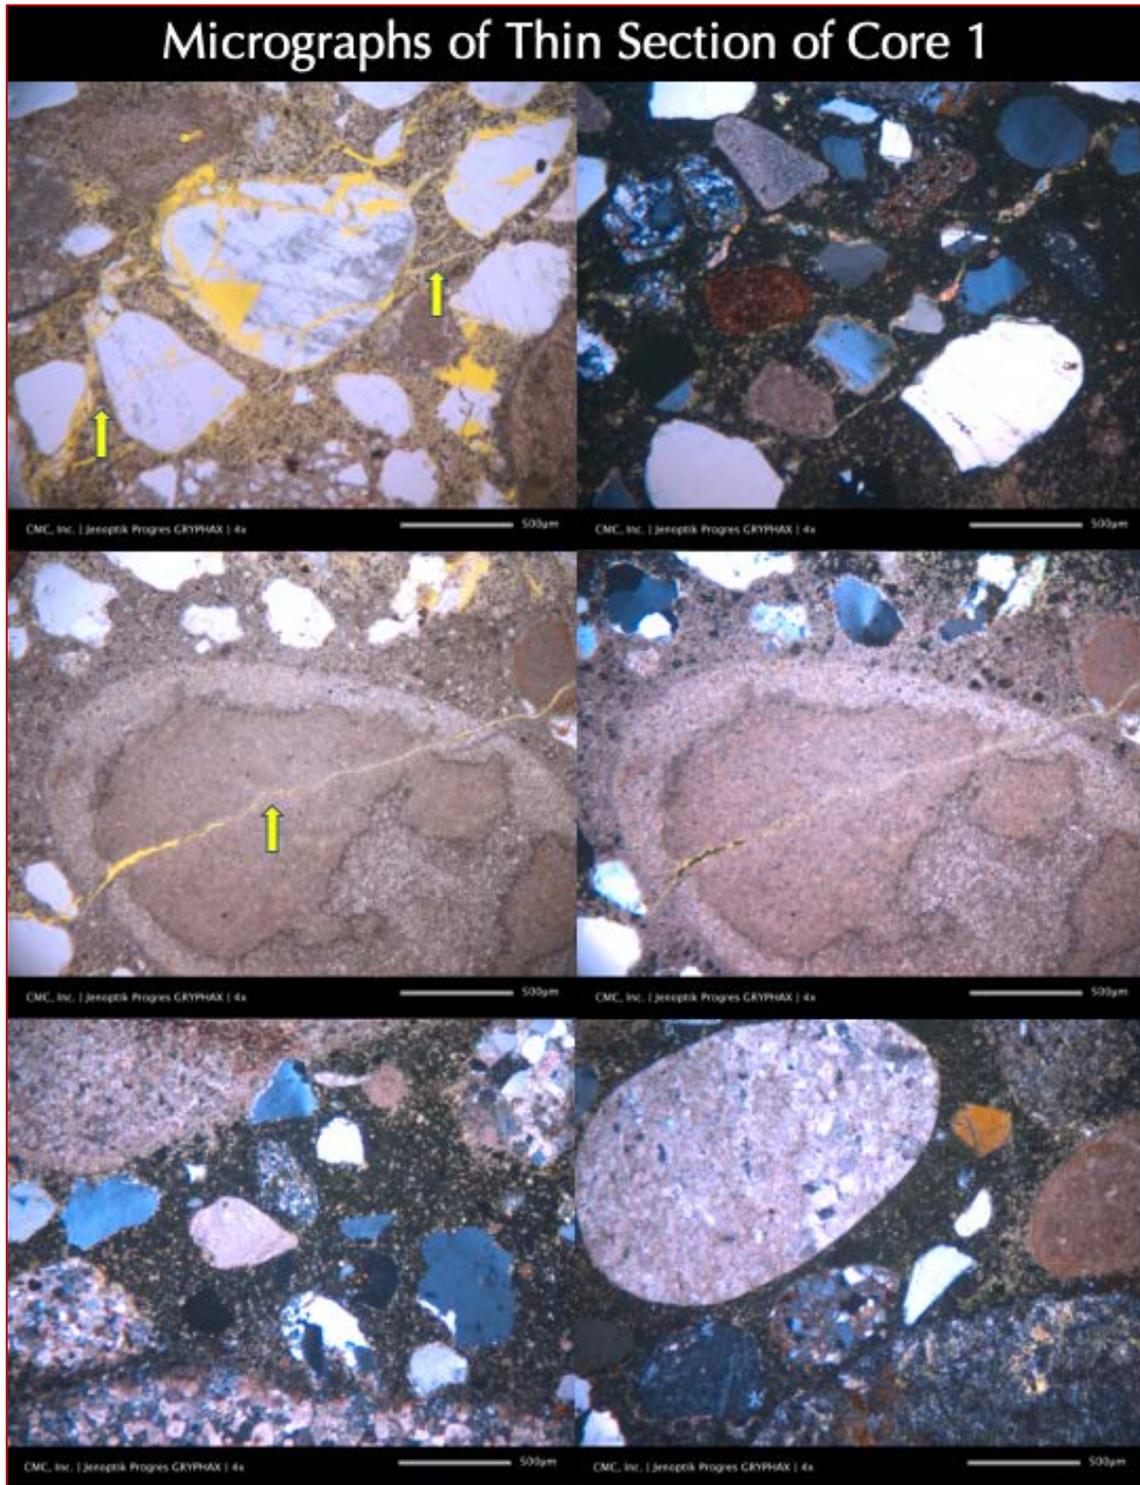
Figure 39: Micrographs of thin section of Core 1 taken with a Nikon Eclipse E600 POL Petrographic microscope with an attached Jenoptik Progres Gryphax camera showing many microcracks extending from cherty limestone and dolomitic chert gravel coarse aggregate particles to the paste where many such cracks from reactive aggregates to paste contain alkali-silica reaction gel formed due to reactions between such potentially reactive fine-grained cryptocrystalline to microcrystalline silica or chert components in limestone or dolomite and high alkali from cement in the presence of moisture. These microcrystalline silica or chert inclusions in limestone and dolomite are found in many gravel coarse aggregate particles across all three cores that are found to be reactive to cement alkalis in the presence of moisture

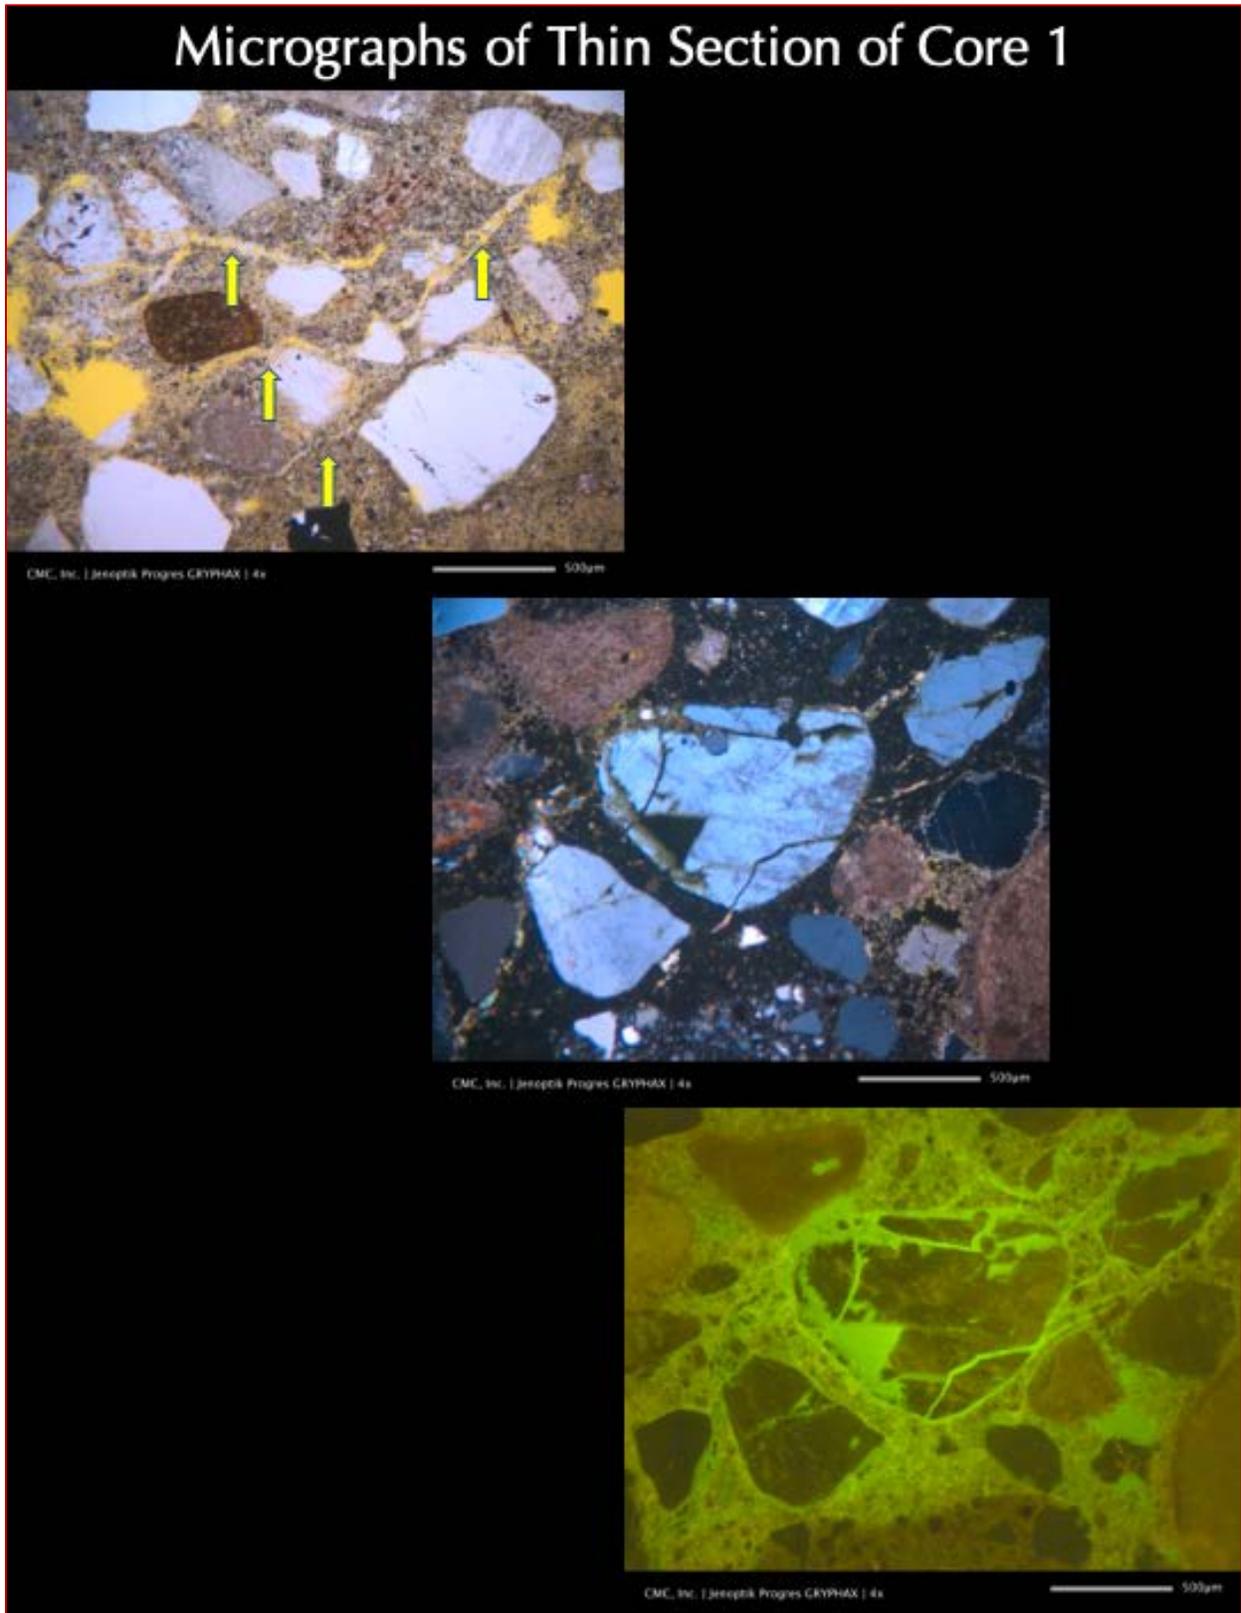
Figure 40: Micrographs of thin section of Core 1 taken with a Nikon Eclipse E600 POL Petrographic microscope with an attached Jenoptik Progres Gryphax camera showing microcracks extending in concrete transected and circumscribed the aggregate particles. Cracks are highlighted by fluorescent epoxy in plane, crossed, and fluorescent light modes from the top to bottom images, respectively.

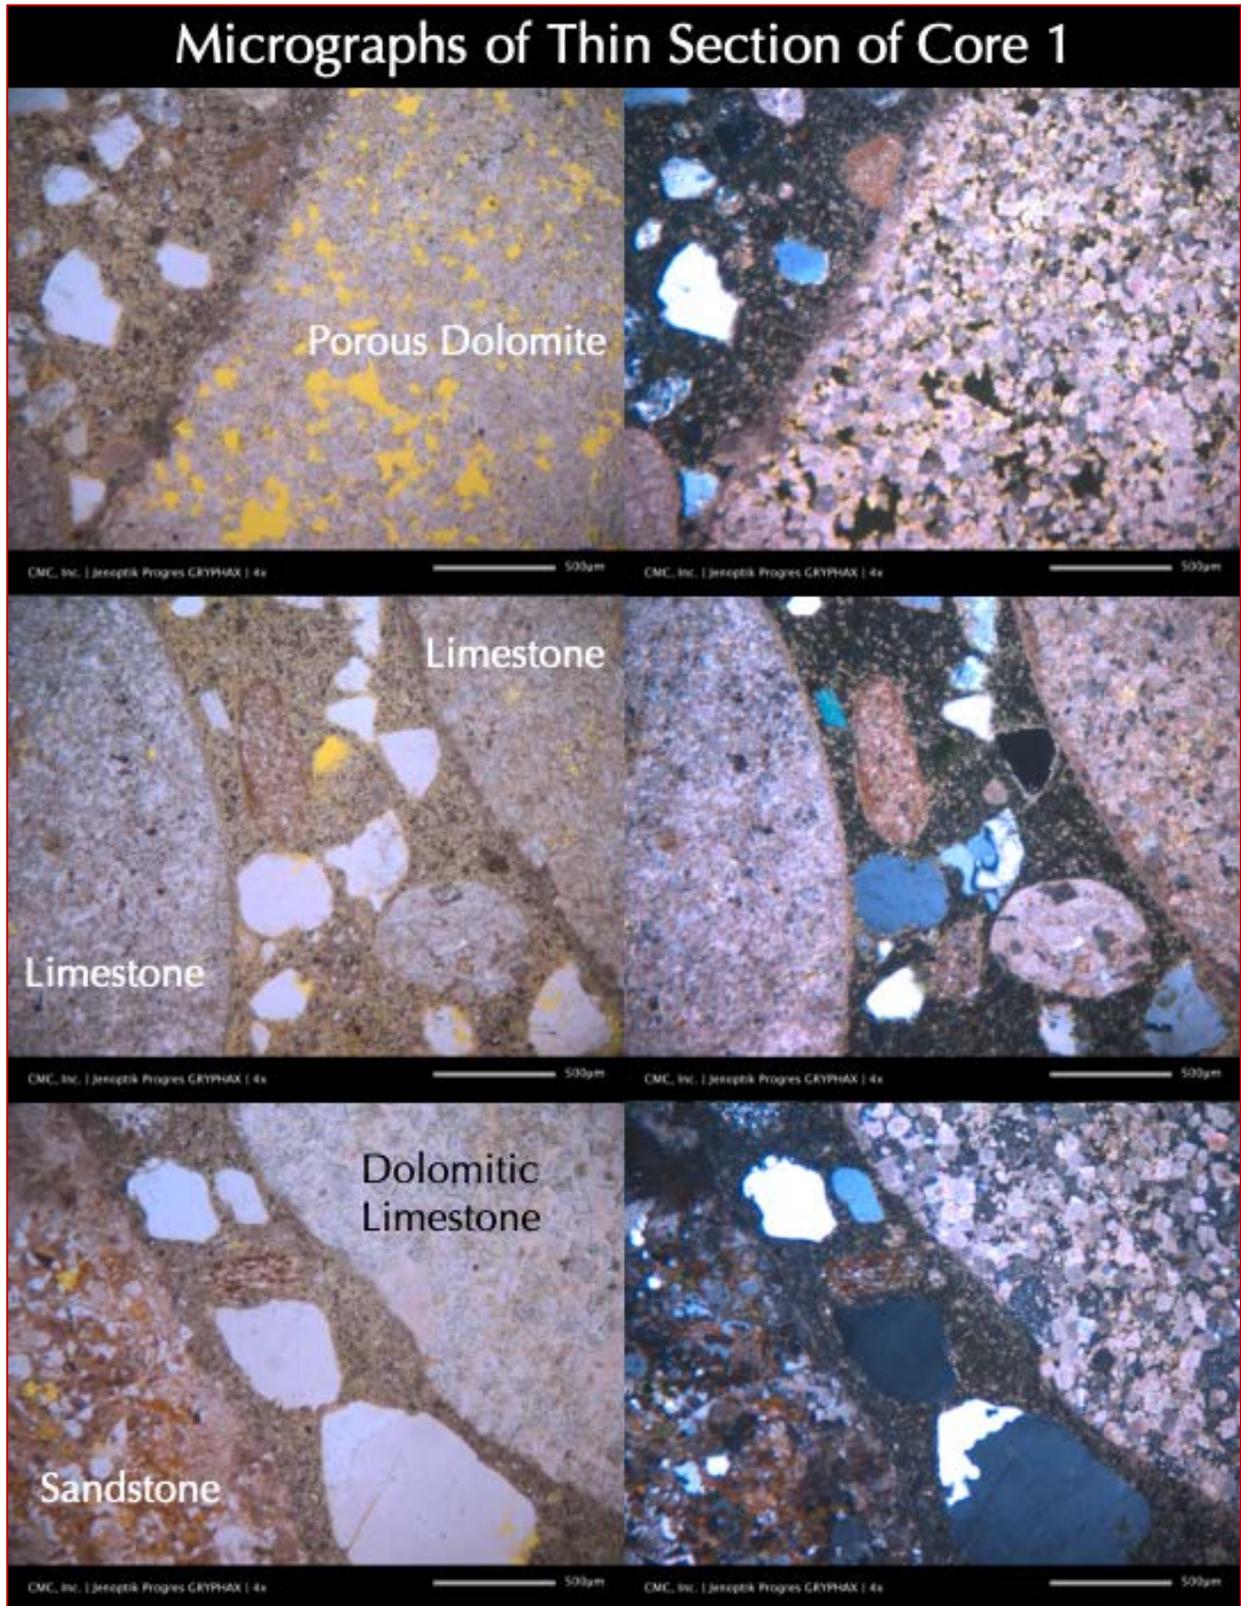
Figure 41: Micrographs of thin section of Core 1 taken with a Nikon Eclipse E600 POL Petrographic microscope with an attached Jenoptik Progres Gryphax camera showing many calcareous gravel particles in coarse aggregate and siliceous-calcareous particles in the interstitial fine aggregate scattered over variably carbonated Portland cement paste.

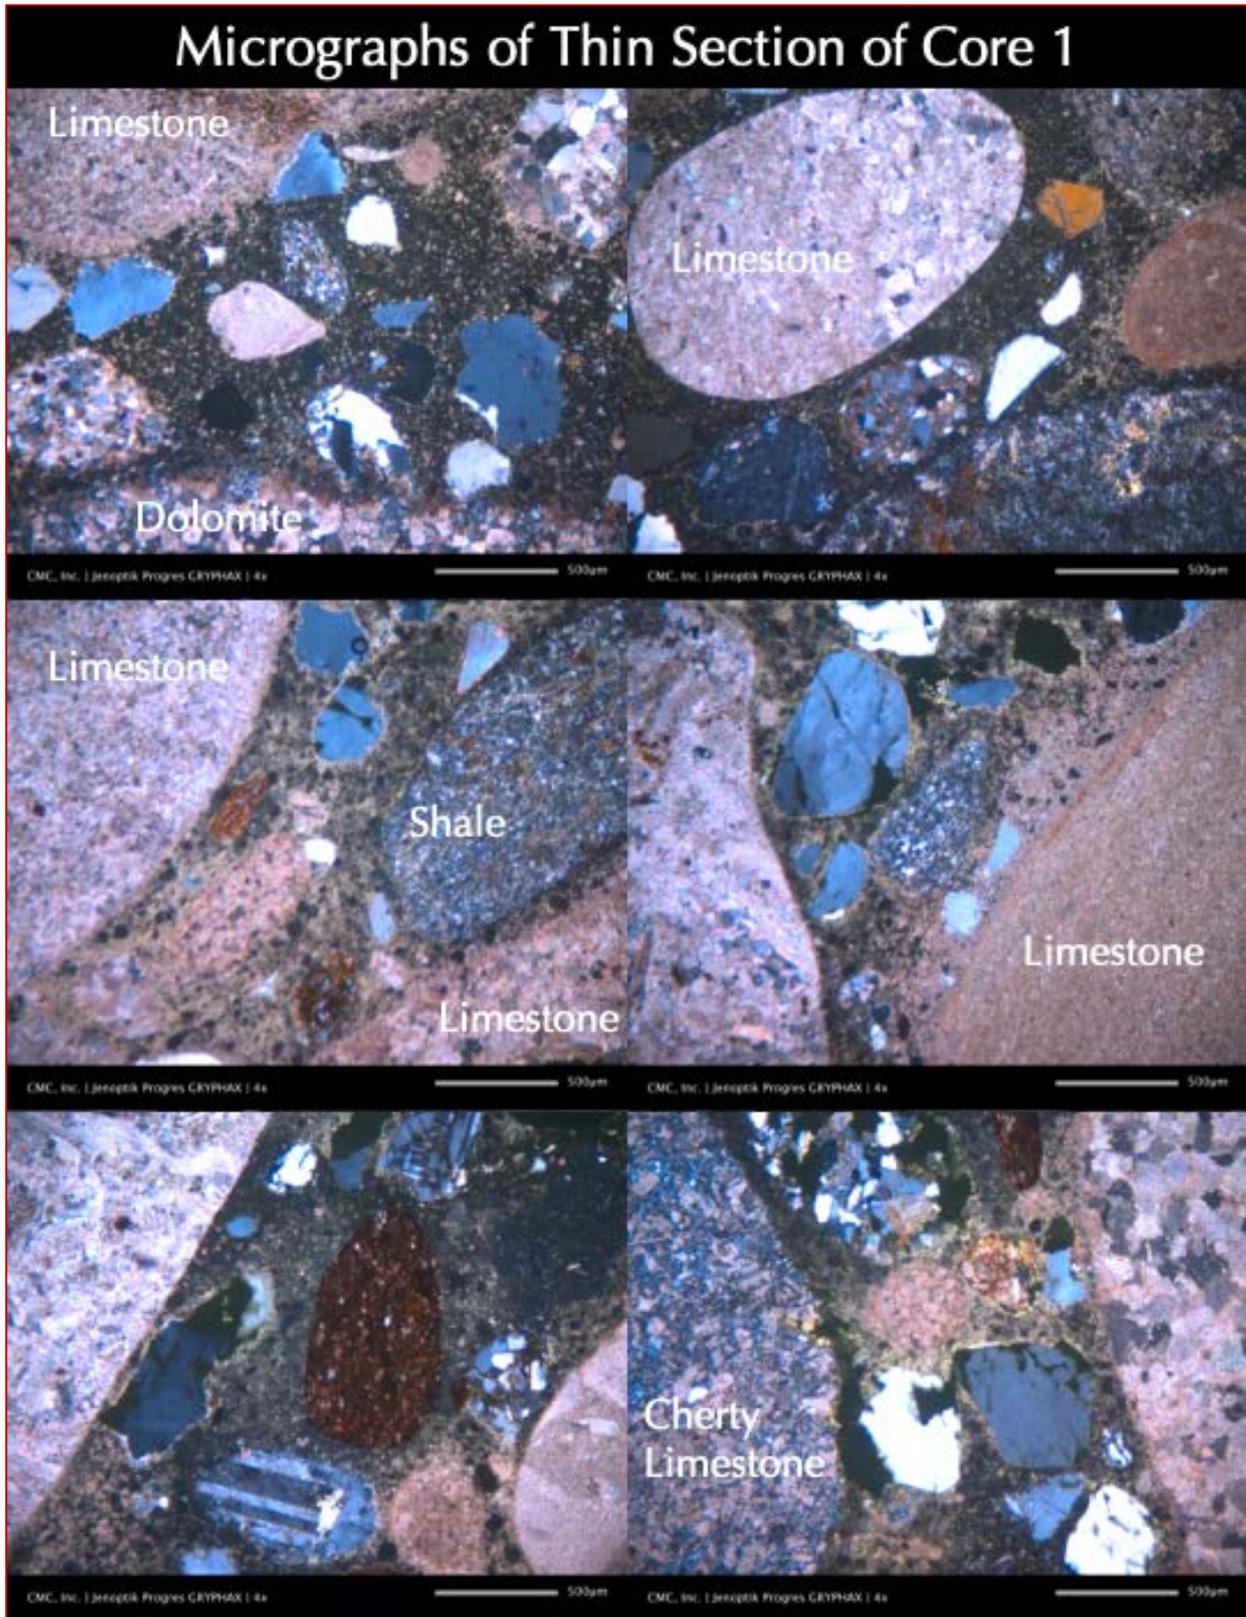
Figure 42: Micrographs of thin section of Core 1 taken with a Nikon Eclipse E600 POL Petrographic microscope with an attached Jenoptik Progres Gryphax camera showing many calcareous gravel particles in coarse aggregate and siliceous-calcareous particles in the interstitial fine aggregate scattered over variably carbonated Portland cement paste.

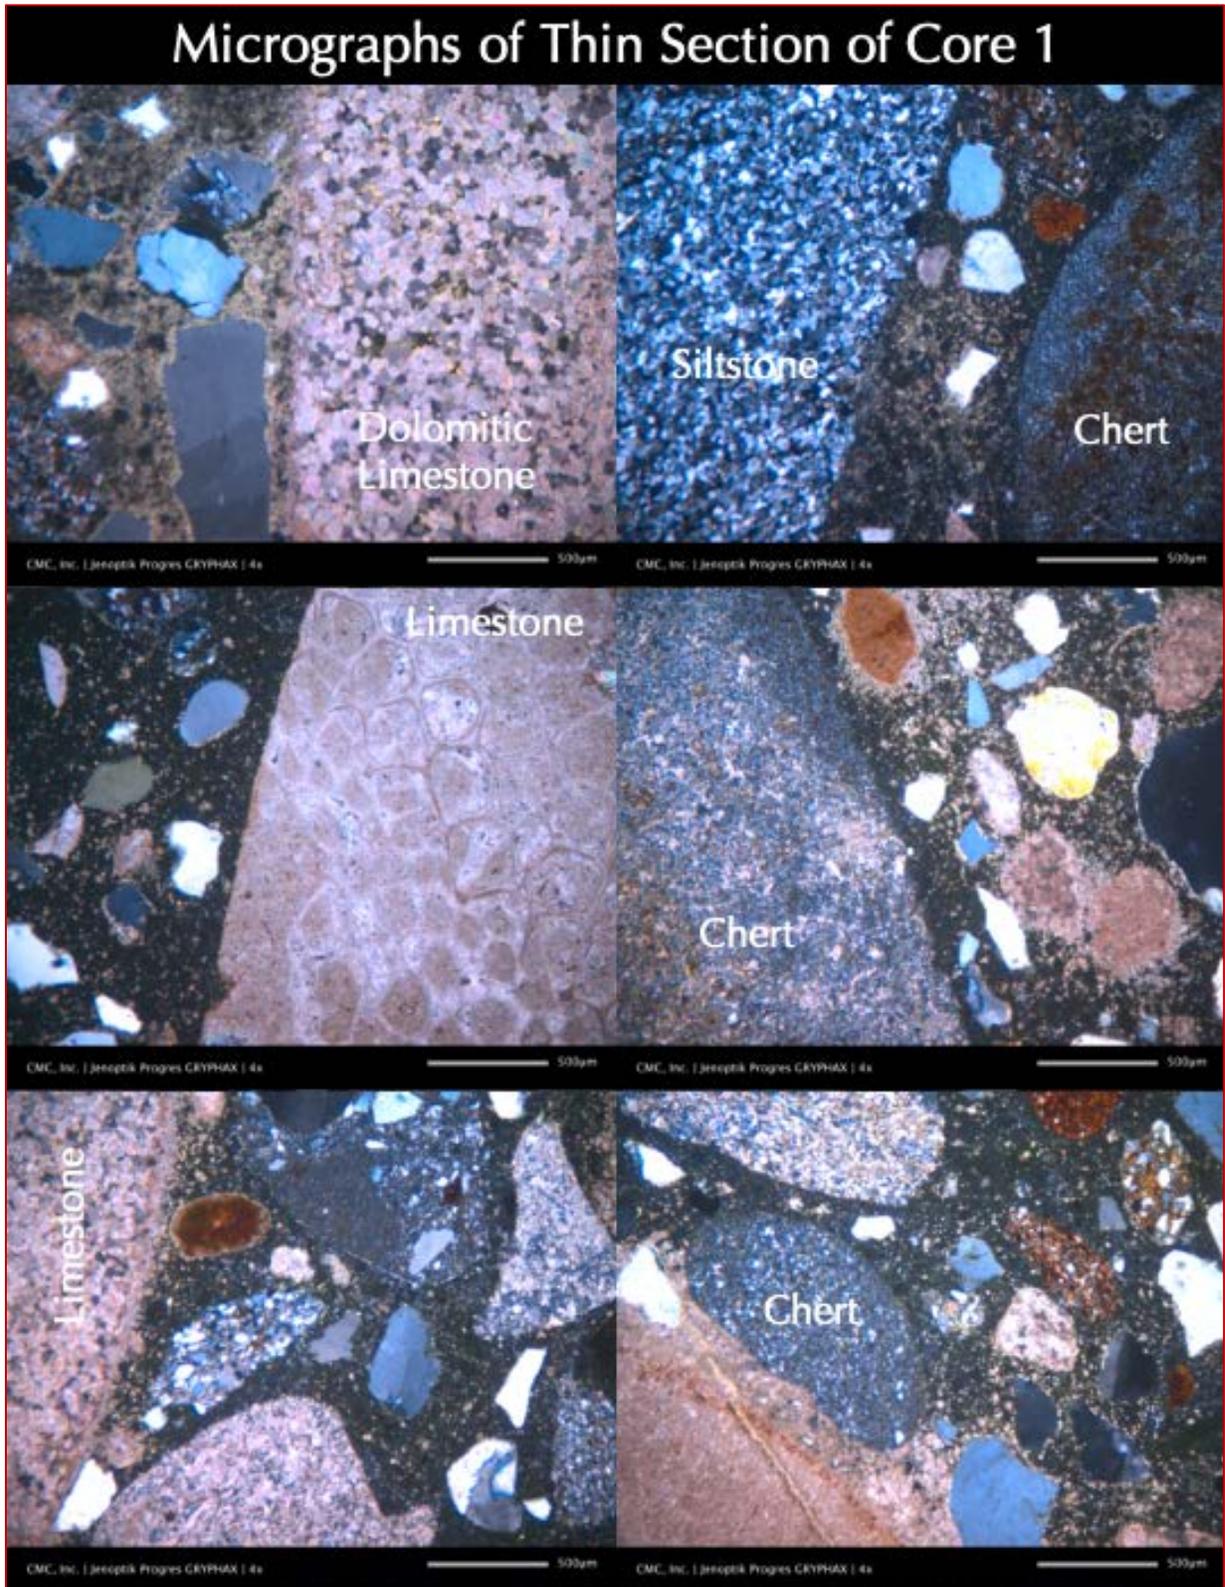
Figure 43: Micrographs of thin section of Core 1 taken with a Nikon Eclipse E600 POL Petrographic microscope with an attached Jenoptik Progres Gryphax camera showing many calcareous gravel particles in coarse aggregate and siliceous-calcareous particles in the interstitial fine aggregate scattered over variably carbonated Portland cement paste.

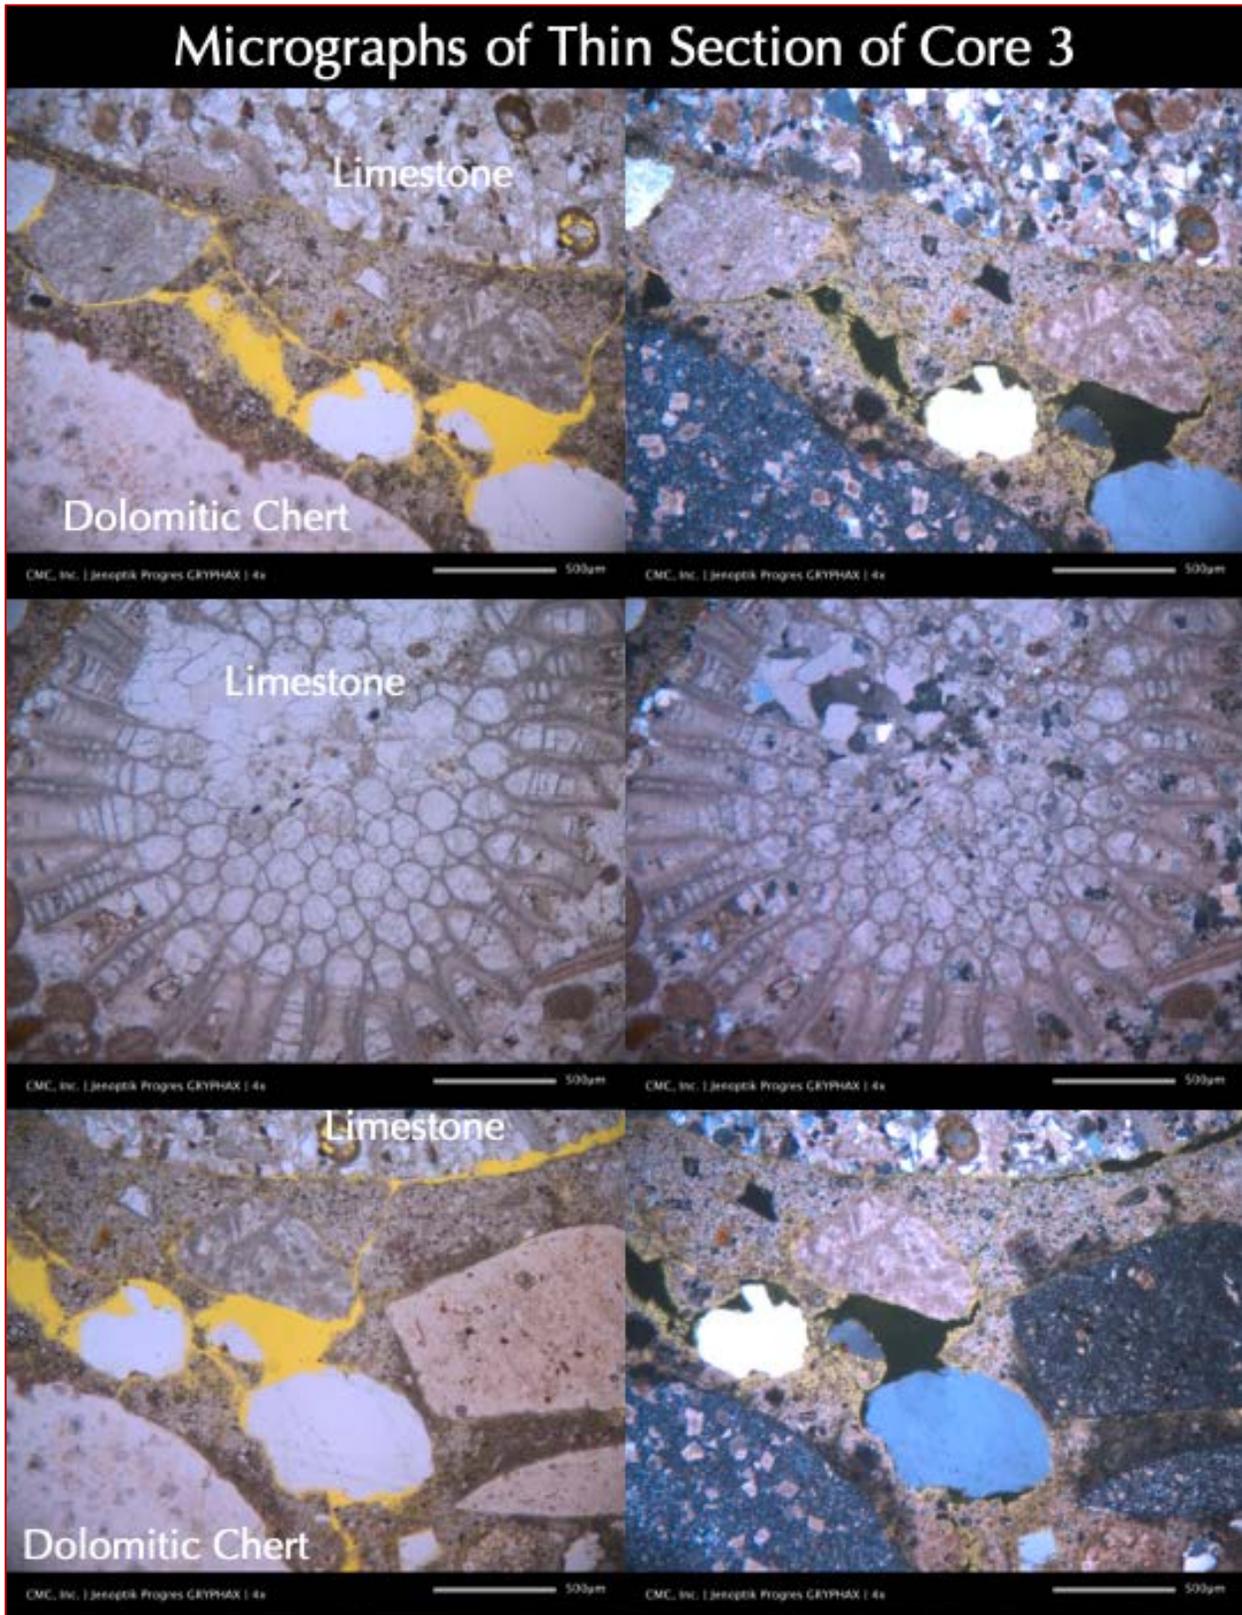
Figure 44: Micrographs of thin section of Core 3 taken with a Nikon Eclipse E600 POL Petrographic microscope with an attached Jenoptik Progres Gryphax camera showing many calcareous gravel particles in coarse aggregate and siliceous-calcareous particles in the interstitial fine aggregate scattered over variably carbonated Portland cement paste.

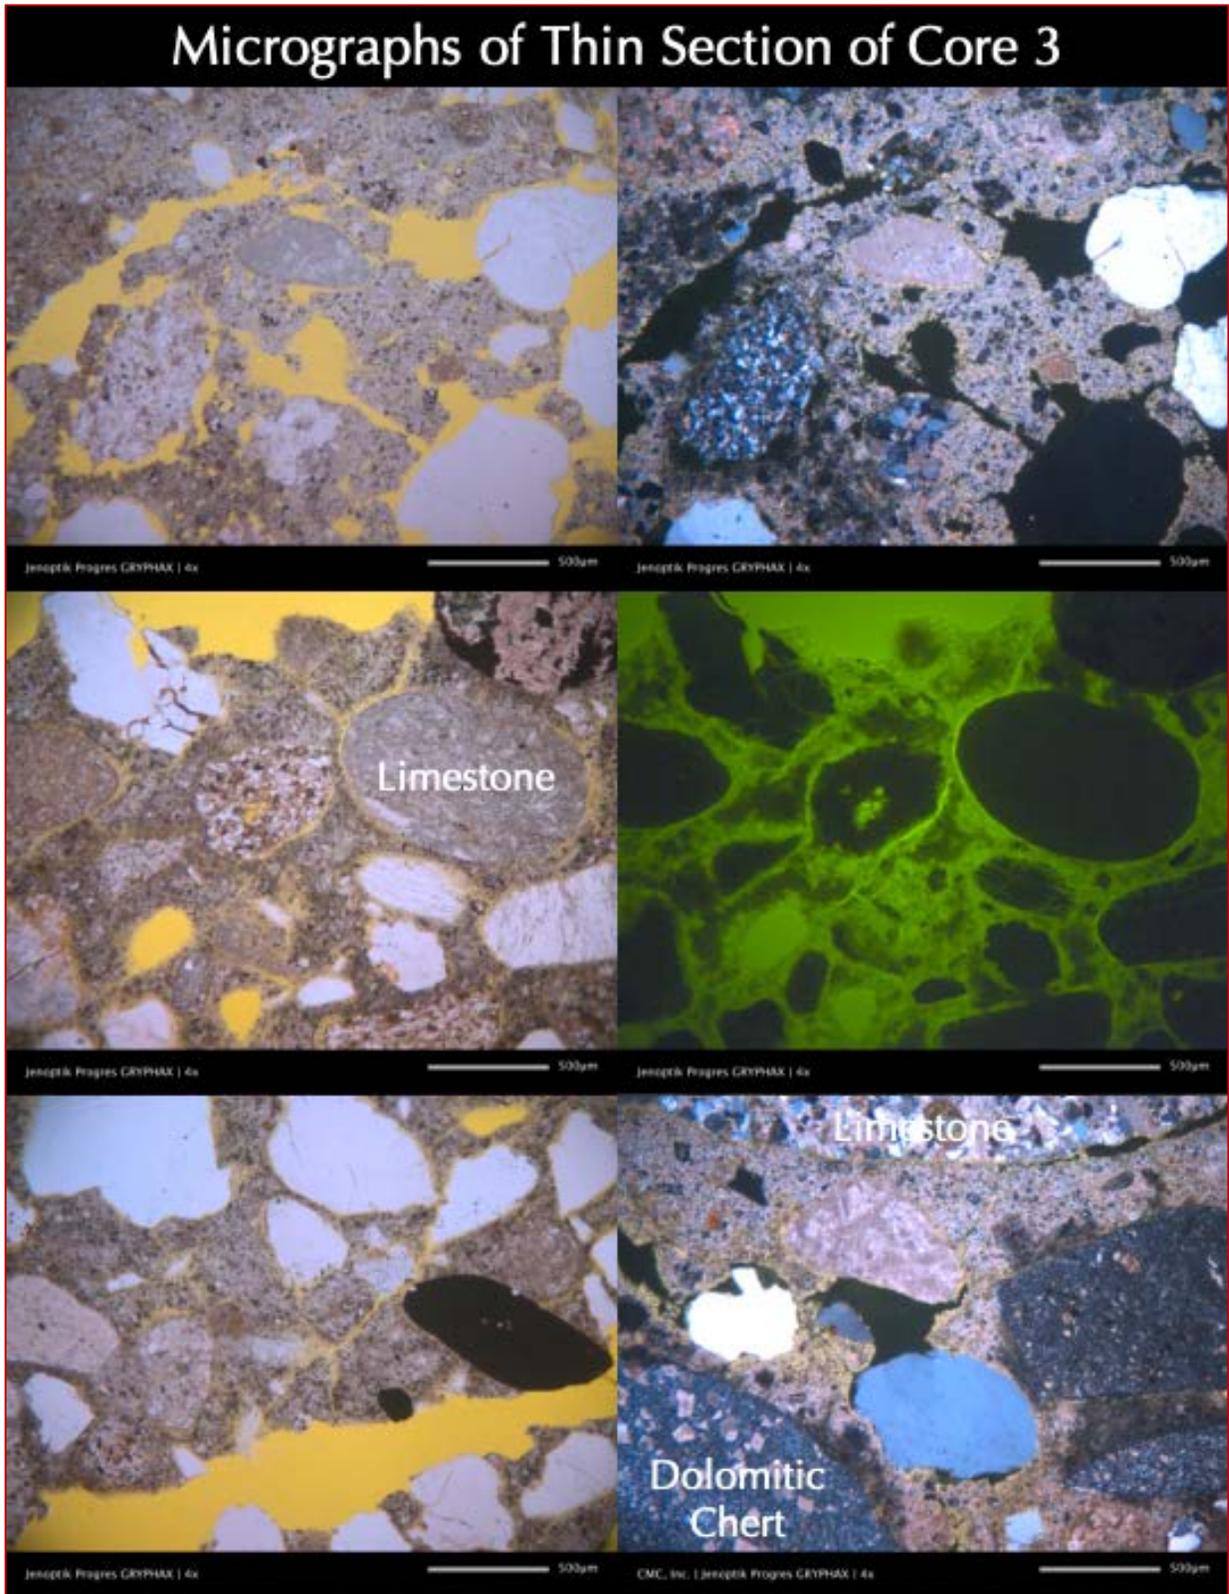
Figure 45: Micrographs of thin section of Core 3 taken with a Nikon Eclipse E600 POL Petrographic microscope with an attached Jenoptik Progres Gryphax camera showing microcracks extending into concrete transecting and circumscribing the aggregate particles. Cracks are highlighted in fluorescent epoxy in plane, crossed, or fluorescent light modes.

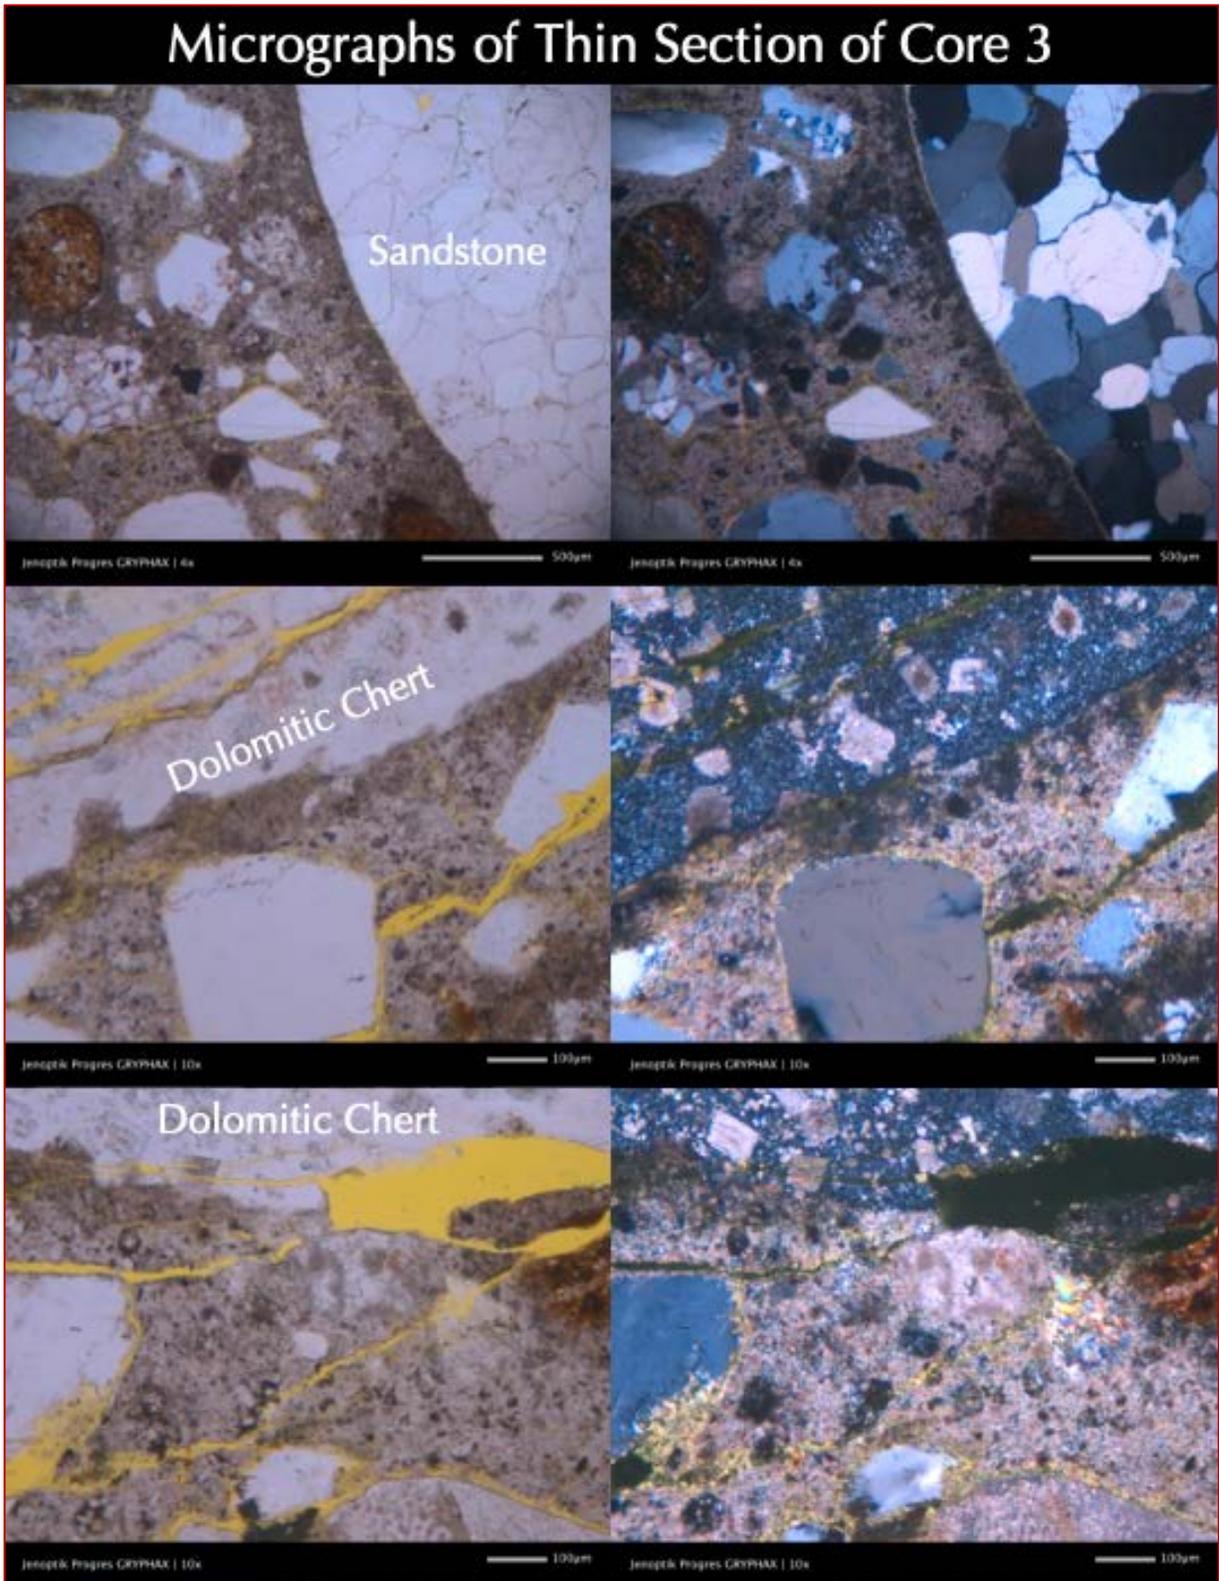
Figure 46: Micrographs of thin section of Core 3 taken with a Nikon Eclipse E600 POL Petrographic microscope with an attached Jenoptik Progres Gryphax camera showing many calcareous gravel particles in coarse aggregate and siliceous-calcareous particles in the interstitial fine aggregate scattered over variably carbonated Portland cement paste.

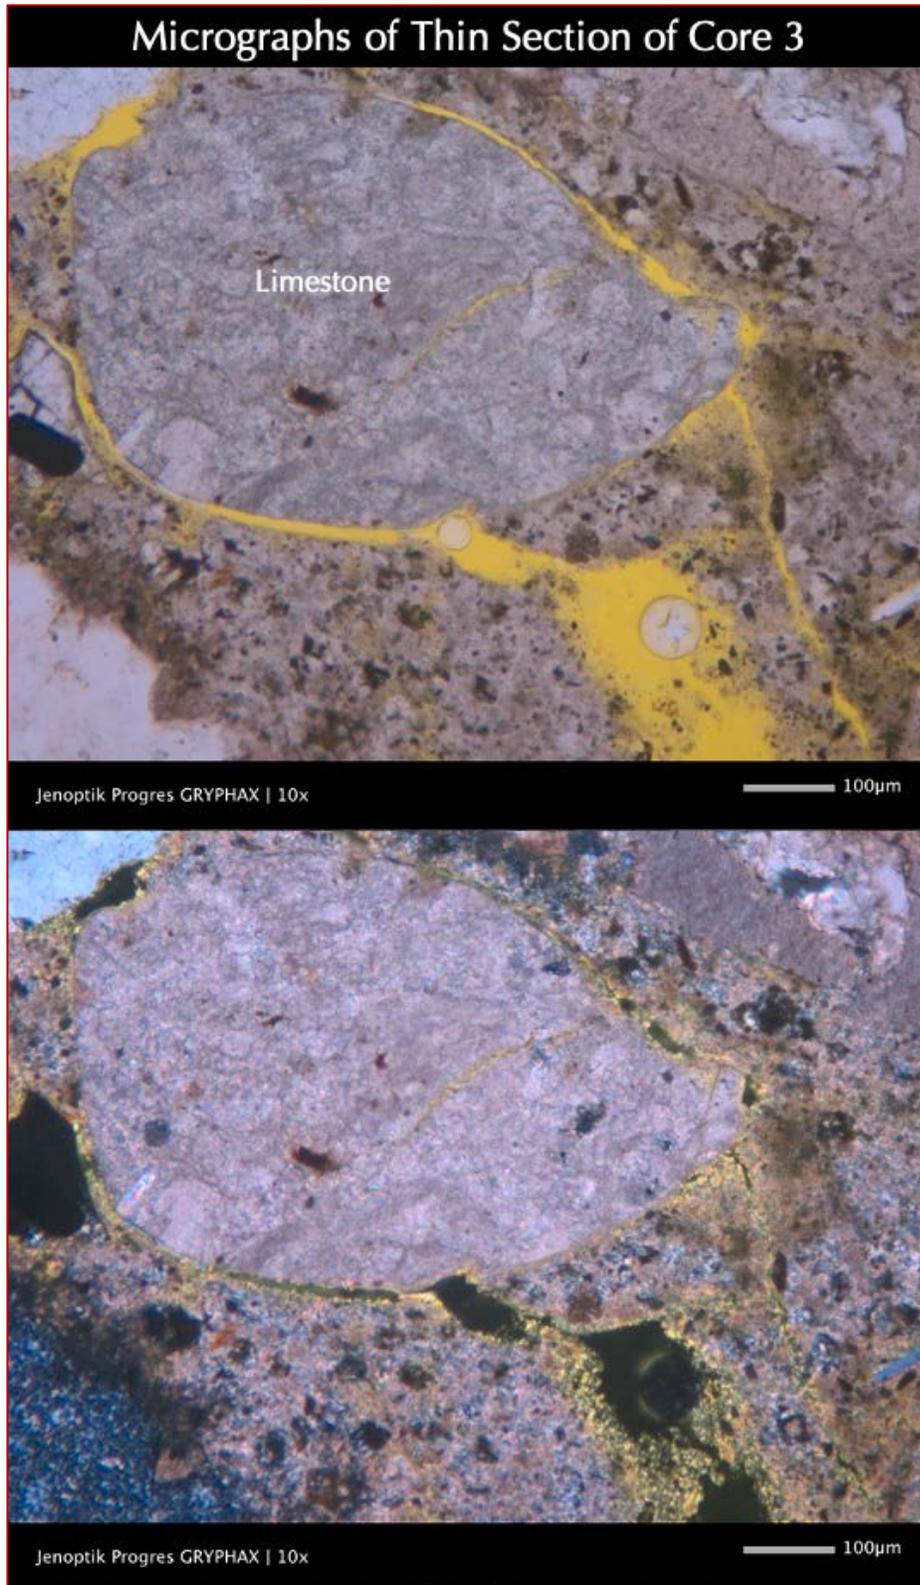
Figure 47: Micrographs of thin section of Core 3 taken with a Nikon Eclipse E600 POL Petrographic microscope with an attached Jenoptik Progres Gryphax camera showing many calcareous gravel particles in coarse aggregate and siliceous-calcareous particles in the interstitial fine aggregate scattered over variably carbonated Portland cement paste.
