## Chloride and Carbonation-Induced Corrosion of Reinforcing Steel In A Concrete Column – A Case Study

North Carolina State University  
Mann Hall Column Testing

**Background** - Exposed perimeter reinforced concrete columns at 4-story Mann Hall (constructed in 1963) in North Carolina State University has experienced corrosion of reinforcing steel in columns resulting in various levels of distress from vertical and horizontal cracking, delamination and spalls. Previous tests have determined the presence of elevated chlorides in some columns and deep carbonation, hence potential chloride-induced and/or carbonation-induced corrosion of steel in concrete to cause the distress. A repair attempt in 1993 was taken to reduce chloride and carbonation ingress by patching many deteriorated concrete covers over corroded rebars with adequate concrete cover of 1 to 4 in. thicknesses. However, continued deterioration over the past couple of decades has led to other engineering firms evaluate these columns in 2017. Recently, field evaluation of these columns were done in August of 2019 from visual surveying to audible sounding, excavations, chloride powder sampling, and removal of cores for pre

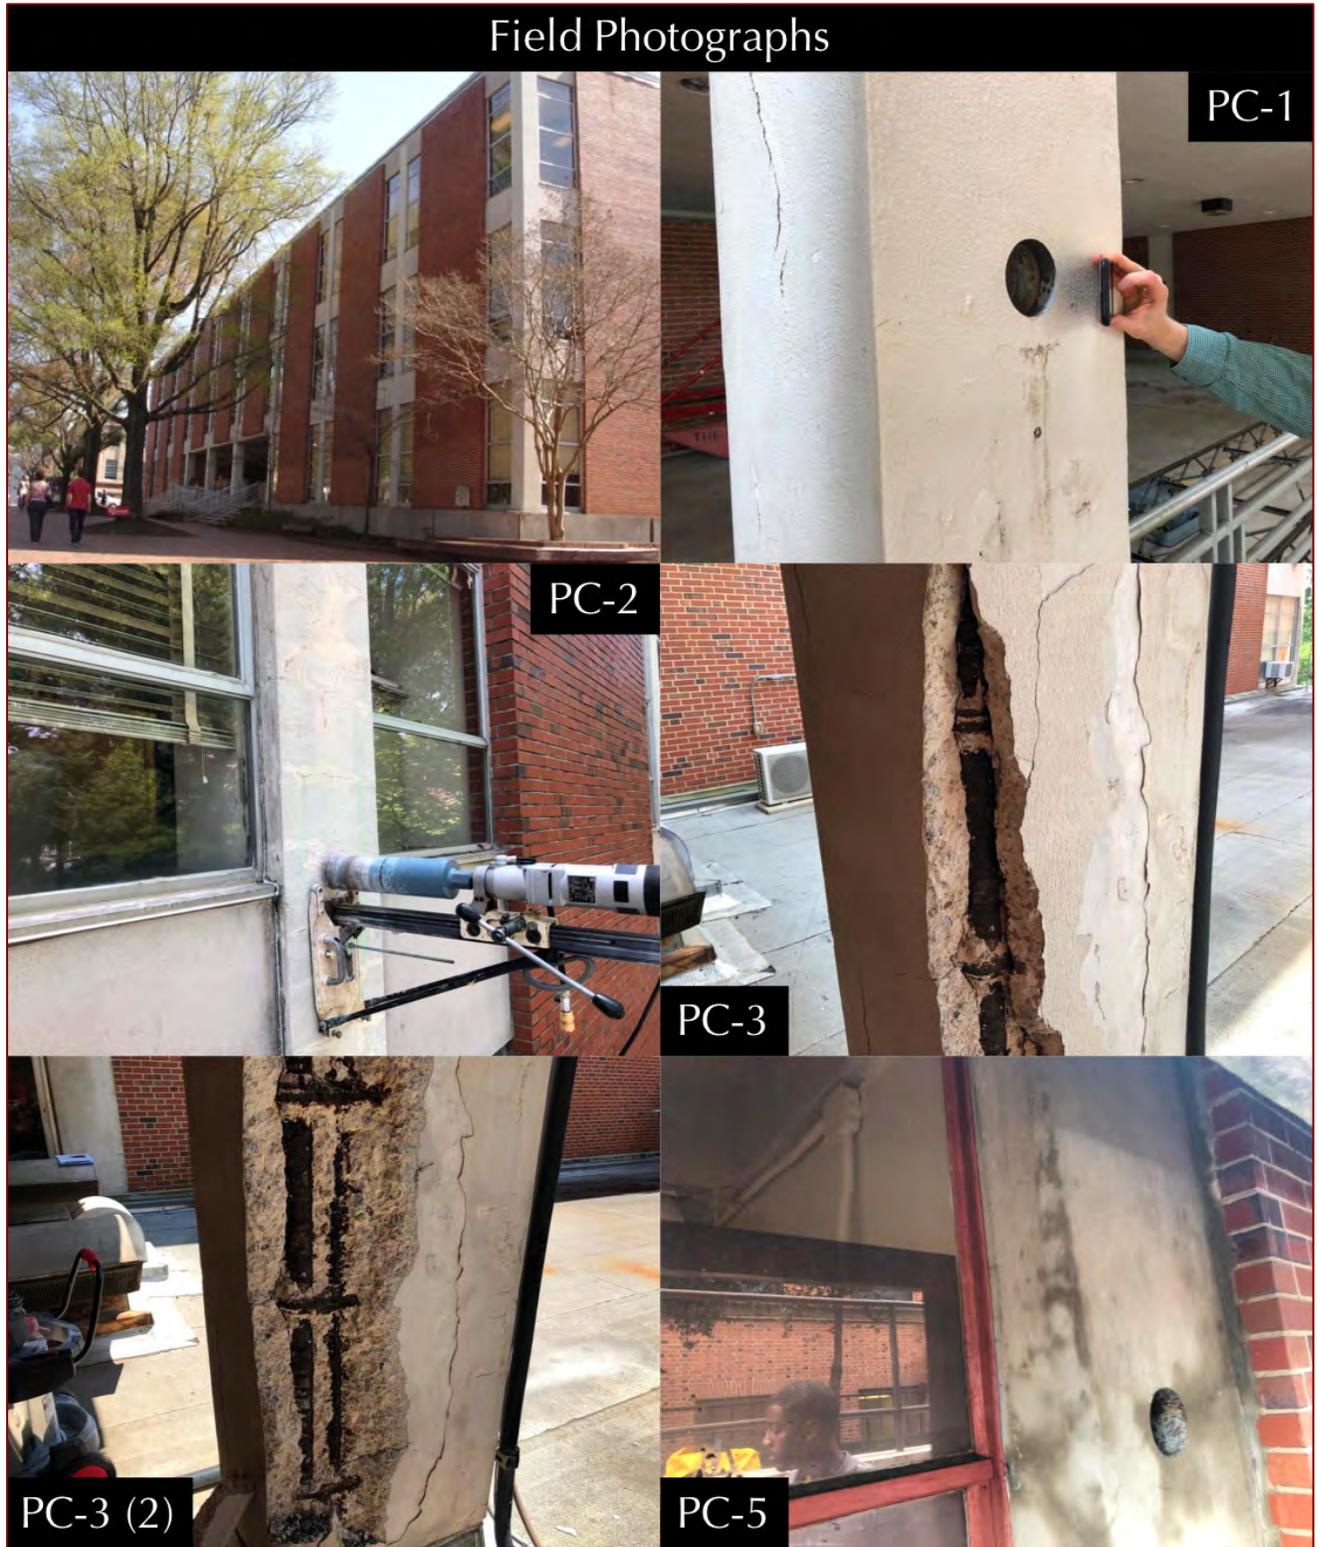
Figure 1 shows overall views of Mann Hall at North Carolina State University. Figure 2 shows locations of cores extracted for present laboratory testing. The column at the location of Core PC-3 shows severe delamination and exposure of corroded rebar.

Figure 2: Field photos showing the locations at which core samples were taken for the present laboratory investigation.

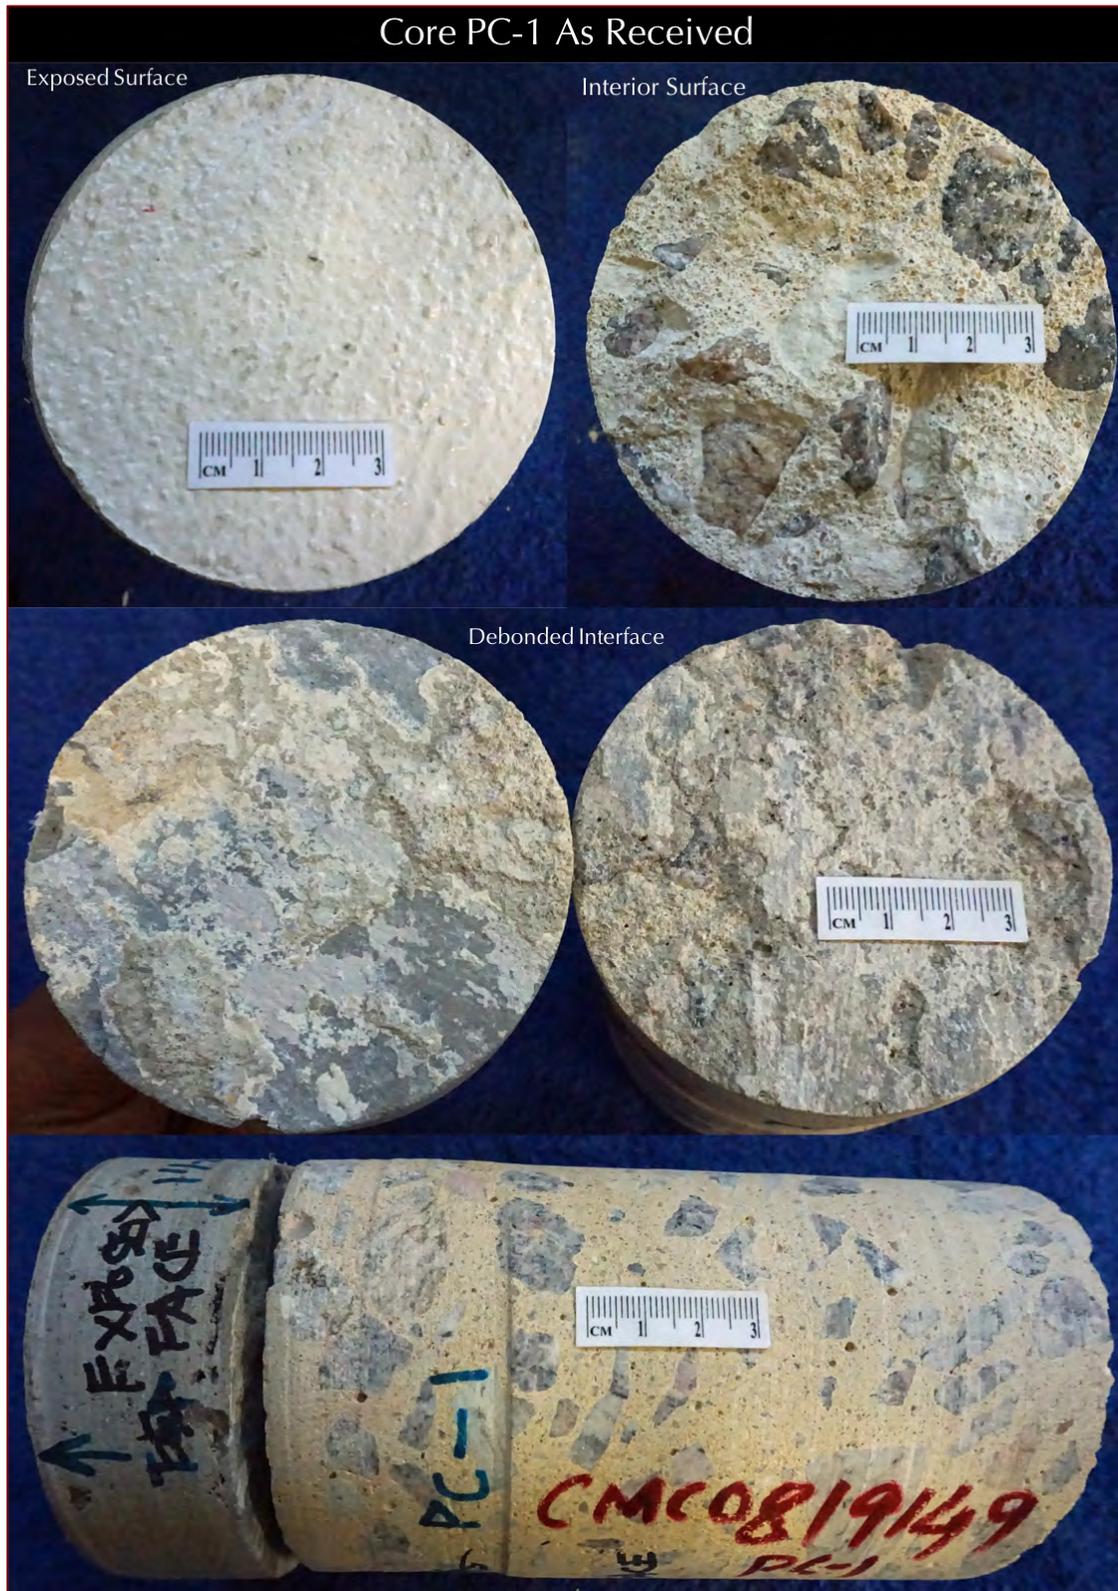
Figure 7: Core PC-1, as received, showing: (a) shiny beige paint on the exposed surface (top left), (b) a fresh fractured interior concrete surface (top right), (c) completely debonded overlay-concrete interface where only a few remains of concrete are seen at the underside of overlay (middle), and (d) side cylindrical view showing the overly completely debonded from the concrete, and sound, crack free nature of overlay and interior concrete (bottom).

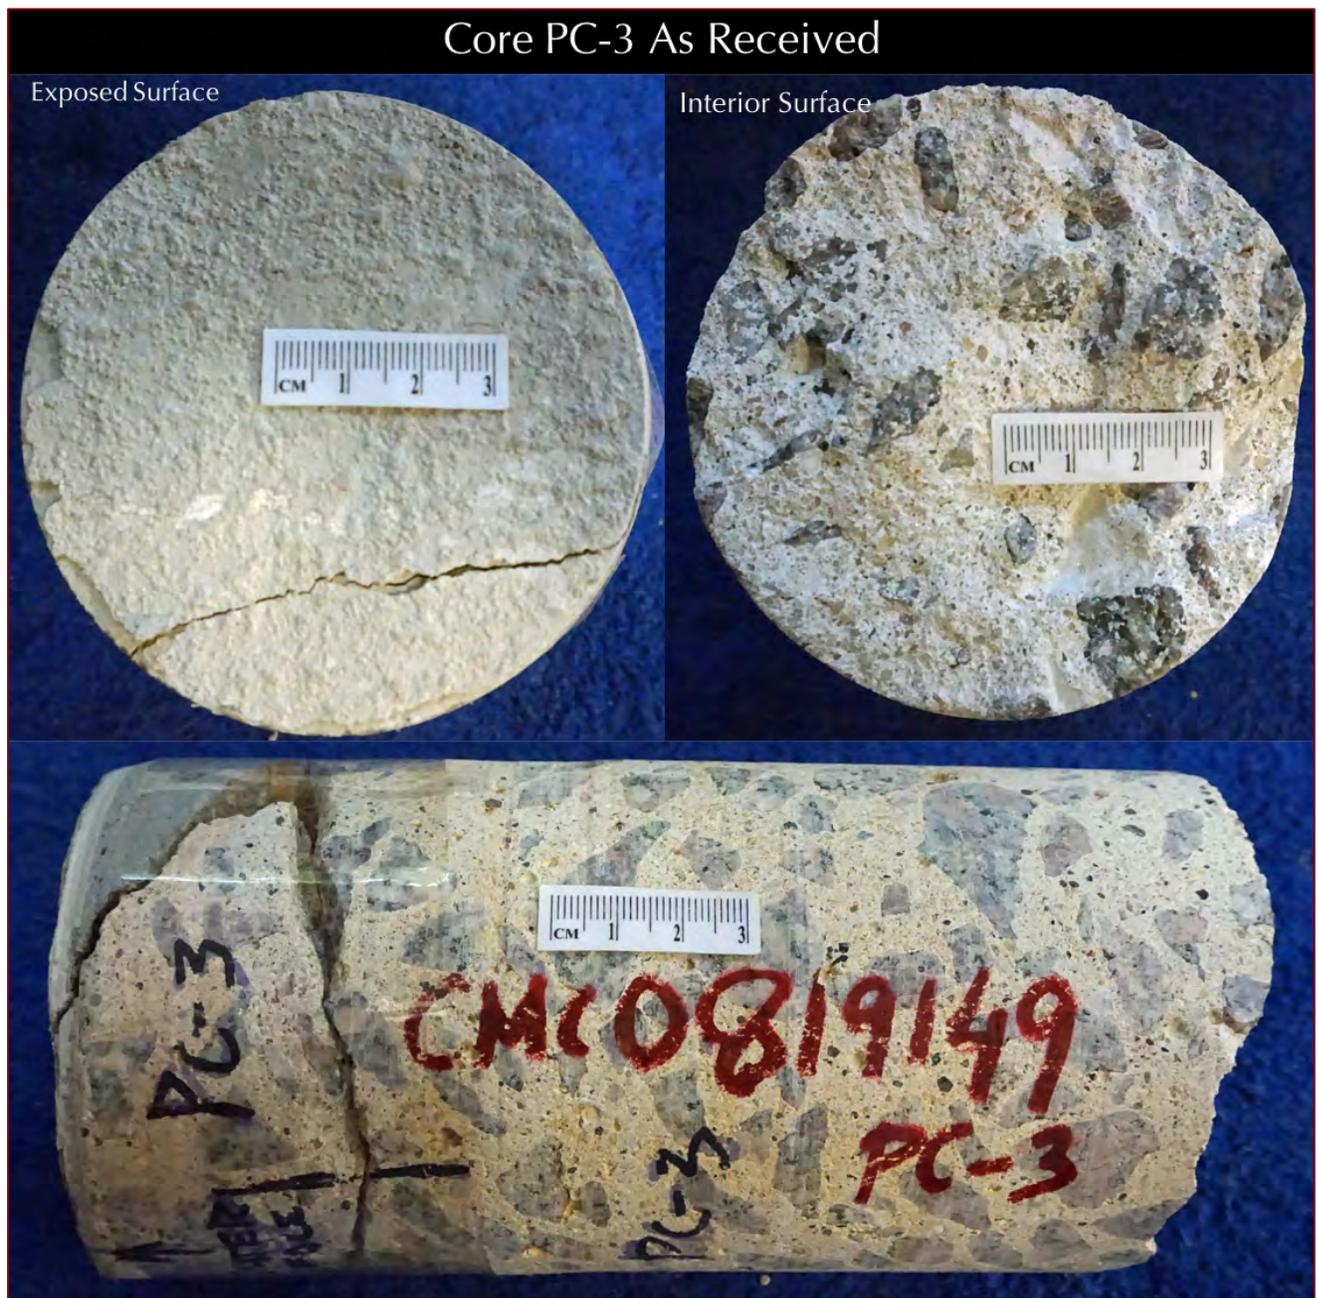
Figure 8: Core PC-3, as received, showing: (a) top gray paint coat on the exposed surface with a visible crack (top left), (b) fresh fractured interior concrete surface (top right), and (c) side cylindrical view showing portion of gray overly separated from concrete by a visible diagonal crack, and two major intersecting-diagonal cracks, which extend to 2 in. from the exposed surface (bottom).

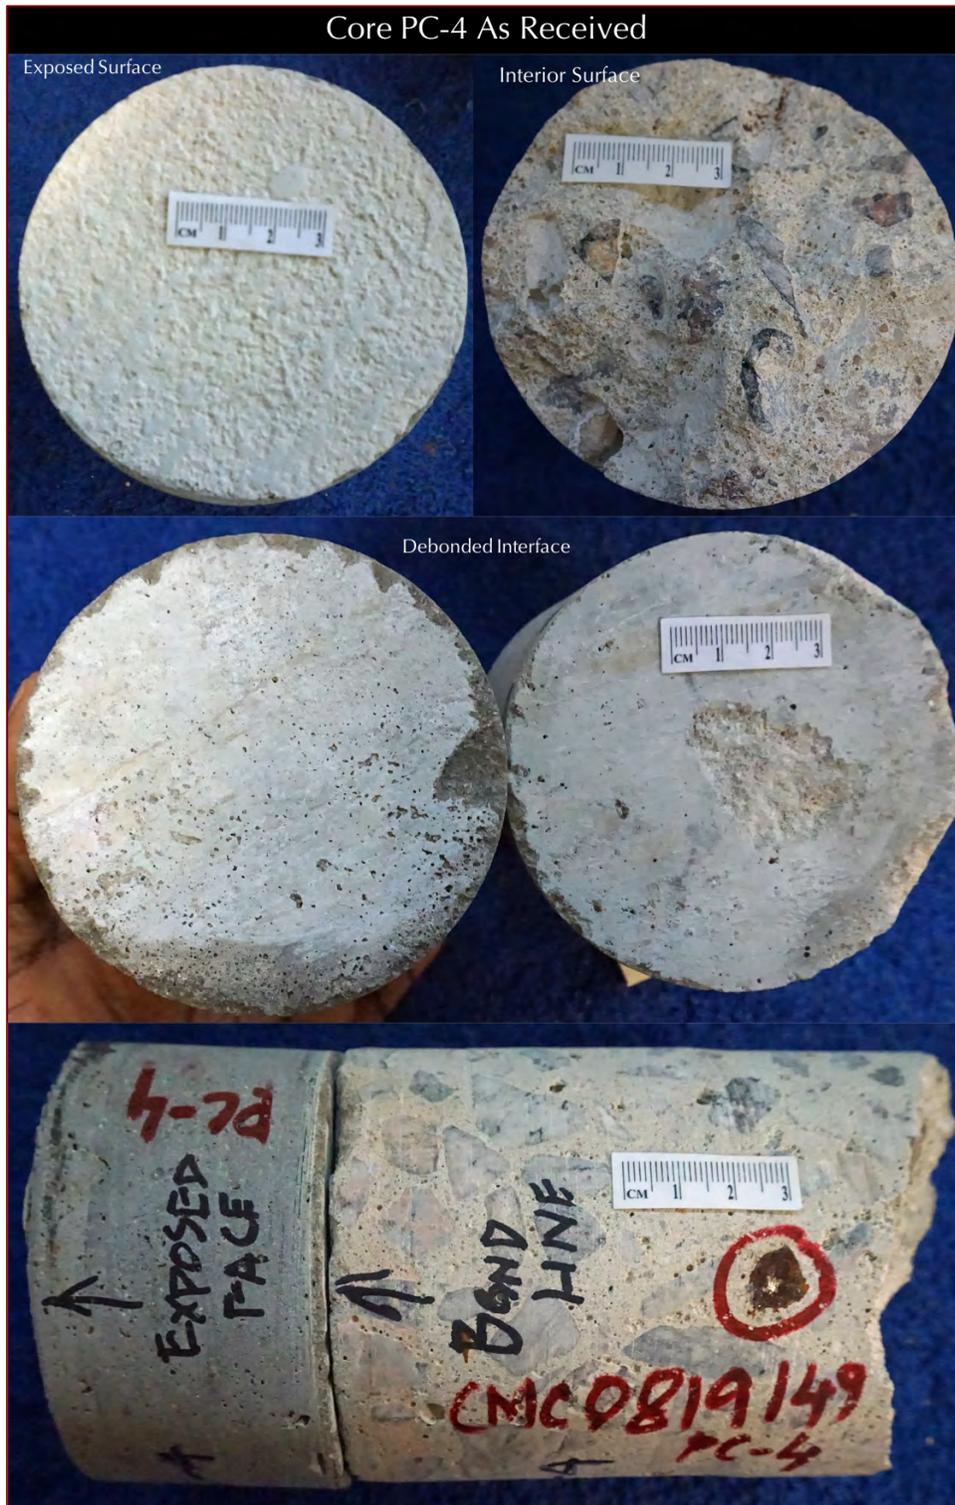
A No. 3 rebar is present at a depth of 5 in. in Core PC-4 that shows surface corrosion (Figure 9 bottom photo). Core PC-5 also contain No. 3 rebar at depths of 2<sup>3</sup>/<sub>4</sub> in. and 5<sup>1</sup>/<sub>2</sub> in. that also show surface corrosion (Figure 10). Bottom fresh fractured surface of concrete in PC-5 shows an exposed No. 3 rebar (Figure 10, right photo) and impression of another No. 3 rebar (Figure 10 right photo).

Figure 9: Core PC-4, as received, showing: (a) textured matte-finished cream paint coat on the exposed surface (top left), (b) fresh fractured interior concrete surface (top right), (c) completely debonded overlay-concrete interface where overlay shows clean separation from concrete without any traces of concrete on the underside of overlay (middle), and (d) side cylindrical view showing the overlay completely debonded from the concrete, the sound, crack free nature of overlay and interior concrete, and a No. 3 reinforcing steel within the concrete at a depth of 5 in. from the top surface (circled), which shows severe surface corrosion (bottom, circled).

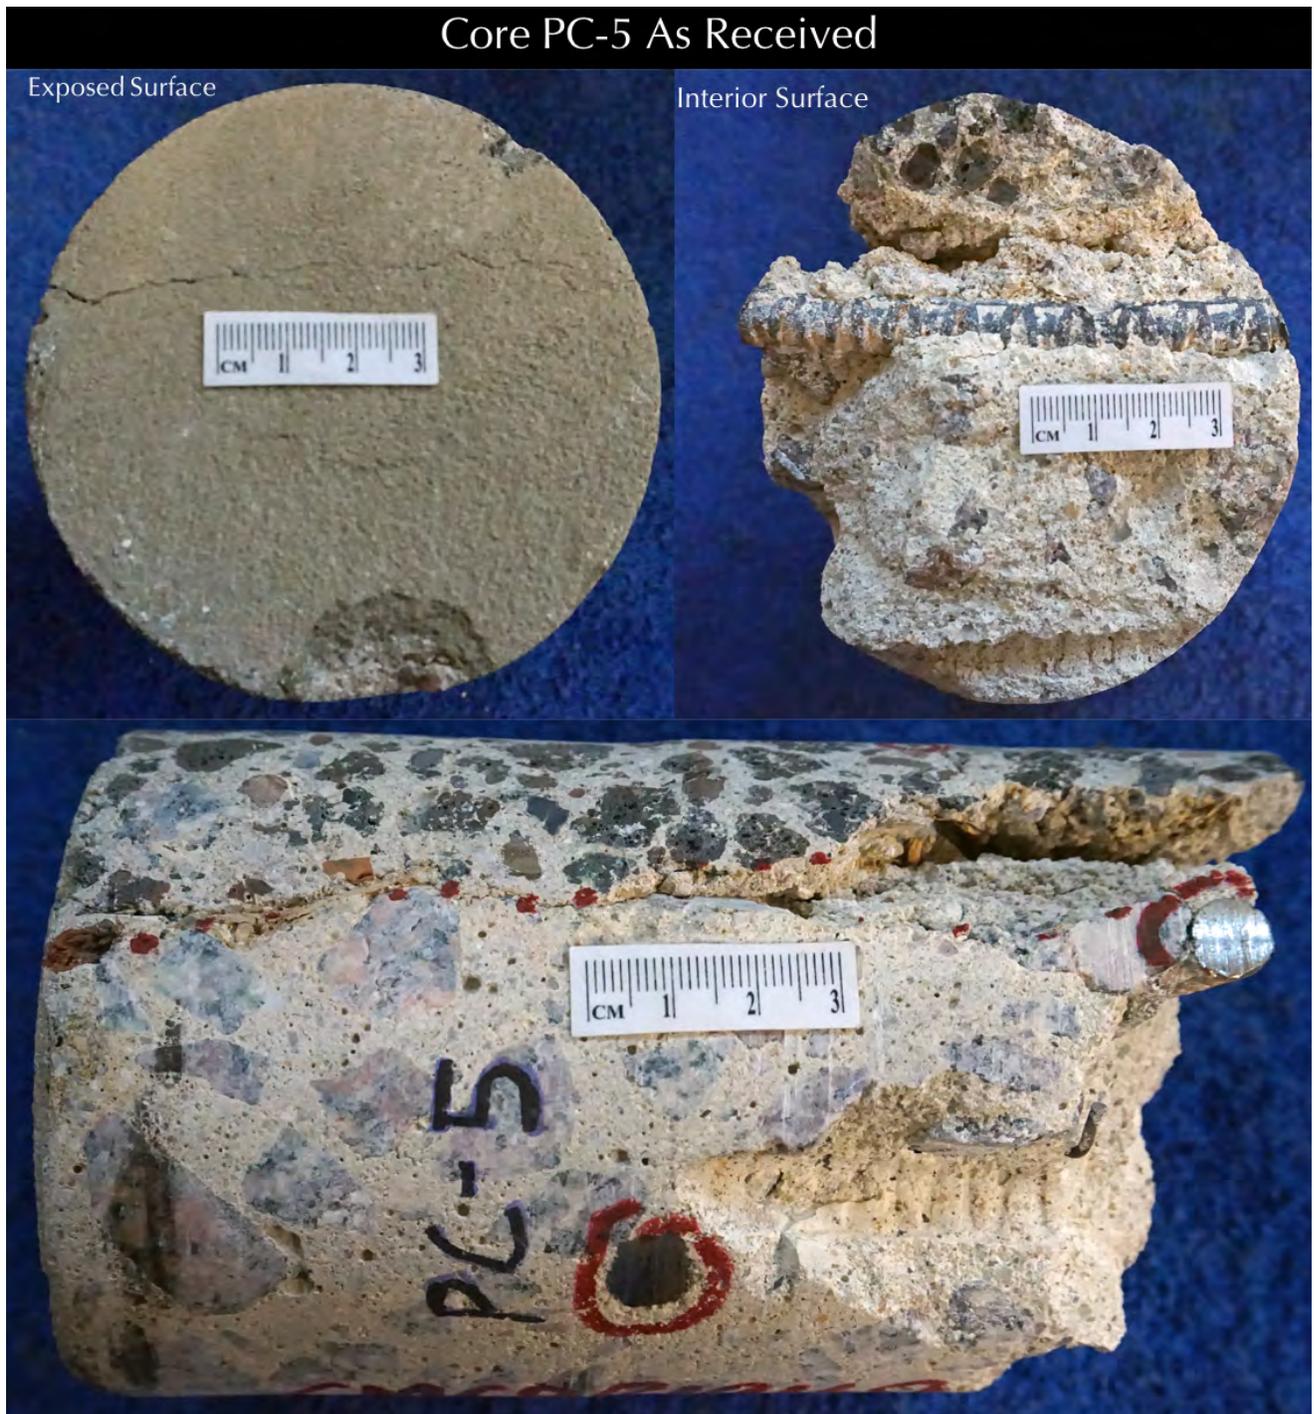
Figure 10: Core PC-5, as received, showing: (a) a thin top gray repair coat well-bonded to two concretes separated by a cold joint – a lightweight aggregate concrete that represents portion of the beam concrete and a normal-weight concrete from the underlying column (bottom), (b) fresh fractured interior surface of both concretes with an exposed No. 3 reinforcing steel and impression of another No. 3 reinforcing steel (top right), and (c) side cylindrical view showing full-depth extension of cold joint, and No. 3 reinforcing steels at depths of  $2\frac{3}{4}$  in. and  $5\frac{1}{2}$  in. at the bottom (circled).

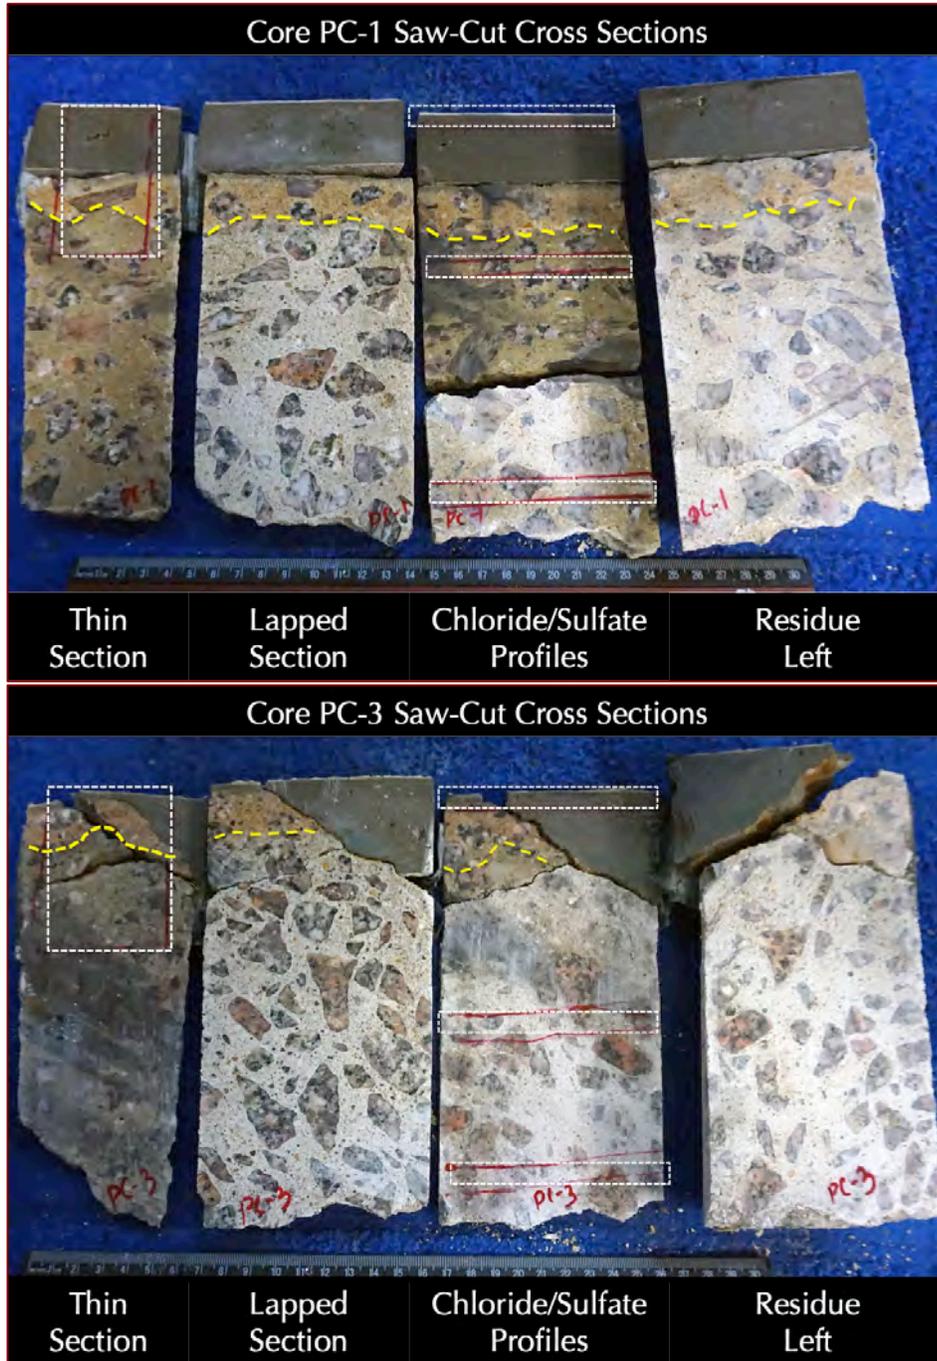
Figure 11: Saw-cut cross sections of Core PC-1 (top) and PC-3 (bottom) showing dark gray repair mortar overlay across all sections and different testing strategies employed on different sections, e.g., (a) thin section from the leftmost section showing the portion trimmed for thin sectioning in dashed rectangular box, (b) lapped section on 2<sup>nd</sup> section from left, (c) three sectioned profiles from dashed rectangular boxes on the 3<sup>rd</sup> section from left for chloride, sulfate and other water-soluble anions, and (d) keeping the rightmost section as reserve. Yellow dashed lines show depths of carbonation in column concrete prior to the installation of overlay.

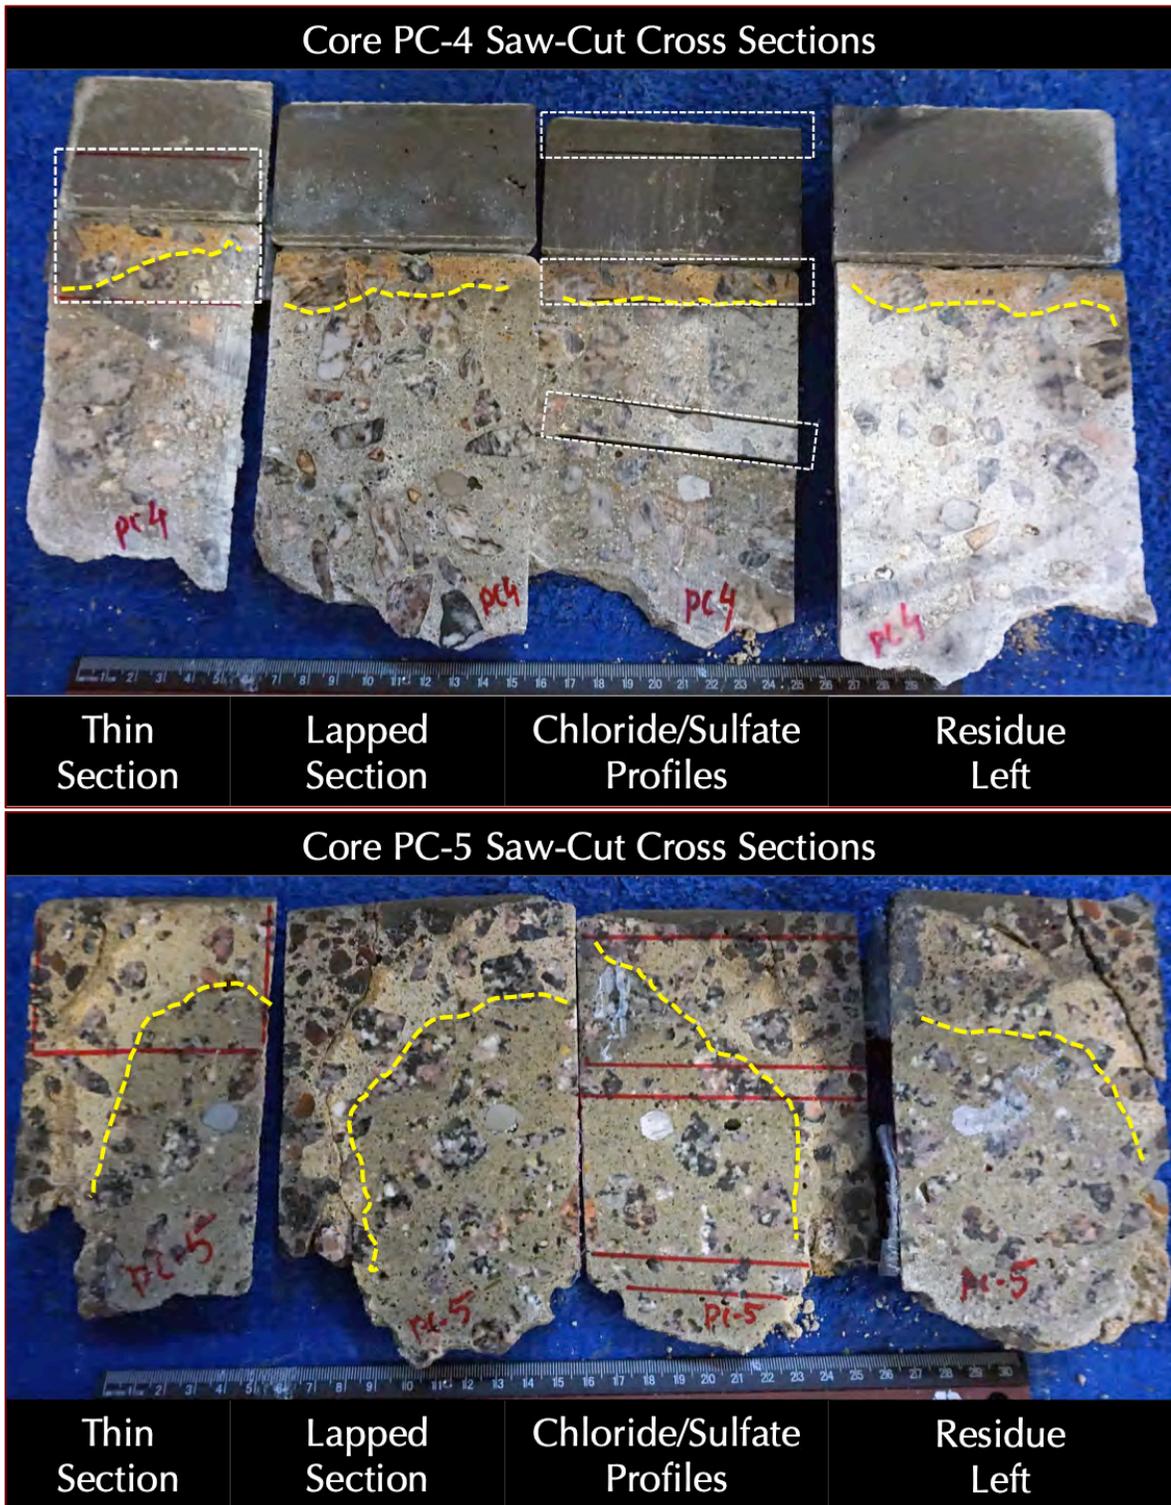
Figure 12: Saw-cut cross sections of Core PC-4 (top) and PC-5 (bottom) showing dark gray repair mortar overlay across all sections and different testing strategies employed on different sections, e.g., (a) thin section from the leftmost section showing the portion trimmed for thin sectioning in dashed rectangular box, (b) lapped section on 2<sup>nd</sup> section from left, (c) three sectioned profiles from dashed rectangular boxes on the 3<sup>rd</sup> section from left for chloride, sulfate and other water-soluble anions, and (d) keeping the rightmost section as reserve. Yellow dashed lines show depths of carbonation in column concrete (for PC-5 in the beam concrete as well) prior to the installation of overlay.

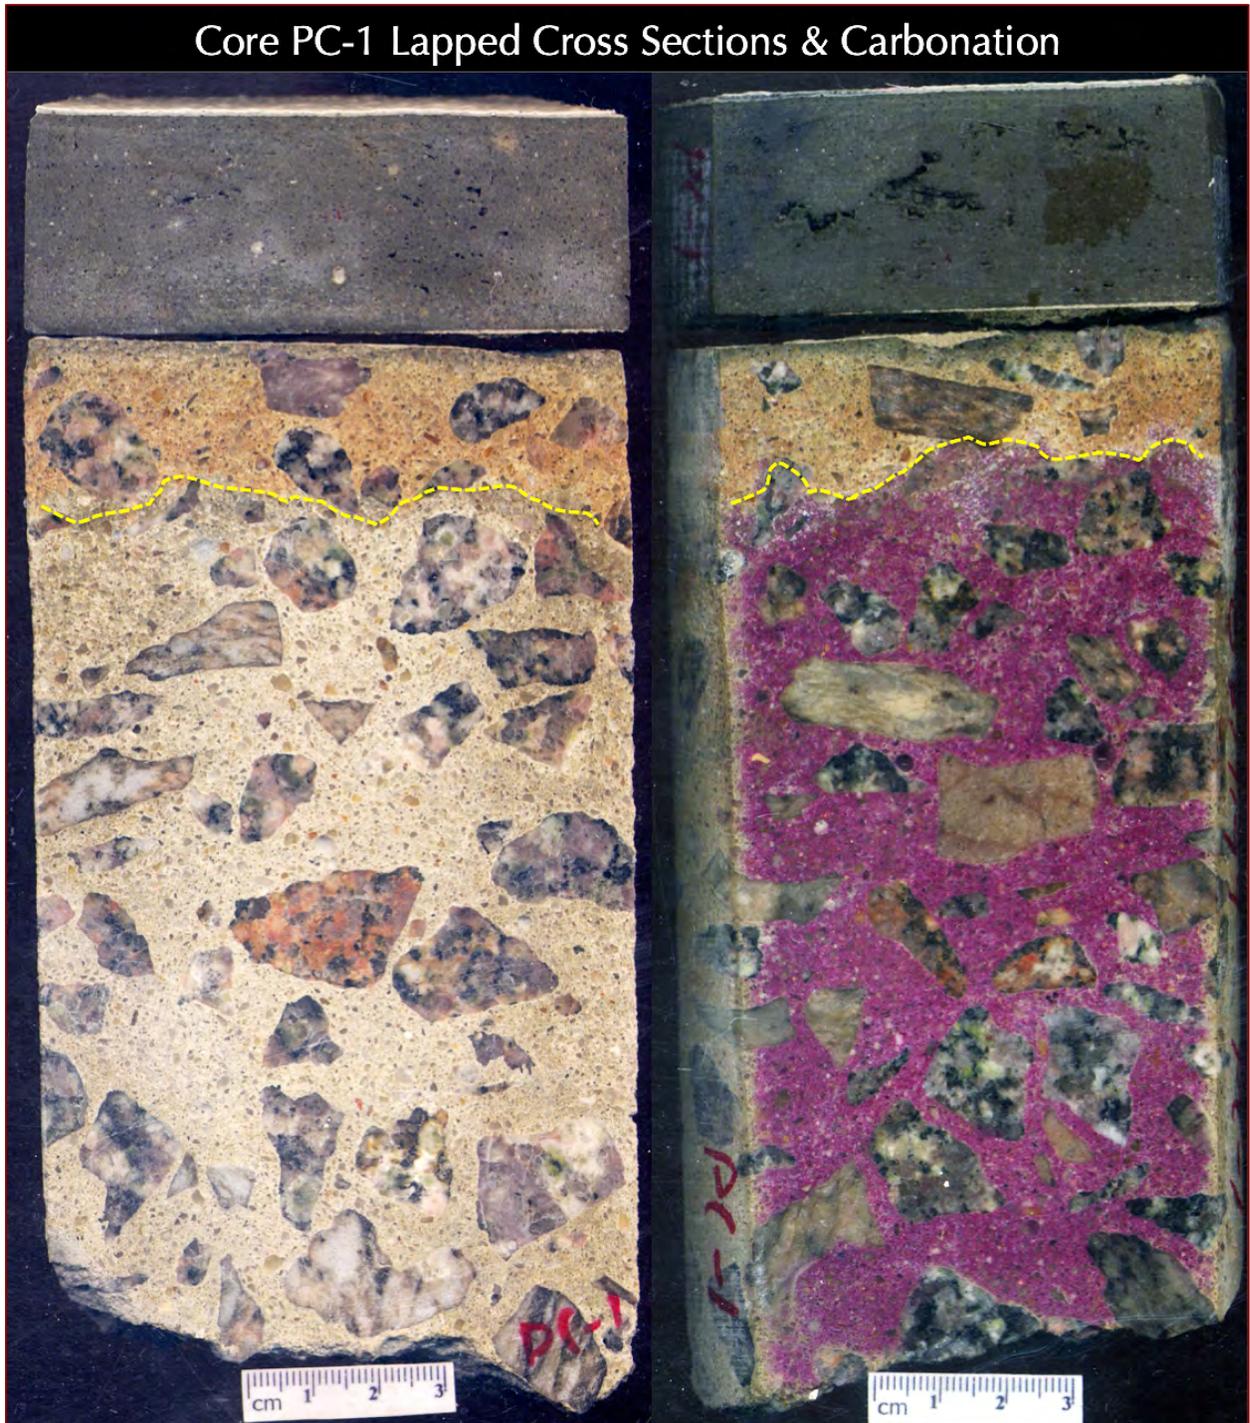
Figure 13: Lapped cross section of Core PC-1 showing a thin white protective coating at the top applied over a dark gray repair mortar overlay of 1 1/4 in. (35 mm) thickness. The overlay is completely debonded from the column concrete. Column concrete shows crushed granite coarse aggregate particles that are dense, angular, nominal 3/4 in. (19 mm) in size, well-graded, well-distributed, and present in sound condition. Accompanying lapped cross section at right shows depth of carbonation of column concrete prior to the application of overlay as beige discolored concrete at the top for the carbonated zone, extended to a depth of 1 in. (25 mm). Yellow dashed lines show depths of carbonation in both cross sections.

In all cross sections from Figures 13 through 16, the second lapped cross sections at right were treated with phenolphthalein alcoholic solutions where carbonated concrete remains beige or grey but non-carbonated interior concrete turns pink. The beige discoloration at the top of concretes in all cores is found to be due to carbonation of column prior to the application of the repair overlay and protective coating systems.

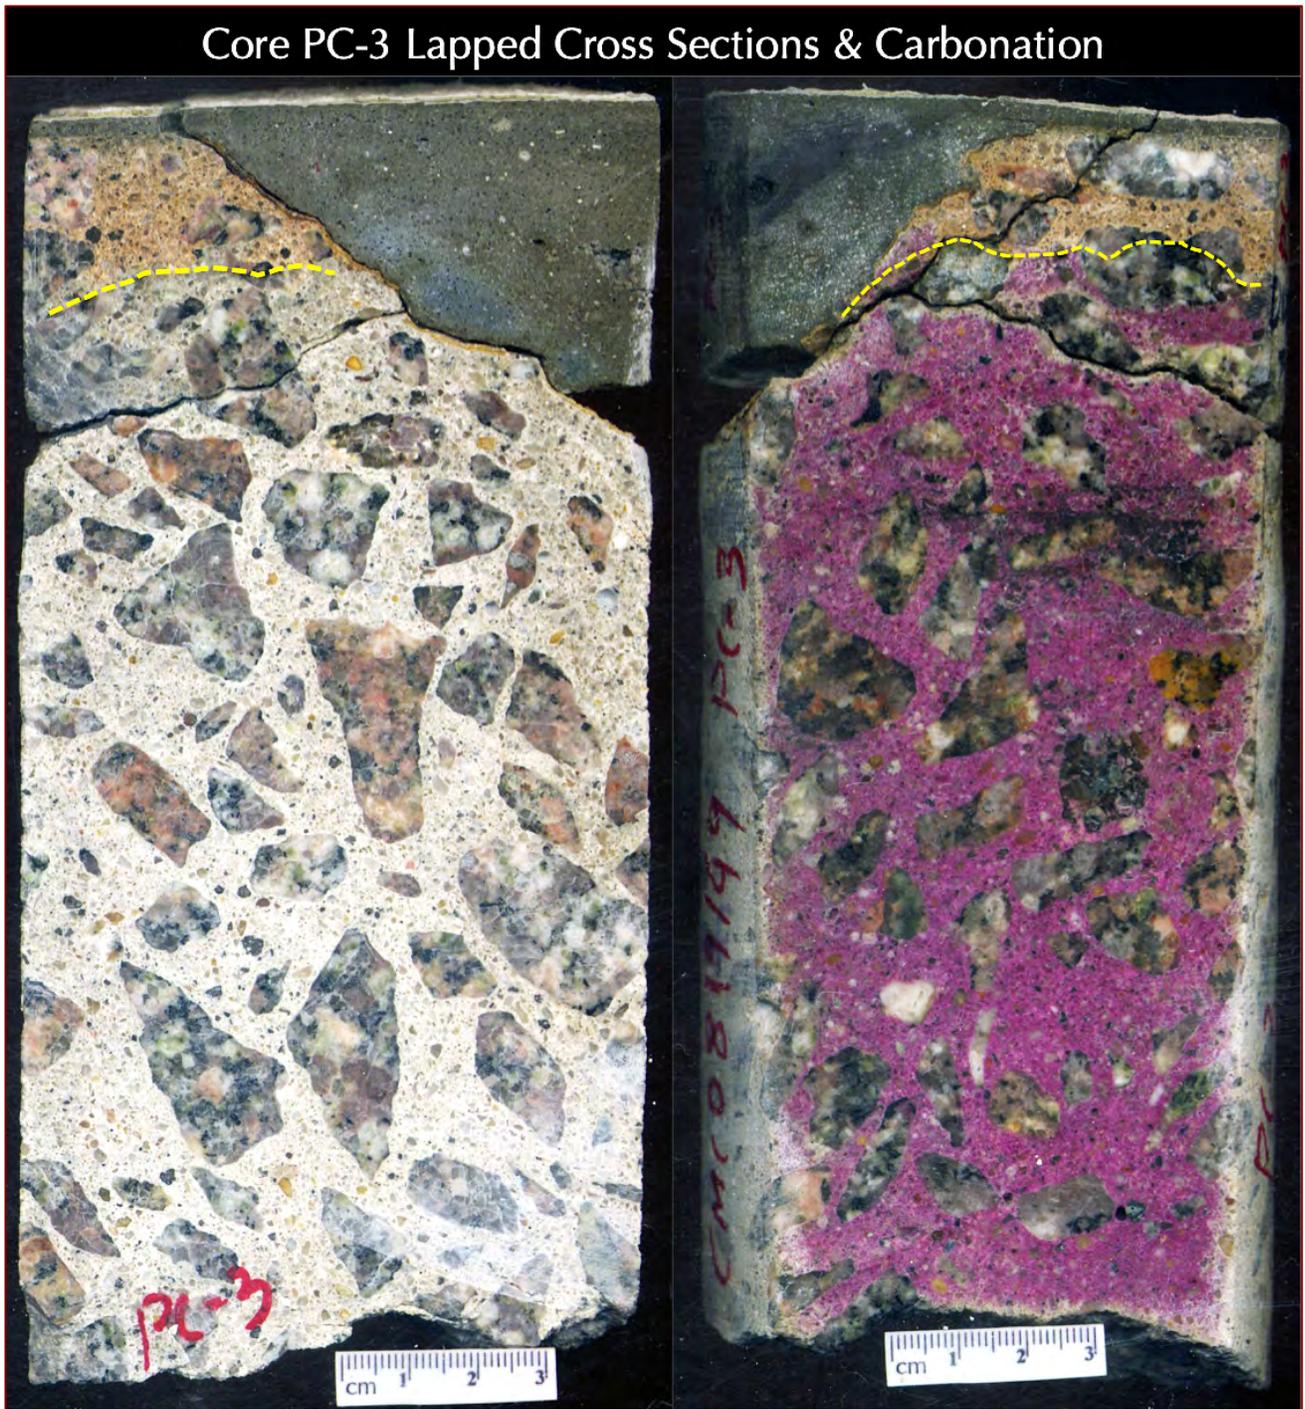
Figure 14: Lapped cross section of Core PC-3 showing a thin white protective coating at the top applied over a dark gray repair mortar overlay which is tapered down from minimum  $\frac{1}{8}$  in. (4 mm) to maximum 2 in. (50 mm). The overlay is detached from the column concrete by a visible diagonal crack. Two diagonal cracks are seen within top 2 in. of core. Column concrete shows crushed granite coarse aggregate particles that are dense, angular, nominal  $\frac{3}{4}$  in. (19 mm) in size, well-graded, well-distributed, and present in sound condition. Accompanying lapped cross section at right shows depth of carbonation of column concrete prior to the application of overlay as beige discolored concrete at the top for the carbonated zone, extended to a depth of  $\frac{3}{4}$  in. (19 mm) to 1 in. (25 mm). Yellow dashed lines show depths of carbonation in both cross sections.

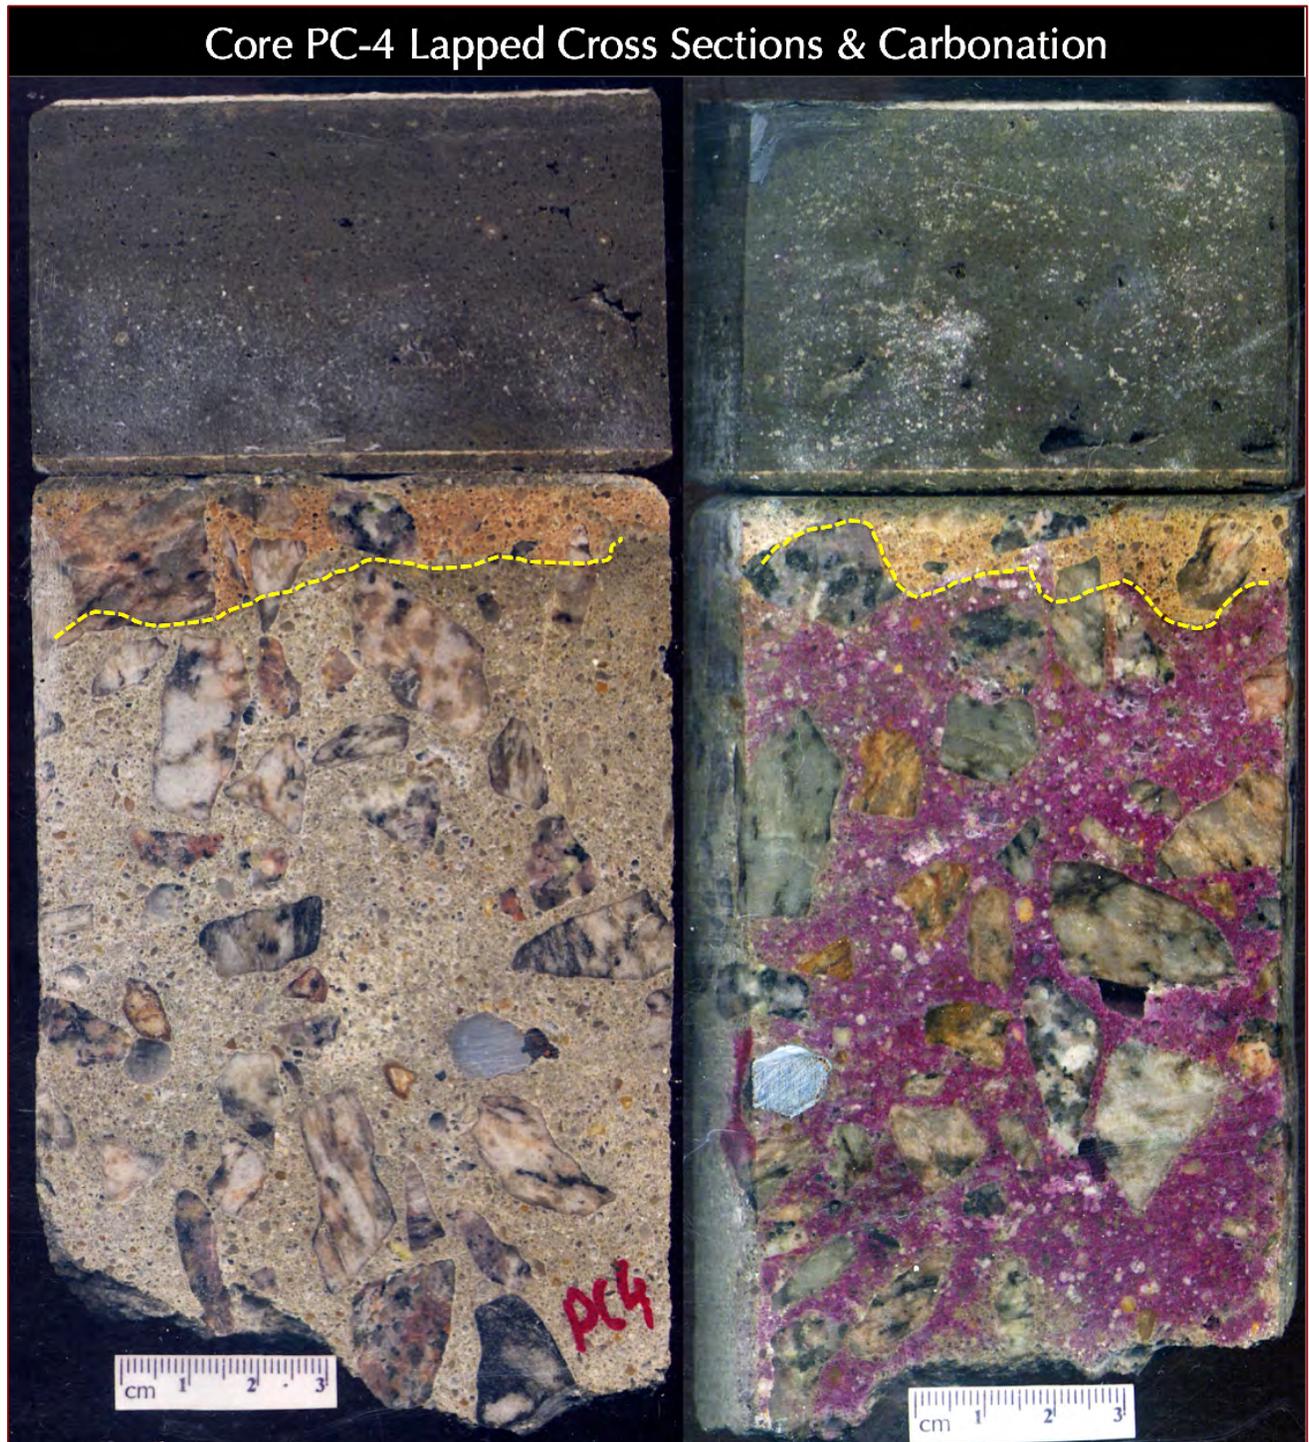
Figure 15: Lapped cross section of Core PC-4 showing a thin white protective coating at the top applied over a dark gray repair mortar overlay of 2 in. (50 mm) thickness. The overlay is completely debonded from the column concrete. Column concrete shows crushed granite coarse aggregate particles that are dense, angular, nominal  $\frac{3}{4}$  in. (19 mm) in size, well-graded, well-distributed, and present in sound condition. Accompanying lapped cross section at right shows depth of carbonation of column concrete prior to the application of overlay as beige discolored concrete at the top for the carbonated zone, extended to a depth of  $\frac{1}{2}$  in. (12.5 mm) to  $\frac{3}{4}$  in. (19 mm). Yellow dashed lines show depths of carbonation in both cross sections. Steel rebar within the non-carbonated interior concrete shows no corrosion.

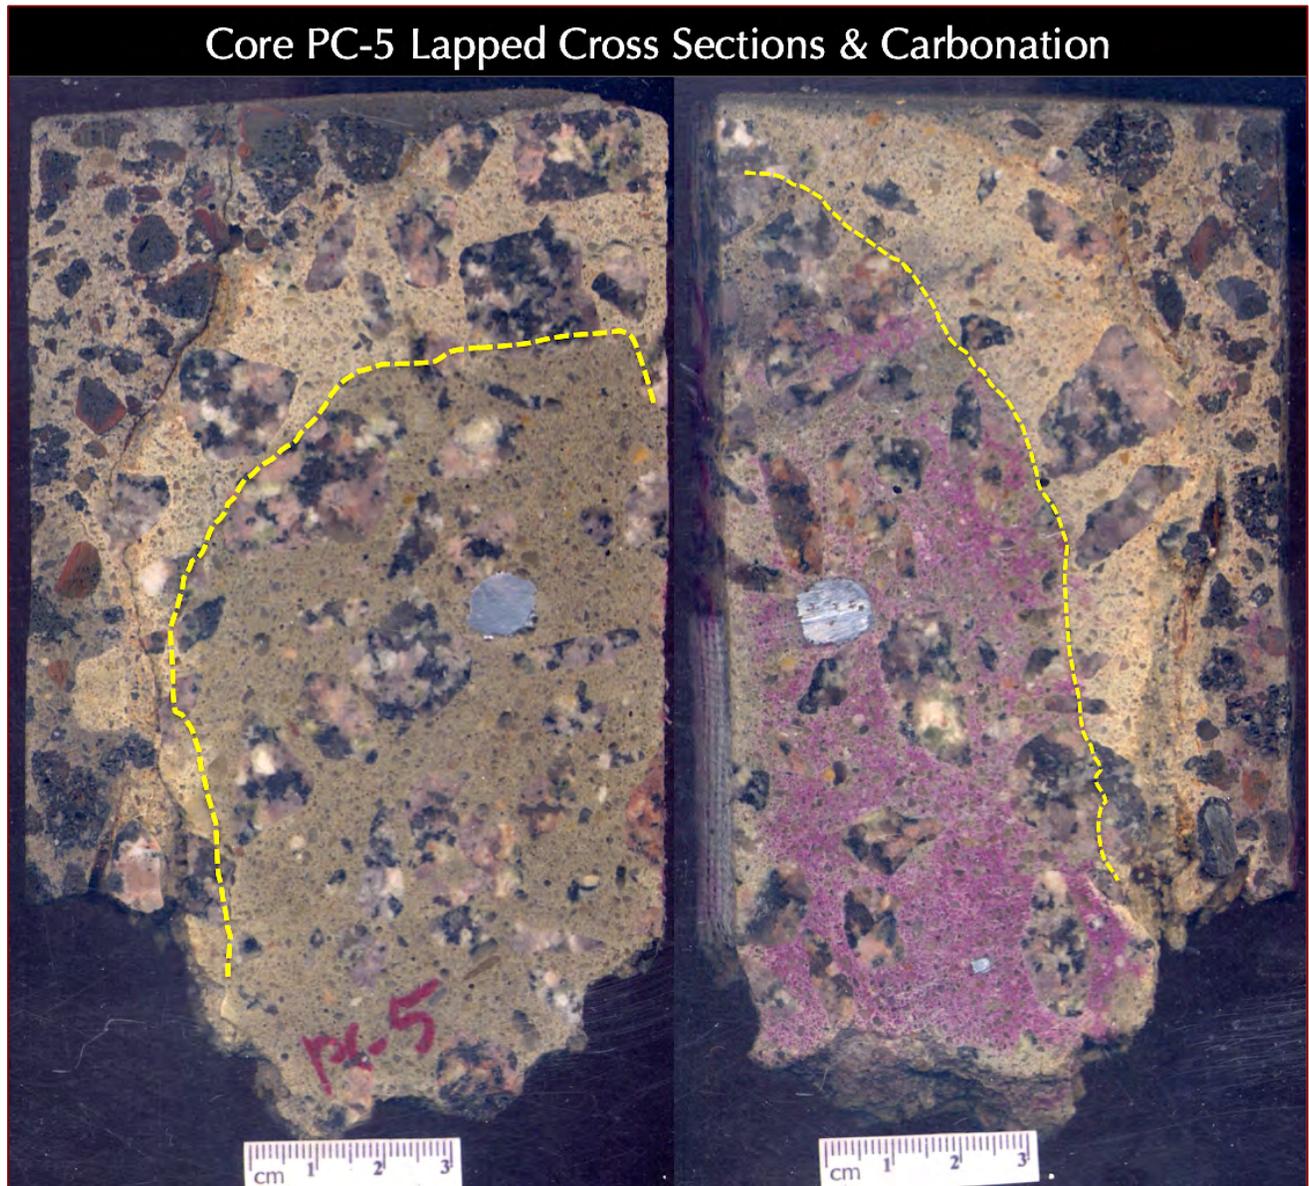
Figure 16: Lapped cross section of Core PC-5 showing a thin dark gray repair mortar overlay of  $\frac{1}{8}$  in. (4 mm) thickness applied over column concrete, where the column concrete is attached by a cold joint to a lightweight aggregate concrete, which is the beam concrete. The overlay is adhered to the column concrete. Column concrete shows crushed granite coarse aggregate particles that are dense, angular, nominal  $\frac{3}{4}$  in. (19 mm) in size, well-graded, well-distributed, and present in sound condition. The lightweight aggregate concrete from the beam contains expanded shale and clay lightweight aggregate particles that are well-graded, and well-distributed. Accompanying lapped cross section at right shows depth of carbonation of beam and column concretes where the yellow dashed lines show depths of carbonation in both cross sections encompassing the entire lightweight aggregate beam concrete and to a depth of  $\frac{1}{2}$  in. (12.5 mm) to 1 in. (25 mm) into the normal-weight column concrete. Steel rebar within the non-carbonated interior concrete shows no corrosion.

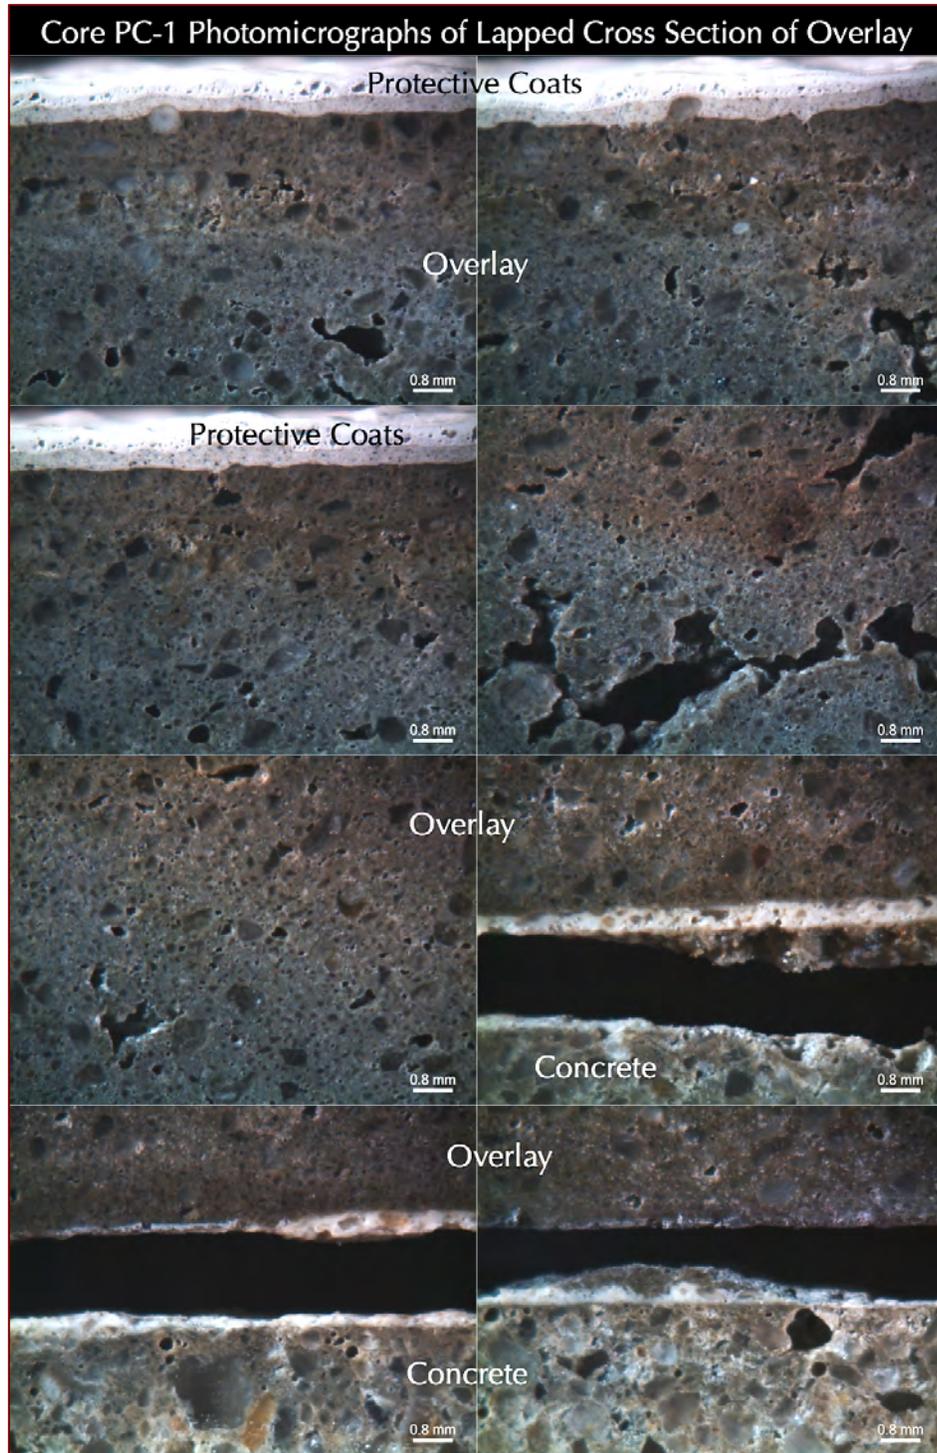
Figure 17: Photomicrographs of lapped cross section of Core PC-1 from the protective coating and repair overlay at the top showing two layers of protective coatings (white and off-white) applied over the dense, dark gray repair overlay where each coat is approx. 0.25 mm in thickness, well-bonded to each other and to the overlay (top row, 2<sup>nd</sup> row left). The gray overlay shows lack of adequate air entrainment but many coarse and irregularly-shaped voids. The base of overlay is completely de-bonded from concrete except only remains of concrete adhered to the underside.
