## Chloride and Carbonation-Induced Corrosion of Reinforcing Steel In A Concrete Column – A Case Study

North Carolina State University  
Mann Hall Column Testing

**Background** - Exposed perimeter reinforced concrete columns at 4-story Mann Hall (constructed in 1963) in North Carolina State University has experienced corrosion of reinforcing steel in columns resulting in various levels of distress from vertical and horizontal cracking, delamination and spalls. Previous tests have determined the presence of elevated chlorides in some columns and deep carbonation, hence potential chloride-induced and/or carbonation-induced corrosion of steel in concrete to cause the distress. A repair attempt in 1993 was taken to reduce chloride and carbonation ingress by patching many deteriorated concrete covers over corroded rebars with adequate concrete cover of 1 to 4 in. thicknesses. However, continued deterioration over the past couple of decades has led to other engineering firms evaluate these columns in 2017. Recently, field evaluation of these columns were done in August of 2019 from visual surveying to audible sounding, excavations, chloride powder sampling, and removal of cores for pre

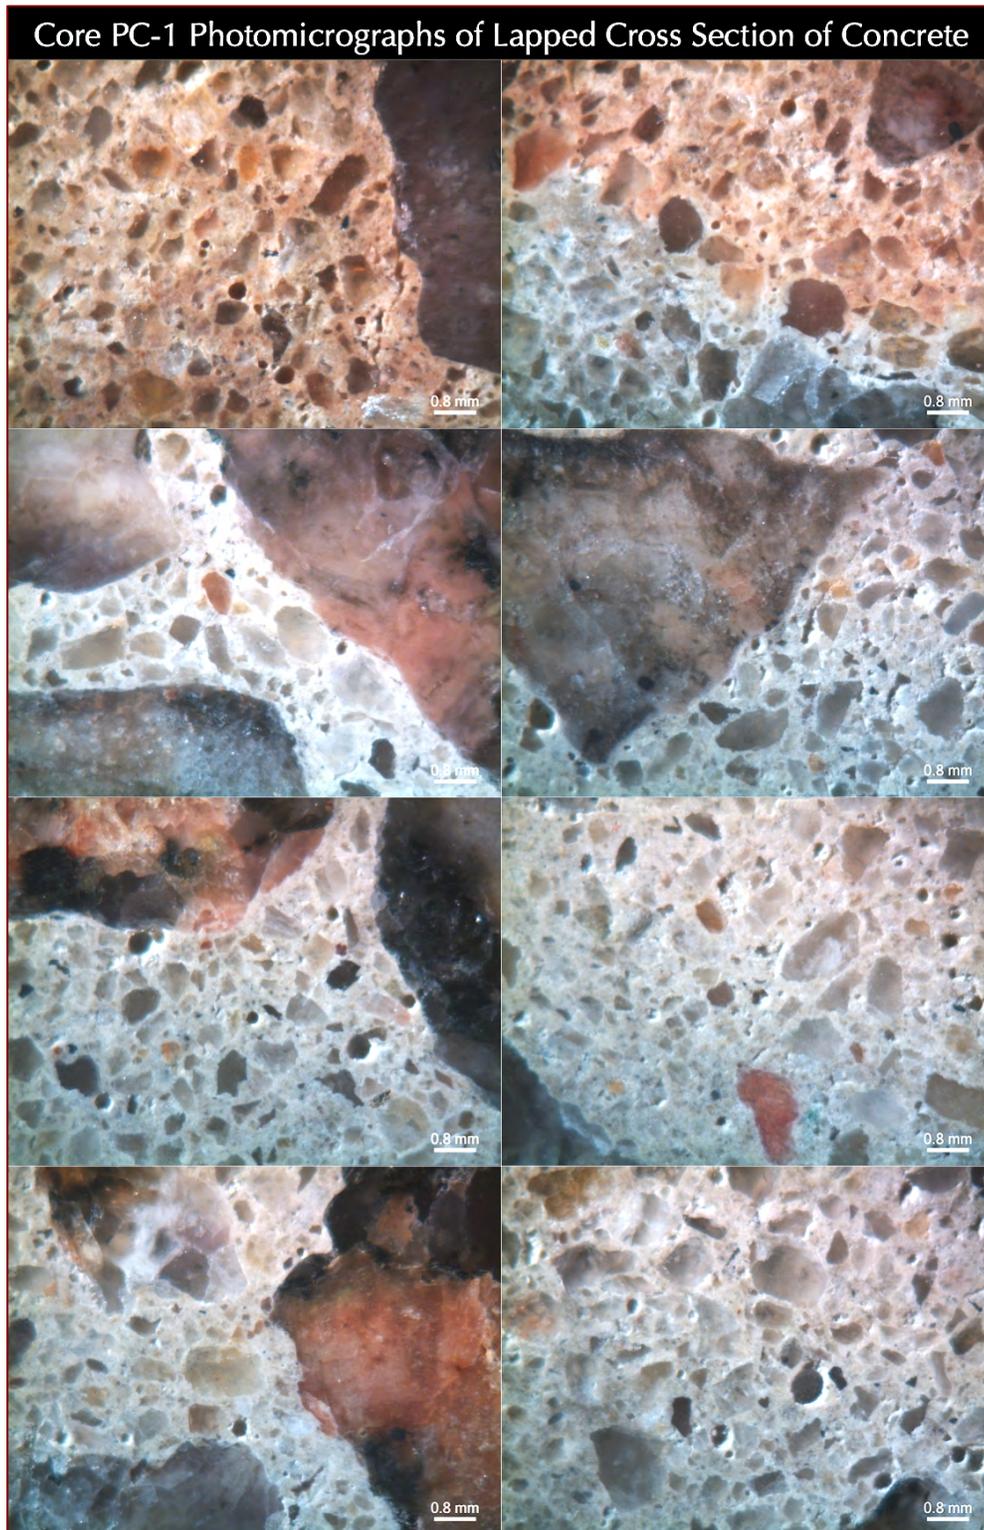
Figure 18: Photomicrographs of lapped cross section of Core PC-1 from the column concrete portion showing beige discoloration of concrete at the top (top row) due to atmospheric carbonation of column prior to the application of repair overlay, non-air-entrained nature of the column concrete having a few coarse and irregular-shaped voids but no intentionally introduced fine, discrete spherical entrained air voids of 1 mm or less size, and overall sound crack-free condition of the column concrete.

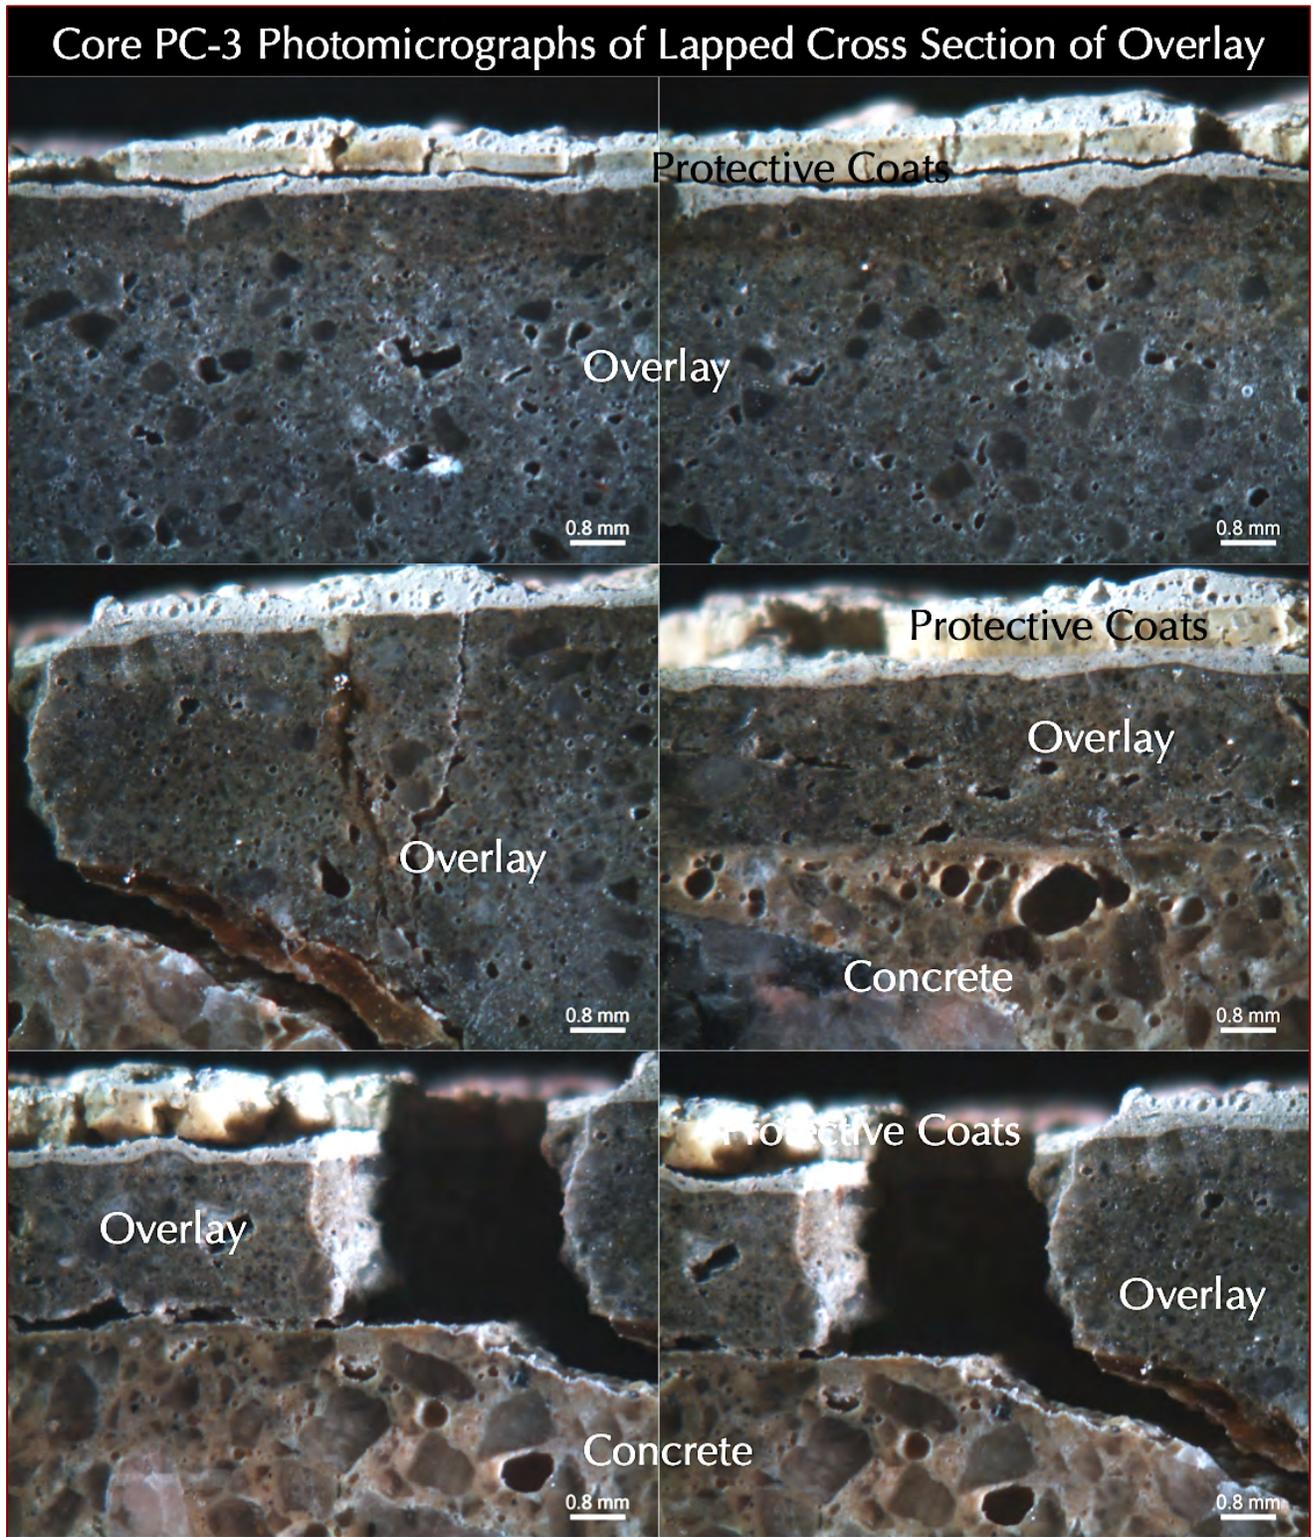
Figure 19: Photomicrographs of lapped cross section of Core PC-3 from the protective coating and repair overlay at the top showing two layers of protective coatings (white and off-white) applied over the dense, dark gray repair overlay where each coat is approx. 0.25 mm in thickness, well-bonded to each other and to the overlay but with a visible horizontal crack within the base coat (top and 2<sup>nd</sup> rows). The gray overlay shows lack of adequate air entrainment but many coarse and irregularly-shaped voids. The base of overlay is completely de-bonded from concrete by a major visible crack (bottom row and left photo in middle row).

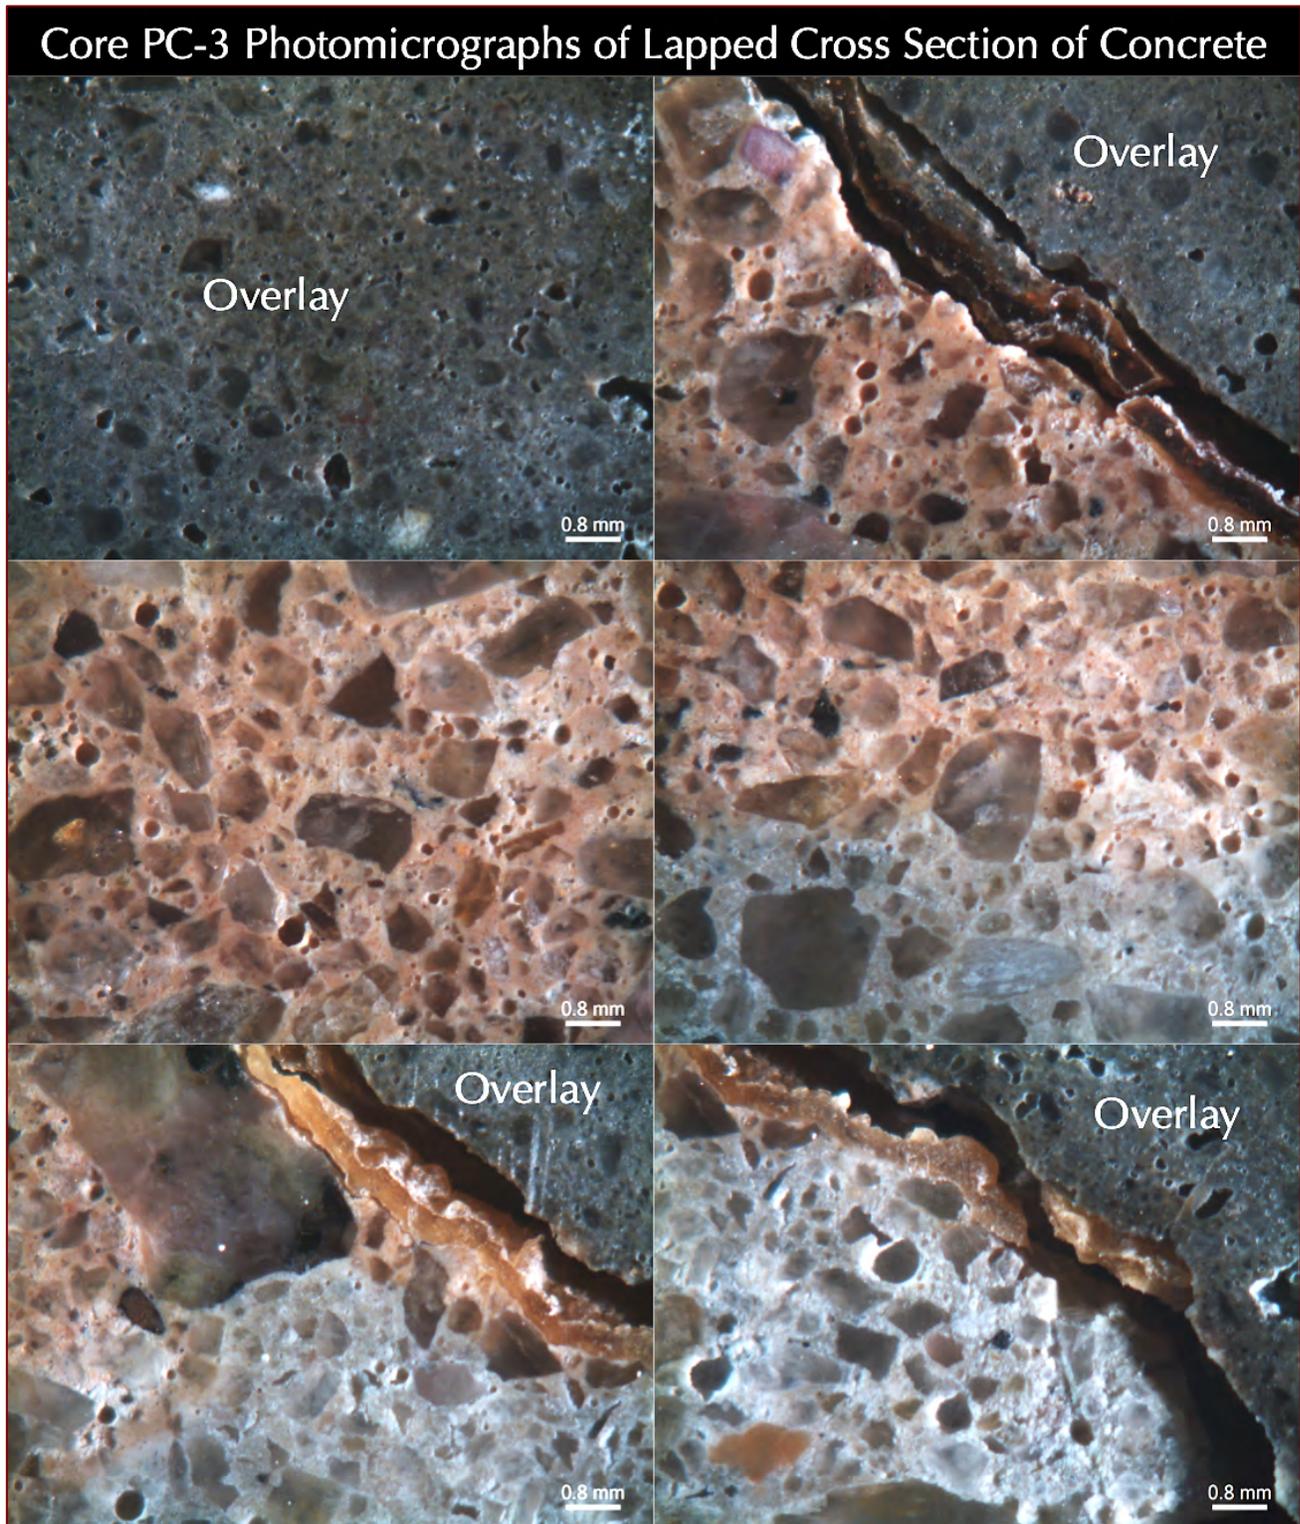
Figure 20: Photomicrographs of lapped cross section of Core PC-3 from the column concrete portion showing beige discoloration of concrete at the top (top row right photo, middle row, and bottom row left photo) due to atmospheric carbonation of column prior to the application of repair overlay, non-air-entrained nature of the column concrete having a few coarse and irregular-shaped voids but no intentionally introduced fine, discrete spherical entrained air voids of 1 mm or less size, and overall sound crack-free condition of the column concrete. An epoxy layer is present between the dark gray repair overlay and column concrete at the diagonal crack (top right and bottom row photos).

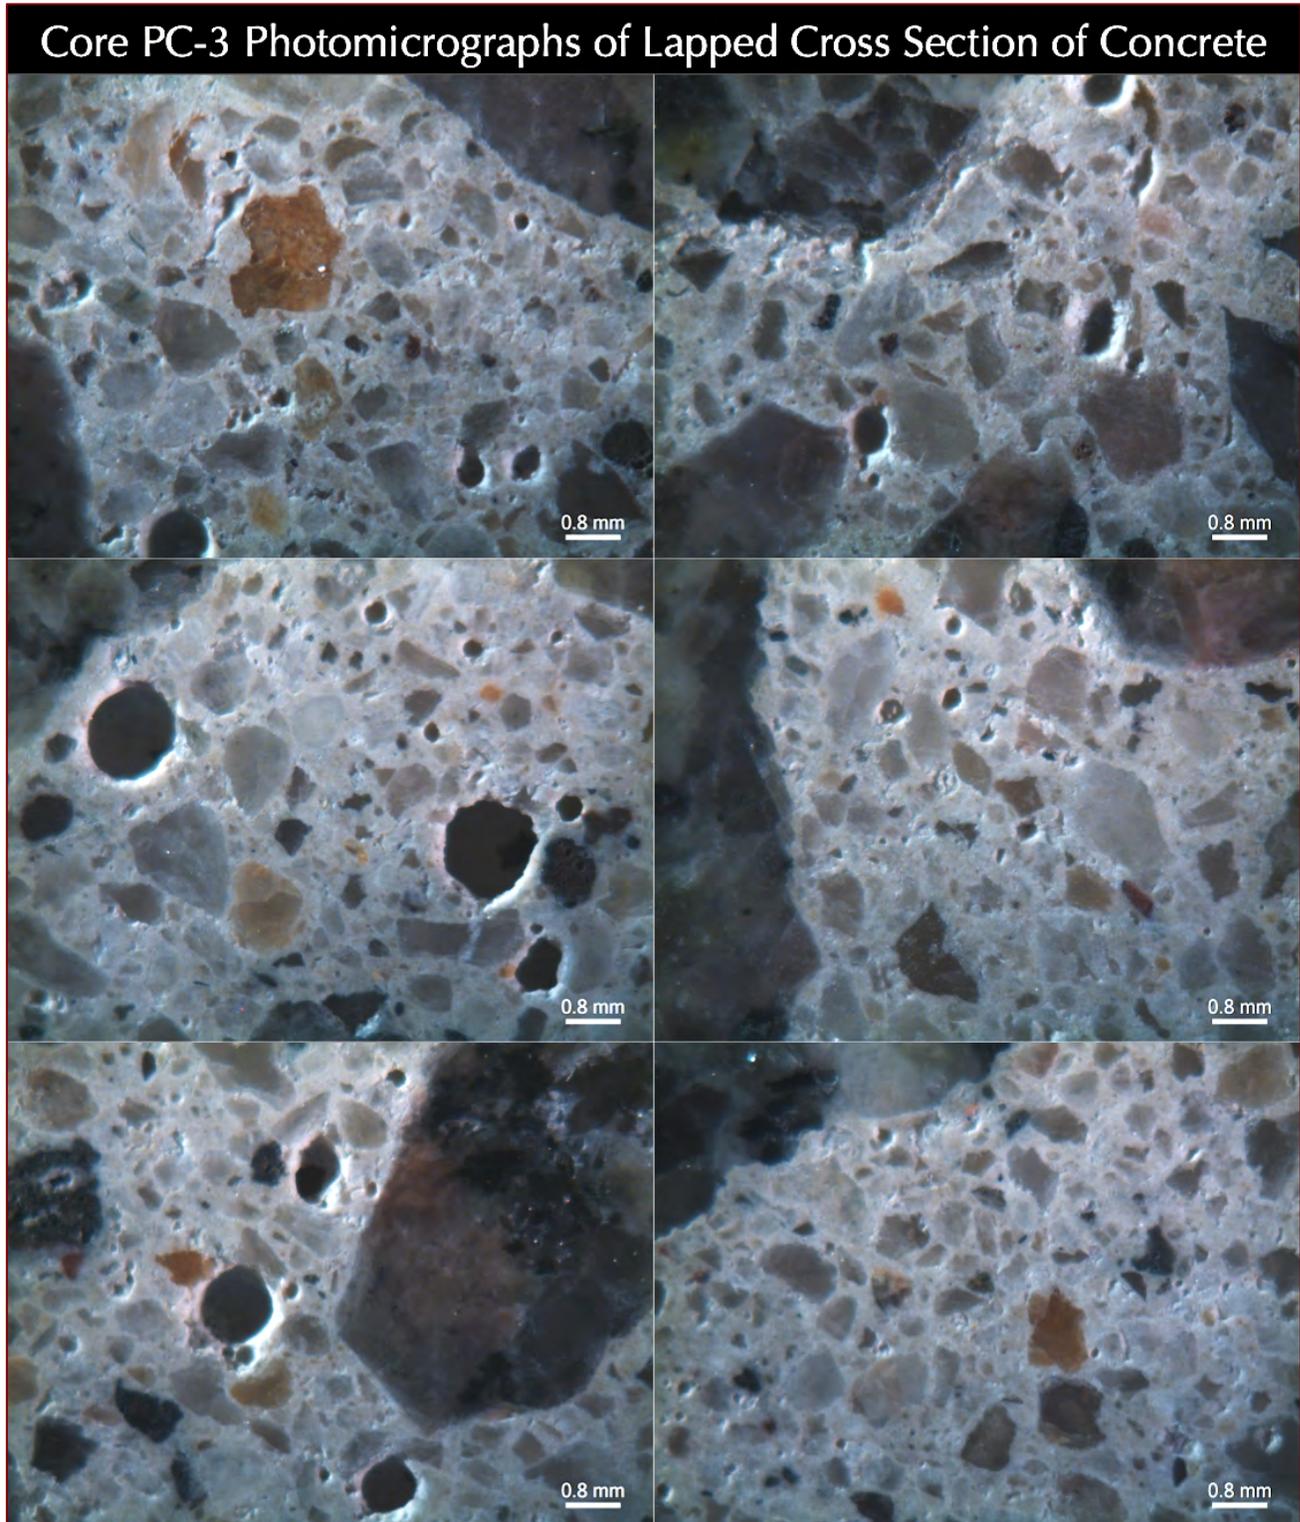
Figure 21: Photomicrographs of lapped cross section of Core PC-3 from the column concrete portion showing non-air-entrained nature of the column concrete having a few coarse and irregular-shaped voids but no intentionally introduced fine, discrete spherical entrained air voids of 1 mm or less size, and overall sound crack-free condition of the column concrete.

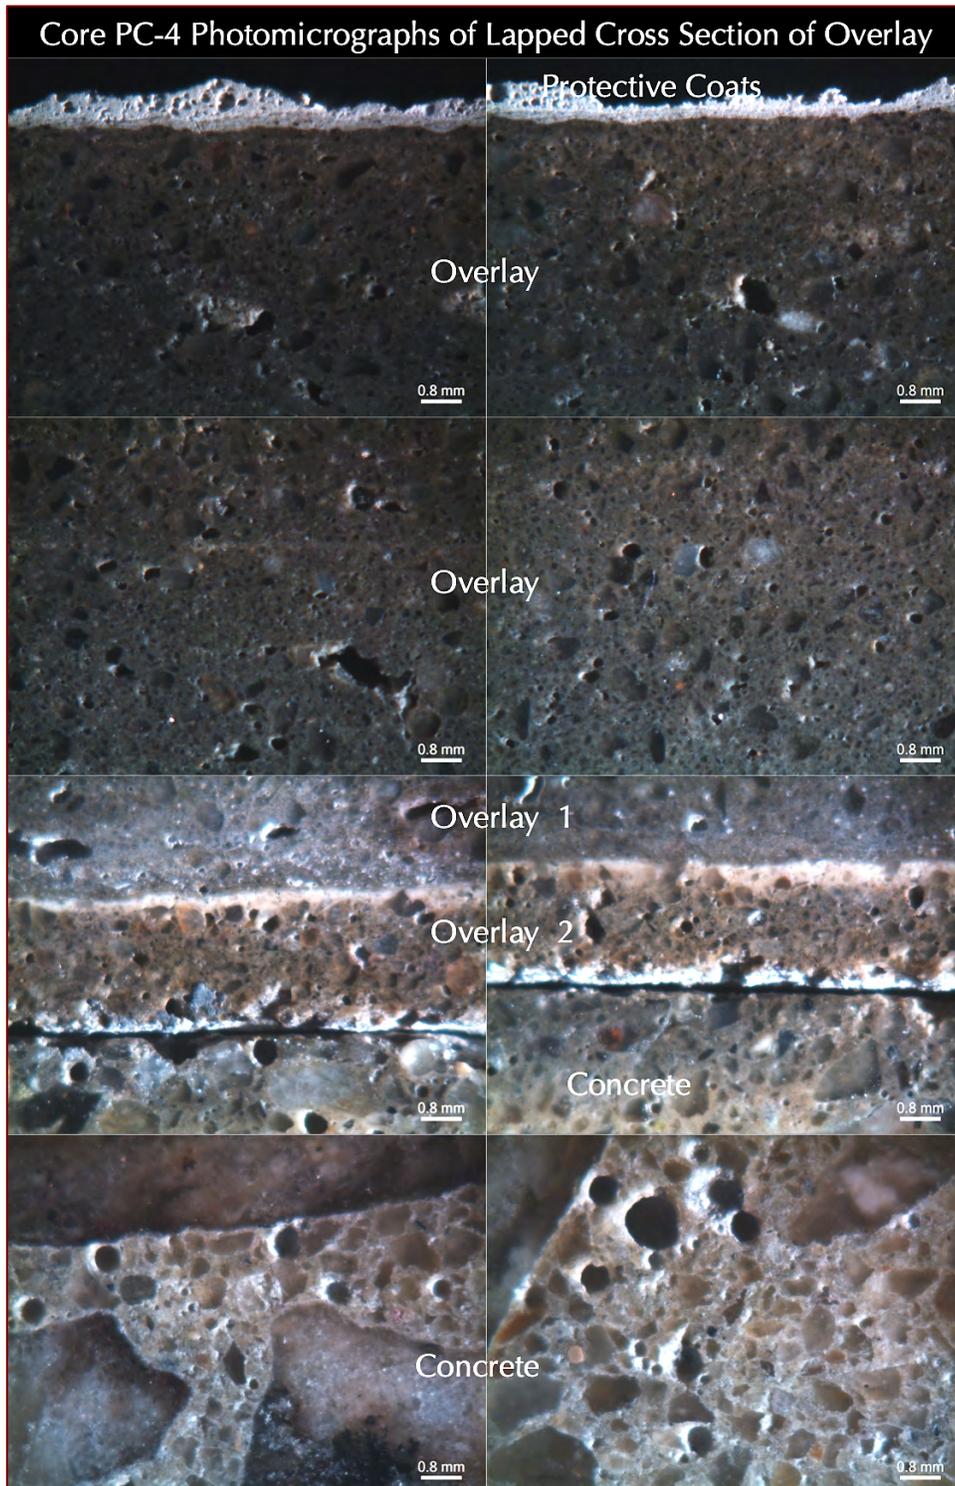
Figure 22: Photomicrographs of lapped cross section of Core PC-4 from the protective coating and repair overlay at the top showing two layers of protective coatings (white and off-white) applied over the dense, dark gray repair overlay where each coat is approx. 0.25 mm in thickness, well-bonded to each other and to the overlay (top row, 2<sup>nd</sup> row left). The gray overlay shows lack of adequate air entrainment but many coarse and irregularly-shaped voids. The base of overlay is completely de-bonded from concrete and shows the presence of a separate thin repair coat of 2 to 3 mm thickness at the base of the main overlay of 2 in. (50 mm). The main overlay is well-bonded to the thin coat at the base but the latter shows clean debonding from the concrete.

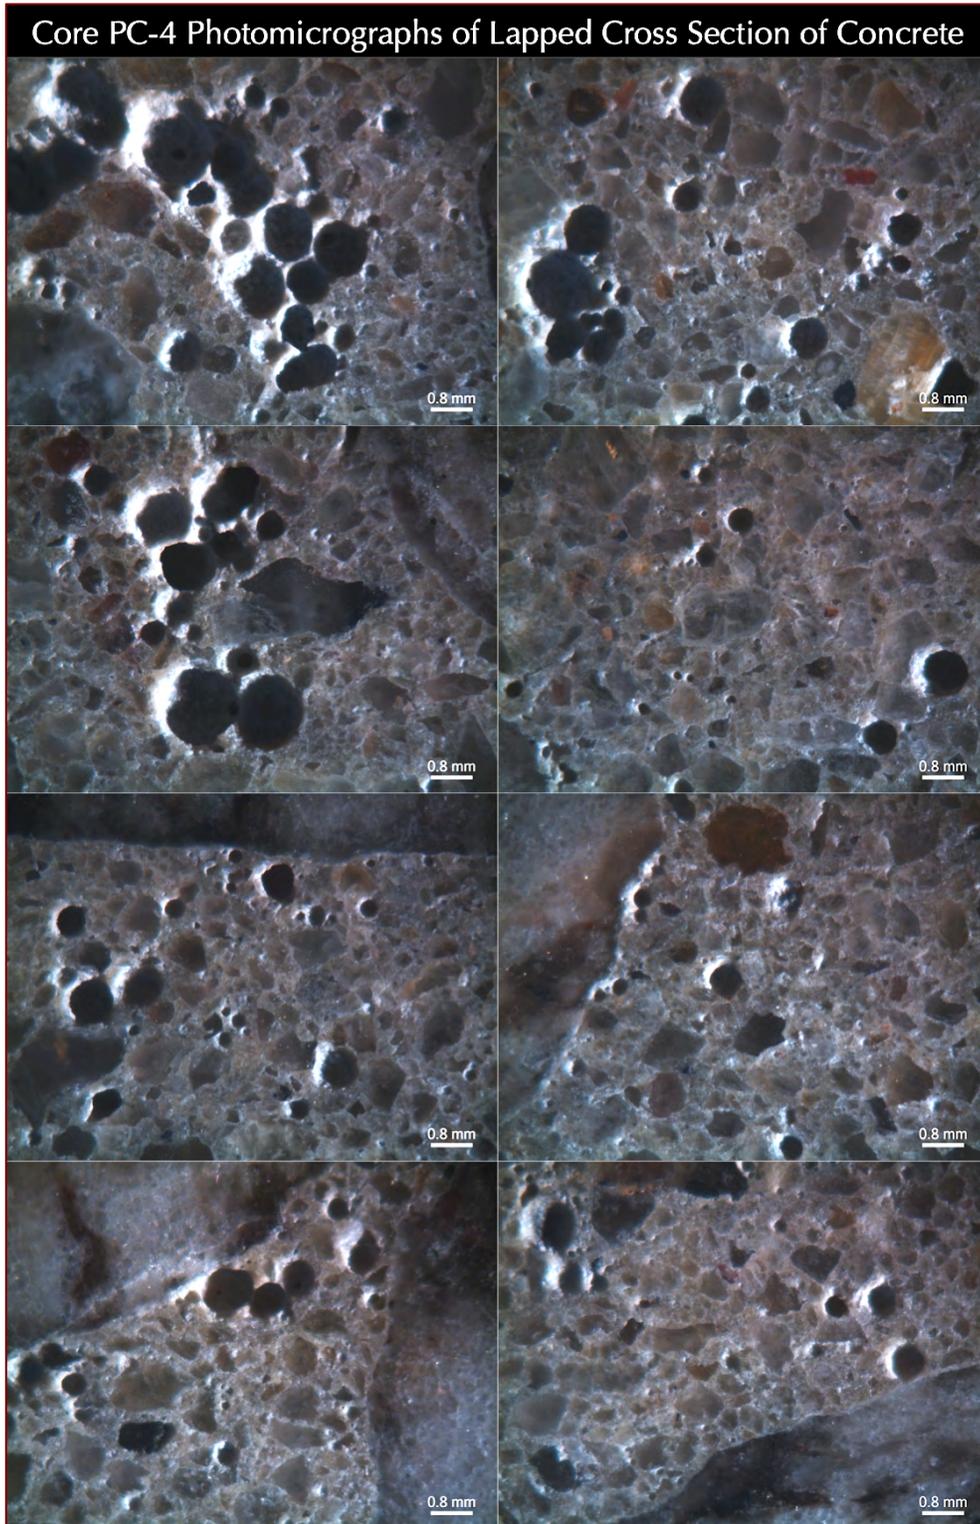
Figure 23: Photomicrographs of lapped cross section of Core PC-4 from the column concrete portion showing non-air-entrained to marginally air-entrained nature of the column concrete having a few coarse and irregular-shaped voids but no intentionally introduced fine, discrete spherical entrained air voids of 1 mm or less size for most of the areas except some clustering of spherical air voids at isolated locations, and overall sound crack-free condition of the column concrete.

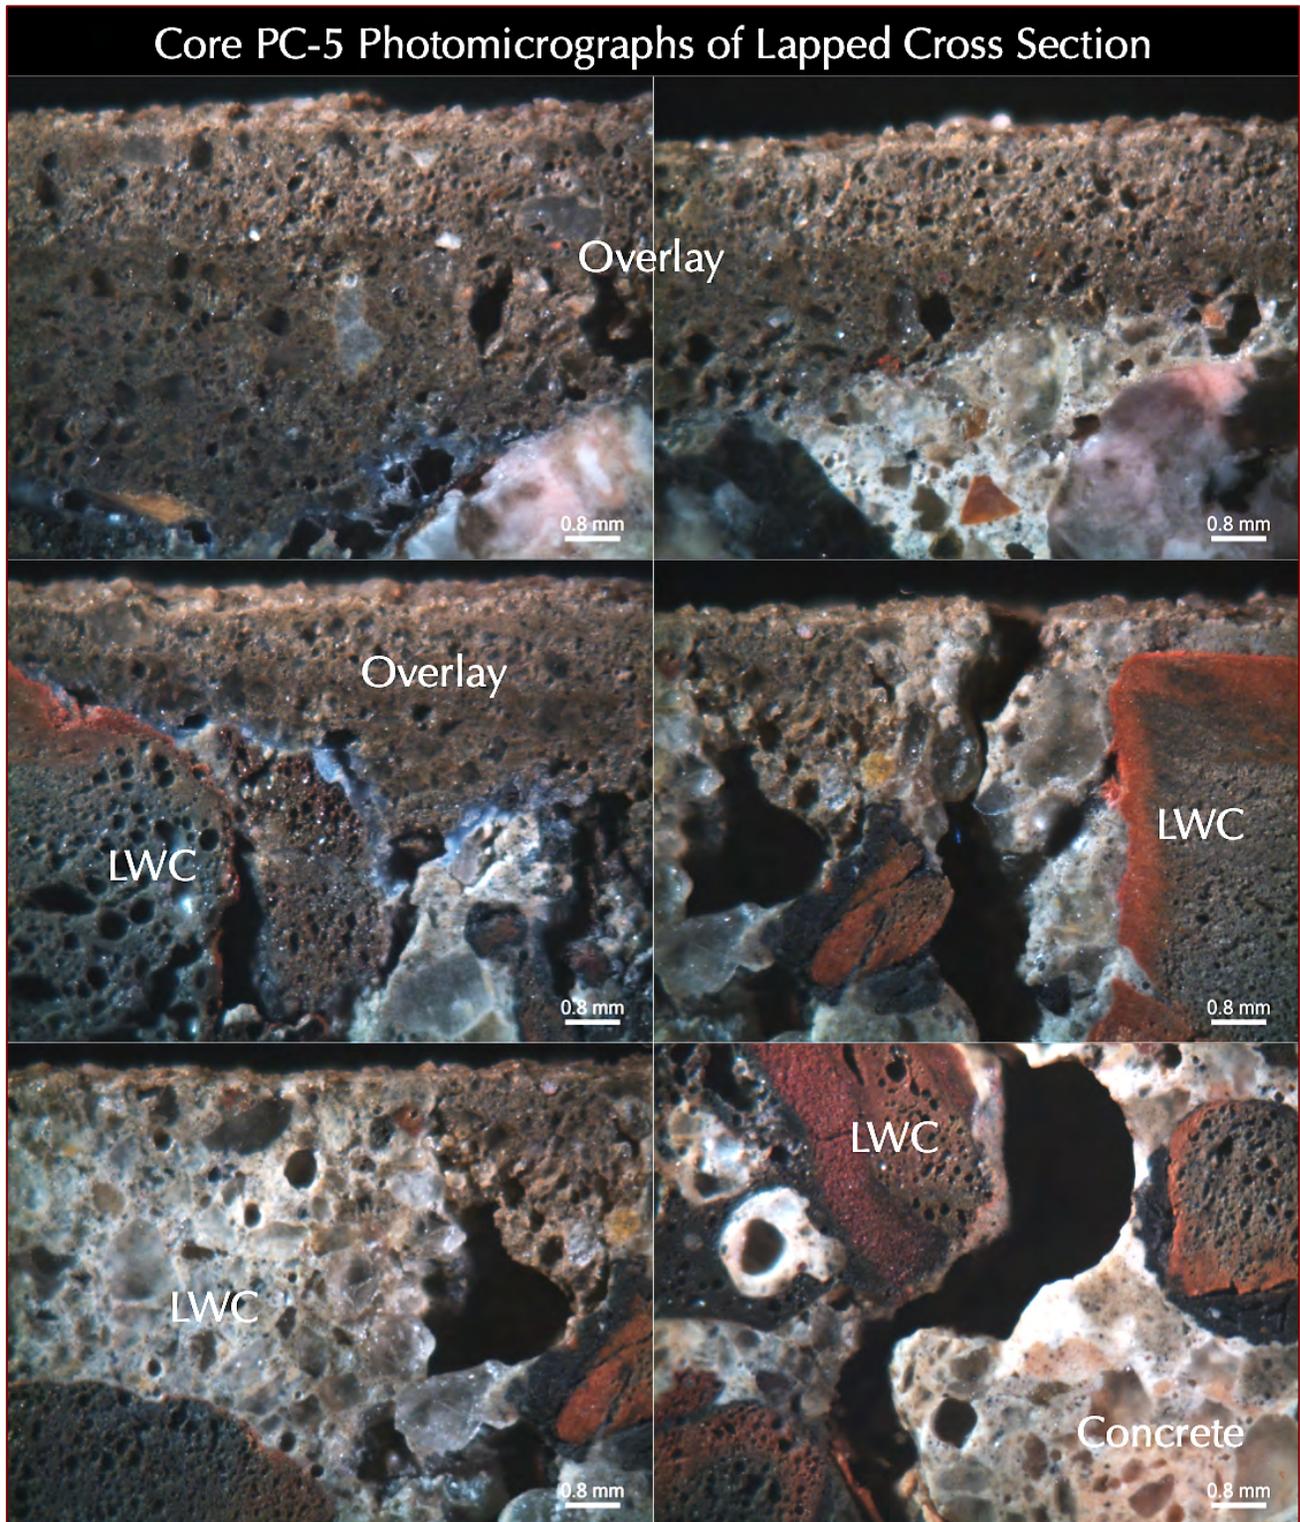
Figure 24: Photomicrographs of lapped cross section of Core PC-5 from the repair overlay at the top showing a porous medium gray repair overlay (about 1 mm thick) at the very top (top row) well-bonded to a dense darker gray overlay beneath (about 1-2 mm thick, top row), which is well-bonded to the concretes beneath. The dense dark gray overlay shows lack of adequate air entrainment. Notice reddish brown oxidation rims around some expanded clay and shale lightweight aggregate particles in the beam concrete.

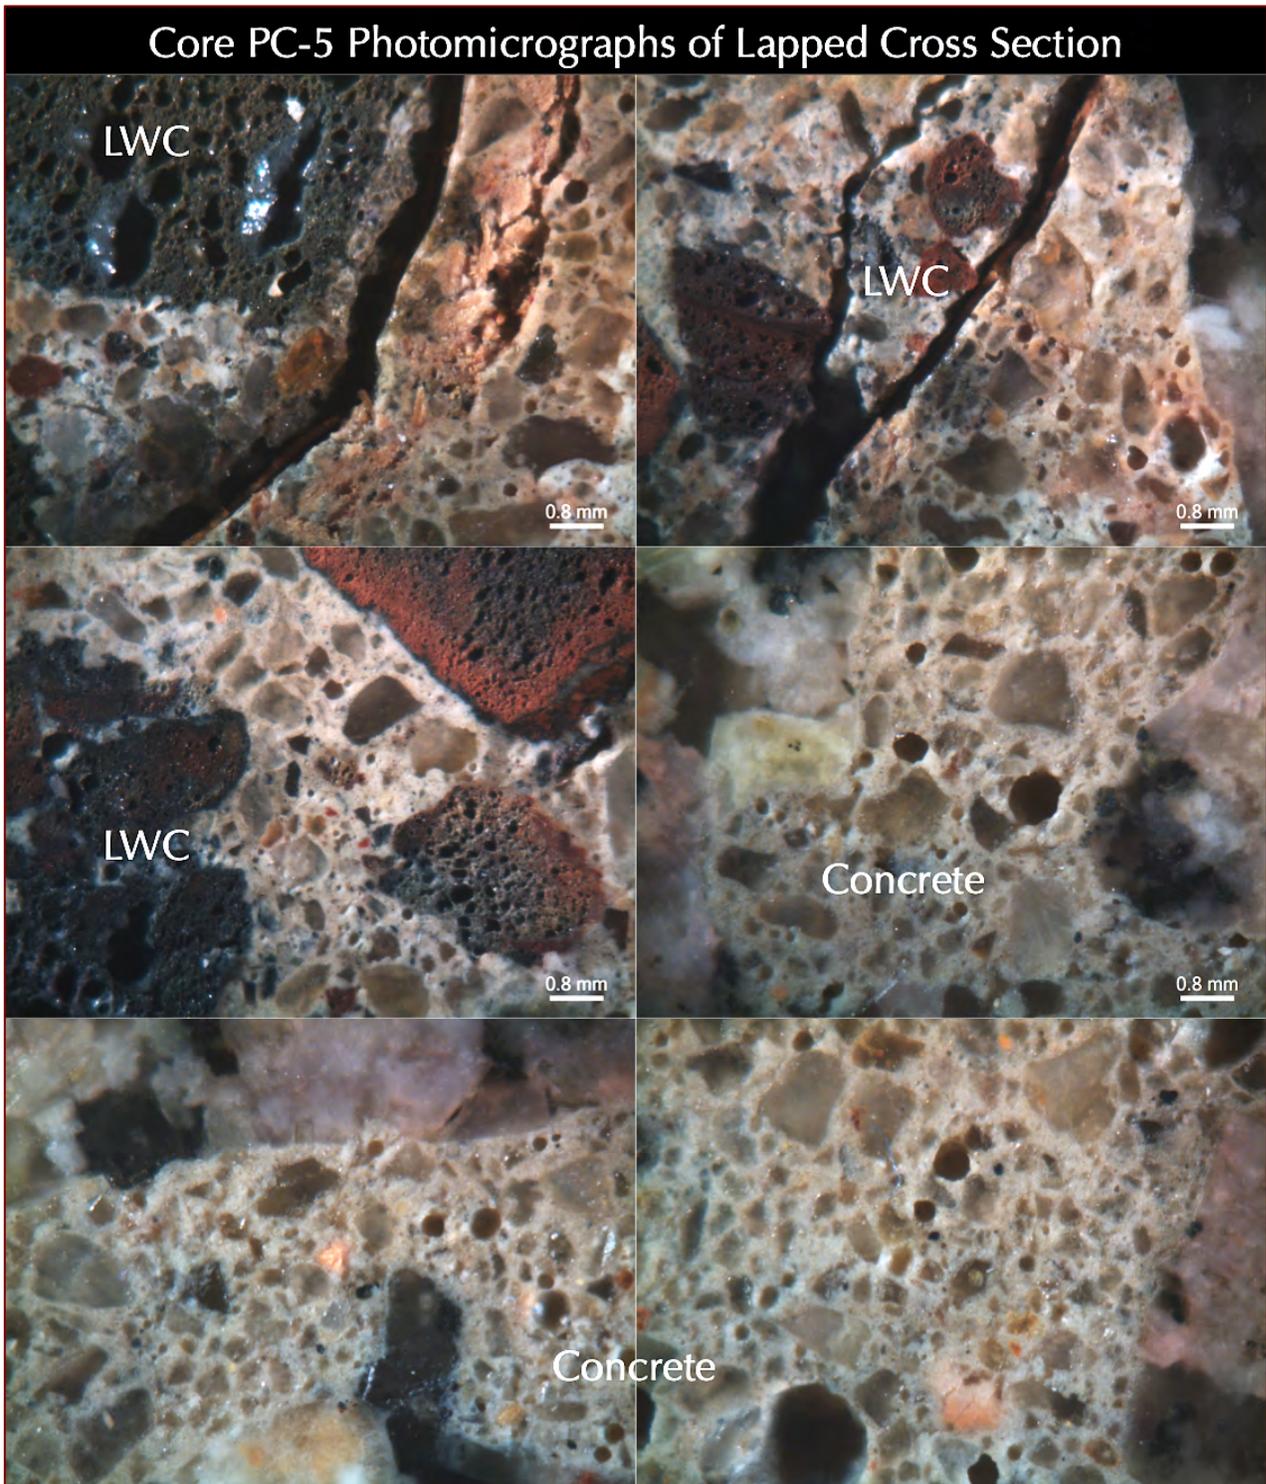
Figure 25: Photomicrographs of lapped cross section of Core PC-5 from the column and beam concrete portions showing beige discoloration of concrete at the top (top row) due to atmospheric carbonation of column prior to the application of repair overlay, non-air-entrained nature of the column concrete having a few coarse and irregular-shaped voids but no intentionally introduced fine, discrete spherical entrained air voids of 1 mm or less size, marginally air-entrained nature of the lightweight aggregate beam concrete, and overall sound crack-free condition of the beam and column concretes. Notice reddish brown oxidation rims around some expanded clay and shale lightweight aggregate particles in the beam concrete.

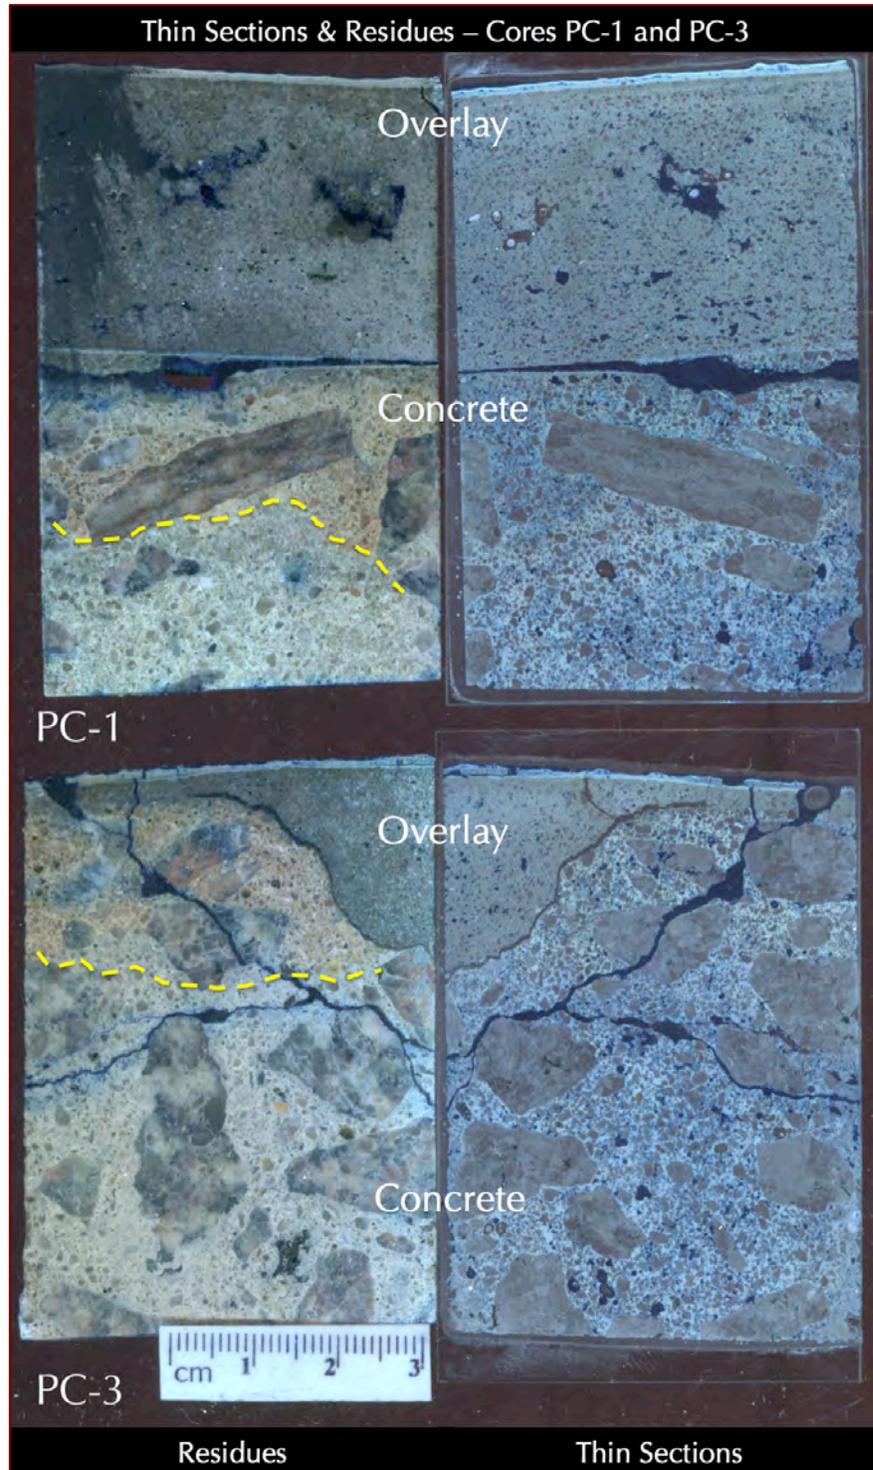
Figure 26: Blue dye-mixed epoxy-impregnated thin sections (right) residues left after thin sectioning (left) of Cores PC-1 (top) and PC-3 (bottom) showing white protective coats at the top of dark gray dense repair overlays, debonding of overlays from column concretes, visible major cracks in the column concrete in Core PC-3, and beige carbonation of column concretes where carbonation fronts are marked by yellow dashed lines. Notice lack of entrained air voids in the column concretes or overlays which would have been highlighted by blue epoxy.

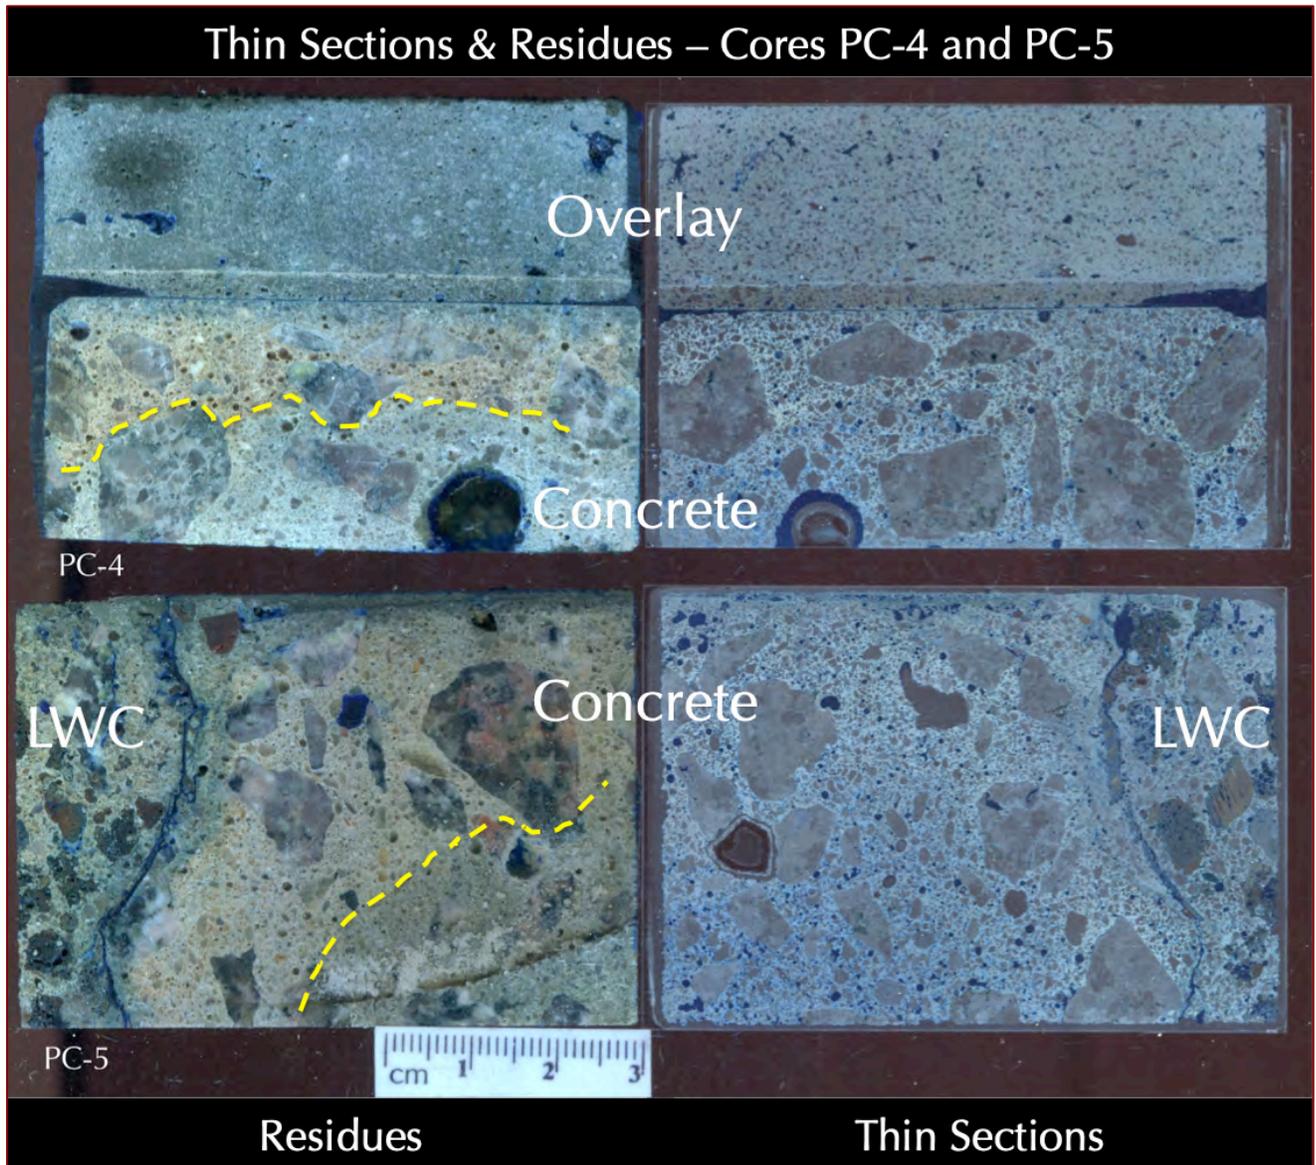
Figure 27: Blue dye-mixed epoxy-impregnated thin sections (right) residues left after thin sectioning (left) of Cores PC-4 (top) and PC-5 (bottom) showing dark gray dense repair overlays, debonding of overlay from column concrete in Core PC-4 where overlay shows a thin (2 to 3 mm thick) repair coat at the base, well bond of thin repair overlay to concrete in Core PC-5 and a cold joint between lightweight aggregate beam concrete and normal-weight aggregate column concrete. Beige carbonation of beam and column concretes are marked by yellow dashed lines separating carbonated portions from interior non-carbonated concretes. Notice lack of entrained air voids in the column concretes or overlays, which would have been highlighted by blue epoxy. Even the lightweight aggregate beam concrete where air entrainment is common due to density requirements are not evident by the blue epoxy.

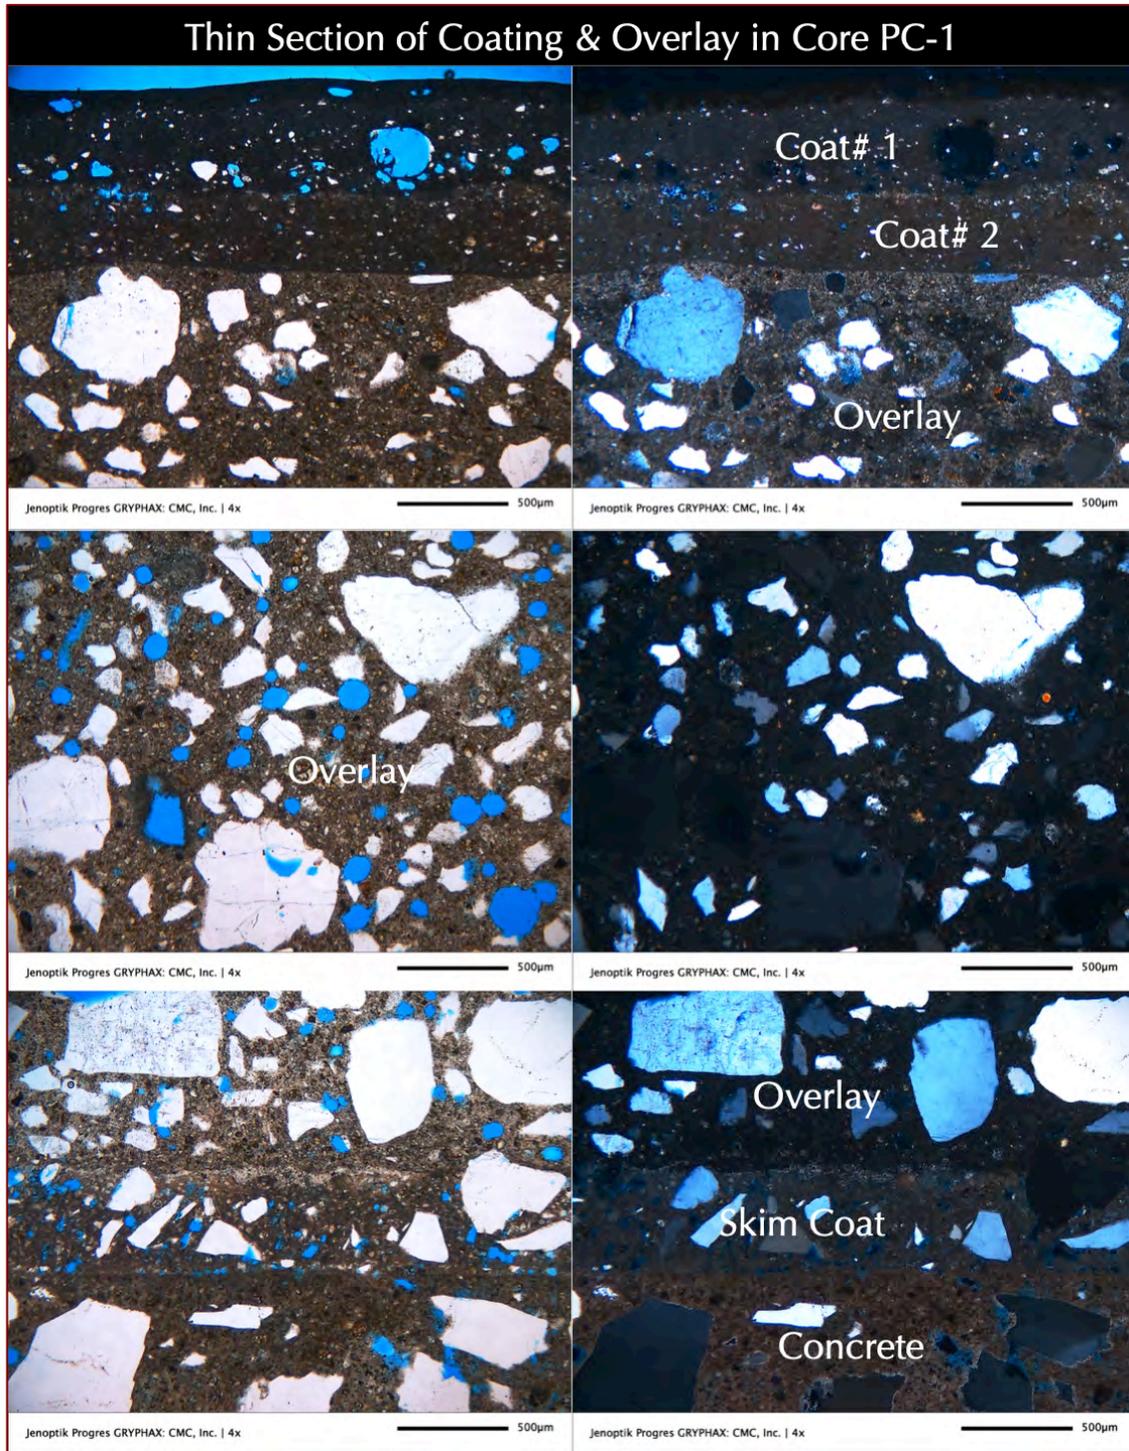
Figure 28: Photomicrographs of thin section of Core PC-1 showing: (a) two protective coats (#1 and 2) that are well-bonded to each other and to the repair overlay beneath; Coat #1 is more porous and polymer-based whereas Coat #2 is denser and has cementitious component (top row), (b) repair overlay, which is dense and containing crushed silica sand of 1 mm maximum size, dense low water-cement ratio Portland cement paste, and many spherical air voids highlighted by blue epoxy (middle row), (c) a skim coat at the base of repair overlay of crushed silica sand and Portland cement paste, which is bonded to the concrete beneath (bottom row).

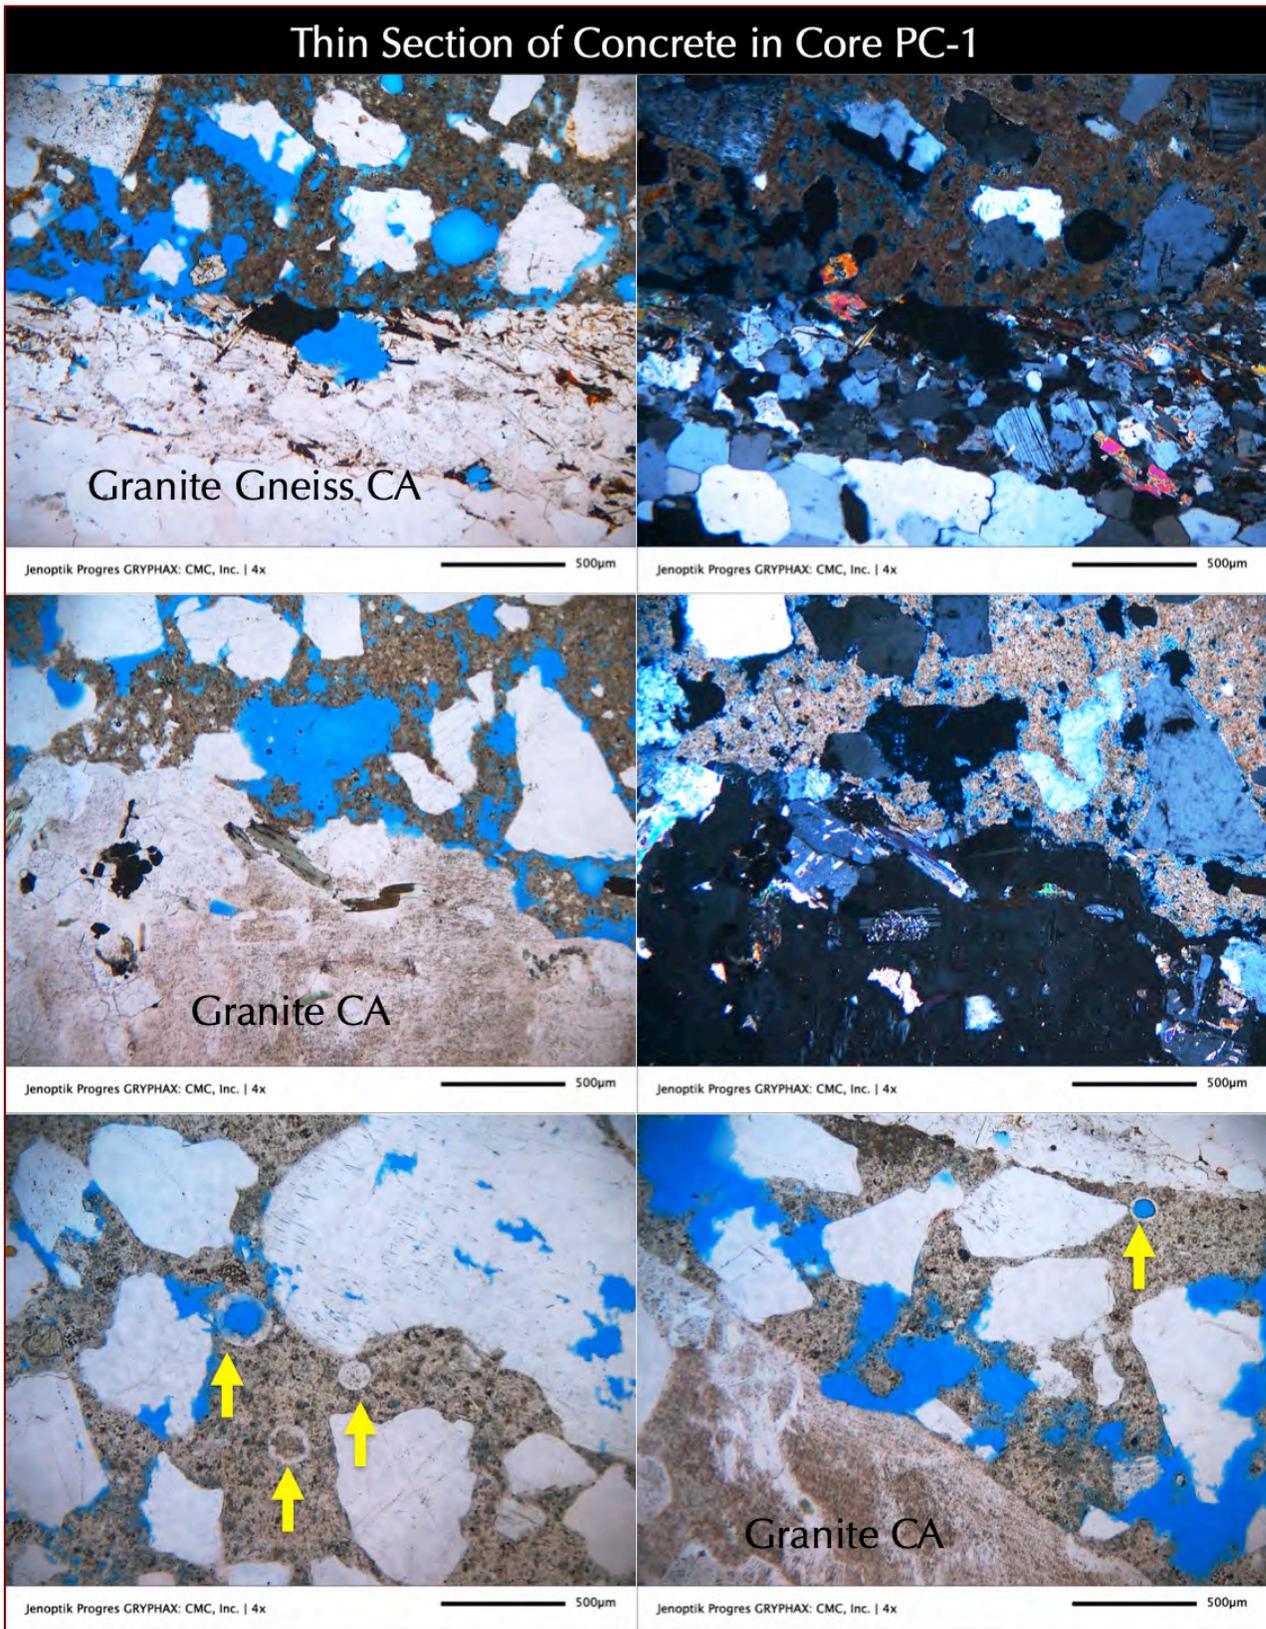
Figure 29: Photomicrographs of thin section of Core PC-1 from the column concrete showing crushed granite and granite gneiss coarse aggregate particles, crushed silica sand fine aggregate, carbonated Portland cement paste at the top, and secondary ettringite deposits lining a few air voids (arrows).
