## Chloride and Carbonation-Induced Corrosion of Reinforcing Steel In A Concrete Column – A Case Study

North Carolina State University  
Mann Hall Column Testing

**Background** - Exposed perimeter reinforced concrete columns at 4-story Mann Hall (constructed in 1963) in North Carolina State University has experienced corrosion of reinforcing steel in columns resulting in various levels of distress from vertical and horizontal cracking, delamination and spalls. Previous tests have determined the presence of elevated chlorides in some columns and deep carbonation, hence potential chloride-induced and/or carbonation-induced corrosion of steel in concrete to cause the distress. A repair attempt in 1993 was taken to reduce chloride and carbonation ingress by patching many deteriorated concrete covers over corroded rebars with adequate concrete cover of 1 to 4 in. thicknesses. However, continued deterioration over the past couple of decades has led to other engineering firms evaluate these columns in 2017. Recently, field evaluation of these columns were done in August of 2019 from visual surveying to audible sounding, excavations, chloride powder sampling, and removal of cores for pre

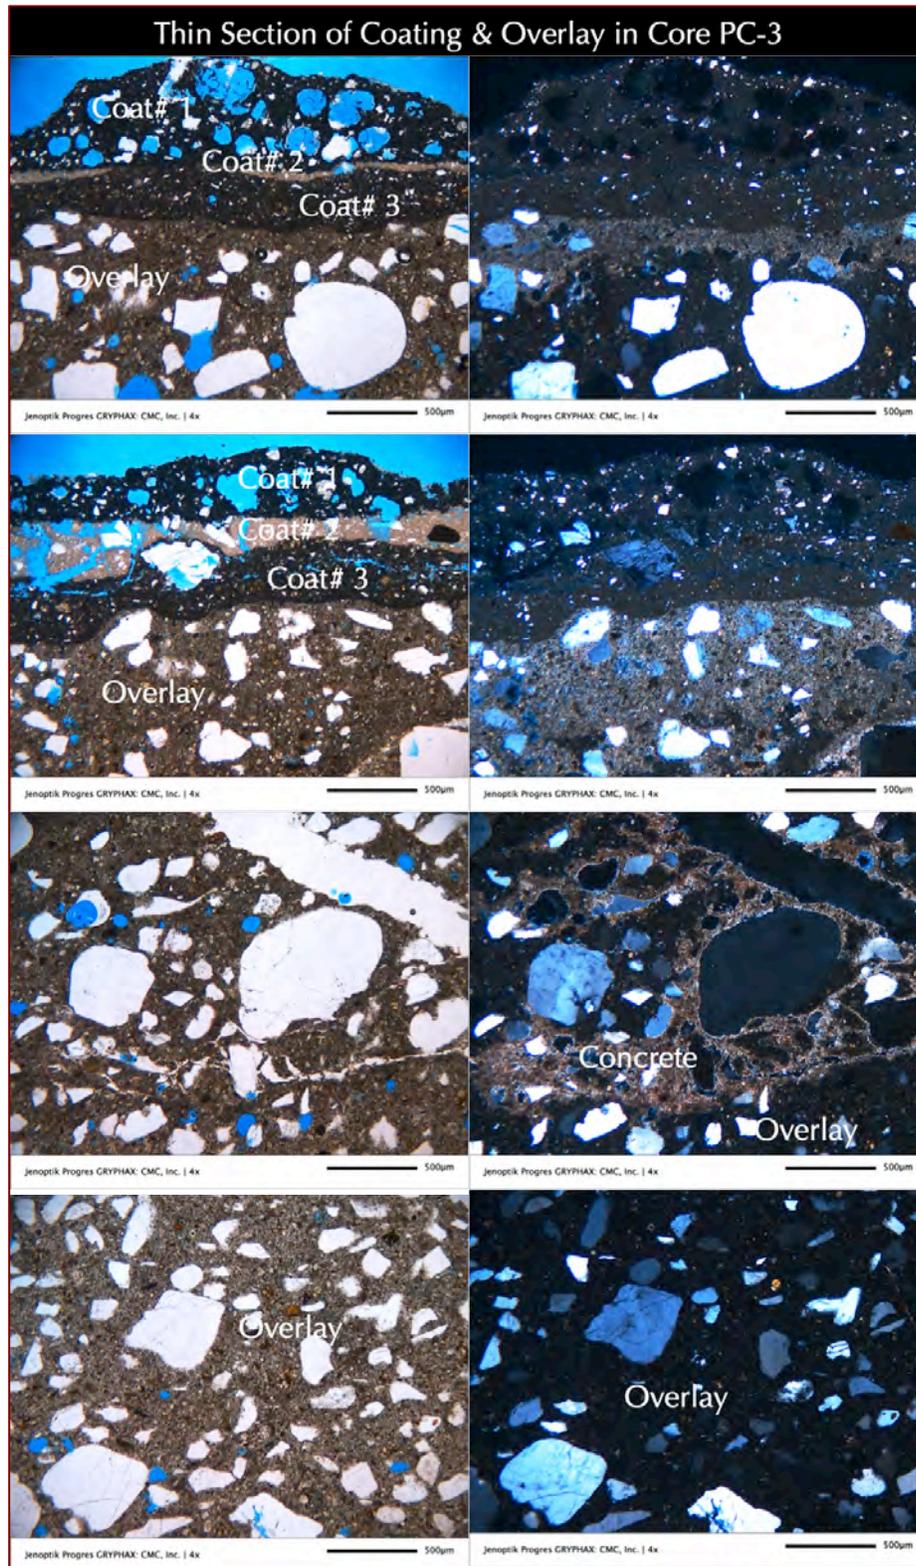
Figure 30: Photomicrographs of thin section of Core PC-3 showing: (a) three protective coats (#1, 2, and 3) that are well-bonded to each other and to the repair overlay beneath (top row), where the very top Coat #1 has perlitic fillers, whereas No. 2 is calcitic coat, and #3 is dense cementitious coat; and (b) repair overlay, which is dense and containing crushed silica sand of 1 mm maximum size, dense low water-cement ratio Portland cement paste, and many spherical air voids highlighted by blue epoxy (middle row).

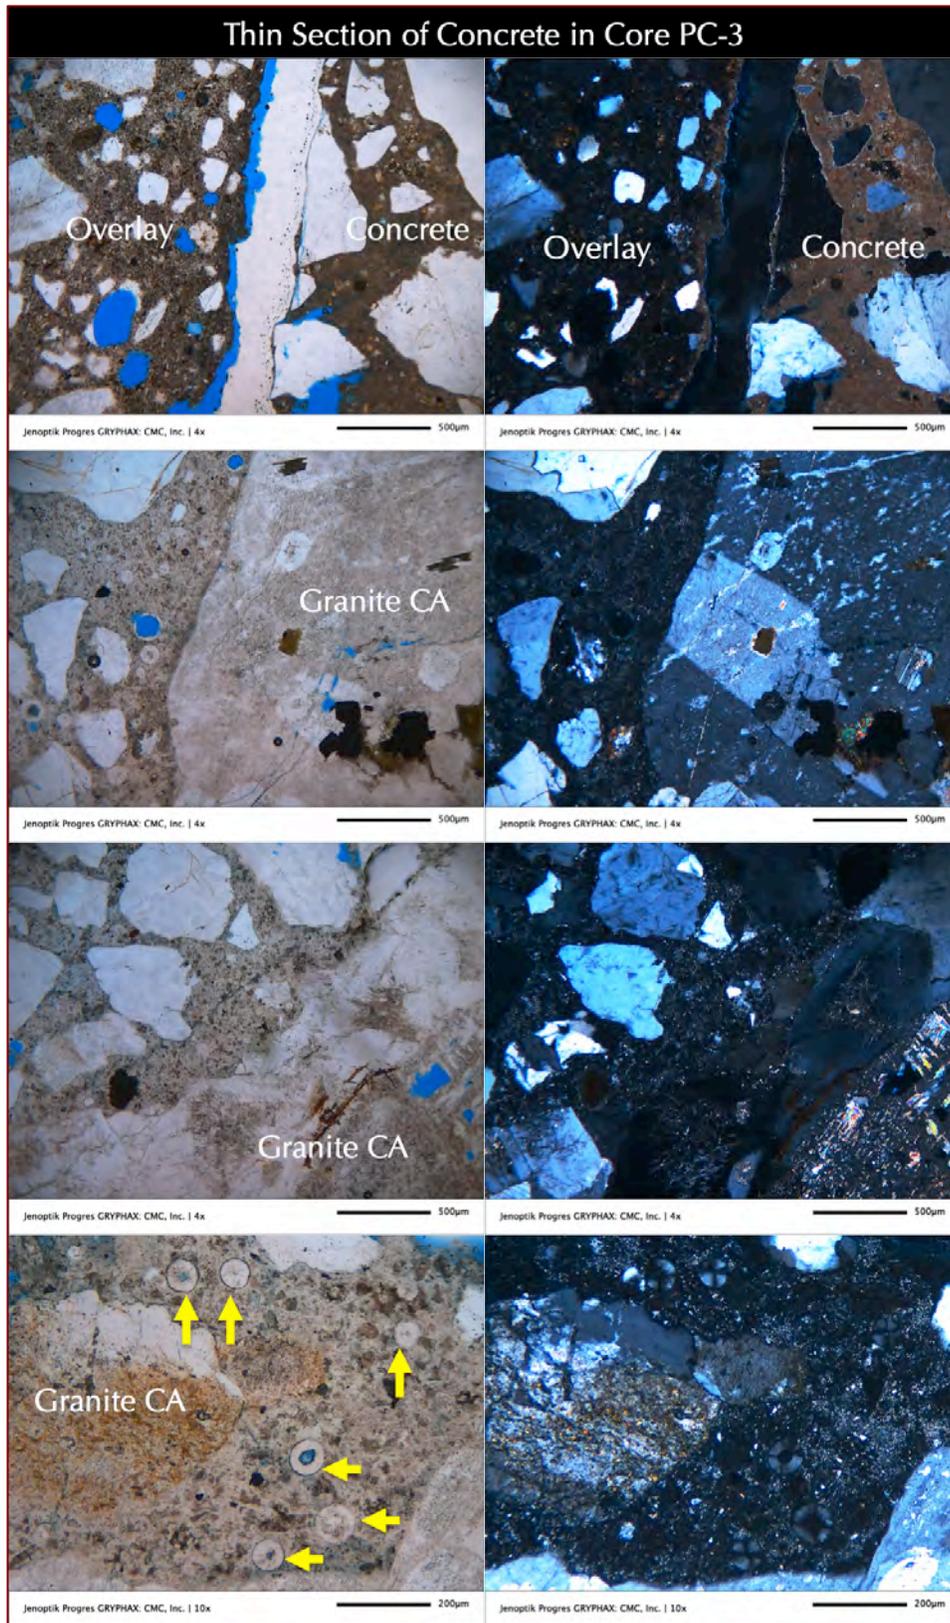
Figure 31: Photomicrographs of thin section of Core PC-3 from the column concrete showing crushed granite and granite gneiss coarse aggregate particles, crushed silica sand fine aggregate, carbonated Portland cement paste at the top, non-carbonated concrete in the interior, and secondary ettringite deposits lining a few air voids (arrows).

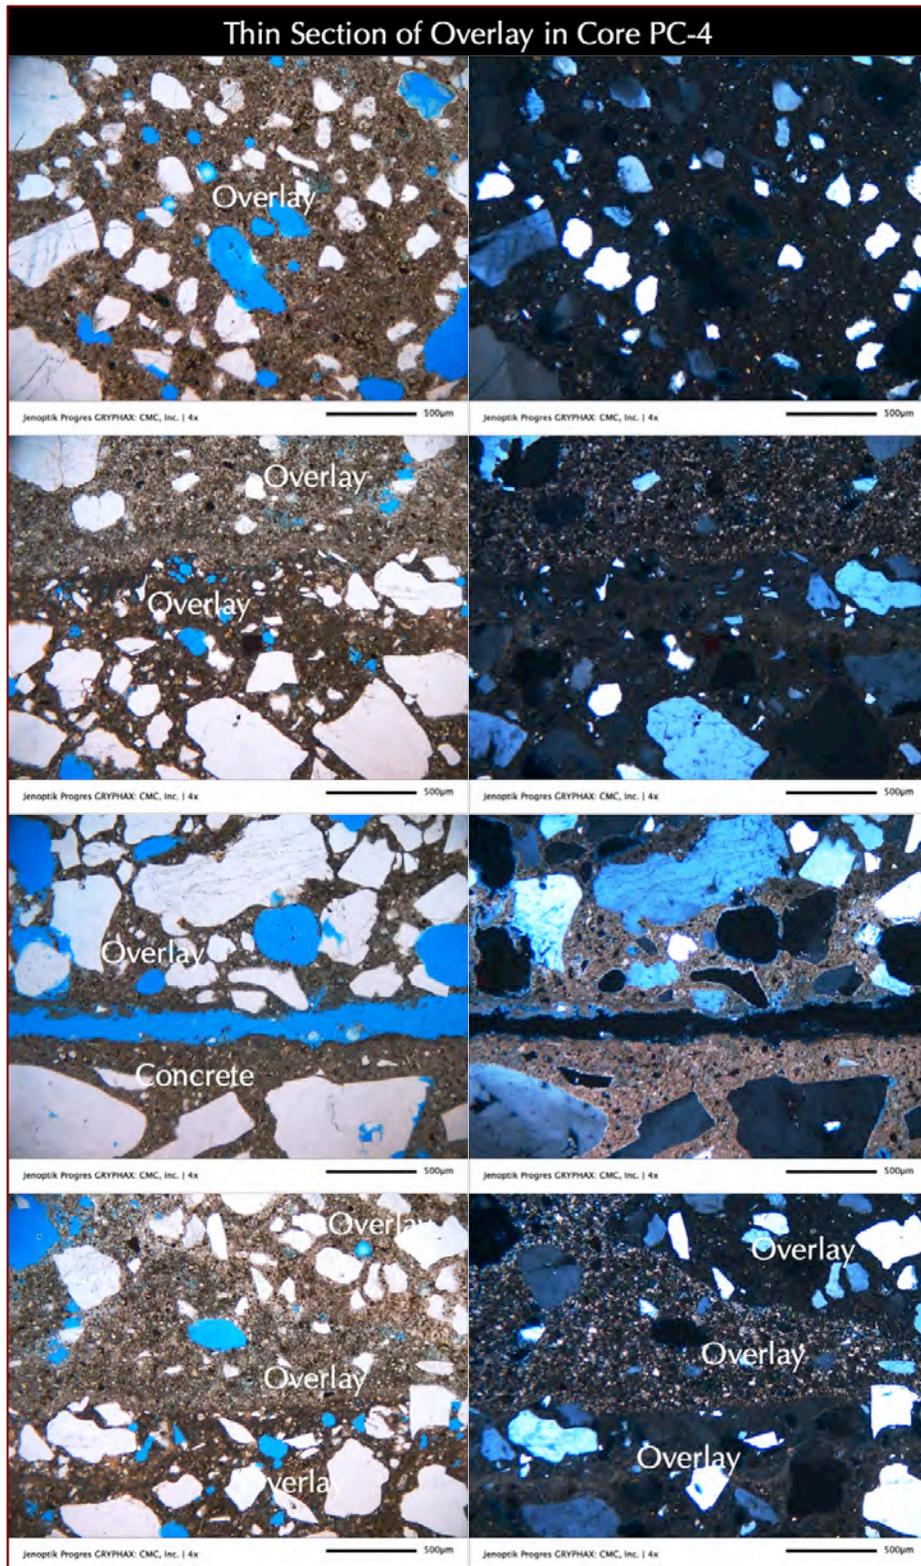
Figure 32: Photomicrographs of thin section of Core PC-4 showing: (a) repair overlay, which is dense and containing crushed silica sand of 1 mm maximum size, dense low water-cement ratio Portland cement paste, and many spherical air voids highlighted by blue epoxy (middle row). Notice multiple applications of overlay of slightly different water-cement ratios that are detected by slight difference in densities of pastes.

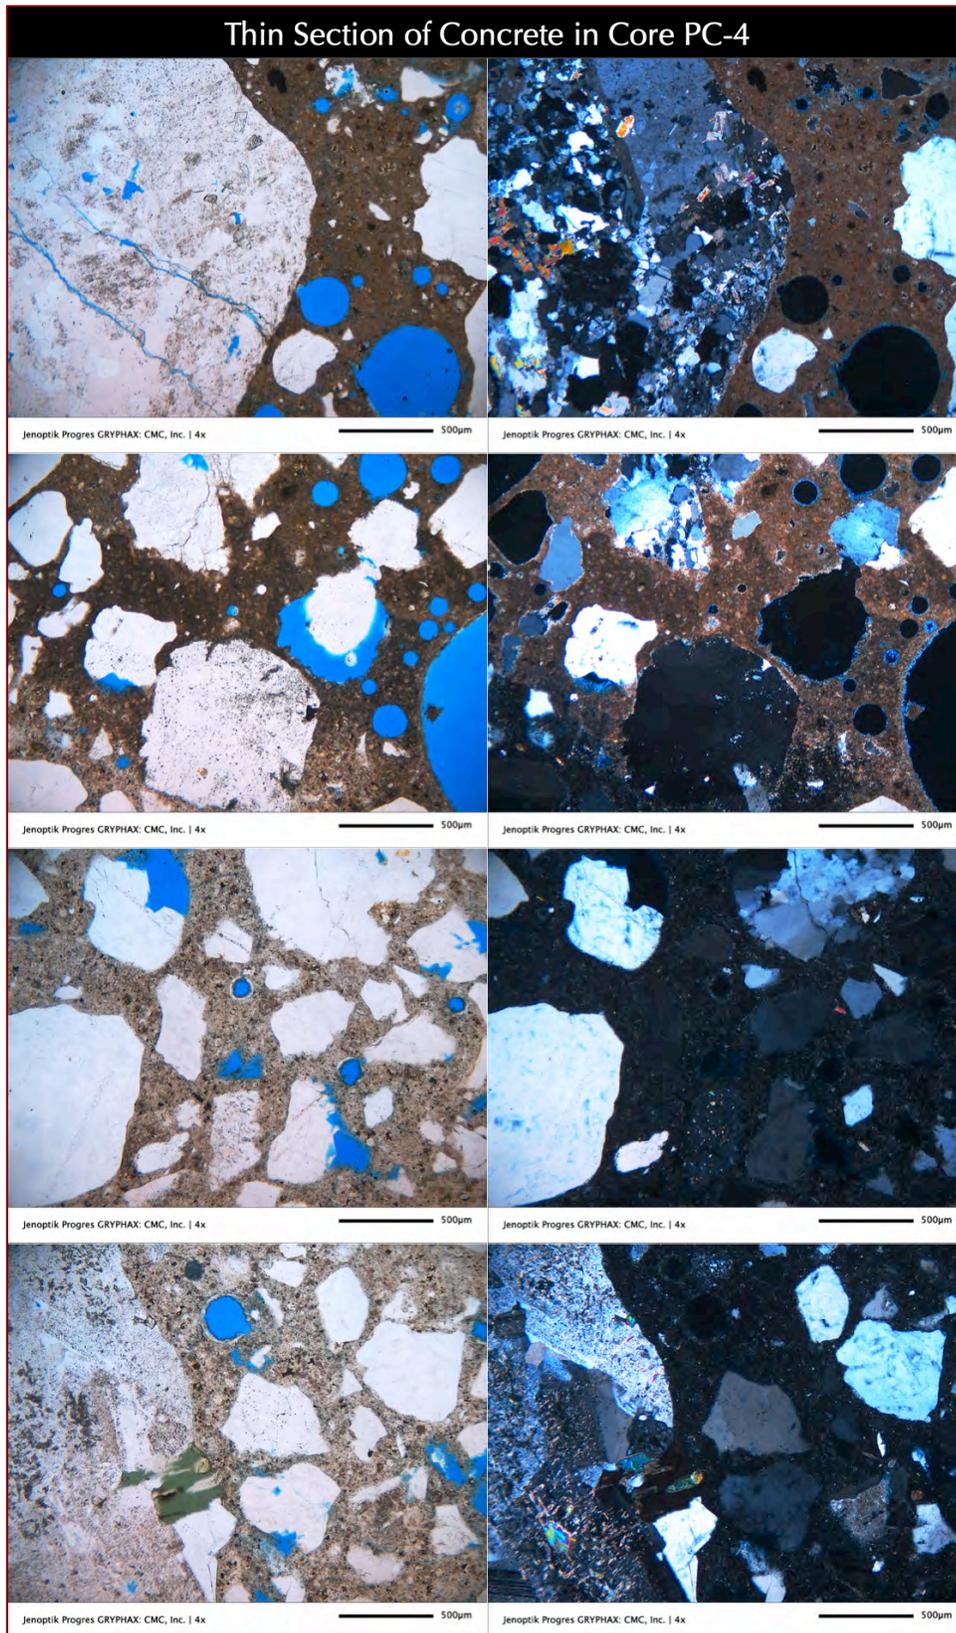
Figure 33: Photomicrographs of thin section of Core PC-4 from the column concrete showing crushed granite coarse aggregate particles, crushed silica sand fine aggregate, carbonated Portland cement paste at the top, non-carbonated concrete in the interior, and secondary ettringite deposits lining a few air voids.

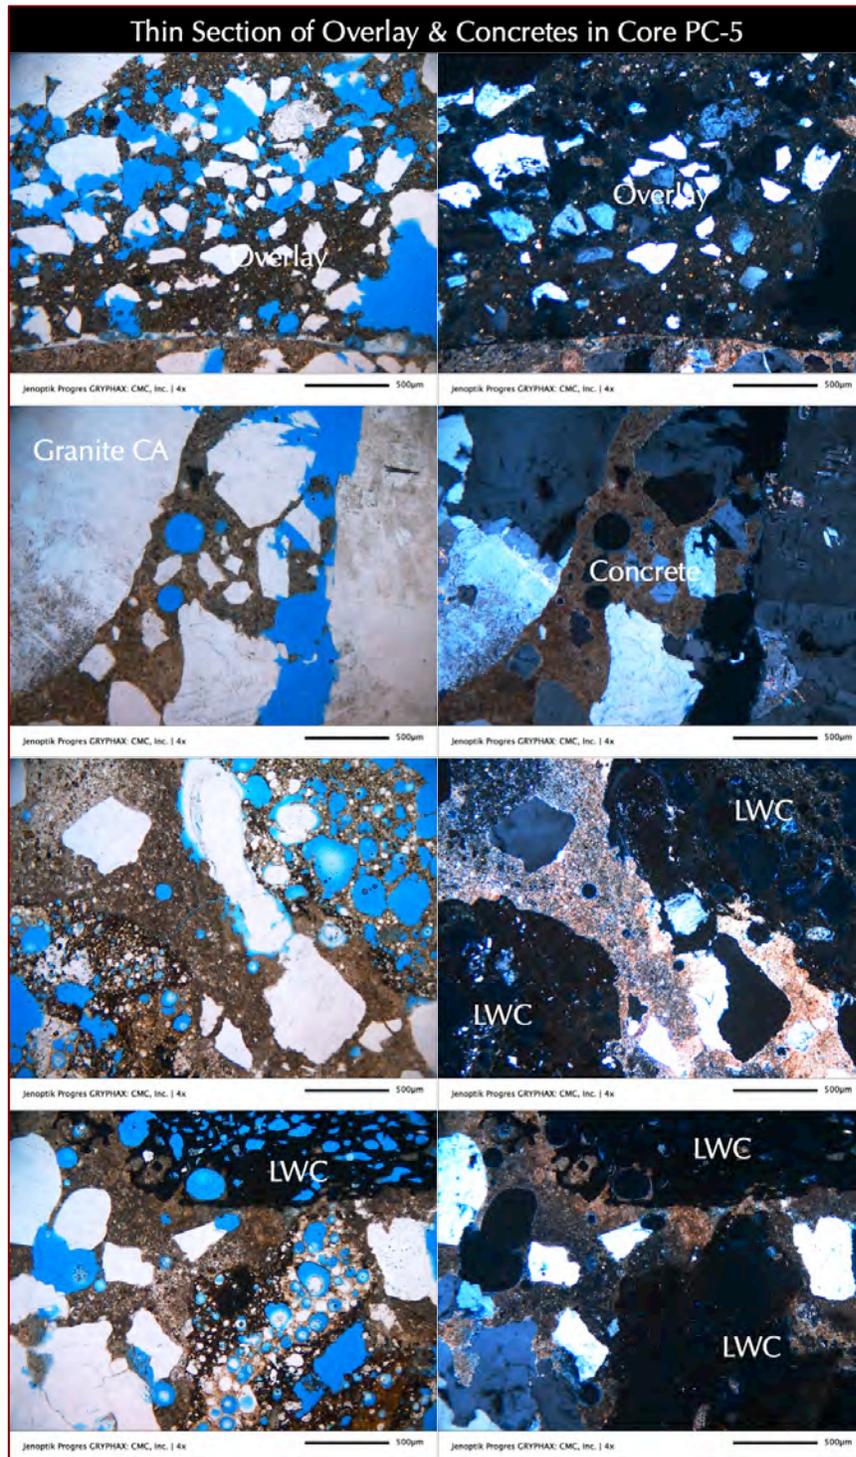
Figure 34: Photomicrographs of thin section of Core PC-5 showing: (a) two repair overlays, one top porous overlay of 0.5 mm to 1 mm thickness that contains crushed fine silica sand plus Portland cement paste but with many coarse irregular-shaped voids, and another underling dense overlay of 0.5 mm thickness that also contains crushed fine silica sand and dense Portland cement paste but no major voids. In both overlay layers sand is nominal 0.5 mm in size, well-graded and well-distributed and paste is dense. The 2<sup>nd</sup> to 4<sup>th</sup> rows show the normal-weight column concrete containing crushed granite coarse aggregate and Portland cement paste, and lightweight beam concrete containing porous, vesicular expanded clay and shale coarse aggregate and Portland cement paste. Pastes in both concretes show carbonation.

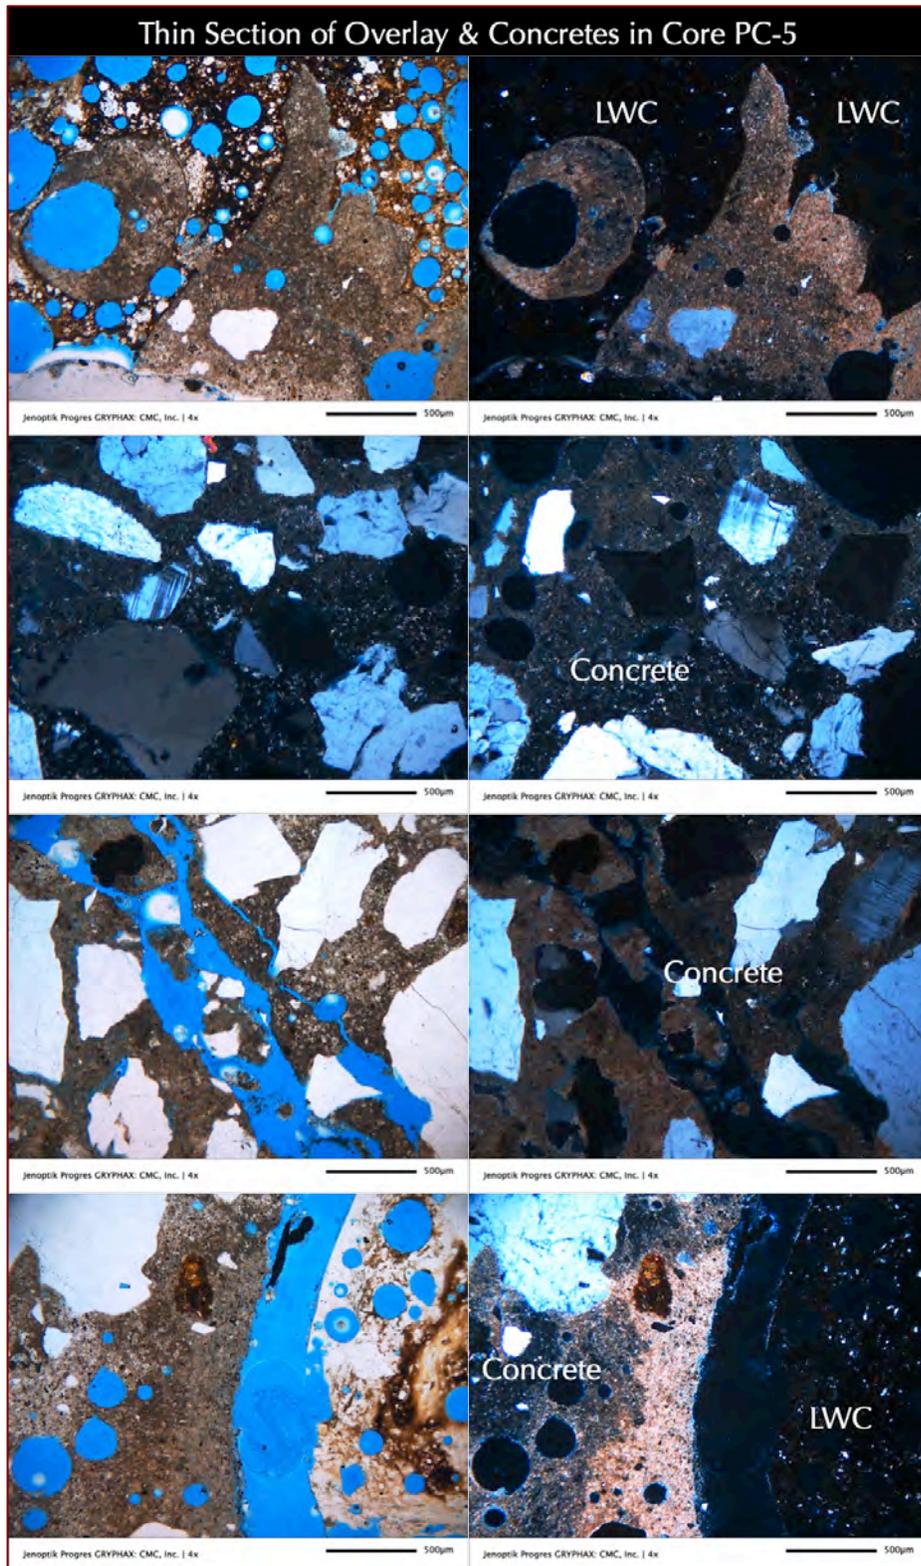
Figure 35: Photomicrographs of thin section of Core PC-5 showing normal-weight column concrete (2<sup>nd</sup> and 3<sup>rd</sup> rows) containing crushed granite coarse aggregate and Portland cement paste, and lightweight beam concrete (1<sup>st</sup> and 4<sup>th</sup> rows) containing porous, vesicular expanded clay and shale coarse aggregate and Portland cement paste. Pastes in both concretes show carbonation.

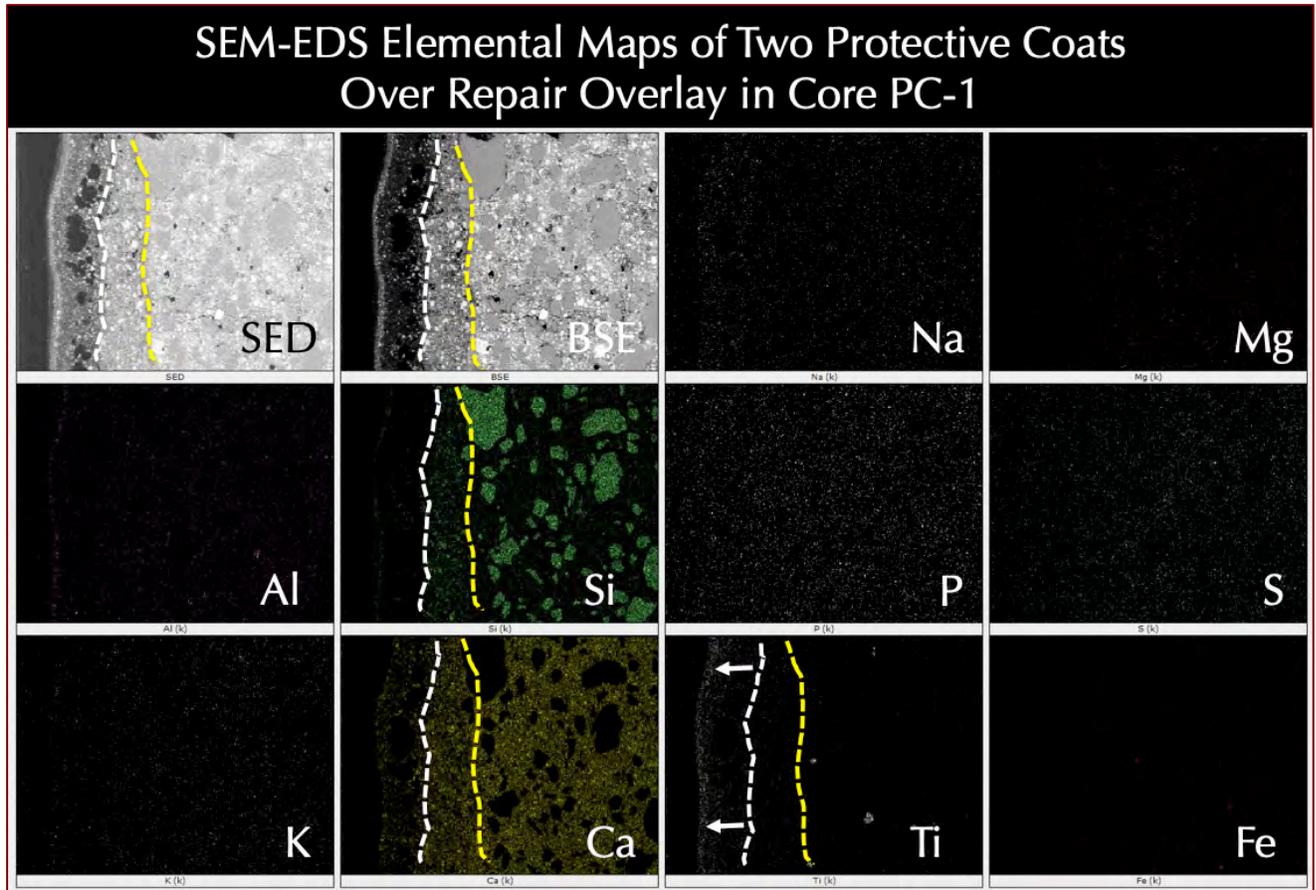
Figure 36: X-ray elemental maps in SEM-EDS of two protective coats over repair overlay in Core PC-1 showing the presence of a titanium-oxide pigment based coat at the top (Coat #1) that has given the characteristic white color of paint and a cementitious (Ca-based) underlying coat (Coat #2) applied over cementitious repair overlay. The overlay contains silica sand (highlighted in Si-map) and Portland cement paste (highlighted in Ca and Si maps). The white and yellow dashed lines separated the two protective coats from each other and from the underlying overlay, respectively.

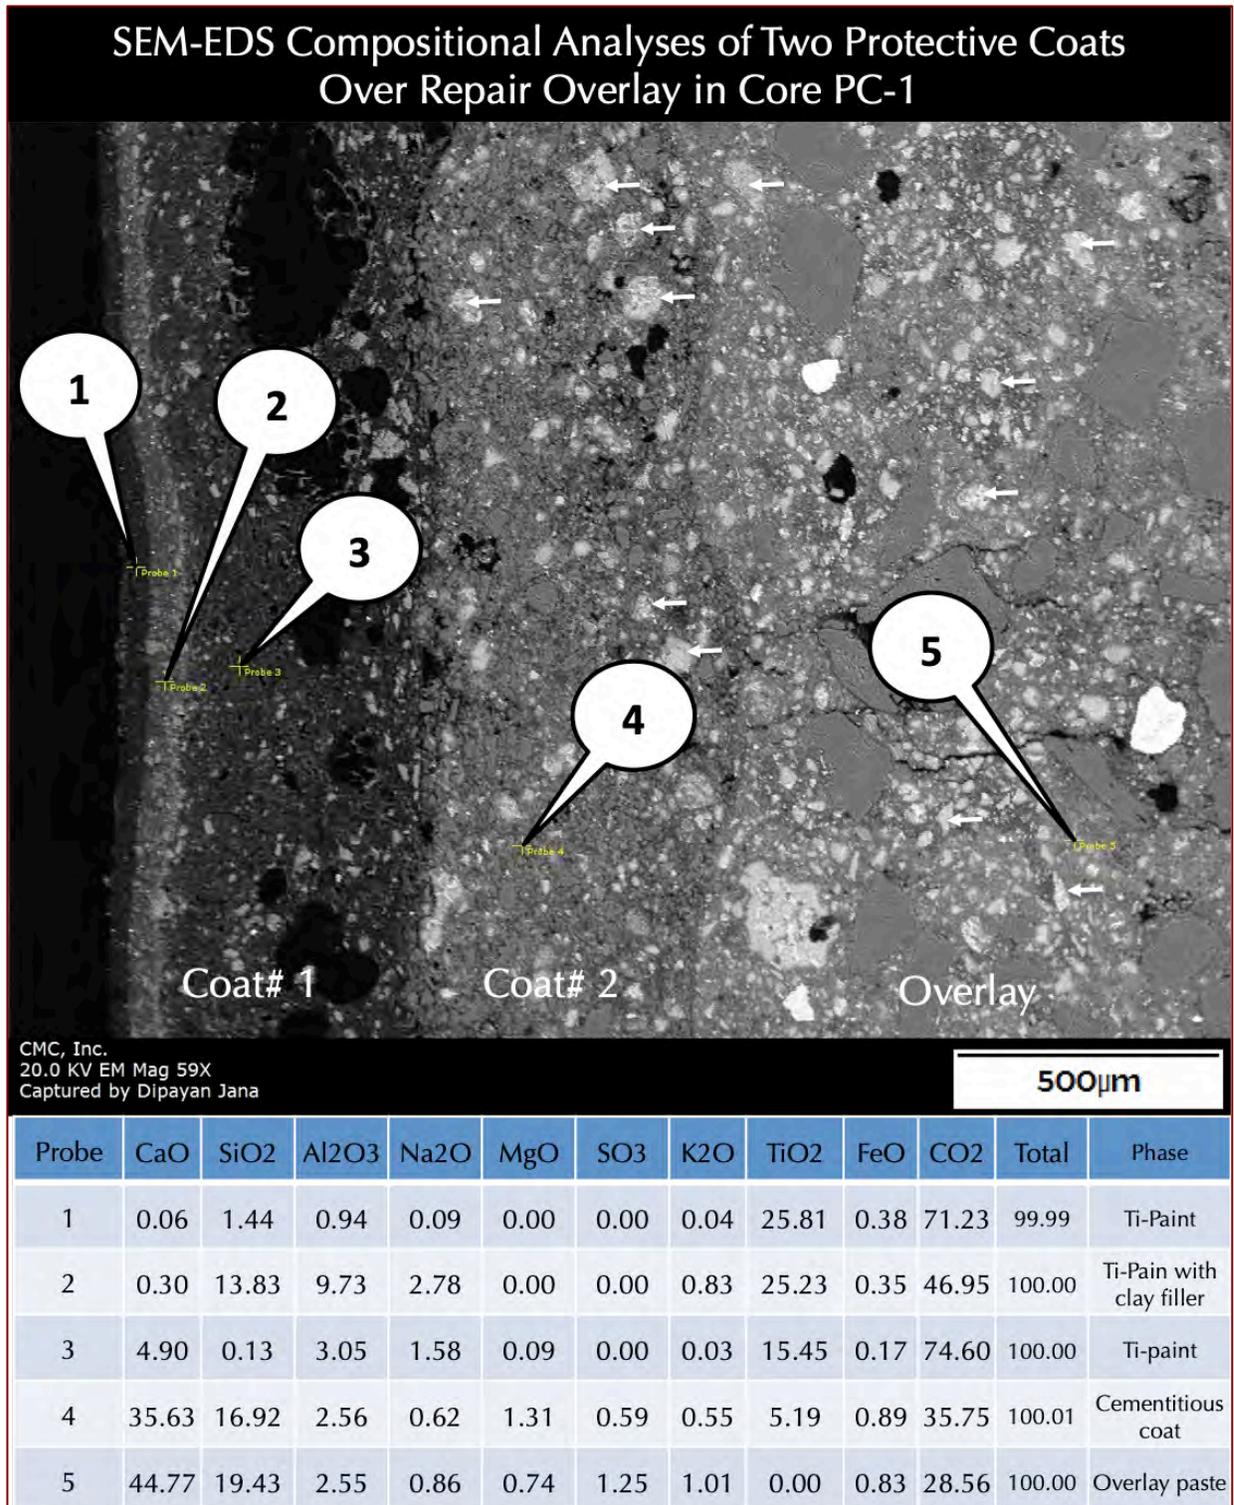
Figure 37: Secondary electron image (top) and X-ray elemental analyses from the tips of callouts from the two protective coats and paste region in the underlying overlay showing characteristic titanium oxide pigment based top coat (Coat #1) above a Ti-oxide pigment mixed with china clay filler in the paint (Coat #1, clay gave high silica and alumina) and underlying cementitious coat (Coat #2) having typical calcium silicate hydrate composition of Portland cement paste in the overlay. Fine, bright particles in the Coat #2 and in overlay are residual Portland cement particles in paste (some are marked with arrows).

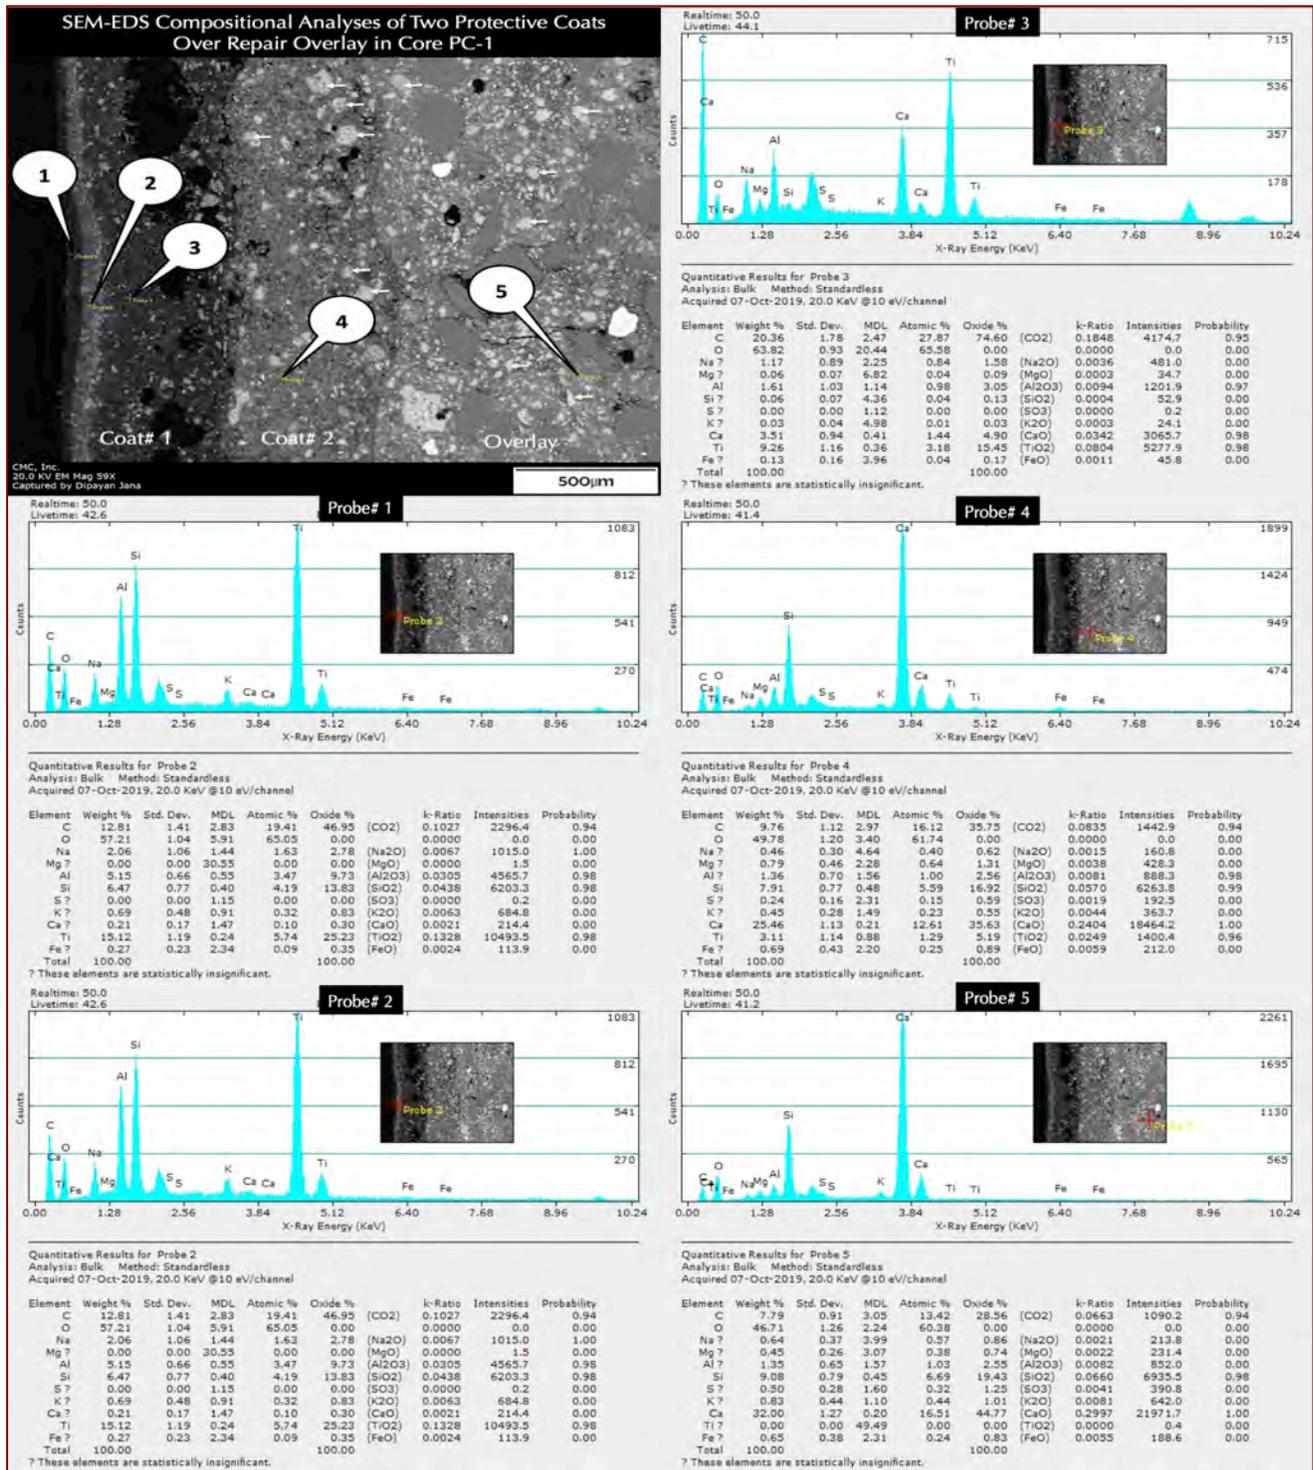
Figure 38: X-ray elemental spectra of five probes across the two protective coats and underlying overlay shown in the previous Figure showing variations in elemental peaks from protective coats to the overlay. Notice titanium peaks are found only in the first three probes taken from the top of Coat #1 whereas Probe #4 from the underlying Coat #2 shows negligible titanium but calcium and silica peaks from calcium silicate hydrate Portland cement paste. The overlay shows typical calcium and silica enrichment from calcium silicate hydrate composition of portland cement paste in Probe #5.

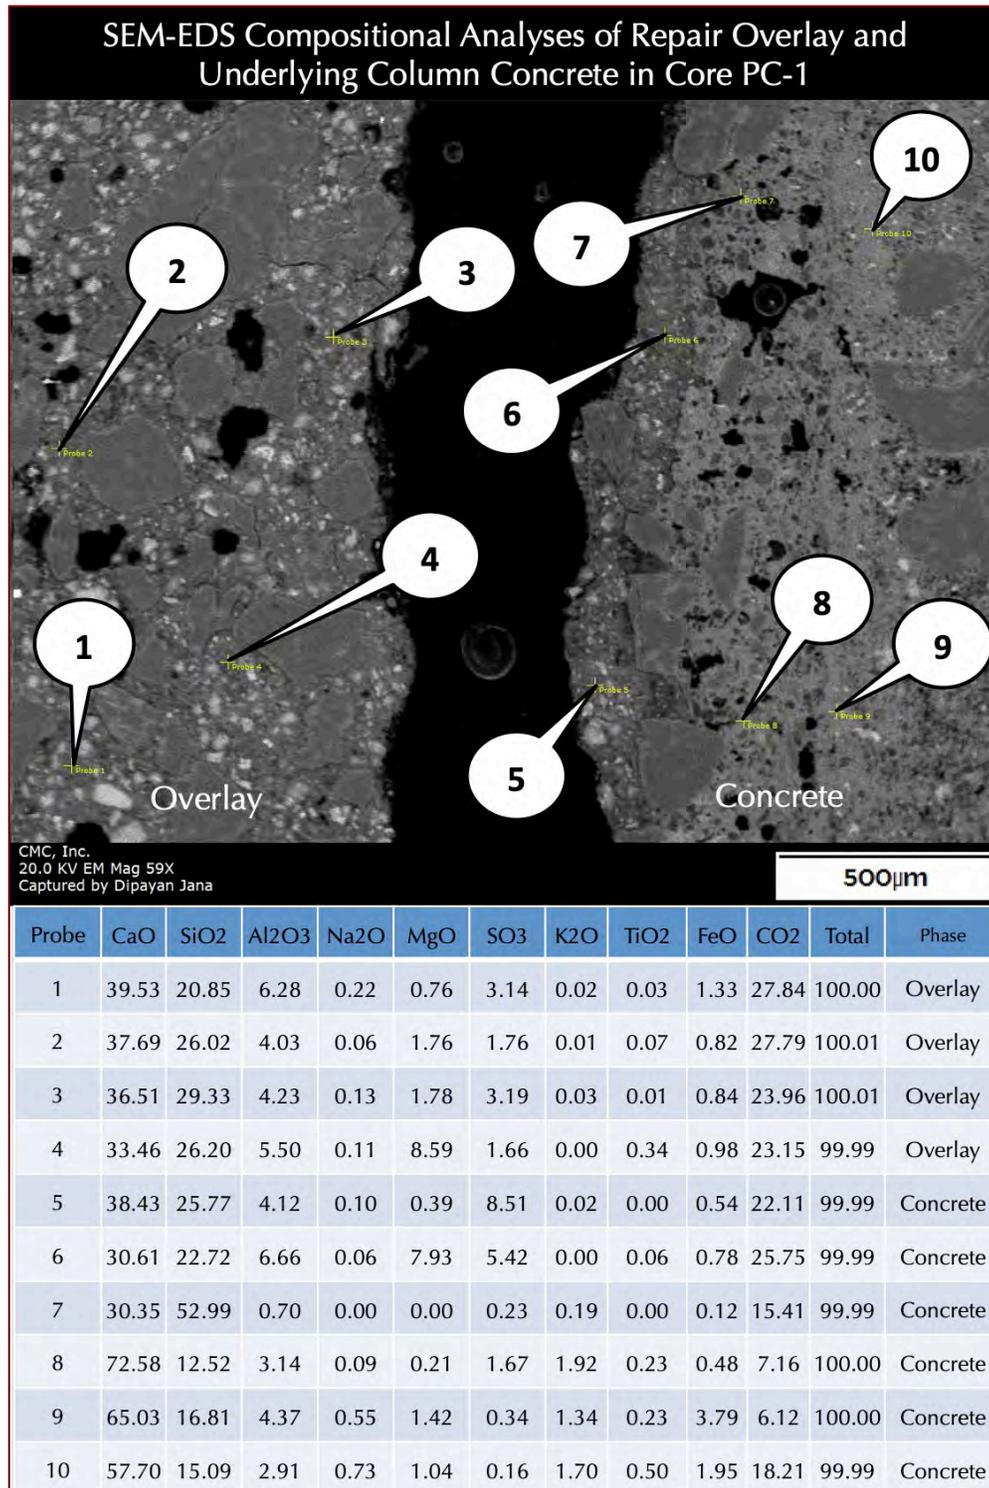
Figure 39: Secondary electron image (top) and X-ray elemental analyses from the tips of callouts from the underside of repair overlay at left and column concrete at right in Core PC-1 showing characteristic enrichment in calcium and silica from calcium silicate hydrate paste of Portland cement in both the overlay and the concrete. Notice high sulfate content in the overlay compared to concrete due to high cement content of overlay, and variable sulfate contents in paste in the concrete (high sulfate found in Probe #5 and 6 are from remains of overlay on concrete surface). Fine, bright particles in the overlay at left are residual Portland cement particles in paste.

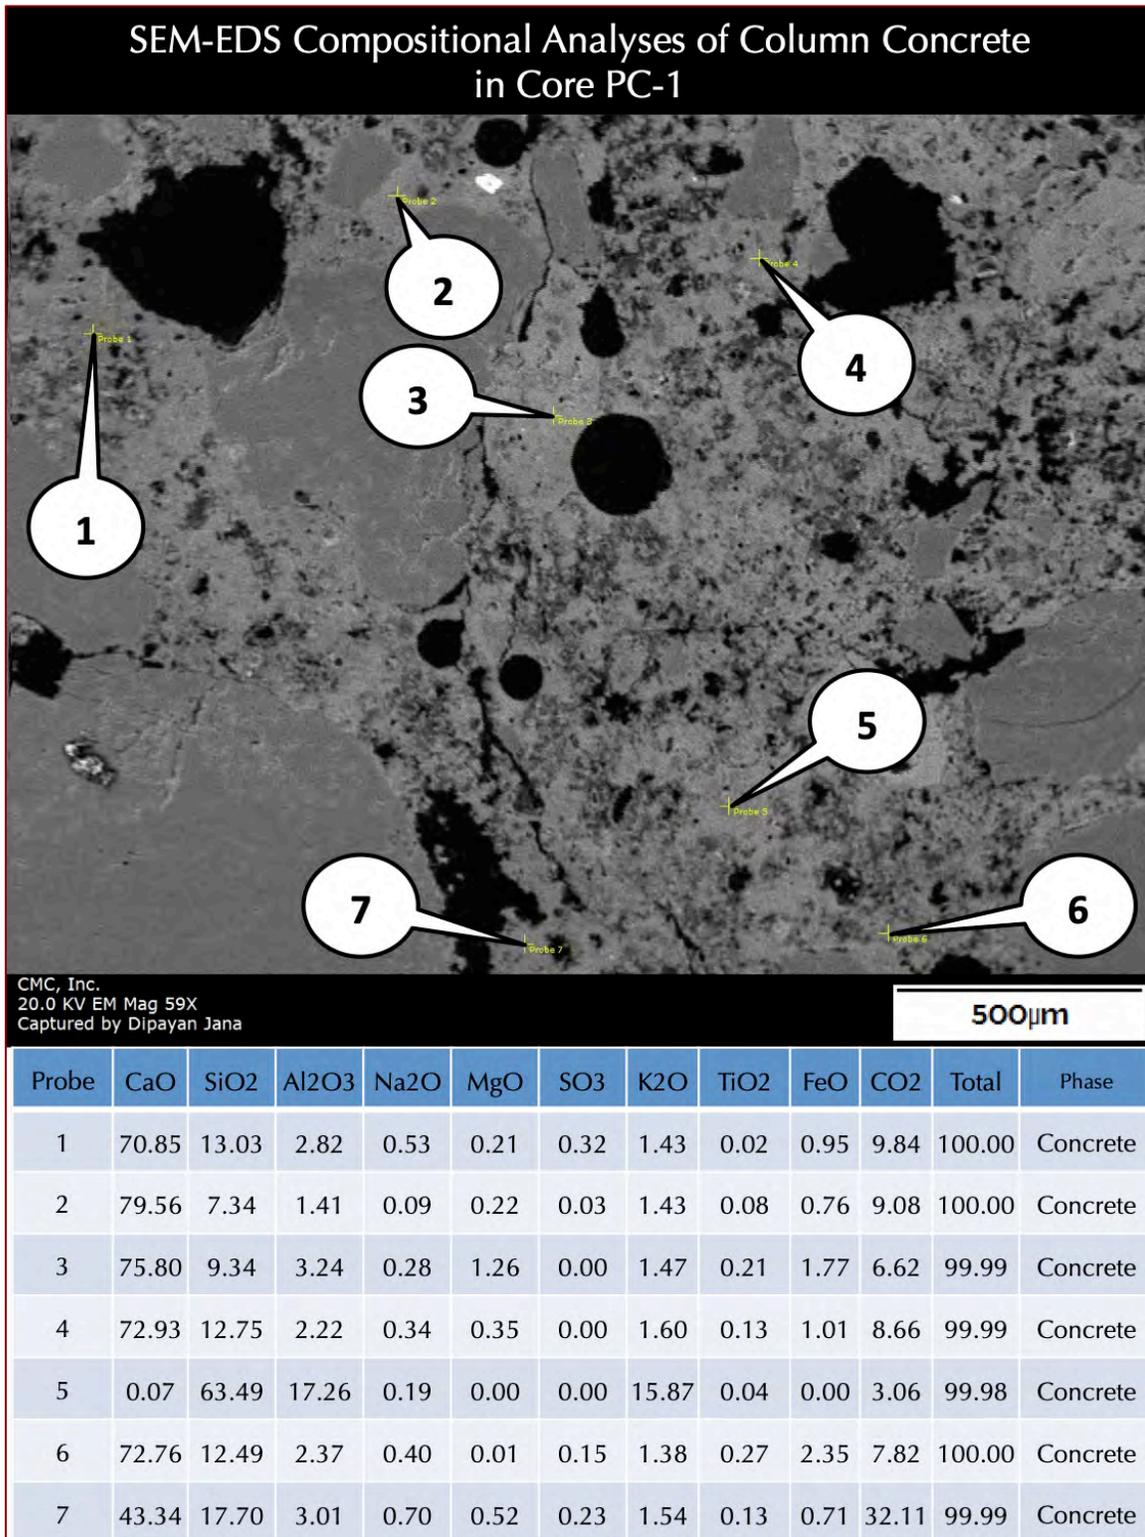
Figure 40: Secondary electron image (top) and X-ray elemental analyses from the tips of callouts from the paste region of column concrete in Core PC-1 showing characteristic enrichment in calcium and silica from calcium silicate hydrate paste of Portland cement. Notice the overall absence of any sulfate enrichment in the paste of column concrete indicating no internal sulfate attack in the concrete.

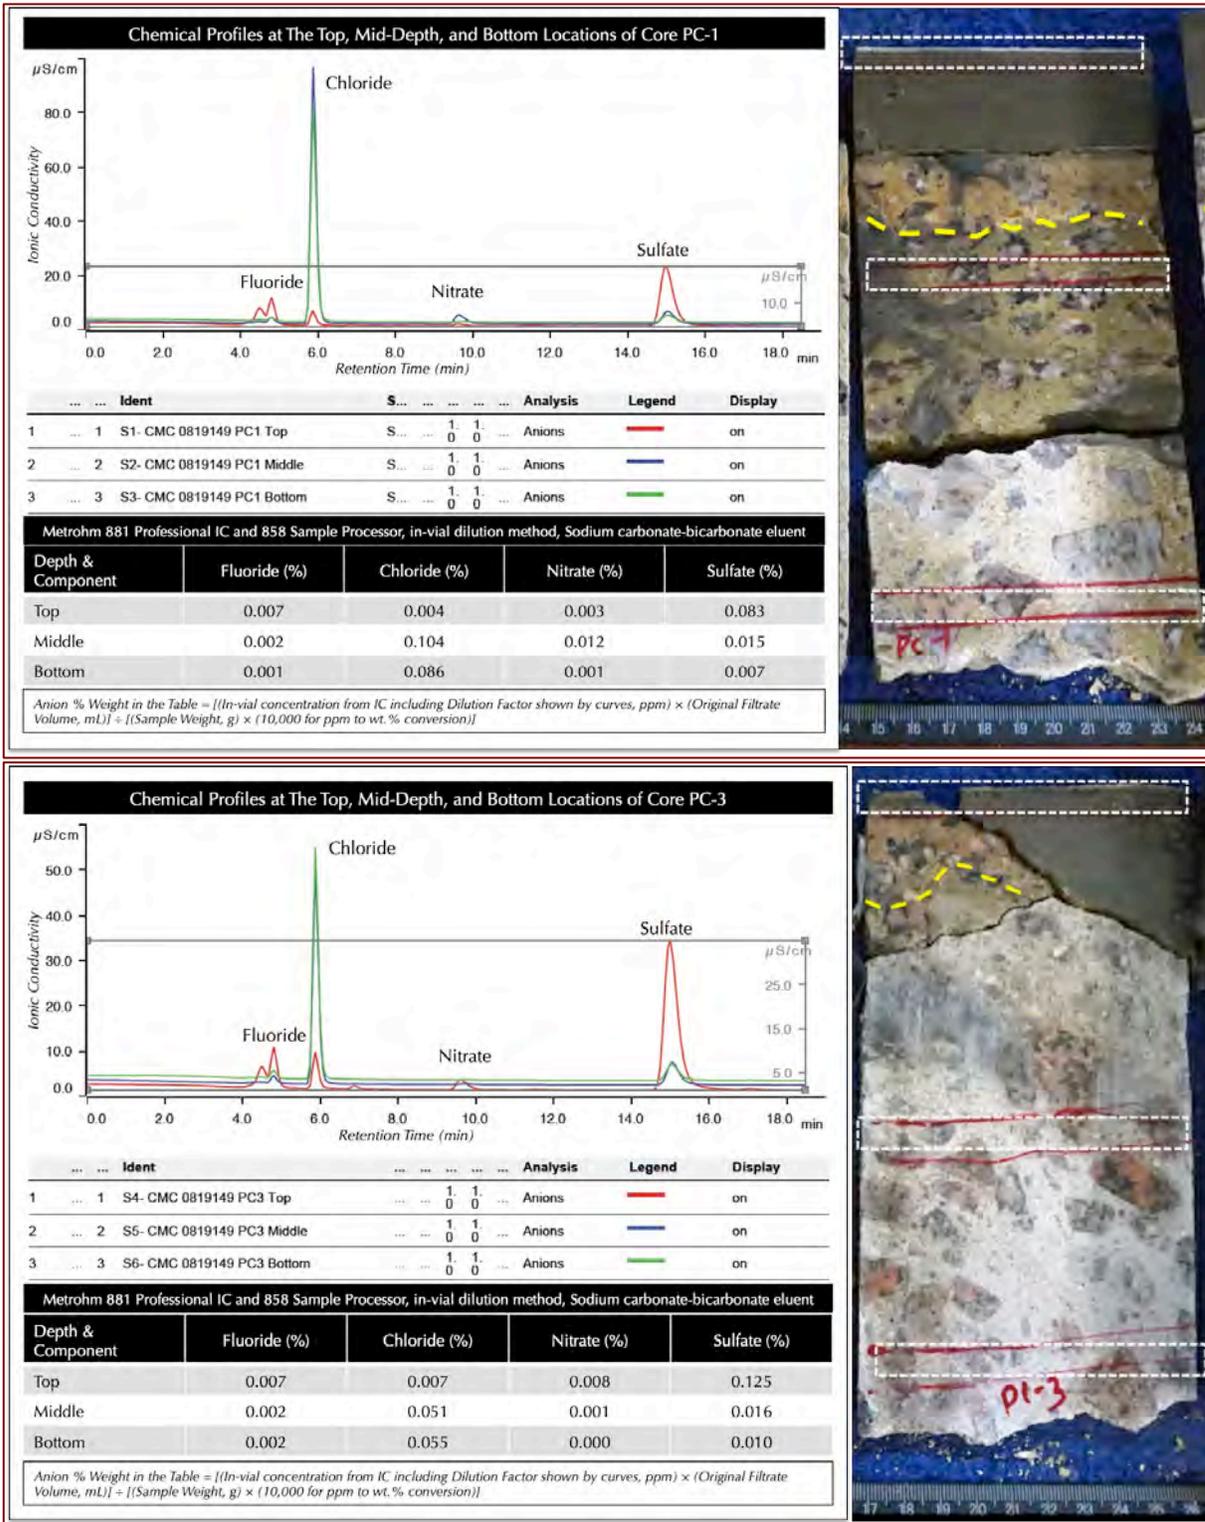
Figure 42: Results of ion chromatography of water-soluble anions of deionized water-digested pulverized concrete from top, mid-depth, and bottom region of Core PC-1 (top) and PC-3 (bottom). For each core, chromatograms from three depths are superposed on each other. In both cores, overlay showed negligible chloride for dense nature and high sulfate for high cement content compared to column concrete. Chloride contents at mid-depth and bottom ends of both cores are higher than threshold chloride content of 0.2 percent by mass of cement to initiate corrosion of reinforcing steel in concrete in the presence of oxygen and moisture.

Figure 42 shows ion chromatograms of water-soluble anions of deionized water-digested pulverized concrete from exposed (top), mid-depth, and interior (bottom) region of columns in Core PC-1 and PC-3. For each core, chromatograms from three depths are superposed on each other. In both cores, the repair overlay showed negligible chloride contents for dense and near-impermeable nature of low w/c pastes, and high sulfate contents for high cement content of overlay (lack of coarse aggregate and very fine crushed sand) compared to the column concrete. Chloride contents at mid-depth and bottom ends of both cores are higher than the threshold chloride content of 0.2 percent by mass of cement to initiate corrosion of reinforcing steel in concrete in the presence of oxygen and moisture.

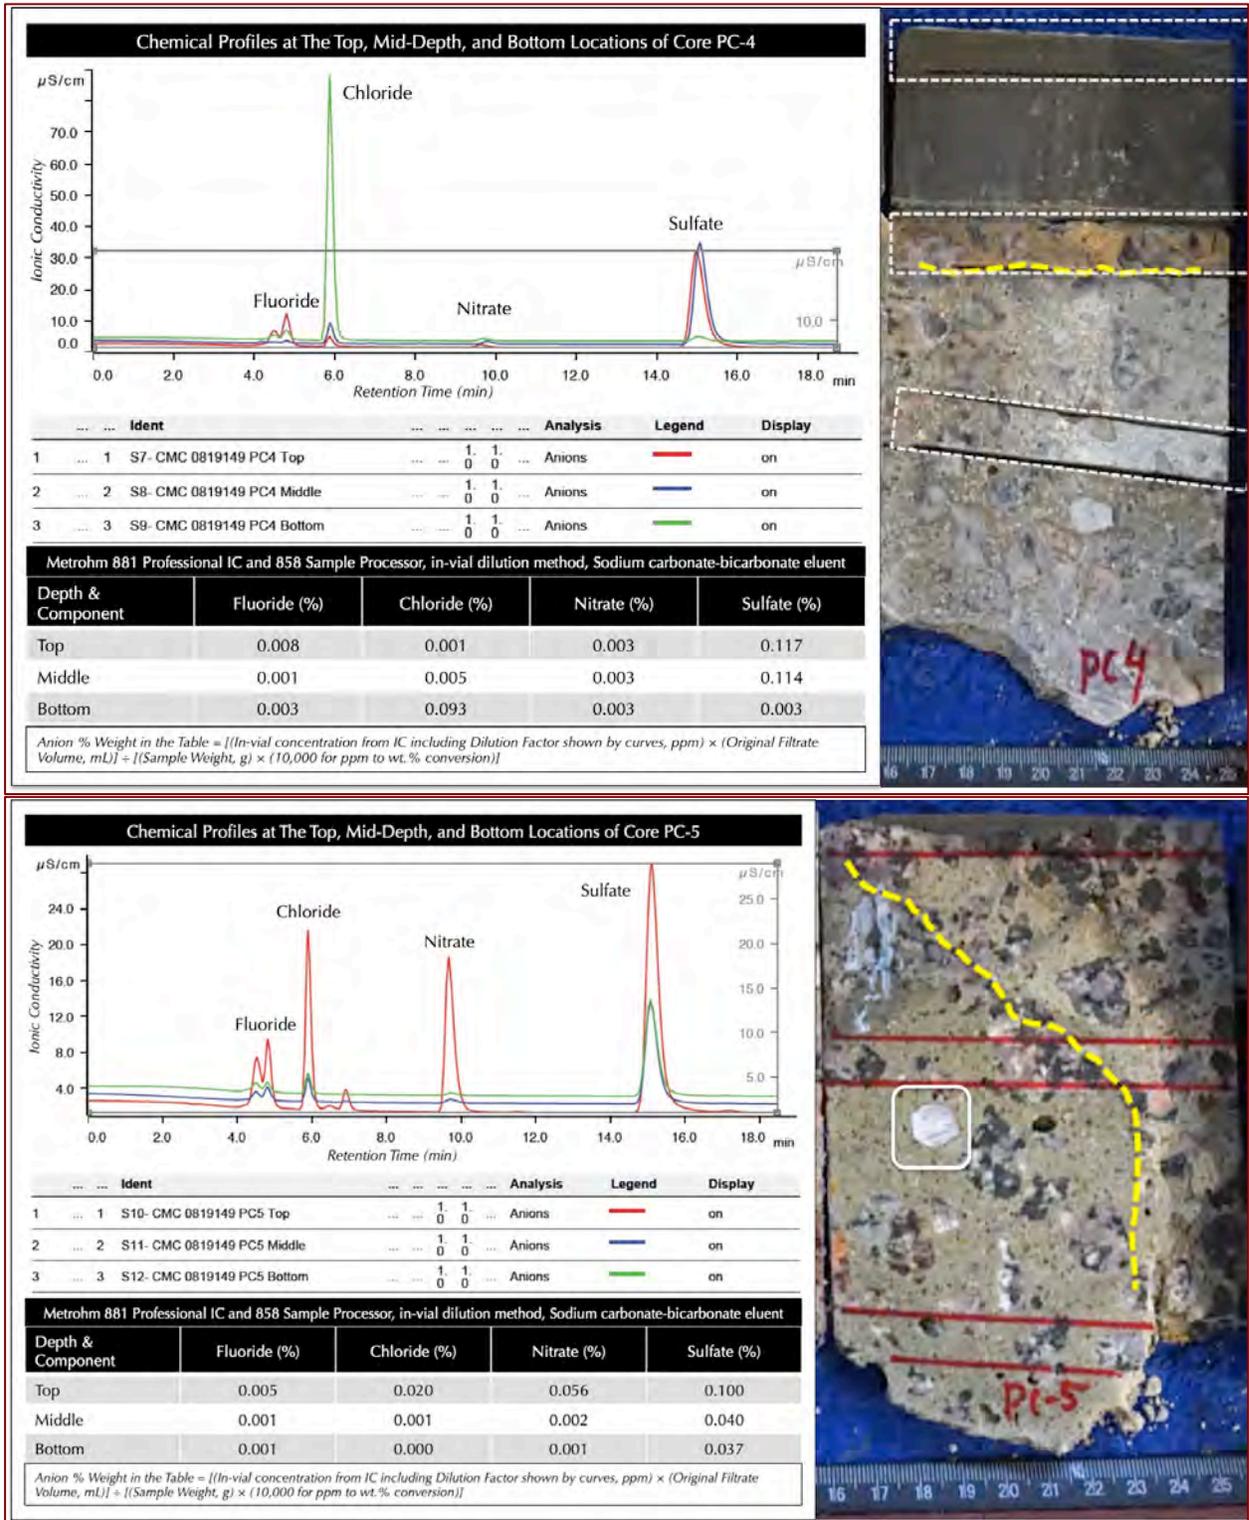
Figure 43: Results of ion chromatography of water-soluble anions of deionized water-digested pulverized concrete from top, mid-depth, and bottom region of Core PC-4 (top) and PC-5 (bottom). For each core, chromatograms from three depths are superposed on each other. Chloride content in the interior of Core PC-4 is higher than threshold chloride content of 0.2 percent by mass of cement to initiate corrosion of reinforcing steel in concrete in the presence of oxygen and moisture. For PC-5 chloride content in concretes are low. High nitrate at the top of PC-5 is from repair overlay, which is not found in any other overlays or concretes.
