## Chloride and Carbonation-Induced Corrosion of Reinforcing Steel In A Concrete Column – A Case Study

North Carolina State University  
Mann Hall Column Testing

**Background** - Exposed perimeter reinforced concrete columns at 4-story Mann Hall (constructed in 1963) in North Carolina State University has experienced corrosion of reinforcing steel in columns resulting in various levels of distress from vertical and horizontal cracking, delamination and spalls. Previous tests have determined the presence of elevated chlorides in some columns and deep carbonation, hence potential chloride-induced and/or carbonation-induced corrosion of steel in concrete to cause the distress. A repair attempt in 1993 was taken to reduce chloride and carbonation ingress by patching many deteriorated concrete covers over corroded rebars with adequate concrete cover of 1 to 4 in. thicknesses. However, continued deterioration over the past couple of decades has led to other engineering firms evaluate these columns in 2017. Recently, field evaluation of these columns were done in August of 2019 from visual surveying to audible sounding, excavations, chloride powder sampling, and removal of cores for pre

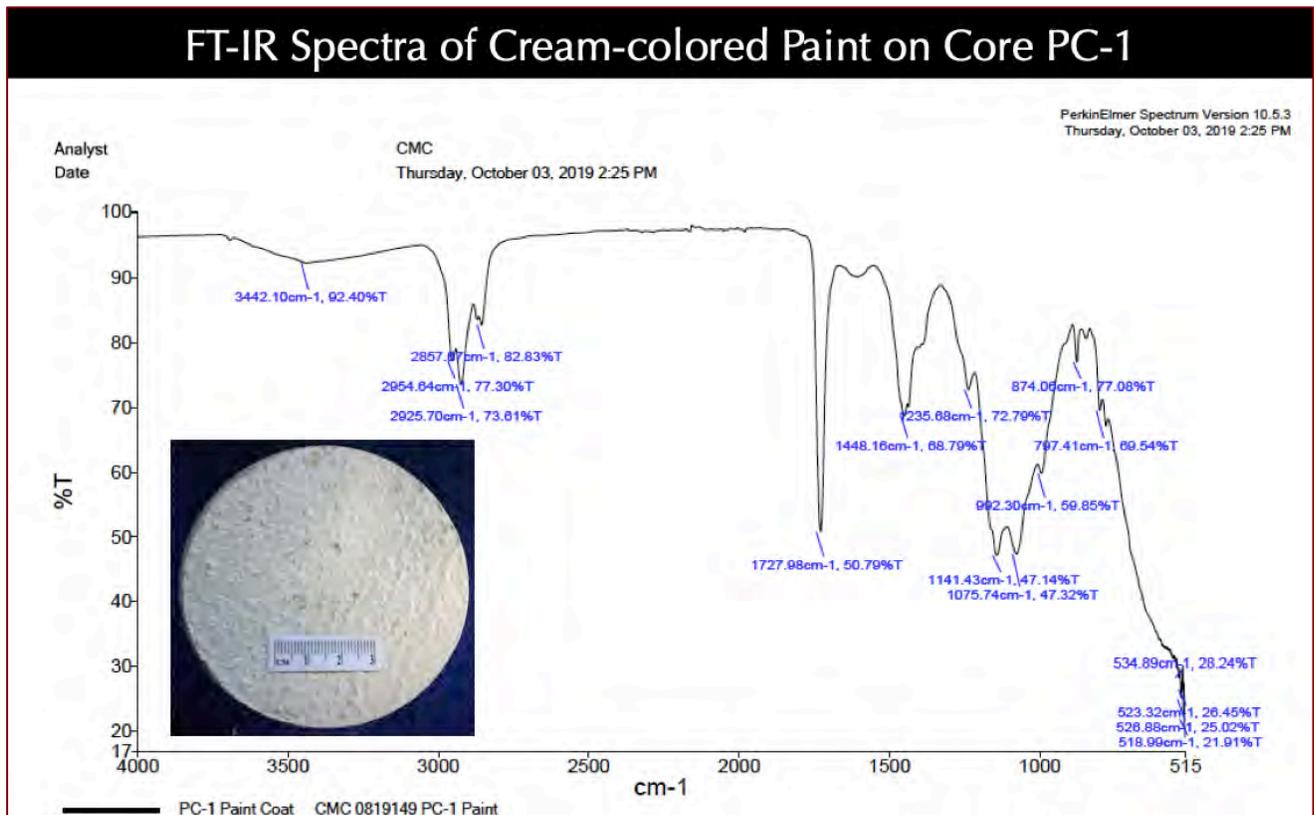
Figure 44: FT-IR spectrum of the top exposed paint coat (Coat #1) in Core PC-1 showing the presence of china clay filler and PVC-based binder.
