Petrographic Examinations Of Two Concrete Cores From An 80-Year-Old Hotel In A Marine Environment

Normandie Hotel, San Juan, Puerto Rico

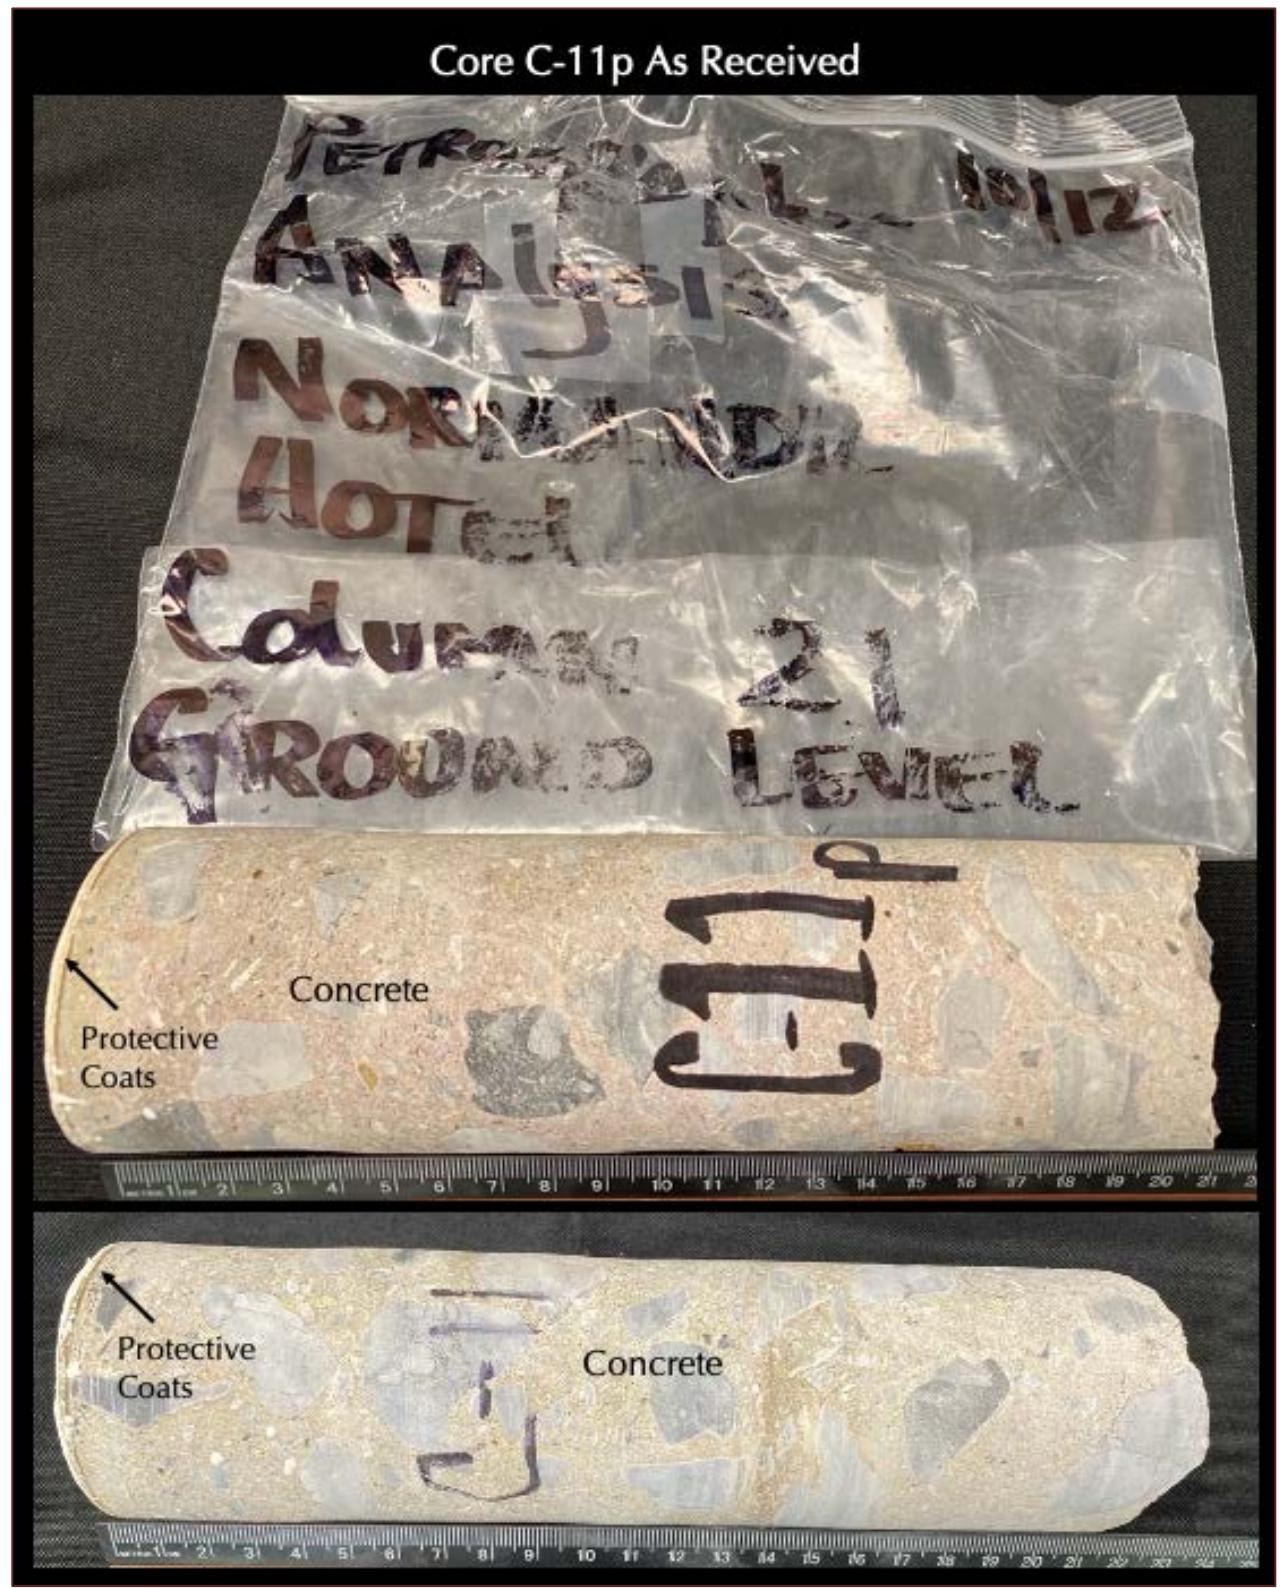
Figure 1: Core C-11p from Column 21, Ground Level, as received showing an off-white protective paint coat and a few more layers of a protective coating system, which is well-bonded to the underlying concrete body.

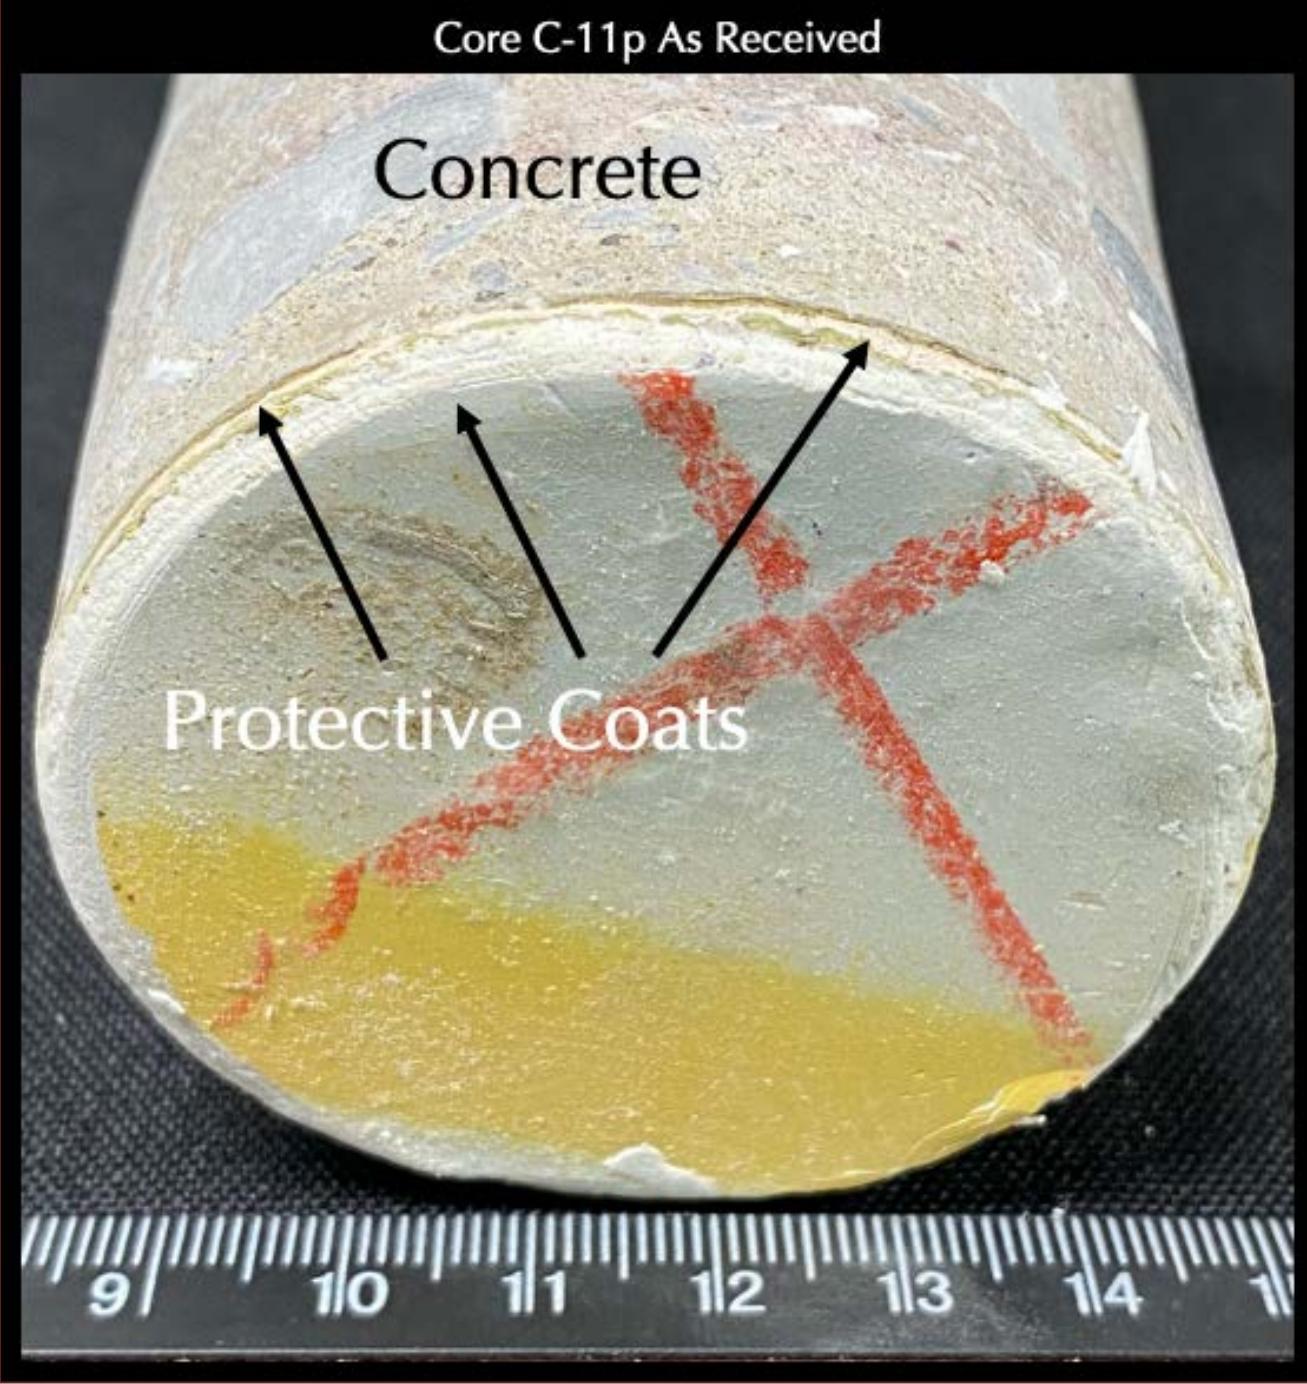
Figure 2: Core C-11p from Column 21, Ground Level, as received showing an off-white protective paint coat and a few more layers of a protective coating system, which is well-bonded to the underlying concrete body.

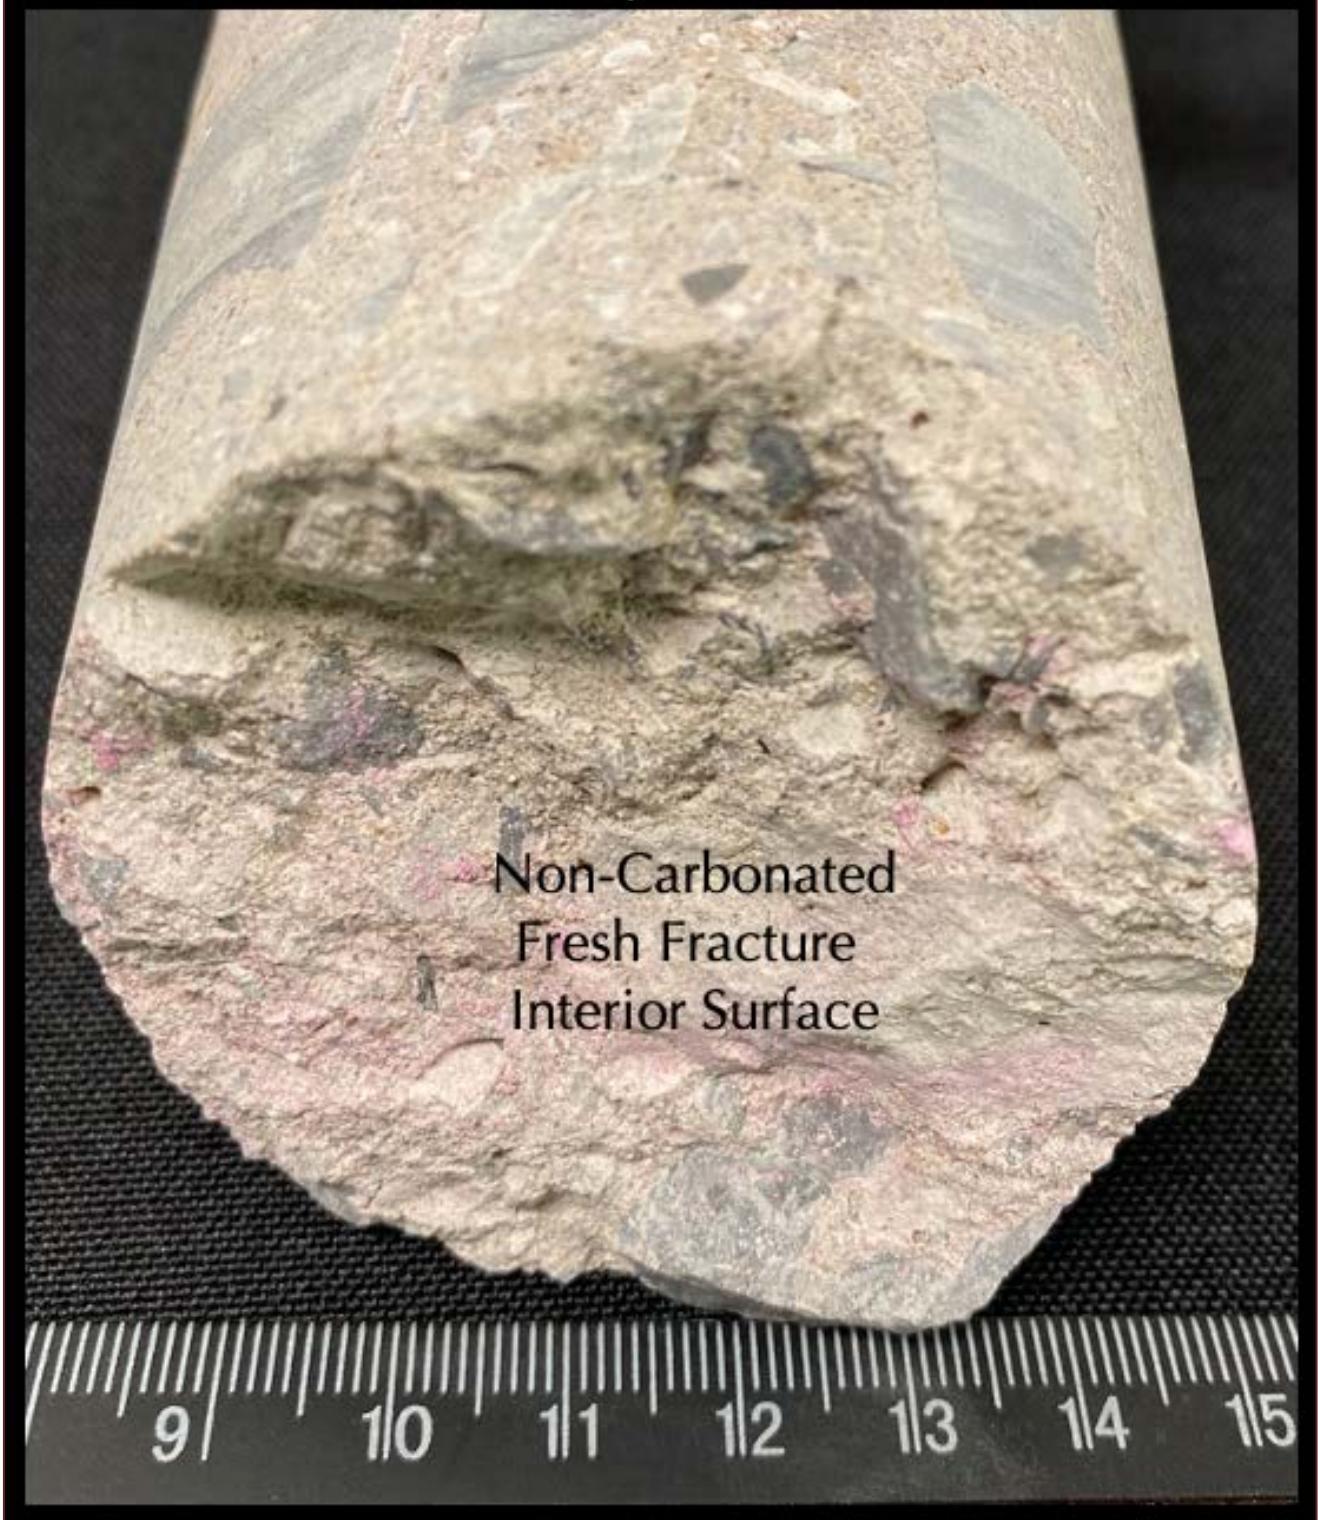
Figure 3: Fresh fractured interior opposite end of Core C-11p with a pinkish-discoloration due to field test of carbonation with phenolphthalein alcoholic solution.

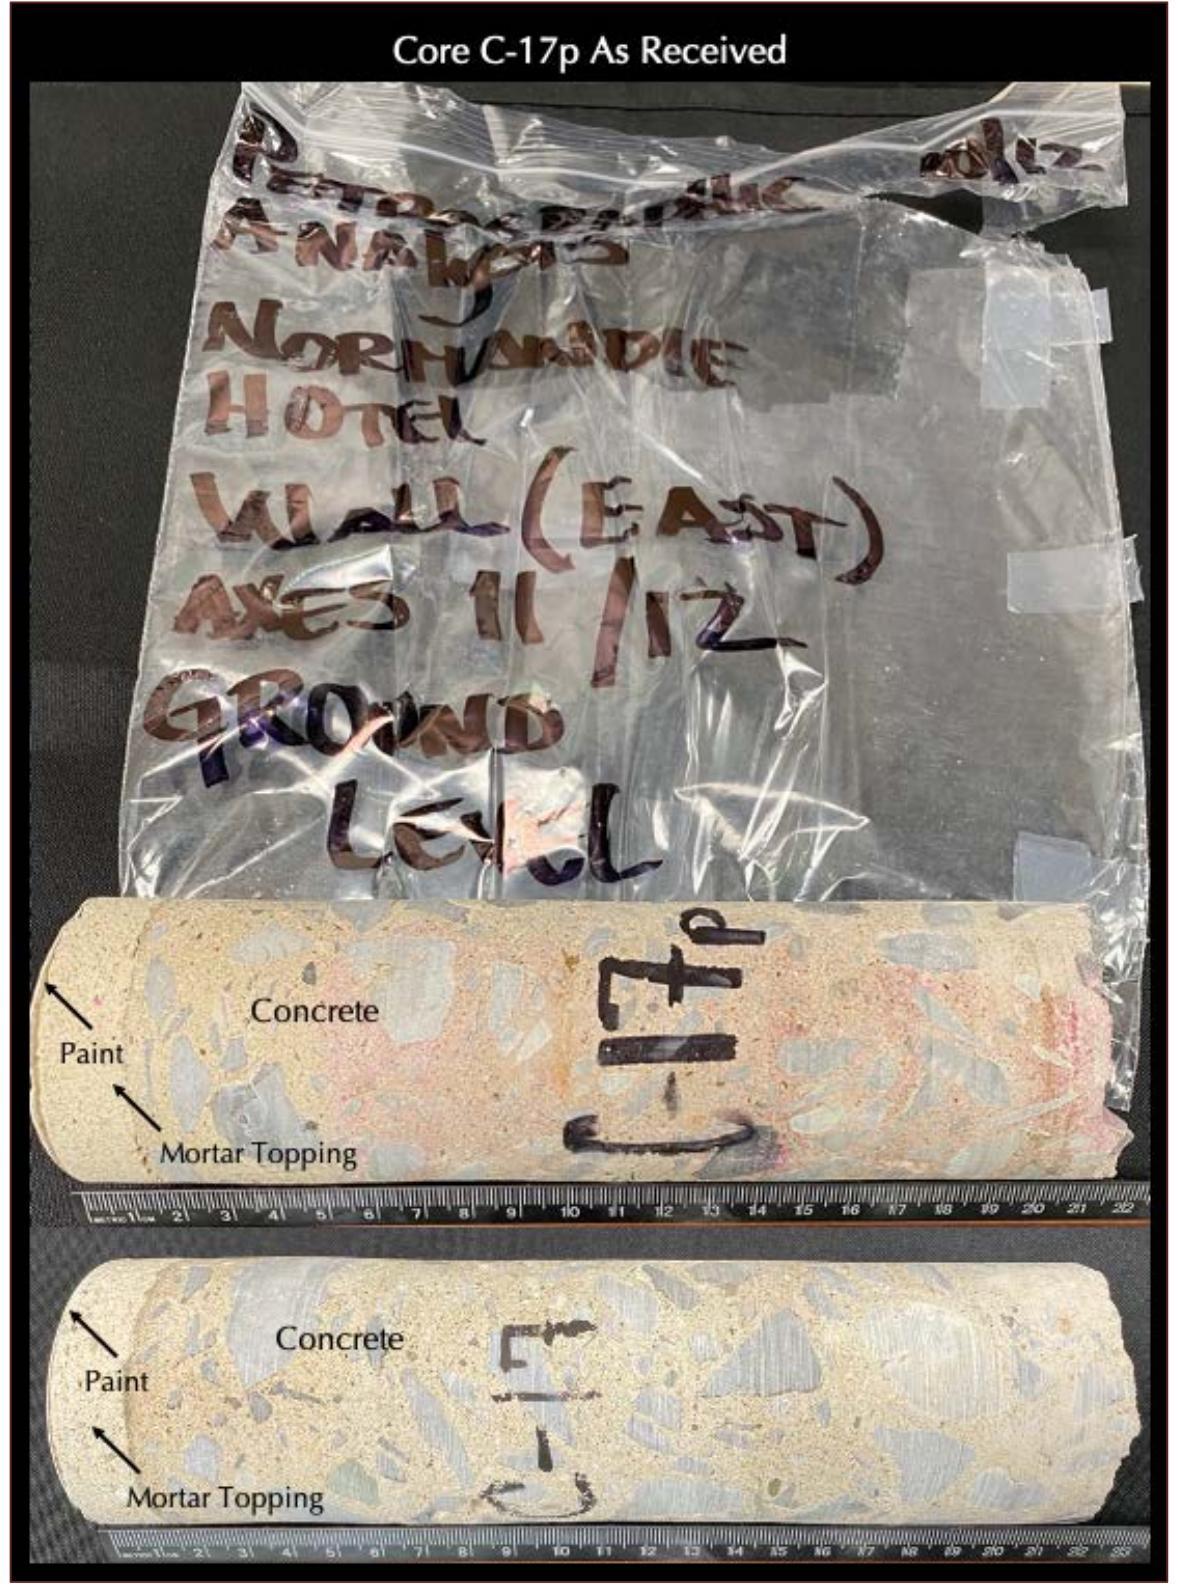
Figure 4: Core C-17p from East Wall, Ground Level, as received showing an off-white protective paint coat, an underlying thick mortar coat, and a few more layers of a protective coating system, which are all well-bonded to each other and eventually to the underlying main concrete body. Notice pinkish-discoloration of interior non-carbonated concrete body beyond approximately 40 mm thick carbonated concrete where pinkish-discoloration appeared after a field test of concrete carbonation with phenolphthalein alcoholic solution.

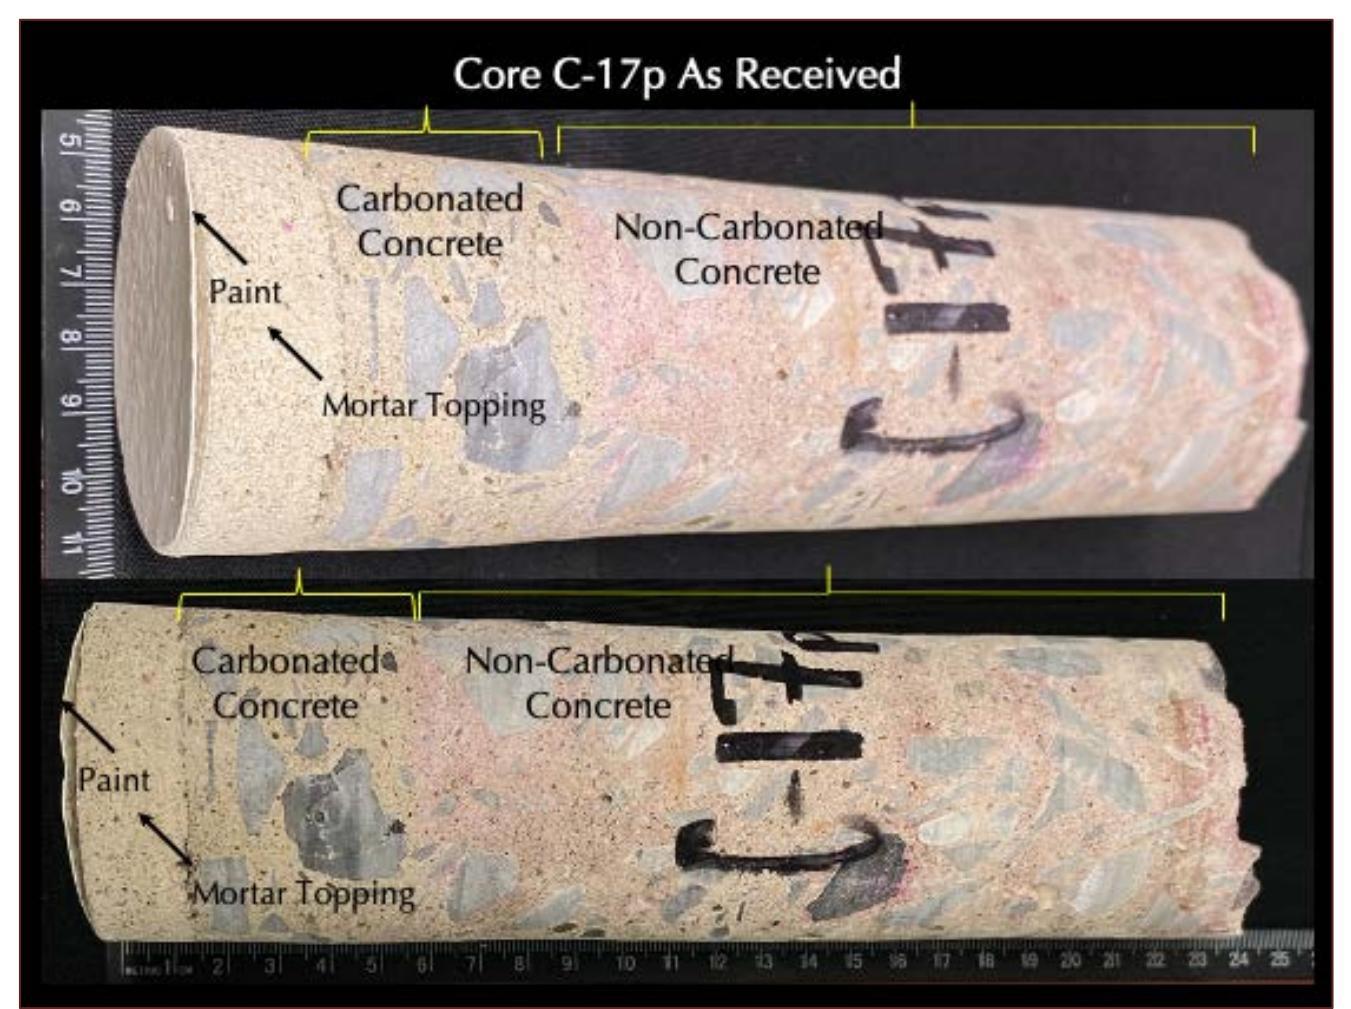
Figure 5: Core C-17p from East Wall, Ground Level, as received showing an off-white protective paint coat, an underlying thick mortar coat, and a few more layers of a protective coating system, which are all well-bonded to each other and eventually to the underlying main concrete body. Notice pinkish-discoloration of interior non-carbonated concrete body beyond approximately 40 mm thick carbonated concrete where pinkish-discoloration appeared after a field test of concrete carbonation with phenolphthalein alcoholic solution.

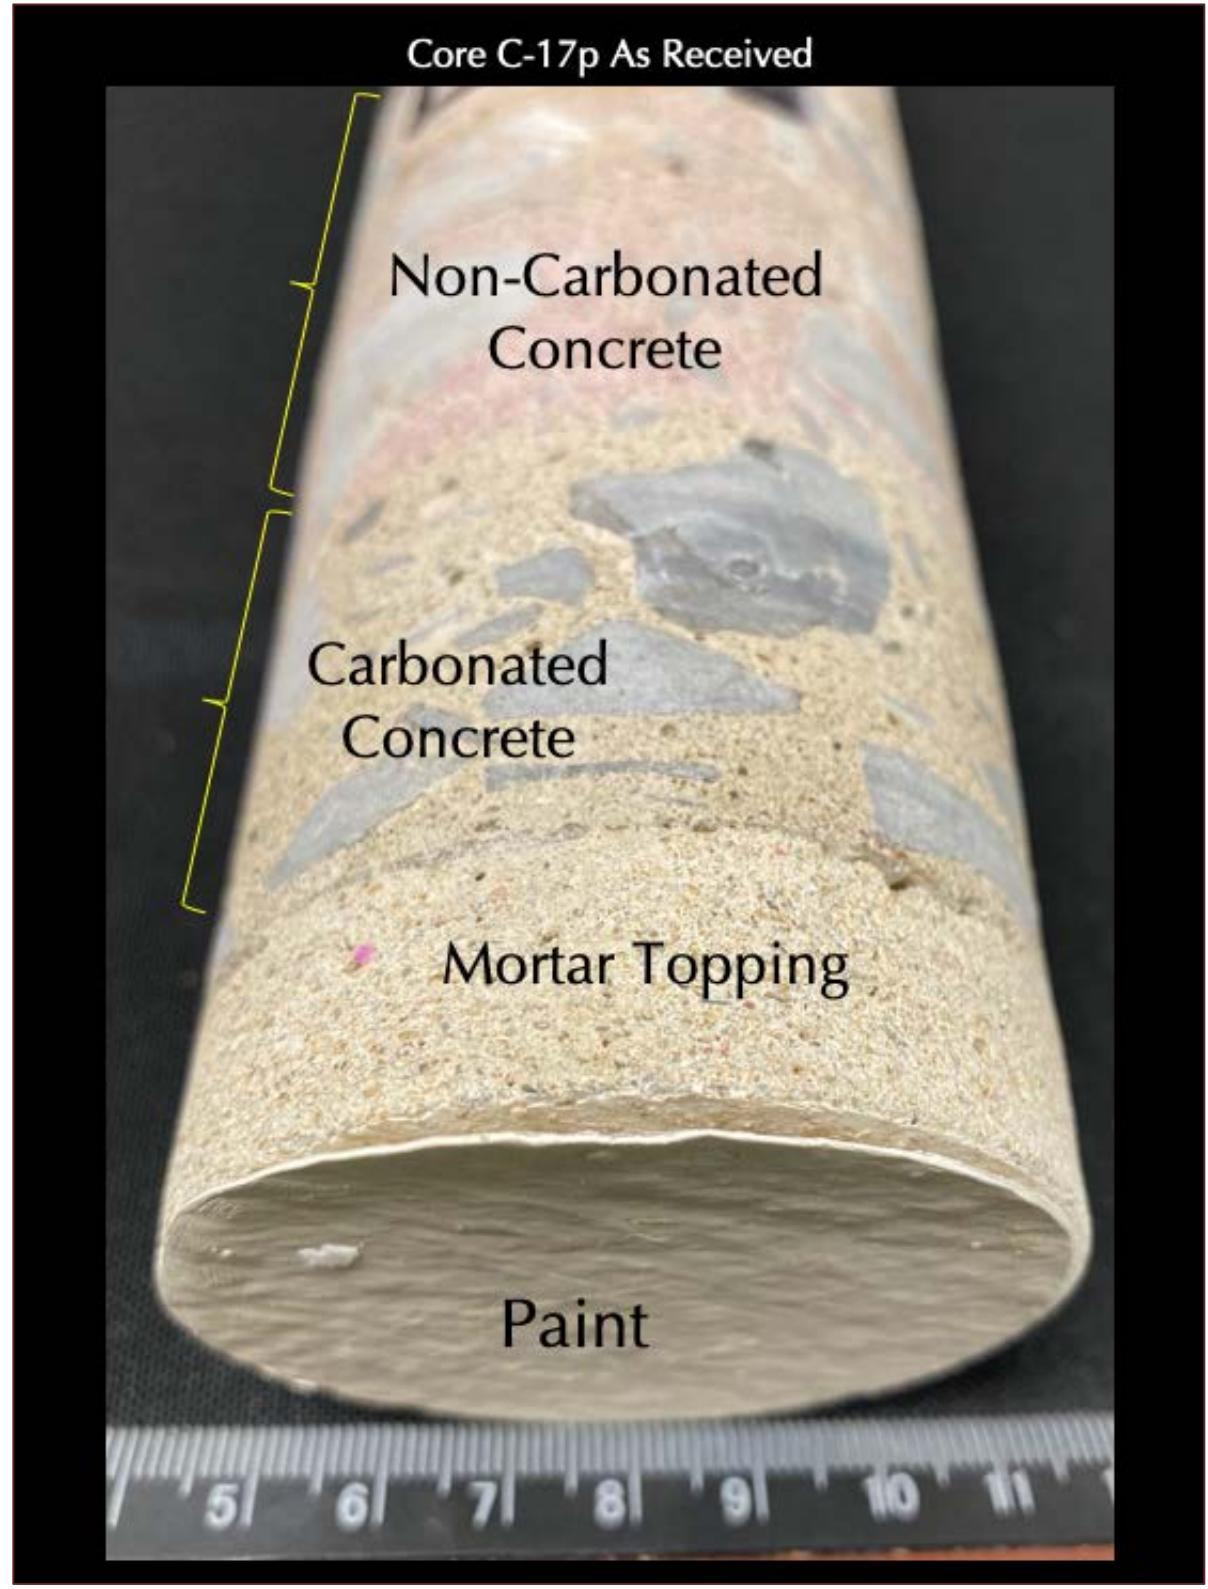
Figure 6: Core C-17p from East Wall, Ground Level, as received showing an off-white protective paint coat, an underlying thick mortar coat, and a few more layers of a protective coating system, which are all well-bonded to each other and eventually to the underlying main concrete body. Notice pinkish-discoloration of interior non-carbonated concrete body beyond approximately 40 mm thick carbonated concrete where pinkish-discoloration appeared after a field test of concrete carbonation with phenolphthalein alcoholic solution.

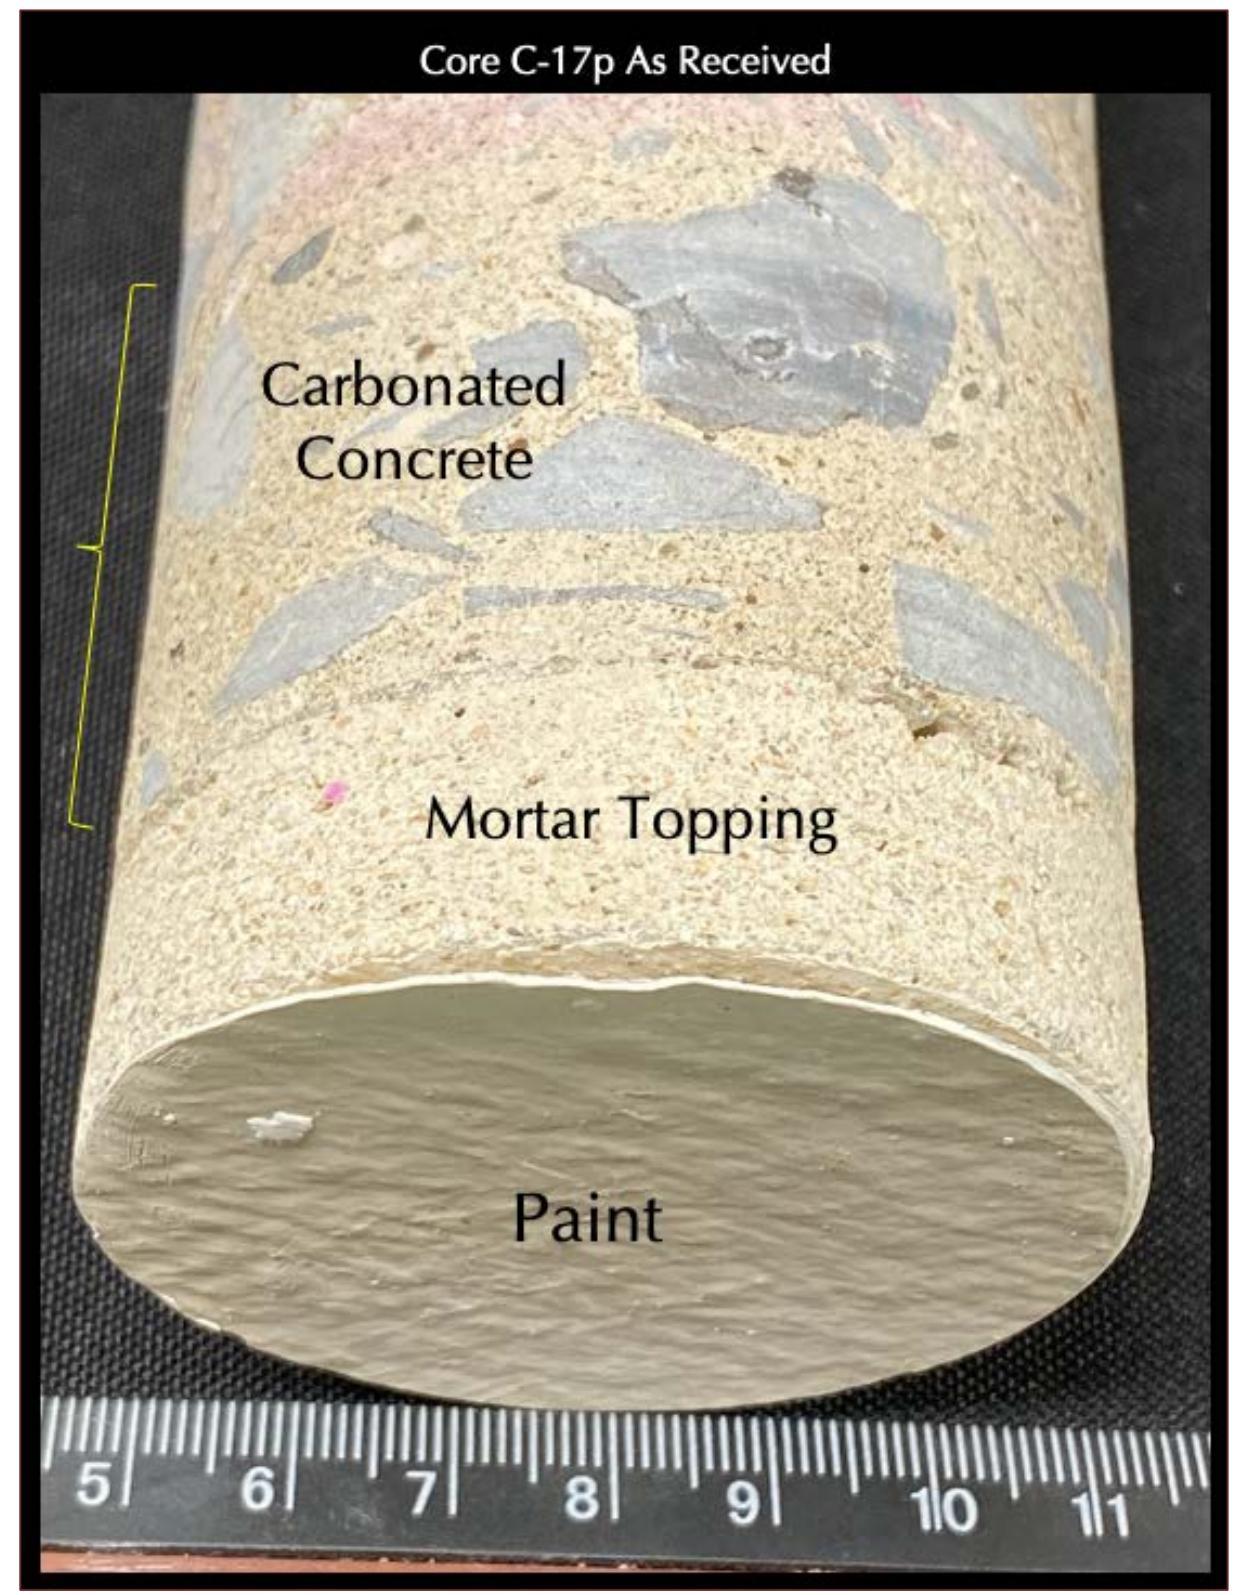
Figure 7: Core C-17p from East Wall, Ground Level, as received showing an off-white protective paint coat, an underlying thick mortar coat, and a few more layers of a protective coating system, which are all well-bonded to each other and eventually to the underlying main concrete body. Notice pinkish-discoloration of interior non-carbonated concrete body beyond approximately 40 mm thick carbonated concrete where pinkish-discoloration appeared after a field test of concrete carbonation with phenolphthalein alcoholic solution.

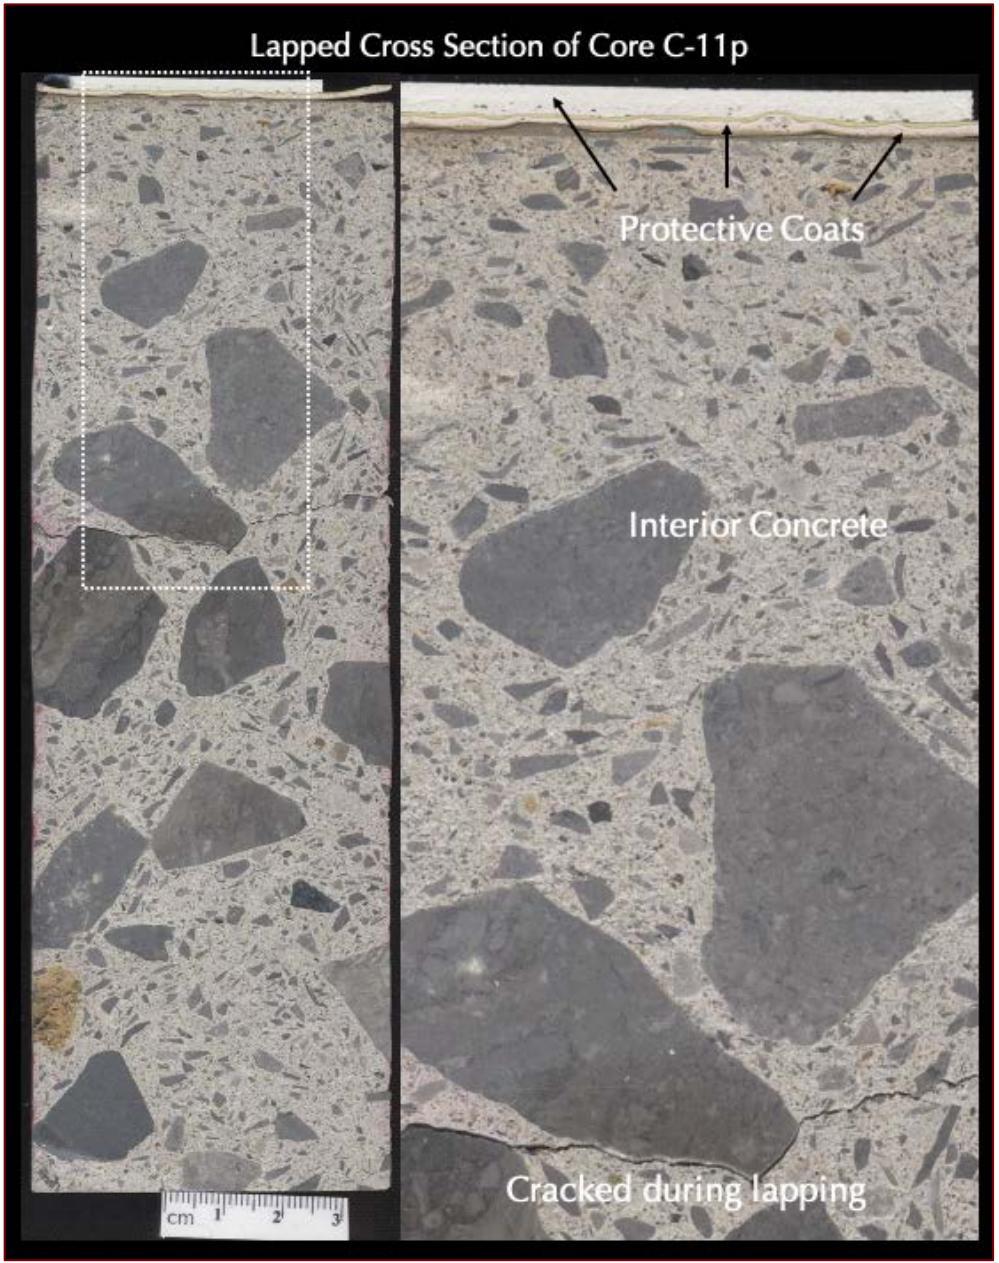
Figure 9: Lapped cross section at left and an enlarged view of the boxed area of lapped cross section at the right of Core C-11p. Notice the overall dense and well-consolidated nature of concrete in both sections containing dense, dark gray, crushed limestone coarse aggregate, where the coarse particles are poorly graded due to the deficiency of some intermediate and finer size fractions. The fine aggregate is a mixture of crushed limestone, marine shell fragments, and finer-size crushed siliceous fragments (quartz, feldspar, chert, quartzite, siltstone, etc.), which are well-graded and well-distributed throughout the depth of the core. Notice a series of protective coats applied on the exposed side of concrete to protect the concrete from penetration of potentially deleterious agents (chloride, carbon dioxide, moisture, etc.) from the marine environment.

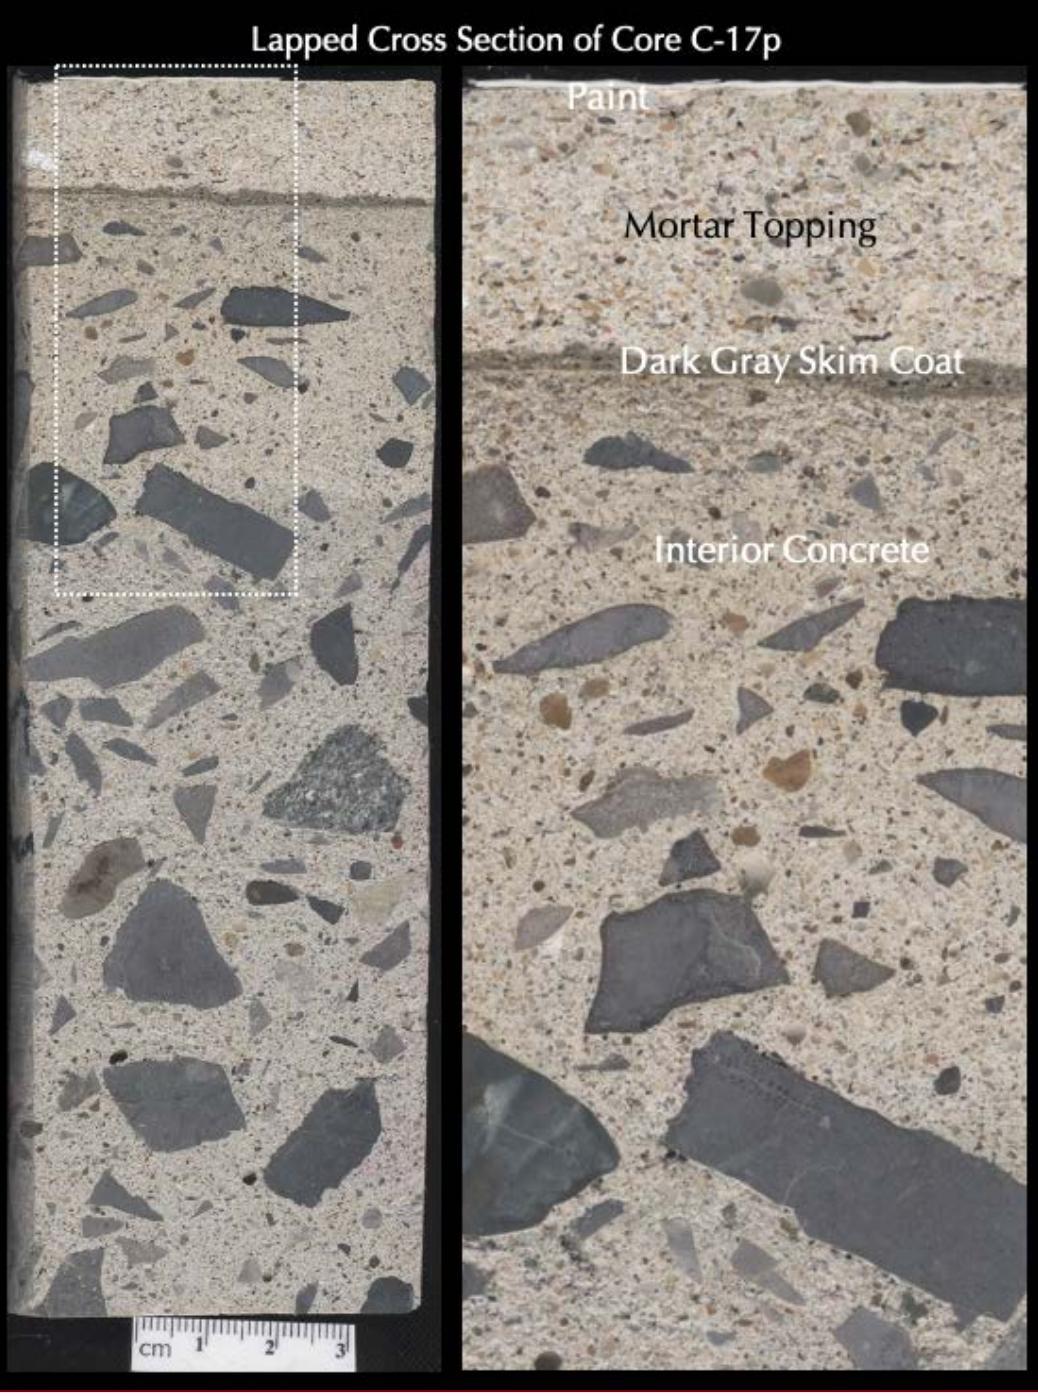
Figure 10: Lapped cross section at left and an enlarged view of the boxed area of lapped cross section at the right of Core C-17p. Notice the overall dense and well-consolidated nature of concrete in both sections containing dense, dark gray, crushed limestone coarse aggregate, where the coarse particles are poorly graded due to the deficiency of some intermediate and finer size fractions. The fine aggregate is a mixture of crushed limestone, marine shell fragments, and finer-size crushed siliceous fragments (quartz, feldspar, chert, quartzite, siltstone, etc.), which are well-graded and well-distributed throughout the depth of the core. Notice a series of protective coats sandwiched between a thick mortar coat, all applied on the exposed side of concrete to protect the concrete from penetration of potentially deleterious agents (chloride, carbon dioxide, moisture, etc.) from the marine environment.

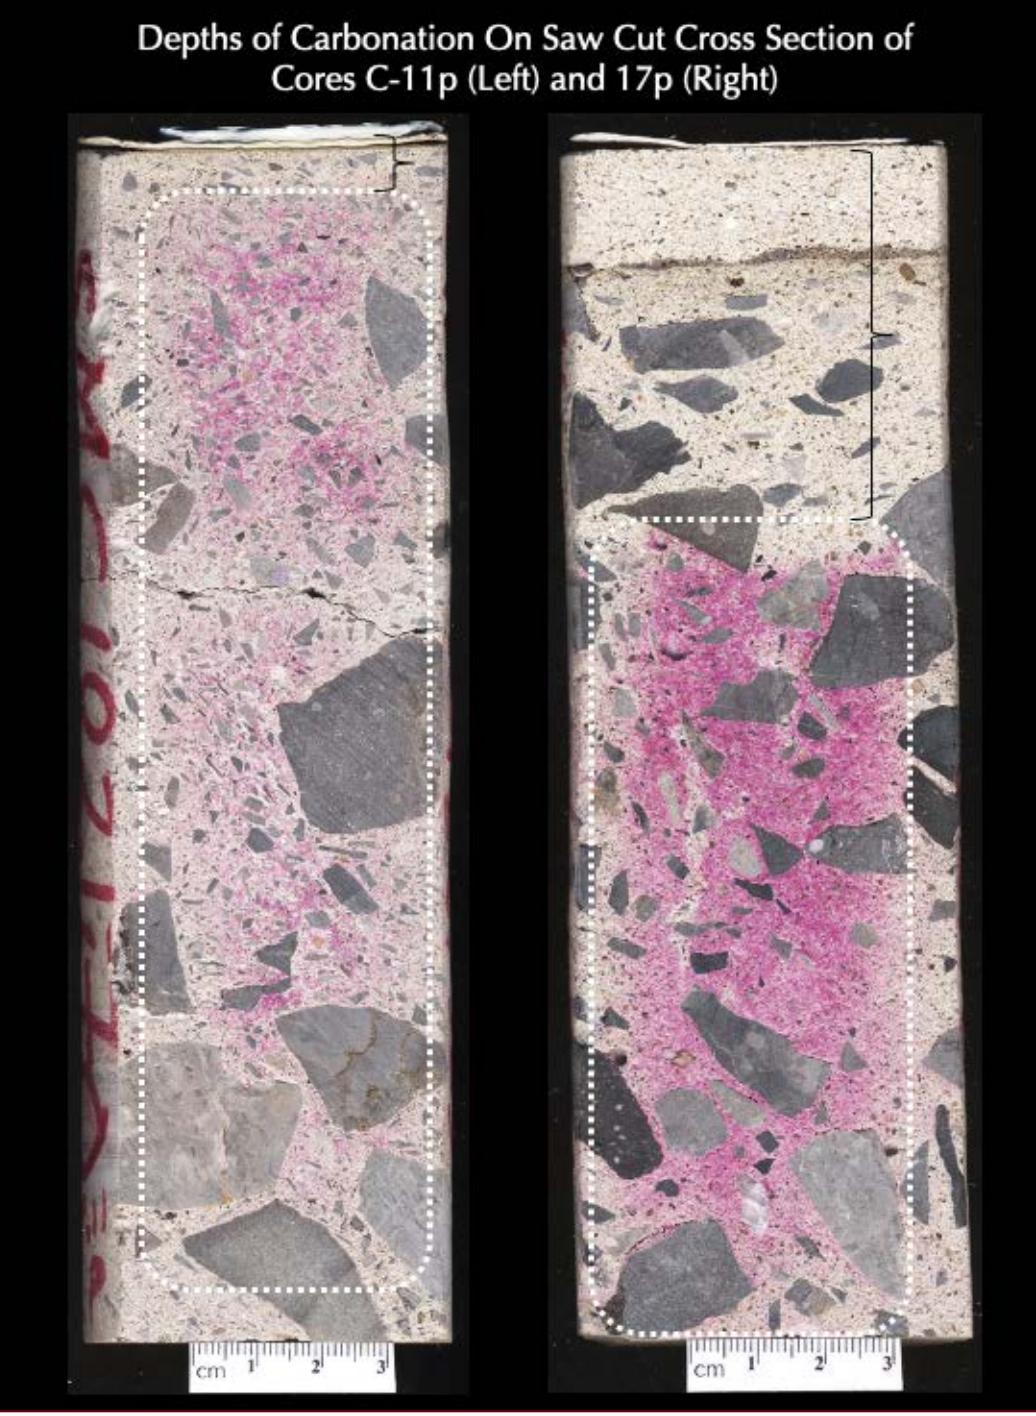
Figure 11: Saw-cut cross sections of Core C-11p (left) and C-17p (right) after treatment with phenolphthalein alcoholic solutions to show significantly deeper depth of carbonation of concrete in Core C-17p at right, which is measured to be approximately 40 mm after which the remaining 170 mm of concrete is non-carbonated and discolored to pink tone. Core C-11p, on the other hand, shows only a shallow depth of carbonation at the exposed surface region measured to be approximately 10 mm, after which the remainder of the concrete shows sporadic patchy carbonation due to inherent porous and permeable nature of concrete to atmospheric carbon dioxide. Boxed areas in both cross sections show interior non-carbonated or less carbonated concrete that have turned pink compared to carbonated surface regions that remained light gray after treatment with phenolphthalein solutions.

Due to the overall soft, porous, high water-cement ratio natures of paste, atmospheric carbonation has extended as deep as 40 mm at the location of Core C-17p, and from severe carbonation at the top 10 mm of exposed end to patchy carbonation throughout the retrieved depth in Core C-11p. Such deep carbonation from inherent porous and permeable high water-cement ratio concrete can initiate corrosion of reinforcing steel in concrete in the presence of oxygen and moisture. There is, however, no evidence of any reinforcing steel detected in either core, or evidence of corrosion of steel in concrete.

Due to the suspected high chloride environment, water-soluble chloride contents should be determined from the exposed ends to the interior of the cores to determine the depth of penetration of chloride. Chloride, especially in a carbonated concrete can easily initiate corrosion of steel in the presence of oxygen and moisture. Therefore, additional chloride content analyses at the exposed end and interior depths of the cores are recommended.

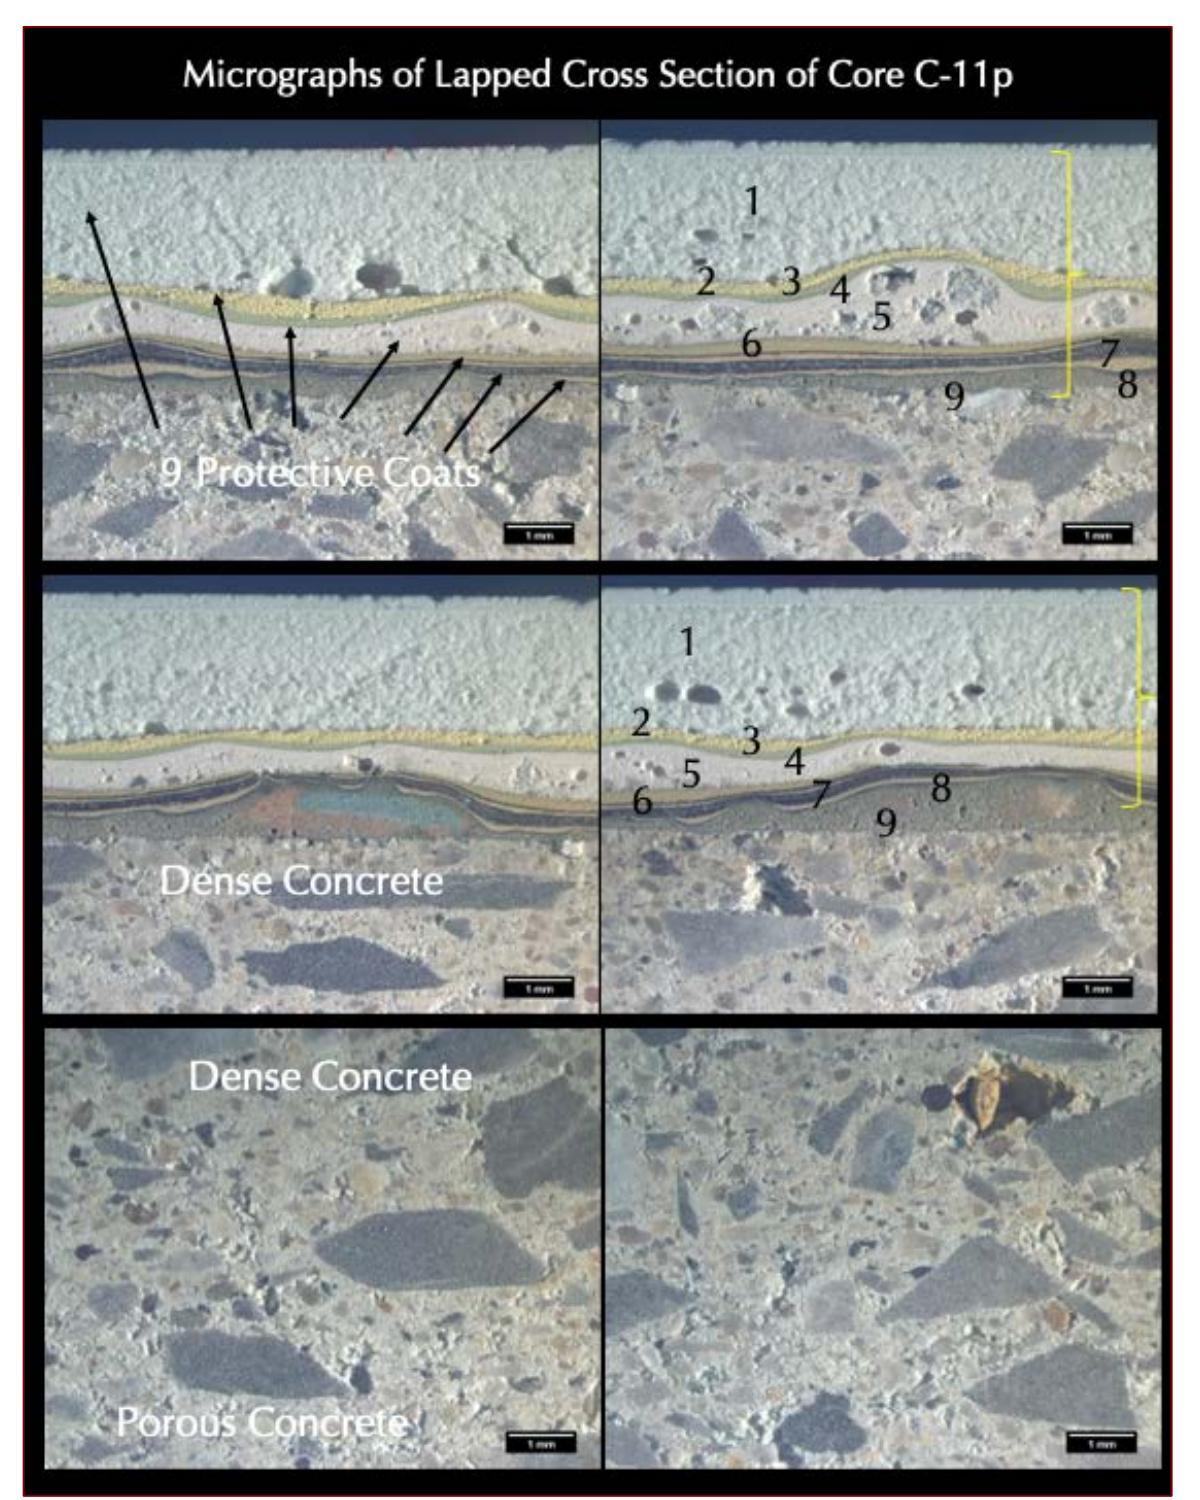
Figure 12: Micrographs of lapped cross section of Core C-11p showing: (a) multiple layers of protective coating system, which is measured to be approximately 4 to 5 mm total, consisting of at least 9 detectable layers that are all well-bonded to each other, and, eventually to the interior concrete; (b) the non-air-entrained nature of the concrete (all photos) due to the lack of any spherical entrained air voids except seeing only a few coarse entrapped voids; (c) crushed limestone coarse aggregate and crushed limestone and seashell fragments in fine aggregate; and (d) the overall sound, but soft, porous, well-consolidated nature of the concrete in the core (all photos).

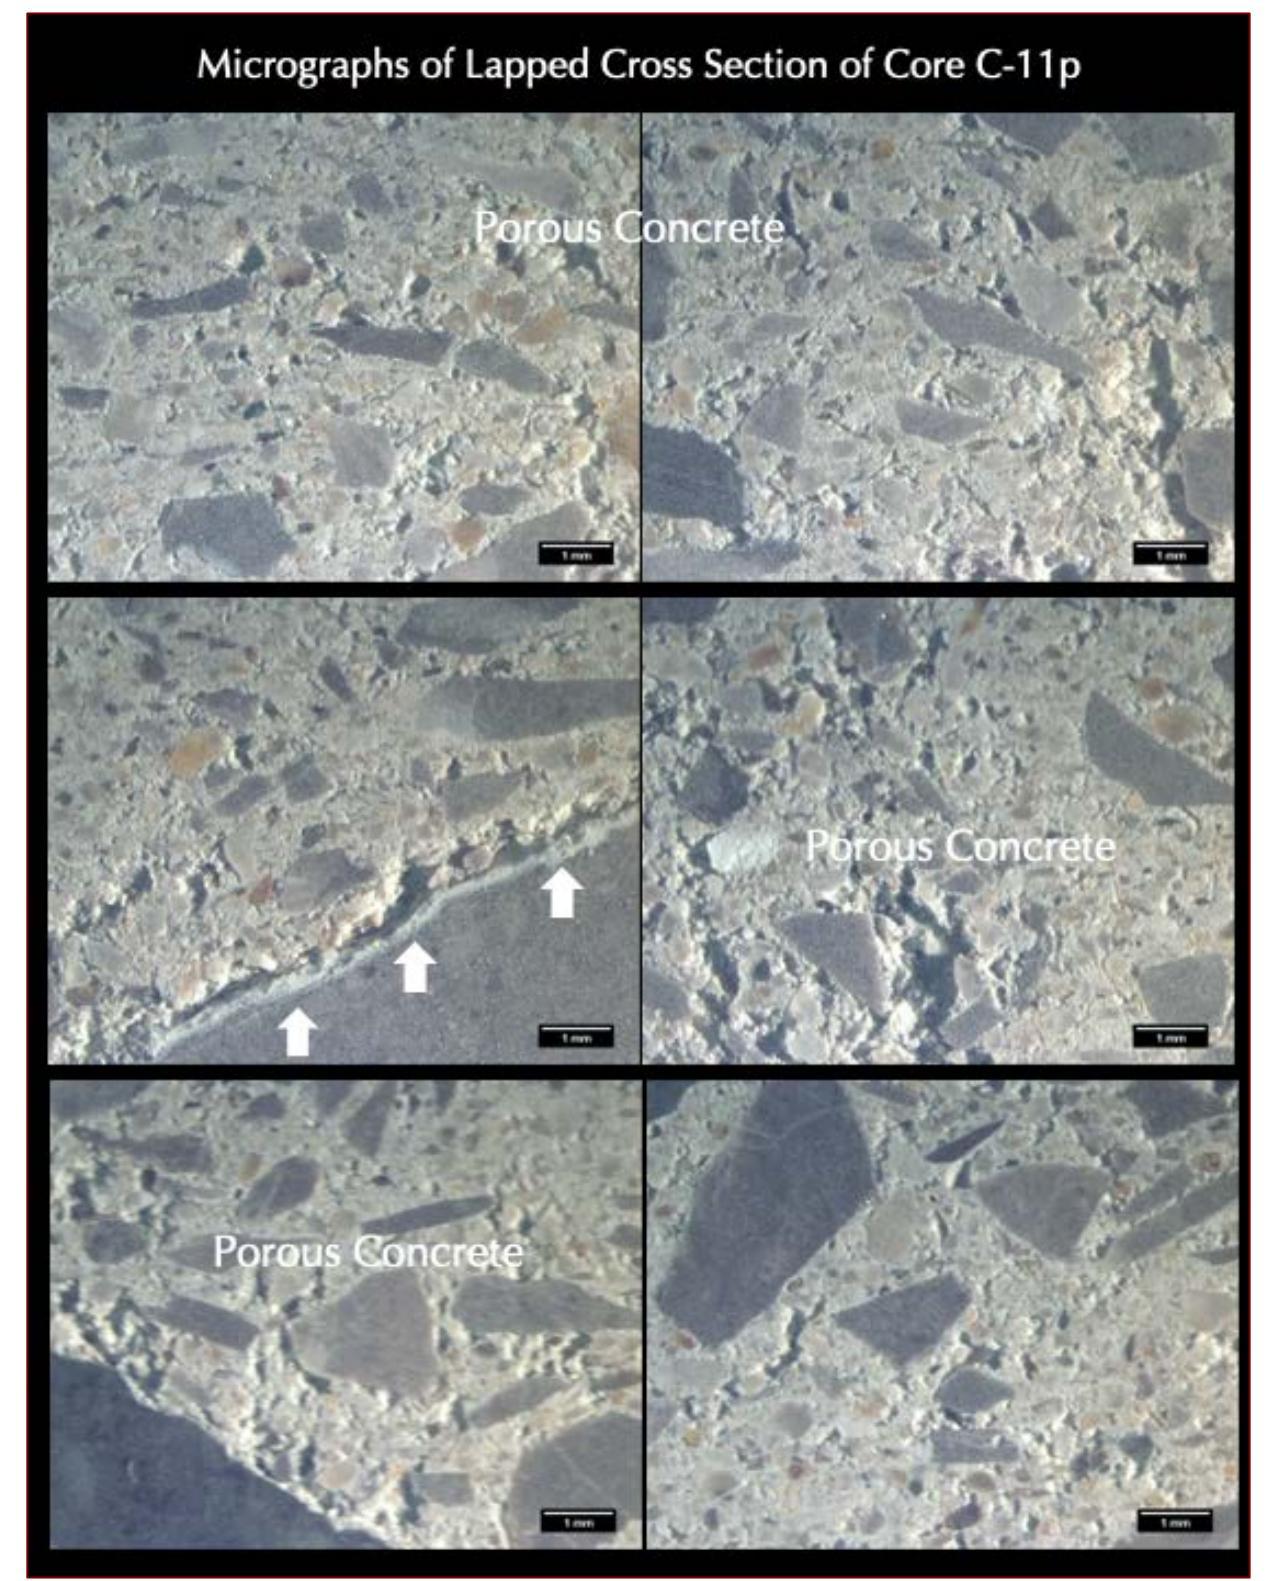
Figure 13: Micrographs of lapped cross section of Core C-11p showing: (a) the non-air-entrained nature of the concrete (all photos) due to the lack of any spherical entrained air voids except seeing only a few coarse entrapped voids; (b) crushed limestone coarse aggregate and crushed limestone and seashell fragments in fine aggregate; and (c) the overall sound, but soft, porous, well-consolidated nature of the concrete in the core (all photos).
