Petrographic Examinations Of Two Concrete Cores From An 80-Year-Old Hotel In A Marine Environment

Normandie Hotel, San Juan, Puerto Rico

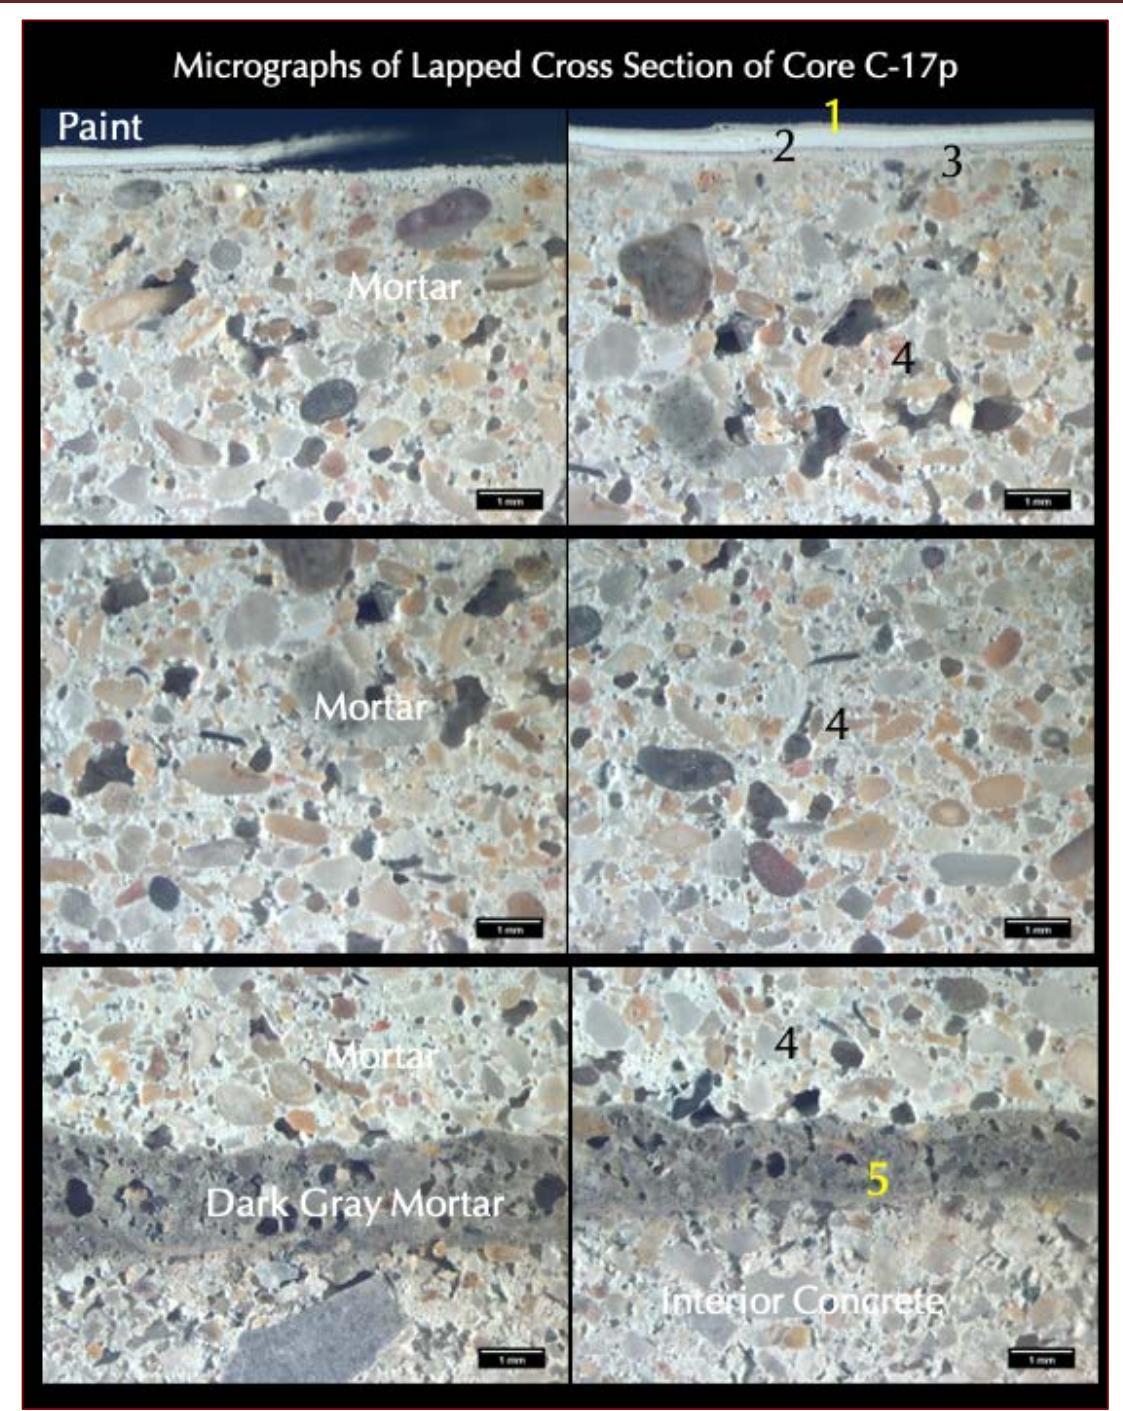
Figure 14: Micrographs of lapped cross section of Core C-17p showing: (a) multiple layers of protective coating system, which is measured to be approximately 16 to 17 mm total, consisting of at least 5 detectable layers, where a 15 mm thick mortar layer is sandwiched between thinner coats, where individual coats are all well-bonded to each other, and, eventually to the interior concrete; (b) overall air-entrained nature of the mortar coat consisting of many fine, discrete, uniformly distributed spherical (< 1 mm size) entrained air voids and a few coarse, near-spherical and irregularly-shaped entrapped voids (all photos), (c) but the non-air-entrained nature of the concrete (shown in the next Figure) due to the lack of any spherical entrained air voids, except seeing only a few coarse entrapped voids; (d) rounded mostly elliptical carbonate sand particles well-dispersed in well-consolidated off-white to light gray paste in the mortar coat (all photos); (e) crushed limestone coarse aggregate and crushed limestone and seashell fragments in fine aggregate (next Figure); and (d) the overall sound, but soft, porous, well-consolidated nature of the concrete in the core (next photos).

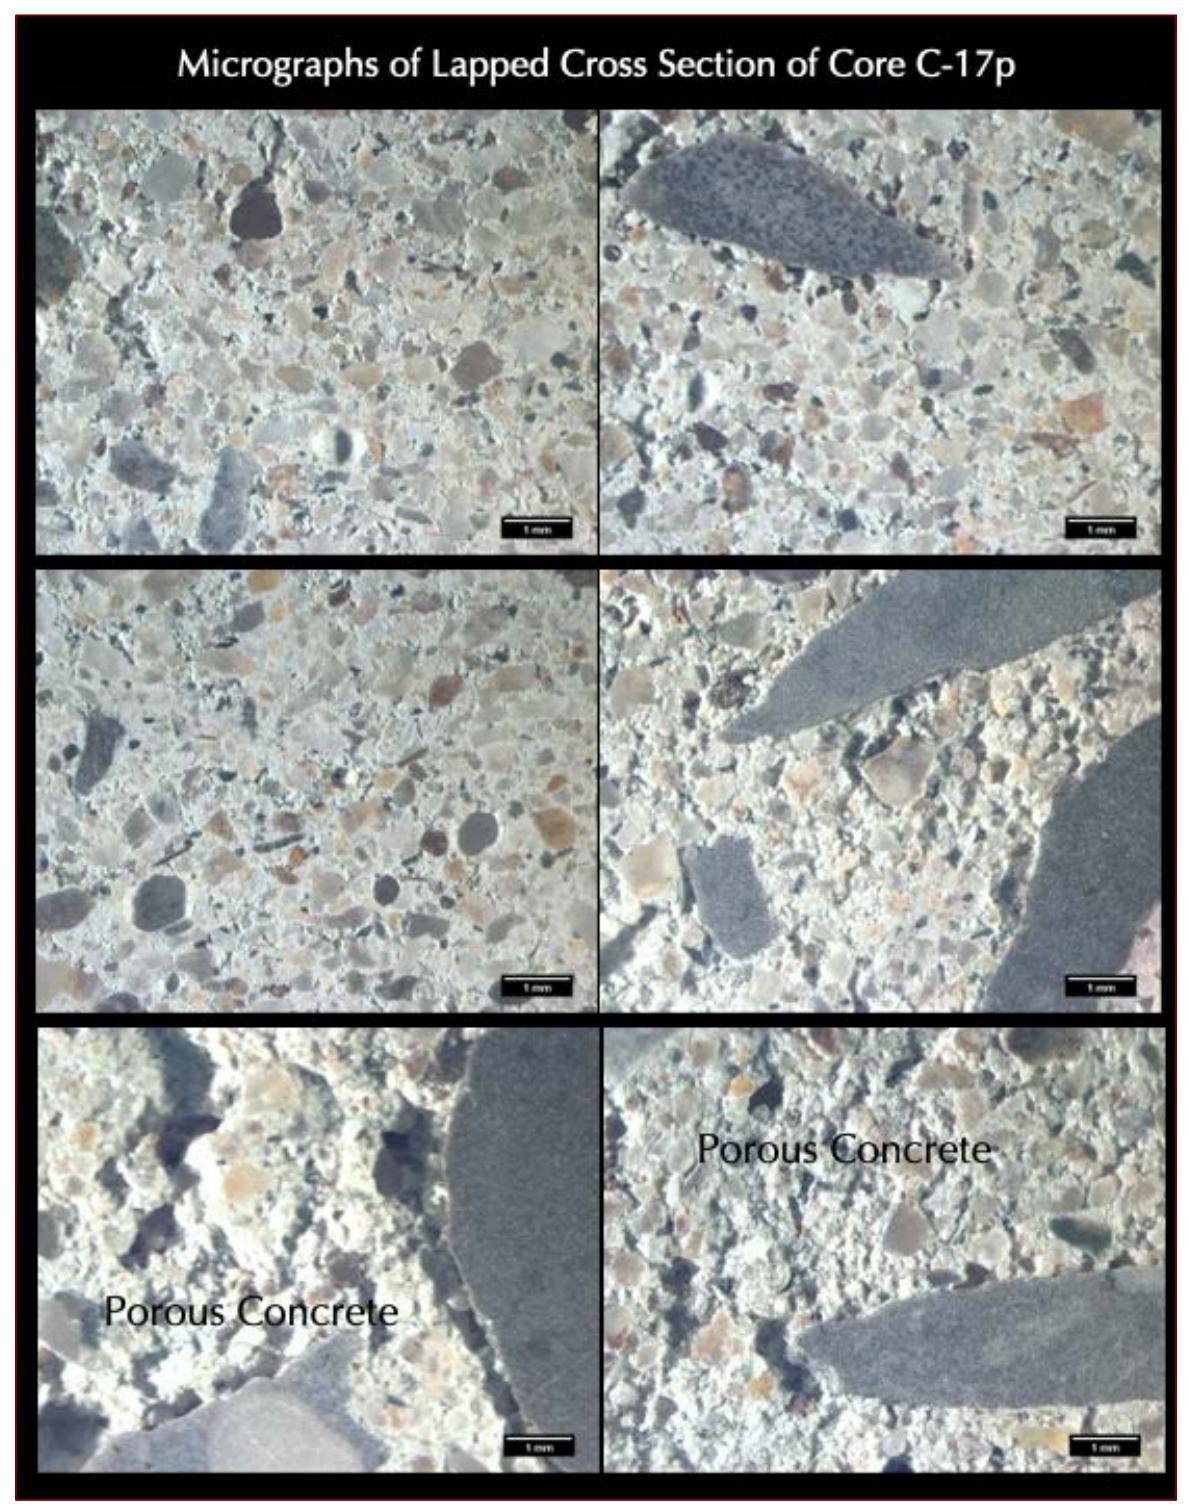
Figure 15: Micrographs of lapped cross section of Core C-17p showing: (a) overall air-entrained nature of the mortar coat consisting of many fine, discrete, uniformly distributed spherical (< 1 mm size) entrained air voids and a few coarse, near-spherical and irregularly-shaped entrapped voids (top two rows of photos), (b) but the non-air-entrained nature of the concrete (bottom row) due to the lack of any spherical entrained air voids, except seeing only a few coarse entrapped voids; (c) rounded mostly elliptical carbonate sand particles well-dispersed in well-consolidated off-white to light gray paste in the mortar coat (top two rows); (e) crushed limestone coarse aggregate and crushed limestone and seashell fragments in fine aggregate (bottom row); and (d) the overall sound, but soft, porous, well-consolidated nature of the concrete in the core (bottom row).

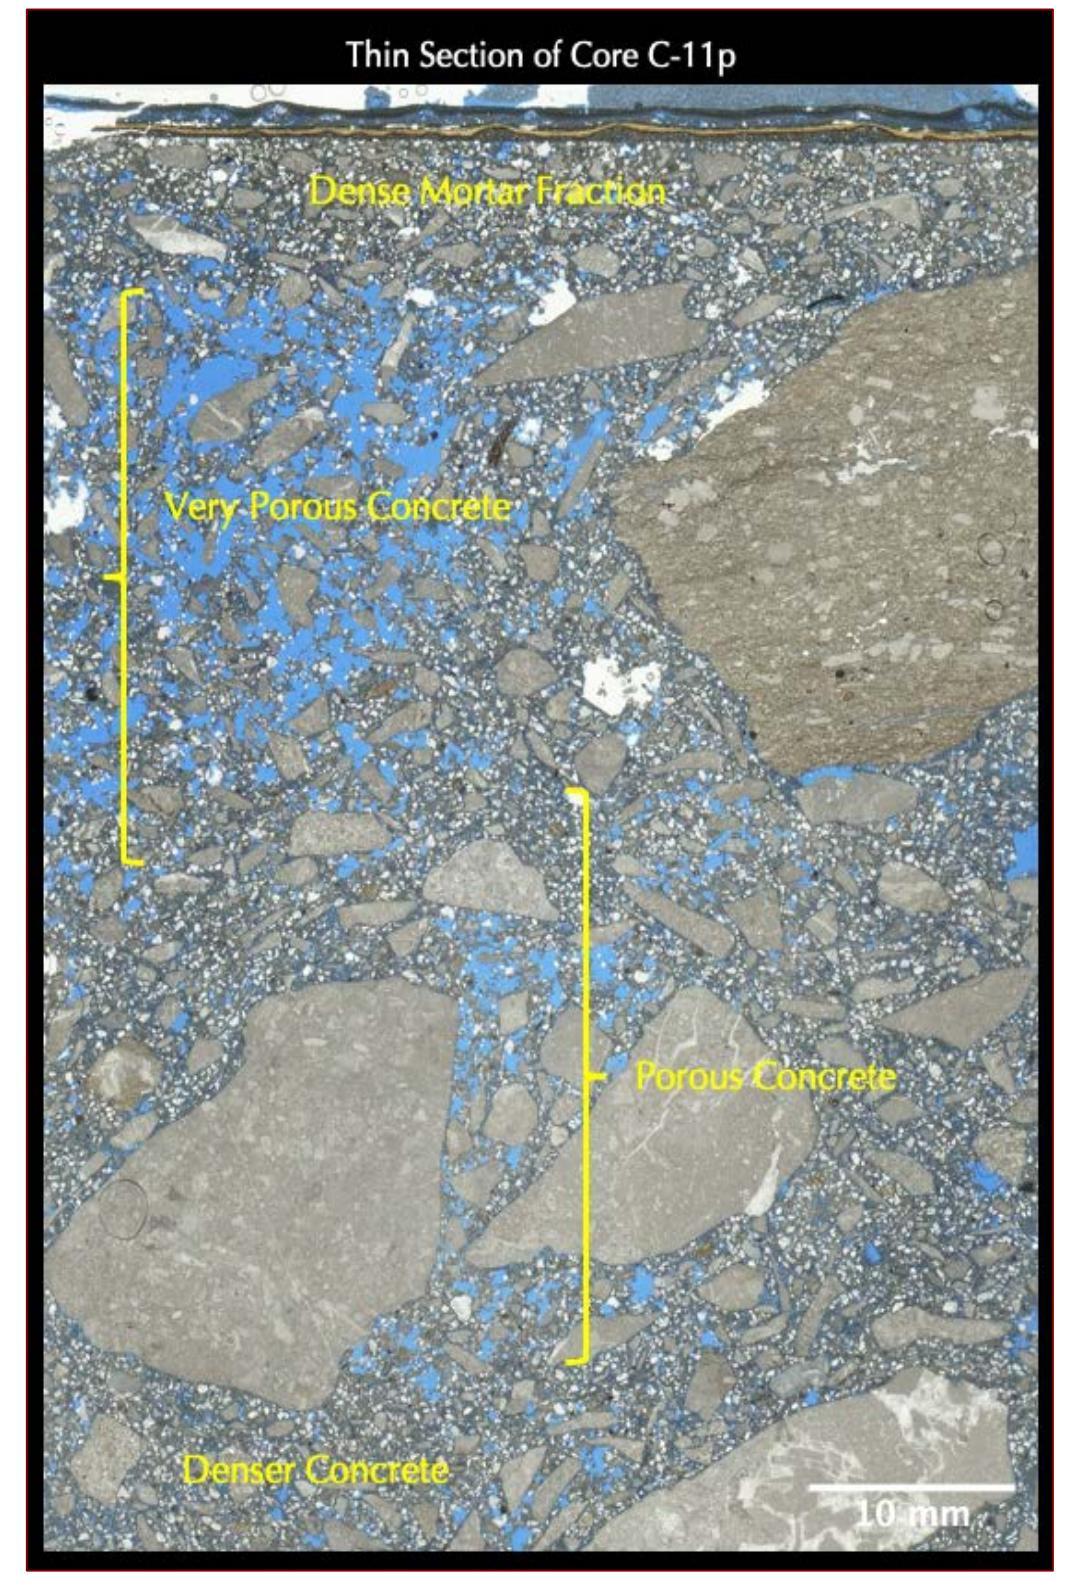
Figure 16: Blue dyemixed epoxyimpregnated thin section of Core C-11p showing:

(a) Protective coats at the top exposed end of core;

(b) Variably dense and porous regions of concrete highlighted by blue epoxy;

(c) Crushed limestone coarse aggregate and mixture of crushed limestone, seashell fragments, and very fine crushed quartz particles in fine aggregate; and,

(d) The non-airentrained nature of concrete where air voids are highlighted by blue epoxy.

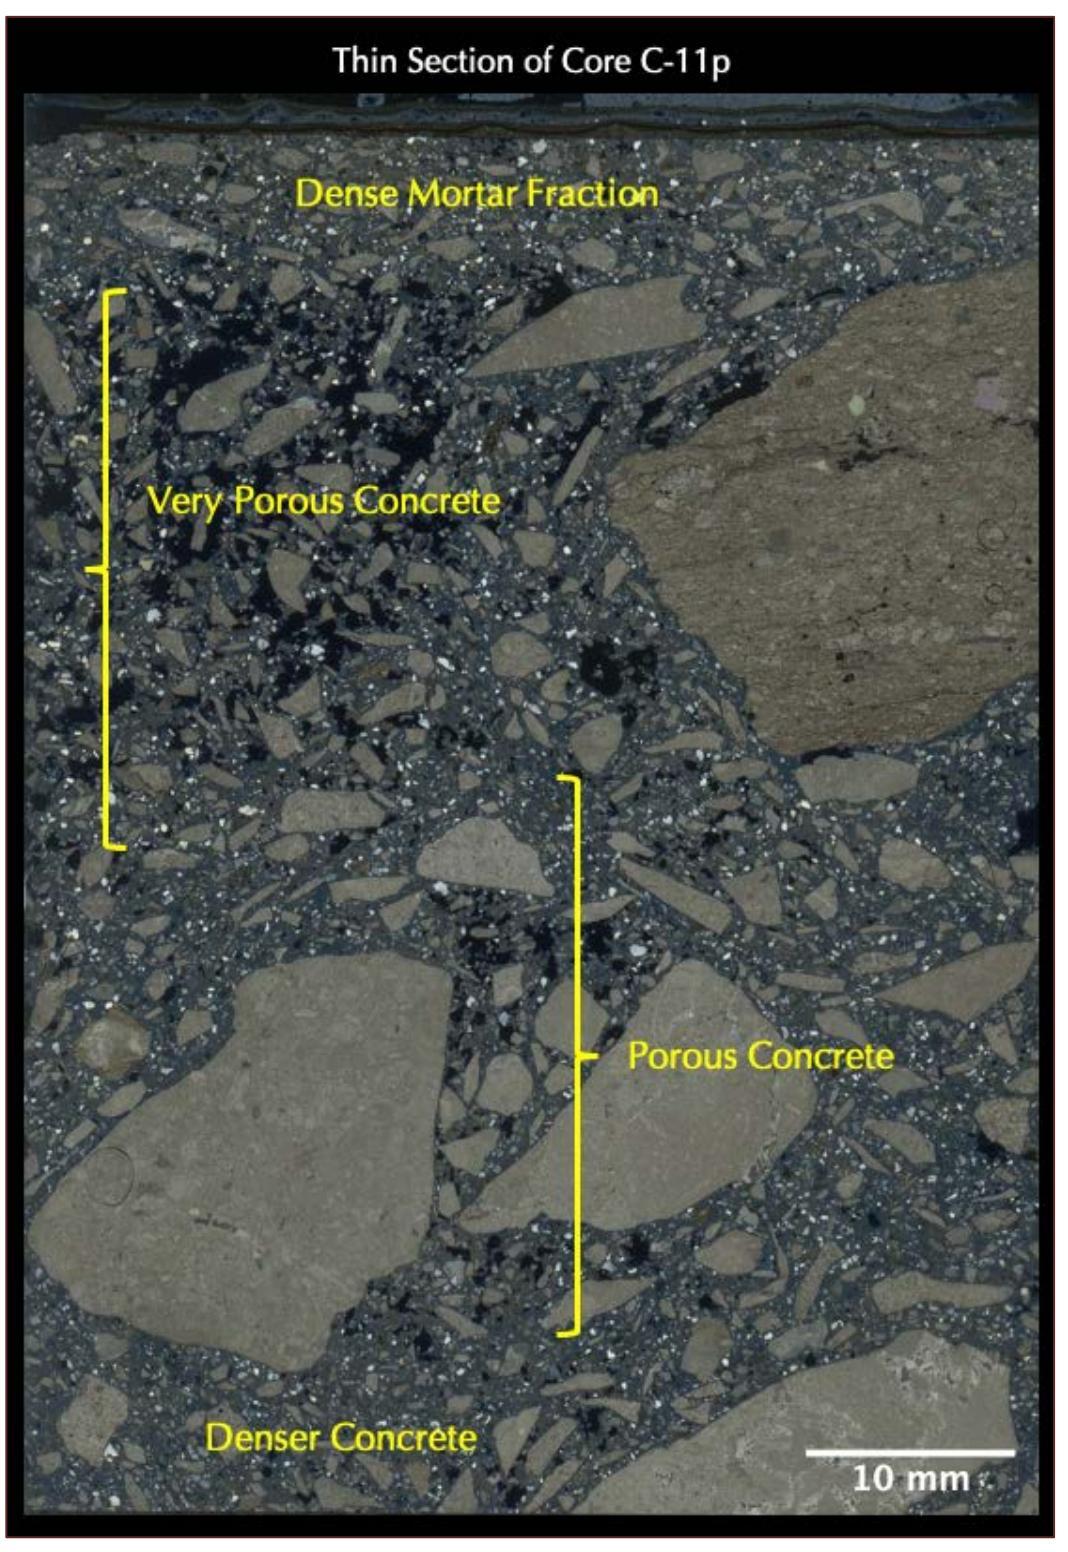
Figure 17: Blue dyemixed epoxyimpregnated thin section of Core C-11p showing:

(a) Protective coats at the top exposed end of core;

(b) Variably dense and porous regions of concrete highlighted by blue epoxy;

(c) Crushed limestone coarse aggregate and a mixture of crushed limestone, seashell fragments, and very fine crushed quartz particles in fine aggregate; and,

(d) The non-air-entrained nature of concrete.

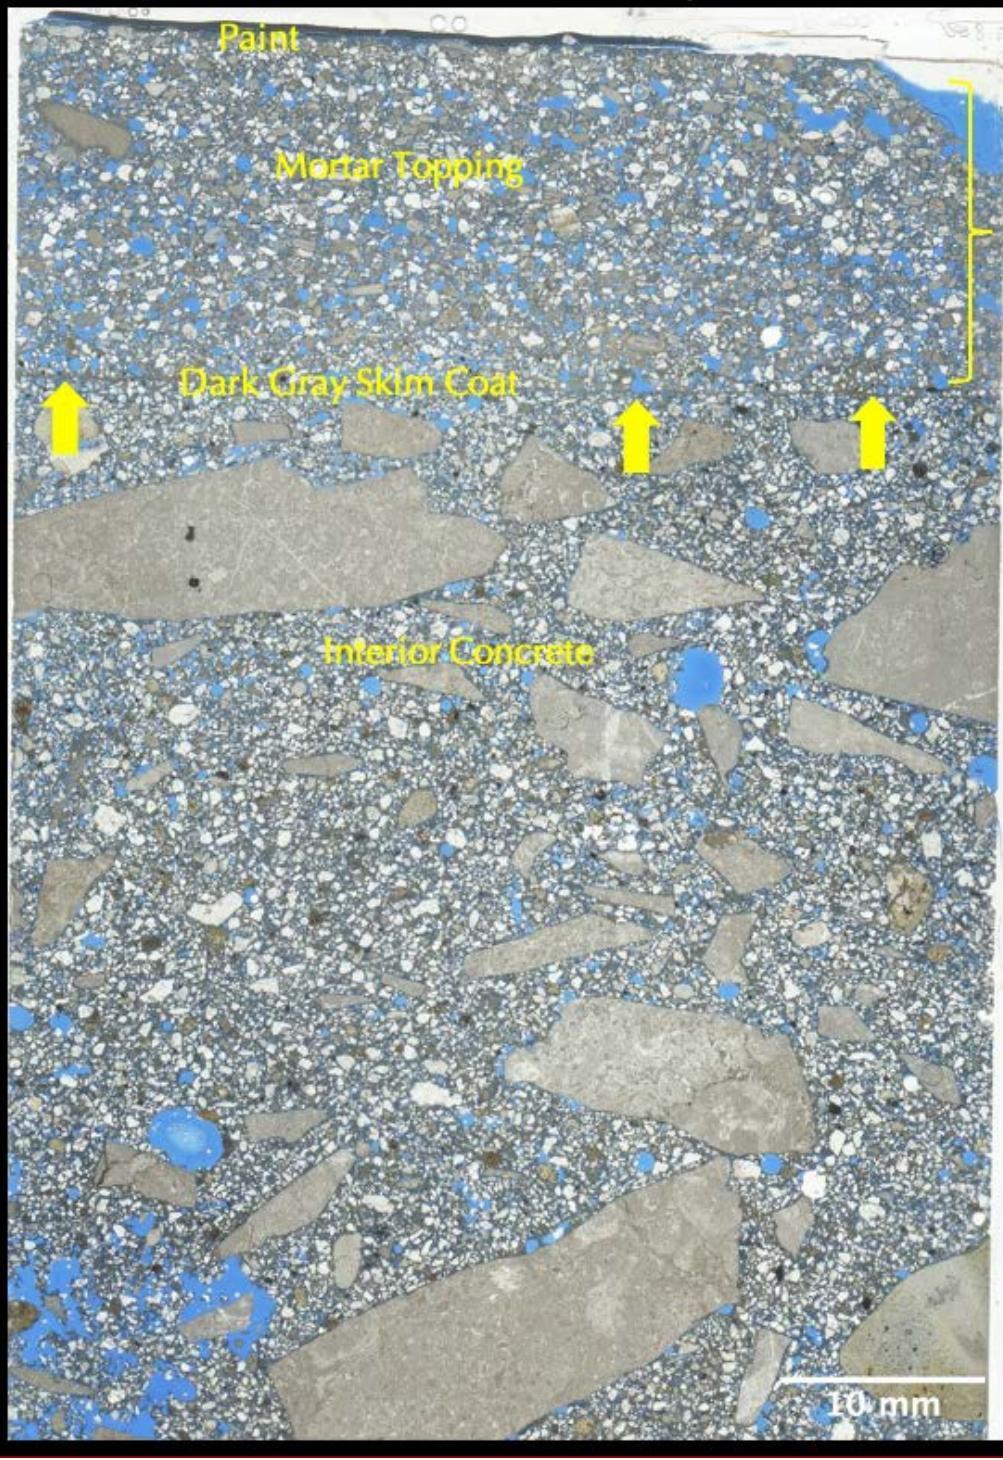
Thin Section of Core C-17p

Figure 18: Blue dyemixed epoxy-impregnated thin section of Core C-17p showing:

(a) Protective coats at the top exposed end of core, where a thick mortar coat is sandwiched between other thinner coats;

(b) Variably dense and porous regions of concrete highlighted by blue epoxy;

(c) Crushed limestone coarse aggregate and a mixture of crushed limestone, seashell fragments, and very fine crushed quartz particles in fine aggregate; and,

(d) The non-air-entrained nature of concrete where air voids are highlighted by blue epoxy.

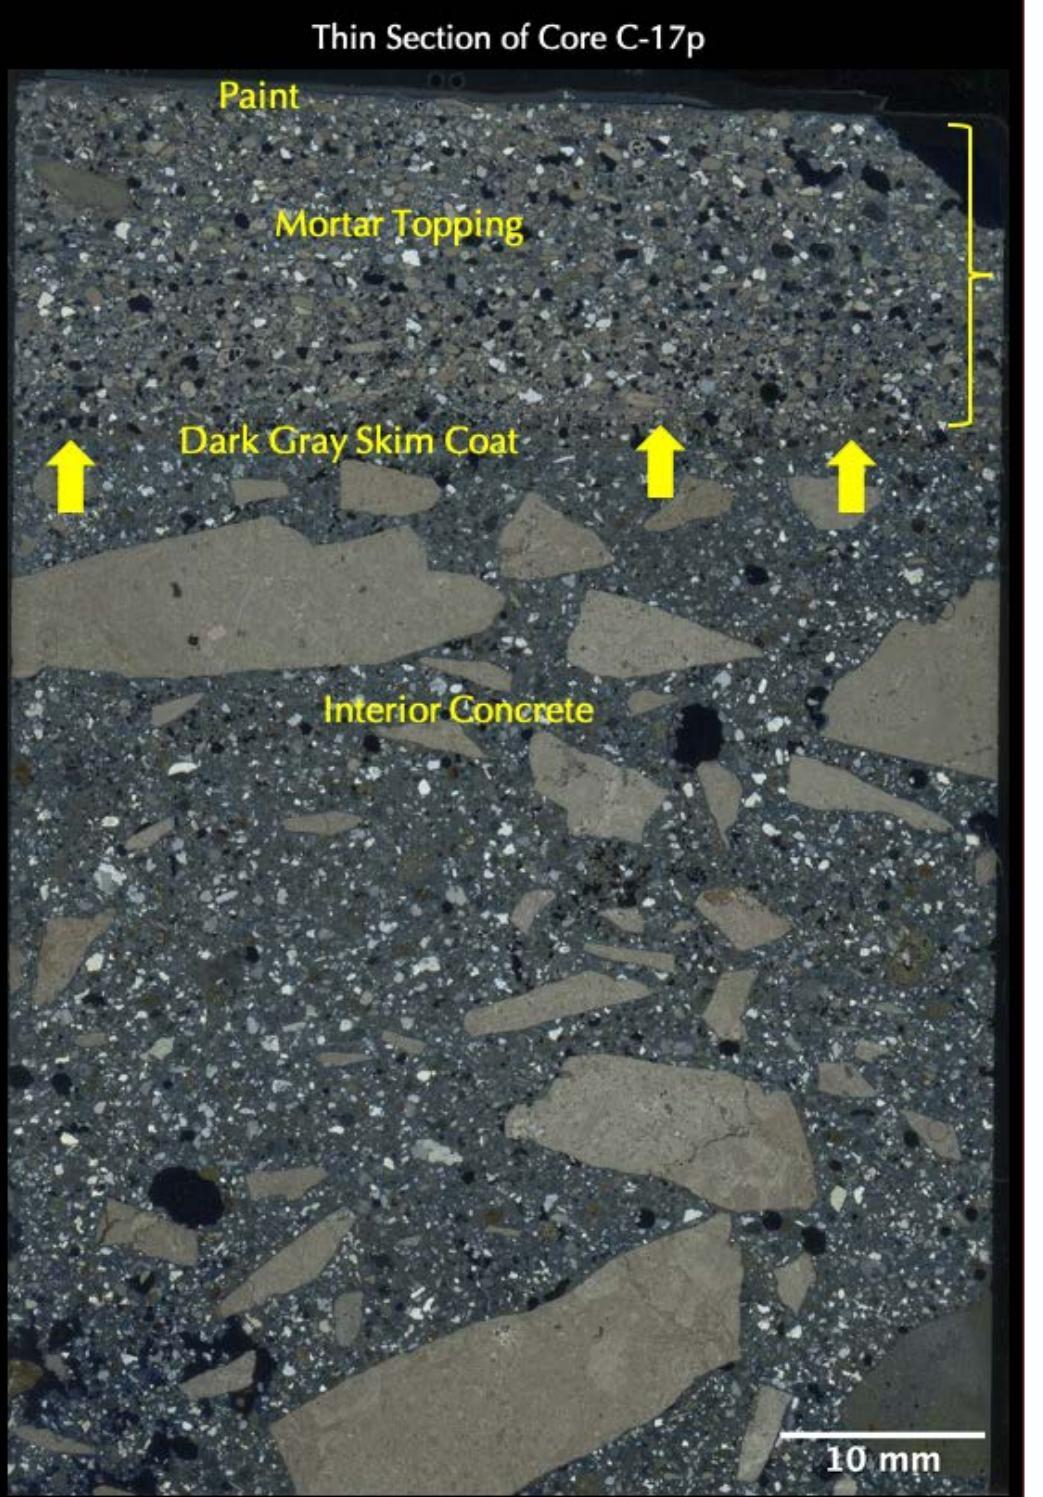
Figure 19: Blue dyemixed epoxyimpregnated thin section of Core C-17p showing:

(a) Protective coats at the top exposed end of core where a thick mortar coat is sandwiched between other thinner coats;

(b) Variably dense and porous regions of concrete highlighted by blue epoxy;

(c) Crushed limestone coarse aggregate and a mixture of crushed limestone, seashell fragments, and very fine crushed quartz particles in fine aggregate;

(d) The non-air-entrained nature of concrete.

Notice a higher proportion of crushed fine siliceous particles in this Core compared to Core C-11p.

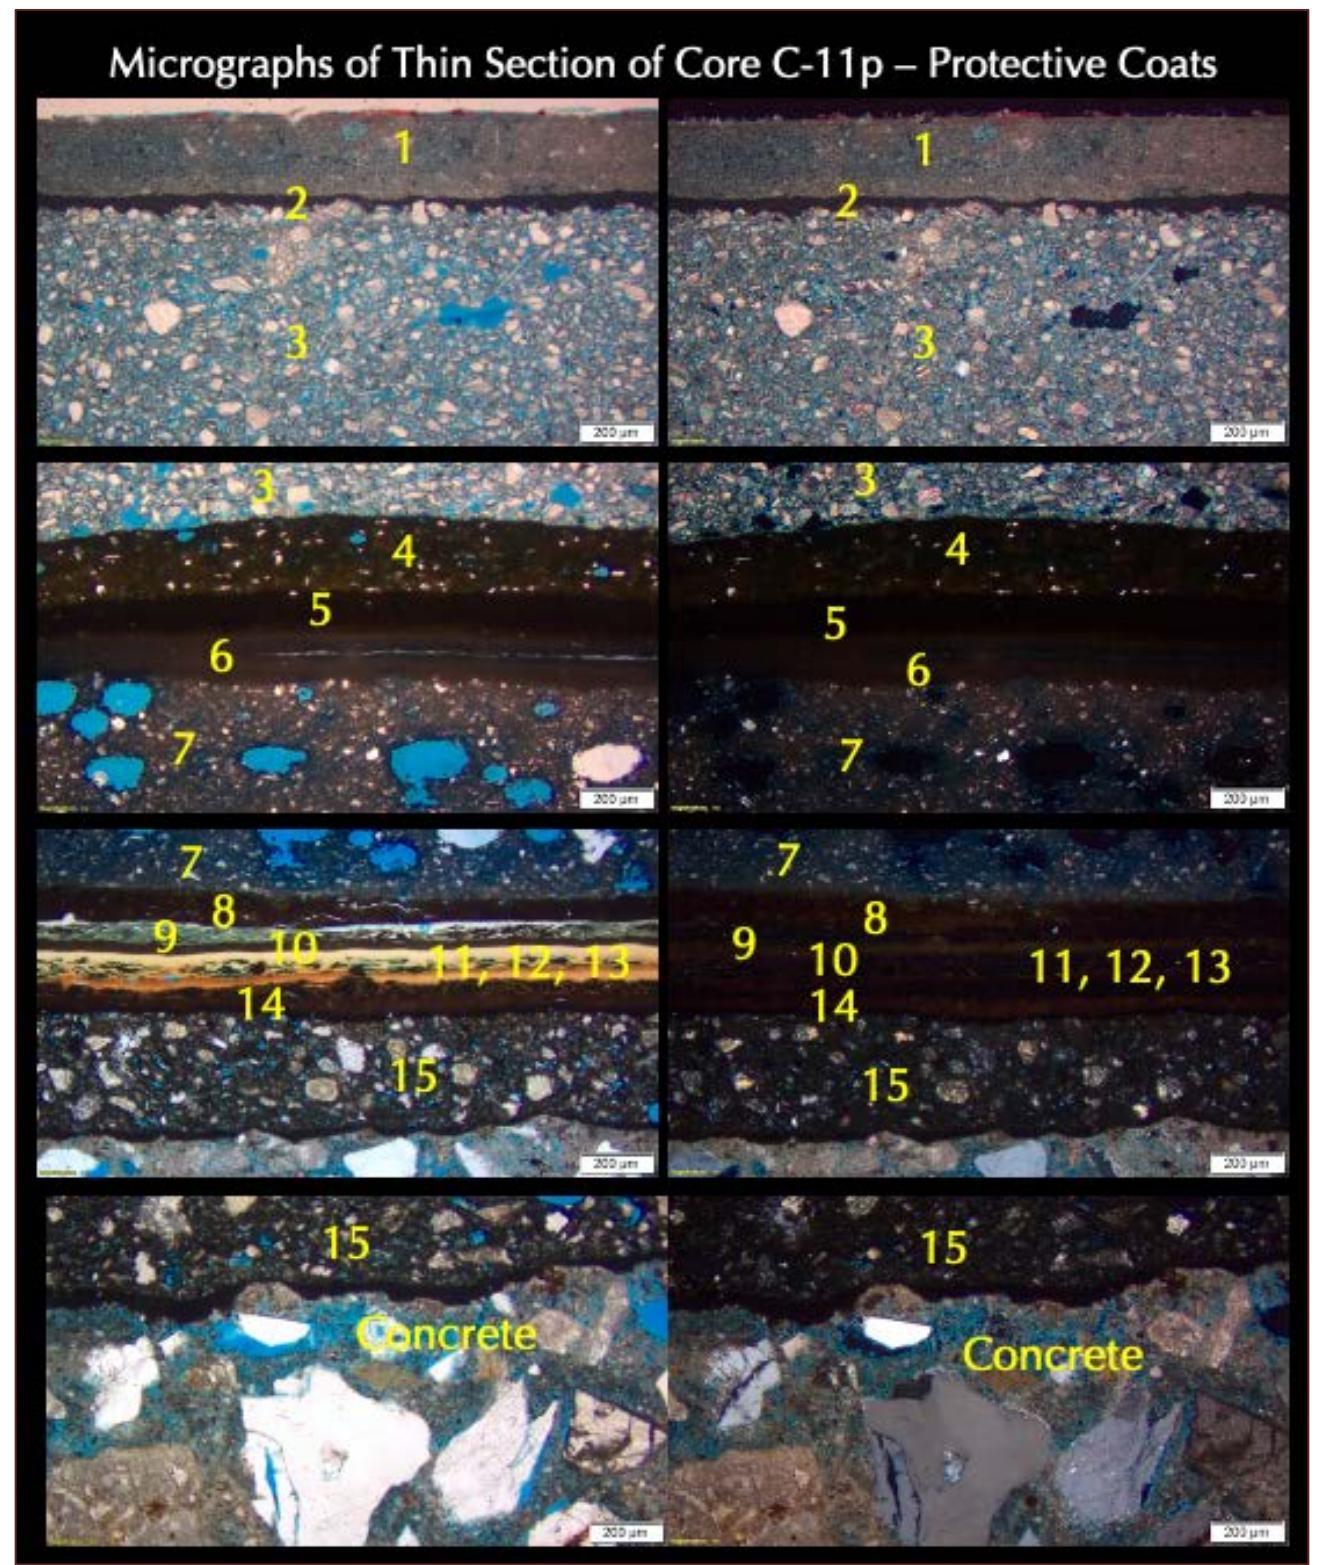
Figure 20: Micrographs of thin section of Core C-11p showing as many as 15 distinct protective coats applied on the exposed surface of concrete that consist of both polymeric (e.g., paint) and crystalline layers, marked as #1 through 15, which are all well-bonded to each other and as a whole well-bonded to underlying concrete.

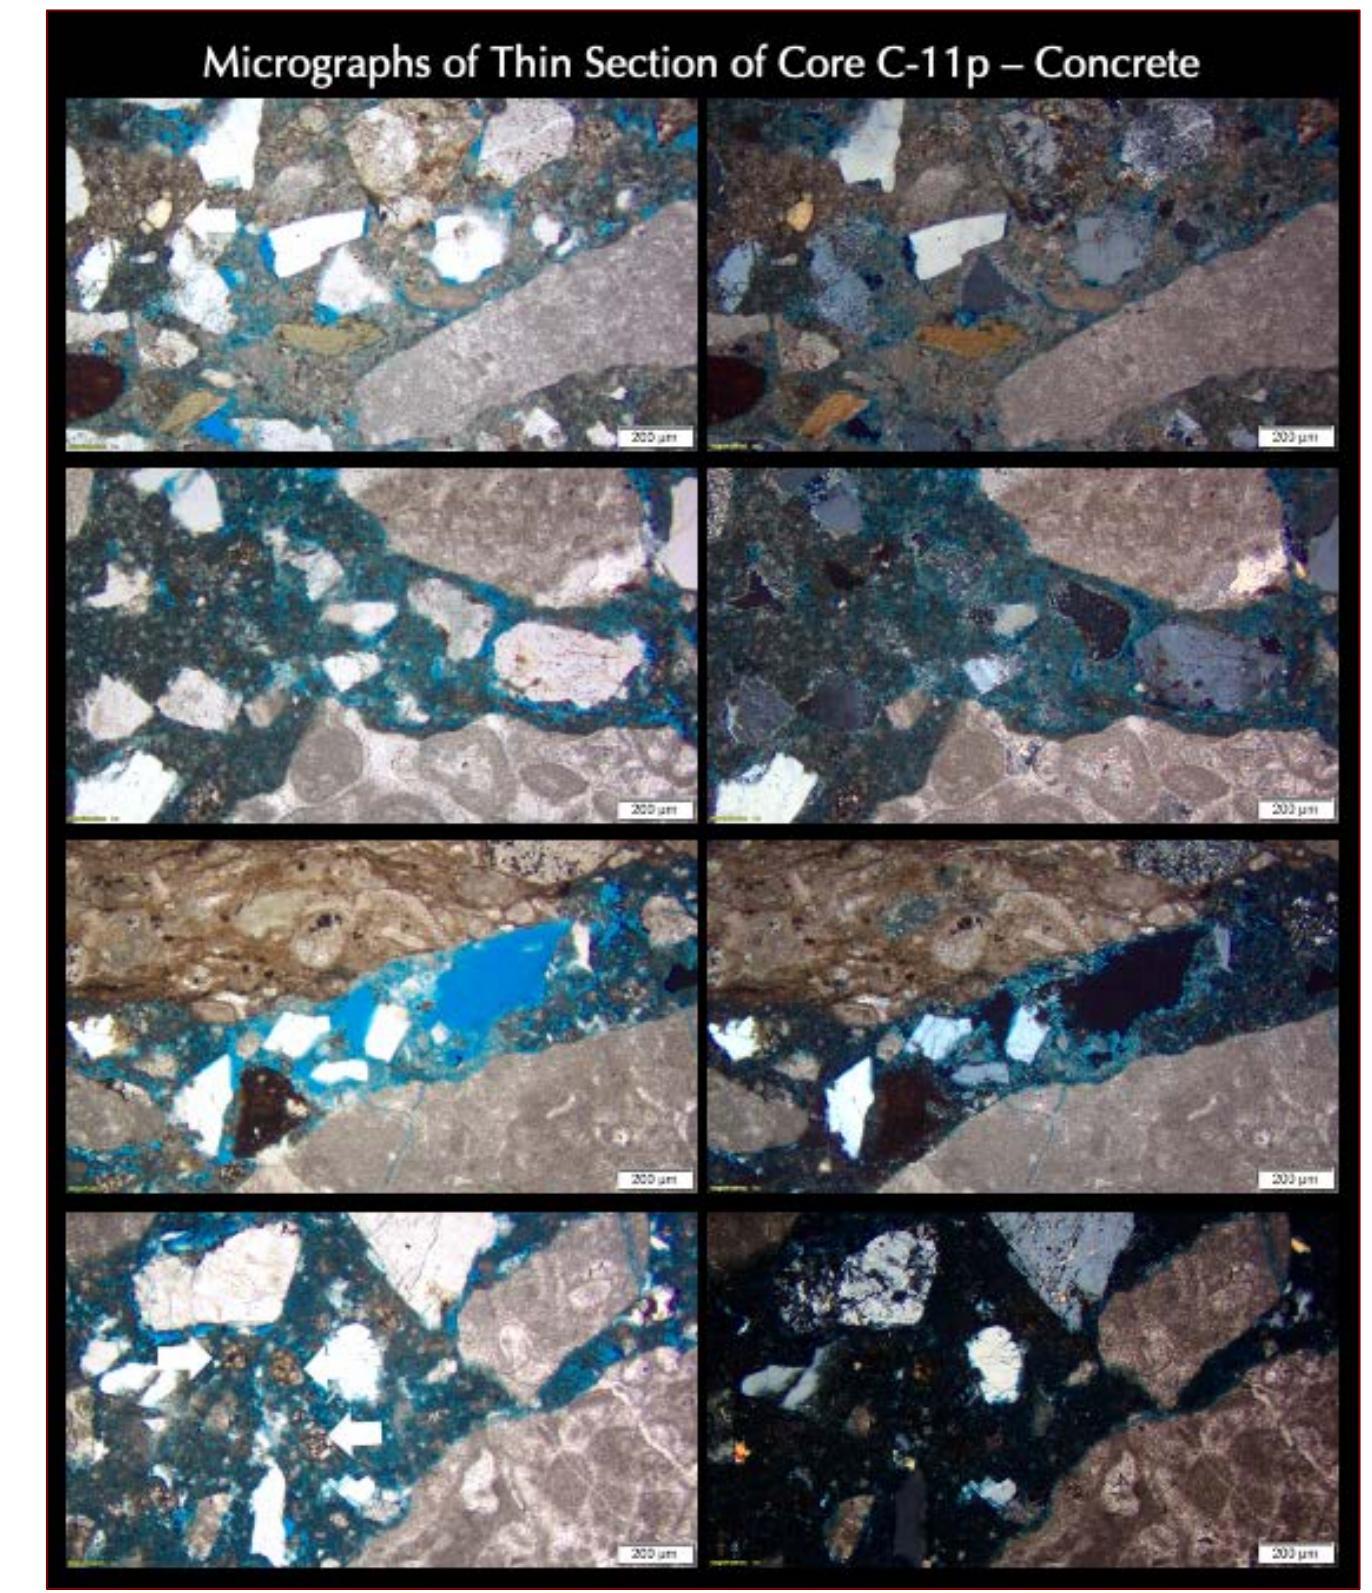
Figure 21: Micrographs of thin section of Core C-11p showing: (a) crushed limestone (biomicrite, biosparite, micrite) coarse aggregate and a mixture of crushed limestone, seashell fragments, and very fine crushed quartz particles in fine aggregate; (b) variably dense Portland cement paste containing many residual Portland cement particles scattered over variably porous and carbonated paste of cement hydration products; and (c) the non-air-entrained nature of concrete where air voids are highlighted by blue epoxy in the left column plane polarized light photos.

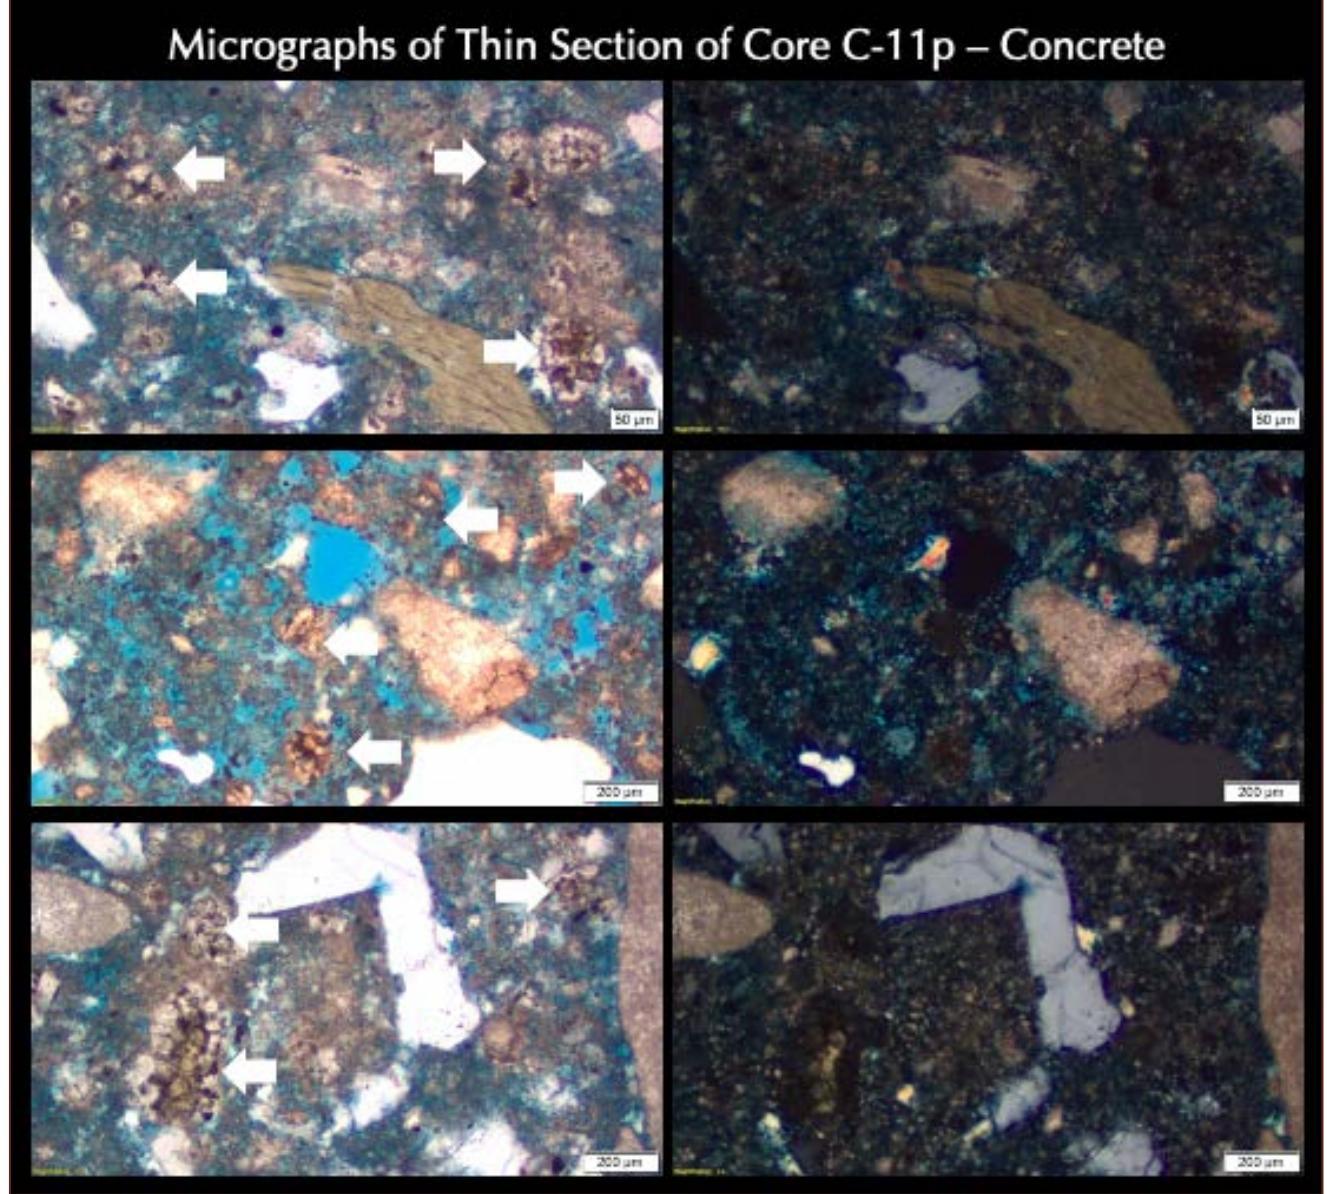
Figure 22: Micrographs of thin section of Core C-11p showing variably dense and porous Portland cement paste containing many residual Portland cement particles (many are indicated by arrows in left column) scattered over variably porous and carbonated paste of cement hydration products.

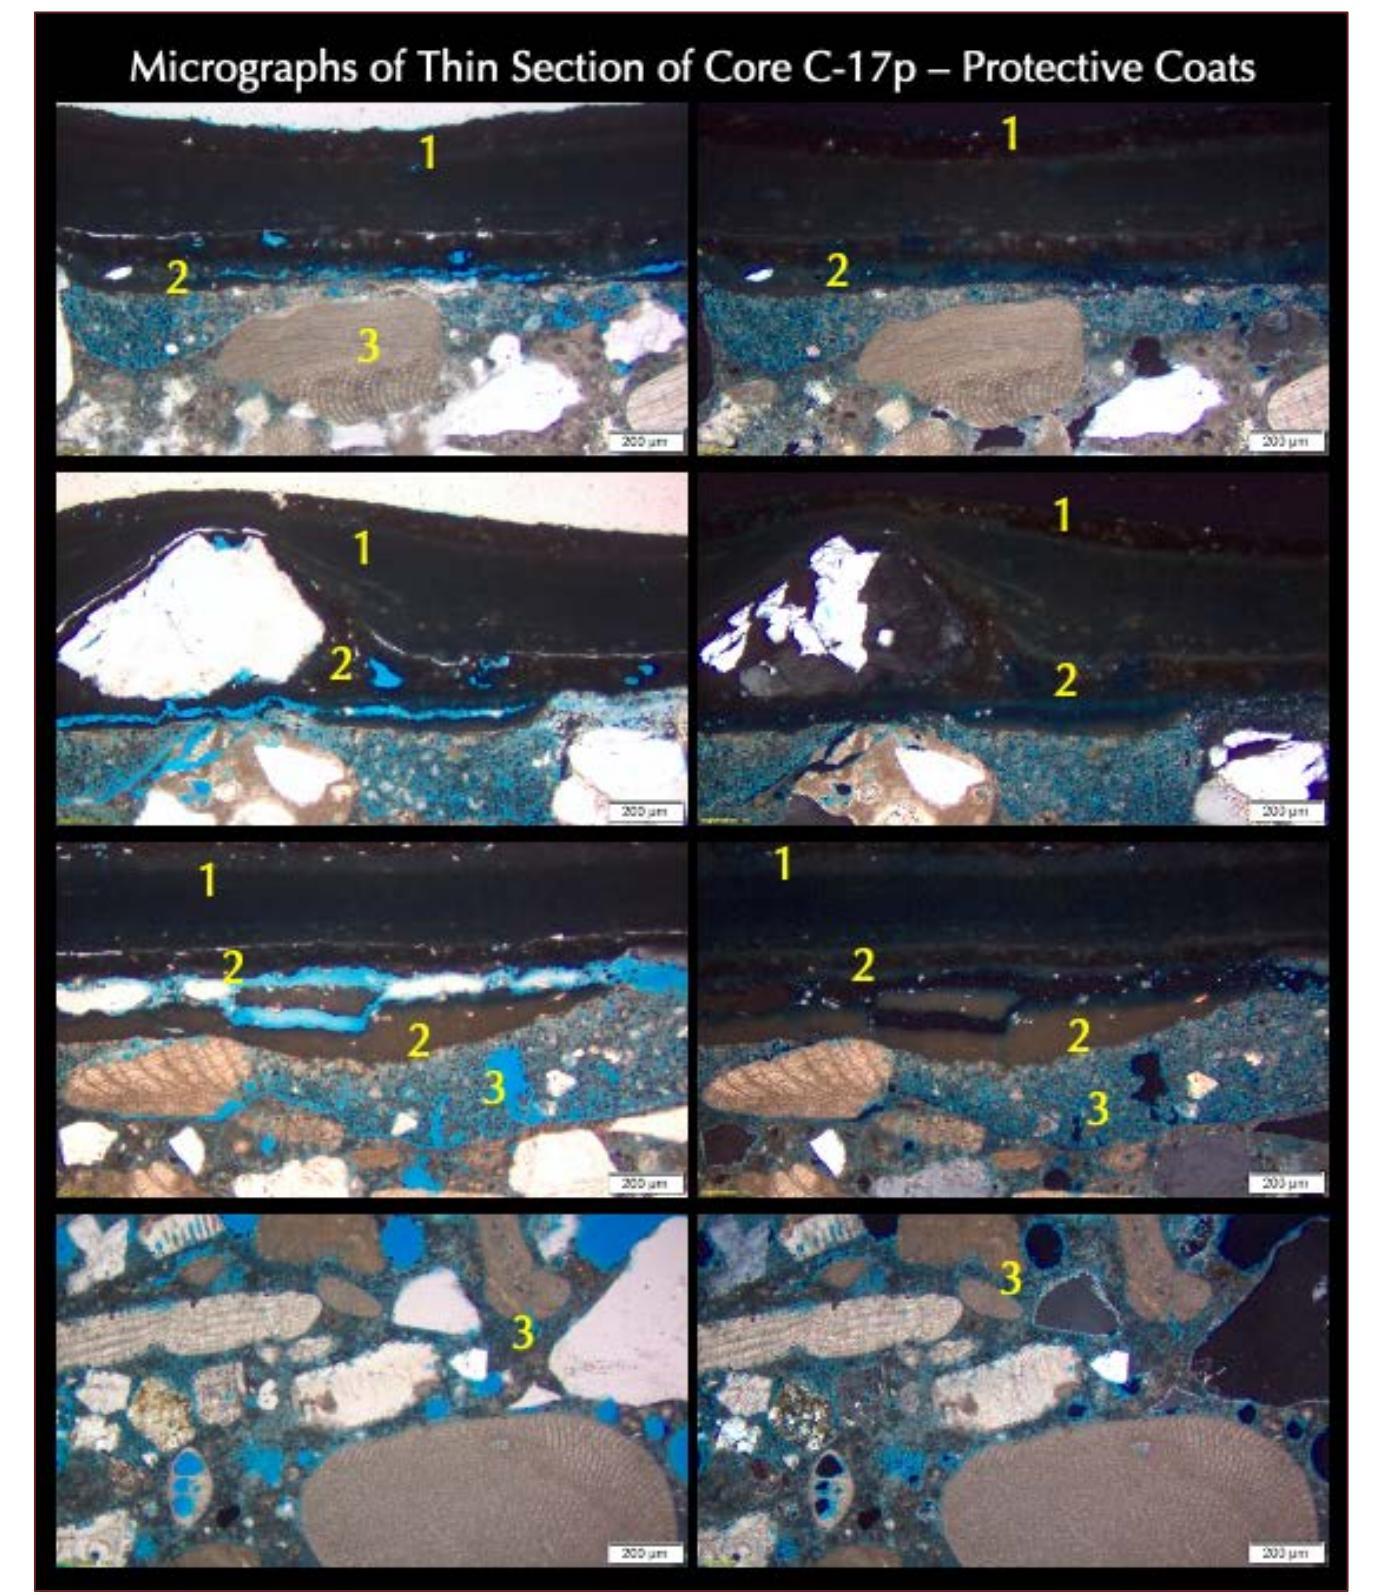
Figure 23: Micrographs of thin section of Core C-17p showing as many as 6 distinct protective coats applied on the exposed surface of concrete that consist of both polymeric (e.g., paint) and crystalline layers, marked as #1 through 6, which are all well-bonded to each other and as a whole well-bonded to the underlying concrete.

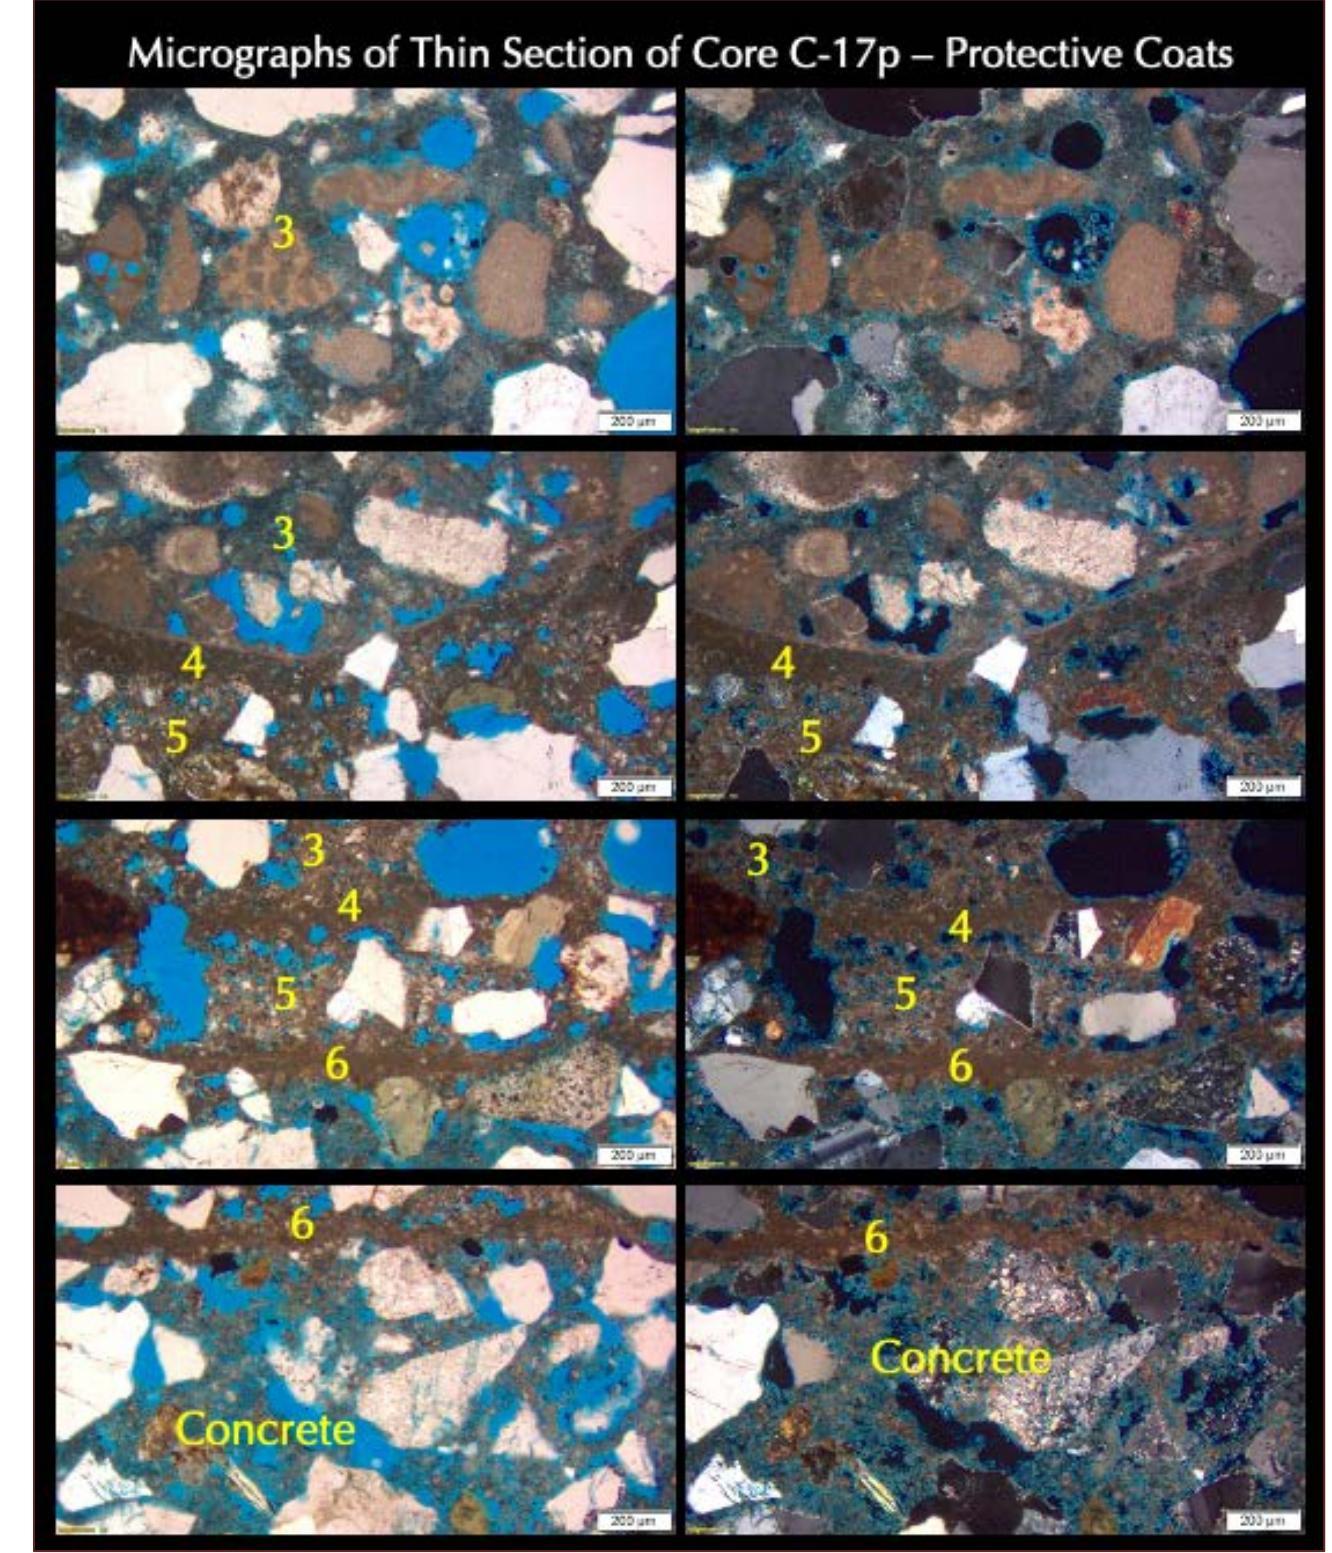
Figure 24: Micrographs of thin section of Core C-17p showing as many as 6 distinct protective coats applied on the exposed surface of concrete that consist of both polymeric (e.g., paint) and crystalline layers, marked as #1 through 6, which are all well-bonded to each other and as a whole well-bonded to the underlying concrete.
