Petrographic Examinations Of Two Concrete Cores From An 80-Year-Old Hotel In A Marine Environment

Normandie Hotel, San Juan, Puerto Rico

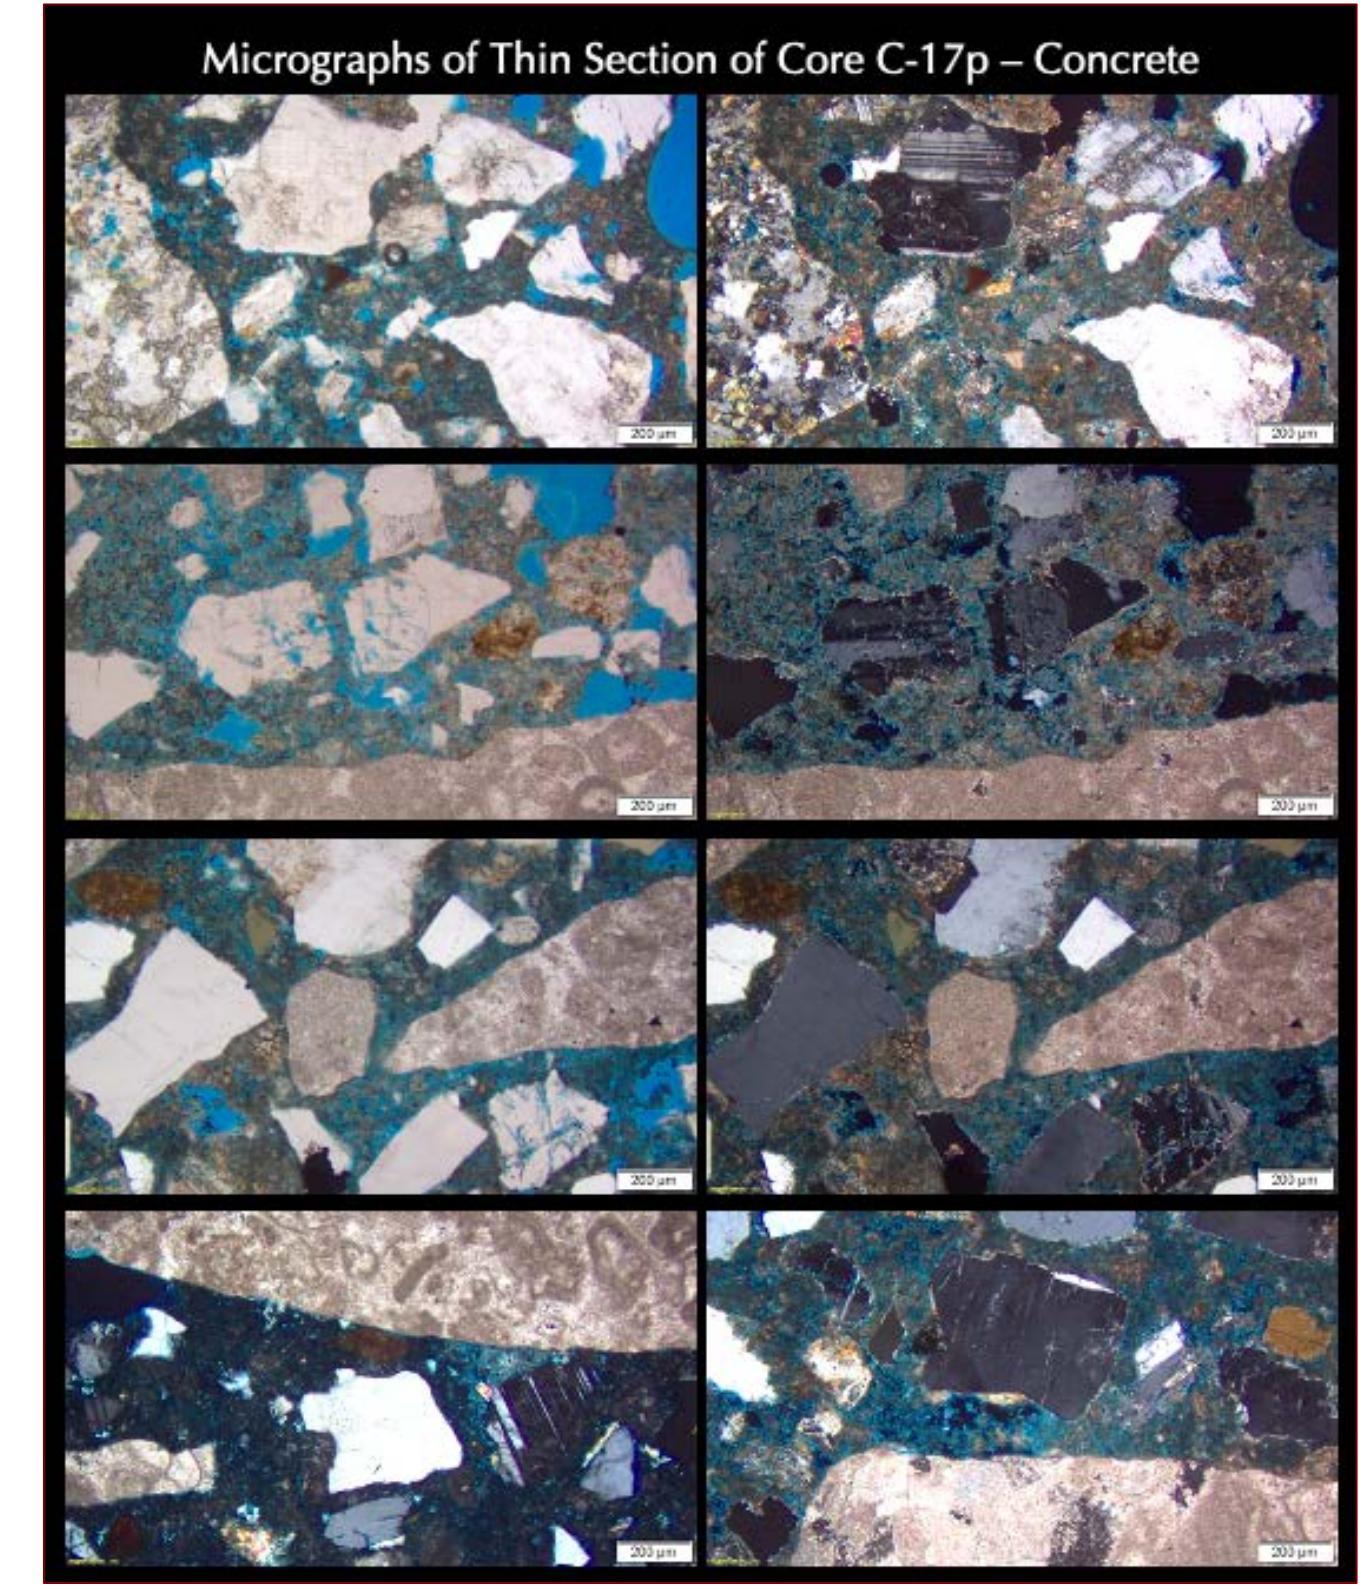
Figure 25: Micrographs of thin section of Core C-17p showing: (a) crushed limestone (biomicrite, biosparite, micrite) coarse aggregate and a mixture of crushed limestone, seashell fragments, and very fine crushed quartz particles in fine aggregate; (b) variably dense Portland cement paste containing many residual Portland cement particles scattered over variably porous and carbonated paste of cement hydration products; and (c) the non-air-entrained nature of concrete where air voids are highlighted by blue epoxy in the left column plane polarized light photos.
