### Swimming Pool Plaster Discoloration – A Case Study From Field & Laboratory-Cured Plasters

Primera Stone Sapphire Treasure & Blue Ocean

CONSTRUCTION MATERIALS CONSULTANTS, INC.

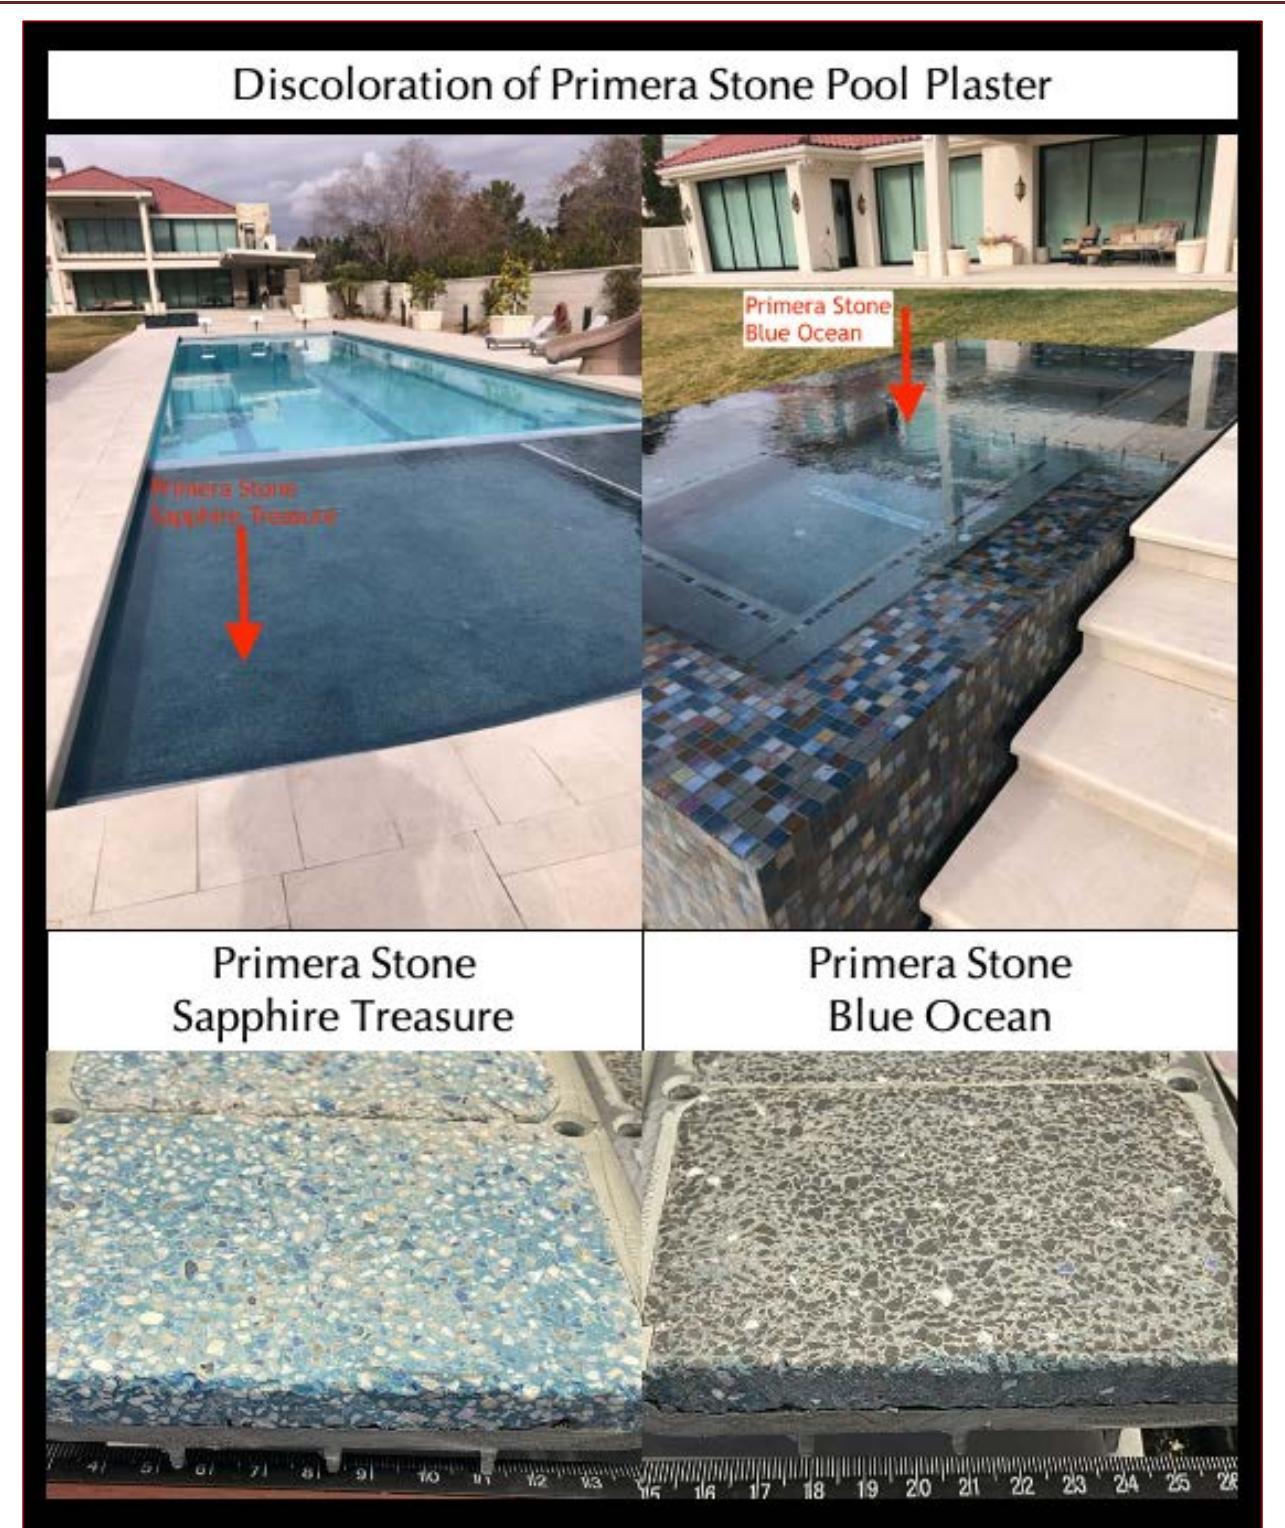
Two types of discoloration are seen on the exposed surfaces of both Sapphire Treasure and Blue Ocean plasters, which are seen in the field photos as well as in the two plaster samples received. These are classified as: (a) darker to lighter faded blue discoloration of plaster, which occupies the majority of the interstitial spaces between the exposed aggregate particles, and, (b) more localized, medium gray to beige discolored patches of plaster mostly occurring at the edges of many exposed aggregate particles. Both types have created blotchy discoloration of plaster surfaces, irrespective of the plaster types.

Figure 1: Field photos of Primera Stone Sapphire Treasure plaster at left and Blue Ocean plaster at right along with corresponding blotchy discoloration of exposed surfaces of plasters from respective pools in the bottom row. The Sapphire Treasure plaster has an overall blue color with exposed light gray, white, and blue color aggregates, and patchy discoloration of darker to lighter shade or fading of blue color and beige gray discoloration of paste around exposed aggregate particles. The Blue Ocean plaster has an overall gray color tone of exposed surface with dark gray exposed aggregate particles, and patchy discoloration of darker to lighter shade or fading of color and beige gray discoloration of paste around beige gray discoloration of paste around exposed aggregate particles.

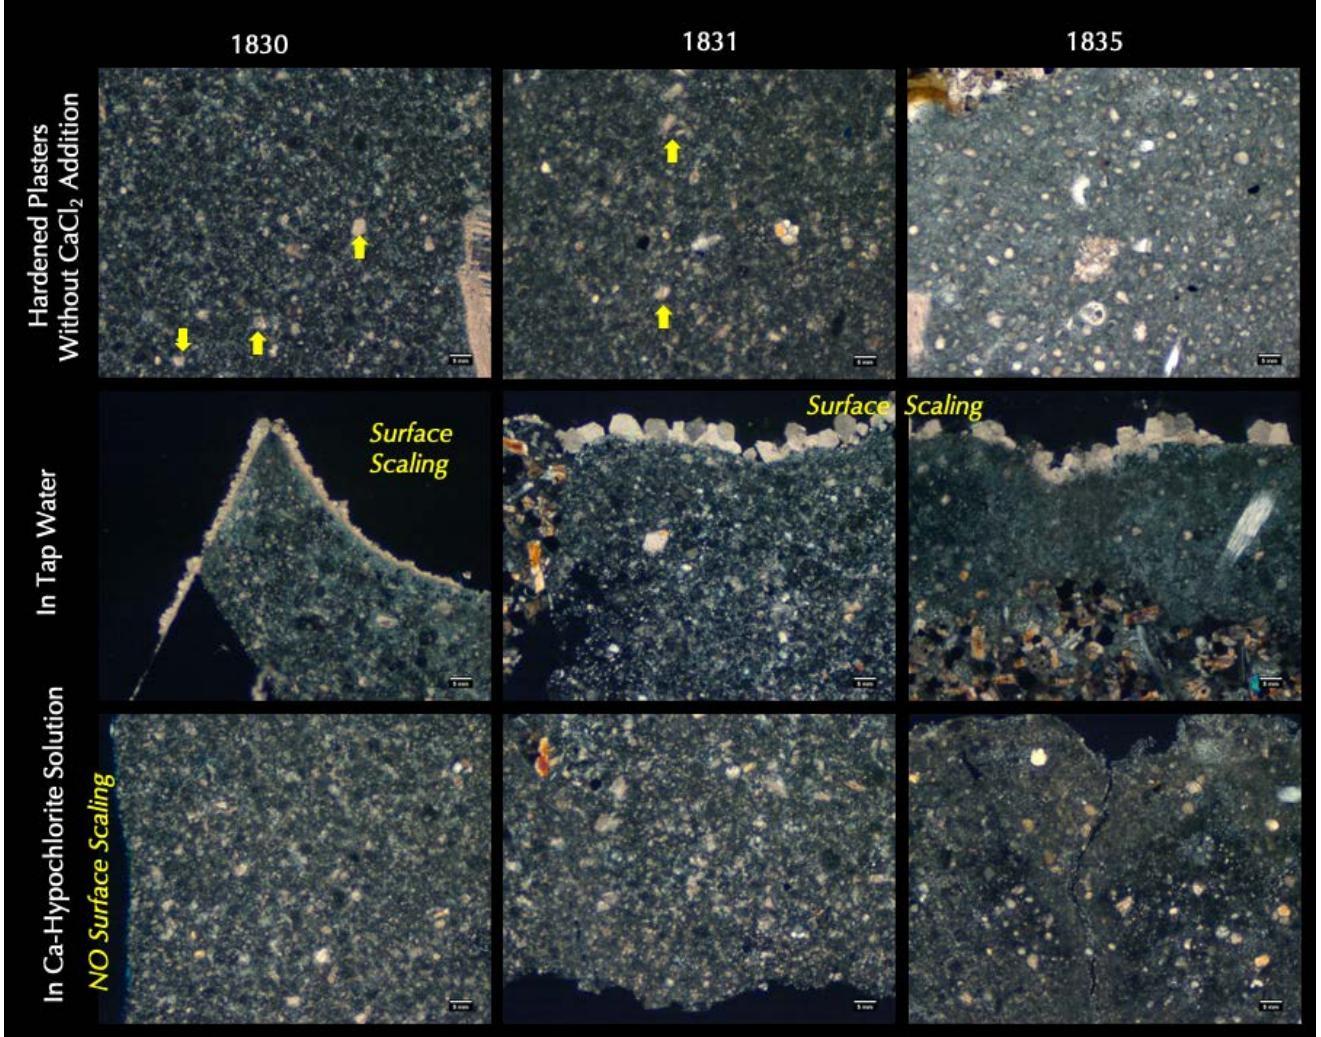
Figure 27: Micrographs of thin sections of hardened pastes of three plaster kits *without* CaCl<sub>2</sub> addition and after immersion in tap water and calcium hypochlorite disinfectant solution showing the following:

- a. Three hardened plaster kits# 1830, 1831, and 1835 without CaCl<sub>2</sub> addition (top row) showed typical mineralogies of residual calcium silicates (alite and belite) from white Portland cement, and limestone fine microfillers (mostly for kit# 1830 and 1831) as seen in their dry microstructures except having an overwhelming matrix of calcium silicate hydrate hydration products of cement on which the residual cement grains are scattered, fine-grained short prismatic or lath-shaped grains of water-soluble calcium hydroxide component of cement hydration, sometimes appearing as coarsely crystalline laths in air voids.

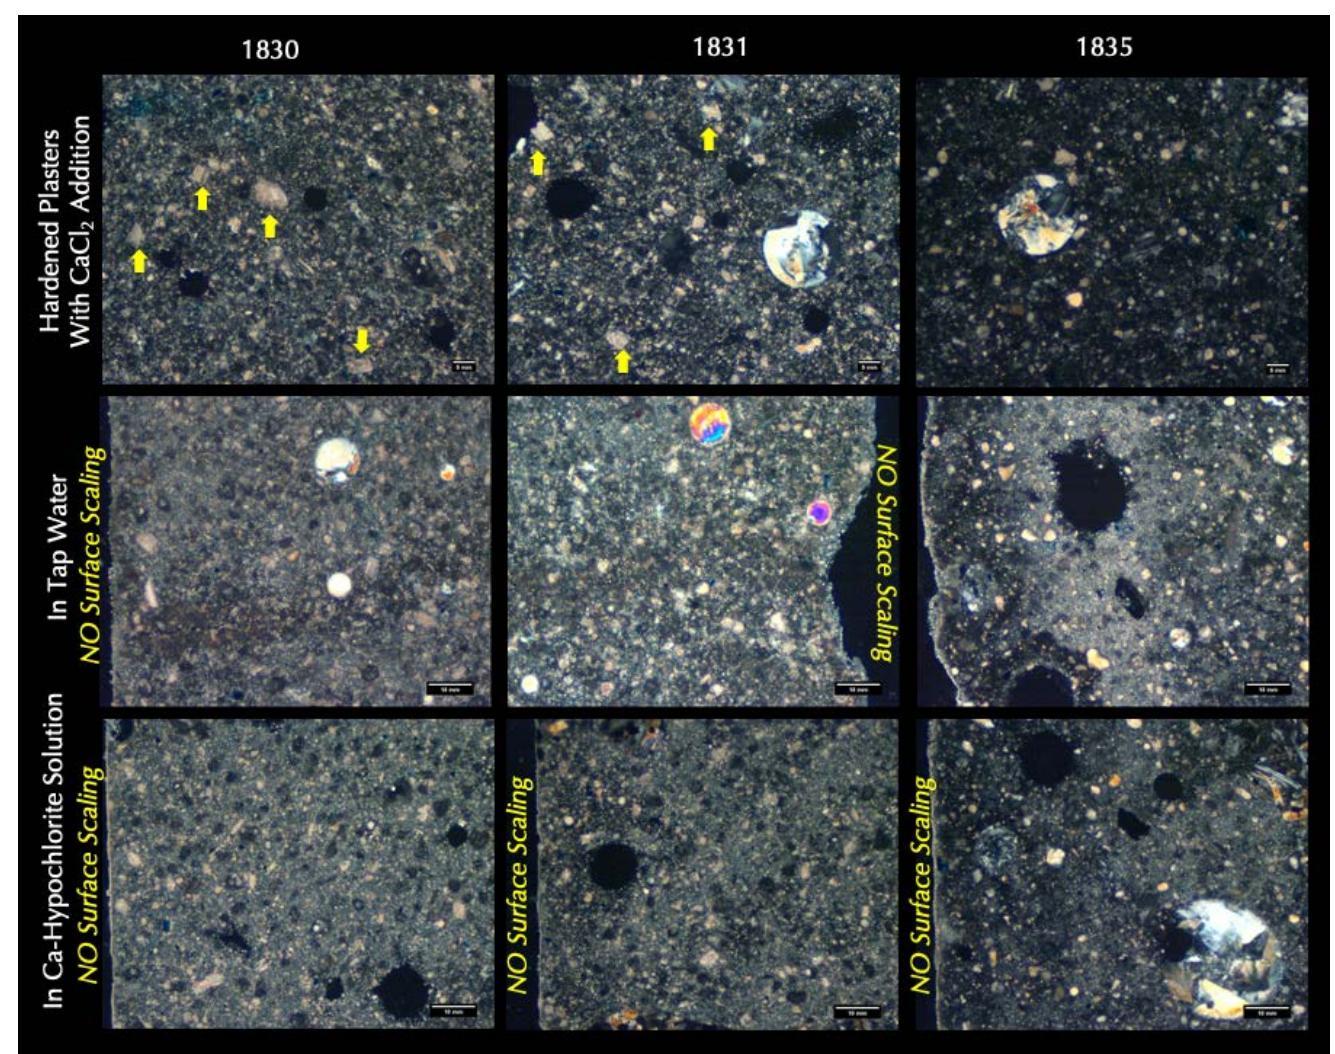
Figure 28: Micrographs of thin sections of hardened pastes of three plaster kits *with* CaCl<sub>2</sub> addition and after immersion in tap water and calcium hypochlorite disinfectant solution showing the following:

- a. Addition of CaCl<sub>2</sub> accelerator in the mix water during preparation of hardened plasters from kit# 1830, 1831, and 1835 showed no major difference in microstructure compared to the companion CaCl<sub>2</sub>-free ones. There is no evidence of any increase in the frequency of fine hairline drying shrinkage microcracks that are present in all hardened plasters irrespective of CaCl<sub>2</sub> addition. All three hardened plaster kits showed typical mineralogies of residual calcium silicates (alite and belite) from white Portland cement, and limestone fine microfillers (mostly for kit# 1830 and 1831) as seen in their dry microstructures except having an overwhelming matrix of calcium silicate hydrate hydration products of cement on which the residual cement grains are scattered, fine-grained short prismatic or lath-shaped grains of water-soluble calcium hydroxide component of cement hydration.

- c. Similar microstructures of localized dissolution but no surface scaling is found when the CaCl<sub>2</sub> doped kit were immersed in calcium hypochlorite disinfectant solution. Abundant coarse lath-shaped secondary calcium hydroxide deposits in air voids in all three kits indicates high solubility of this component of white Portland cement hydration.

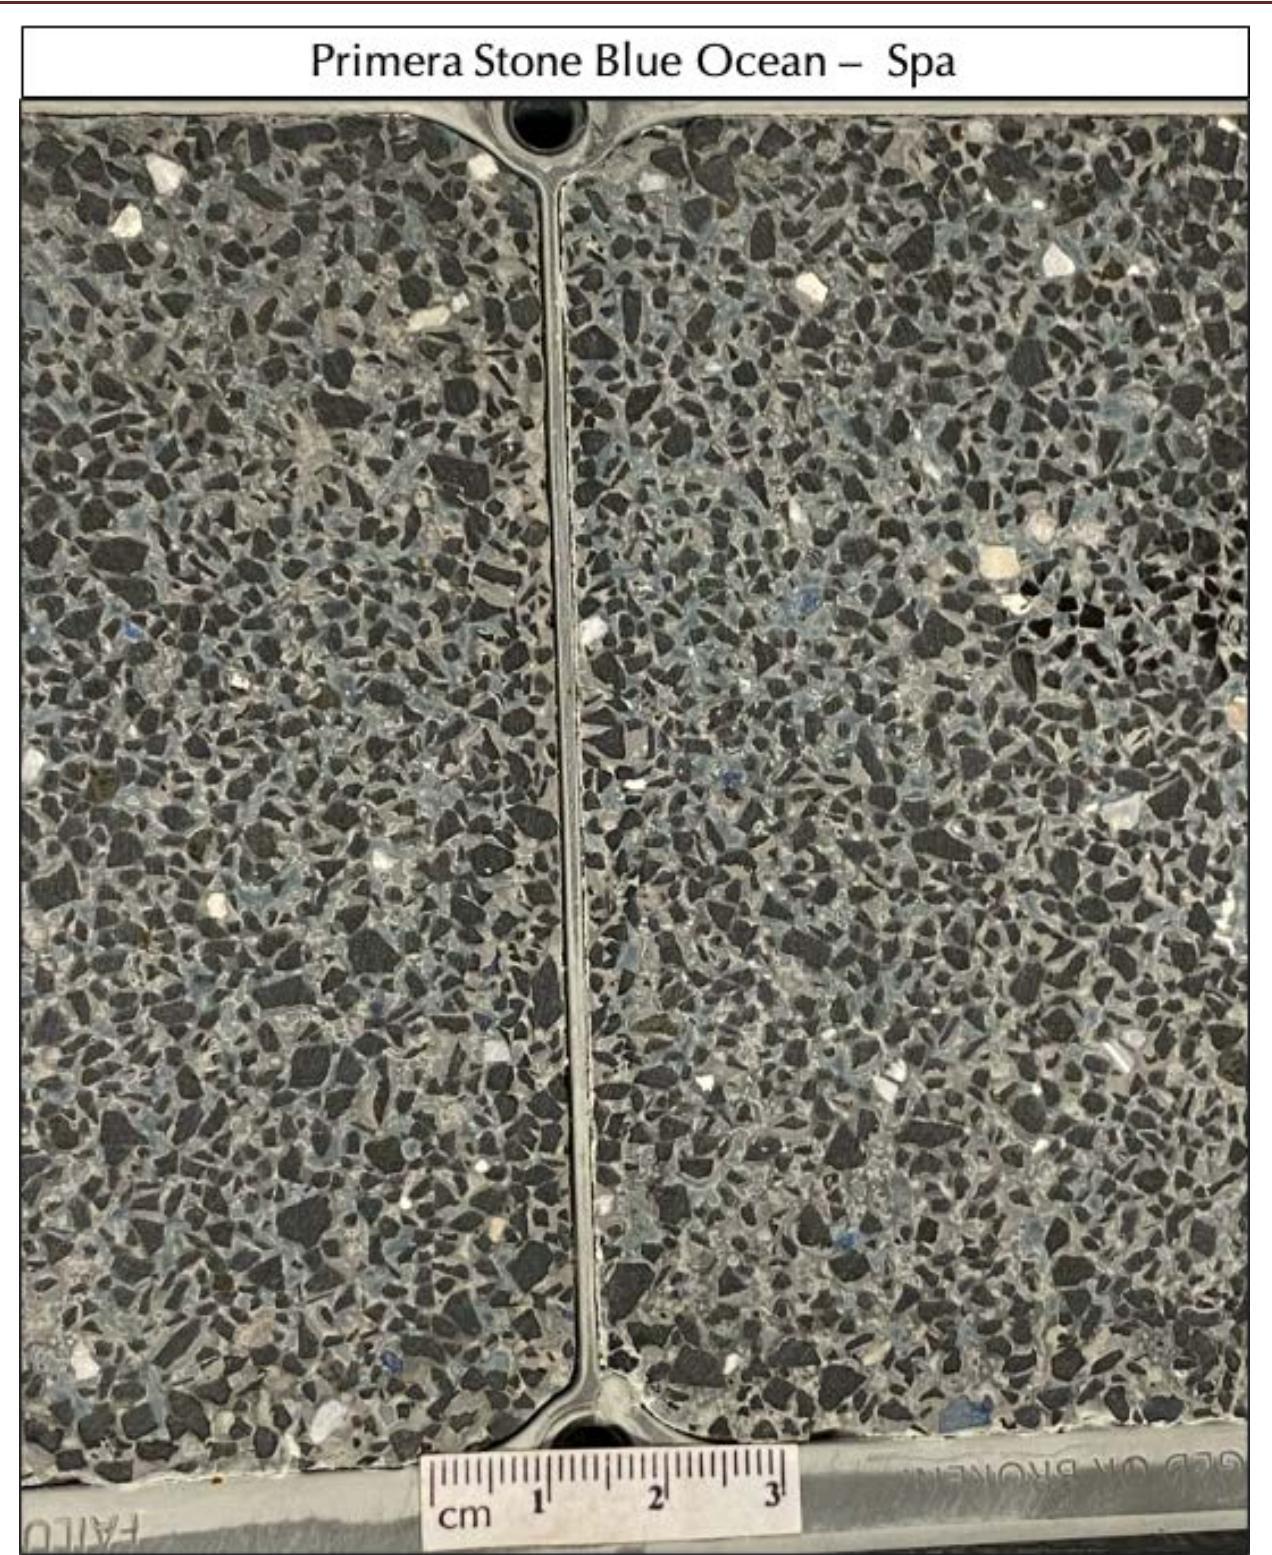
Fig. A 9: Blotchy discoloration (mottling) of exposed surface of Primera Stone Blue Ocean plaster.

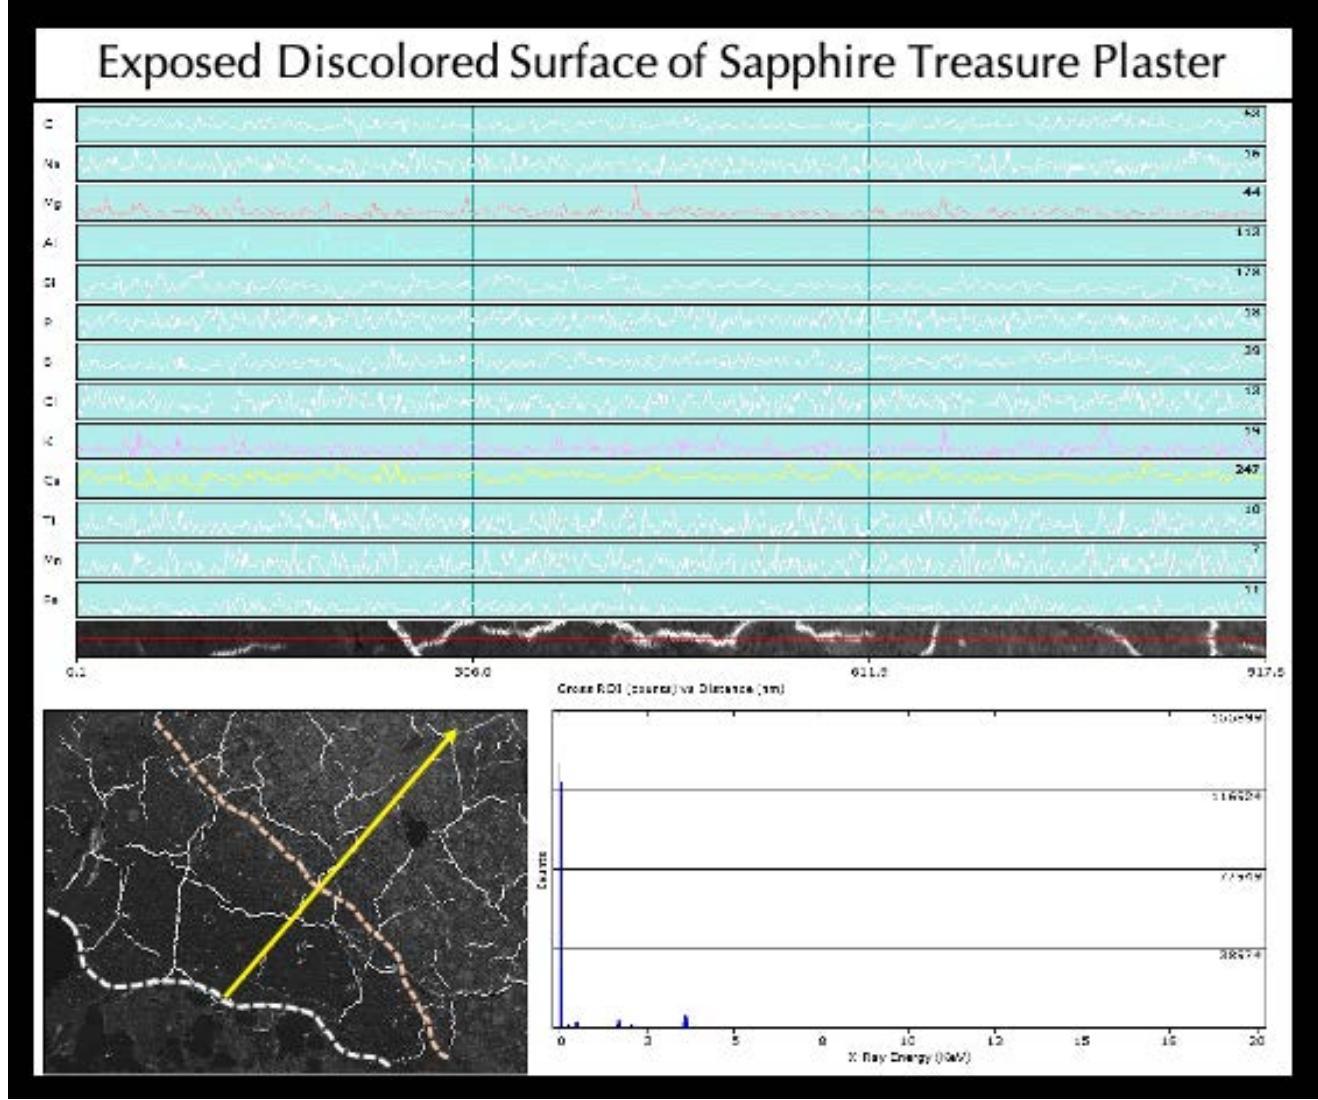
Fig. A 26: X-ray elemental analysis along the line traversing from darker to lighter gray area of paste showing the compositional variations in the paste due to variations in inherent porosities that has caused the blotchy appearance of paste due to differential dissolution of plaster by the pool water.

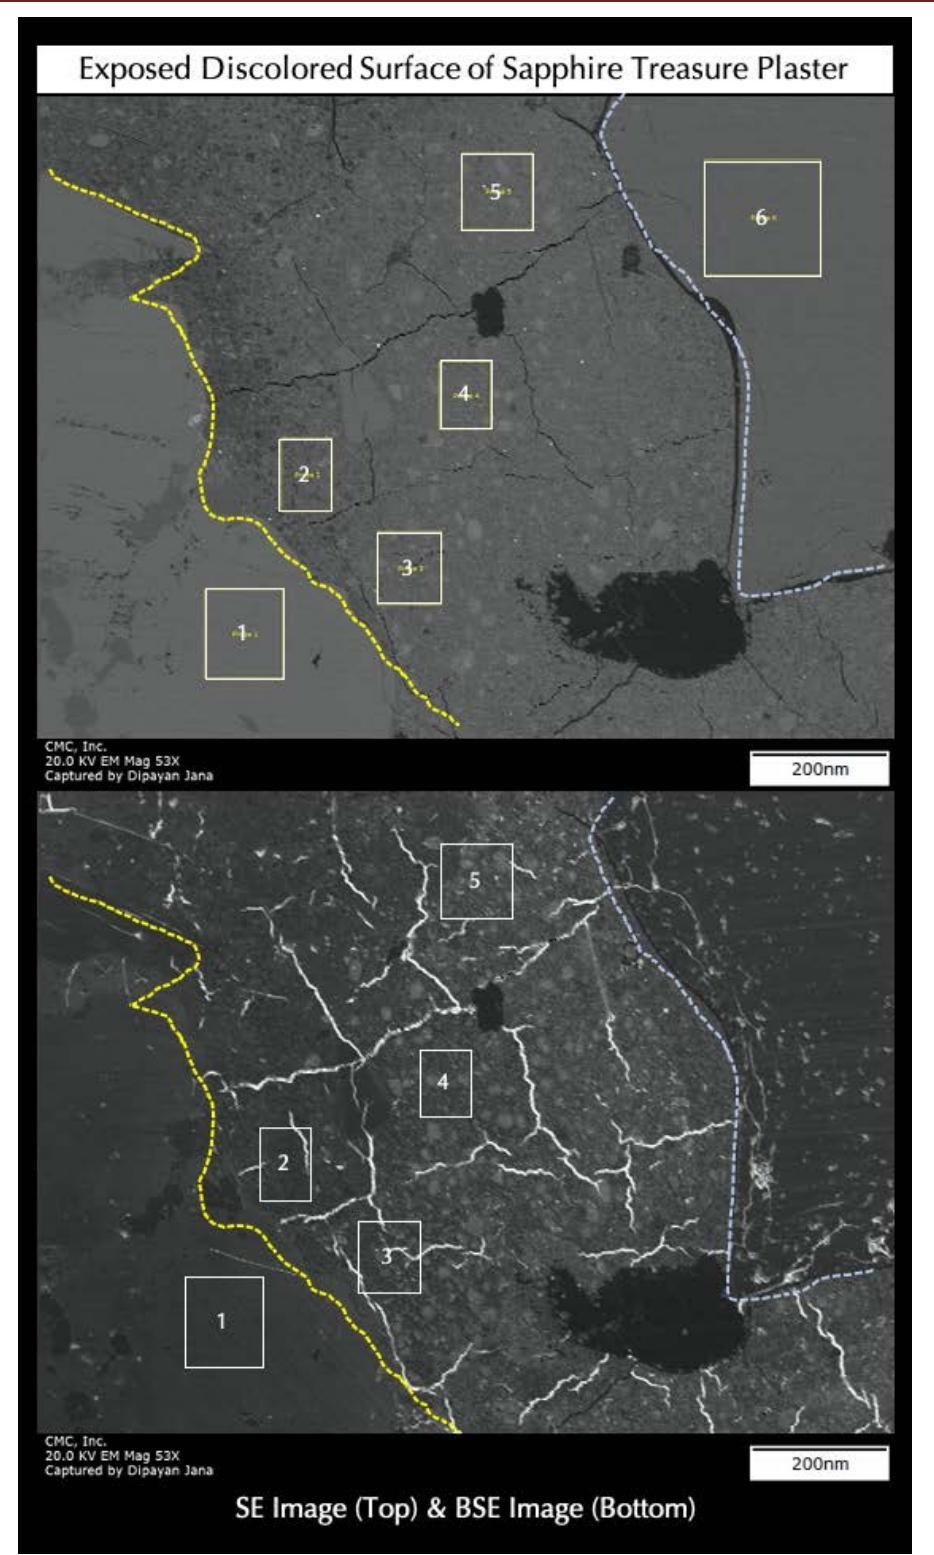
Fig. A 27: Backscatter electron (BSE) image (top) and corresponding secondary electron (SE) image (bottom) of the exposed discolored surface of Primera Stone Sapphire Treasure plaster showing different shades of lighter and darker gray areas of paste due to variations in chemical compositions of aggregates and interstitial paste where the latter shows numerous fine hairline shrinkage microcracks in the middle separated from the aggregate particles by dashed lines. Boxed areas are analyzed in the next Figure.

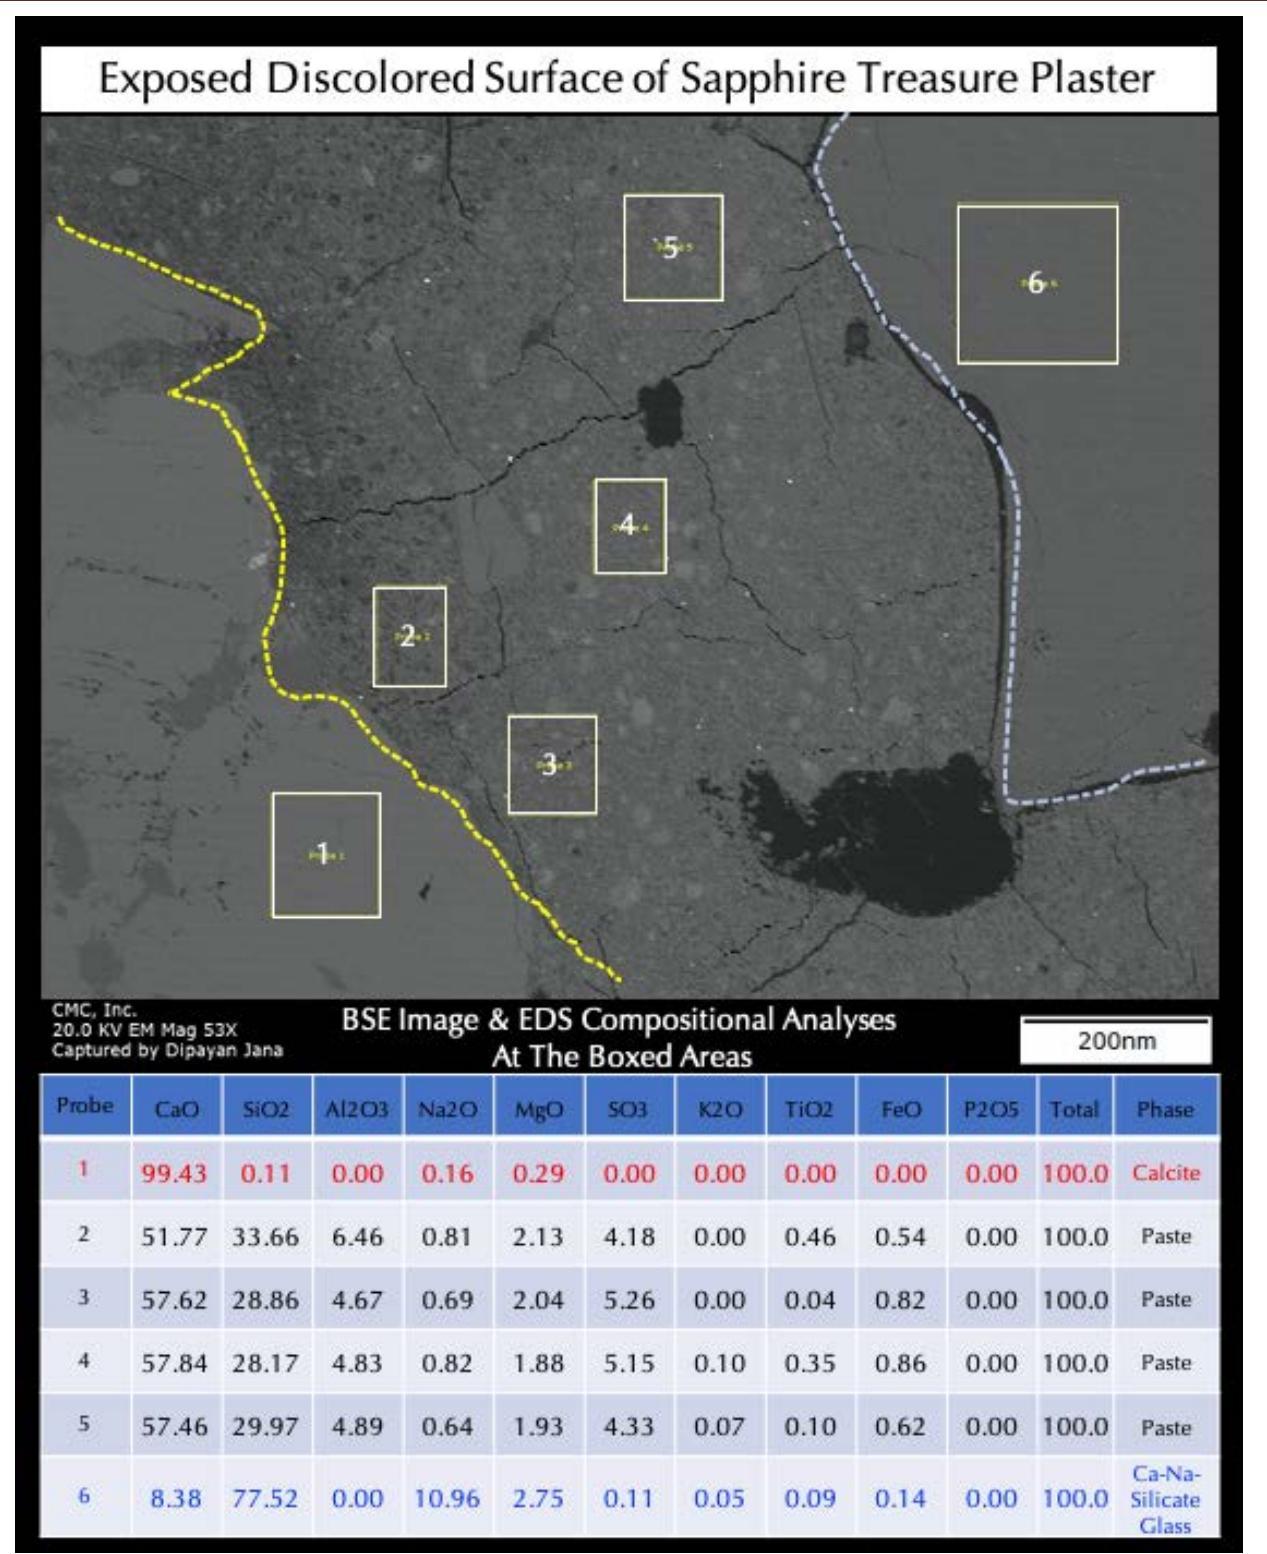
Fig. A 28: Backscatter electron (BSE) image (top) and X-ray microanalyses at the boxed areas on the exposed discolored surface of Primera Stone Sapphire Treasure plaster showing: (a) calcite grain in marble (probed at No. 1); (b) an alkali-silicate glass (Probed at No. 6); and (c) interstitial calcium silicate hydrate and calcium hydroxide components of white Portland cement paste (Probed at Nos. 2 to 5). Each component is showing its characteristic chemical composition. Sulfate contents in the paste are higher than that contributed from Portland cement, which is found to be from the barium sulfate extender present in the pigment dyes.

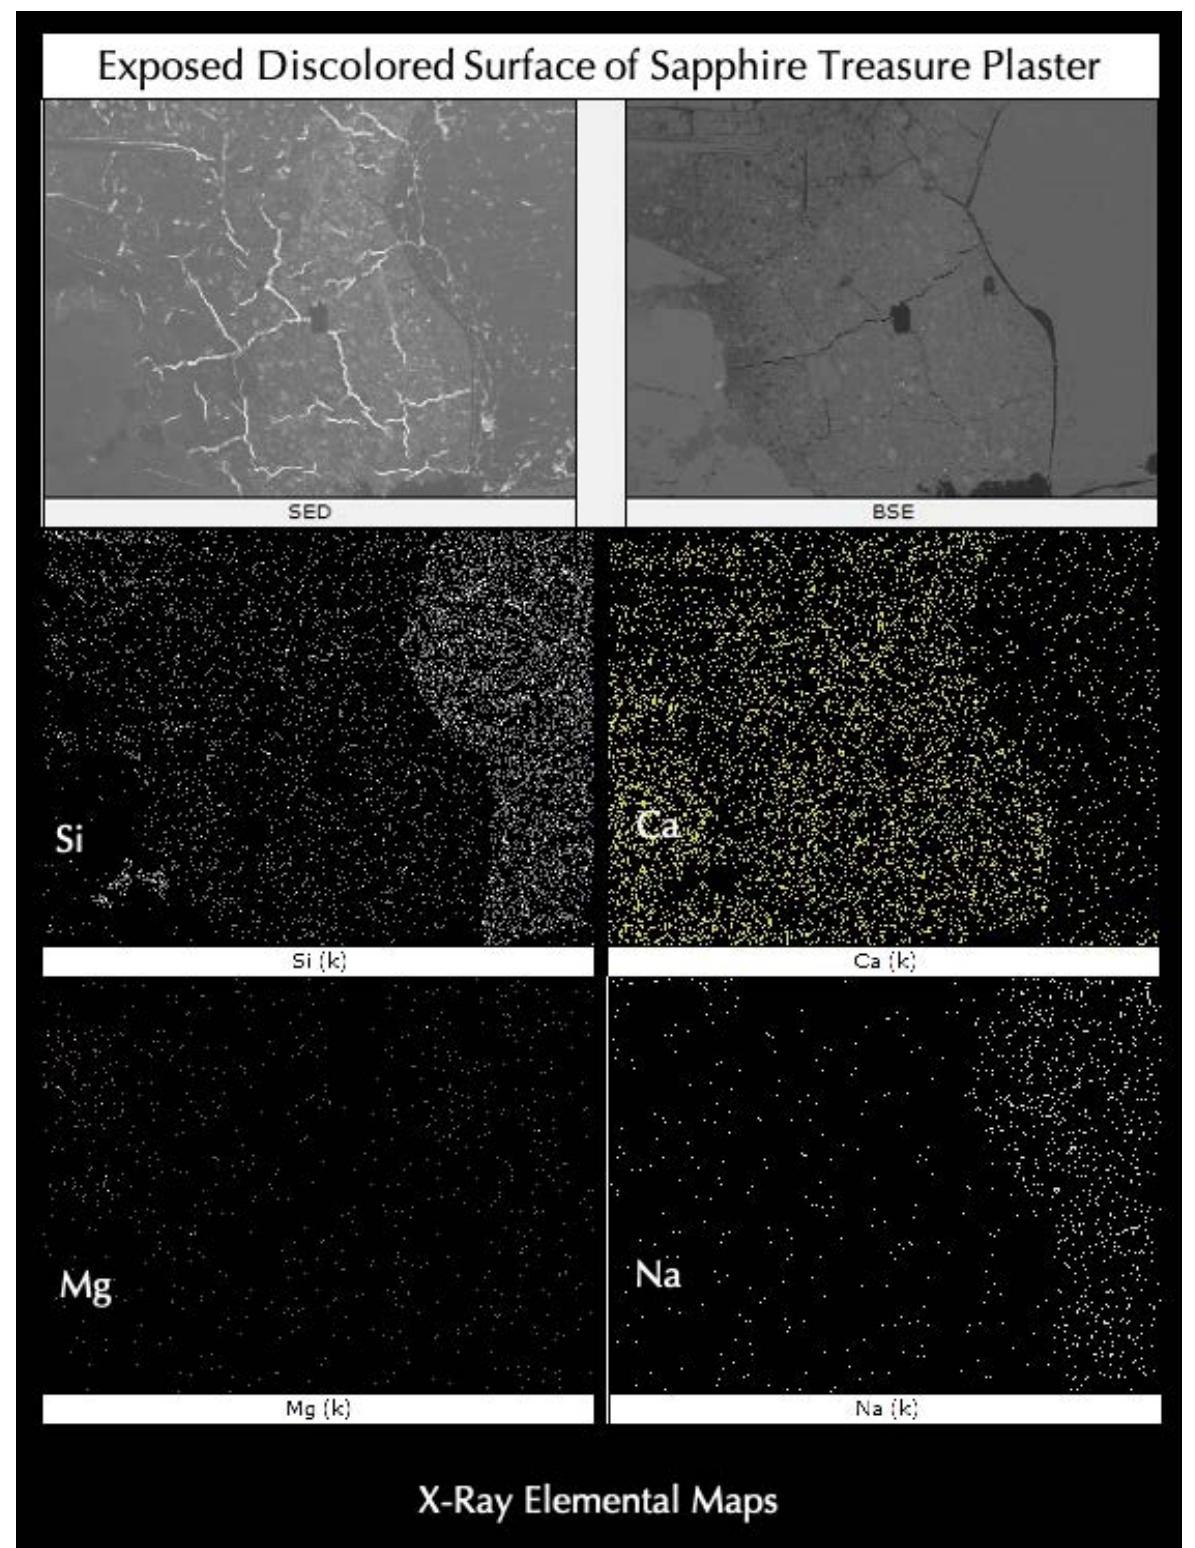
Fig. A 29: X-ray elemental maps of different elements showing compositional variations of the exposed discolored surface of Primera Stone Sapphire Treasure plaster where paste is showing: (a) characteristic calcium enrichment from calcium silicate hydrate and calcium hydroxide composition of cement hydration, and distinguished from (b) sodium silicate glass at the right edge having enriched Na and Si in the respective maps. Notice excessive fine hairline shrinkage microcracks in the paste portion that are prominent in the SE image.

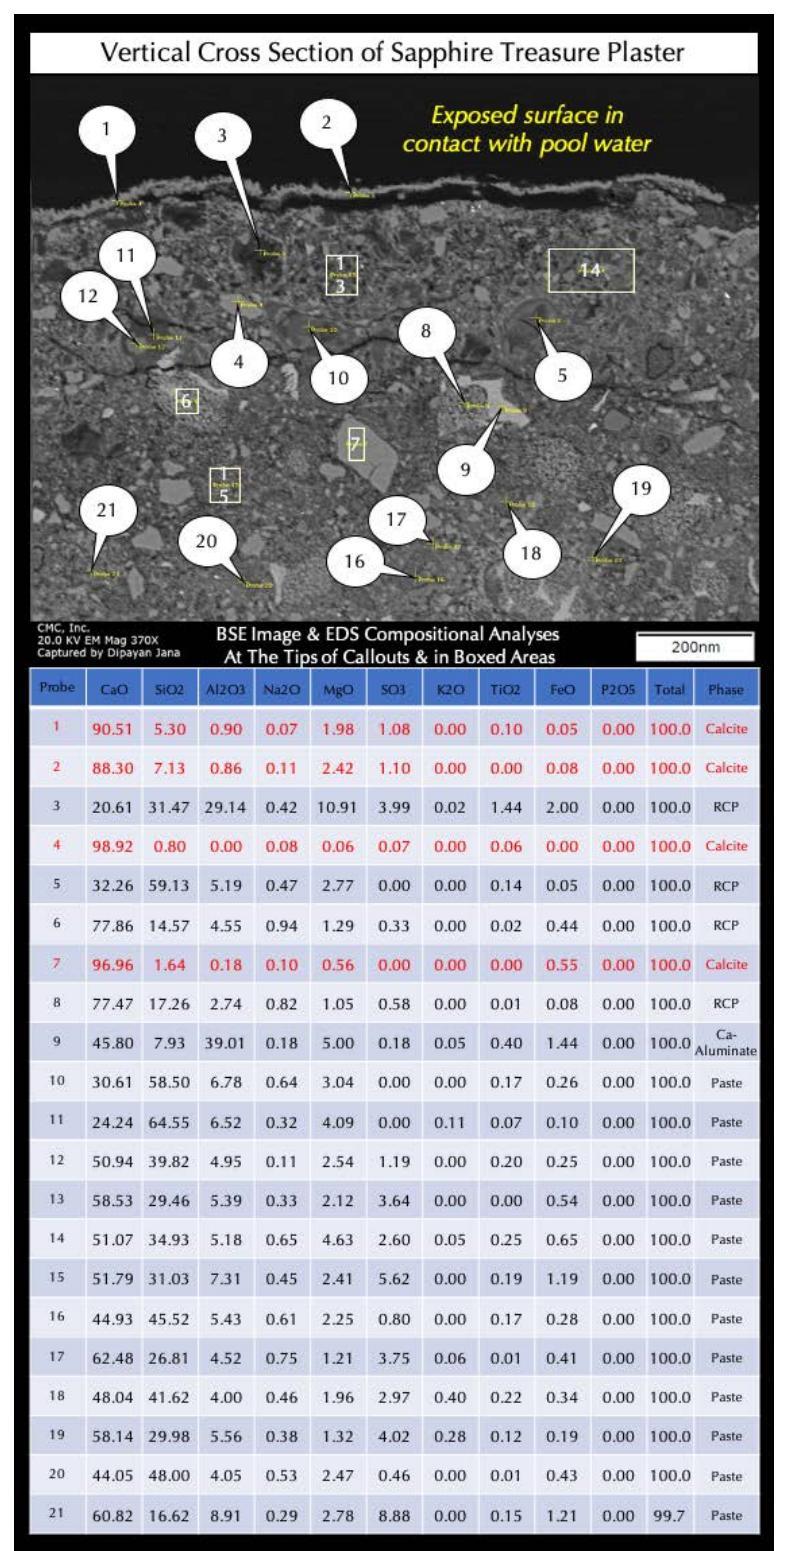
Fig. A 41: Backscatter electron (BSE) image (top) and X-ray microanalyses at the tips of callouts on the vertical cross section of Primera Stone Sapphire Treasure plaster showing: (a) a thin film of secondary calcium precipitate at the exposed surface (Probe# 1, and 2) due to localized scaling. Paste in the interior (Probe# 10 to 21) shows typical compositions of calcium silicate hydrate and calcium hydroxide components of cement hydration products except higher sulfate than that contributed from Portland cement, which is found to be from the barium sulfate extender present in the pigment dyes used in the plaster. Sulfate content is variable due to dissolution of plaster by pool water.

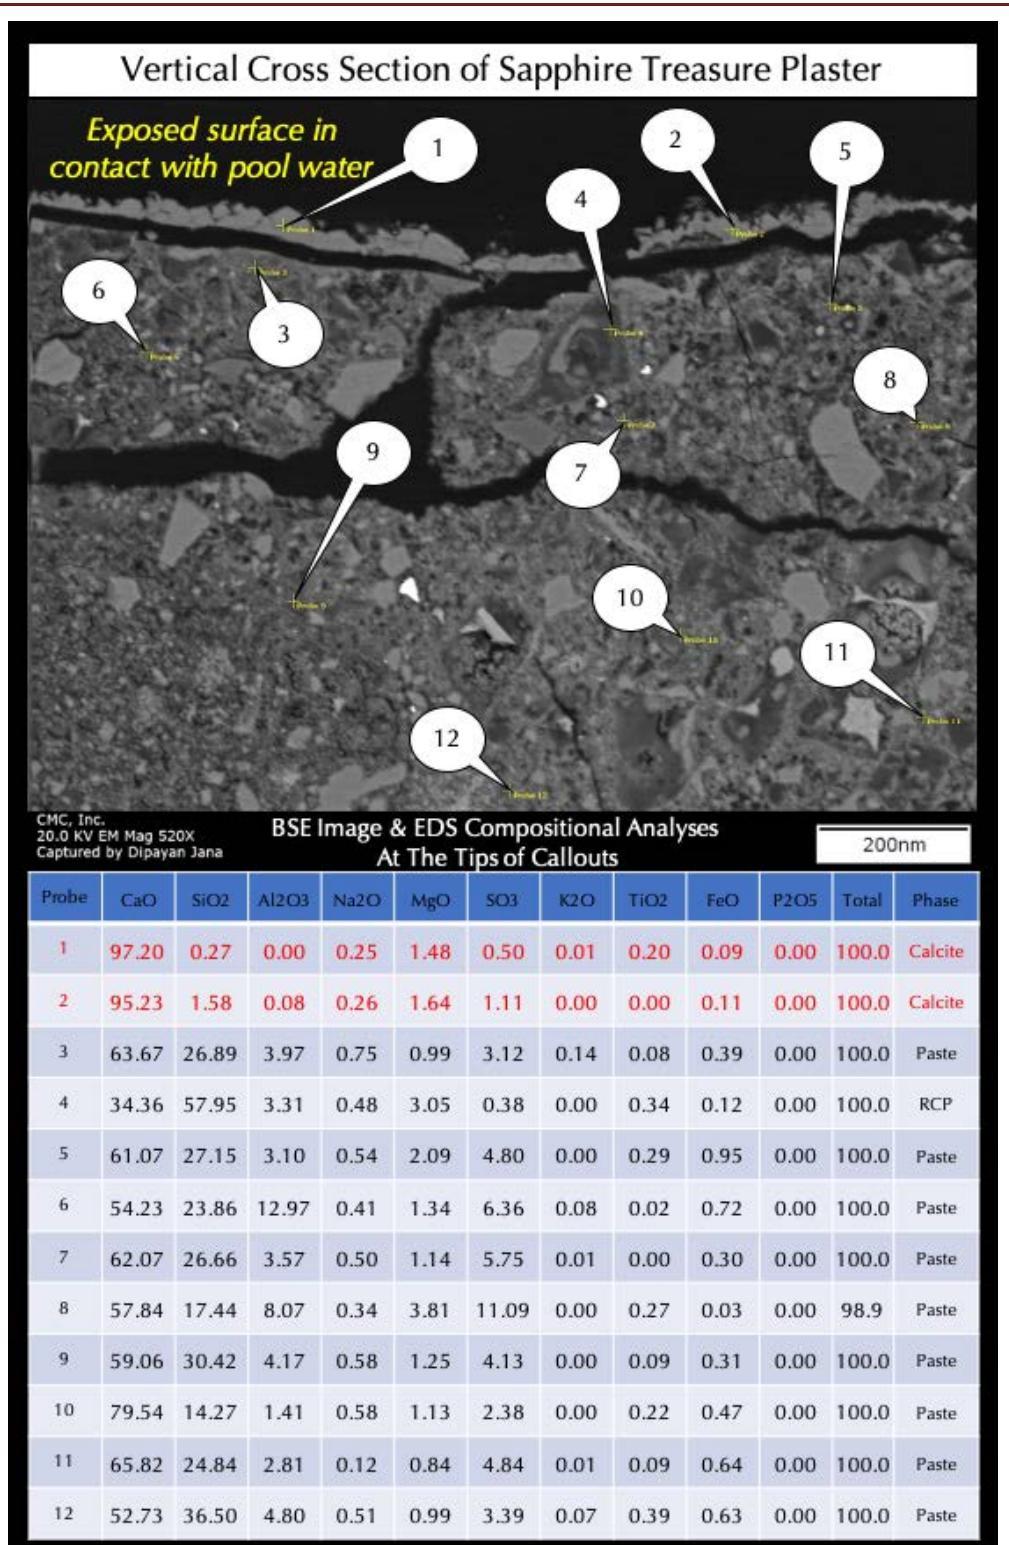
Fig. A 42: Backscatter electron (BSE) image (top) and X-ray microanalyses at the tips of callouts on the vertical cross section of Primera Stone Sapphire Treasure plaster showing: (a) a thin film of secondary calcium precipitate at the exposed surface (Probe# 1, and 2) due to localized scaling. Paste in the interior (Probe# 5 to 12) shows typical compositions of calcium silicate hydrate and calcium hydroxide components of cement hydration products except higher sulfate than that contributed from Portland cement, which is found to be from the barium sulfate extender present in the pigment dyes used in the plaster. Sulfate content is variable due to dissolution of plaster by pool water.

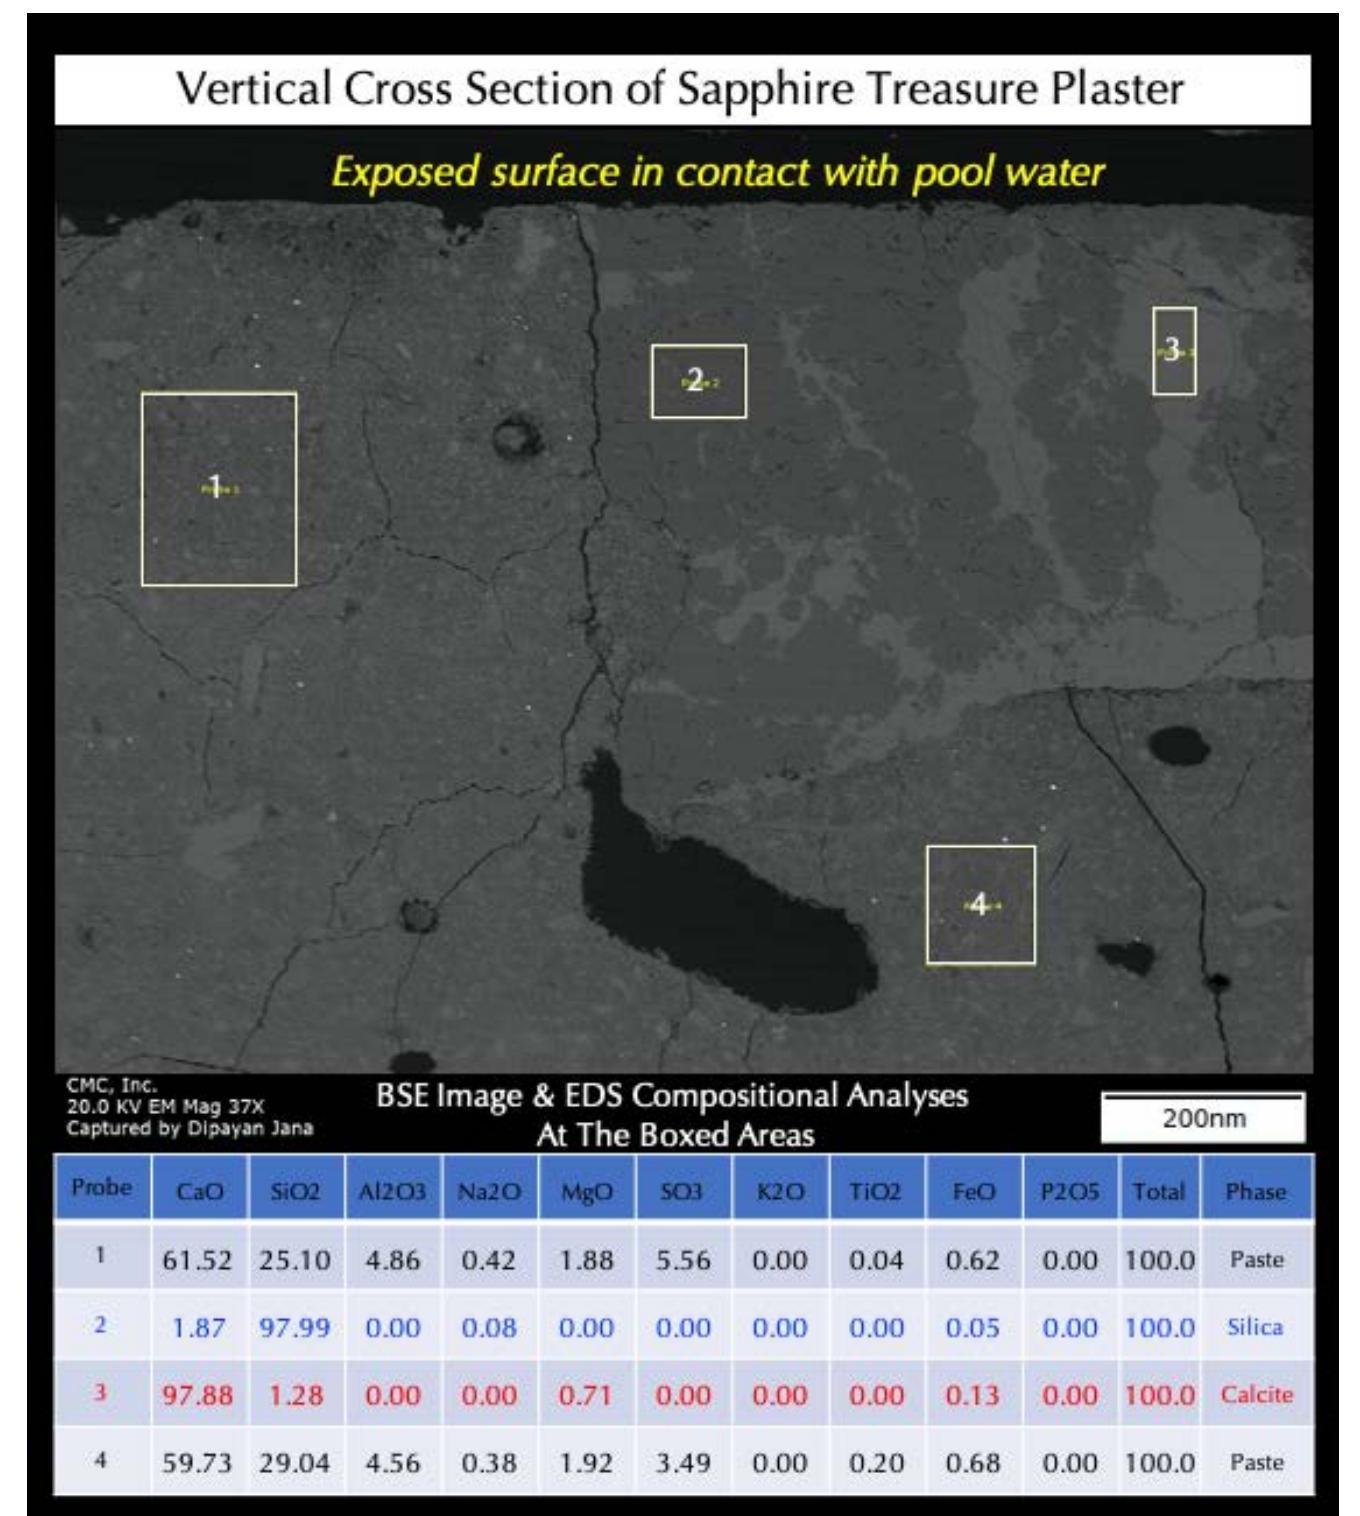
Fig. A 44: Backscatter electron (BSE) image (top) and X-ray microanalyses at the boxed areas on the vertical cross section of Primera Stone Sapphire Treasure plaster showing compositional variations of paste (Probe# 1 and 4), silica sand (Probe# 2), and calcium in marble (Probe# 3). Notice many fine hairline shrinkage microcracks that appear as dark lines in the image.

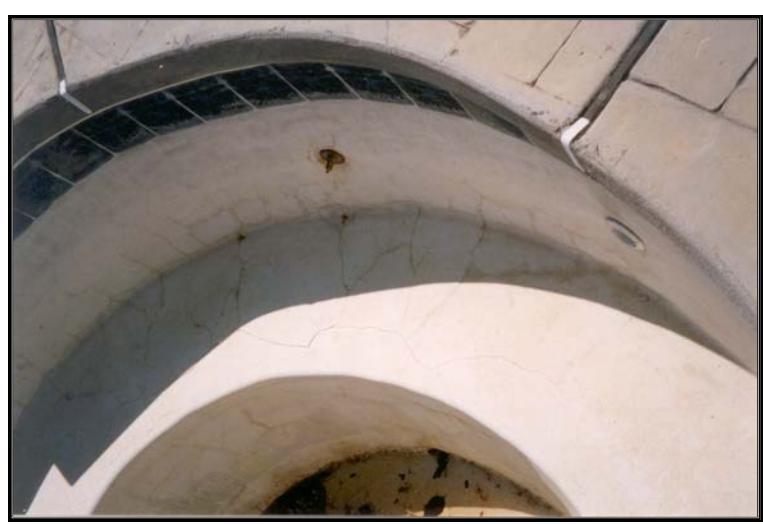
Figure 1 – A pool plaster showing random cracks on the steps.

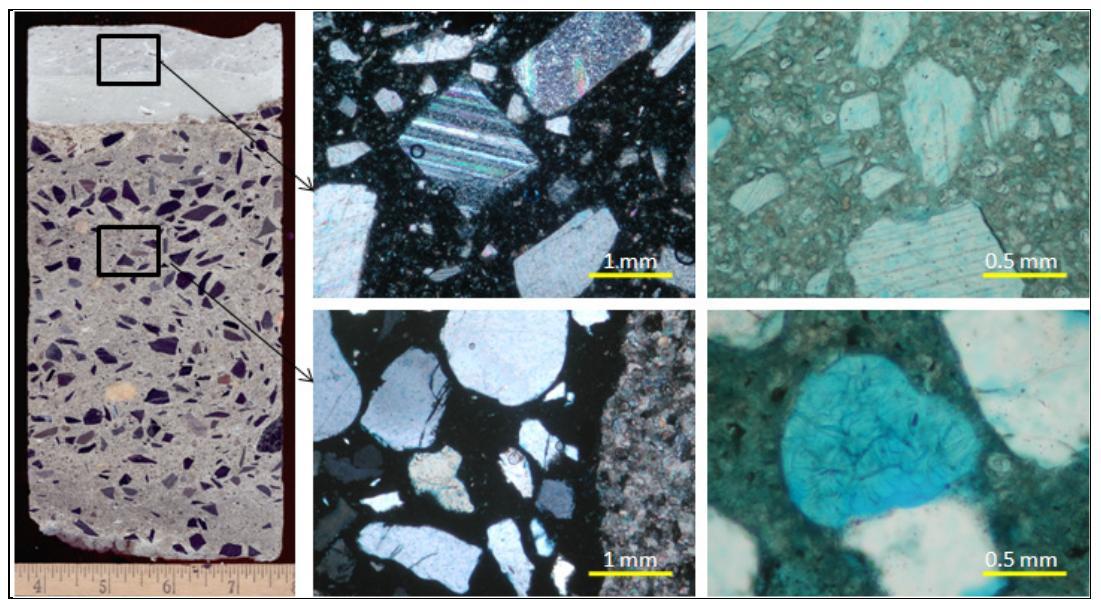
Figure 2 – Left - Lapped cross section of a core from the pool shown in Figure 1. The section shows a thick plaster (comprising two  $^{1}/_{2}$  to  $^{3}/_{4}$  in. thick applications), which is intimately bonded to the concrete substrate. Middle = Thin section photomicrographs of plaster (top) and concrete substrate (bottom) showing marble aggregates in plaster and dolomite-quartz aggregates in concrete, and portland cement pastes. Right = Thin section photomicrographs of plaster showing marble aggregates in plaster (top), and an air void in concrete, which is filled with secondary ettringite deposits (bottom).

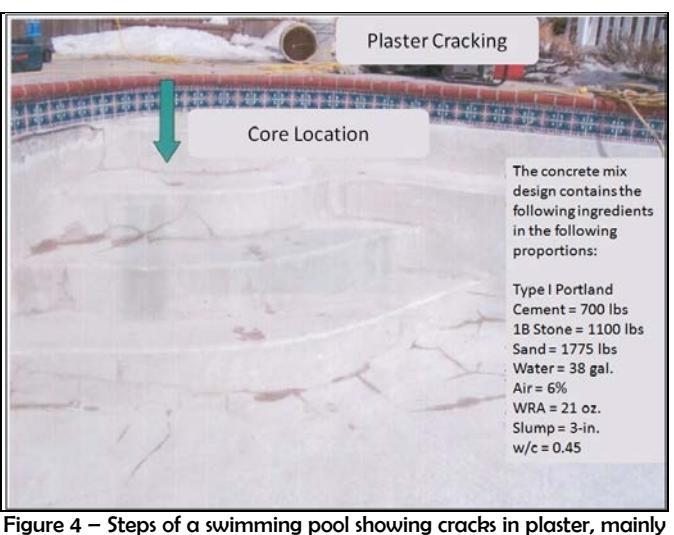
Figure 4 – Steps of a swimming pool showing cracks in plaster, mainly along the bases of the steps. Notice the radial pattern of cracks from the steps. Also shown is the location of the core presented for laboratory study (Case Study 3).

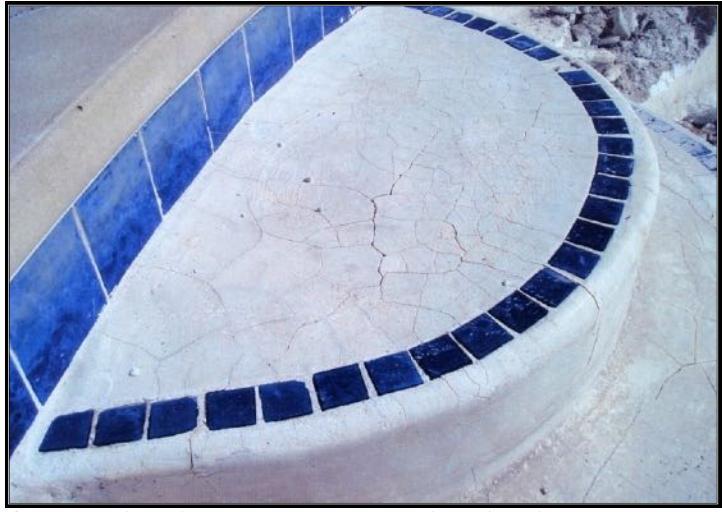
Figure 6 - Photo showing severe polygonal-shaped cracking in a pool plaster.
