### Swimming Pool Plaster Discoloration – A Case Study From Field & Laboratory-Cured Plasters

Primera Stone Sapphire Treasure & Blue Ocean

CONSTRUCTION MATERIALS CONSULTANTS, INC.

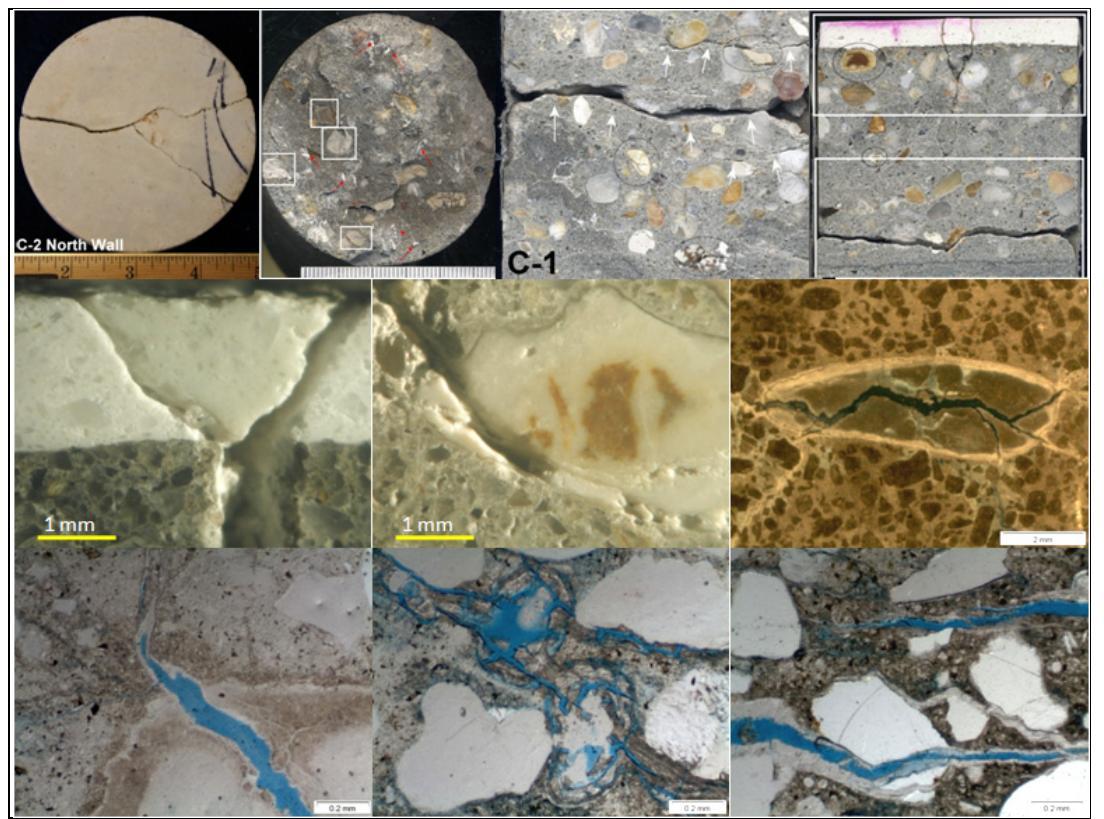
Figure 7 – Top Row from Left = Top surface of a core showing cracks; fractured surface of concrete substrate showing alkali-silica reactive chert and quartzite aggregates (boxed) and alkali-silica gel deposits in voids (arrows); lapped section of concrete substrate showing parallel cracks formed due to cyclic freezing and thawing of concrete at critically saturated conditions. Middle Row from Left = Photomicrographs of lapped cross section of the core showing cracks in plaster that have originated from the concrete substrate; cracking of an alkali-silica reactive chert aggregate in concrete; right photo shows thin section of concrete where an elliptical reactive chert aggregate shows severe cracking due to alkali-silica reaction. Bottom = Photomicrographs of thin section of core showing microcracking due to alkali-silica reaction, many originated from the reactive particle and extended to the paste; also notice alkali-silica gel deposits lining the walls of the microcracks.

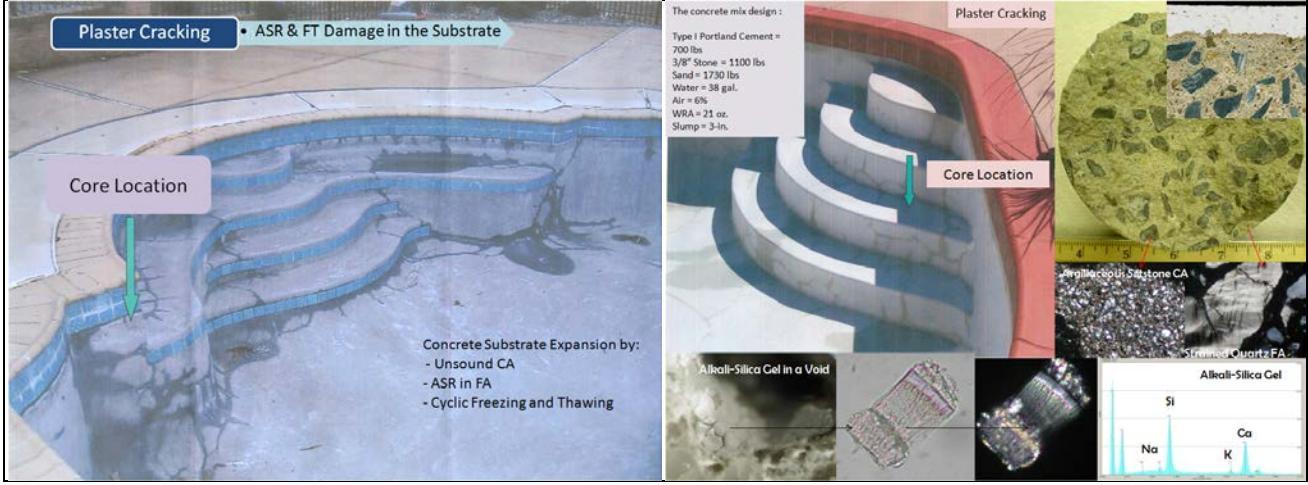
Figure 8 – Two separate pools showing cracking of pool plaster due to expansion of the underlying concrete substrate, which occurred due to unsoundness of argillaceous siltstone coarse aggregate and alkali-silica reaction of severely strained quartz-quartzite particles in fine aggregate in the concrete substrate. The right photo shows white ASR gel deposits on fresh fractured surfaces of reactive aggregates and dark reaction rims; unsound siltstone and reactive quartz particles in aggregate, white gel deposits lining the walls of voids, oil immersion mounts of gel showing its layered type birefringent nature, and EDS composition of gel having Na, K, Ca, and Si.

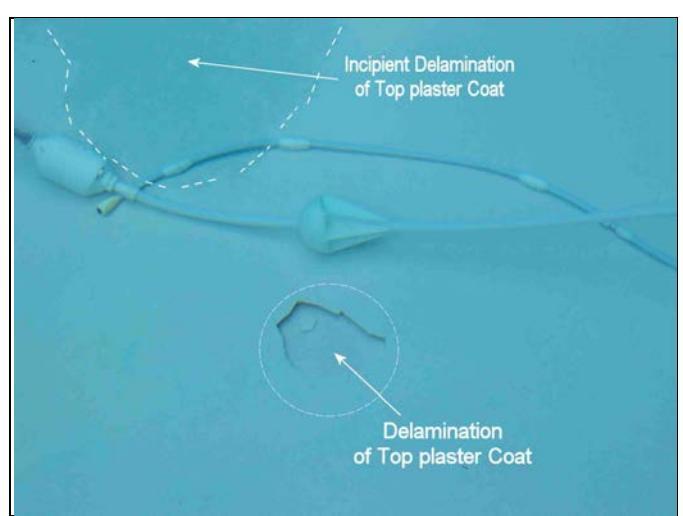
Figure 9 – Incipient and Complete Delamination of Pool Plaster.

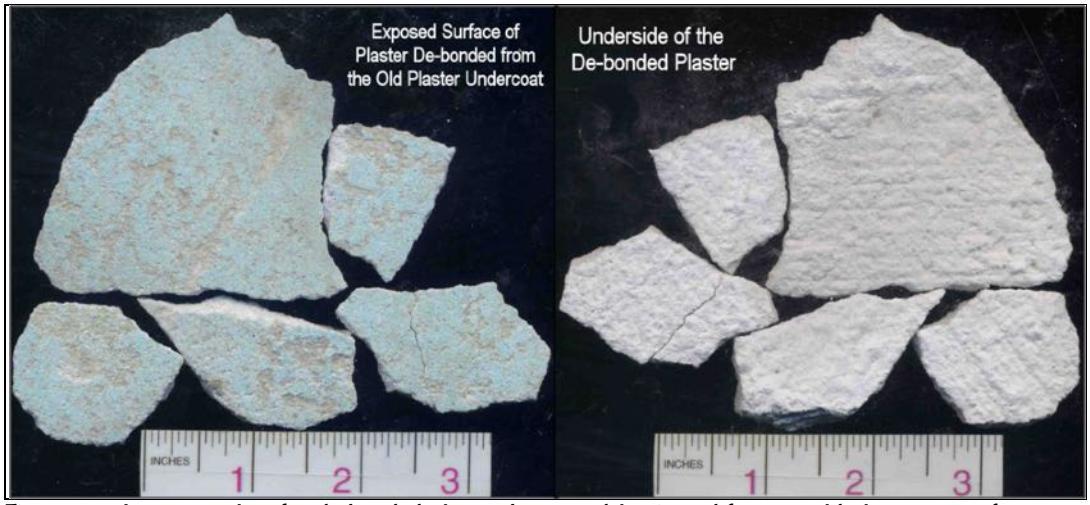
Figure 10 – Loose samples of a de-bonded plaster that was delaminated from an old plaster coat, after a replastering project. Notice the light green copper stain on the exposed surfaces of plaster pieces.

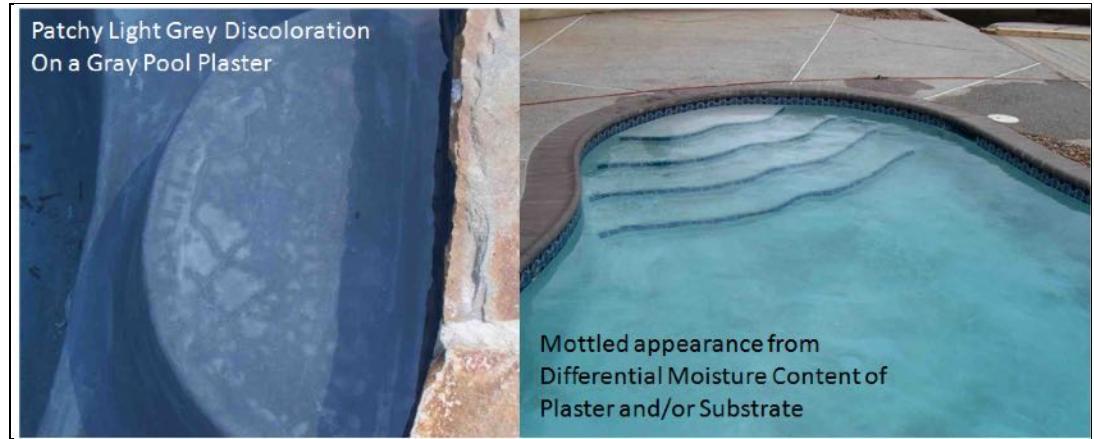
Figure 19 – Mottled Discoloration of Pool Plasters.
