Pyrite and Pyrrhotite

Managing the Risks in Construction Materials
and New Applications

Chapter 5

Concrete Deterioration from the Oxidation of Pyrrhotite: A State-of-the-Art Review

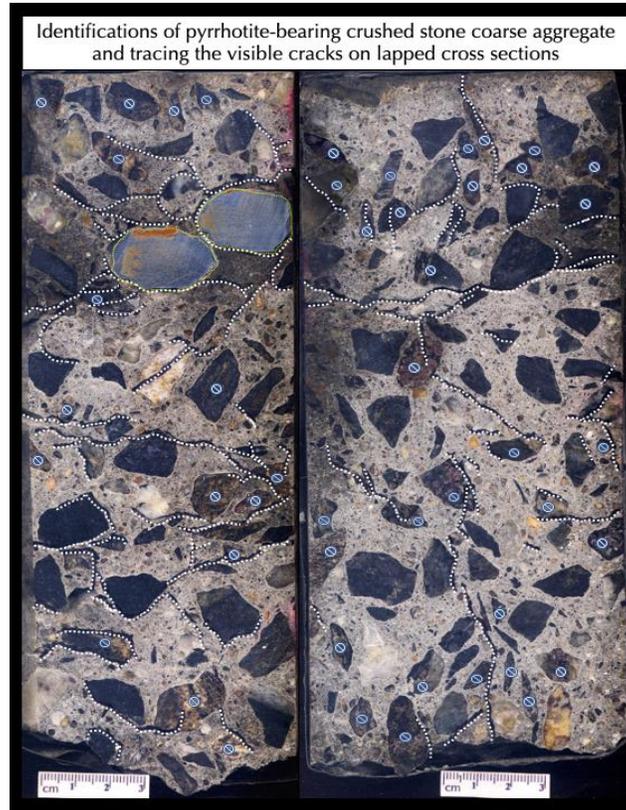
Figure 8. Lapped cross sections from a core from a distressed foundation in eastern Connecticut are examined in a low-power stereomicroscope to trace all visible cracks (shown in white dotted lines) as well as the pyrrhotite-bearing potentially unsound crushed stone coarse aggregate particles where particles with known detection of pyrrhotite from stereomicroscopical examinations are marked for further examination.
