# Delamination: The Sometime Curse of Entrained Air

By Dipayan Jana and  
Bernard Erlin

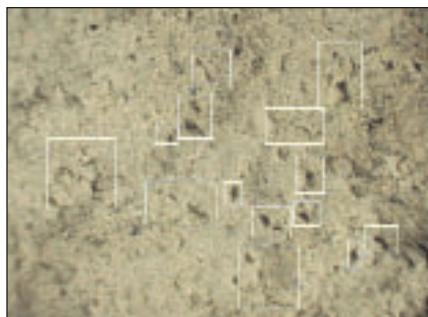
**Figure 3. Concrete in the underside of the delaminated concrete from the warehouse floor has irregularly shaped and elongated voids that indicate there was trapped bleed water (boxed areas).**

The delamination plane is horizontal, parallel to the finished surface, and at a depth of about  $\frac{1}{4}$  inch (Fig. 1). On the underside of the delaminated surface layer are many fine, irregularly shaped, horizontal, elongated voids (Fig. 3), and in the concrete below the delamination are fine, vertical channels that terminate at the delamination plane. Our opinion is that the elongated voids and channels were caused by trapped bleed water. These features demonstrate that finishing occurred before the concrete had stopped bleeding. The higher water-cement ratio paste sandwiched between the lower water-cement ratio paste above and below indicate that finishing manipulations trapped bleed water below the surface and that finishing continued after bleeding stopped, which
