Durability of Concrete Structures in Denmark

A Study of Field Behaviour and Microscopic Features - by G. M. Idorn

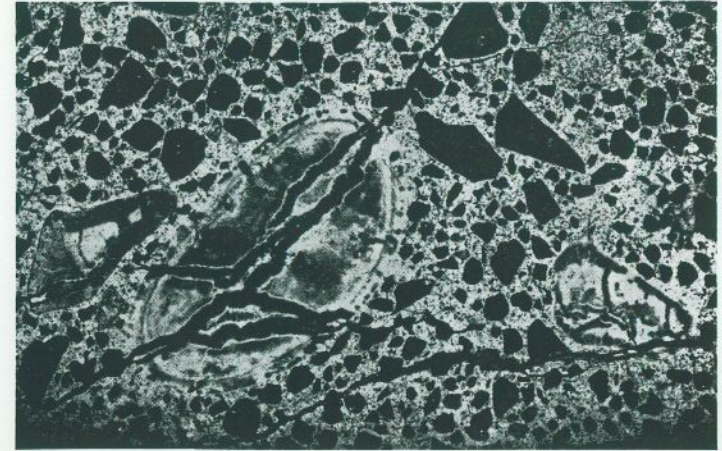
Fig. 16. Three reacted particles of porous flint (the mottled effect is due to impregnation with araldite) in thin section made from a concrete core, Oddesund Bridge. The mineral substance is partially dissolved, but the main-cracks show that a certain solidity and mechanical strength are retained. There is marked zonal dissolution along the main-cracks which continue into the surrounding mortar. From (3971). Thin section No. 54.5.30-10. V.

Fig. 16 shows three particles of porous flint with partial dissolution of the mineral substance and internal main-cracks, the appearance of which shows that the remaining structure of the material has retained considerable solidity and mechanical strength. As a macroscopic parallel to this reaction picture, reference can, for instance, be made to the formation of pop-outs shown in (2910) figs. 75 and 76, and to the porous flint particles in a section of core No. 54.5.30 from the Oddesund Bridge, shown in (2911) figs. 8 and 9.

Particles with typical phenomena of this type are shown in *fig. 16* above. *Figs. 45, 50, 51* in (3971), are other examples. It appears that the 'discolored' zones along the internal cracks of the particles frequently fail to become impregnated during slide preparation. This may be due to gel formation of the same kind as along the rim zones of the particles, cf. *fig. 24* and others. In such cases there may be a question of secondary 'rim zones', since the internal main cracks can be said to divide a reacting particle into several smaller particles.

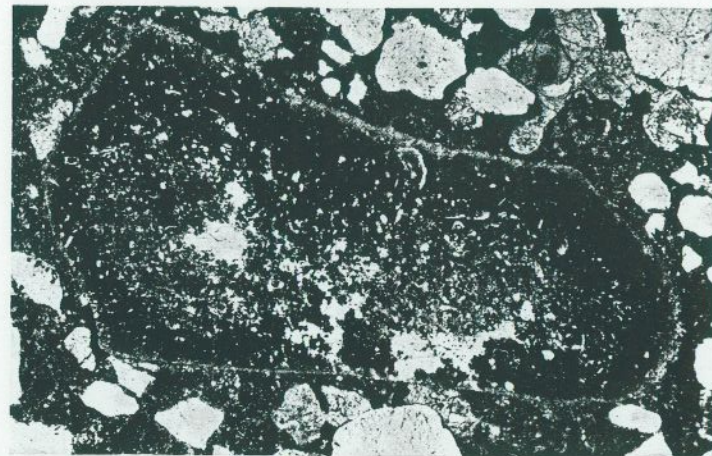
Fig. 19. Reacted particle of porous flint in thin section of concrete core, Odde-sund Bridge. The interior structure of the flint is highly dissolved and altered into a dark gel, but there are no cracks in the surrounding matrix. Thin section No. 54.5.70-4. ○.

Fig. 19 shows a particle of porous flint with extensive internal alteration, but without crack formations due to expansion, i. e. without visible, mechanical effects of reaction in the surrounding paste.

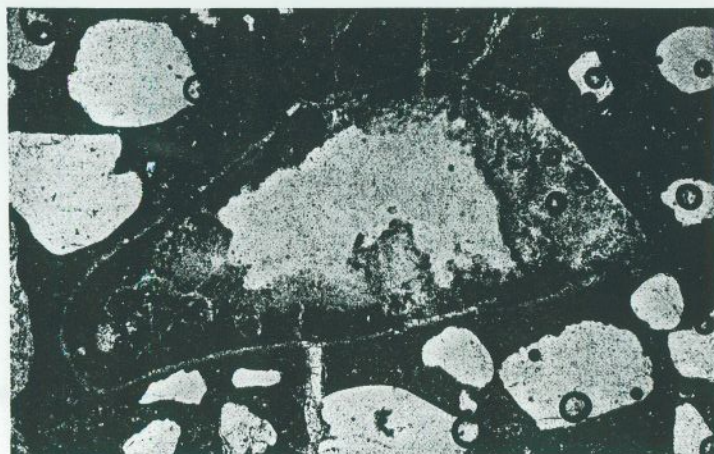
Fig. 22. Reacted particle of porous flint in thin section of concrete core, Oddeund Bridge. The particle, with its gel-filled cracks radiating into the surrounding matrix, is typical of alkali-aggregate reaction. Chalcedonic parts of the particle (light areas in the picture) have remained unaltered and solid during reaction. The very light part in the interior of the particle is where part of the mineral substance has been abraded during preparation of the thin section. From (3971). Thin section No. 54.5.13-3. ○.

Fig. 22 represents the reaction picture of porous flint that might immediately be expected. The formation of gel in the particle structure has led to expansion, with consequent radiation of gel-filled cracks into the surrounding matrix. The picture has numerous parallels in (3971). A macroscopic parallel is (2911) fig. 9. It should be noted that in thin sections, the crack picture, which can be adduced to expansion during gel formation, can be superimposed by crack formations due to drying shrinkage (preparation), so that the primary mechanism is difficult or impossible to ascertain in the individual cases.

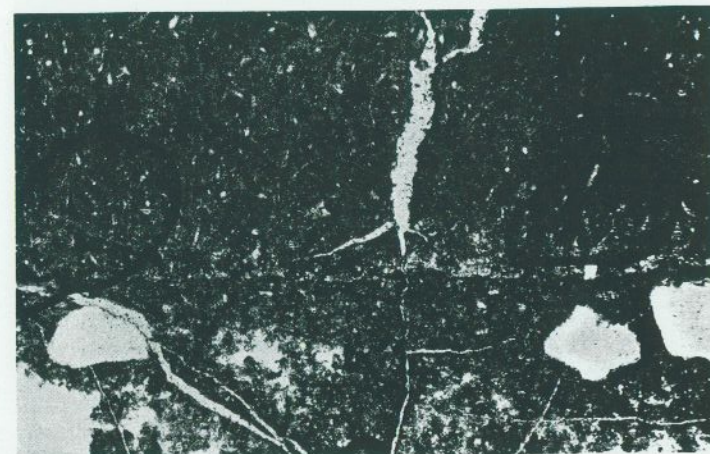
Fig. 23. Detail of reacted pebble of porous flint in thin section of concrete core, Oddeund Bridge. Swelling of the particle has produced a crack in the paste perpendicular to the rim of the particle. Subsequent shrinkage has caused parts of the paste 'to follow the particle', and a system of secondary cracks in the paste has been superimposed on the original expansion crack. A succession like this of shrinkage following expansion must be expected when swelling gel has developed in porous flint. The dark rings are air bubbles which have developed between the cover glass and the thin section during some years' storage in the laboratory. From (3971). Thin section No. 54.5.13-5. ○.

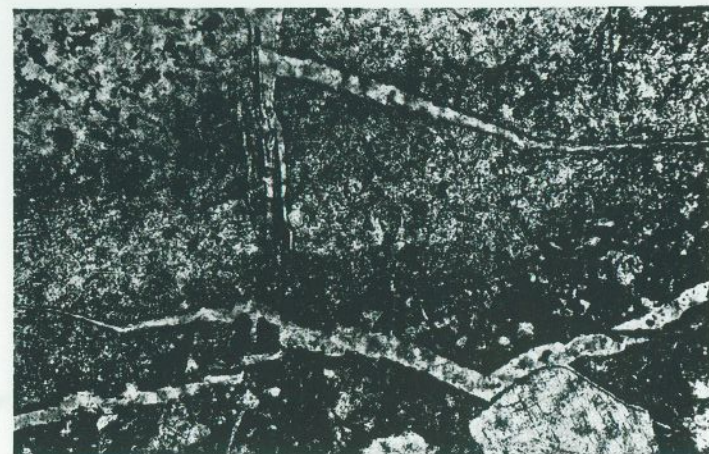
Fig. 24. Detail of reacted particle of porous flint in fig. 18 and 21. Cracks due to drying shrinkage are seen in the altered interior of the particle and in the cement paste along the particle boundary. There is no tendency to cracking between the reaction rim and the interior of the particle. Thin section No. BFL 4-3. ○.

Figs. 24 and 25 show a part of the particle in *fig. 18*, with shrinkage cracks in the interior gel substance of the particle and in the cement paste along the rim of the particle. *Fig. 25* emphasizes the distinct isotropy of the substance in the rim zone. (3971) *figs. 42, 43 and 44*, illustrates the same phenomenon. In the last two figures, the interior gel mass of the particle is seen to surround spherulitic calcite precipitates, while the gel substance in the rim zone is completely isotropic. It is characteristic of the reaction rim phenomena mentioned that the actual edge of the particle stands out clearly against the surrounding cement paste.

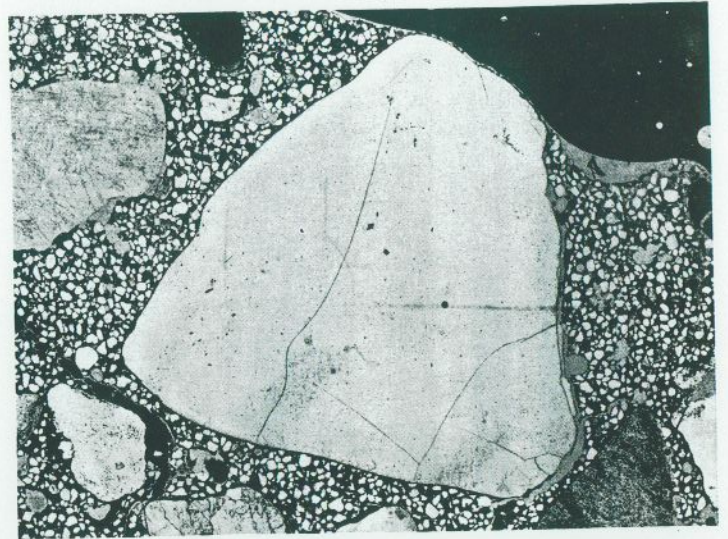
Fig. 27. Pebble of dense black, homogeneous flint in thin section from concrete specimen in groyne block, north barrier of the Lim Fiord. The pebble is traversed by narrow, almost closed main-cracks which cannot have been present when the concrete was placed. Minor cracks extend only a short distance inwards from the boundary, and gel is present in the crack which separates part of the periphery of the pebble from the surrounding mortar. The phenomena described are considered evidence of moderate alkali-aggregate reaction. From (2910). Thin section No. G 19-34-[44.13.1-(5908)]. 11.

Fig. 27 shows a dense, black homogeneous flint particle in badly deteriorated concrete. The particle is traversed by thin, closed main-cracks, which may have occurred as a result of internal expansion during invisible dissolution of, and formation of gel in, the mineral structure. (The cracks cannot have arisen before the concrete was cast because the particle could not in that case have kept its shape and size during mixing and casting). Similar, slight crack formations in uniform, dense flint are shown in (3971).

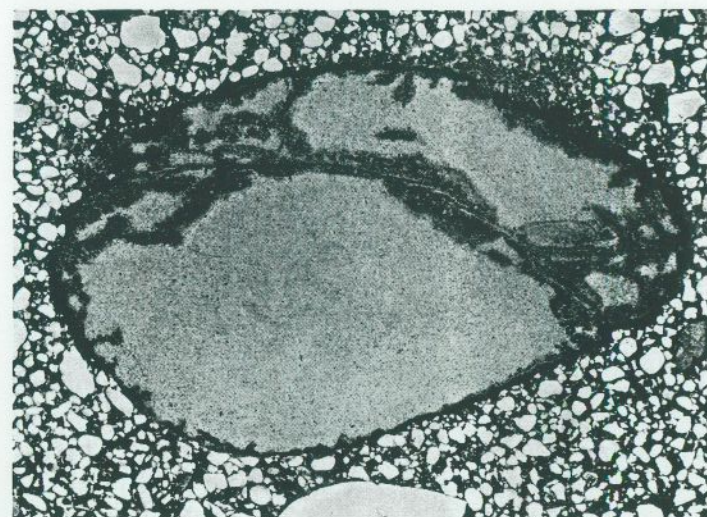
Fig. 29. Reacted pebble of dense flint in thin section of concrete specimen from factory chimney. The pebble is traversed by narrow, open cracks along which advanced alteration of the mineral substance has taken place. Alteration has also been severe in a narrow zone at the rim of the pebble (rim corrosion). At some places a main-crack separates the reaction rim from the interior of the pebble, i. e. the bond between the boundary and the surrounding paste has been stronger than that between the altered mineral substance and the reaction rim. The alteration may have been the first step of reaction if the pebble originally contained relatively porous parts where cracking could then follow the mechanical weakening of the structure. Or, a traversing crack may have developed in the pebble as a result of the accumulated hydraulic pressure in the submicroscopic pores of the flint and visible alteration can have accompanied the crack development as the second phase of reaction. Thin section No. BFL 4-6. 11.

Fig. 29 shows a particle of dense flint from a factory chimney examined on a consultation basis. The particle is traversed by thin cracks along which advanced dissolution of the mineral substance has taken place. The same course of reaction has occurred along the particle rim.

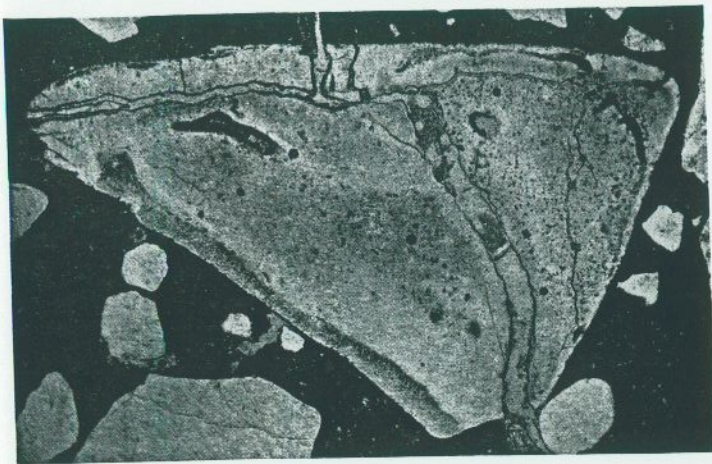
Fig. 30. Reacted particle of dense flint in thin section of concrete core, Oddesund Bridge. The picture is typical of alkali-aggregate reaction in dense flint in Danish concrete. The broad, open main-cracks have allowed gel to flow from the altered rock into cracks radiating into the surrounding cement paste. Inside the particle the pattern of cracking may have been determined by the presence of relatively porous and possibly opaline parts of the particle. From (2681). Thin section No. 54.5.13-6. ○.

Fig. 30 can in continuity of the above, still be regarded as a representative illustration of the crack-producing action of alkali-aggregate reaction in reacted particles of dense flint. The broad, open main-cracks, which have carried gel from altered mineral substance out into cracks radiating from the particle into the surrounding cement paste are repeatedly encountered in (3971). It is frequently noted that the course of cracks and crack ramifications inside the particles follow parts of the particle that seem originally to have had relatively high porosity or opaline content (pigmentation), i. e. relatively low mechanical strength (3971).

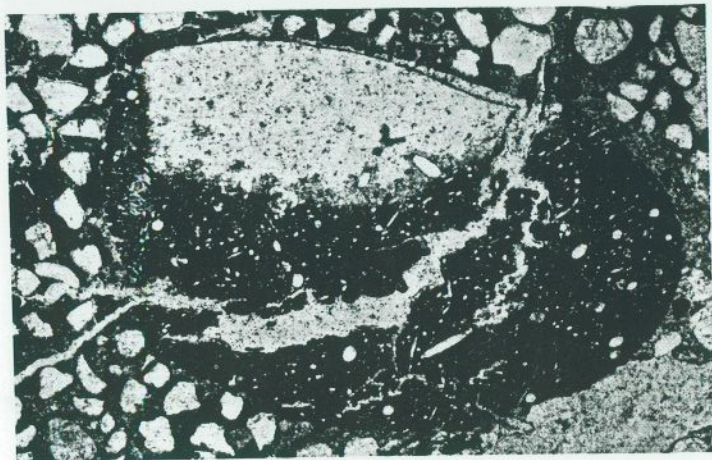
Fig. 31. Reacted pebble of flint partly porous calcareous (dark in picture) and partly dense chalcedonic (light in picture), in thin section of concrete specimen from groyne block, north barrier of the Lim Fiord. The porous part is severely cracked, and partial dissolution and weakening of the mineral substance can be seen. The boundary of this part of the pebble is at some places almost 'opening up' towards the surrounding mortar. The dense part of the flint appears to be almost unaffected. From (2910). Thin section No. G 22-[44.13.2-(5908)]. 11.

Figs. 31 and 32 are examples of these phenomena, and (2910) *fig. 93*, shows another typical case.

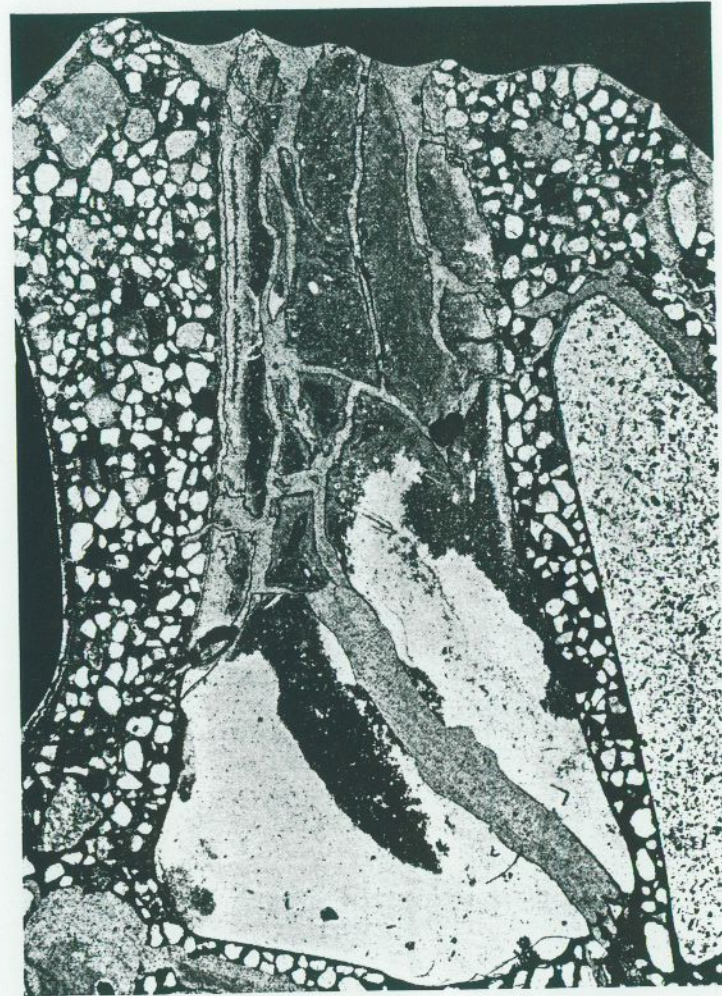
Fig. 32. Reacted pebble of partly porous, partly dense chalcedonic flint in thin section of concrete specimen from groyne block, north barrier of the Lim Fiord. (The same thin section as the pebble shown in fig. 31). The porous part of the flint shows intense dissolution and thorough cracking of the mineral substance. The dense part shows a clear cut, wide open main-crack continuing into the surrounding mortar. The increase in volume of the pebble caused by the cracking must mean a movement of the surrounding matrix. Thin section No. G 22-[44.13.2-(5908)]. 11.

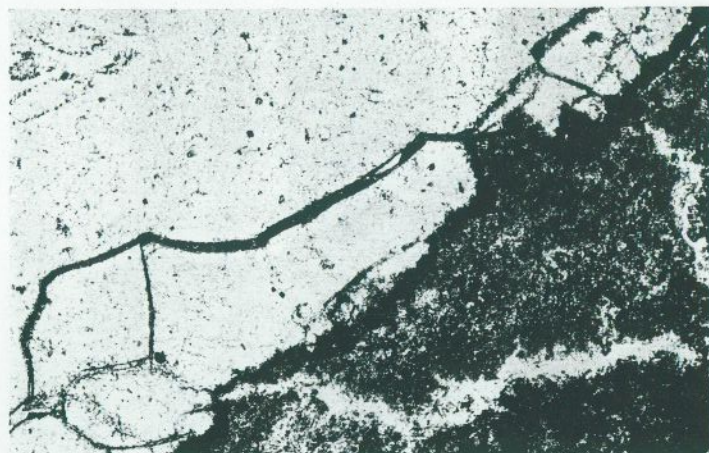
Fig. 34. Reacted pebble of dense chalcedonic flint in thin section of concrete from the interior of bascule pier below water level, Oddeund Bridge. The picture shows extensive main-cracking in the boundary area of the pebble, and alteration of the boundary itself to a pigmented, amorphous substance extending into the adjacent cement paste. This is the phenomenon designated rim corrosion, see also fig. 29. Thin section No. G 22-[54.5.118]. O.

Figs. 33, 34 and 35 show that in some particles of reacted, dense flint, unusual micro-crack formations can be seen in the rim zones.

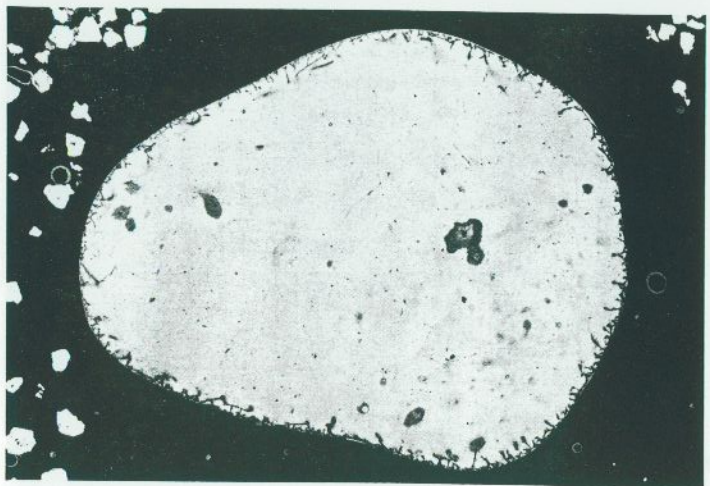
Fig. 37. Unreacted pebble of dense chalcedonic flint from submarine gravel deposit off the Skaw, Jutland. The thin section was made of the pebble in its natural condition. Thus, the rim cracks and the apparent dissolution along the cracks must be due to natural action, i. e. surf impact and slow silica dissolution by sea water. The surface character shown may be an important factor in the development of bond strength in sound concrete. In cases of alkali-aggregate reaction, the surface character may facilitate the development of gel in pebbles of dense flint. Thin section No. BFL 3-13. 11.

Fig. 37 shows a thin section of a flint pebble from a submarine deposit near the Skaw, Jutland. This flint had not been used for concrete, and both the rim crack formations and dissolution along the rim cracks can only have resulted from natural action, i. e. wave action and slow silica dissolution.

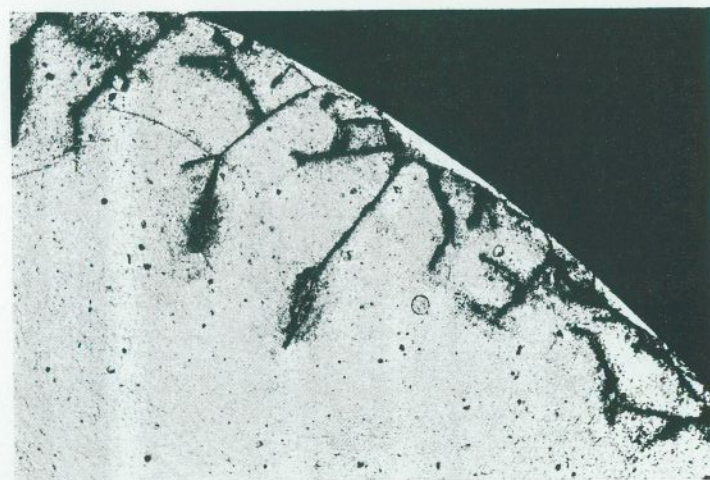
Fig. 38. Detail of the boundary of the pebble in fig. 37. The picture emphasizes the type and extent of the microscopic surface cracking and the slight dissolution of mineral substance along the cracks. These phenomena represent the mechanism by which dense flint pebbles are rounded and comminuted by marine erosion. Polymineral or laminated rocks etc. can be expected to show other phenomena of erosion to be predominant. Thin section No. BFL 3-13. O.

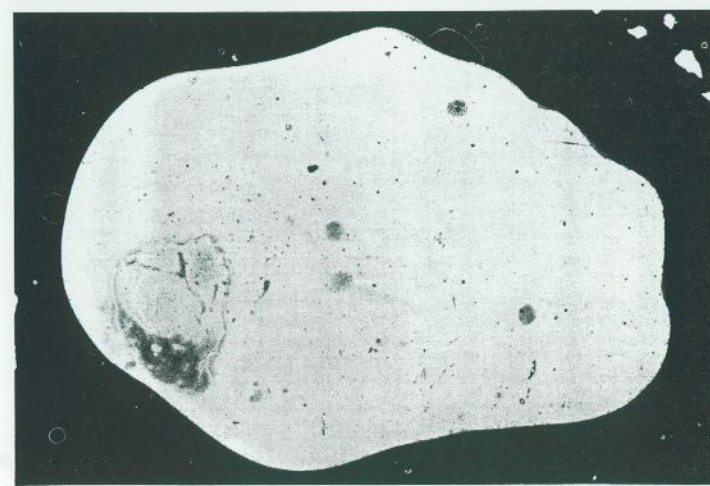
Fig. 39. Unreacted pebble of dense chalcedonic flint from the same deposit as the pebble shown in figs. 37 and 38. The thin section was made from the pebble in its natural condition. In this case the surface cracking is indistinct. Thin section No. BFL 3-12. 11.

Fig. 39 shows a thin section of a flint pebble from the same deposit. The phenomena of rim corrosion are so weak in this case that they can only be seen at high magnification, as shown in *fig. 40*.

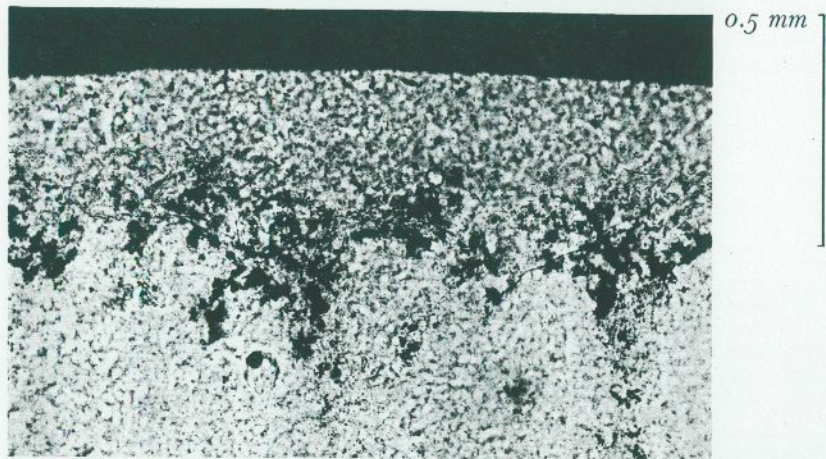
Fig. 40. Detail of boundary of the pebble shown in fig. 39. The microscopic surface cracking at the edge is not as deep as with the pebble shown in figs. 37 and 38. Thin section No. BFL 3-12. ○.

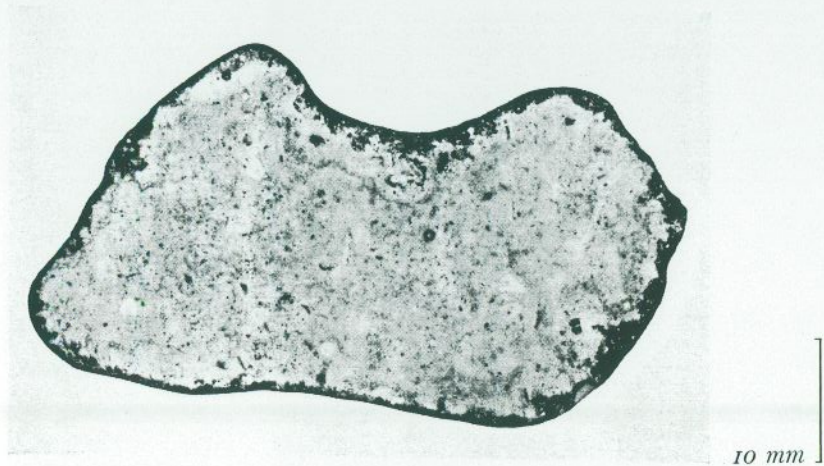
Fig. 41. Unreacted pebble of dense chalcedonic flint from submarine deposit off the Skaw. The section was made from the pebble in its natural condition and was not ground down to usual thickness (20 microns). The pebble originally had the appearance of ordinary dense black flint. Preparation of the section revealed that the black colour was confined to the outermost surface layer. Inside, as can be distinguished in the picture, is a narrow brown zone around the grey interior mass of dense flint. It must be assumed that the originally grey flint was first stained brown in a glacial deposit on land by the penetration of ground water containing ferric iron. Later, in the marine deposit, reduction of the outermost layer must have taken place. Thin section No. BFL 5-2 (unfinished). √.

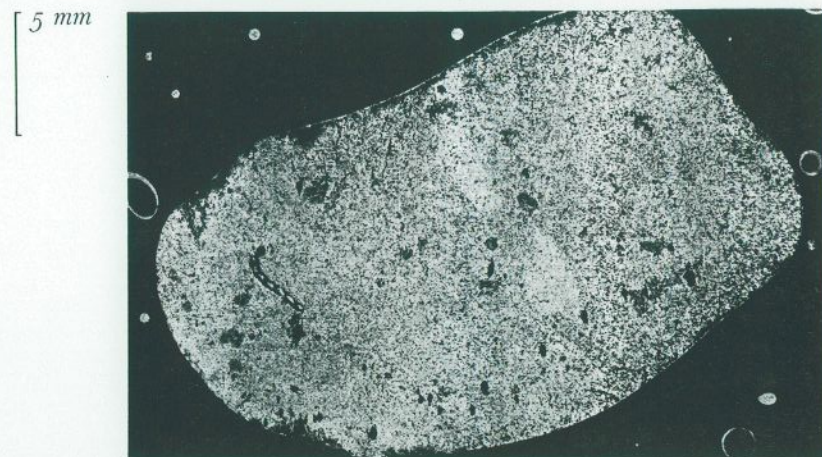
Fig. 42. Unreacted pebble of dense flint from glacial or glaciostuvial deposit on land. The thin section was made from the pebble in its natural condition. The darker zone at the edge shows where brown staining caused by the penetration of ground water containing dissolved ferric iron has occurred. The surface of the pebble was smooth. Thin section No. BFL 5-3. √.

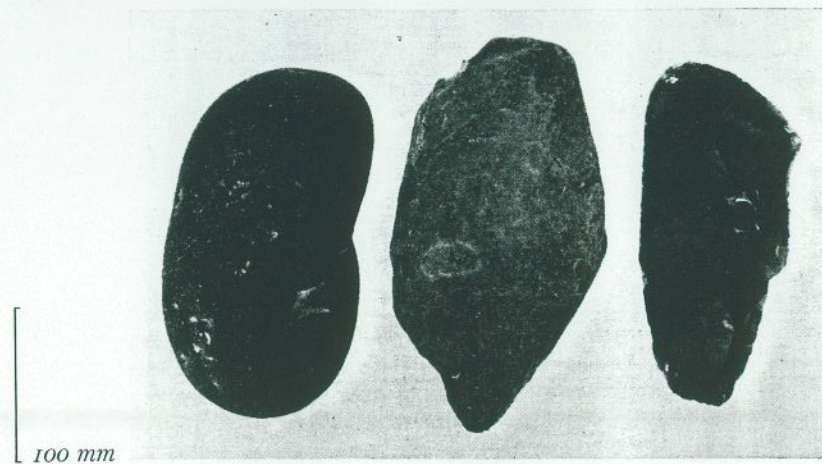
Fig. 43. Two pebbles and a broken fragment of dense flint demonstrating the character of natural surface corrosion shown in figs. 37-42. The pebble to the left is from a submarine deposit and shows severe surface scarring and pitting, reflecting impact and wear from surf erosion. The gravel pit pebble in the middle shows an abraded but smooth surface, partly even waxy. The broken faces of the piece of primary flint taken from a limestone formation, show very even and smooth surfaces. (There is some evidence from archaeology that flint submerged since the Stone Age in acidic fresh water can attain a quite polished surface).

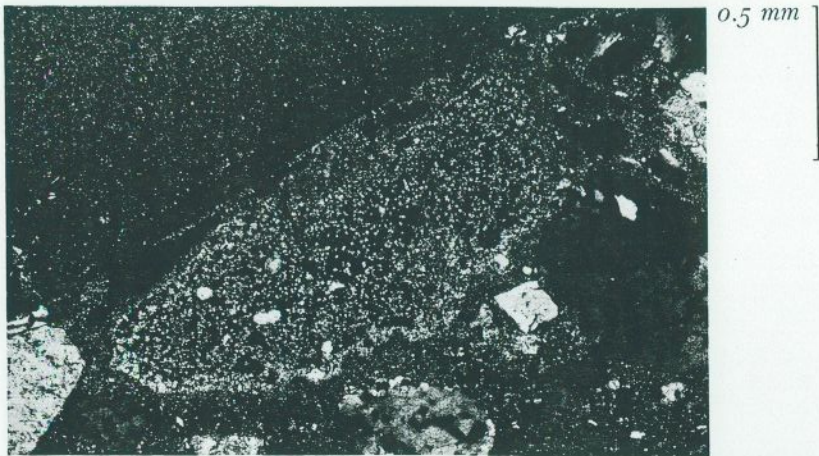
Fig. 44. Particle of dense flint in thin section of a lime mortar from a 600 years old wall of church near Randers, Jutland. It must be assumed that repeated repair work and lime-washing of the mortar in the course of time have enhanced reaction between calcium hydroxide and the flint substance. The extensive rim corrosion of the particle is attributed to this reaction. A slight reactivity of this kind may take place invisibly in ordinary concrete and contribute to the development of bond between any acidic rock particle and the adjacent matrix. Thin section No. BFL 2-9b. Ø.

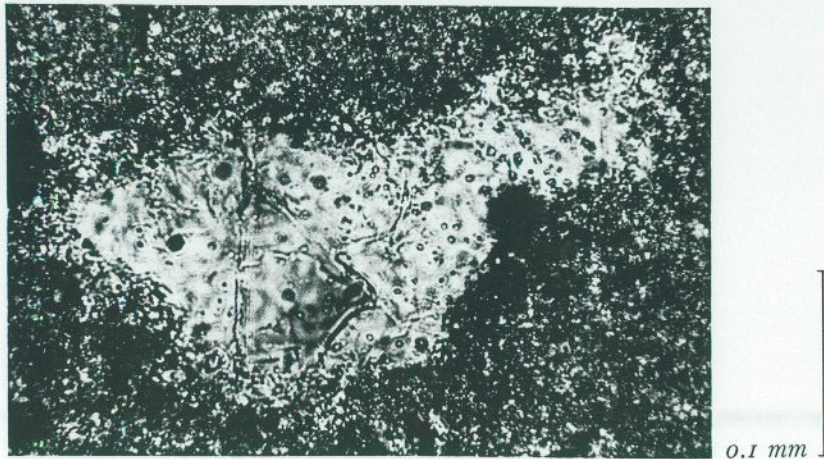
Fig. 45. Quartz particle in the thin section of mortar from church wall, fig. 44. The quartz has probably been affected by the same kind of reaction as the flint in fig. 44, but in this case the result must be designated rim corrosion. Previously published by P. Nepper-Christensen (5522). Thin section No. BFL 2-9b. Ø.

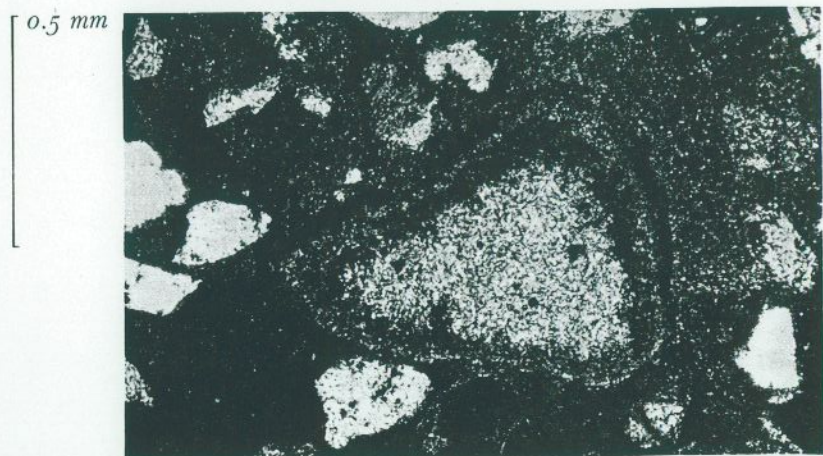
Fig. 46. Particle of dense flint in thin section of Roman mortar from Caesarea, Israel. The particle shows severe rim corrosion similar to the phenomenon in fig. 44. Hydrated calcium silicates are presumably primary reaction products, but the optical character of the altered rim substance does not allow microscopic identification. The same thin section showed intense rim corrosion of the quartz grains and advanced dissolution of a plagioclase particle. Thin section No. BFL 3-48. Ø.

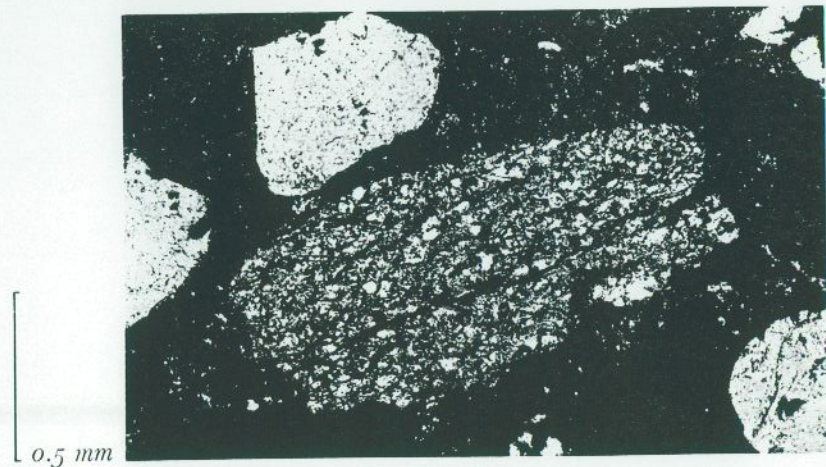
Fig. 47. Oblong particle of phyllitic rock, with quartz as the main constituent, in thin section of Norwegian concrete with alkali-aggregate reaction. The longitudinal main-crack follows the indistinct stratification in the rock structure. Subsidiary cracks in the same direction can be distinguished. Thin section No. Rosenqvist 60. Ø.

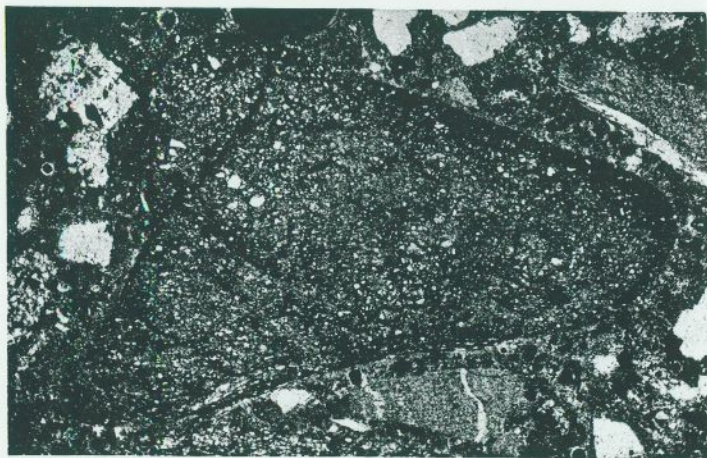
Fig. 48. Triangular pebble of phyllitic rock in thin section of Norwegian concrete with alkali-aggregate reaction. The particle has quartz grains scattered in the rather amorphous ground mass. The reaction has resulted in mechanical weakening and irregular cracking and distortion similar to that found after reaction in some types of porous flint. Thin section No. Rosenqvist 58. ○.

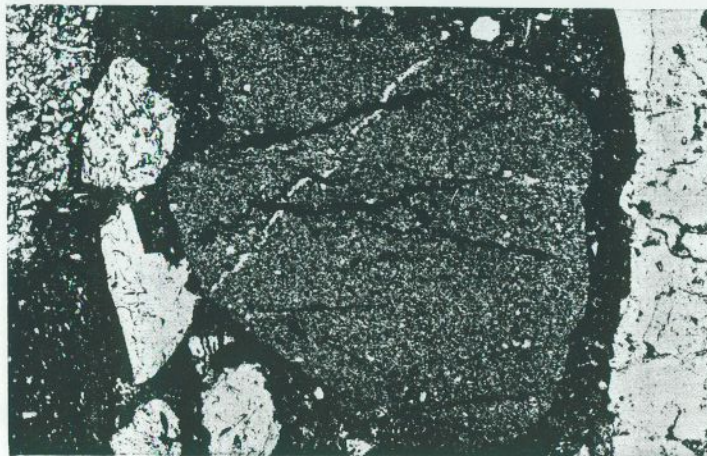
Fig. 49. Compact rounded particle of phyllitic rock in thin section of Norwegian concrete with alkali-aggregate reaction. The main constituents are argillaceous substances which contain a few scattered quartz grains. The shapes of the traversing main-cracks and of the subsidiary narrow cracks indicate partial dissolution and mechanical weakening of the rock structure during the reaction. Thin section No. Rosenqvist 58. ○.

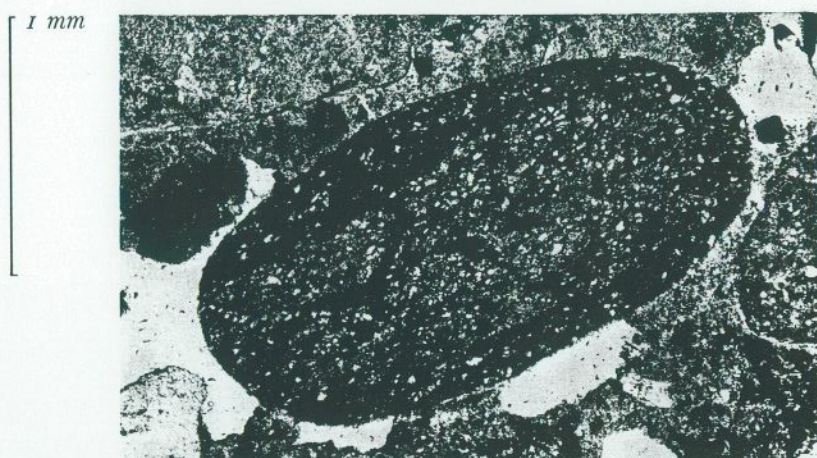
Fig. 50. Oval particle of phyllitic rock in thin section of Norwegian concrete with alkali-aggregate reaction. The particle shows a distinct dark reaction rim and interior dissolution and disruption of the structure, very much as when porous, calcareous flint has reacted. Thin section No. Rosenqvist 58. ○.

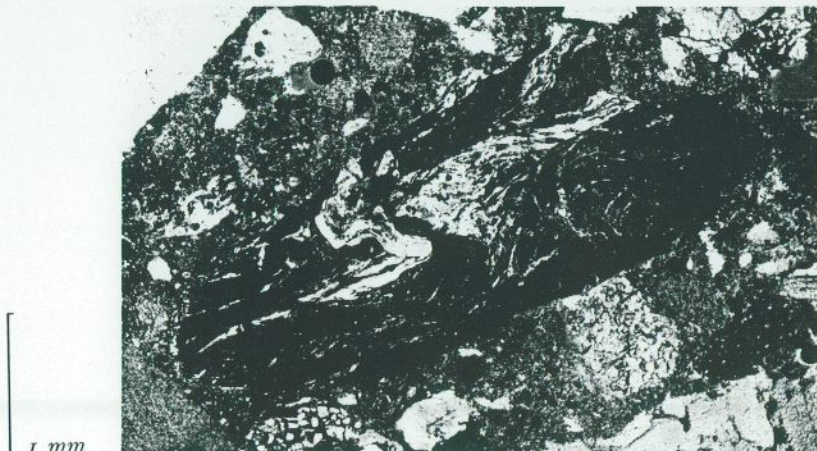
Fig. 51. Oblong pebble of a strongly foliated phyllitic rock, containing banded crystalline quartz, in thin section of Norwegian concrete with alkali-aggregate reaction. Narrow, open main-cracks follow the direction of the foliation of the structure which to a great extent seems to have kept its mechanical strength, very much as when dense flint reacts. Thin section No. Rosenqvist 58. ○.

Fig. 51 shows an oblong particle of a strongly foliated structure, containing bands of coarse crystalline quartz. The cracks can be seen to follow the directions of stratification of the rock, and it is obvious that the structural strength of this rock was considerable, even after the reaction. The feature of reactivity in this particle may be described as open, folded main-cracks.

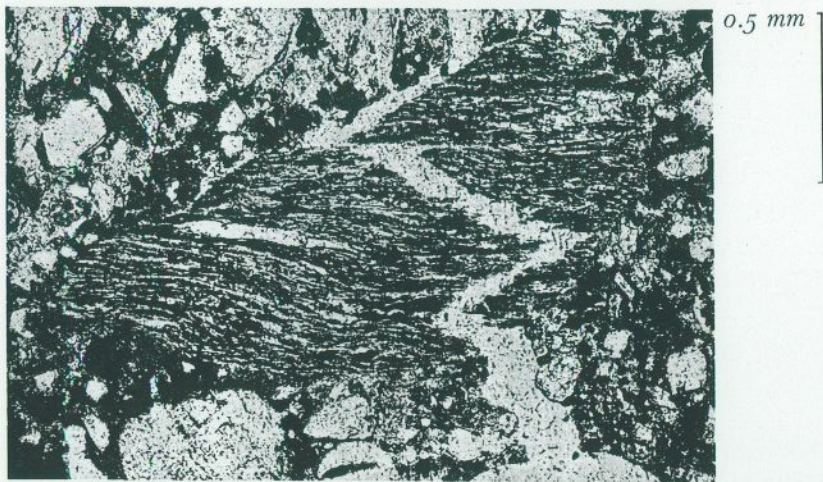
Fig. 52. Wedge-shaped particle of laminated phyllitic rock in thin section of Norwegian concrete with alkali-aggregate reaction. Dissolution and cracking have followed the direction of the layers of the rock structure. A connecting crack traverses the particle. Thin section No. Rosenqvist 56. ○.

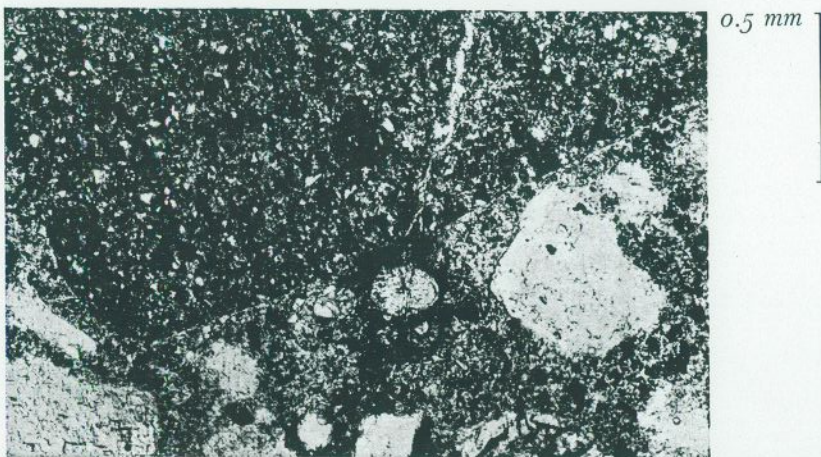
Fig. 56. Detail of particle in fig. 54, showing the traversing main-crack continuing into the surrounding mortar. The crack crosses a spherical void (0.2 mm dia.) completely filled with gel. The cement paste along the crack appears dark due to impregnation with gel. Thin section No. Rosenqvist 627/3-60. O.

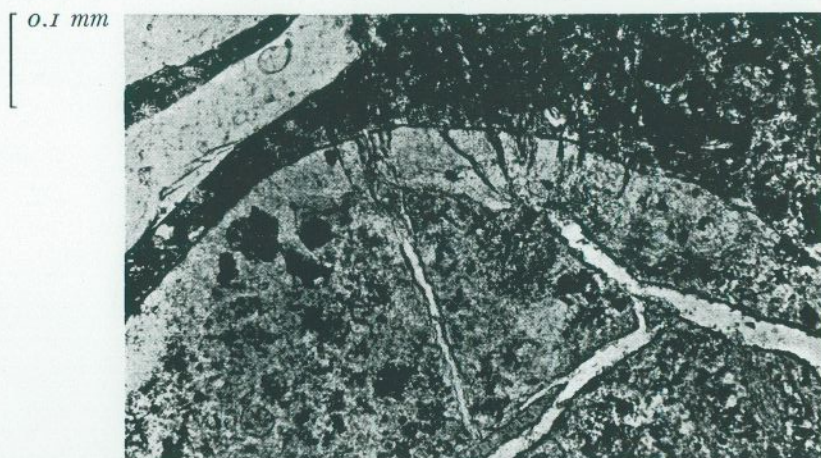
Fig. 58. Detail of basaltic pebble in fig. 57. A narrow rim zone has been altered to an isotropic substance, i. e. a reaction rim. Main-cracks from the interior of the pebble ramify through the reaction rim and continue (less distinctly) in the surrounding paste where they contain gel exuded from the pebble. Shrinkage during drying may have influenced the crack development. Thin section No. Rosenqvist 627/3-60. O.

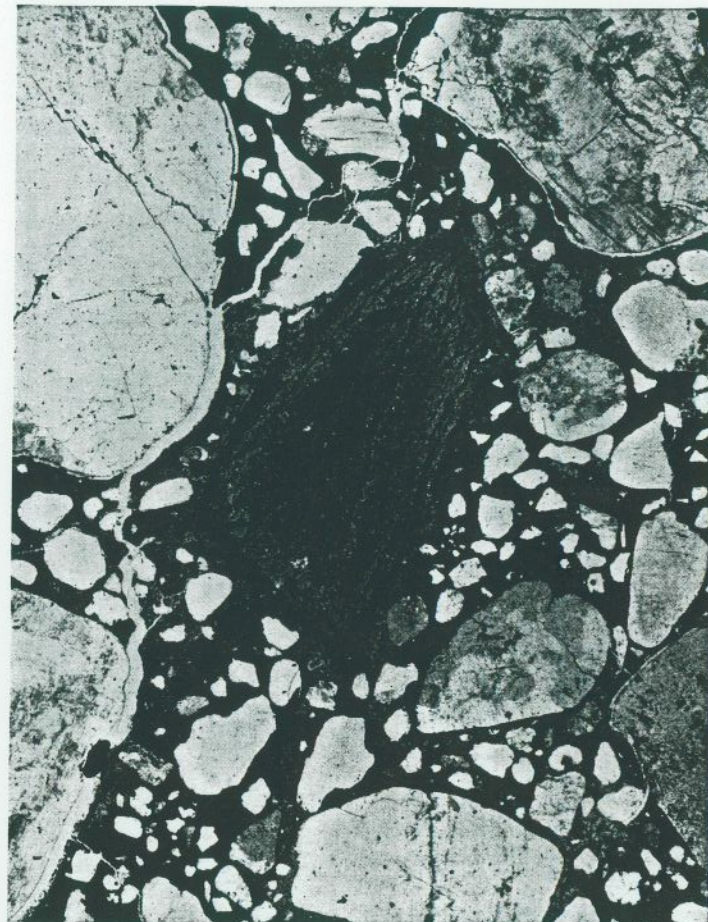
Fig. 62. Reacted shale particle in thin section of concrete from Nebraska, USA. The rather weak, stratified rock shows main-cracks which follow the direction of the strata, bending and gathering towards the corners of the particle. Ramified gel-filled cracks continue into the surrounding mortar. A reaction rim can be distinguished at the boundary of the particle. Thin section No. BFL 4-2. 11.

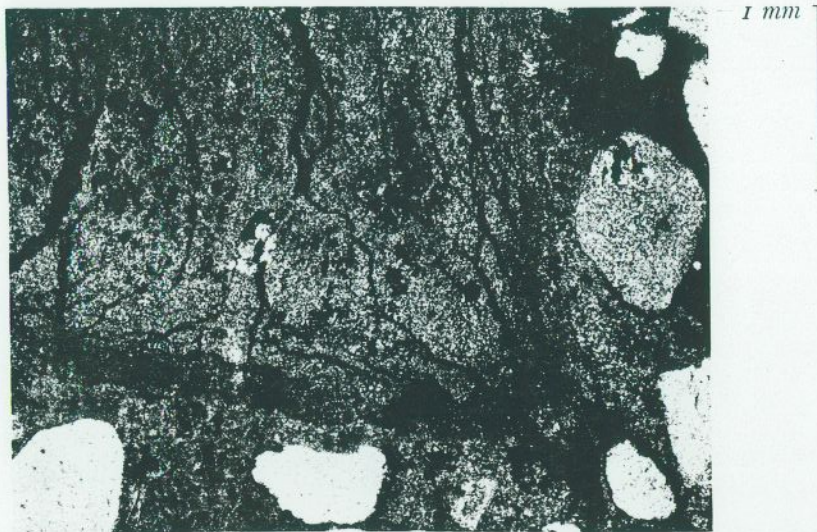
Fig. 63. Detail of reacted shale particle, fig. 62. The extensive cracking in the interior of the particle, the main directions of the cracks, and the dark reaction rim, are easily discernible. Thin section No. BFL 4-2. O.

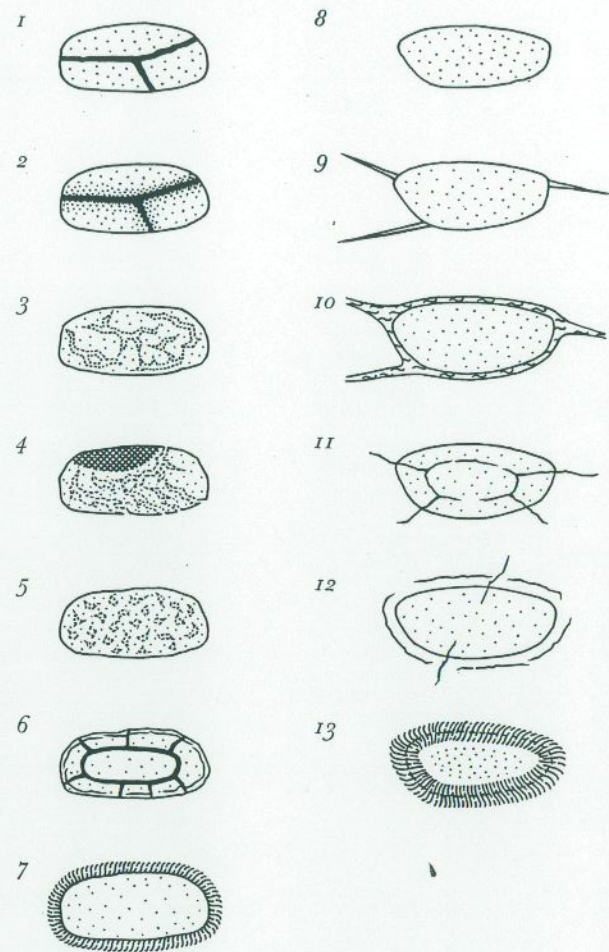
Plate XIII. Typical phenomena of alkali-aggregate reaction in particles of porous flint. The sketches on the left (1 to 7) show phenomena inside particles, the sketches on the right (8 to 13) show effects of reaction on surrounding paste. 1 and 2 show particles which still have an internal structure strong enough to cause the development of open main-cracks. Partial dissolution of the rock substance always occurs with porous flint, and is indicated by dotting. 3 to 6 show advanced internal dissolution, 7 shows gel impregnation of the surrounding paste. 8 to 10 show the mechanical effects of particle swelling. 11 and 12 represent subsequent drying shrinkage. 13 shows an unusually extensive alteration of the particle rim. Range of particle size: About 3 to 32 mm.

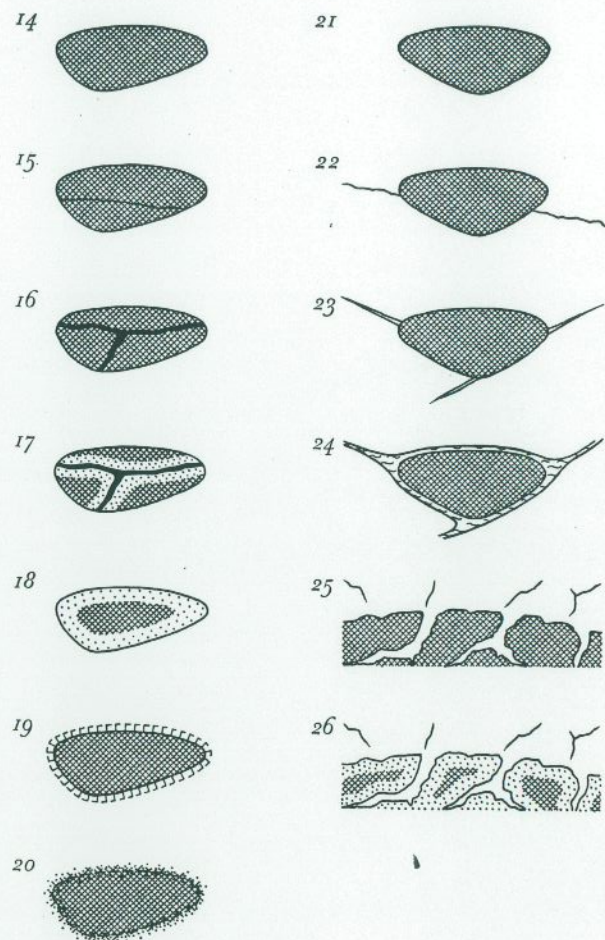
Plate XIV. Typical phenomena of alkali-aggregate reaction in particles of dense flint. The sketches on the left (14 to 20) show phenomena inside particles, the sketches on the right (21 to 24) show effects of reaction on surrounding paste. 25 and 26 represent reaction in the actual surface layer of large pebbles. 14 and 21 are reminders that most particles of dense flint show no signs of reaction. 15 and 22 represent indistinct effects of reaction. 16 and 17 show common types of open main-cracks. 18 shows dissolution of rock substance from the external boundary, an uncommon feature. 19 indicates invisible improvement of the bond between particle and paste, and 20 shows more extensive rim corrosion found only in exceptional cases. 23 is the most typical pattern of cracking in surrounding paste. 24 shows the same, but with a gel rim around the particle. Range of particle size: About 3 to 32 mm.

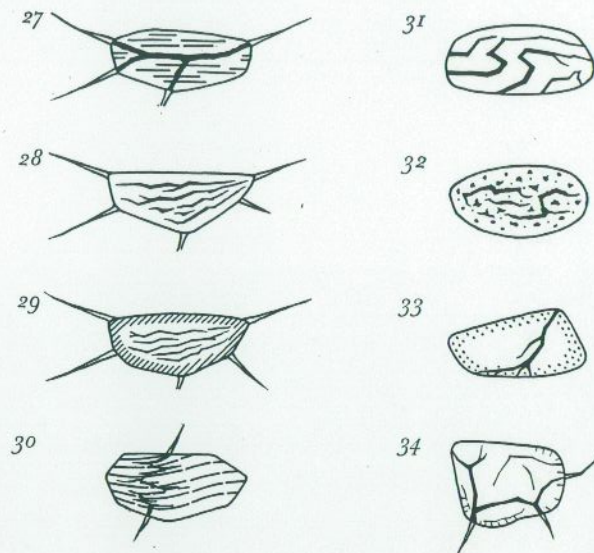
Plate XV. Characteristic phenomena of reaction in polymineral rocks in which soluble silica is only a minor constituent. 27 to 30 are angular pebbles of stratified rocks (schists, phyllites, etc.). The extent of internal disruption depends on the solidity of the rock structure as a whole. The cracks follow the path of dissolution, i. e. mechanical weakening. 31 and 32 show rounded, foliated rocks with characteristic features of cracking and dissolution. 33 and 34 represent a homogeneous rock (basalt) with cracking very much like that in dense flint. Range of particle size: About 3 to 32 mm.

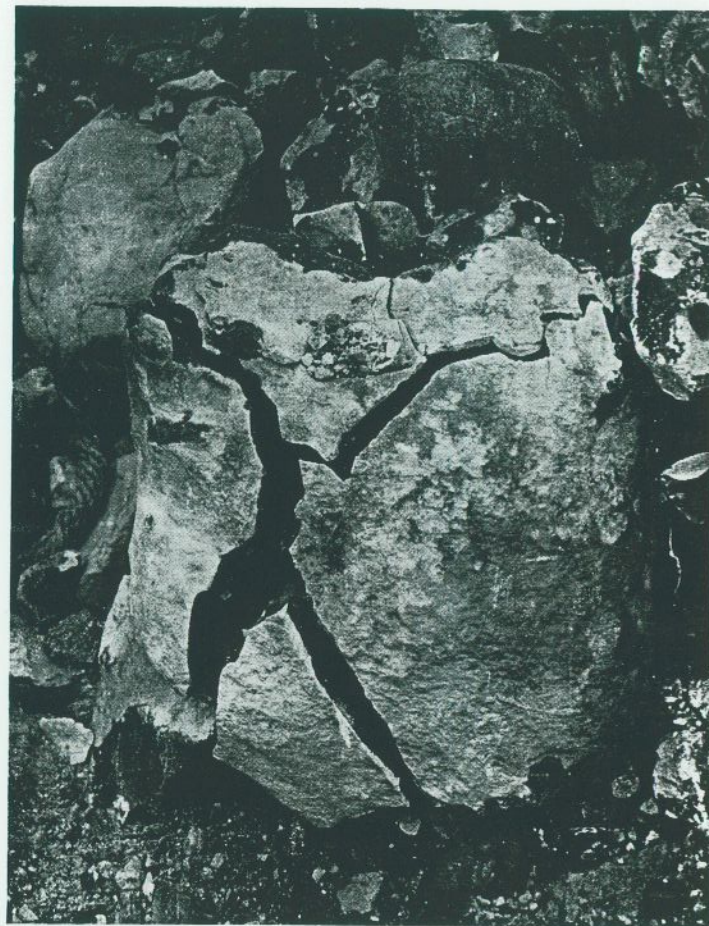
Fig. 64. Fist-size pebble of dense flint from the foot of slope in gravel pit at Outtrup, Jutland. The photograph was taken at the end of the winter as being typical of numerous examples of explosive cracking due to swelling pressure resulting from freezing of the pore water in the flint. All cracked pebbles which were opened had a porous interior, often with a hollow space, often with rust stains, indicating that the penetrating water had contained iron. The mechanism of the disruption must be considered to be very much the same as when alkali-silica gel accumulates in the pores of reacting dense flint in concrete and then imbibes water. From (2928).

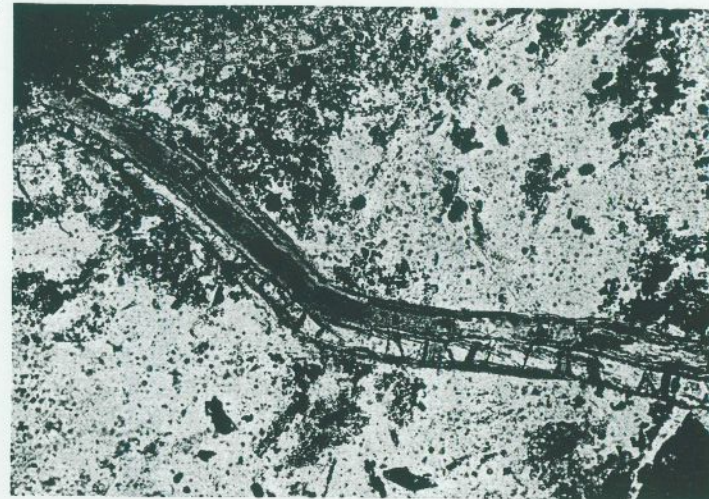
Fig. 67. Large pebble of dense, pigmented flint, in thin section of concrete from exterior wall of bascule pier below water level, Oddesund Bridge. The traversing main-crack is lined with gel, an unusual phenomenon among the writer's observations on alkali-aggregate reaction. The gel has possibly seeped into the crack from another reacted pebble. From (3971). Thin section No. I-44-[54.5.101]. ○.

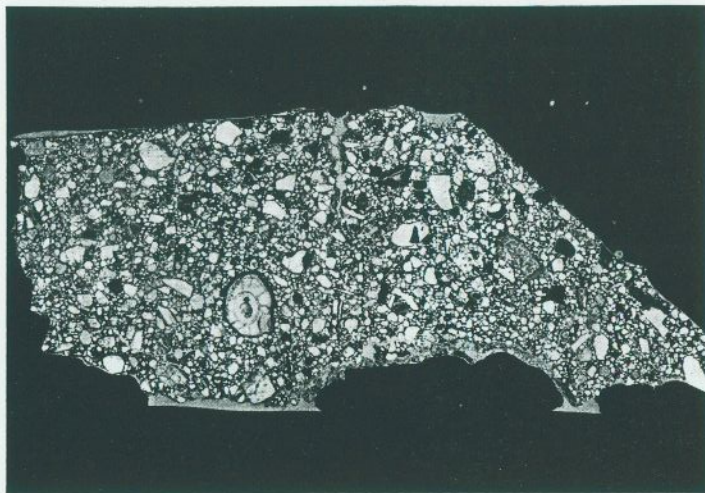
Fig. 71. Thin section of concrete from old caisson in the harbour of Ålborg, Jutland. The thin section contains the reacted pebble of porous flint shown in figs. 18, 21, 24, and 25. The whole section is severely cracked and contains many pebbles and sand grains of flint which are thoroughly reacted. The cement paste is partly dissolved along the cracks. This concrete has reached the stage of disintegration. Thin section No. BFL 4-3. 11.

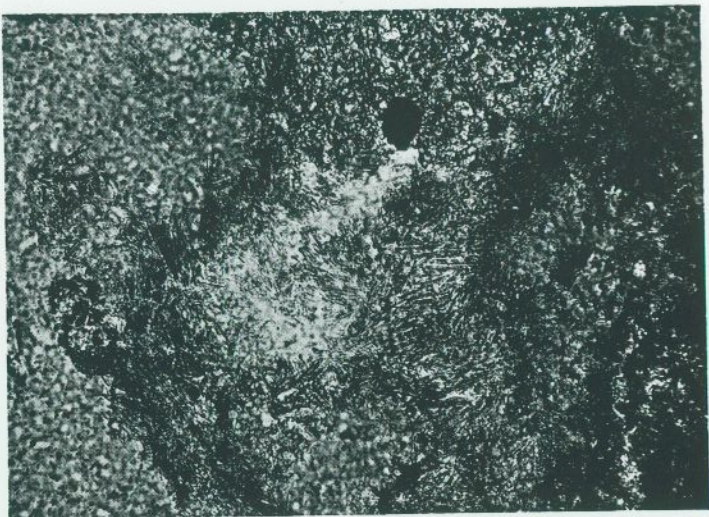
Fig. 73. Open crack radiating from severely cracked phyllitic pebble in thin section of concrete from dam in Norrland, Sweden. The crack is filled with secondary, granular calcite intermingled with lath-like calcium aluminate sulphate. From (2910). Thin section No. III-1-[122|54-BET. 4]. O.

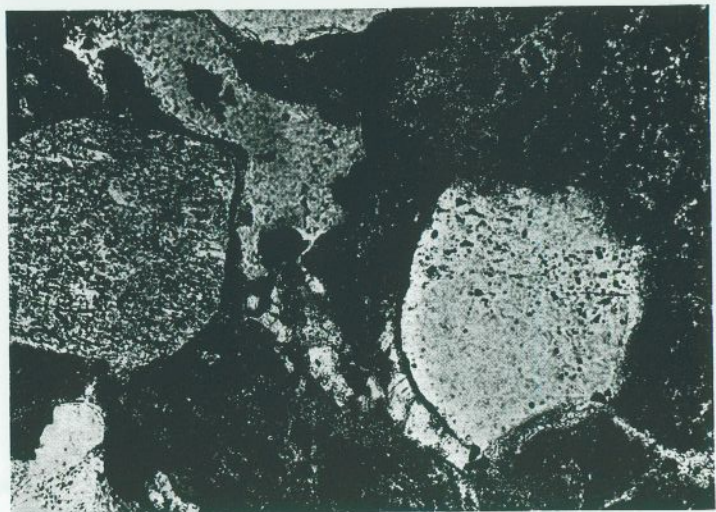
Fig. 74. Fractured mortar showing sand grains, cement paste and open spaces in thin section of concrete from exterior wall below water level of bascule pier, Oddesund Bridge. Anhydrous and submicroscopic gypsum has crystallized adjacent to the quartz grain and in the adjoining fracture, possibly replacing calcium hydroxide. From (3971). Thin section No. I-41-[54.5.101]. O.

Figs. 74, 75, 76, 77 and 78 show characteristic precipitations of gypsum, magnesium hydroxide and aragonite to illustrate the disintegration of cement paste under the conditions mentioned. Precipitations of calcium carbonate in the form of calcite in these samples are probably due to carbonation during drying after removal from the structure.

Surface coatings of aggregates have been observed with gypsum as the precipitate, see *fig. 74*. In this case gypsum may have replaced calcium hydroxide by a slow solid phase reaction, but this would probably be exceptional. Most frequently gypsum is found as a replacement substance in dissolved or diluted cement paste, with a tendency to parallel orientation of the anhedral microscopic crystals. *Fig. 75* is a typical example of such crystalline aggregates. It is noteworthy that the traversing crack has cut some of the gypsum crystals, thus indicating that the formation as a whole is a weak zone in the matrix, compared with surrounding areas of less deteriorated cement paste.
