Durability of Concrete Structures in Denmark

A Study of Field Behaviour and Microscopic Features - by G. M. Idorn

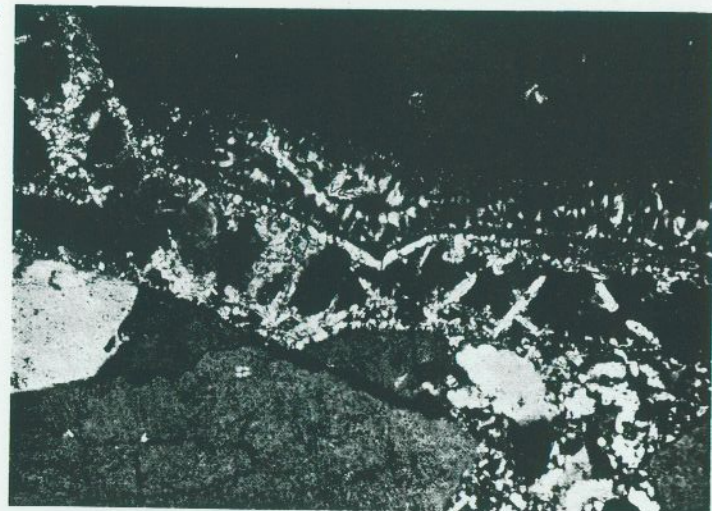
Fig. 77. 0.3 mm wide crack besides granitic pebble in thin section of concrete from exterior wall below water level of bascule pier, Oddesund Bridge. One half of the crack (originally, apparently the whole crack) is occupied by banded magnesium hydroxide. The other half, apparently formed by a second disruption, contains lath-like crystallites of aragonite. From (3971). Thin section No. 1-45-[54.5.101]. Ø.

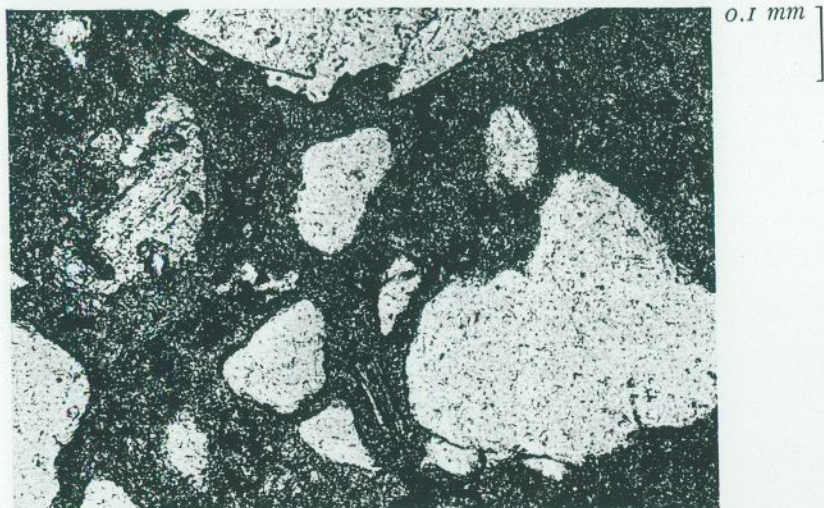
Fig. 79. Mortar in thin section of concrete from sulphuric acid plant in Jutland. The original cement paste is completely replaced by microcrystalline gypsum which must have been deformable in the moist condition and weak and brittle after drying. Thin section No. BFL 3-15. O.

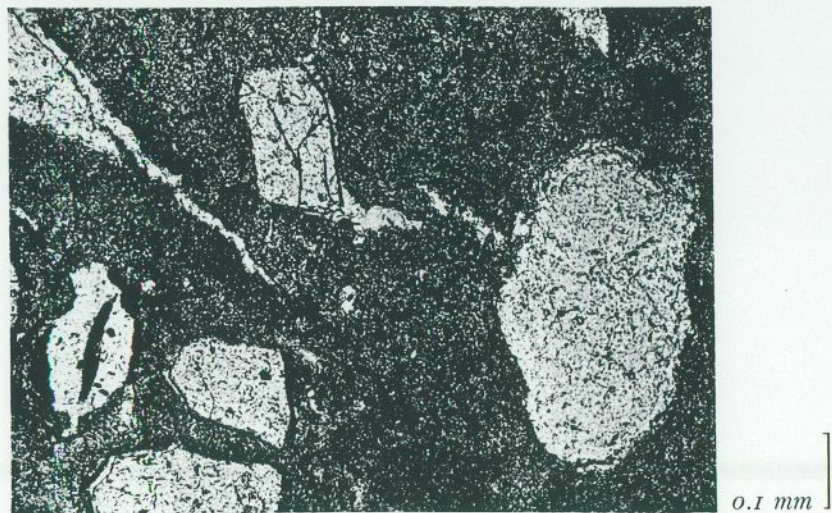
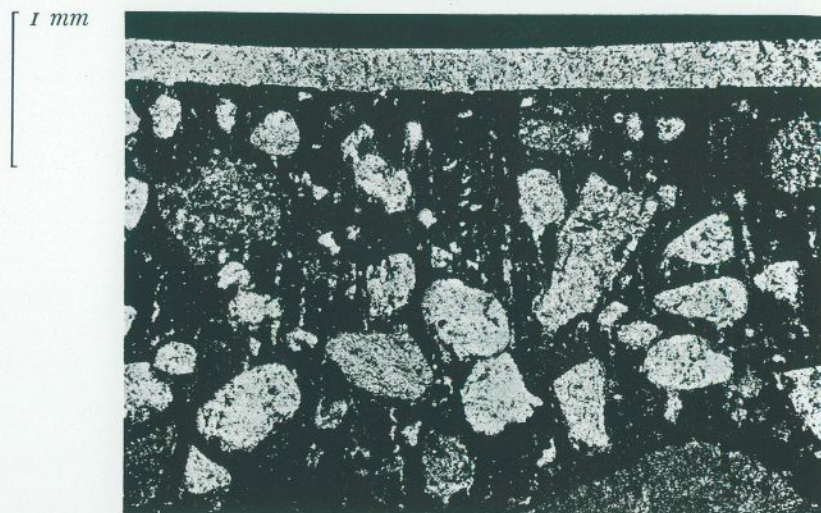
Figs. 81 & 82. Details of thin section of concrete bar which had been exposed to -20°C after three hours' prehardening at $+20^{\circ}\text{C}$. Groups of imprints of ice lenses are seen in patches perpendicular to the edge of the thin section which represents the original surface of the bar. The spaces left by the ice have been occupied by secondary crystalline calcium hydroxide. Slight carbonation has occurred in patches at the original surface. Thin section No. G 22-[6001-III B-1]. Fig. 81: O. Fig. 82: Ø.

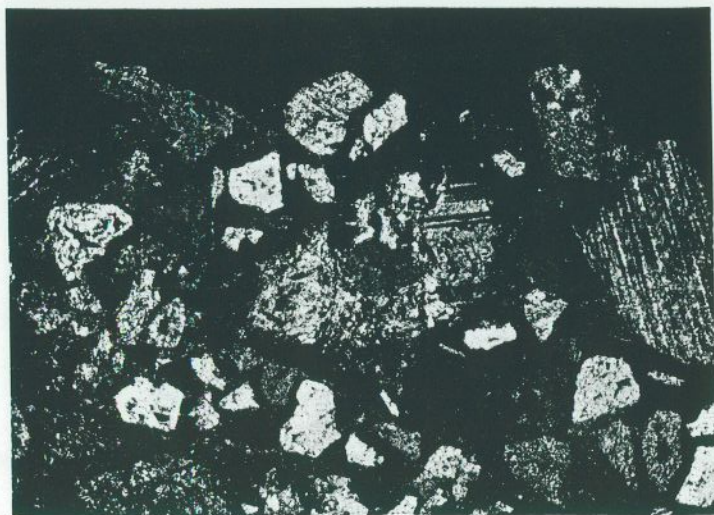
Figs. 83 & 84. Details of thin section of experimental concrete slab from Godthåb, Greenland. The thin section is a part of the concrete surface and shows scarring of an originally smooth surface, due to severe freezing/thawing in the tidal zone. Carbonation of the paste can be distinguished. Thin section No. G 22-[5905-1 a]. Fig. 83: O. Fig. 84: Ø.

Figs. 83 and 84 show scarring of the concrete surface with subsequent carbonation. *Fig. 85* shows bond cracks with a connection crack, and *figs. 86 and 87* show exceptional crystallization of calcium hydroxide.

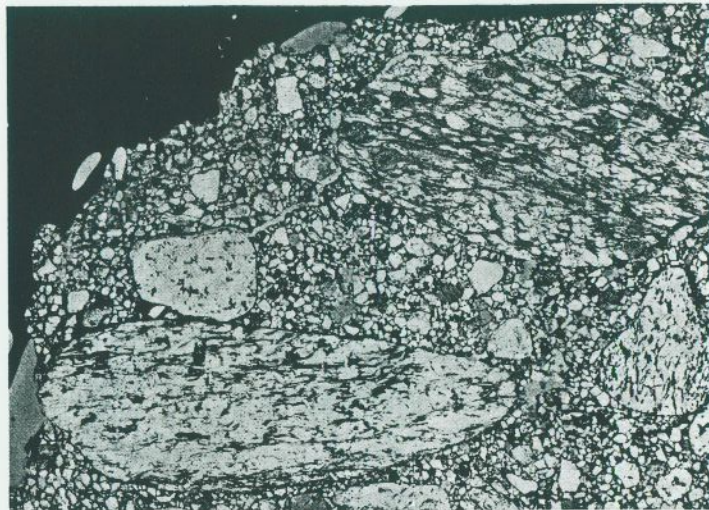
Fig. 85. Detail of thin section of experimental concrete slab from Godthåb, Greenland. The photograph shows part of the original concrete surface, now scarred by frost action, with bond cracks along granitic aggregate pebbles and a connecting crack between two pebbles. Thin section No. G 22-[5905-1]. ll.

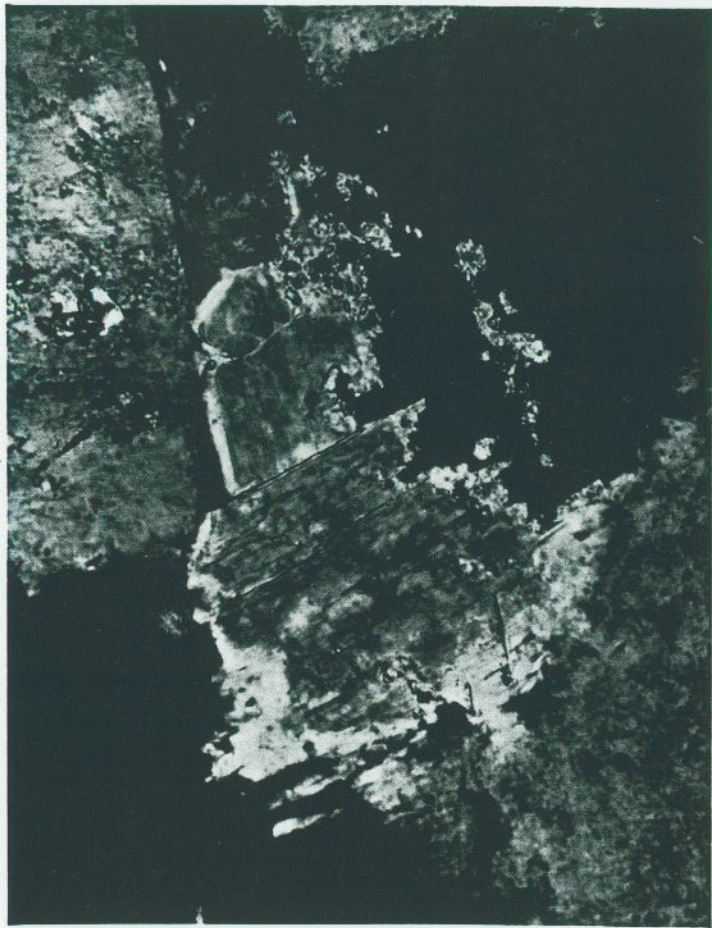
Fig. 87. Accumulated crystallization of subhedral calcium hydroxide in a space between two quartz grains in thin section of experimental concrete slab from Godthåb, Greenland. The calcium hydroxide is seen to adhere closely - in fact, almost to protrude from the boundary of one quartz grain. The basal cleavage of the calcium hydroxide can be distinguished. Thin section No. G 22-[5905-1]. Ø.

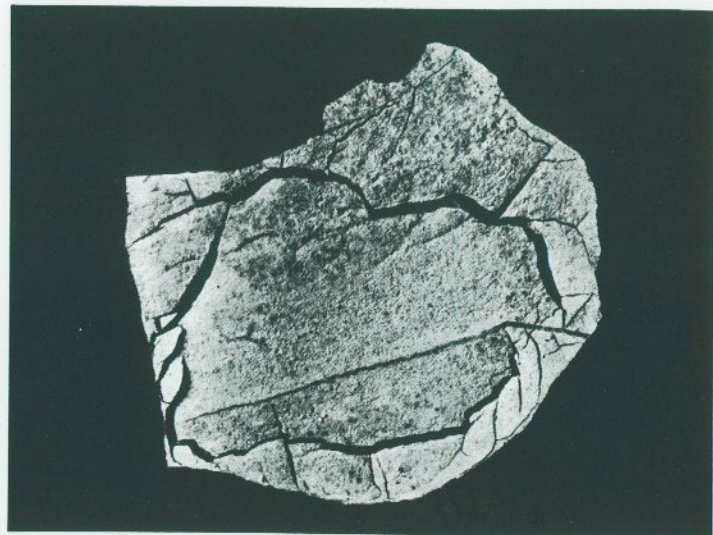
Fig. 88. Pebble of silicified, argillaceous limestone subjected to alkali-aggregate reaction after embedment in araldite, and thereafter shrunk during drying of the weakened rock substance. The compressed interior is separated by a wide open fracture from the boundary area which has remained firmly adhering to the surrounding matrix. From (2681). V.

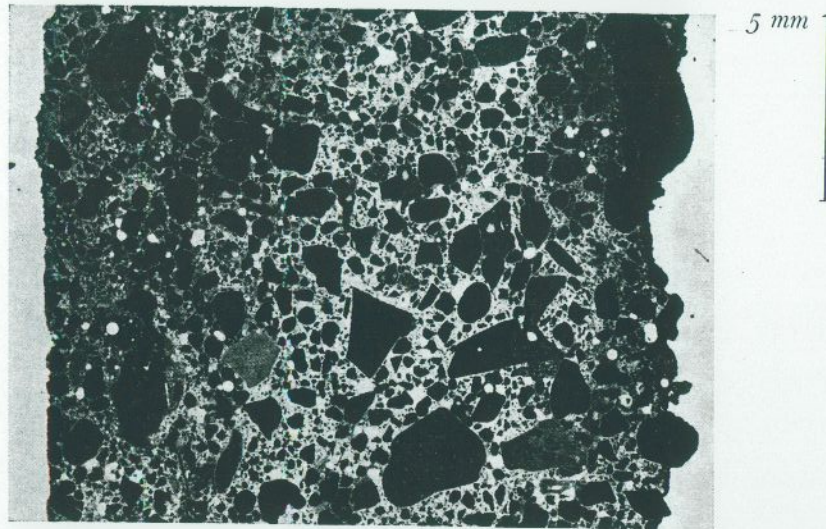
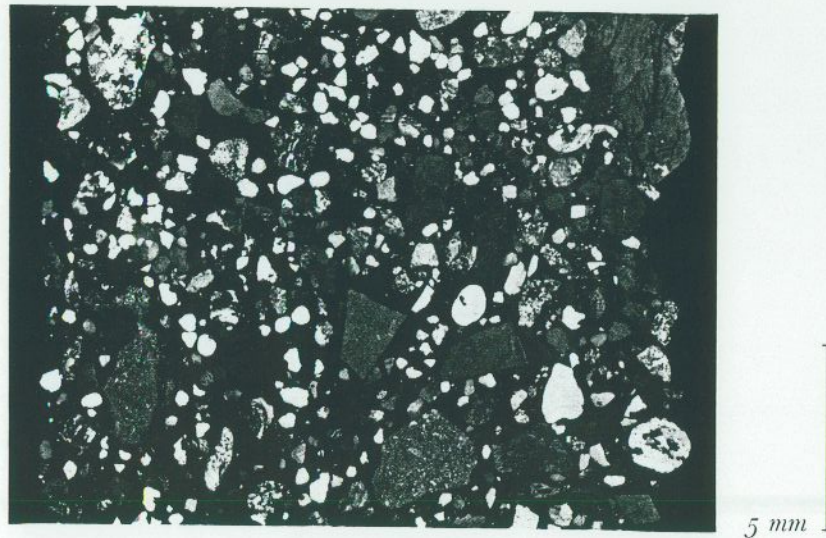
Figs. 89 & 90. Details from thin section of cross section of concrete roofing tile cast in Fåborg, Funen, in 1884. The tile had been exposed to the weather on a roof until 1955, but no sign of deterioration was found except for abrasion of the upper surface. Carbonation was limited to the actual surface layers, and calcium hydroxide and β -dicalcium silicate were plentiful in the cement paste. On the whole, the concrete showed little evidence of ageing despite the time of exposure. Thin section No. BFL 4-31. Fig. 89: \vee . Fig. 90: \times .
