Investigation of Concrete Driveway Distress by Laboratory Examinations of A Concrete Core

ABC Drive
Franklinton, North Carolina

Prepared for:
ABC Engineers, Inc.

Construction Materials Consultants, Inc.

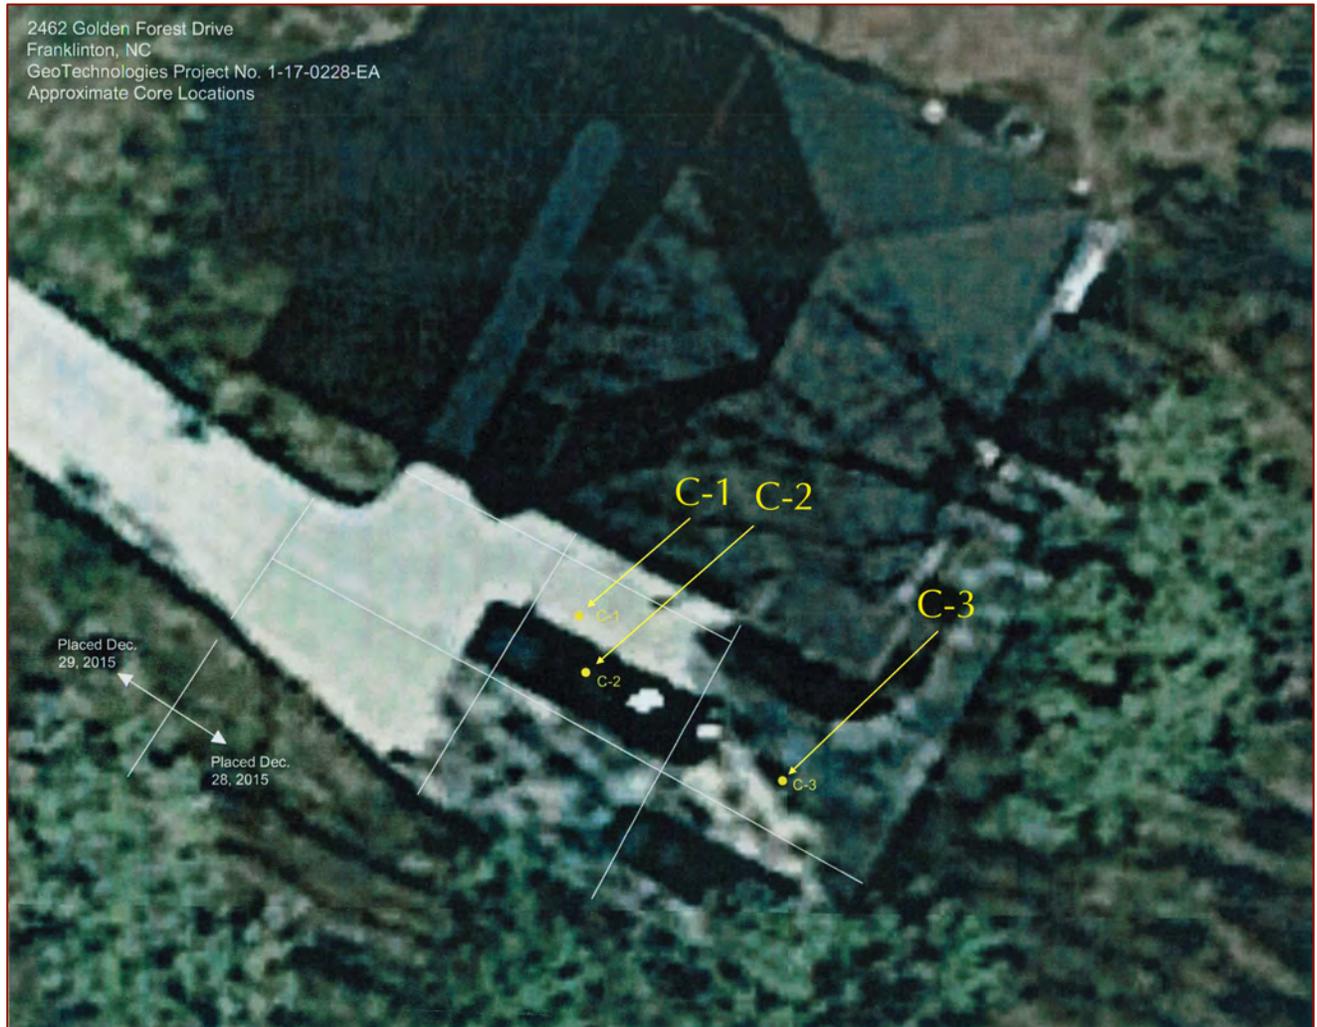
Figure 1: Map of the reported driveway showing the location of the core C-1 received (left), and locations of two additional cores, C-2 and C-3, which were not received.

All 3 cores obtained from December 28 placement. Cores C-1 and C-2 obtained from areas of scaling. Core C-3 obtained from an area with less obvious surface deterioration. Some loss of material from surface has occurred at C-3, and surface can be easily rubbed away with bare hand. Request that 1 core be selected for petrographic analysis, preferably C-1 or C-2 where the distress was most significant, unless Petrographer feels otherwise."

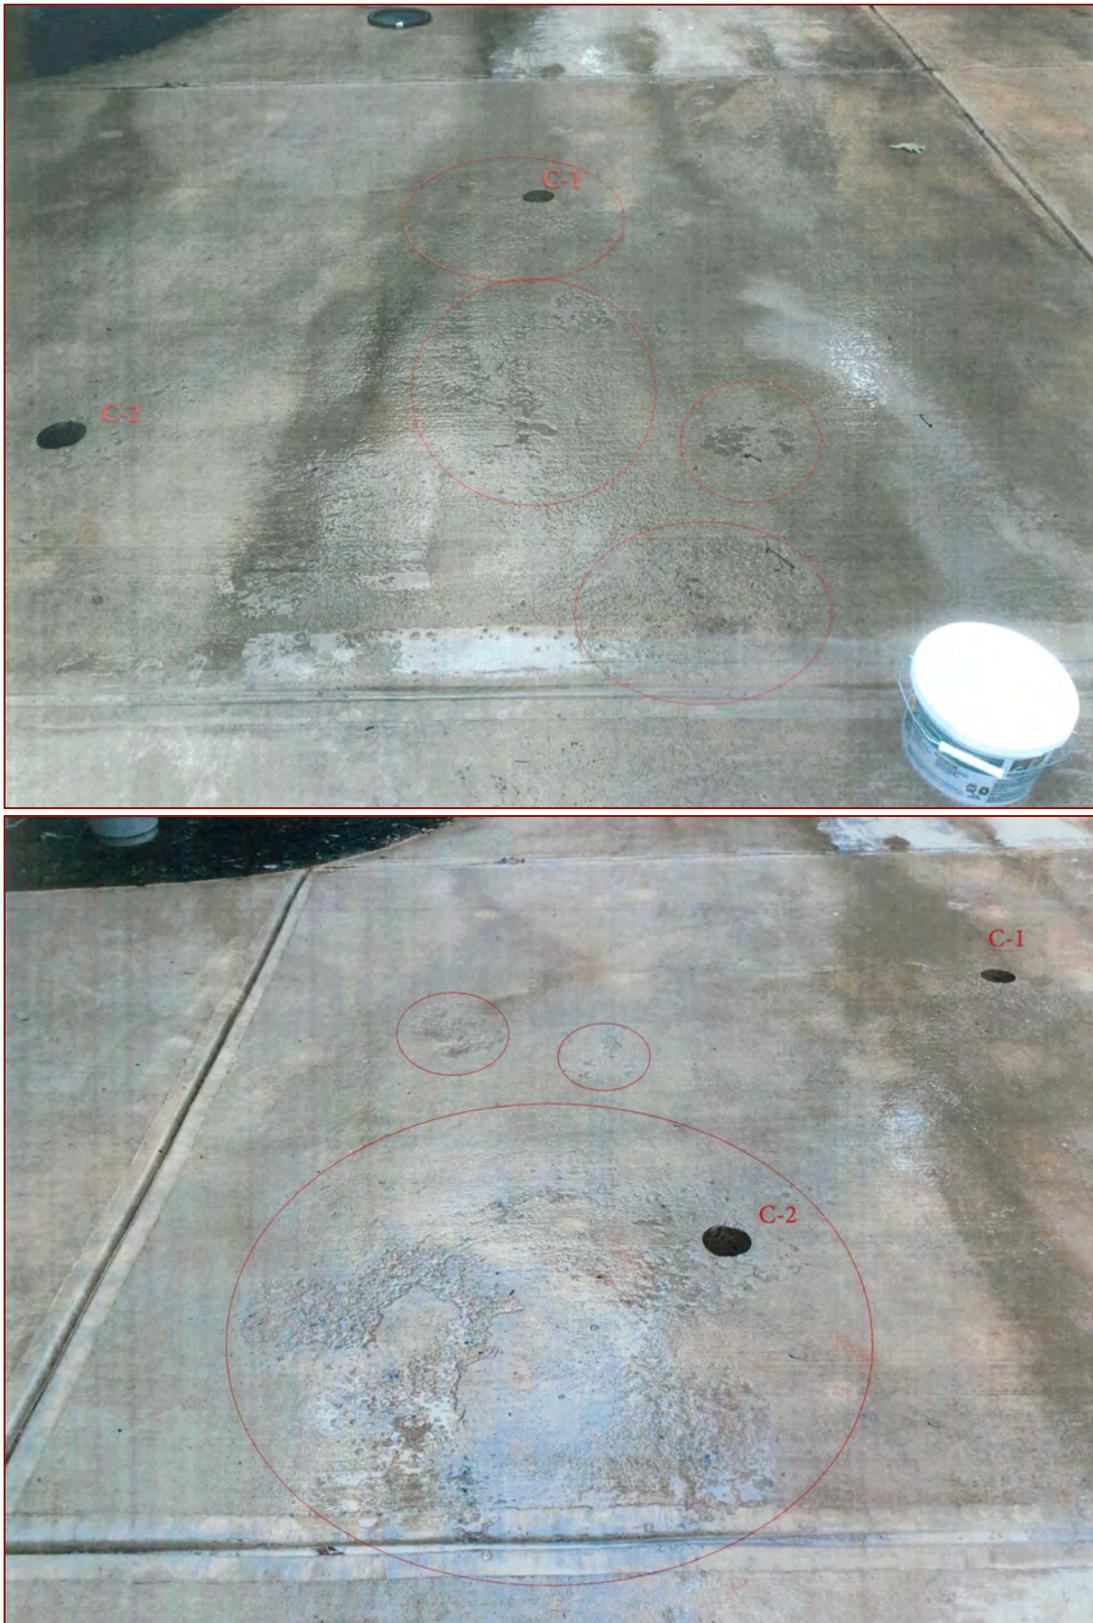
Figure 2 shows condition of concrete driveway at the locations of Cores C-1 and C-2. As seen in both photos, isolated areas on the driveway show loss of the original broom-finished surface of concrete as **surface scaling**, and exposures of underlying paste and aggregates.

Figure 2: Conditions of concrete surface at the locations of two cores C-1 and C-2. At both core locations the driveway surface shows isolated areas of scaling as loss of the original finished surface of the slab.

Although both types of scaling, as described above are the consequences of improper finishing operations, either of these two types, however can also occur from cyclic freezing and thawing of a poor quality concrete at critically saturated conditions, e.g., a concrete having improper air-void system and/or inadequate amount of entrained air that is needed for protection of concrete in a moist outdoor environment exposed to freezing, salts, and snow.

The former type of scaling can also occur from premature application of salt on a concrete surface that has: (a) not been matured, or (b) a concrete that has inadequate air and/or improper air-void system at the surface or (c) has a soft, porous surface that is not resistant to the potentially deleterious actions of salts. A chemically corrosive salt (magnesium sulfate, ammonia based salt) can also cause chemical erosion of paste from the surface apparently creating a distress similar to local loss of the original finished surface as seen in the field photos.
