## Investigation of Surface Distress Of Concrete Slabs – A Comprehensive Study From Petrography, Chloride-Sulfate Profiles, and Compressive Strength Tests

Norbeck Crossing HOA  
Silver Spring, Maryland

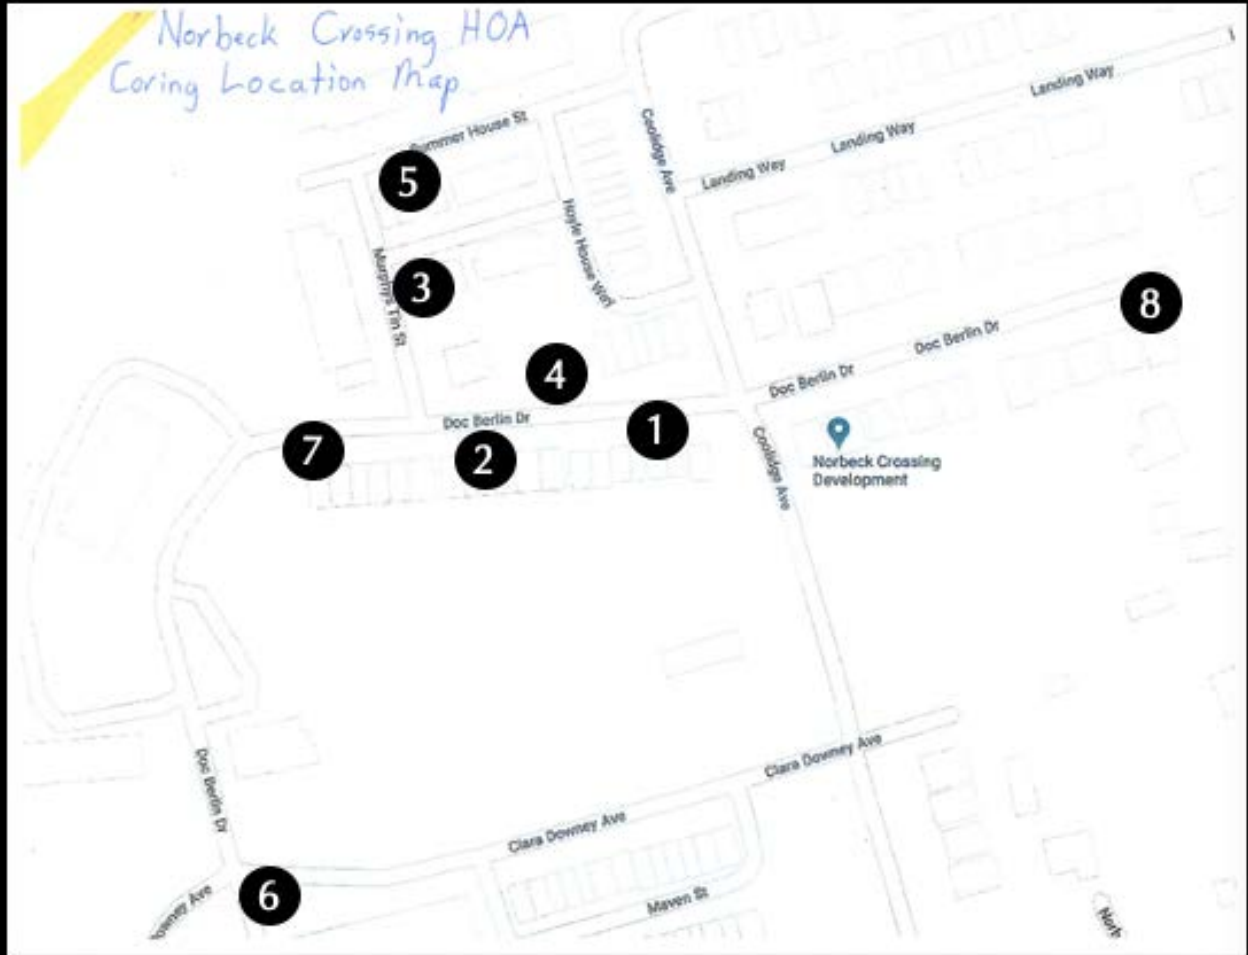
Figure 1: Locations of eight concrete cores collected across residential concrete sidewalks and curbs.

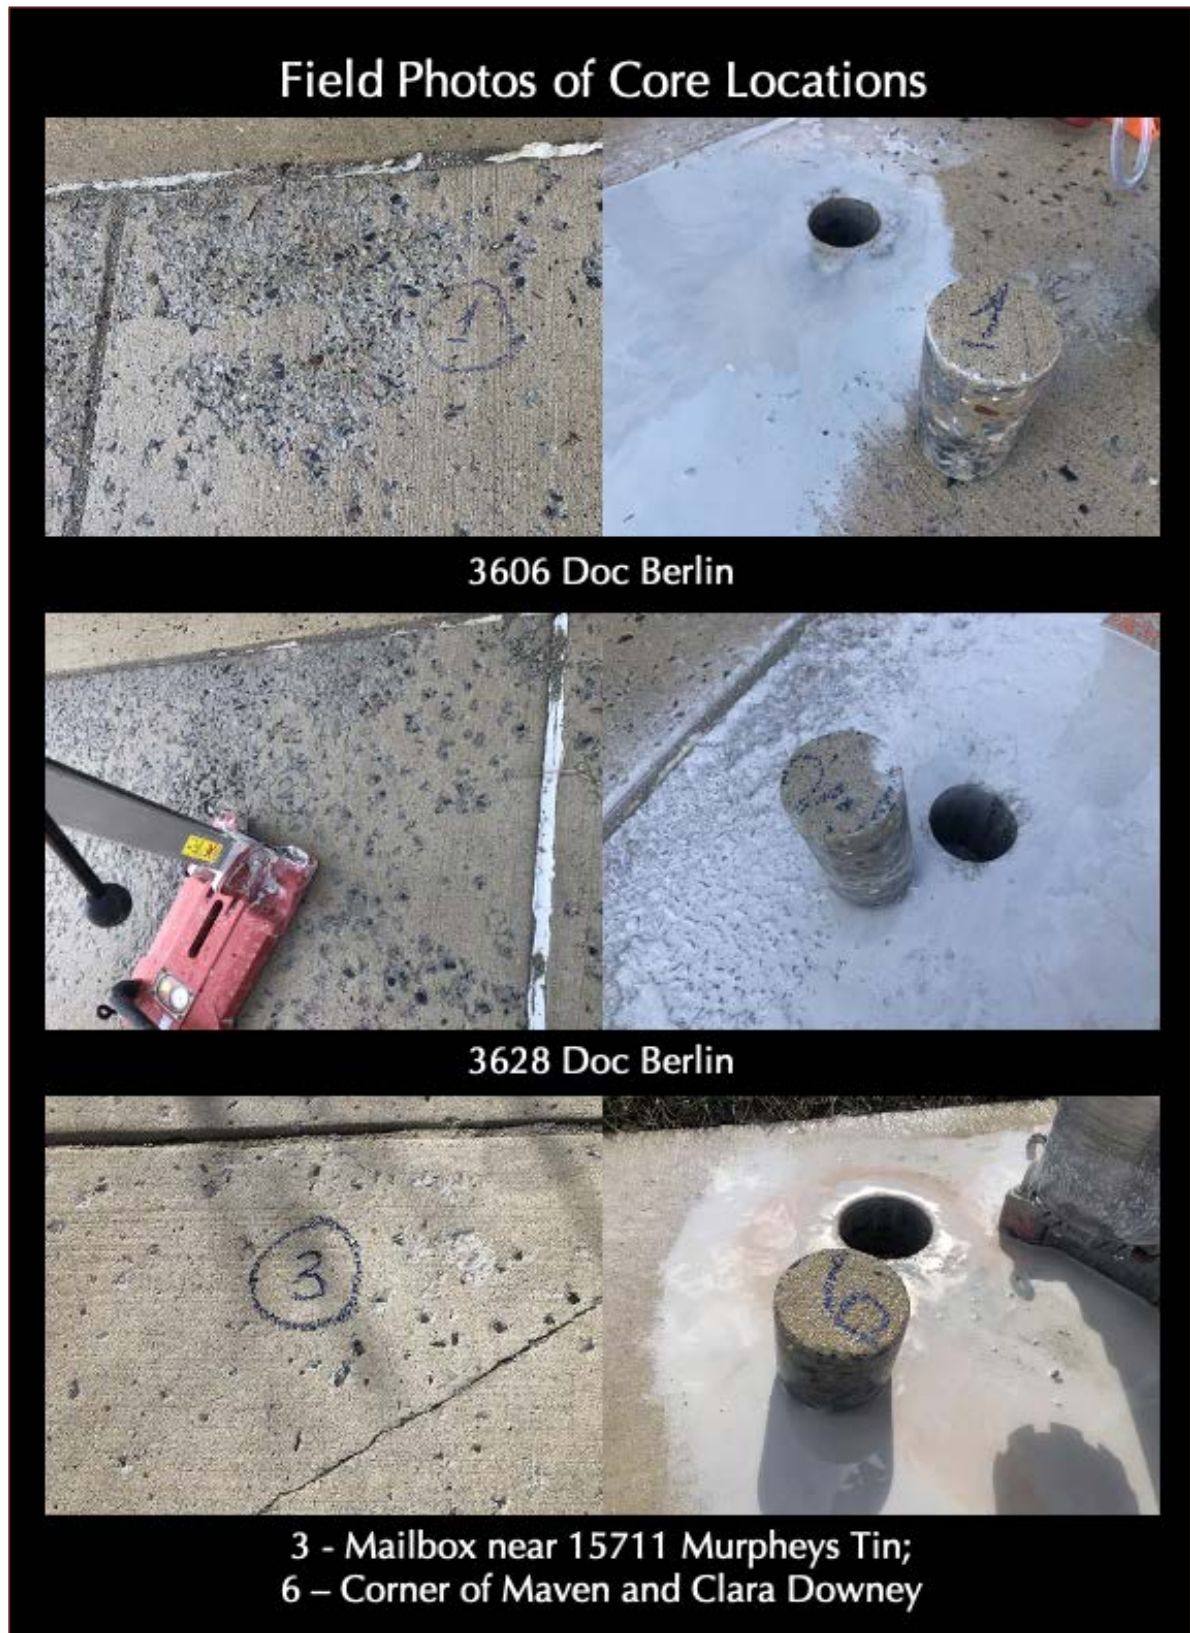
Figure 2: Field photographs showing surface scaling of concrete slab surface at the locations of Cores 1, 2, 3, and 6.

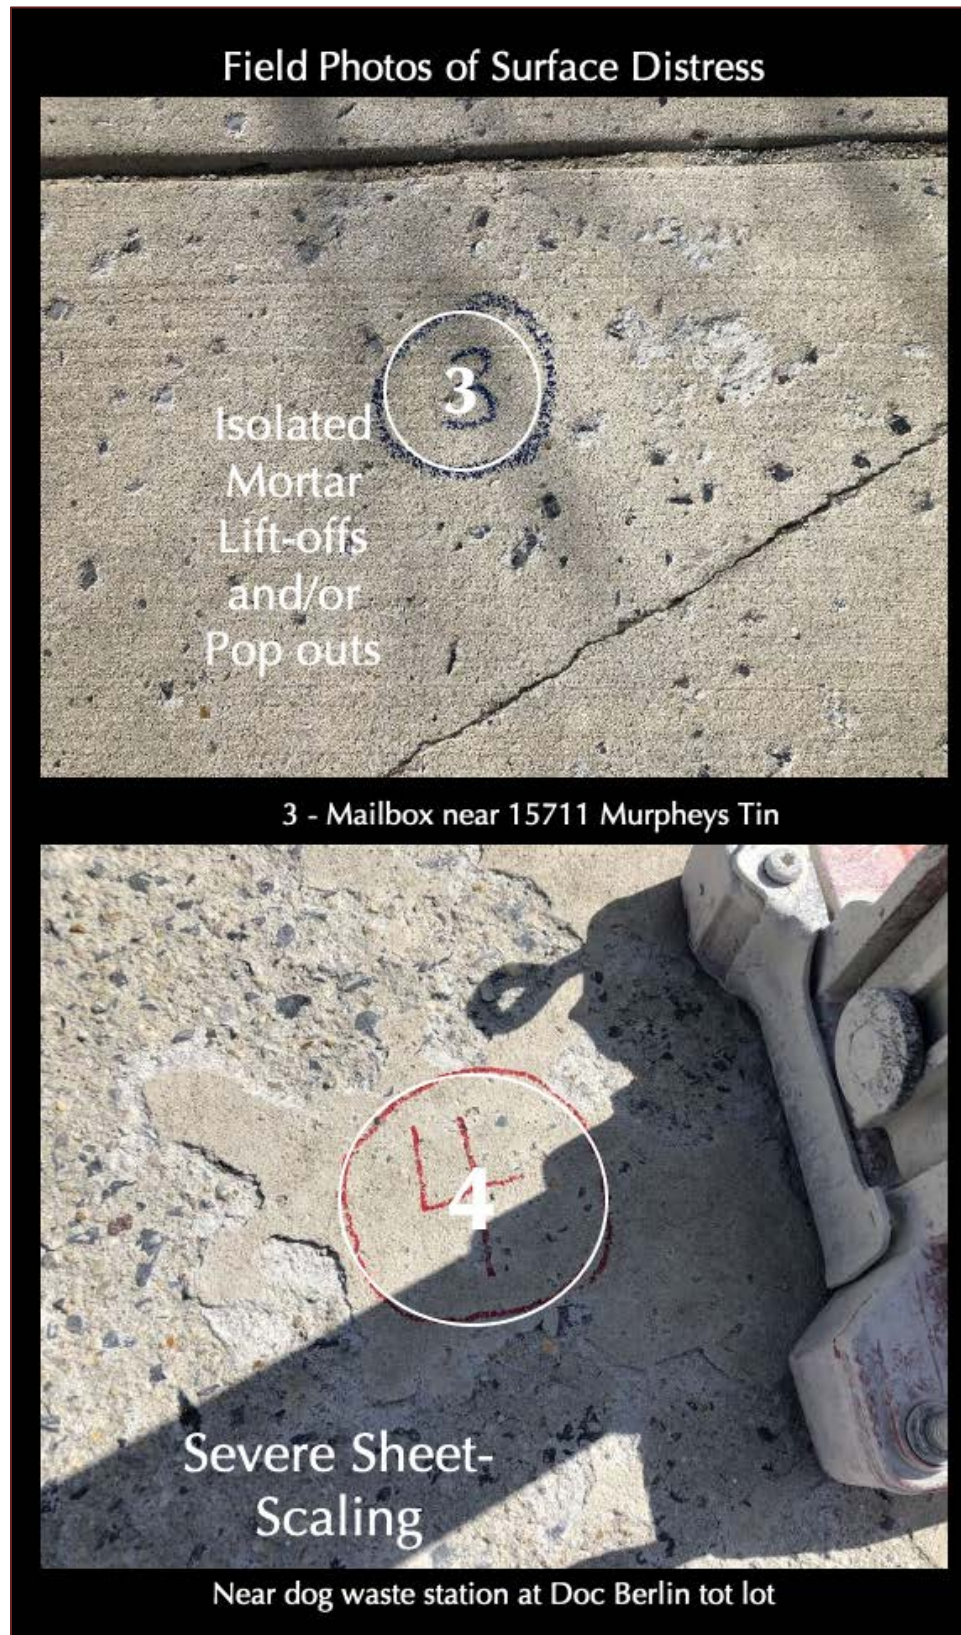
Figure 5: Isolated occurrences of surface distress as exposures of near-surface coarse aggregate particles as mortar lift-offs and/or pop-outs at the location of Core 3, but severe sheet-style surface scaling due to accumulation of bleed water underneath prematurely finished surface at the location of Core 4.

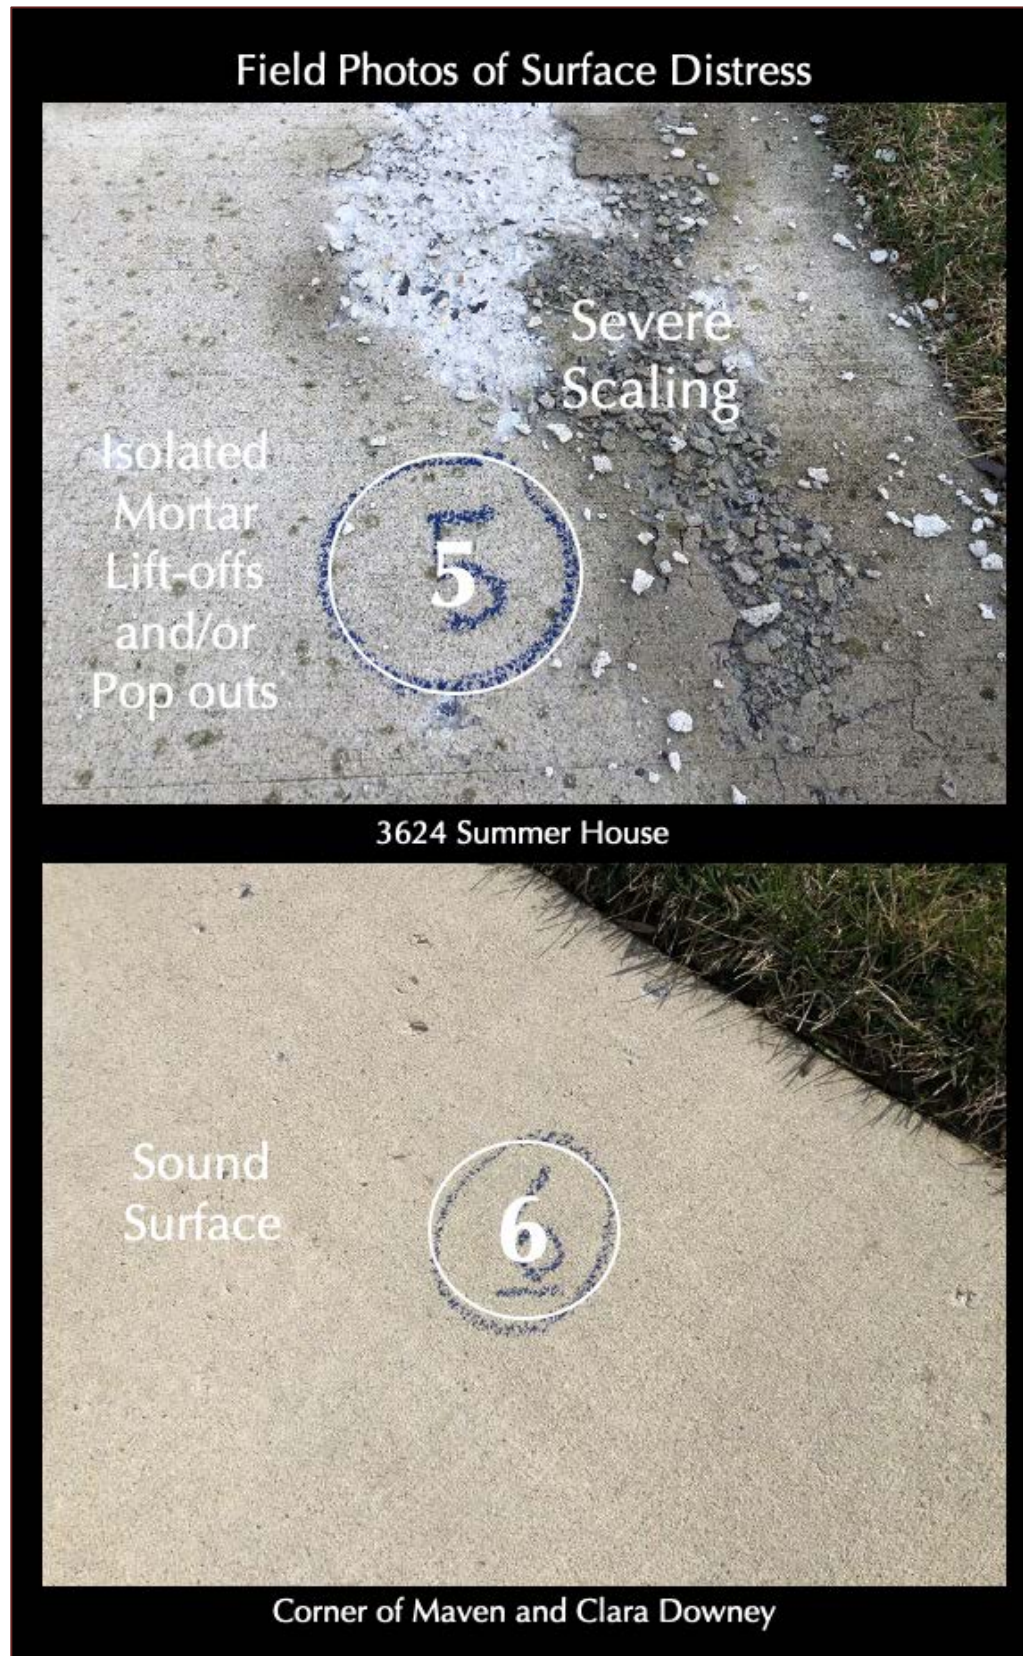
Figure 6: Severe scaling at the location of Core 5 whereas sound visually distress-free surface at the location of Core 6.

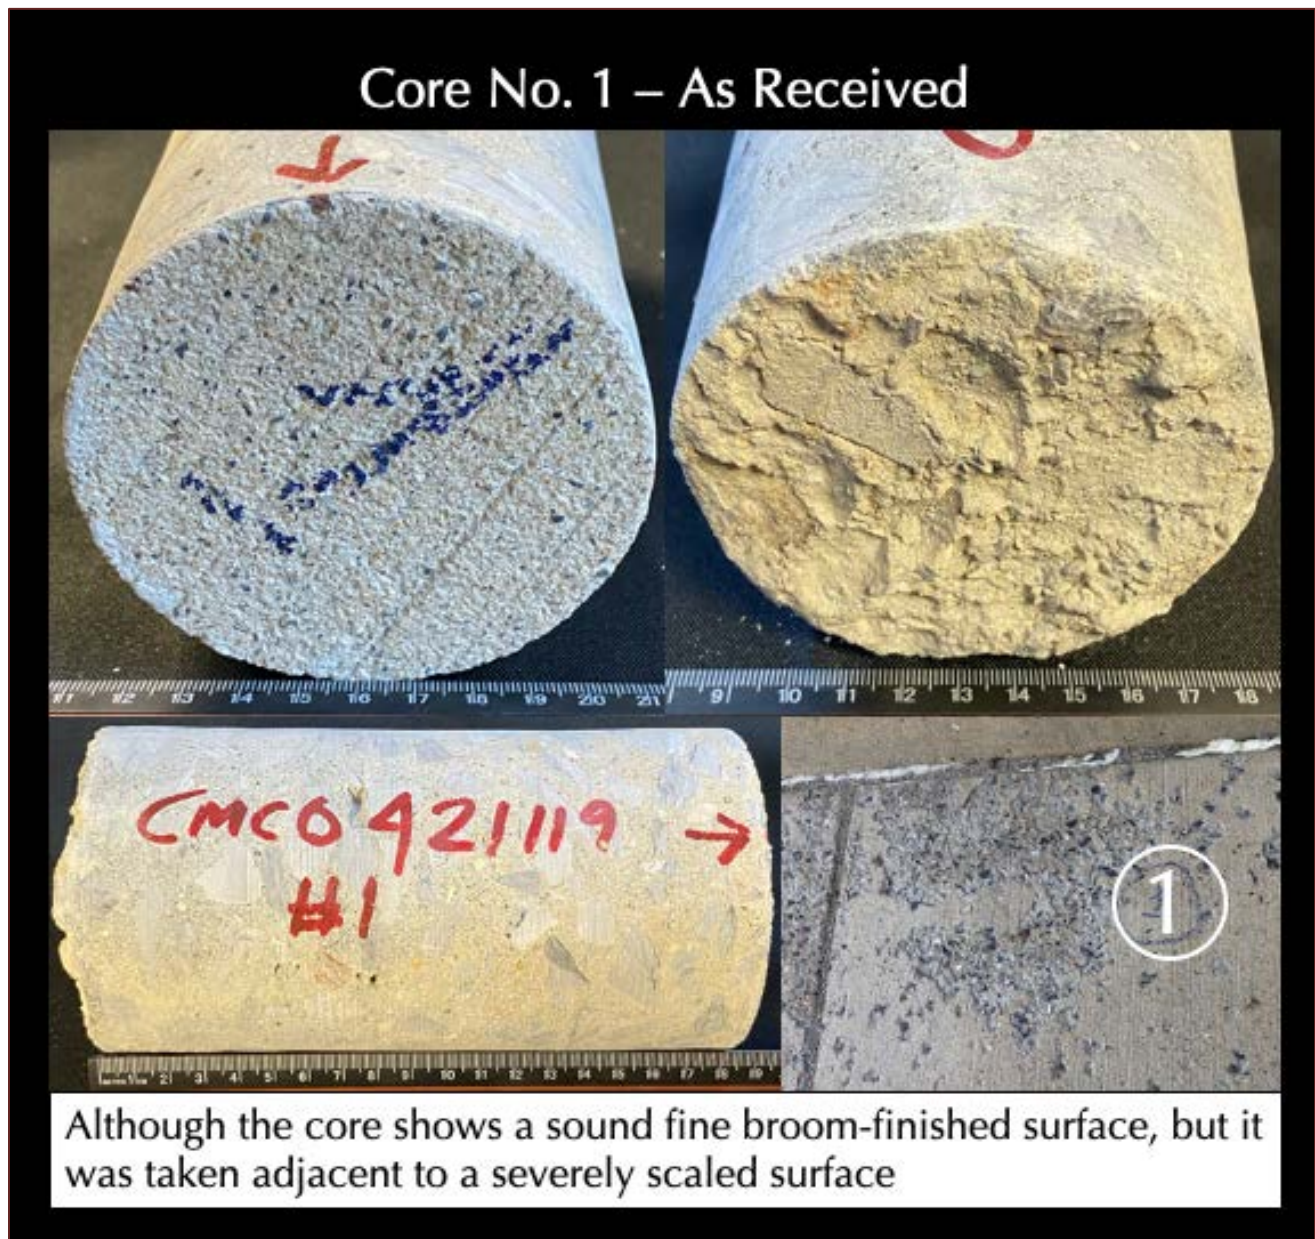
Figure 8: Core 1 as received showing fine broom-finished surface at the top left photo even though the core was taken from a scaled area (see Figures 1 and 3 and at the bottom right inset), bottom surface of core at the top right, and side cylindrical surface at the bottom left photo.

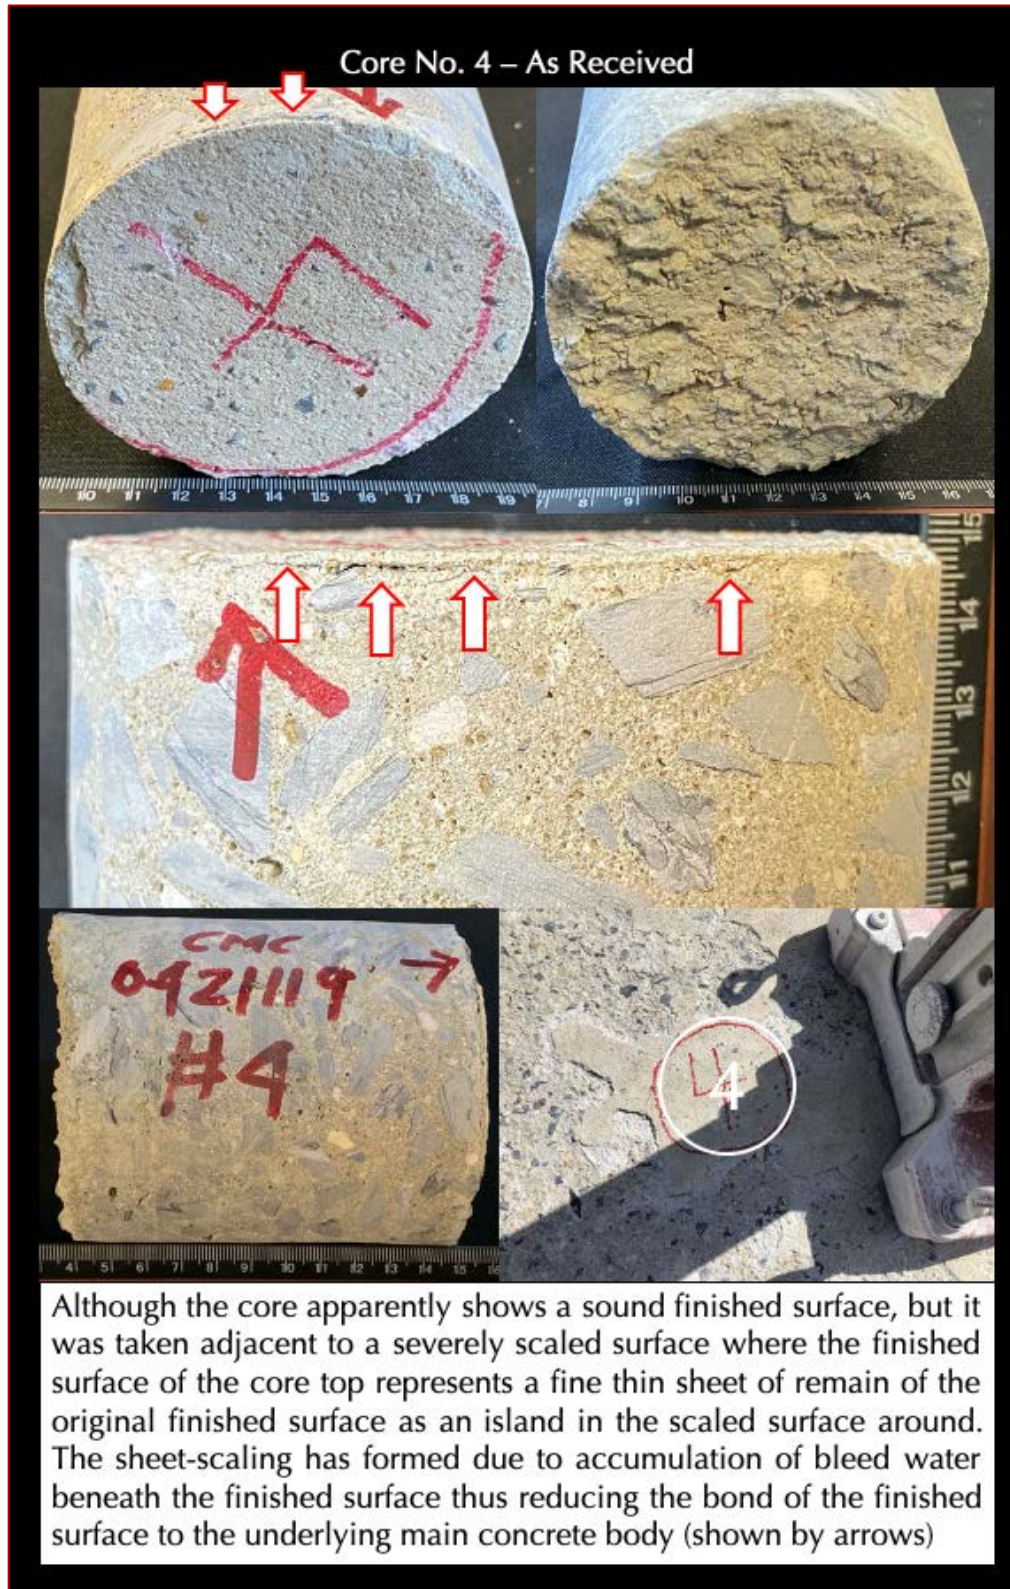
Additionally, there is evidence of premature finishing, i.e., finishing prior to the cessation of bleeding as sheet-scaling, which forms due to accumulation of bleed water beneath the finished surface eventually causing separation of the top thin sheet of finished surface from the main body of concrete to cause sheet-scaling.

Figure 11: Core 4 as received showing thin sheet-style incipient scaling where the original finished surface is loosely adhered to the main body with a weak bond marked by arrows in the middle row, which is consistent with sheet-scaling at the core location at the bottom right inset due to accumulation of bleed water underneath the prematurely finished surface, bottom surface of core at the top right, and side cylindrical surface at the bottom left photo.

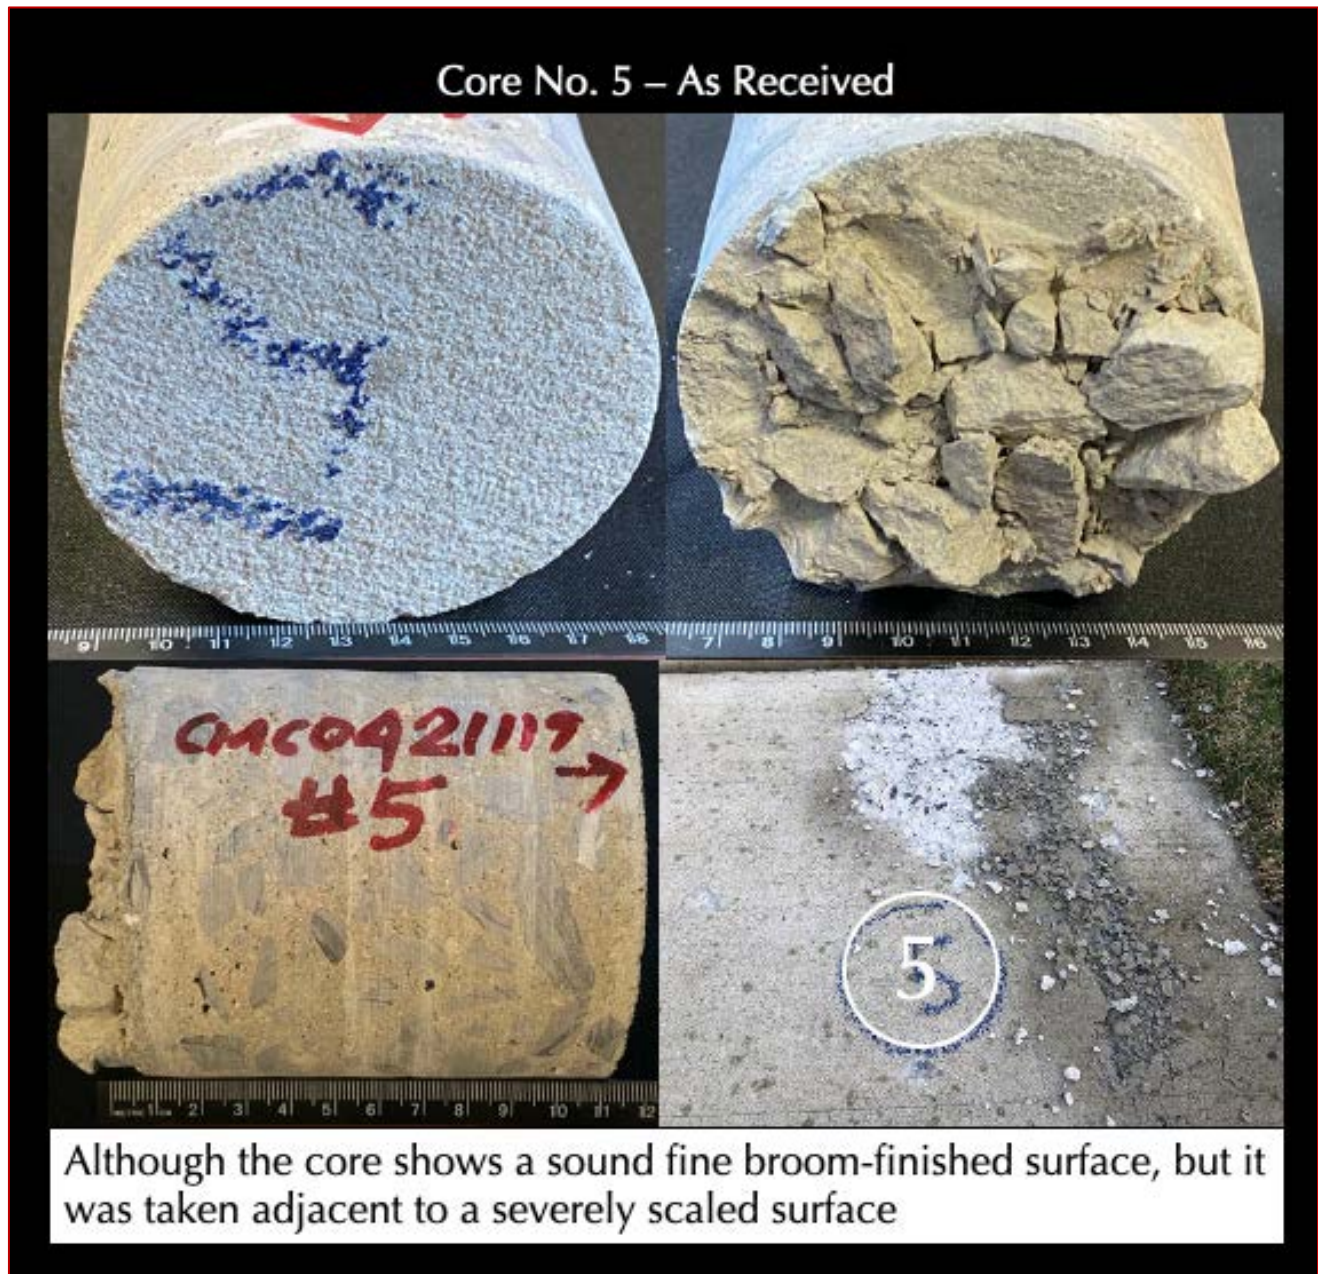
Figure 12: Core 5 as received showing sound fine broom-finished surface even though the core was taken from a scaled area as shown in the bottom right inset of field photo, bottom surface of core at the top right, and side cylindrical surface at the bottom left photo.

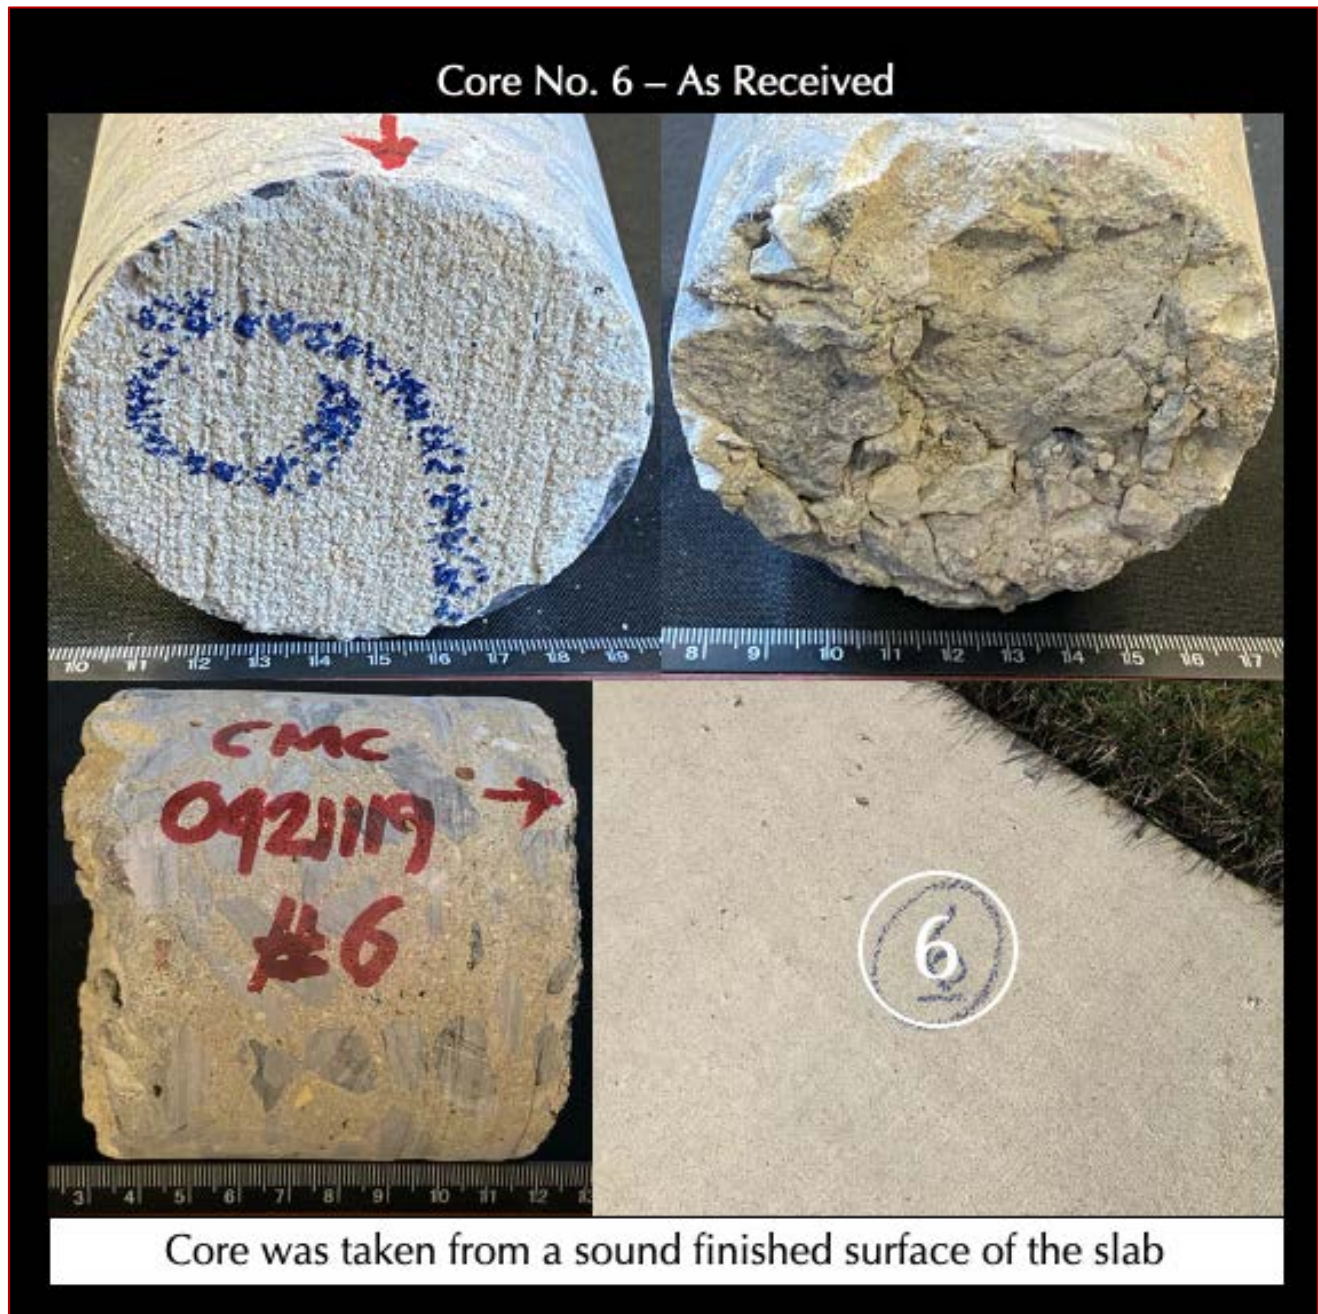
Figure 13: Core 6 as received showing the sound fine broom-finished surface, which is consistent with its collection from a sound location of slab as seen in the bottom right inset, bottom surface of core at the top right, and side cylindrical surface at the bottom left photo.

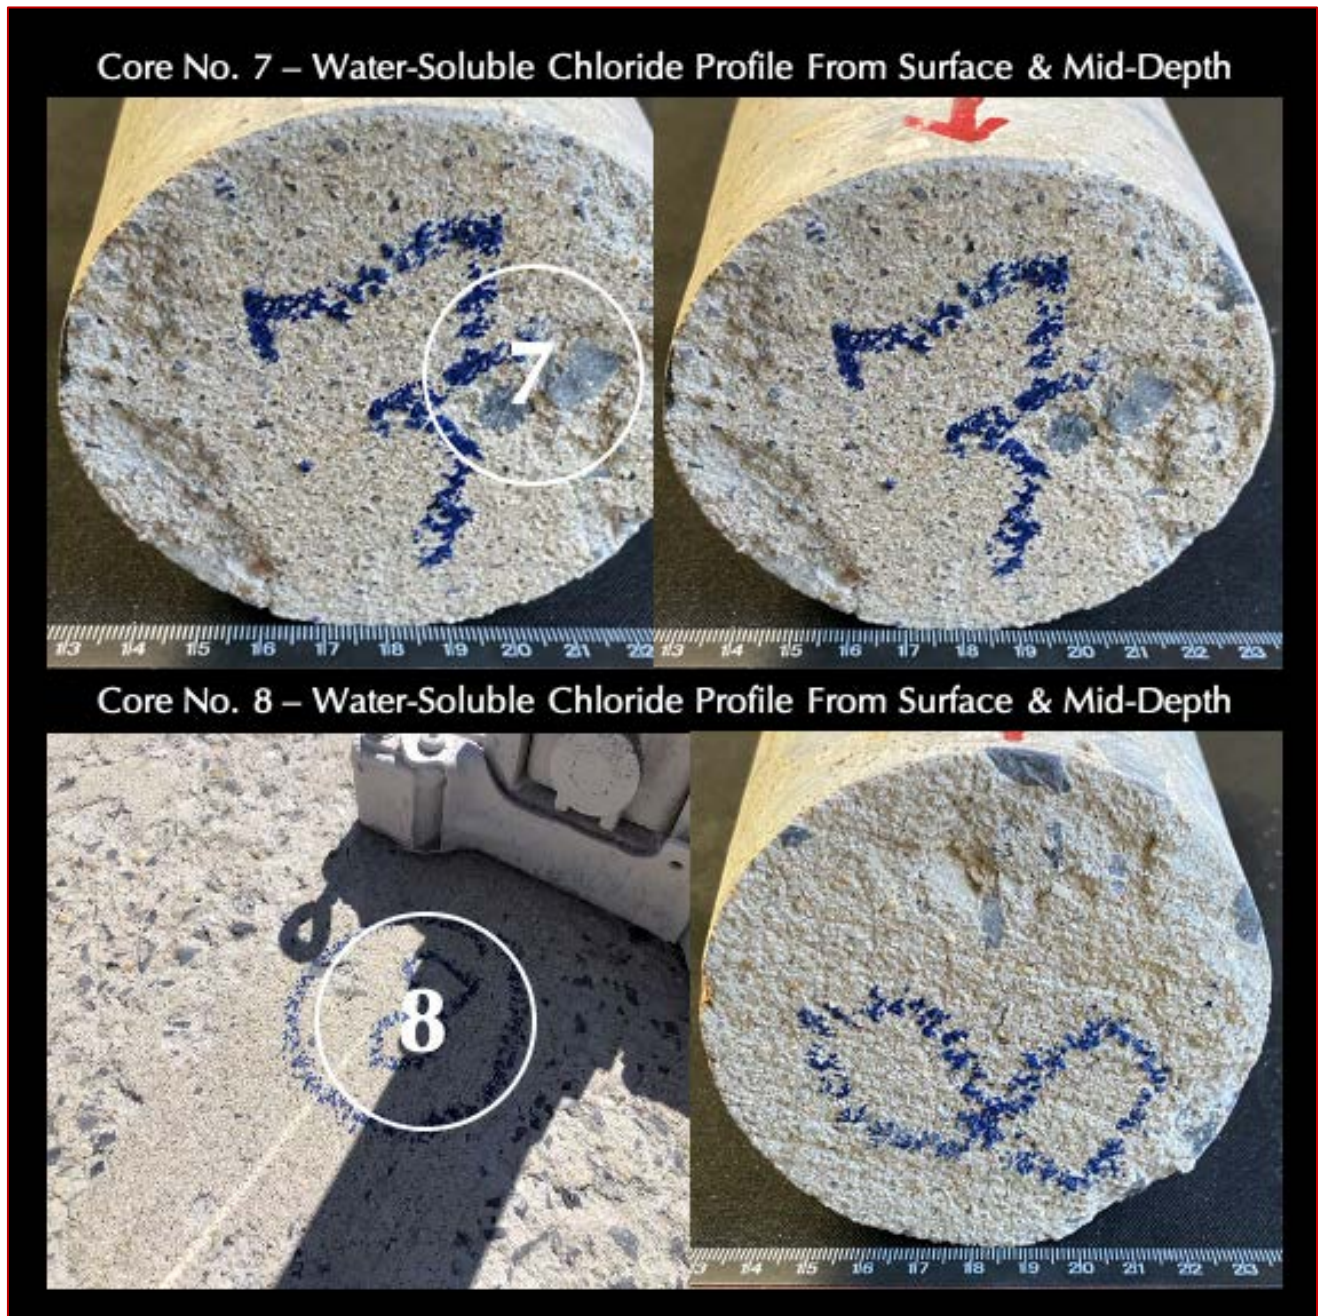
Figure 18: Water-soluble chloride contents of concrete were determined from the top distressed surface locations and at mid-depth locations of Cores 7 and 8.

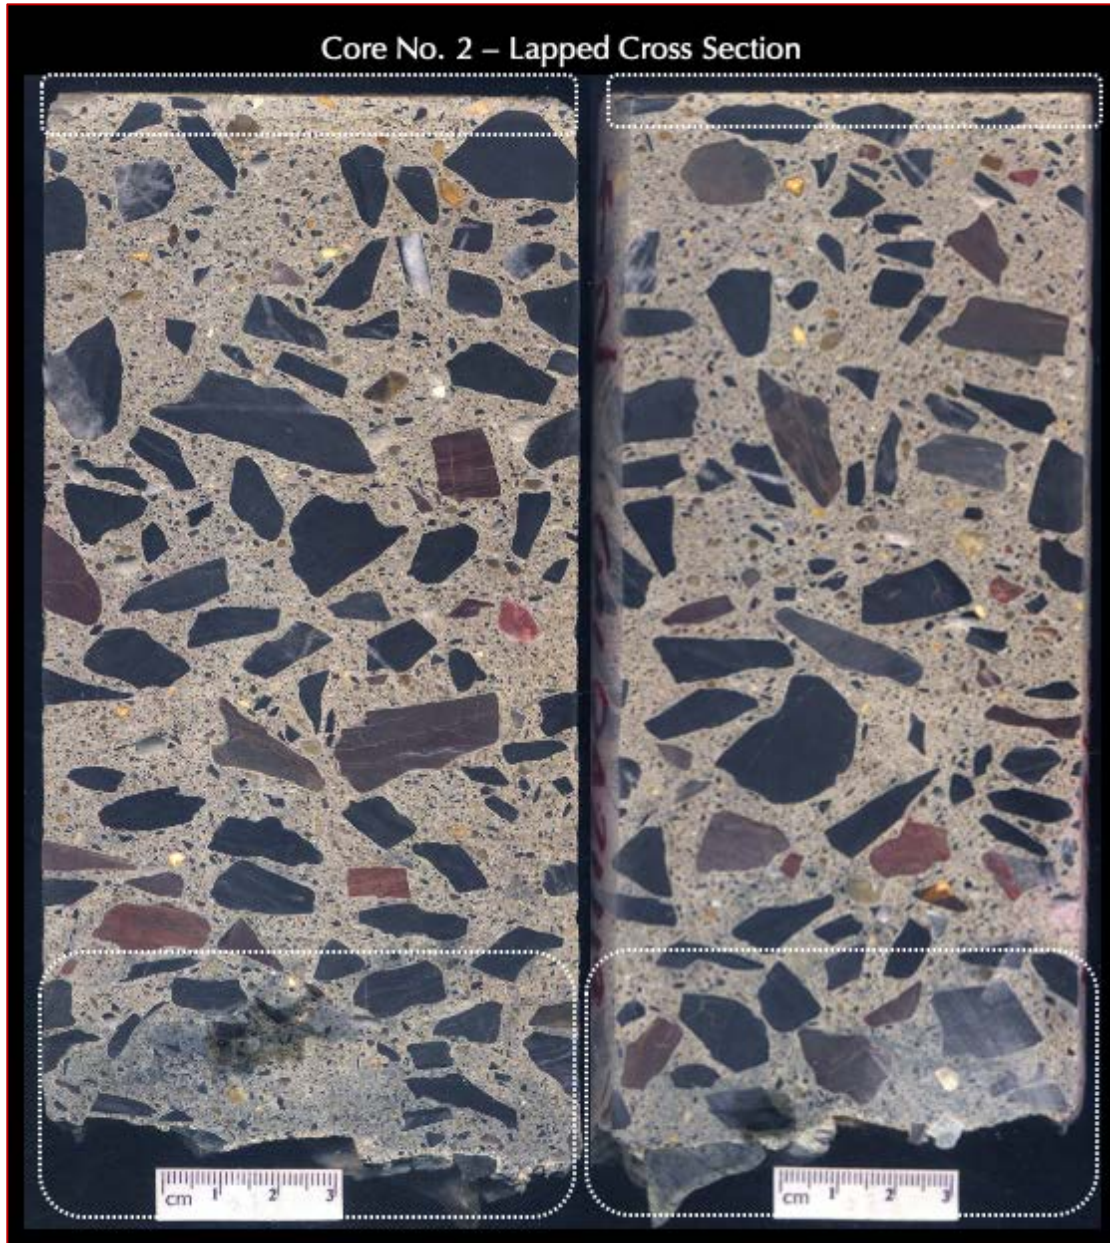
Petrographic examinations of Cores 2 and 6, however, found evidence of higher  $w/cm$  at the very top 5 to 6 mm resulting in lighter toned paste from the interior which could have formed from addition of water during finishing and/or finishing in the presence of bleed water at the surface. Such practices can reduce the overall freeze-thaw durability and wearing resistance of surface despite having a good air entrainment.

Figure 21: Two parallel lapped cross sections of Core 2 showing: (a) lightened gray toned paste at the top 5 to 6 mm of exposed surface (boxed) compared to relatively darker toned paste in the interior body, which occurs due to addition of water during finishing operations and/or finishing in the presence of bleed water at the surface, either practice would increase the porosity and water-cementitious materials ratio of paste and decrease the wear resistance and durability of exposed surface; (b) crushed limestone coarse aggregate particles, which are well-graded but show slight segregation at the top inch of the finished surface; (c) overall dense, and well-consolidated nature of concrete in the body; and greenish-gray discoloration of paste at the bottom 1 to 2 inches (boxed) due to the presence of ground granulated blast furnace slag as a cementitious component in the paste.

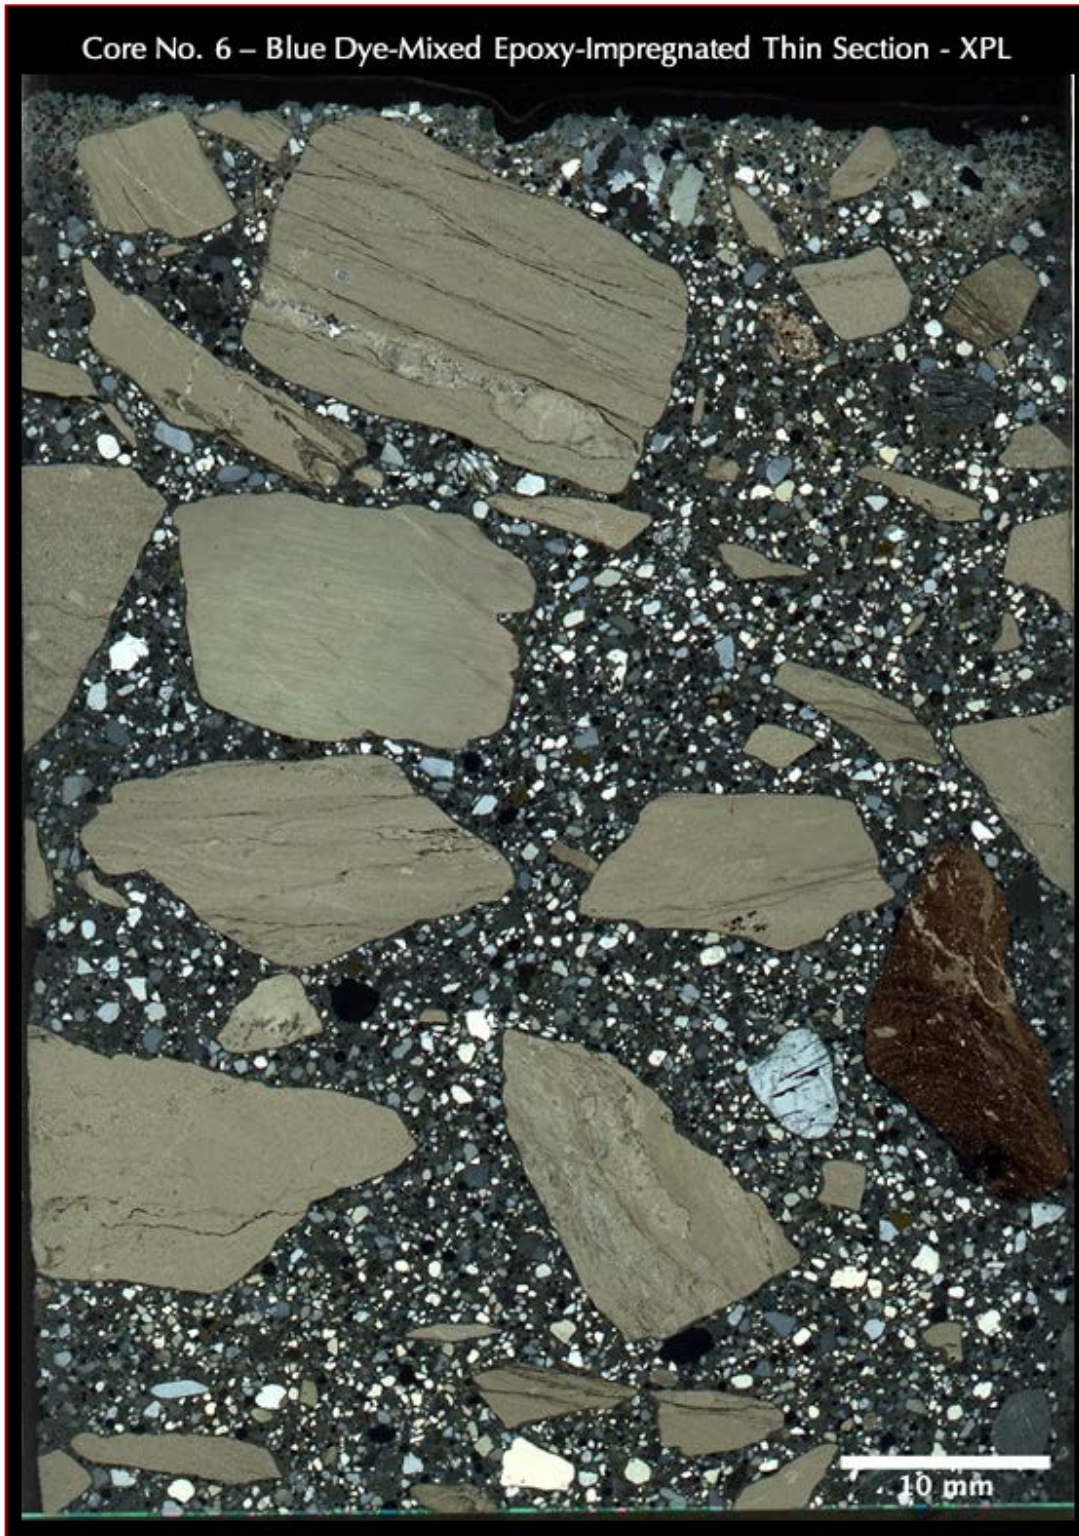
Figure 34: Blue dye-mixed epoxy-impregnated large-area (50 mm × 75 mm size) thin section of Core 6 shown in crossed-polarized light mode to highlight the coarse and fine aggregates in concrete. The thin section was scanned on a film scanner with two perpendicular polarizing filters.

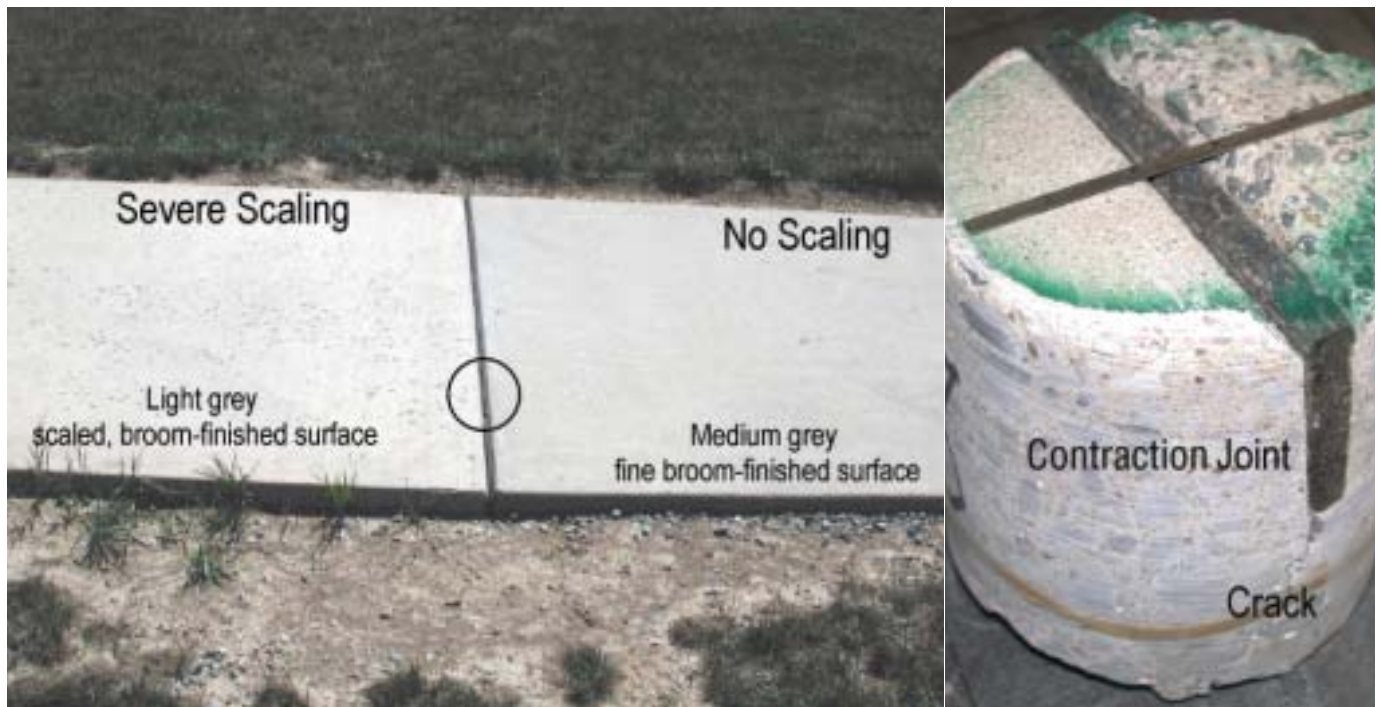
Fig. 2: Case study II (Scaling due to finishing in the presence of excess water at the surface)—Concrete core from a contraction joint showing adjacent sound and scaled surfaces

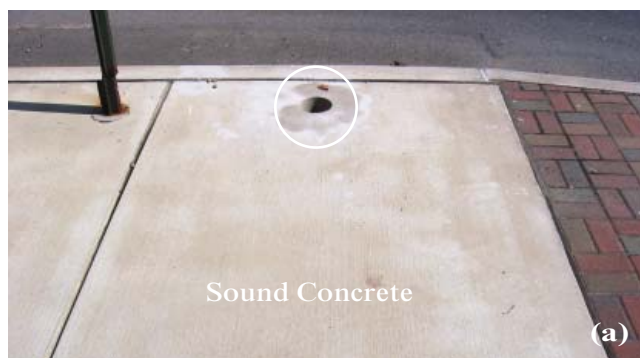
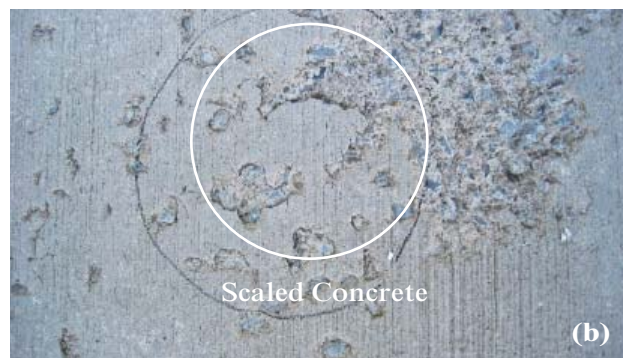
Fig. 2: Case study II: Scaling due to improper air entrainment (coarse air-void system with low air content and wide void spacing). Photos (a) and (b) show the surface conditions of panels where cores were taken; the graphs show profiles of air-void parameters in scaled (in red) and sound (in blue) concretes; and photos (c) and (d) show air-void systems in cross sections of sound and scaled cores. Note: 1 in. = 25.4 mm

The second example in Table 2 shows a case study of scaling in a downtown concrete sidewalk exposed to severe winter weather and the heavy application of salt. The core from a sound panel has an excellent air-void system—the air content, specific surface, and void spacing factor all conform to the industry recommendations. The core from a severely scaled panel, though air entrained, has a low air content and a coarse air-void system with a low specific surface and a high void-spacing factor (Fig. 2). A coarse air-void system can occur due to a low dosage of air-entraining admixture, excessive mixing of the concrete, or retempering or excessive addition of water (the other causes of a coarse air-void system—for example, the presence of high-range water-reducing admixtures or cement-admixture incompatibility—were not present). In spite of deicing salt being the alleged factor for scaling, the chloride content was found to be similar in both scaled and sound cores (due to their similar salt exposures) and, in fact, was higher in the sound core. Scaling was initiated in the panels having improper air-void systems and became aggravated in the presence of salt. Although both sound and scaled panels

experienced some finishing-induced loss of air at the surface, the air bubbles at the surface of the sound panel were still close enough to each other to provide the necessary protection of paste against distress due to cyclic freezing and thawing. This indicates that for scaling resistance, the air-void-spacing factor is more important than the air content. Figure 3 shows another very similar case where the “total air” content of the scaled core fulfilled the design air requirement, but the concrete still scaled due to such a coarse air-void system having widely-spaced bubbles.
