Investigation of Presence of Pyrrhotite in A Residential Concrete Foundation In Mansfield Center, Connecticut

154 Coventry Road
Mansfield Center, Connecticut

August 23, 2018
CMC 0718143

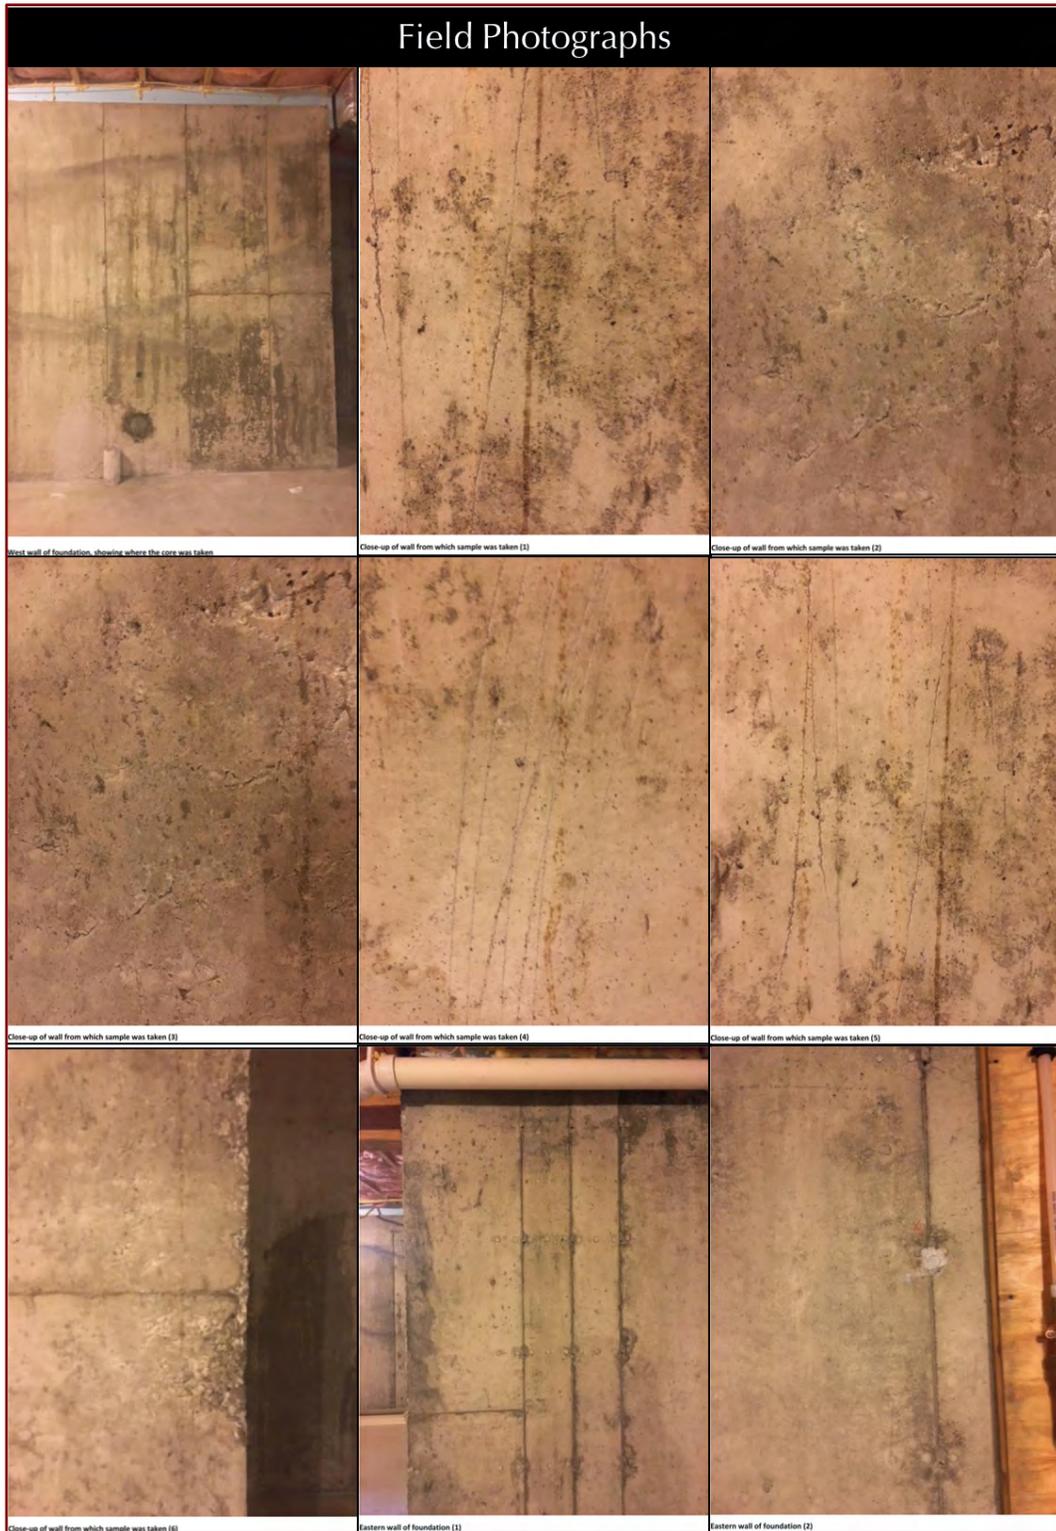
Figure 1 shows field photographs of the subject foundation wall that *does not* show random and/or closed polygonal-shaped map cracking that are common and found in many other homes from the neighborhood from pyrrhotite-related distress in concrete. The top left photo in Figure 1 shows the core location from a wall extracted from near the ground-level along with the core of this study after extraction. The retrieved 8 in. (200 mm) length of the core represents partial thickness of the wall. The wall in all photos appears to be present in sound condition without any cracking, except some long striation marks that are judged unrelated to any concrete distress.

Figure 1: Field photographs showing the overall sound condition of the foundation walls, and the location on the wall from where the core for the present study was reportedly retrieved (top left photo).

The foundation is currently in good condition with no visible horizontal cracking on the exterior or interior. There are small vertical cracks in a few places possibly due to settlement.

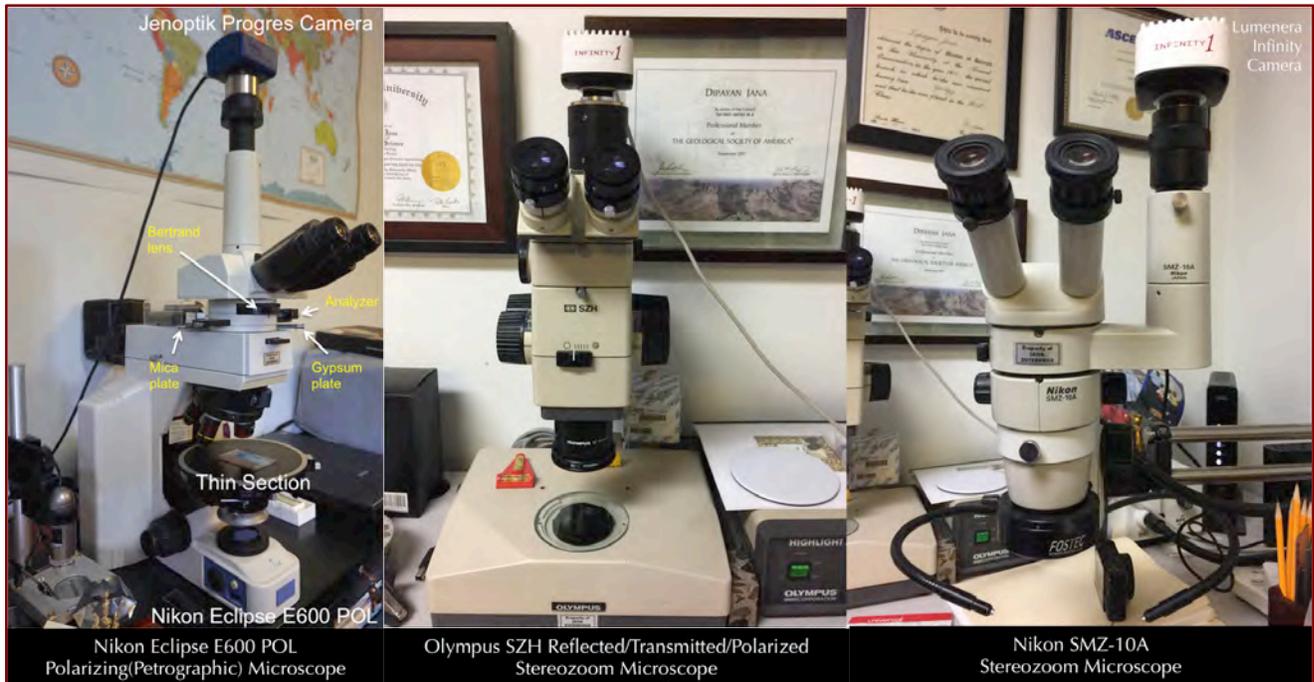
Figure 2: Optical Microscopy: Left - A Nikon Eclipse E600 POL polarizing (petrographic) microscope at left with reflected, transmitted, polarized-light, and fluorescent-light capabilities; Middle – An Olympus SZH reflected/transmitted/polarized-light Stereozoom microscope; and Right – A Nikon SMZ-10A Stereozoom microscope. All microscopes are equipped with Jenoptik Gryphax and Lumenera Infinity digital cameras.

- xi. A Nikon Eclipse 600 POL petrographic microscope attached to a Jenoptik Progres GRYPHAX high-resolution digital camera were used for petrographic examinations and collecting photomicrographs of thin sections of concretes (Figure 2). A Nikon SMZ-10A stereomicroscope (Figure 2) and an Olympus SZH stereo zoom microscope (equipped with transmitted polarizing light facilities) were used for examinations of fresh fractured and lapped sections and transmitted-light examinations of thin sections, respectively.

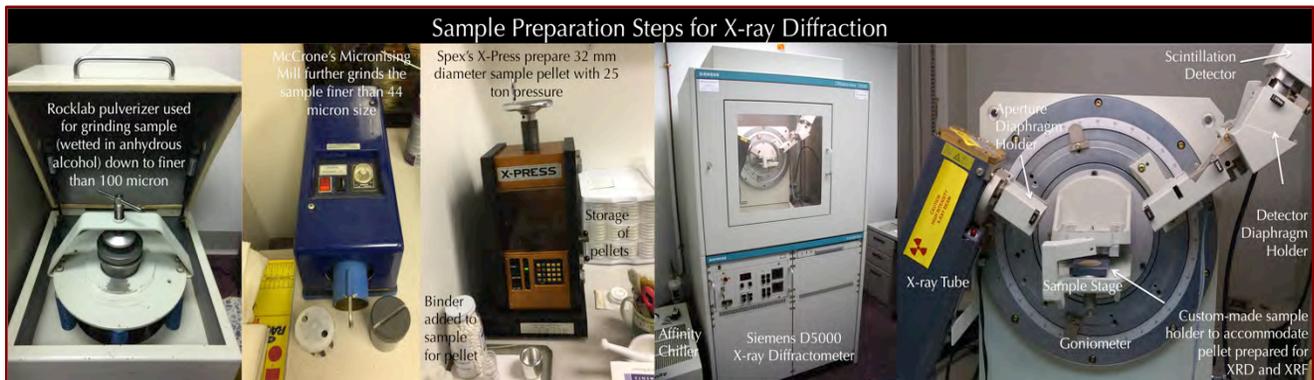
Figure 3: XRD: Siemens D5000 X-ray diffractometer and MDI Jade search/match software used for determination of mineralogical compositions of extracted concrete aggregates. Left to right: Rocklab pulverizer for initial grinding of aggregate with anhydrous alcohol; McCrone micronizing mill for final grinding; Spex 25-ton press for pellet preparation; Siemens D5000 X-ray diffractometer; and custom-made sample holder to place a 32-mm diameter pellet on sample stage.

A few crushed stone coarse aggregate particles containing metallic-lustered iron sulfide minerals (as detected from the core as received, and from its lapped cross section) were extracted from the core, pulverized, and used for X-ray diffraction to determine the iron sulfide species (e.g., pyrite, pyrrhotite) present in the aggregate.

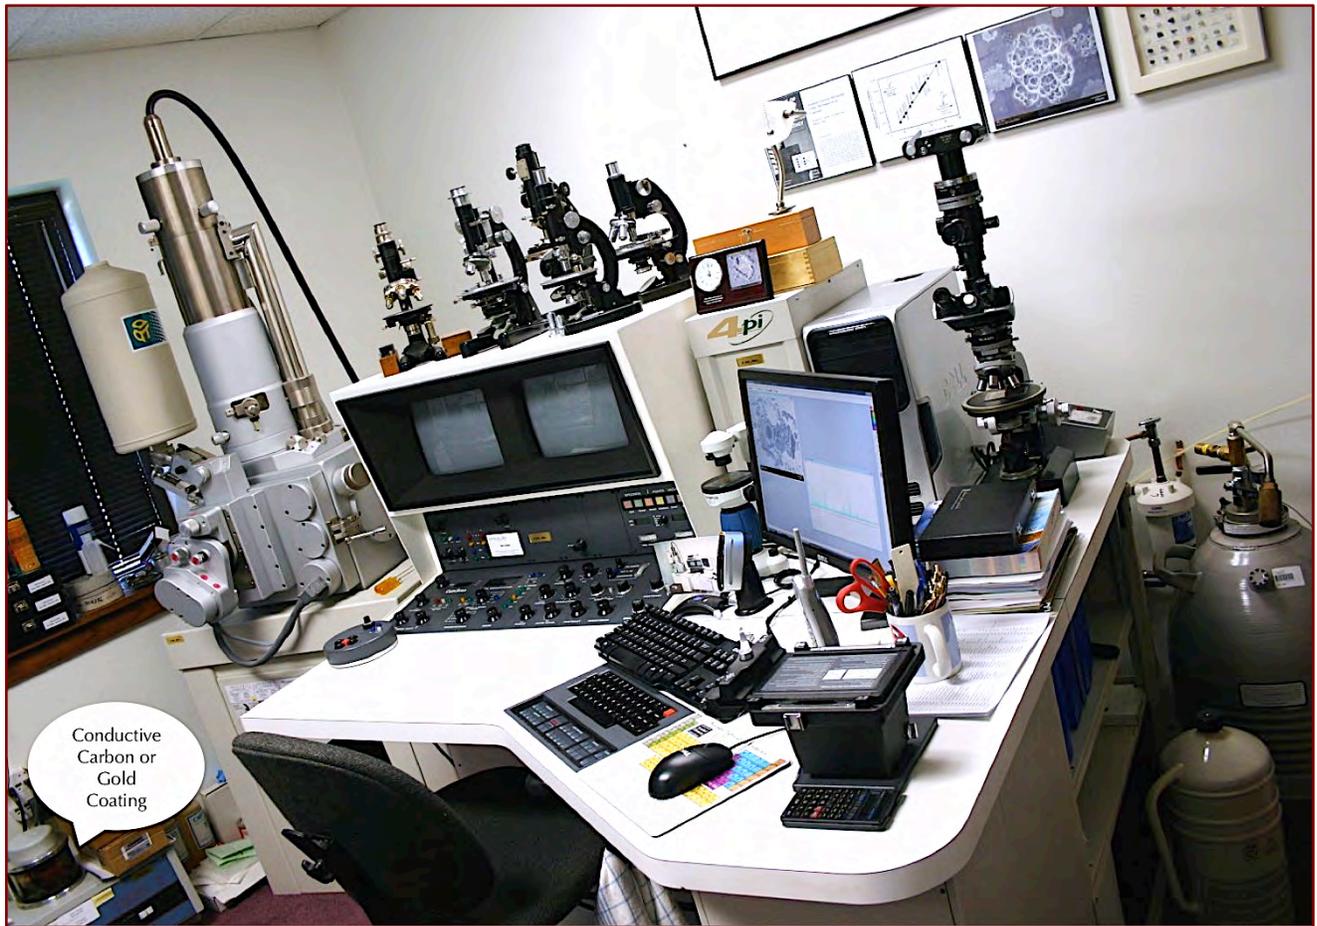
Figure 4: SEM-EDS: Cambridge CamScan Series II Scanning Electron Microscope and 4Pi Revolution software, backscatter detector, secondary electron detector, and energy-dispersive X-ray fluorescence spectrometer used for microstructural and microchemical analyses of concrete and aggregate.

Polished and gold-palladium coated thin sections of core already examined by optical microscopy were selected for SEM-EDS studies and examined in a Cambridge CamScan Series II scanning electron microscope equipped with a backscatter detector, a secondary electron detector, and x-ray fluorescence spectrometer (Figure 4) to observe pyrrhotite or other potentially unsound constituents in concrete and aggregate and their effect on the performance and durability of concrete, as well as evidence of internal sulfate attack and secondary ettringite formation in the paste from released sulfate.

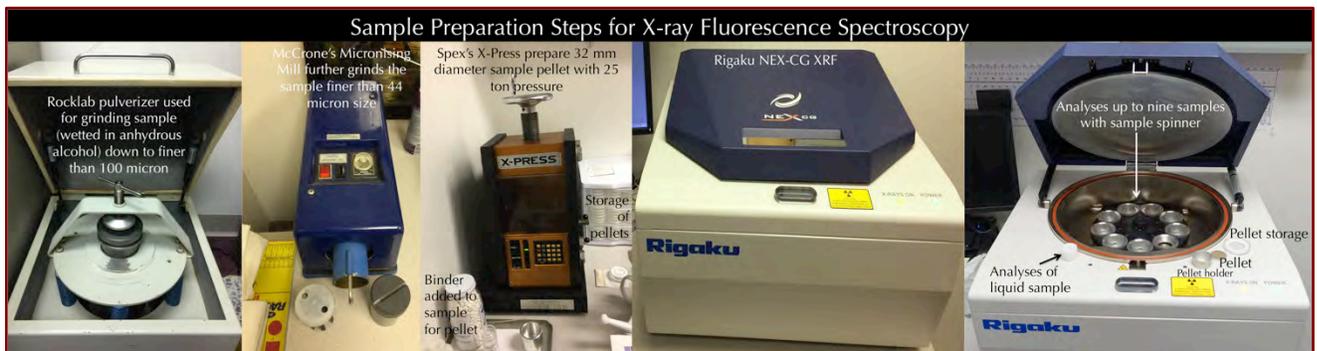
Figure 5: XRF: Rigaku NEX-CG bench-top ED-XRF unit used for bulk chemical compositions of aggregates.

An energy-dispersive bench-top X-ray fluorescence unit from Rigaku Americas Corporation (NEX-CG, Figure 5) was used for determination of bulk chemical (oxide) composition and sulfur (as SO₃) content of unsound aggregate particles, and concrete. The instrument is calibrated by using various certified (CCRL, NIST, GSA, and Brammer) reference standards of rocks. The sample pellet prepared for X-ray diffraction is used for X-ray fluorescence studies as well. The main focus of this analysis was to determine the sulfur content (as SO₃) in the aggregate particles as well as sulfate content (as SO₃) in concrete.

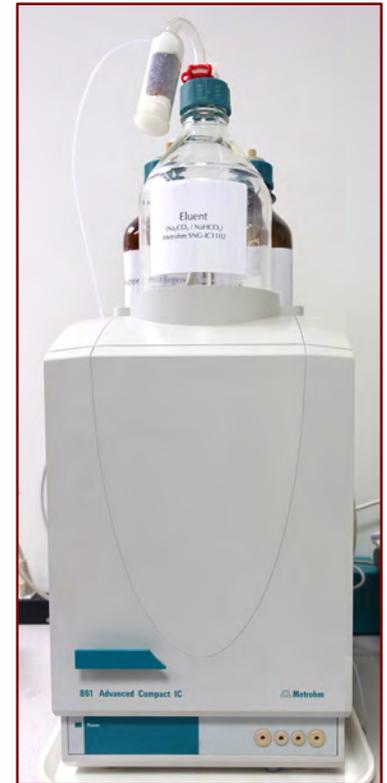
Figure 6: IC: Metrohm 861 Advanced IC used for analysis of sulfate released from aggregate.

The filtrate was then diluted to 250 mL with distilled water to be analyzed by Metrohm's 861 Advanced Ion Chromatograph (Figure 6) for determination of released sulfates from oxidation of sulfides.

Procedures followed in Ion chromatography are described in ASTM D 4327 "Standard Test Method for Anions in Water by Chemically Suppressed Ion Chromatography." The IC was calibrated against six (6) different custom-made Metrohm anion standard solutions having sulfate from 0.1-ppm to 100-ppm levels.

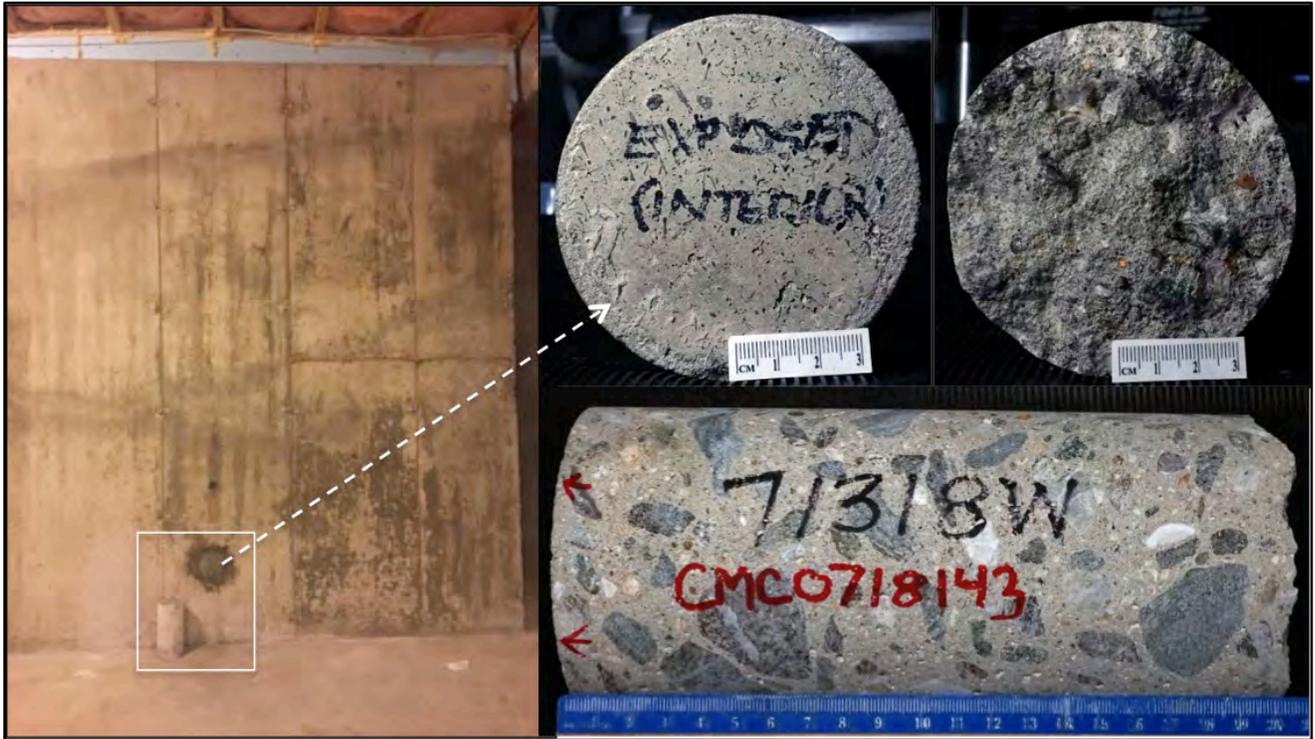
Received was one concrete core identified as 71318W. Figure 7 shows the exposed formed surface of the core on the left that represents the foundation wall's interior surface, the fresh fractured inside surface on the right due to partial-depth extraction of the core from the wall, and, the cylindrical side views of the core in the middle column. The core is 8 in. (200 mm) in total length, and 3⁵/₈ in. (92 mm) in nominal diameter.

The exposed surface of core (wall) is a smooth flat formed surface of wall with no visible cracking (Figure 6, top left photo of core). The opposite surface is fresh fractured.

Figure 7: Shown are the location on the foundation wall from which the sample was taken (left), the formed exposed surface (right column top left), fresh fractured inside surface (right column top right), and cylindrical side view of the core (right column bottom), as received. Arrows in the right column photo indicate the exposed surface.

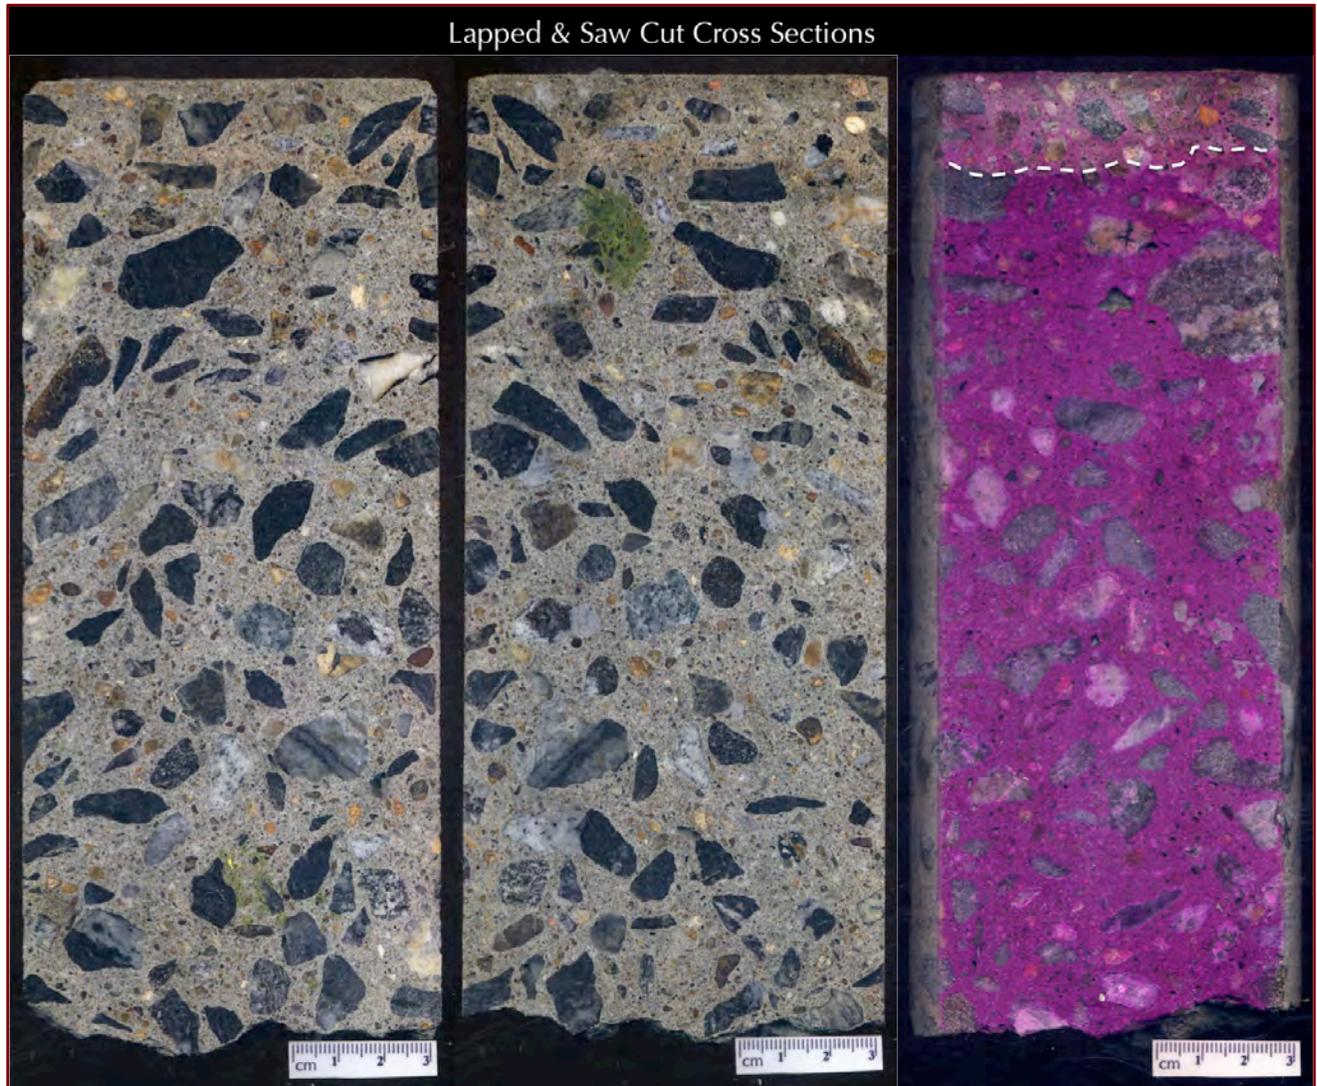
Figures 8 through 10 show: (a) two lapped cross sections (Figure 8 left and middle photos), (b) one saw-cut cross section after treatment with a phenolphthalein alcoholic solution to highlight non-carbonated concrete that has turned pink after treatment and carbonated concrete at the exposed surface region that has remained gray or light pink due to atmospheric carbonation of concrete (Figure 8 right photo), (c) two additional fluorescent dye-mixed epoxy-impregnated cross sections of core (Figure 9 left and 2nd from left photos) to highlight voids and cracks, if

Figure 8: Lapped cross sections of the core showing: (a) no cracking in concrete as opposed extensive cracking found in many other foundation walls from eastern Connecticut that are affected by pyrrhotite-related distress in concrete; and (b) a saw-cut cross section at right after treatment with a phenolphthalein alcoholic solution to highlight non-carbonated concrete that has turned pink after treatment and carbonated concrete at the exposed surface region that remained gray or light pink to a depth of 20 to 30 mm from the exposed surface due to atmospheric carbonation of concrete. Notice good grading and well-distribution of the crushed stone coarse aggregate particles in all cross sections.

Saw-cut cross section in Figure 8 shows non-carbonated nature of the interior concrete where the phenolphthalein-treated section has turned pink but carbonated portion at the 20 to 30 mm of exposed surface region has remained light grey to light pink color tone of paste. The dashed line separates the interior non-carbonated concrete from the carbonated exposed end of the wall. Depth of carbonation is measured to be a distance of 20 to 30 mm from the exposed face of the wall. Densification of paste due to carbonation at the exposed end of the core (foundation Wall) is clear in all cross sections.

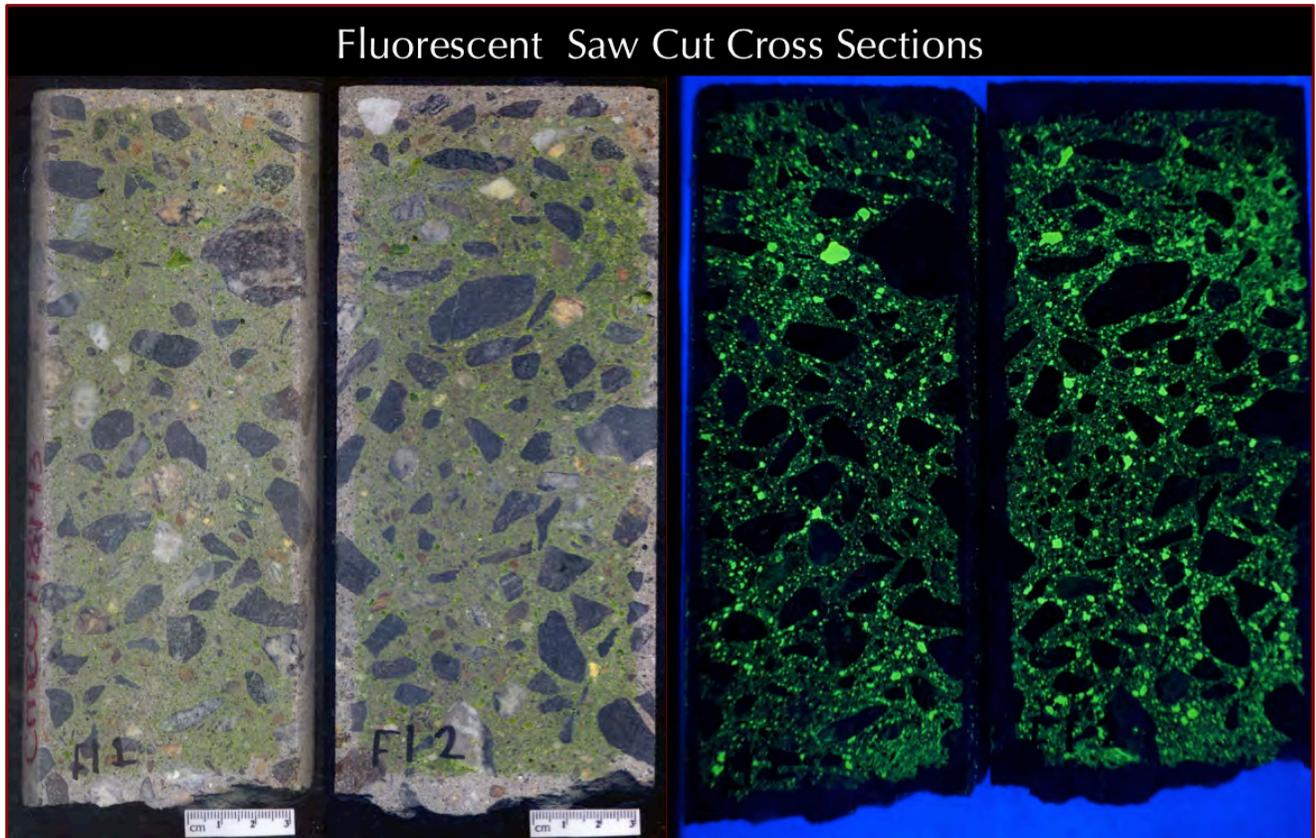
The startling feature from such exercises, especially after viewing two fluorescent epoxy-impregnated cross sections of core in UV light in Figure 9 is the absence of any cracking either in the crushed stone coarse aggregate particles or in the mortar fraction of concrete, which is the common microstructural manifestation of pyrrhotite-related distress in concrete. Concrete from other foundation walls from Eastern Connecticut areas that are affected by pyrrhotite-related cracking showed extensive cracking during such fluorescent treatments. Absence of such cracking in this examined core indicates sound condition of concrete at least during the time of this investigation. Air voids

in concrete as well as many coarse voids are highlighted in fluorescent treatment under UV light. Crushed stone coarse aggregate particles appear dark with no prominent cracking to be highlighted by absorption of fluorescent epoxy.

Figure 9: Fluorescent dye-mixed epoxy-impregnated cross sections of core (left and 2nd from left photos) to highlight voids and cracks, if any in the cross sections of core that are prominent when such sections are viewed in a short wavelength ultraviolet (UV) light in a dark room as shown in the 3rd and 4th from left photos.

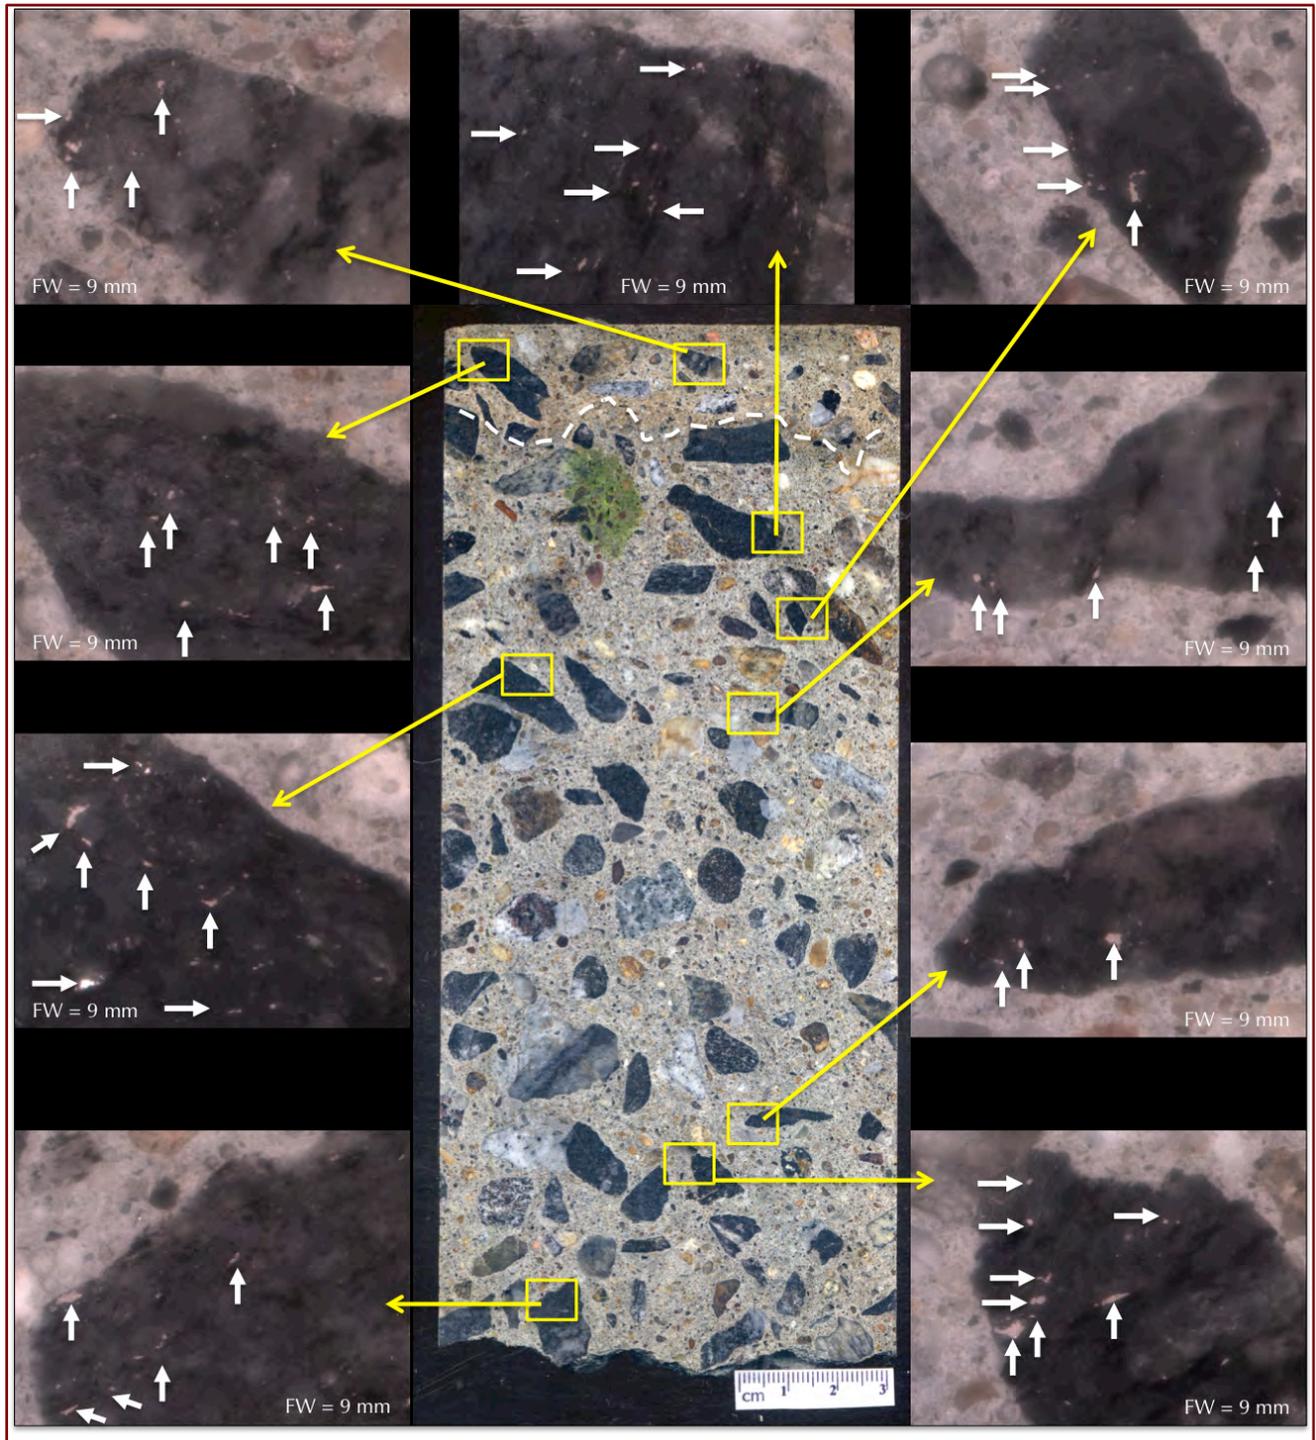
Figure 10 shows photomicrographs of lapped cross section of core where metallic lustered golden or brown color tone iron sulfide minerals are marked with arrows for some individual dark gray to black crushed stone coarse aggregate particles (boxed). Many of these tiny particles marked with arrows are determined to be pyrrhotite-based iron sulfide minerals consistent with pyrrhotite found in similar coarse aggregate from other foundation walls in eastern Connecticut homes affected by pyrrhotite-related cracking. The present pyrrhotite inclusions did not show

any cracking or reddish brown oxidation products common in other homes, which indicate an absence of moisture that is necessary for oxidation of pyrrhotite and related cracking.

Figure 10: Lapped cross section of core and photomicrographs taken from various locations showing metallic lustered iron sulfide inclusions (arrows) in dark gray to black crushed stone coarse aggregate particles (boxed).

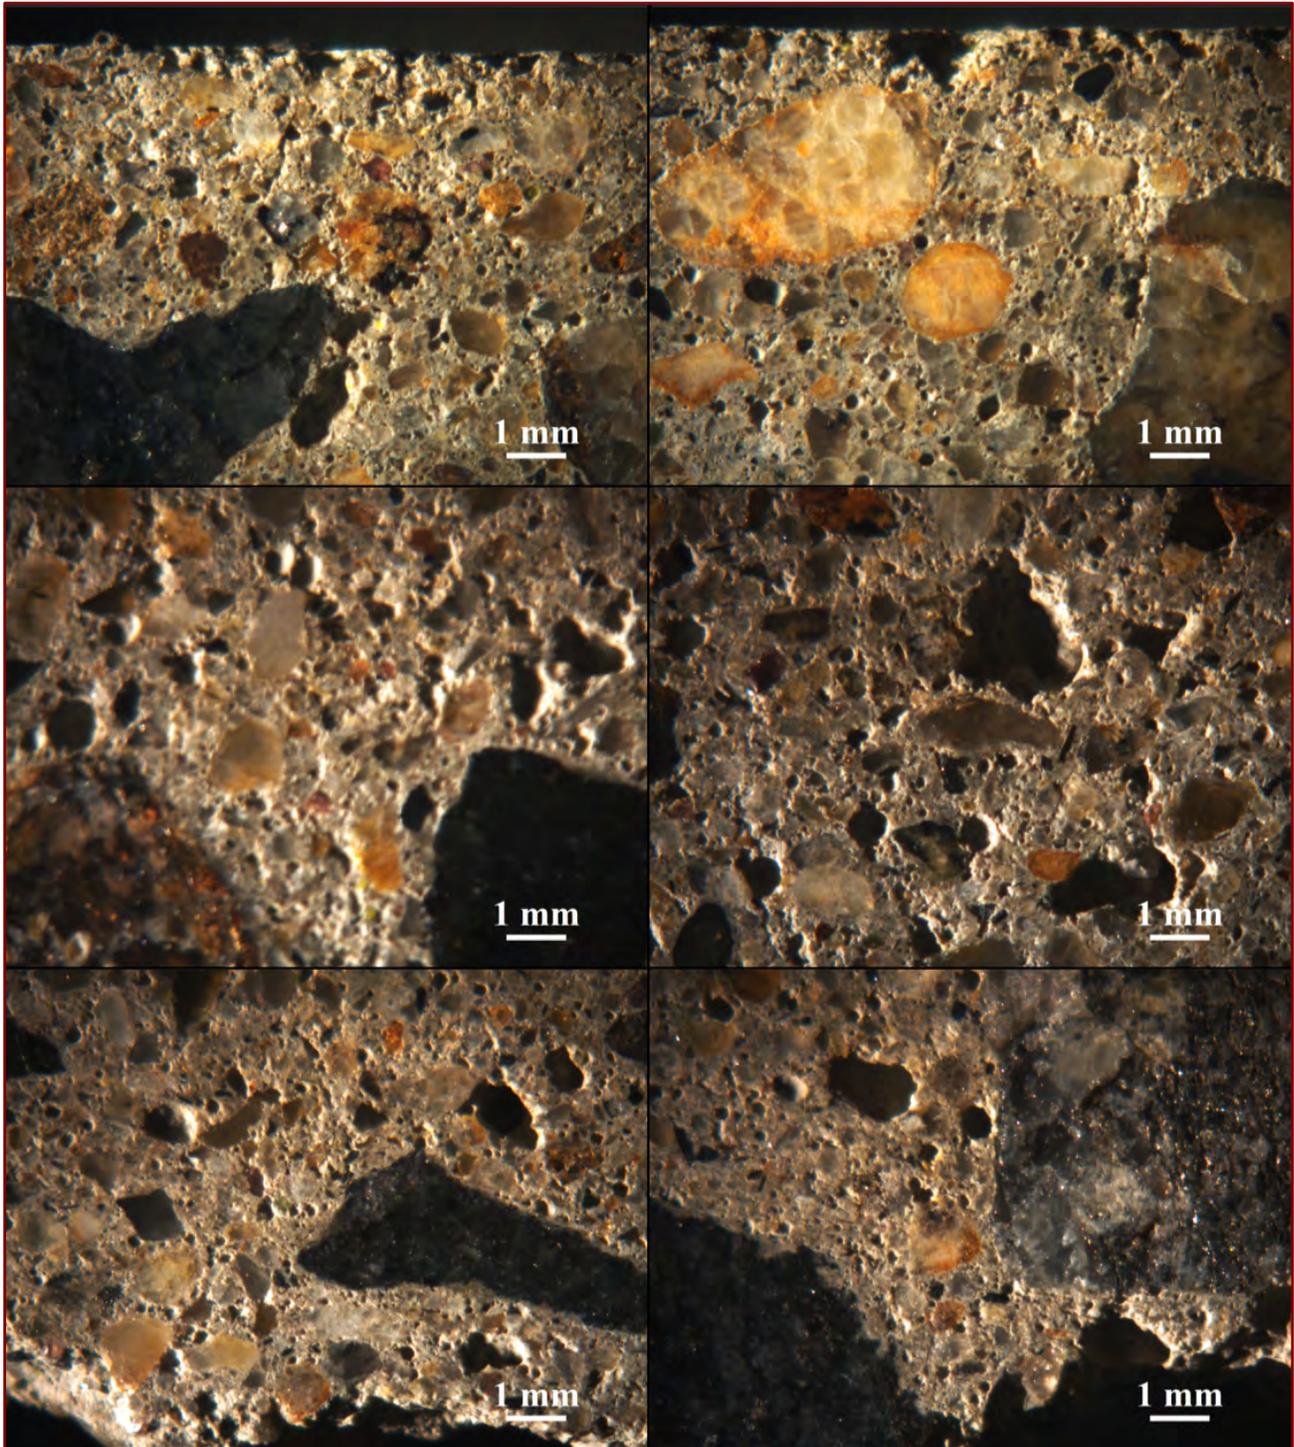
Figure 11 shows six (6) photomicrographs of lapped cross section of core from various depths, taken by using a stereomicroscope to depict the overall air-entrained nature of concrete.

Figure 11: Photomicrographs of lapped cross section showing the air-entrained nature of concrete and many fine to coarse spherical and irregularly-shaped air-voids.

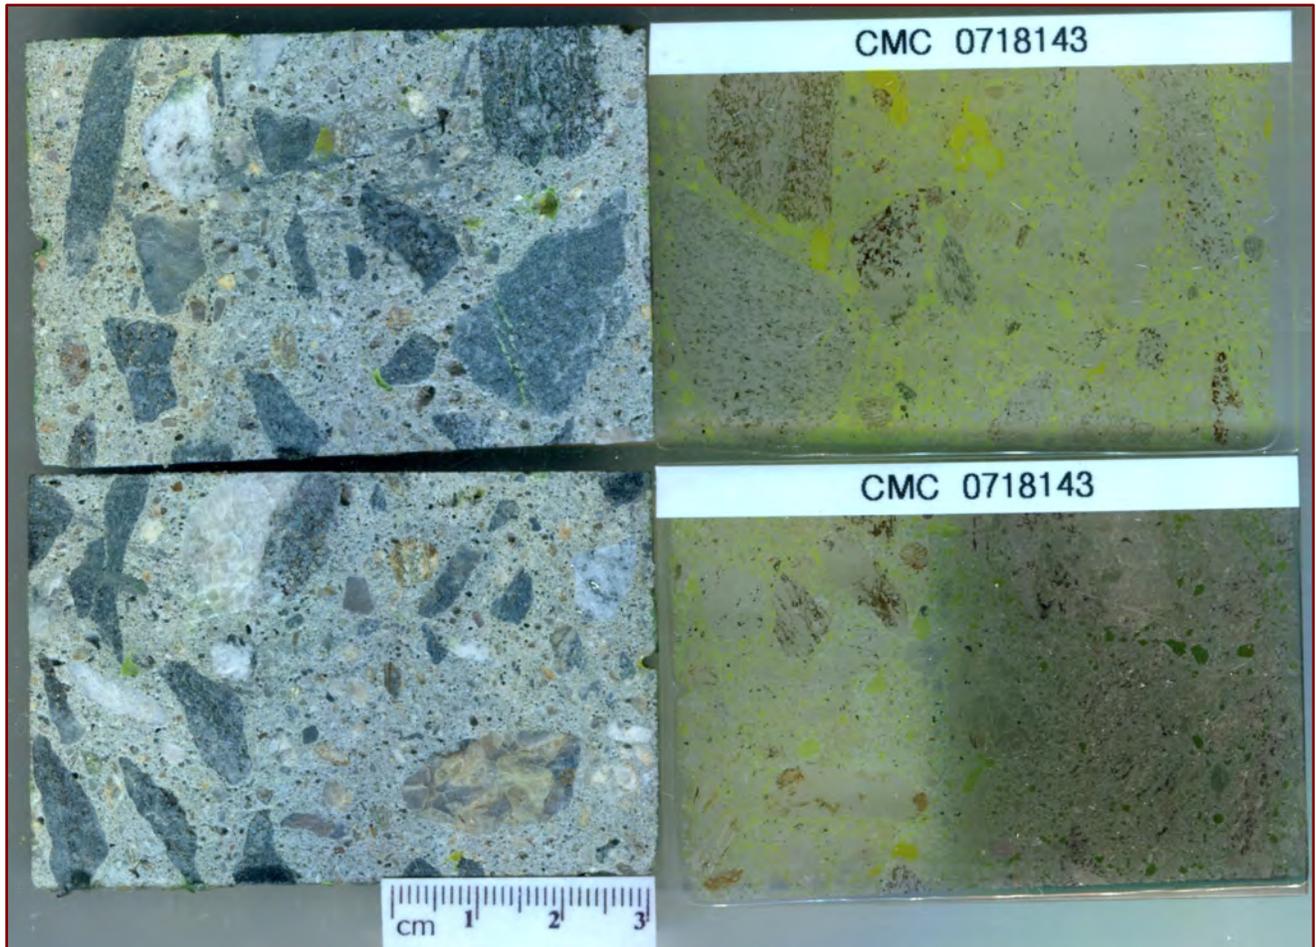
Figure 12 shows fluorescent dye-mixed epoxy-impregnated thin sections of core prepared from exposed surface region and interior of core to highlight voids, pore spaces, and cracks in concrete and aggregates.

Figure 12: Fluorescent dye-mixed epoxy-impregnated thin sections (30 micron thickness) and corresponding residues left from thin sections. These thin sections are examined: (a) in a stereozoom microscope, in transmitted and reflected light modes along with UV light attachment to highlight pores, air voids, and cracks, and, (b) in a petrographic microscope to examine the microstructural features at higher magnifications than that from stereomicroscope. The bottom thin section at right was partially coated with thin film of gold for SEM-EDS studies.

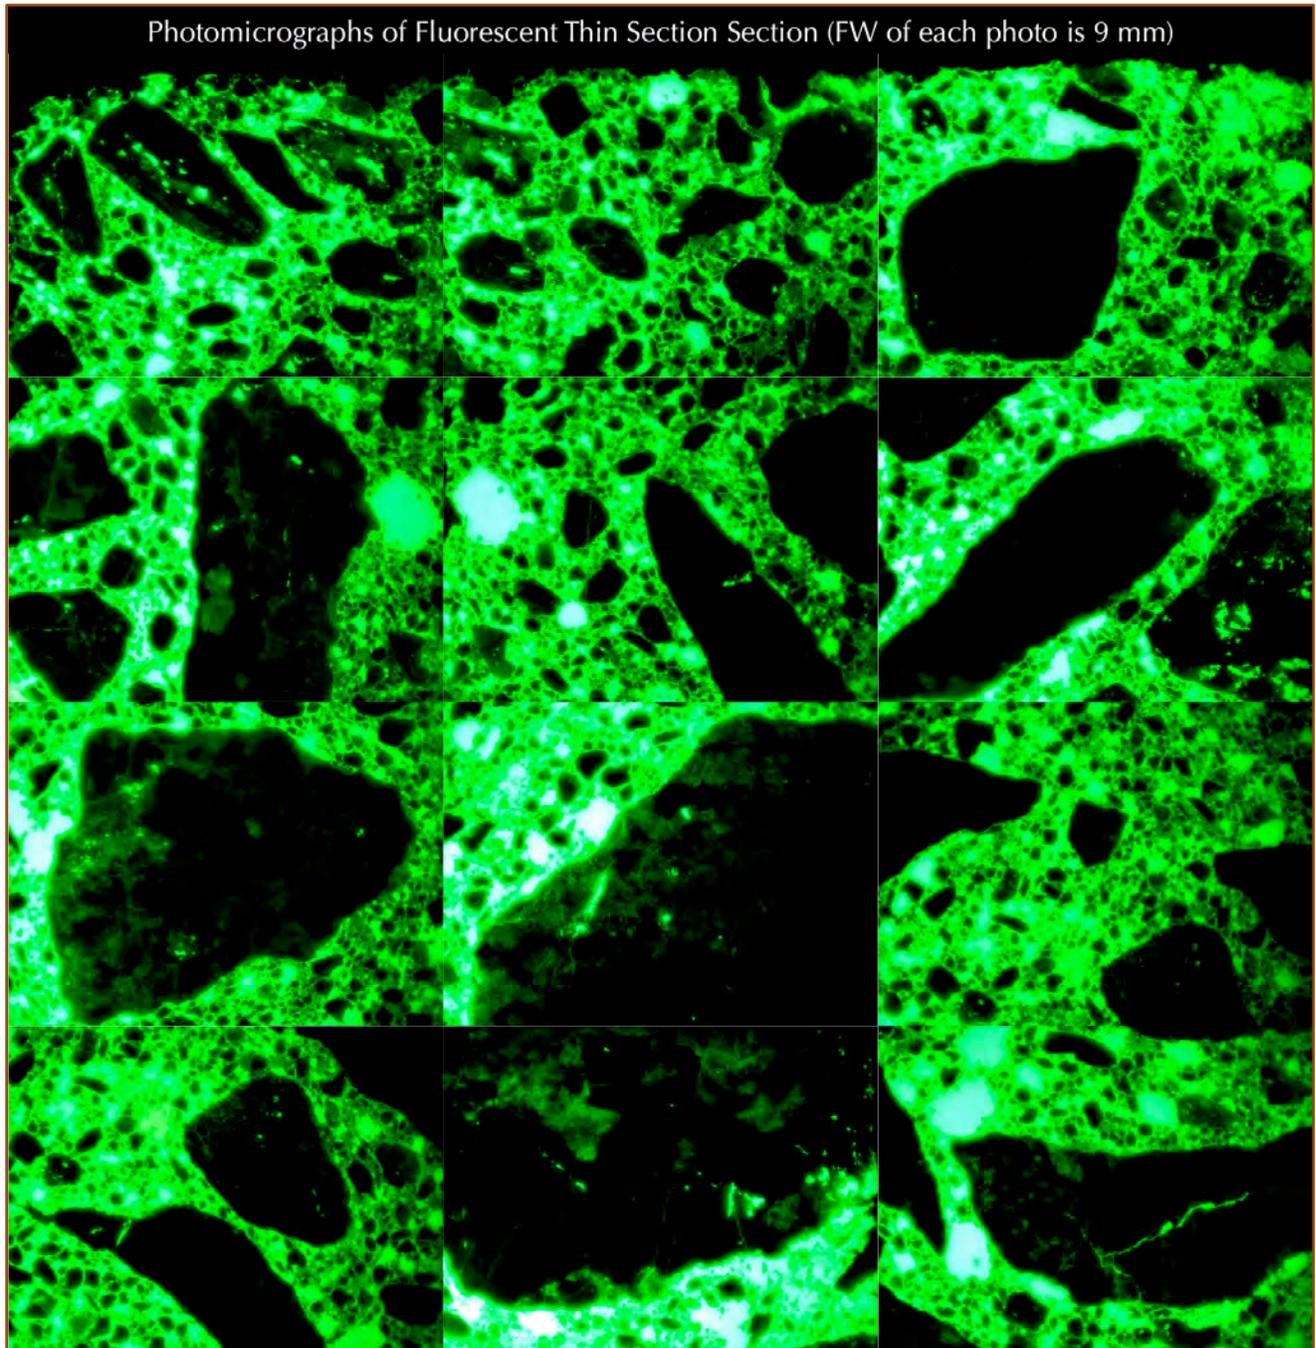
Figure 13 shows photomicrographs of fluorescent-epoxy impregnated thin sections of core viewed in a reflected-light Stereozoom microscope equipped with UV light facilities to examine the fluorescent thin section in such light.

Figure 13: Photomicrographs of fluorescent-epoxy impregnated thin section of core viewed in a reflected-light Stereozoom microscope equipped with UV light facilities to highlight porous areas, air voids, and cracks in aggregates and concrete.

This UV-light examination of fluorescent thin sections at high magnification in a stereomicroscope shows the overall sound condition and absence of cracking in the concrete and in its aggregates, except for some minor areas (e.g., the bottom row in Figure 14) where a few crushed stone particles show some cracking highlighted by the absorbed fluorescent epoxy.

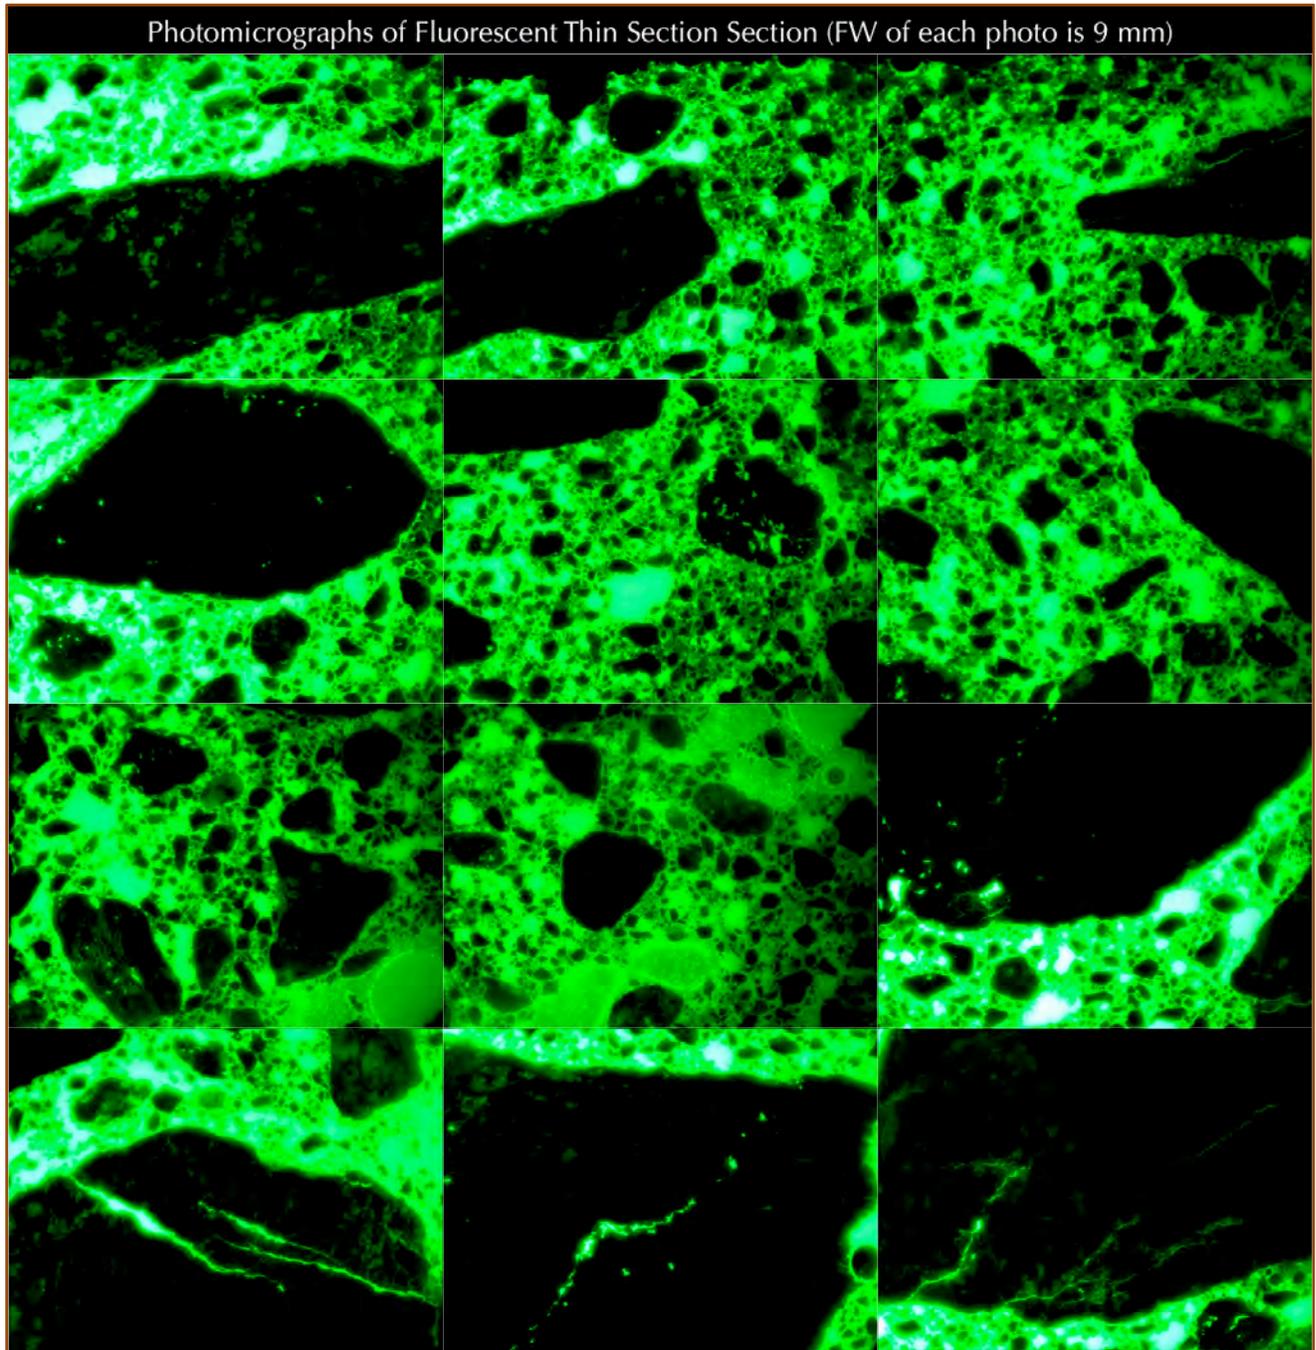
Figure 14: Photomicrographs of fluorescent-epoxy impregnated thin section of core viewed in a reflected-light Stereozoom microscope equipped with UV light facilities to highlight porous areas, air voids, and cracks in aggregates and concrete.

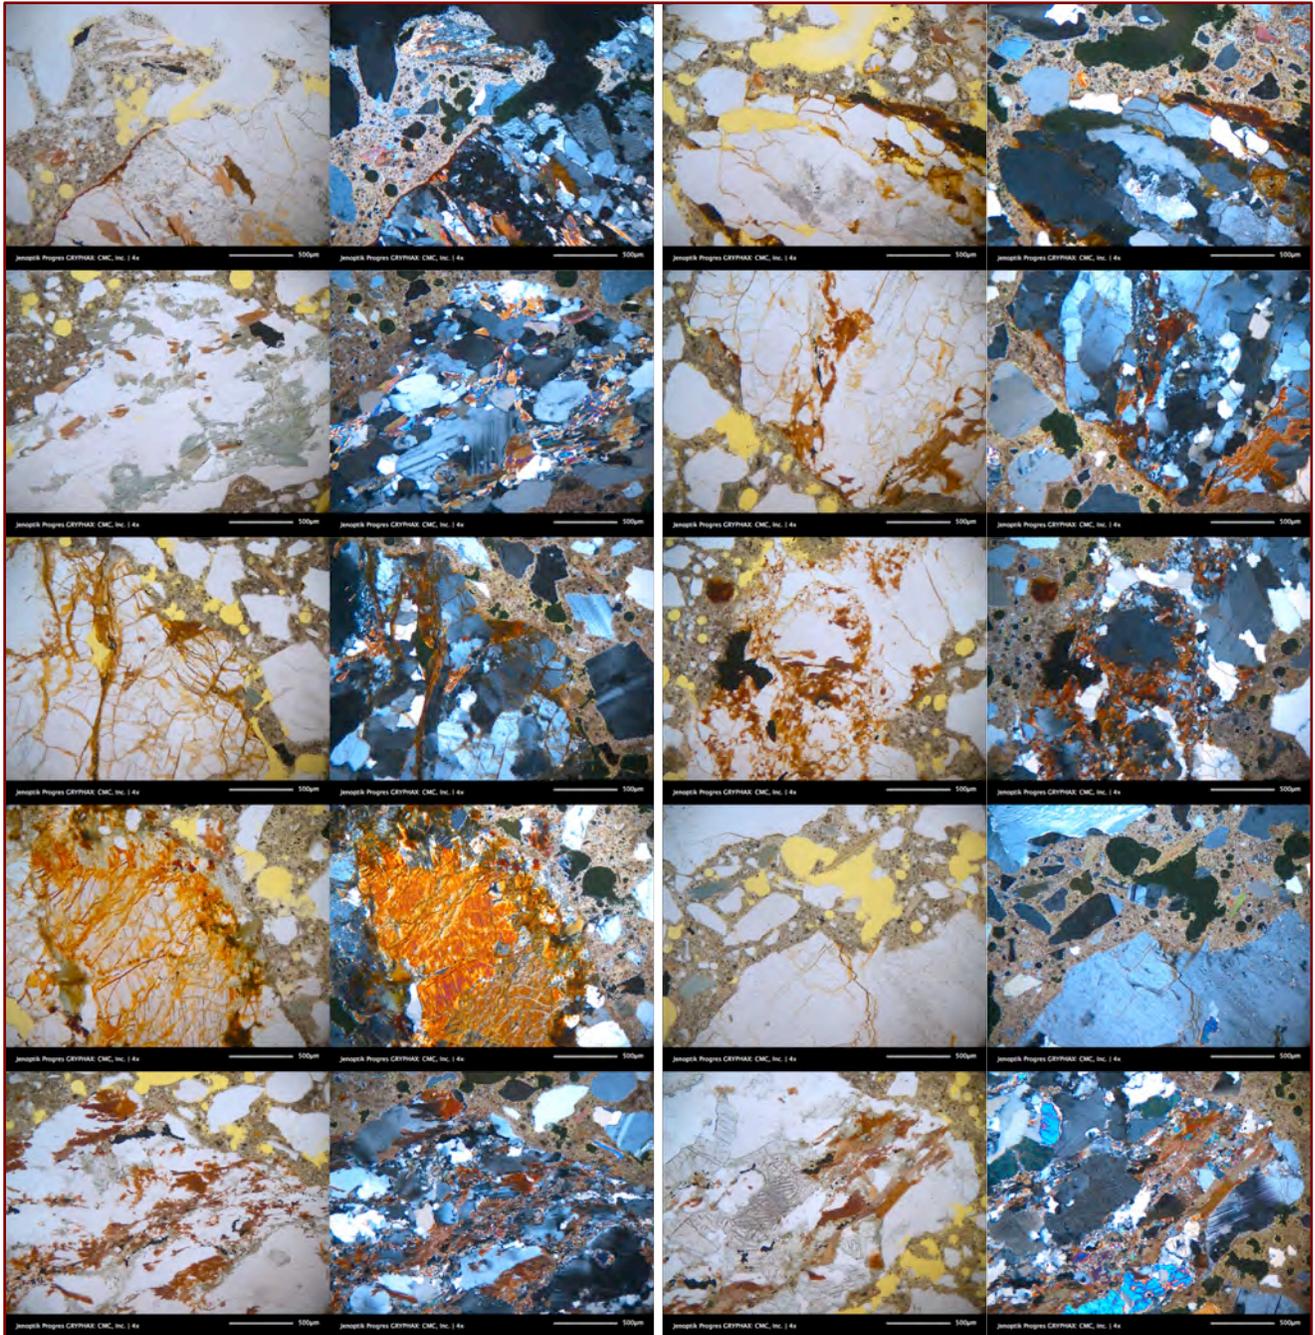
Figure 15: Photomicrographs of blue dye-mixed epoxy-impregnated thin section (30 micron thickness) of core showing: (a) crushed gneiss coarse aggregate having alternating bands of light-colored quartzo-feldspathic and dark brown colored pleochroic biotite and light-colored muscovite/chlorite micaceous minerals defining the gneissose texture common in these crushed gneiss coarse aggregate particles, (b) dark opaque iron sulfide and iron oxide minerals, (c) poikiloblastic garnet grains with mineral inclusions in gneiss, and (d) the absence of cracking or reddish brown oxidation of iron sulfide inclusions in gneiss coarse aggregate. Air voids are highlighted by fluorescent-dye-mixed epoxy. Right column photomicrographs were taken in crossed-polarized light mode and left column in corresponding plane polarized mode in a petrographic microscope.
