Investigation of Presence of Pyrrhotite in A Residential Concrete Foundation In Mansfield Center, Connecticut

154 Coventry Road
Mansfield Center, Connecticut

August 23, 2018
CMC 0718143

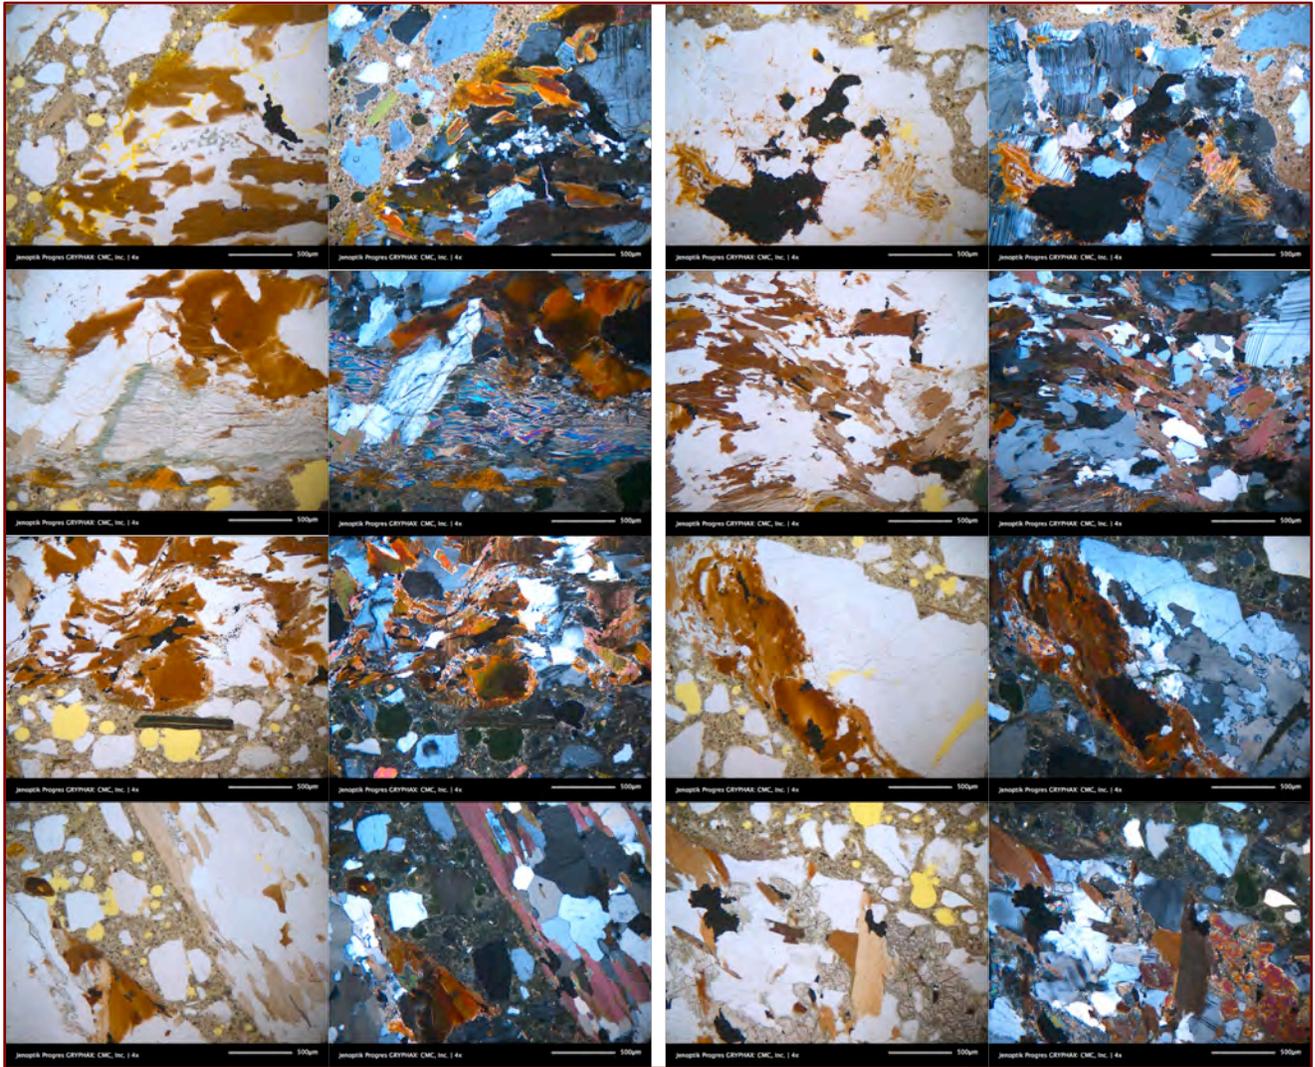
Figure 16: Photomicrographs of blue dye-mixed epoxy-impregnated thin section (30 micron thickness) of core showing: (a) crushed gneiss coarse aggregate having alternating bands of light-colored quartzo-feldspathic and dark brown colored pleochroic biotite and light-colored muscovite/chlorite micaceous minerals defining the gneissose texture common in these crushed gneiss coarse aggregate particles, (b) dark opaque iron sulfide and iron oxide minerals, (c) poikiloblastic garnet grains with mineral inclusions in gneiss, and (d) the absence of cracking or reddish brown oxidation of iron sulfide inclusions in gneiss coarse aggregate. Air voids are highlighted by fluorescent-dye-mixed epoxy. Right column photomicrographs were taken in crossed-polarized light modes and left column in corresponding plane polarized modes in a petrographic microscope.

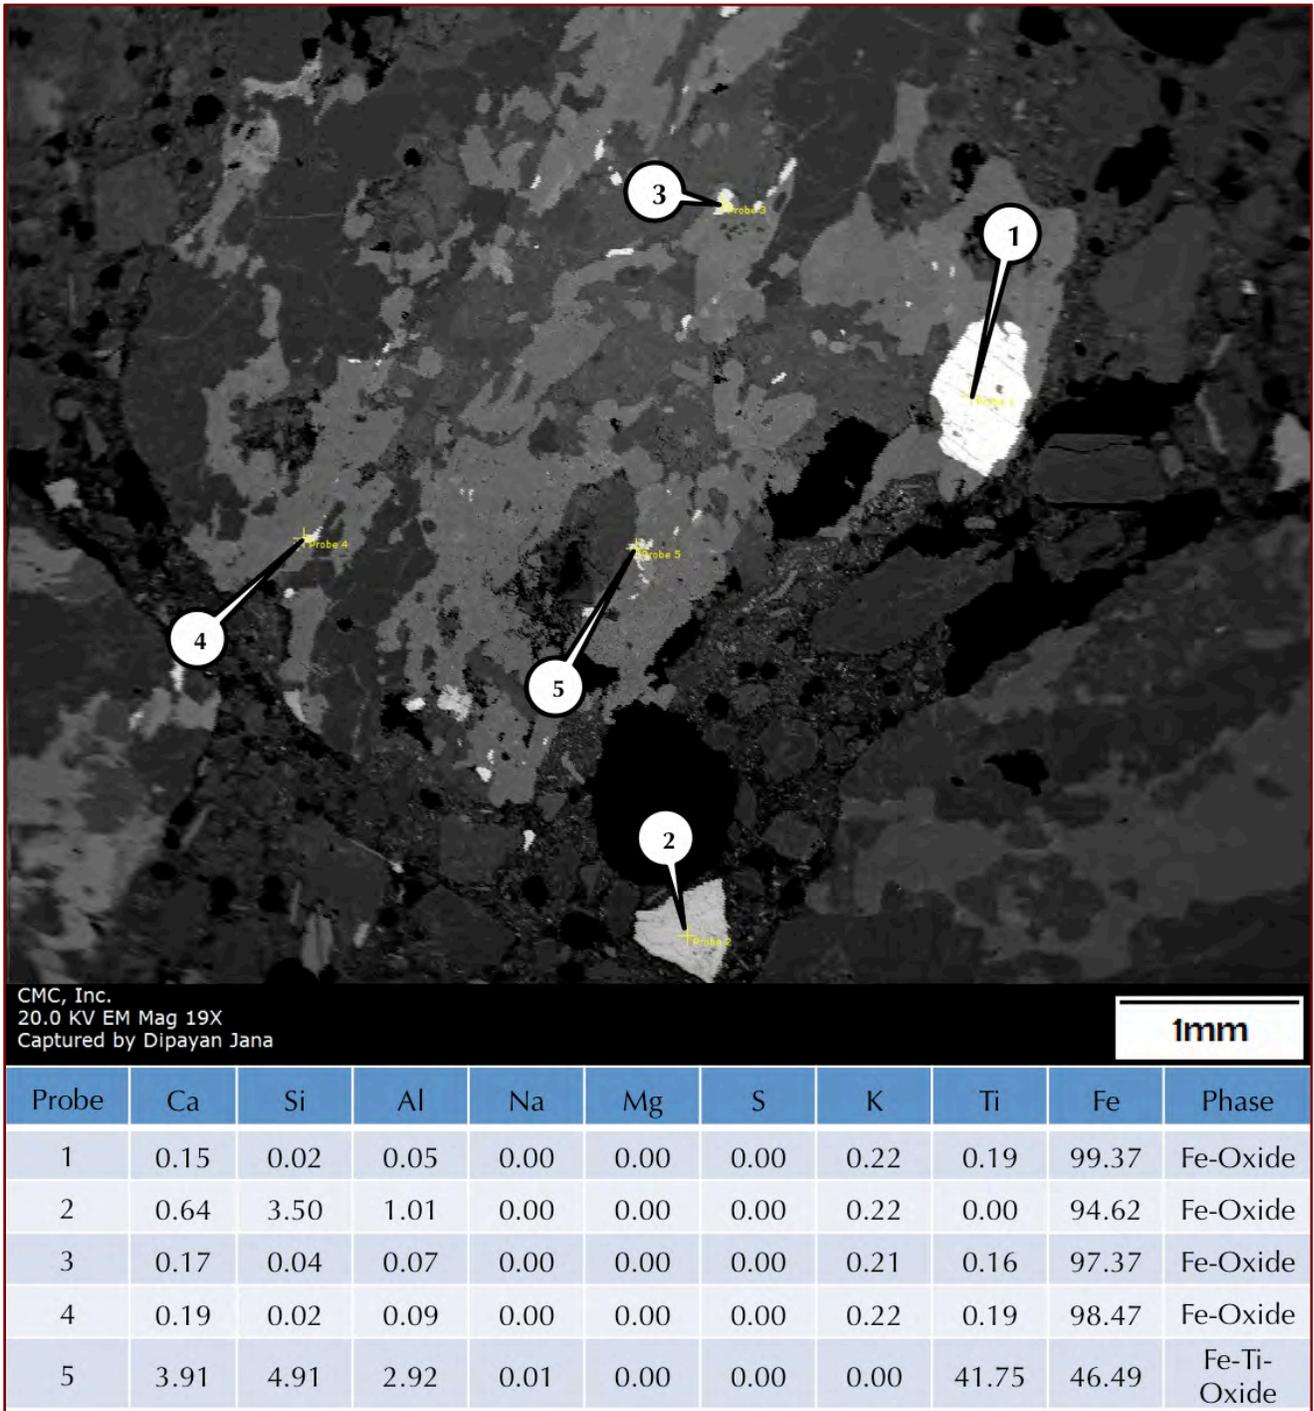
Figure 17: Backscatter electron image and X-ray elemental analysis of various bright iron-bearing minerals in a crushed geniss coarse aggregate particle showing the iron oxide and iron-titanium oxide compositions of these minerals, as opposed to iron sulfide. Magnetite (iron oxide) and ilmenite (iron titanium oxide) are commonly associated with iron sulfide minerals as contaminants in many rocks, including geniss.

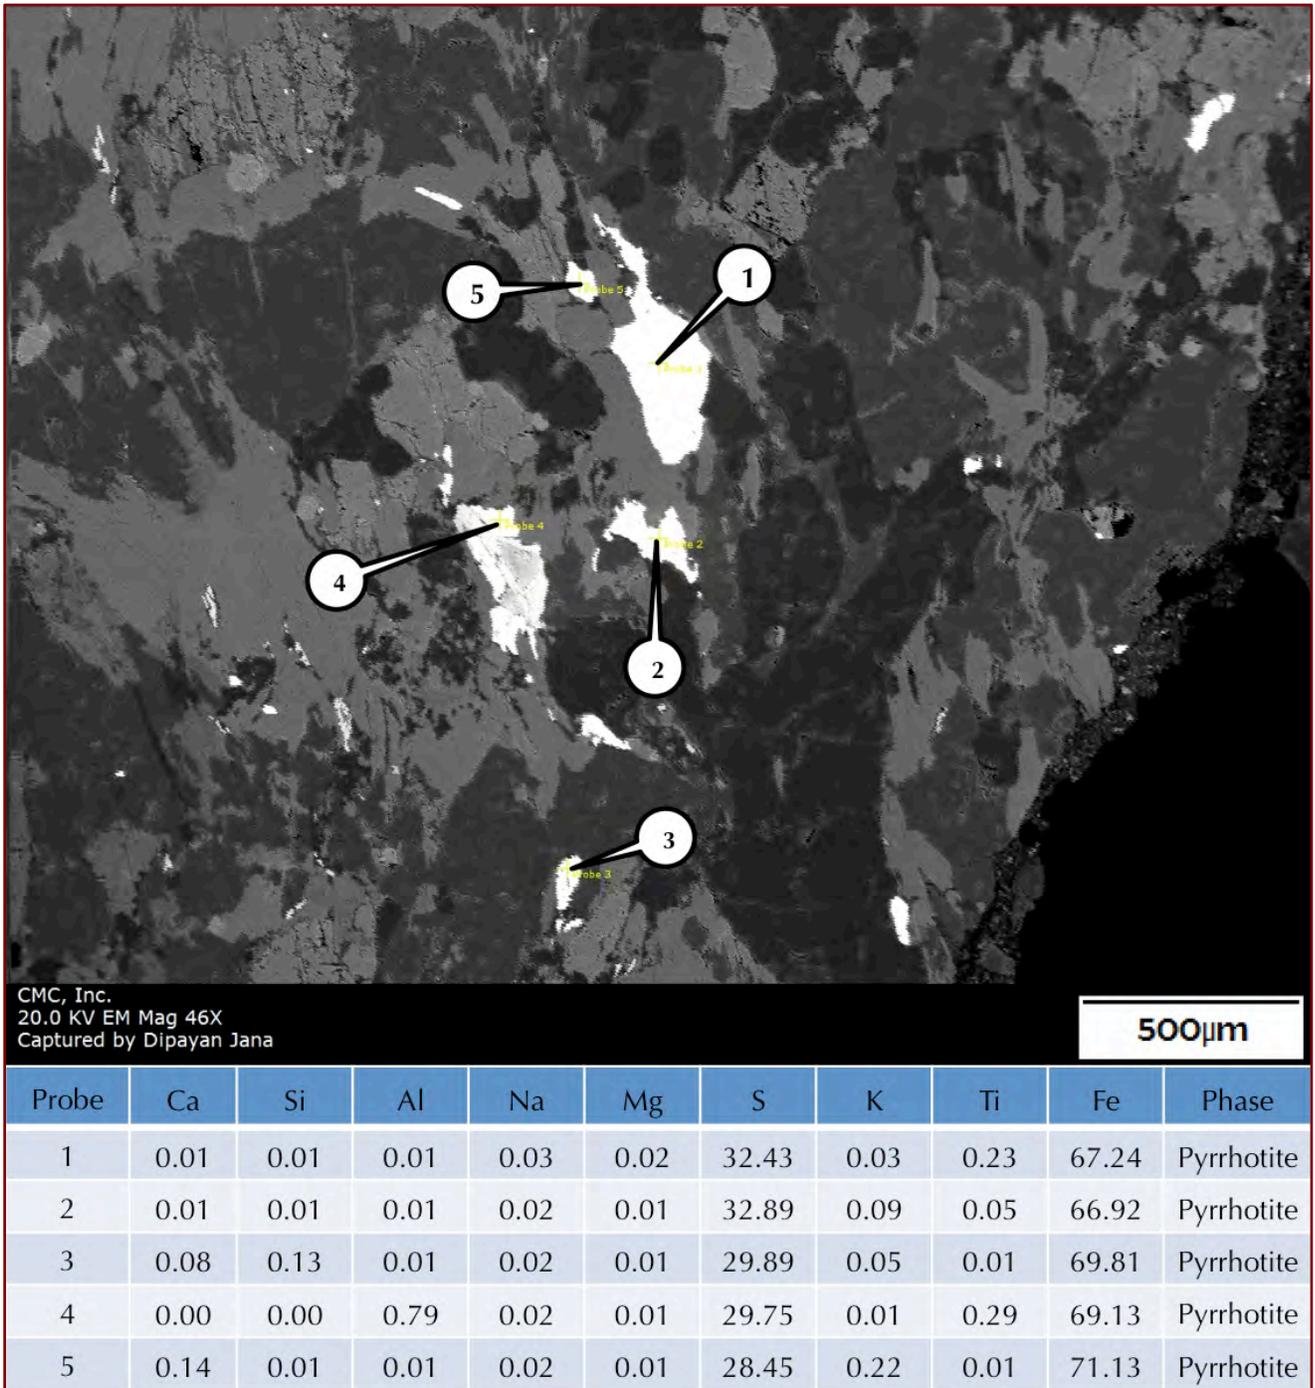
Figure 18: Backscatter electron image and X-ray elemental analysis of various bright iron-bearing minerals in a crushed geniss coarse aggregate particle showing the iron sulfide mineral - pyrrhotite.

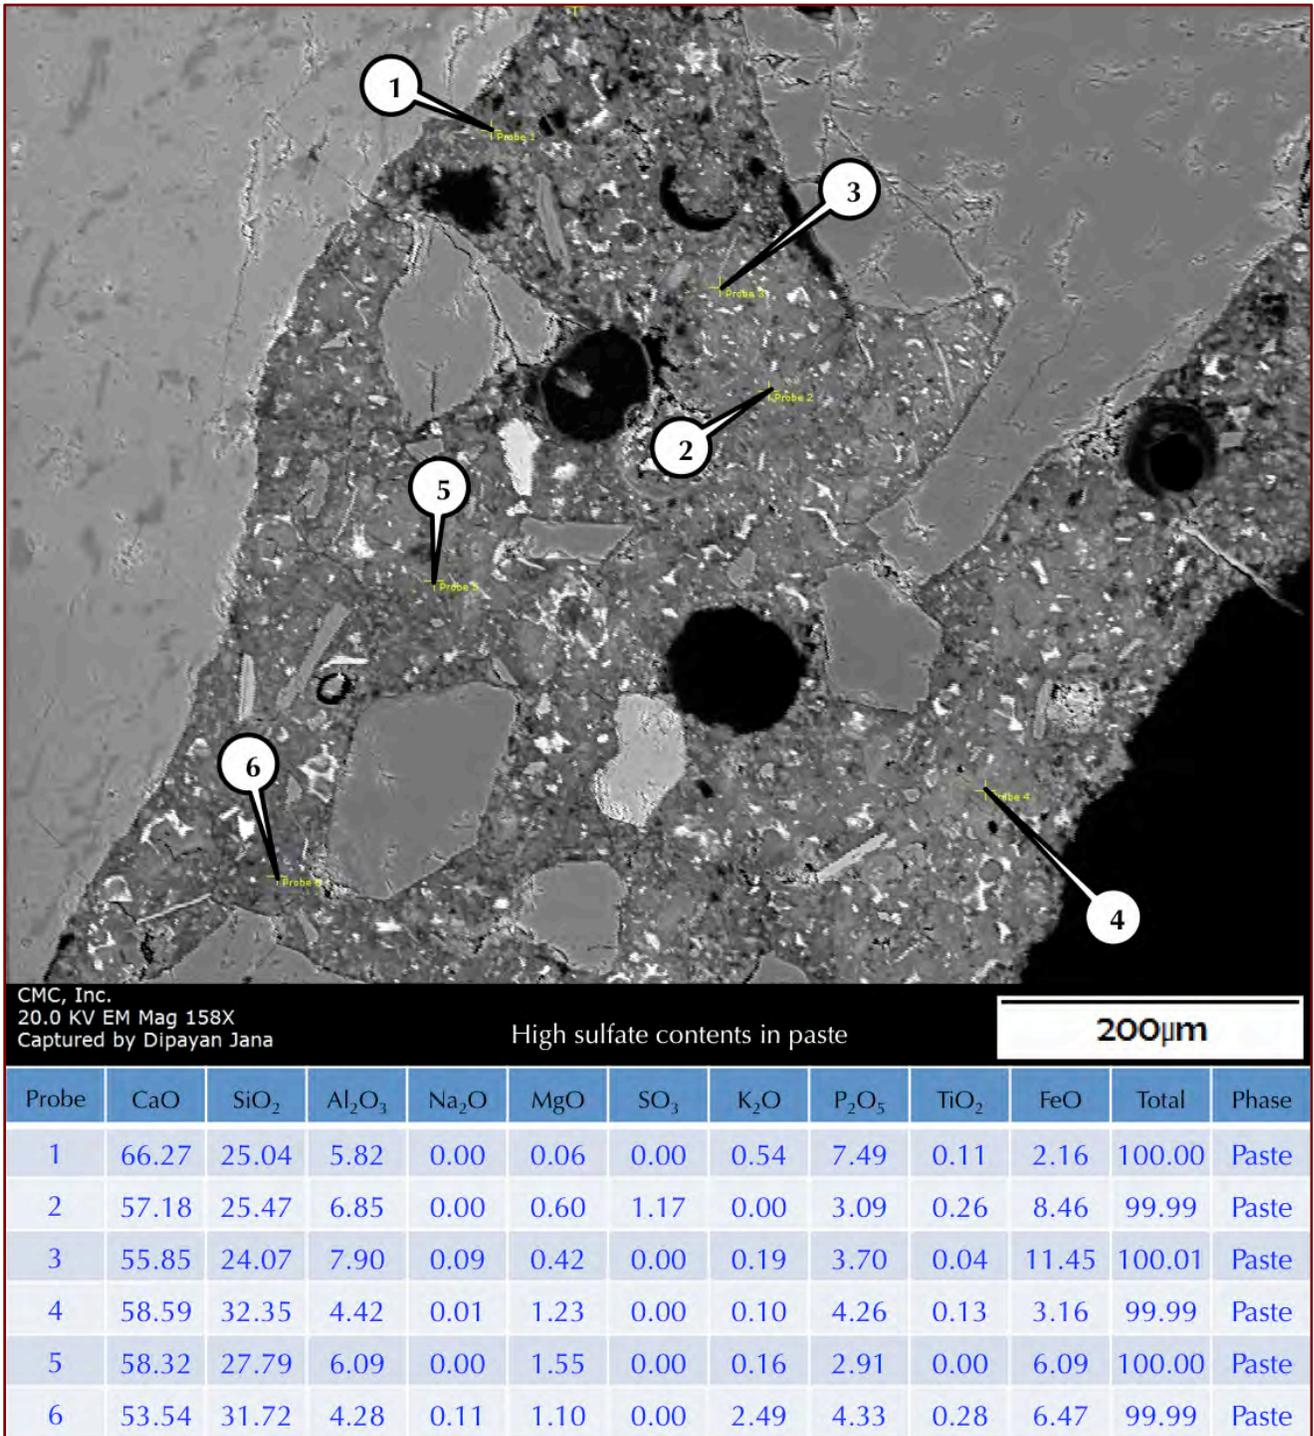
Figure 19: Backscatter electron image and X-ray elemental analysis of paste in concrete showing the absence of cracking, absence of any secondary ettringite crystallization in the paste or along aggregate-paste interfaces, which were found in other distressed foundations, and low sulfate levels in paste, as opposed to high sulfate found in the paste in other distressed foundations – this confirms absence of moisture and no noticeable release of sulfate from pyrrhotite-bearing gneiss to the paste.

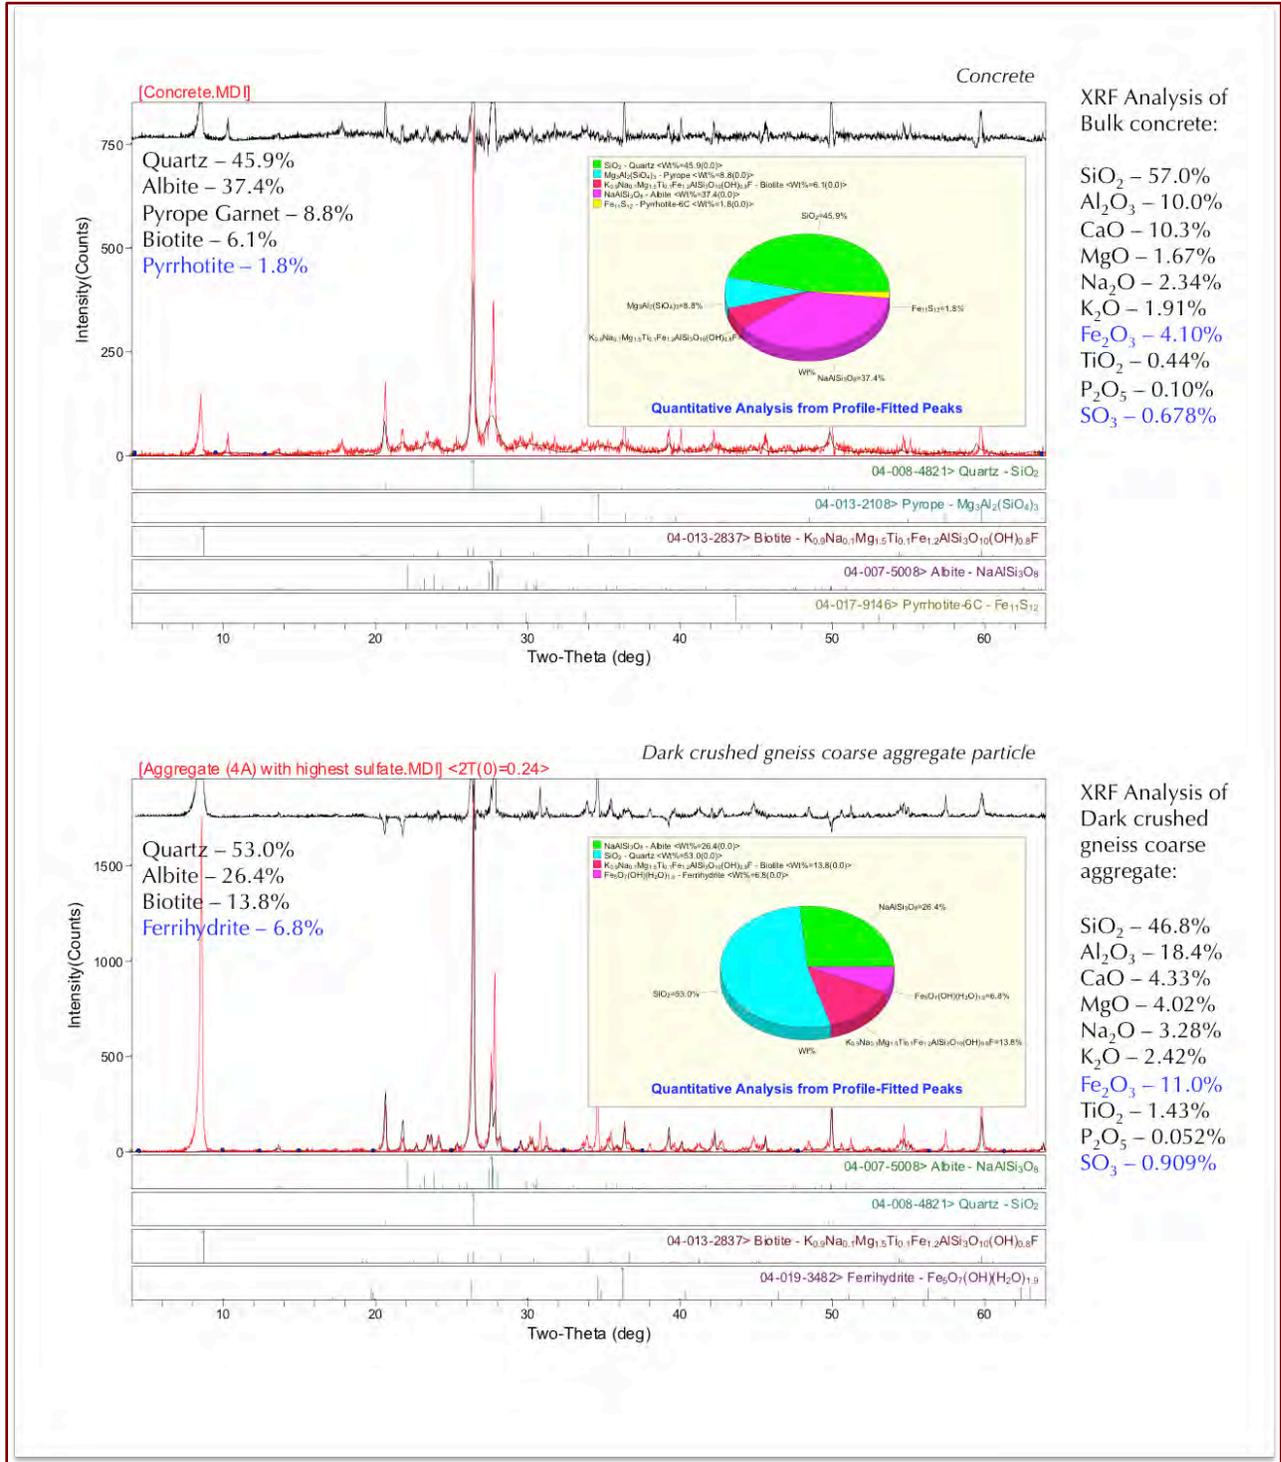
Figure 20: X-ray diffraction patterns, quantitative proportions of minerals, and X-ray fluorescence analyses of bulk concrete (top) and a representative dark gray crushed gneiss coarse aggregate (bottom) showing the presence of pyrrhotite in concrete and its oxidation product ferrihydrite in the aggregate. Insets show semi-quantitative proportions of different minerals in concrete and coarse aggregate, as well as oxide compositions from XRF.

XRD analyses of coarse aggregate particles extracted from the core have confirmed the iron sulfide minerals to be pyrrhotite, along with ferrihydrite as its oxidation product, which are, again, in line with previous findings from other deteriorated foundations (Wille and Zhong, 2016, Jana 2017). XRD and XRF studies of both crushed gneiss types showed characteristic difference in mineralogy and chemistry between these types, e.g., having higher quartz in lighter brown particle, higher pyrrhotite in darker gray particles, higher iron oxide and sulfate in dark gray particle in XRF, etc.

Contrary to the extracted crushed gneiss coarse aggregate particles, XRD analysis of bulk concrete, however showed 1.8 percent pyrrhotite, with a total sulfate level of 0.678 percent which has not only confirmed the presence of pyrrhotite in the concrete and that it was contributed from crushed gneiss coarse aggregate but also its potential to cause oxidation-related distress in concrete as found in other similar gneiss coarse aggregates in distressed concretes. Despite the potential for distress, absence of any visible or invisible cracking in the core indicates absence of moisture – the essential player for oxidation of pyrrhotite and subsequent release of sulfate to cause internal sulfate attack in concrete.

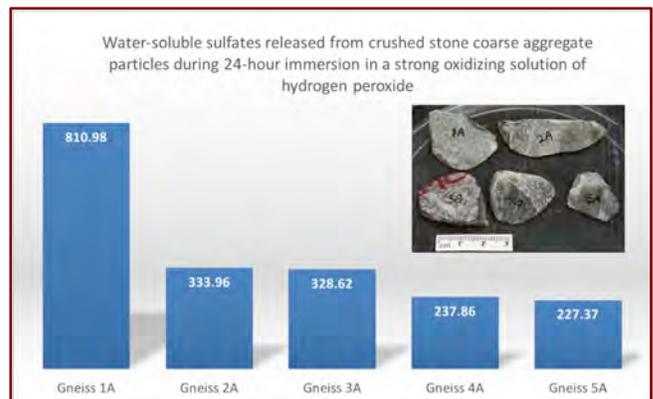
Five pyrrhotite-bearing crushed gneiss coarse aggregate particles were carefully extracted from the core and cleaned of all adhered paste to be crushed and immersed in a strong oxidant (35% hydrogen peroxide) solution. For each extracted aggregate, after crushing, one gram of pulverized aggregate was selected for determining released sulfate contents after 24 hours of immersion. Each sample was immersed in a 25-mL hydrogen peroxide (35%) solution, then at the end of run filtered all solid residues with a 25-micron filter paper, the filtrate was then re-filtered through a 0.45-micron filter paper. The filtrate thus prepared is then diluted with distilled water to 100 mL to be analyzed in IC. All coarse aggregate particles showed release of sulfates in an oxidizing environment in 24 hours. Apparently, released sulfates from these aggregate particles is possible to contaminate the paste, and form the seeds for internal sulfate attack by reactions with cement hydration products – as long as moisture is present during service.

Figure 16: Results of accelerated oxidation test of five crushed gneiss coarse aggregate particles extracted from the core and cleaned of all adhering paste to be crushed and immersed in a strong oxidant (35% hydrogen peroxide) solution for 24 hours.

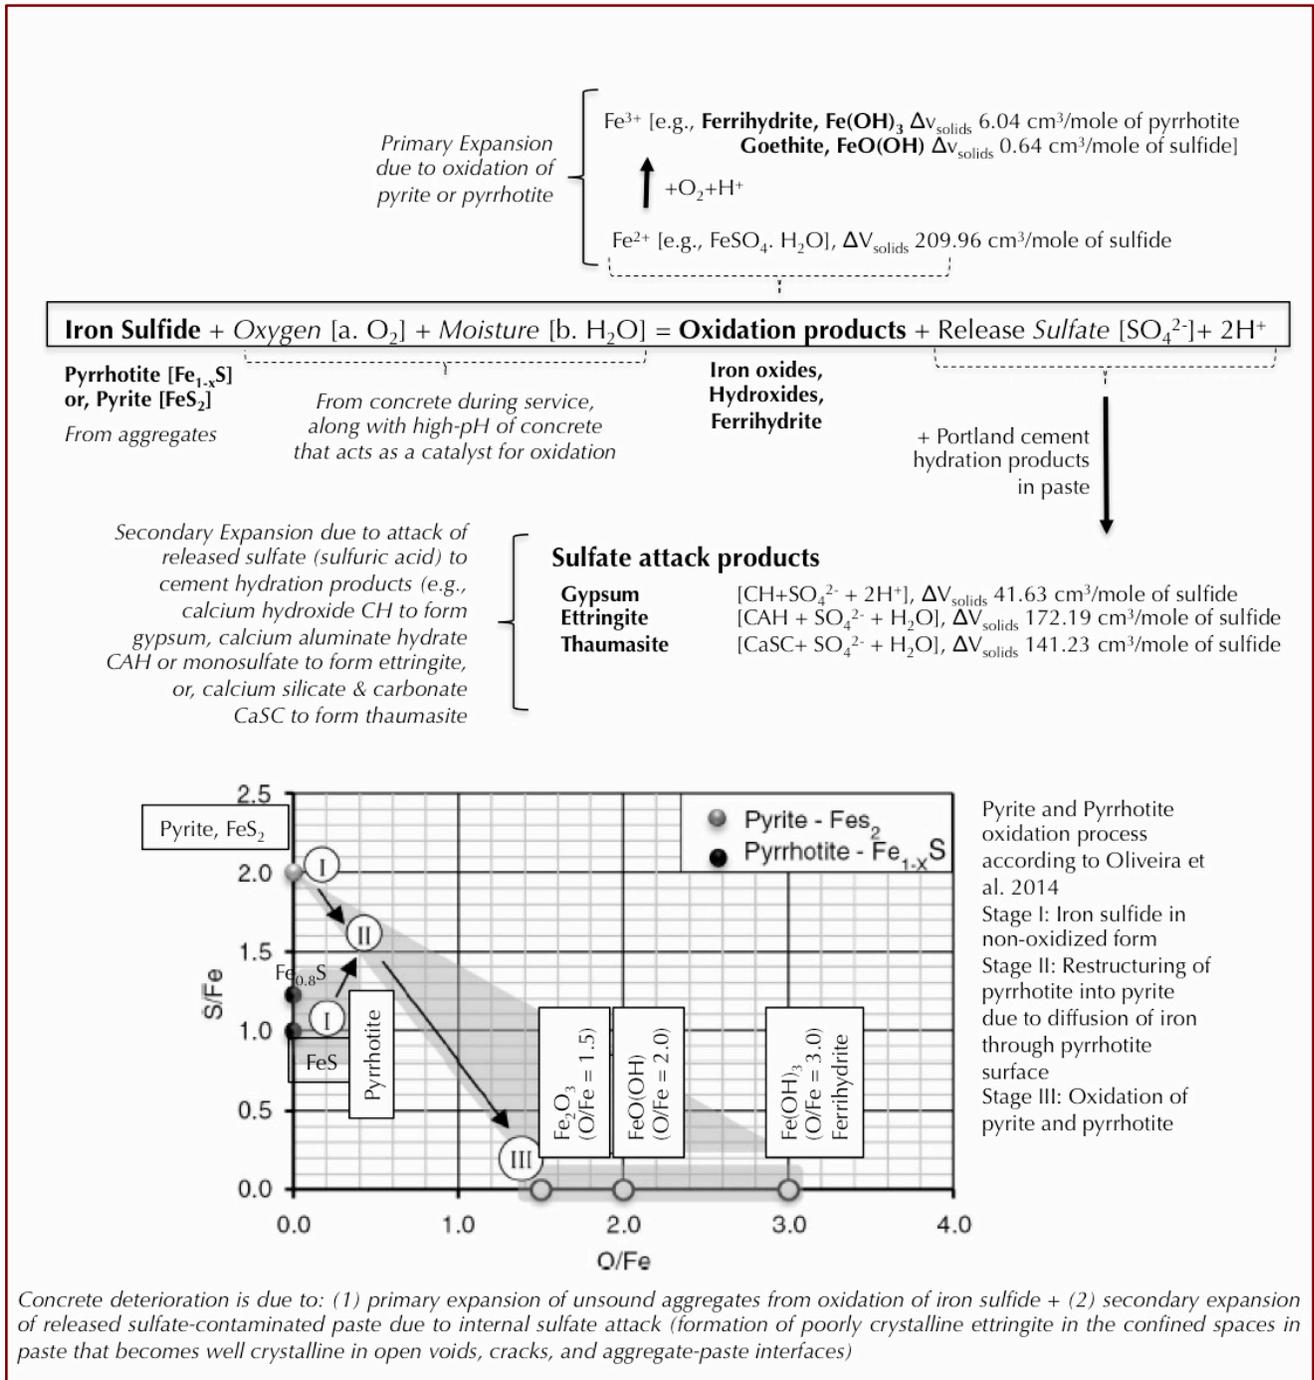
Figure 22: Mechanisms of oxidation of iron sulfide minerals in concrete according to various authors, and primary expansion due to oxidation of iron sulfide to various forms of iron oxides, hydroxides, ferrihydrite, followed by secondary expansions due to reactions between the released sulfates and hydrogen ions from oxidation reactions (sulfuric acid) and cement hydration products (calcium hydroxide, calcium aluminat, and monosulfoaluminat hydrate) to form ettringite (or thaumasite if carbonate ions are present).

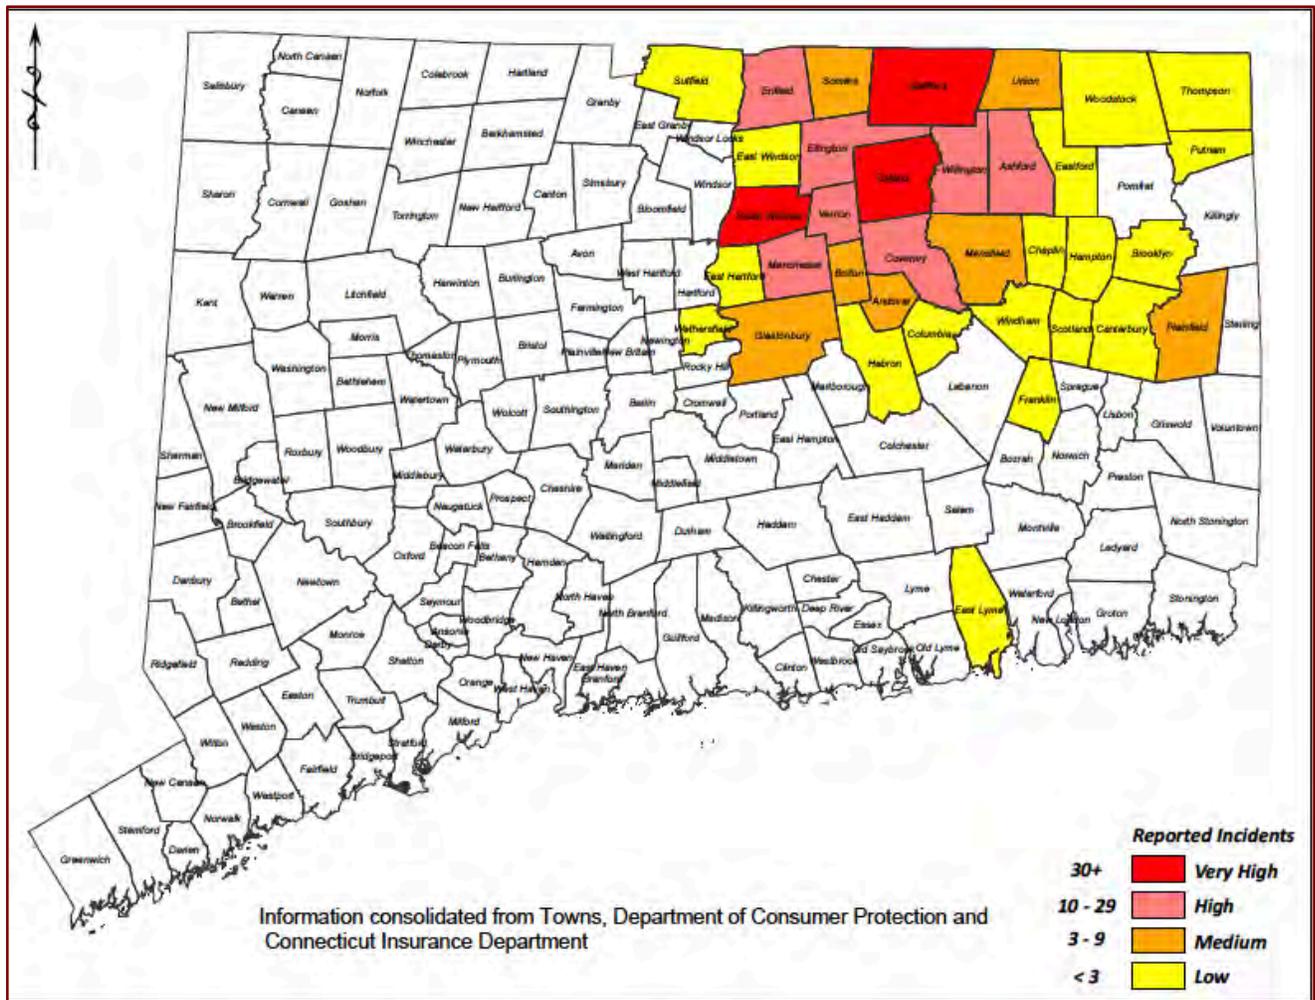
Figure 23: Reported incidences of pyrrhotite-related concrete deterioration in northeastern Connecticut. Note the present residential house in Mansfield Center falls under Medium-risk zone for concrete containing aggregates reportedly supplied from the Becker’s quarry.

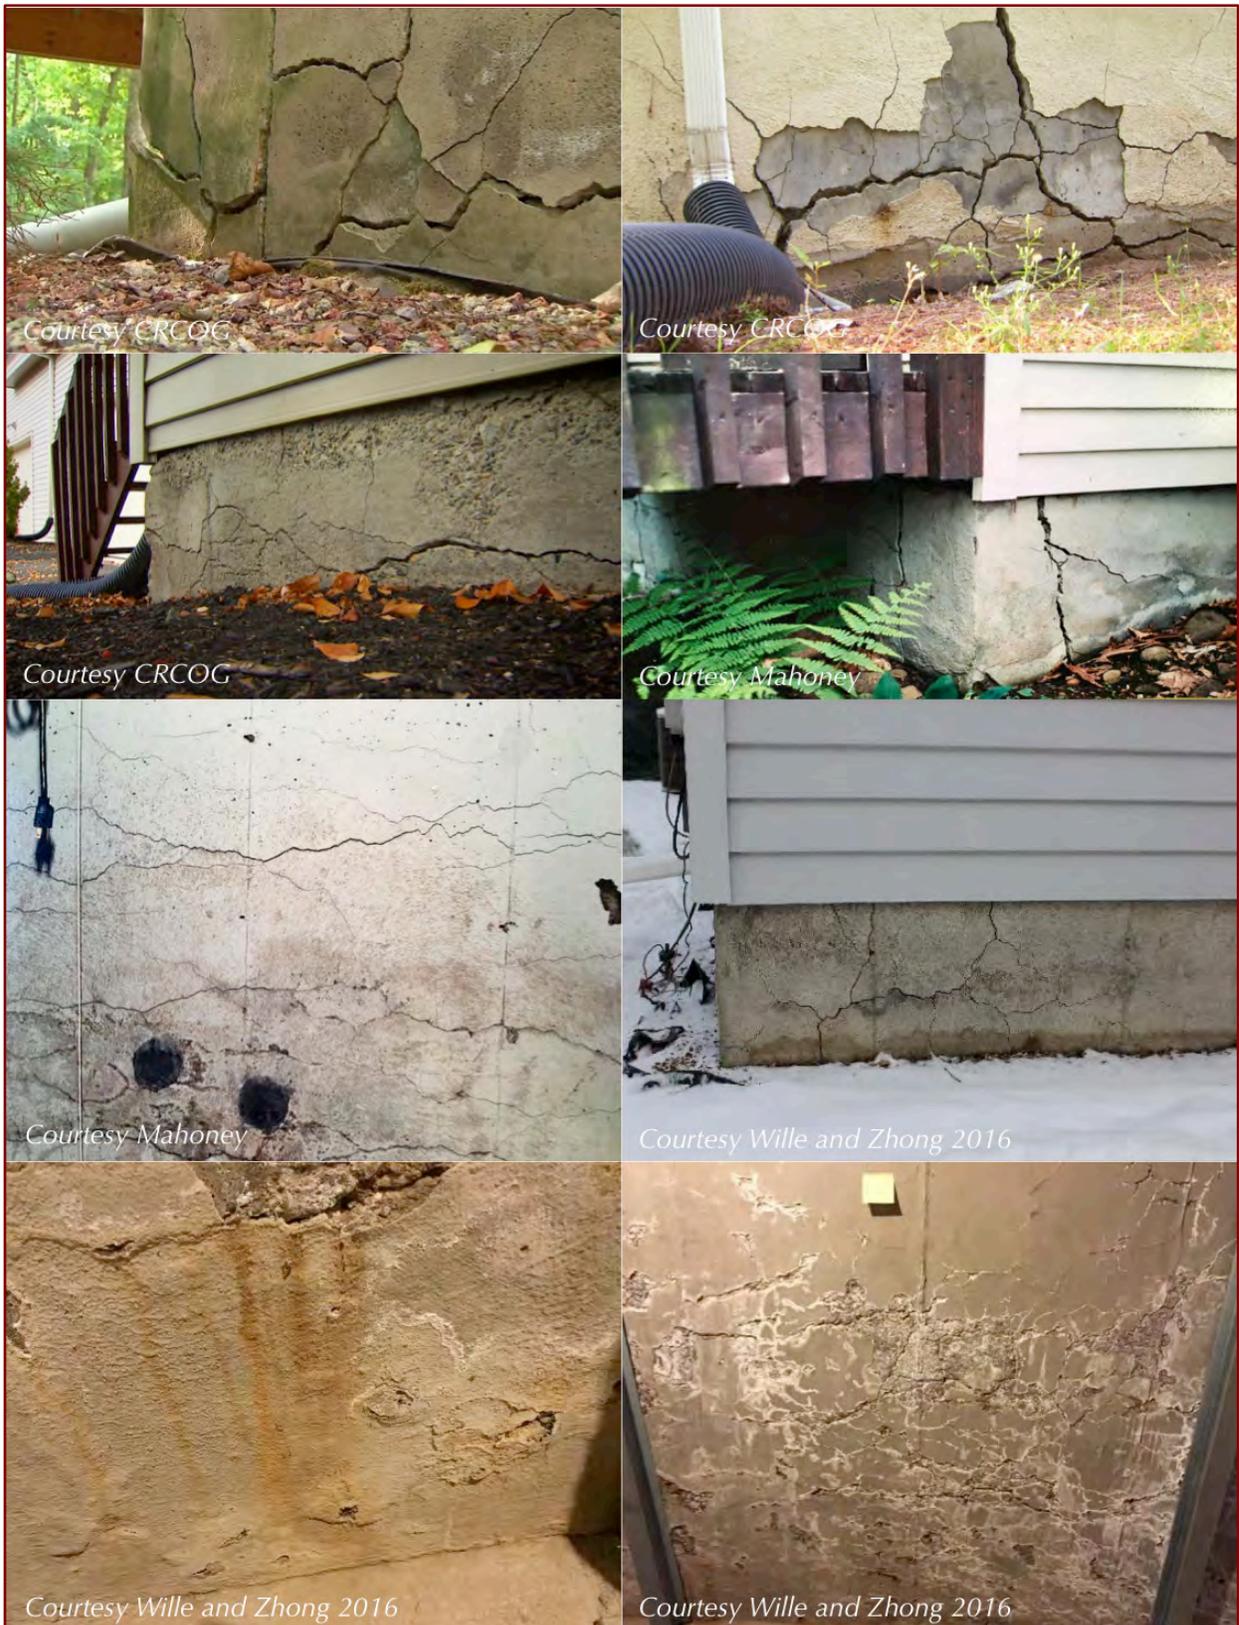
Figure 24: Cracking of concrete foundations in Connecticut due to oxidation of pyrrhotite bearing aggregates in concrete. Notice wide cracks in the top row as well as a network of numerous fine cracks in the wall in the bottom right row all from pyrrhotite oxidation and associated expansion of concrete.

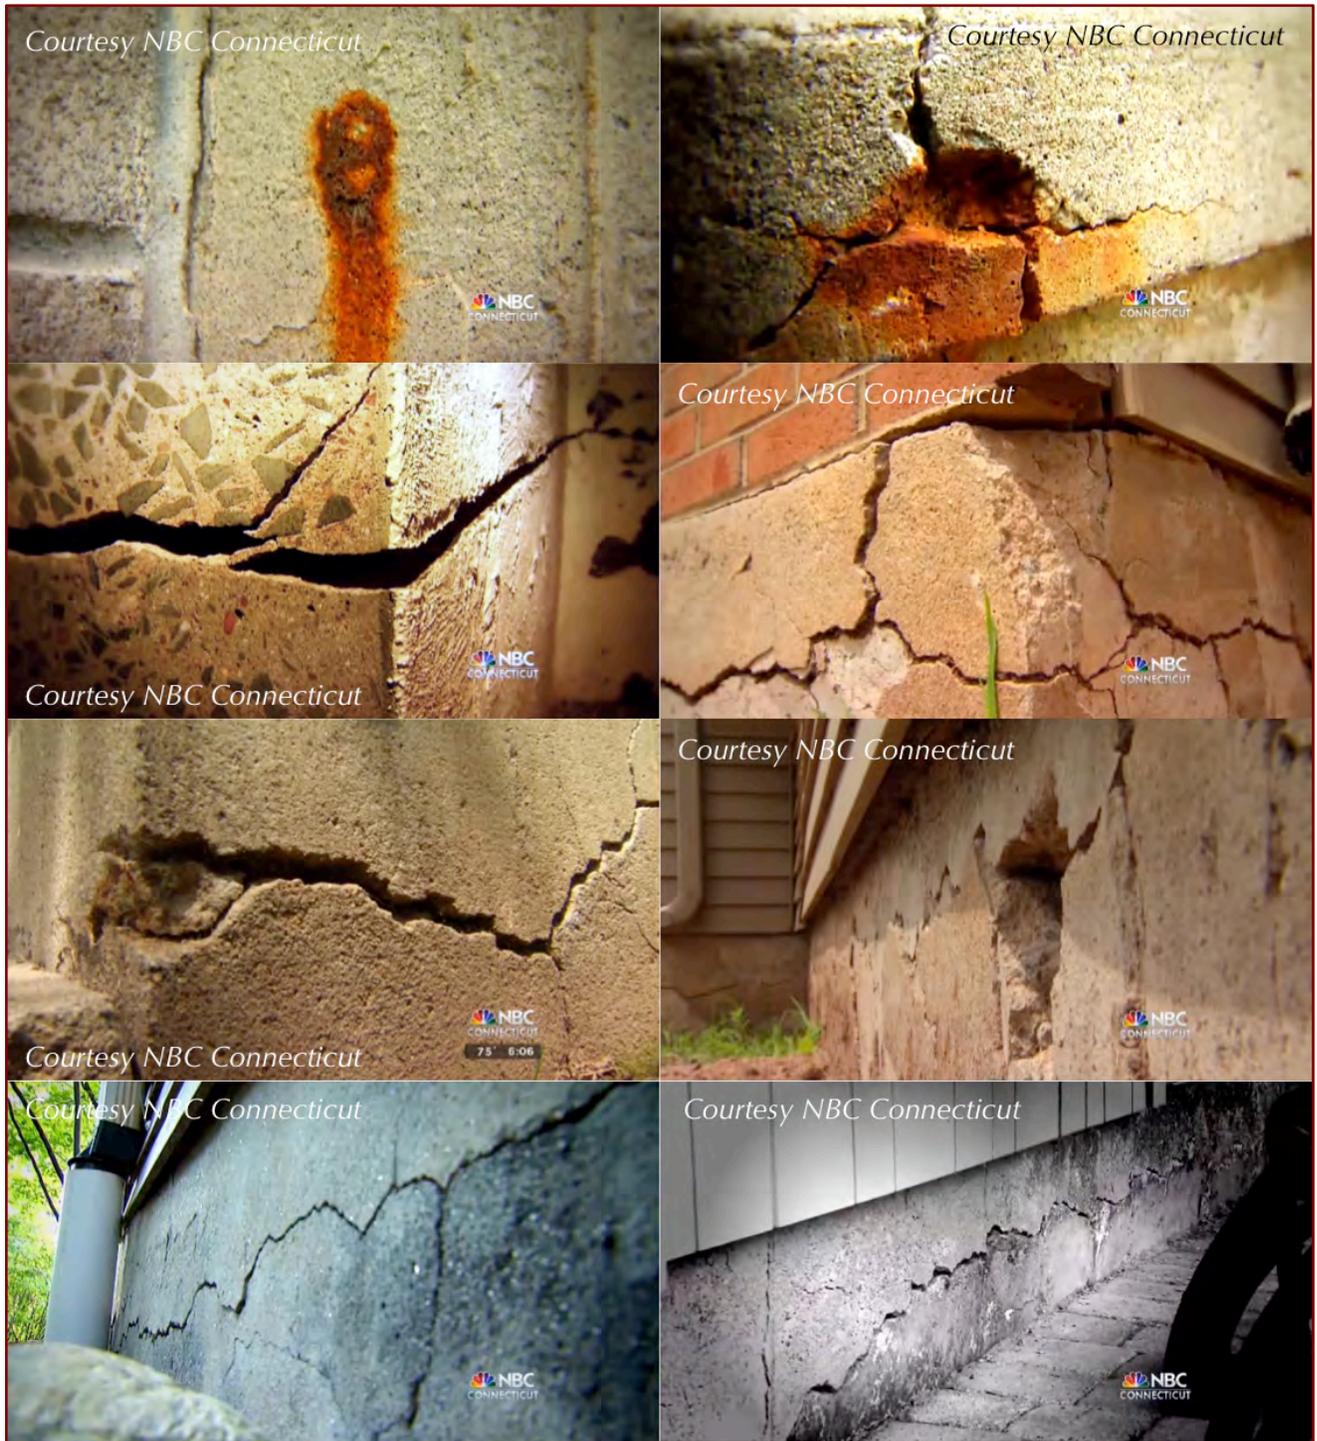
Figure 25: Cracking of concrete foundations in Connecticut due to oxidation of pyrrhotite bearing aggregates in concrete. Notice dark reddish brown rust staining on the wall and associated cracking in the top row from pyrrhotite oxidation and formation of ferric oxy-hydroxide oxidation products (goethite, limonite, ferrihydrite rust minerals). Notice wide cracks in the 2nd through 4th rows from pyrrhotite oxidation and associated expansion of concrete.

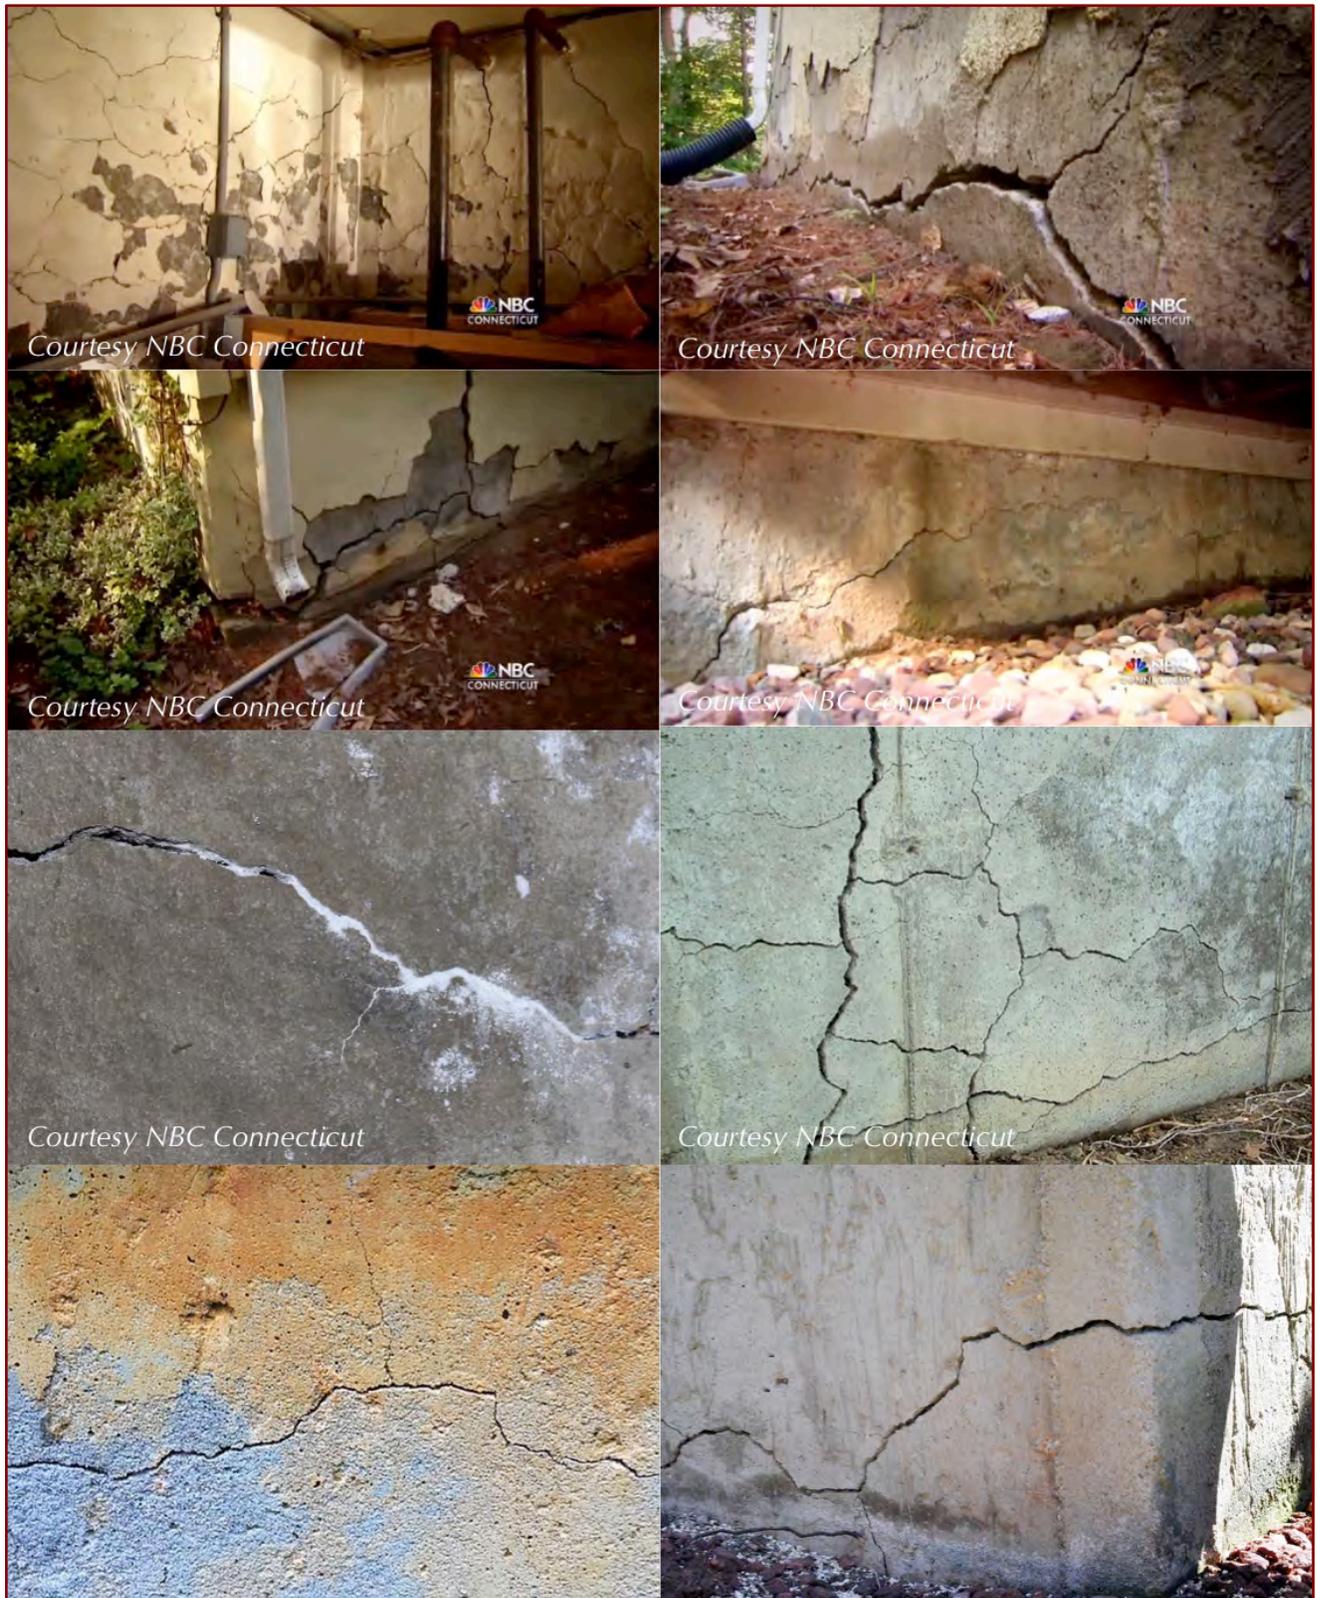
Figure 26: Cracking of concrete foundation in Connecticut due to oxidation of pyrrhotite bearing aggregates in concrete. Notice wide cracks in the foundation walls, extensive cracking of walls in the top left photo all reportedly from pyrrhotite oxidation and associated expansion of concrete.

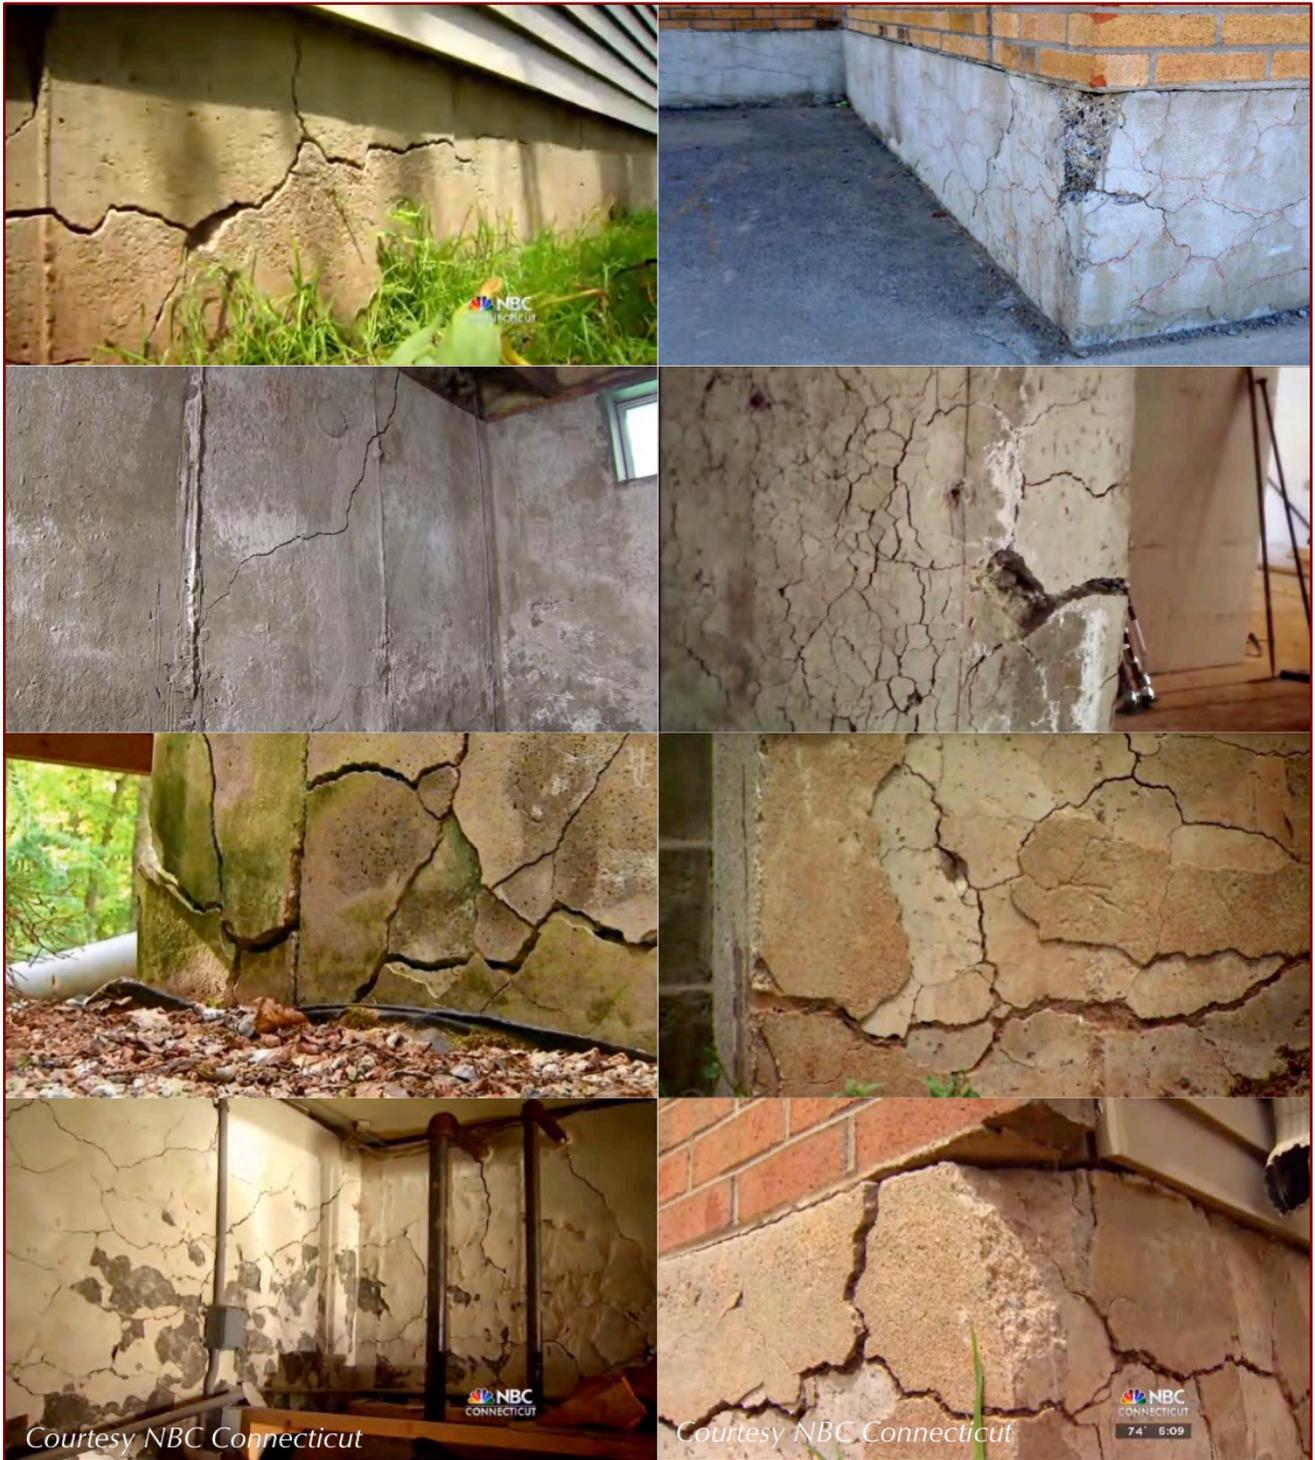
Figure 27: Cracking of concrete foundation in Connecticut due to oxidation of pyrrhotite bearing aggregates in concrete. Notice extensive cracking of foundation in all photos reportedly from pyrrhotite oxidation and associated expansion of concrete.
