Delamination and Potential Surface Alteration
Of An Indoor Concrete Slab-on-Grade
– A Comprehensive Study From
Two Concrete Cores &
An Incinerator Ash As A Potential Surface Contaminant

Inashco North America, Inc.
Metals Recovery Facility
3049 River Rd, Conestoga, PA 17516

October 8, 2021
CMC 0921159

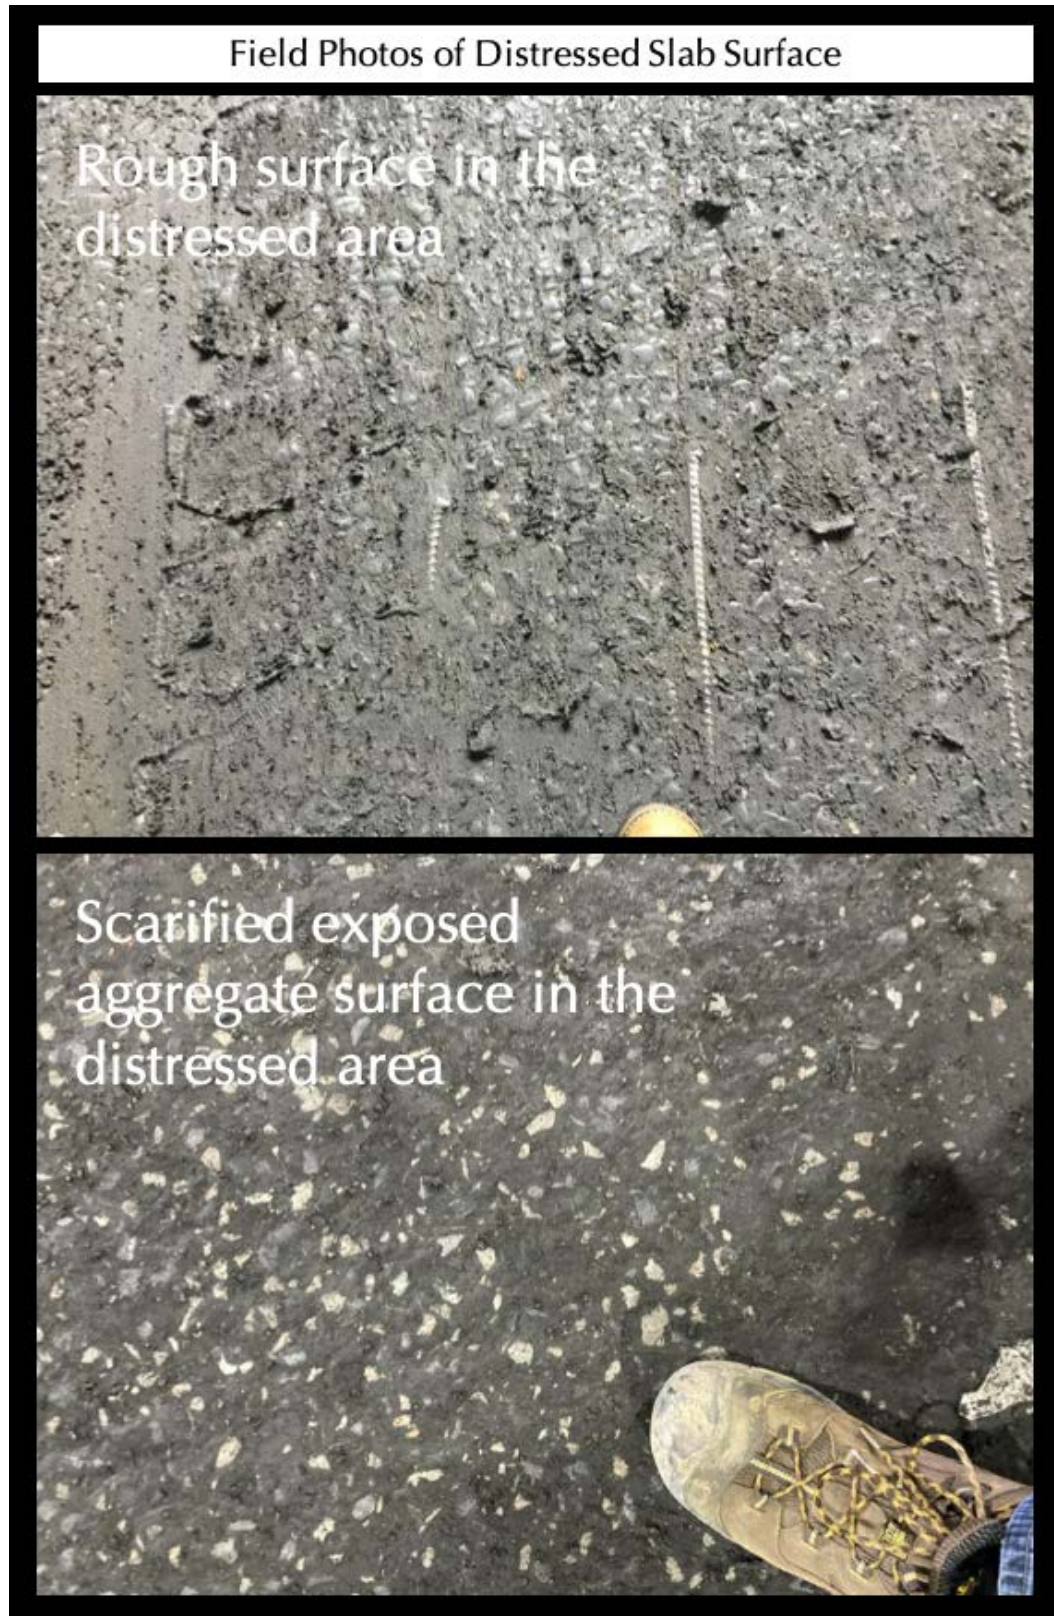
Figure 2: Field photos of rough distressed area in the top and scarified surface in the bottom photos that were subjected to delamination from loss of the original densified trowel-finished surface.

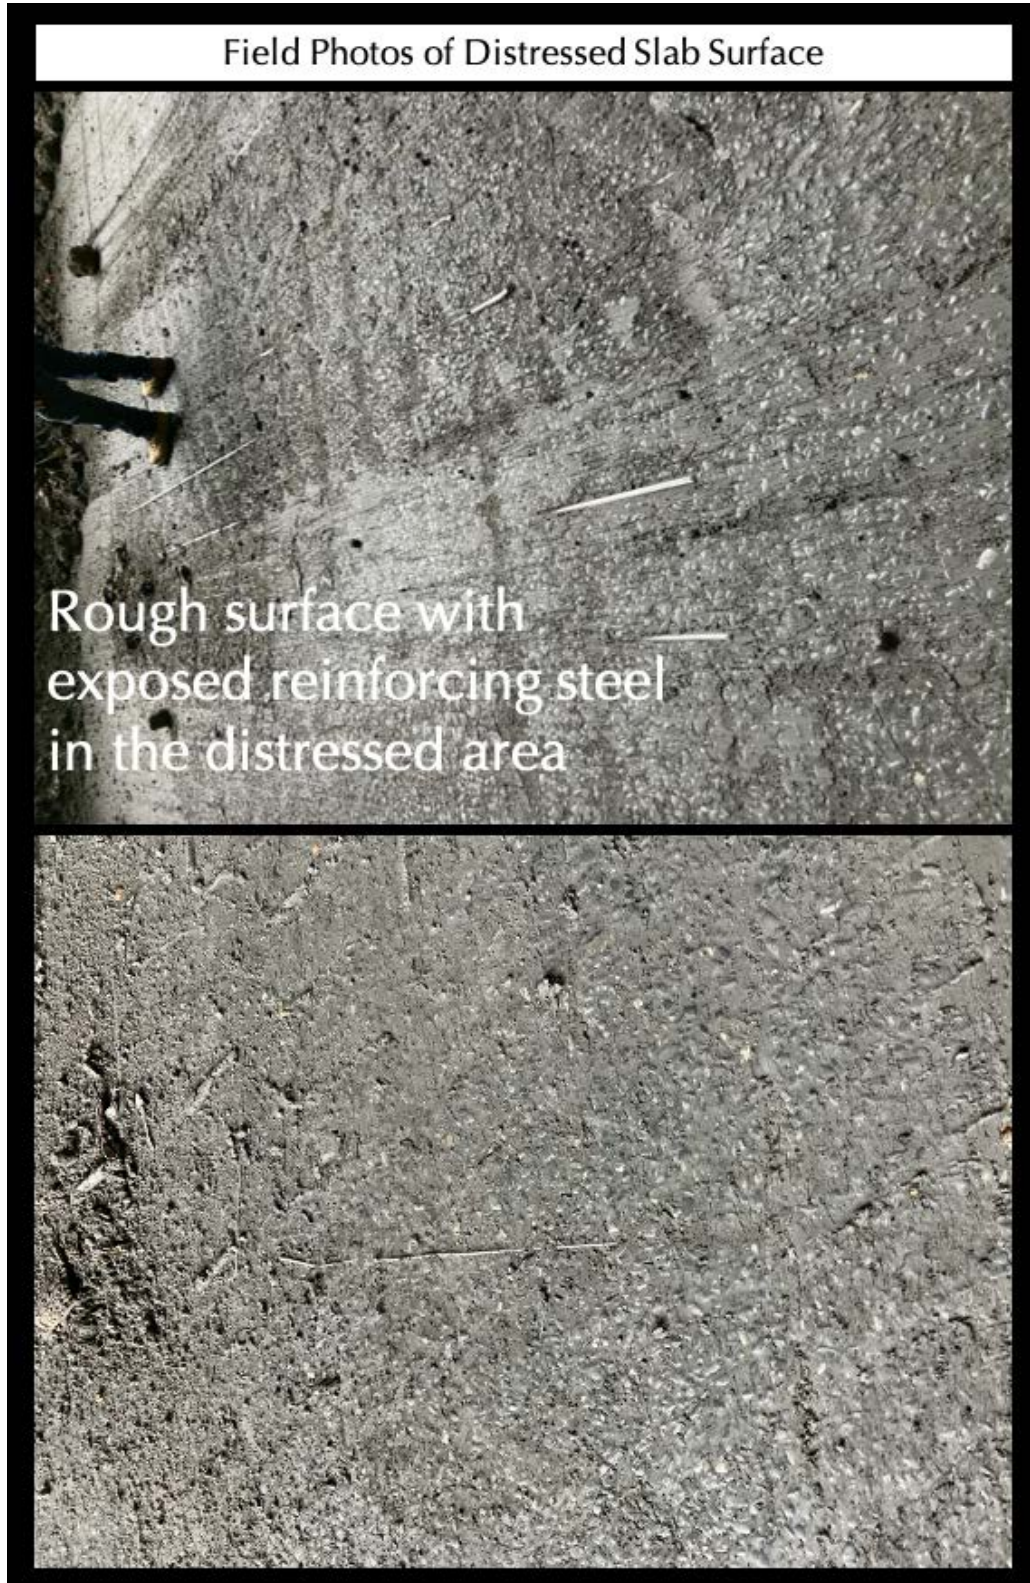
Figure 3: Field photo of the distressed concrete slab surface showing rough surface with exposed reinforcing steel at the surface where the original trowel-finished surface has, reportedly, delaminated.

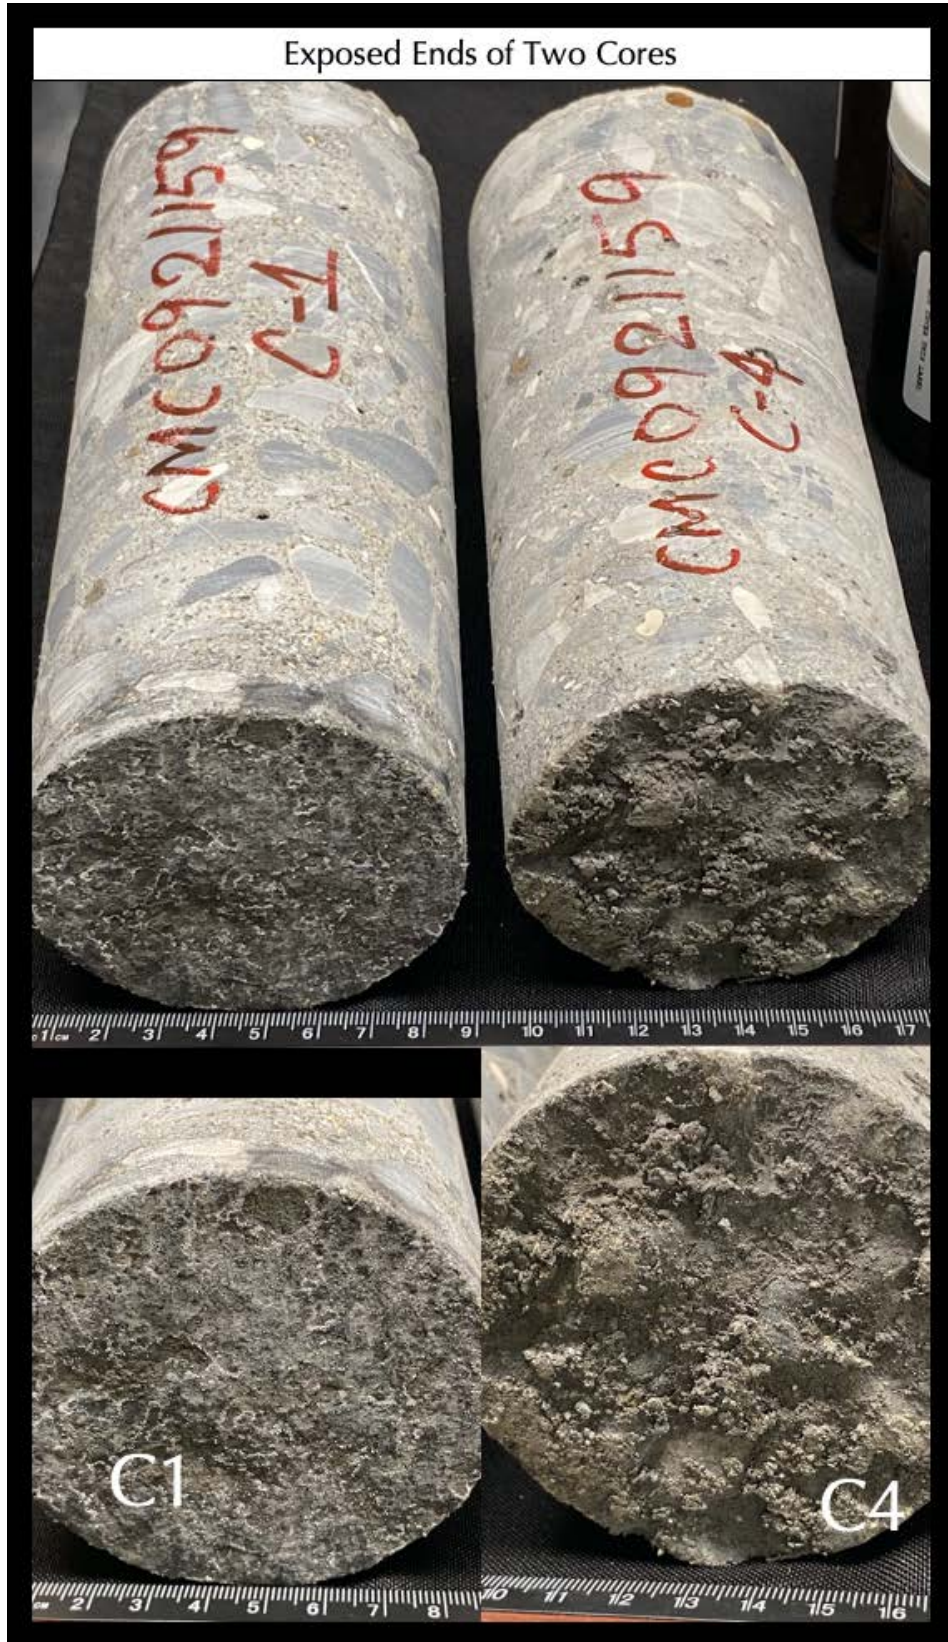
Figure 6: End surface (exposed ends) of Cores C1 and C4, as received, showing rough surfaces where Core C1 has a near-surface 'incipient delamination' present as elongated separations or 'tears,' whereas C4 has no such near-surface separations, but the entire exposed surface is rough.

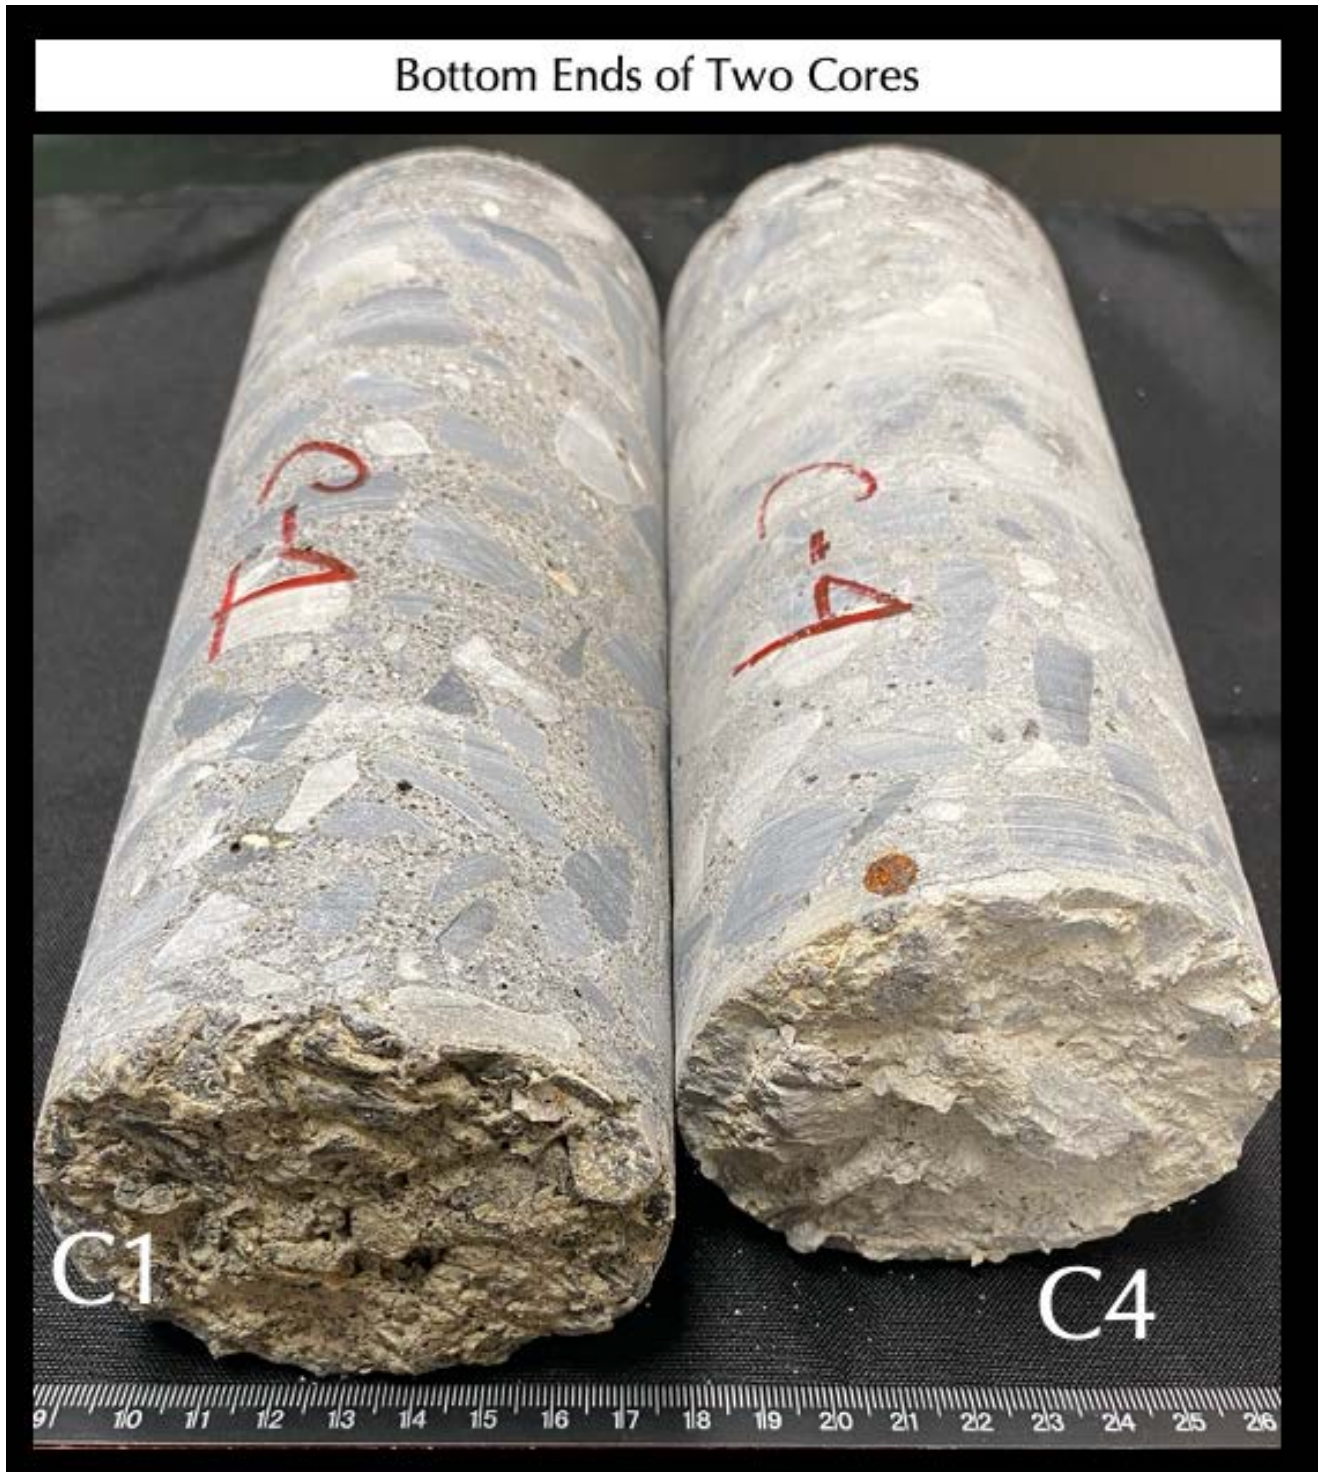
Figure 7: Opposite bottom ends of the cores, as received, showing the subbase materials indicating full-depth retrieval of cores at their respective locations.

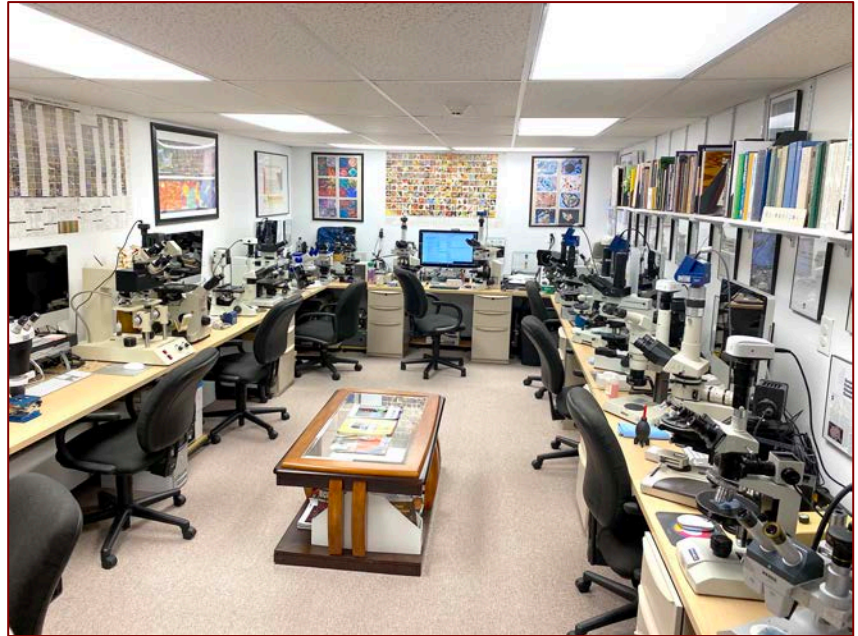
Figure 8: The optical microscopy laboratory at CMC which houses many microscopes used for this project.

- viii. Figure 8 shows various microscopes in the optical microscopy lab that were used during petrographic examinations of concrete and ash samples.

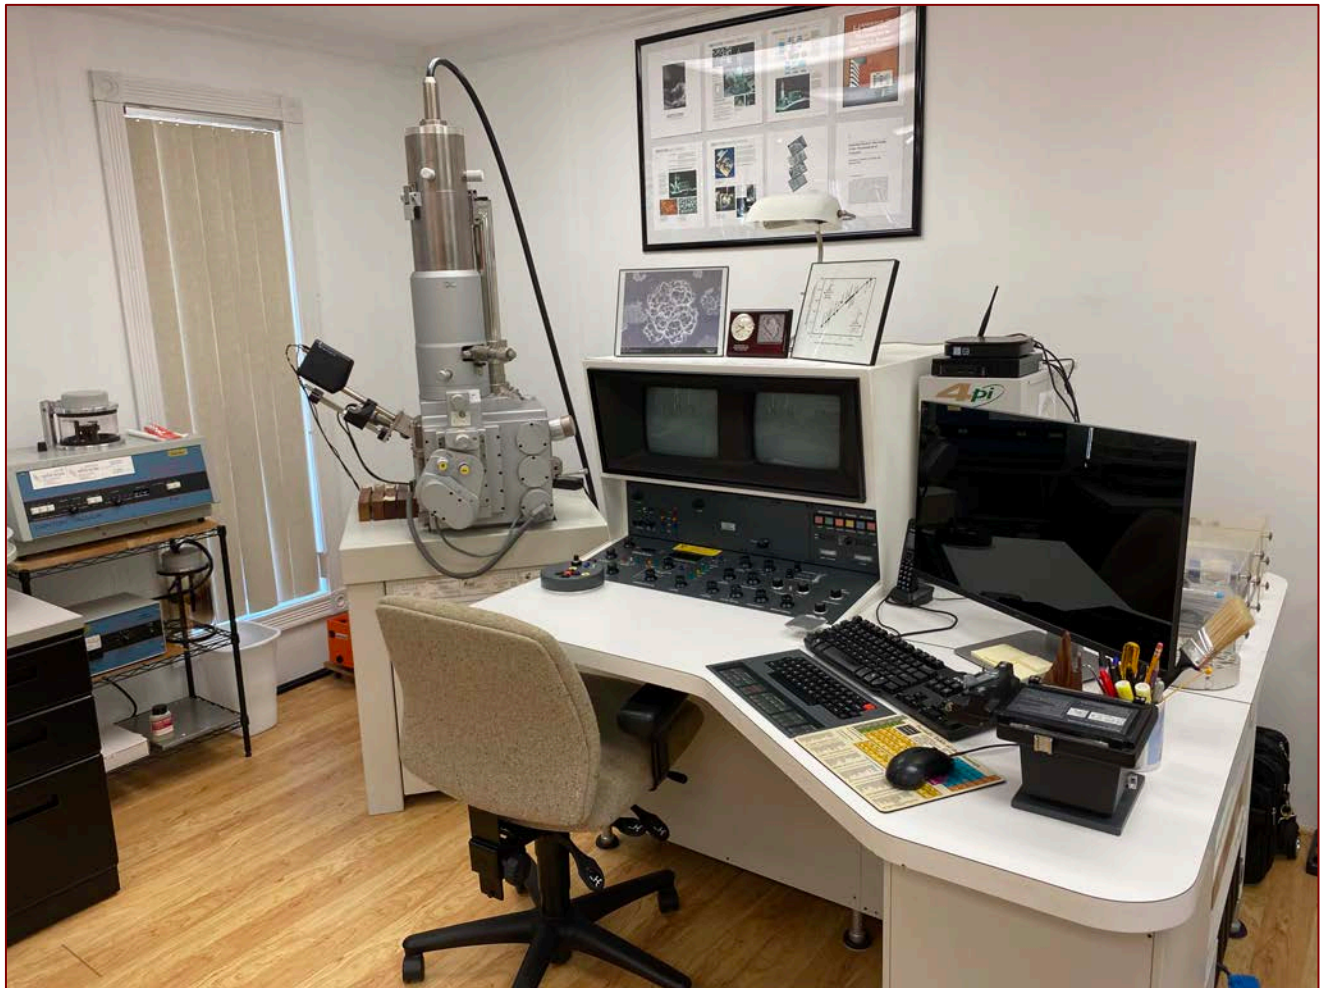
Figure 9: SEM-EDS: Cambridge CamScan Series II Scanning Electron Microscope and 4Pi Revolution software, backscatter detector, secondary electron detector, and energy-dispersive X-ray fluorescence spectrometer used for microstructural and microchemical analyses of surface deposits in Core C1 as well as of the ash sample.

Surface deposits on concrete cores as well as a representative portion of oven-dried mass of the ash sample were examined from their respective thin sections already prepared and used in optical microscopy for further determinations of compositions and identity by Cambridge CamScan Series II scanning electron microscope equipped with a backscatter detector, a secondary electron detector, and energy-dispersive X-ray fluorescence.

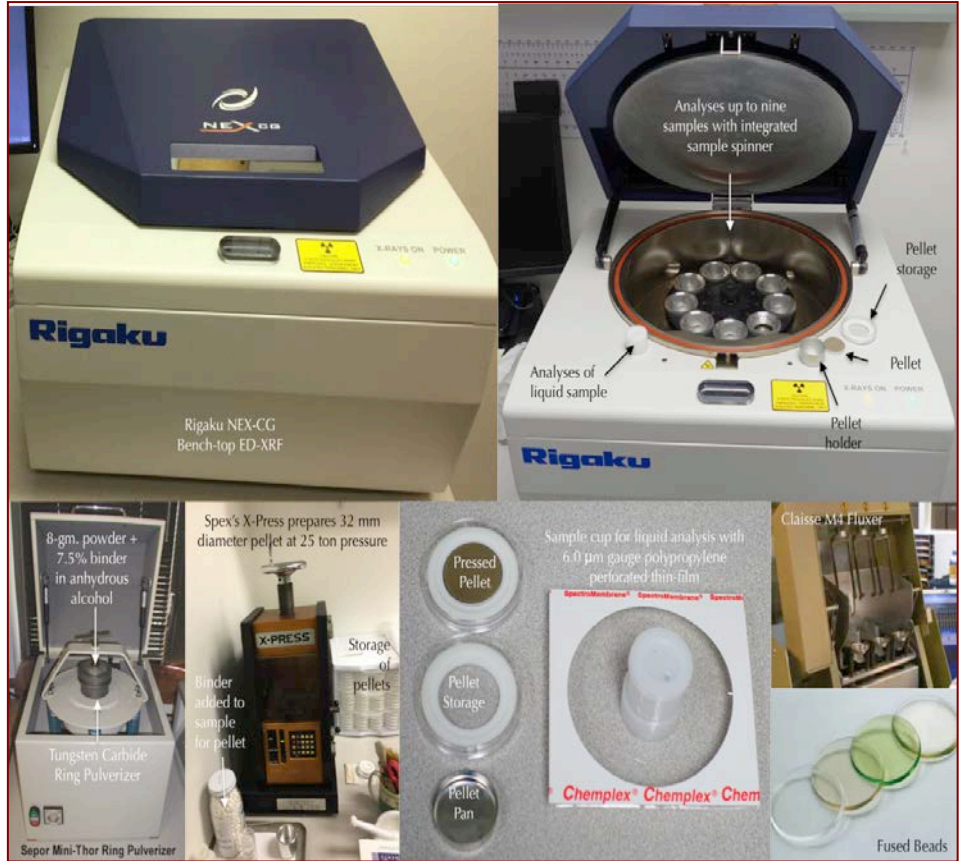
Figure 11: Rigaku NEX-CG in CMC, which can perform analyses of 9 pressed pellet or fused bead of sample. Samples are prepared either as pressed pellet (usually the one already prepared for XRD) or can also accommodate fused bead with proper calibration of standard beads.

An energy-dispersive bench-top X-ray fluorescence unit from Rigaku Americas Corporation (NEX-CG) was used (Figure 11). Rigaku NEX CG delivers rapid qualitative and quantitative determination of major and minor atomic elements in a wide variety of sample types with minimal standards. Unlike conventional EDXRF analyzers, the NEX CG was engineered with a unique close-coupled Cartesian Geometry (CG) optical kernel that dramatically increases signal-to-noise. By using monochromatic secondary target excitation, instead of conventional direct excitation, sensitivity is further improved. The resulting dramatic reduction in background noise, and simultaneous increase in element peaks, result in a spectrometer capable of routine trace element analysis even in difficult sample types. The instrument is calibrated by using various certified (CCRL, NIST, GSA, and Brammer) reference standards of cements and rocks.

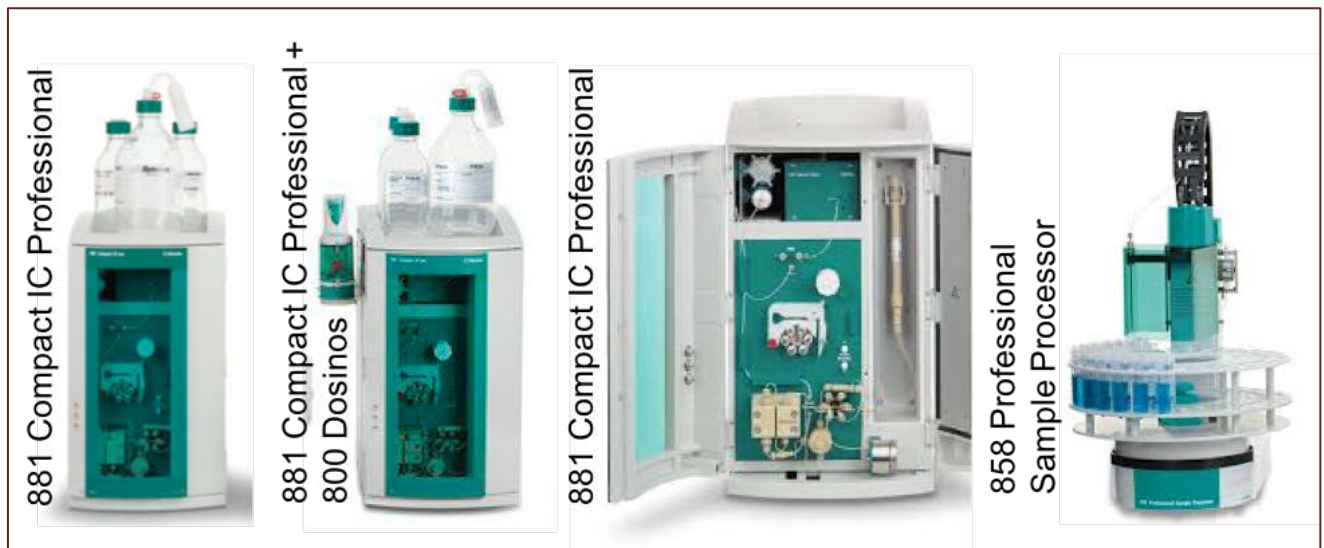
Figure 12: Set-ups for chloride and sulfate analysis by ion chromatography and pH of ash sample.

The digested sample solution was then filtered under vacuum, first through two 2.5-micron filter papers, followed by another filtration through two 0.2-micron filter papers to collect the filtrate. The filtrate thus obtained was diluted to a final volume of 500 ml in a volumetric flask. The filtrates thus prepared were used for ion chromatography by following the methods of ASTM C 4327 using Metrohm 881 Compact IC Professional with 858 professional sample processor (Figure 12). The instrument was calibrated with standard anion solutions of known concentrations.

In addition, alkalinity of the deionized water-digested ash sample was measured in a Metrohm 744 pH meter as well as from a pH strip.

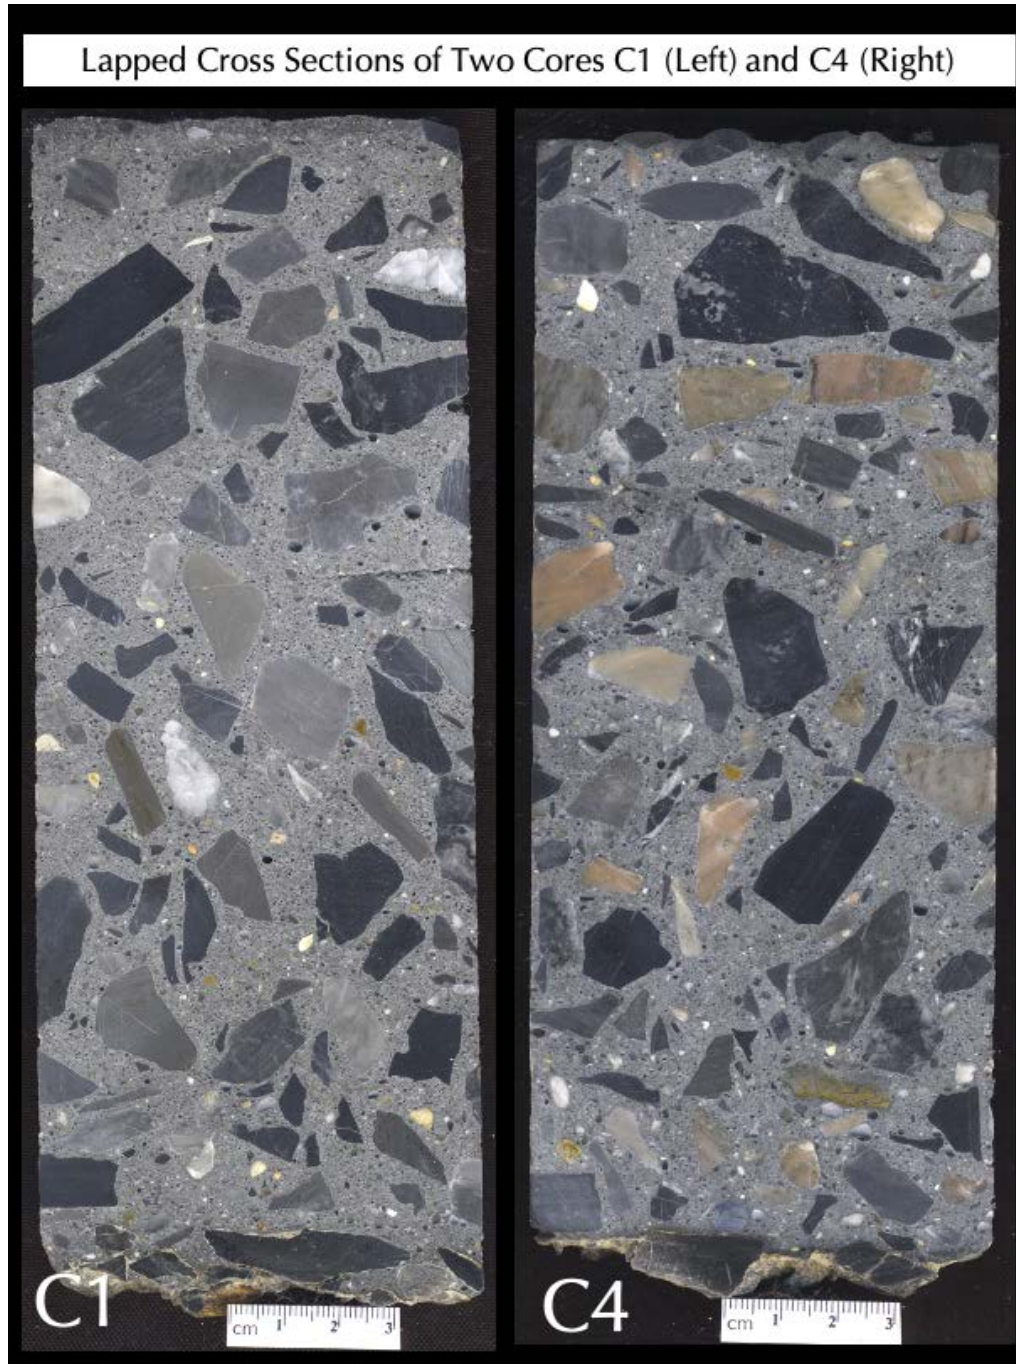
Figure 13: Lapped cross sections of Cores C1 and C4 showing overall densified concrete containing compositionally similar, medium to dark gray, angular, equidimensional to a few elongated, well-graded, well-distributed, crushed limestone coarse aggregates, dark gray paste due to the incorporation of fly ash along with Portland cement, rough exposed surface ends at top, and, adhered subbase material at the bottom ends indicating full-depth recovery of cores from the slab. Notice the overall good consolidation of concrete at both core locations as well as sound, visually crack-free natures, and free of any discolorations at the surface regions from any surface contaminants.

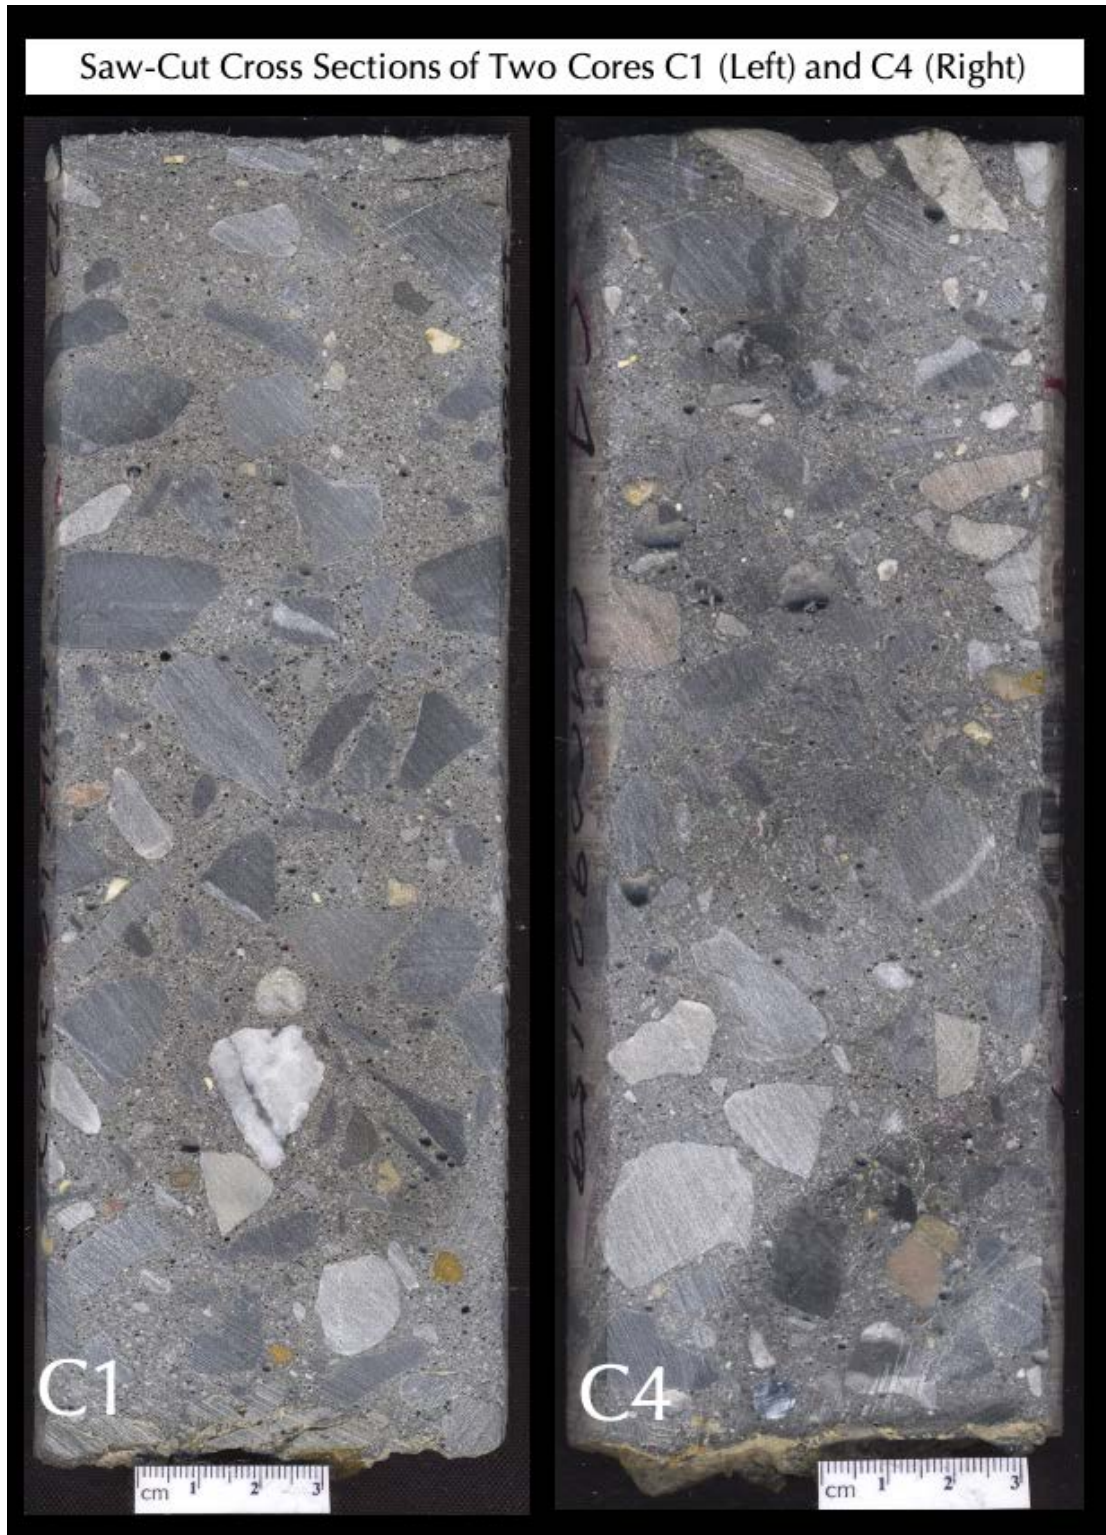
Figure 14: Saw-cut cross sections of Cores C1 and C4 showing overall densified concrete containing compositionally similar, medium to dark gray, angular, equidimensional to a few elongated, well-graded, well-distributed, crushed limestone coarse aggregates, dark gray paste due to the incorporation of fly ash along with Portland cement, rough exposed surface ends at top, and adhered subbase material at the bottom ends indicating full-depth recovery of cores from the slab.

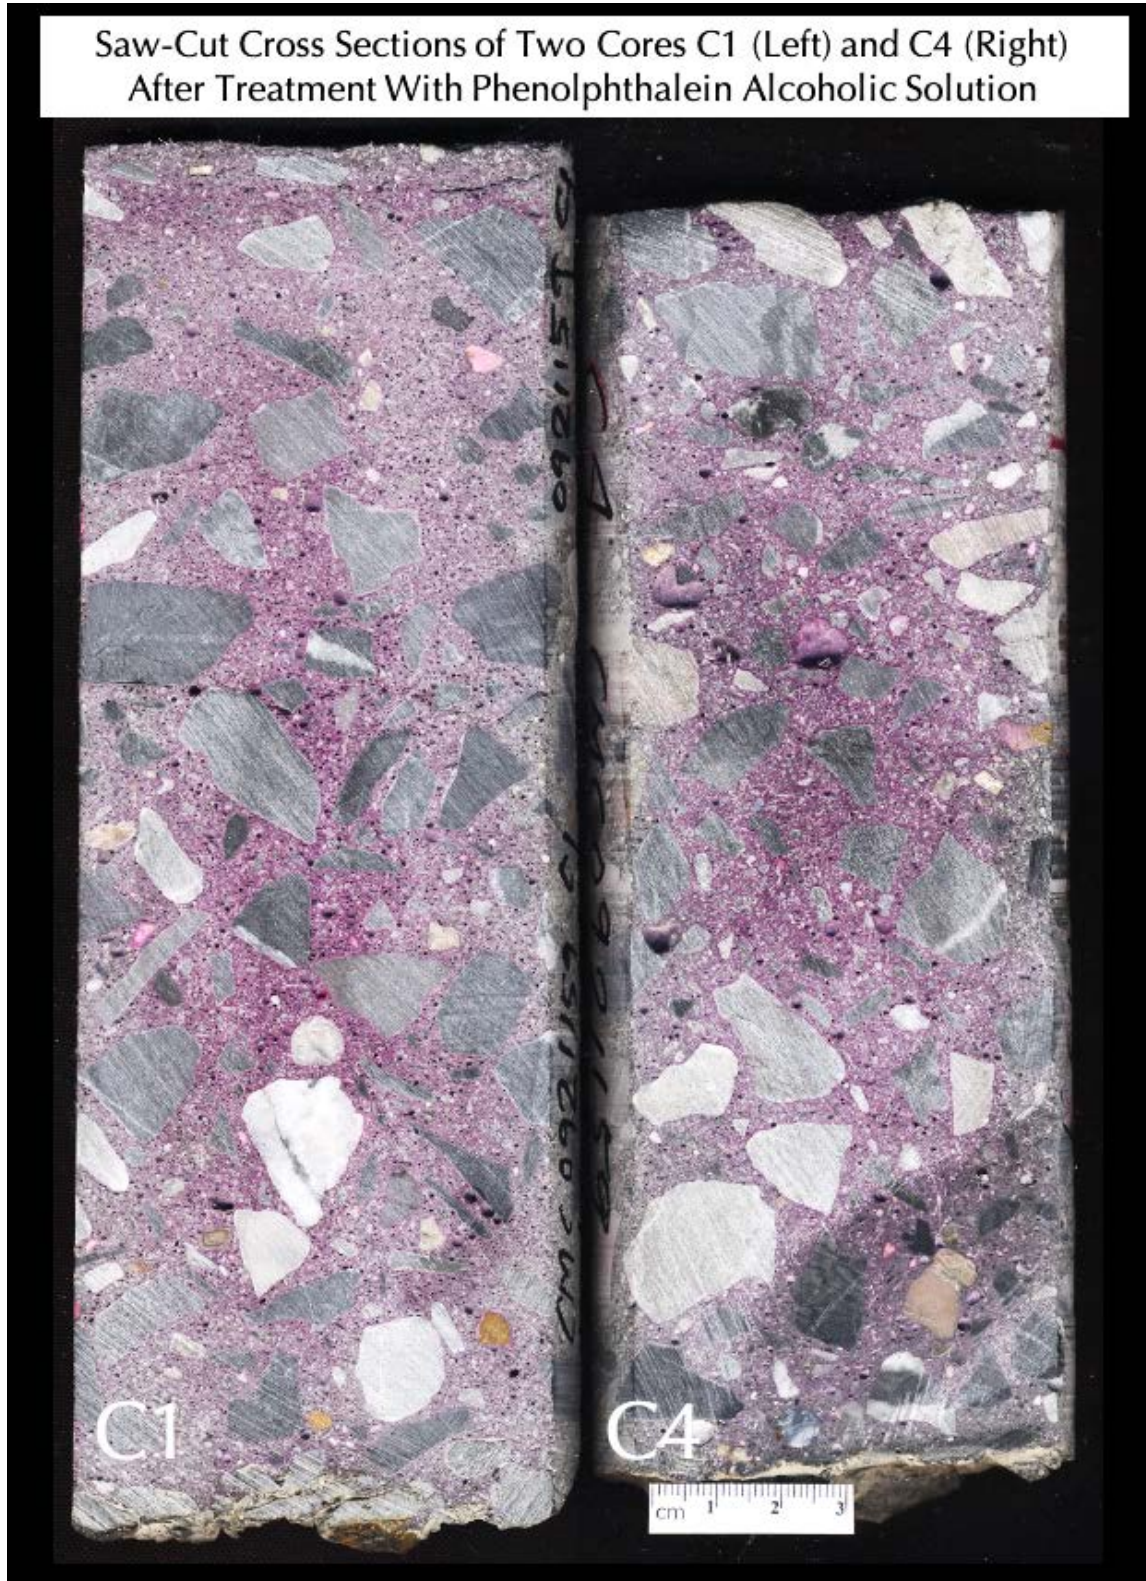
Figure 15: Saw-cut cross sections from Figure 14 after treatment with phenolphthalein alcoholic solutions showing overall dense non-carbonated nature of concrete except only minimal patchy carbonation at the surface that are only detected from thin sections.

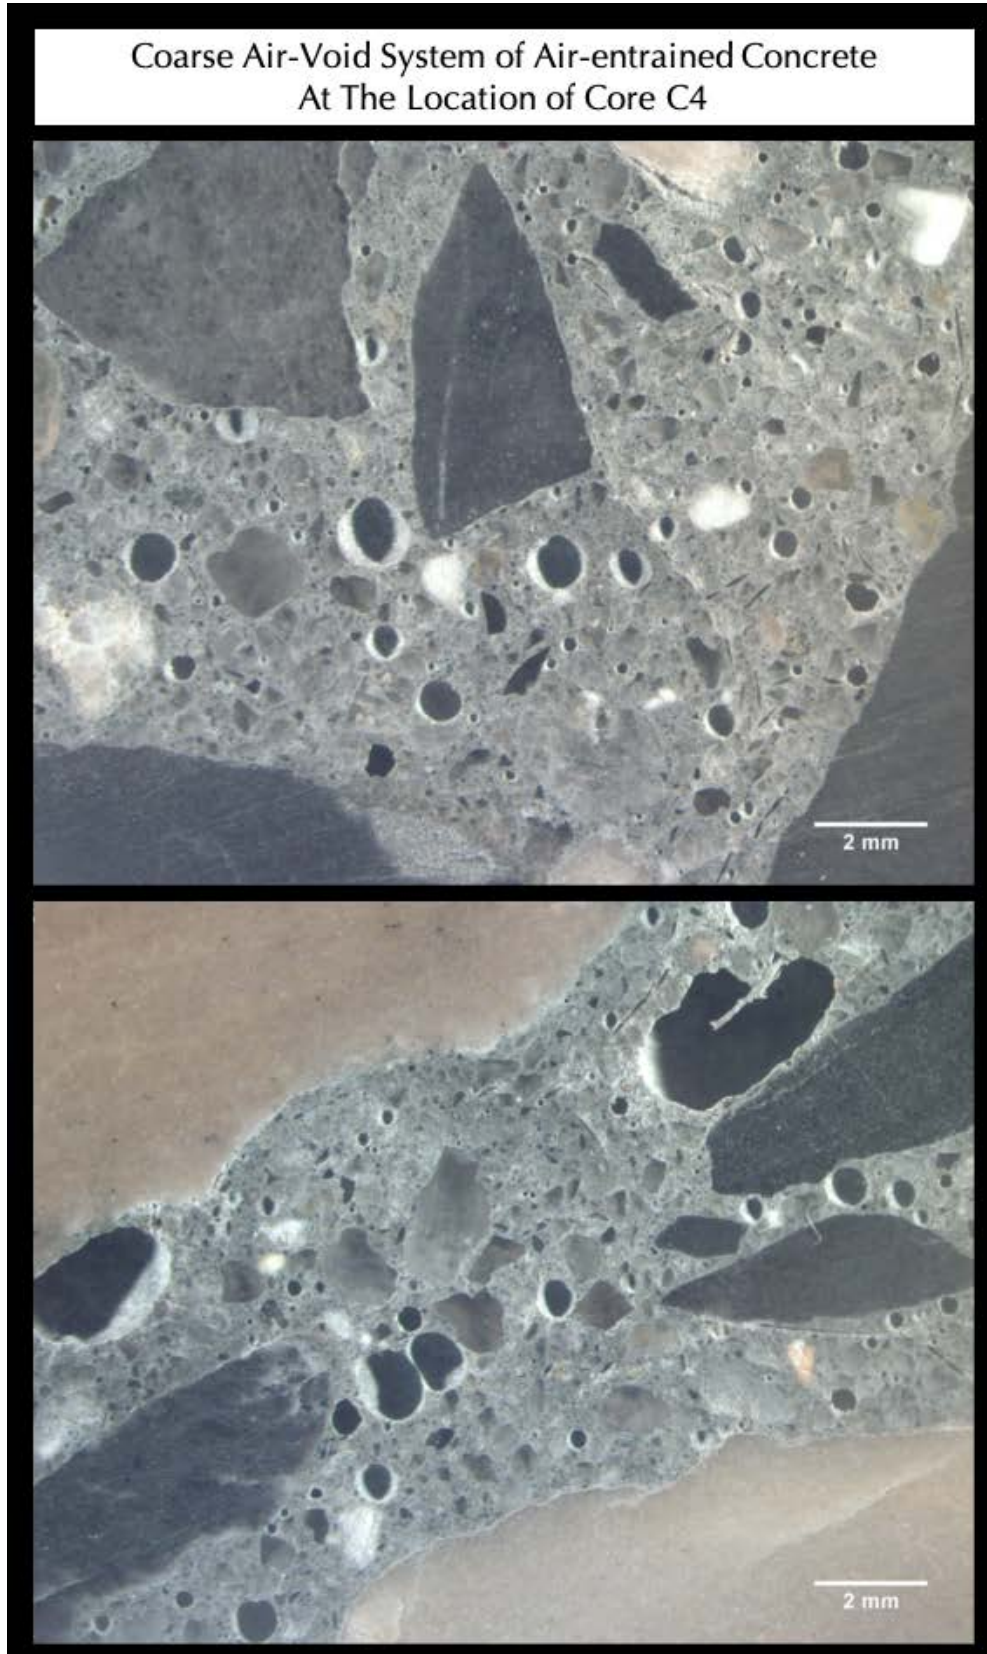
Figure 28: Micrographs of lapped cross section of Core C4 showing the marginally air-entrained nature of concrete having mostly coarse air voids at moderate amounts, as opposed to excessive air-entrainment of many very fine air voids as seen in Core C1. Notice some synthetic fibers in the bottom photo.

Figure 29: Micrographs of lapped cross section of Core C4 showing the marginally air-entrained nature of concrete having mostly coarse air voids at moderate amounts, as opposed to excessive air-entrainment of many very fine air voids as seen in Core C1.

Figure 30: Micrographs of lapped cross section of Core C4 showing the marginally air-entrained nature of concrete having mostly coarse air voids at moderate amounts, as opposed to excessive air-entrainment of many very fine air voids as seen in Core C1.

Figure 31: Micrographs of lapped cross section of Core C4 showing the marginally air-entrained nature of concrete having mostly coarse air voids at moderate amounts, as opposed to excessive air-entrainment of many very fine air voids in Core C1. Notice some synthetic fibers in the top photo.

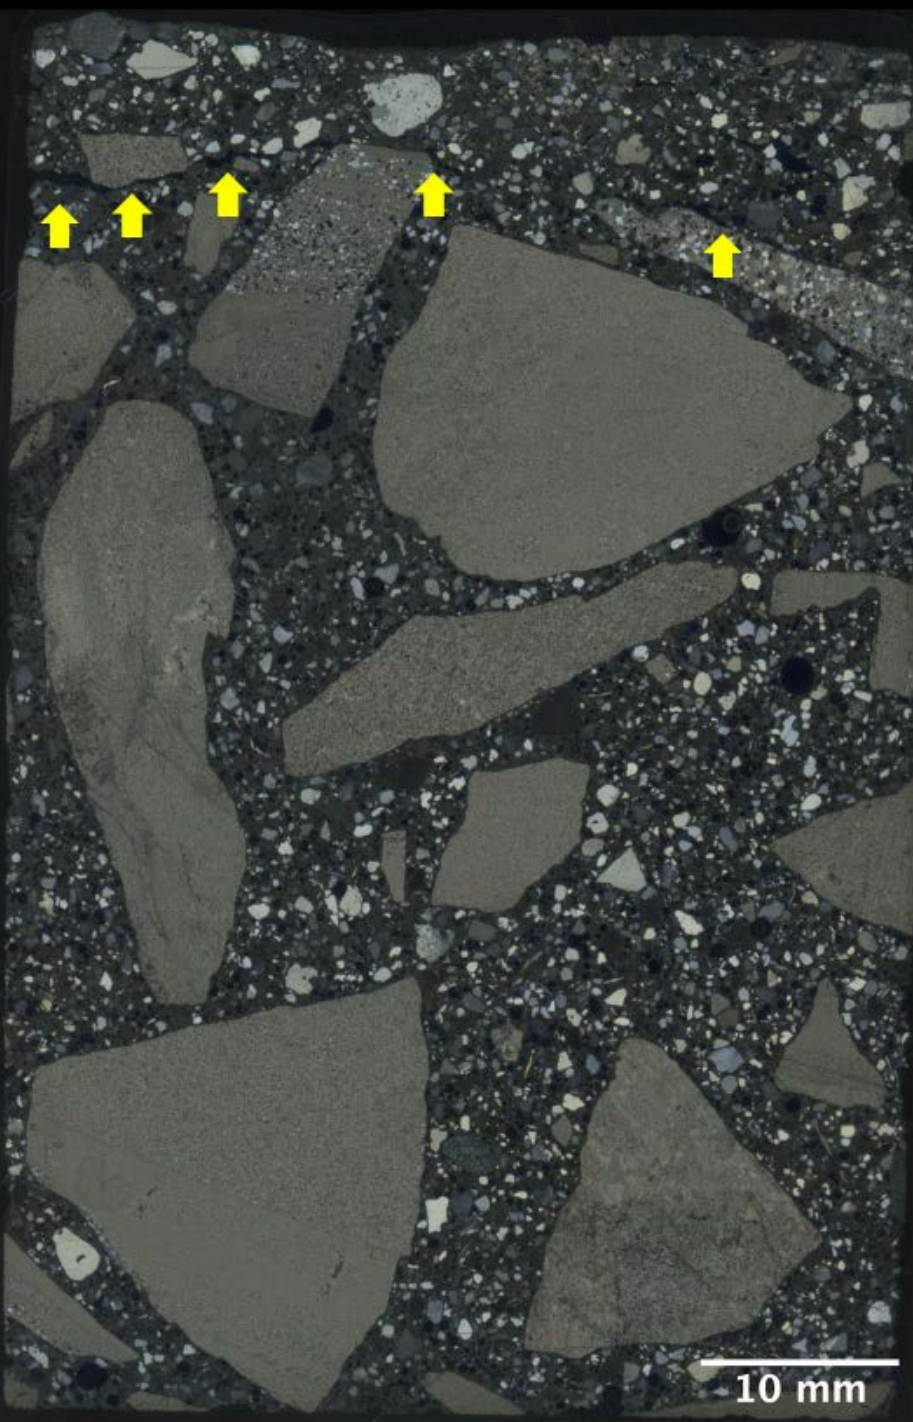
Figure 33: Blue dye-mixed epoxy-encapsulated thin section of Core C1 taken by using a flatbed film scanner, where thin section was scanned with two polarizing filters at perpendicular orientations to recreate cross polarized light view of sample where crushed limestone coarse aggregate and natural siliceous sand fine aggregates are highlighted. Arrows show near-surface incipient delamination.

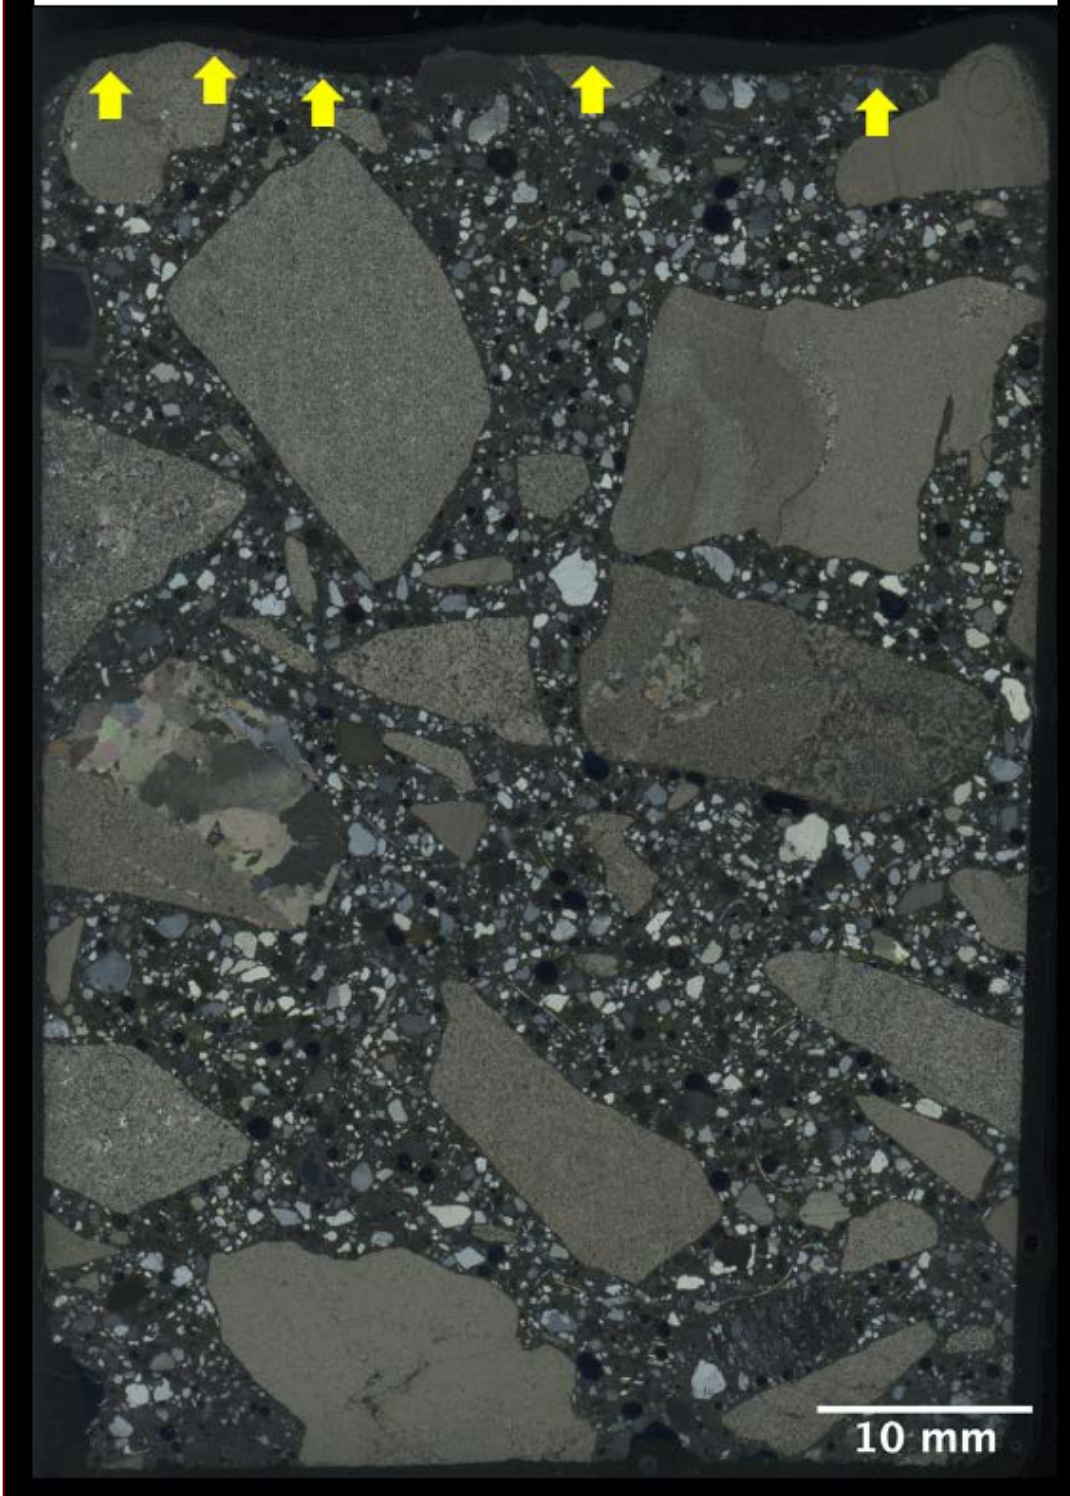
Figure 35: Blue dye-mixed epoxy-encapsulated thin section of Core C4 taken by using a flatbed film scanner, where thin section was scanned with two polarizing filters at perpendicular orientations to recreate cross polarized light view of sample where crushed limestone coarse aggregate and natural siliceous sand fine aggregates are highlighted. Arrows show surface delamination.
