CONCRETE INDUSTRY BOARD

Vol. 33 No. 3 September 1997

Microscopy: A Practical Solution to Concrete Problems

By Dipayan Jana and Akin A. Cole

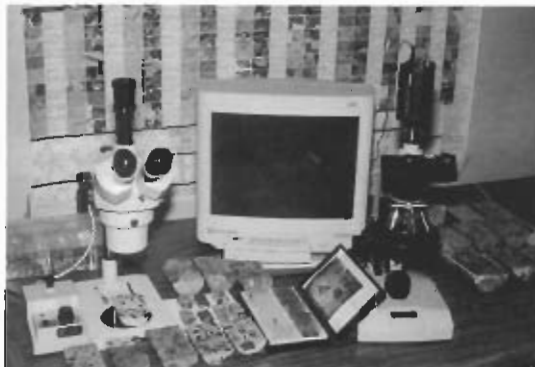
Photo 1, left: Reflected (left) and transmitted (right) light microscopes: two indispensable tools for solving common concrete problems.

The ability of various optical and electron microscopes to magnify objects by more than 100,000 times allows for the thorough examination of the texture and microstructure of concrete (Photo 1). The

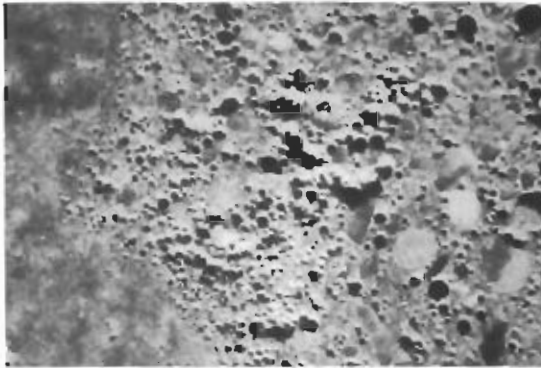
Photo 5, left:
Inadequate mixing: air void clustering

Mixing problems: Inadequate mixing can be suspected from clustering of aggregates or air voids (Photo 5) or unhydrated cement particles (Photo 6, marked with arrows), variation in mortar density, or from the presence of sand streaks (Photo 7).
