## Pyrrhotite Epidemic in Eastern Connecticut: A Case Study From Tolland, CT

Tolland Board of Education  
Birch Grove School  
247 Rhodes Road  
Tolland, CT 06084

January 10, 2019  
CMC 1218175

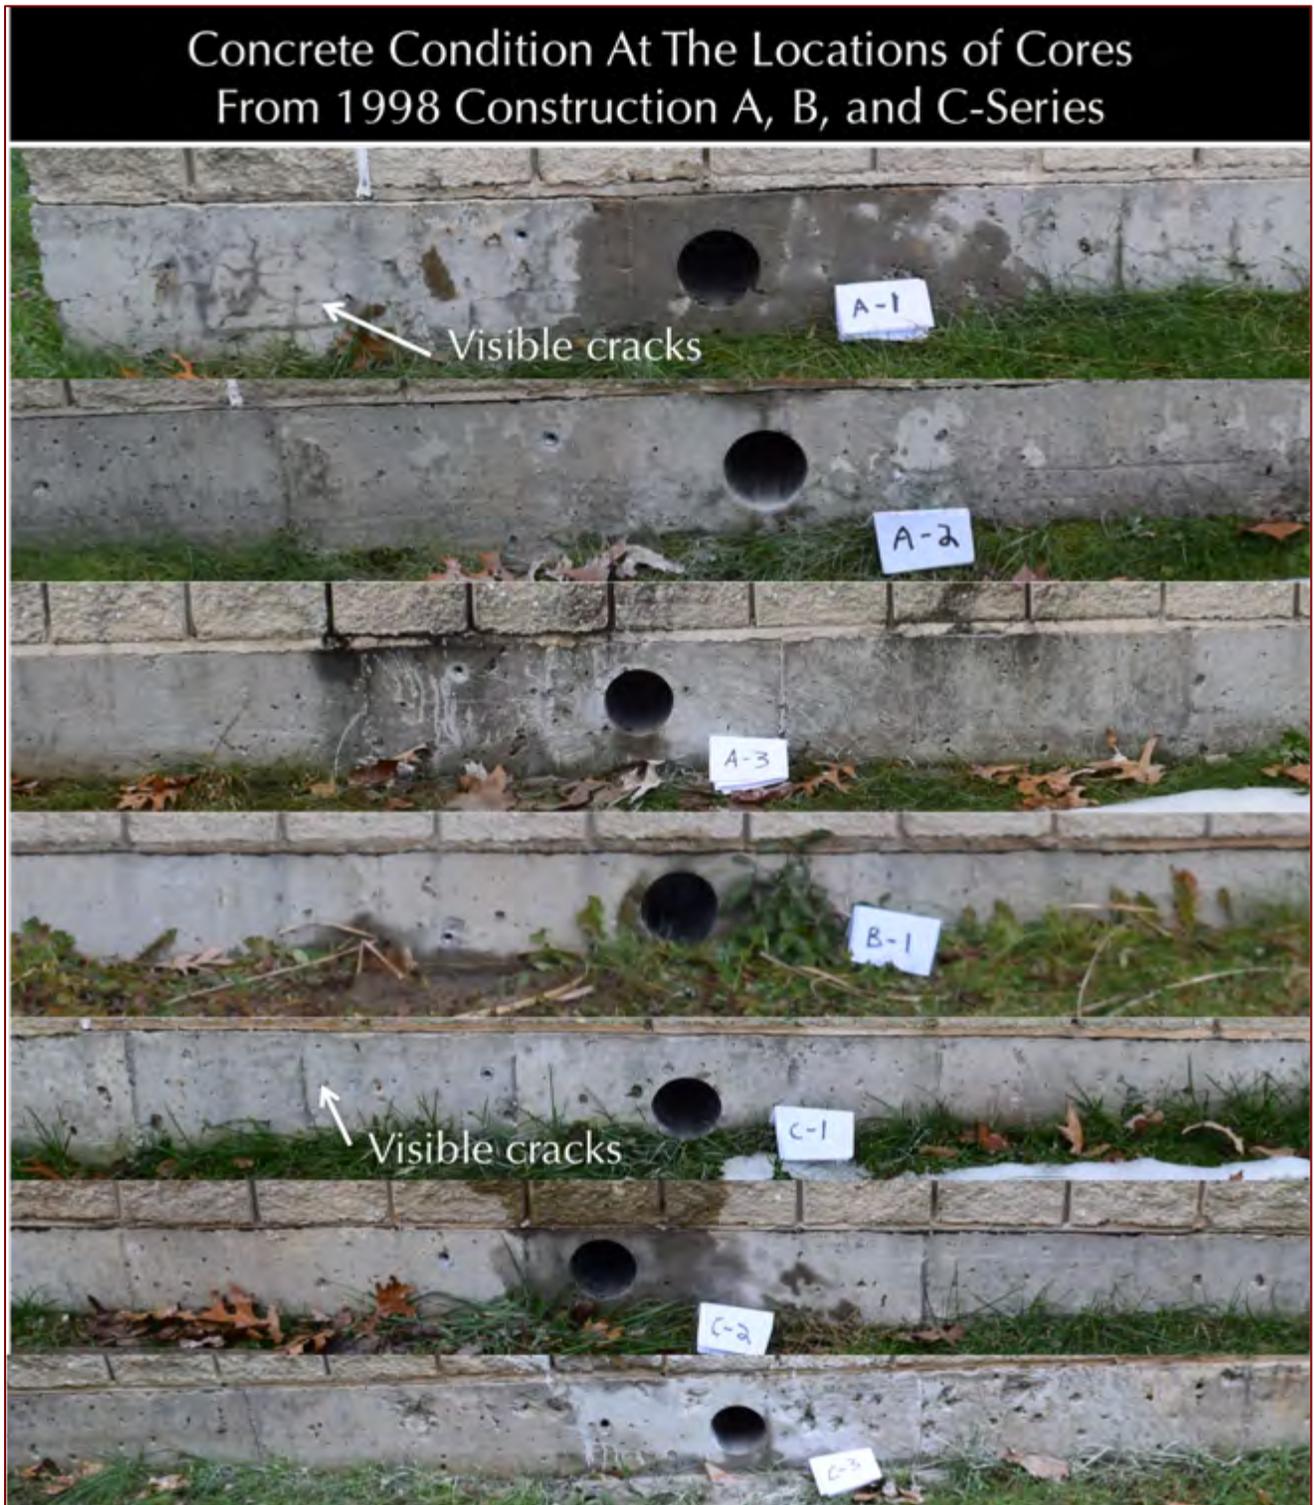
Figure 2: Field photographs at the locations of Cores A-1 to A-3, B-1, and C-1 to C-3 showing visible cracking of the foundation wall at the locations of A-1 and C-1, but no discernable cracks in other locations. Cracking of foundation wall at the location of Core A-1 is similar to typical map cracking pattern, which is common in many pyrrhotite-related deteriorations of foundation walls across eastern Connecticut. See Appendix A for details.

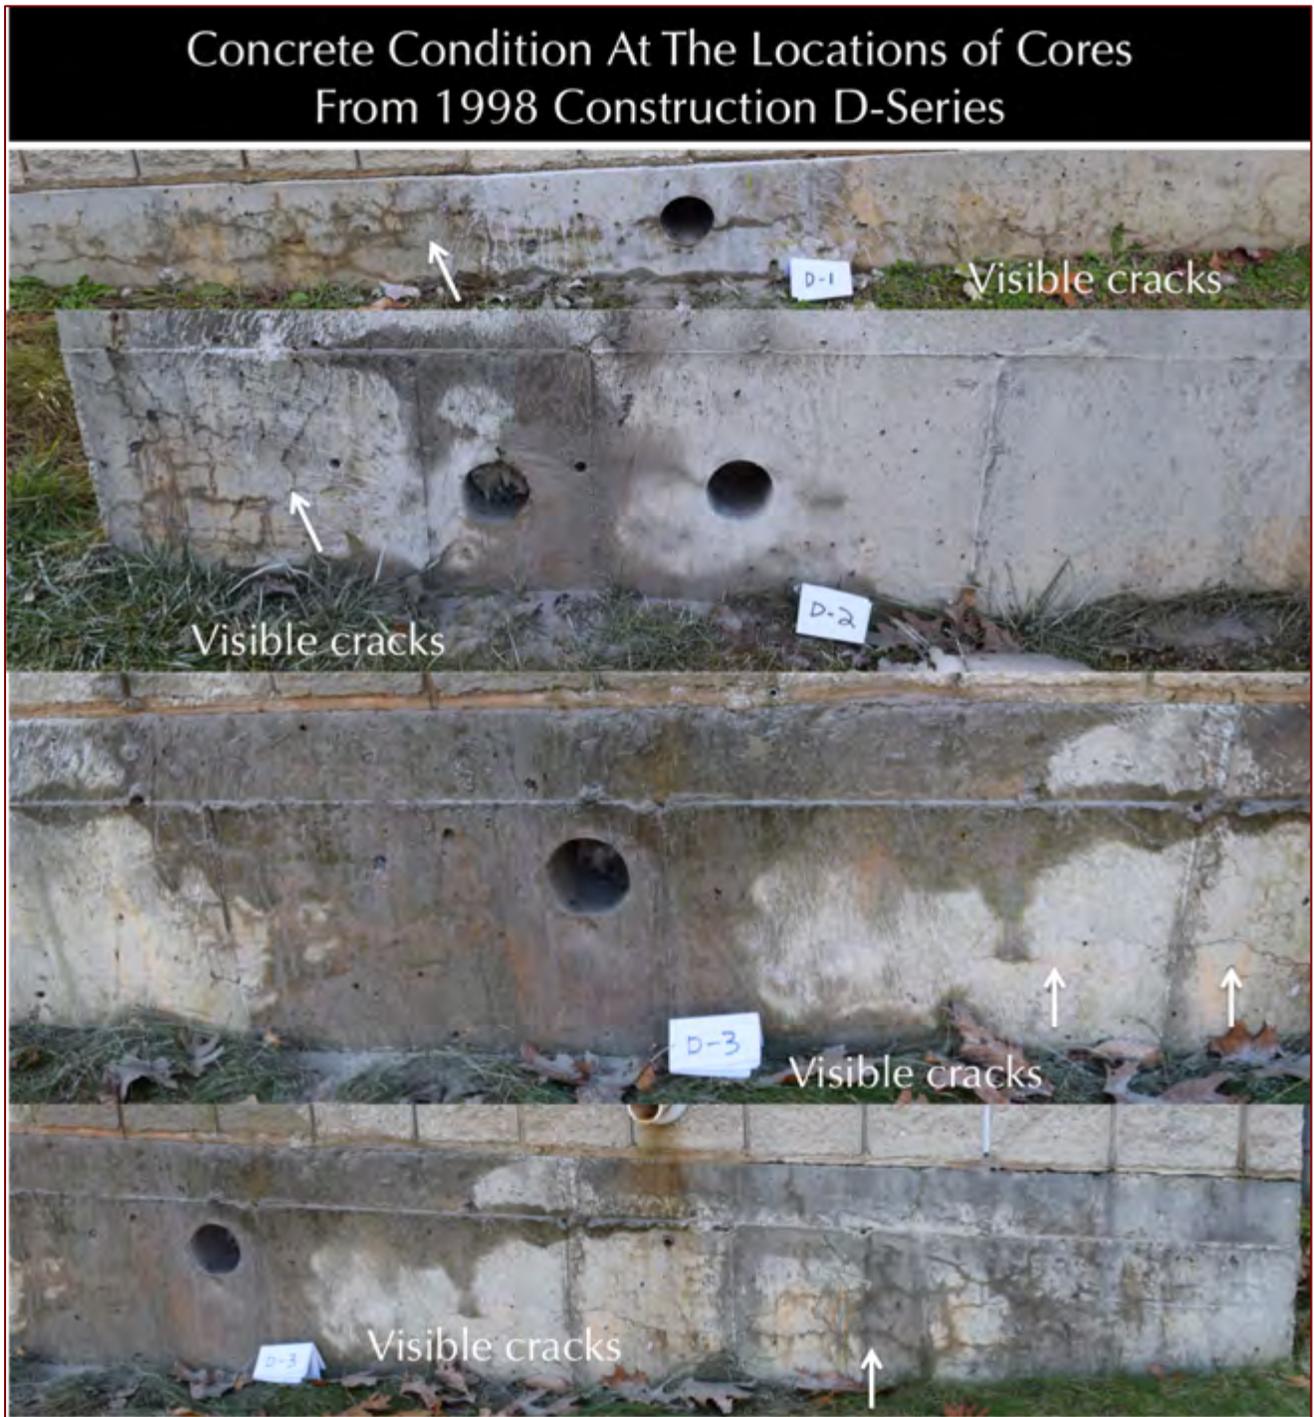
Figure 3: Field photographs at the locations of Cores D-1 to D-3 showing visible cracking of the foundation wall at the locations of all three cores. Map cracking is visible at the locations of all three cores, which is common in many pyrrhotite-related deteriorations of foundation walls across eastern Connecticut. See Appendix A for details.

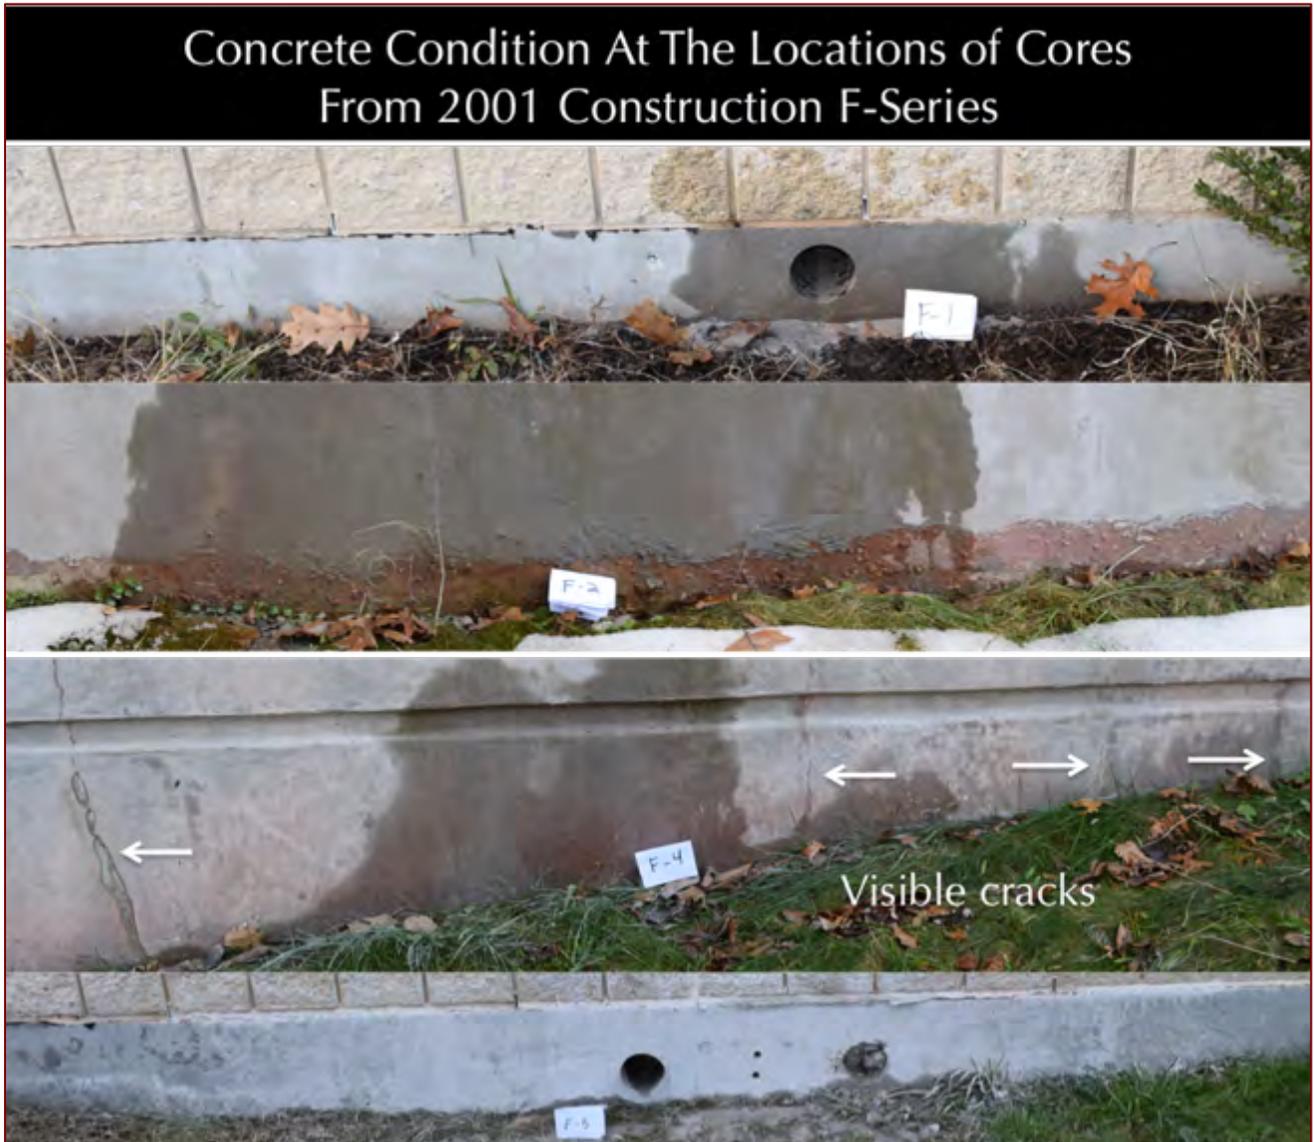
Figure 4: Field photographs at the locations of Cores F-series showing isolated vertical visible cracking of the foundation wall at the location of F-4 but no discernable cracks in other locations, or map cracking found in the walls from 1998 construction. See Appendix A for details.

Field photographs of concrete conditions at the locations of fifteen cores show map cracking of foundation at the location of Core A-1 (Figure 2), D-1, D-2, D-3 (Figure 3), a few long vertical cracks across the thickness of foundation at the location of Core C-1 (Figure 2), and a few isolated vertical cracks at the location of Core F-4. Amongst the 1998 construction, foundation walls at the locations of Cores A-1, D-1, D-2, and D-3 showed most visible map cracking, which are consistent with the observed through-depth cracks in those cores when received. Extensive cracking in Cores C-1 and C-2, however are found when received but no corresponding visible cracking are found in the field photos of those locations on the exposed surfaces of foundations. Moderate cracking mostly at the exposed end of Core A-2, and minimal cracking in Cores A-3, B-1, and C-3 when received are also not seen on the exposed foundation walls of their locations in the field photos (Figures 2 to 4).

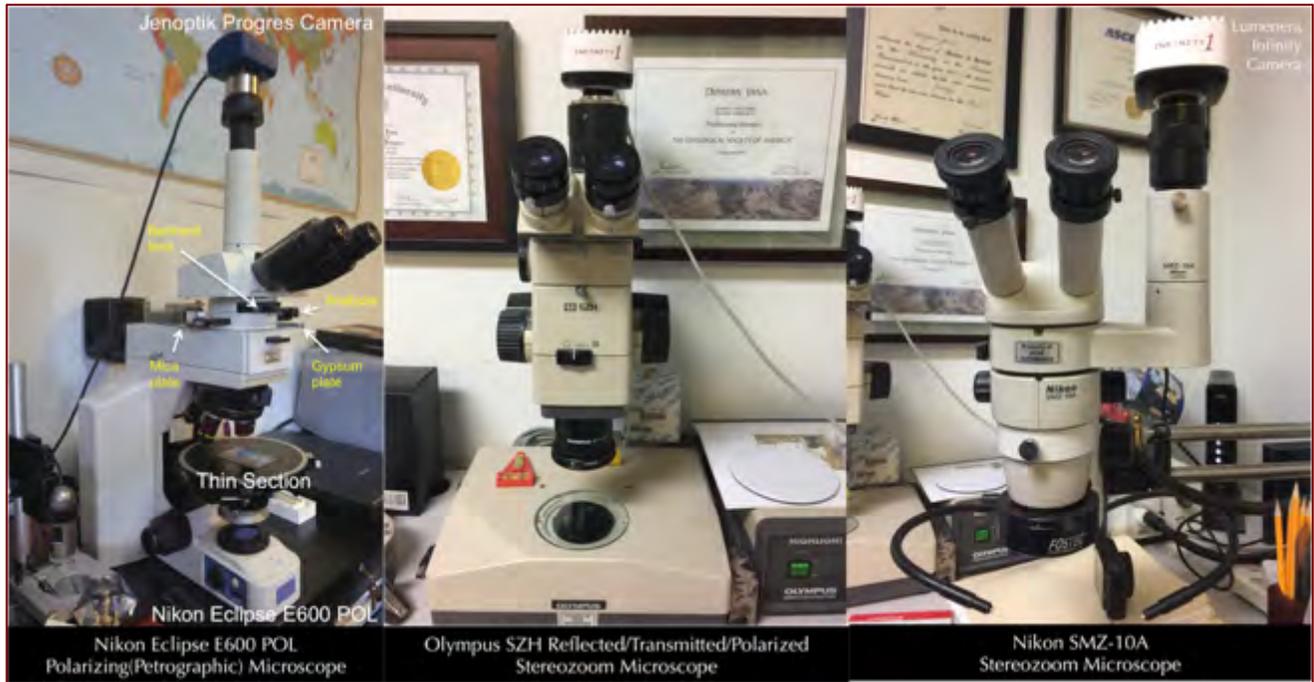
Figure 5: Optical Microscopy: Left - A Nikon Eclipse E600 POL polarizing (petrographic) microscope at left with reflected, transmitted, polarized-light, and fluorescent-light capabilities; Middle – An Olympus SZH reflected/transmitted/polarized-light Stereozoom microscope; and Right – A Nikon SMZ-10A Stereozoom microscope. All microscopes are equipped with Jenoptik Gryphax and Lumenera Infinity digital cameras.

- xi. A Nikon Eclipse 600 POL petrographic microscope attached to a Jenoptik Progres GRYPHAX high-resolution digital camera were used for petrographic examinations and collecting photomicrographs of thin sections of concretes (Figure 5). A Nikon SMZ-10A stereomicroscope (Figure 5) and an Olympus SZH stereozoom microscope (equipped with transmitted polarizing light facilities) were used for examinations of fresh fractured and lapped sections and transmitted-light examinations of thin sections, respectively.

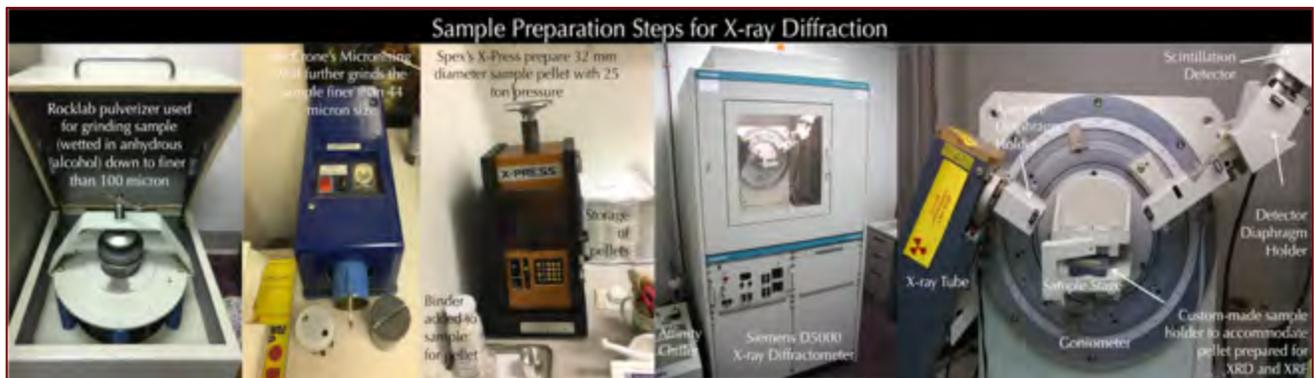
Figure 6: XRD: Siemens D5000 X-ray diffractometer and MDI Jade search/match software used for determination of mineralogical compositions of concretes and extracted concrete aggregates. Left to right: Rocklab pulverizer for initial grinding of aggregate with anhydrous alcohol; McCrone micronizing mill for final grinding; Spex 25-ton press for pellet preparation; Siemens D5000 X-ray diffractometer; and custom-made sample holder to place a 32-mm diameter pellet on sample stage.

X-ray diffraction was carried out in a Siemens D5000 Powder diffractometer ( $\theta$ - $2\theta$  goniometer, Figure 6) employing a long line focus Cu X-ray tube, divergent and anti-scatter slits fixed at 1 mm, a receiving slit (0.6 mm), diffracted and incident beam Soller slits (0.04 rad), a curved graphite diffracted beam monochromator, and a sealed proportional counter. Generator settings used are 40 kV and 30mA. Sample was placed in a custom-made circular sample holder and excited with the copper radiation of 1.54 angstroms. Tests were scanned at  $2\theta$  from  $4^\circ$  to  $64^\circ$  with a step of  $0.02^\circ$   $2\theta$  integrated at 1 sec.  $\text{step}^{-1}$  dwell time.

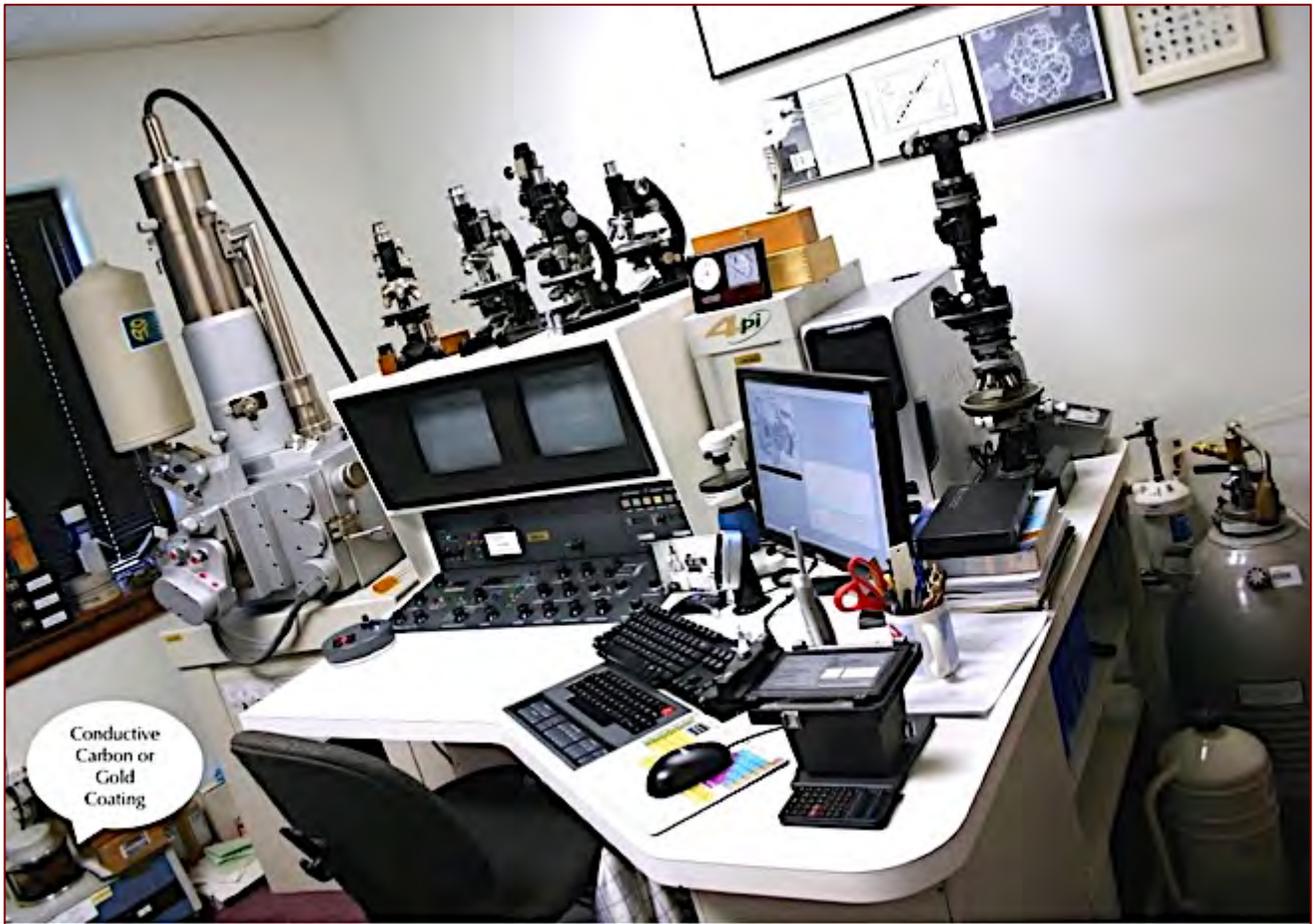
Figure 7: SEM-EDS: Cambridge CamScan Series II Scanning Electron Microscope and 4Pi Revolution software, backscatter detector, secondary electron detector, and energy-dispersive X-ray fluorescence spectrometer used for microstructural and microchemical analyses of concretes and aggregates.

Polished and gold-palladium coated thin sections of cores already examined by optical microscopy were selected for SEM-EDS studies and examined in a Cambridge CamScan Series II scanning electron microscope equipped with a backscatter detector, a secondary electron detector, and x-ray fluorescence spectrometer (Figure 7) to observe pyrrhotite or other potentially unsound constituents in concretes and aggregates and their effect on the performance and durability of concrete, as well as evidence of internal sulfate attack and secondary ettringite formation in the paste from released sulfate.

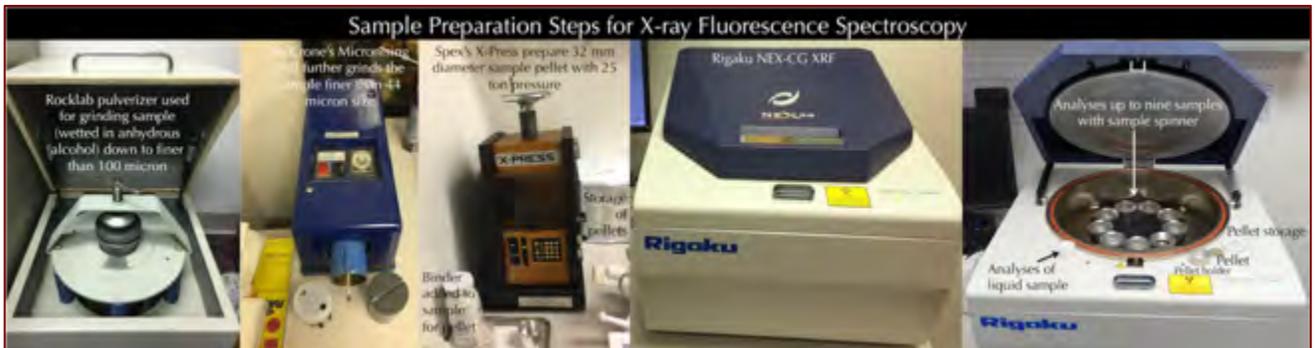
Figure 8: XRF: Rigaku NEX-CG bench-top ED-XRF unit used for bulk chemical compositions of concretes and aggregates.

An energy-dispersive bench-top X-ray fluorescence unit from Rigaku Americas Corporation (NEX-CG, Figure 8) was used for determination of bulk chemical (oxide) compositions and sulfur (as  $SO_3$ ) contents of concretes and unsound aggregate particles on pressed pellets, which were previously examined in XRD. The instrument is calibrated by using various certified (CCRL, NIST, GSA, and Brammer) reference standards of rocks. The sample pellet prepared for X-ray diffraction is used for X-ray fluorescence studies as well. The main focus of this analysis was to determine the sulfur contents (as  $SO_3$ ) in the aggregate particles as well as bulk sulfate contents (as  $SO_3$ ) in concretes.

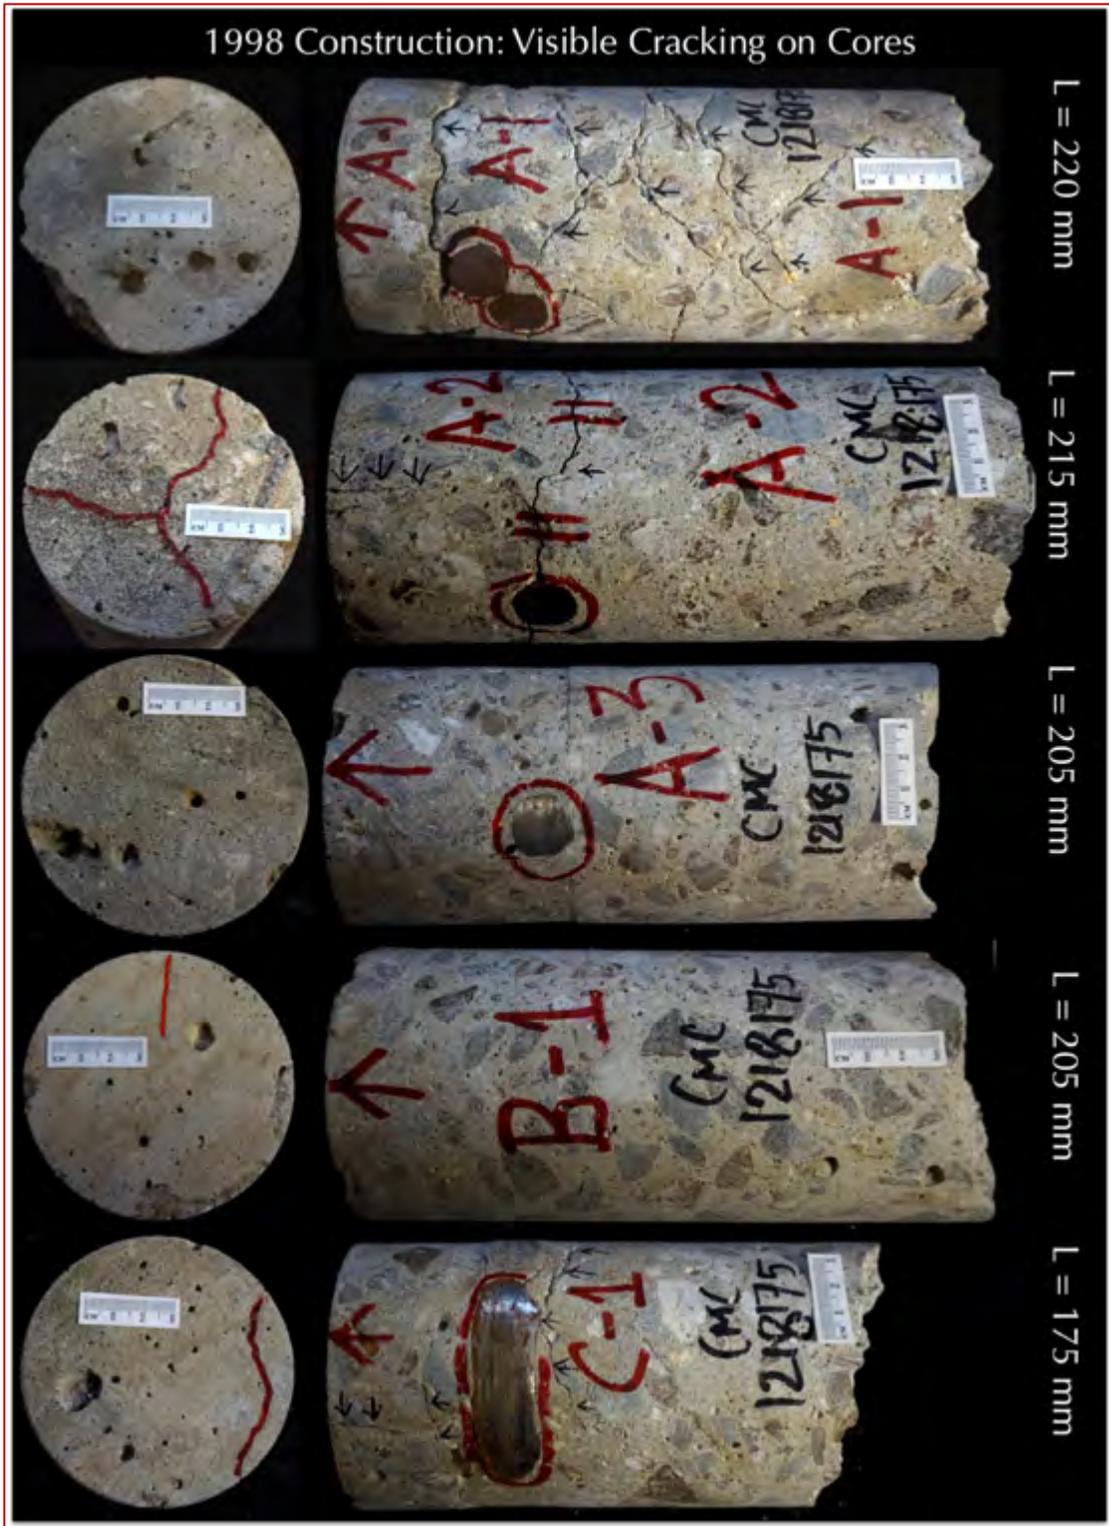
Figure 10: Shown are the exposed formed end surfaces (left), and cylindrical side views of Cores A-1 through A-3, B-1, and C-1 (right), as received. Red arrows in the right column point to the formed exposed ends. Small black arrows on cylindrical side surfaces indicate visible cracks. Nominal lengths of cores are given at right. Reinforcing steels are marked. See Appendix A for details.

Figures 10 to 12 show all fifteen cores as received where visible cracks on the exposed surfaces as well as side cylindrical surfaces are marked to show variations in crack intensities to classify them into four groups. Based on observations of cracking in field photos as well as the cores received it is, therefore, confirmed that cracking of foundation walls have occurred in A, C, and D-series cores in varying degrees, whereas no visible cracking on the wall at the location of Core B-1, or, in the 2001 construction (except a few isolated vertical cracks not similar to the typical map cracking found in the walls of 1998 construction. Map cracking is the common manifestation of pyrrhotite-related deterioration as observed in many other foundations across eastern Connecticut.

Figures 10 to 12 and Appendix A show the exposed and opposite ends of the cores as well as the cylindrical surfaces, where visible cracks when noticed are marked. Figures 10 to 12 show the nominal lengths of the cores. Table 1 shows various degrees of cracking observed in the cores when received. Table 2 provides dimensions, opposite surfaces, integrity, and embedded items.

Figures 10 to 12, Appendix A and Table 1 provide visible cracking in ten cores from 1998 construction. Cracking is most visible (both in field photos and in cores received) in A-1, C-1 and all three cores of D-series. All visible cracks in field photos show the typical map cracking, which is common in many pyrrhotite-related distress of concrete foundations in eastern Connecticut.

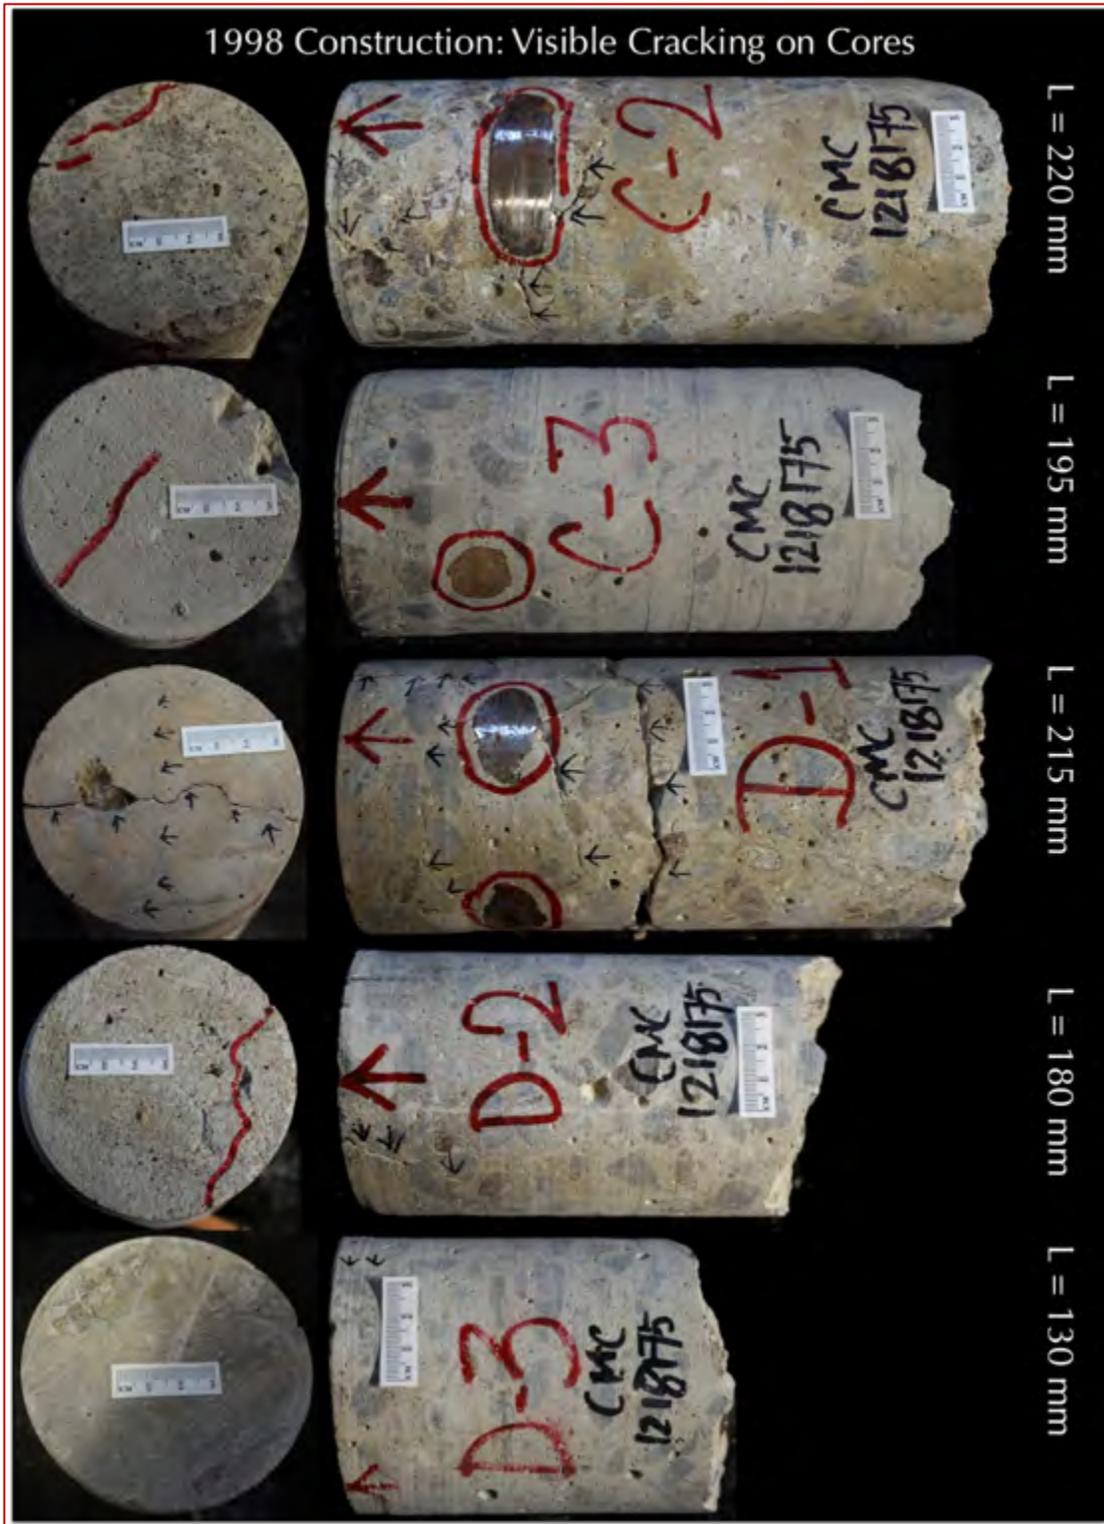
Figure 11: Shown are the exposed formed end surfaces (left), and cylindrical side views of Cores C-2, C-3, D-1 through D-3 (right), as received. Red arrows in the right column point to the formed exposed ends. Small black arrows on cylindrical side surfaces indicate visible cracks. Nominal lengths of cores are given at right. Reinforcing steels are marked. See Appendix A for details.

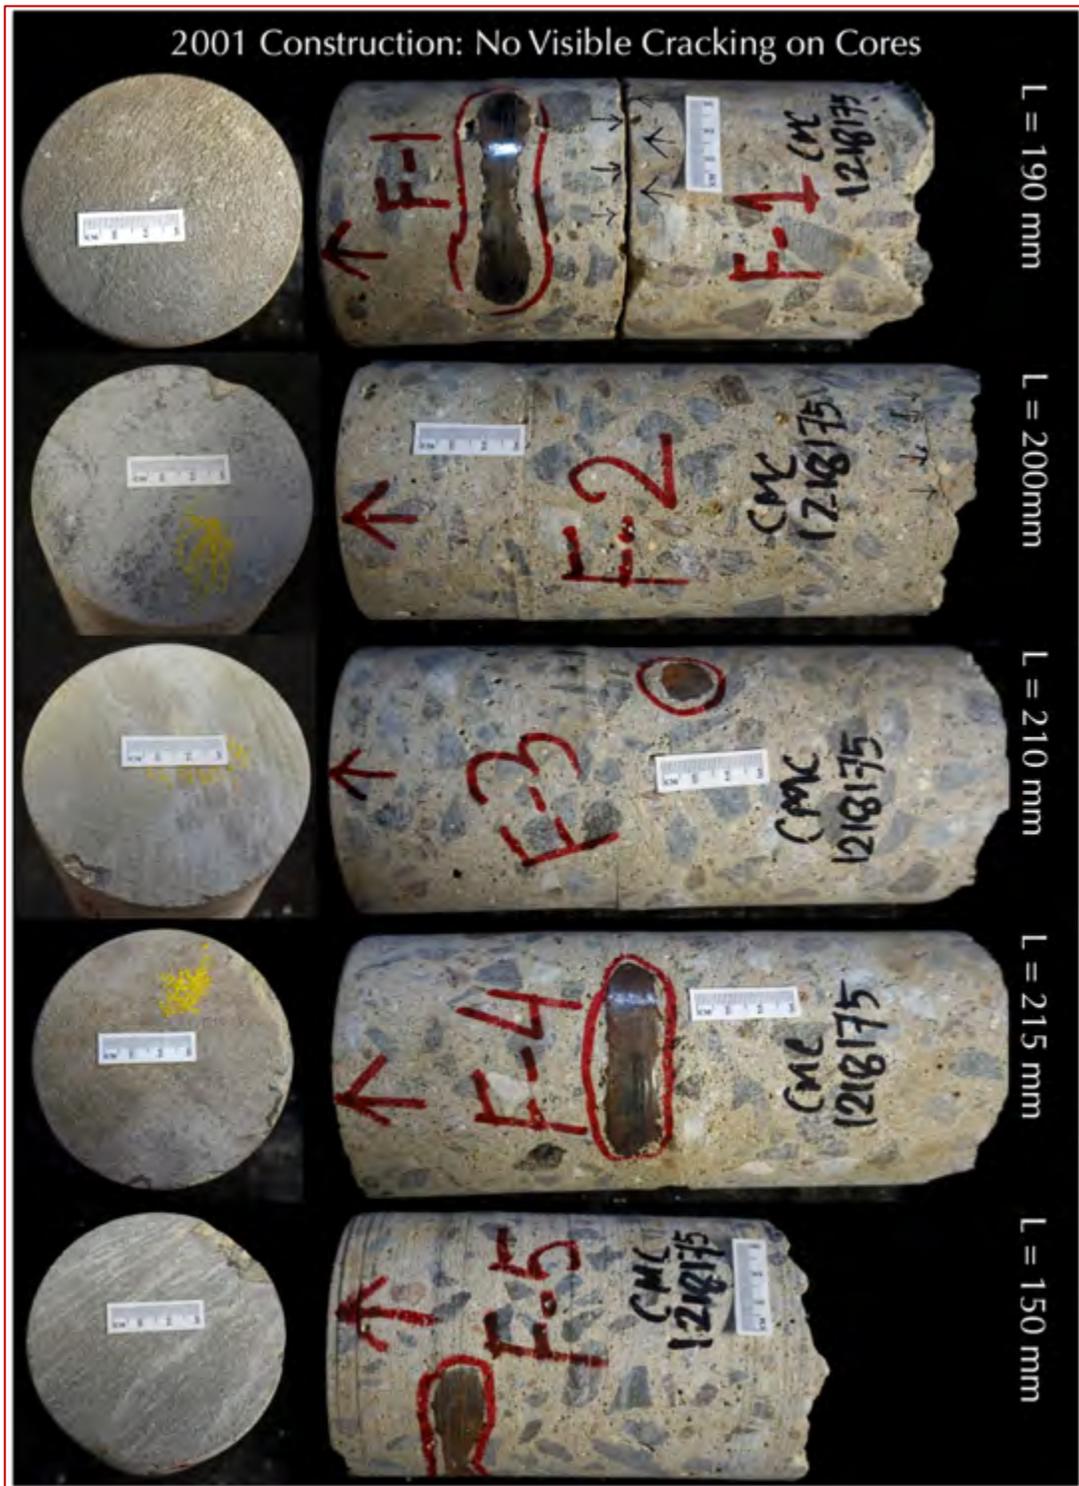
Figure 12: Shown are the exposed formed end surfaces of Cores from F-series from 2001 construction where a thin (1 mm thick) dark gray cementitious protective skim coat is detected (left), and cylindrical side views of cores (right), as received. Red arrows in the right column point to the formed exposed ends. Reinforcing steels are marked. Black arrows in Core F-1 indicate a possible construction joint. Nominal lengths of cores are given at right. See Appendix A for details.

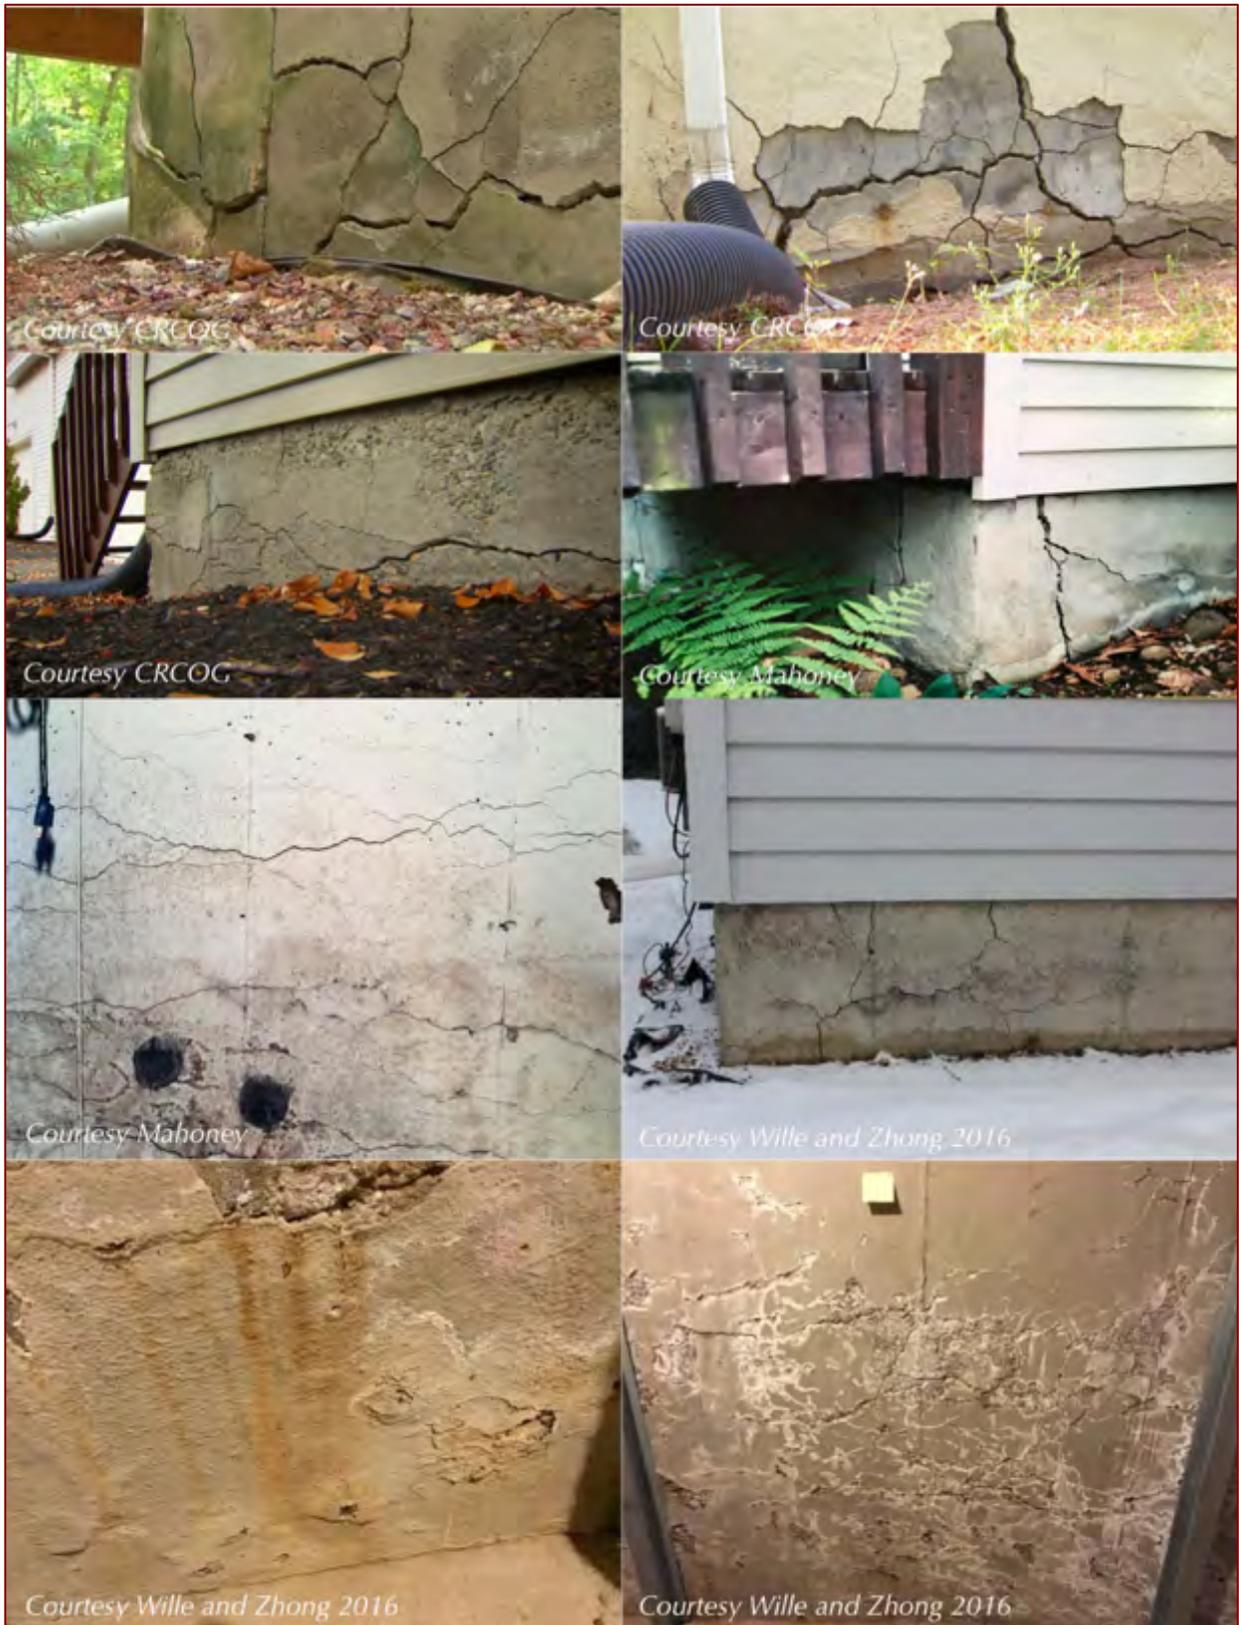
Figure 38: Cracking of concrete foundations in Connecticut due to oxidation of pyrrhotite bearing aggregates in concrete. Notice wide cracks in the top row as well as a network of numerous fine cracks in the wall in the bottom right row all from pyrrhotite oxidation and associated expansion of concrete.

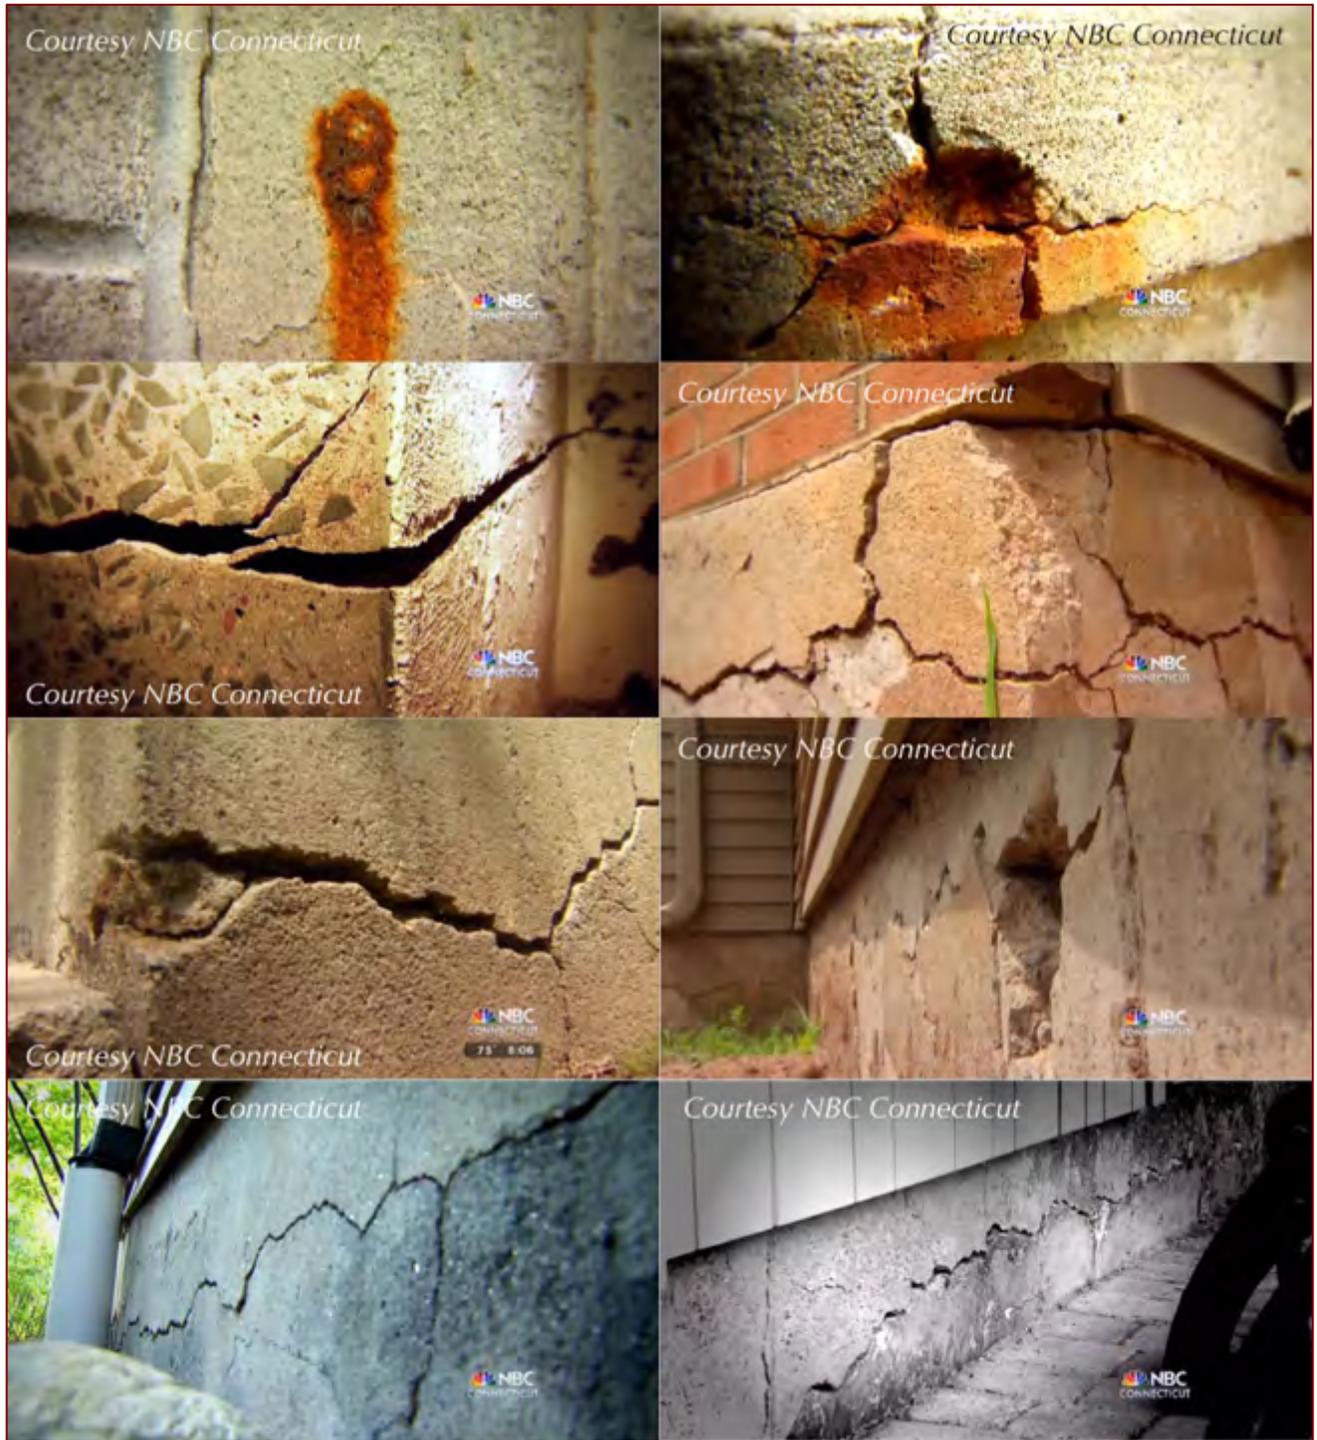
Figure 39: Cracking of concrete foundations in Connecticut due to oxidation of pyrrhotite bearing aggregates in concrete. Notice dark reddish brown rust staining on the wall and associated cracking in the top row from pyrrhotite oxidation and formation of ferric oxy-hydroxide oxidation products (goethite, limonite, ferrihydrite rust minerals). Notice wide cracks in the 2<sup>nd</sup> through 4<sup>th</sup> rows from pyrrhotite oxidation and associated expansion of concrete.

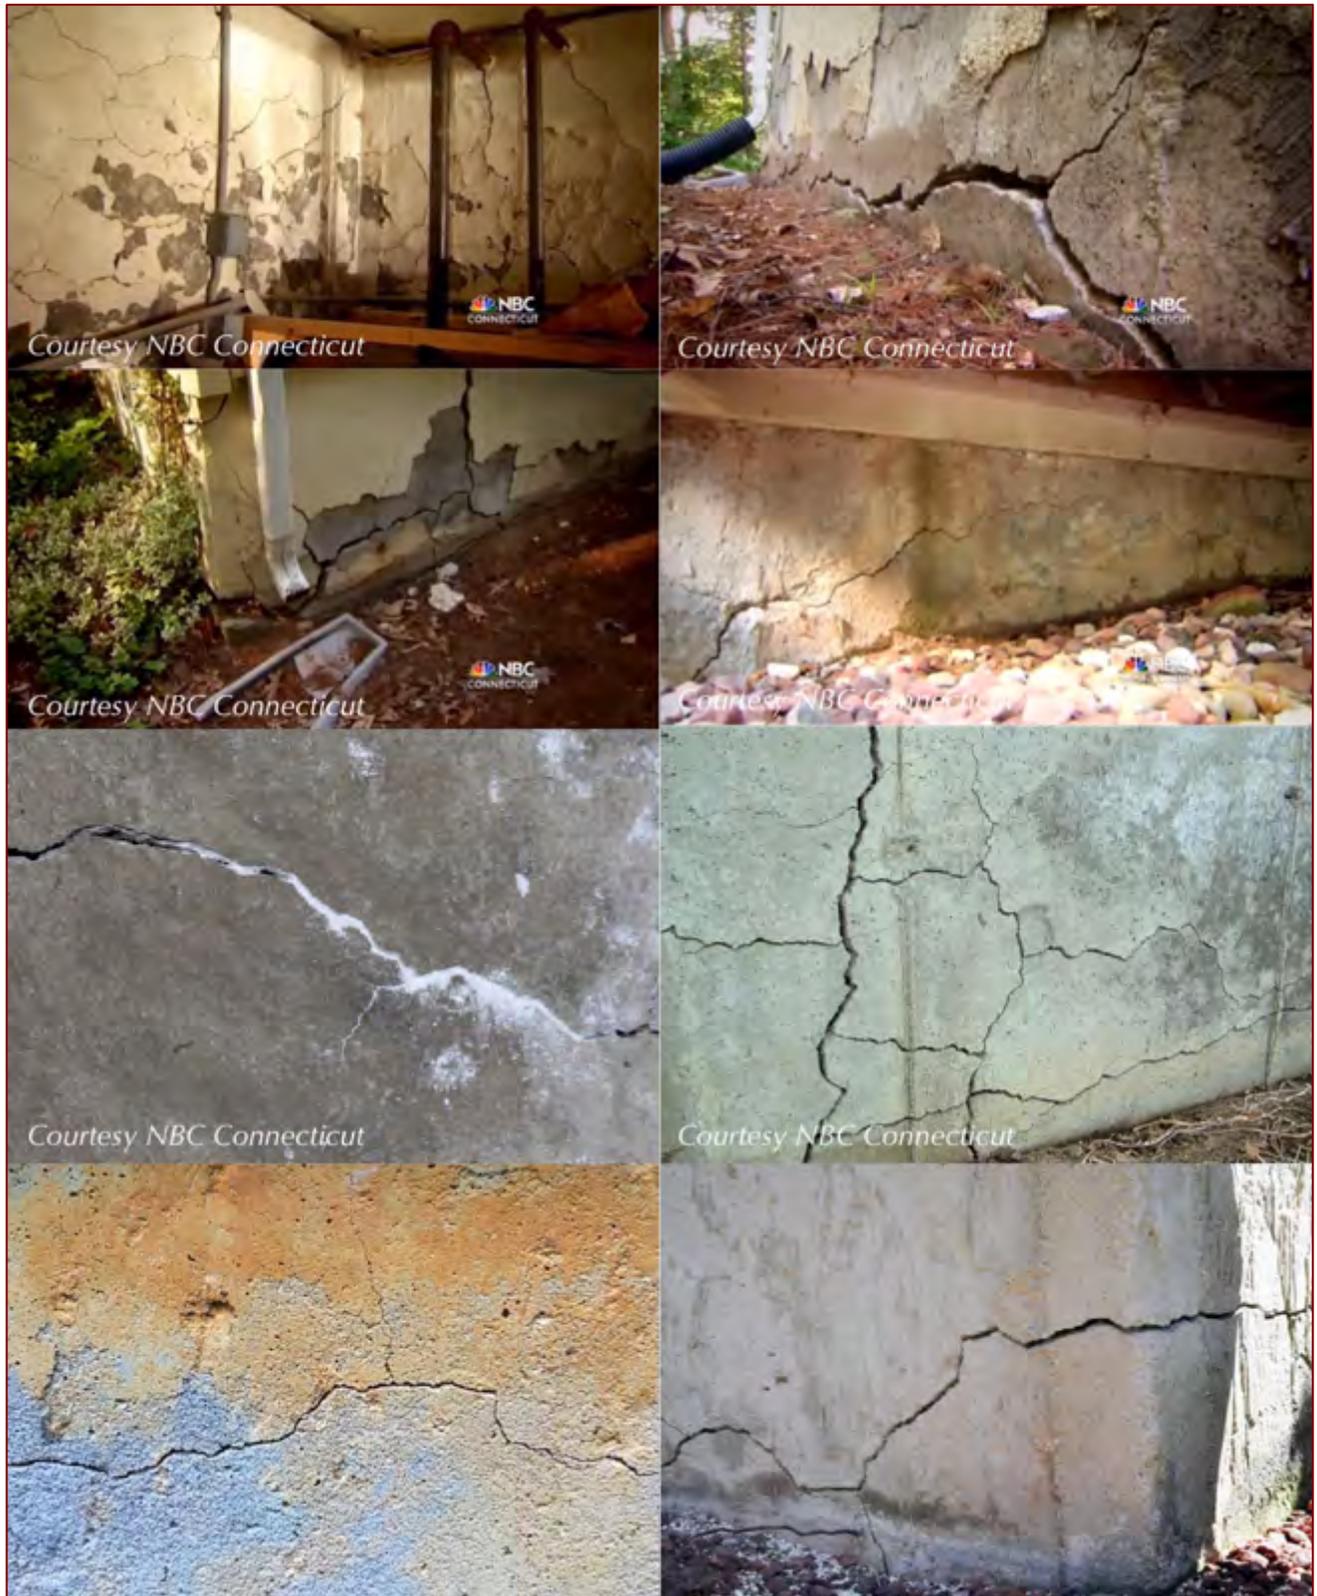
Figure 40: Cracking of concrete foundation in Connecticut due to oxidation of pyrrhotite bearing aggregates in concrete. Notice wide cracks in the foundation walls, extensive cracking of walls in the top left photo all reportedly from pyrrhotite oxidation and associated expansion of concrete.
