## Pyrrhotite Epidemic in Eastern Connecticut: A Case Study From Tolland, CT

Tolland Board of Education  
Birch Grove School  
247 Rhodes Road  
Tolland, CT 06084

January 10, 2019  
CMC 1218175

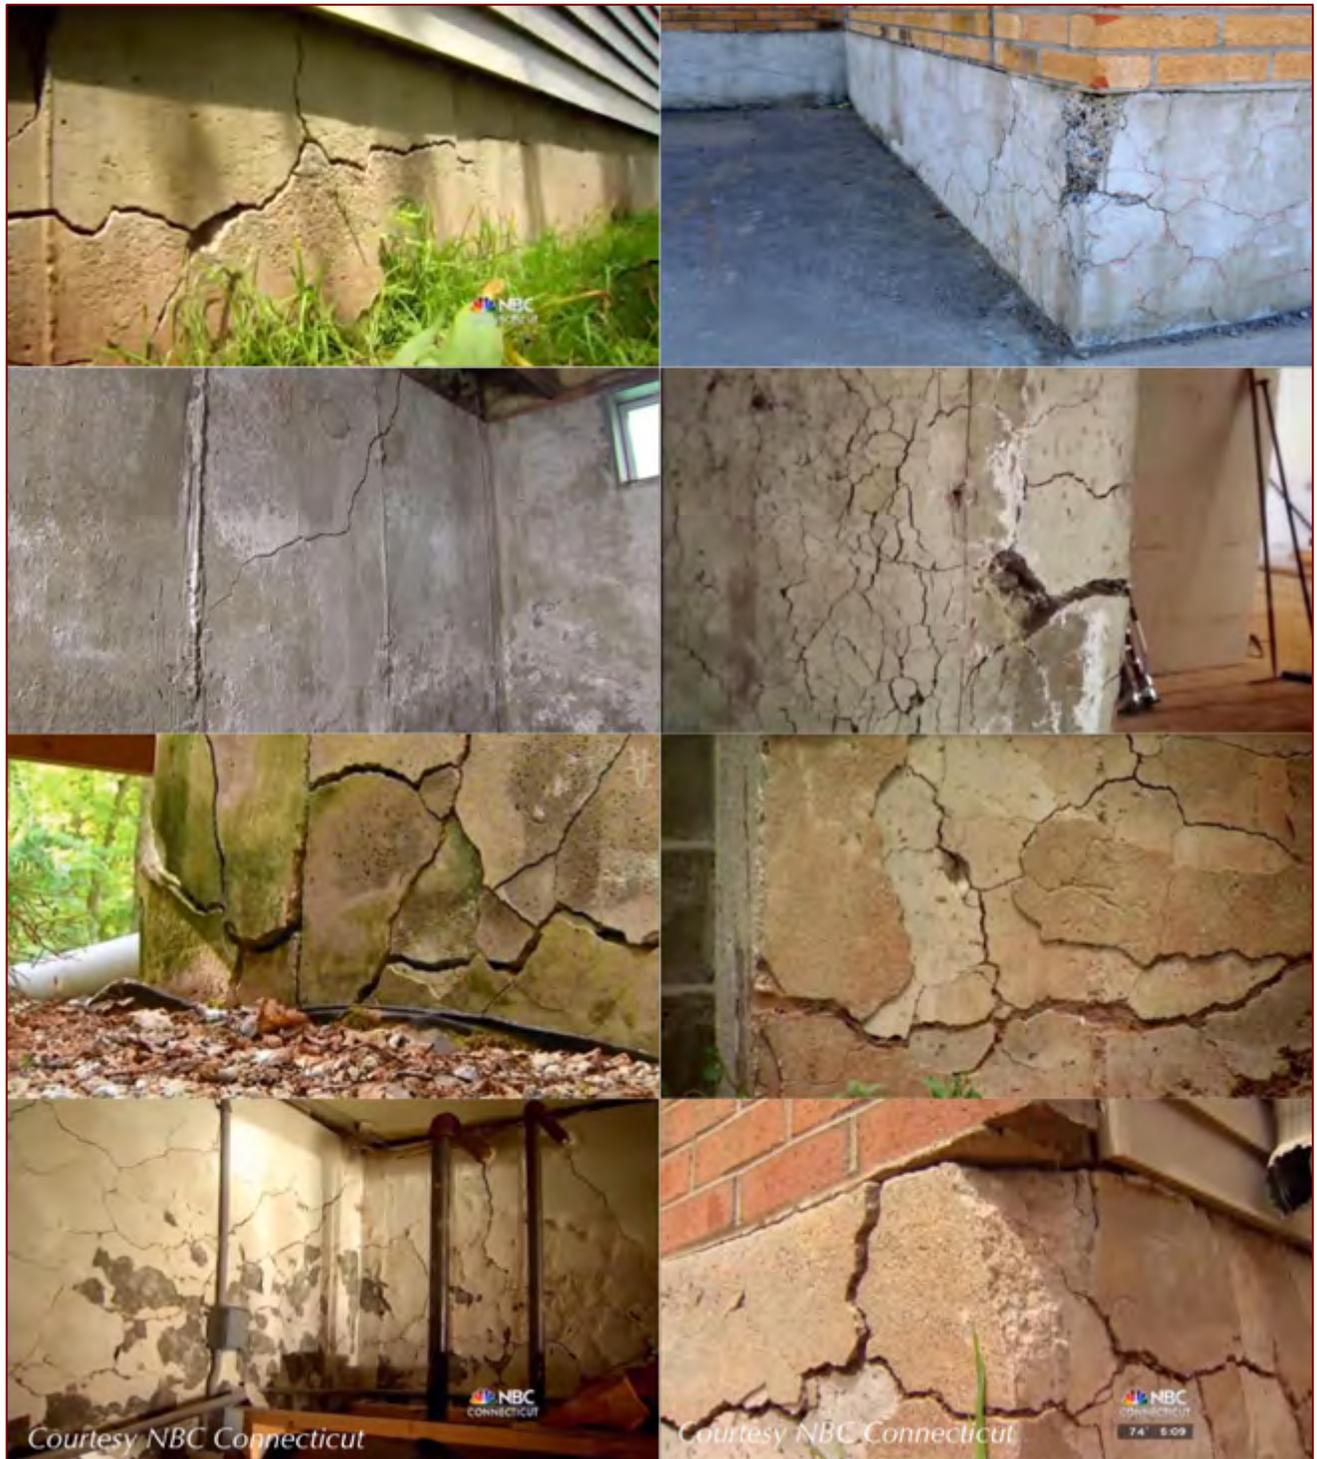
Figure 41: Cracking of concrete foundation in Connecticut due to oxidation of pyrrhotite bearing aggregates in concrete. Notice extensive cracking of foundation in all photos reportedly from pyrrhotite oxidation and associated expansion of concrete.

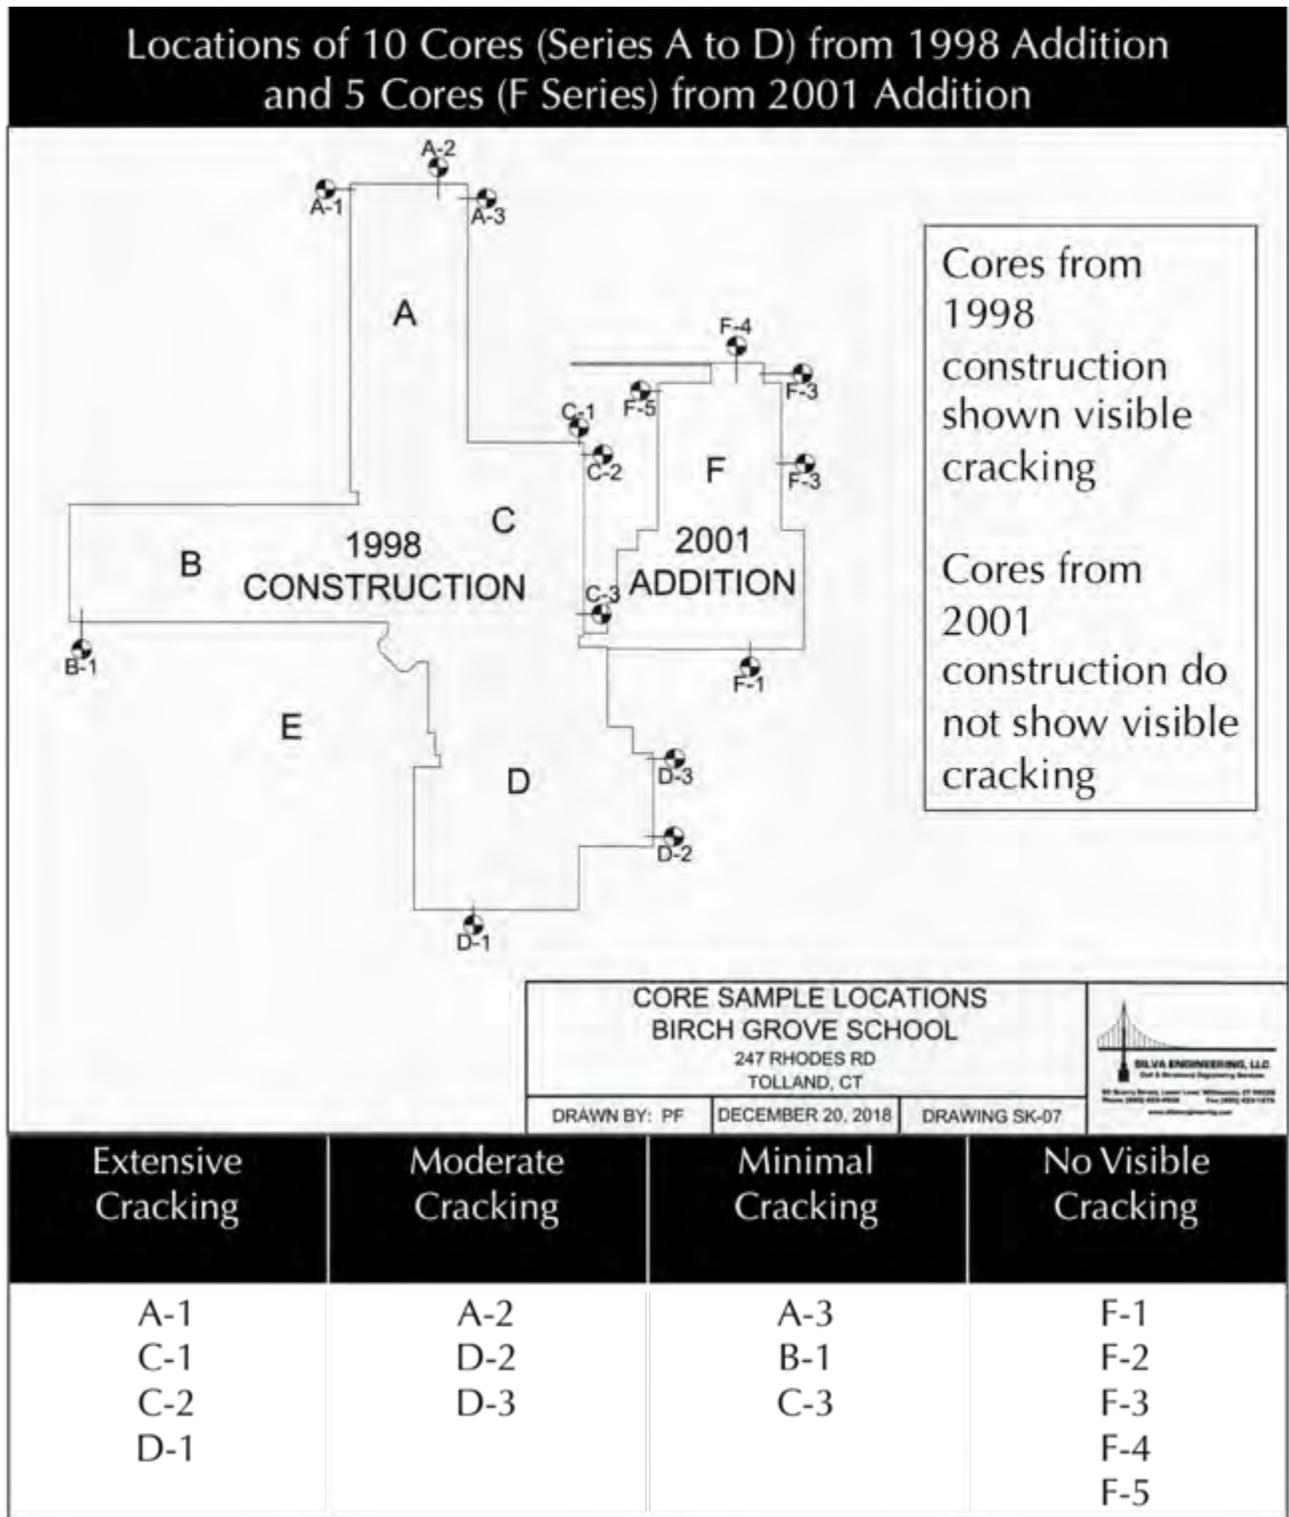
Figure A 2: Schematic drawing showing locations of cores collected from around the buildings from 1998 and 2001 constructions. Different degree of cracking visible on the cylindrical and exposed surfaces of cores from 1998 construction related to availability of moisture into concrete during service to trigger pyrrhotite-related deteriorations to cause cracking.

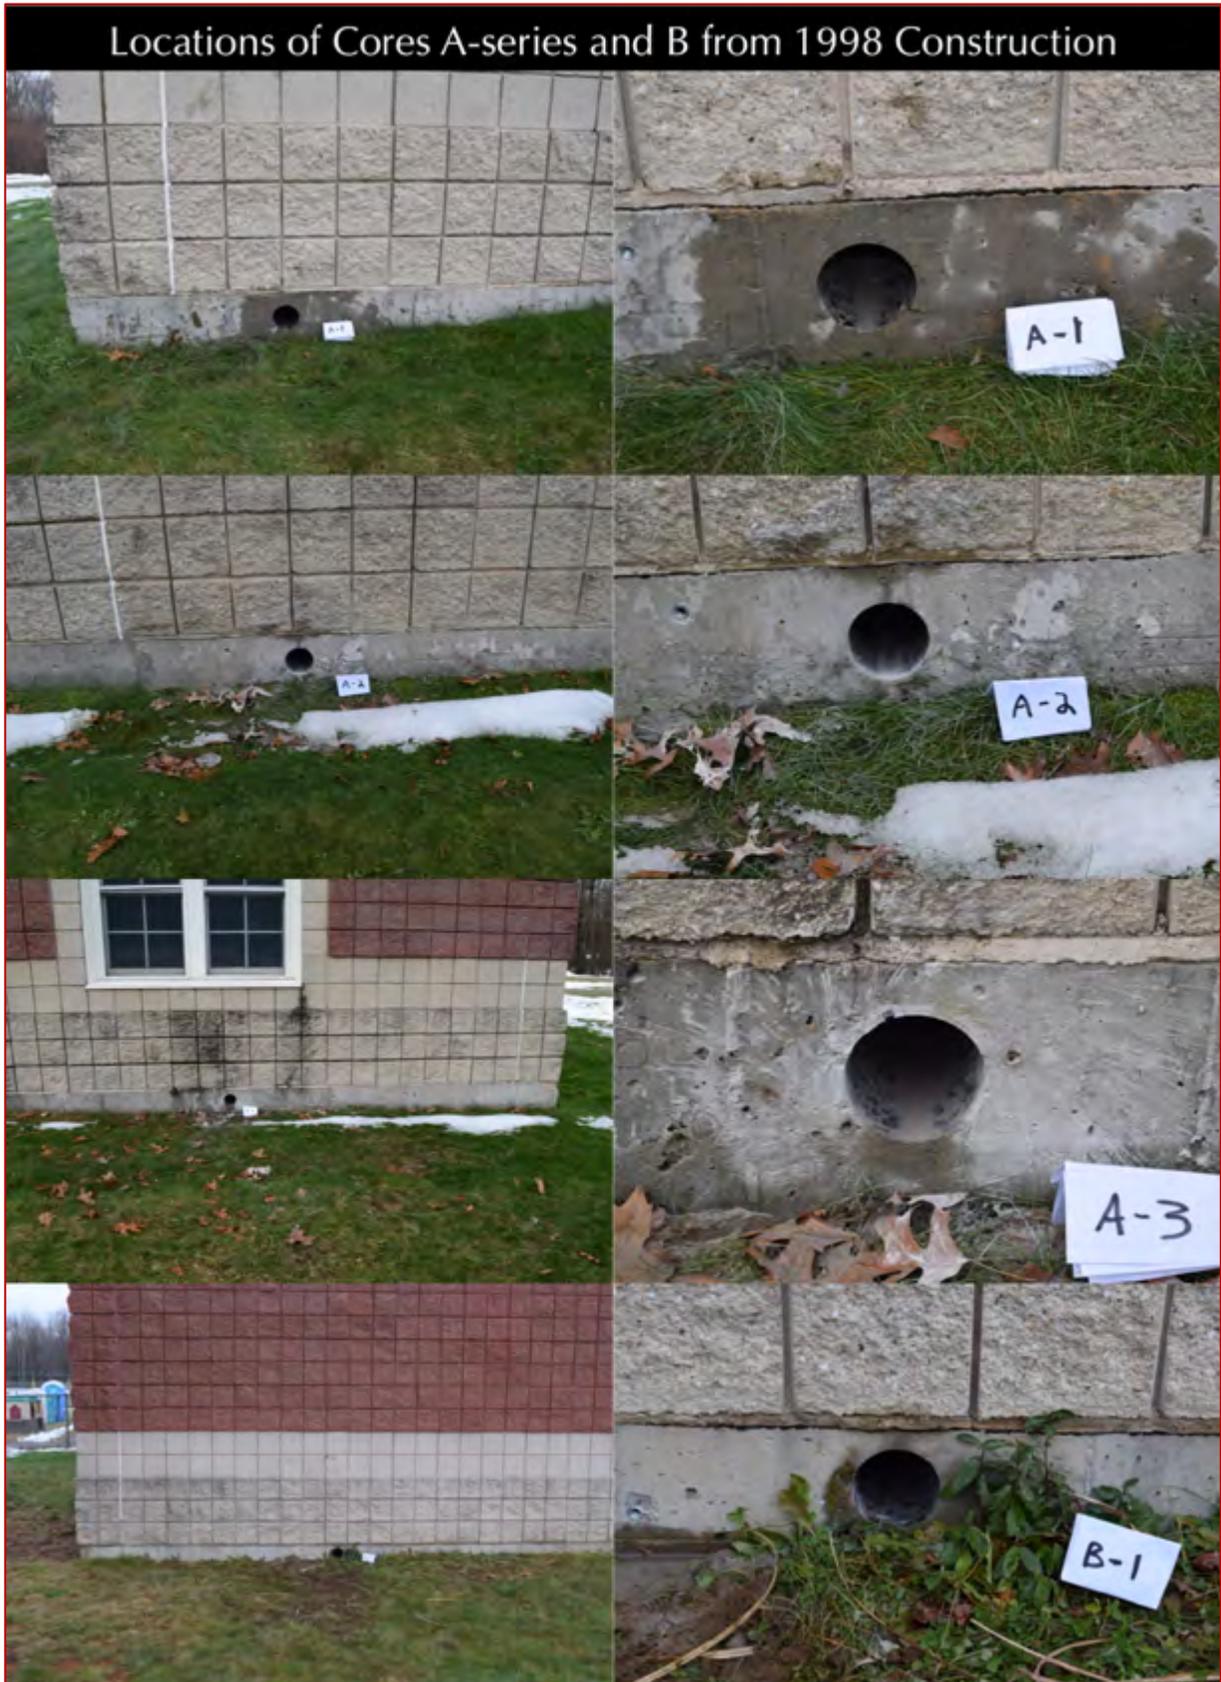
Figure A 3: Conditions of concrete foundations at the locations of cores from A-series, and B-1. Some visible map cracks are seen in the foundation from where Core A-1 was retrieved.

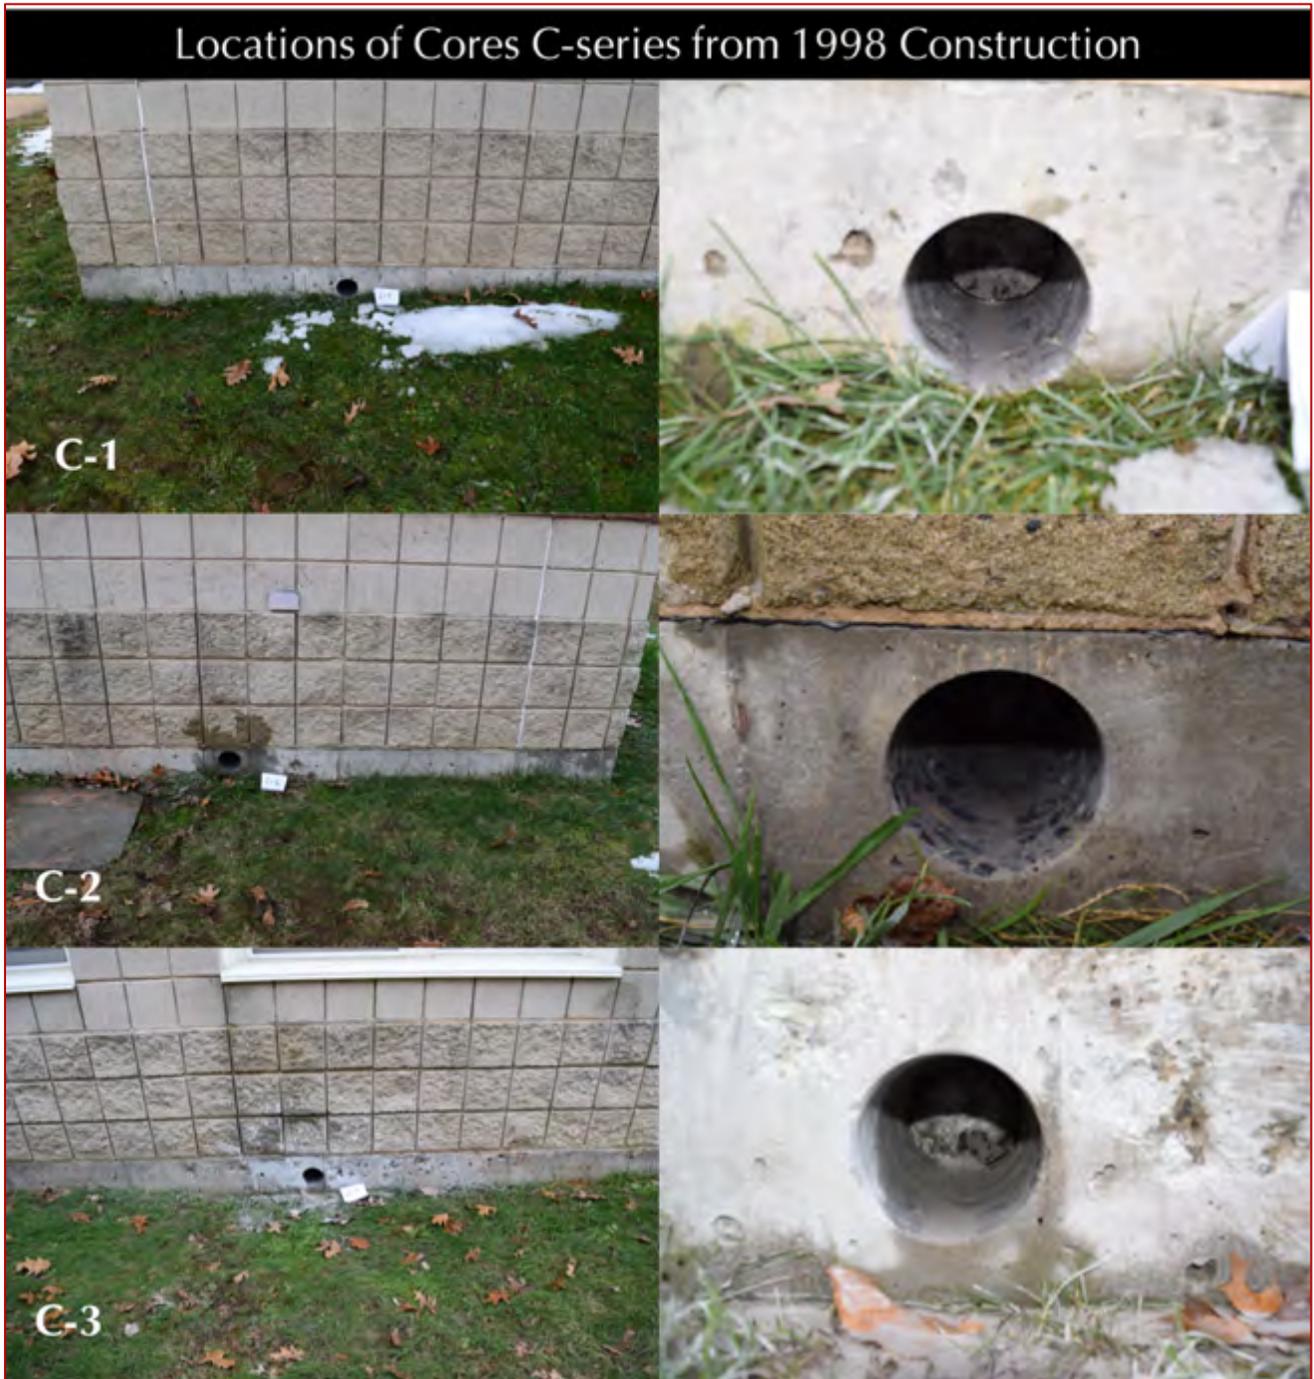
Figure A 4: Conditions of concrete foundations at the locations of cores from C-series. Some visible map cracks are seen in the foundation from where Core C-1 was retrieved.

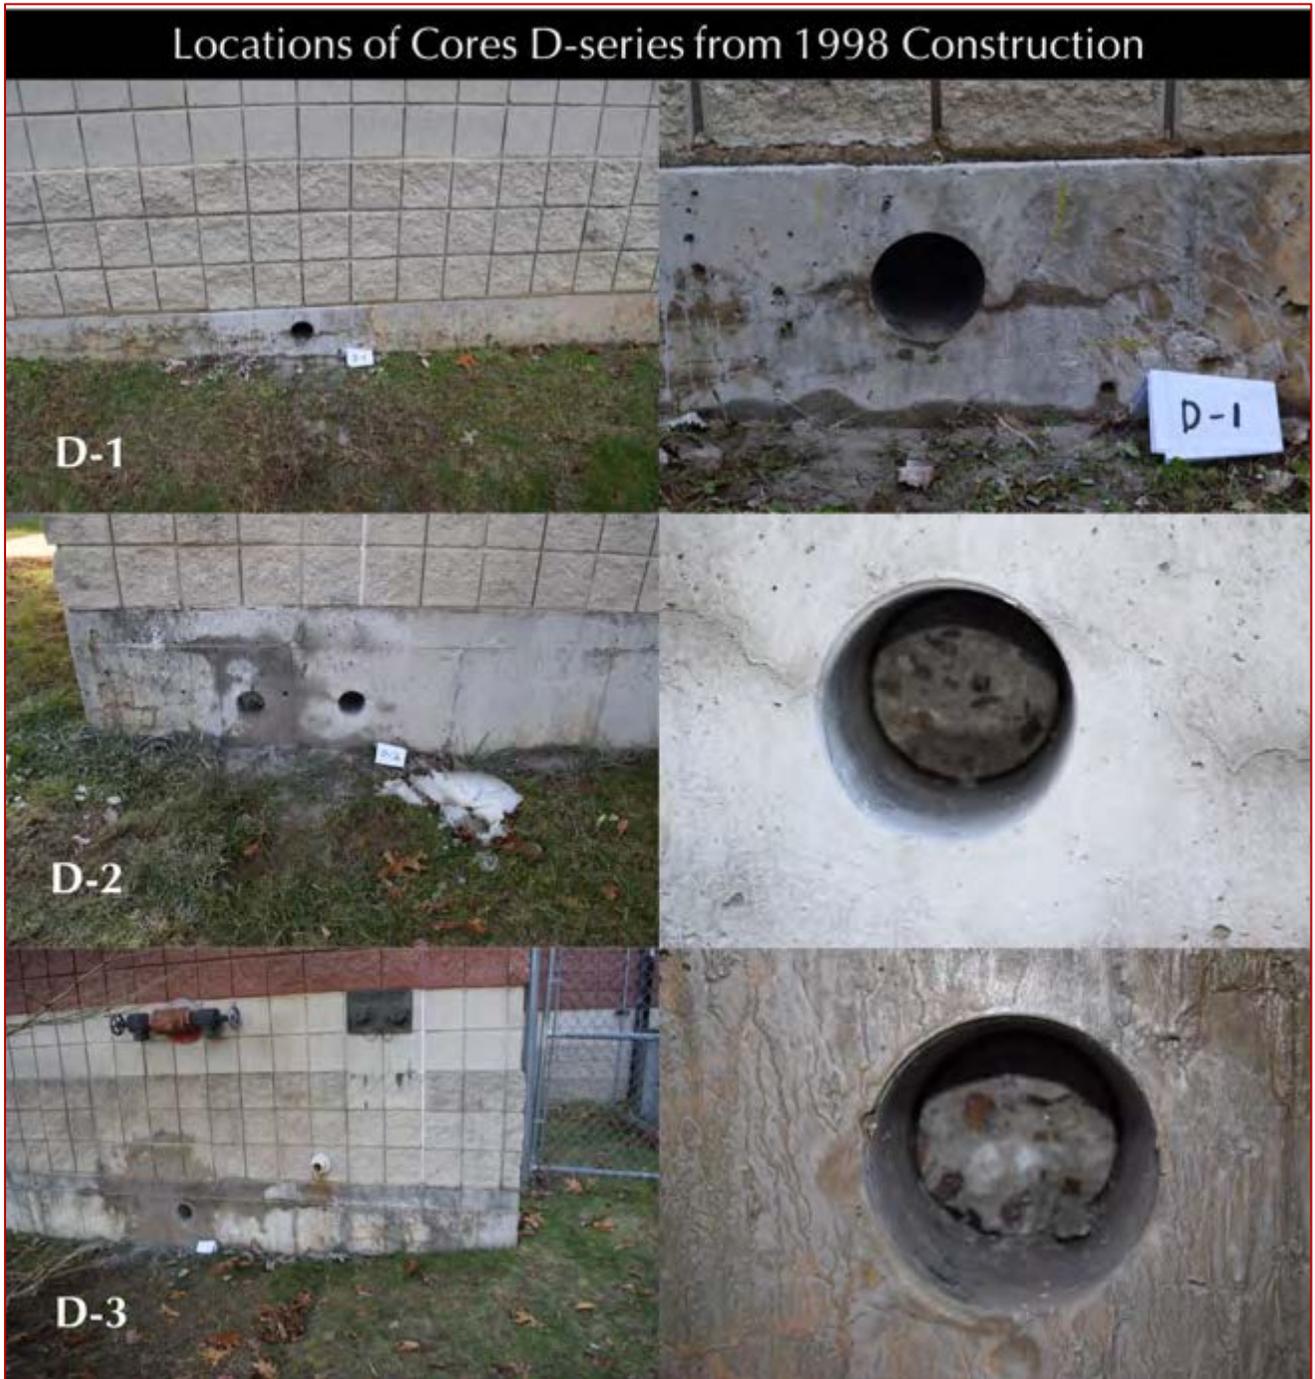
Figure A 5: Conditions of concrete foundations at the locations of cores from D-series. Some visible map cracks are seen in the foundation from all three core locations.

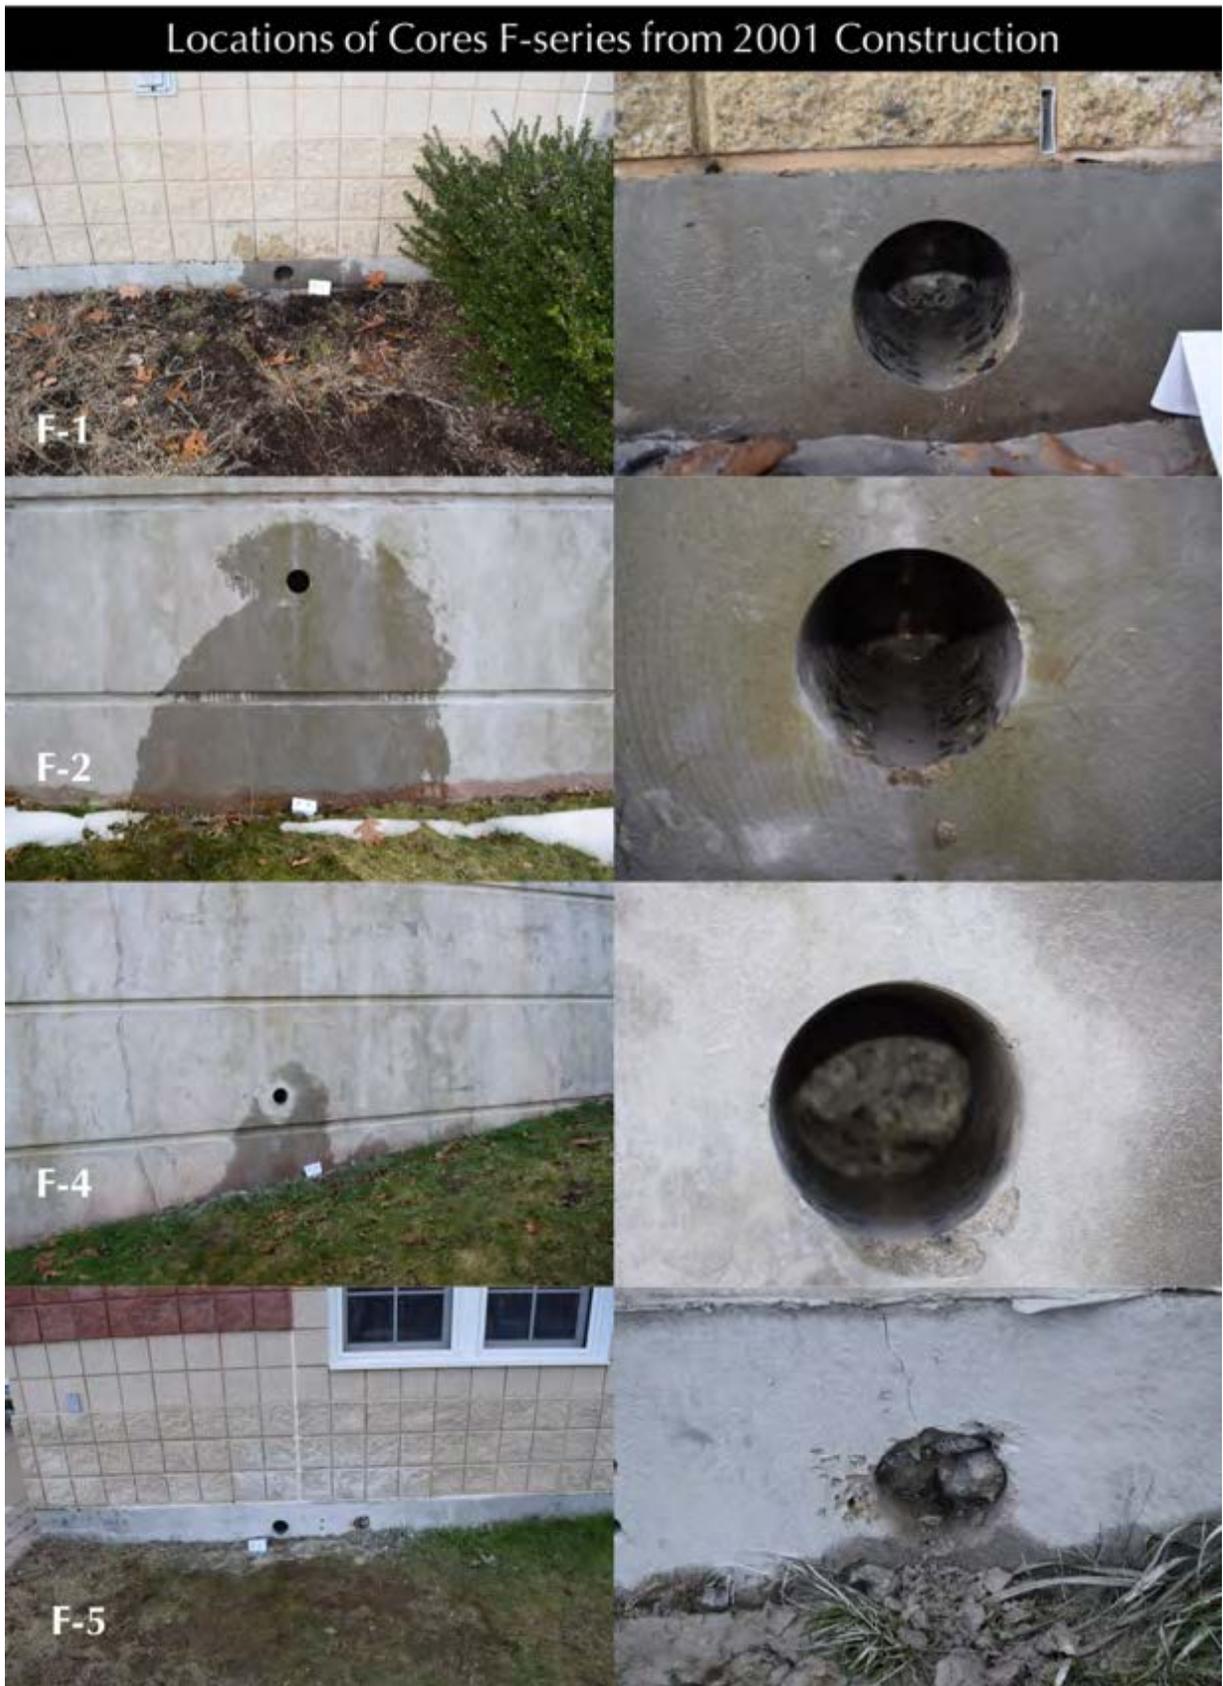
Figure A 6: Conditions of concrete foundations at the locations of cores from F-series. Some visible map cracks are seen in the foundation from where Core F-4 was retrieved.

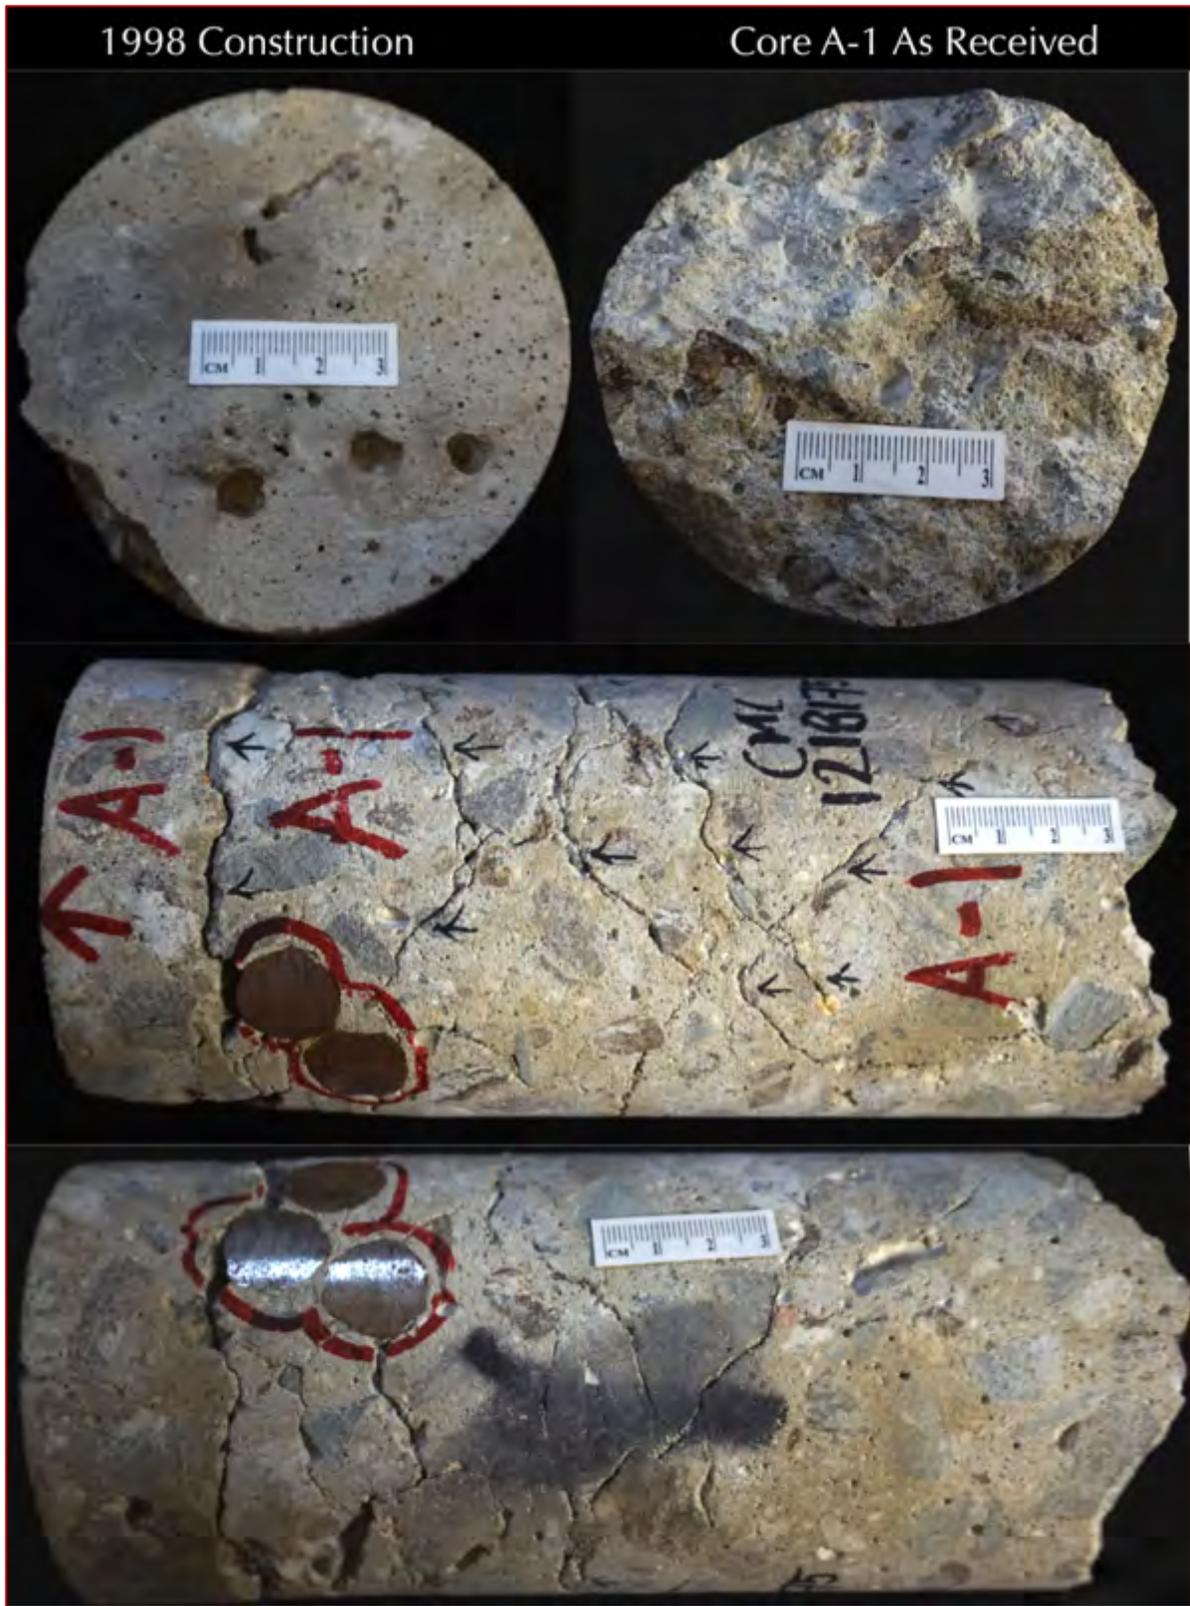
Figure A 7: Shown are the formed exposed wall surface with coarse voids and no visible cracking (top left), the fresh fractured inside surface (top right), and cylindrical side views of Core A-1 (middle and bottom), as received. Notice extensive cracking of concrete throughout the depth of the core in the cylindrical side surfaces many of which are marked with arrows.

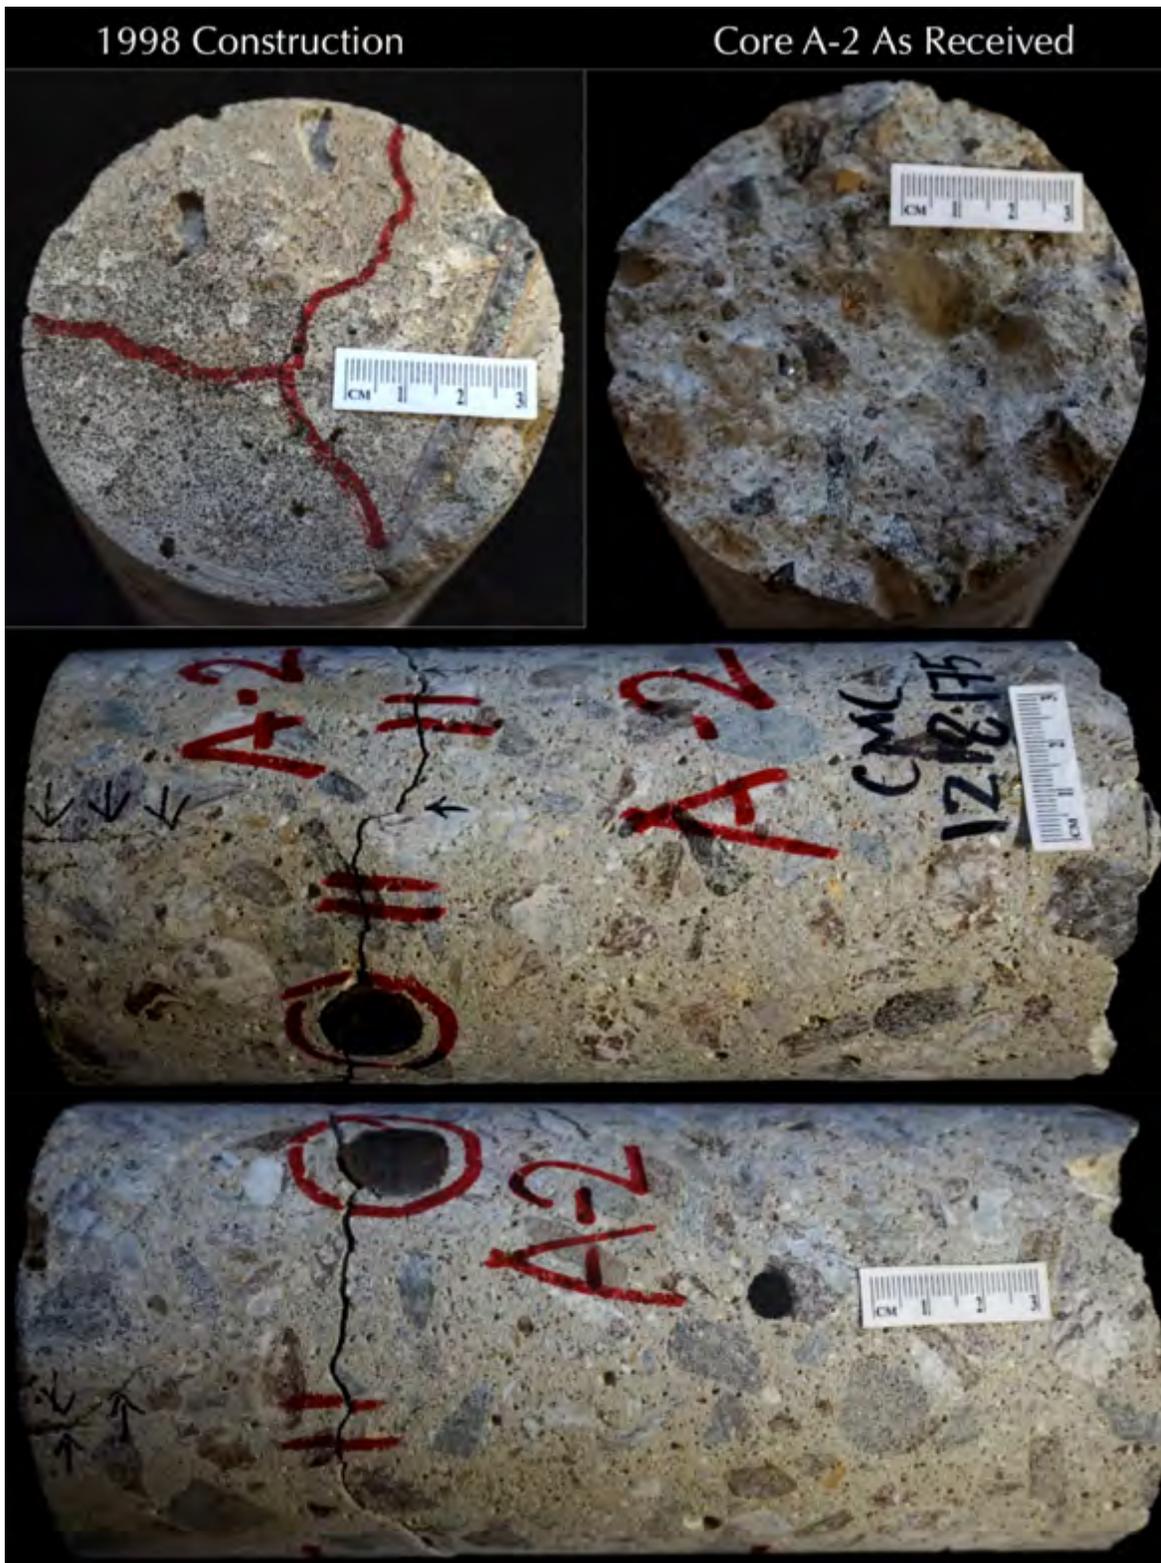
Figure A 8: Shown are the formed exposed wall surface with a few coarse voids and Y-shaped visible cracking (top left), the fresh fractured inside surface (top right), and cylindrical side views of Core A-2 (middle and bottom), as received. Notice moderate cracking of concrete, mostly at the exposed surface end of the core at the left edge of cylindrical side surfaces which are marked with arrows. Core was received in two unequal pieces probably cracked during coring operation and/or during transportation to our laboratory, probably broke along a pre-existing crack.

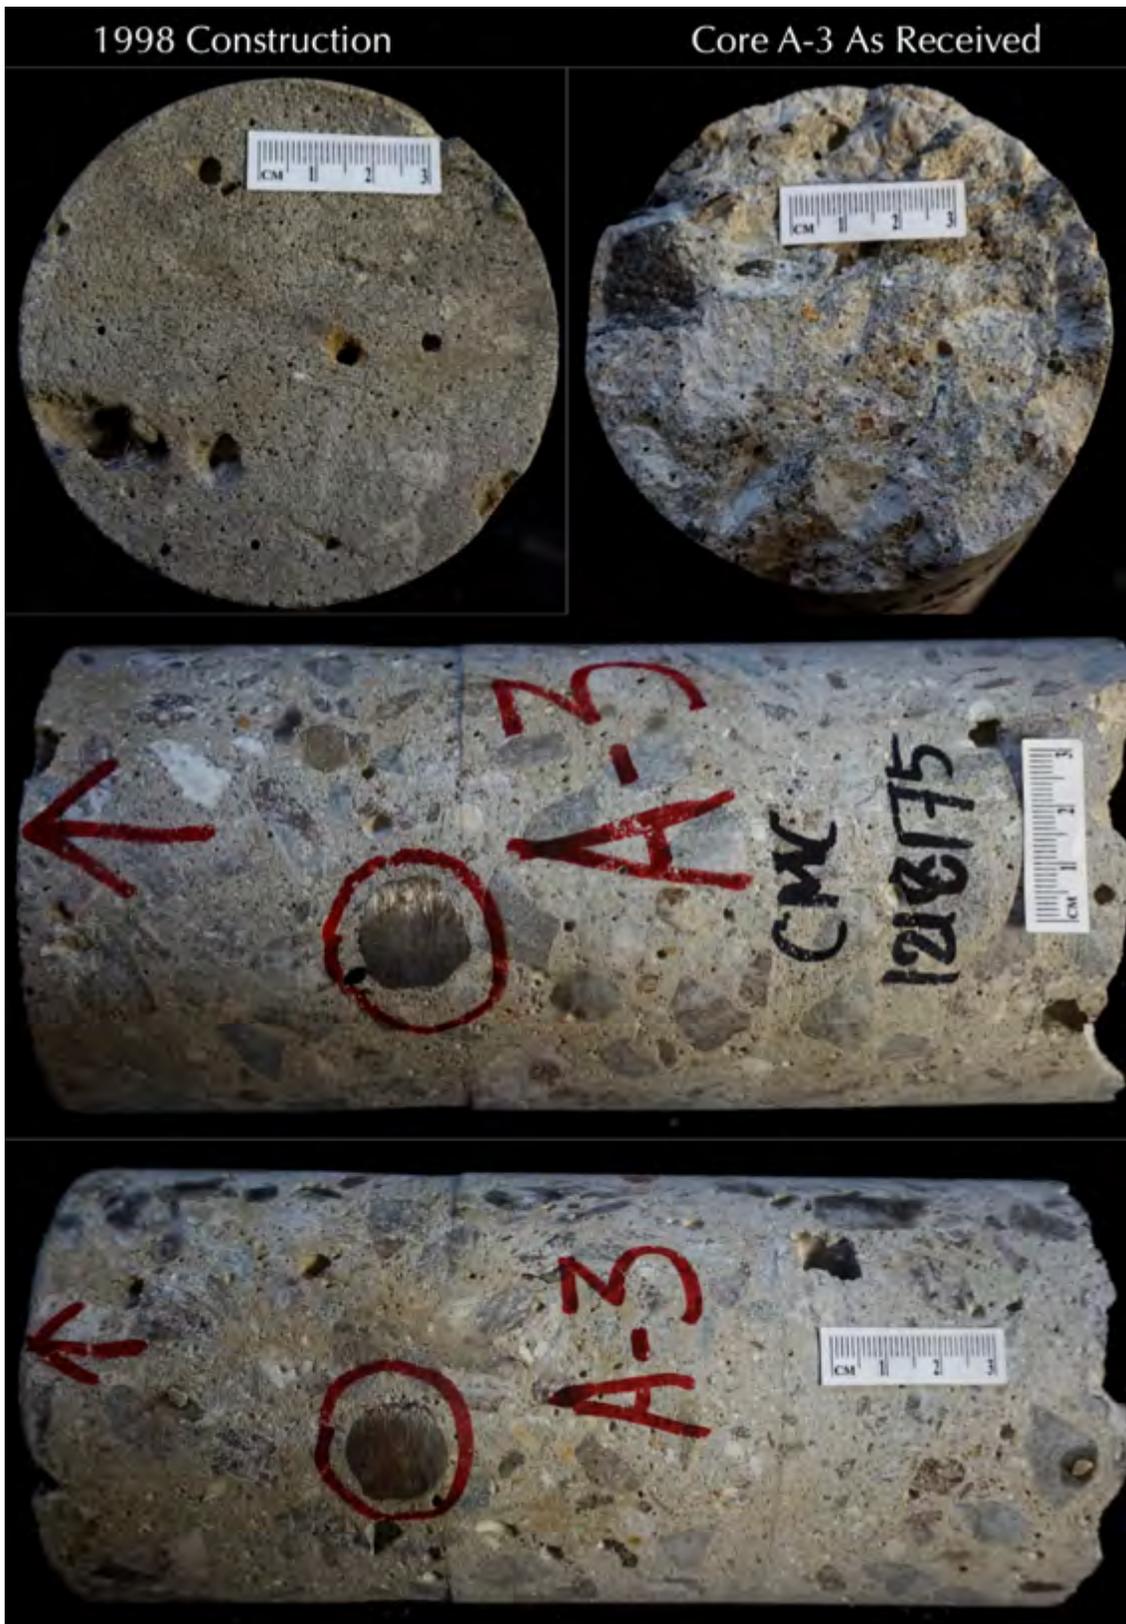
Figure A 9: Shown are the formed exposed wall surface with coarse voids and no visible cracking (top left), the fresh fractured inside surface (top right), and cylindrical side views of Core A-3 (middle and bottom), as received. Notice no visible cracking of concrete throughout the depth of the core in the cylindrical side surfaces.

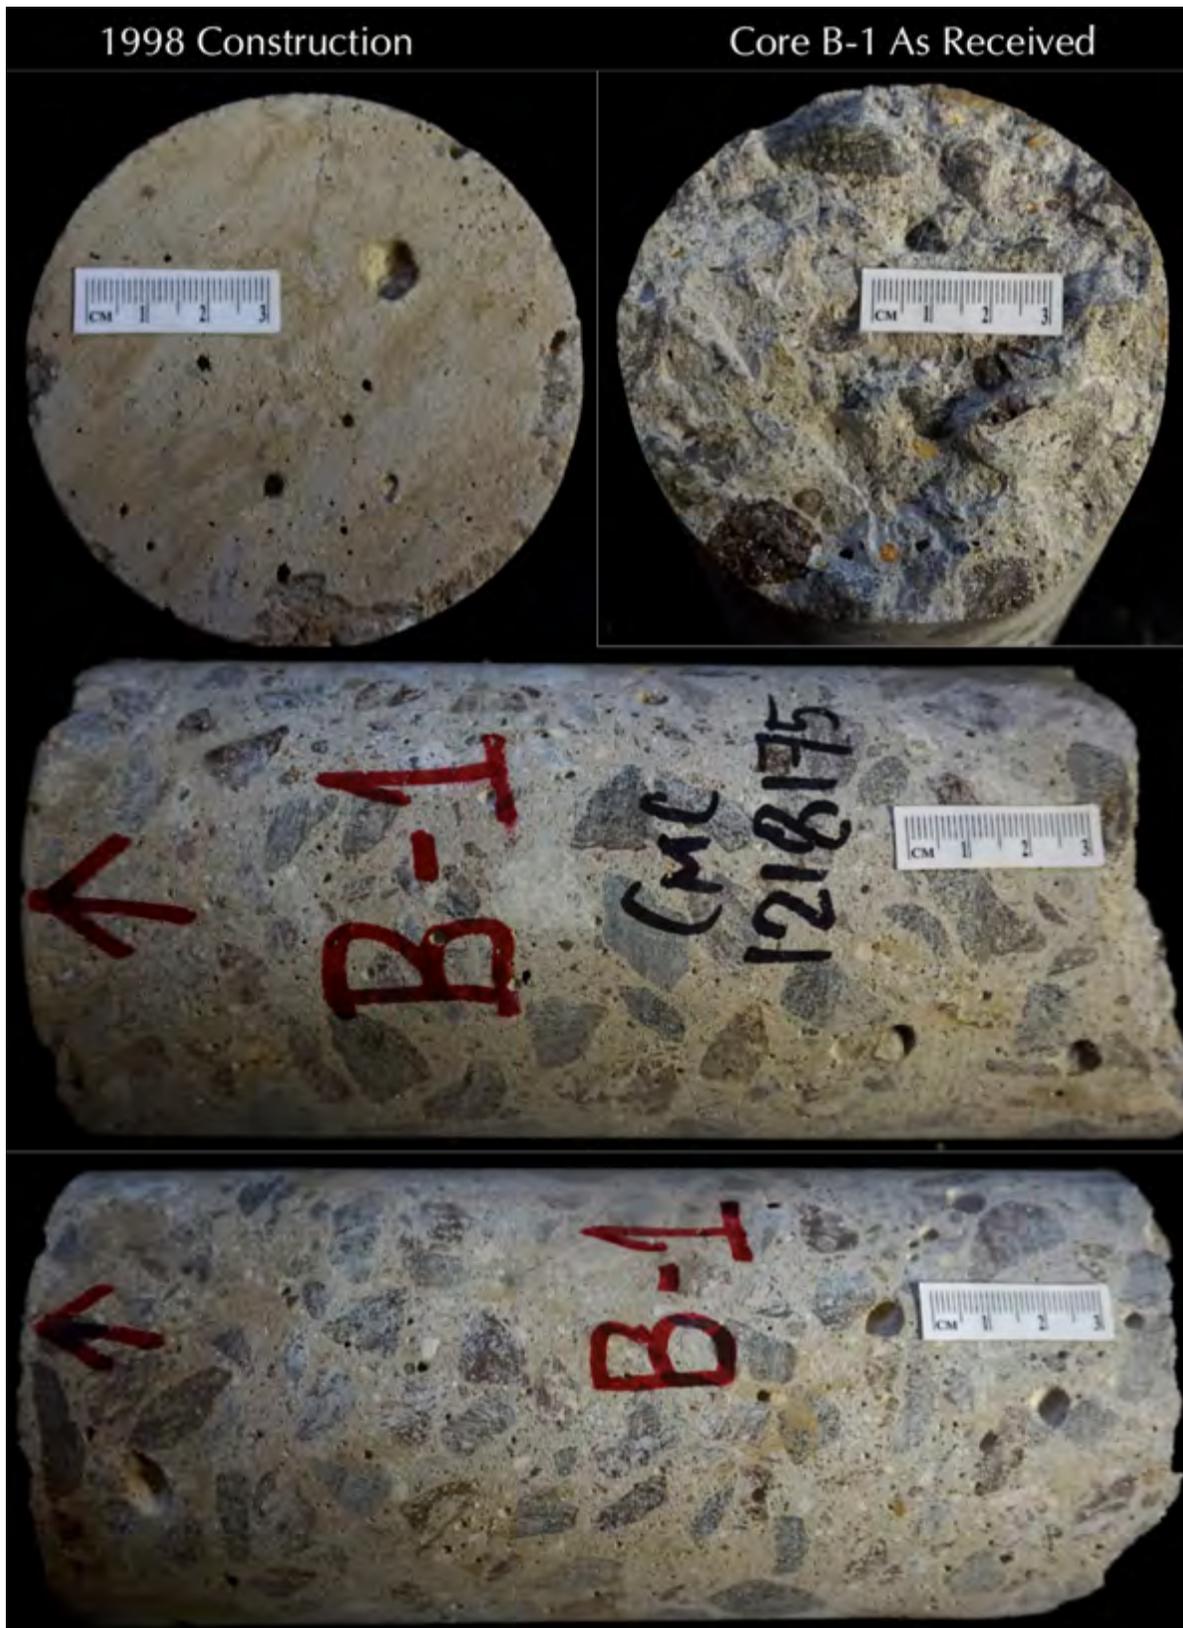
Figure A 10: Shown are the formed exposed wall surface with coarse voids and no visible cracking (top left), the fresh fractured inside surface (top right), and cylindrical side views of Core B-1 (middle and bottom), as received. Notice no visible cracking of concrete throughout the depth of the core in the cylindrical side surfaces.

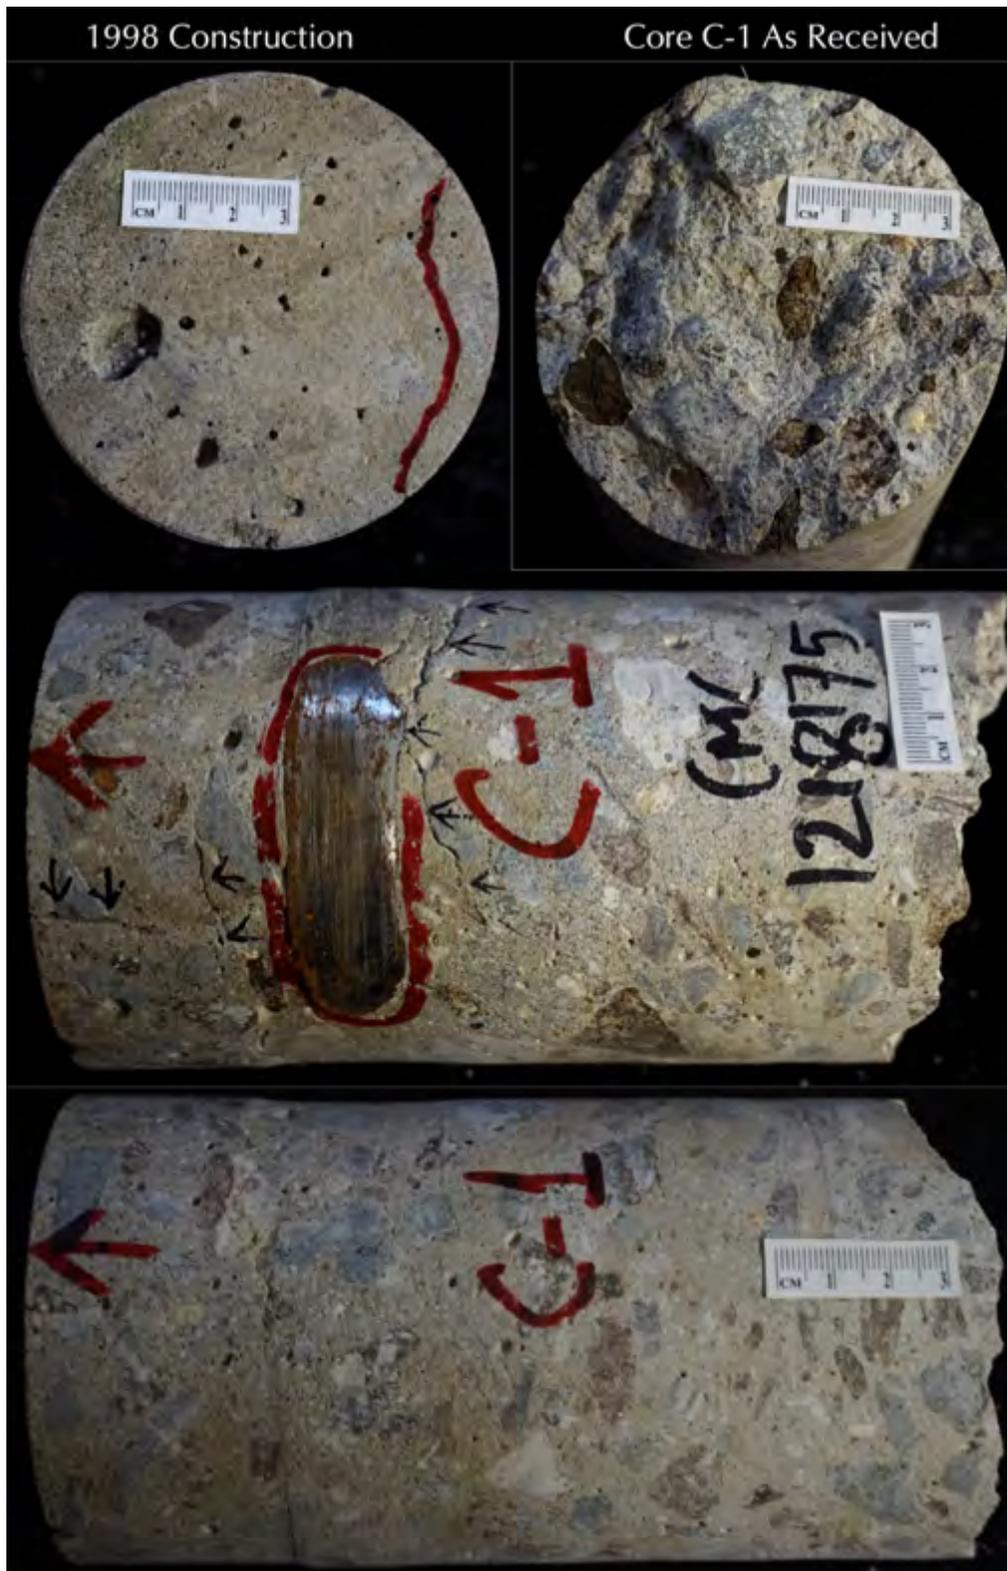
Figure A 11: Shown are the formed exposed wall surface with coarse voids and a visible crack marked in red line (top left), the fresh fractured inside surface (top right), and cylindrical side views of Core C-1 (middle and bottom), as received. Notice extensive cracking of concrete throughout the depth of the core in the cylindrical side surfaces many of which are marked with arrows. A No. 6 reinforcing steel at a depth of  $1\frac{3}{4}$  in. from the exposed surface is marked.
