## Pyrrhotite Epidemic in Eastern Connecticut: A Case Study From Tolland, CT

Tolland Board of Education  
Birch Grove School  
247 Rhodes Road  
Tolland, CT 06084

January 10, 2019  
CMC 1218175

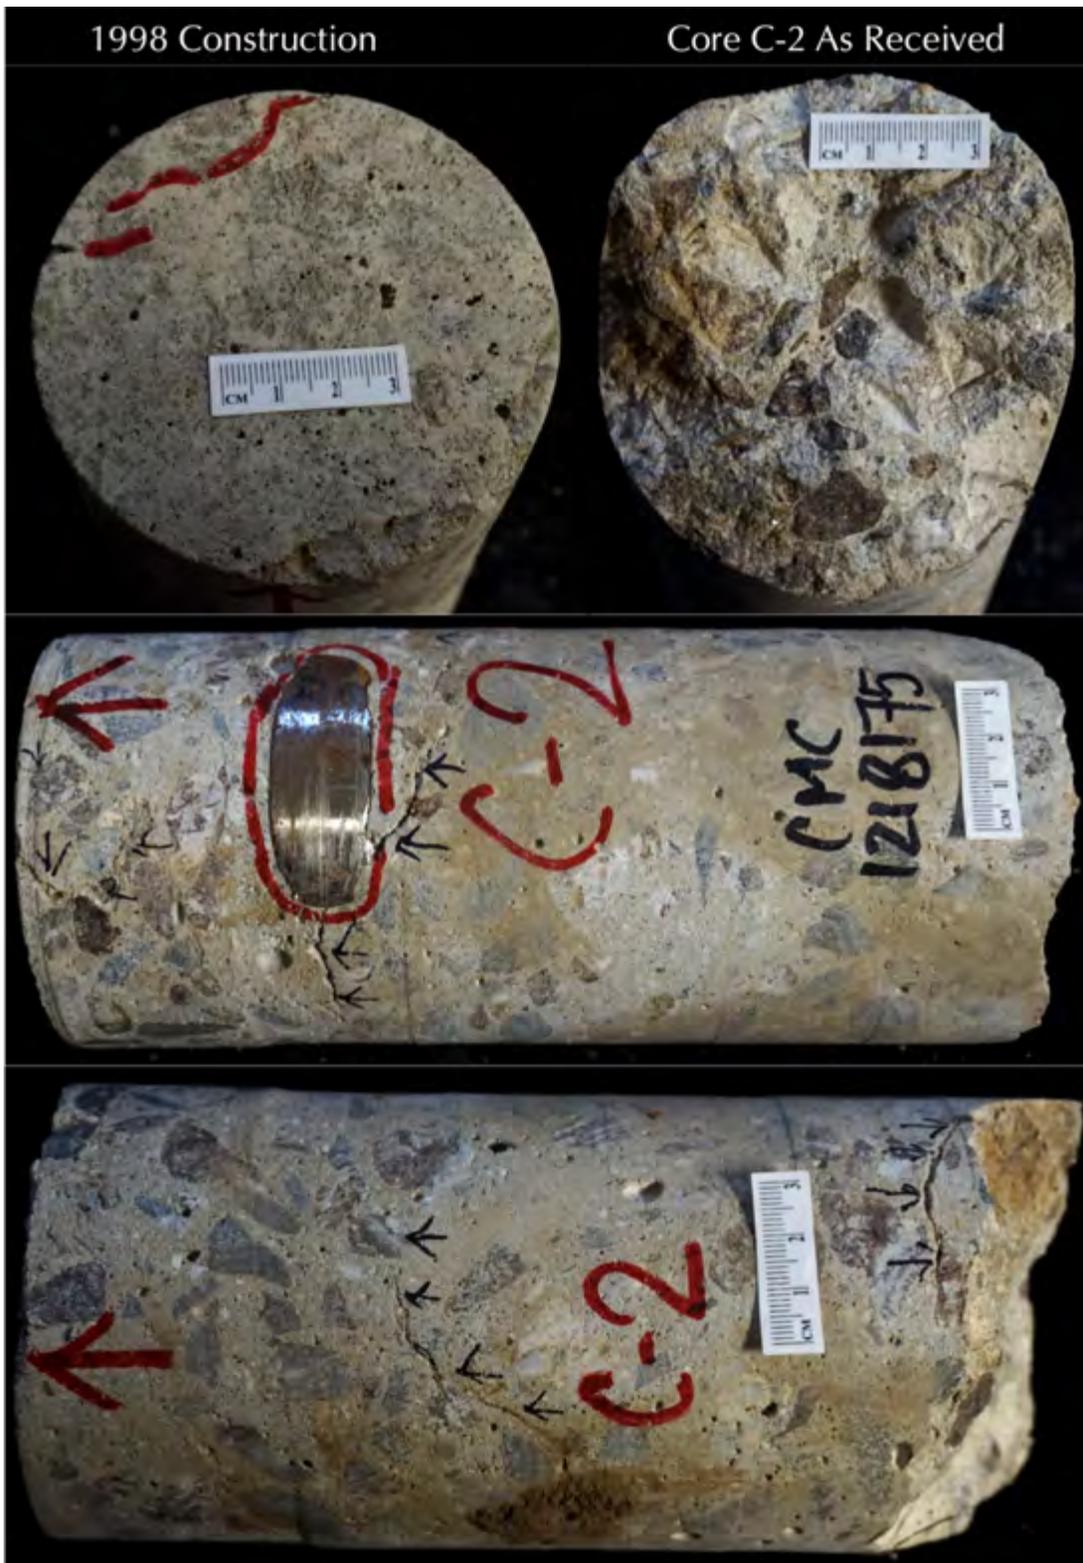
Figure A 12: Shown are the formed exposed wall surface with coarse voids and a visible crack marked in red line (top left), the fresh fractured inside surface (top right), and cylindrical side views of Core C-2 (middle and bottom), as received. Notice extensive cracking of concrete throughout the depth of the core in the cylindrical side surfaces many of which are marked with arrows. A No. 6 reinforcing steel at a depth of 2 in. from the exposed surface is marked.

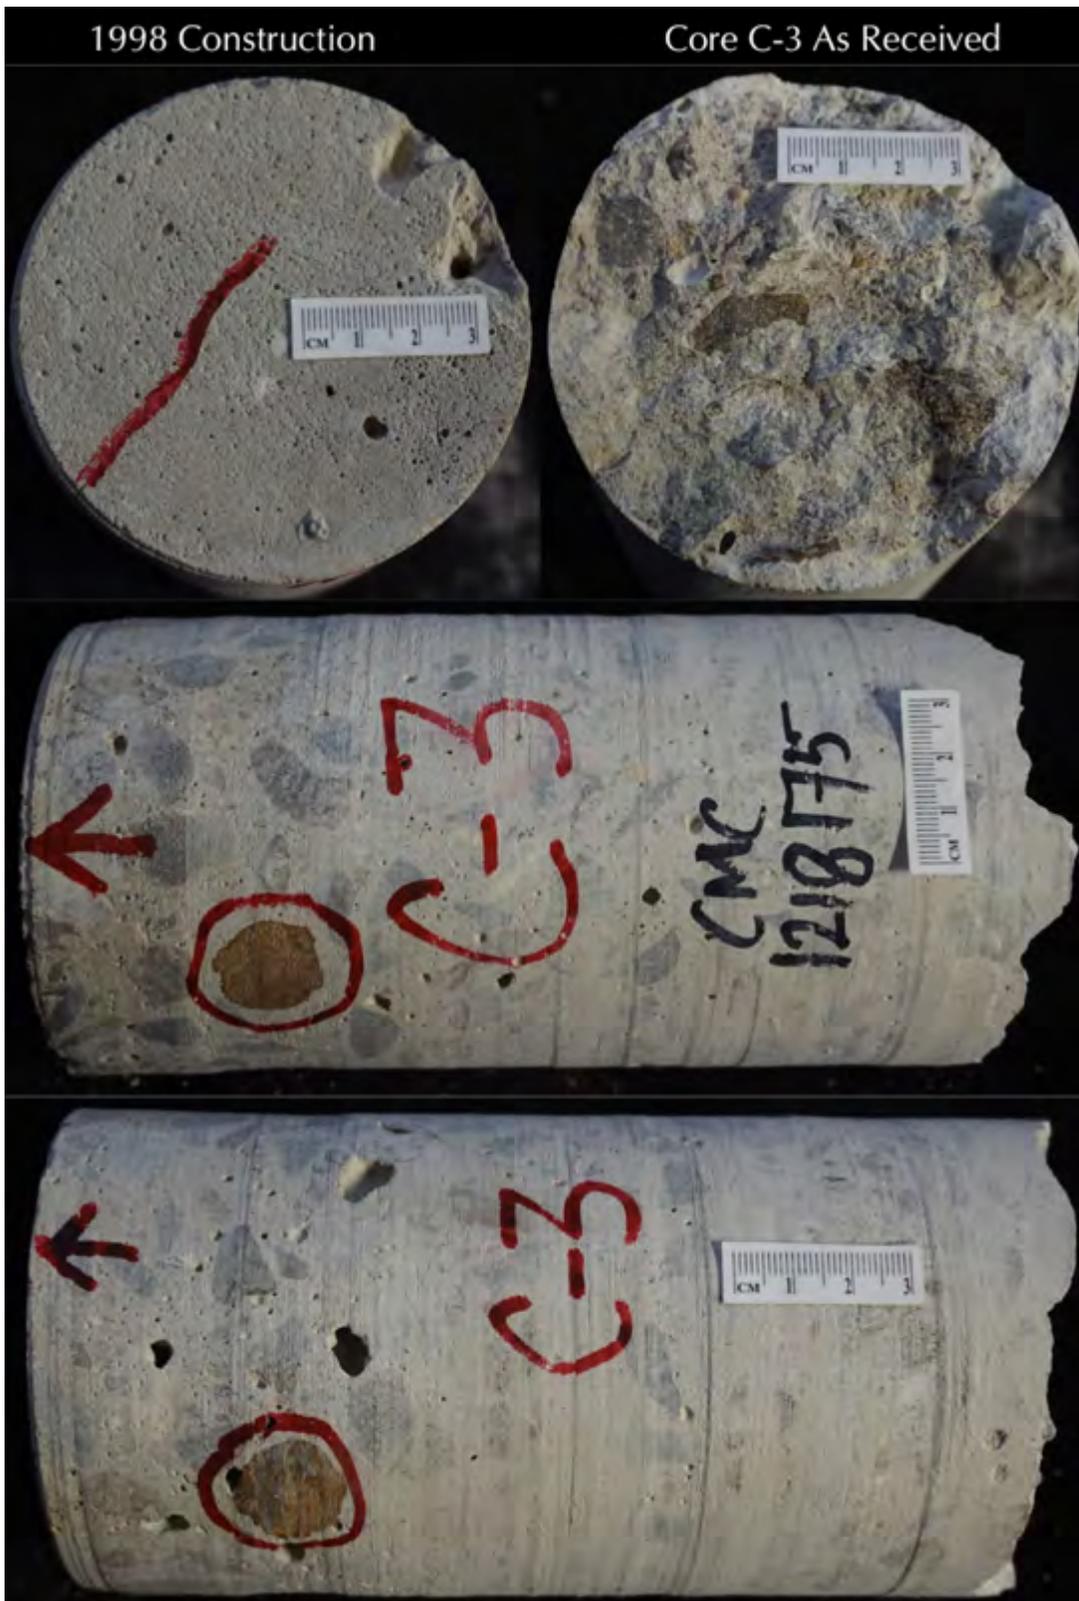
Figure A 13: Shown are the formed exposed wall surface with coarse voids and a visible crack marked in red line (top left), the fresh fractured inside surface (top right), and cylindrical side views of Core C-3 (middle and bottom), as received. Notice no visible cracking of concrete throughout the depth of the core in the cylindrical side surfaces. A No. 6 reinforcing steel at a depth of 1<sup>1</sup>/<sub>4</sub> in. from the exposed surface is marked.

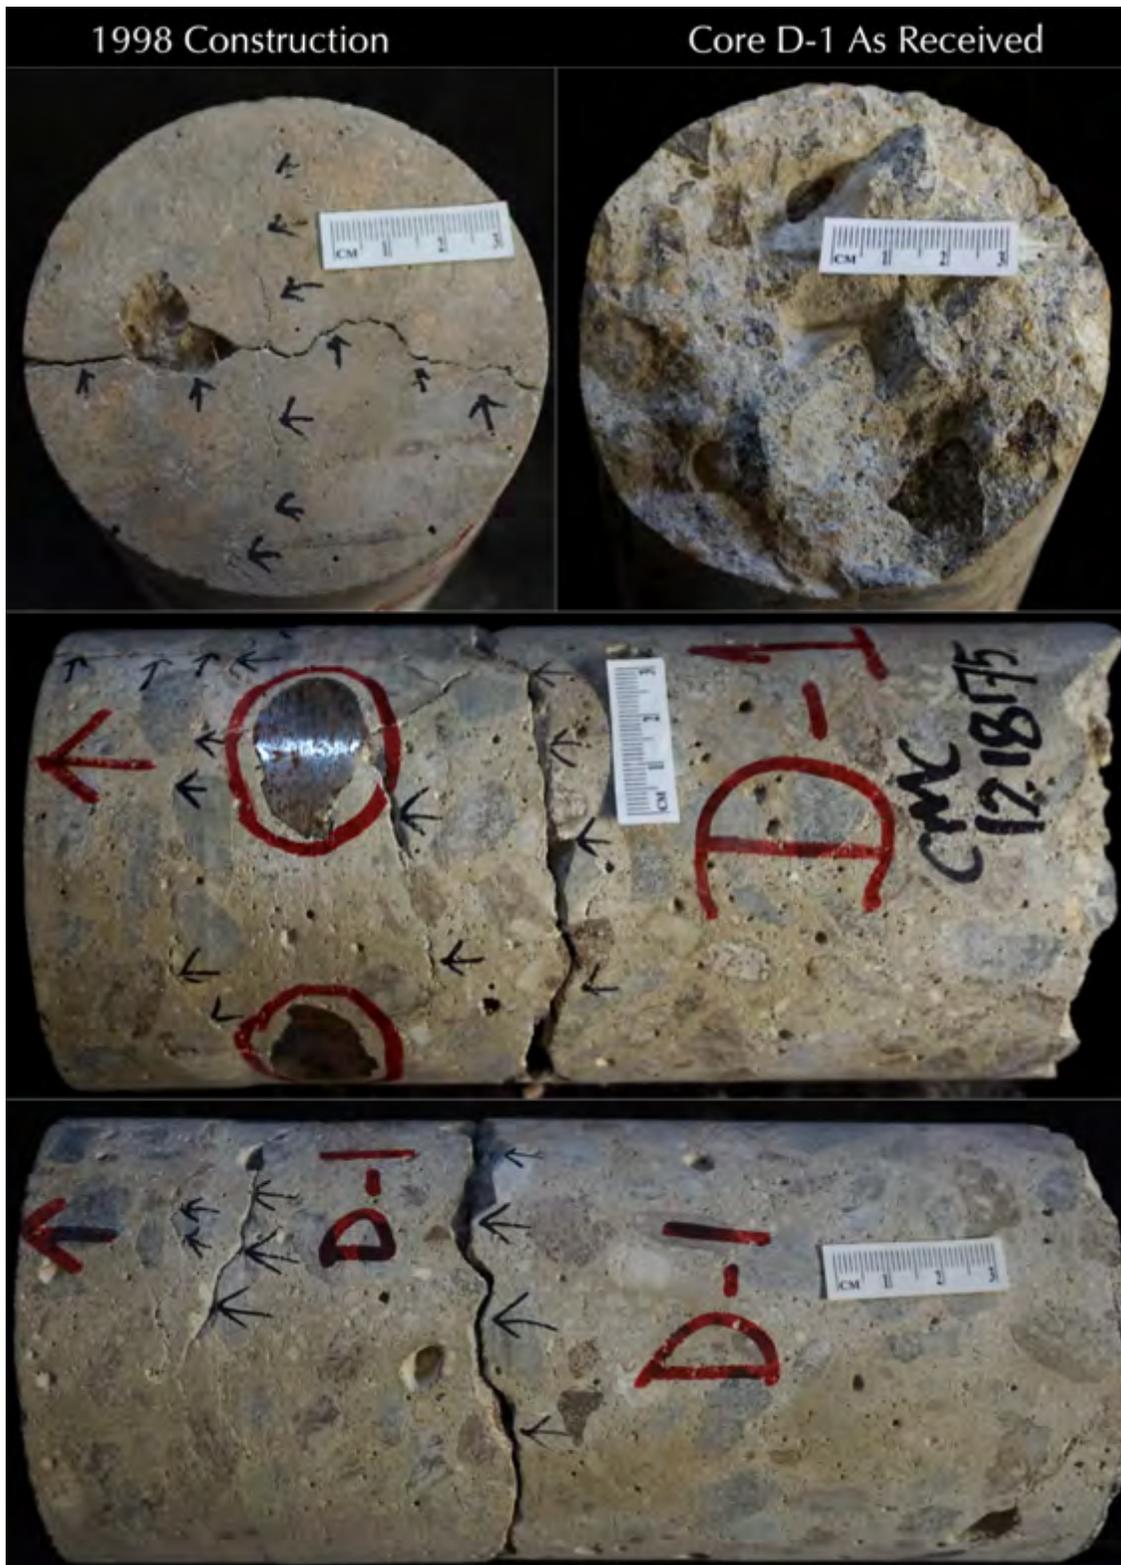
Figure A 14: Shown are the formed exposed wall surface with coarse voids and two perpendicular visible cracks on the exposed surface marked with arrows (top left), the fresh fractured inside surface (top right), and cylindrical side views of Core D-1 (middle and bottom), as received. Notice extensive cracking of concrete throughout the depth of the core in the cylindrical side surfaces many of which are marked with arrows. A No. 6 reinforcing steel at a depth of 1½ in. from the exposed surface is marked.

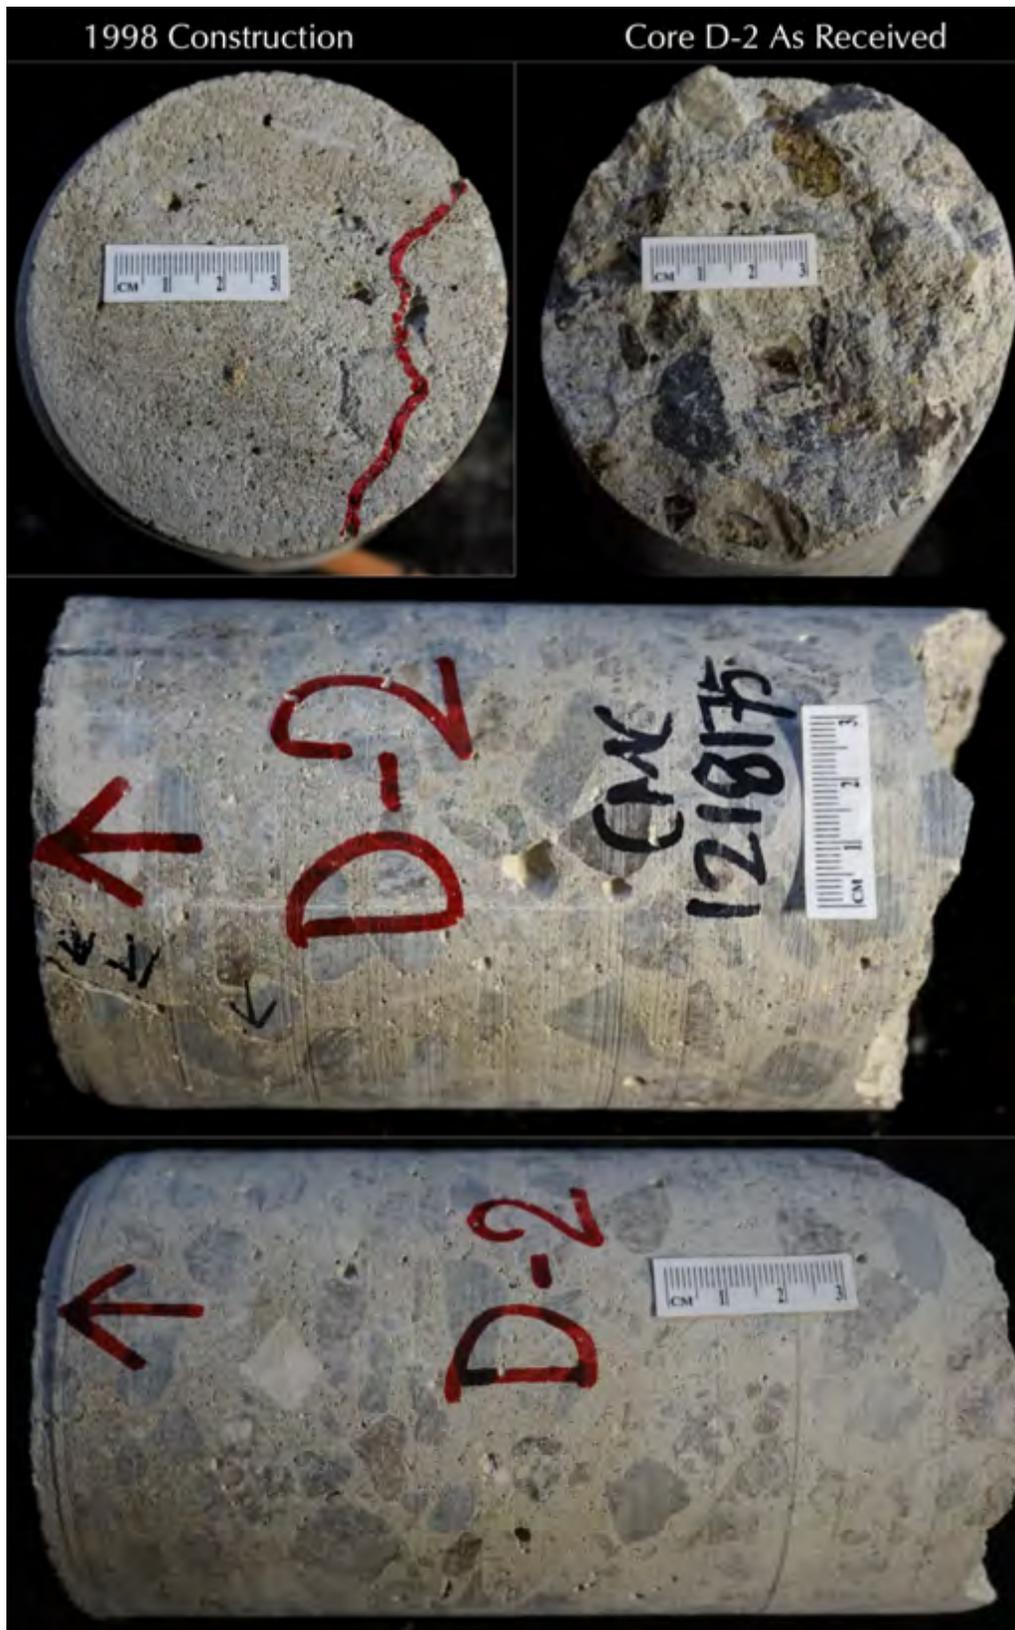
Figure A 15: Shown are the formed exposed wall surface with a visible crack marked in red line (top left), the fresh fractured inside surface (top right), and cylindrical side views of Core D-2 (middle and bottom), as received. Notice moderate cracking of concrete mostly at the exposed surface end of the core.

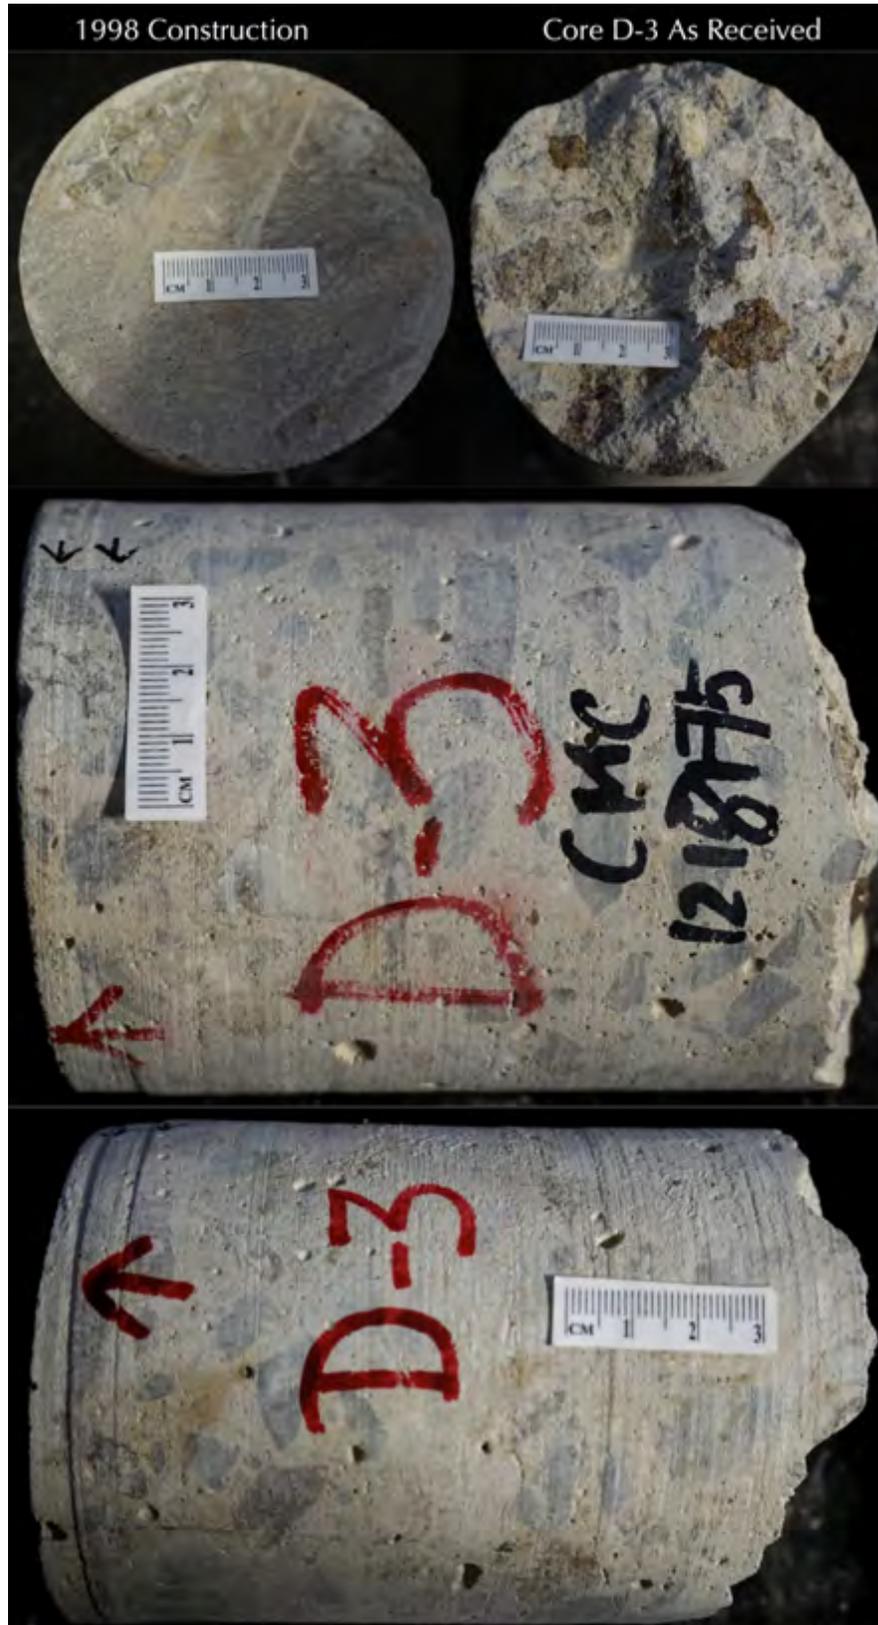
Figure A 16: Shown are the formed exposed wall surface (top left), the fresh fractured inside surface (top right), and cylindrical side views of Core D-3 (middle and bottom), as received. Notice moderate cracking of concrete mostly at the exposed surface end of the core.

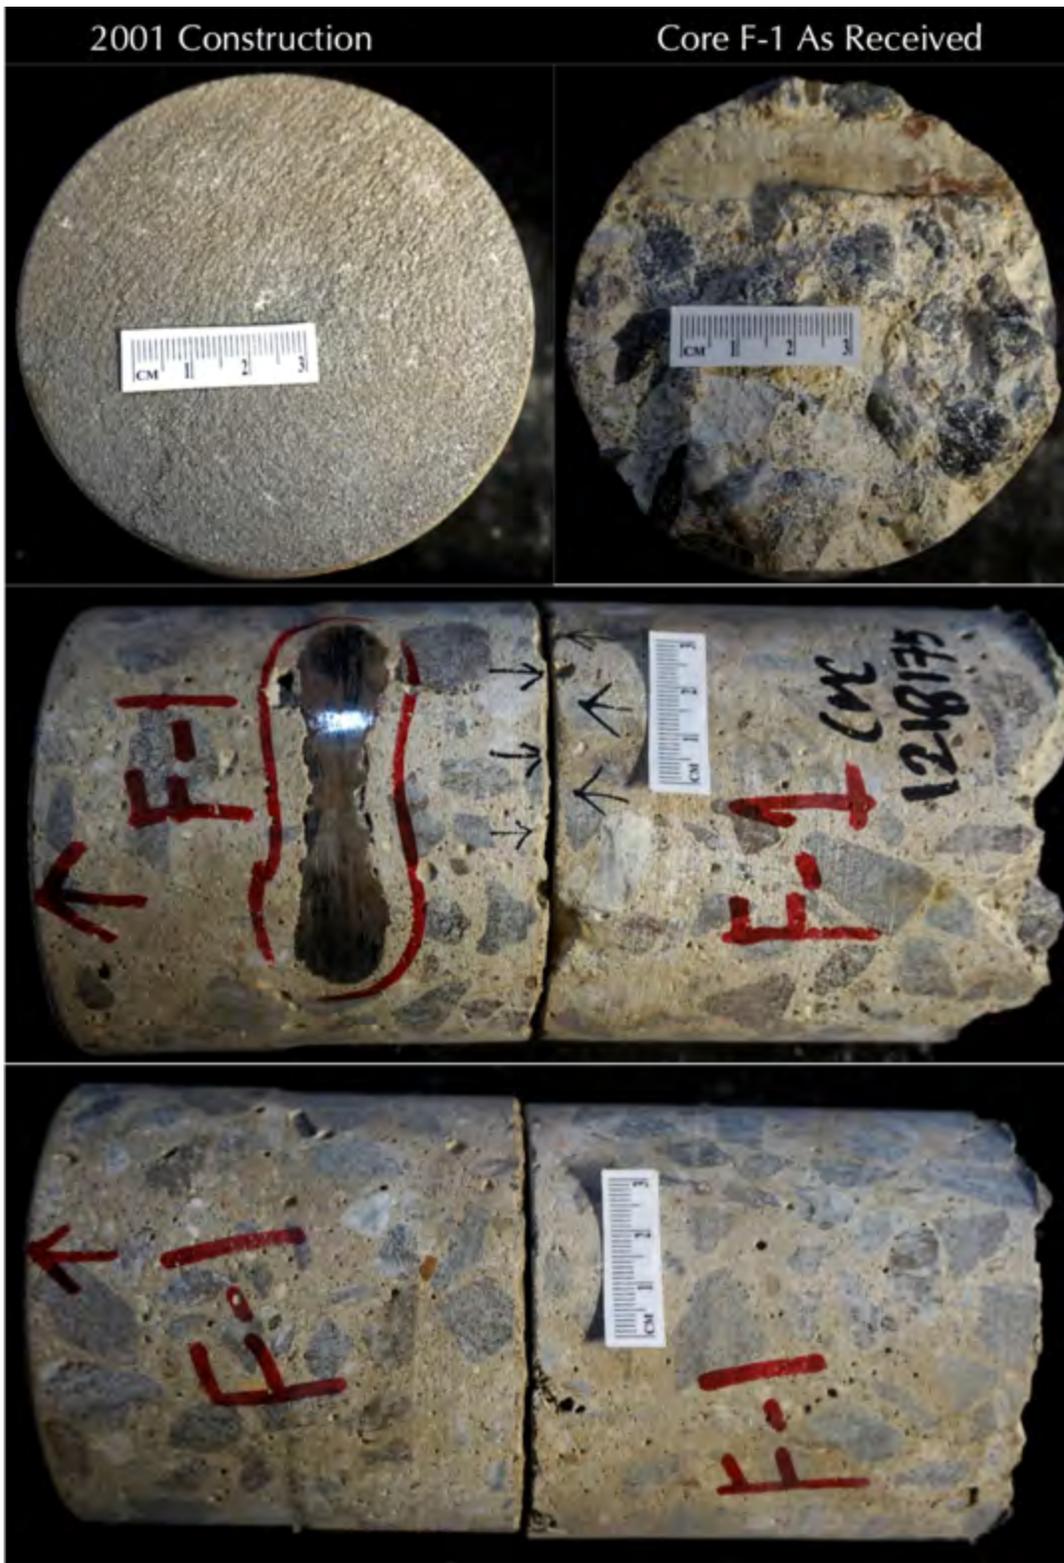
Figure A 17: Shown are the exposed surface with a thin (~1 mm) protective skim coat (top left), the fresh fractured inside surface (top right), and cylindrical side views of Core F-1 (middle and bottom), as received in two portions with a possible construction joint between the two (marked with arrows in the middle photo). Notice the visibly crack free nature of the concrete throughout the depths of the core. A No. 6 reinforcing steel at a depth of 2 in. from the exposed surface is marked.

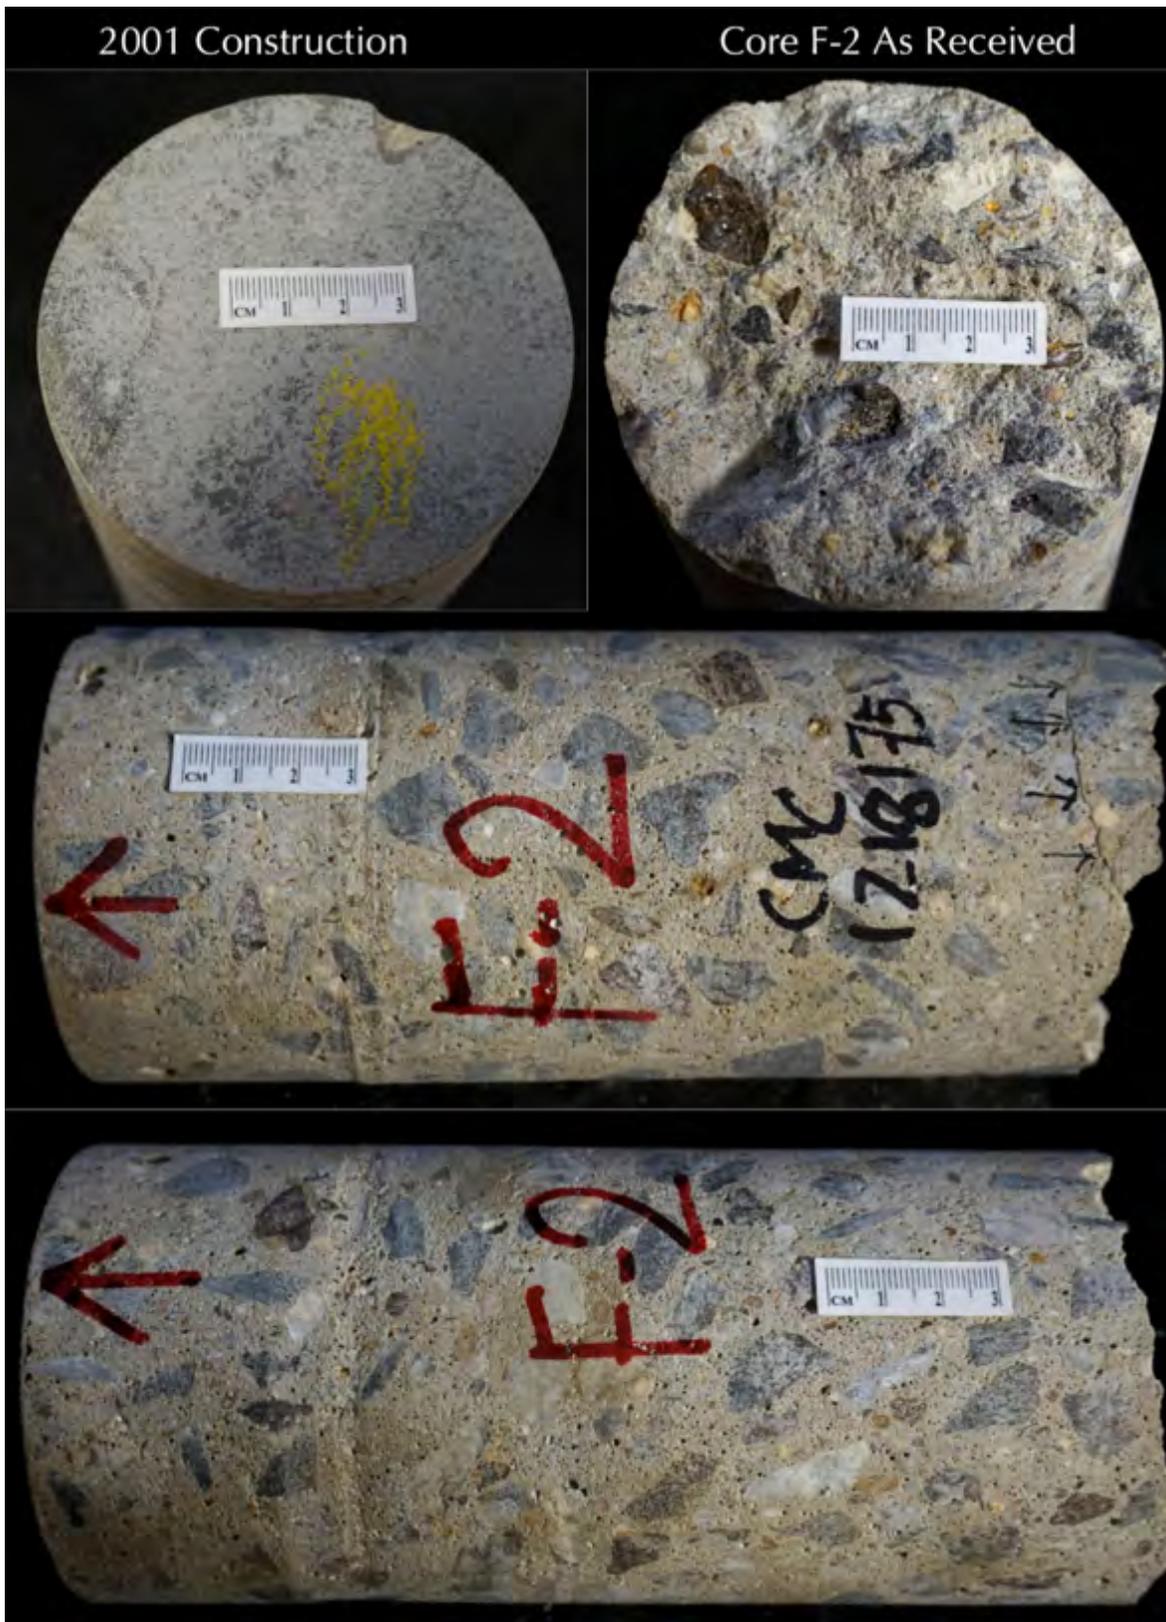
Figure A 18: Shown are the exposed surface with a thin (~1 mm) protective skim coat (top left), the fresh fractured inside surface (top right), and cylindrical side views of Core F-2 (middle and bottom), as received. Notice the relatively crack free nature of the concrete throughout the depths of the core.

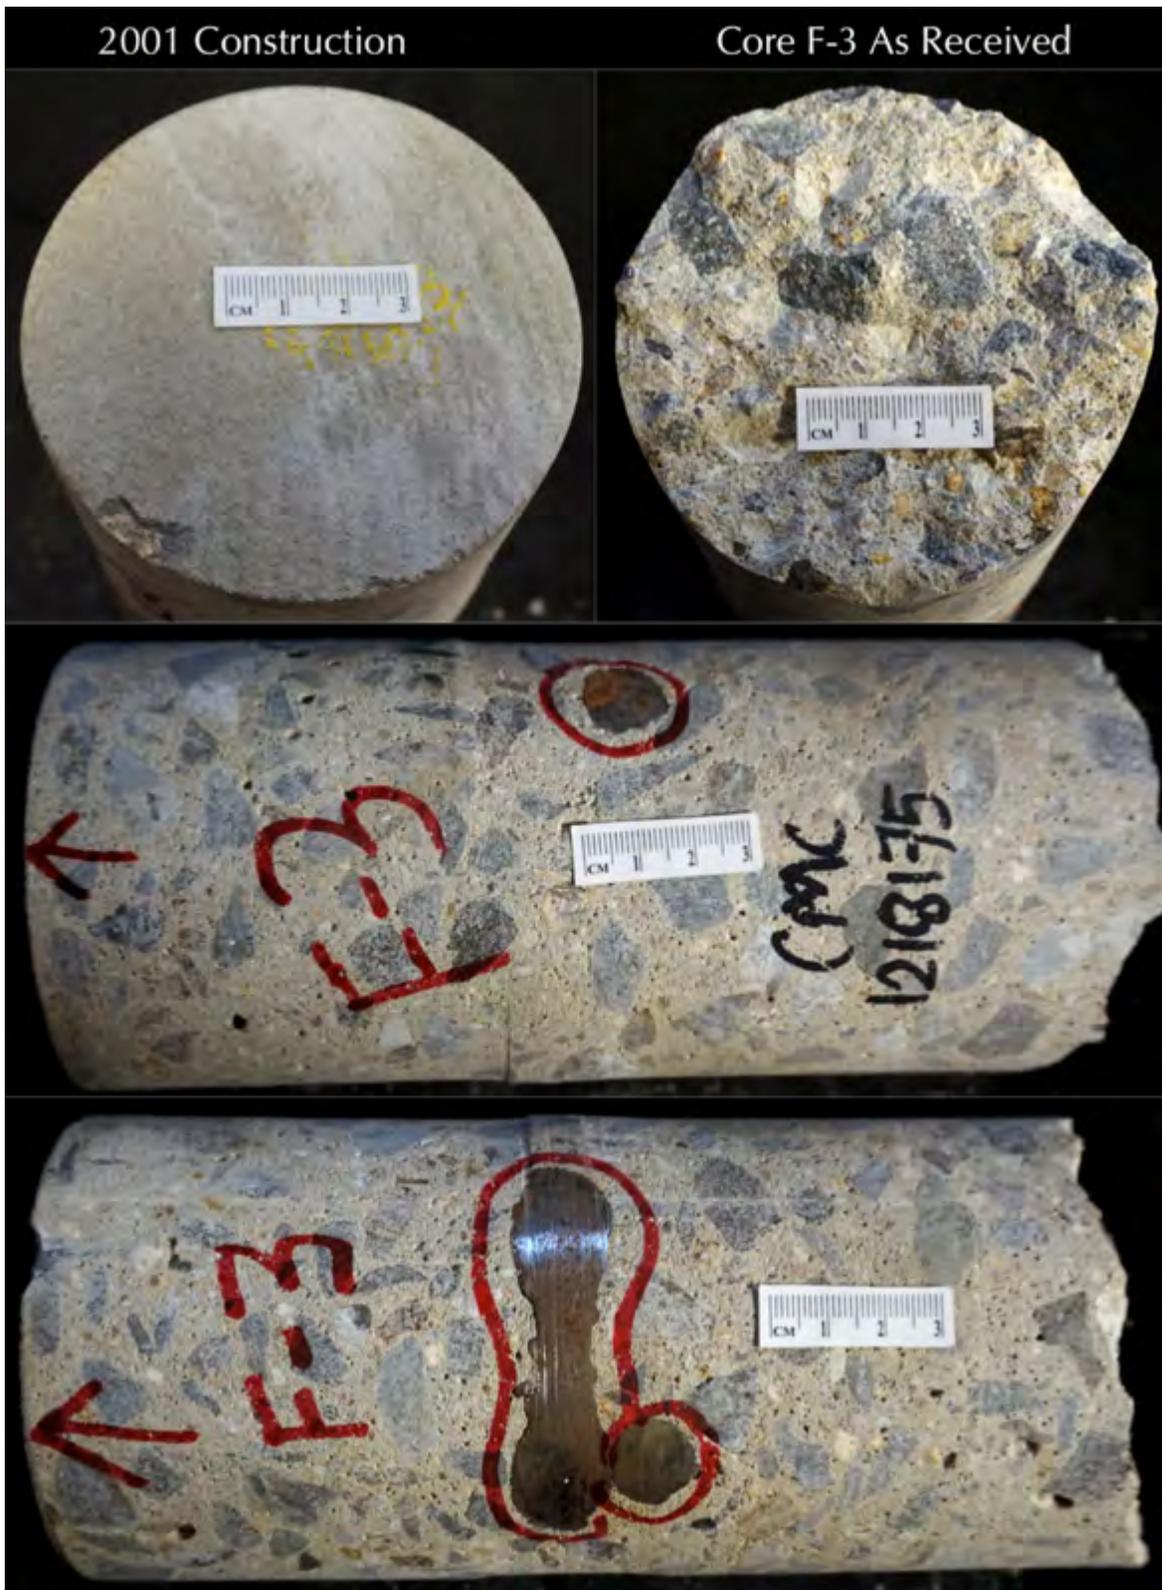
Figure A 19: Shown are the exposed surface with a thin (~1 mm) protective skim coat (top left), the fresh fractured inside surface (top right), and cylindrical side views of Core F-3 (middle and bottom), as received. Notice the visibly crack free nature of the concrete throughout the depths of the core. A No. 6 reinforcing steel at a depth of 4 in. from the exposed surface is marked.

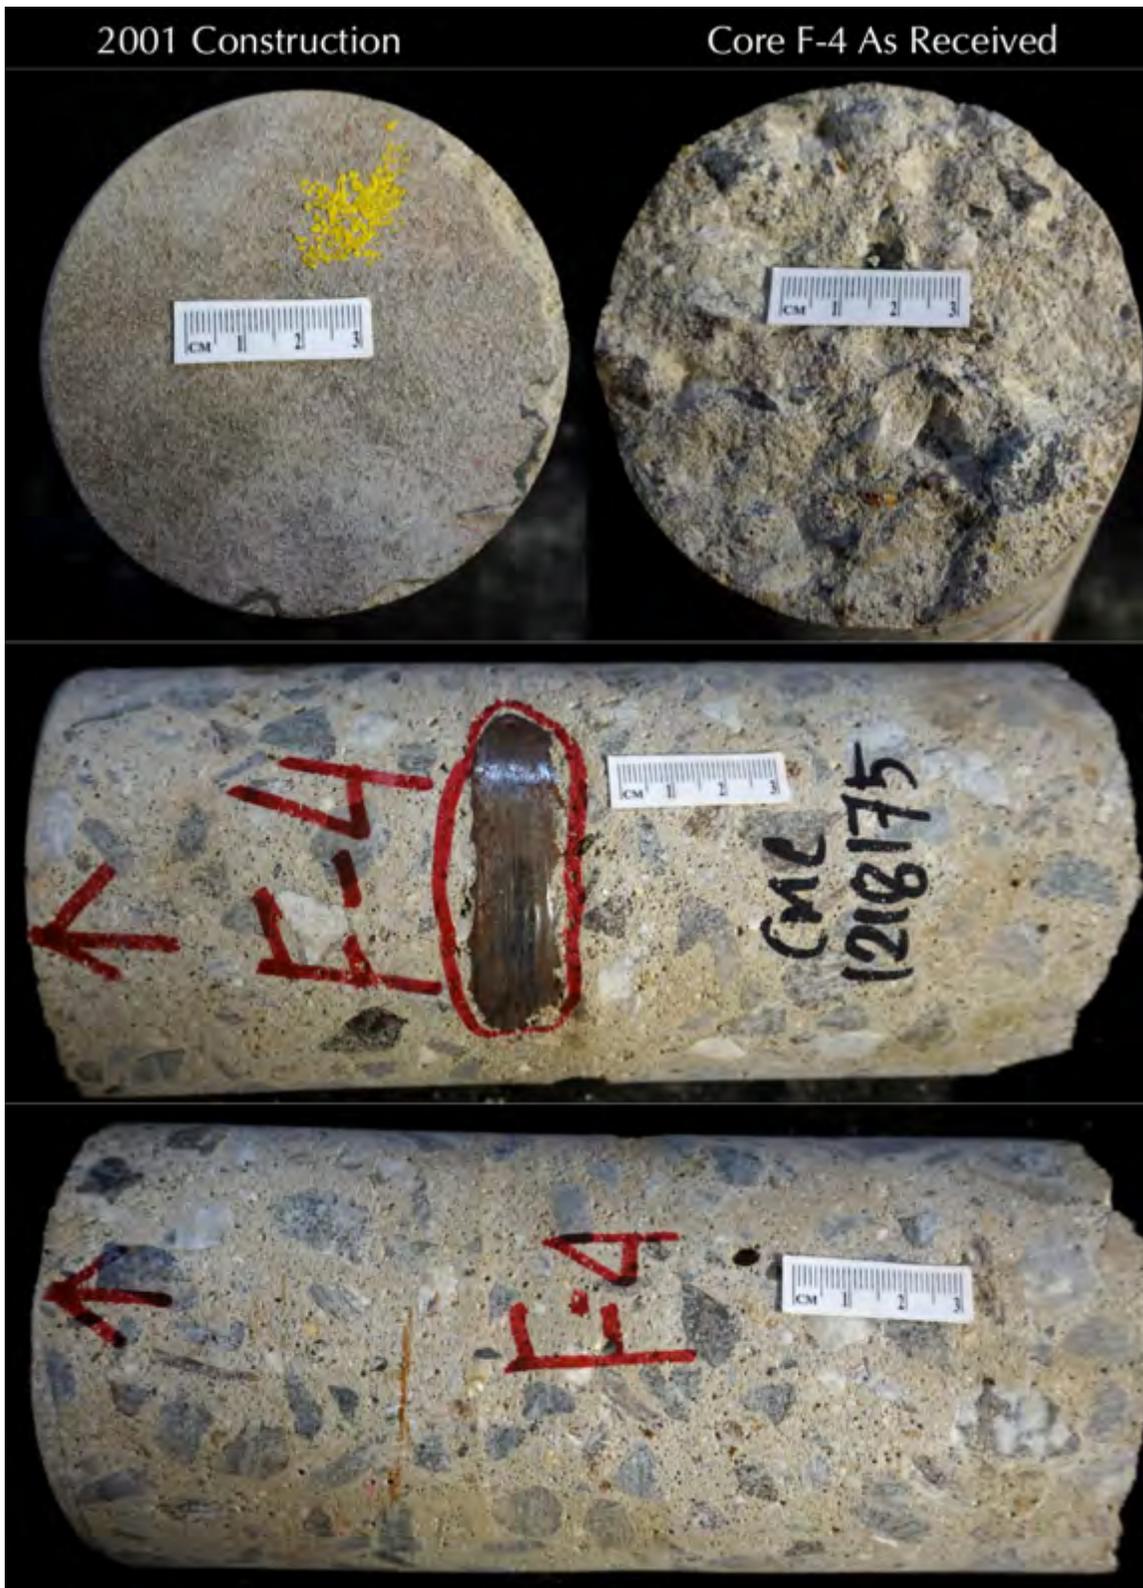
Figure A 20: Shown are the exposed surface with a thin (~1 mm) protective skim coat (top left), the fresh fractured inside surface (top right), and cylindrical side views of Core F-4 (middle and bottom), as received. Notice the visibly crack free nature of the concrete throughout the depths of the core. A No. 6 reinforcing steel at a depth of 3 1/4 in. from the exposed surface is marked.

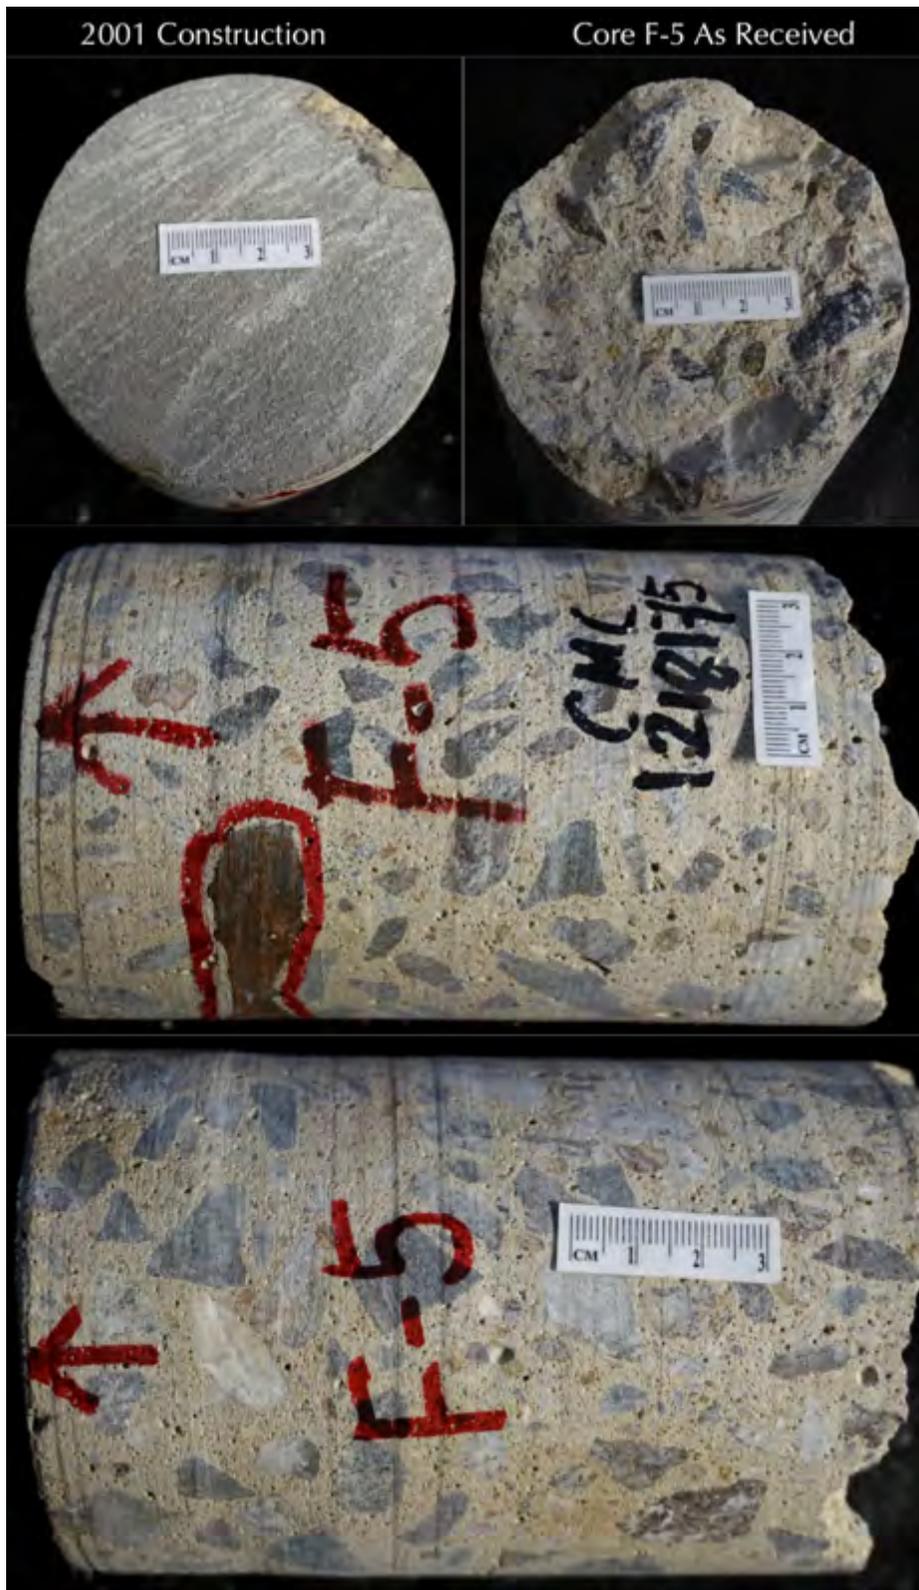
Figure A 21: Shown are the exposed surface with a thin (~1 mm) skim coat (top left), the fresh fractured inside surface (top right), and cylindrical side views of Core F-5 (middle and bottom), as received. Notice the relatively crack free nature of the concrete throughout the depths of the core, except along the fresh fractured inside surface (middle photos). A No. 6 reinforcing steel at a depth of 1 1/4 in. from the exposed surface is marked.

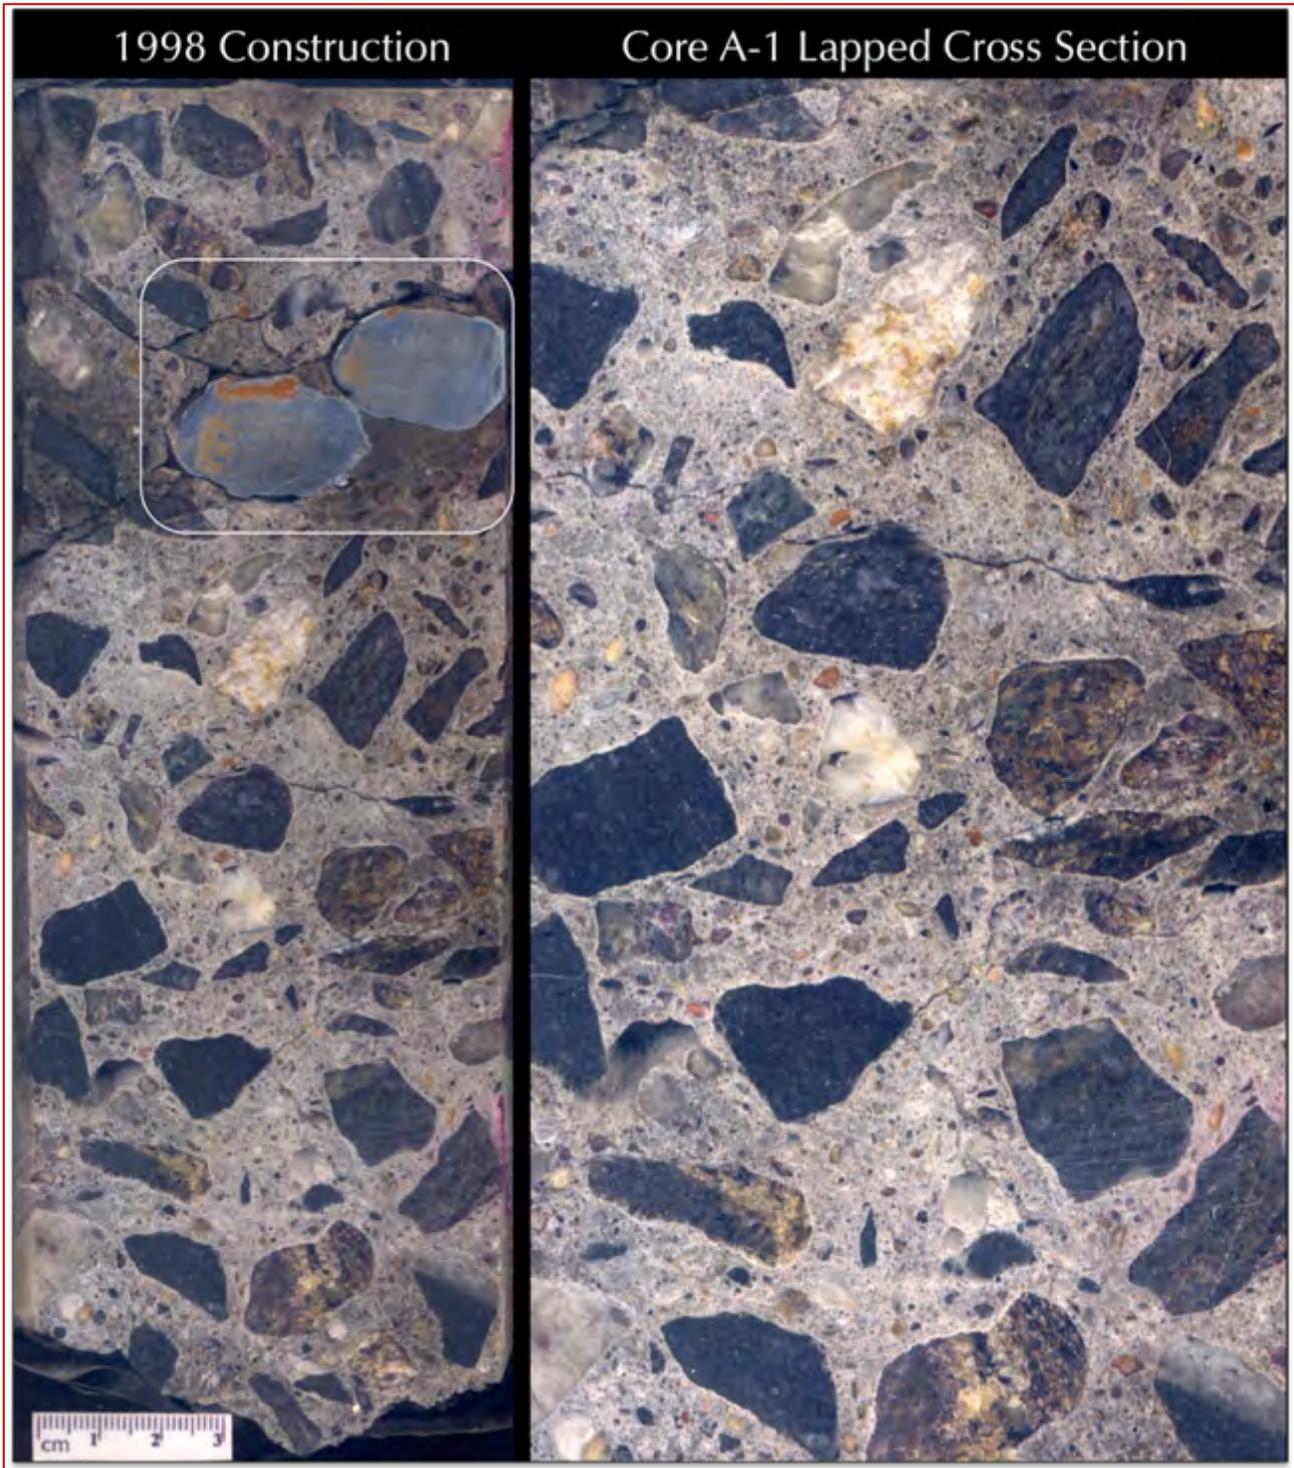
Figure B 1: Lapped cross sections of Core A-1 (right one is enlarged from the left full-depth section) showing: (a) size, shape, angularity, gradation, and distribution of crushed stone coarse aggregate consisting of mixture of a dark gray stone and a lighter pinkish-brown stone, which are found to be metamorphosed gabbro (pyroxene granulite) and garnetiferous quartz-feldspar-biotite gneiss, respectively; (b) natural siliceous sand fine aggregate, (c) reinforcing steels (boxed) that show some surface corrosion; (d) overall dense and well-consolidated nature of concrete across the wall from the exposed end at the top to the opposite fractured end at the bottom; and, most importantly, (e) extensive visible cracking all throughout the depth of the core, which are marked in the next Figure.

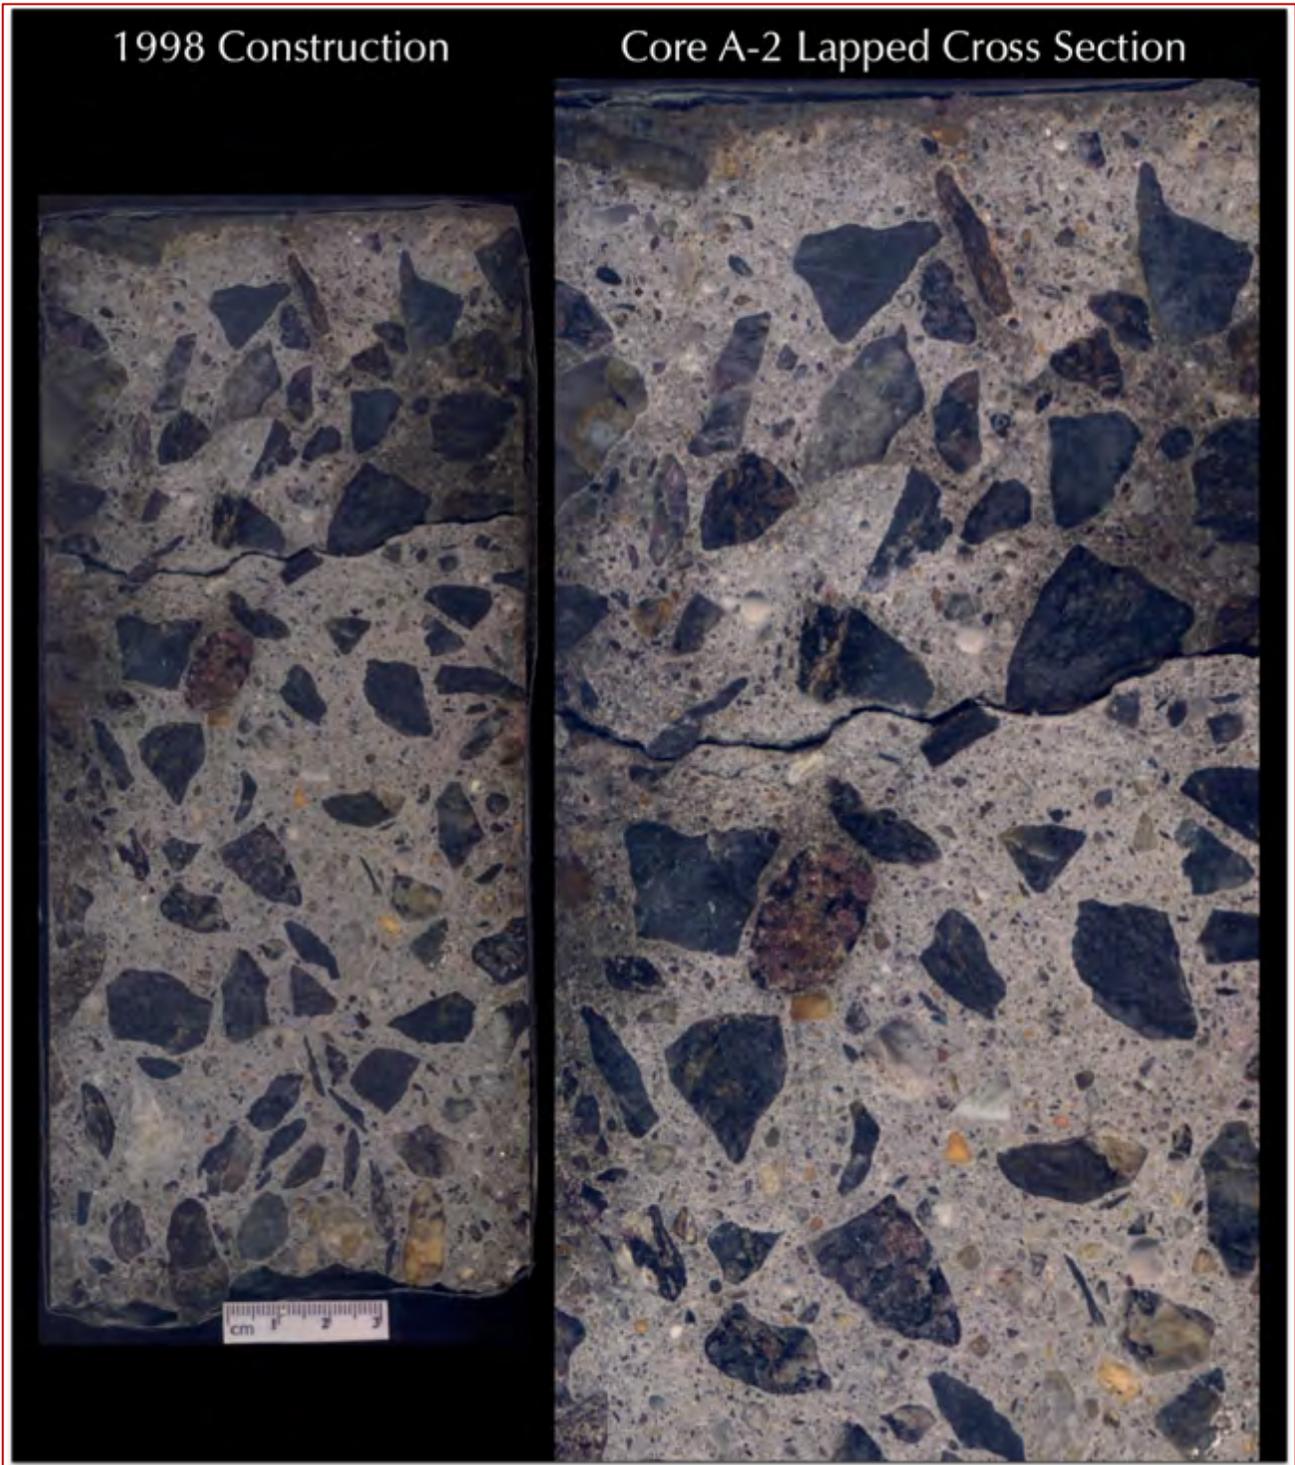
Figure B 3: Lapped cross sections of Core A-2 (right one is enlarged from the left full-depth section) showing: (a) size, shape, angularity, gradation, and distribution of crushed stone coarse aggregate consisting of mixture of a dark gray stone and a lighter pinkish-brown stone, which are found to be metamorphosed gabbro (pyroxene granulite) and garnetiferous quartz-feldspar-biotite gneiss, respectively; (b) natural siliceous sand fine aggregate, (c) overall dense and well-consolidated nature of concrete across the wall from the exposed end at the top to the opposite fractured end at the bottom; and, most importantly, (d) moderate visible cracking all throughout the depth of the core, which are marked in the next Figure.
