## Pyrrhotite Epidemic in Eastern Connecticut: A Case Study From Tolland, CT

Tolland Board of Education  
Birch Grove School  
247 Rhodes Road  
Tolland, CT 06084

January 10, 2019  
CMC 1218175

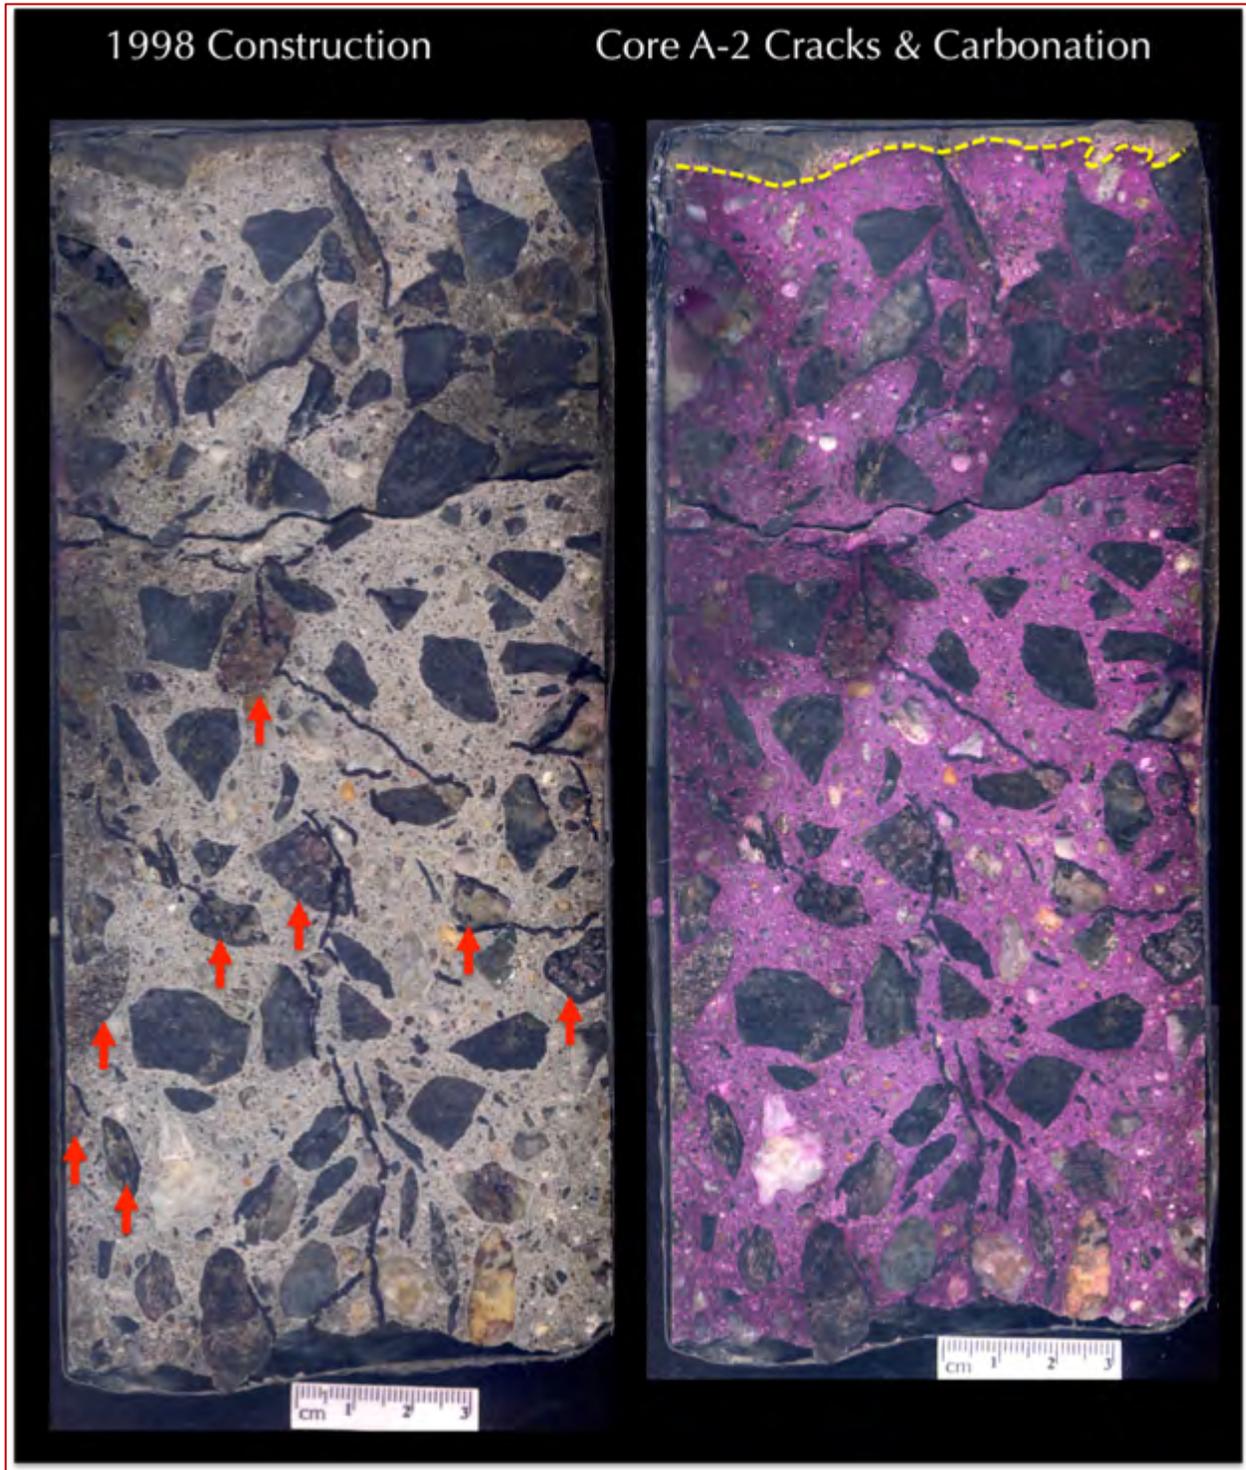
Figure B 4: Lapped cross sections of Core A-2 showing: (a) moderate cracking all throughout the depth of the core, where all visible cracks revealed during stereo-microscopical examination of the lapped cross section are marked with a black marker pen, along with a few unsound light pinkish-brown crushed stone coarse aggregate (garnetiferous quartz-feldspar biotite gneiss) marked in red arrows in the left; and (b) minimal (less than 5 mm deep) carbonation from the formed exposed end of concrete (carbonation front is marked in dashed yellow line on right) after 20 years of service since 1998, a testament of dense, well-consolidated nature of concrete.

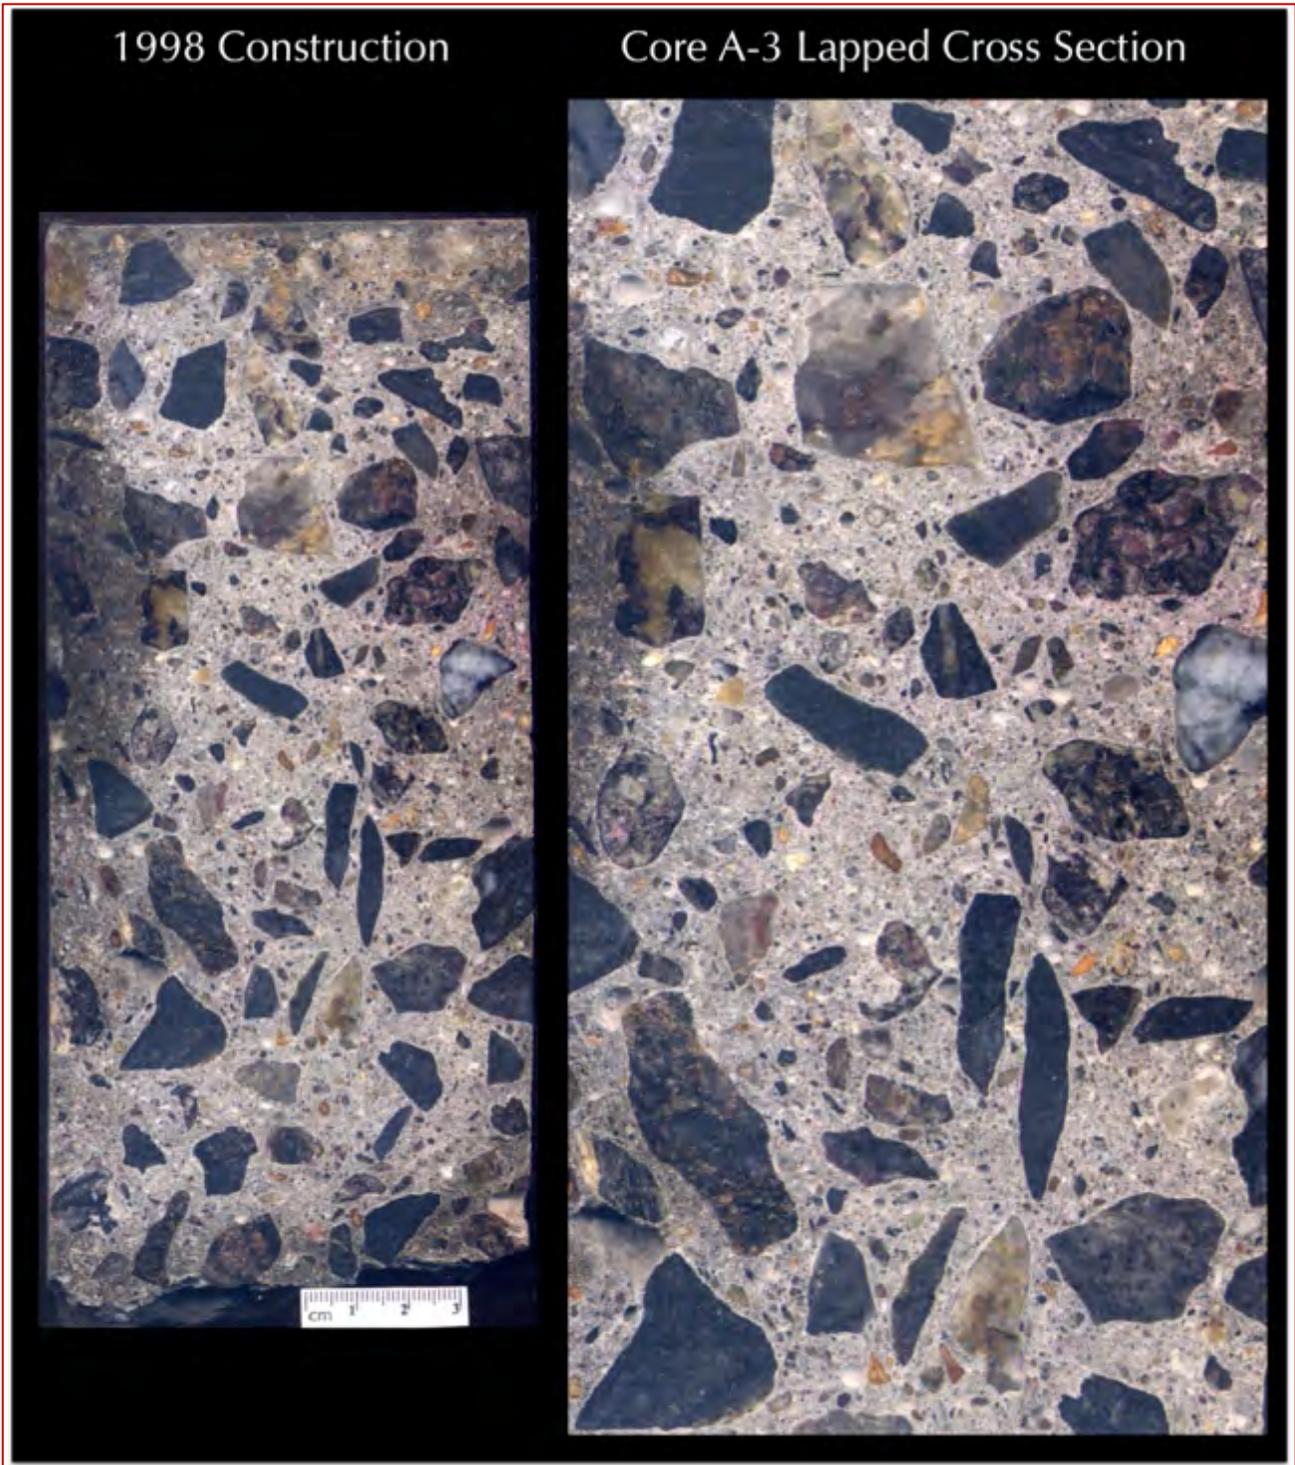
Figure B 5: Lapped cross sections of Core A-3 (right one is enlarged from the left full-depth section) showing: (a) size, shape, angularity, gradation, and distribution of crushed stone coarse aggregate consisting of mixture of a dark gray stone and a lighter pinkish-brown stone, which are found to be metamorphosed gabbro (pyroxene granulite) and garnetiferous quartz-feldspar-biotite gneiss, respectively; (b) natural siliceous sand fine aggregate, (c) overall dense and well-consolidated nature of concrete across the wall from the exposed end at the top to the opposite fractured end at the bottom; and, most importantly, (d) minimal localized visible cracking confined mostly within some crushed stone aggregates.

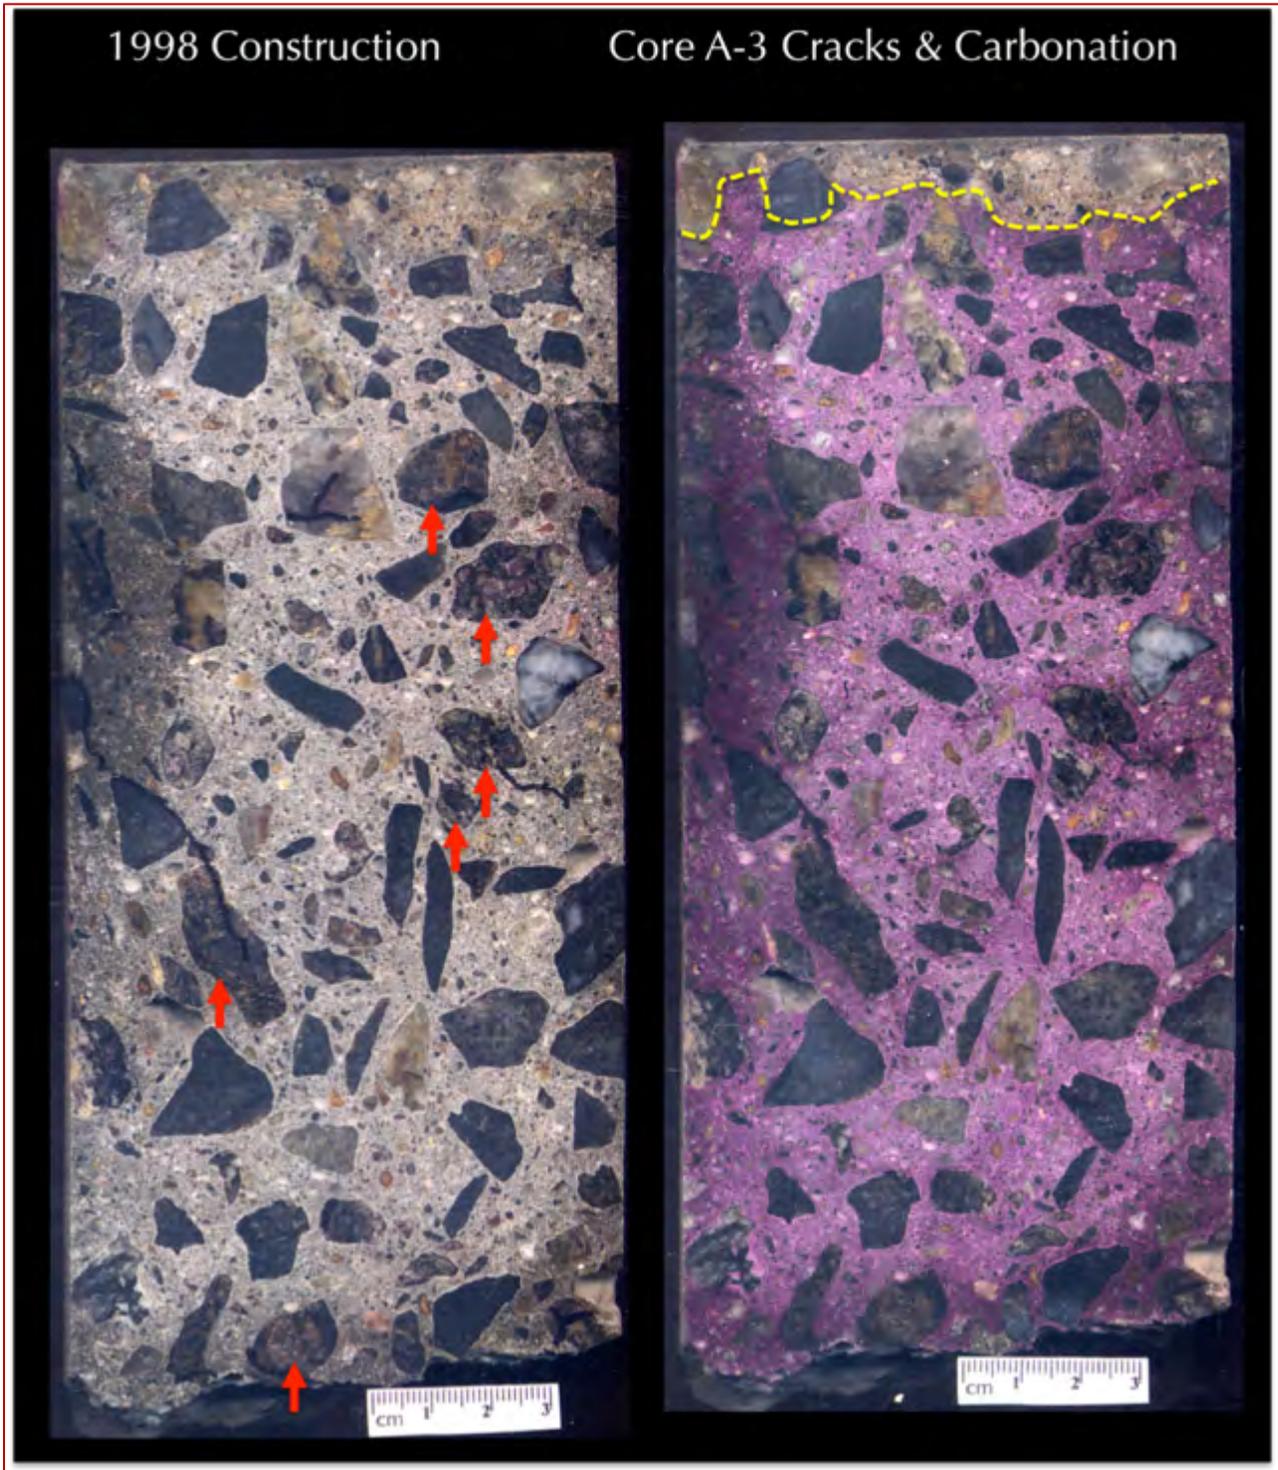
Figure B 6: Lapped cross sections of Core A-3 showing: (a) minimal localized visible cracking confined mostly within some crushed stone aggregates, where visible cracks revealed during stereo-microscopical examination of the lapped cross section are marked with a black marker pen, along with a few unsound light pinkish-brown crushed stone coarse aggregate (garnetiferous quartz-feldspar biotite gneiss) marked in red arrows in the left; and (b) minimal (less than 15 mm deep) carbonation from the formed exposed end of concrete (carbonation front is marked in dashed yellow line on right) after 20 years of service since 1998, a testament of dense, well-consolidated nature of concrete.

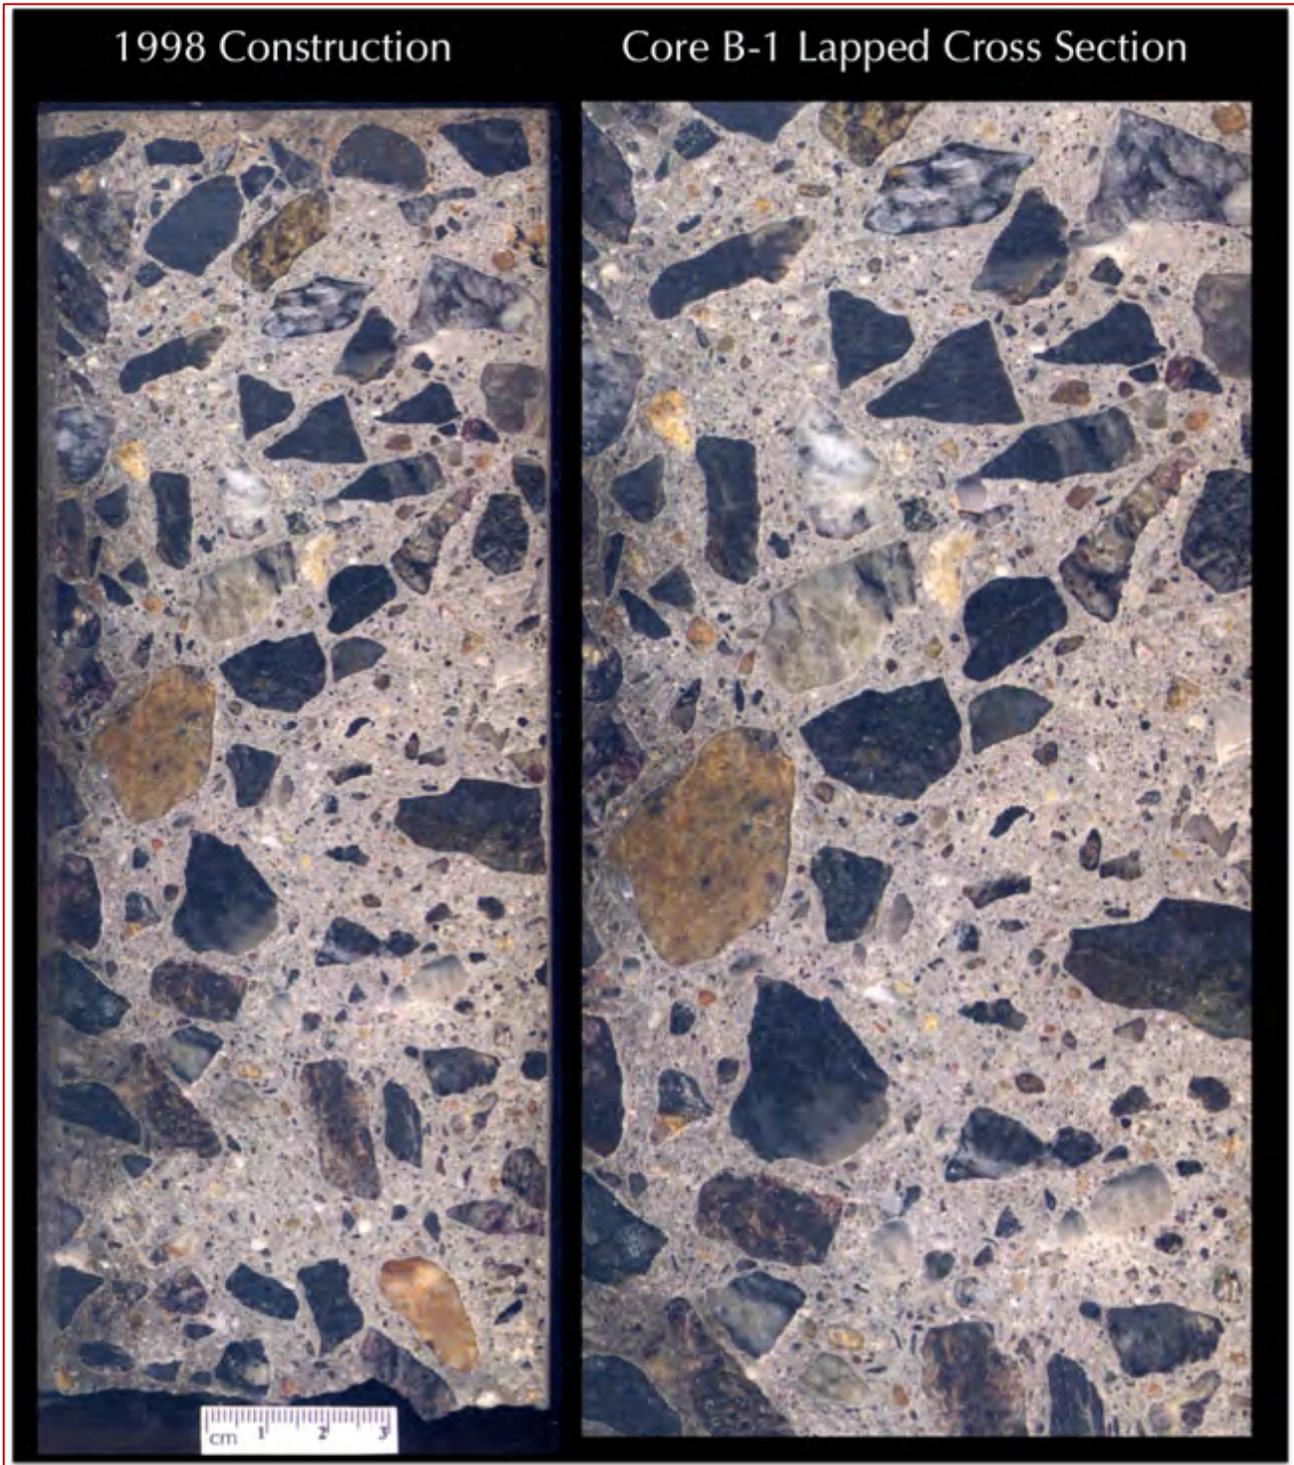
Figure B 7: Lapped cross sections of Core B-1 (right one is enlarged from the left full-depth section) showing: (a) size, shape, angularity, gradation, and distribution of crushed stone coarse aggregate consisting of mixture of a dark gray stone and a lighter pinkish-brown stone, which are found to be metamorphosed gabbro (pyroxene granulite) and garnetiferous quartz-feldspar-biotite gneiss, respectively; (b) natural siliceous sand fine aggregate, (c) overall dense and well-consolidated nature of concrete across the wall from the exposed end at the top to the opposite fractured end at the bottom; and, most importantly, (d) minimal localized visible cracking confined mostly within some crushed stone aggregates.

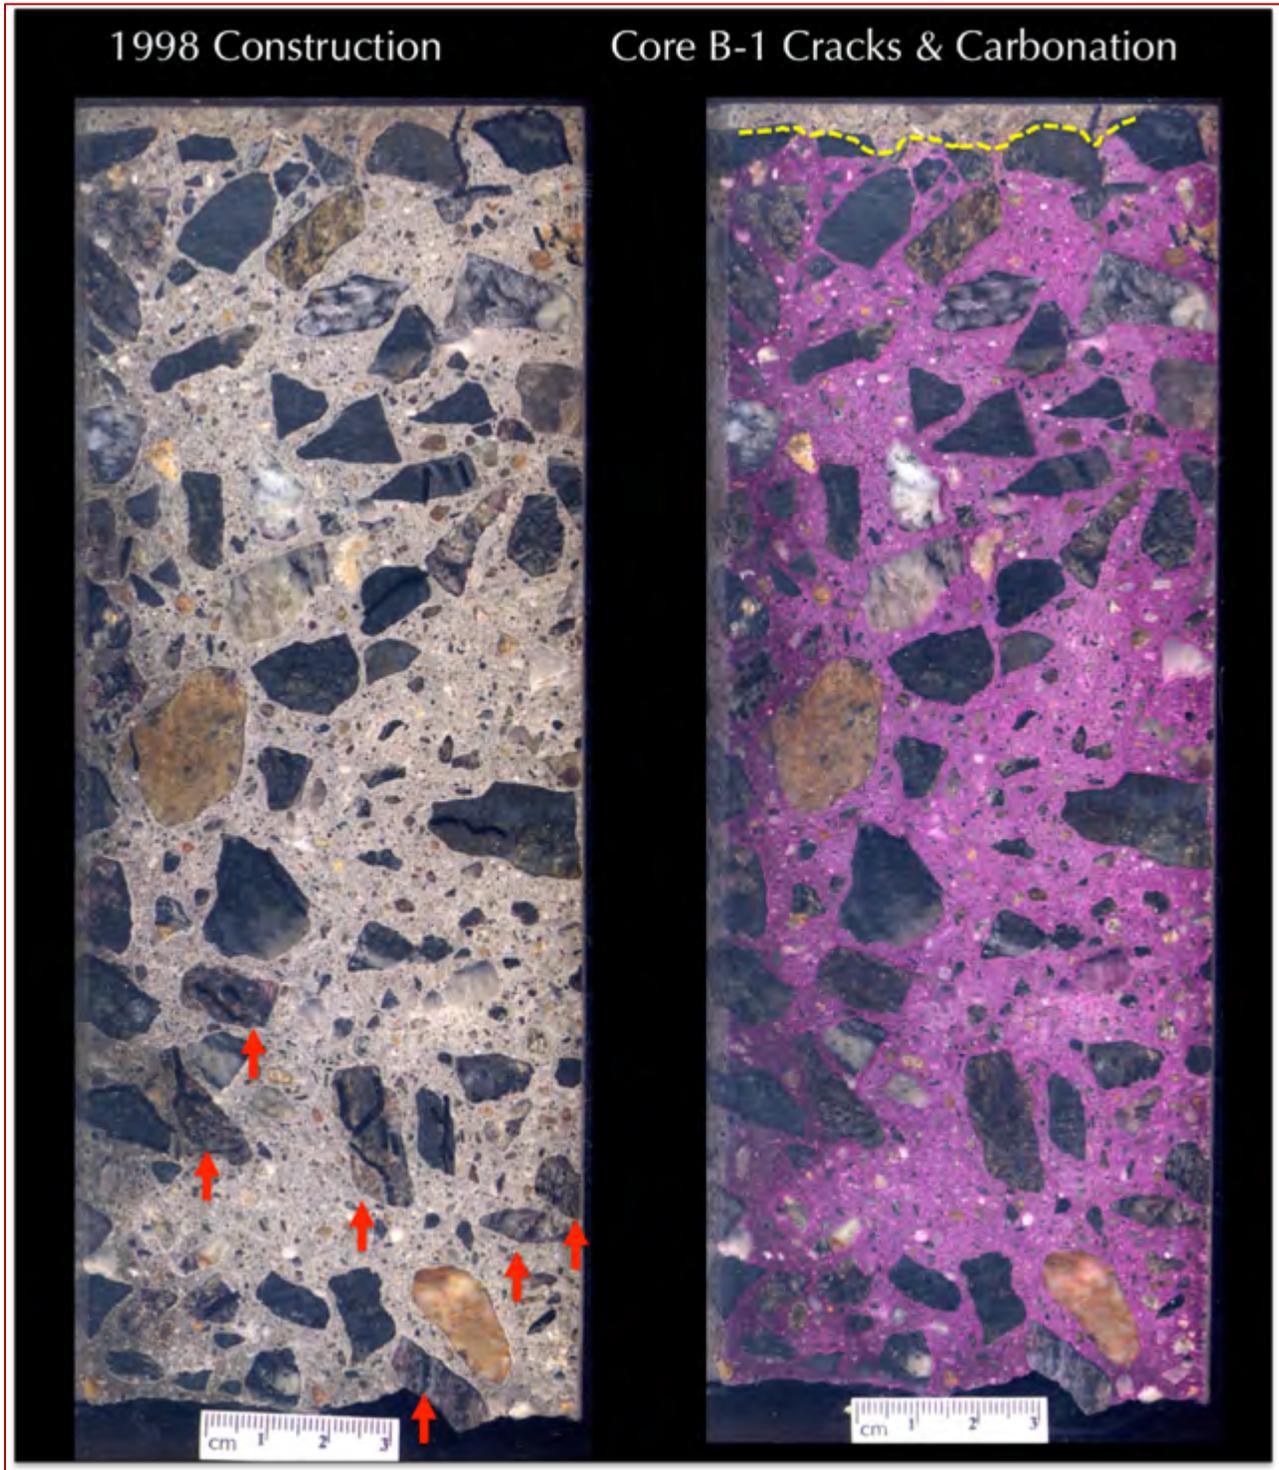
Figure B 8: Lapped cross sections of Core B-1 showing: (a) minimal localized visible cracking confined mostly within some crushed stone aggregates, where visible cracks revealed during stereo-microscopical examination of the lapped cross section are marked with a black marker pen, along with a few unsound light pinkish-brown crushed stone coarse aggregate (garnetiferous quartz-feldspar biotite gneiss) marked in red arrows in the left; and (b) minimal (less than 5 mm deep) carbonation from the formed exposed end of concrete (carbonation front is marked in dashed yellow line on right) after 20 years of service since 1998, a testament of dense, well-consolidated nature of concrete.

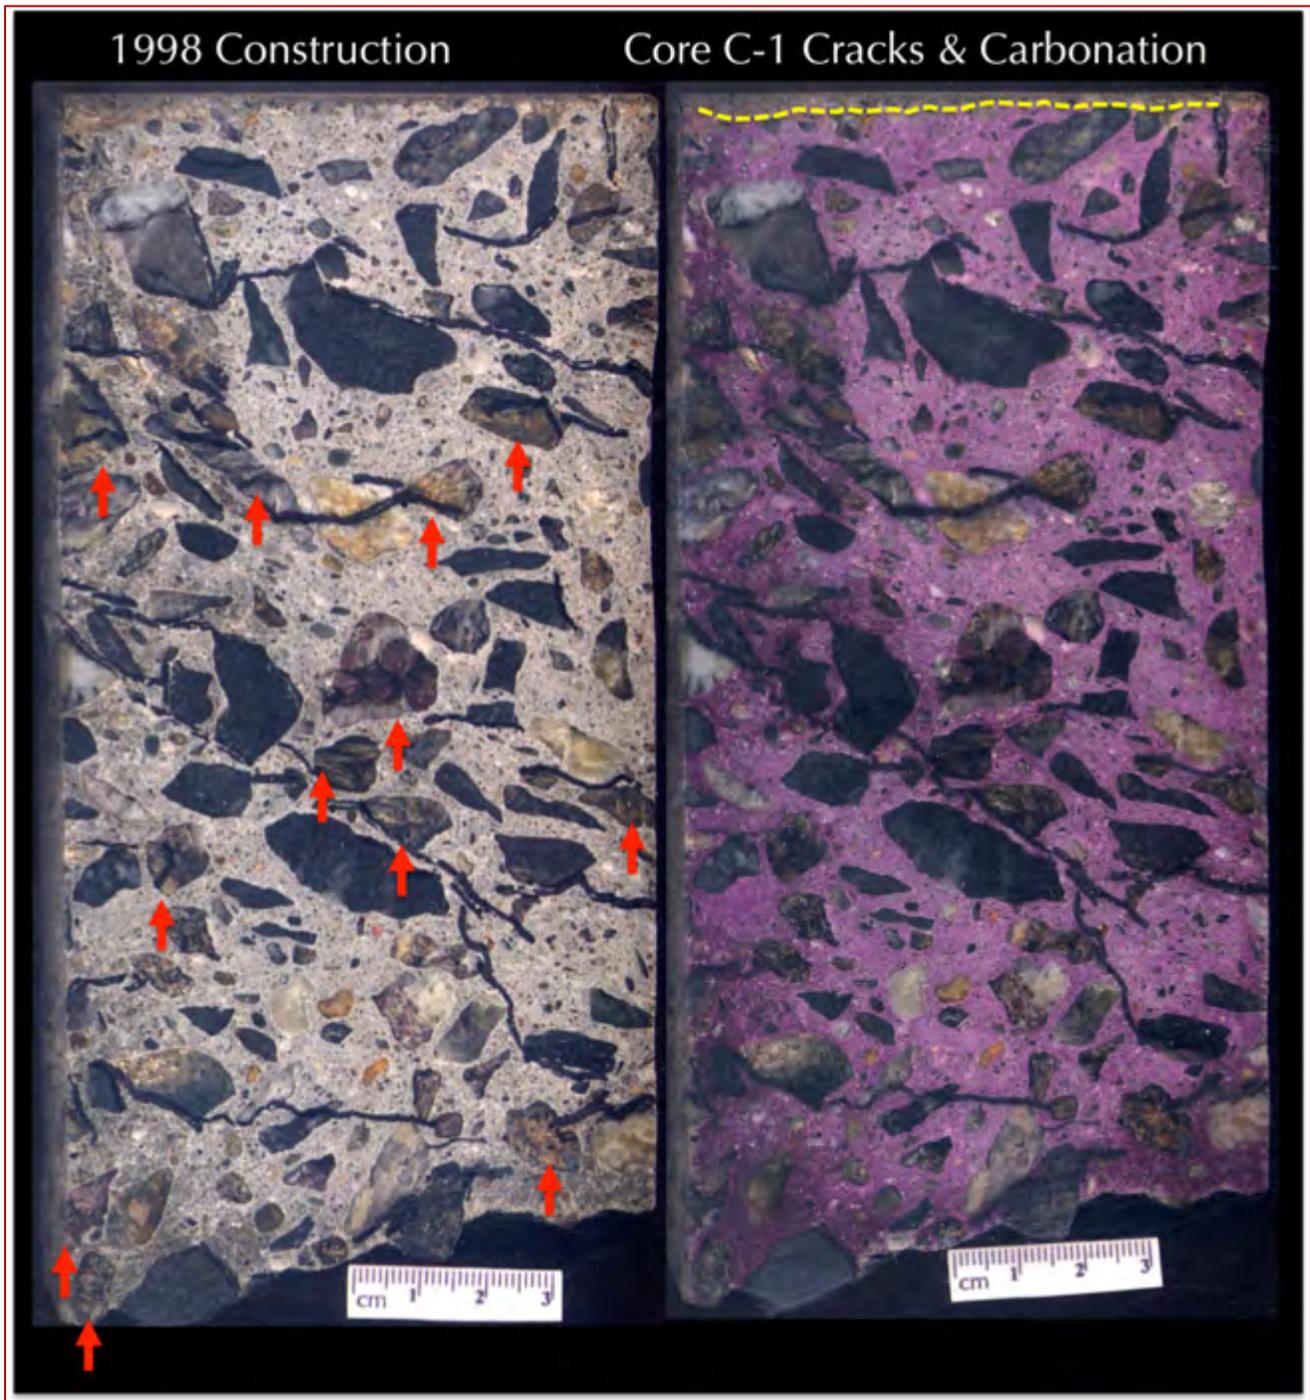
Figure B 10: Lapped cross sections of Core C-1 showing: (a) extensive cracking all throughout the depth of the core, where all visible cracks revealed during stereo-microscopical examination of the lapped cross section are marked with a black marker pen, along with a few unsound light pinkish-brown crushed stone coarse aggregate (garnetiferous quartz-feldspar biotite gneiss) marked in red arrows in the left; and (b) minimal (less than 5 mm deep) carbonation from the formed exposed end of concrete (carbonation front is marked in dashed yellow line on right) after 20 years of service since 1998, a testament of dense, well-consolidated nature of concrete.

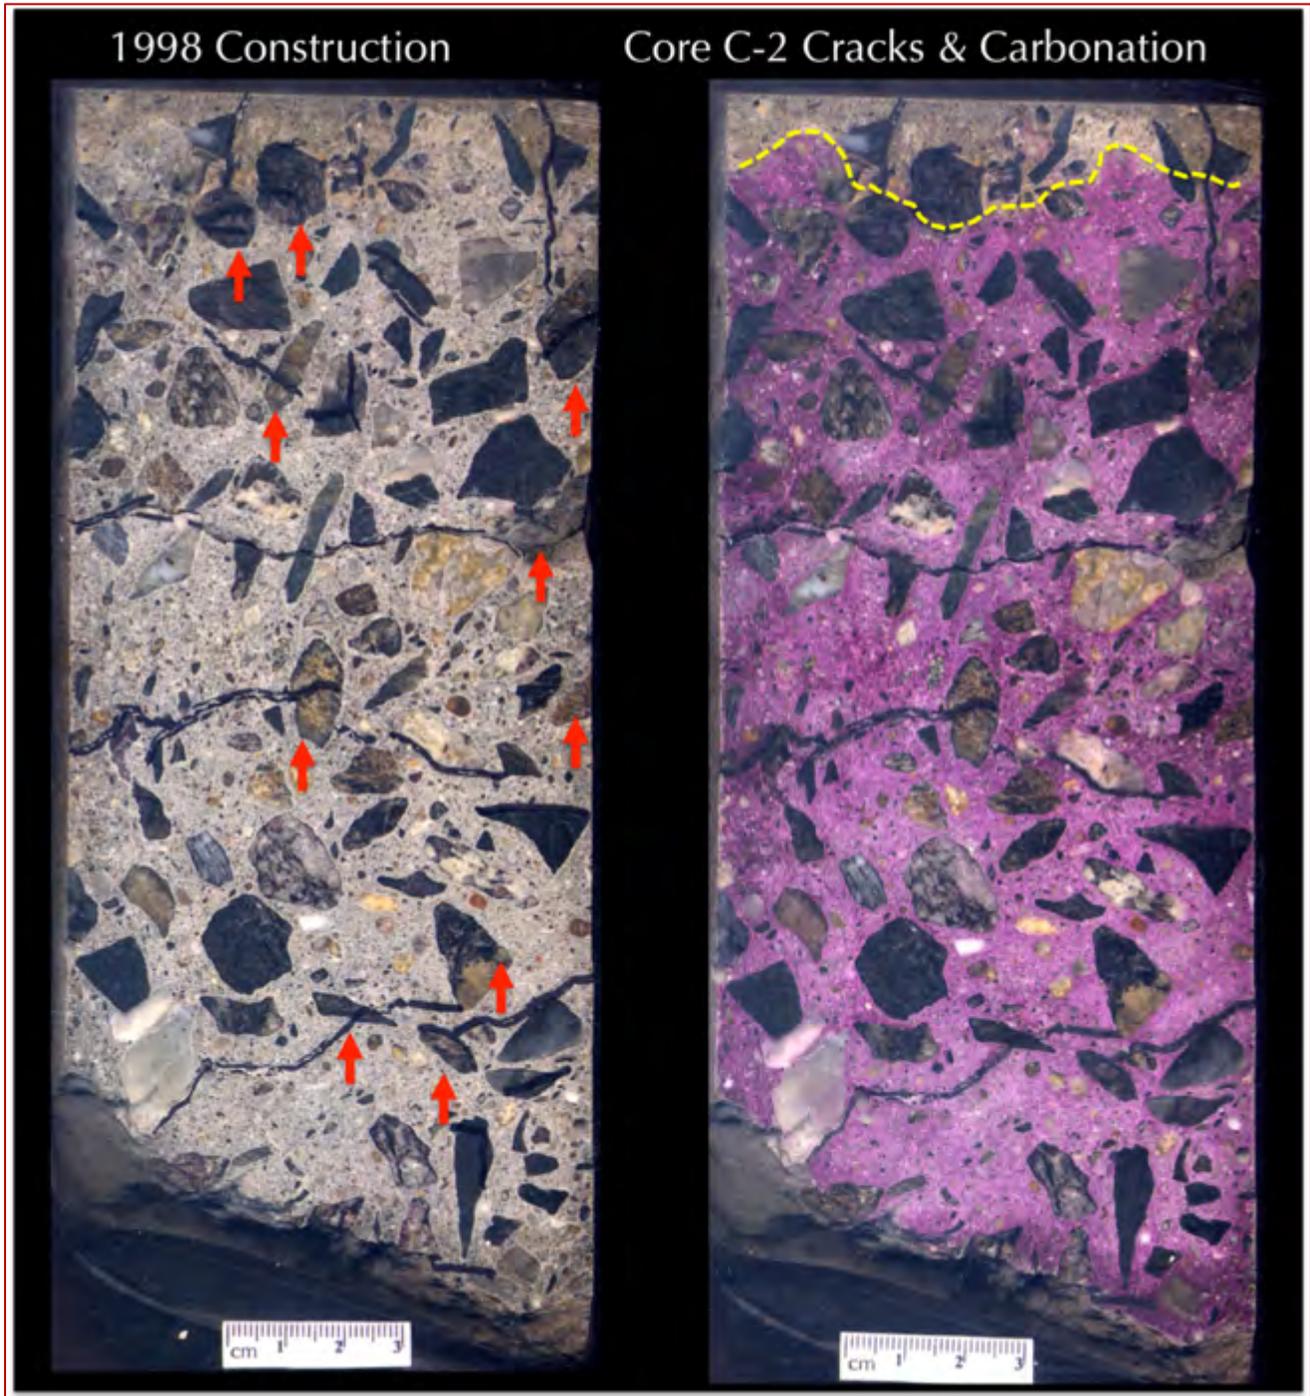
Figure B 12: Lapped cross sections of Core C-2 showing: (a) extensive cracking all throughout the depth of the core, where all visible cracks revealed during stereo-microscopical examination of the lapped cross section are marked with a black marker pen, along with a few unsound light pinkish-brown crushed stone coarse aggregate (garnetiferous quartz-feldspar biotite gneiss) marked in red arrows in the left; and (b) minimal (less than 20 mm deep) carbonation from the formed exposed end of concrete (carbonation front is marked in dashed yellow line on right) after 20 years of service since 1998, a testament of dense, well-consolidated nature of concrete.

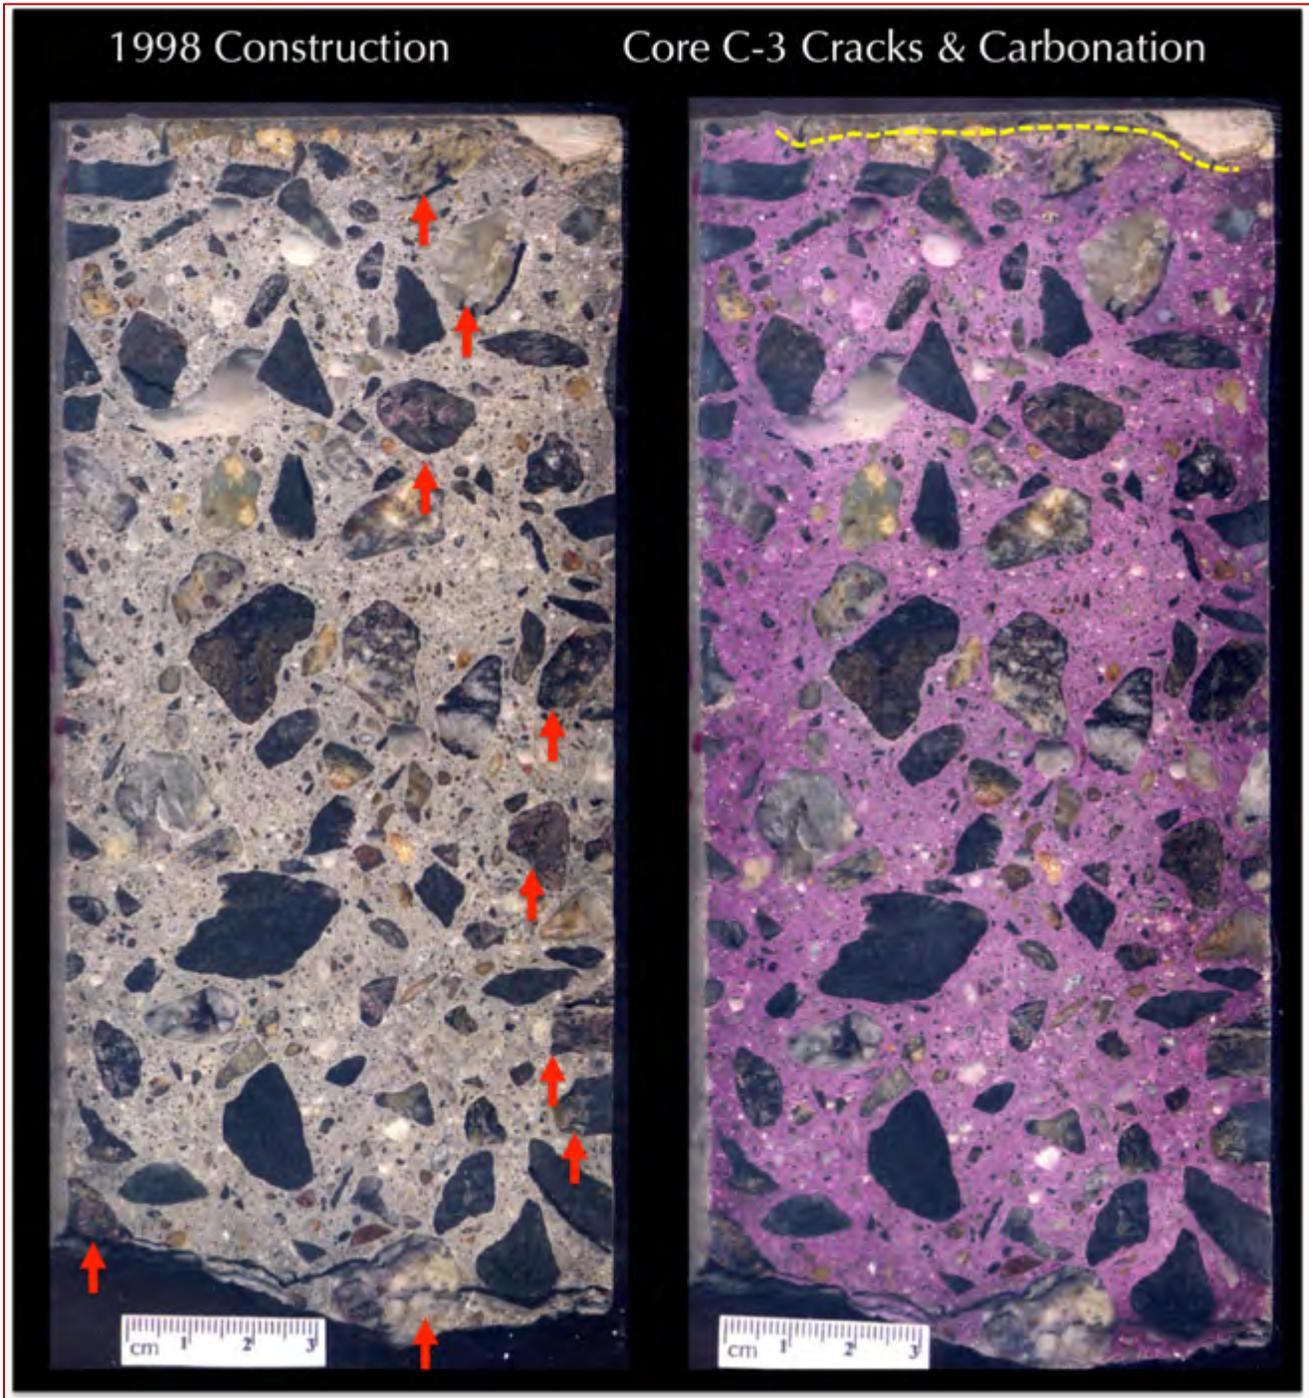
Figure B 14: Lapped cross sections of Core C-3 showing: (a) minimal localized visible cracking confined mostly within some crushed stone aggregates, where visible cracks revealed during stereo-microscopical examination of the lapped cross section are marked with a black marker pen, along with a few unsound light pinkish-brown crushed stone coarse aggregate (garnetiferous quartz-feldspar biotite gneiss) marked in red arrows in the left; and (b) minimal (less than 5 mm deep) carbonation from the formed exposed end of concrete (carbonation front is marked in dashed yellow line on right) after 20 years of service since 1998, a testament of dense, well-consolidated nature of concrete.

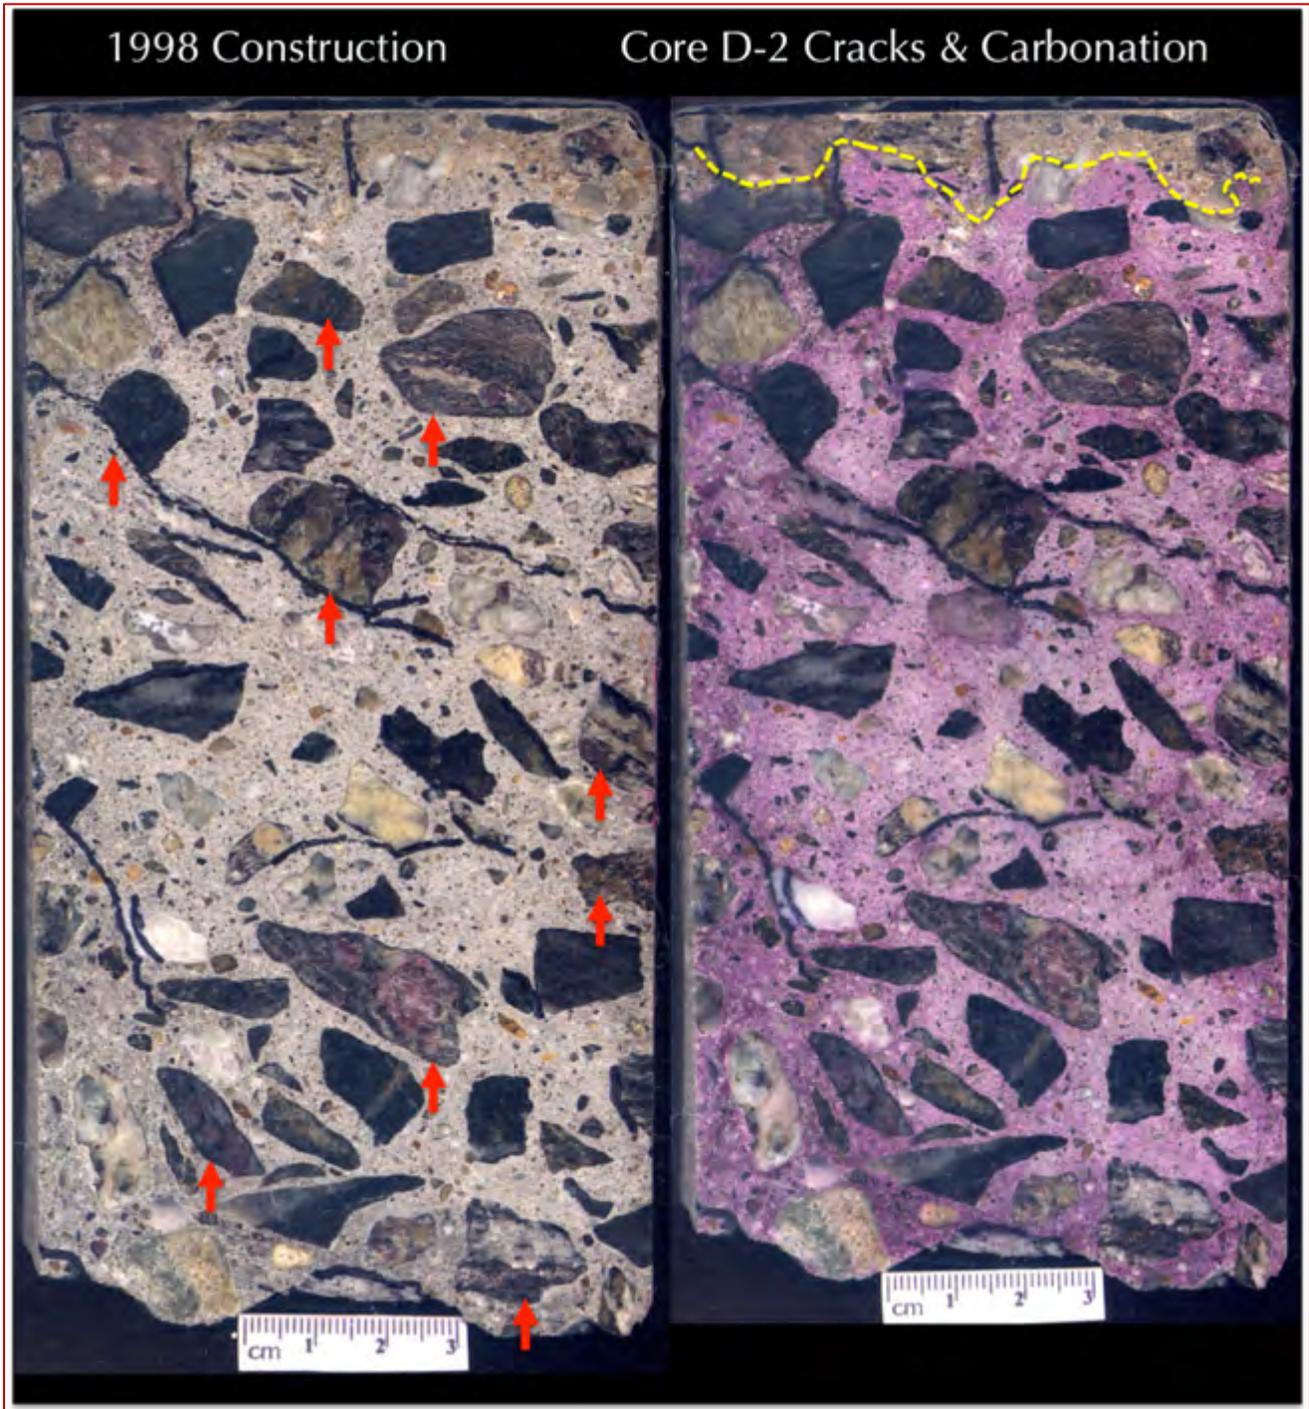
Figure B 18: Lapped cross sections of Core D-2 showing: (a) moderate to extensive cracking all throughout the depth of the core, where all visible cracks revealed during stereo-microscopical examination of the lapped cross section are marked with a black marker pen, along with a few unsound light pinkish-brown crushed stone coarse aggregate (garnetiferous quartz-feldspar biotite gneiss) marked in red arrows in the left; and (b) minimal (less than 20 mm deep) carbonation from the formed exposed end of concrete (carbonation front is marked in dashed yellow line on right) after 20 years of service since 1998, a testament of dense, well-consolidated nature of concrete.

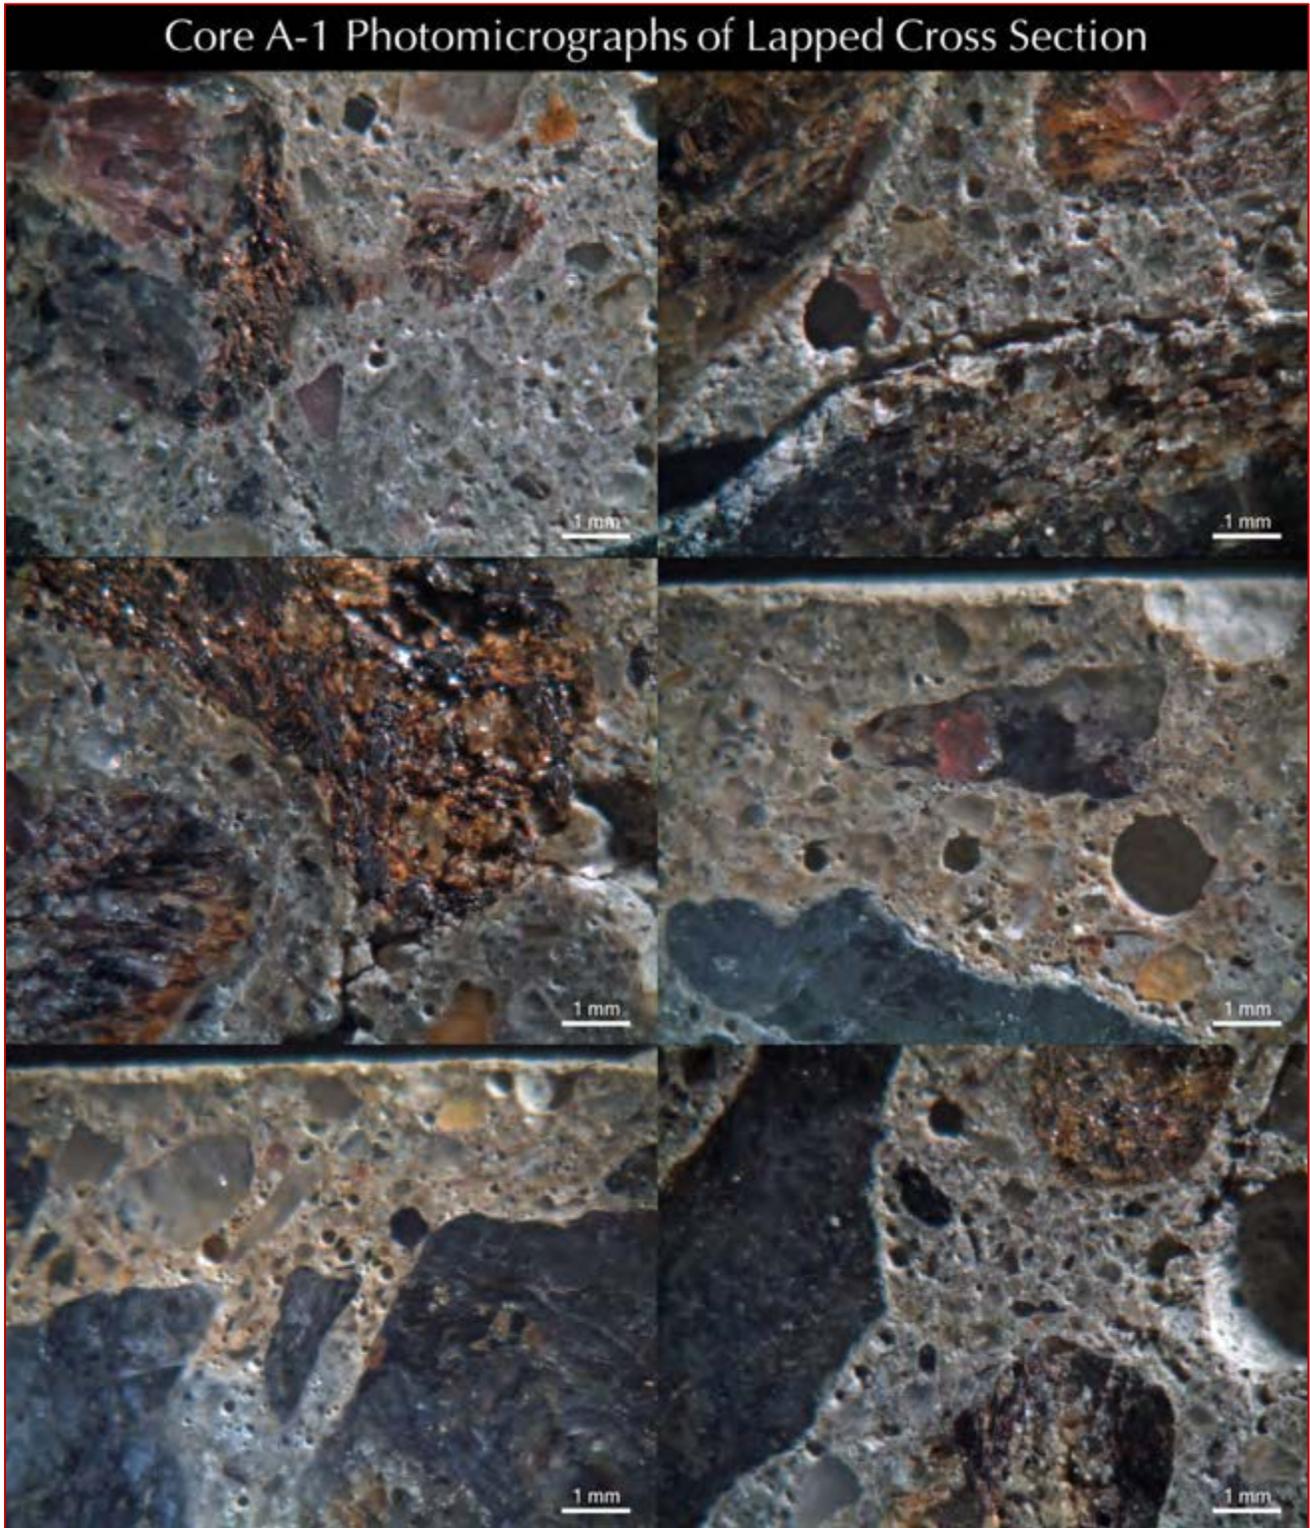
Figure C 1: Photomicrographs of lapped cross section of Core A-1 showing: (a) air-entrained nature of concrete having numerous fine (< 1 mm size), discrete spherical entrained air-voids; and (b) cracking in many unsound crushed gneiss coarse aggregate particles.

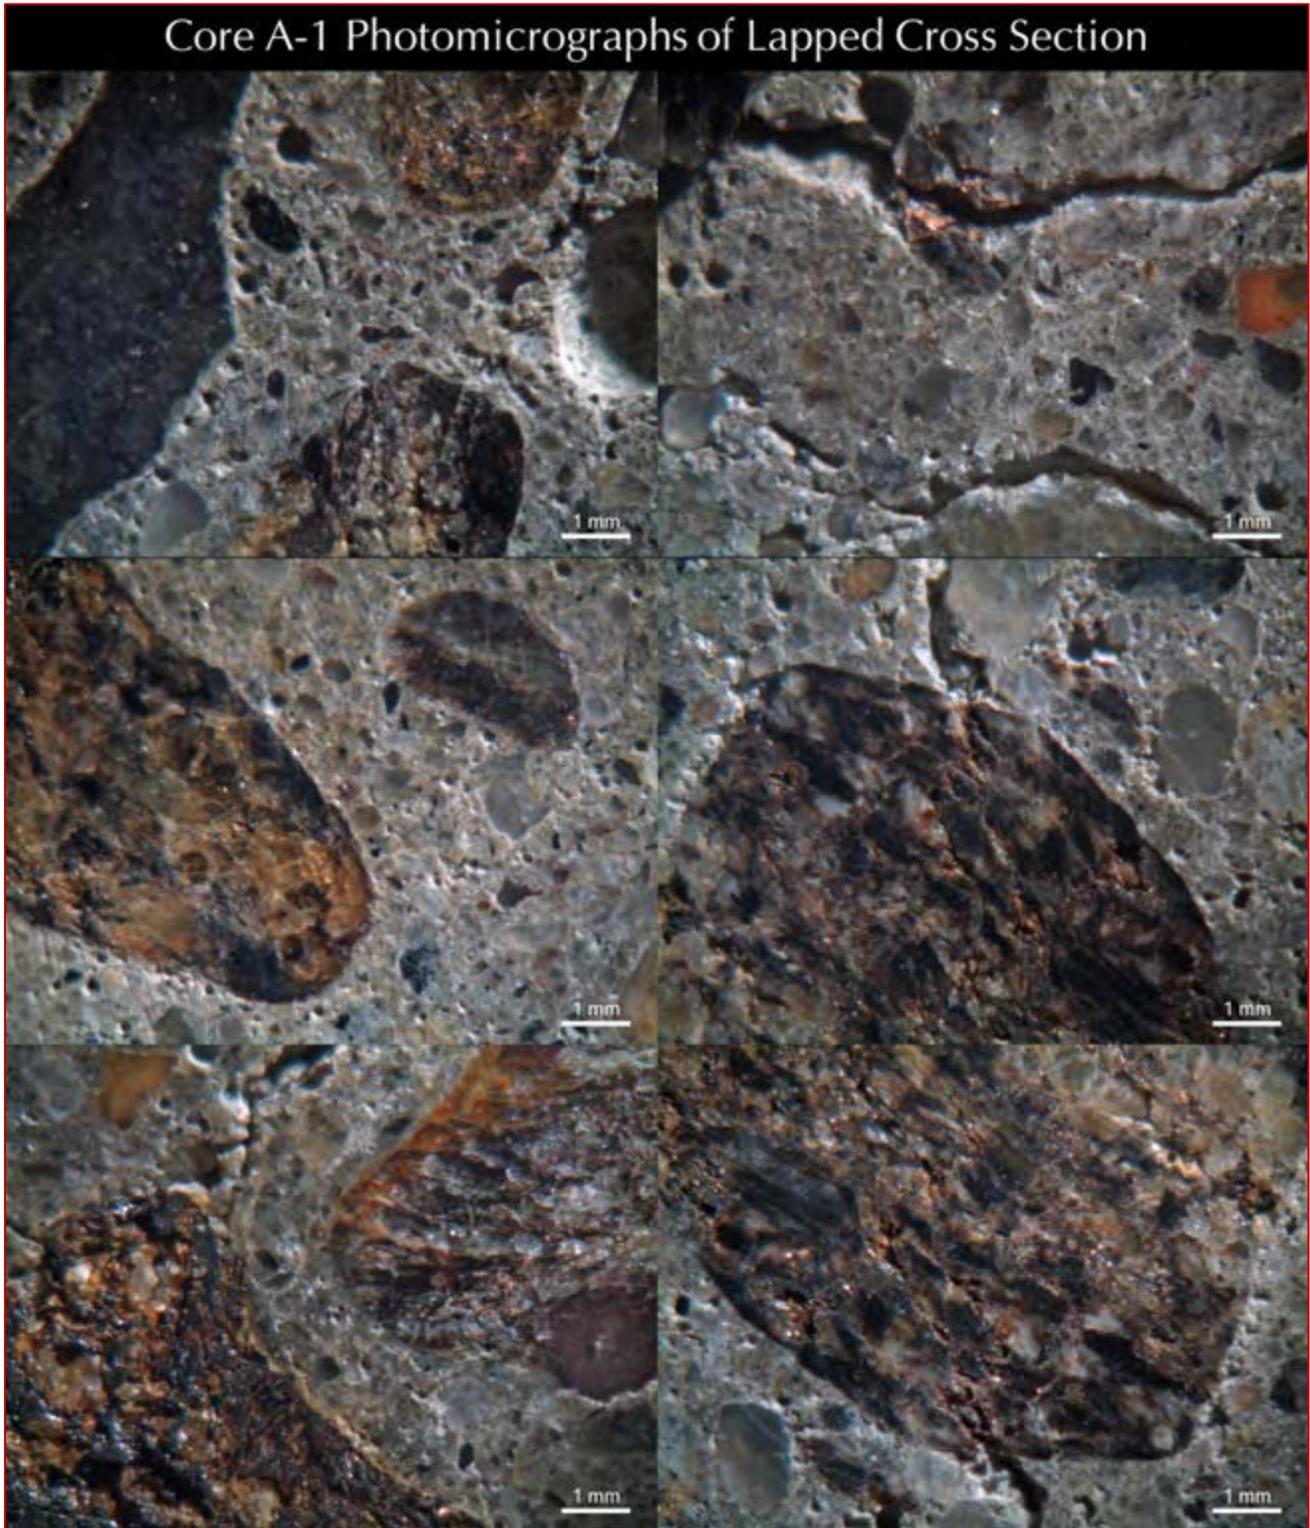
Figure C 2: Photomicrographs of lapped cross section of Core A-1 showing: (a) air-entrained nature of concrete having numerous fine (< 1 mm size), discrete spherical entrained air-voids; and (b) cracking in many unsound crushed gneiss coarse aggregate particles.
