## Pyrrhotite Epidemic in Eastern Connecticut: A Case Study From Tolland, CT

Tolland Board of Education  
Birch Grove School  
247 Rhodes Road  
Tolland, CT 06084

January 10, 2019  
CMC 1218175

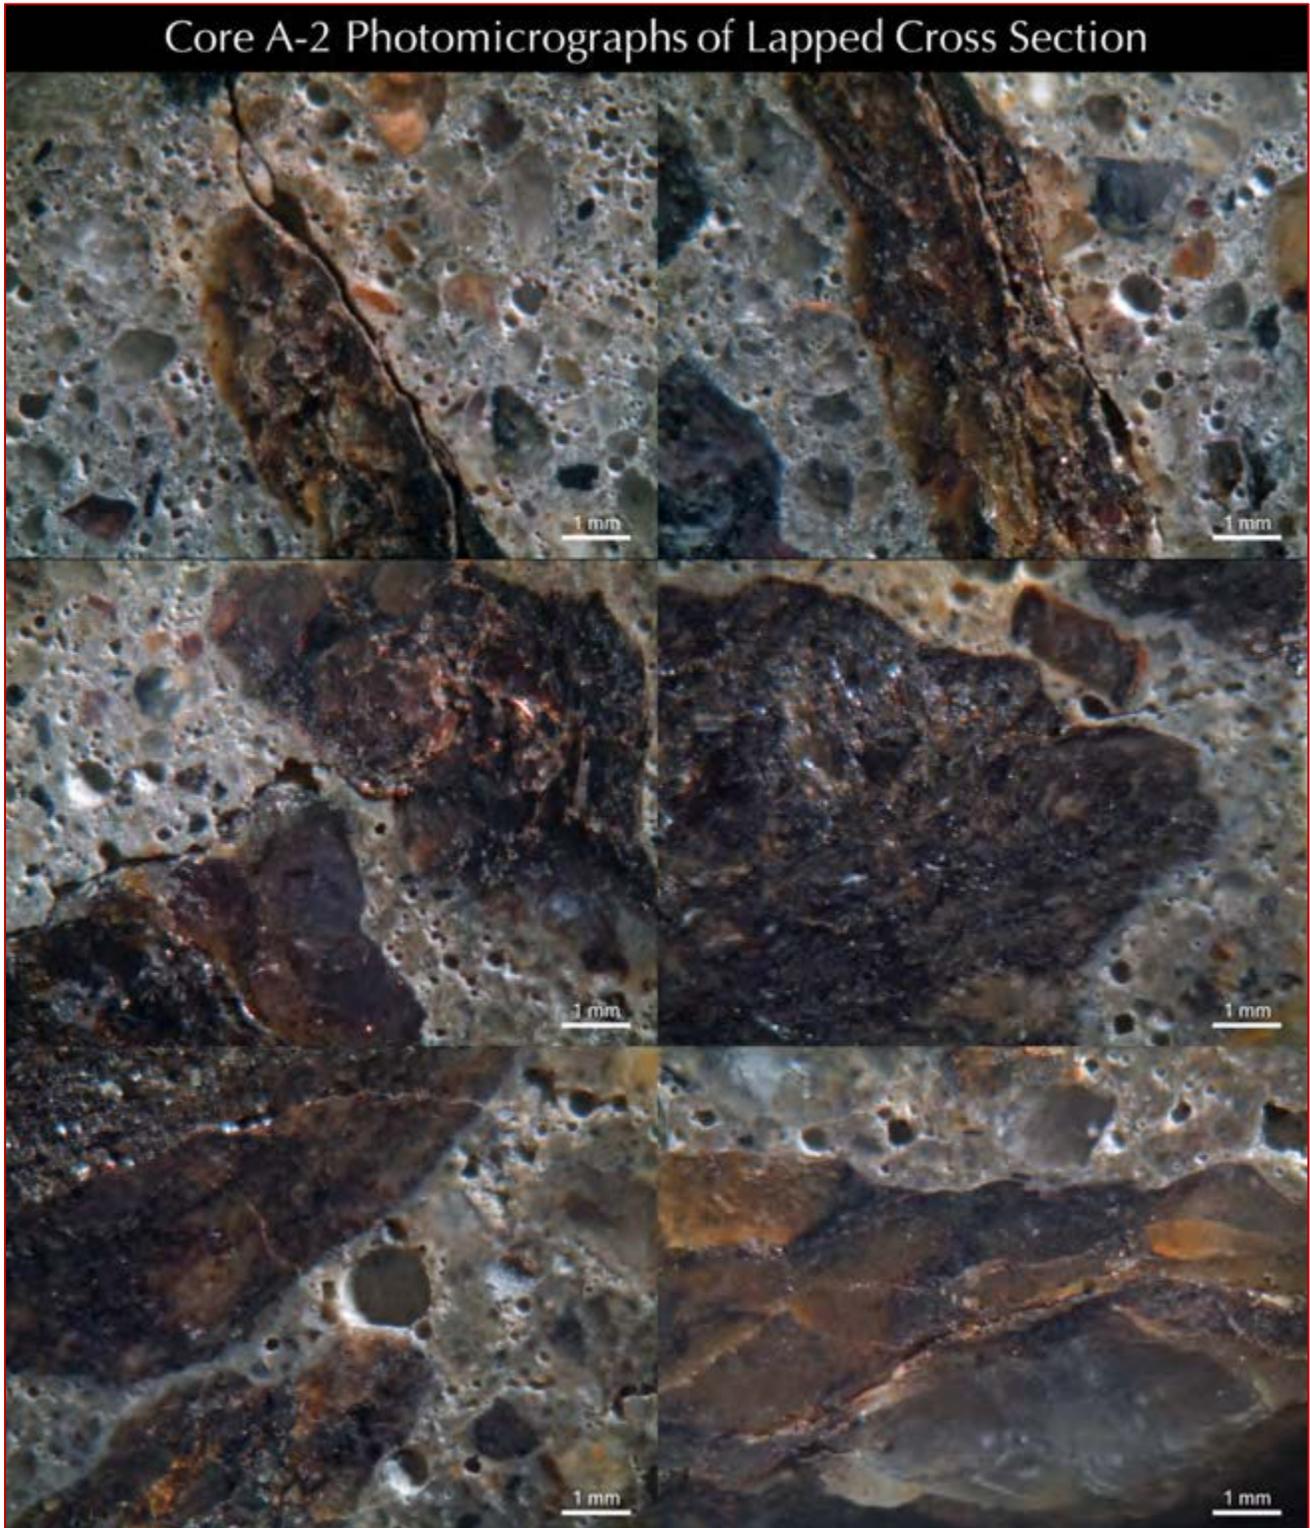
Figure C 3: Photomicrographs of lapped cross section of Core A-2 showing: (a) air-entrained nature of concrete having numerous fine (< 1 mm size), discrete spherical entrained air-voids; and (b) cracking in many unsound crushed gneiss coarse aggregate particles.

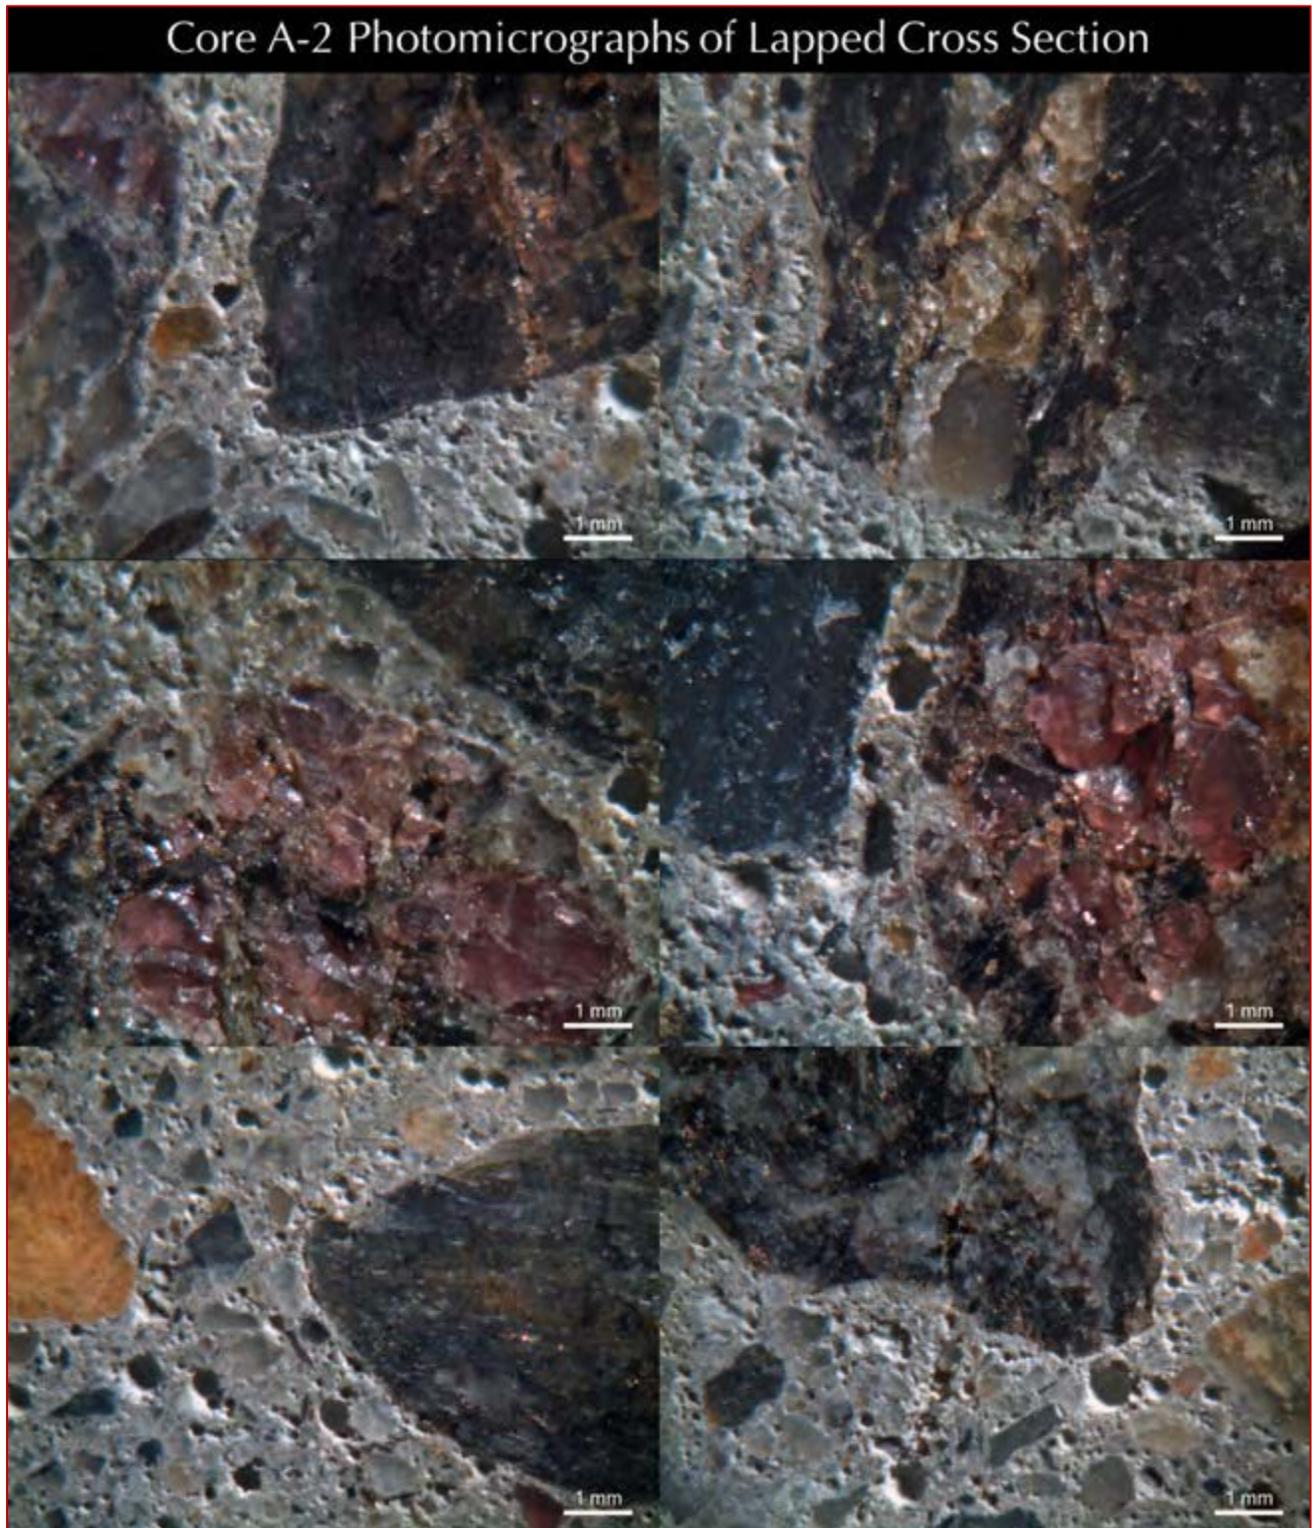
Figure C 4: Photomicrographs of lapped cross section of Core A-2 showing: (a) air-entrained nature of concrete having numerous fine (< 1 mm size), discrete spherical entrained air-voids; and (b) cracking in many unsound crushed gneiss coarse aggregate particles. Notice some large red almandine garnet crystals in gneiss.

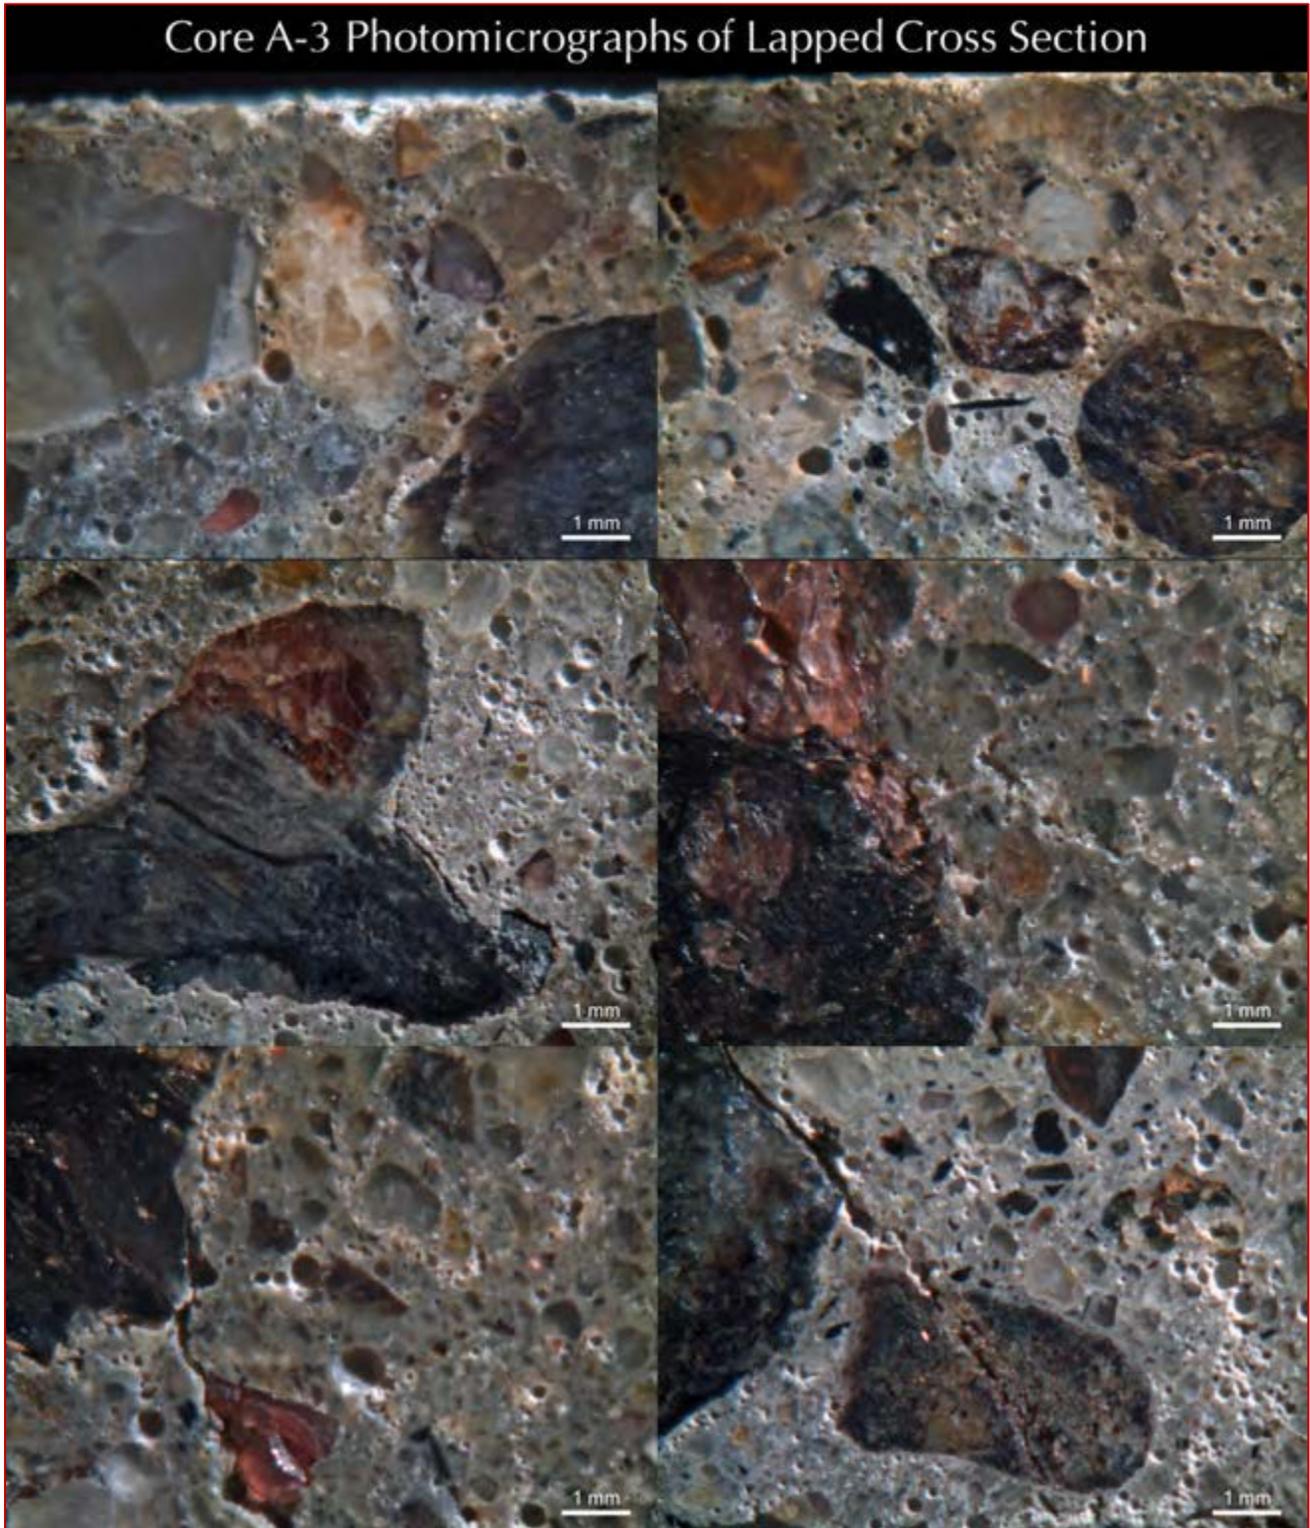
Figure C 5: Photomicrographs of lapped cross section of Core A-3 showing: (a) air-entrained nature of concrete having numerous fine (< 1 mm size), discrete spherical entrained air-voids; and (b) cracking in many unsound crushed gneiss coarse aggregate particles. Notice some large red almandine garnet crystals in gneiss.

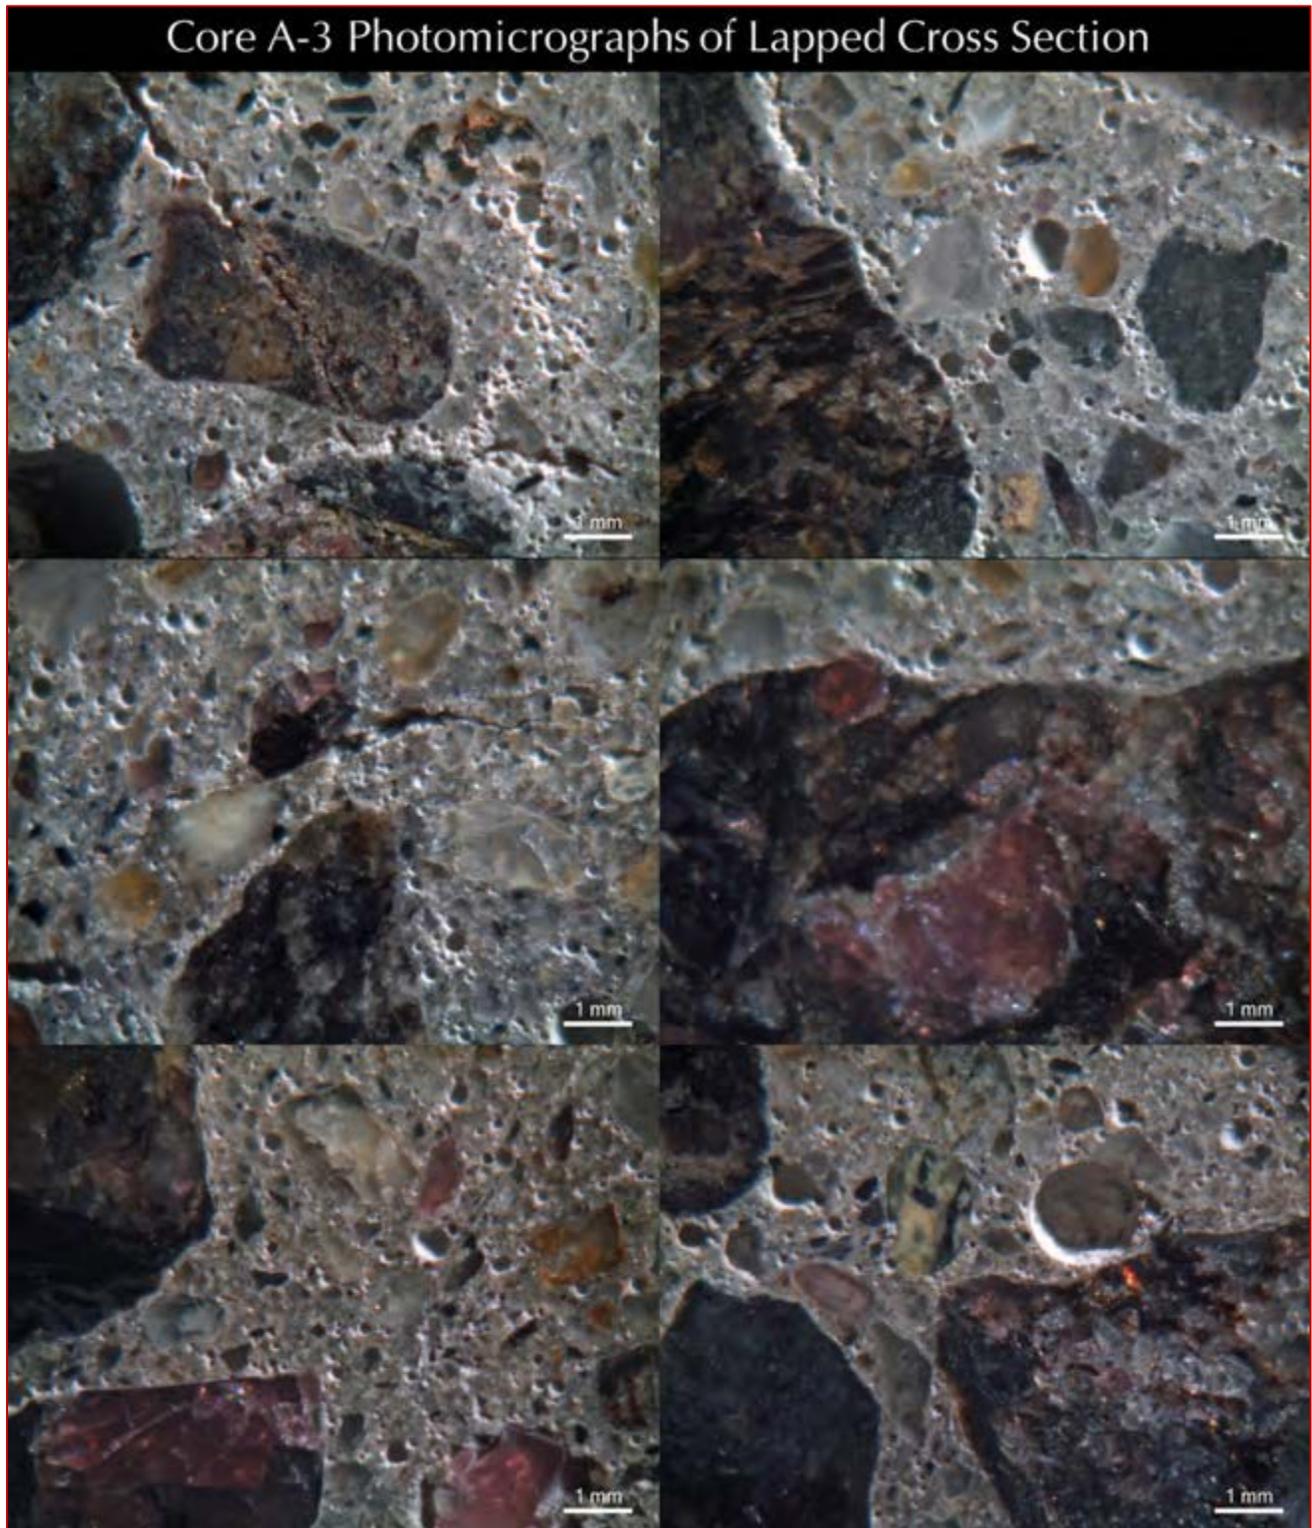
Figure C 6: Photomicrographs of lapped cross section of Core A-3 showing: (a) air-entrained nature of concrete having numerous fine (< 1 mm size), discrete spherical entrained air-voids; and (b) cracking in many unsound crushed gneiss coarse aggregate particles. Notice some large red almandine garnet crystals in gneiss.

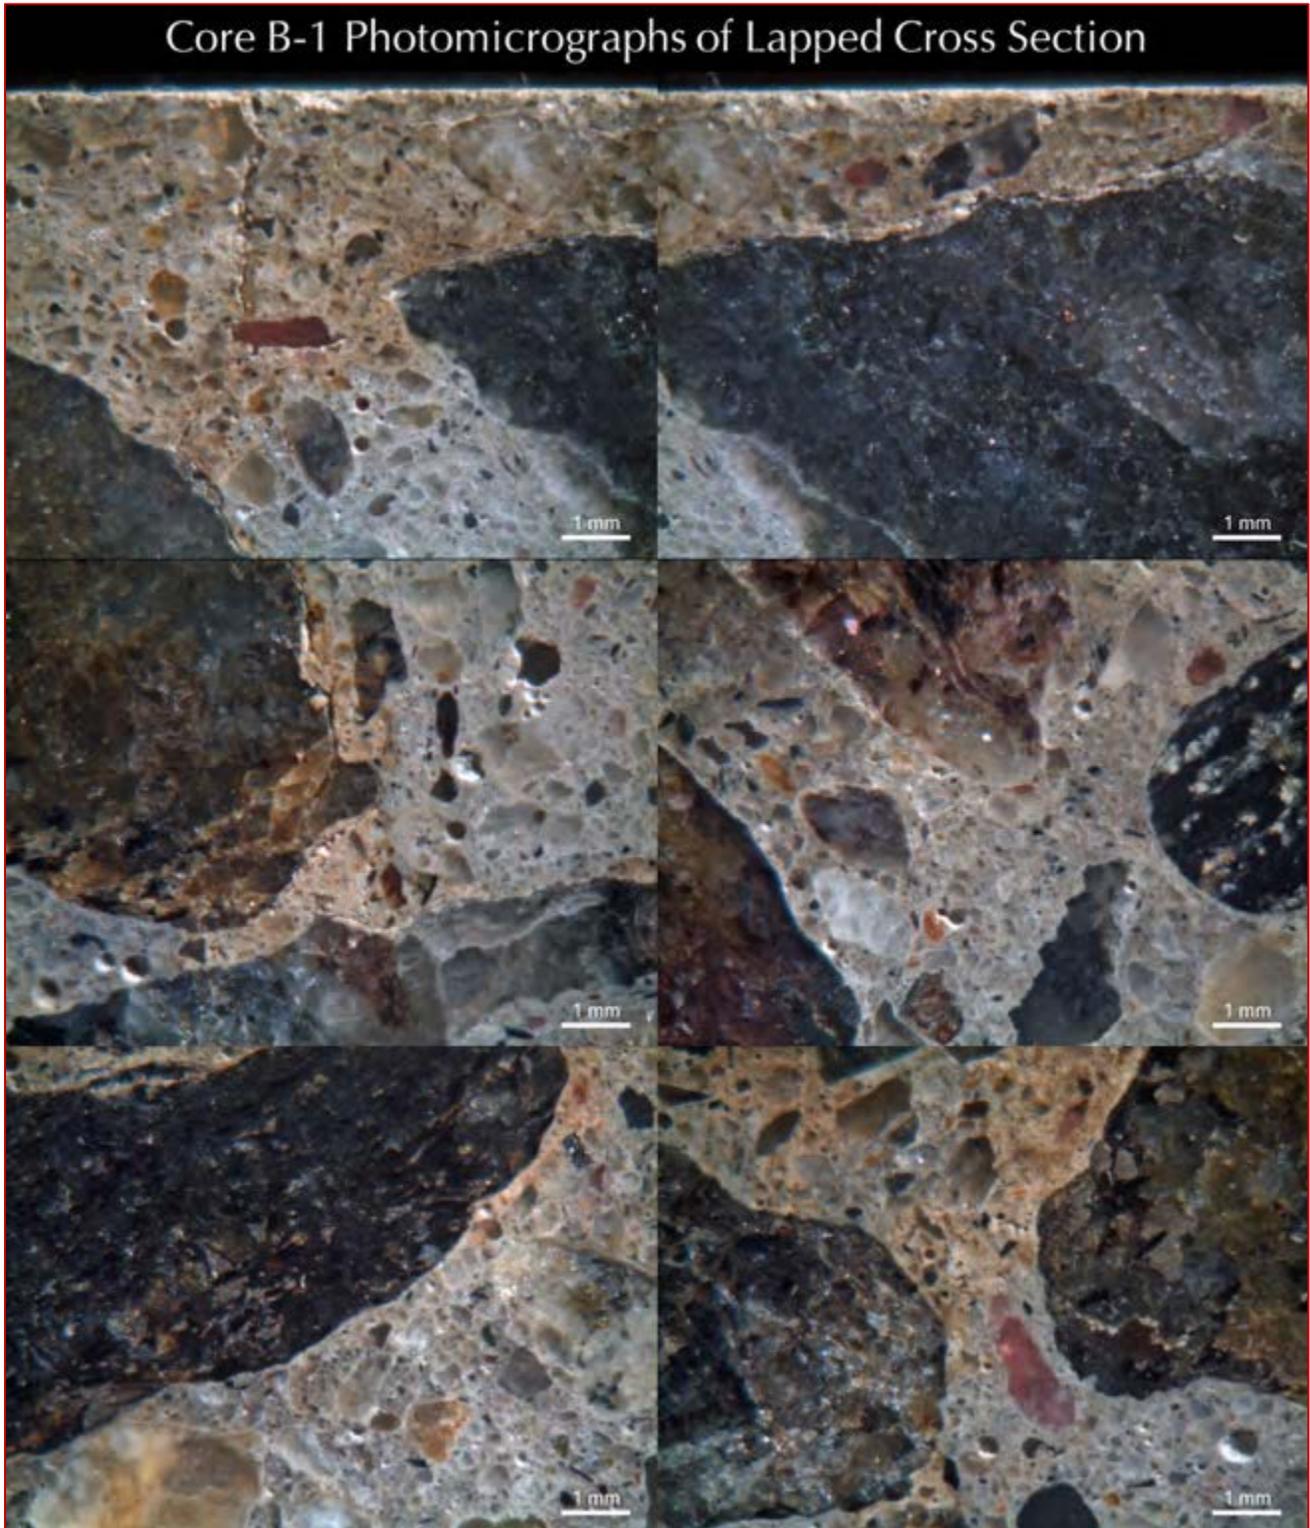
Figure C 7: Photomicrographs of lapped cross section of Core B-1 showing: (a) air-entrained nature of concrete having numerous fine (< 1 mm size), discrete spherical entrained air-voids; and (b) many unsound crushed gneiss coarse aggregate particles.

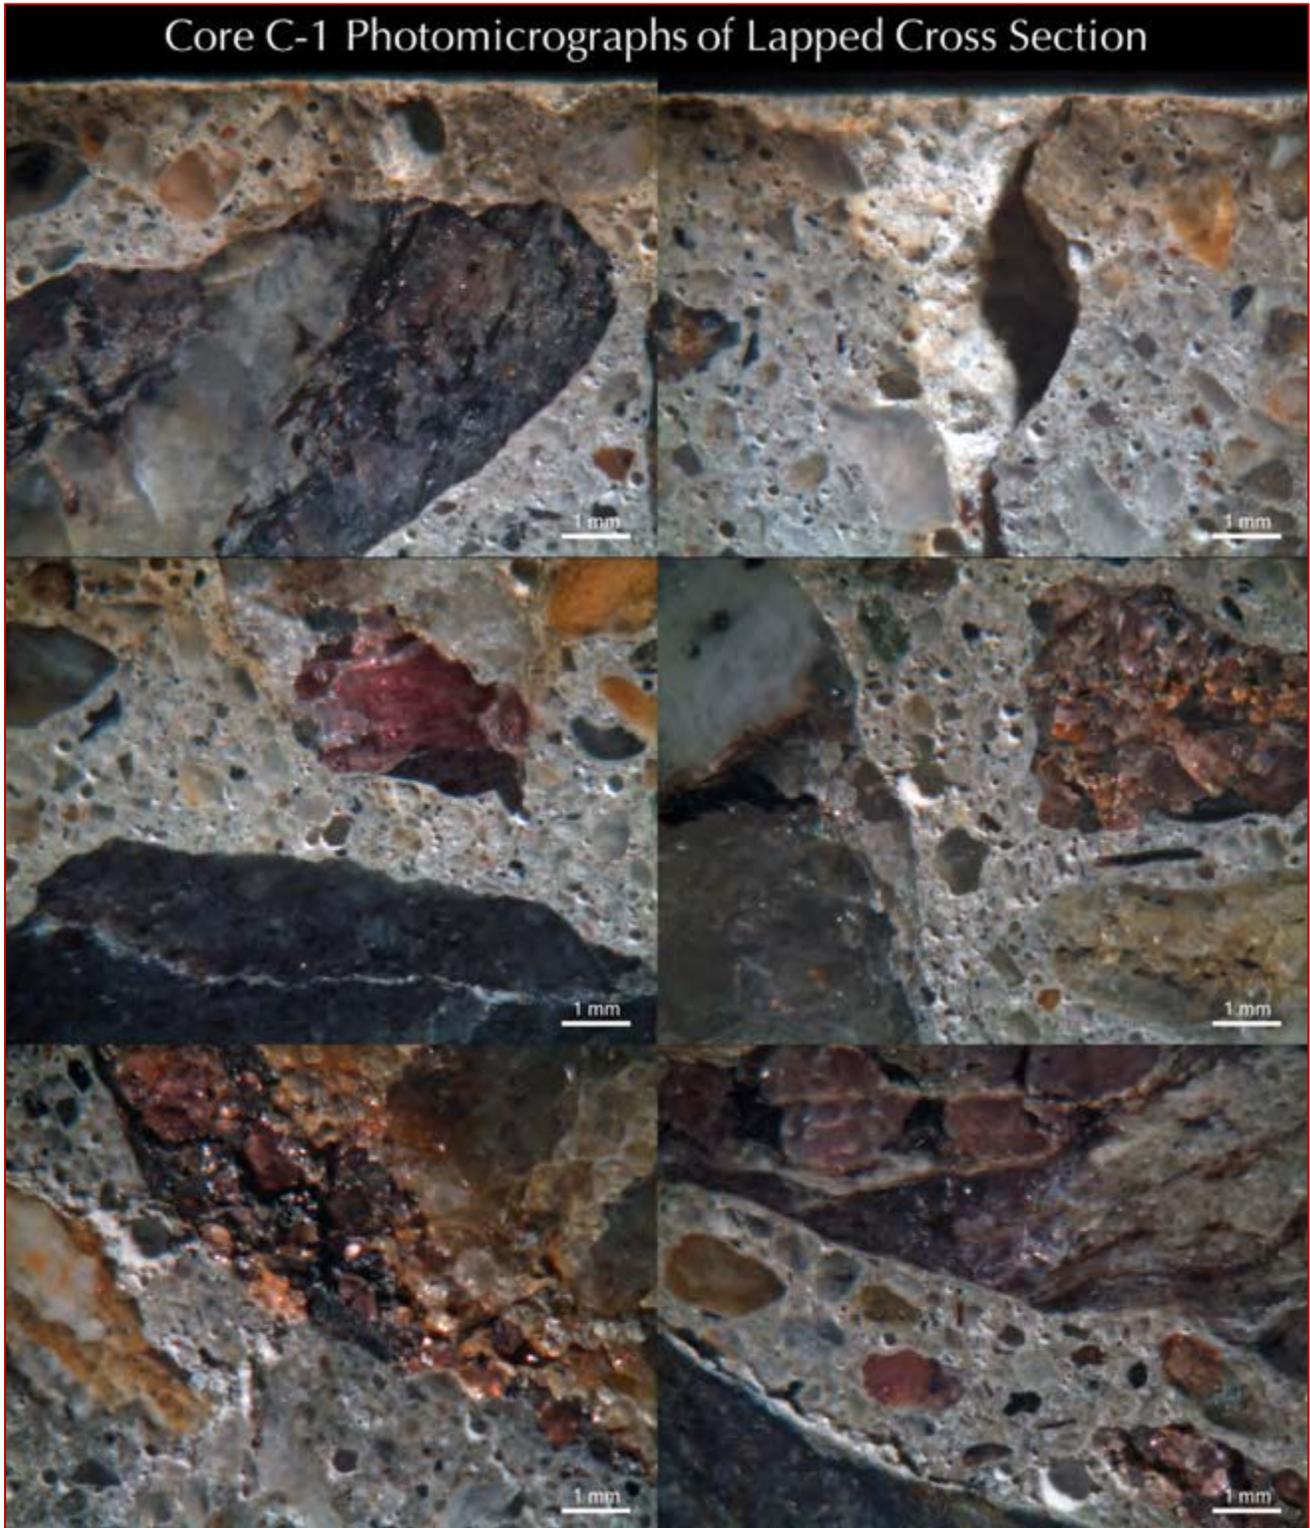
Figure C 9: Photomicrographs of lapped cross section of Core C-1 showing: (a) air-entrained nature of concrete having numerous fine (< 1 mm size), discrete spherical entrained air-voids; and (b) cracking in many unsound crushed gneiss coarse aggregate particles. Notice some large red almandine garnet crystals in gneiss.

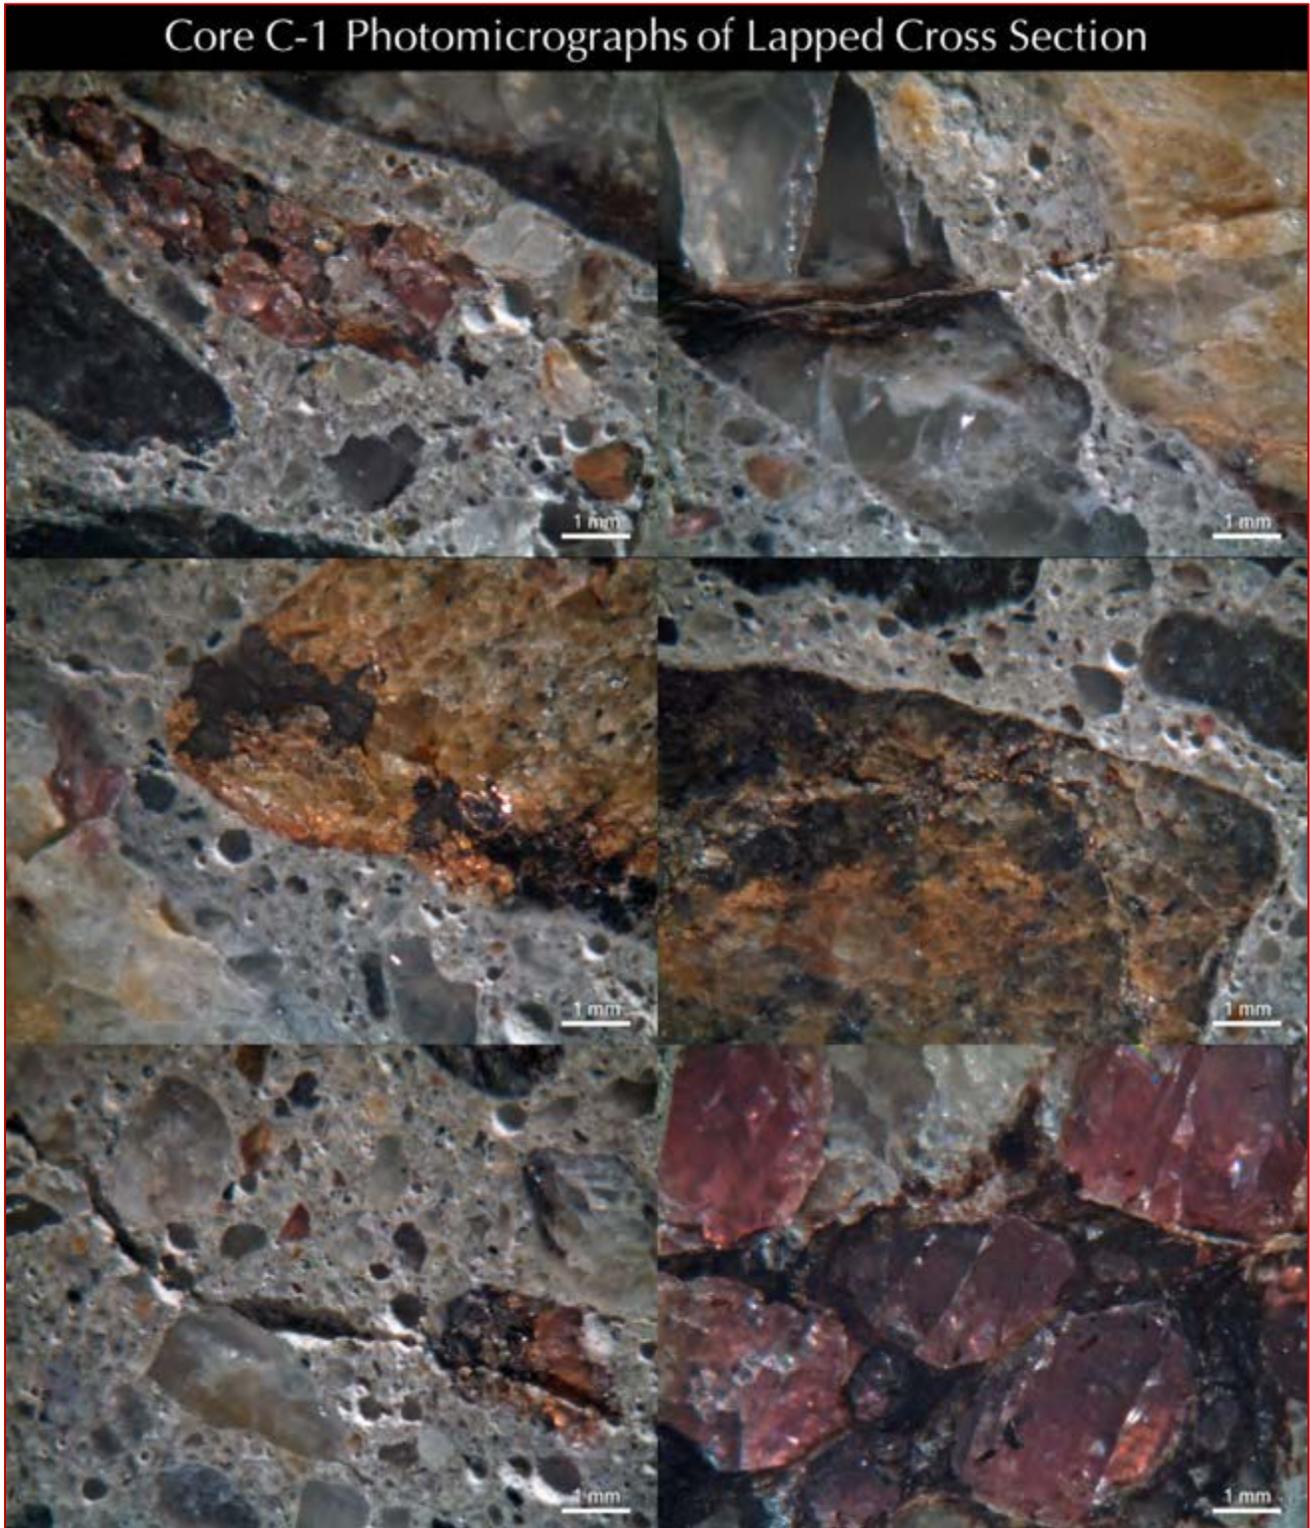
Figure C 10: Photomicrographs of lapped cross section of Core C-1 showing: (a) air-entrained nature of concrete having numerous fine (< 1 mm size), discrete spherical entrained air-voids; and (b) cracking in many unsound crushed gneiss coarse aggregate particles. Notice some large red almandine garnet crystals in gneiss.

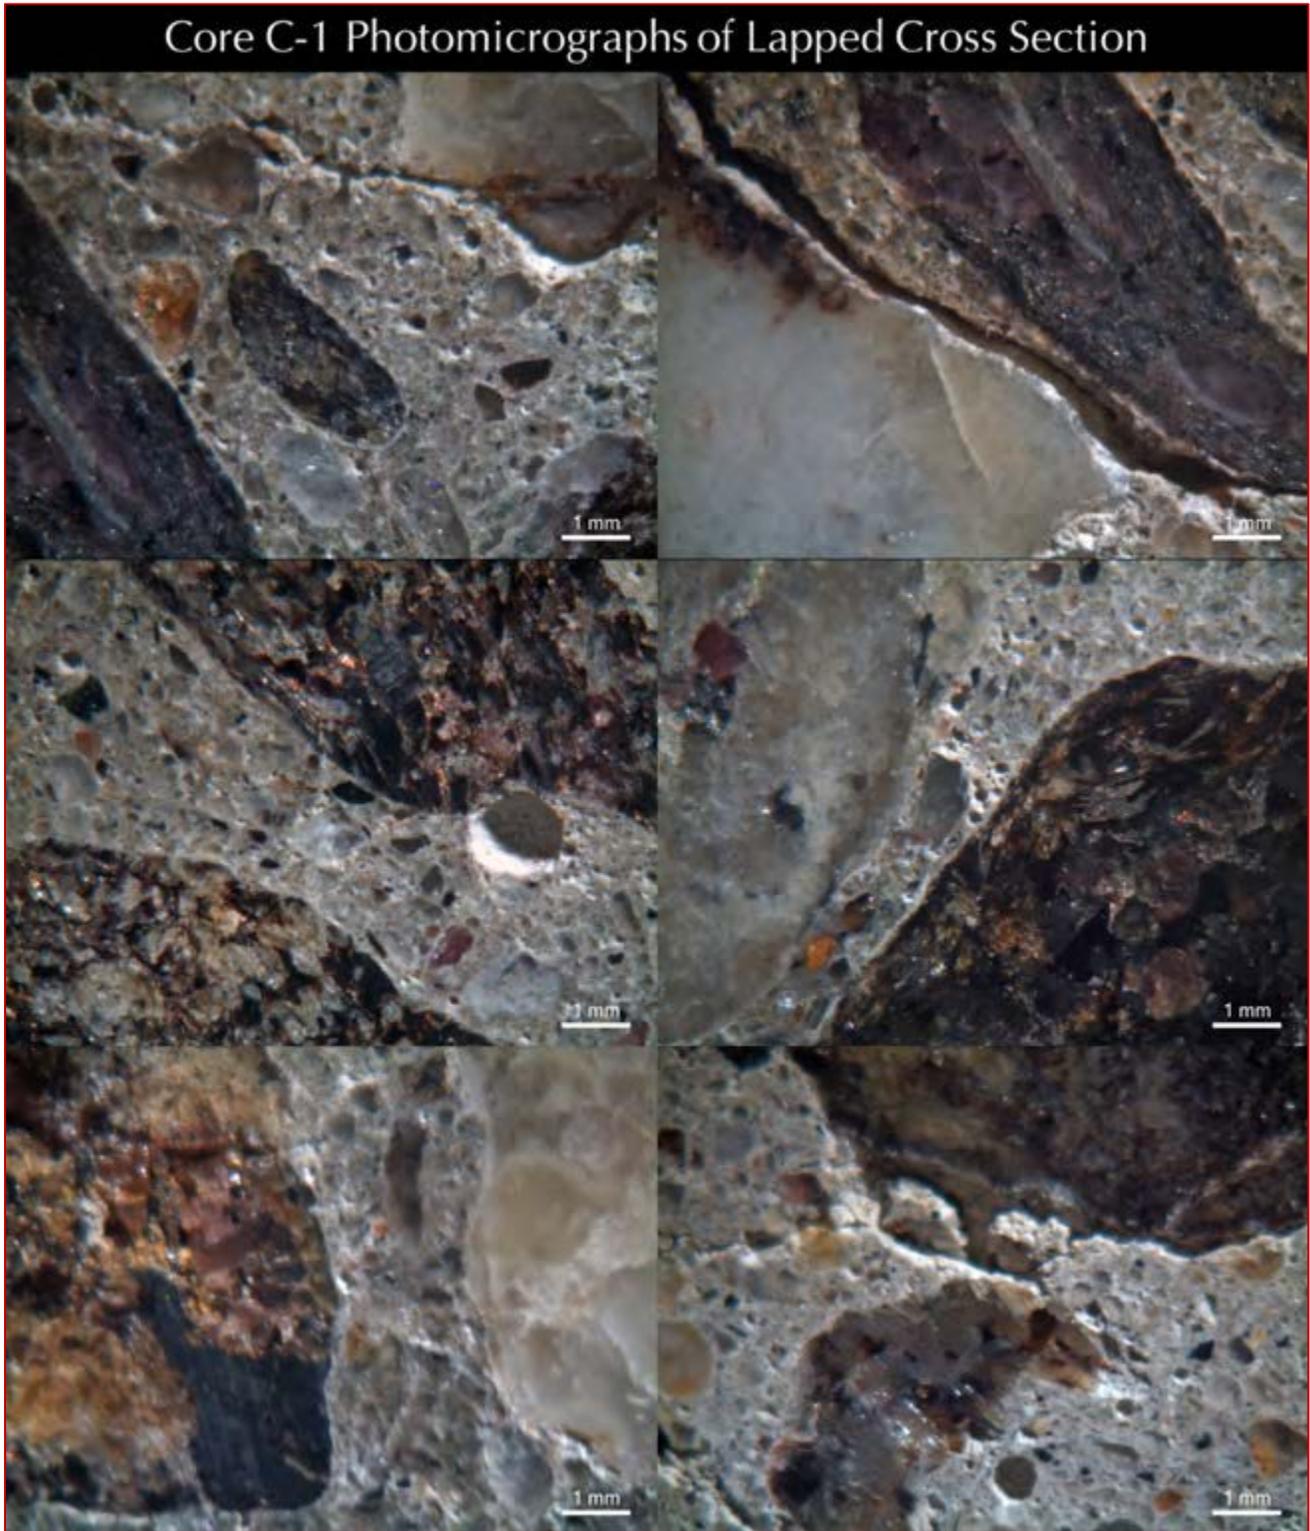
Figure C 11: Photomicrographs of lapped cross section of Core C-1 showing: (a) air-entrained nature of concrete having numerous fine (< 1 mm size), discrete spherical entrained air-voids; and (b) cracking in many unsound crushed gneiss coarse aggregate particles.

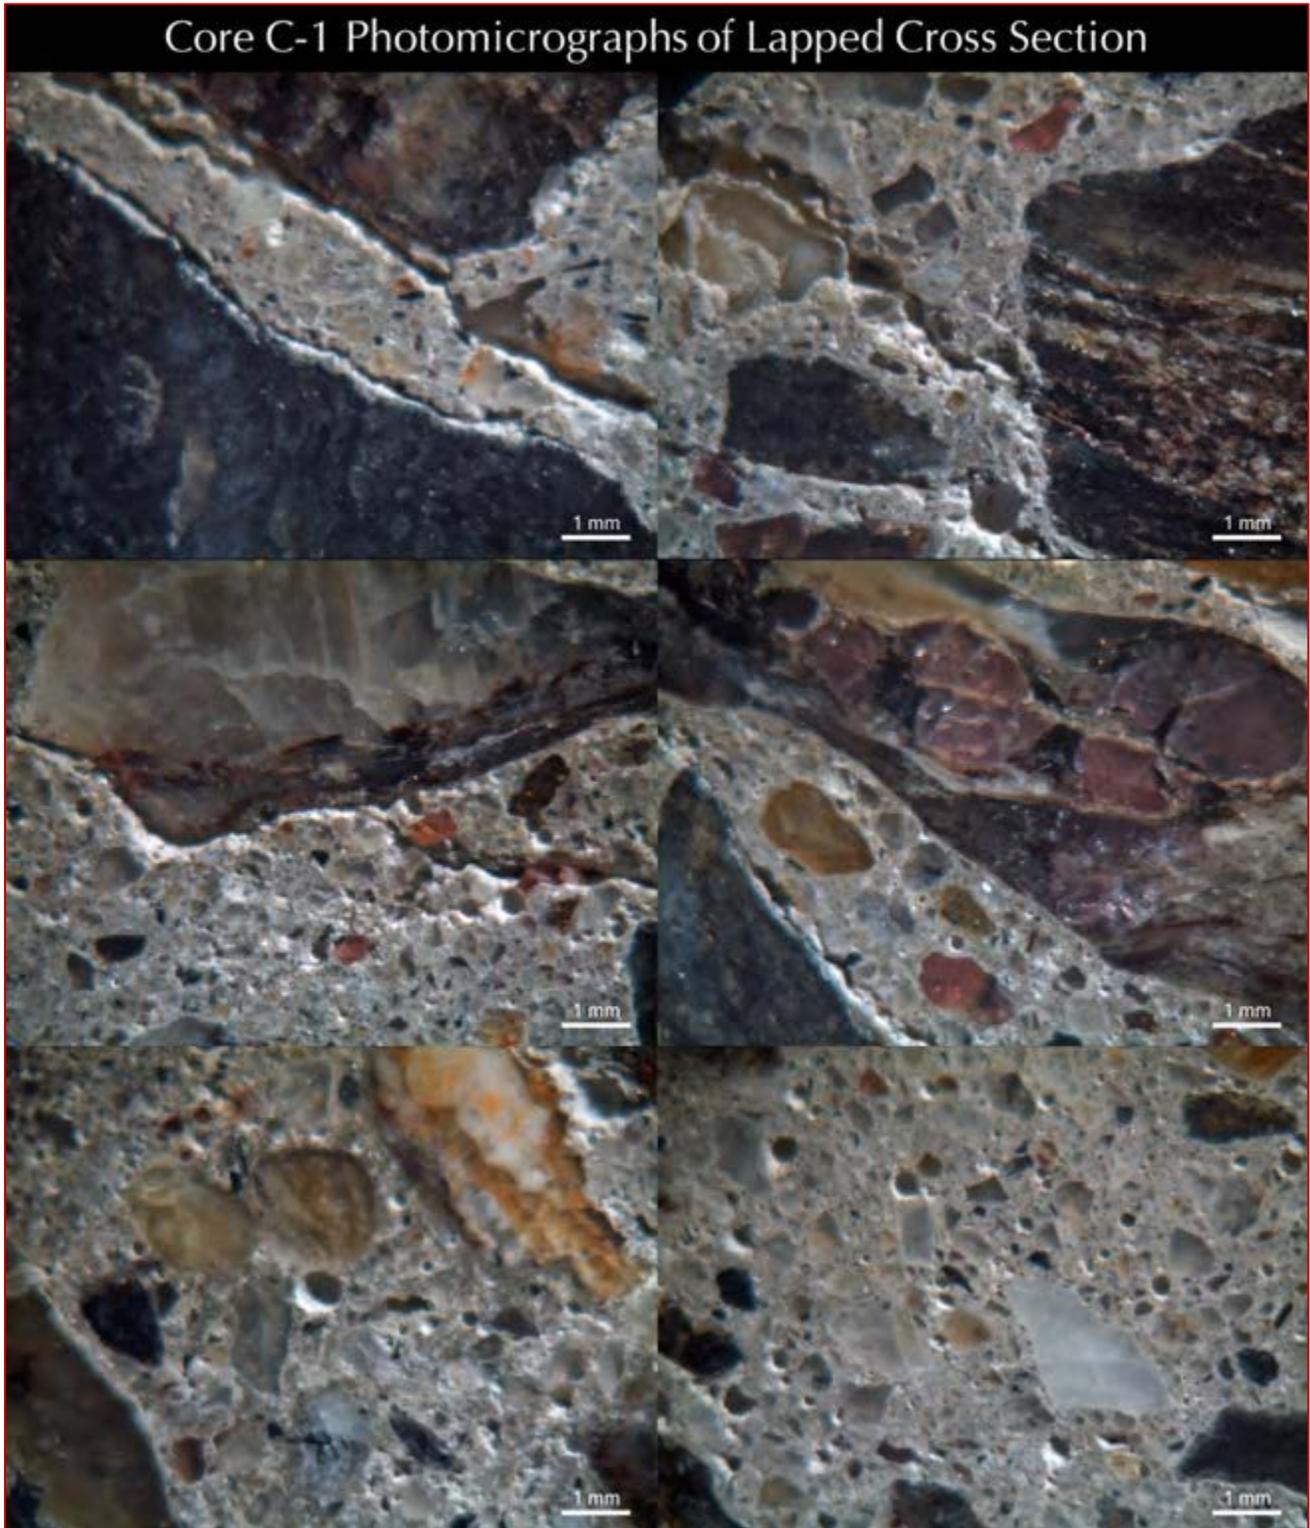
Figure C 12: Photomicrographs of lapped cross section of Core C-1 showing: (a) air-entrained nature of concrete having numerous fine (< 1 mm size), discrete spherical entrained air-voids; and (b) cracking in many unsound crushed gneiss coarse aggregate particles. Notice some large red almandine garnet crystals in gneiss.

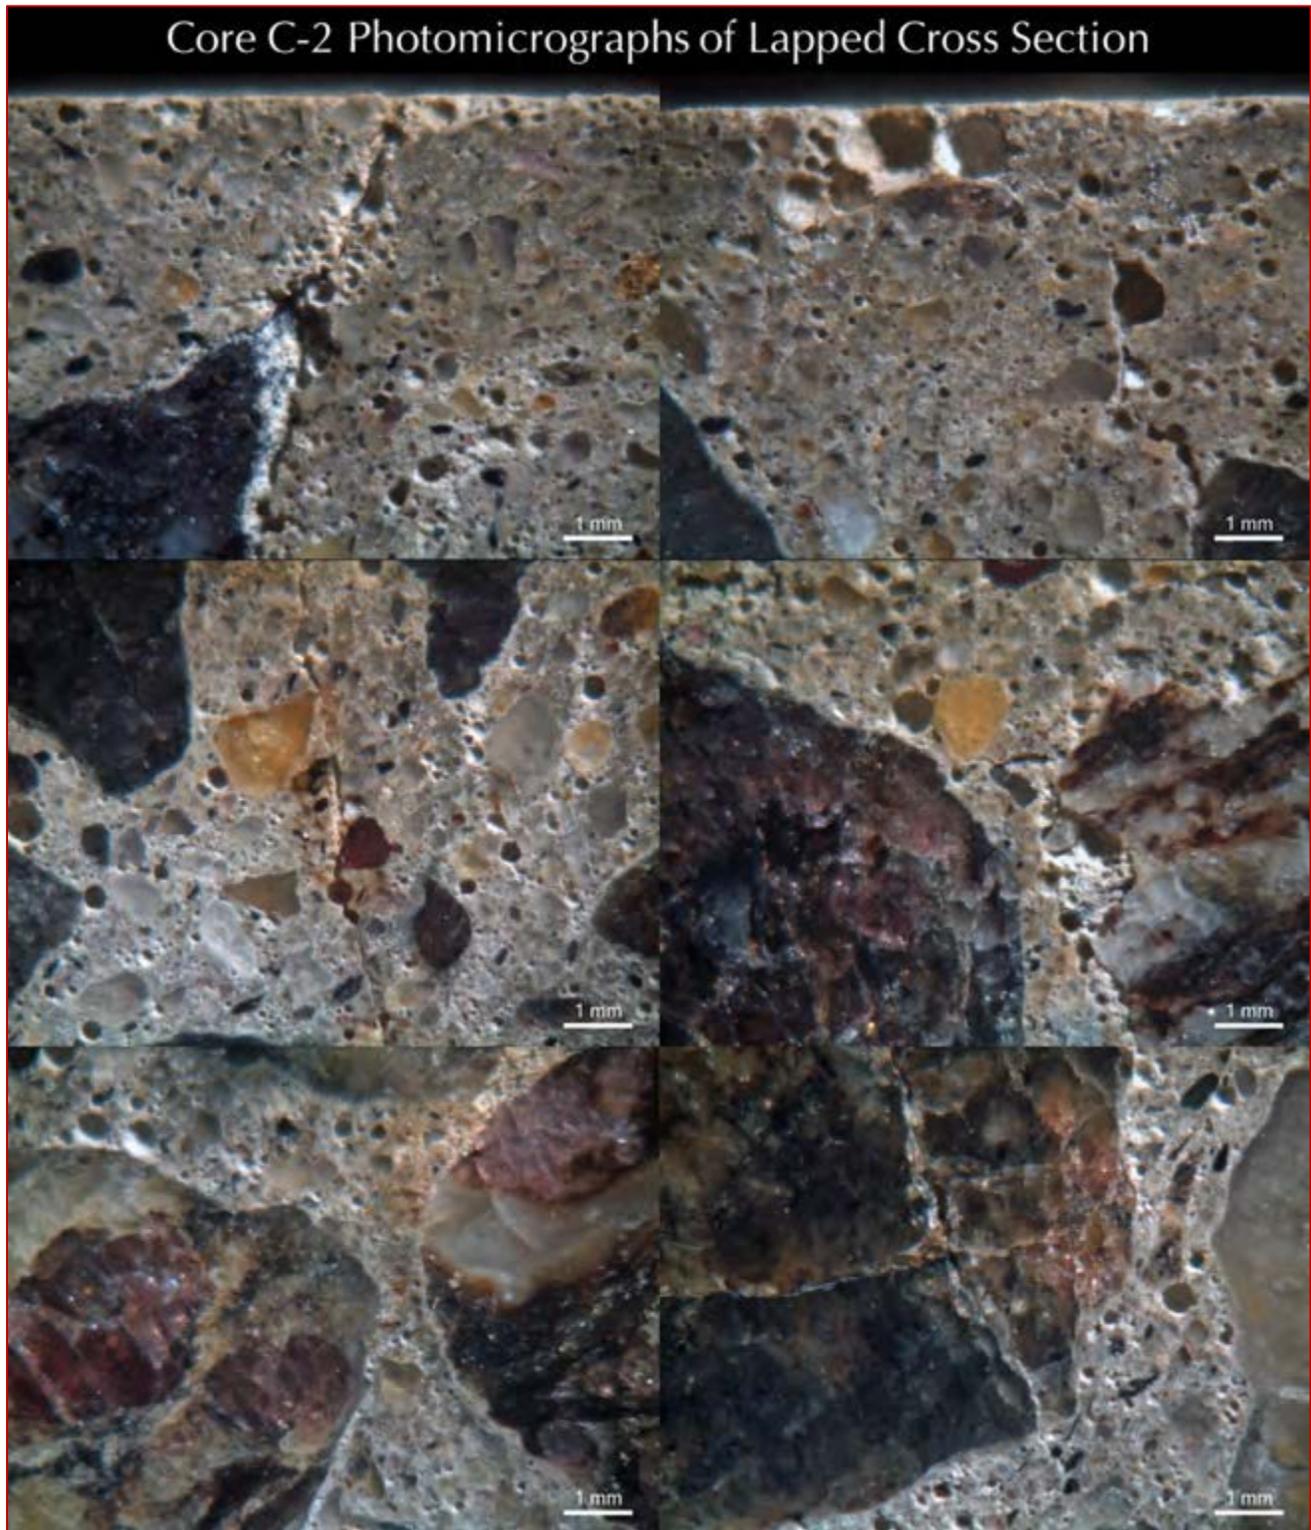
Figure C 13: Photomicrographs of lapped cross section of Core C-2 showing: (a) air-entrained nature of concrete having numerous fine (< 1 mm size), discrete spherical entrained air-voids; and (b) cracking in many unsound crushed gneiss coarse aggregate particles. Notice some large red almandine garnet crystals in gneiss.

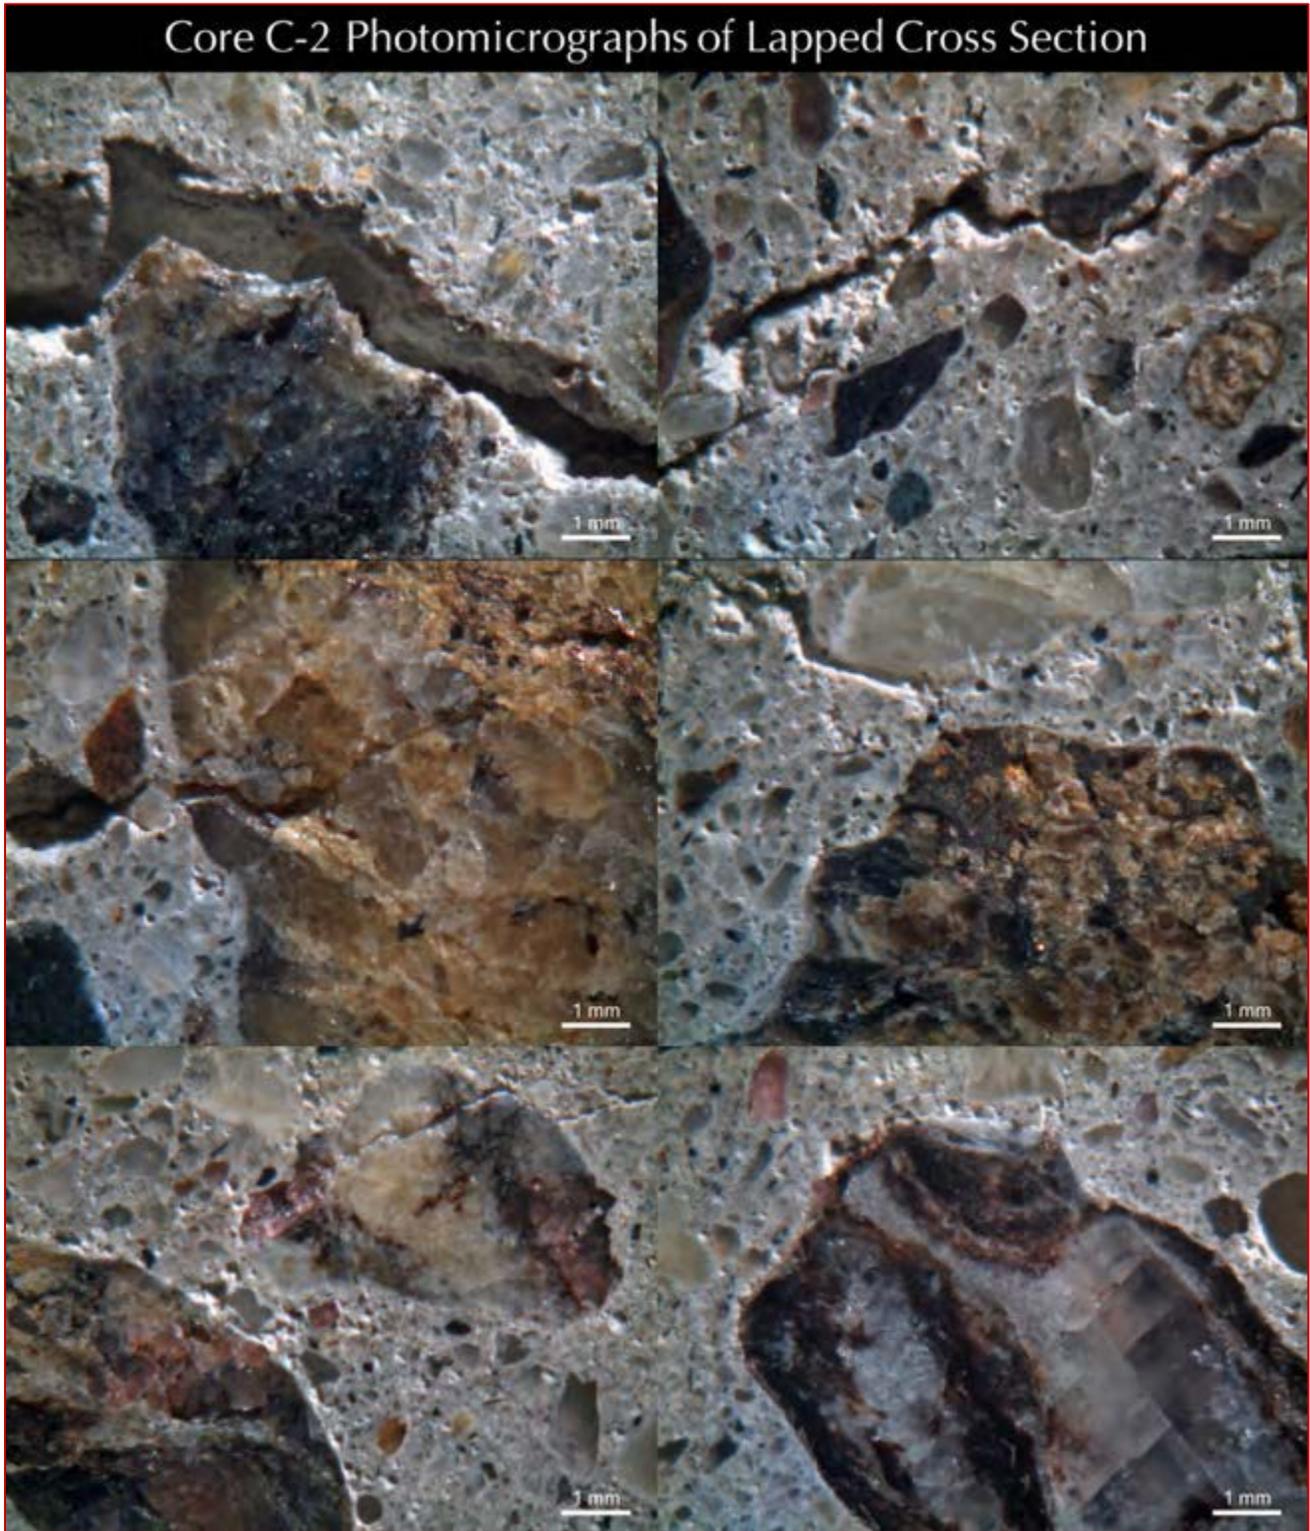
Figure C 14: Photomicrographs of lapped cross section of Core C-2 showing: (a) air-entrained nature of concrete having numerous fine (< 1 mm size), discrete spherical entrained air-voids; and (b) cracking in many unsound crushed gneiss coarse aggregate particles.
