## Pyrrhotite Epidemic in Eastern Connecticut: A Case Study From Tolland, CT

Tolland Board of Education  
Birch Grove School  
247 Rhodes Road  
Tolland, CT 06084

January 10, 2019  
CMC 1218175

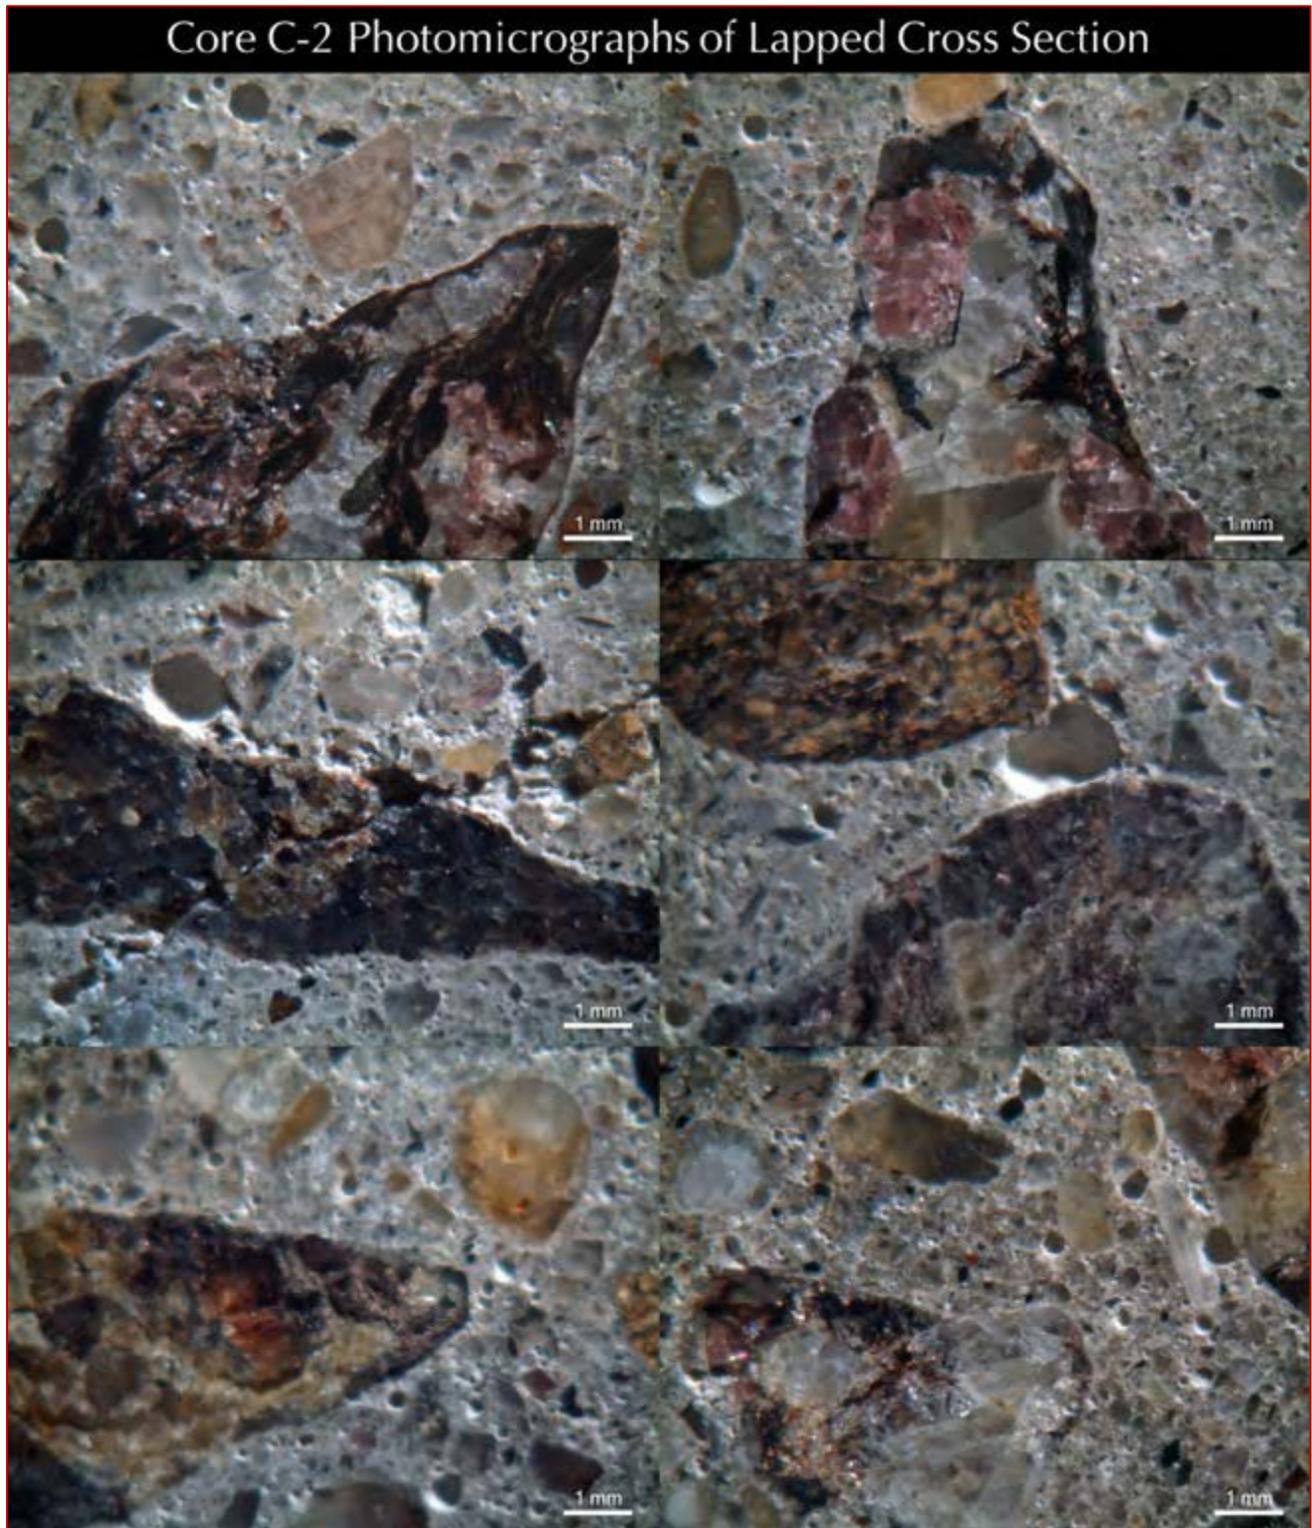
Figure C 15: Photomicrographs of lapped cross section of Core C-2 showing: (a) air-entrained nature of concrete having numerous fine (< 1 mm size), discrete spherical entrained air-voids; and (b) cracking in many unsound crushed gneiss coarse aggregate particles. Notice some large red almandine garnet crystals in gneiss.

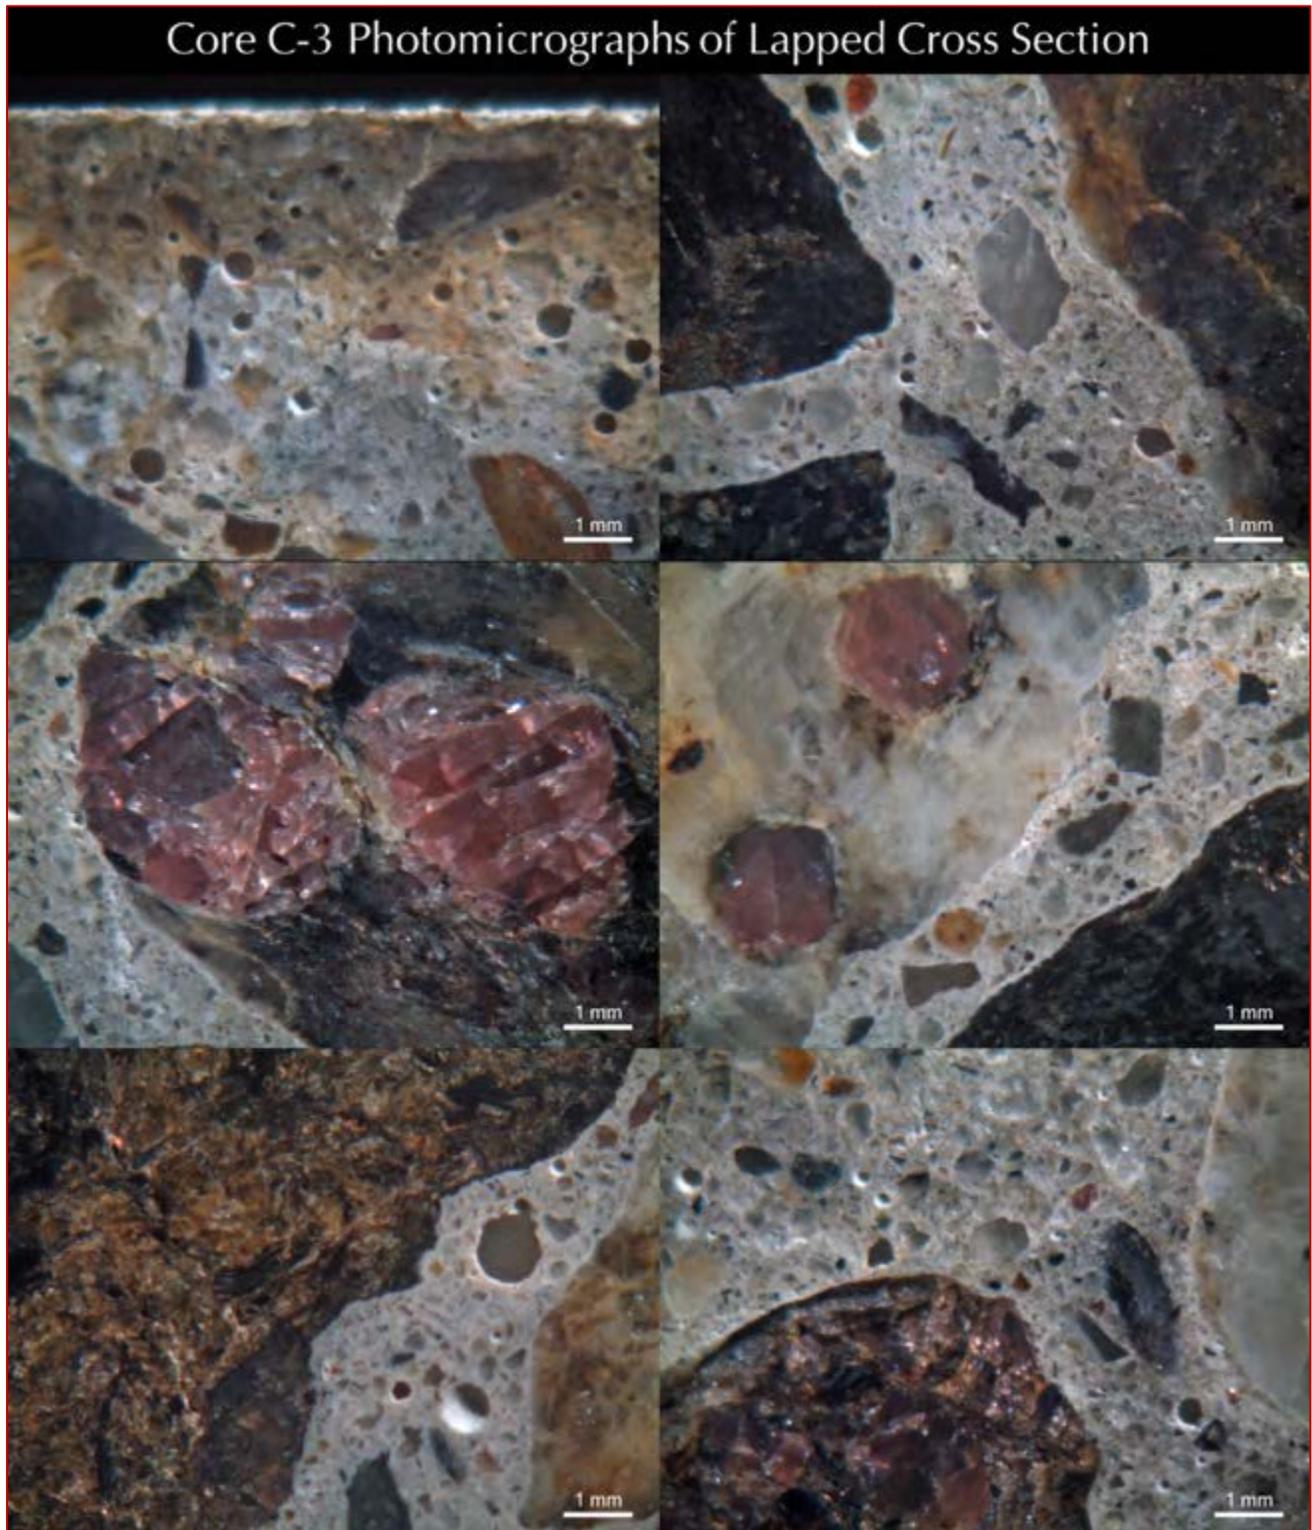
Figure C 16: Photomicrographs of lapped cross section of Core C-3 showing: (a) air-entrained nature of concrete having numerous fine (< 1 mm size), discrete spherical entrained air-voids; and (b) many unsound crushed gneiss coarse aggregate particles. Notice some large red almandine garnet crystals in gneiss.

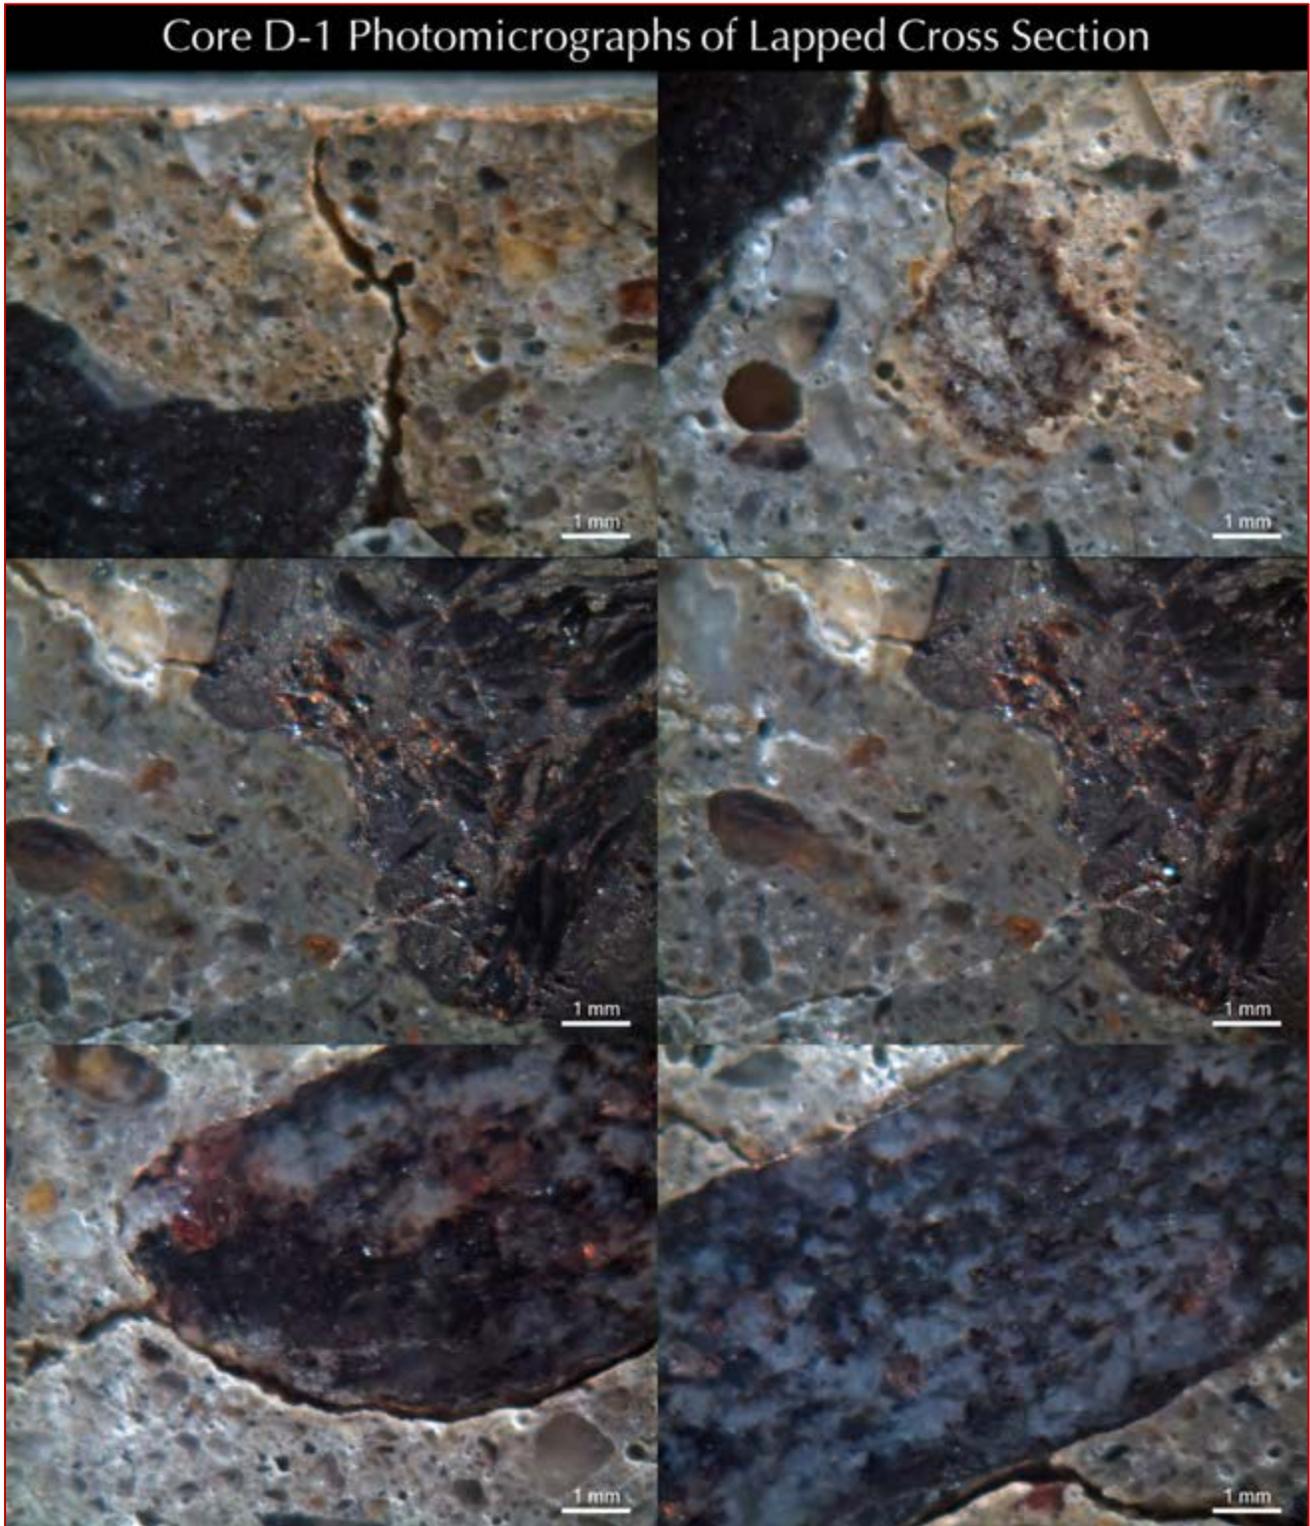
Figure C 18: Photomicrographs of lapped cross section of Core D-1 showing: (a) air-entrained nature of concrete having numerous fine (< 1 mm size), discrete spherical entrained air-voids; and (b) cracking in many unsound crushed gneiss coarse aggregate particles. Notice some large red almandine garnet crystals in gneiss.

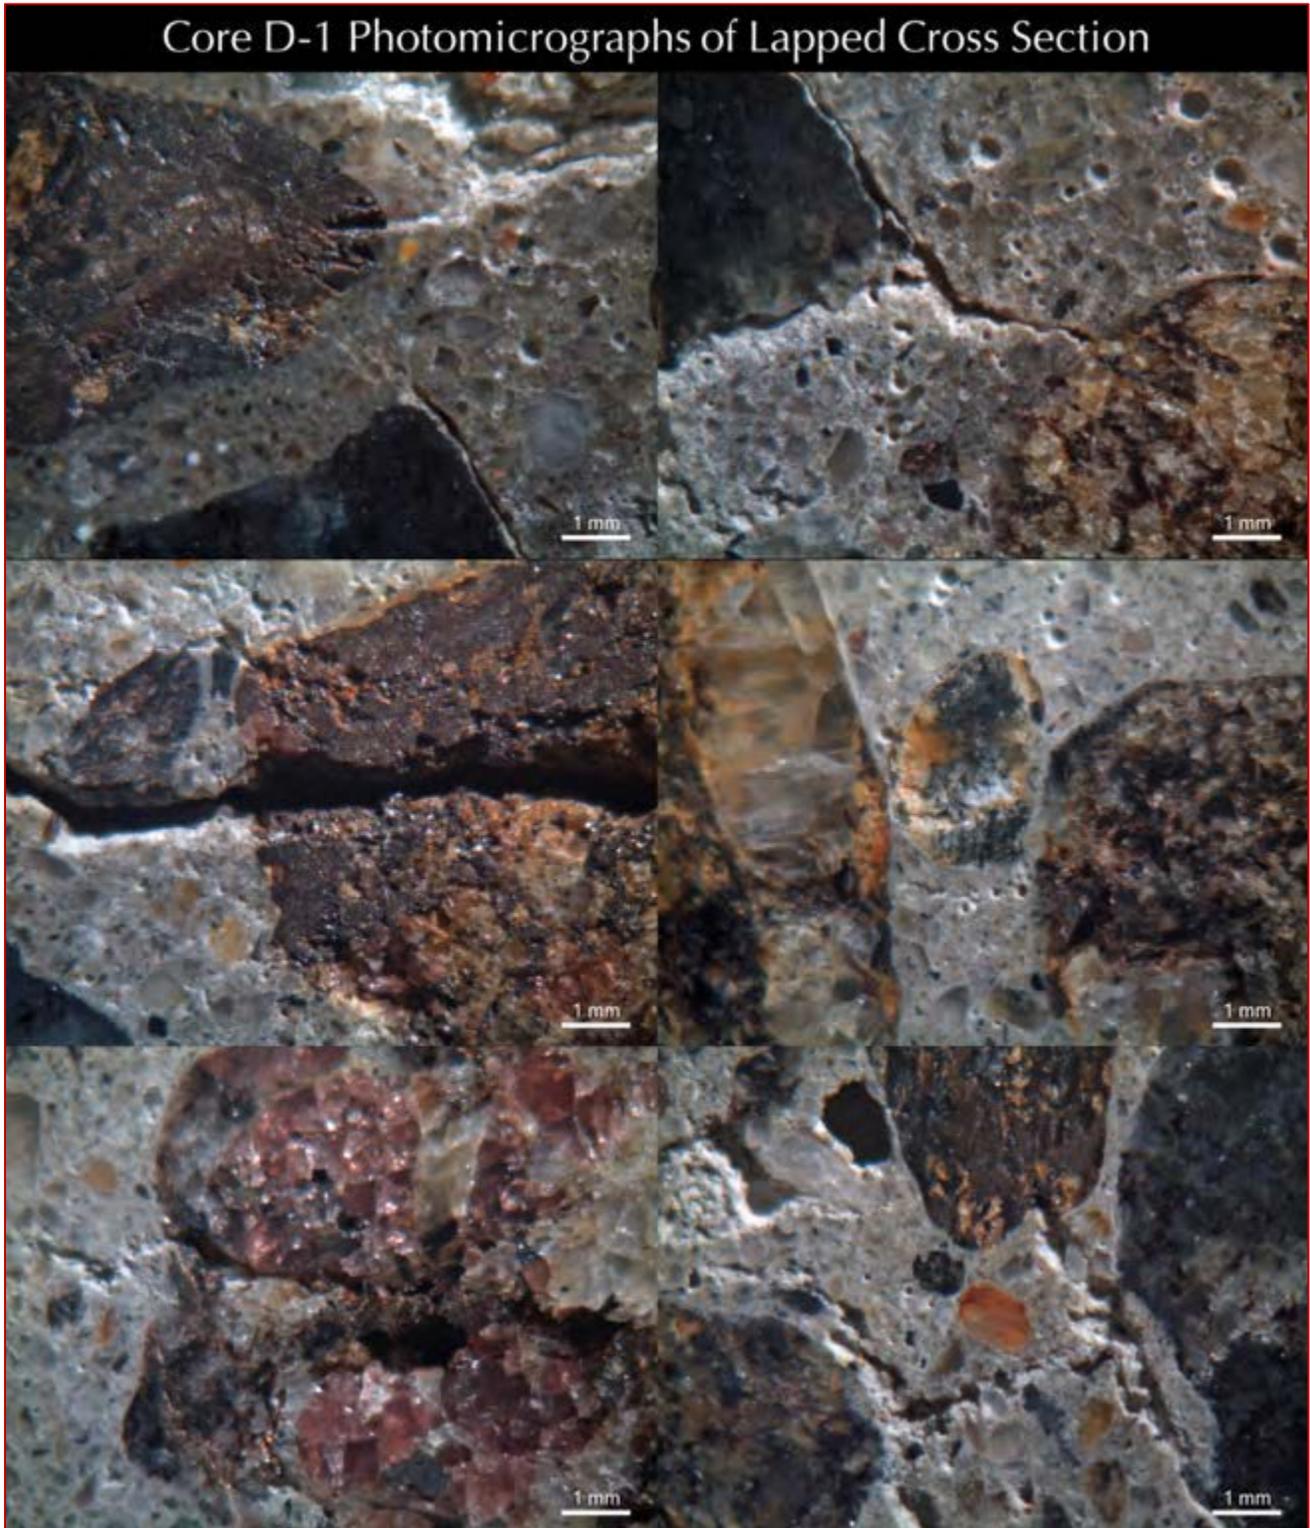
Figure C 19: Photomicrographs of lapped cross section of Core D-1 showing: (a) air-entrained nature of concrete having numerous fine (< 1 mm size), discrete spherical entrained air-voids; and (b) cracking in many unsound crushed gneiss coarse aggregate particles. Notice some large red almandine garnet crystals in gneiss.

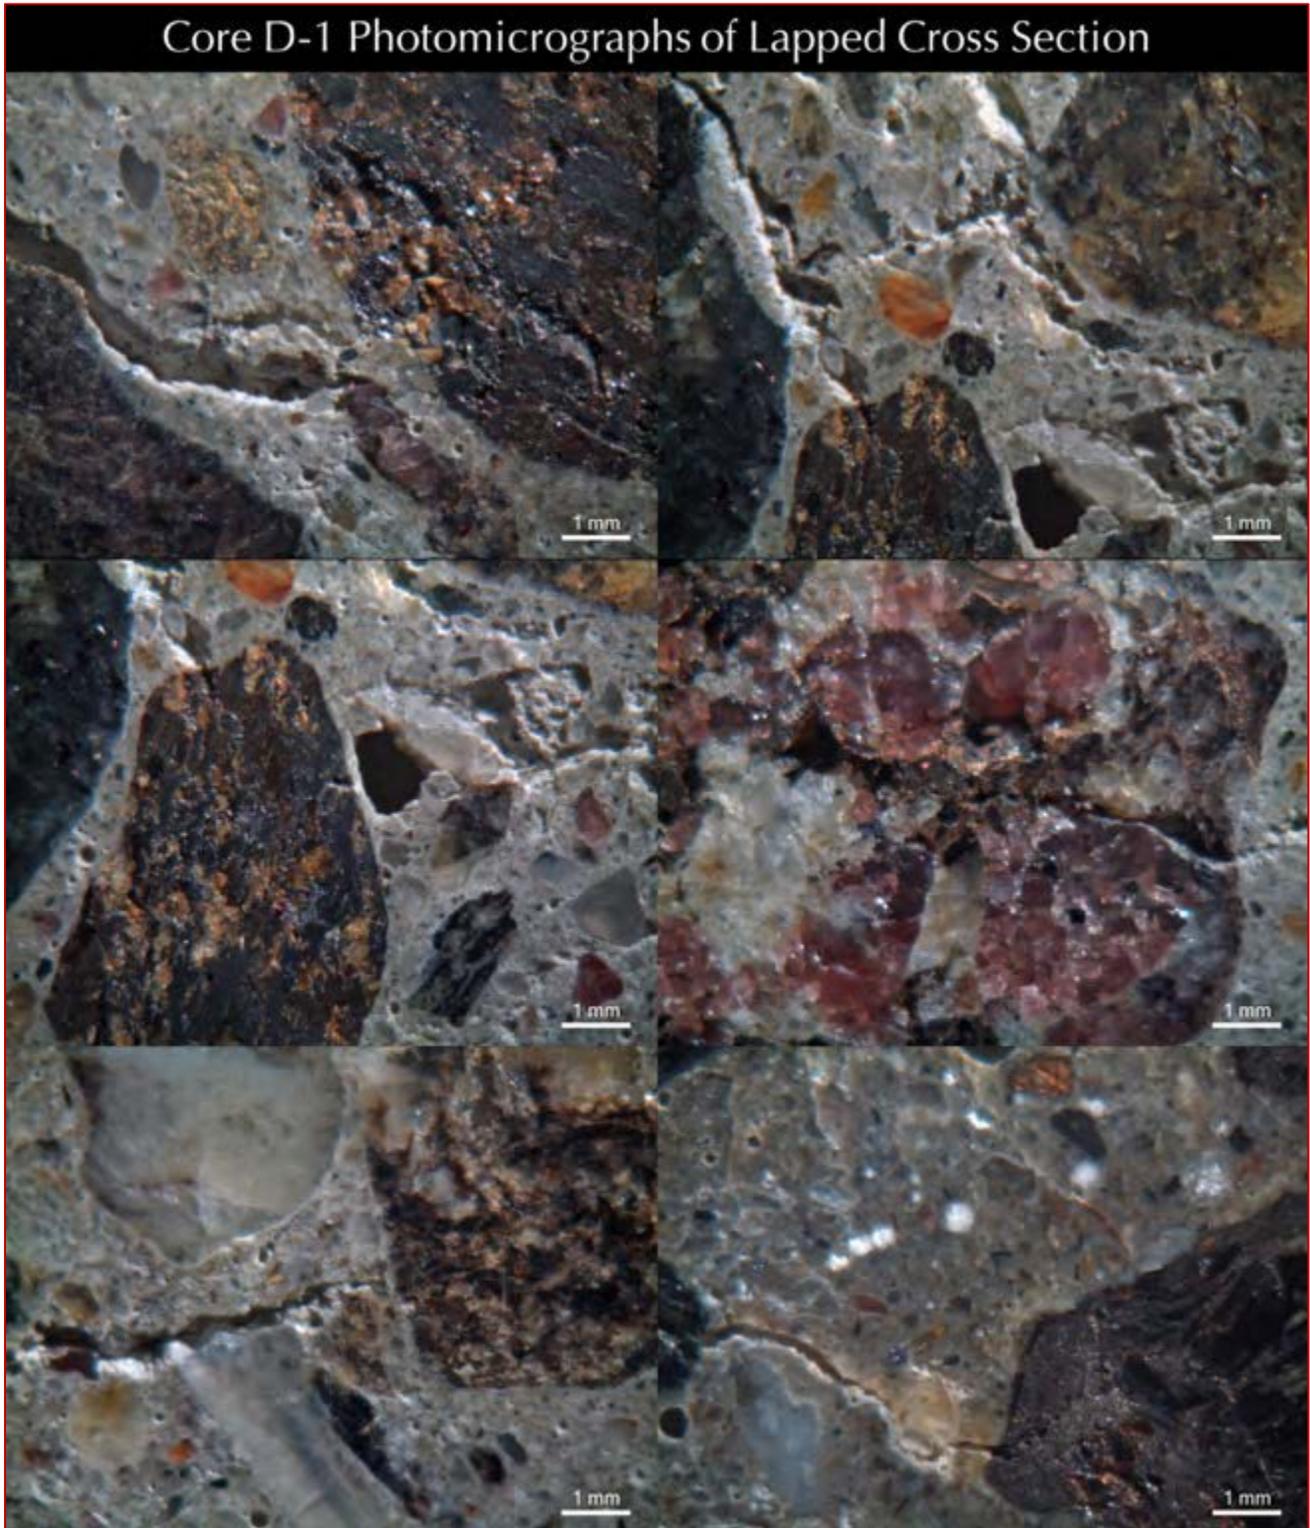
Figure C 20: Photomicrographs of lapped cross section of Core D-1 showing: (a) air-entrained nature of concrete having numerous fine (< 1 mm size), discrete spherical entrained air-voids; and (b) cracking in many unsound crushed gneiss coarse aggregate particles. Notice some large red almandine garnet crystals in gneiss.

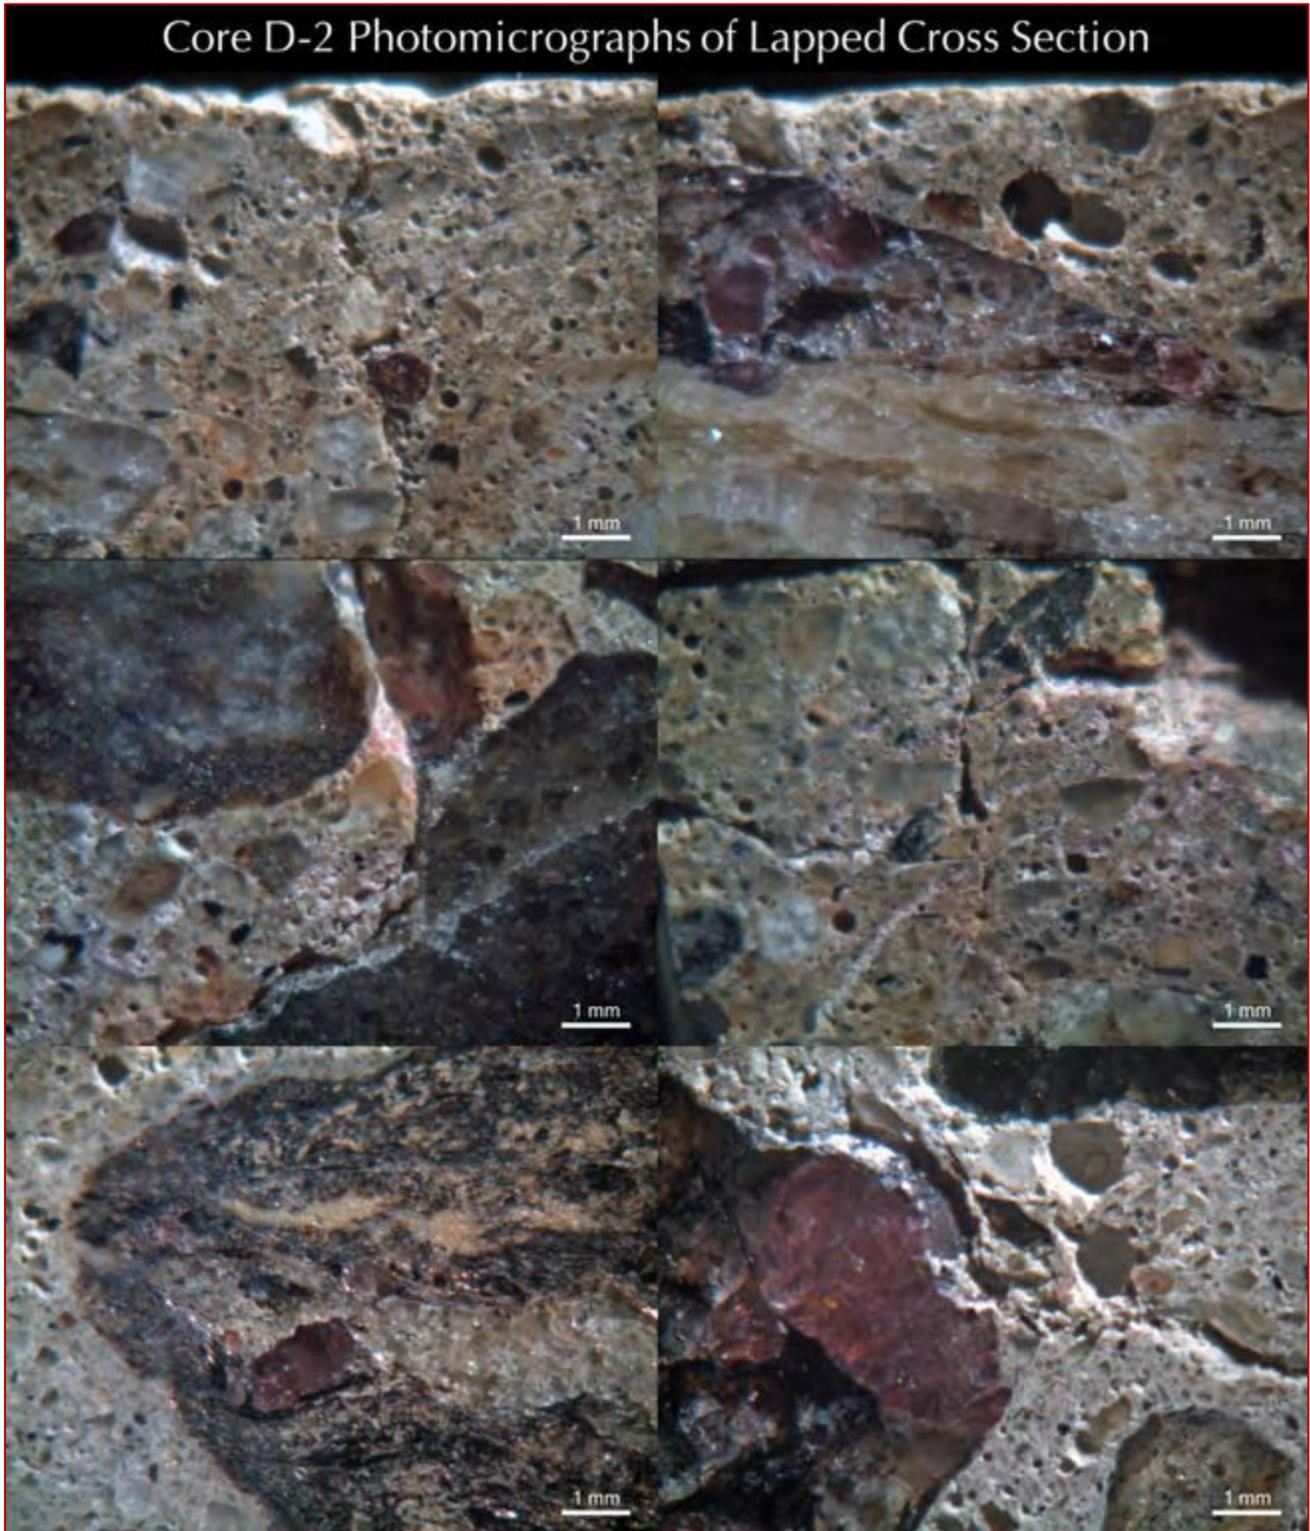
Figure C 21: Photomicrographs of lapped cross section of Core D-2 showing: (a) air-entrained nature of concrete having numerous fine (< 1 mm size), discrete spherical entrained air-voids; and (b) cracking in many unsound crushed gneiss coarse aggregate particles. Notice some large red almandine garnet crystals in gneiss.

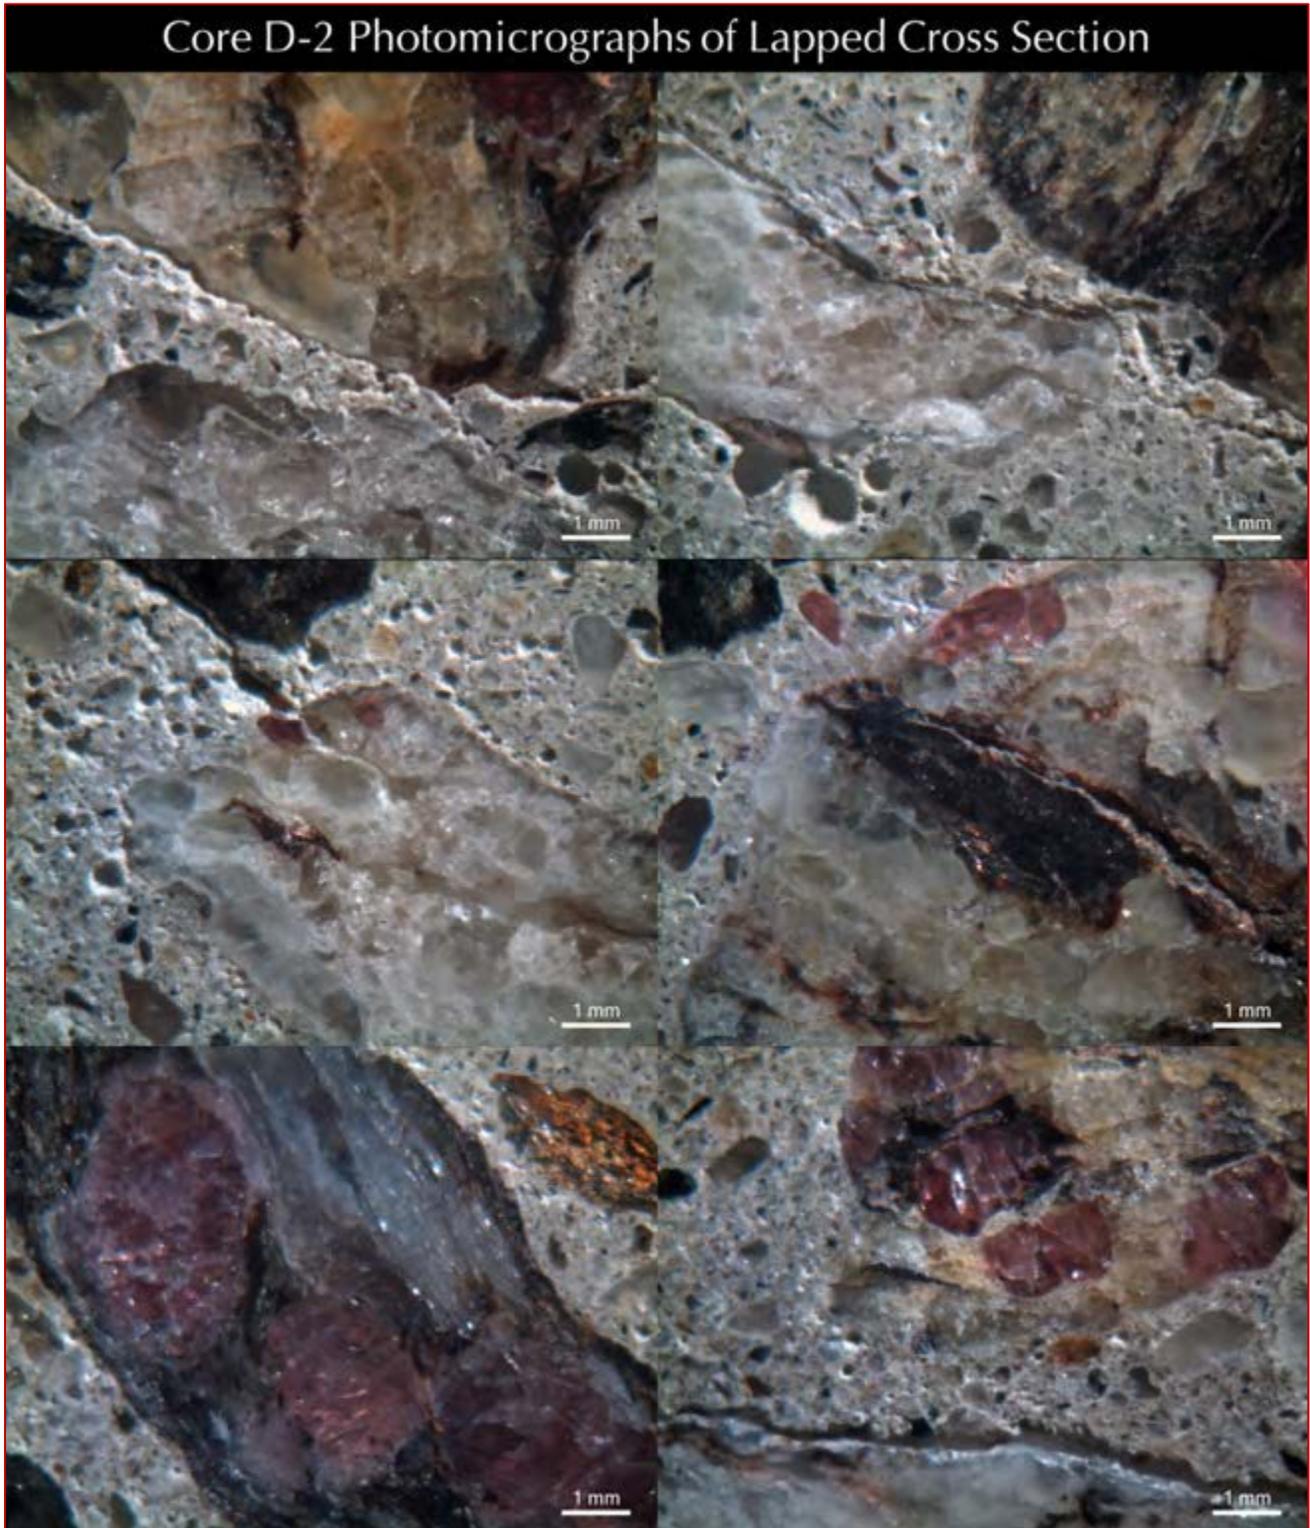
Figure C 22: Photomicrographs of lapped cross section of Core D-2 showing: (a) air-entrained nature of concrete having numerous fine (< 1 mm size), discrete spherical entrained air-voids; and (b) cracking in many unsound crushed gneiss coarse aggregate particles. Notice some large red almandine garnet crystals in gneiss.

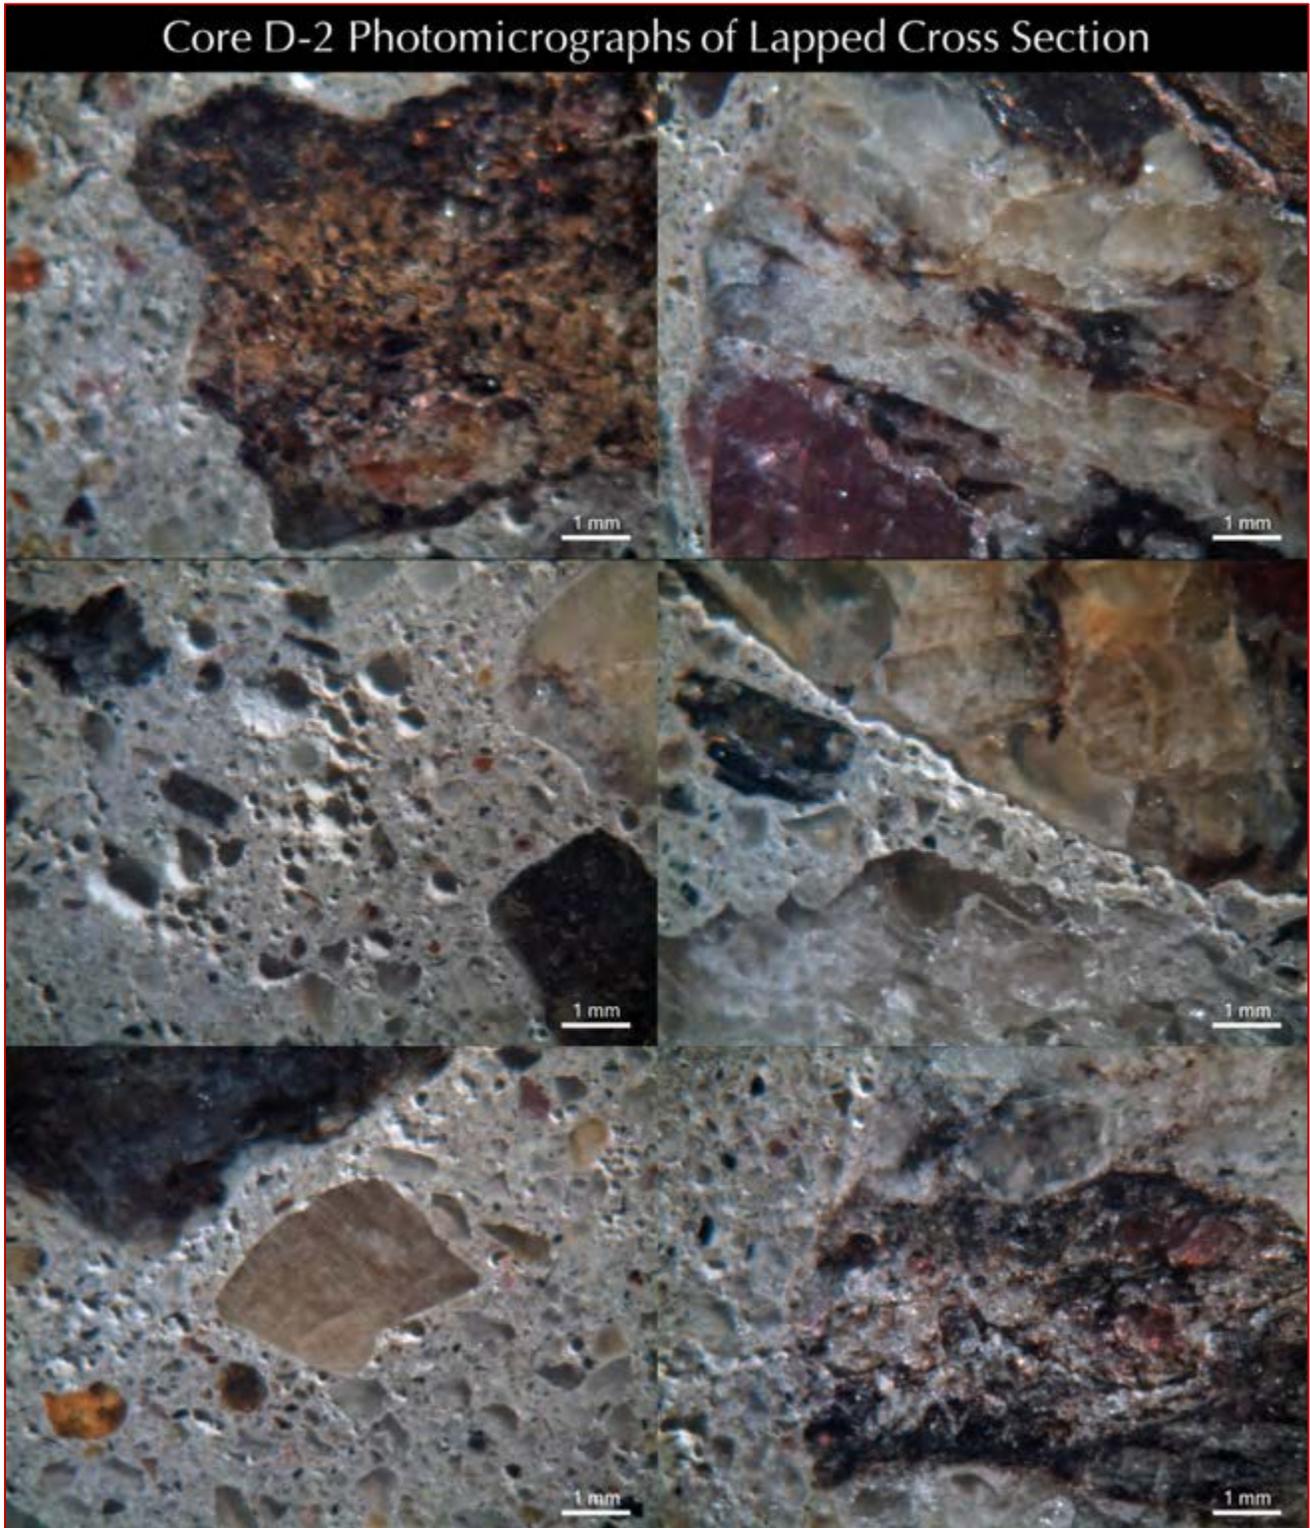
Figure C 23: Photomicrographs of lapped cross section of Core D-2 showing: (a) air-entrained nature of concrete having numerous fine (< 1 mm size), discrete spherical entrained air-voids; and (b) cracking in many unsound crushed gneiss coarse aggregate particles. Notice some large red almandine garnet crystals in gneiss.

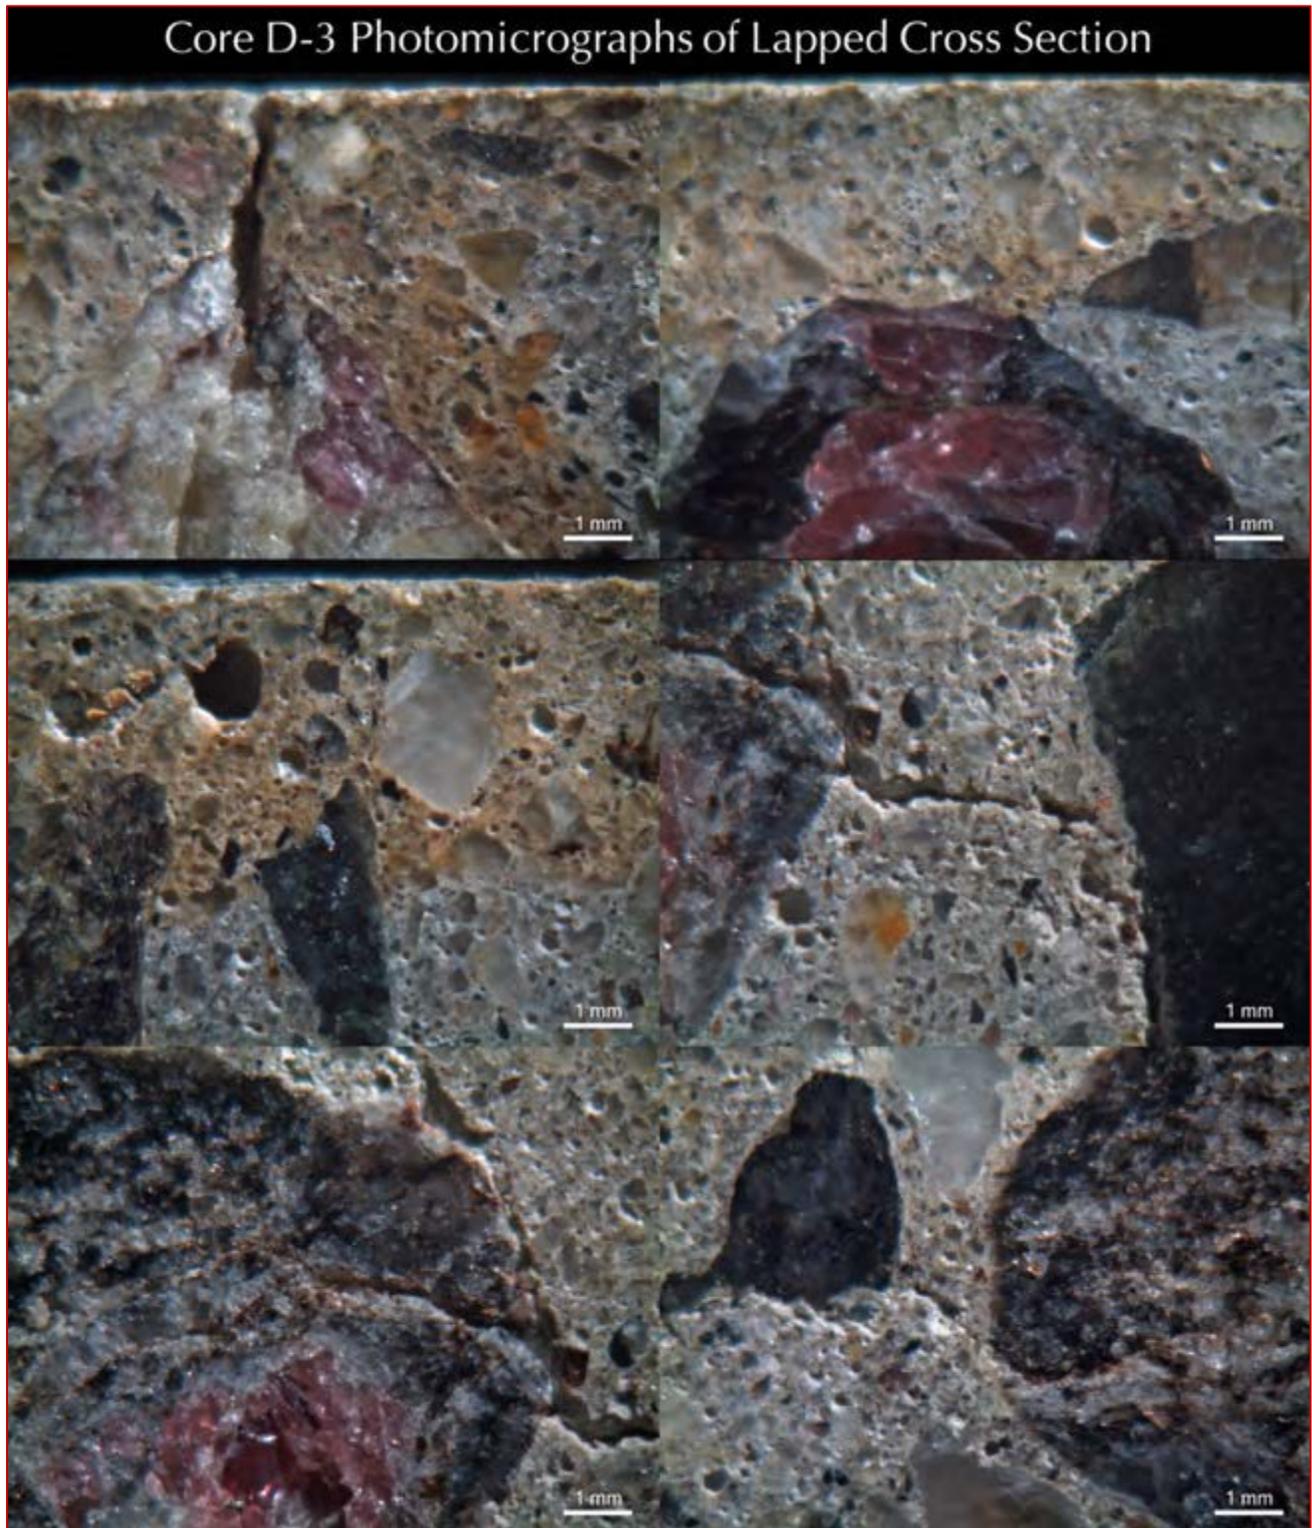
Figure C 24: Photomicrographs of lapped cross section of Core D-3 showing: (a) air-entrained nature of concrete having numerous fine (< 1 mm size), discrete spherical entrained air-voids; and (b) cracking in many unsound crushed gneiss coarse aggregate particles. Notice some large red almandine garnet crystals in gneiss.

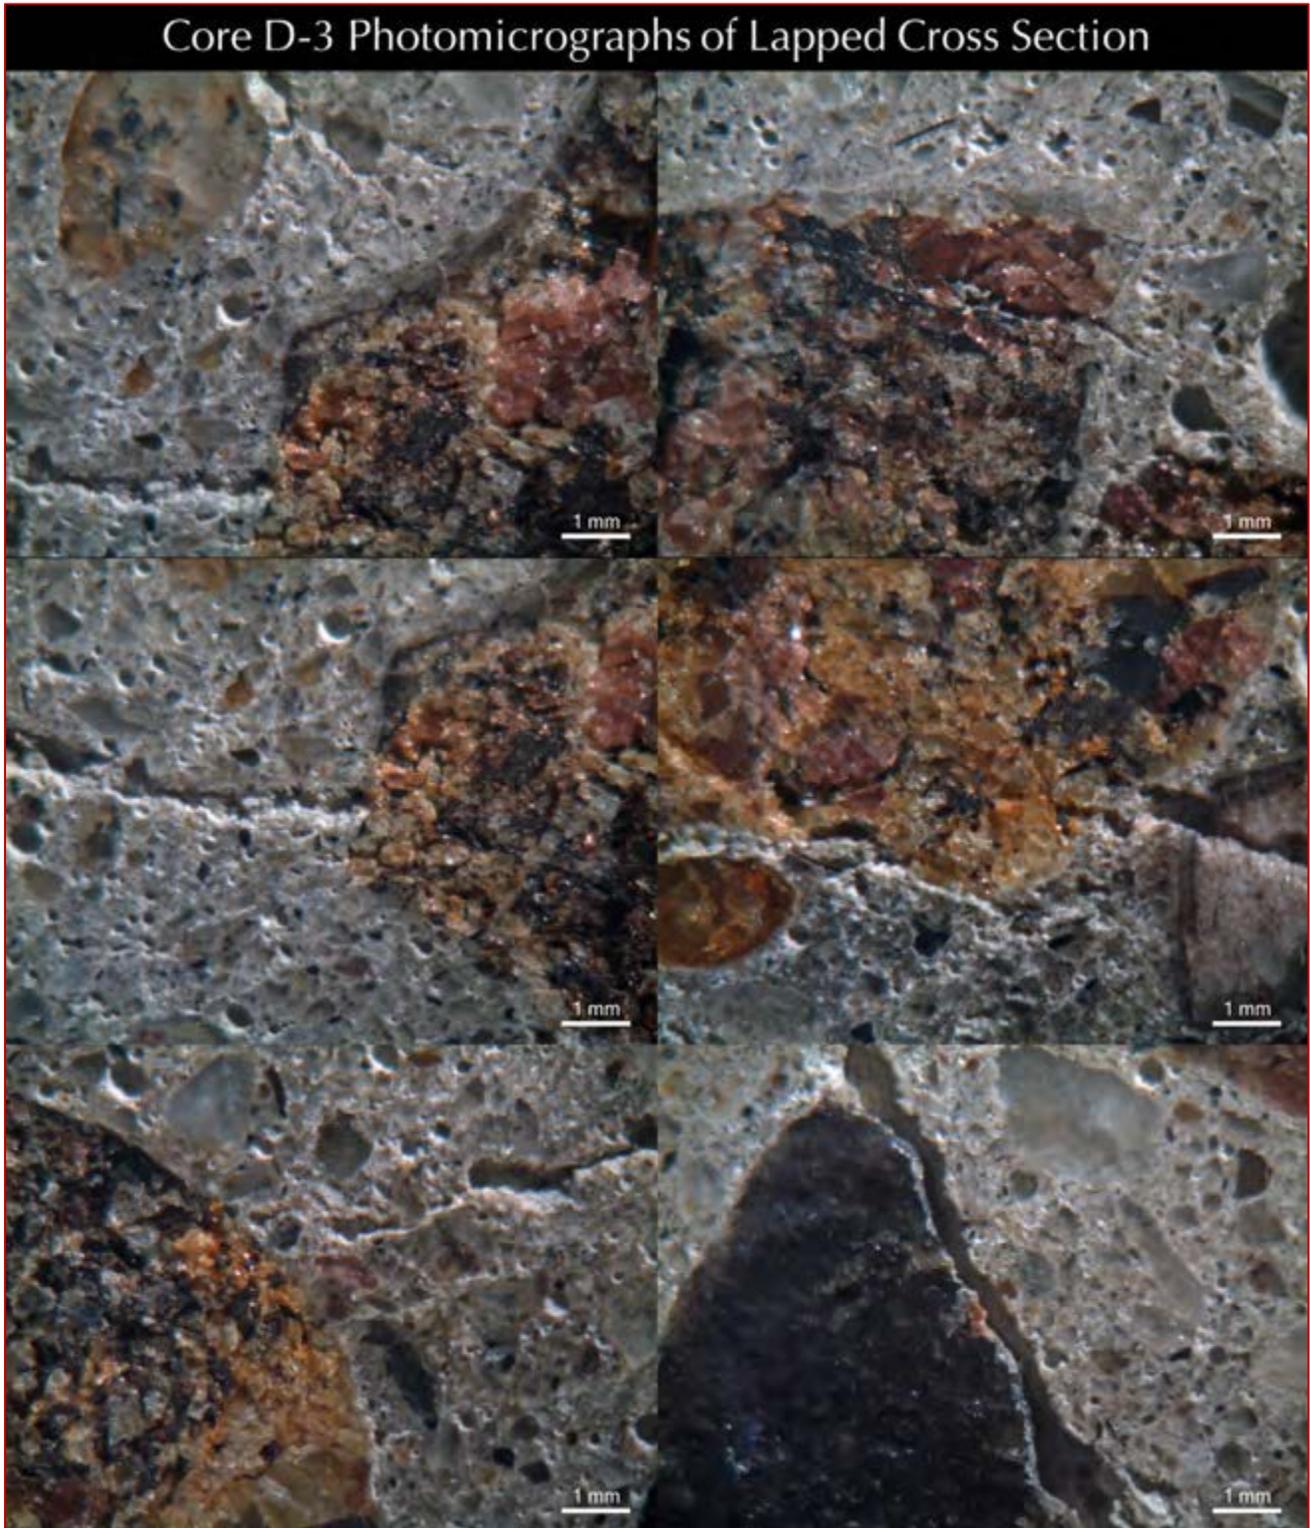
Figure C 25: Photomicrographs of lapped cross section of Core D-3 showing: (a) air-entrained nature of concrete having numerous fine (< 1 mm size), discrete spherical entrained air-voids; and (b) cracking in many unsound crushed gneiss coarse aggregate particles. Notice some large red almandine garnet crystals in gneiss.

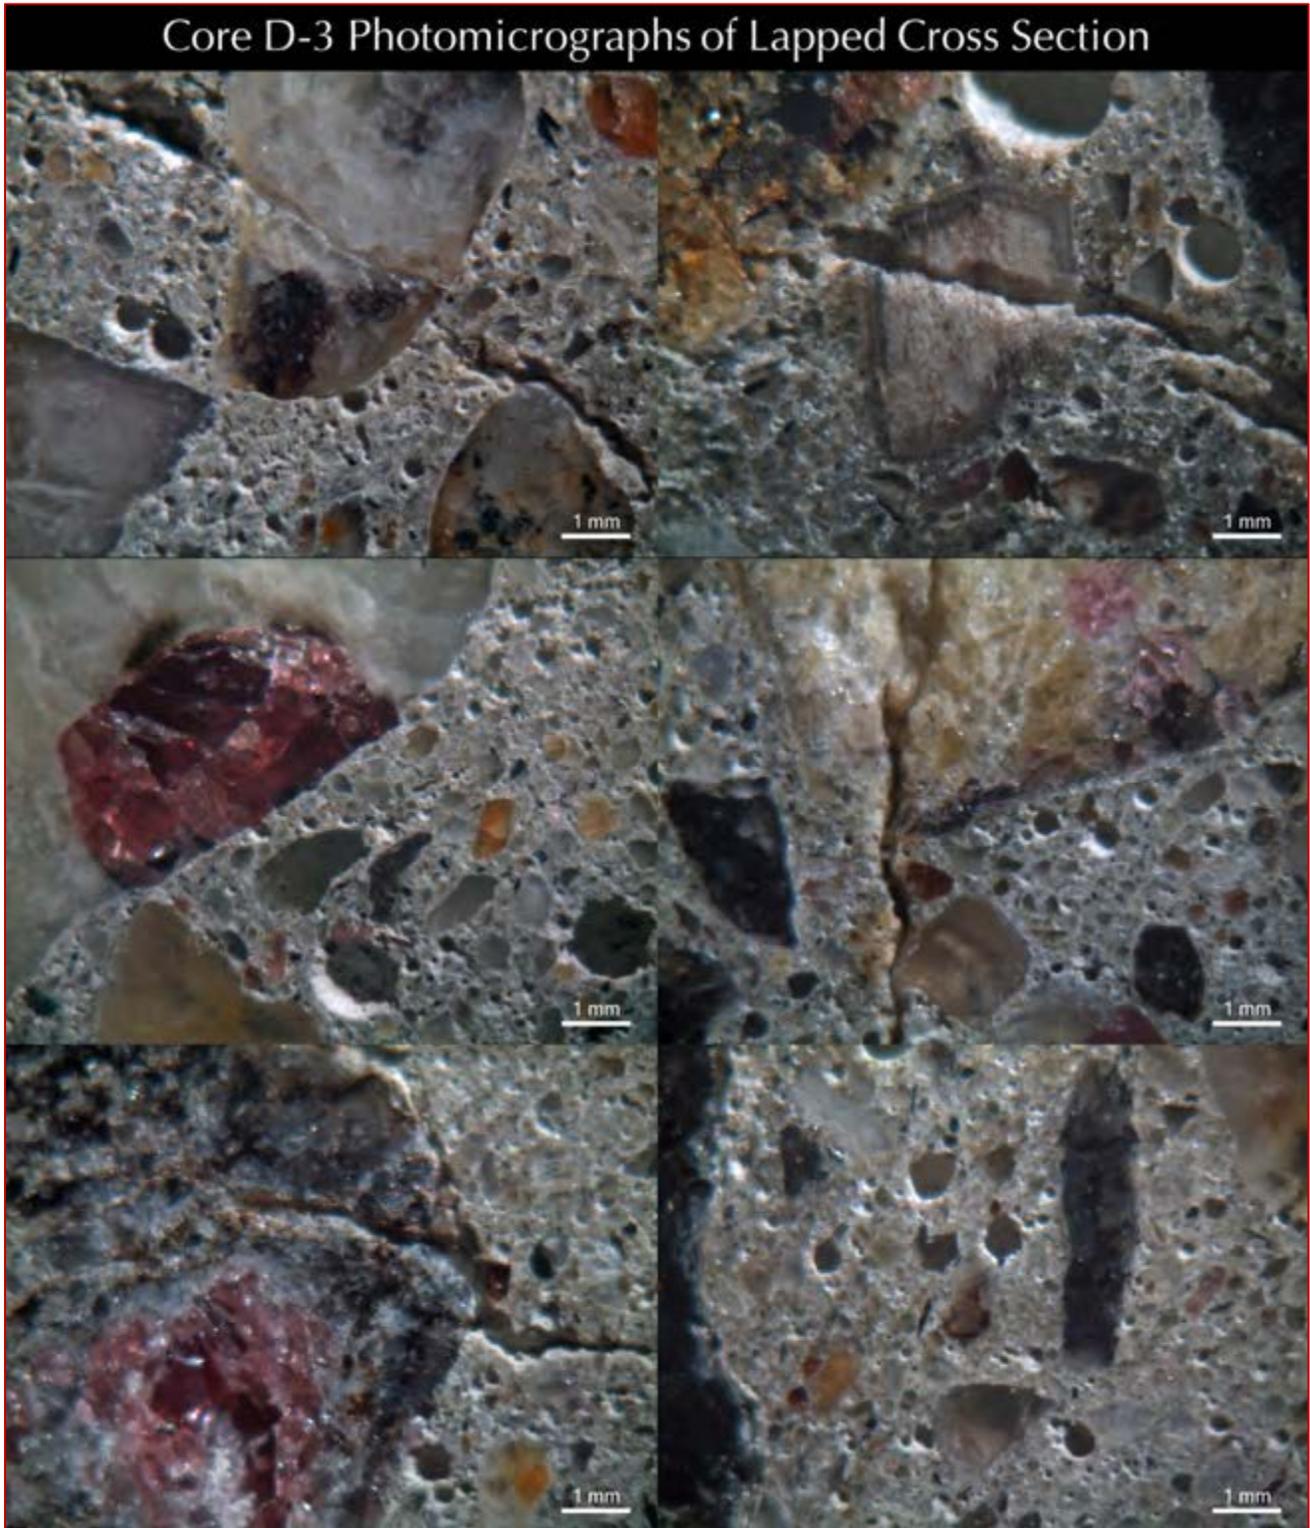
Figure C 26: Photomicrographs of lapped cross section of Core D-3 showing: (a) air-entrained nature of concrete having numerous fine (< 1 mm size), discrete spherical entrained air-voids; and (b) cracking in many unsound crushed gneiss coarse aggregate particles. Notice some large red almandine garnet crystals in gneiss.
