## Pyrrhotite Epidemic in Eastern Connecticut: A Case Study From Tolland, CT

Tolland Board of Education  
Birch Grove School  
247 Rhodes Road  
Tolland, CT 06084

January 10, 2019  
CMC 1218175

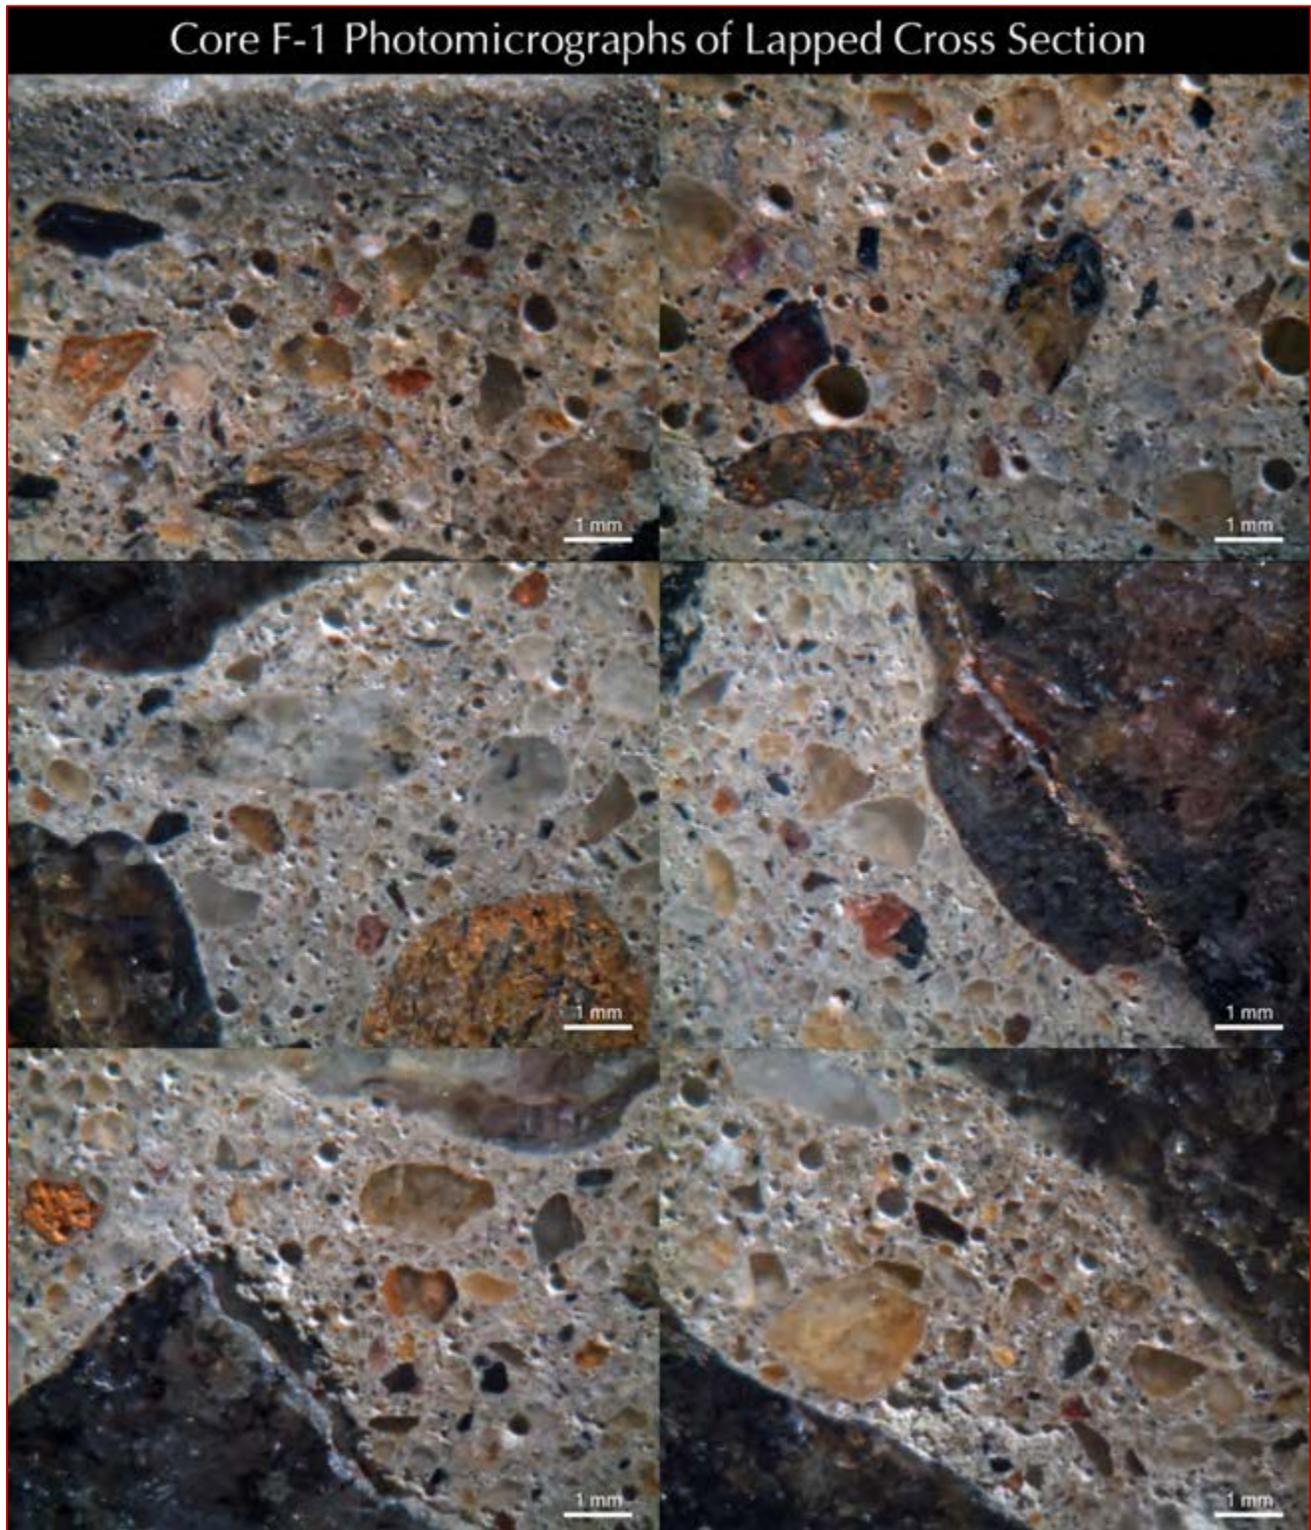
Figure C 27: Photomicrographs of lapped cross section of Core F-1 showing: (a) a thin (< 1 mm thick) air-entrained dark gray cementitious protective skim coat well-bonded to the wall concrete beneath; (b) air-entrained nature of concrete having numerous fine (< 1 mm size), discrete spherical entrained air -oids; and (c) some localized cracking in some potentially unsound crushed gneiss coarse aggregate particles. Notice some large red almandine garnet crystals in gneiss.

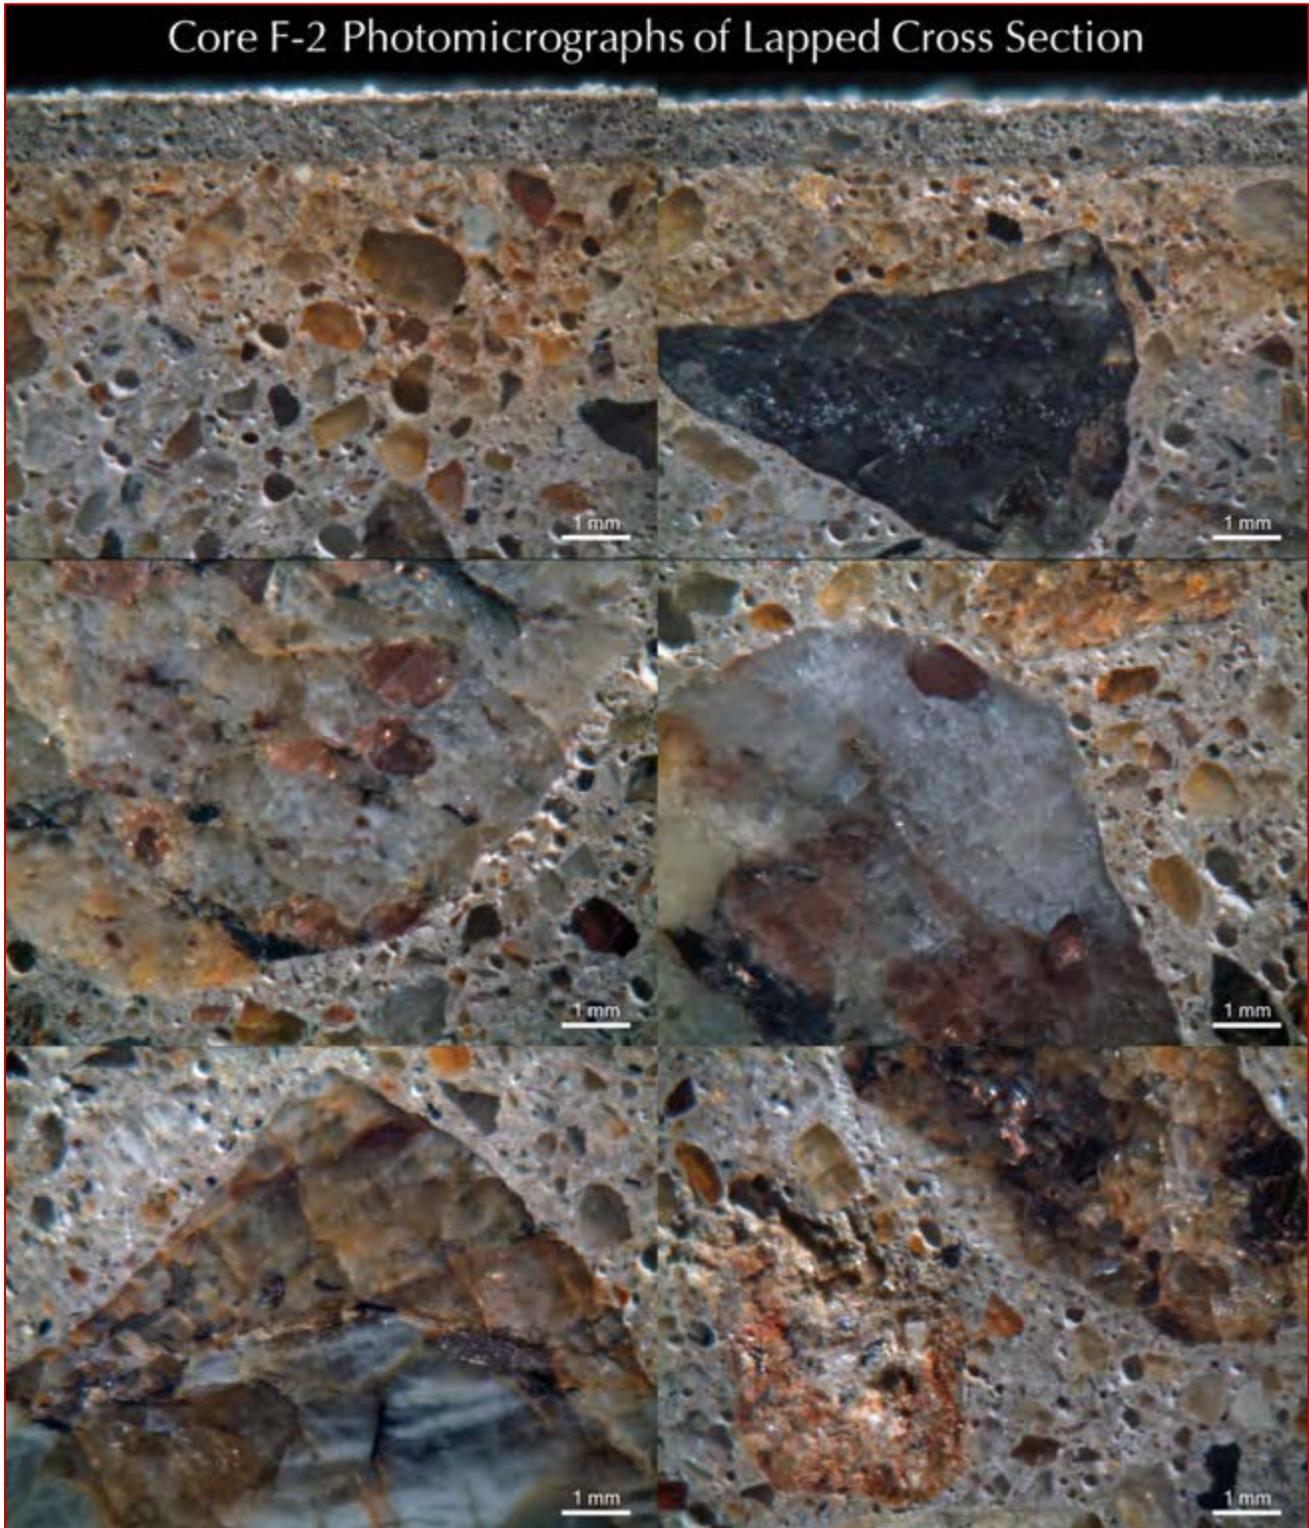
Figure C 29: Photomicrographs of lapped cross section of Core F-2 showing: (a) a thin (< 1 mm thick) air-entrained dark gray cementitious protective skim coat well-bonded to the wall concrete beneath; (b) air-entrained nature of concrete having numerous fine (< 1 mm size), discrete spherical entrained air-voids; and (c) some localized cracking in some potentially unsound crushed gneiss coarse aggregate particles. Notice some large red almandine garnet crystals in gneiss.

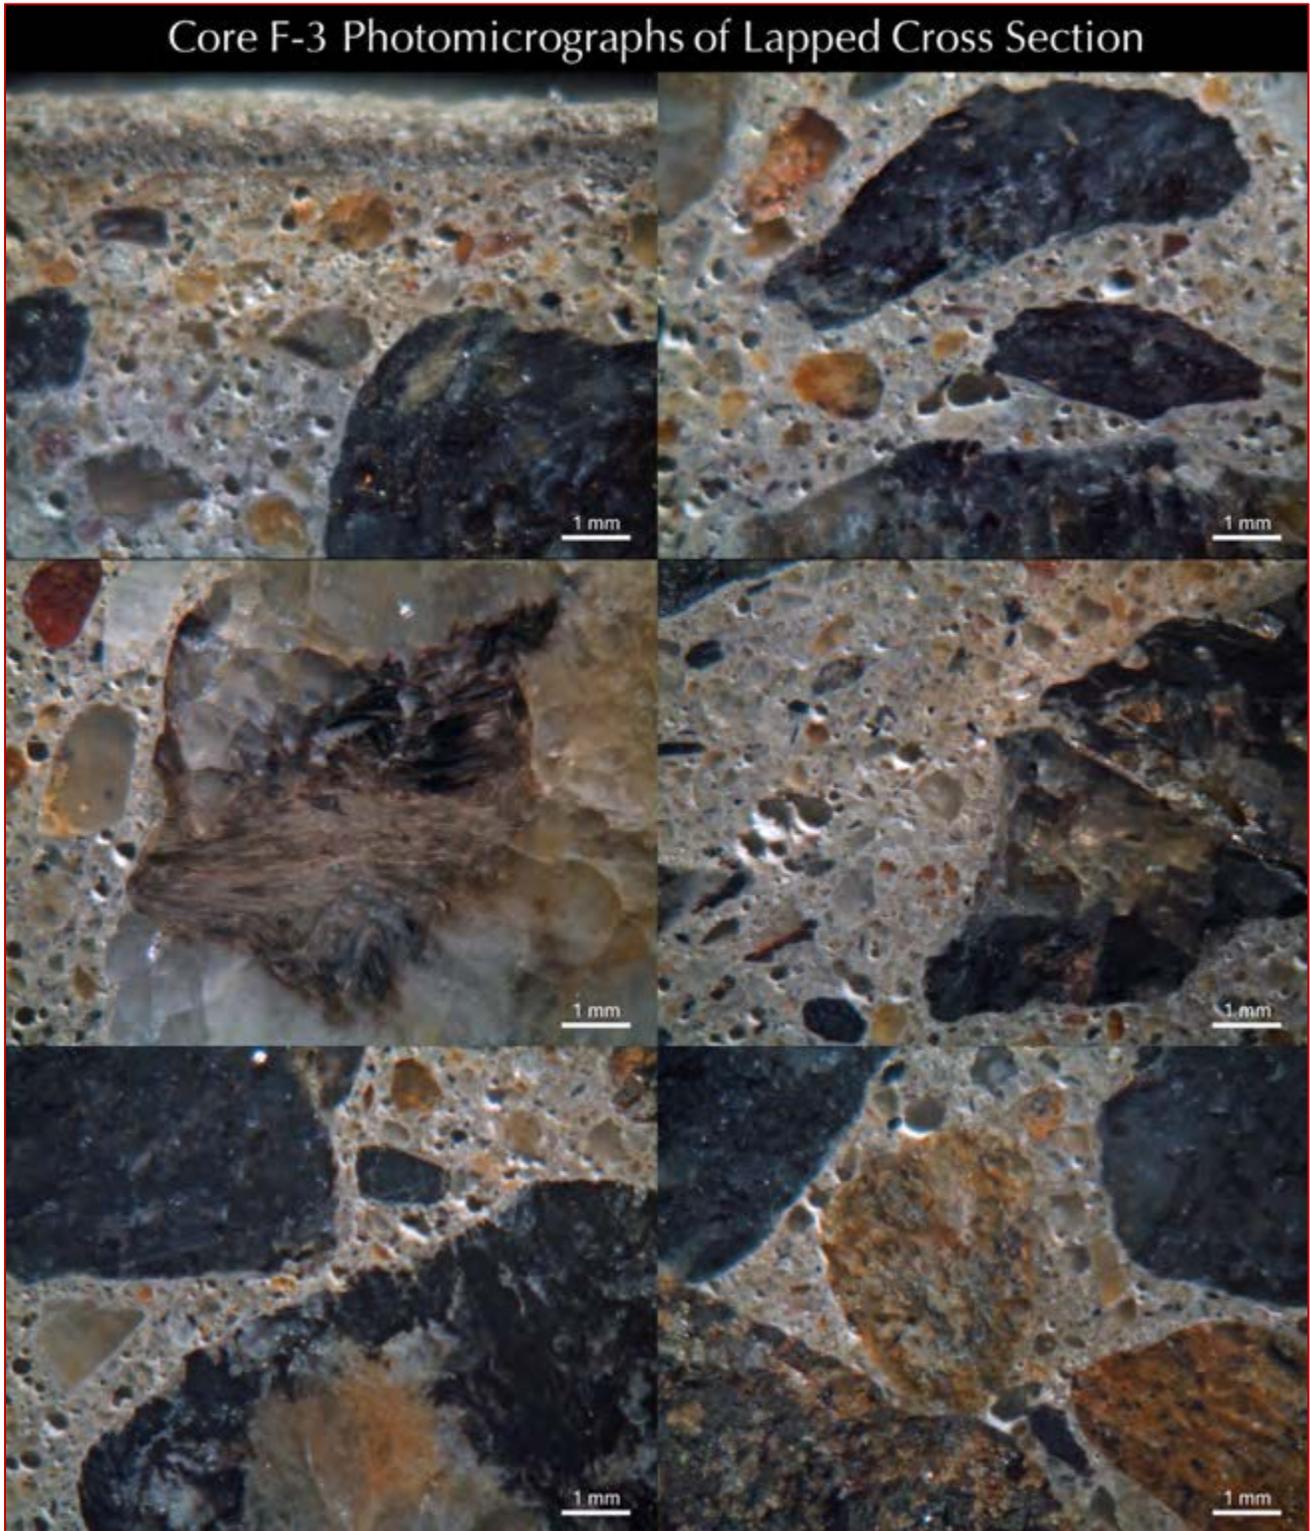
Figure C 31: Photomicrographs of lapped cross section of Core F-3 showing: (a) a thin (< 1 mm thick) air-entrained dark gray cementitious protective skim coat well-bonded to the wall concrete beneath; (b) air-entrained nature of concrete having numerous fine (< 1 mm size), discrete spherical entrained air-voids; and (c) some localized cracking in some potentially unsound crushed gneiss coarse aggregate particles.

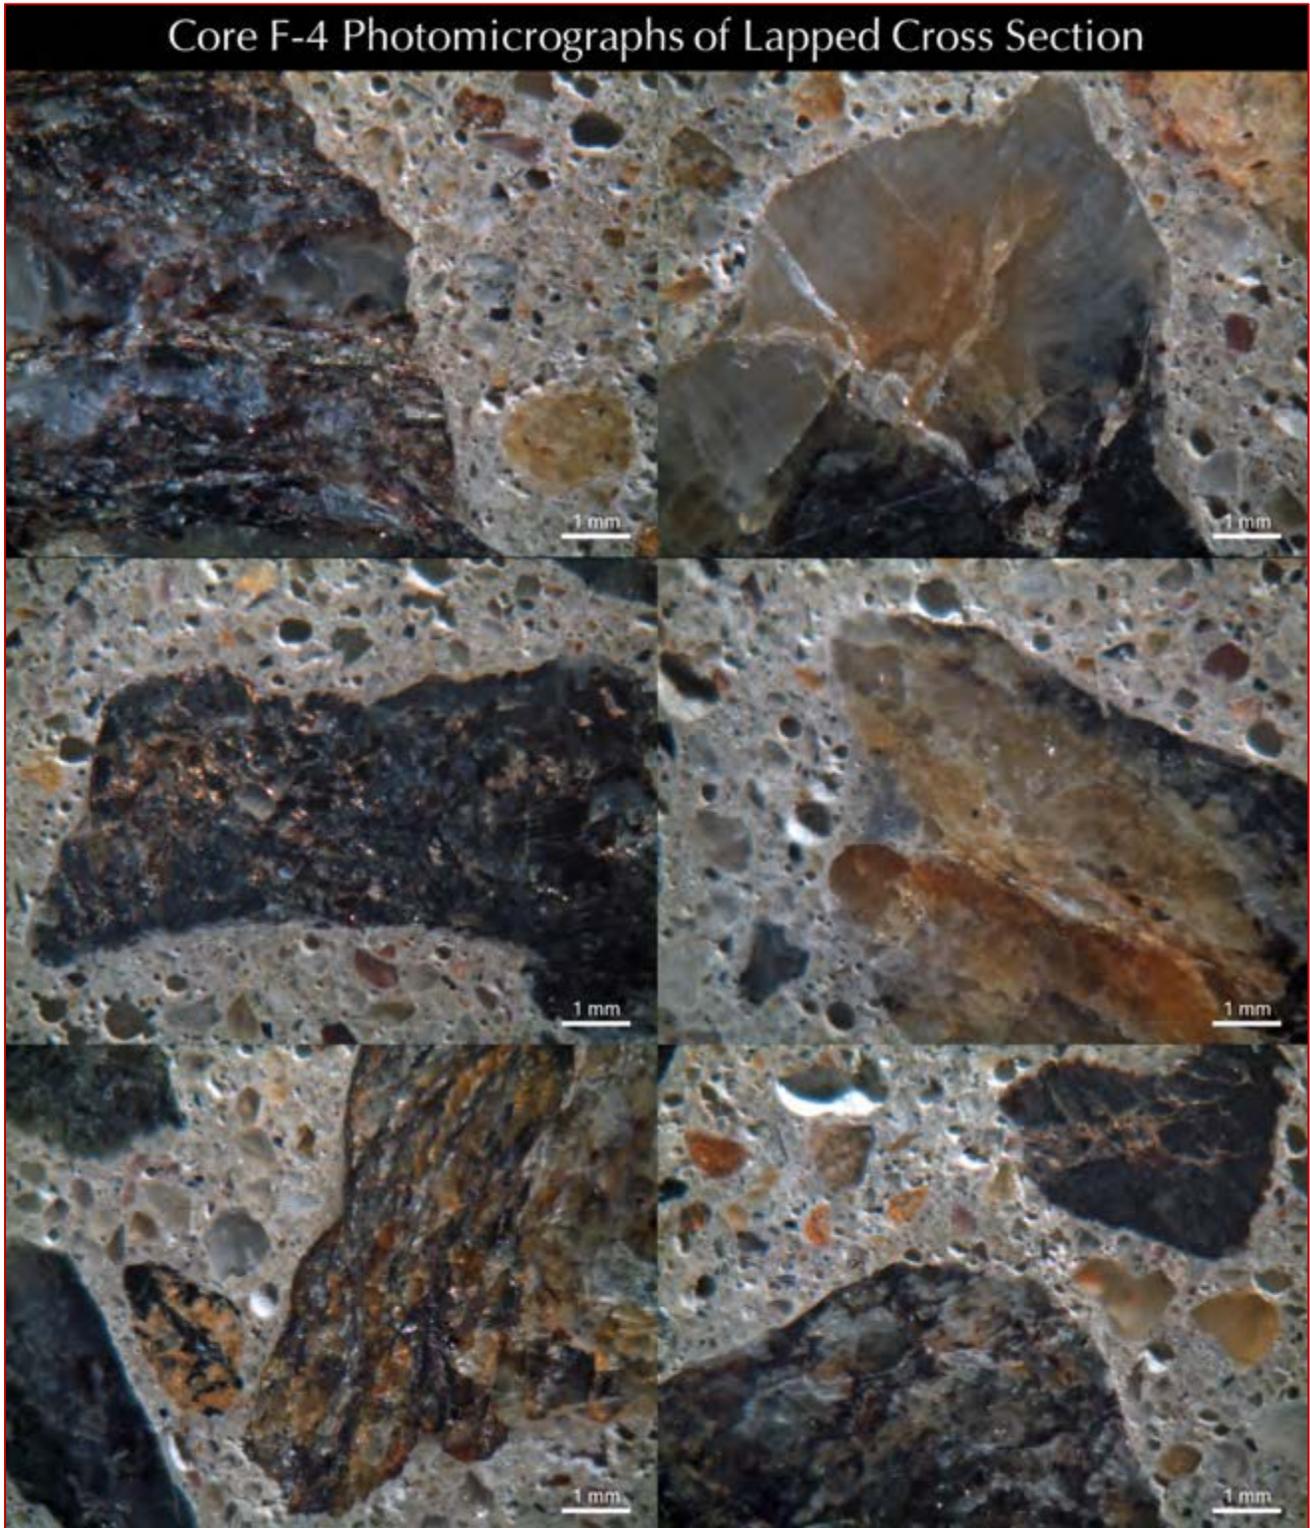
Figure C 34: Photomicrographs of lapped cross section of Core F-4 showing: (a) air-entrained nature of concrete having numerous fine (< 1 mm size), discrete spherical entrained air-voids; and (b) many unsound crushed gneiss coarse aggregate particles that are compositionally similar to the ones found in aggregate used in 1998 construction, apparently from the same concrete supplier.

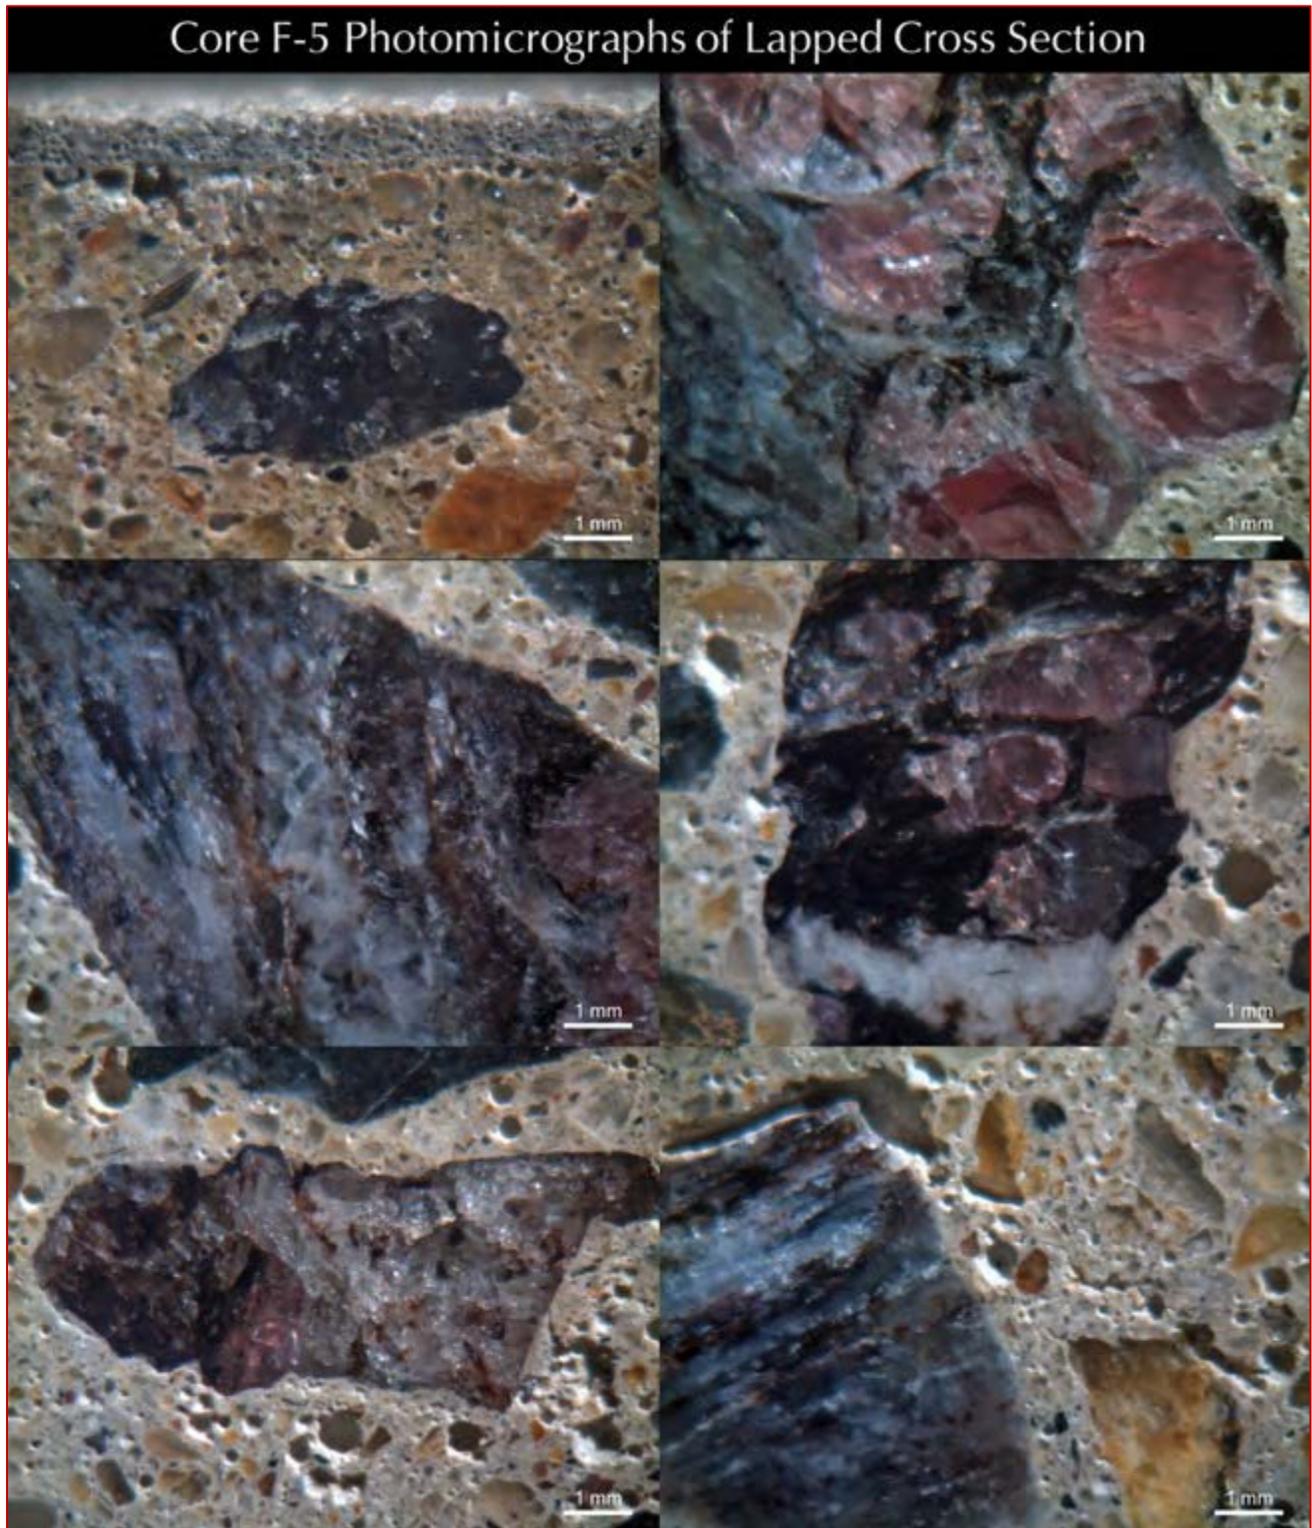
Figure C 35: Photomicrographs of lapped cross section of Core F-5 showing: (a) a thin (< 1 mm thick) air-entrained dark gray cementitious protective skim coat well-bonded to the wall concrete beneath; (b) air-entrained nature of concrete having numerous fine (< 1 mm size), discrete spherical entrained air-voids; and (c) some localized cracking in some potentially unsound crushed gneiss coarse aggregate particles. Notice some large red almandine garnet crystals in gneiss.

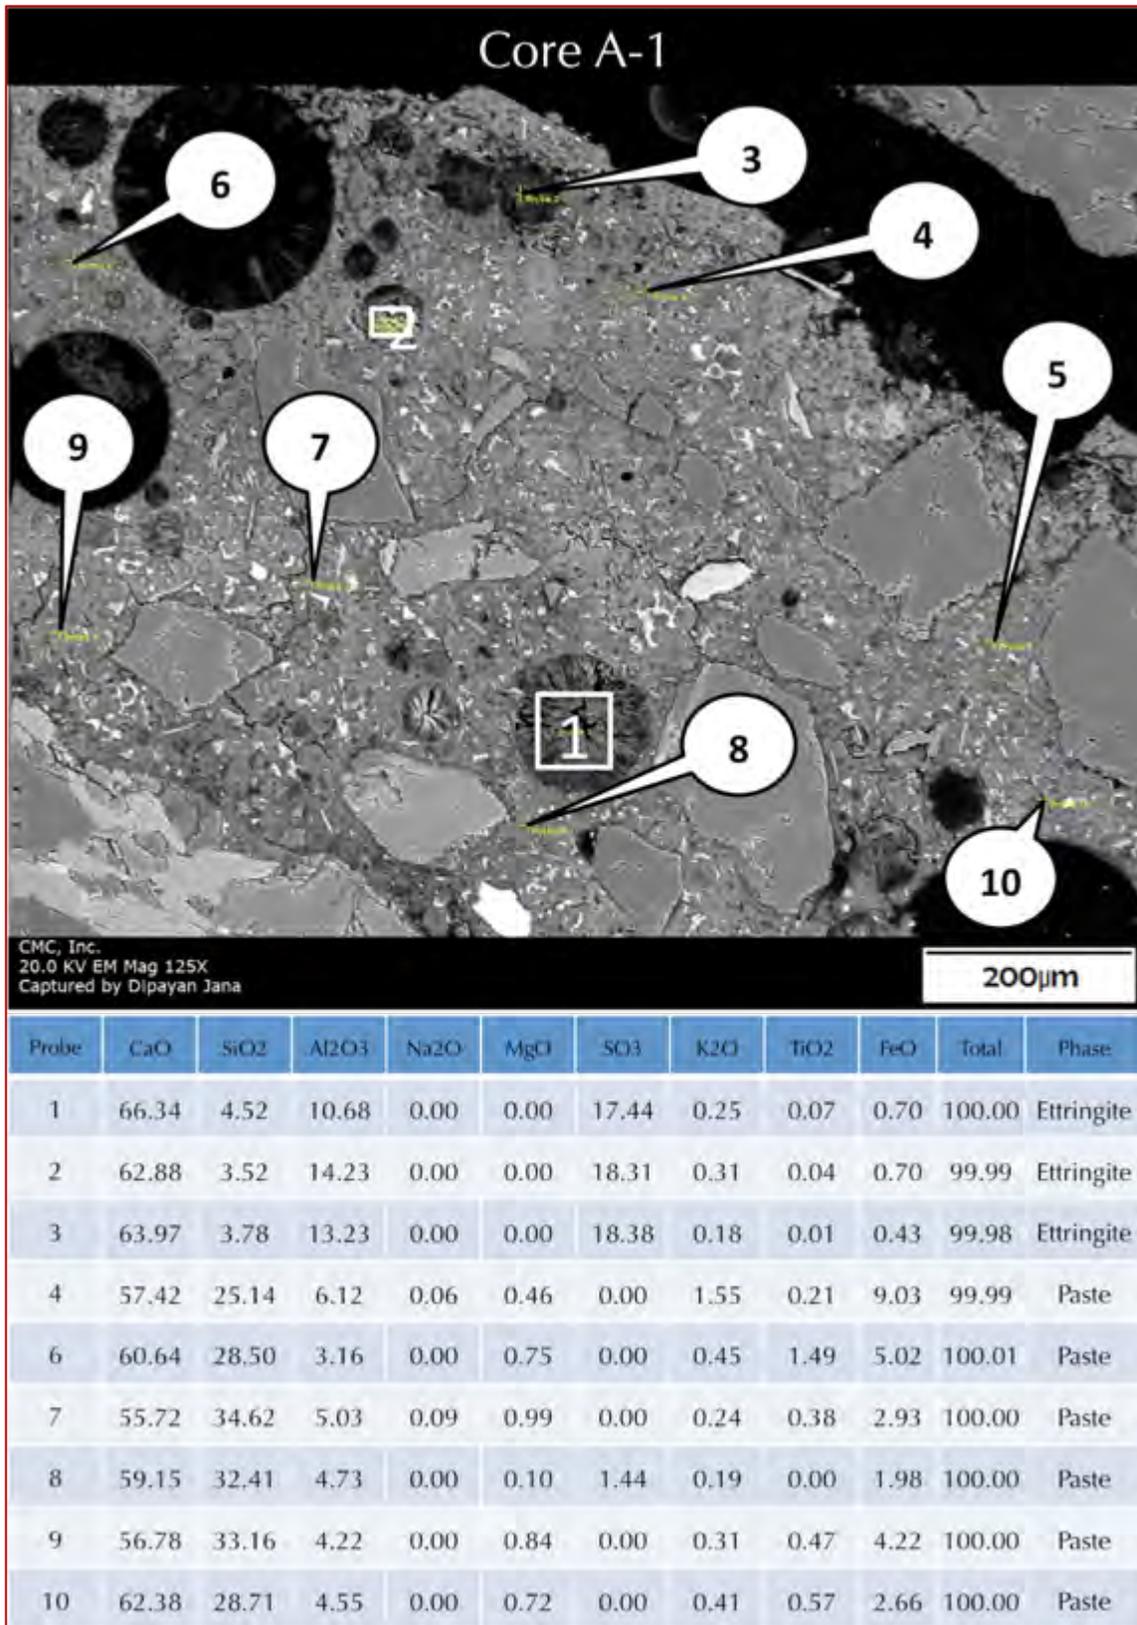
Figure E 3: Backscatter electron image (top) and compositional analyses of selected areas (at the tips of callouts and in boxed areas) by energy-dispersive X-ray fluorescence spectroscopy of a portion of concrete microstructure in Core A-1 showing: (a) secondary ettringite deposits having characteristic calcium, aluminum, sulfur compositions, and (b) Portland cement paste having typical calcium silicate (hydrate) composition.
