Laboratory Investigation Of A Reinforced Concrete Anaerobic Digester In A Wastewater Treatment Plant

Waynesville Wastewater Treatment Plant
Anaerobic Digester Assessment
Waynesville, North Carolina

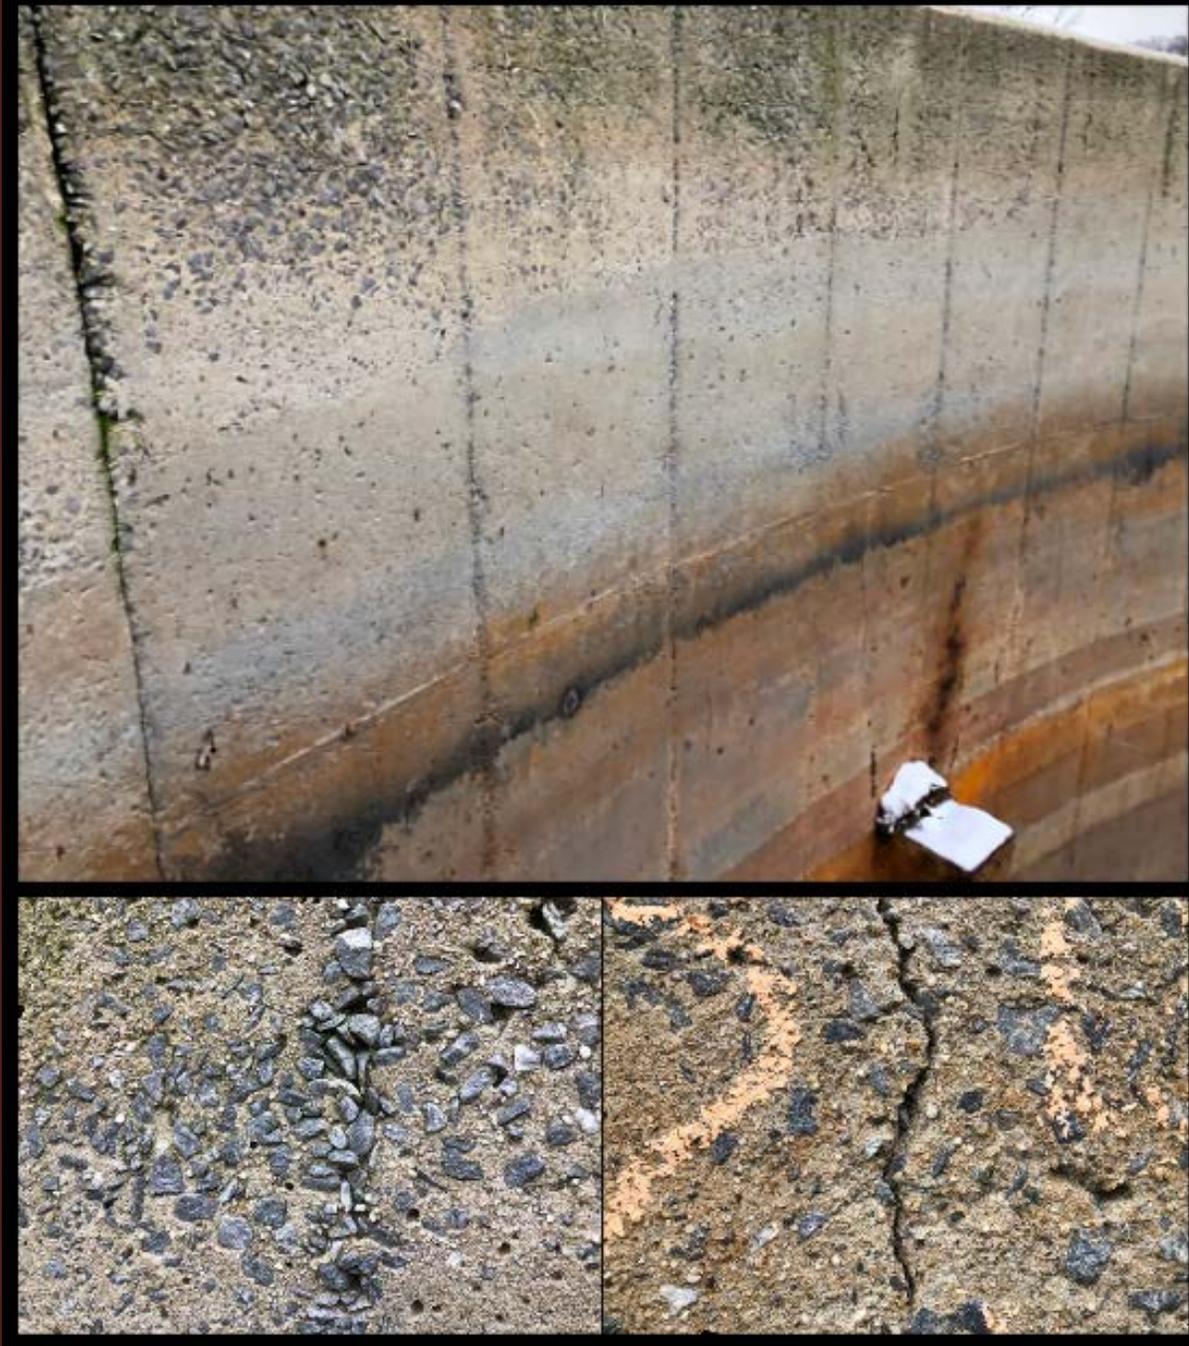
The interior wall of the tank showed (Figures 2 and 3): (a) a cover (depth of steel) thickness estimated about 1-1/2" to 2-1/2" from the surface; (b) vertical lines of segregated coarse aggregates; (c) visible cracking; (d) surface films; (e) variable conditions vertically at the two drops. The exterior of the tank wall showed (Figures 4 and 5): (a) visible cracking with efflorescence indicating water migration through the cracks; (b) orange staining at some cracks suggesting corrosion; (c) failing or failed coatings; (d) a few delamination as cracking subparallel to the surface detected from sounding with a hammer at selected areas; and (d) cover (depth of steel) was estimated to be about 1-1/8" to 2-1/2" from the interior surface.

Figure 2: Field photos of the interior surface of the digester wall showing loss of paste around aggregate particles at the cement gray toned very top portion of the wall with occasional cracks and parallel joints followed by layers of discolored concrete surface where other than discoloration the surface does not show any aggregate exposure as seen at the very top gray zone.

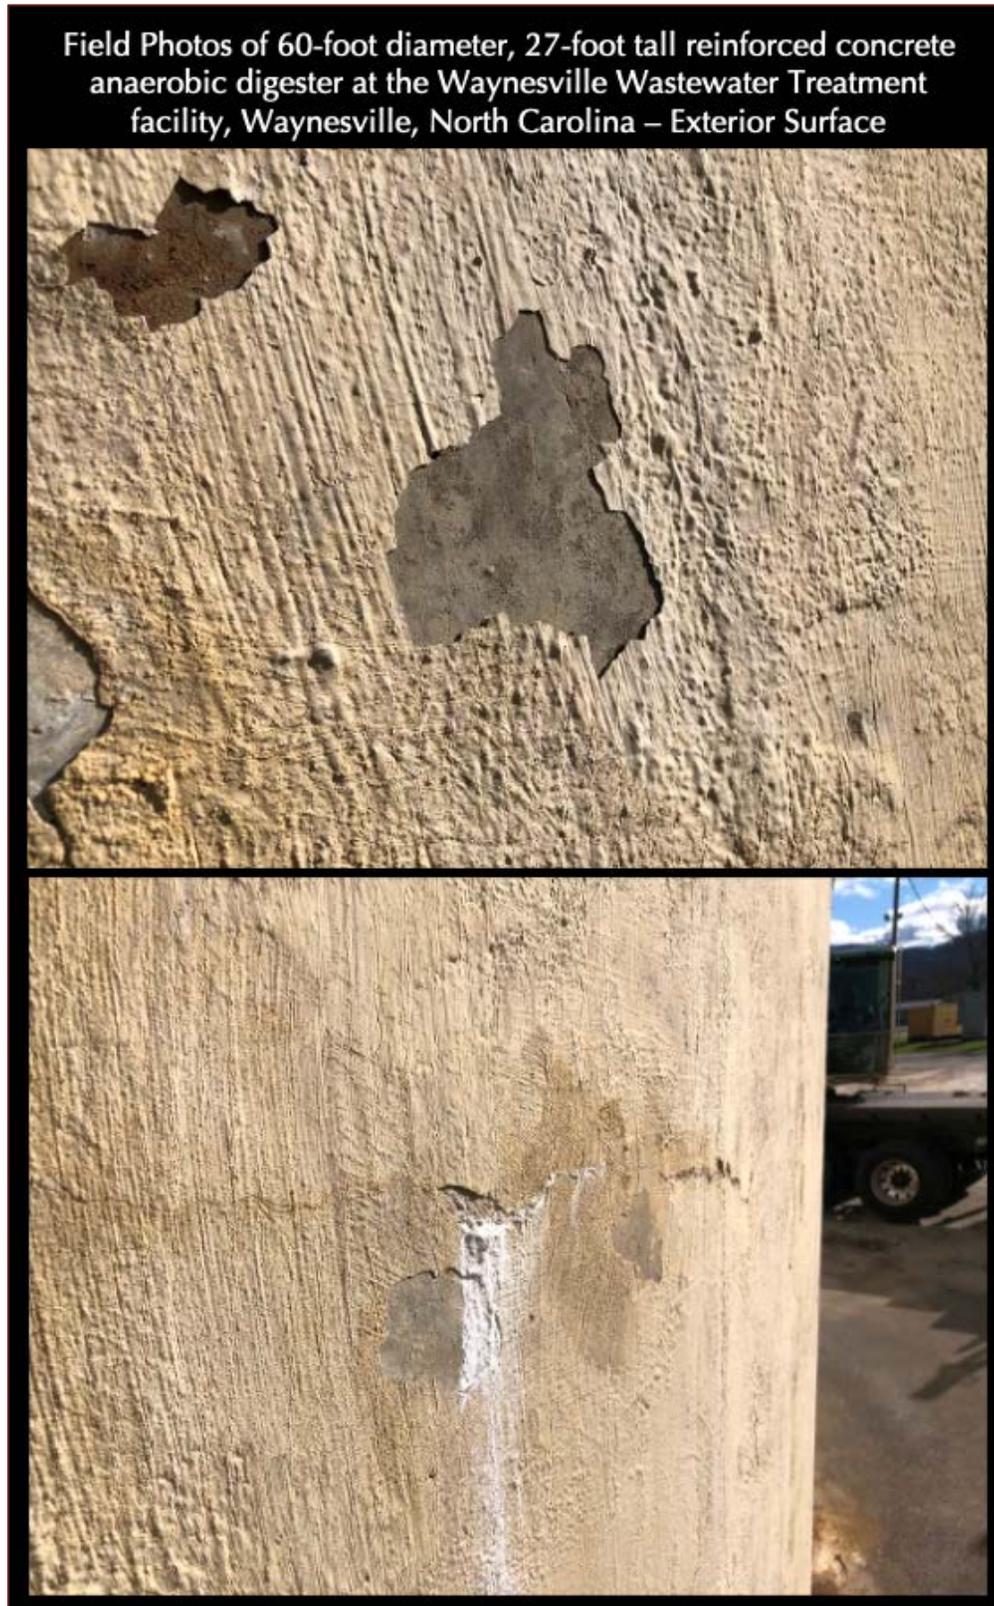
Figure 5: A few localized areas showing spalling of the cementitious protective coating applied on the exterior surface of the digester.

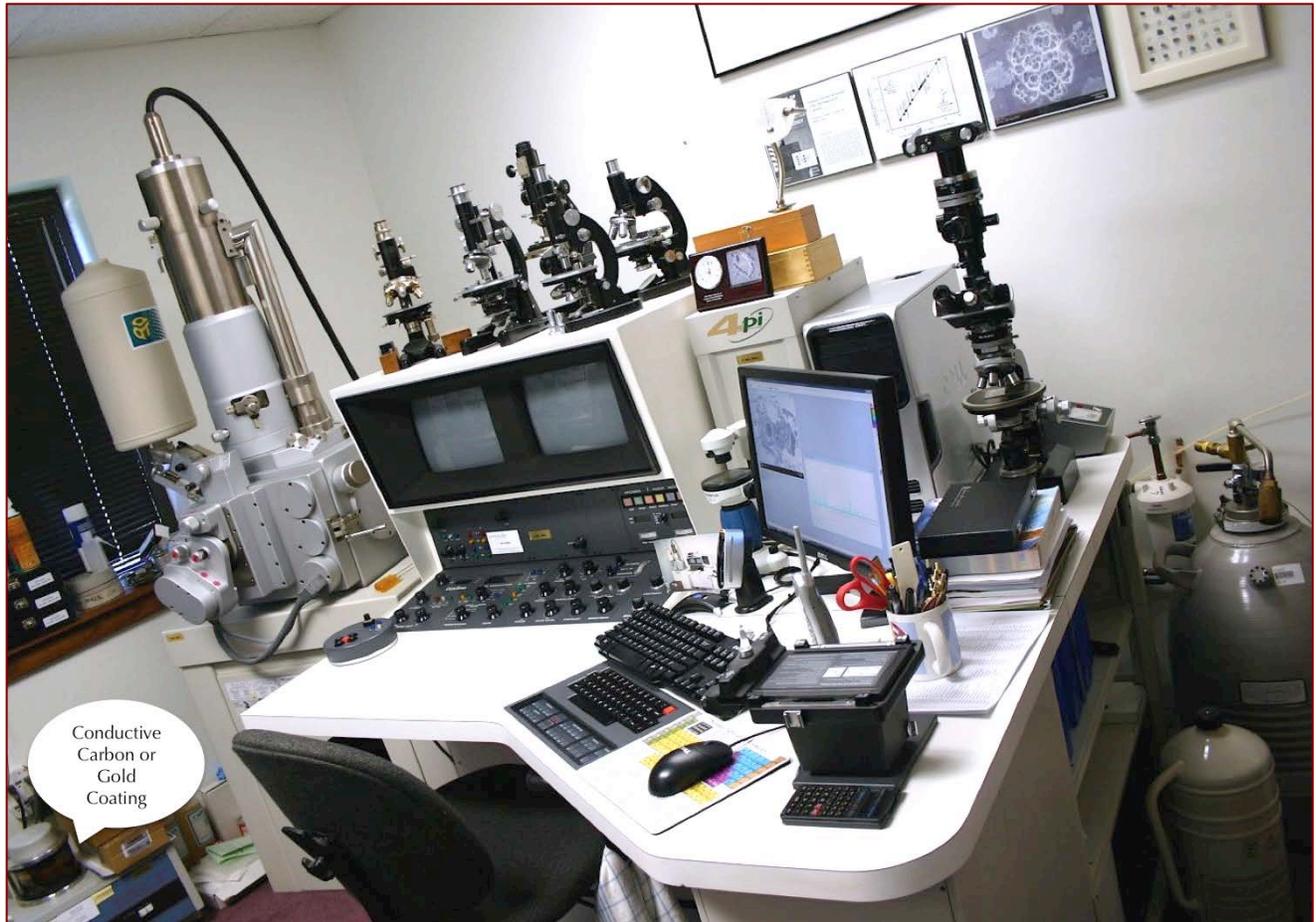
Figure 9: CamScan Series 2 scanning electron microscope used for examination of alteration of interior surface of tank wall.

After optical microscopy, thin section examination was further carried out in a scanning electron microscope (Figure 9) for examination of alteration of interior surface of tank wall in one core. The microscope is equipped with a high-resolution column 40Å tungsten, 40 kV electron optics zoom condenser 75° focusing lens operating at 20 kV, equipped with a variable geometry secondary electron detector, backscatter electron detector, EDS detector for observations of microstructures at high-resolution, compositional analysis, and quantitative determinations of major element oxides from various areas of interest, respectively. Revolution 4Pi software is used for digital storage of secondary electron and backscatter electron images, elemental mapping, and analysis along a line, a point or an area of interest. A 50 mm × 75 mm thin section of the sample was polished, coated with a gold-palladium alloy, and used with a custom-made aluminum sample holder in the large multiported chamber with the eucentric 50 × 100 mm motorized stage.

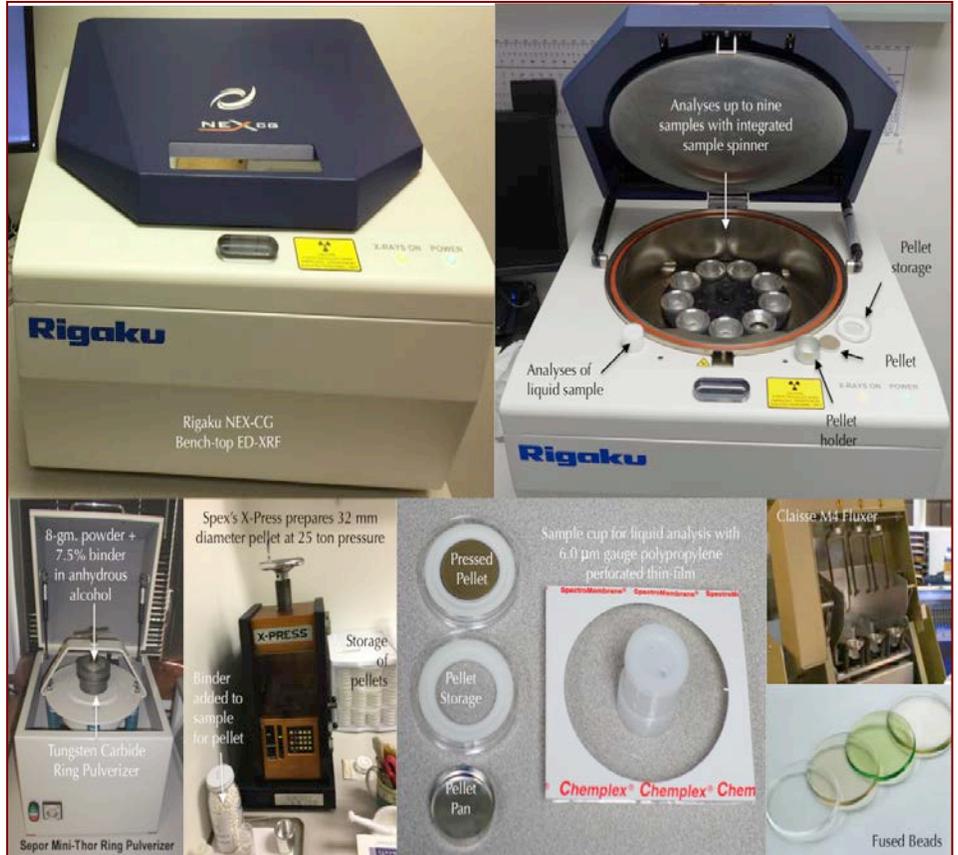
Figure 11: Rigaku NEX-CG in CMC, which can perform analyses of 9 pressed pellet or fused bead of sample. Samples are prepared either as pressed pellet (usually the one already prepared for XRD) or can also accommodate fused bead with proper calibration of standard beads.

An energy-dispersive bench-top X-ray fluorescence unit from Rigaku Americas Corporation (NEX-CG) was used (Figure 11). Rigaku NEX CG delivers rapid qualitative and quantitative determination of major and minor atomic elements in a wide variety of sample types with minimal standards. Unlike conventional EDXRF analyzers, the NEX CG was engineered with a unique close-coupled Cartesian Geometry (CG) optical kernel that dramatically increases signal-to-noise. By using monochromatic secondary target excitation, instead of conventional direct excitation, sensitivity is further improved. The resulting dramatic reduction in background noise, and simultaneous increase in element peaks, result in a spectrometer capable of routine trace element analysis even in difficult sample types. The instrument is calibrated by using various certified (CCRL, NIST, GSA, and Brammer) reference standards of cements and rocks.

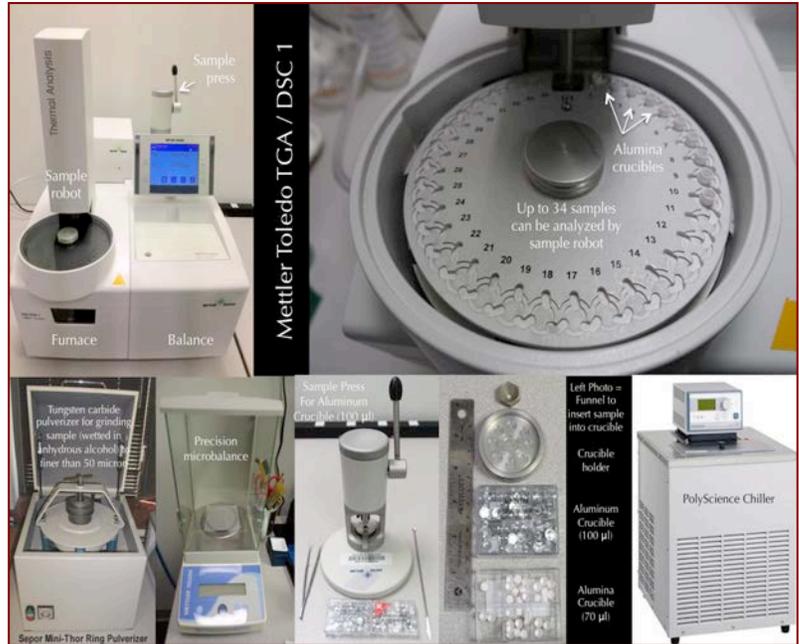
Figure 12: Mettler-Toledo simultaneous TGA/DSC1 unit in CMC that can accommodate 32 samples. The top left photo shows the TGA/DSC1 unit with sample robot for automation as well as the sample holder for pressing aluminum sample holders. Sample is pulverized in a ring pulverizer shown in the bottom left, then a small amount (usually 30-70 mg) is weighed in a precision balance (shown 2nd from left in bottom row) and taken in an alumina sample holder (without lid). For DSC measurements up to 600°C, sometimes sample is taken in an aluminum holder and pressed in sample press (3rd from left in bottom row) and pierced with a needle for release of volatiles from decomposition. A PolyScience chiller (rightmost one in the bottom row) is used to cool the furnace. An ultrapure nitrogen gas is purged through the system during analyses.

(Figure 12) on 30-70 mg of finely ground (<0.6 mm) sample in alumina crucible (70 μ l, no lid) from 30°C to 1100°C at a heating rate of 10°C/min with high purity nitrogen as purge gas at a flow rate of 75.0 ml/min.

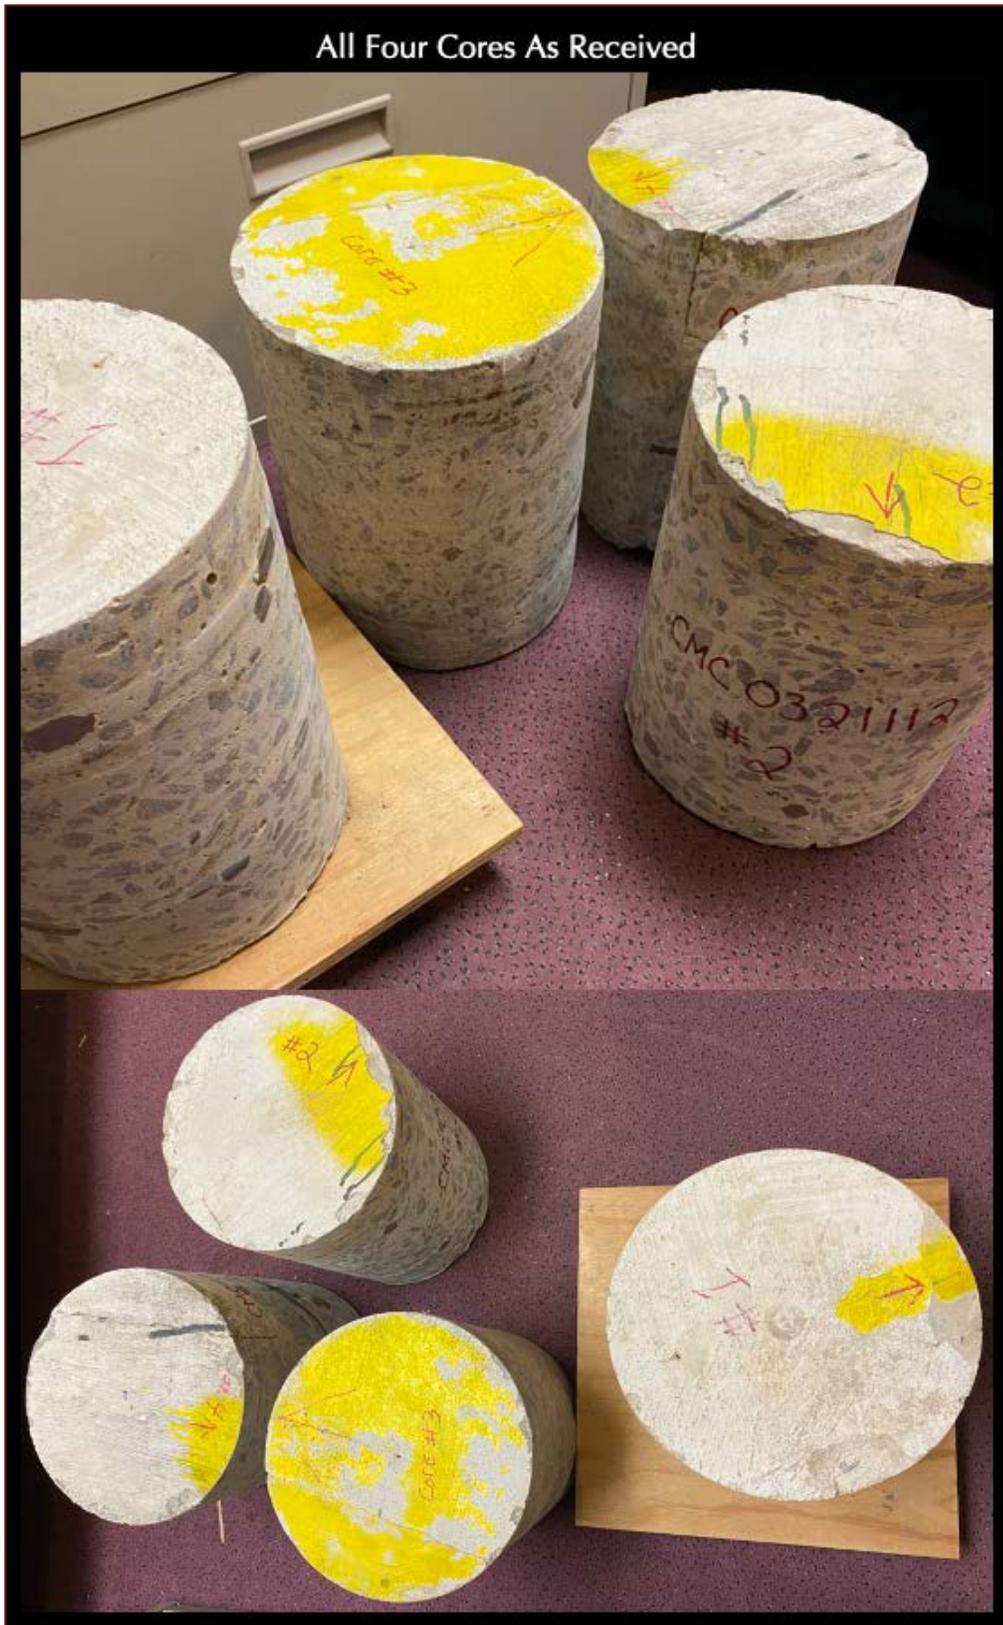
Figure 14: Shown are the exterior surface of tank wall in four cores received where some edge spalling of the protective cementitious coat is seen in some cores.

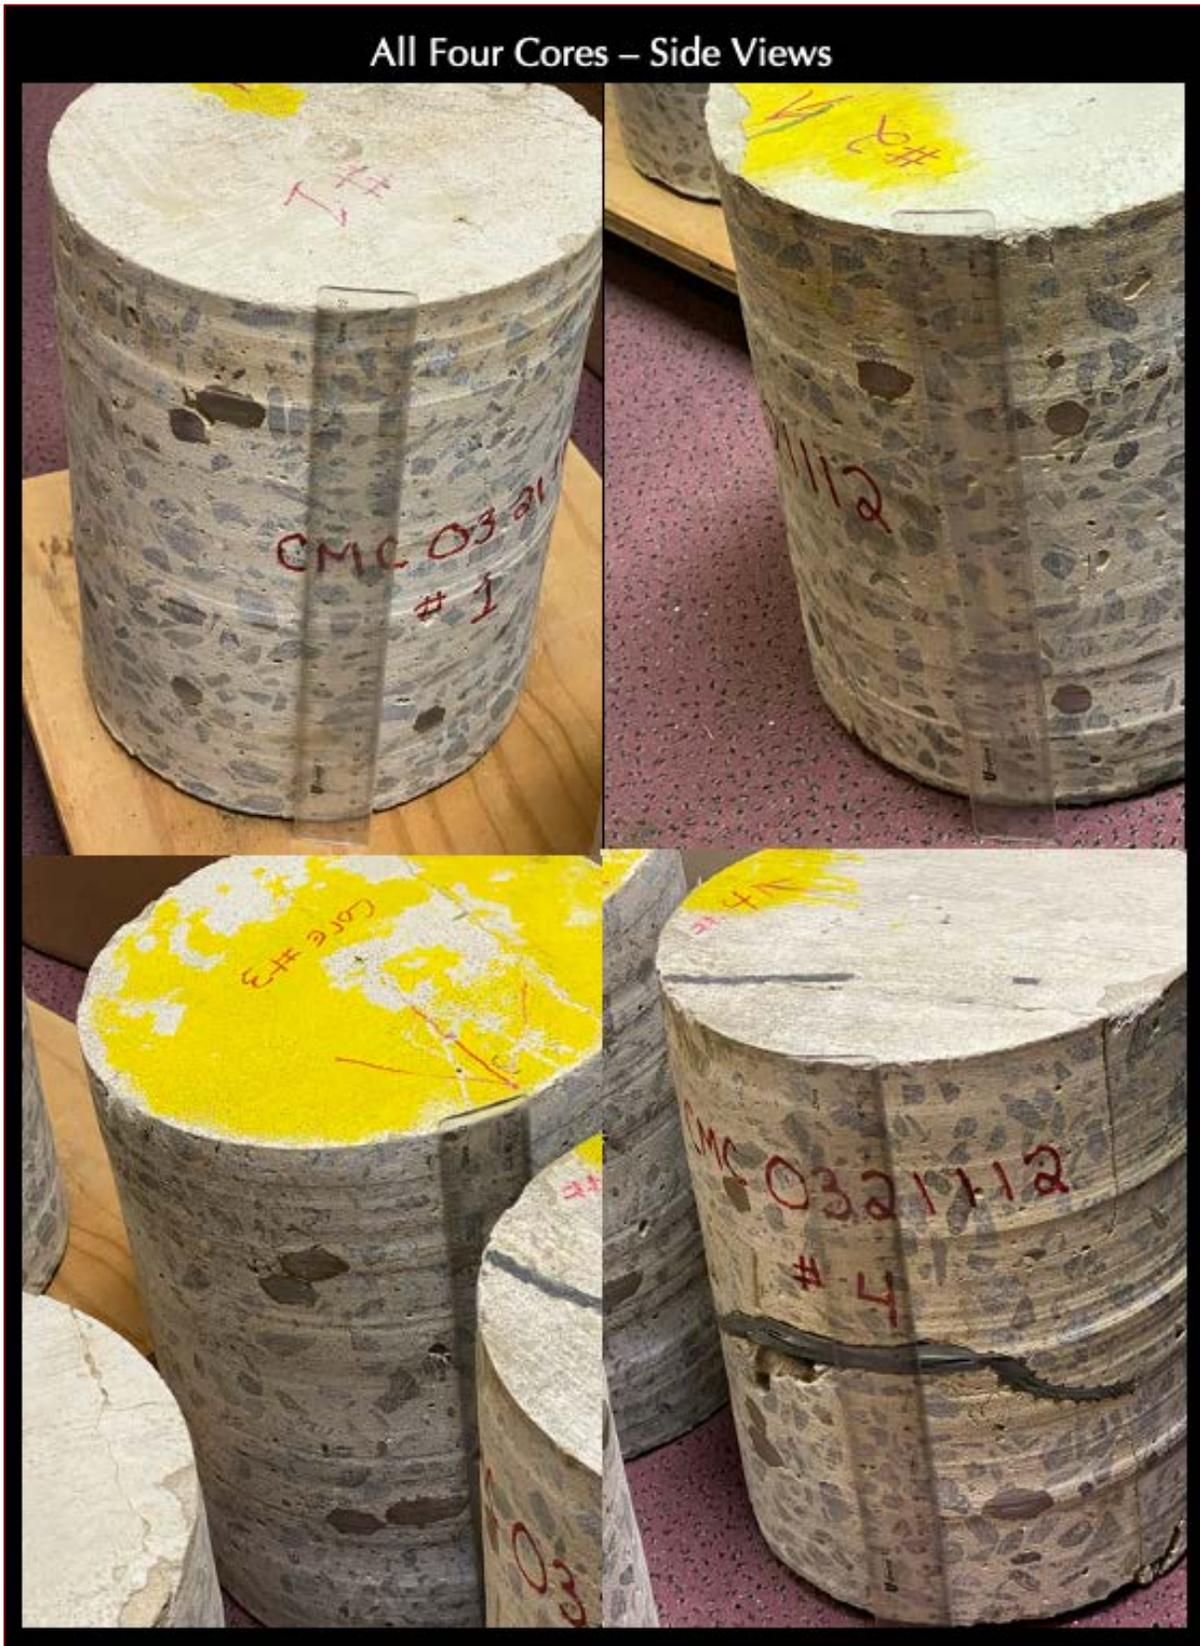
Figure 16: Shown are the exterior surface of tank wall in four cores received where some edge spalling of the protective cementitious coat is seen in some cores.

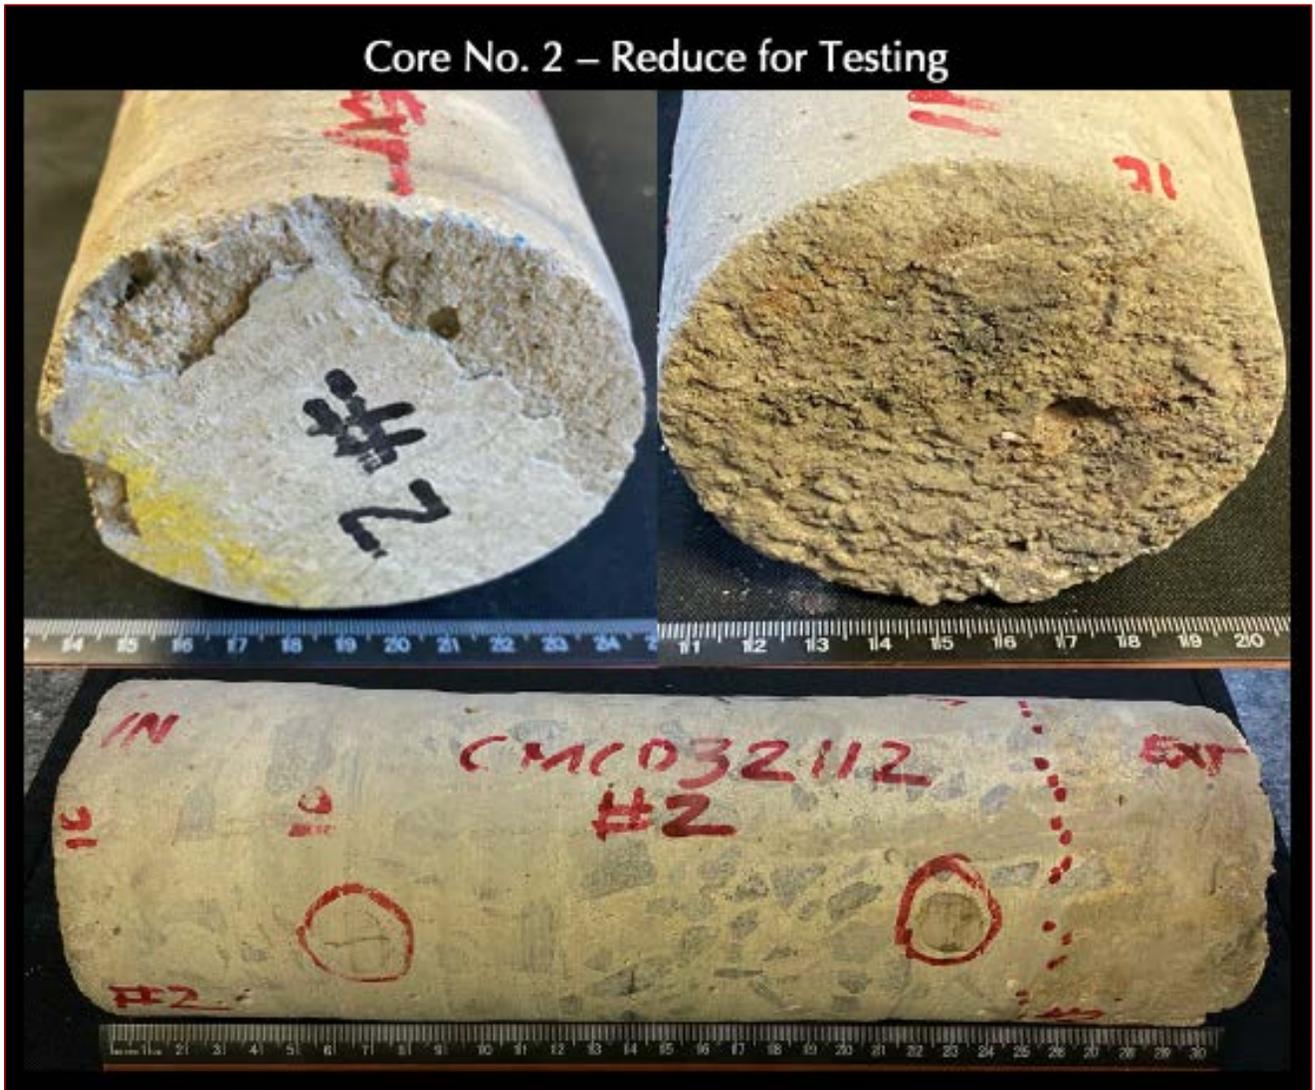
Figure 18: Core C2 reduced in diameter from the original 9½-in. diameter to 4-in. diameter for sample processing, showing the exterior and interior surfaces of tank wall at the opposite ends due to through-depth retrieval of the original core from the entire thickness of the tank wall. Steel reinforcement is circled, and directions of exterior and interior surfaces are marked as ‘ext’ and ‘int,’ respectively.

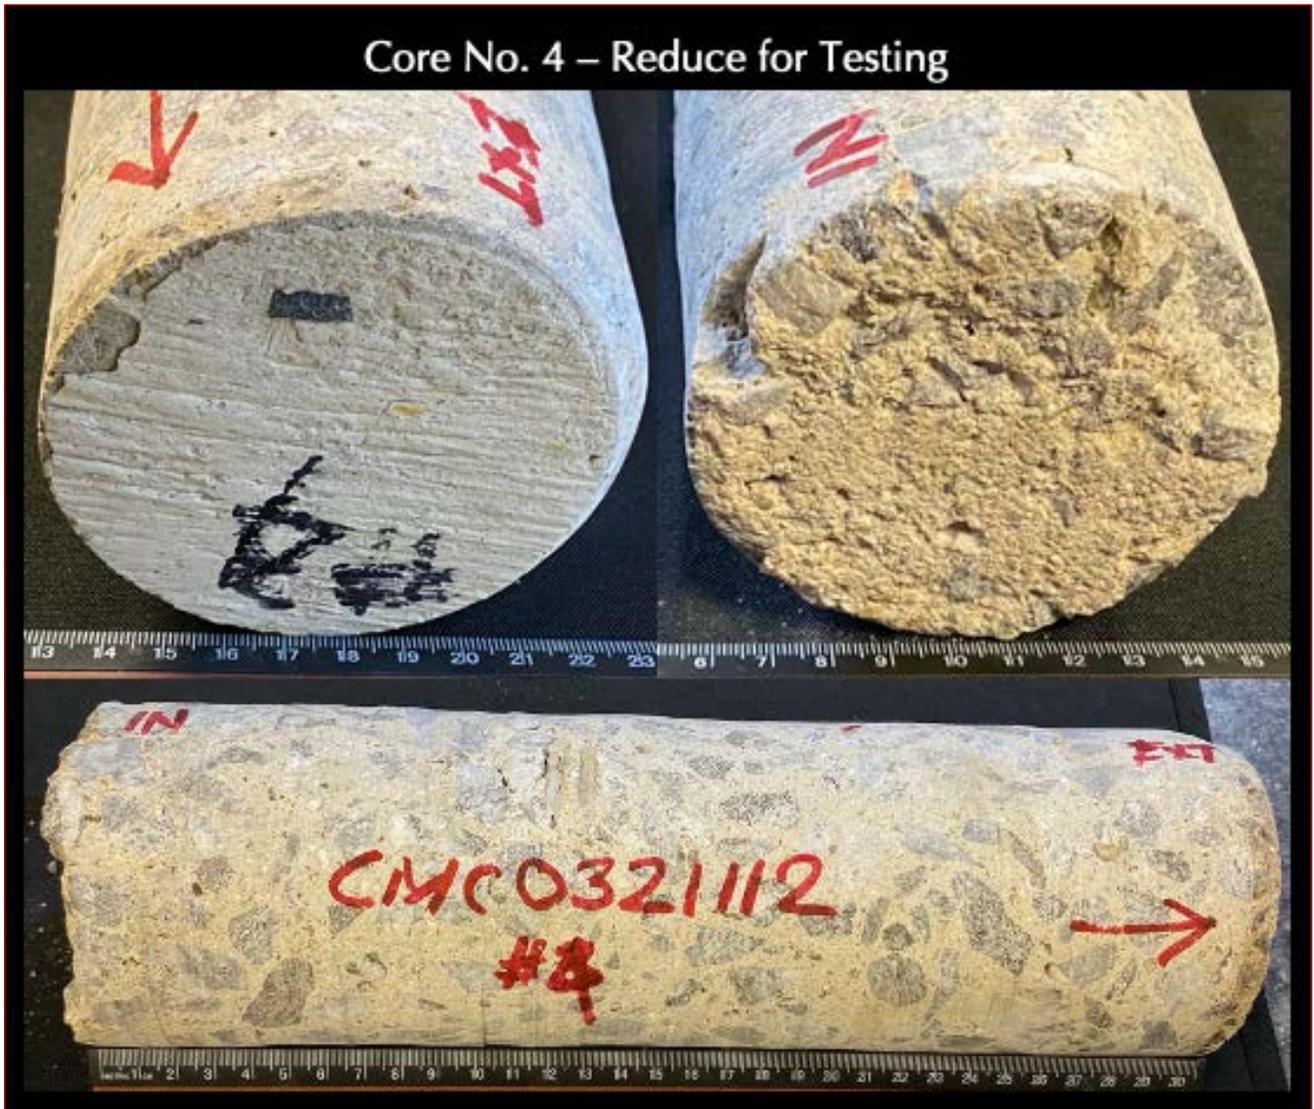
Figure 20: Core C4 reduced in diameter from the original 9½-in. diameter to 4-in. diameter for sample processing showing the exterior, and interior surfaces of tank wall at the opposite ends due to through-depth retrieval of the original core from the entire thickness of the tank wall. Notice some spalling of protective cementitious coat on the exterior tank wall surface in the top left photo. Directions of exterior and interior surfaces are marked as ‘ext’ and ‘int,’ respectively.

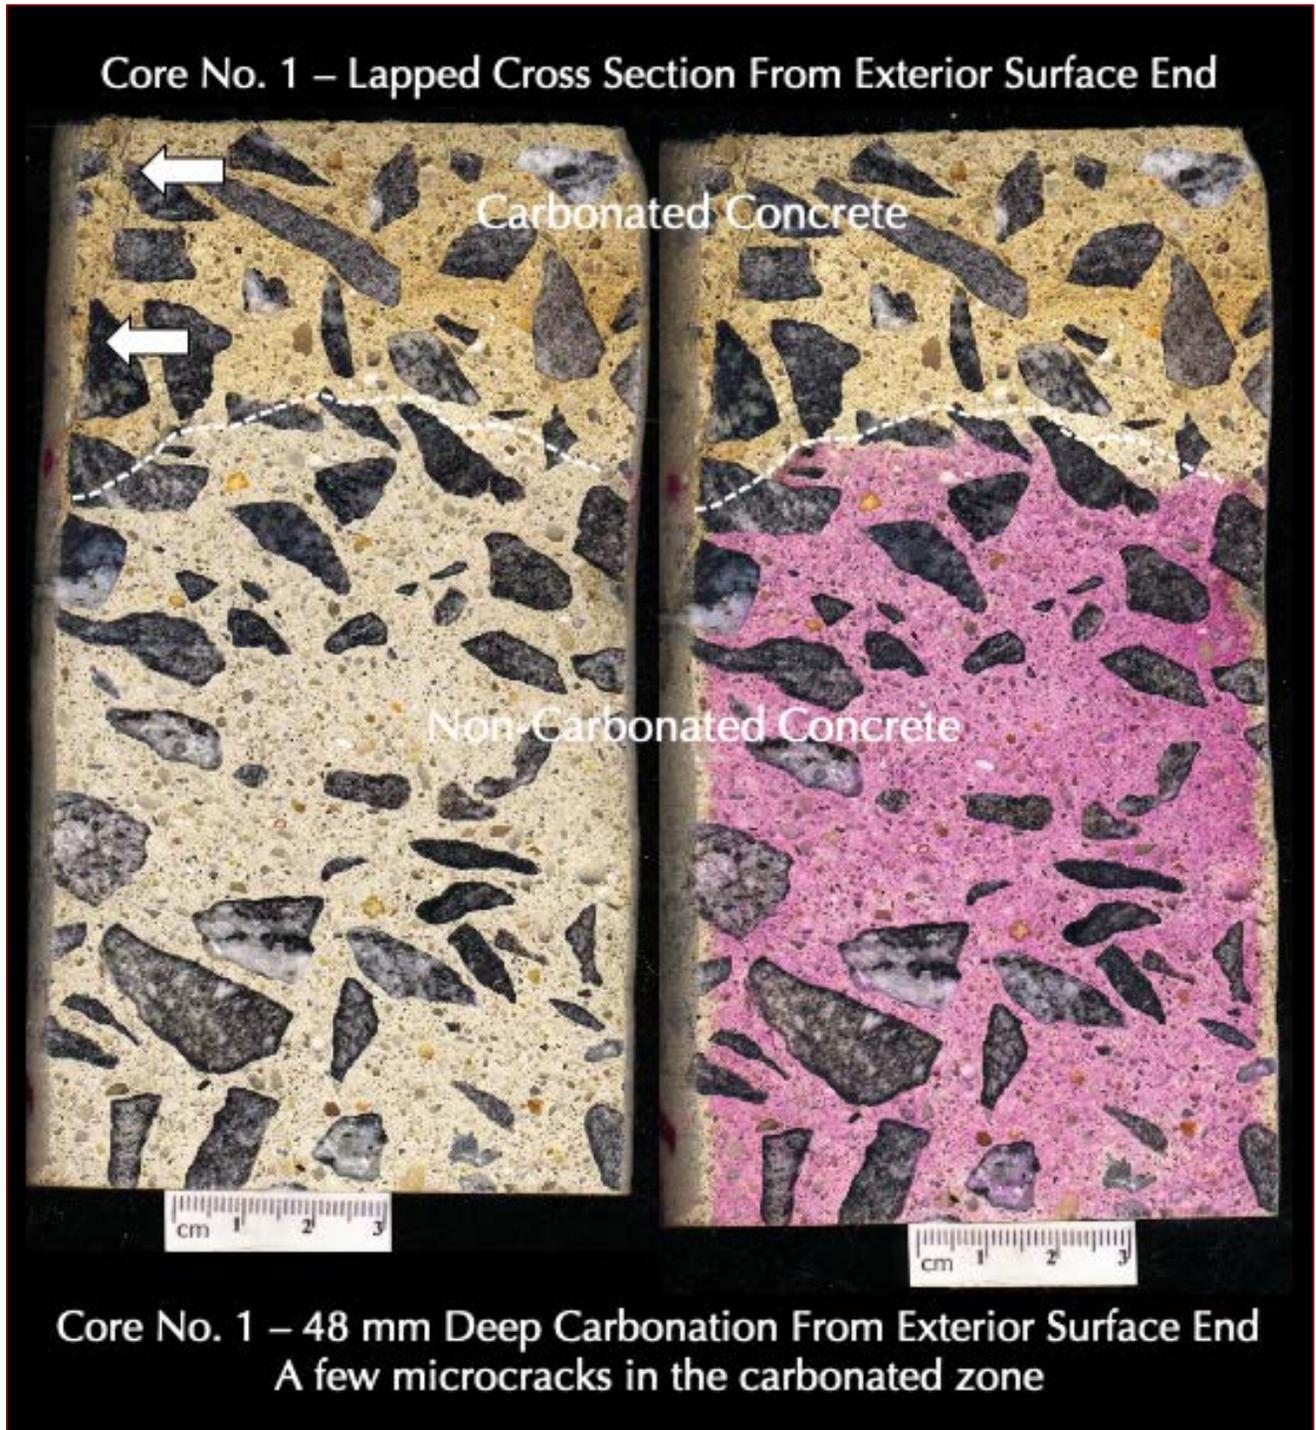
Figure 23: Lapped cross section of Core C1 from the exterior surface end showing before (left) and after (right) treatment with phenolphthalein alcoholic solutions to show carbonated zone at the exterior end where the concrete maintained its original beige discolored zone from interaction with atmospheric carbon dioxide, whereas pink discoloration of paste in the interior non-carbonated concrete. The depth of carbonation is measured to be 48 mm from the exterior end despite having a protective cementitious coating indicating prolonged interaction of the exterior tank wall surface with air prior to the placement of protective coating.

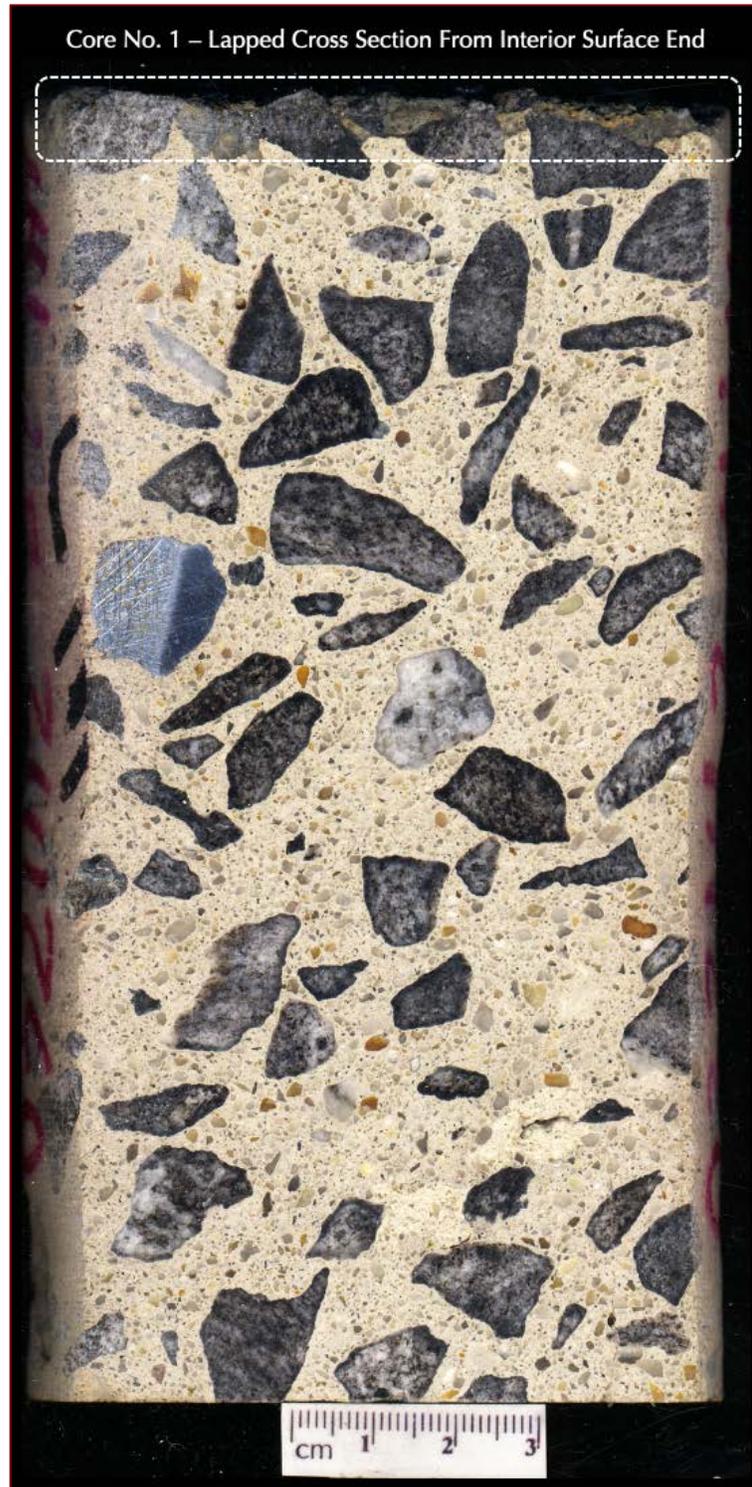
Figure 24: Lapped cross section of Core C1 from the interior surface end showing: (a) layered black and brown discoloration of concrete at the interior surface end due to chemical alterations by interaction with the containment solution of tank to a depth of 5 to 7 mm where the altered zone (boxed) is separated from the interior sound unaltered concrete by a sharp boundary; (b) crushed schist and gneiss coarse aggregate particles many with dark rims where particles are angular, dense, hard, medium gray and white, well-graded, and well-distributed; and (c) sound interstitial mortar fraction of concrete made using Portland cement paste and fine siliceous sand.

Depths of alteration of such zones, however, are shallow in all four cores, measured to be: (a) 5 to 7 mm in Core C1 occurring as a dark gray to black altered layer sometimes with an inner brown layer at the interior wall (Figures 24 to 27, 40); (b) 7 to 8 mm in Core C2, again occurring as a black to dark gray altered layer in the interior wall often with thin brown layer at the interior wall (Figures 30 to 33, 40); and (c) 7 mm from interior wall of Core C4 where instead of a black altered layer mostly beige to brown carbonated layer is seen (Figures 36 to 39, 40). Figure 40 summarizes variations in depths and appearances of these layered zones of concrete at the interior tank wall surface represented in Cores C1, C2, and C4 due to interactions with the containment solutions of the tank.

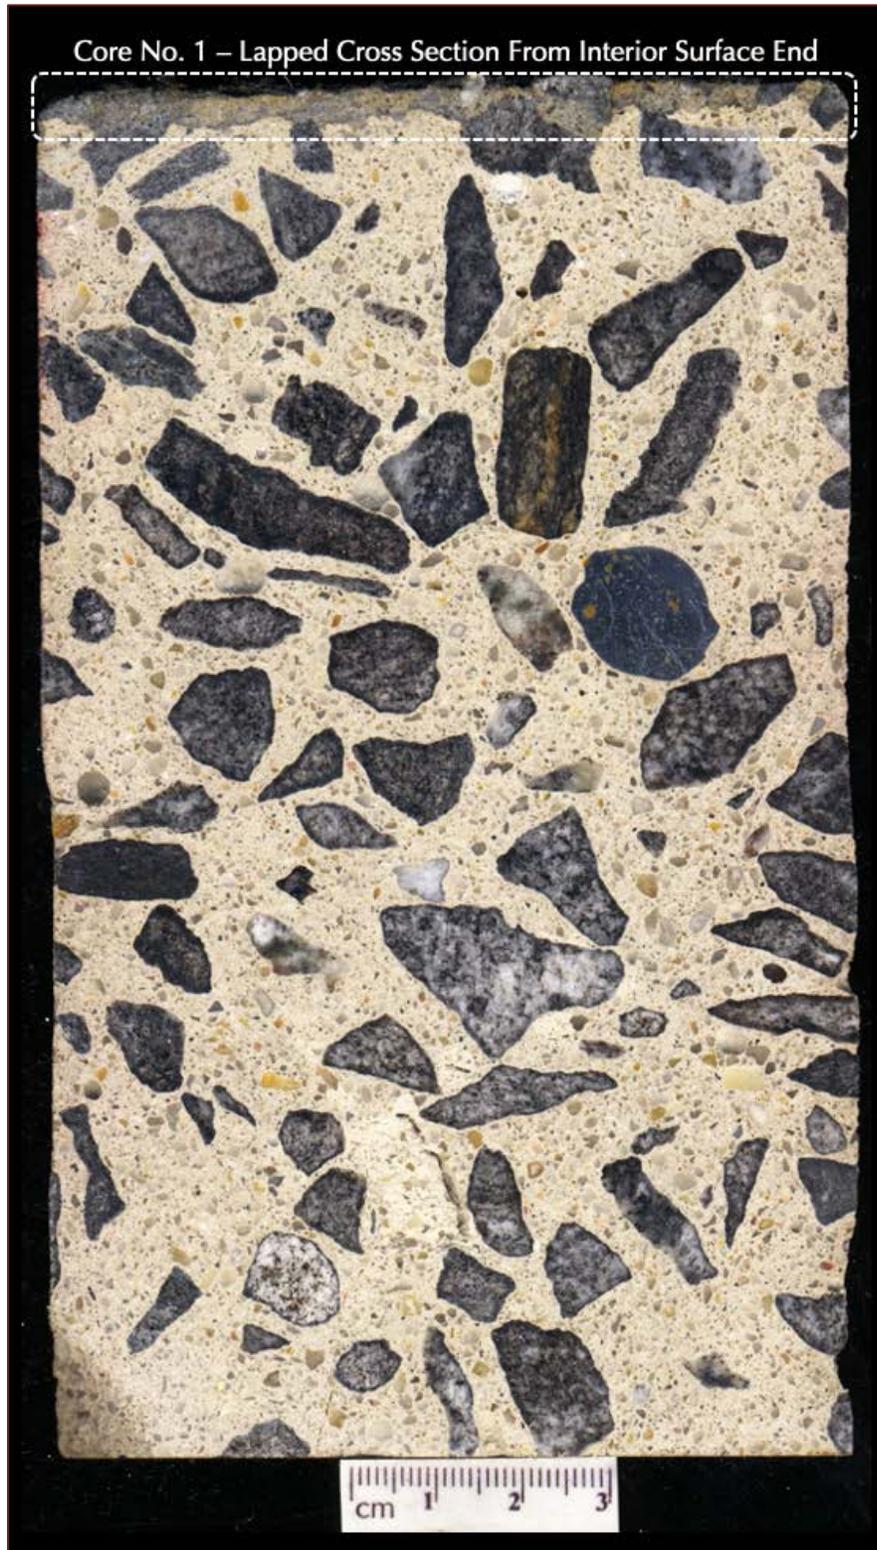
Figure 25: Lapped cross section of Core C1 from the interior surface end showing: (a) layered black and brown discoloration of concrete at the interior surface end due to chemical alterations by interaction with the containment solution of tank to a depth of 5 mm where the altered zone (boxed) is separated from the interior sound unaltered concrete by a sharp boundary; (b) crushed schist and gneiss coarse aggregate particles many with dark rims where particles are angular, dense, hard, medium gray and white, well-graded, and well-distributed; and (c) sound interstitial mortar fraction of concrete made using Portland cement paste and fine siliceous sand.

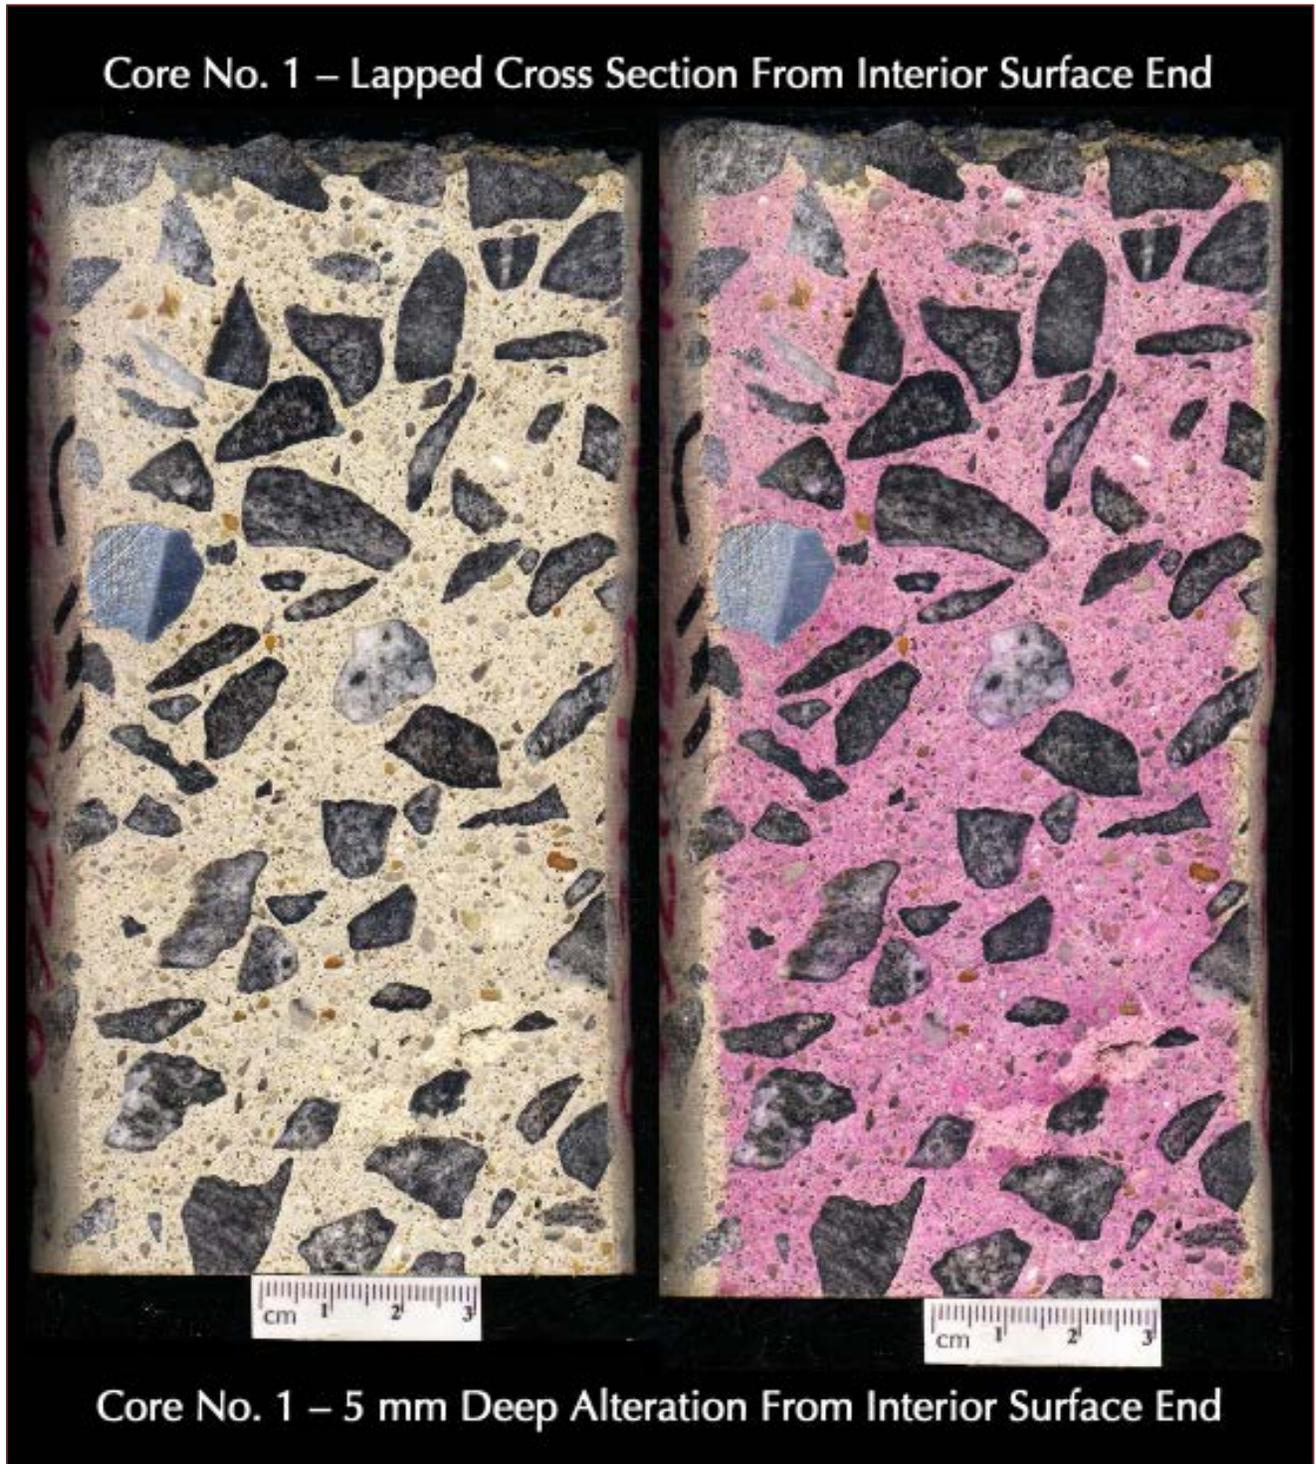
Figure 26: Lapped cross section of Core C1 from the interior surface end showing before (left) and after (right) treatment with phenolphthalein alcoholic solutions to show carbonated zone at the interior end where the concrete maintained its original black discolored zone from interaction with atmospheric carbon dioxide whereas pink discoloration of paste in the interior non-carbonated concrete. The depth of carbonation is measured to be 5 mm from the interior end, which is noticeably lower than the carbonation depth measured from the exterior end.

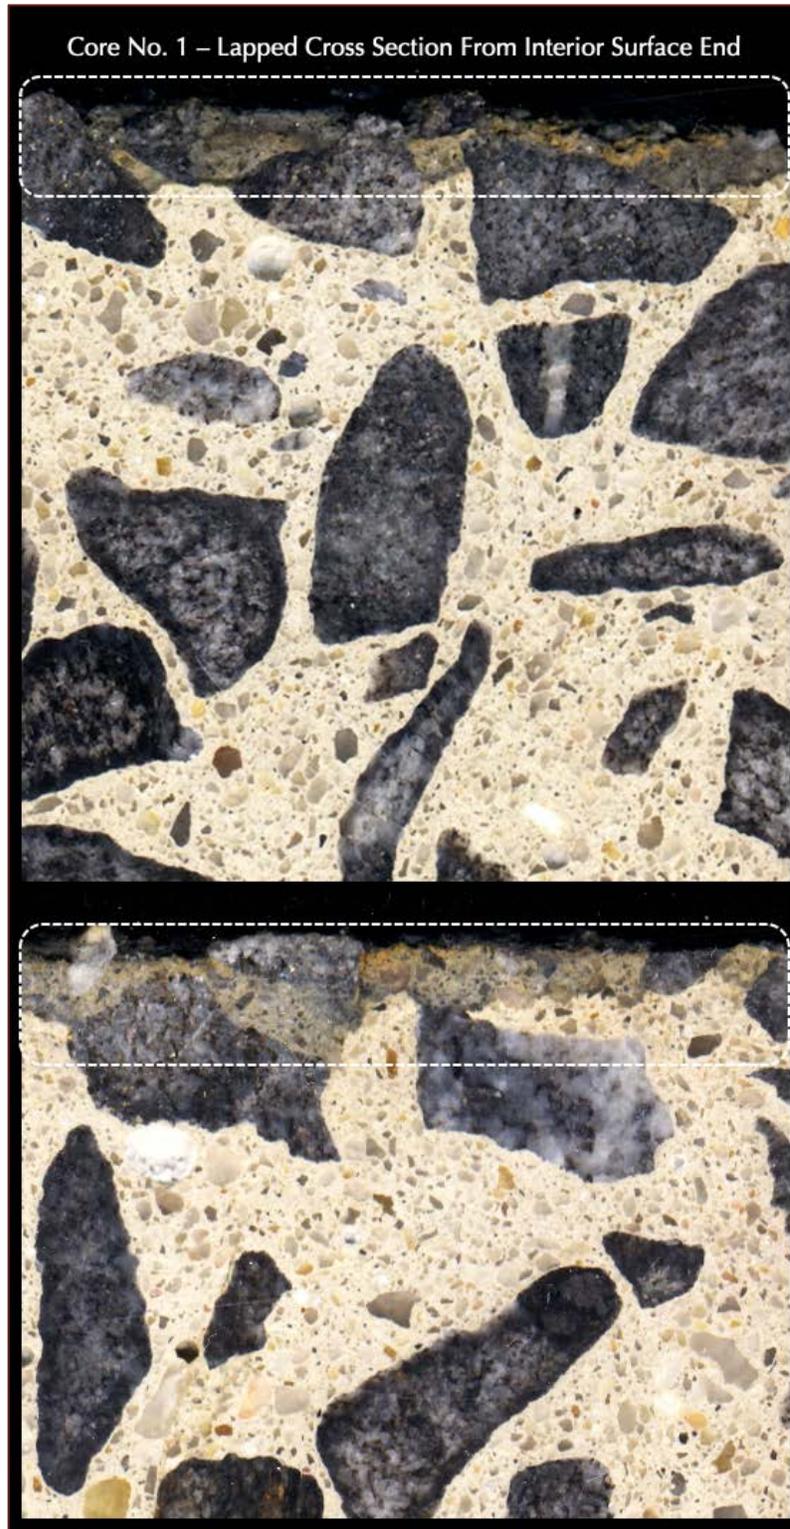
Figure 27: Lapped cross section of Core C1 from the interior surface end showing: (a) layered black and brown discoloration of concrete at the interior surface end due to chemical alterations by interaction with the containment solution of tank to a depth of 5 mm where the altered zone (boxed) is separated from the interior sound unaltered concrete by a sharp boundary; (b) crushed schist and gneiss coarse aggregate particles many with dark rims where particles are angular, dense, hard, medium gray and white, well-graded, and well-distributed; and (c) sound interstitial mortar fraction of concrete made using Portland cement paste and fine siliceous sand.
