Laboratory Investigation Of A Reinforced Concrete Anaerobic Digester In A Wastewater Treatment Plant

Waynesville Wastewater Treatment Plant
Anaerobic Digester Assessment
Waynesville, North Carolina

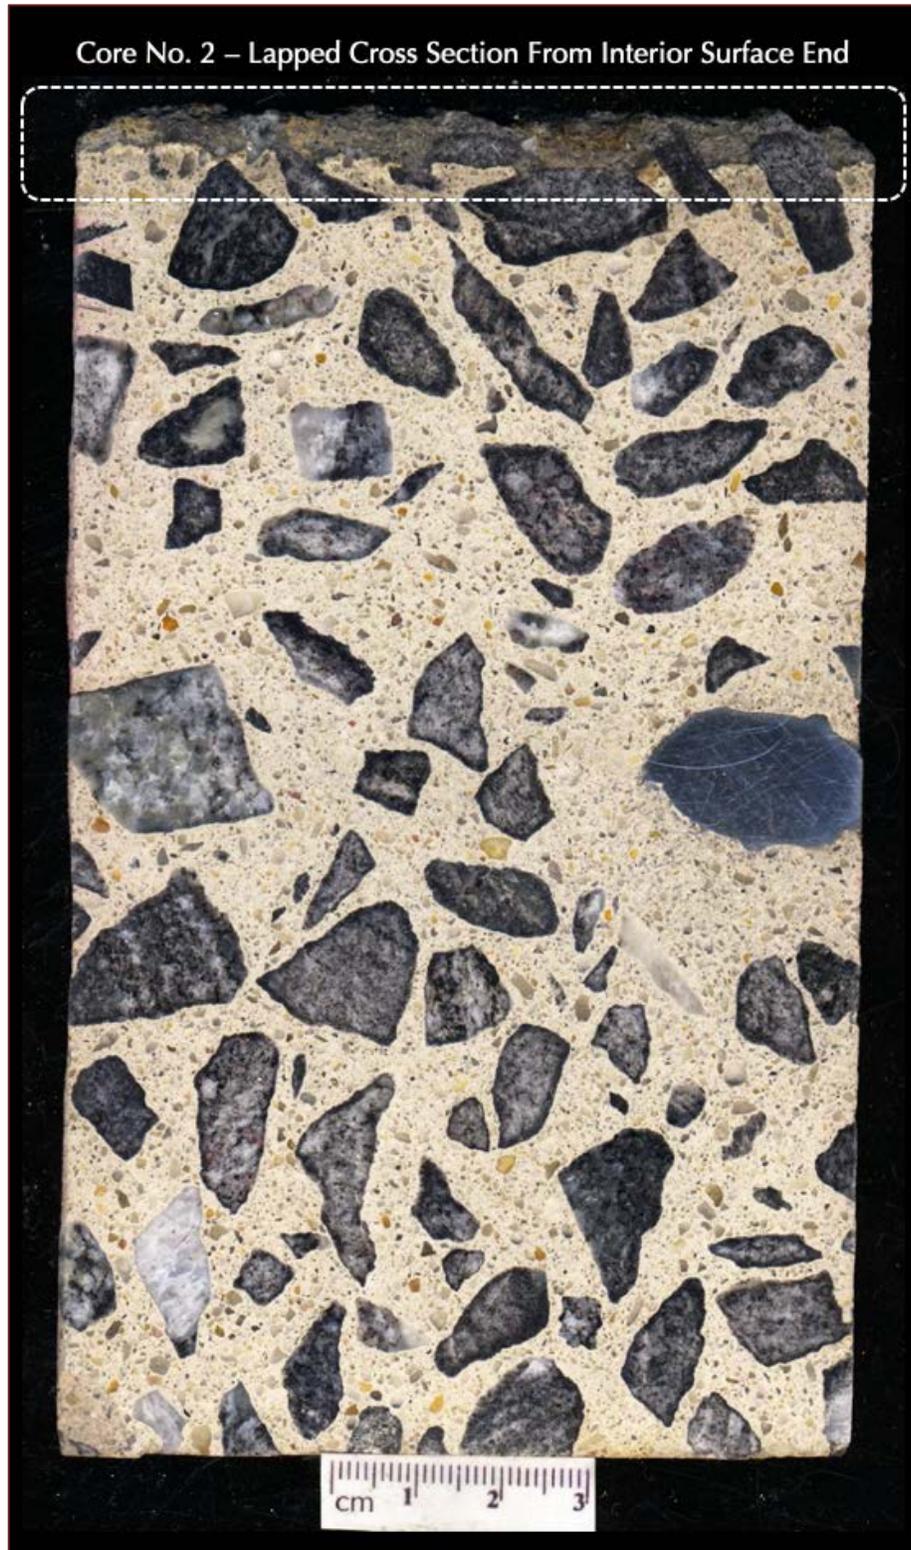
Figure 30: Lapped cross section of Core C2 from the interior surface end showing: (a) black discoloration of concrete at the interior surface end due to chemical alterations by interaction with the containment solution of tank to a depth of 10 mm where the altered zone (boxed) is separated from the interior sound unaltered concrete by a sharp boundary; (b) crushed schist and gneiss coarse aggregate particles many with dark rims where particles are angular, dense, hard, medium gray and white, well-graded, and well-distributed; and (c) sound interstitial mortar fraction of concrete made using Portland cement paste and fine siliceous sand.

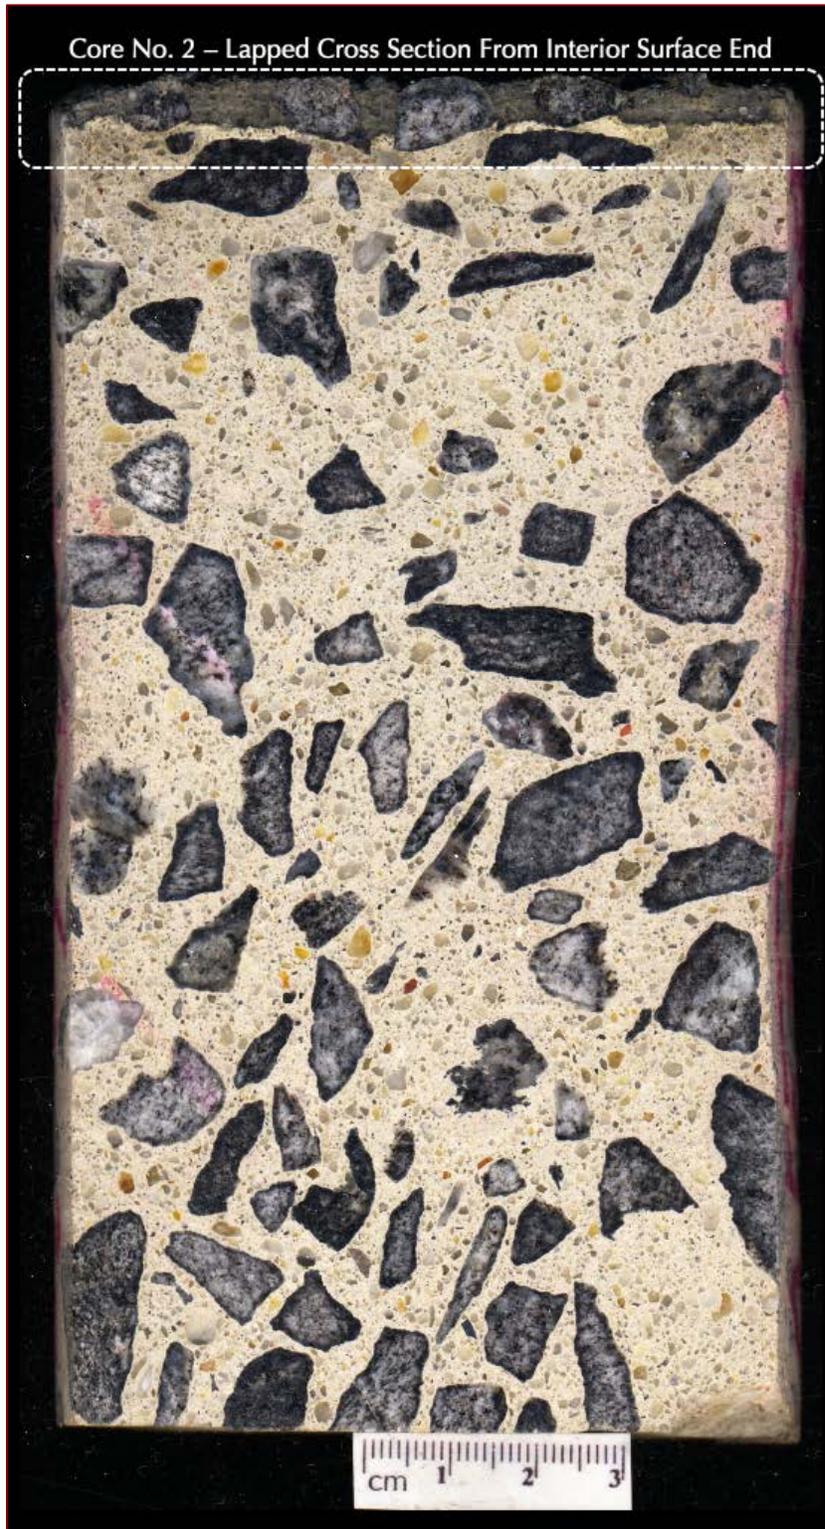
Figure 31: Lapped cross section of Core C2 from the interior surface end showing: (a) black discoloration of concrete at the interior surface end due to chemical alterations by interaction with the containment solution of tank to a depth of 10 mm where the altered zone (boxed) is separated from the interior sound unaltered concrete by a sharp boundary; (b) crushed schist and gneiss coarse aggregate particles many with dark rims where particles are angular, dense, hard, medium gray and white, well-graded, and well-distributed; and (c) sound interstitial mortar fraction of concrete made using Portland cement paste and fine siliceous sand.

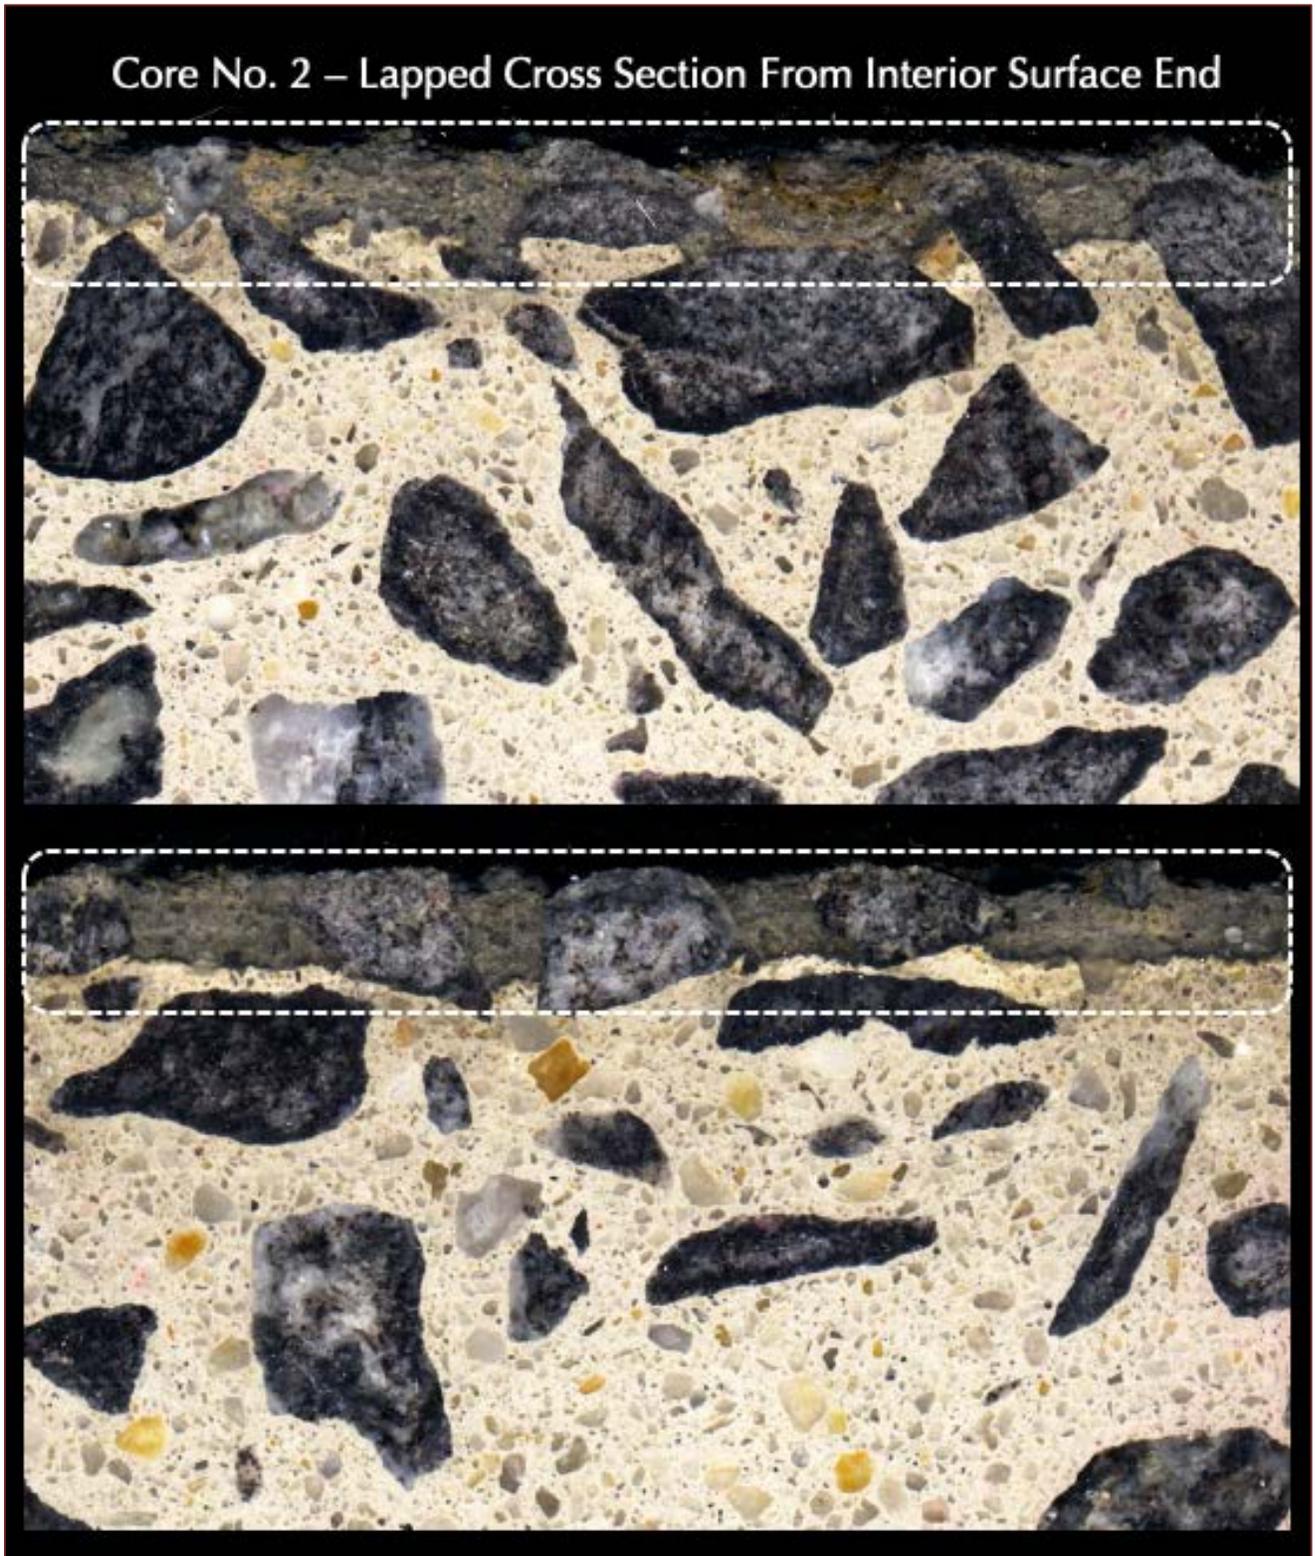
Figure 33: Lapped cross section of Core C2 from the interior surface end showing: (a) black discoloration of concrete at the interior surface end due to chemical alterations by interaction with the containment solution of tank to a depth of 10 mm where the altered zone (boxed) is separated from the interior sound unaltered concrete by a sharp boundary; (b) crushed schist and gneiss coarse aggregate particles many with dark rims where particles are angular, dense, hard, medium gray and white, well-graded, and well-distributed; and (c) sound interstitial mortar fraction of concrete made using Portland cement paste and fine siliceous sand.

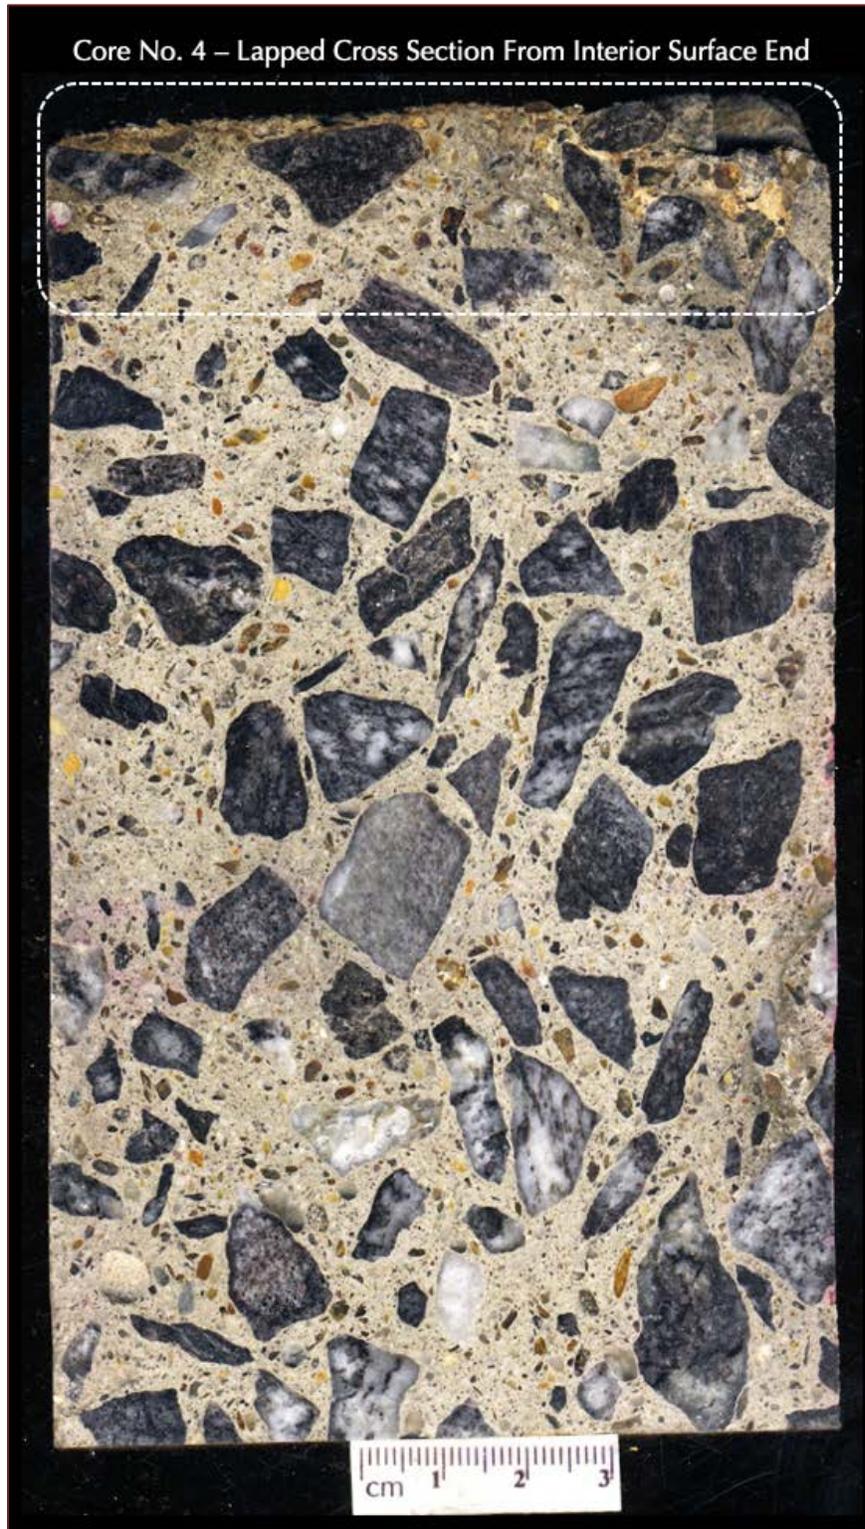
Figure 36: Lapped cross section of Core C4 from the interior surface end showing: (a) brown discoloration of concrete at the interior surface to a depth of 7 mm where the altered zone (boxed) is separated from the interior sound unaltered concrete by a sharp boundary; (b) crushed schist and gneiss coarse aggregate particles many with dark rims where particles are angular, dense, hard, medium gray and white, well-graded, and well-distributed; and (c) sound interstitial mortar fraction of concrete made using Portland cement paste and fine siliceous sand.

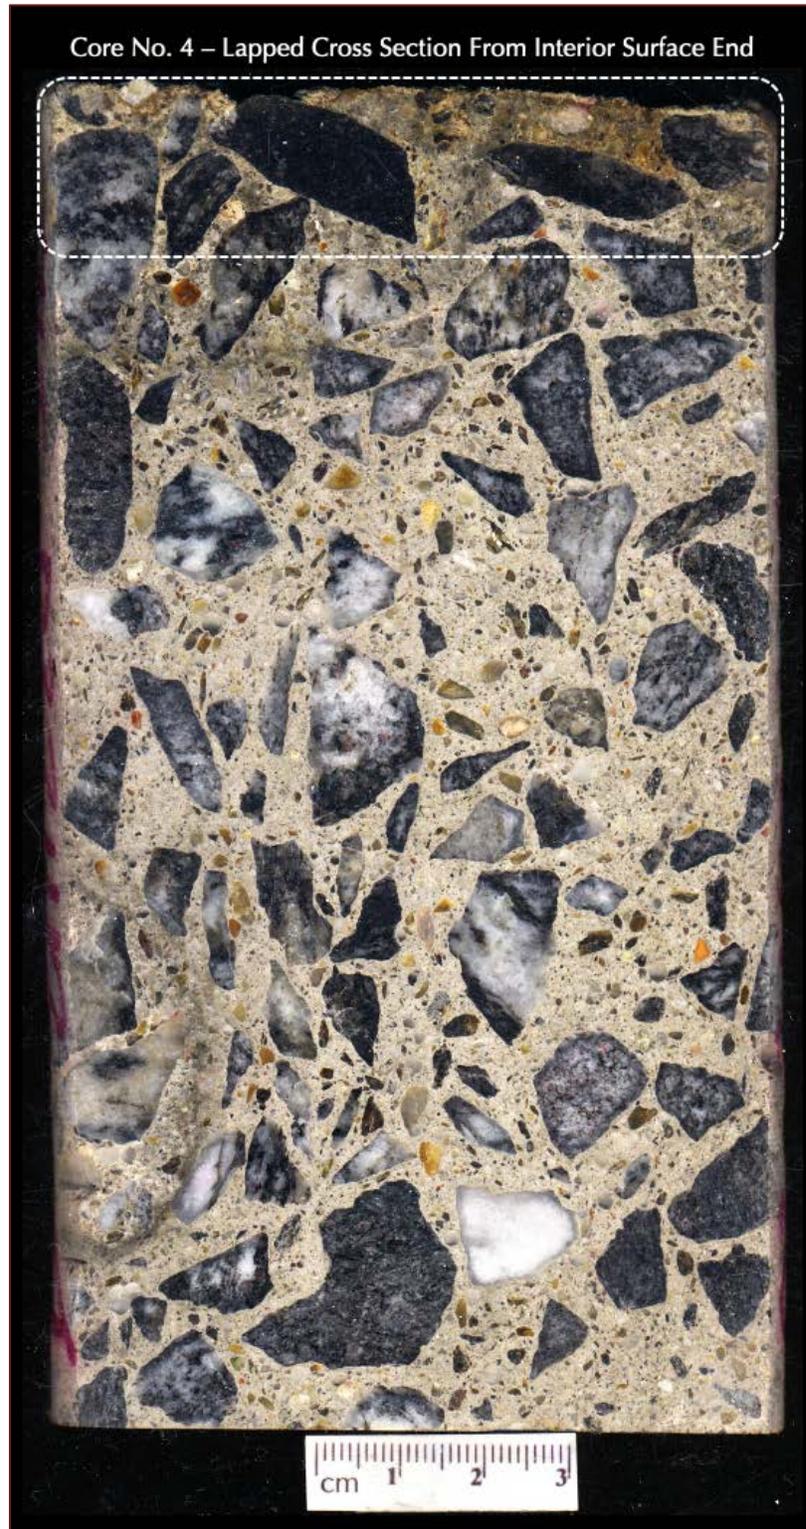
Figure 37: Lapped cross section of Core C4 from the interior surface end showing: (a) brown discoloration of concrete at the interior surface end to a depth of 7 mm where the altered zone (boxed) is separated from the interior sound unaltered concrete by a sharp boundary; (b) crushed schist and gneiss coarse aggregate particles many with dark rims where particles are angular, dense, hard, medium gray and white, well-graded, and well-distributed; and (c) sound interstitial mortar fraction of concrete made using Portland cement paste and fine siliceous sand.

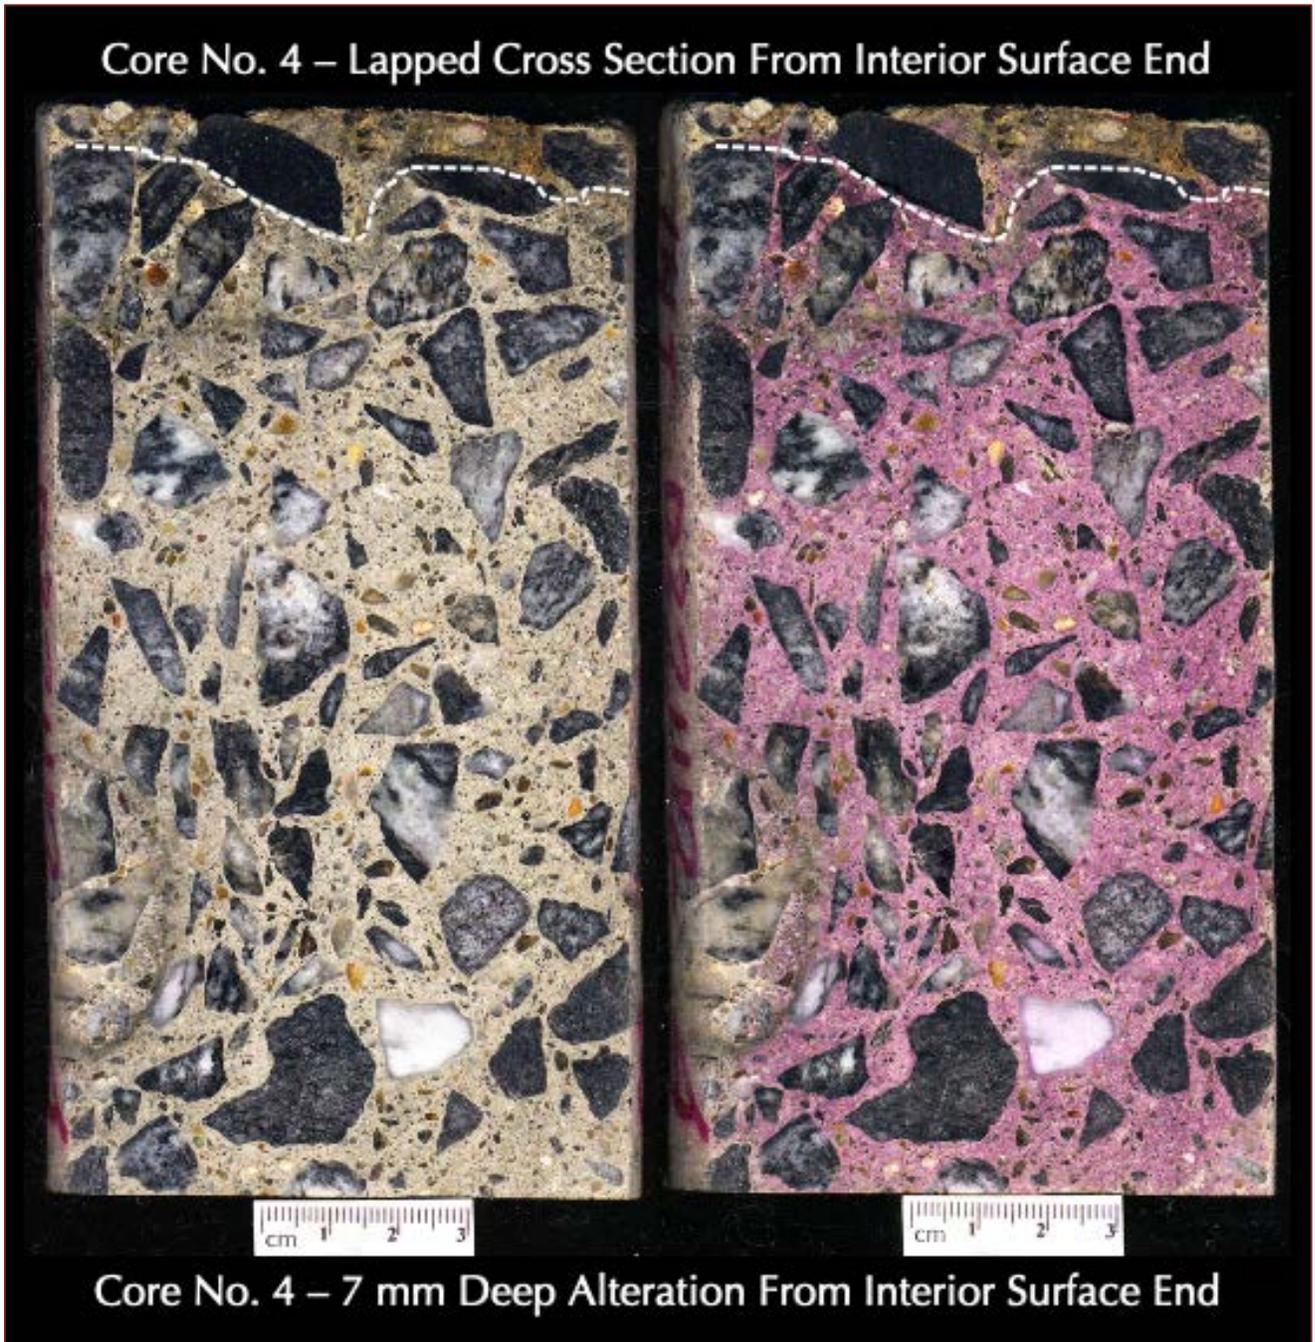
Figure 38: Lapped cross section of Core C4 from the interior surface end showing before (left) and after (right) treatment with phenolphthalein alcoholic solutions to show carbonated zone at the interior end where the concrete maintained its original black discolored zone from interaction with atmospheric carbon dioxide, whereas pink discoloration of paste in the interior non-carbonated concrete. The depth of carbonation is measured to be 7 mm from the interior end, which is noticeably lower than the carbonation depth measured from the exterior end.

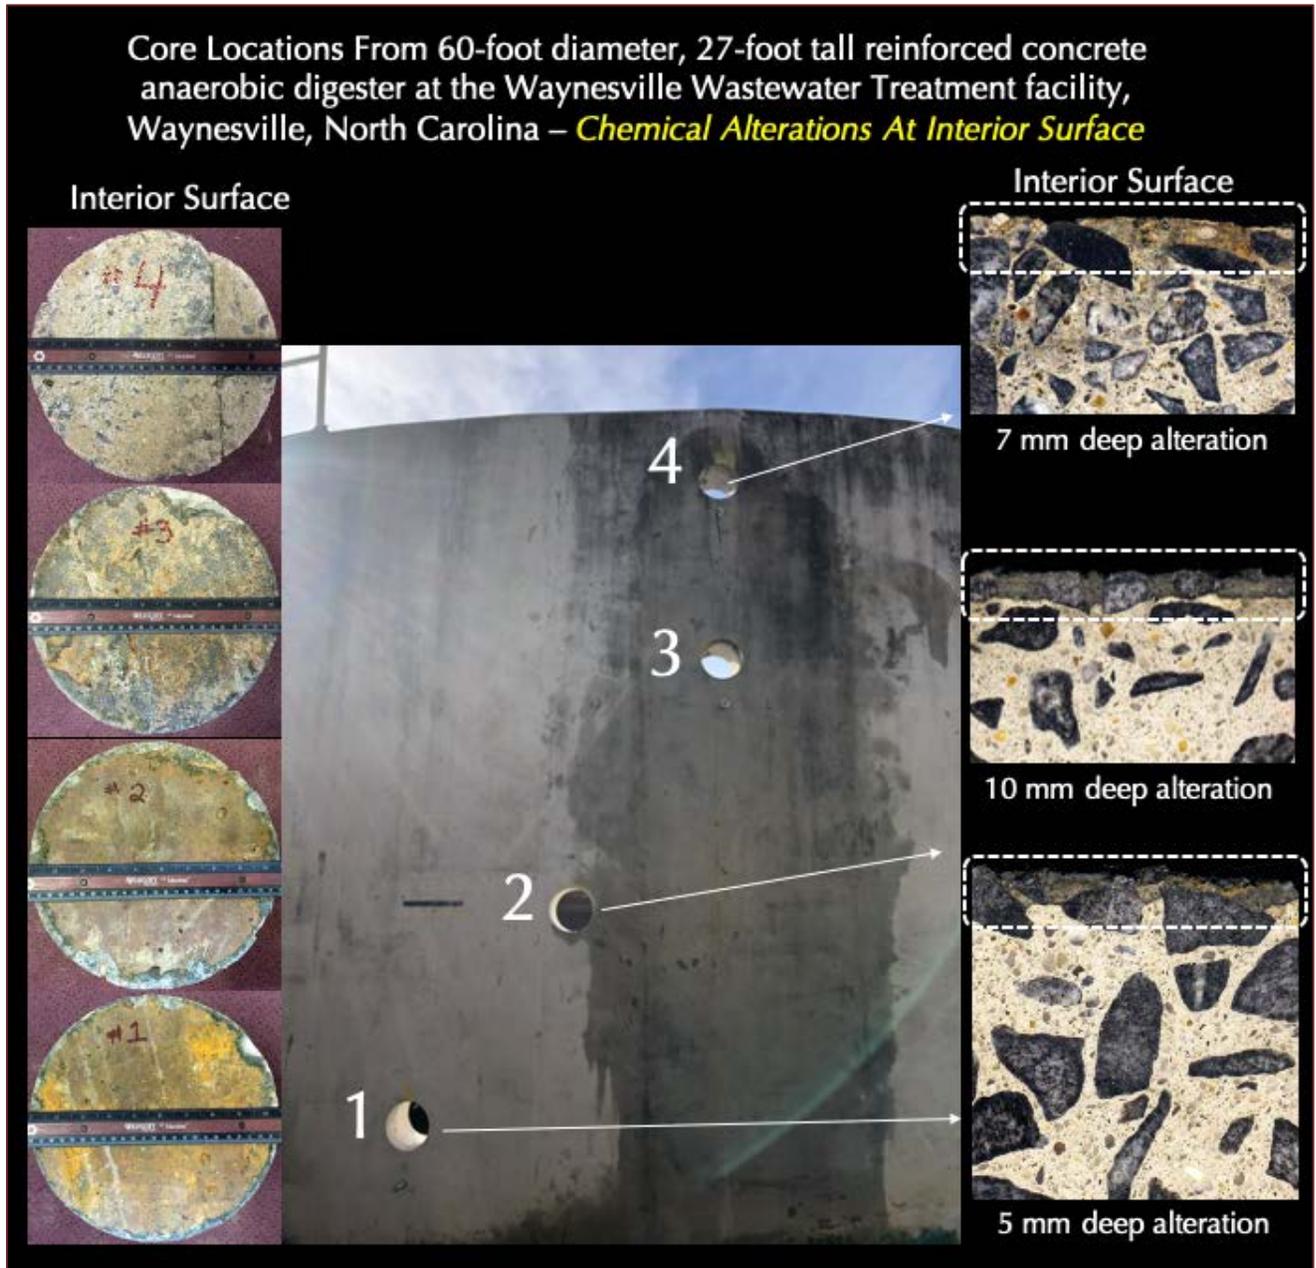
Figure 40: Interior discolored and distressed surface of tank wall in four cores at left and their lapped cross sections at right showing: (a) layered black and brown discoloration to a depth of 5 mm in Core C1 due to interaction with containment solution, (b) black discoloration to a depth of 10 mm in Core C2 due to interactions with containment solution, and (c) brown discoloration with exposed aggregate to a depth of 7 mm in Core C4 due to interaction with gases and moisture from the containment solution.

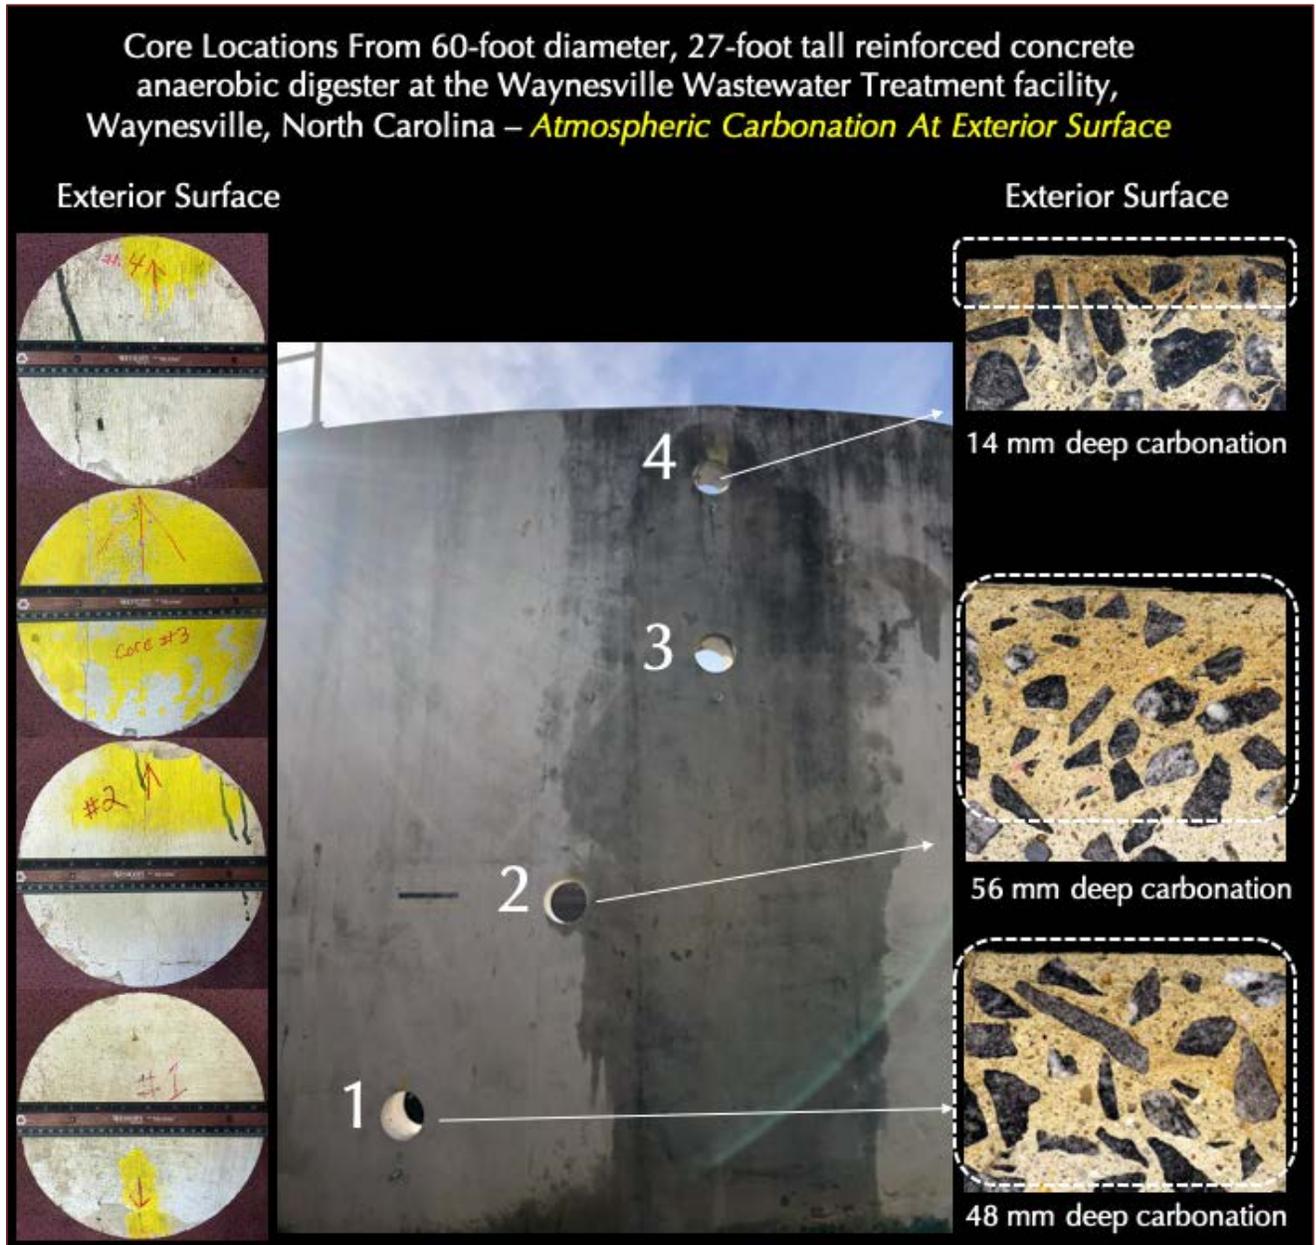
Figure 41: Exterior cement gray surface of protective coating on the tank wall in four cores at left and their lapped cross sections at right showing: (a) beige discoloration due to atmospheric carbonation to a depth of 48 mm in Core C1, (b) beige discoloration due to atmospheric carbonation to a depth of 56 mm in Core C2, and (c) beige discoloration due to atmospheric carbonation to a depth of 14 mm in Core C4.

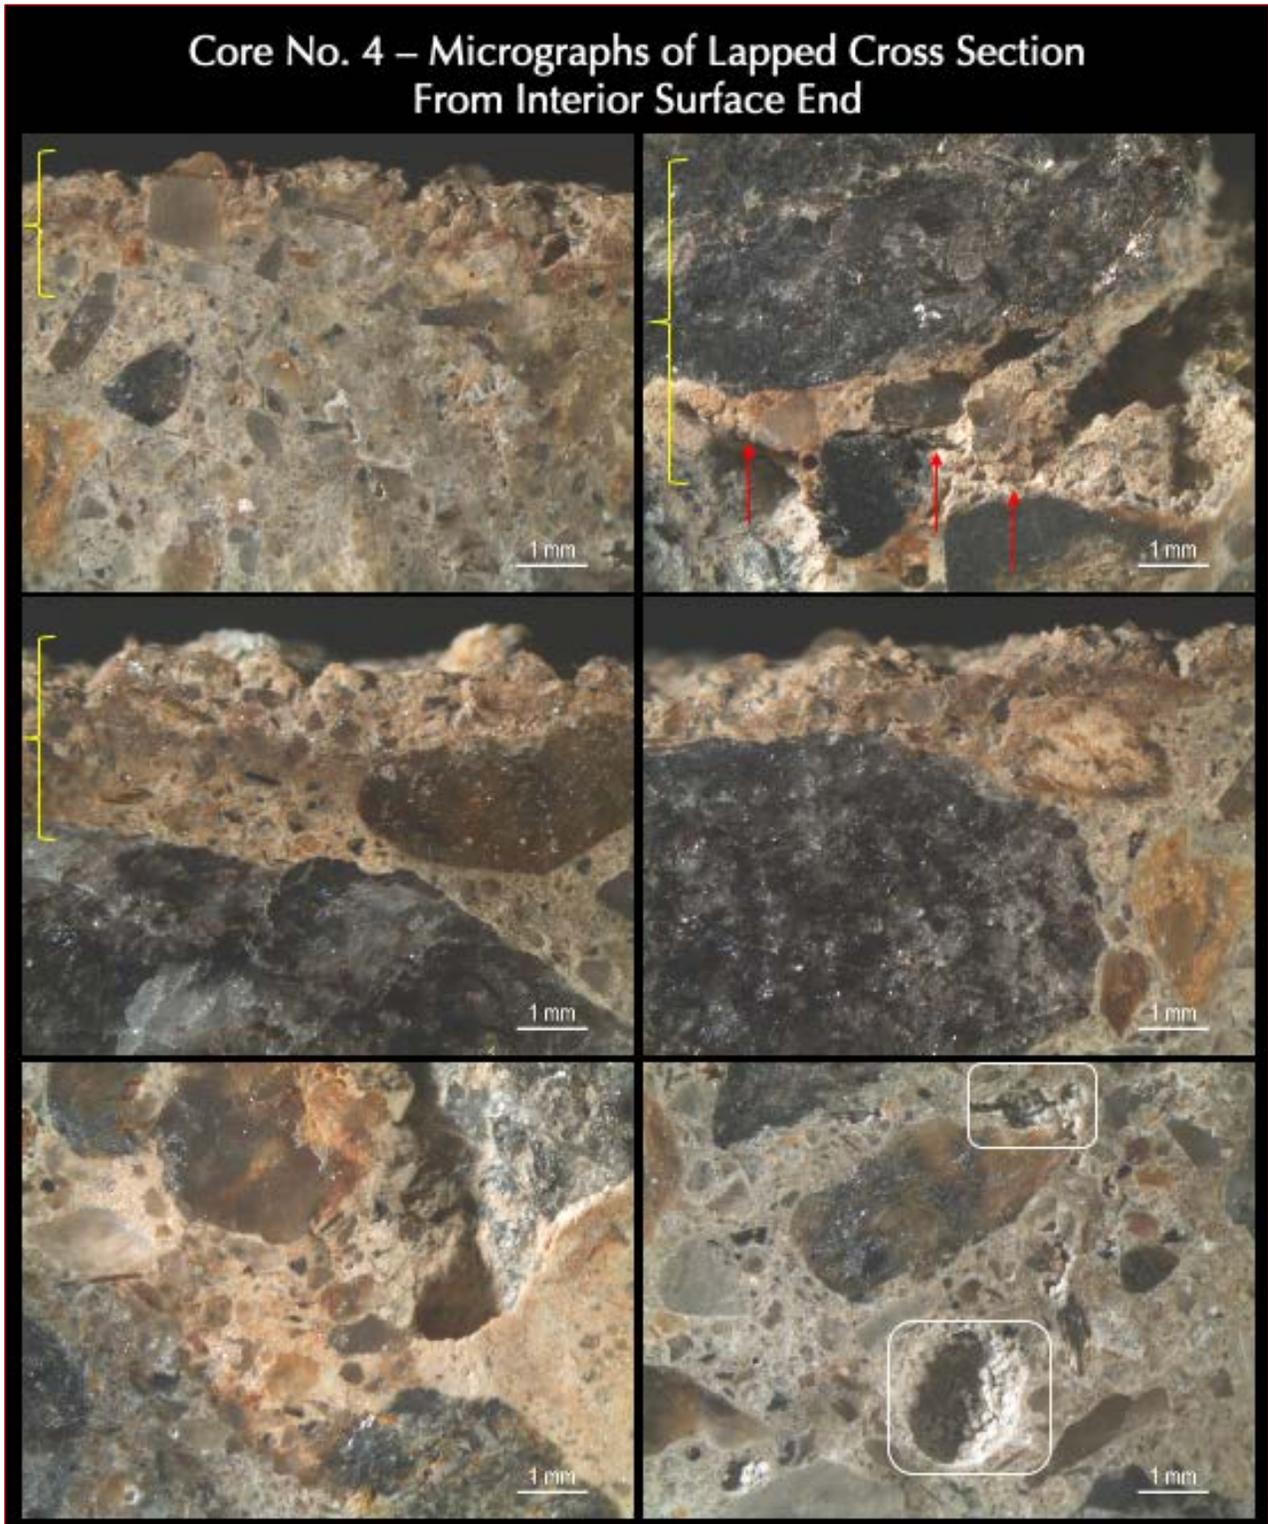
Figure 57: Micrographs of lapped cross section of Core C4 from the interior end showing: (a) beige discolored altered zone at the top 7 mm due to interaction of concrete with the gases, air, and moisture emitted from the containment solution in the tank; (b) secondary ettringite deposits lining the walls of air voids (boxed) indicating prolonged presence of moisture in concrete; and (c) non-air-entrained nature of concrete without any intentionally introduced spherical <1 mm size entrained air (all photos).

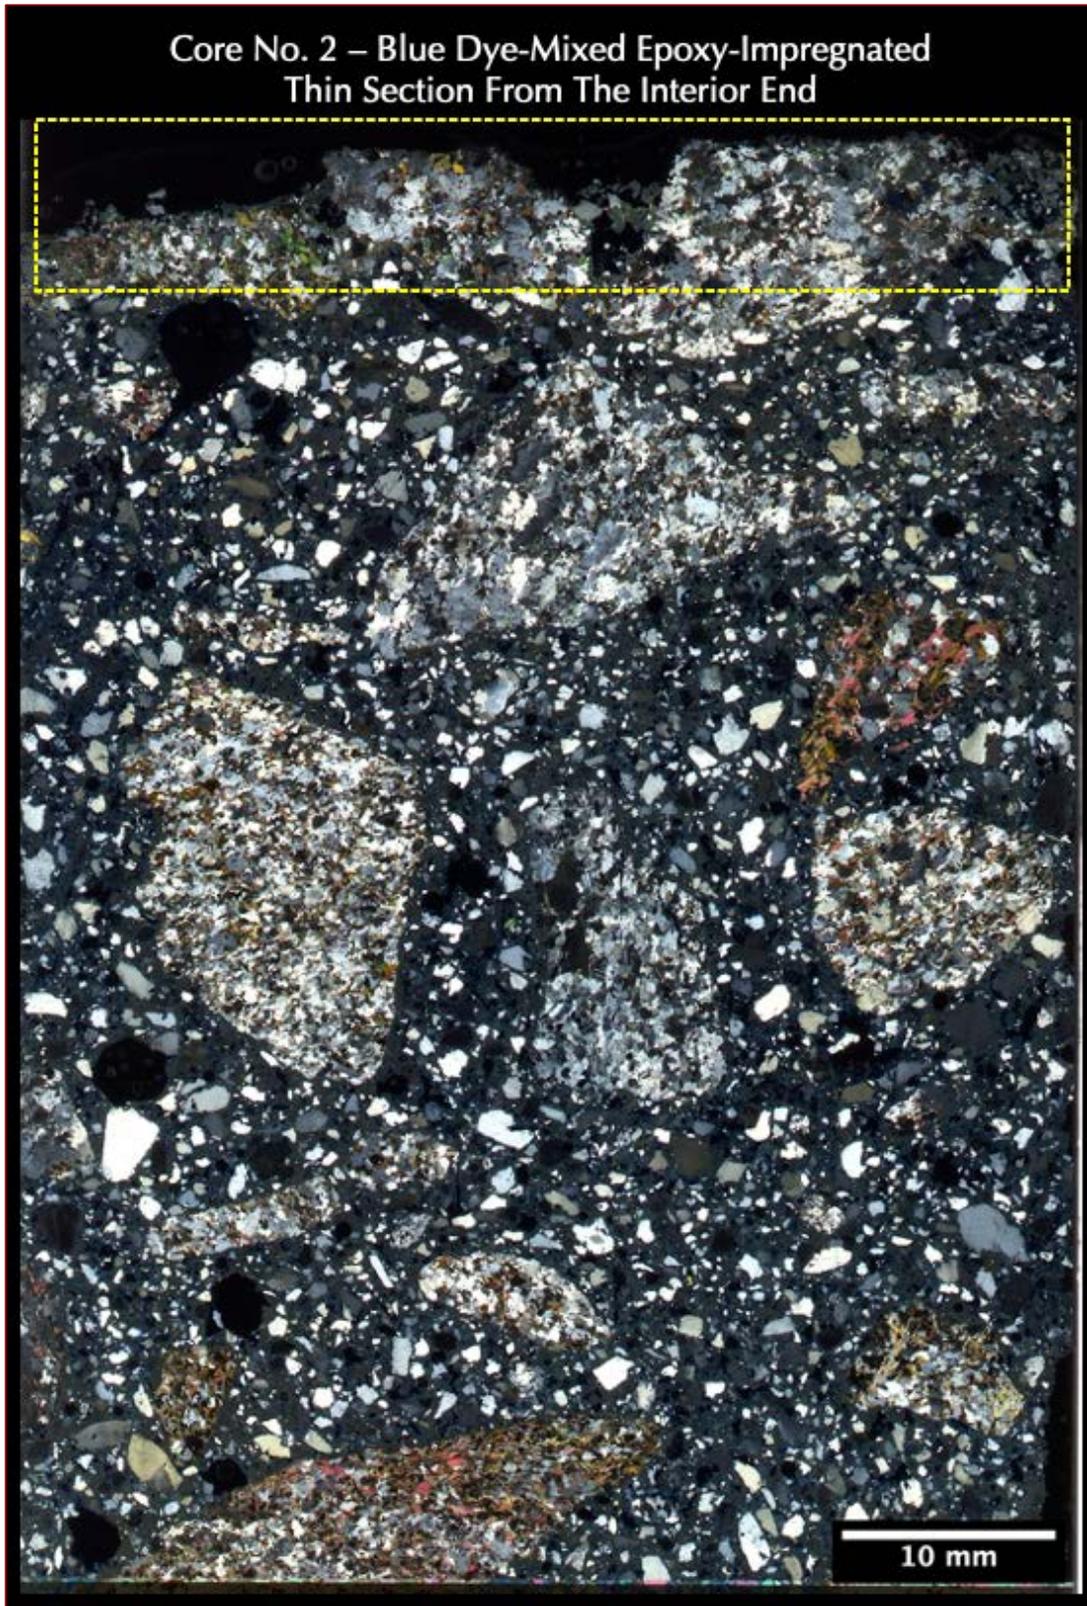
Figure 62: Blue dye-mixed epoxy-impregnated thin section of Core C2 in crossed polarized light (XPL) showing: (a) the chemically altered zone at the top 5 mm of interior surface end (boxed) where paste is carbonated as opposed to non-carbonated interior concrete; and (b) crushed schist and gneiss coarse aggregate and natural siliceous sand fine aggregate.

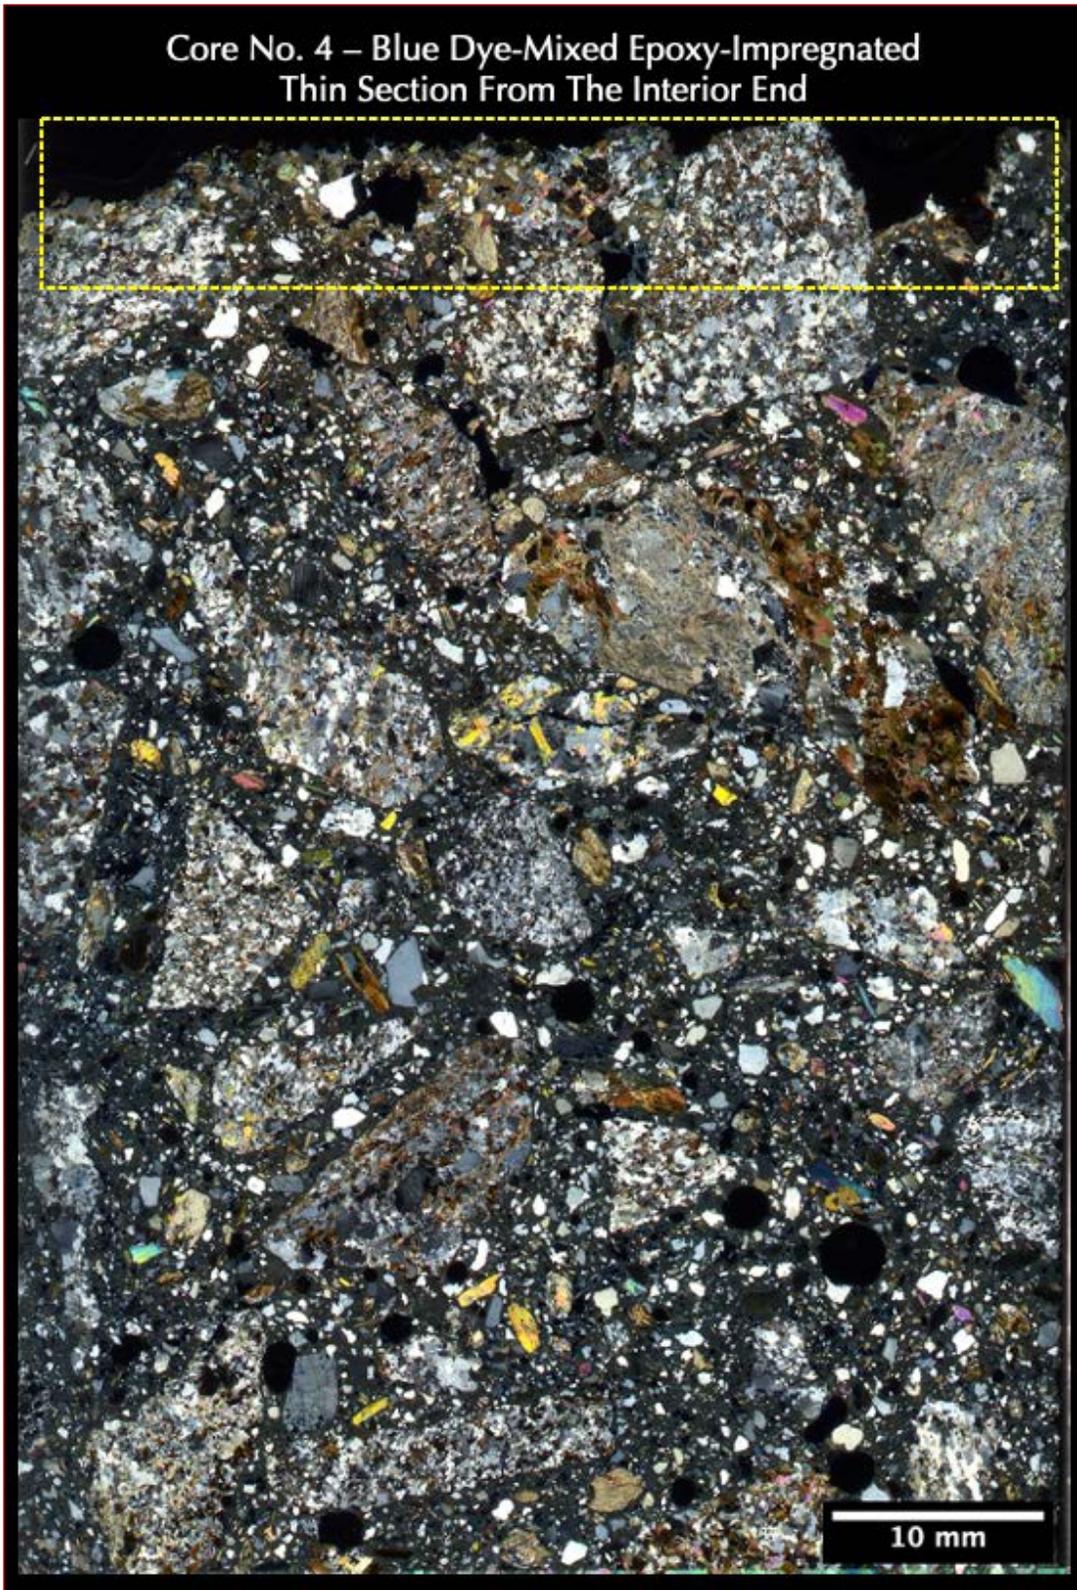
Figure 64: Blue dye-mixed epoxy-impregnated thin section of Core C4 in crossed polarized light (XPL) showing: (a) the altered zone at the top 7 mm of interior surface end (boxed) where paste is carbonated as opposed to non-carbonated interior concrete; and (b) crushed schist and gneiss coarse aggregate and natural siliceous sand fine aggregate.
