## Laboratory Analyses of A Stone & Masonry Mortars From Robert C Weaver Federal Building in Washington, D.C.

Robert C Weaver Federal Building (HUD)  
451 7<sup>th</sup> Street SW  
Washington, D.C.

March 25, 2020  
CMC 0320114

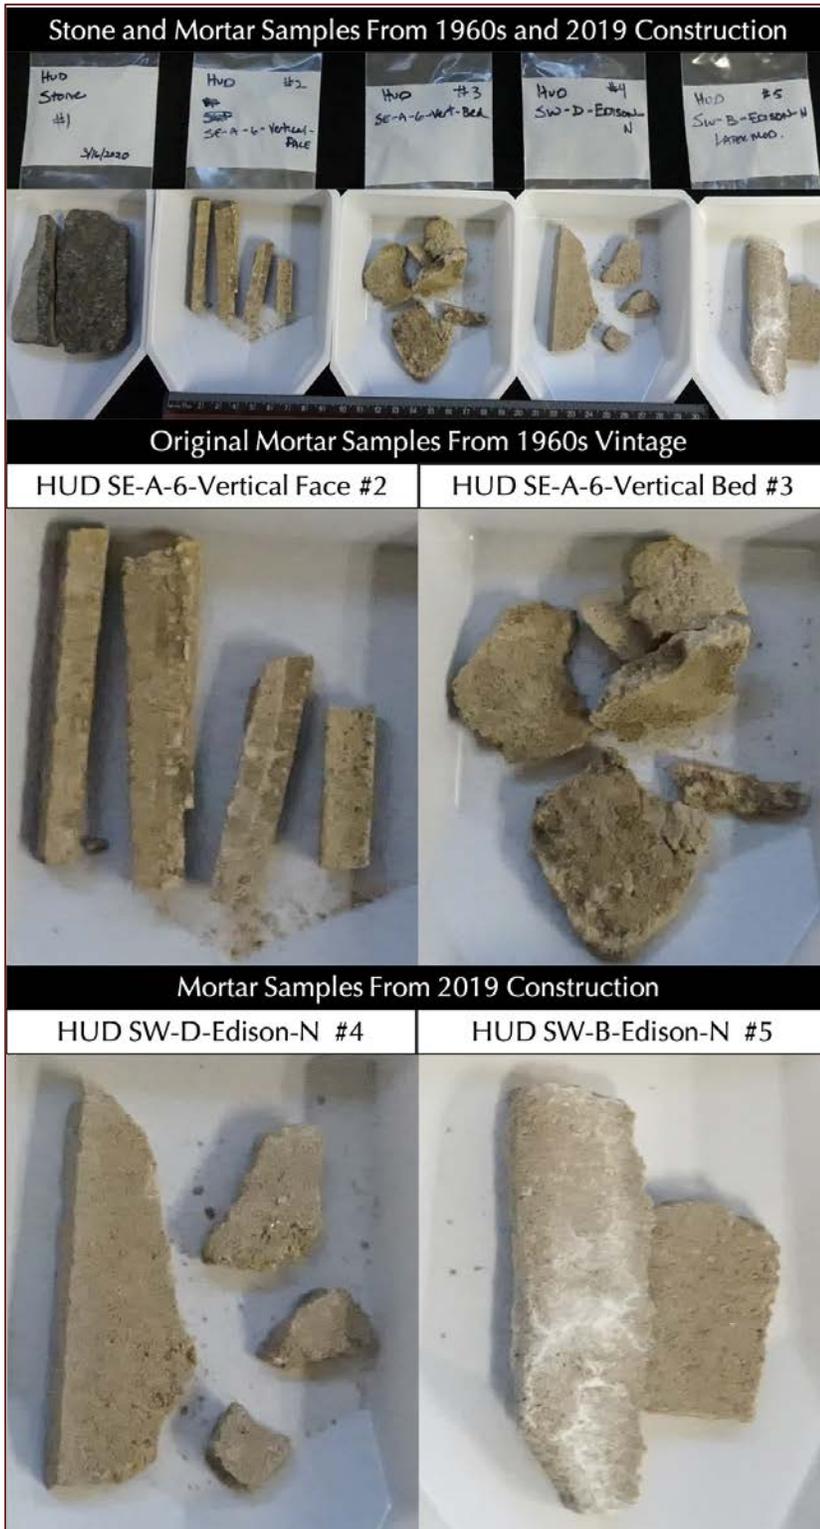
Figure 2: Stone and masonry mortar samples received. Of the four mortars, two are from the original 1960s construction (marked as #2 and 3), whereas the remaining two are from the recent 2019 construction.

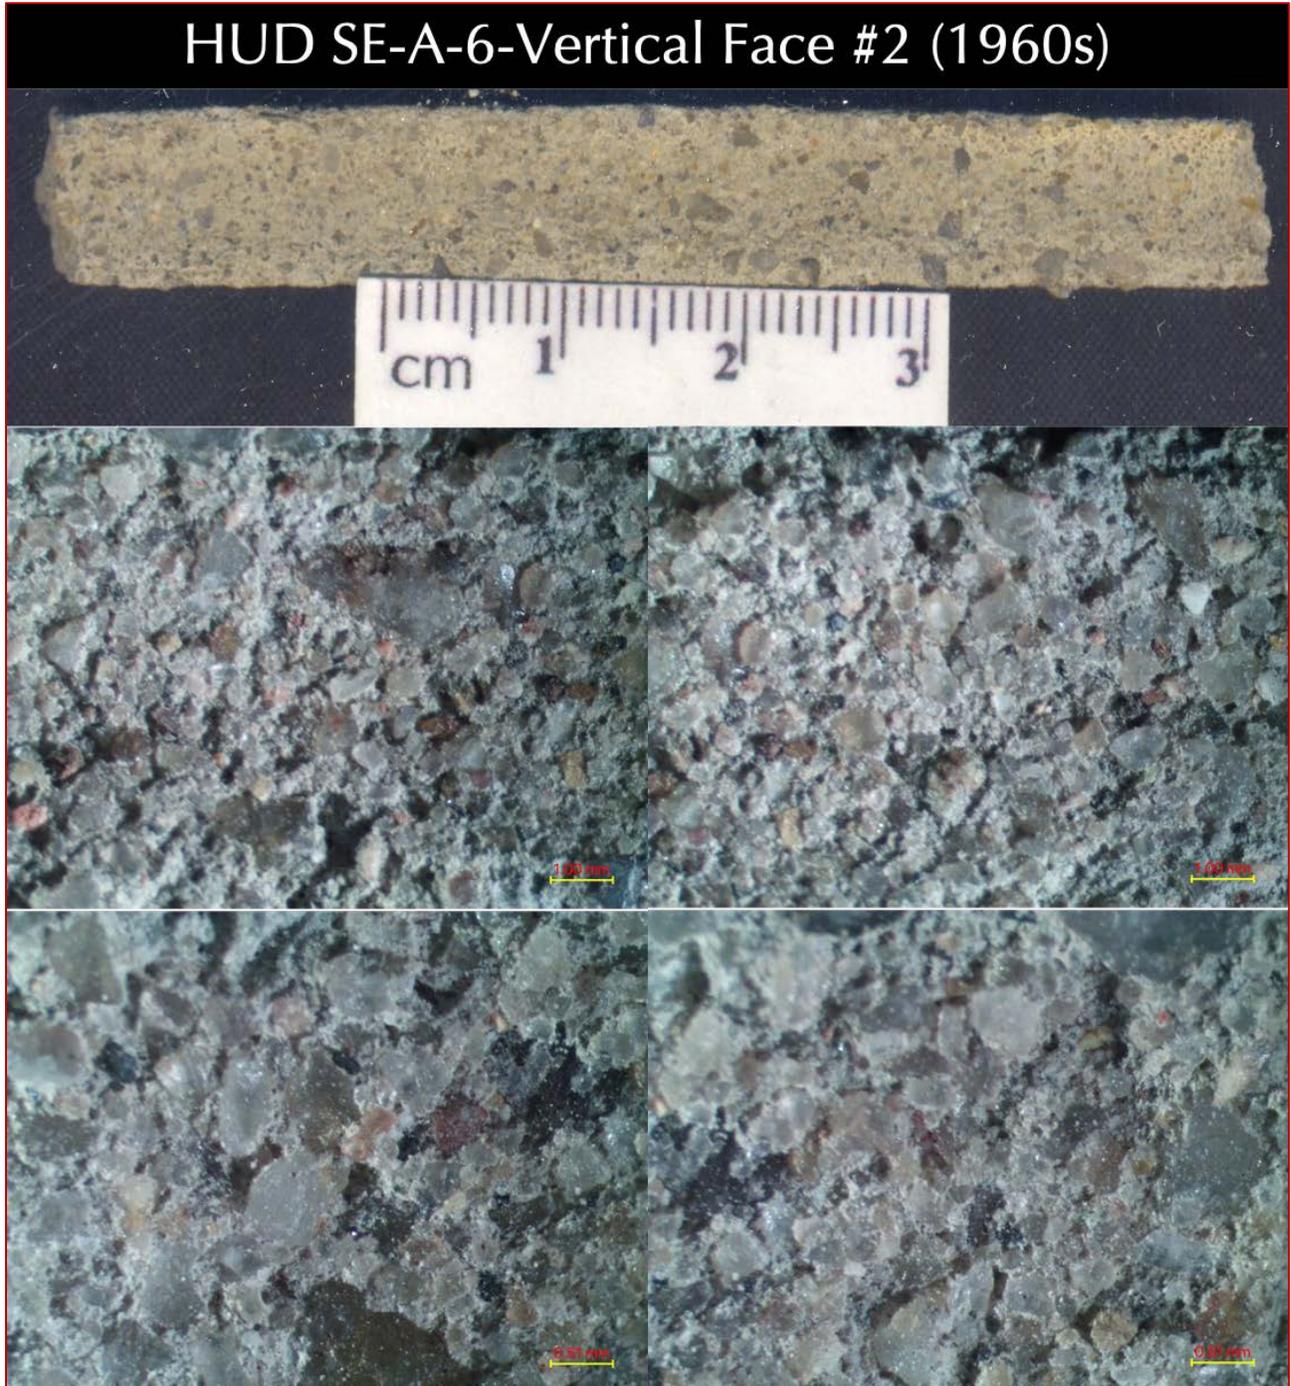
Figure 3: Top photo shows the exposed tooled joint face of the original mortar (#2) from 1960s construction showing the sand particles that are exposed relative to interstitial paste due to leaching of the paste from around sand grains. The middle row shows micrographs of tooled joint face of the mortar where sand grains are seen mostly comprising off-white to light gray colored well-graded and well-distributed silica sand particles. Bottom row shows micrographs of bedding face of the mortar where sand grains are seen along with interstitial paste. Scale bars in the photos are of 1 mm in the middle row and 0.5 mm in the bottom row.

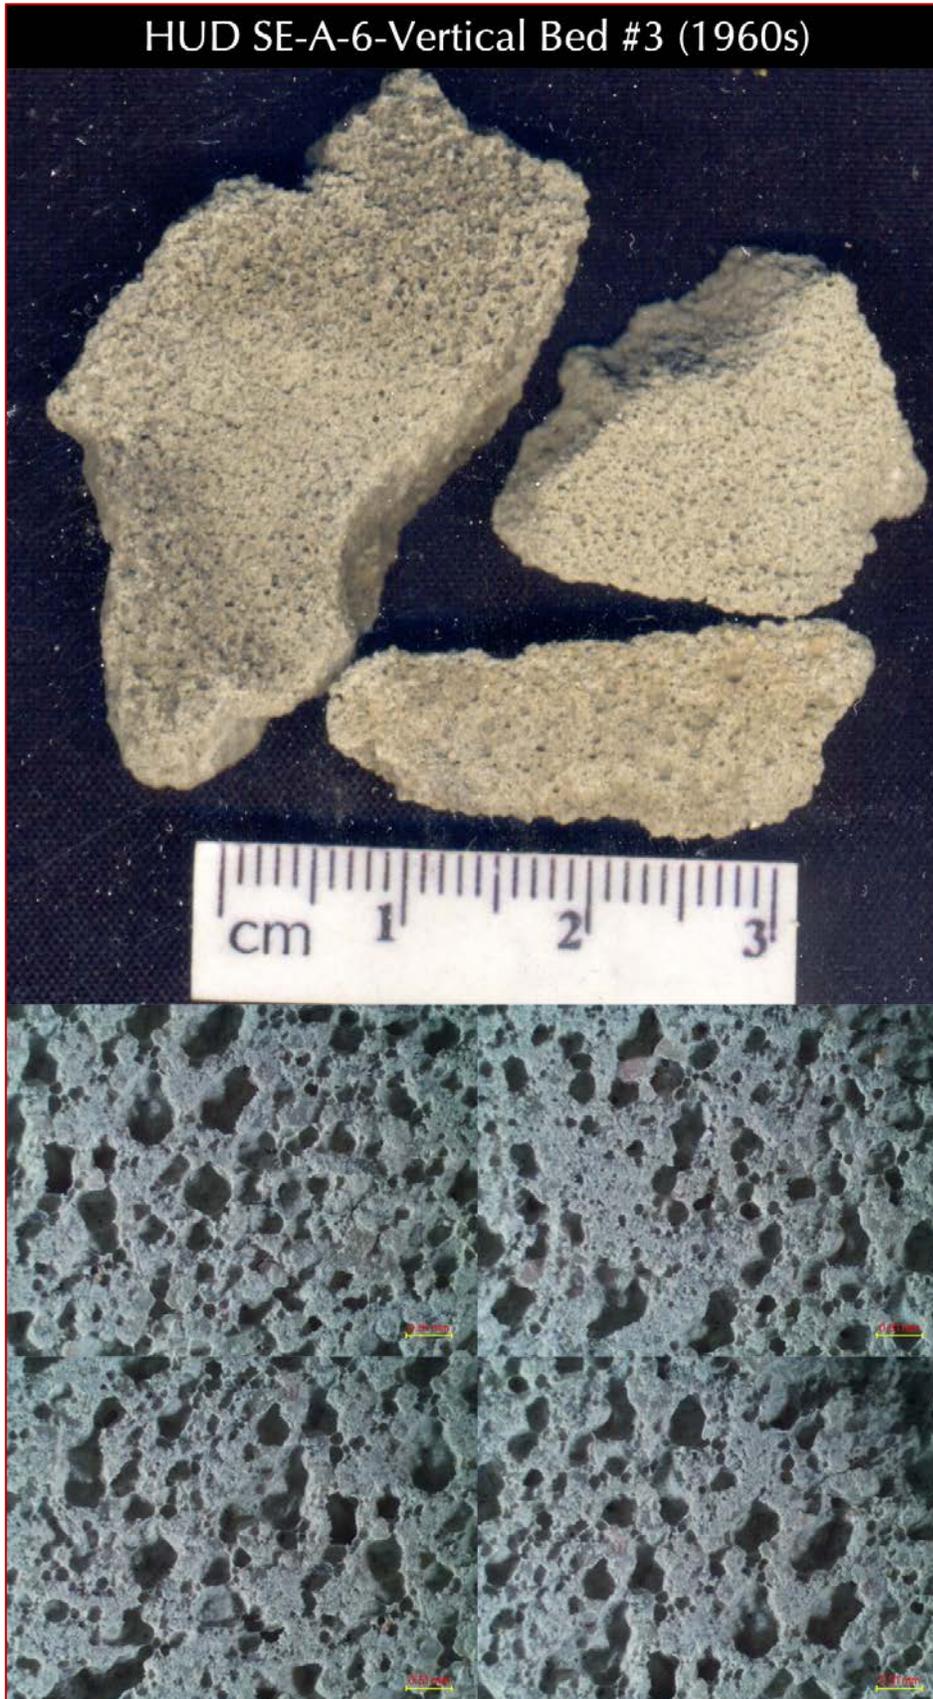
Figure 4: Top photo shows three pieces of the original mortar (#3) from 1960s construction. The middle and bottom row show micrographs of mortar pieces where sand grains are seen mostly comprising off-white to light gray colored well-graded and well-distributed silica sand particles.

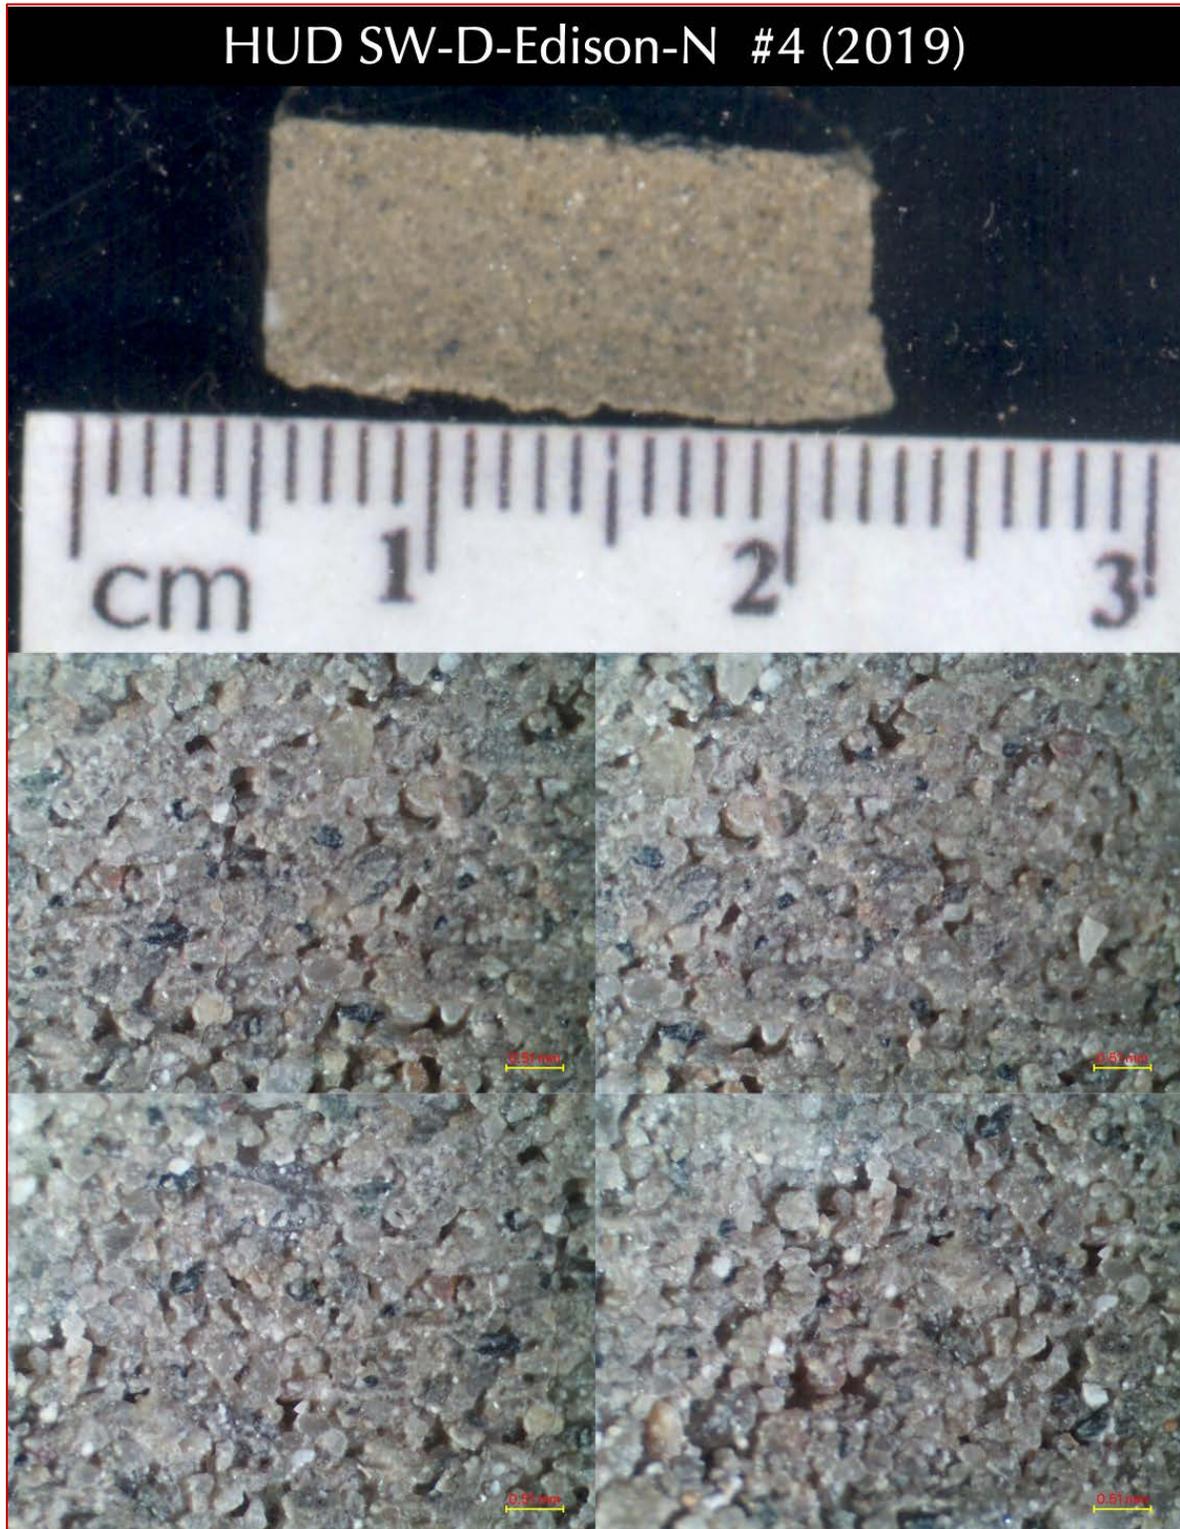
Figure 5: Top photo shows the exposed tooled joint face of the mortar (#4) from 2019 construction showing the sand particles that are exposed relative to interstitial paste. The middle row shows micrographs of tooled joint face of the mortar where sand grains are seen mostly comprising off-white to light gray colored well-graded and well-distributed silica sand particles. Bottom row shows photomicrographs of bedding face of the mortar where sand grains are seen along with interstitial paste. Scale bars in the micrographs are of 0.5 mm.

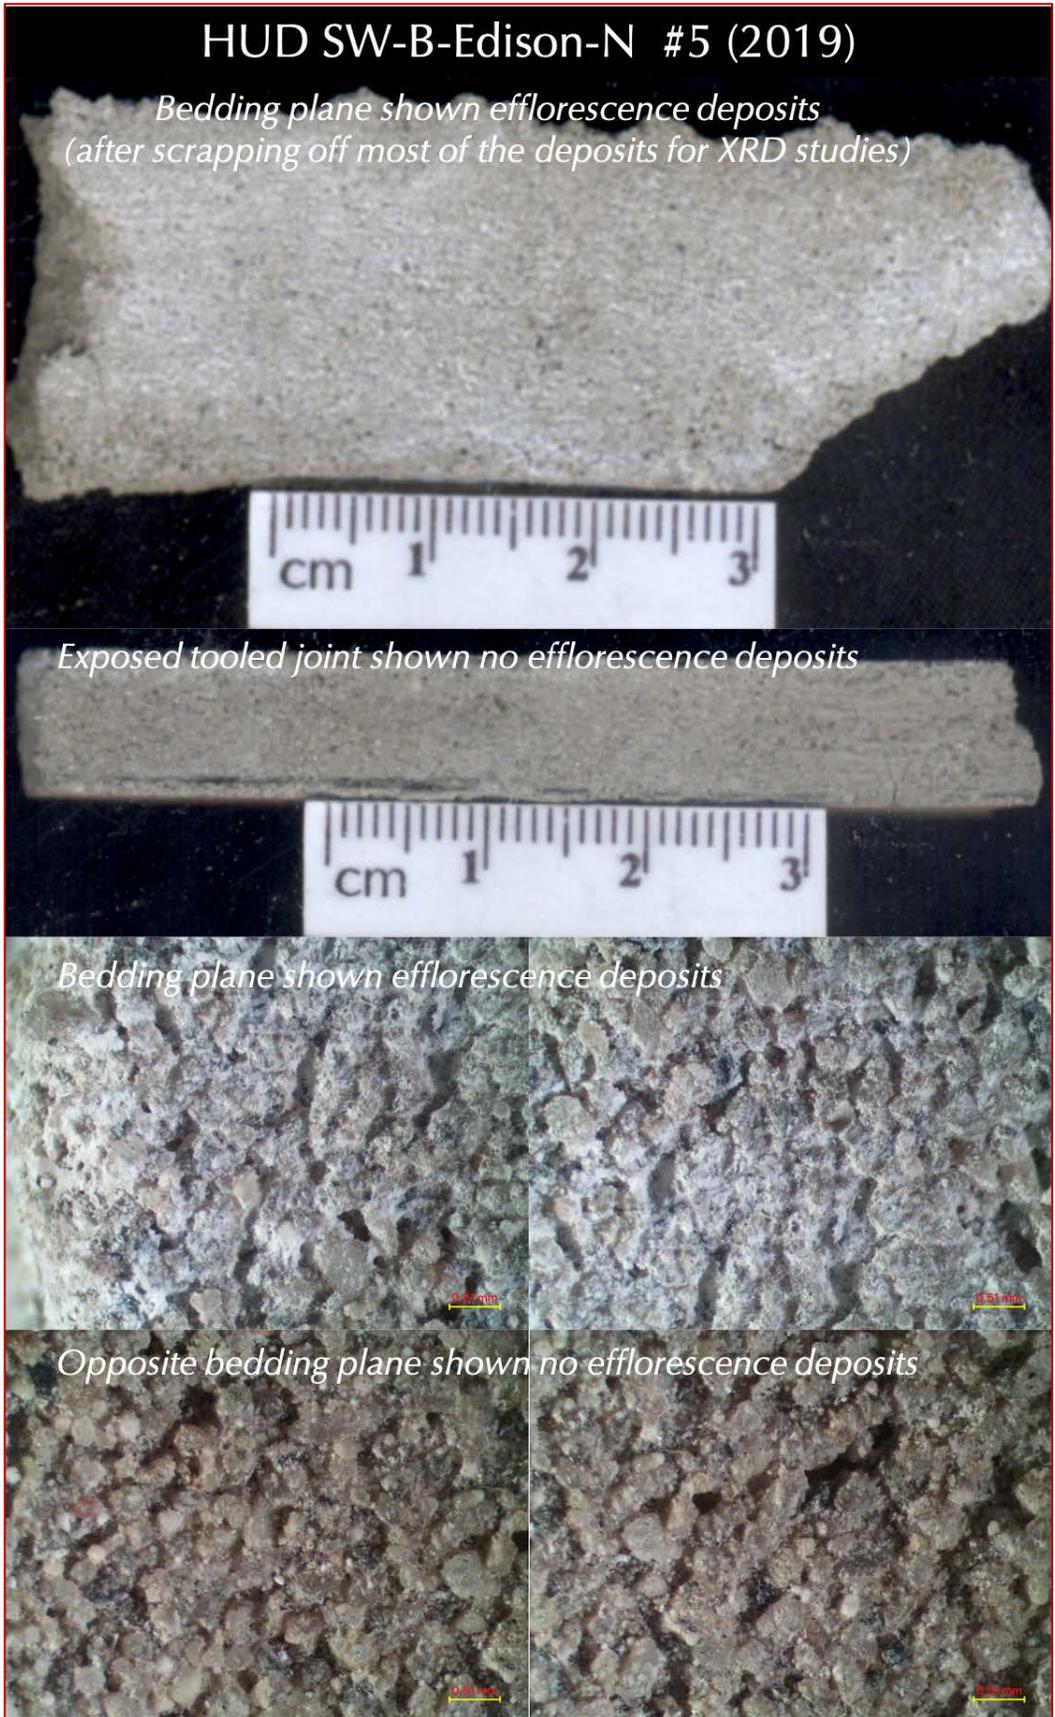
Figure 6: Top photo shows the bedding face of a piece of mortar (#5) from 2019 construction showing remains of white efflorescence deposits (after most of the deposits were scrapped off for X-ray diffraction study).

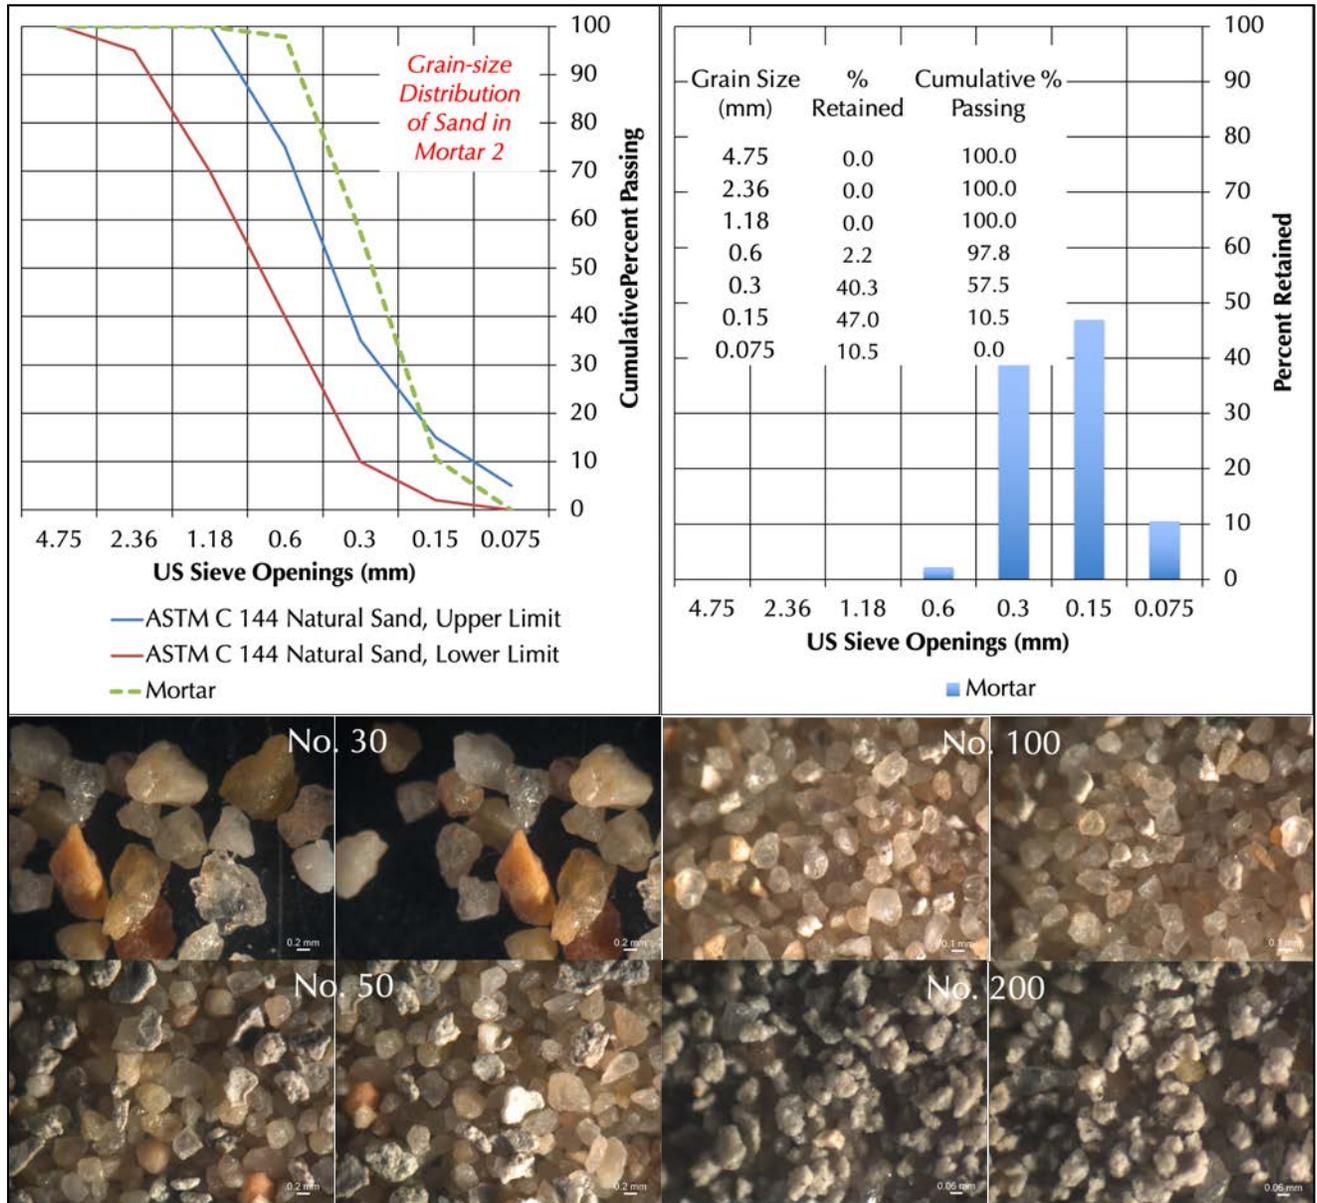
Figure 7: Grain-size distribution of sand extracted from an original mortar (# 2) from 1960s construction after acid digestion. In the top left plot, size distribution of sand is compared with upper and lower limits of natural sand in ASTM C 144 (blue and red lines, respectively). As seen in this plot, grain-size distribution of sand does not fall within the range of size distributions specified for ASTM C 144 masonry sand. The top right 'percent retained' histogram plot shows finer than 'normal' size distribution of sand with enrichment of fines. Bottom photos show stereo-micrographs of sand particles retained on various sieves, including size, shape, angularity, and color variations of sand particles. Note noticeably clear to light brown to off-white color tone of majority of sand particles. Subsequent optical microscopical examinations of sand determined its **siliceous composition**, and lack of any calcareous components. Therefore, sand extracted from acid digestion is determined to be the entire amount of sand without leaving any component and hence results provided here are representative of the bulk sand used.

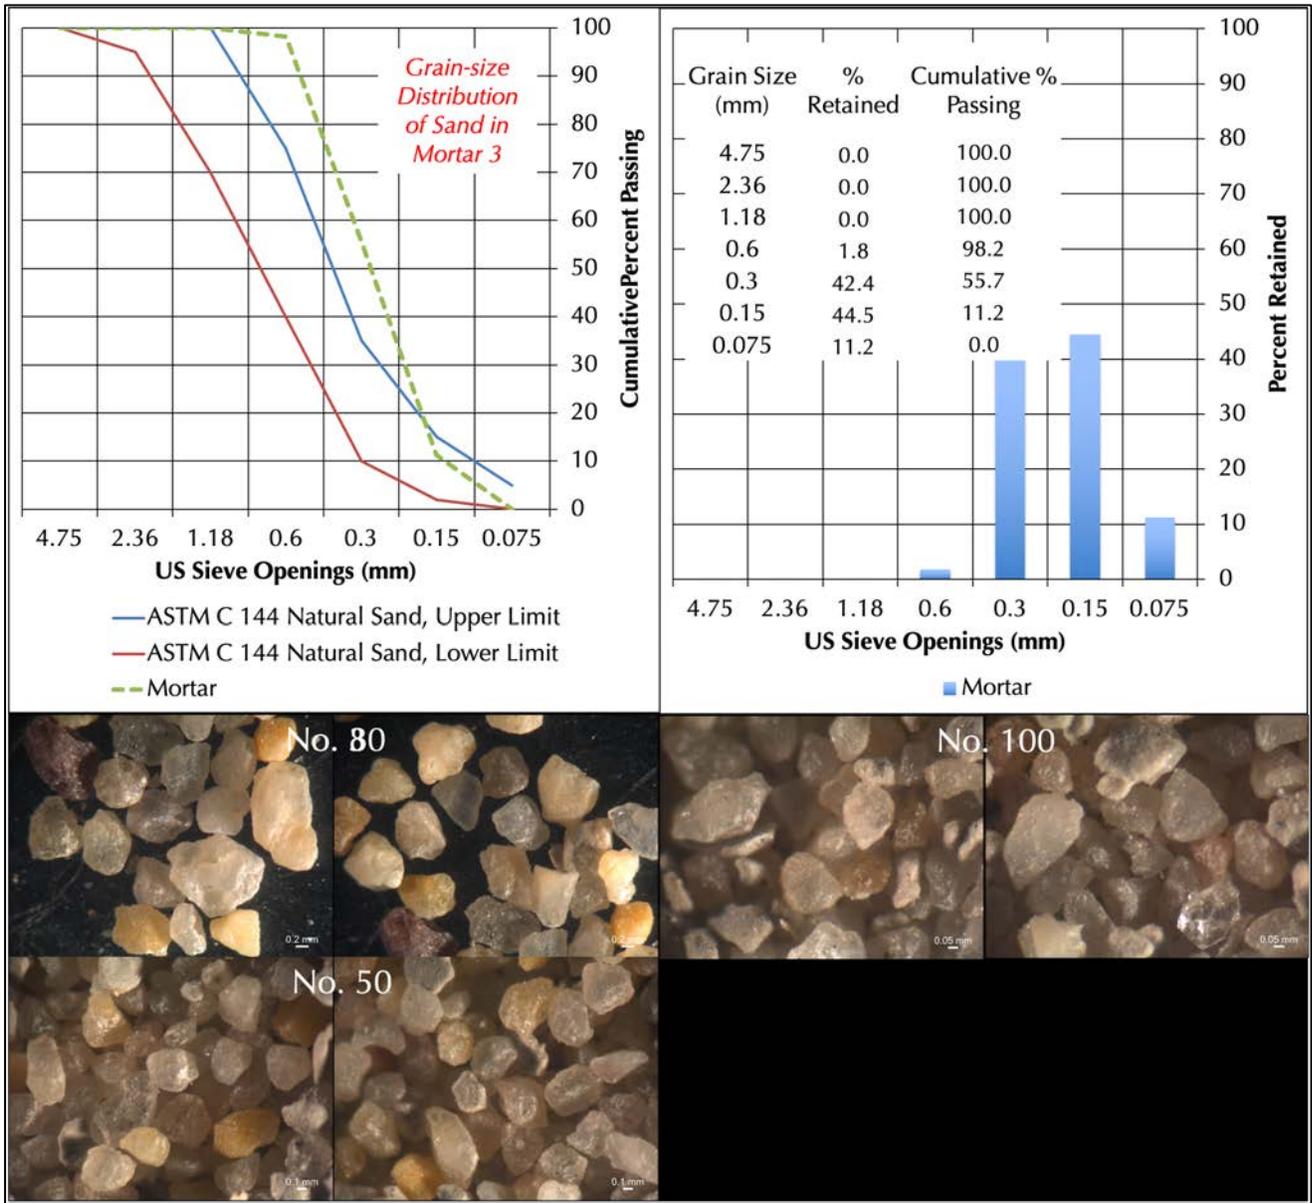
Figure 8: Grain-size distribution of sand extracted from an original mortar (# 3) from 1960s construction after acid digestion. In the top left plot, size distribution of sand is compared with upper and lower limits of natural sand in ASTM C 144 (blue and red lines, respectively). As seen in this plot, grain-size distribution of sand does not fall within the range of size distributions specified for ASTM C 144 masonry sand. The top right 'percent retained' histogram plot shows finer than 'normal' size distribution of sand with enrichment of fines. Bottom photos show stereo-micrographs of sand particles retained on various sieves, including size, shape, angularity, and color variations of sand particles. Note noticeably clear to light brown to off-white color tone of majority of sand particles. Subsequent optical microscopical examinations of sand determined its **siliceous composition**, and lack of any calcareous components. Therefore, sand extracted from acid digestion is determined to be the entire amount of sand without leaving any component and hence results provided here are representative of the bulk sand used.

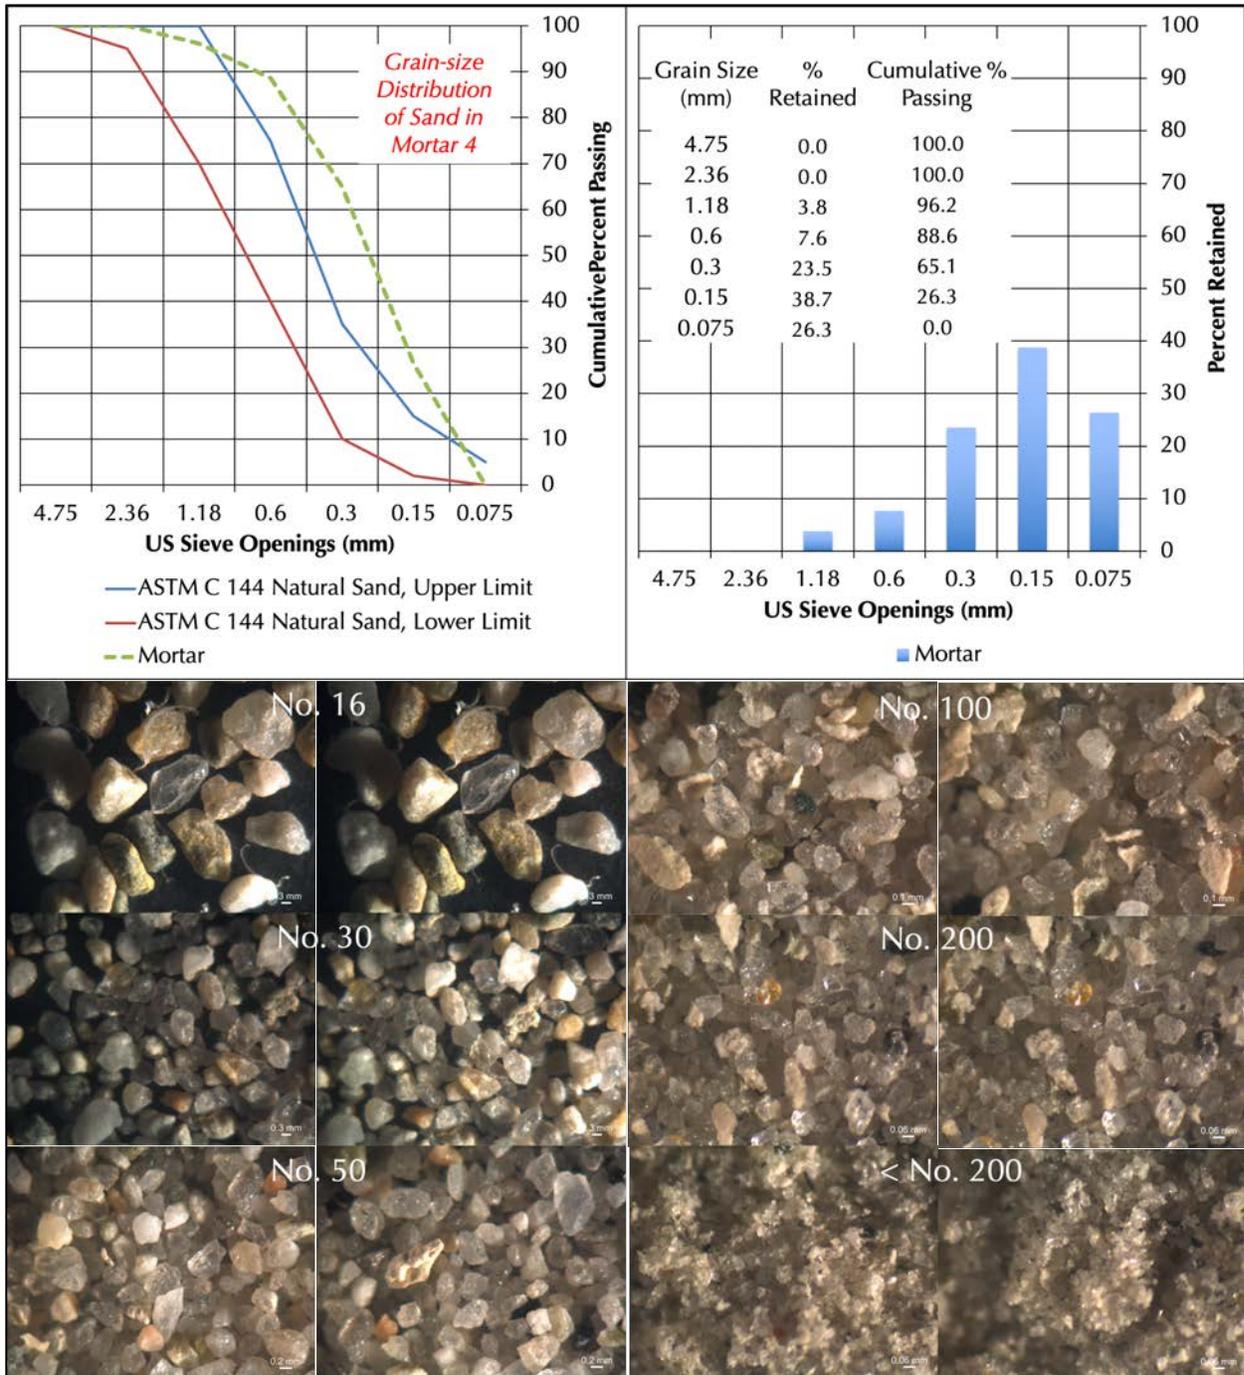
Figure 9: Grain-size distribution of sand extracted from a recent mortar (# 4) from 2019 construction after acid digestion. In the top left plot, size distribution of sand is compared with upper and lower limits of natural sand in ASTM C 144 (blue and red lines, respectively). As seen in this plot, grain-size distribution of sand does not fall within the range of size distributions specified for ASTM C 144 masonry sand. The top right 'percent retained' histogram plot shows finer than 'normal' size distribution of sand with enrichment of fines. Bottom photos show stereo-micrographs of sand particles retained on various sieves, including size, shape, angularity, and color variations of sand particles. Note noticeably clear to light brown to off-white color tone of majority of sand particles. Subsequent optical microscopical examinations of sand determined its **siliceous composition**, and lack of any calcareous components. Therefore, sand extracted from acid digestion is determined to be the entire amount of sand without leaving any component and hence results provided are representative of bulk sand used.

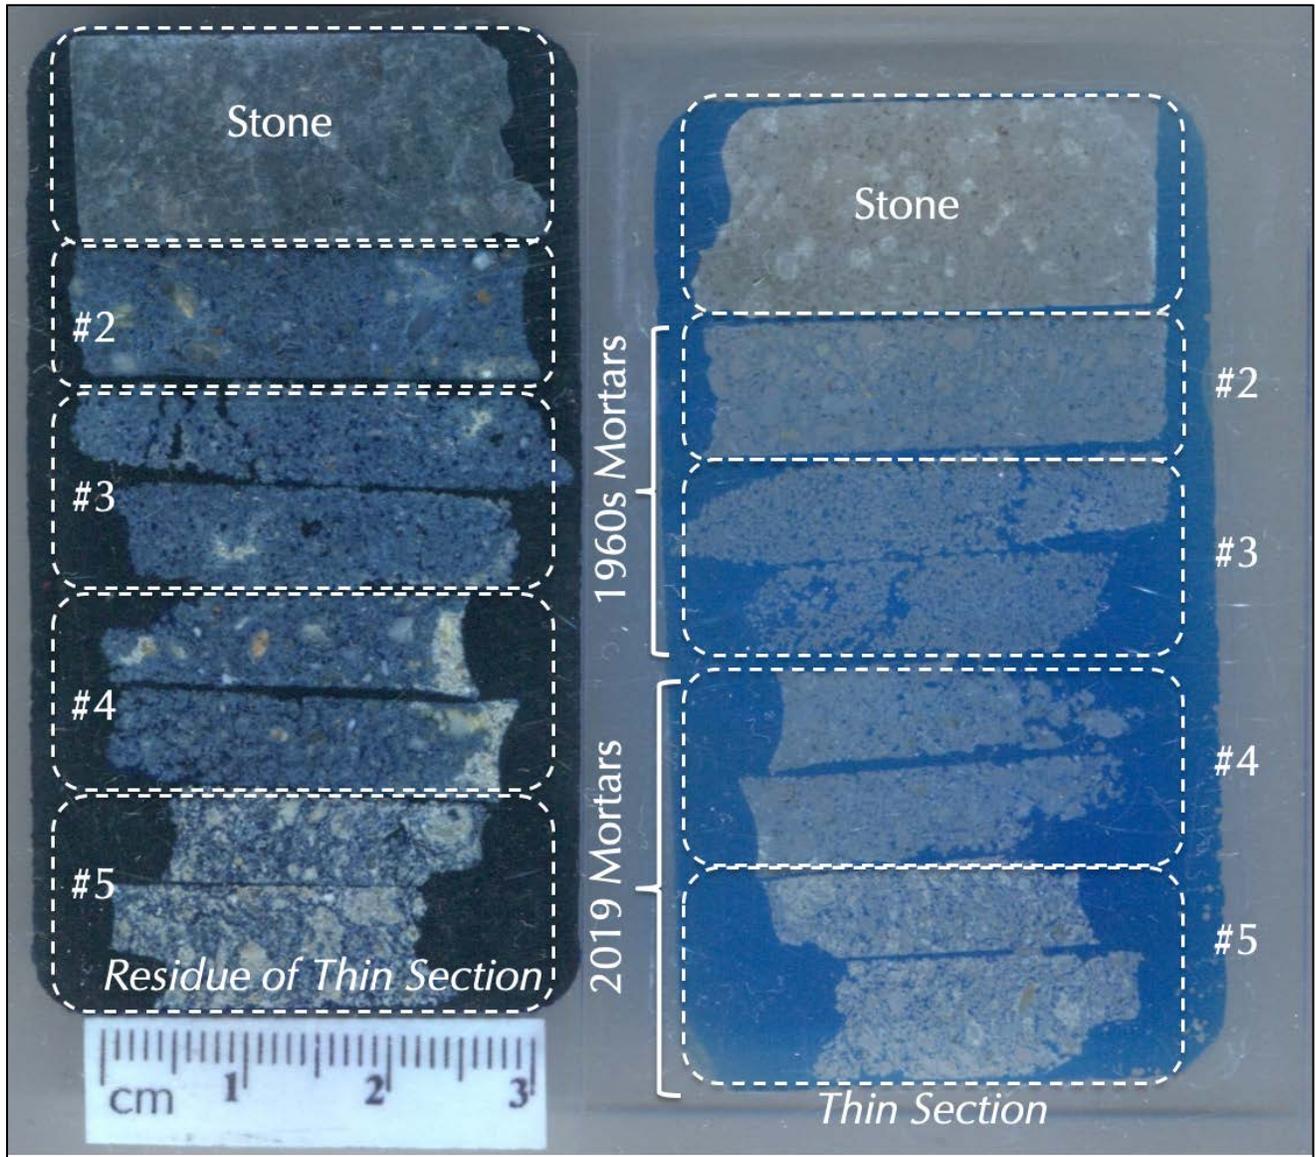
Figure 10: Blue dye-mixed epoxy-impregnated thin section of stone and mortar samples (right) and corresponding residue of epoxy-encapsulated block of samples left after thin section preparation (left). A representative portion of stone was sectioned and encapsulated for thin sectioning, which is shown at the very top of sequence of samples selected. Four mortar samples are arranged in order starting from two samples from 1960s construction, followed by remaining two from 2019 construction. The thin section at right was first used for detailed optical microscopical examinations of stone and mortar samples, after which the section was coated with a thin film of conductive gold alloy for subsequent examinations in a scanning electron microscope.

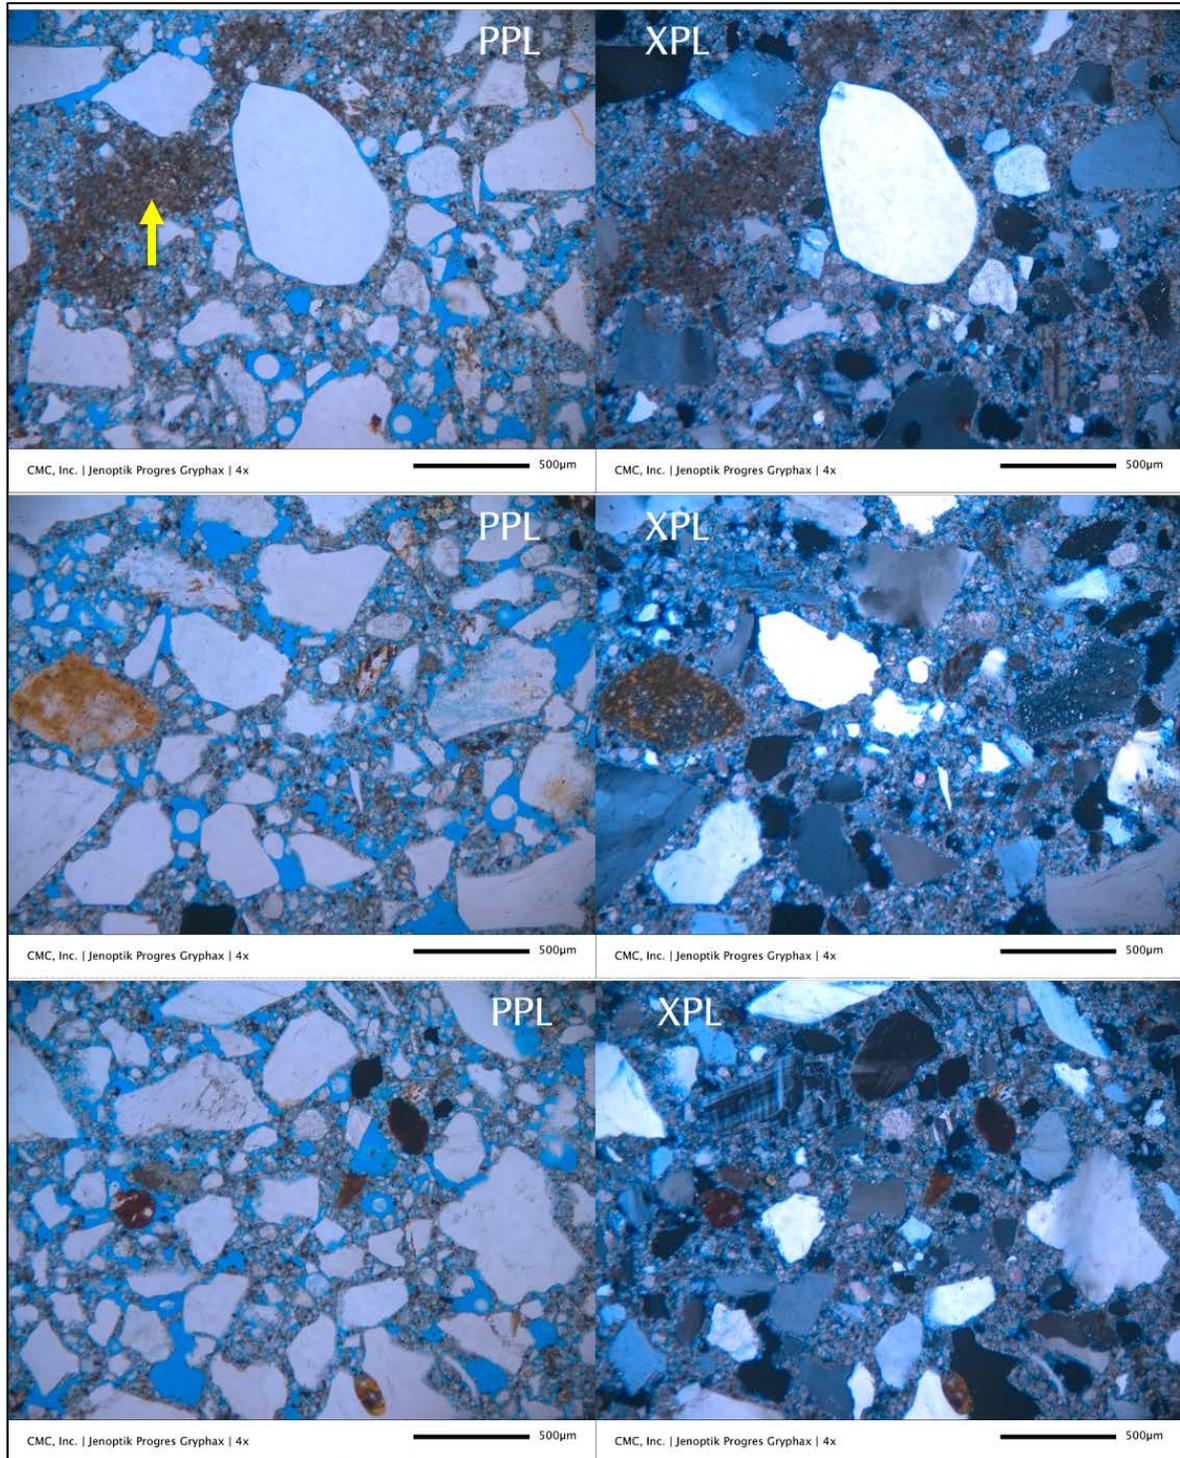
Figure 11: Optical micrographs of the original mortar (#2) from 1960s construction showing: (a) crushed silica sand consisting of major amount of variably strained quartz, and minor amount of quartzite, feldspar, and other siliceous particles (no carbonate components were found in the sand); (b) overall carbonated nature of the interstitial matrix between sand particles, which is a characteristic microstructure of many masonry cement mortars; however, (c) lack of good air-void system and air entriainment, which is also common in many masonry cement mortars.

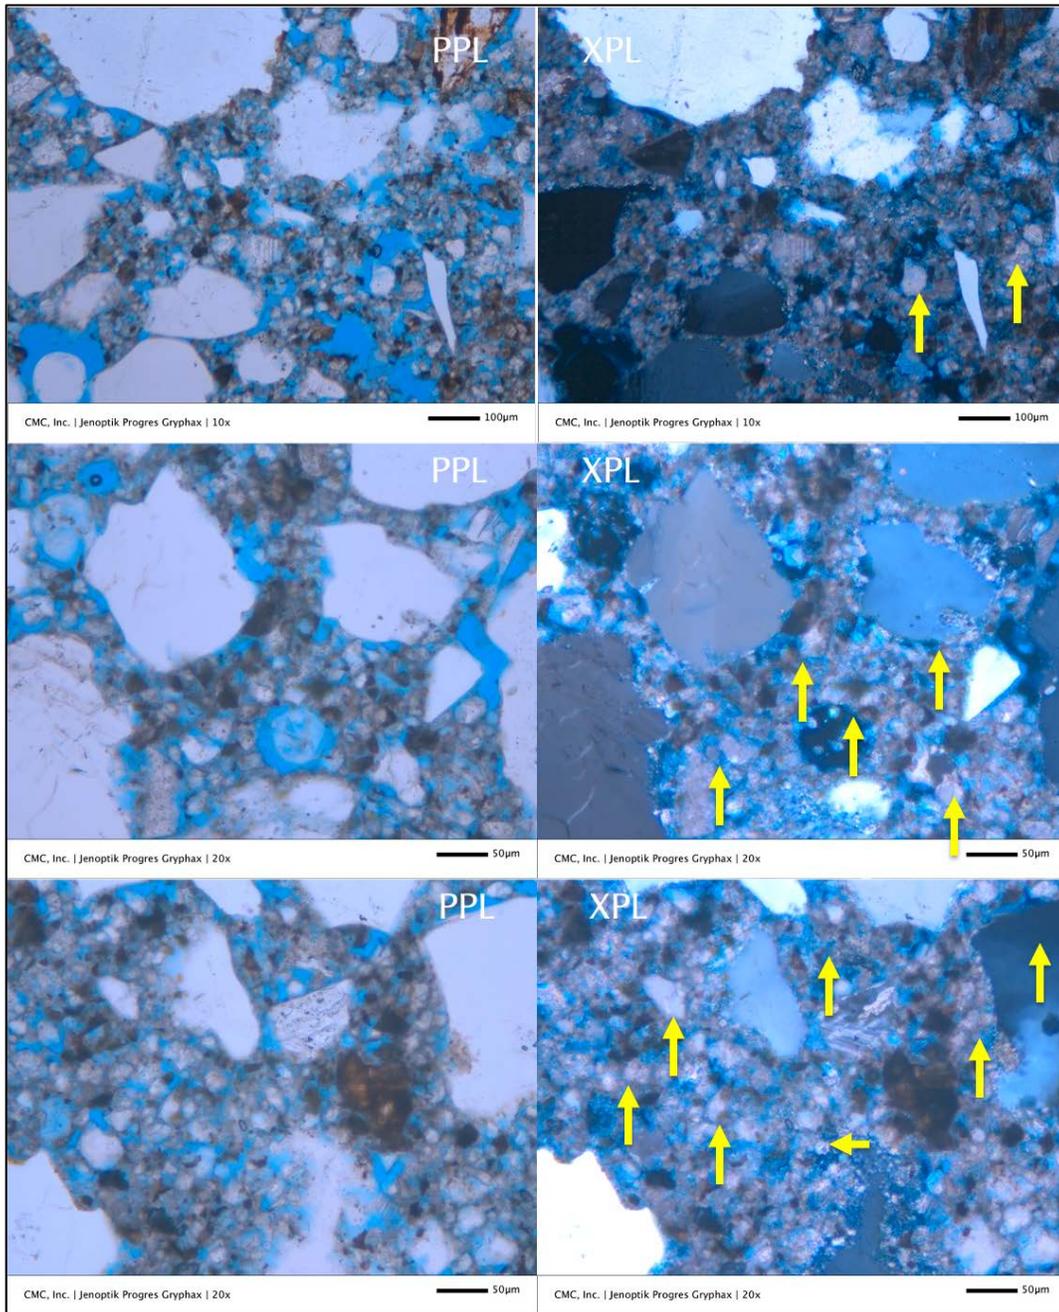
Figure 12: Optical micrographs of the original mortar (#2) from 1960s construction showing: (a) abundant void spaces between the sand and binder components in the matrix where many grains from finer fractions of sand and calcite fine particles from limestone fine component of the binder are not adequately coated to prevent moisture percolation through the mortar; these void spaces are highlighted by the blue epoxy that have filled all voids; (b) binder fraction in the interstitial matrix consisting of hydration products of Portland cement and a few residual and relic Portland cement particles consisting of dark ferrite remains, many hydrated lime remains of the binder mostly present as small clumps, and abundant calcite grains from limestone fine particles added as the main binder component of masonry cement used (many calcite grains are marked with arrows). The mortar shows an overall porous microstructure with characteristic carbonated nature of paste common in many masonry cement mortars, but not a clear air-void system that results in spherical air voids as seen in many masonry mortars. Notice remains of Portland cement particles are very few to detect except for a few dark brown ferrite remains of cement, indicating use of more limestone fines than cement in the original binder (proportions of binder components are similar to an ASTM C 270 Type N masonry cement mortar).

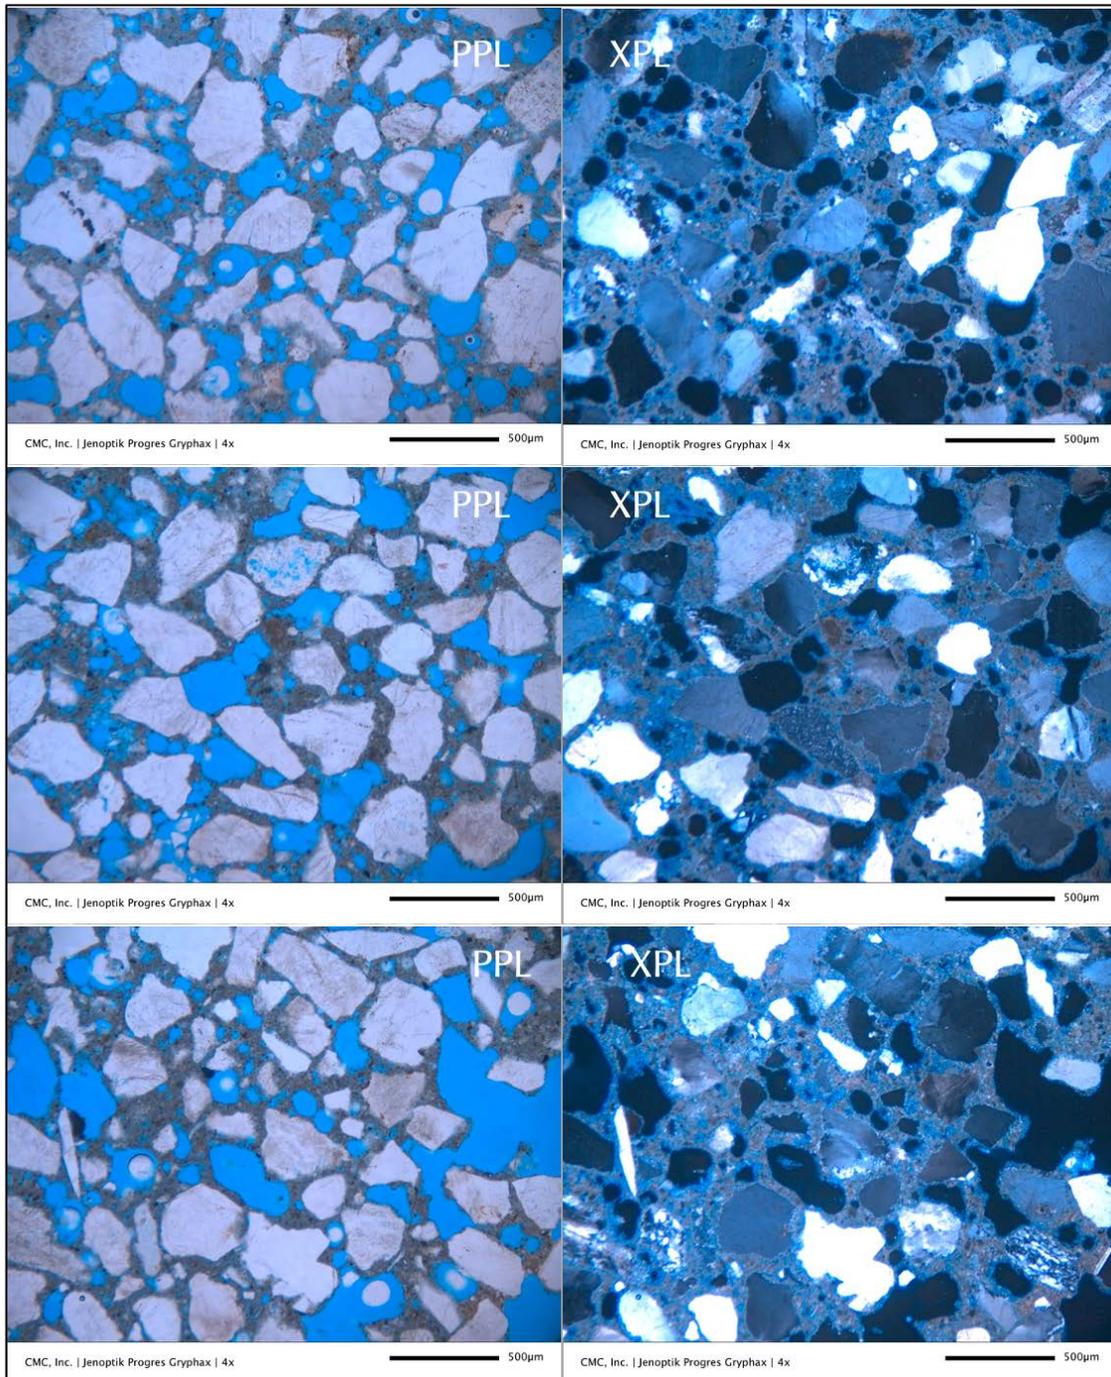
Figure 13: Optical micrographs of the original mortar (#3) from 1960s construction showing: (a) crushed silica sand consisting of major amount of variably strained quartz, and minor amount of quartzite, feldspar, and other siliceous particles (no carbonate components were found in the sand); (b) overall carbonated nature of the interstitial matrix between sand particles, which is a characteristic microstructure of many masonry cement mortars; and also (c) abundant fine, discrete, spherical and near-spherical entrained air voids (highlighted by blue epoxy), which is also common in many masonry cement mortars. The mortar appears to be excessively air-entrained and has too many air bubbles, which is detrimental to development of a good bond to adjacent masonry units. This mortar also appeared to be a masonry cement mortar as the original one (#2) but has abundant air entrainment and minor to trace amounts of limestone fines in the binder and major amount of hydrated lime contrary to lack of a good air entrainment, and abundant limestone fines found in the masonry mortar #2.
